Recommendations from Imtac on public realm proposals for the Clifton Gateway in Belfast

(November 2018)

About this report

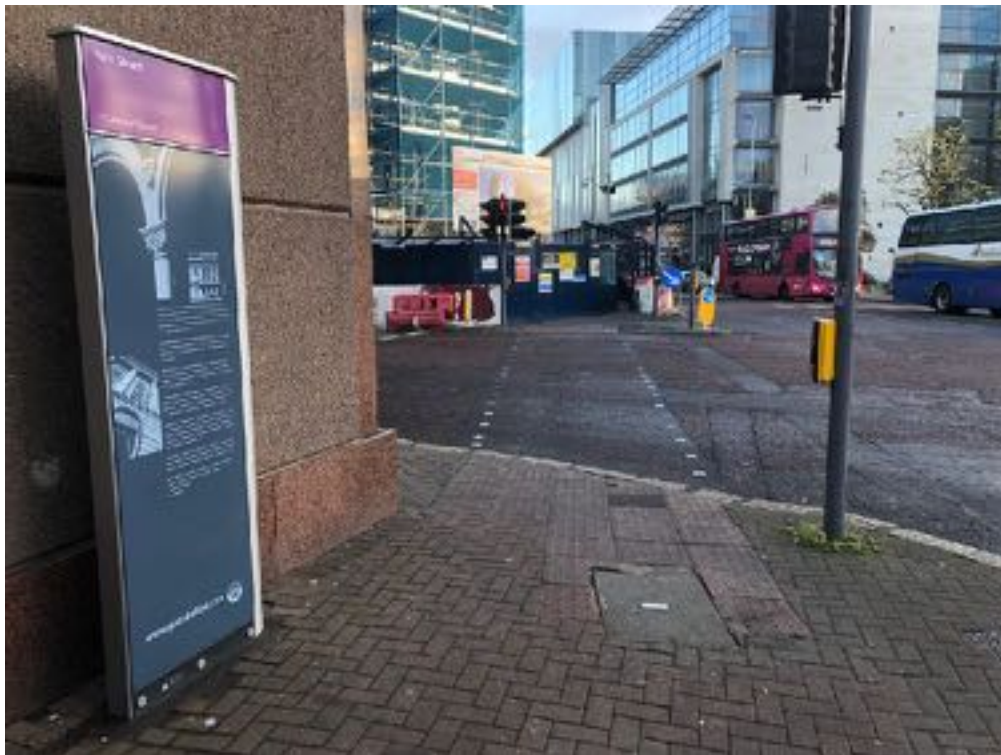
There is a controlled crossing across Donegall Street at its junction with Royal Avenue. The contrast between tactile paving and surrounding paving is poor.

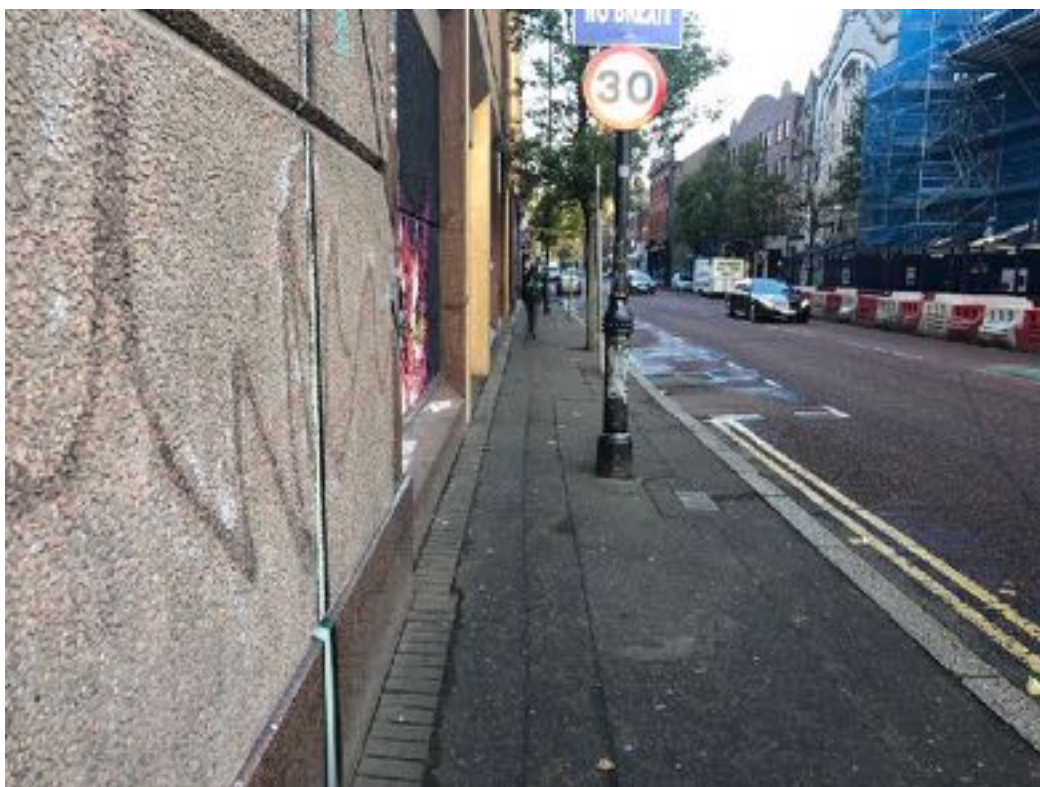
The location of street lighting columns in the middle of the footway on the western footway create an obvious obstruction to the already narrow west side footway.

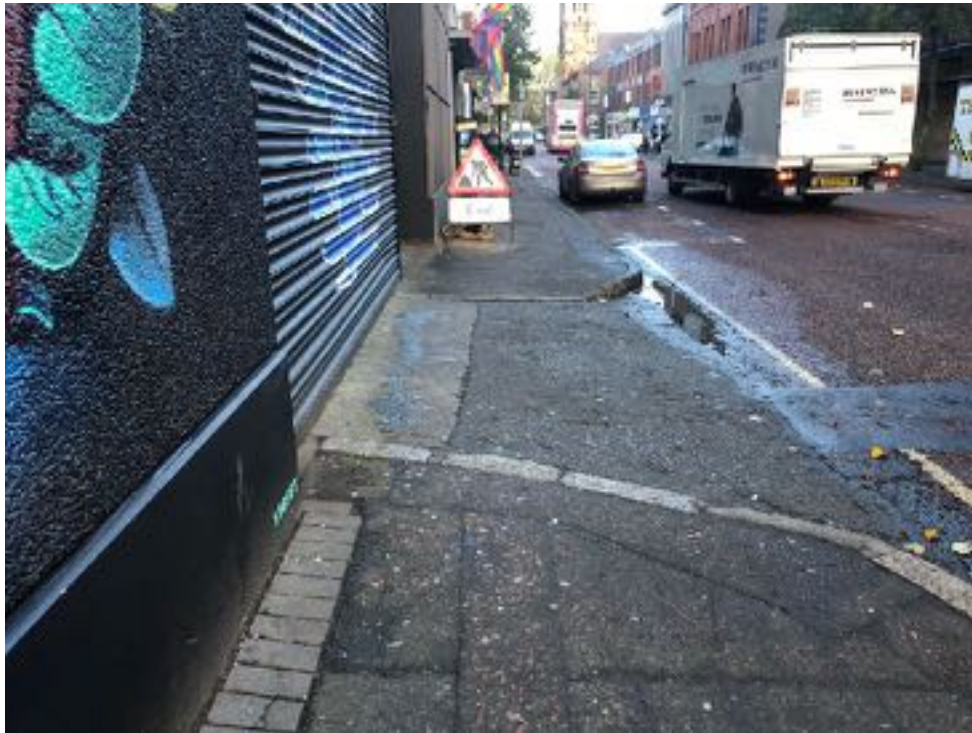
A vehicle entrance to the Telegraph Building results in a section of raised kerb along the footway. A road works sign obstructs the footway shortly after this point.

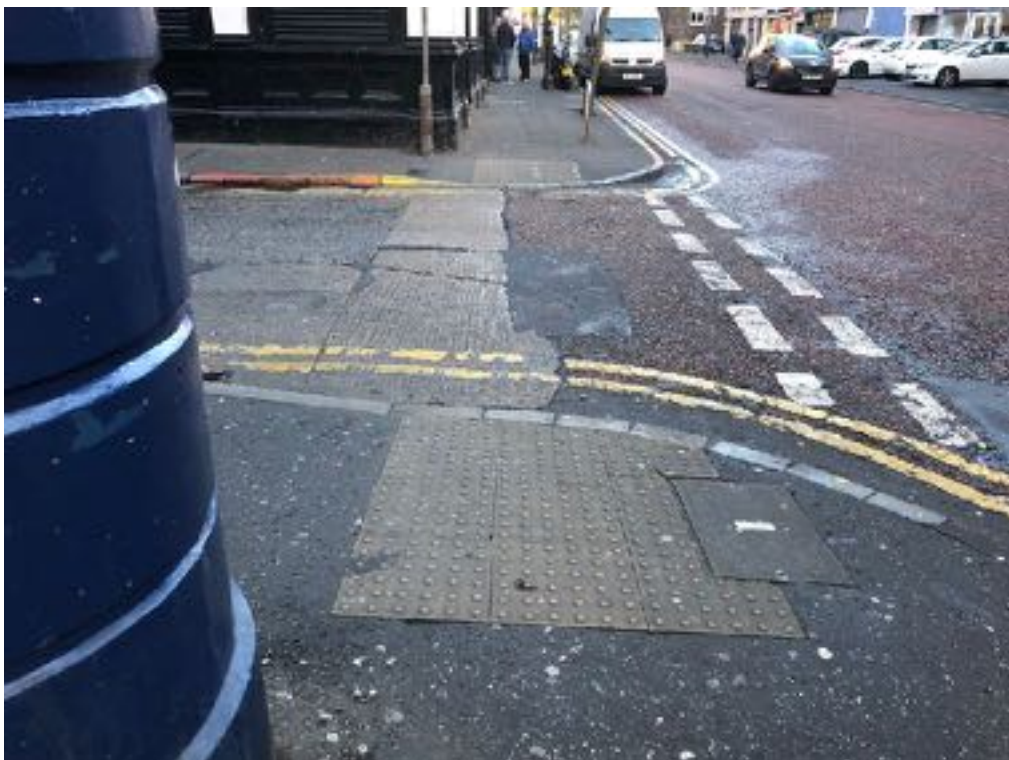
There is an uncontrolled crossing across the junction with Union Street. Whilst in-line and using the correct tactile paving the carriageway surface is in poor condition creating a potential hazard.

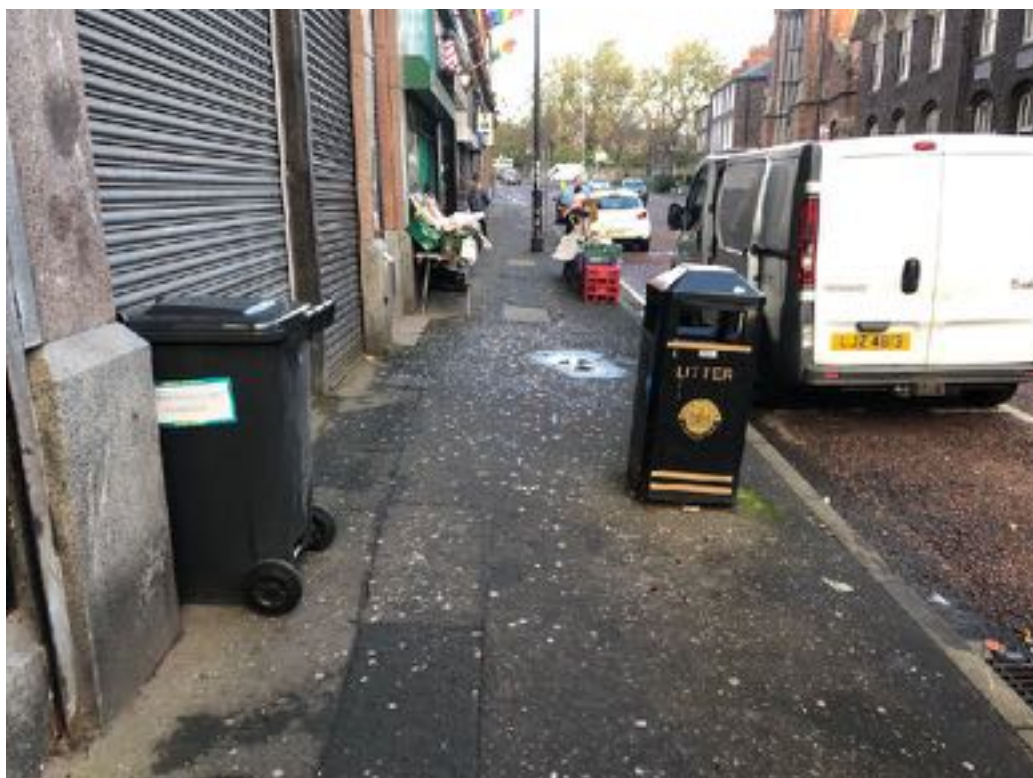
Shop displays on the footway and the location of street lighting columns create potential hazards approaching the junction with Carrick Hill.

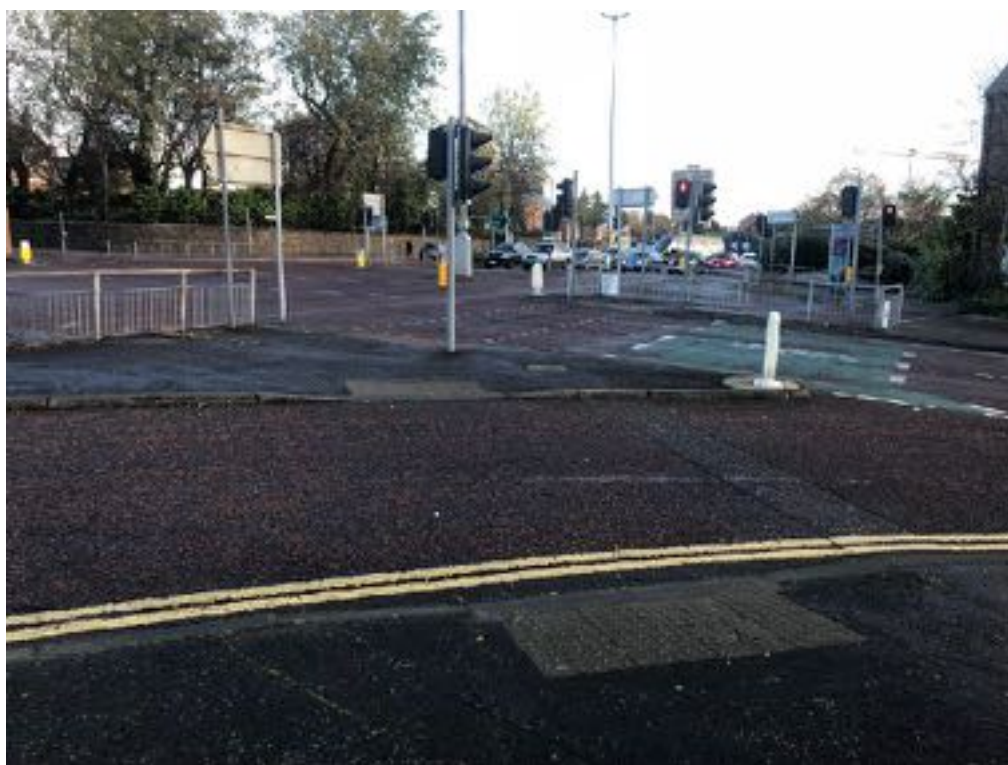
There is a staggered pedestrian crossing with central traffic island across Donegall Street at its junction with Carrick Hill. An uncontrolled rather than a controlled crossing provides access from the western footway to a traffic island. This is likely to create difficulties for some people with a visual impairment. The depth of tactile paving and location of control boxes are issues.

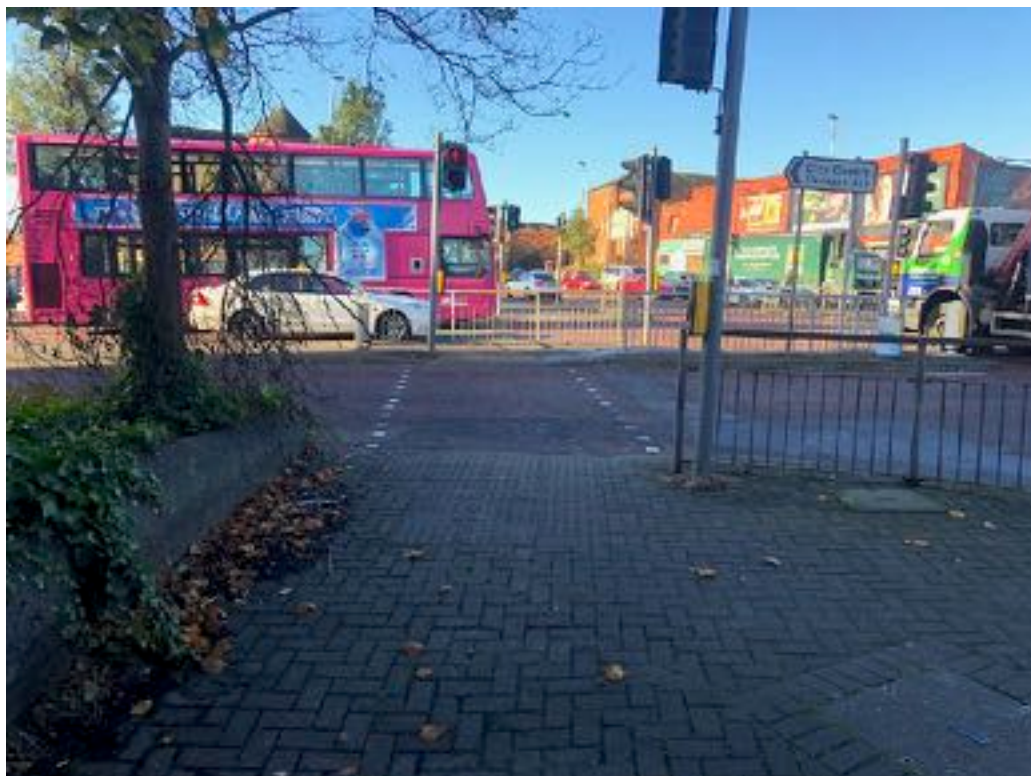
The tactile paving on the eastern footway does not contrast with the surrounding paving on the controlled crossing across Donegall Street on the eastern footway.

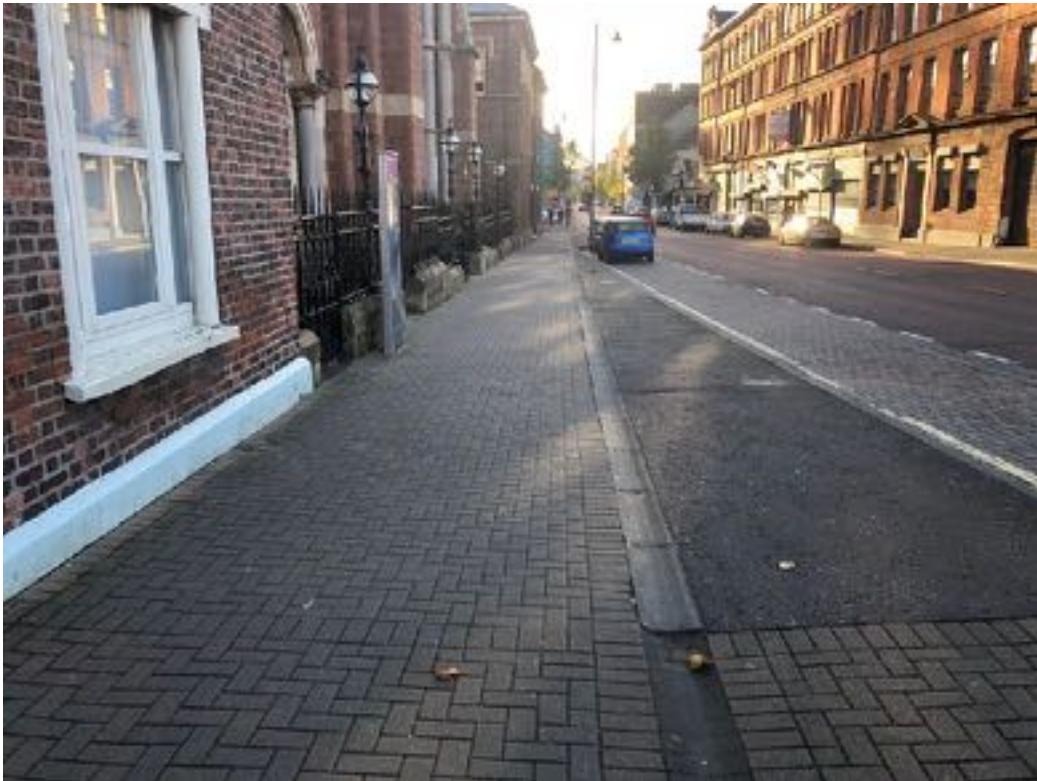
The footway broadens at the front of St Patrick's Church, however a deep dish drainage channel runs the length of this section creating a potential hazard.

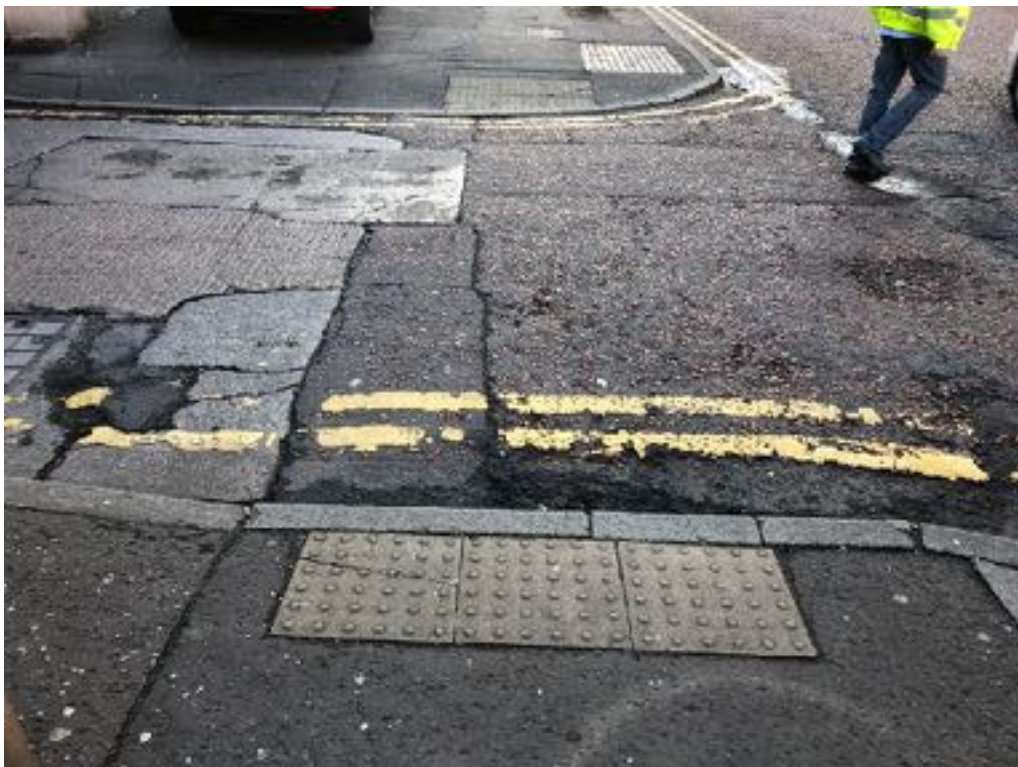
There is an uncontrolled crossing at the junction with Donegall Lane. The tactile paving on the does not meet design requirements in terms of depth. There is a significant section of this junction where the kerb is flush with the carriageway without tactile paving.

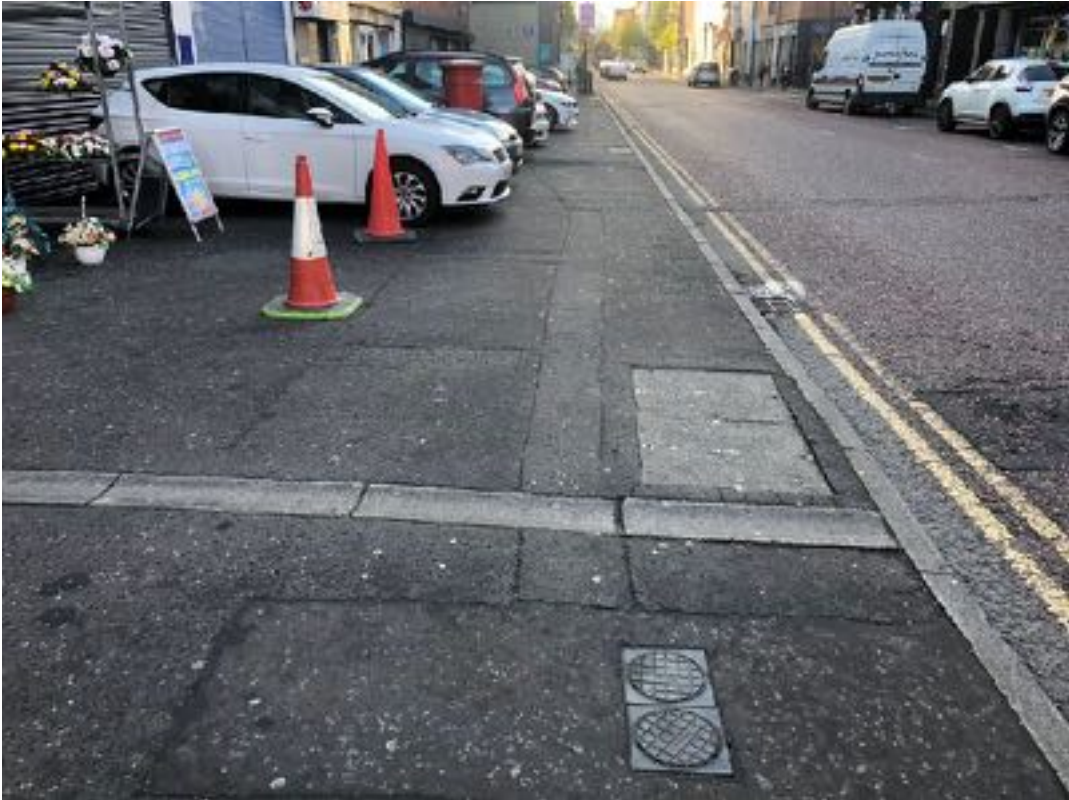
Cars are parked on the footway in front of buildings to the south of this junction. This parking reduces footway widths significantly in parts.

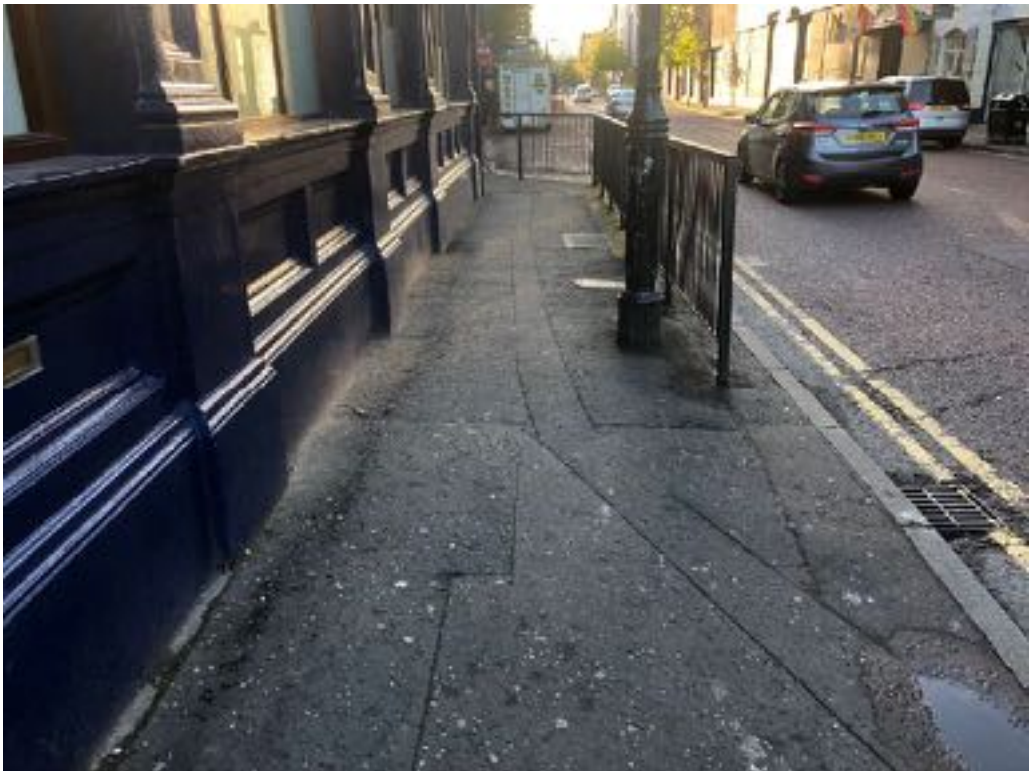
The eastern footway narrows considerably outside the Irish News offices. Railings create further narrowing as the footway turns sharply round the corner of the building.

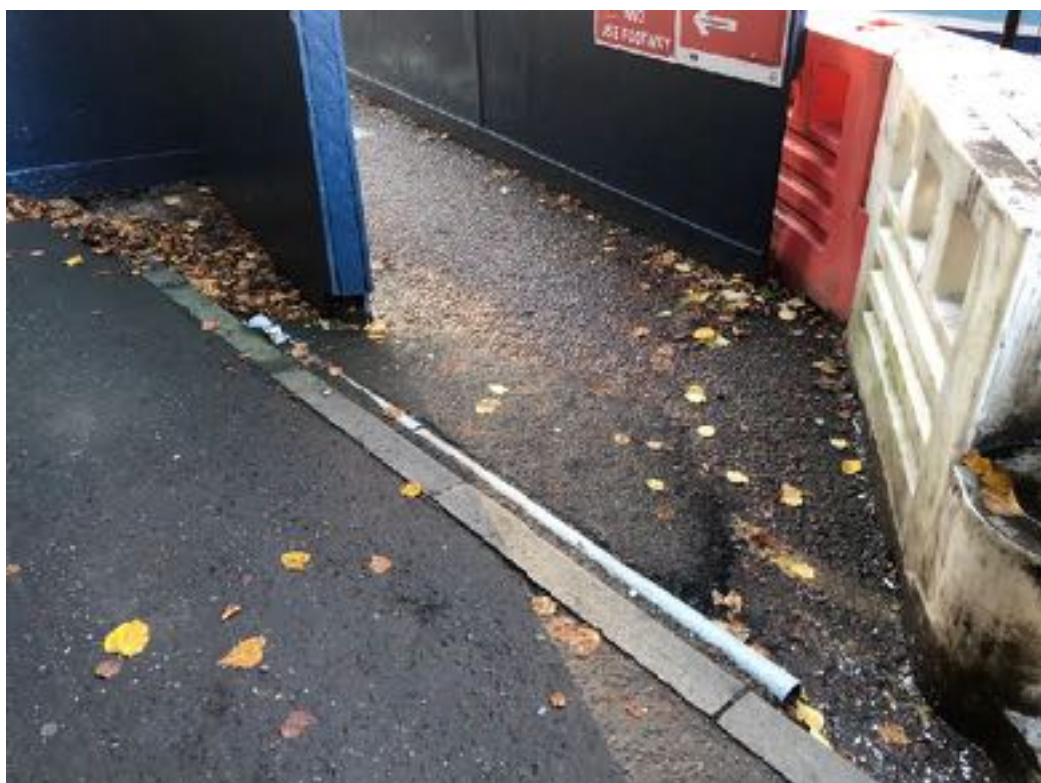
Ramped access to the temporary footway associated with the redevelopment of the University of Ulster has been provided. The design and condition of the ramp is poor and will be a hazard to some disabled people.

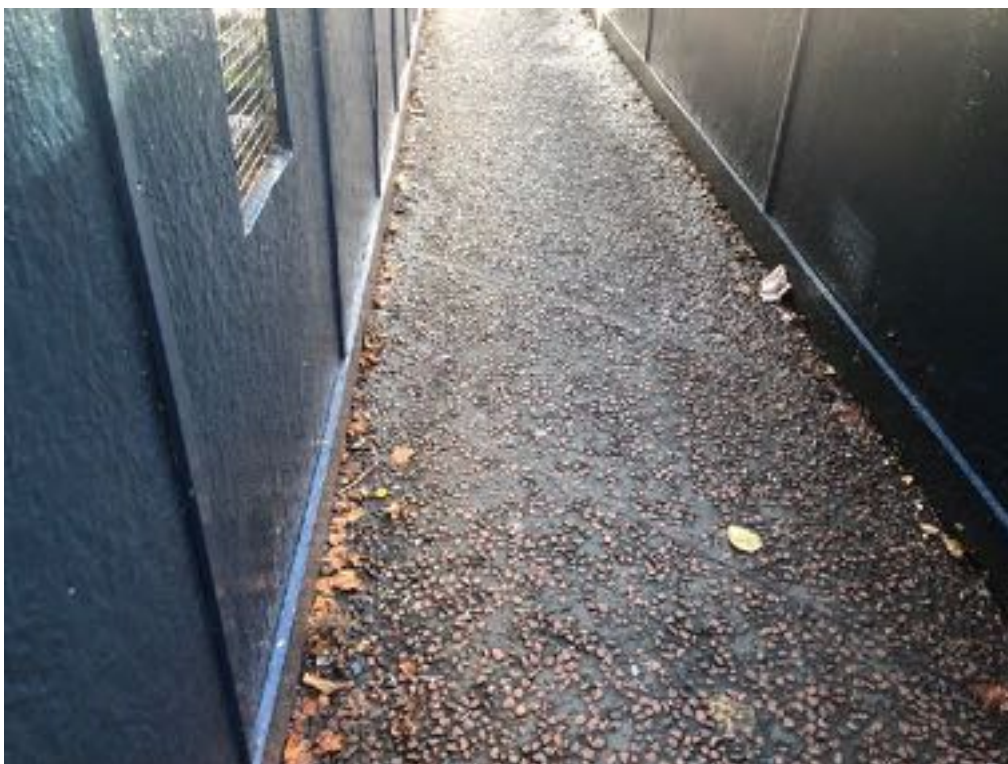
The temporary route is narrow and is poorly maintained with broken glass a problem.

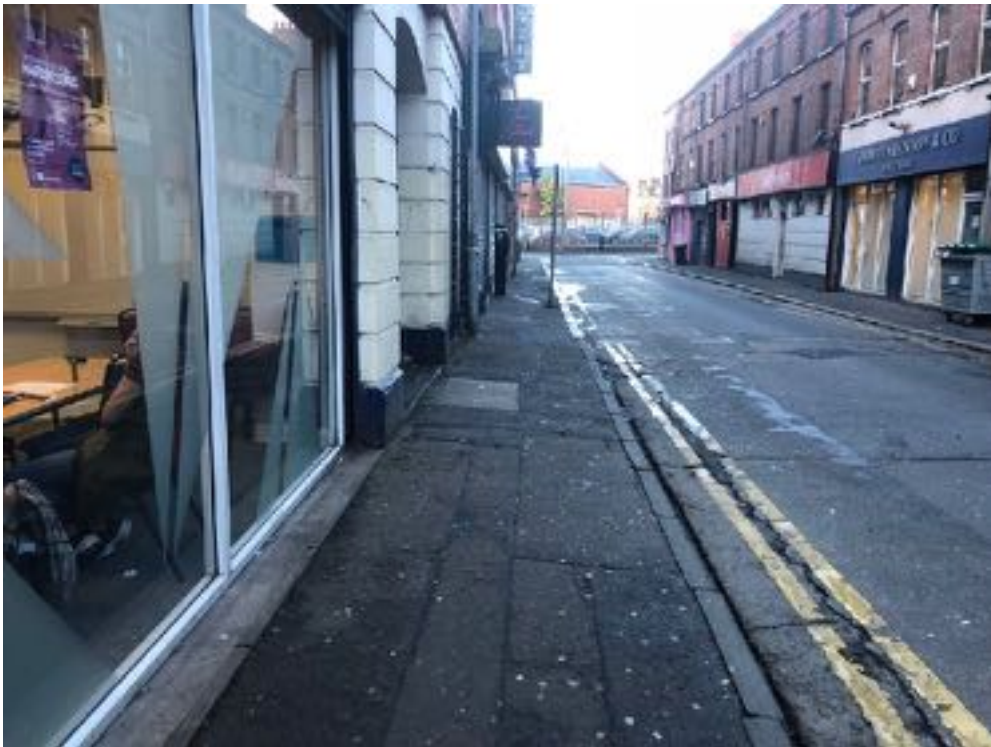
The southern footway on Union Street is narrow and in poor condition.

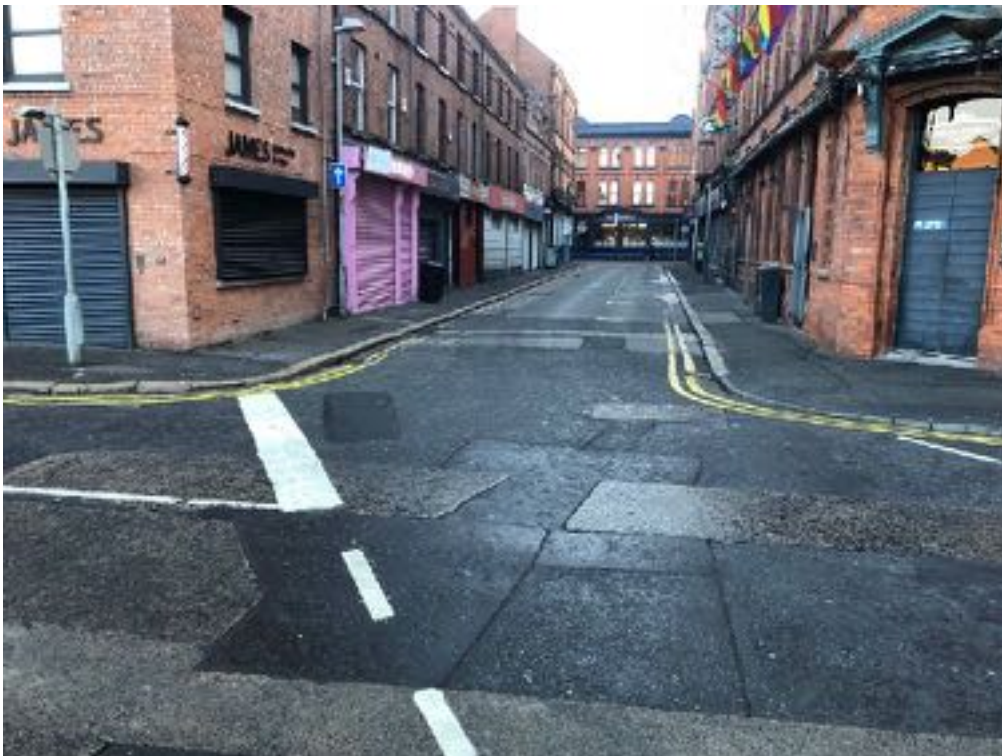
There is no safe and accessible opportunity to cross Union Street at its junction with Little Donegall Street.

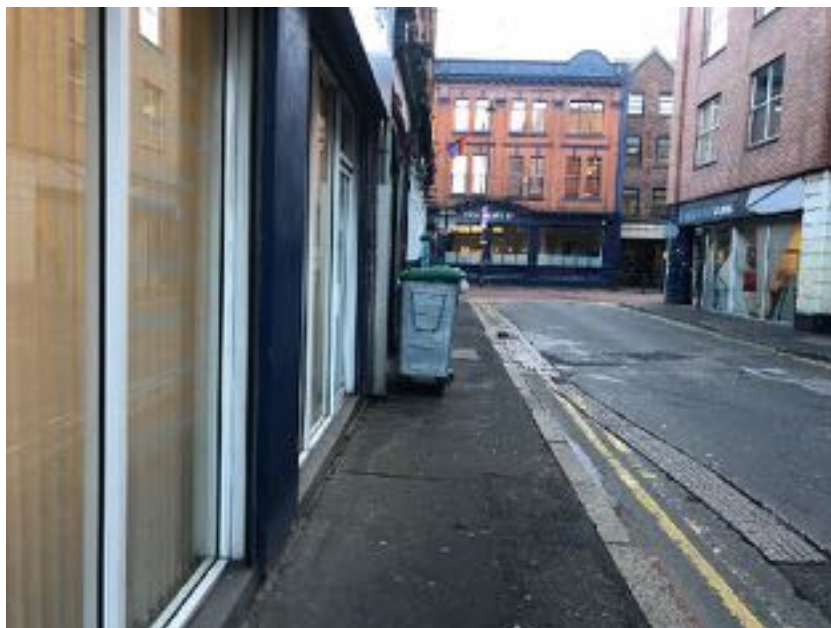
The northern footway on Union Street is narrow and in poor condition with large bins further reducing footway width.

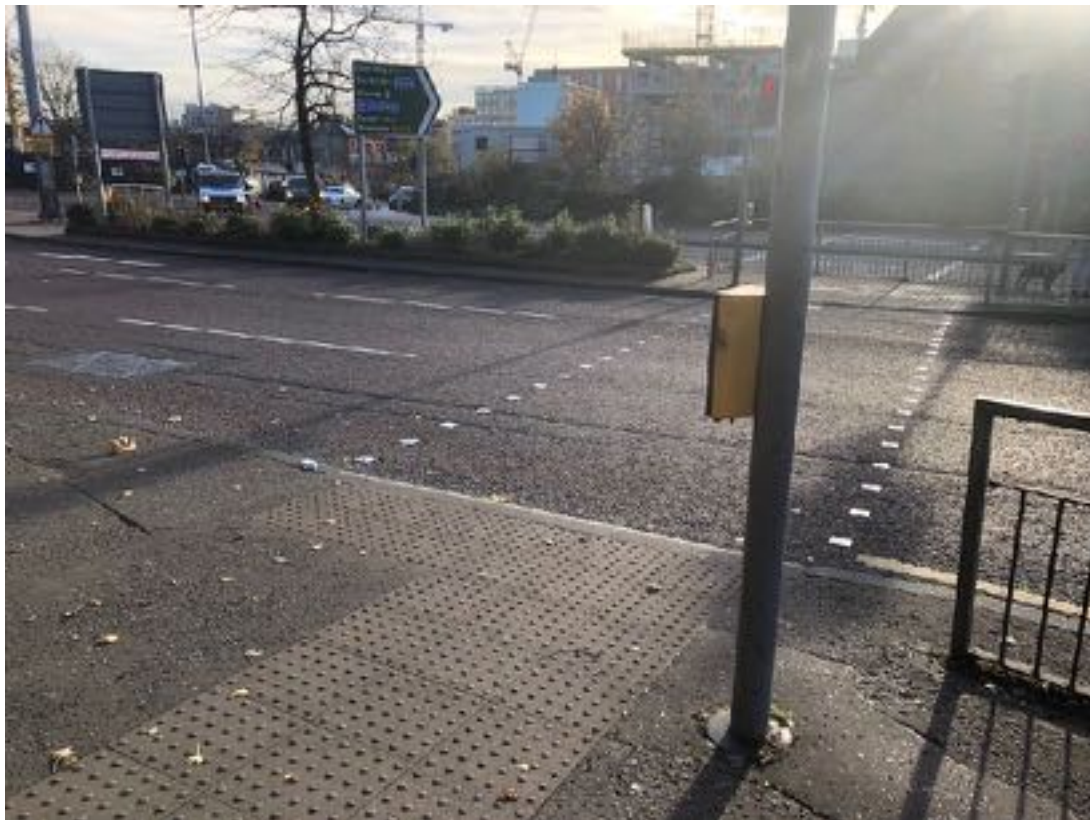
The controls boxes on the traffic island associated with the controlled crossing on the northern footway of Carrick Hill are incorrectly positioned.

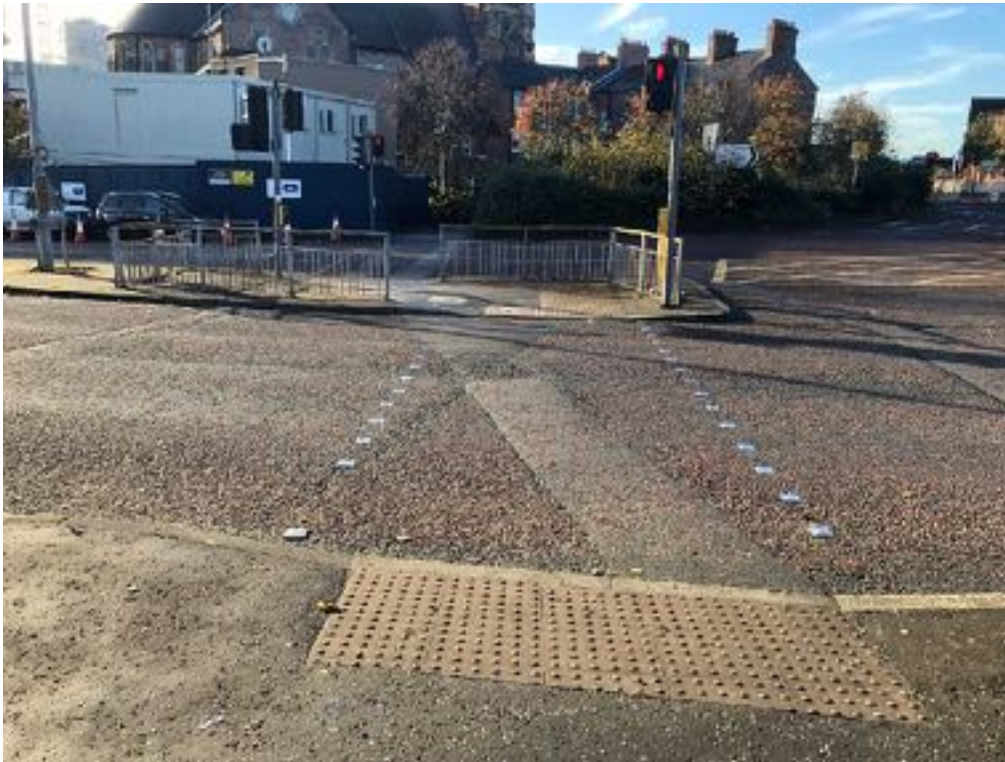
A staggered controlled crossing has been provided where Carrick Hill meets Frederick Street. Tails have been provided with the tactile on the traffic island which is not standard.

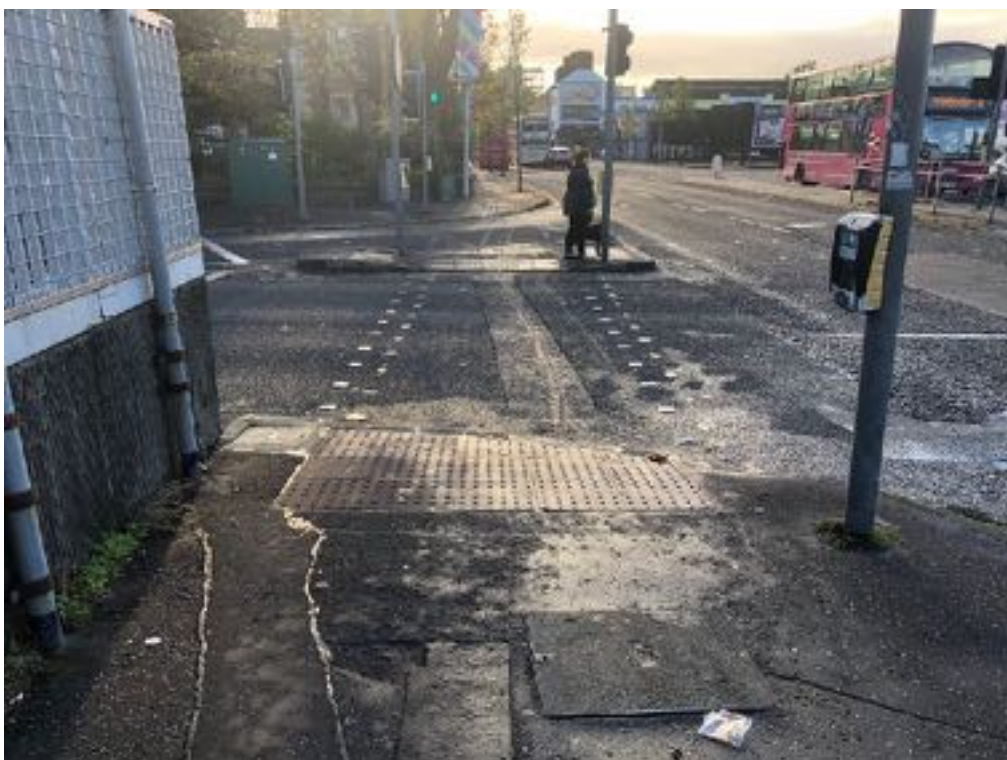
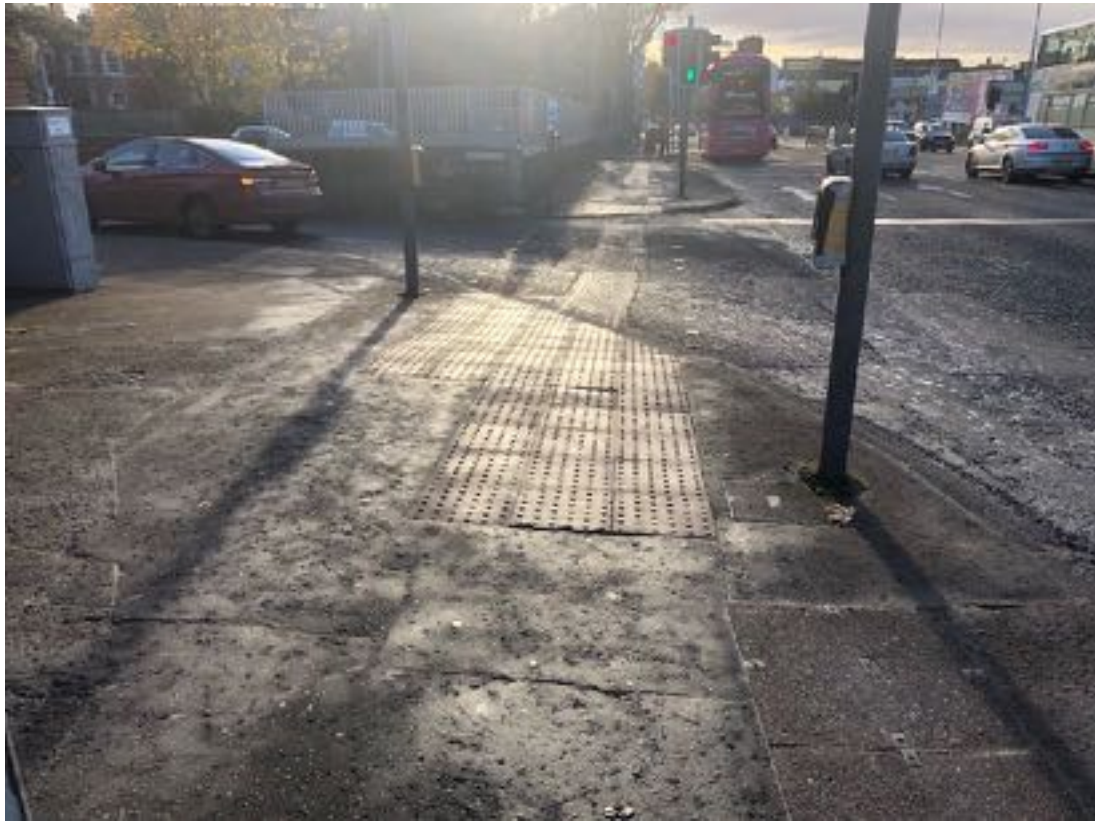
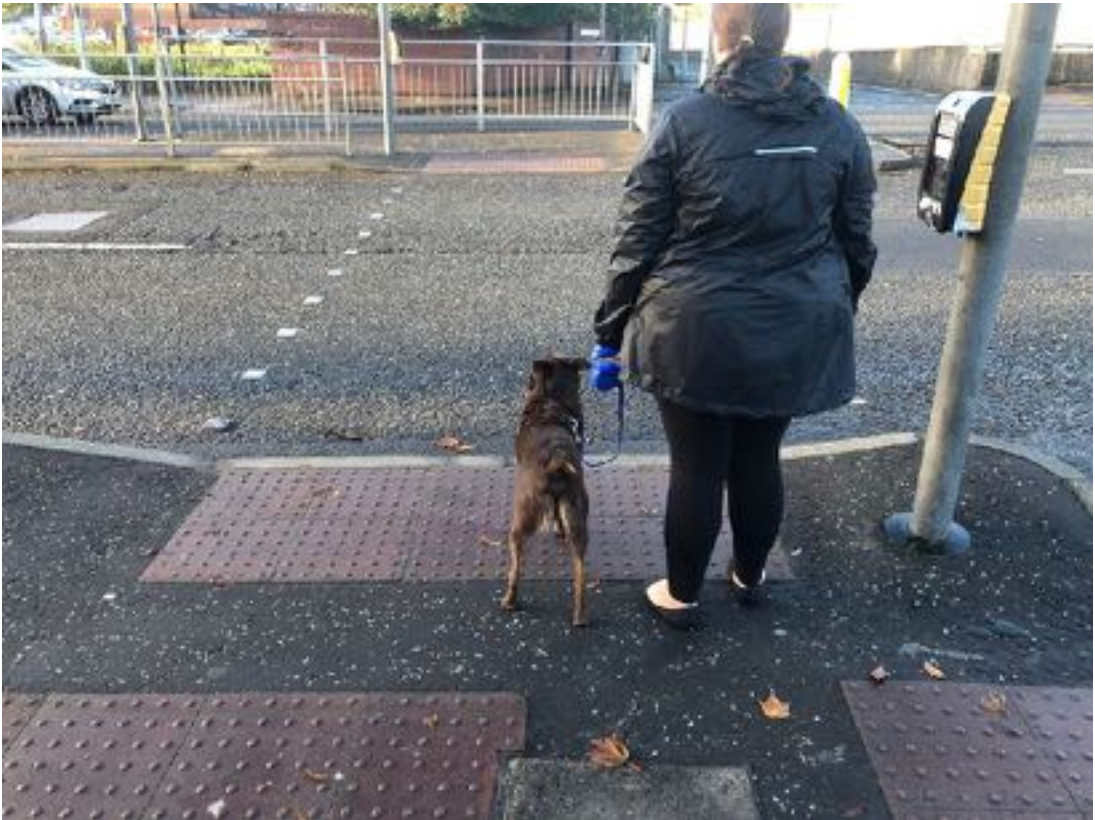
There are controlled crossings on the eastern footway of Clifton Street at its junction with the Westlink slip-on and slip off and a staggered controlled crossing across Clifton Street. The positioning of tactile paving and control boxes makes these junctions difficult to navigate for some disabled people.

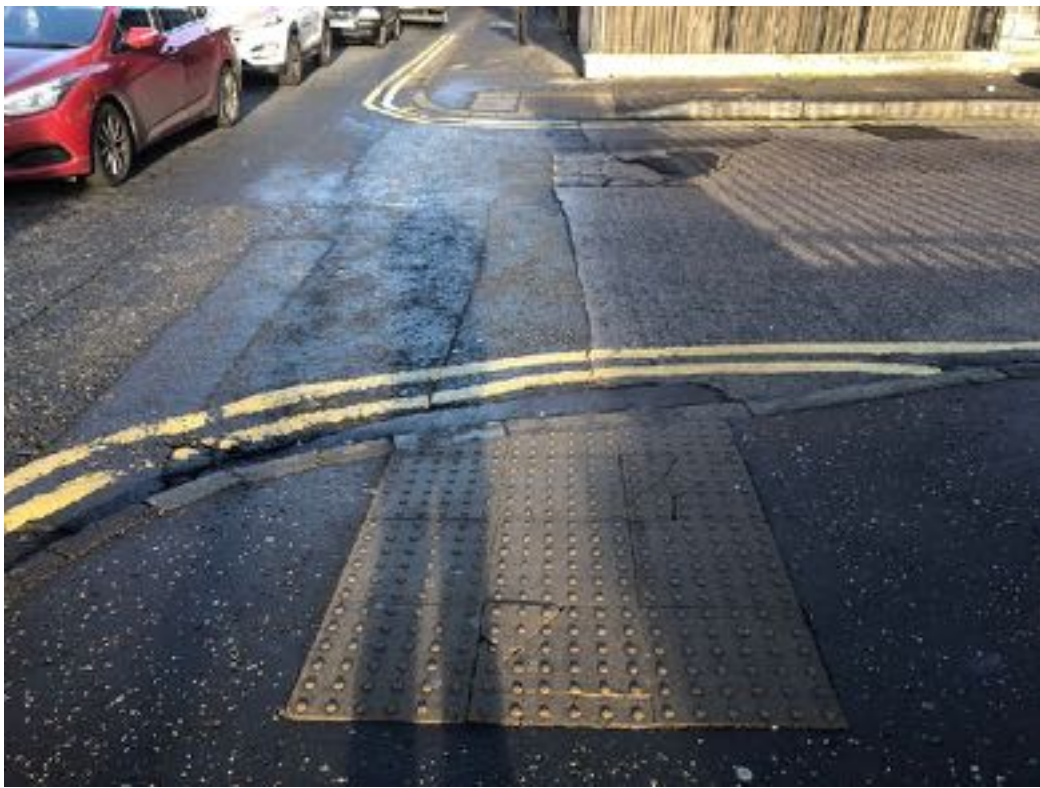
There is a in-line uncontrolled crossing across Clifton Street at its junction with Henry Place. The section of this crossing beside the doctors surgery has a substantial section of dropped kerb around the radius of the corner without tactile paving.

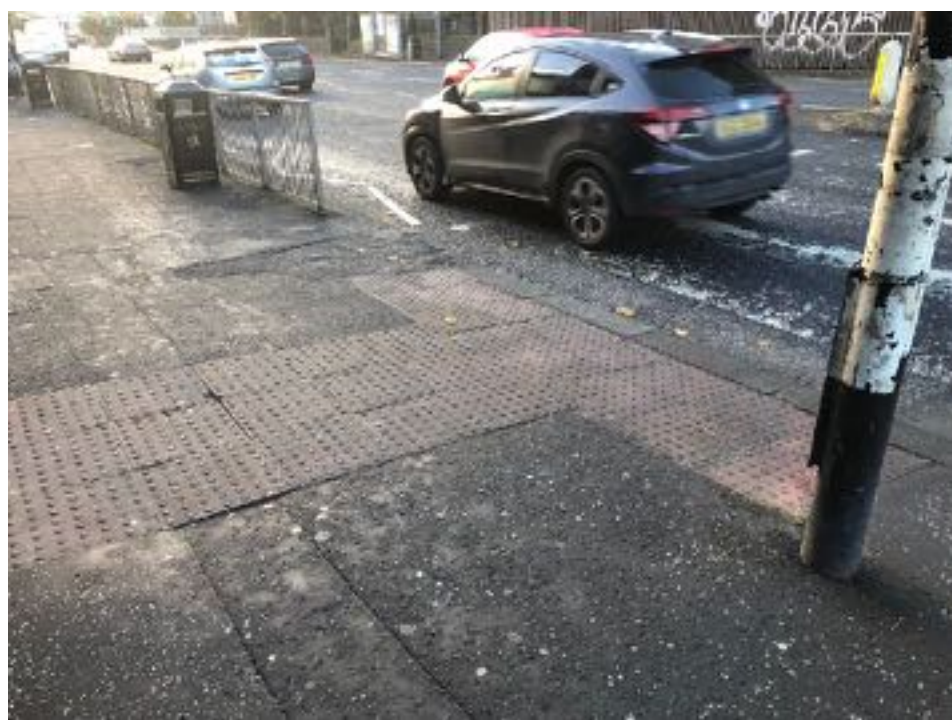
There is a Zebra crossing across Clifton Street close to Carlisle Circus. The tactile paving has been laid incorrectly on the eastern side and the footway condition is poor.

- Zebra crossings currently used in and around Carlisle Circus should be replaced with Puffin crossings.
- An additional control crossing should be considered close to the Crumlin Road Jail/Courthouse.

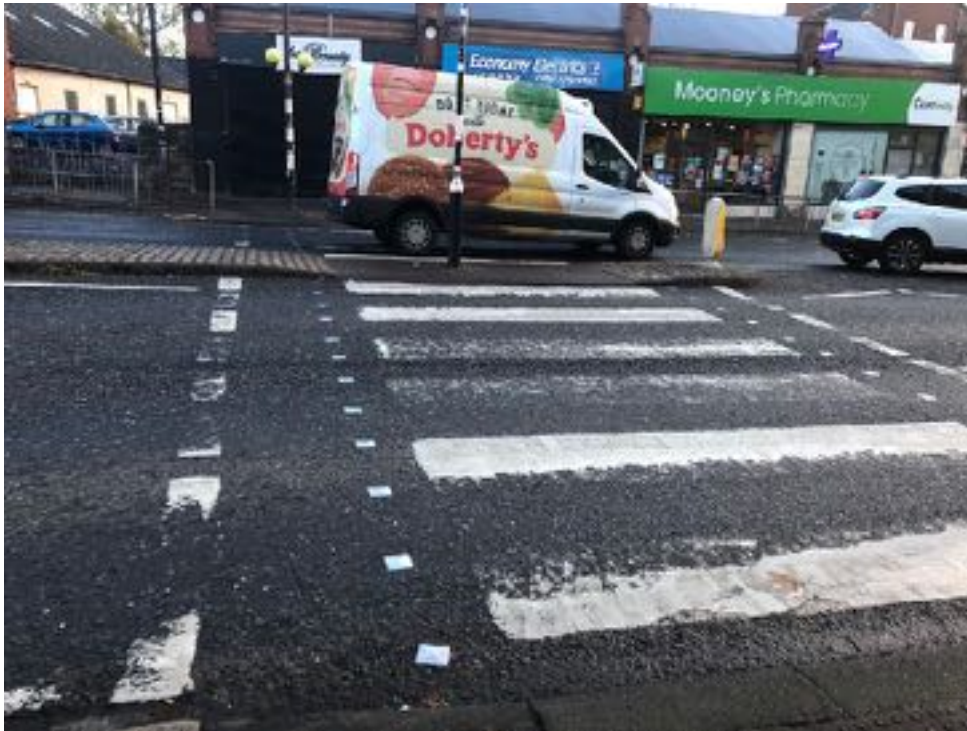
The Zebra crossing has a central refuge with tactile paving and the beacon located centrally, creating a hazard. The tactile paving on the western side has also been laid incorrectly.

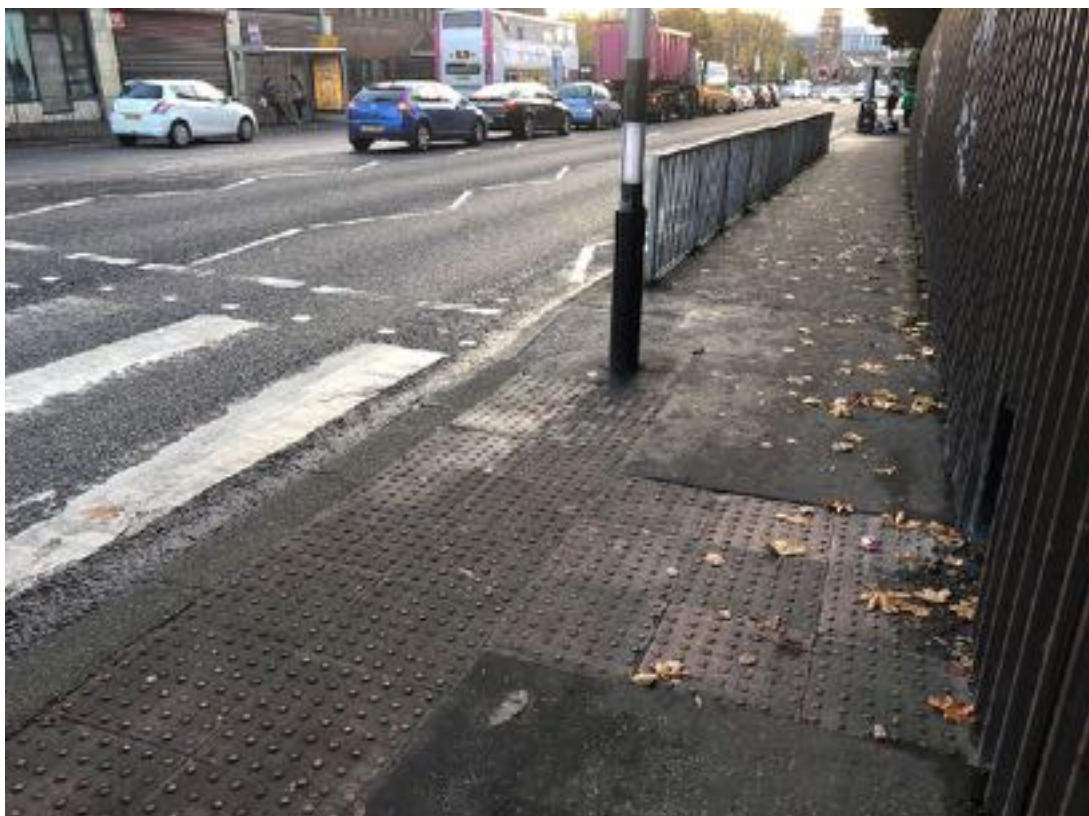
The footway on the western side is narrowed by the pedestrian guardrail and the security screening around a building. Its surface is rough and uneven.

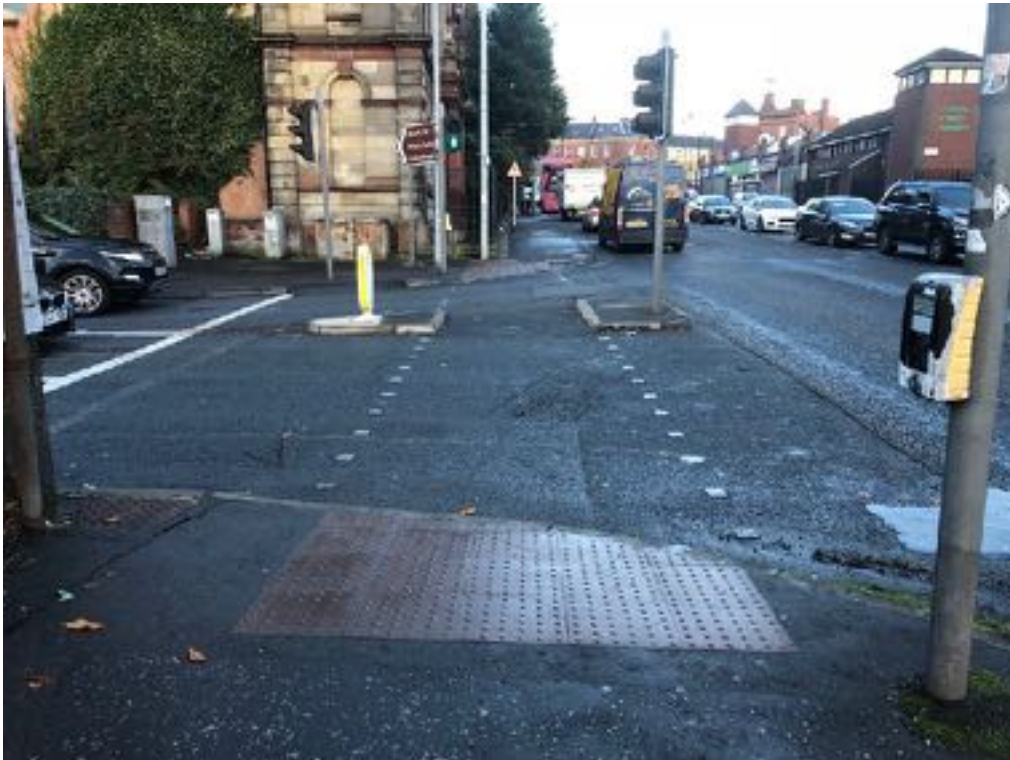
On the west side there is a controlled crossing across the exit from the Westlink onto Clifton Street. The control box at city centre side of the crossing is not beside the tactile paving.

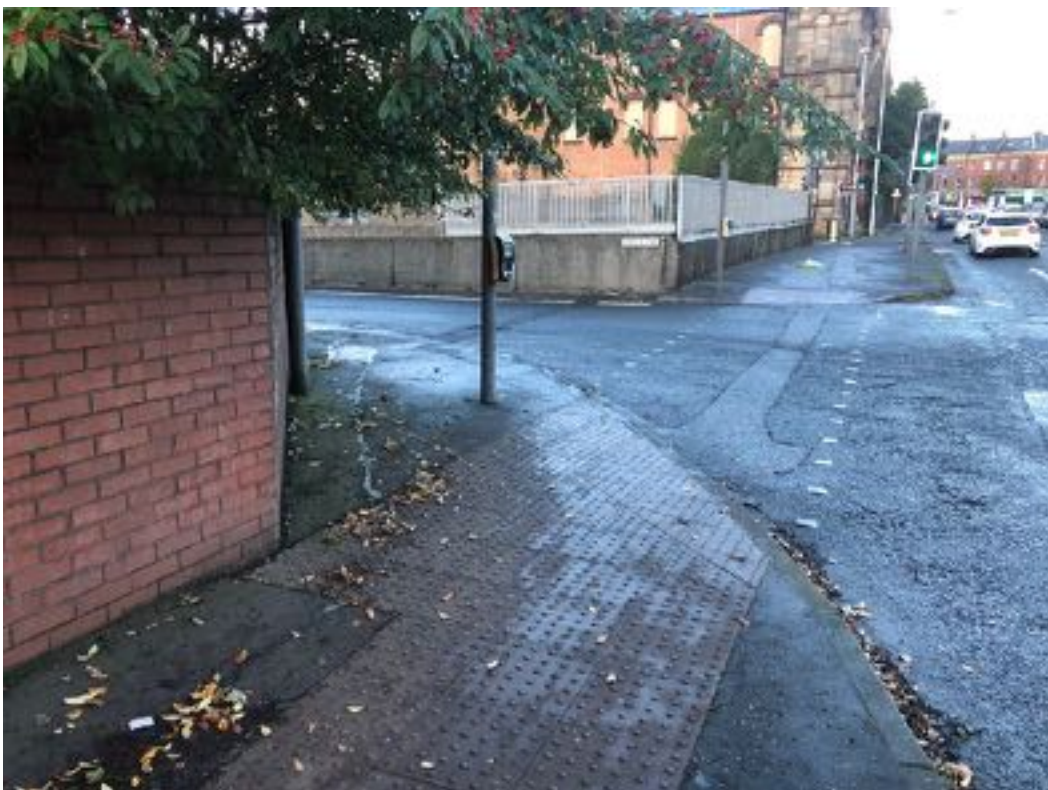
There is a further controlled crossing on the west side across the Westlink westbound on-slip. The positioning of the control box is an issue on the city centre side of the crossing.
