Recommendations from Imtac on public realm proposals for the Clifton Gateway in Belfast

(November 2018)

About this report

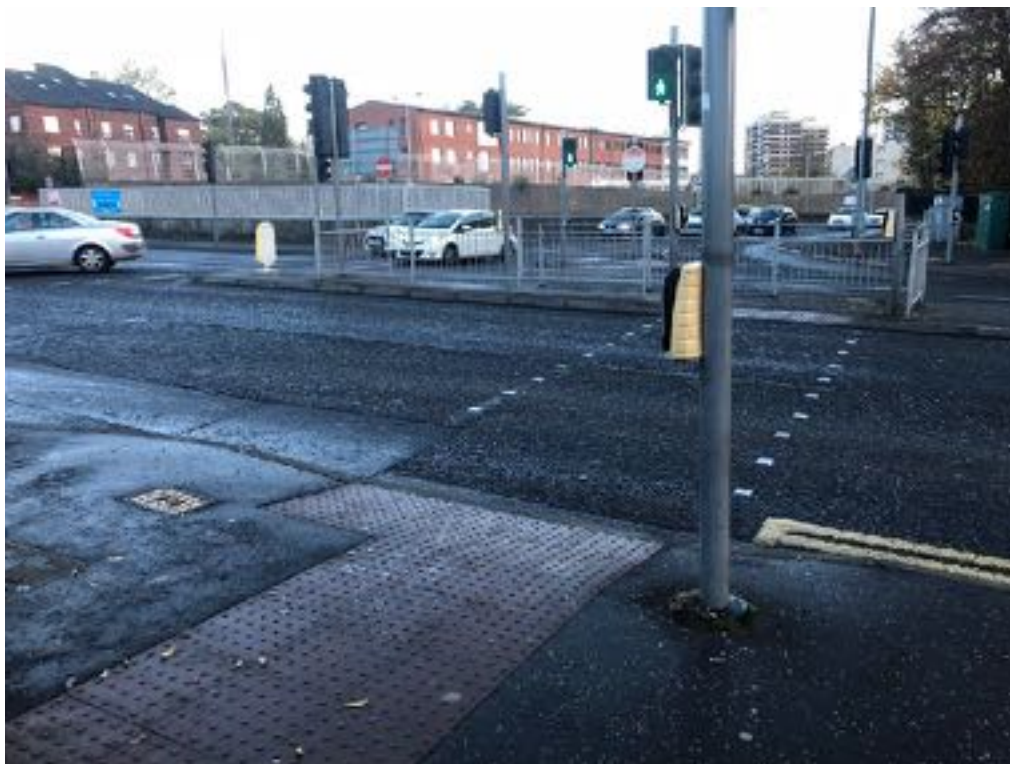
There is a staggered controlled crossing with traffic island across Clifton Street at this point. The incorrect positioning of the control boxes and the single tile depth of tactile paving on the island is problematic.

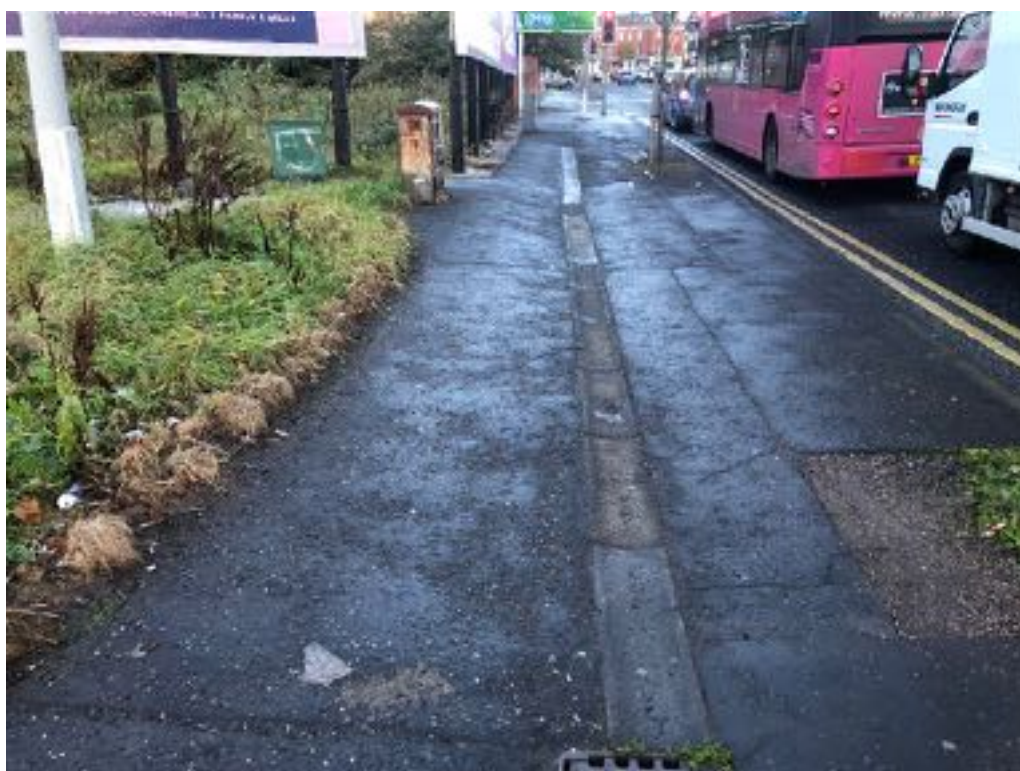
Although broad the footway on the eastern side between the eastbound on-slip and Stanhope Street after this point is rough and uneven. A large dish drainage channel runs down its centre.

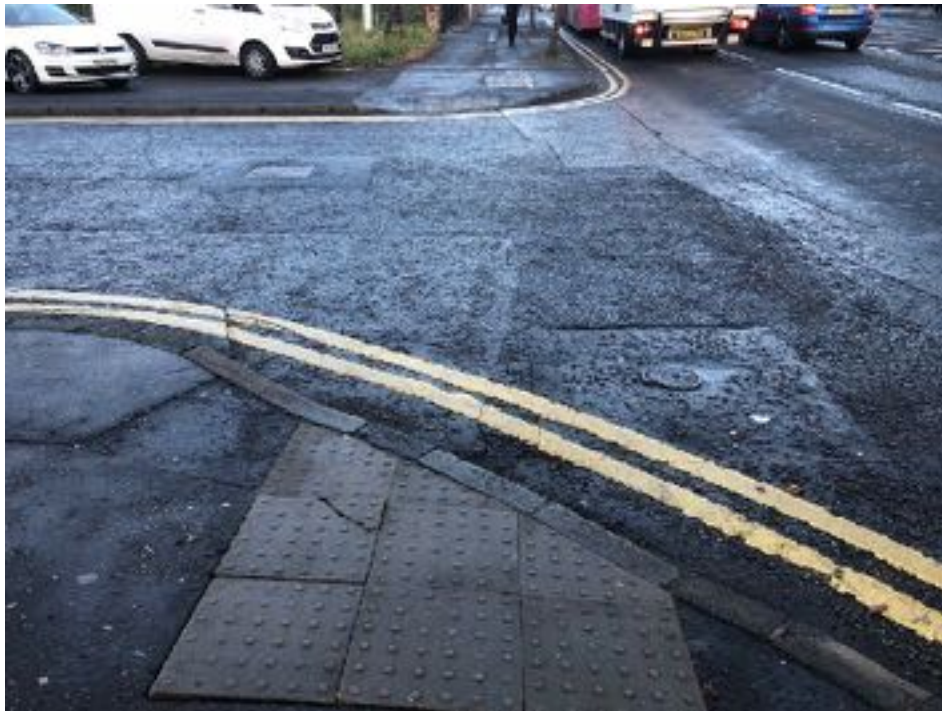
There is an in-line uncontrolled crossing across the junction with Stanhope Street. Tactile paving depth has been reduced in sections due the radius of the kerb at the junction.

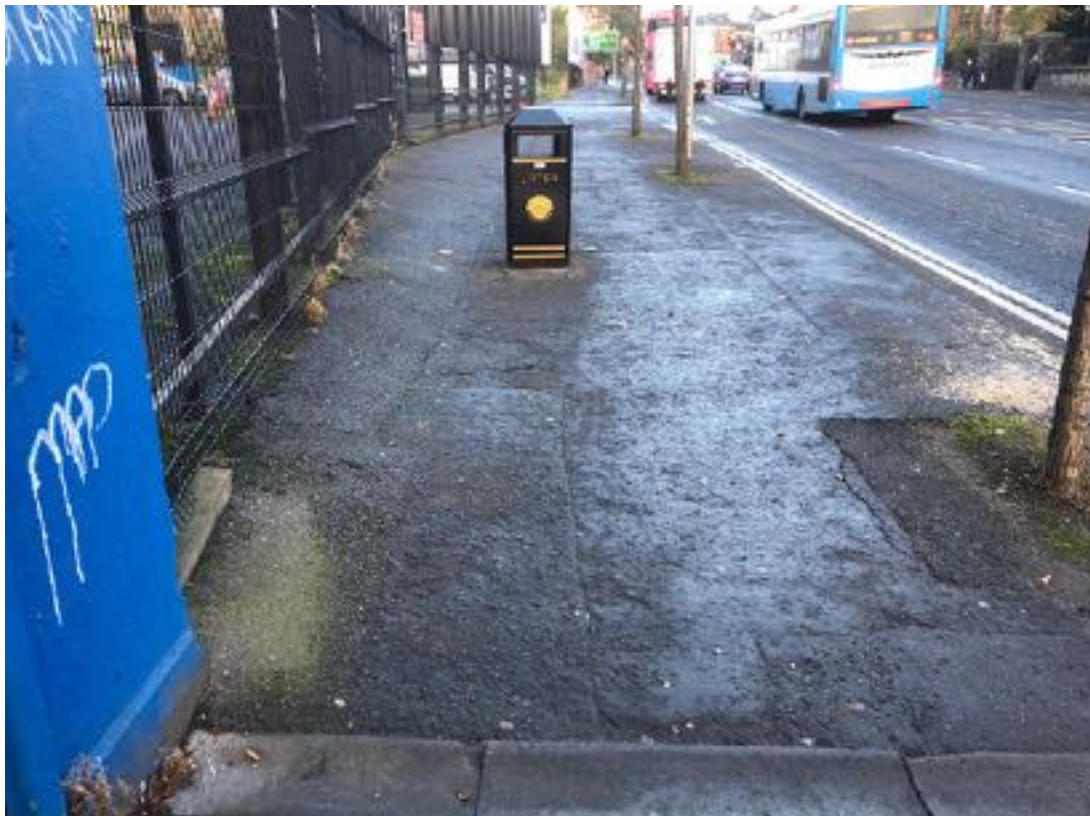
A bin has been placed in the centre of the eastern footway, creating an obvious hazard. A deep transverse dish drainage channel is also a hazard.

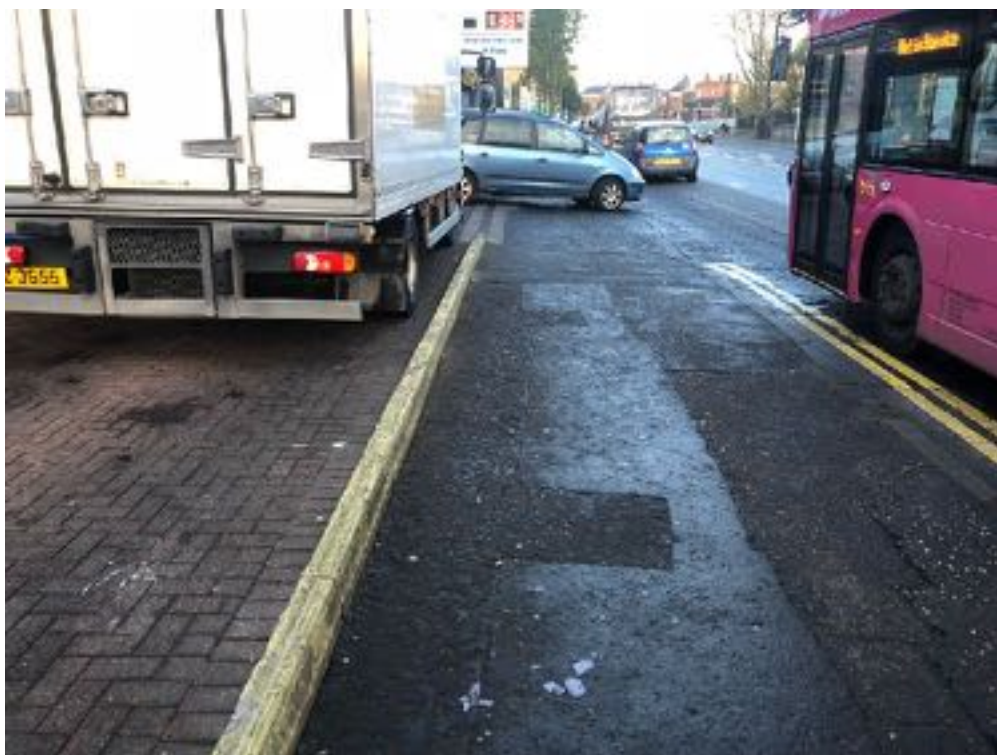
No tactile paving to warn pedestrians with a visual impairment has been provided at the vehicle exit to the garage on Clifton Street.

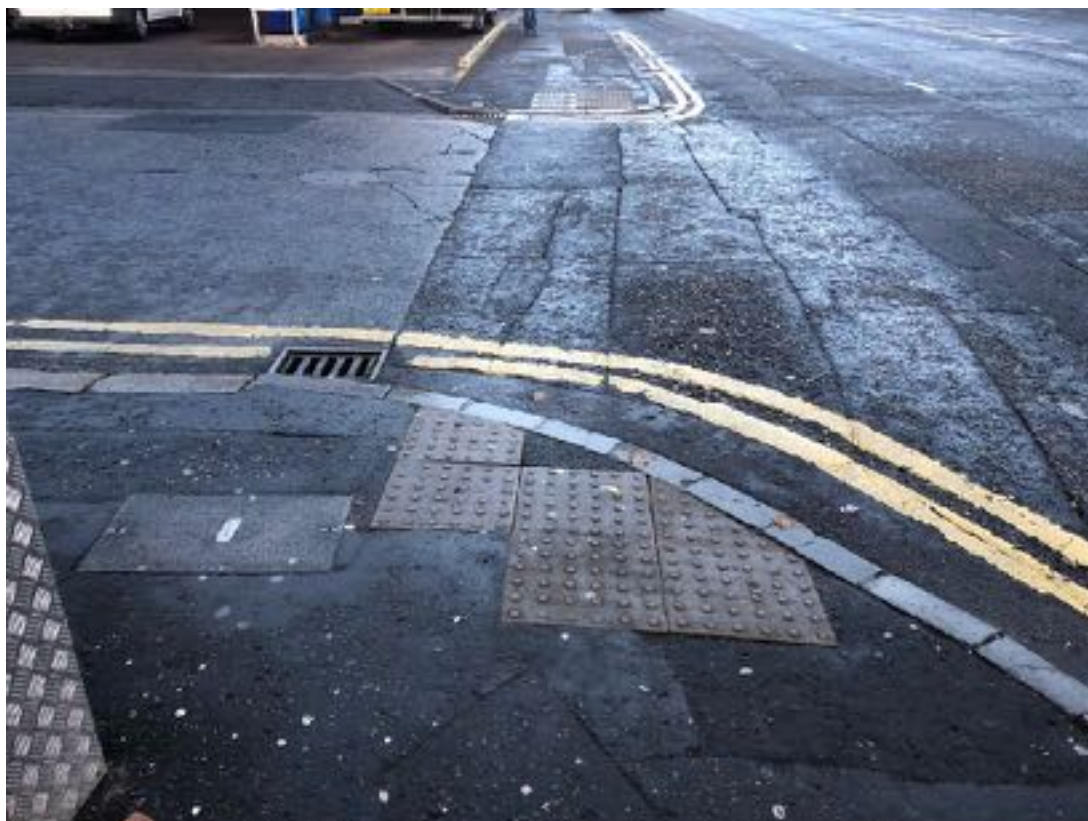
There is an in-line uncontrolled crossing at the junction with Trinity Street. Tactile paving has been poorly laid and lacks the appropriate depth and width particularly on the city centre side partly due to the radius of the kerb.

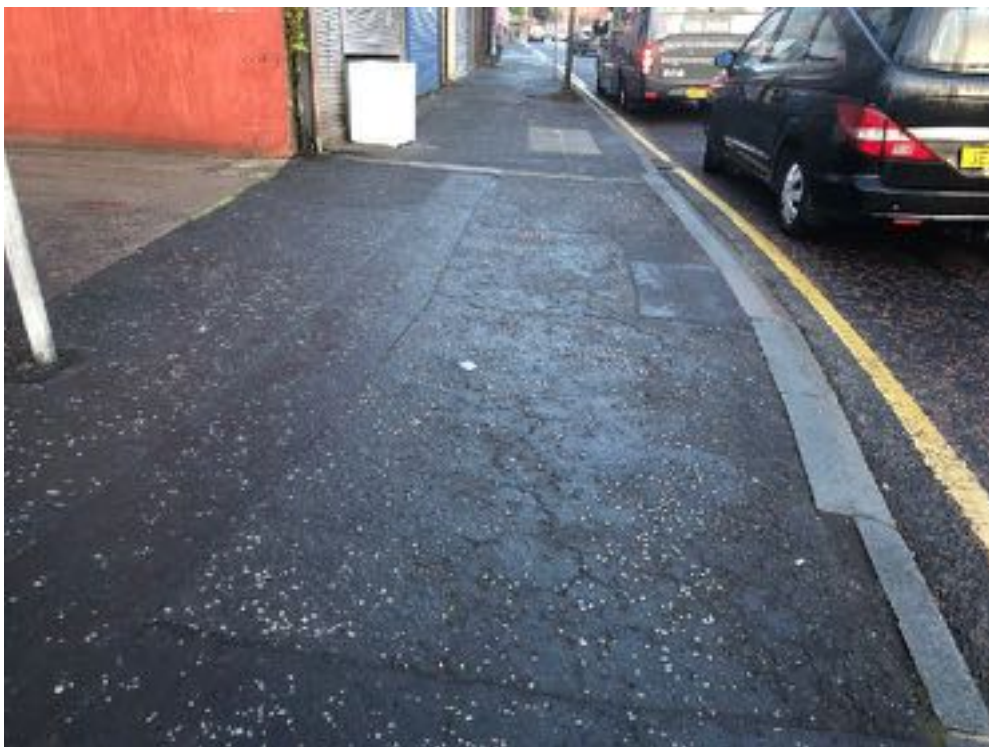
The footway approaching Carrick Hill is rough and uneven and includes dish drainage channels. There is a substantial section of dropped kerb to allow access to a garage.

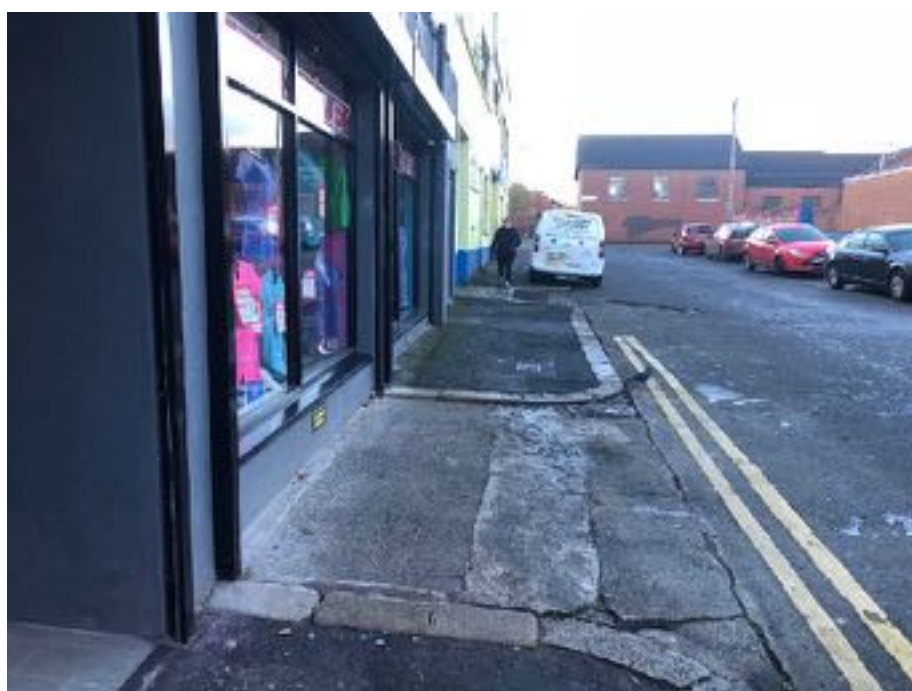
The footway on the southern side of Trinity Street is very rough and uneven with granite kerbing presenting a potential trip hazard at historic vehicle entrances. Cars are parked partially on the pavement.

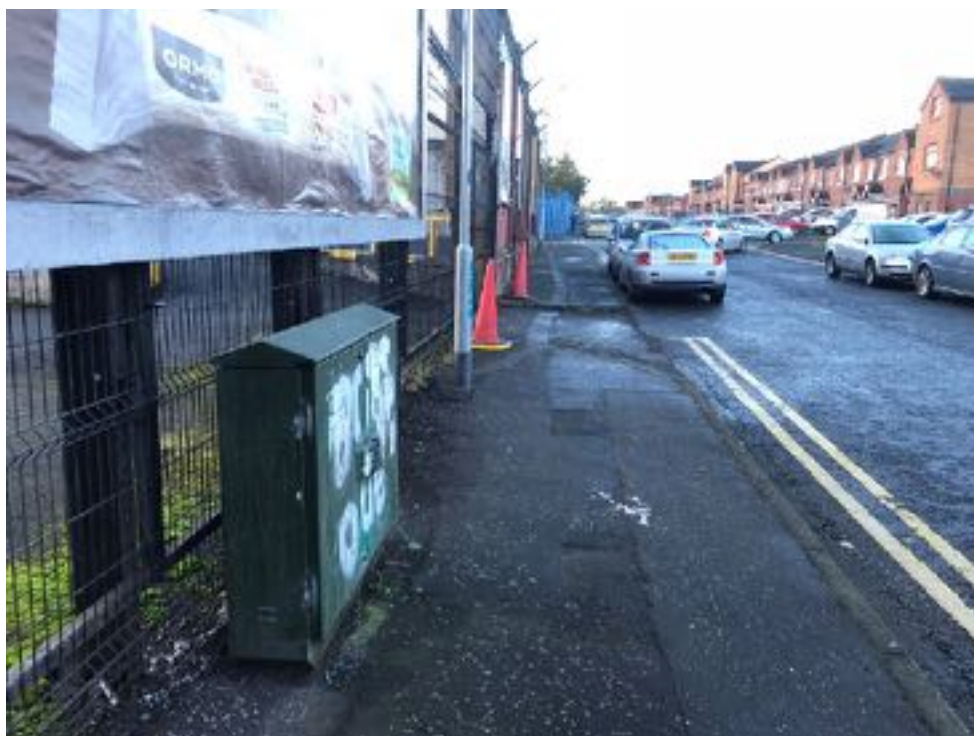
A kerbed vehicle entrance to an off-street car park means step free access along the southern footway of Stanhope Street is impossible.

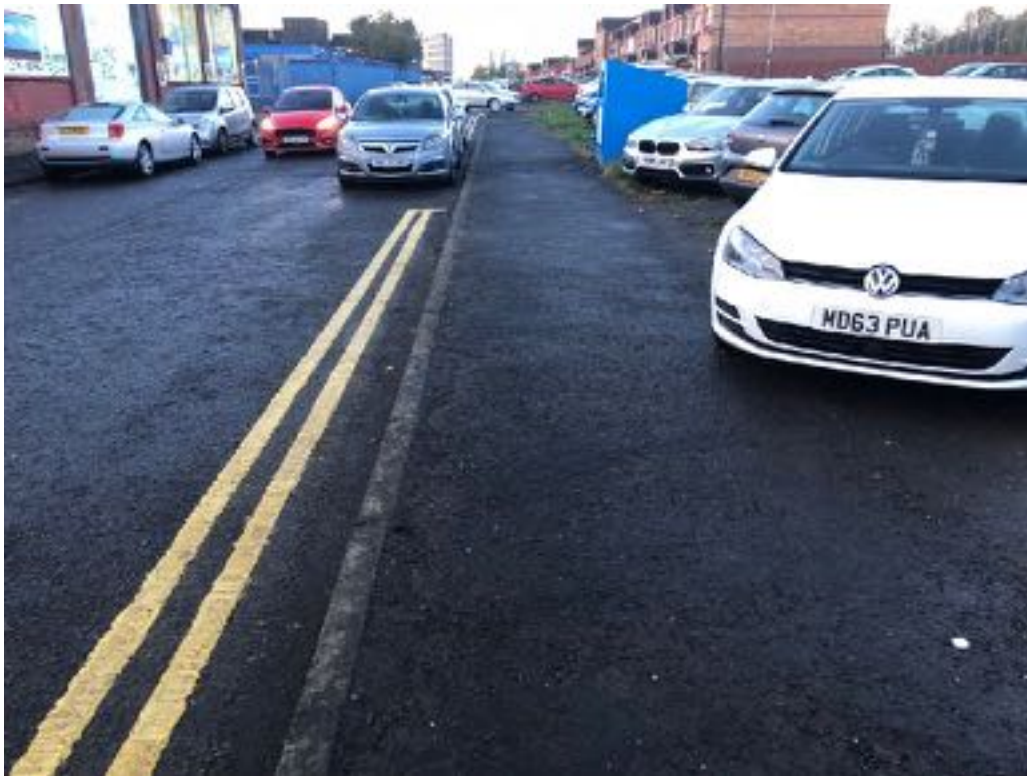
The condition of the northern section of footway is very poor and parked cars reduce its width.

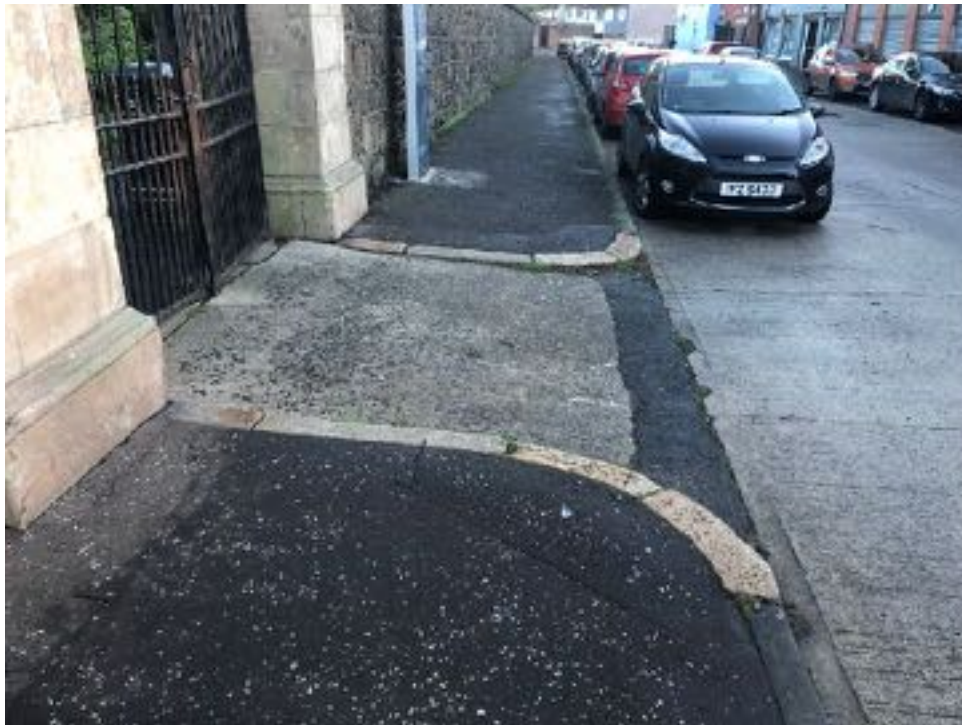
The granite kerbs around the entrance to the historic Clifton Street Cemetery mean there is not barrier free access to the cemetery or the footway as it continues eastwards.

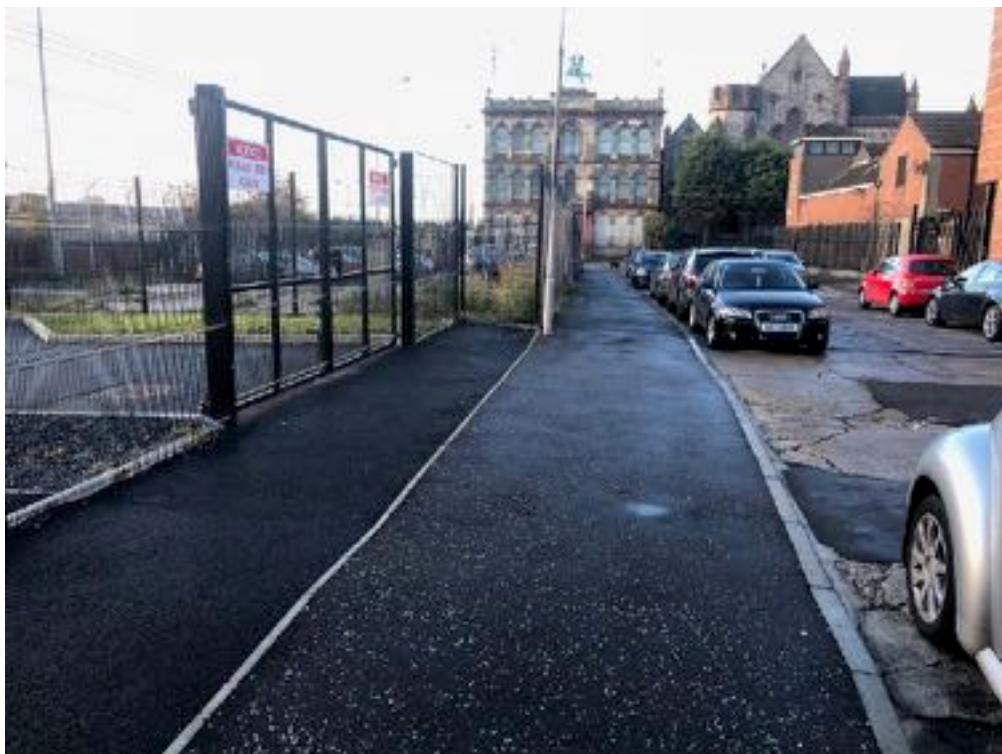
The southern section of footway is clutter free and is in much better condition. However there is a lengthy section of footway flush with the carriageway which could potentially allow someone with a visual impairment to stray onto the carriageway.

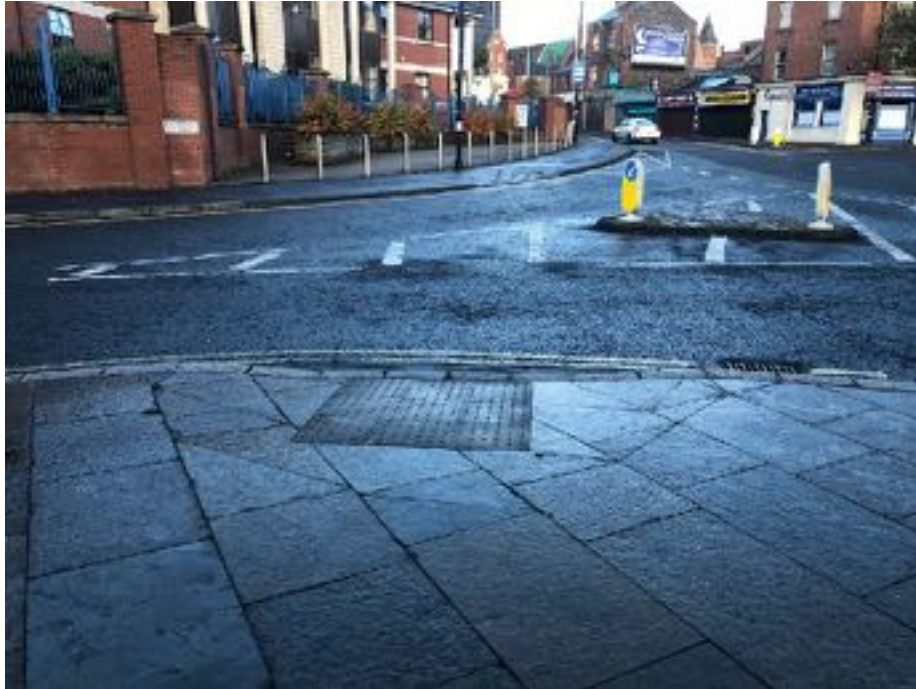
There is an in-line uncontrolled crossing across the junction with Denmark Street. The contrast between paving and the tactile on the southern section is poor. The crossing distance may present an issue for some given traffic levels in the area. There is a case for the provision of a pedestrian refuge at the mid point of the crossing.

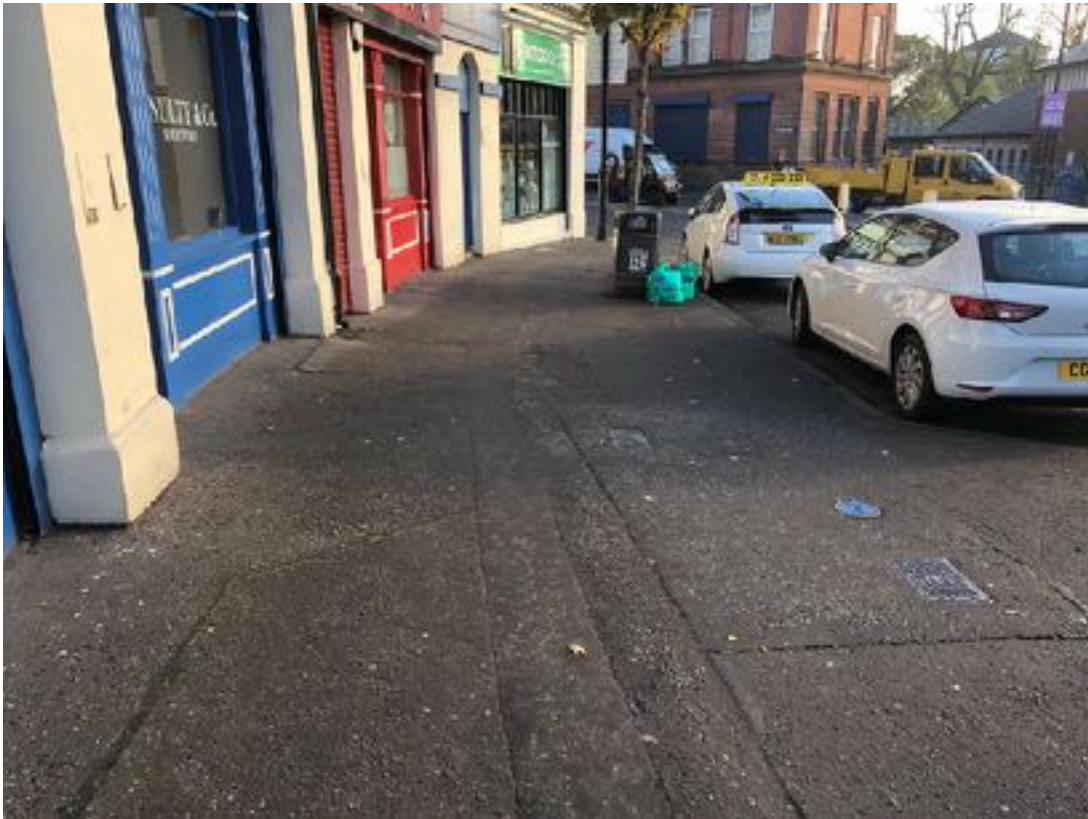
The footway on the northern section of Carlisle Circus between Crumlin Road and Antrim Road is rough and uneven but largely clutter free.

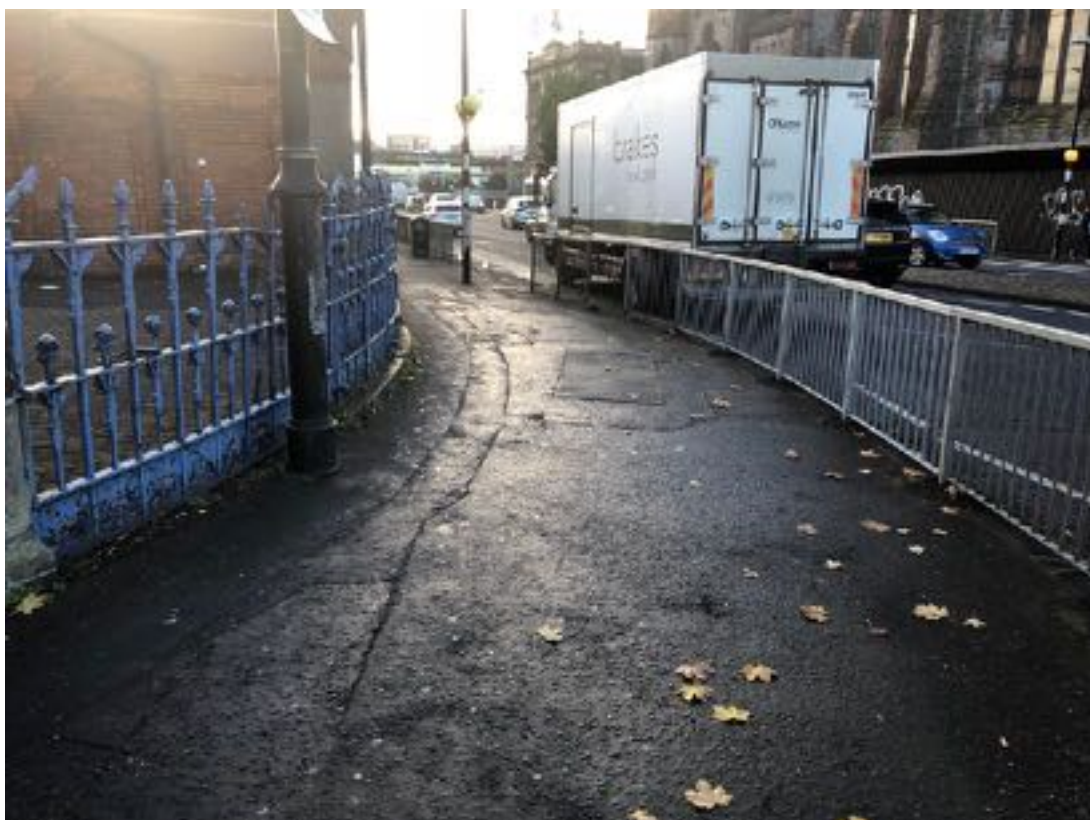
The remaining section of footway is rough and uneven but in the main clutter free as it approaches Clifton Street.

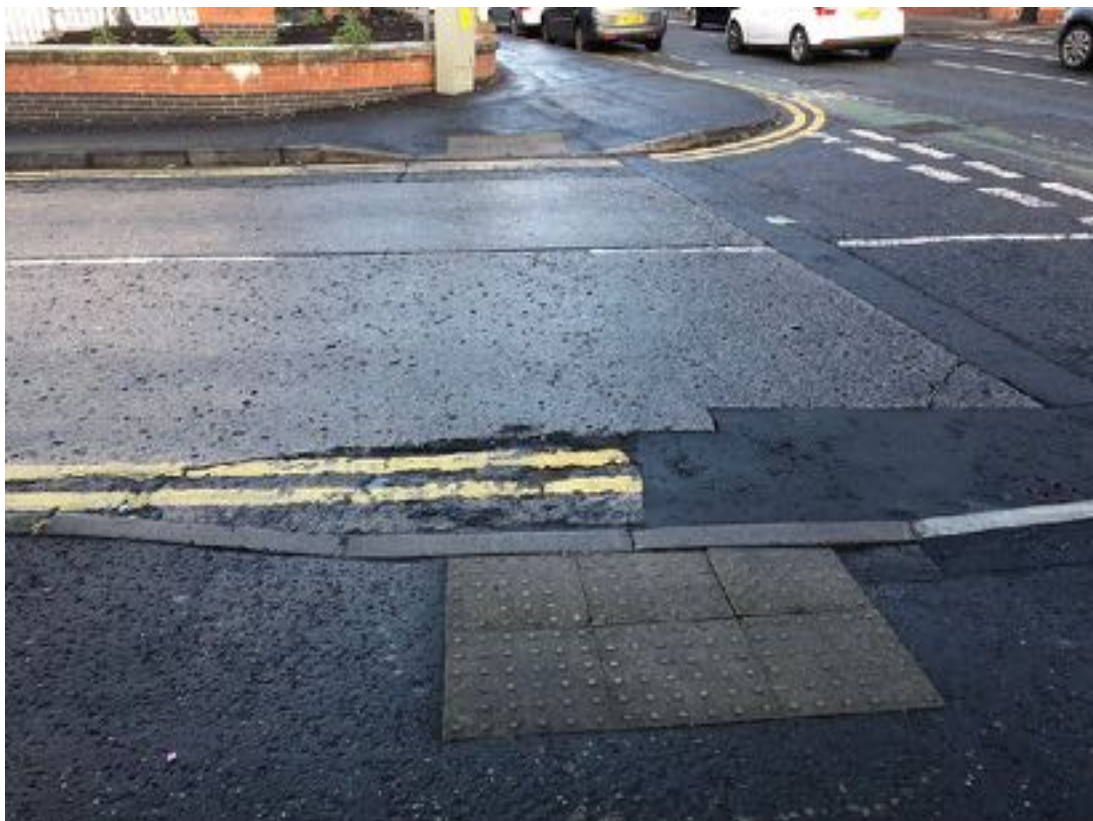
There is an in-line uncontrolled crossing across the junction with Hopewell Street. An additional line of tiles is required to meet tactile paving standards. The carriageway surface is rough and uneven.

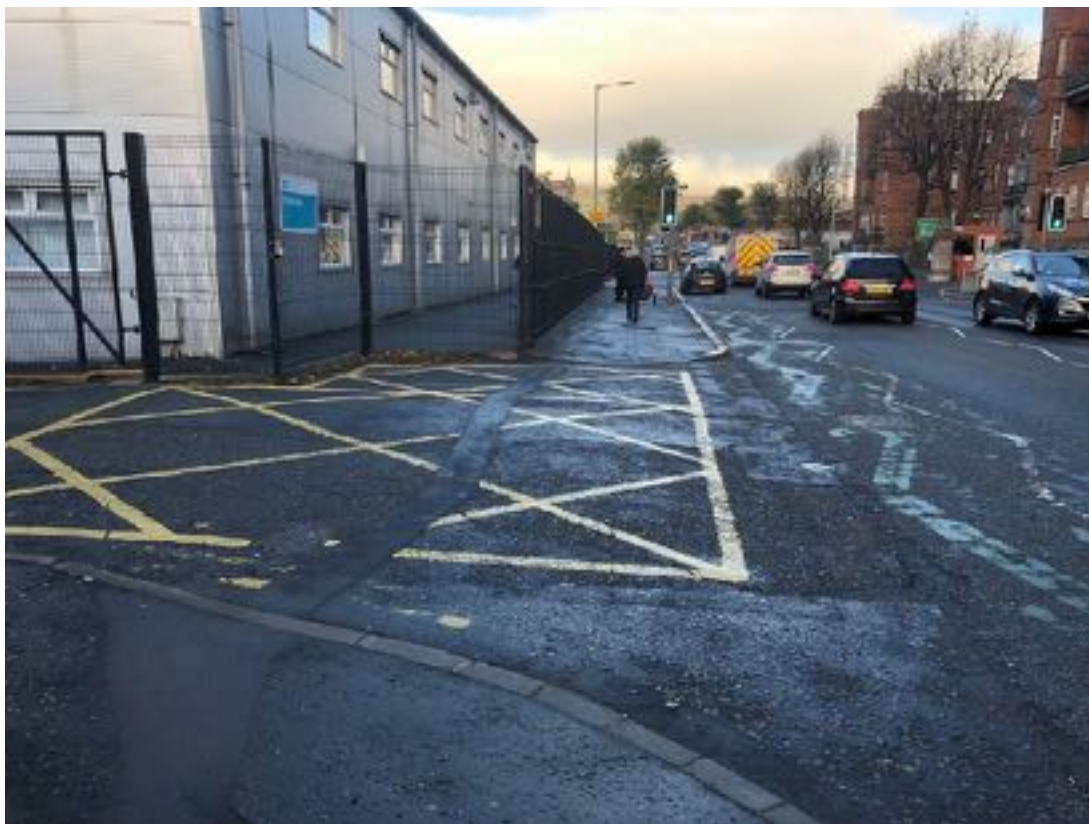
There is a gated vehicle entrance to facilities connected to the Mater Hospital. Although the kerb has been dropped, no tactile paving has been provided to alert pedestrians with a visual impairment.

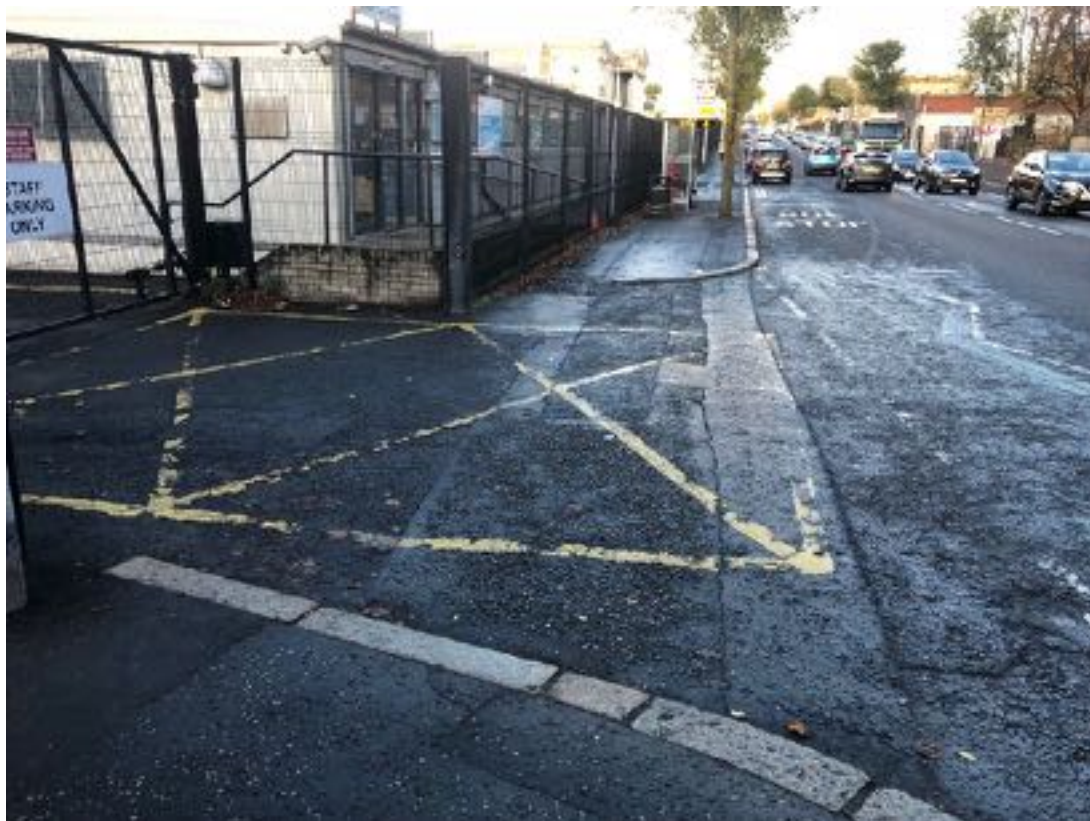
Heading away from the city centre there is another gated vehicle entrance. Once again whilst the kerb is dropped no tactile paving has been provided.

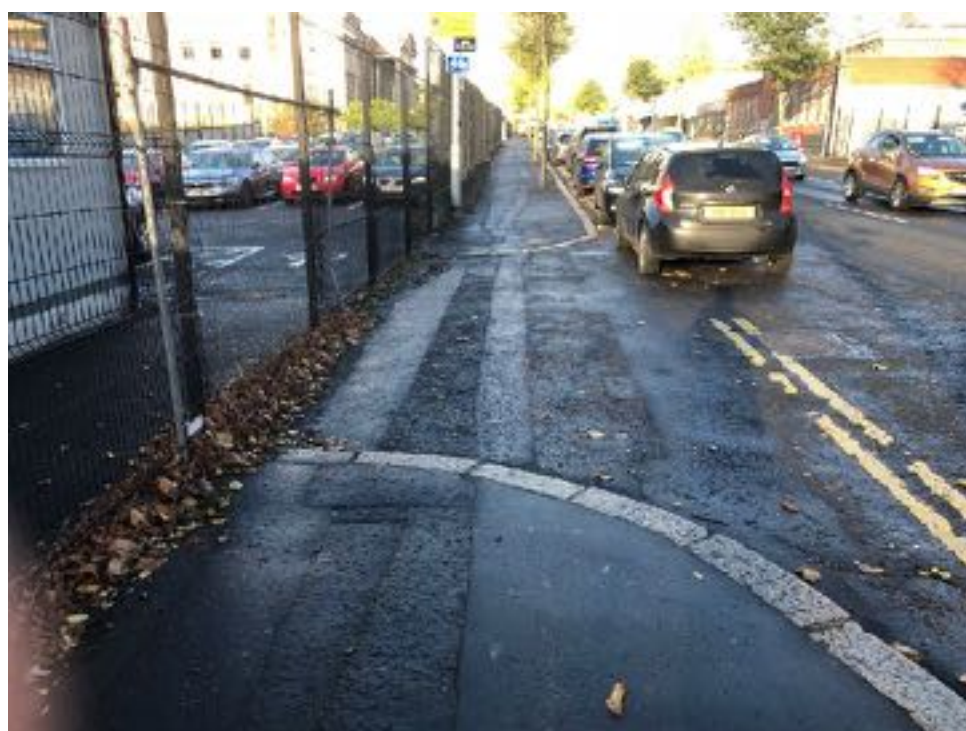
Continuing west historic, redundant vehicle entrances retain granite kerbs which represent potential trip hazards for some disabled people and older people.

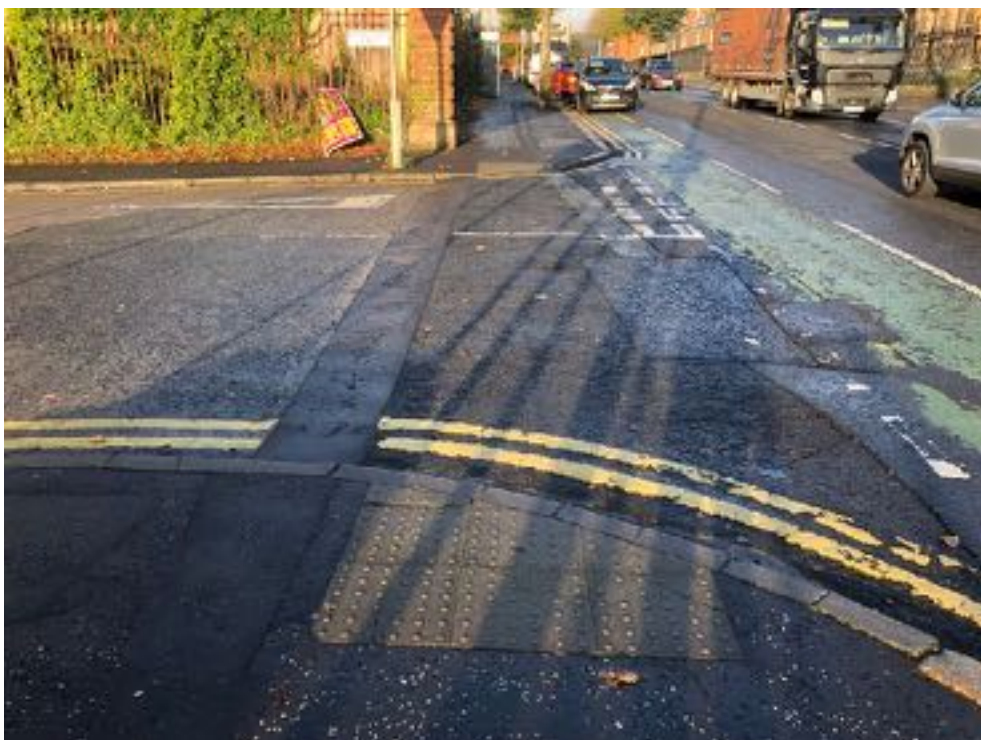
There is an in-line uncontrolled crossing across the junction with Florence Place. The depth of the tactile paving does not meet acceptable standards, partially due to the radius of the kerb. The carriageway surface is rough and uneven.

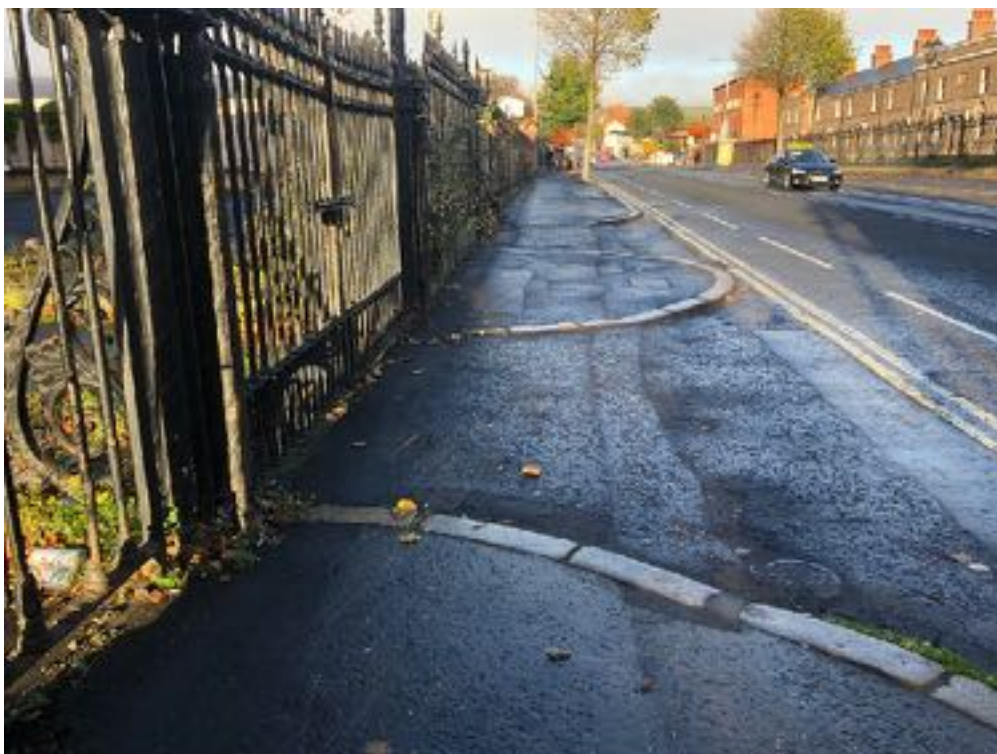
There are a number of currently unused vehicle entrances around the courthouse which retain granite kerbing and represent a potential trip hazard for some older people and disabled people.

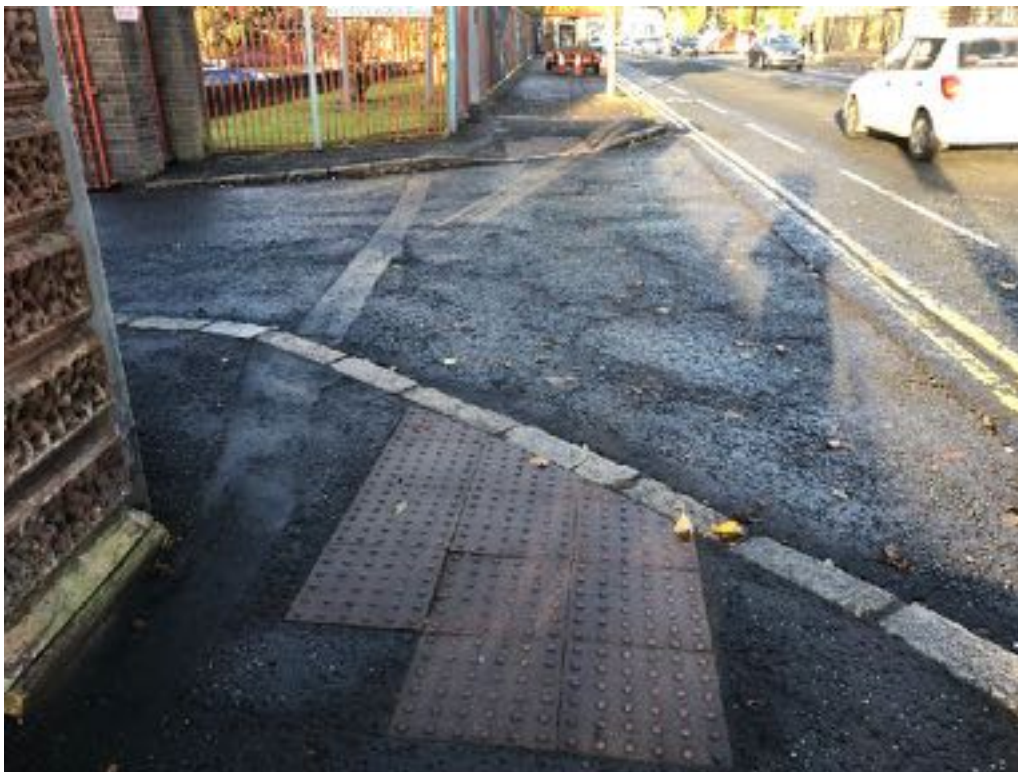
There is an uncontrolled crossing at the entrance to the Crumlin Road Health Centre. The tactile paving is the wrong colour and is not correctly aligned.

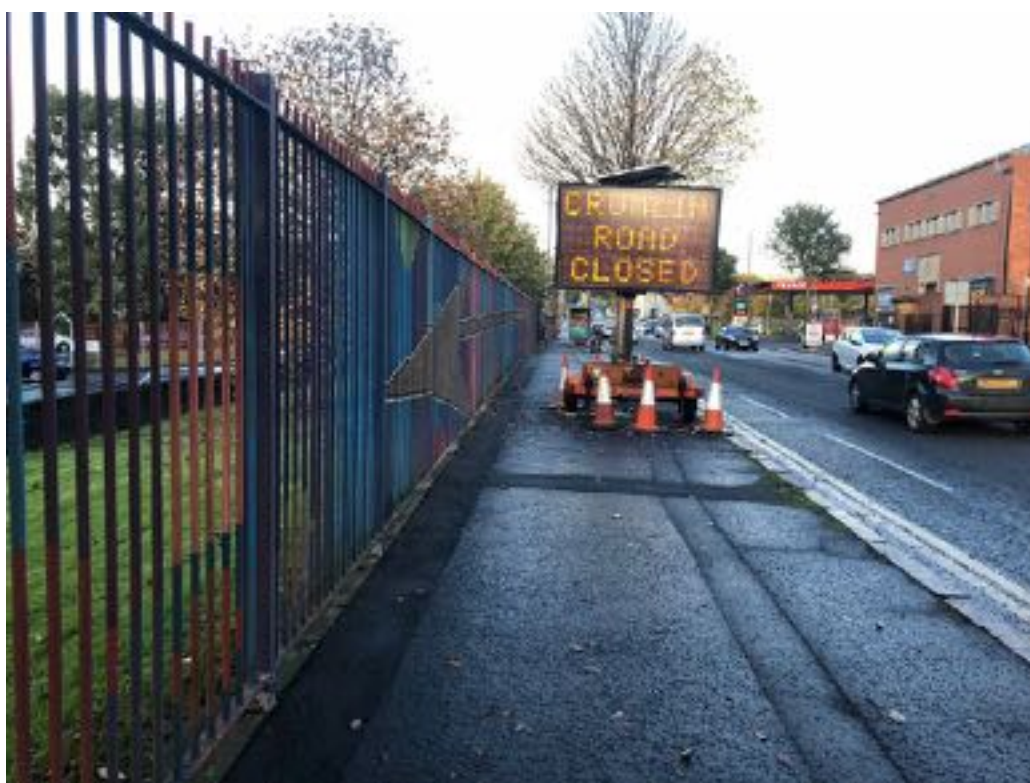
The footway on the western side approaching Agnes Street is rough and uneven. A temporary, large roadworks sign blocks the footway at this point making it difficult or impossible for many users to use the footway at the time of the audit.

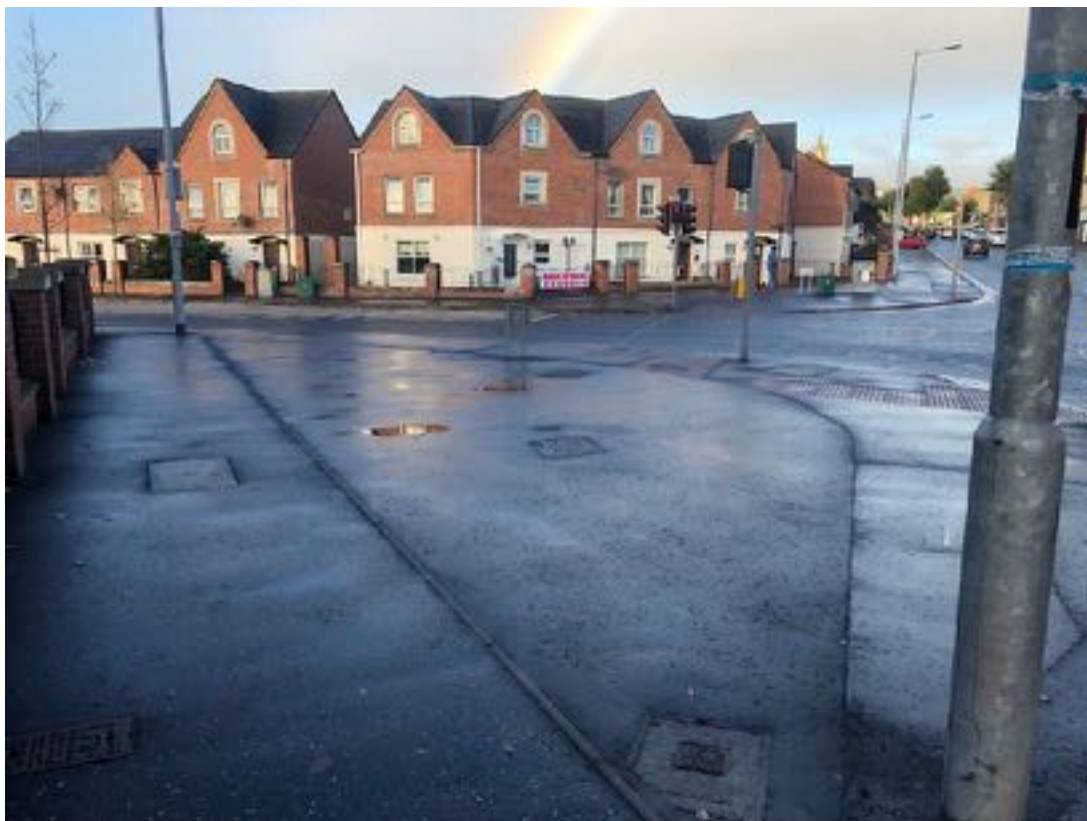
There is a large clear area of footway around the junction of Agnes Street and Crumlin Road. Finding the two controlled crossings, across Agnes Street and Crumlin Road will be a challenge for people with a visual impairment particularly given the limited tactile tail at each crossing.

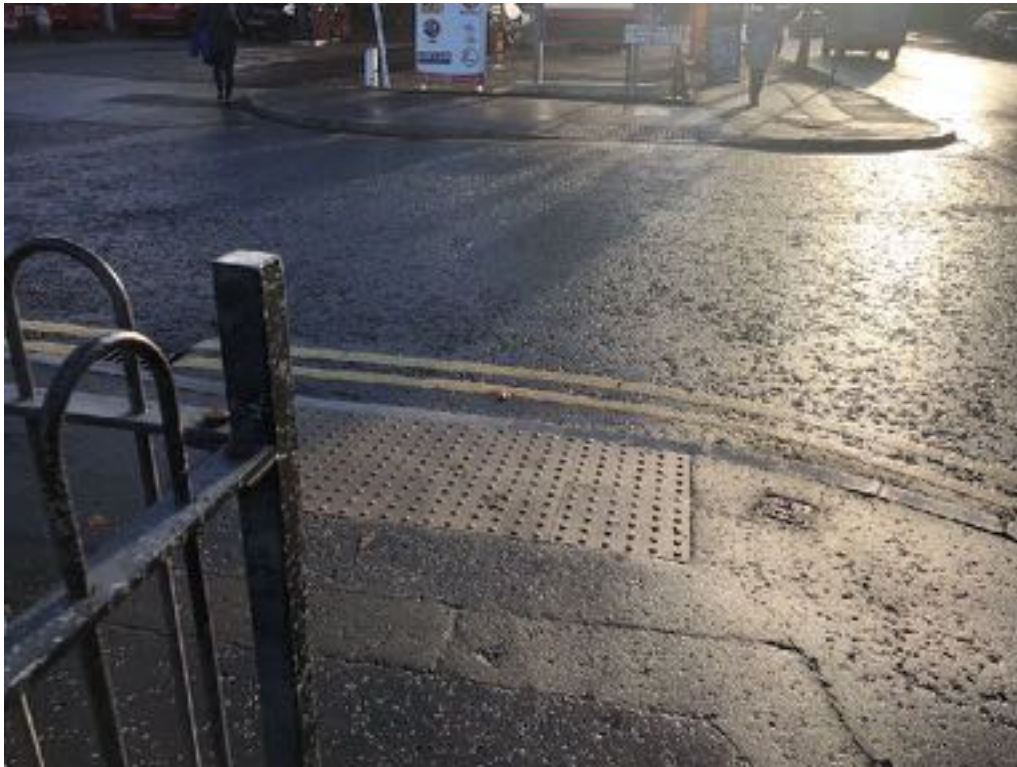
On the northern footway from Agnes Street towards the city centre there is an in-line un-controlled crossing across the junction with Landscape Terrace. The depth of tactile is an issue.

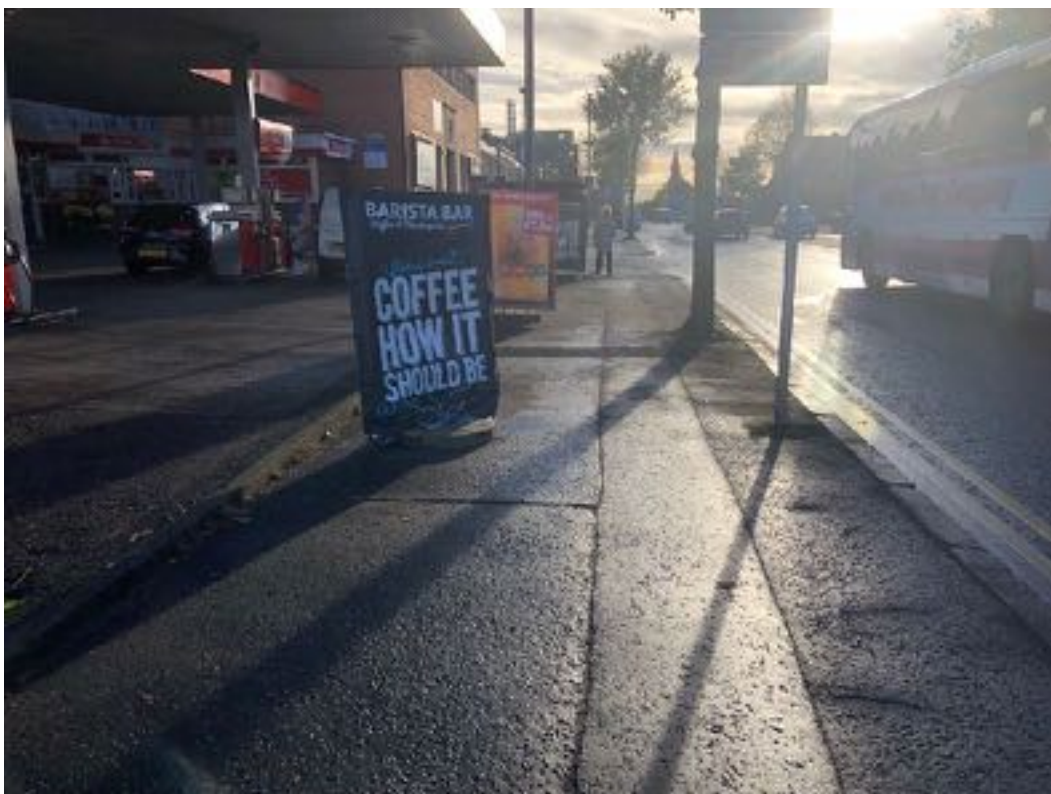
A-Boards associated with the garage obstruct the footway which is rough and uneven.

Other illegal clutter and obstructions also need to be addressed if the scheme is to be successful. Over the past number of years there has been an explosion in the use of A Boards across Belfast and beyond. As well as increasing in number the boards are also increasing in size. It is now time that agencies responsible adopt a zero tolerance to a practice which is illegal and creates a major hazard for older people and disabled people. Imtac recommends that Belfast adopt a city wide ban of the use of A Boards on pavements similar to that recently announced by Edinburgh City Council.

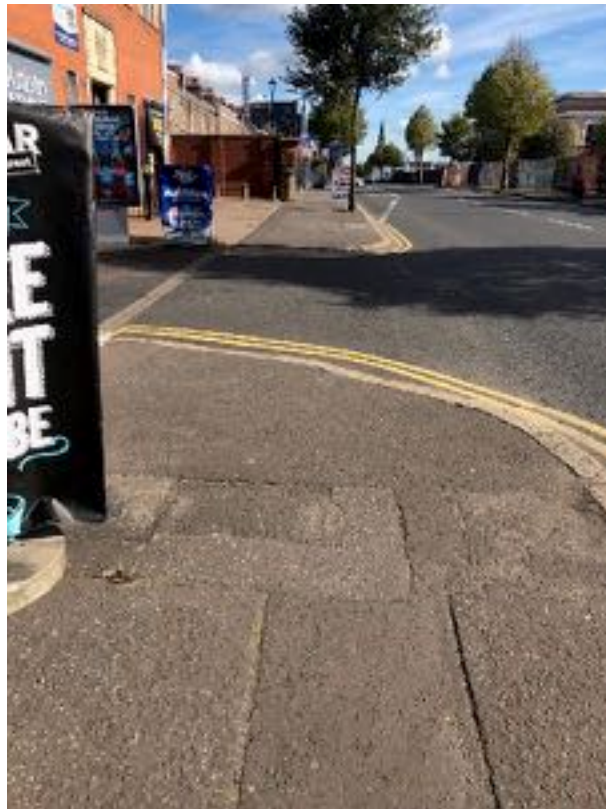
The kerbs are dropped at the garage exit but there is no tactile paving provided to warn pedestrians with a visual impairment. A Boards again obstruct the footway after the exit.

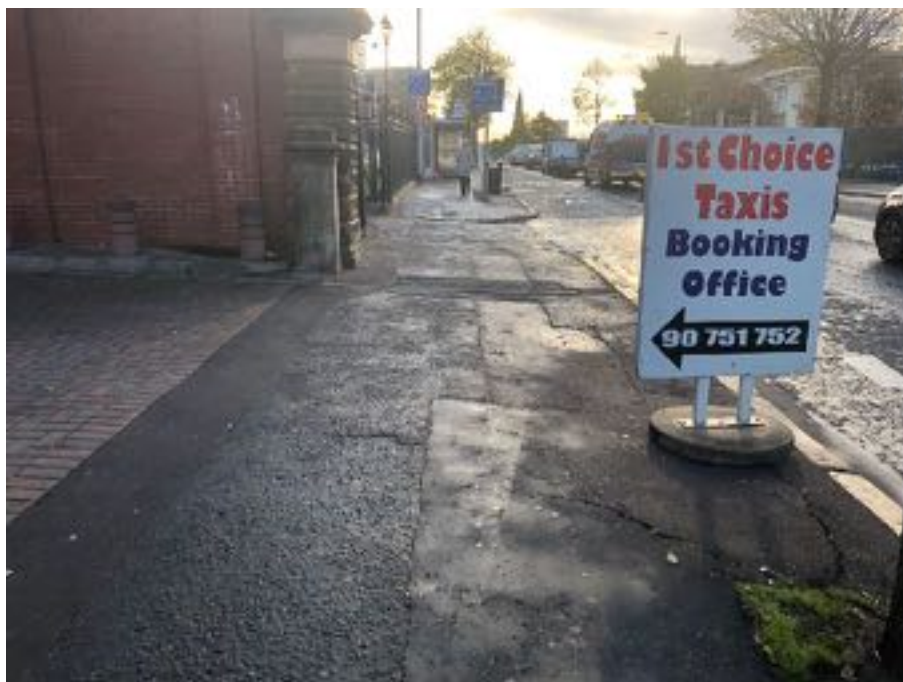
Continuing towards the city centre the footway is rough and uneven with frequent dish drainage channels. Historic vehicle entrance to the Gaol retain granite kerbing which represents a trip hazard for some disabled people and older people.
