Recommendations from Imtac on public realm proposals for the Clifton Gateway in Belfast

(November 2018)

About this report

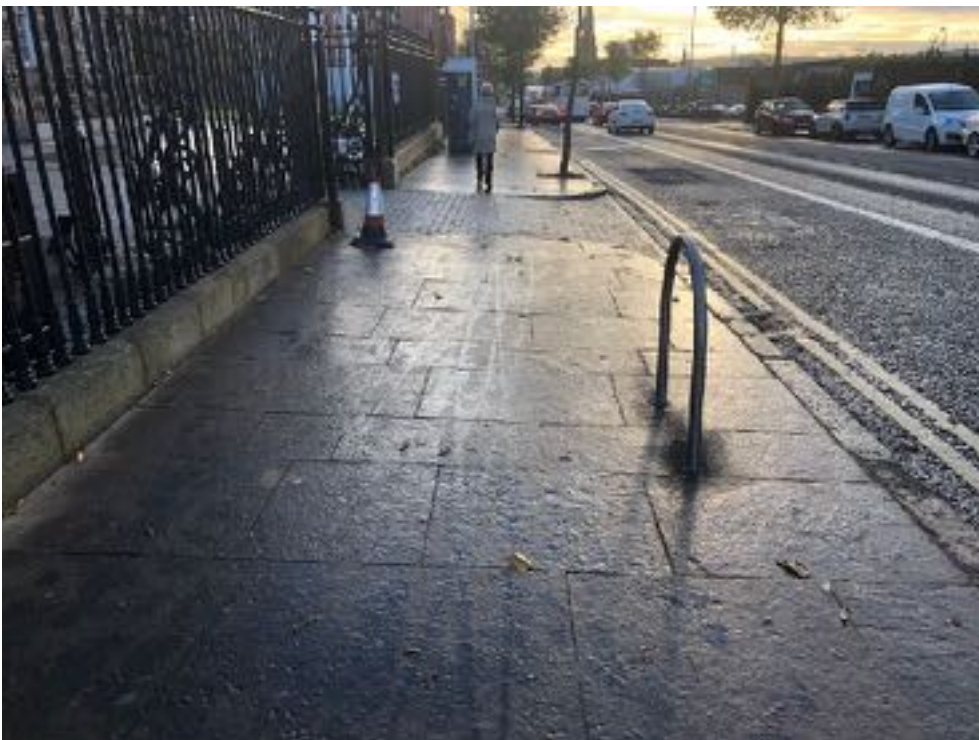
The design and placement of a cycle hoop creates a potential hazard. The main pedestrian entrance to the jail retains granite kerbing some of which represents a potential trip hazard.

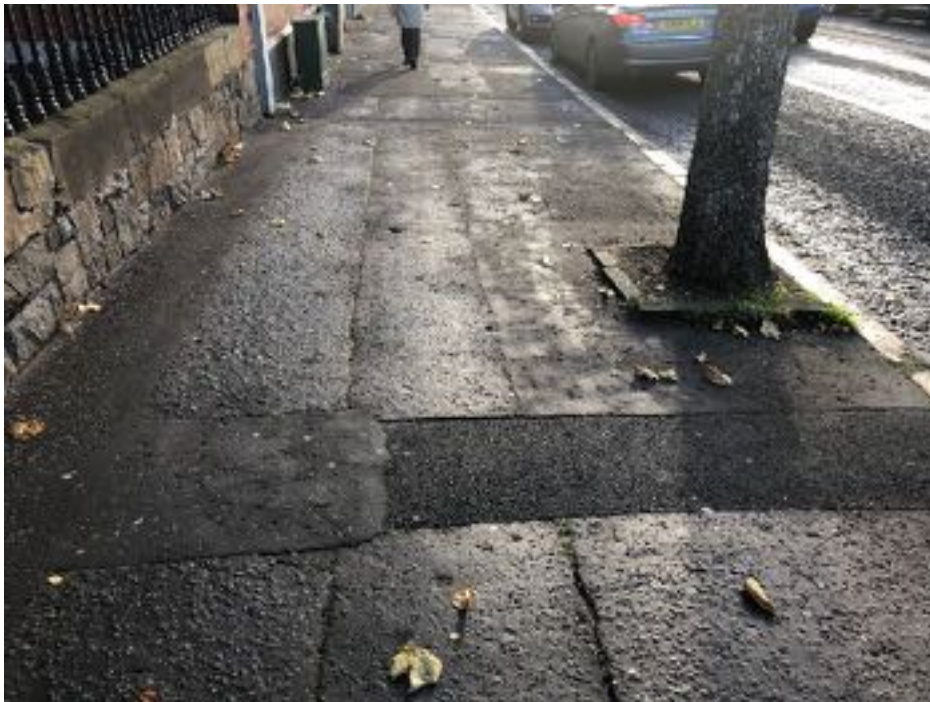
The footway reverts back to a rough and uneven surface approaching the Mater hospital. Kerbing around trees represents a potential trip hazard.

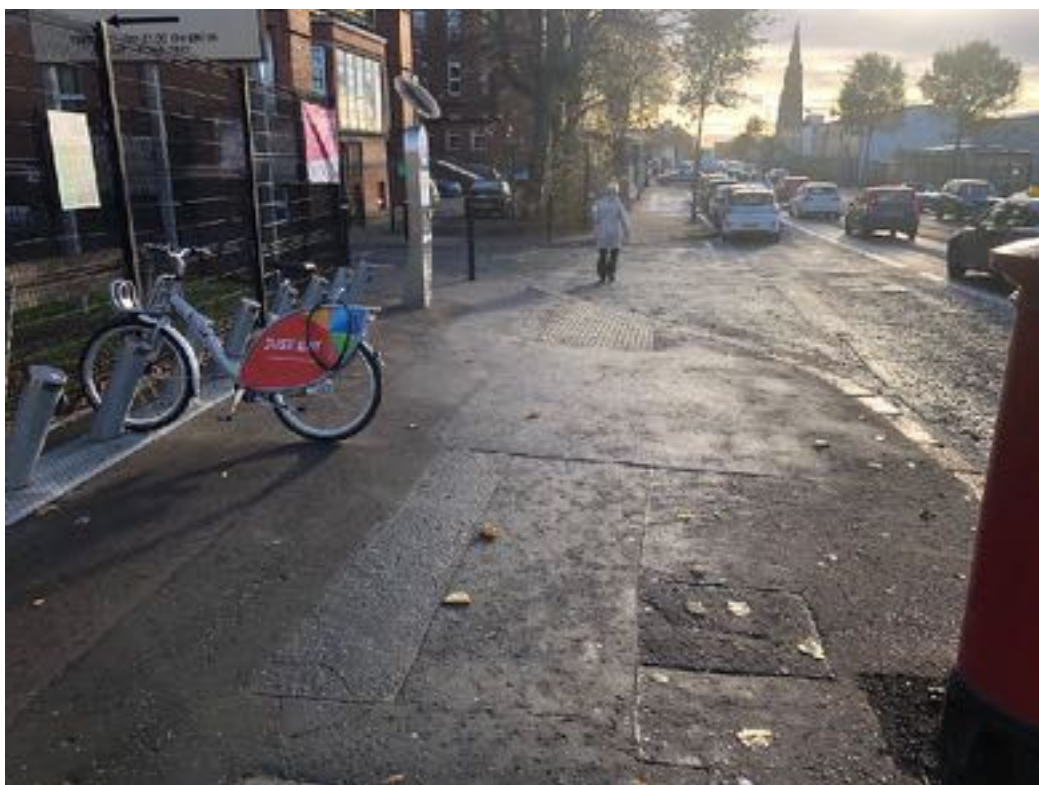
This is a good example of an in-line uncontrolled crossing at the vehicle entrance to the hospital. The positioning of the Belfast Bikes docking station could create a potential hazard close to the crossing when bikes are docked.

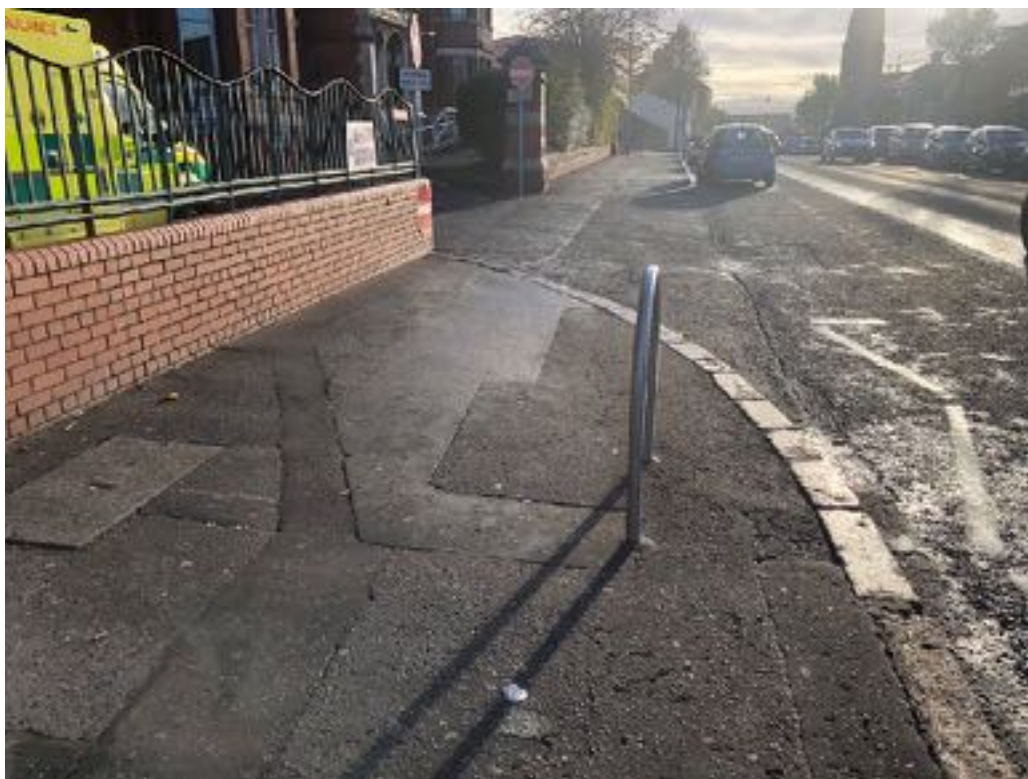
There are a number of other vehicle entrances across the footway at the front of the hospital. Each uses granite kerbing which is dropped but does not provide flush crossing. No tactile paving is provided at these crossings. Design and positioning of cycle hoops is problematic.
