Report on Walking routes in Derry/Londonderry City Centre

July 2013

Audit of key routes

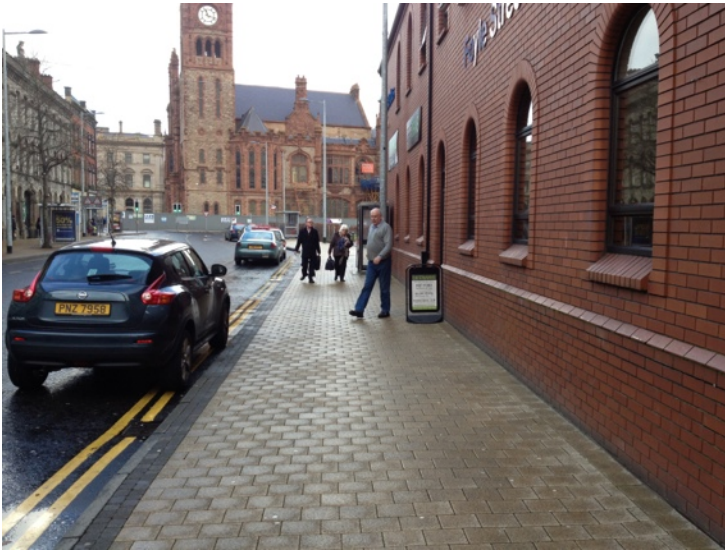
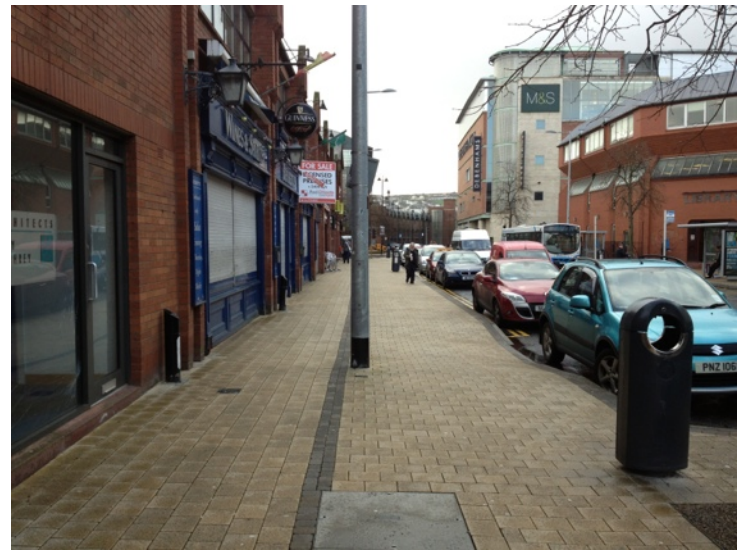
- 1 The pavement outside Foyle Street bus centre provides relatively good barrier free access in both directions.

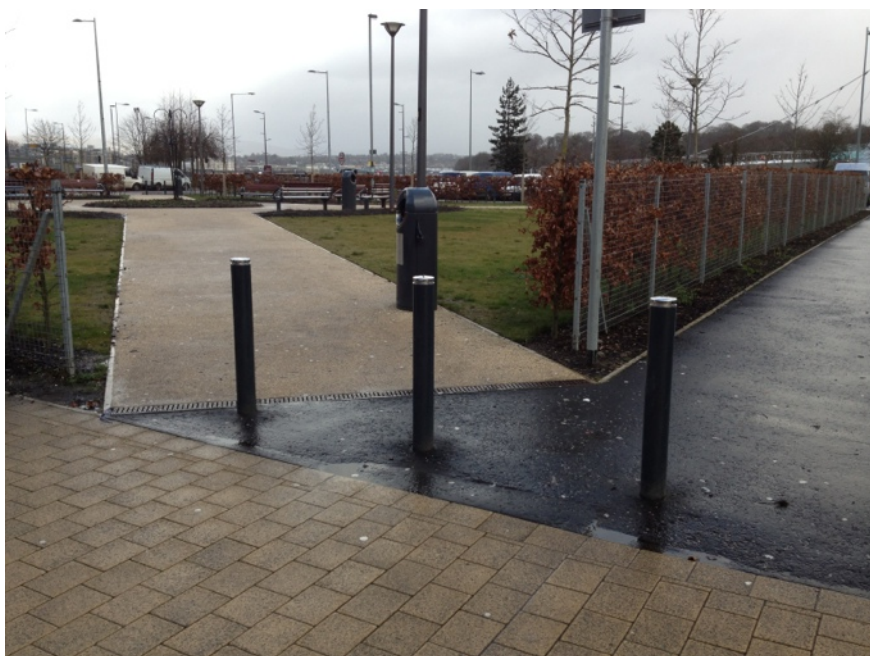
- 2 There are bollards at the northern end of Foyle Street (close to the Guildhall). The design of the bollards fails to provide an acceptable contrasting band for people with a visual impairment.

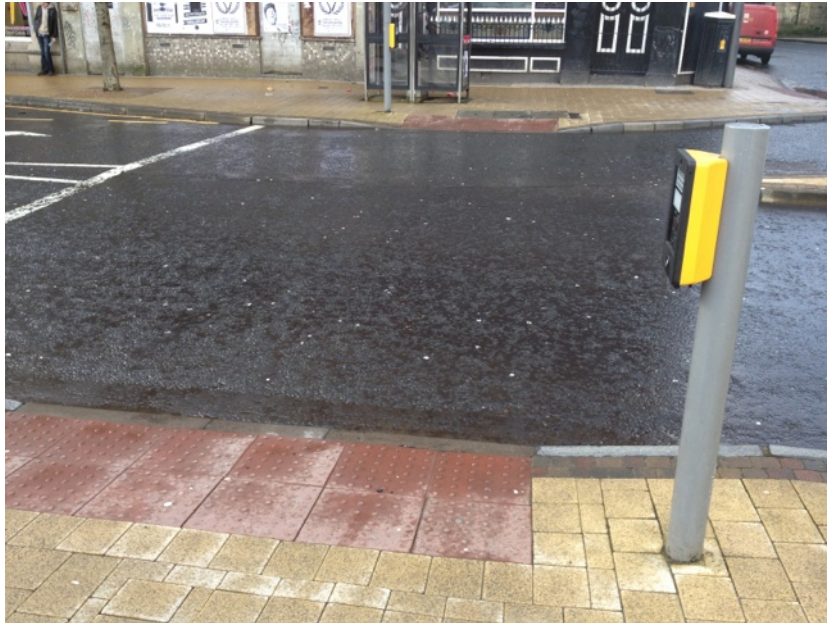
- 3 The controlled crossing at the north end of Foyle Street does not follow standard practice in use of tactile paving as no tail is included. Telephone boxes obstruct access to the control box on the west side.

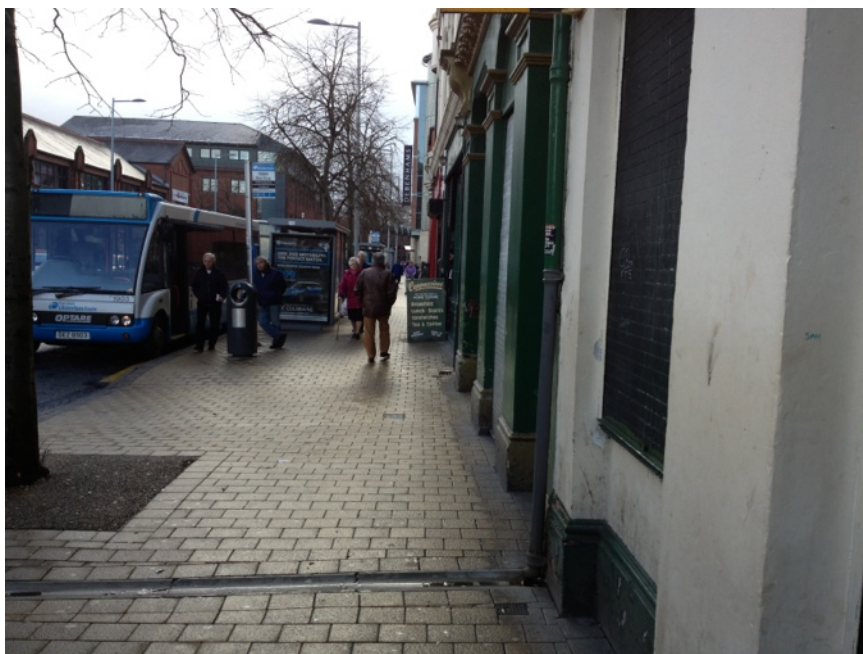
- 4 The pavement on the west side of Foyle Street is narrowed in places due to bus stops and A-Boards.

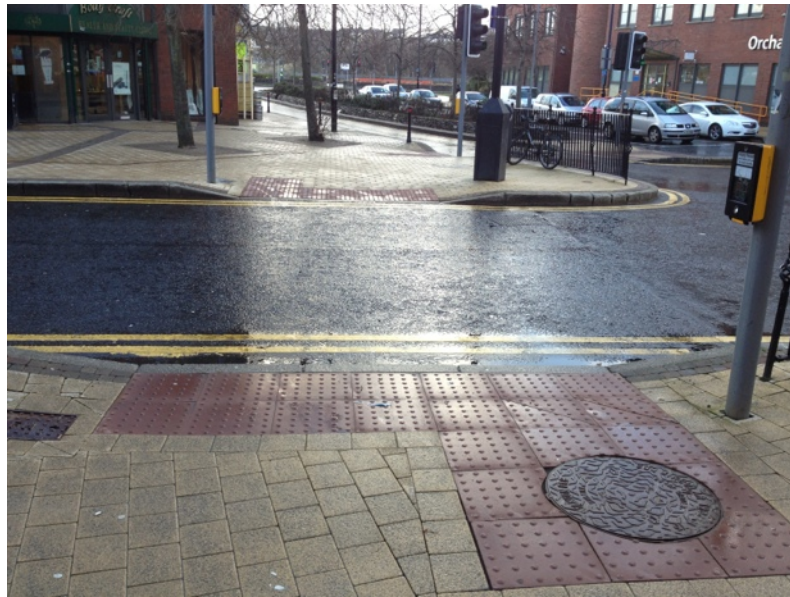
- 5 There is a reasonable example of a controlled crossing at the southern end of Foyle Street although the tail should be longer.

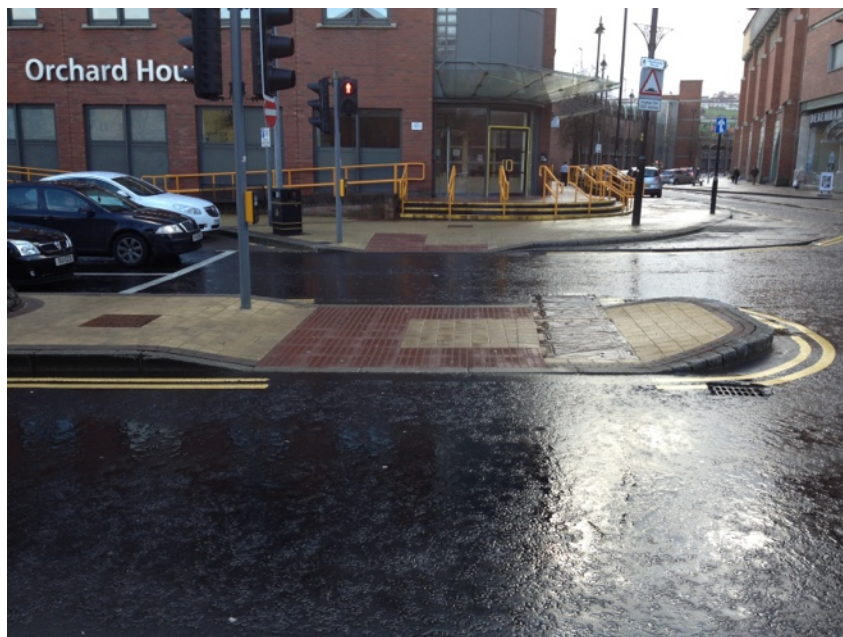
- 6 At the junction of Foyle Street and Water Street there is controlled crossing. As with 5 above the tactile tail should extend to the building line. Also there is an associated traffic island which includes non-standard use of tactile paving.

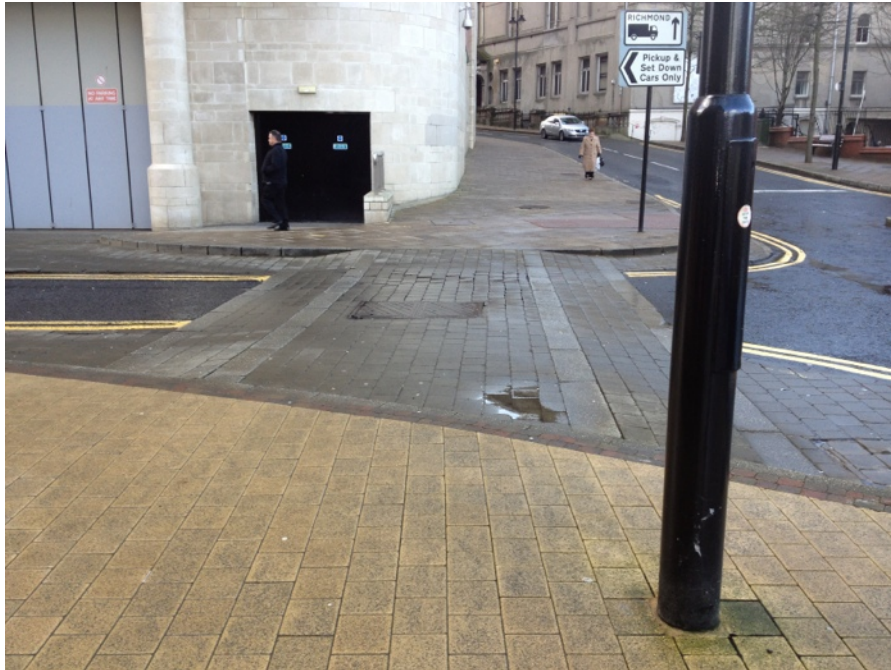
- 7 There is a raised uncontrolled crossing across Foyle Street (close to Foyleside shopping centre service yards). There is no tactile paving on this crossing.

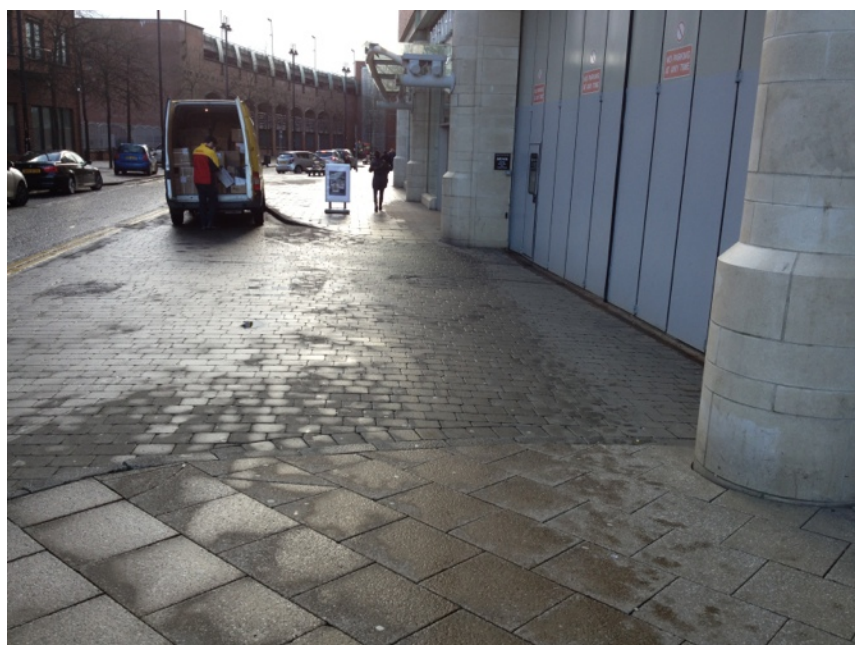
- 8 Tactile paving should also be provided at the service yard entrance on Foyle Street.

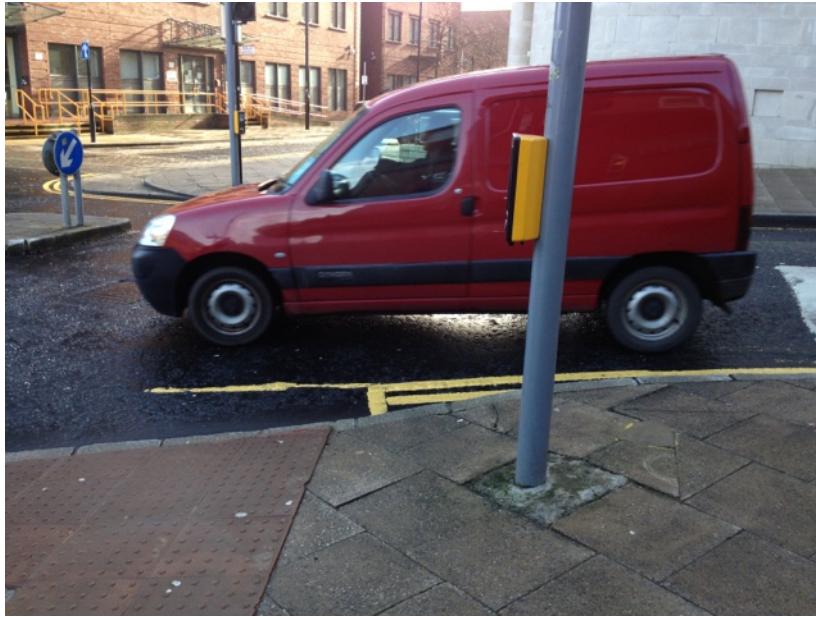
- 9 There is a controlled crossing at the junction of Foyle Street and Orchard Street. The control box is located too far from the tactile paving.

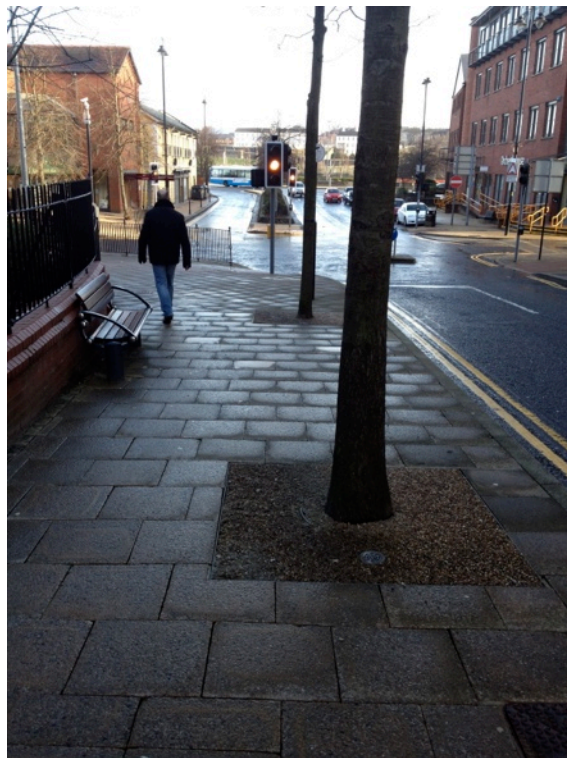
- 10 The location of trees and seating narrows the paving considerably on the northern side of Orchard Street. This makes the area difficult for some disabled people to navigate.

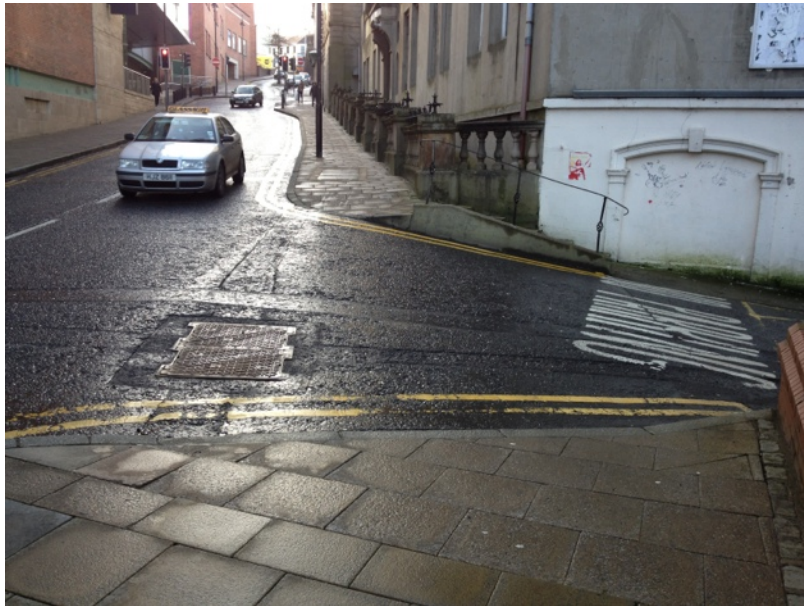
- 11 There is a vehicle entrance on the north side of the street. Whilst there are dropped kerbs these are not in-line and no tactile paving has been provided.

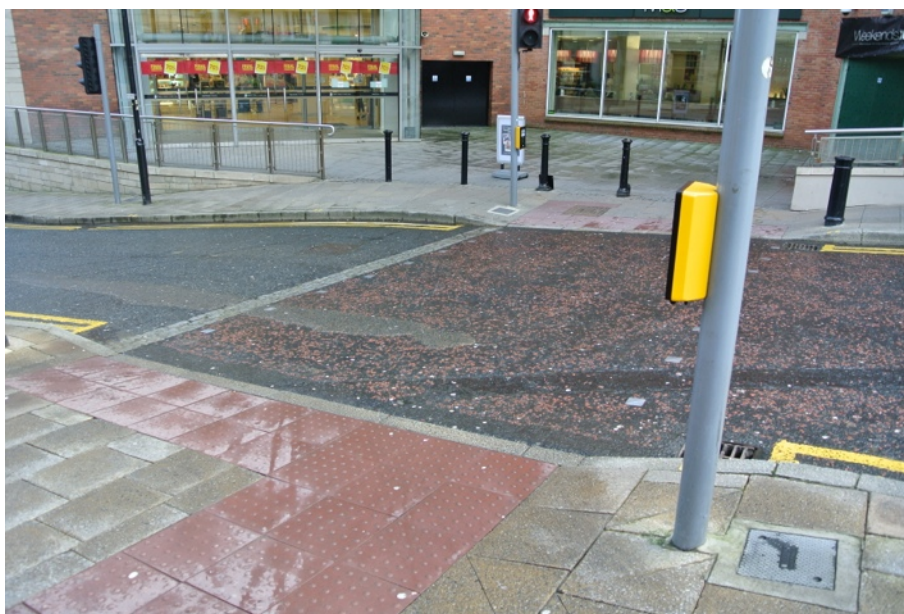
- 12 There is a controlled crossing near to the entrance of Foyleside Shopping Centre. The control button on the crossing is too far from the tactile paving. Bollards in the vicinity have no contrasting band.

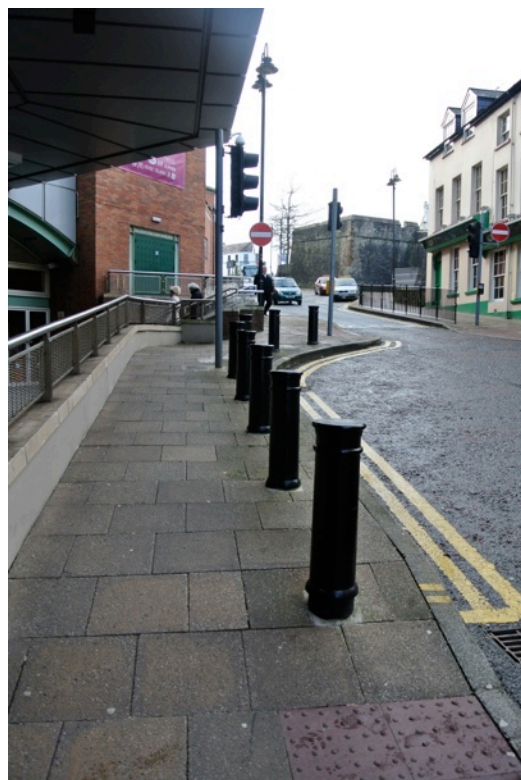
- 14 Bollards along the north side of the street have no contrasting band.

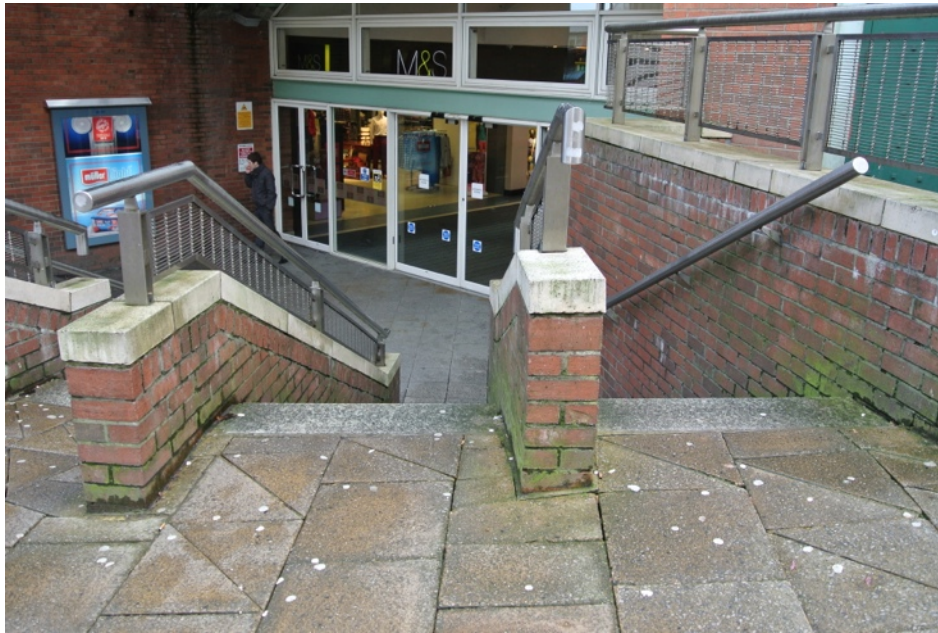
- 15 There is stepped access to Foyleside Shopping Centre. There is no corduroy hazard paving at these steps.

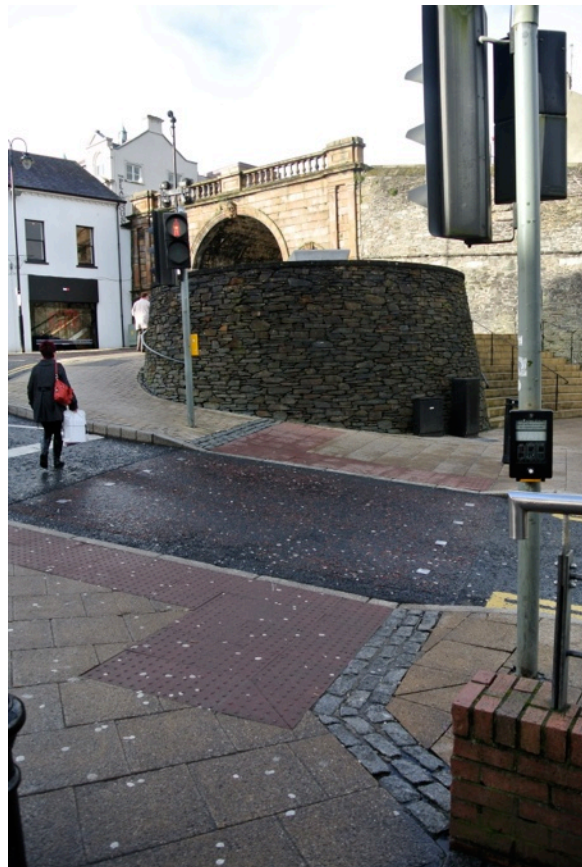
- 16 There is a controlled crossing at the western end of Orchard Street. The control box is placed too high and is too far from the tactile paving.

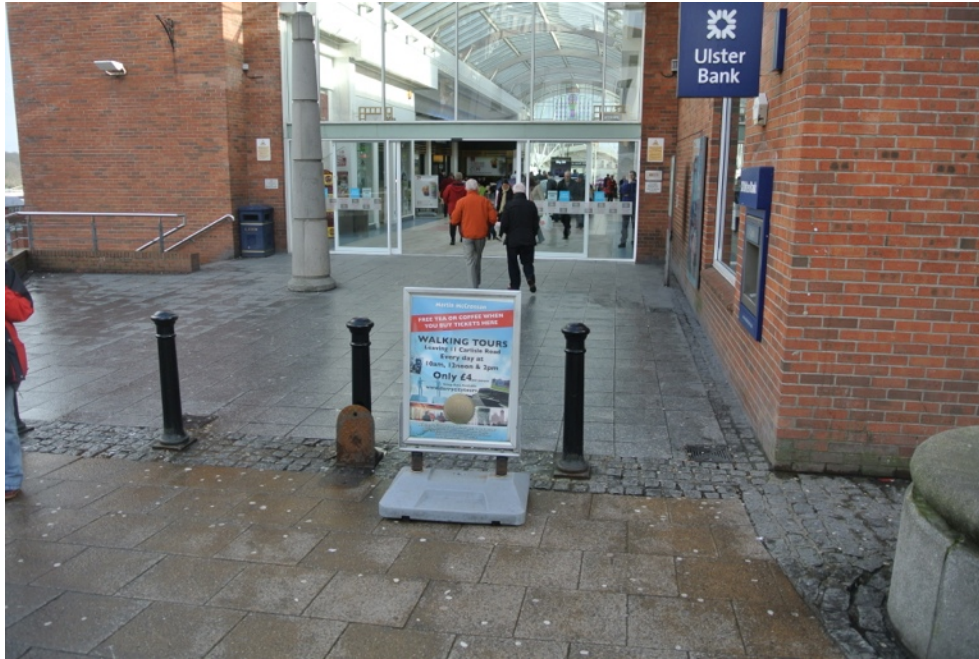
- 17 An A-Board and unmarked bollards restrict access to Foyleside.

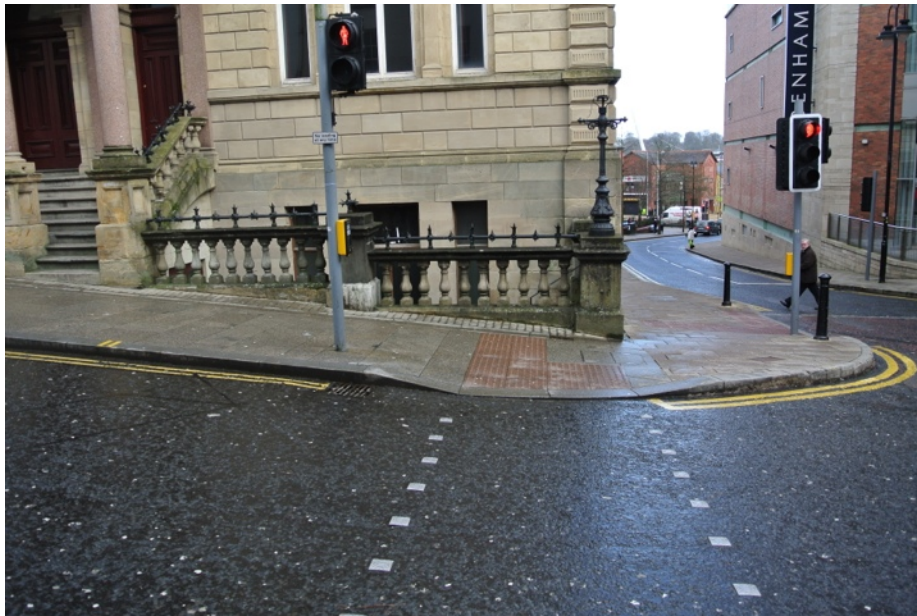
- 18 There is a controlled crossing at the junction of Orchard Street and Newmarket Street. The control box is too far from the tactile paving.

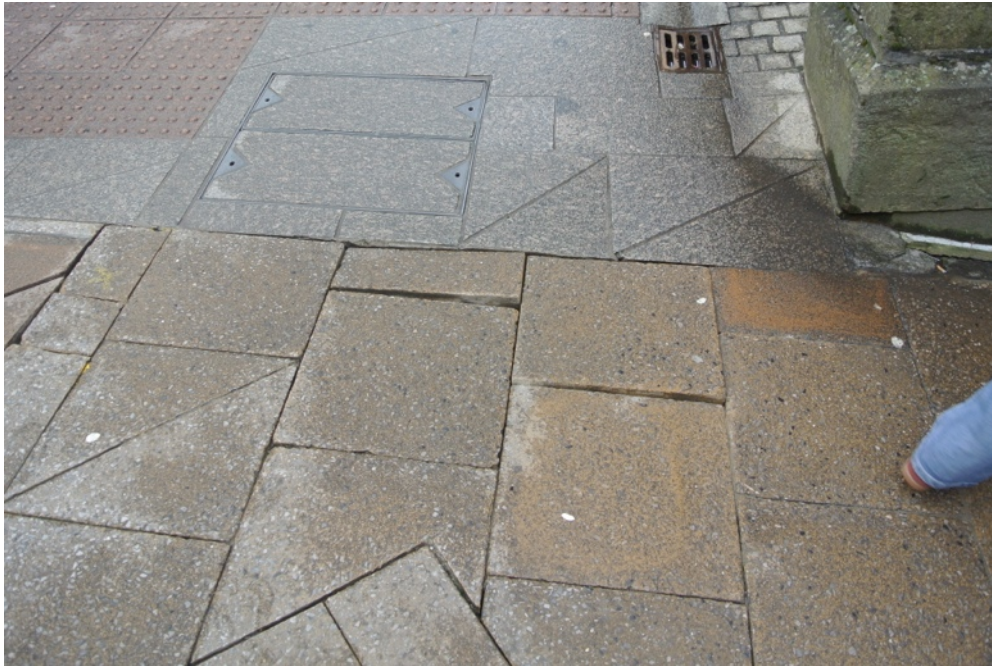
19 Paving slabs in this area are loose and present a trip hazard.

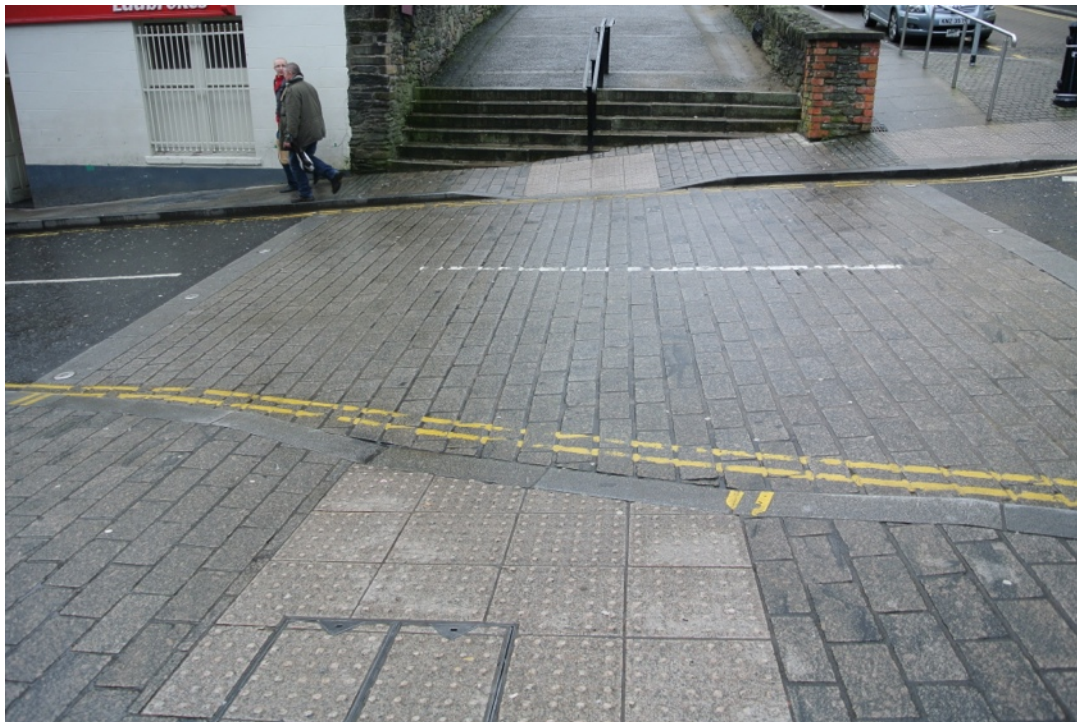
20 There is an in-line uncontrolled crossing between two sections of the Walls.

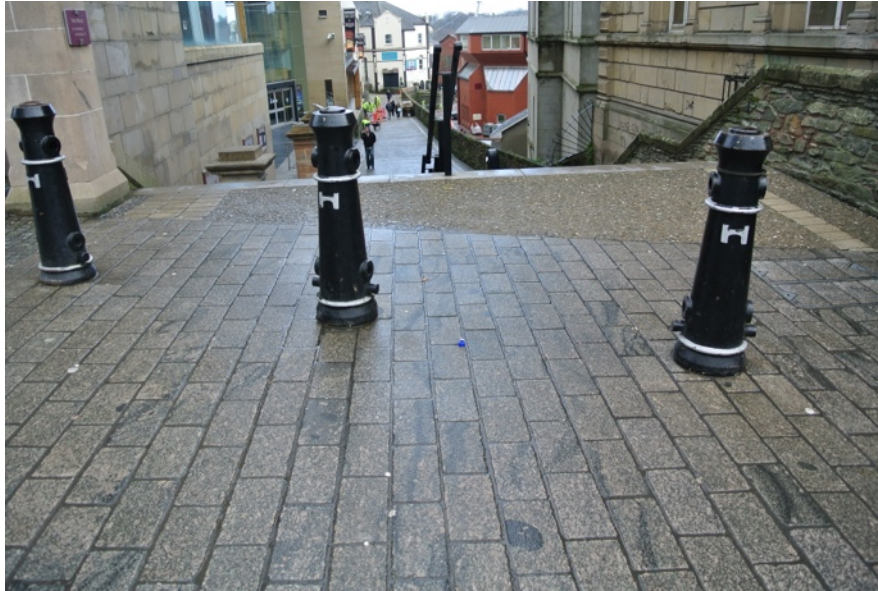
- 21 There is no corduroy hazard paving around the steps in this area. Some attempt has been made to include a white band on bollards but this is not wide enough to provide an acceptable contrasting band.

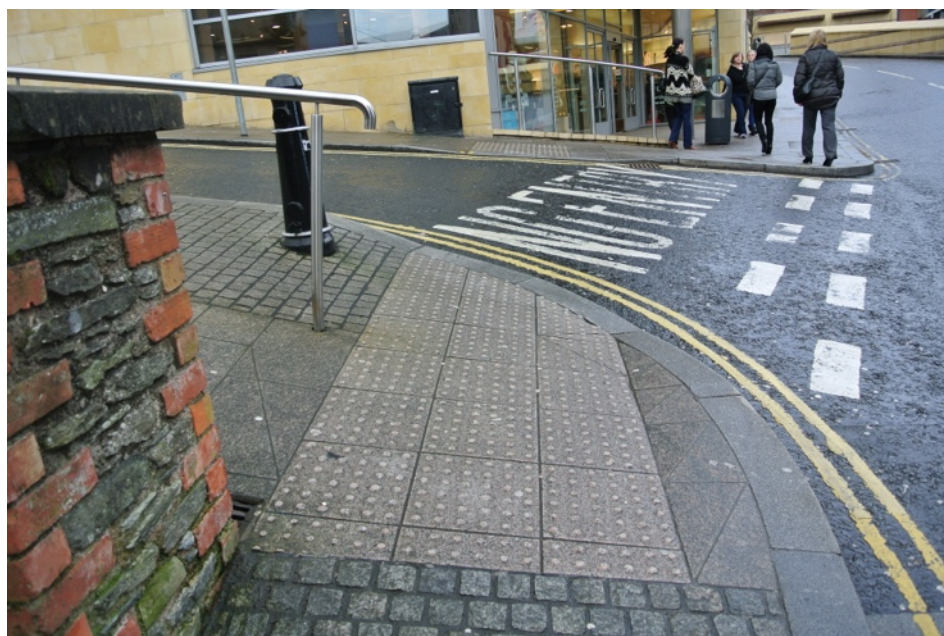
- 22 There is a reasonable in-line uncontrolled crossing at the junction of Market Street and Newmarket Street. The tactile paving is non-standard and fails to provide adequate contrast.

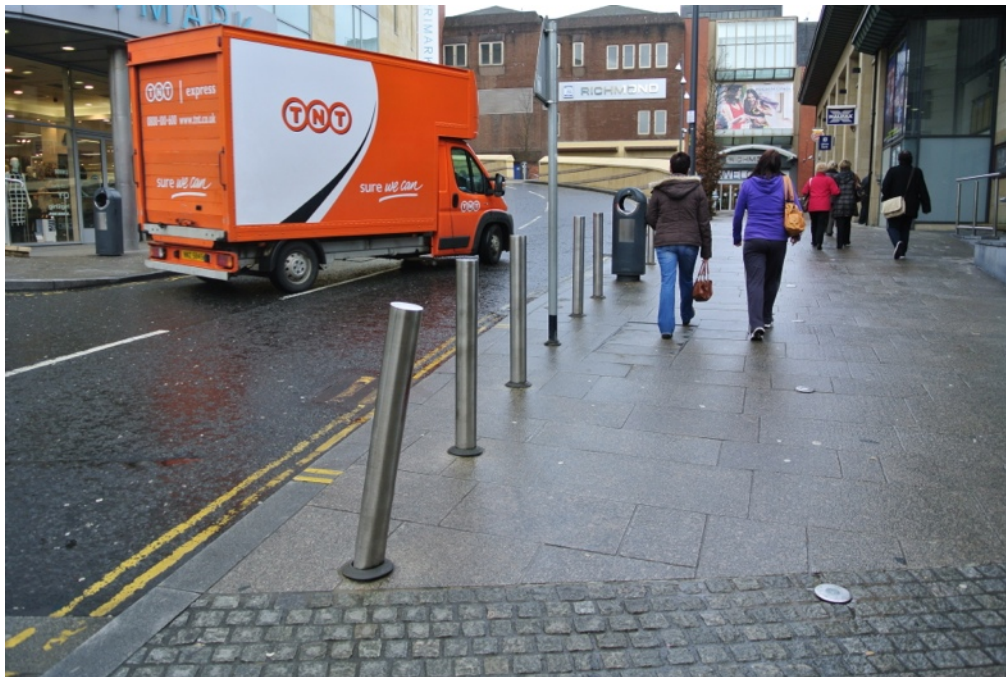
- 23 There are a series of chrome bollards outside the Millennium Forum with no contrasting band to enhance visibility.

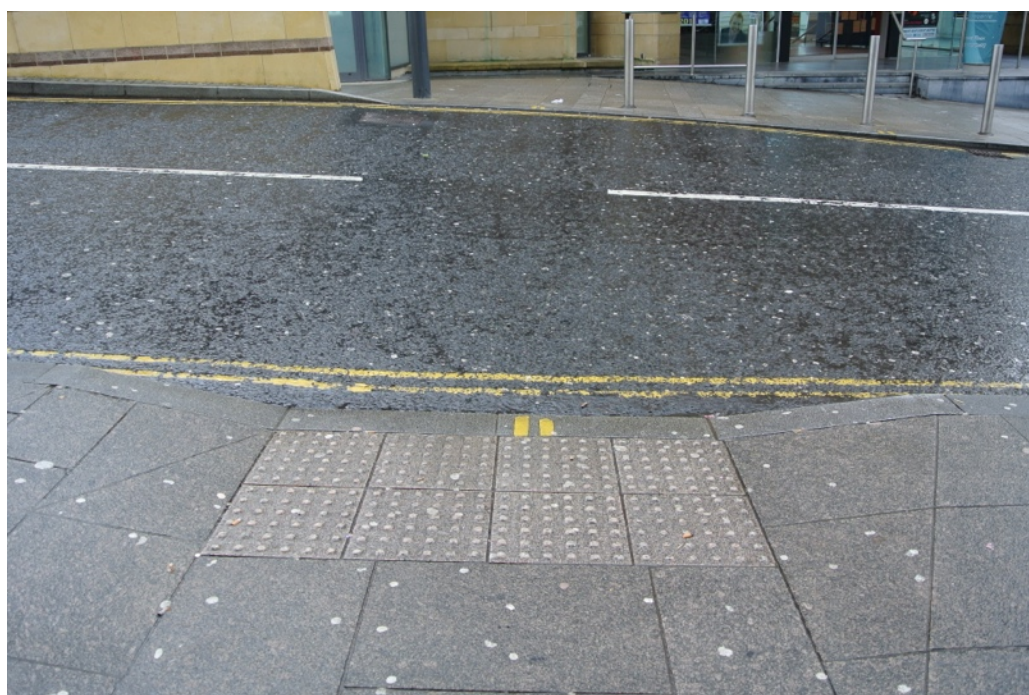
- 24 There is a dropped kerb with tactile paving on the south side of Newmarket Street. There is no provision on the other side.

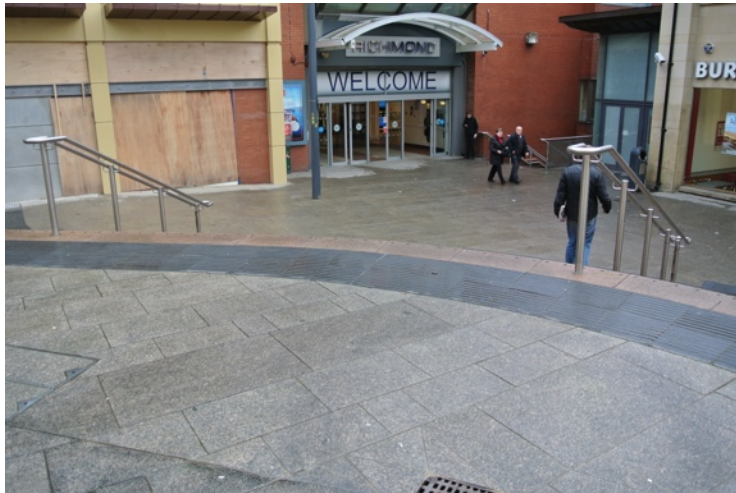
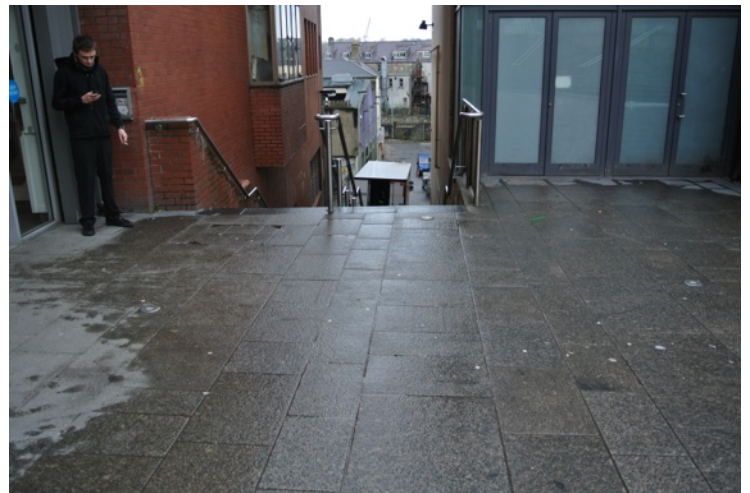
- 25 There is corduroy hazard paving provided around the stepped entrance leading to the Richmond Centre. However the steps beside the entrance to the Centre have no hazard paving.

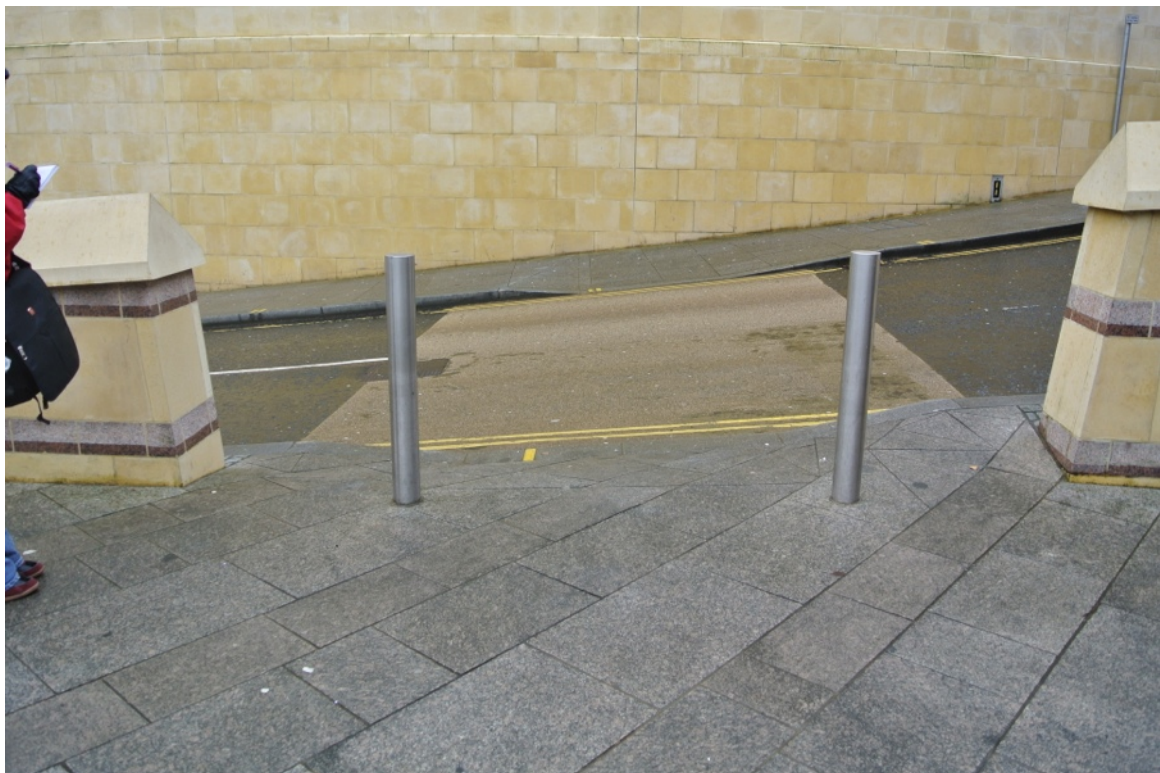
- 26 There is an inline uncontrolled crossing beside the stepped entrance to the Richmond Centre. No tactile paving has been provided and access is hampered by two chrome bollards without contrasting banding.

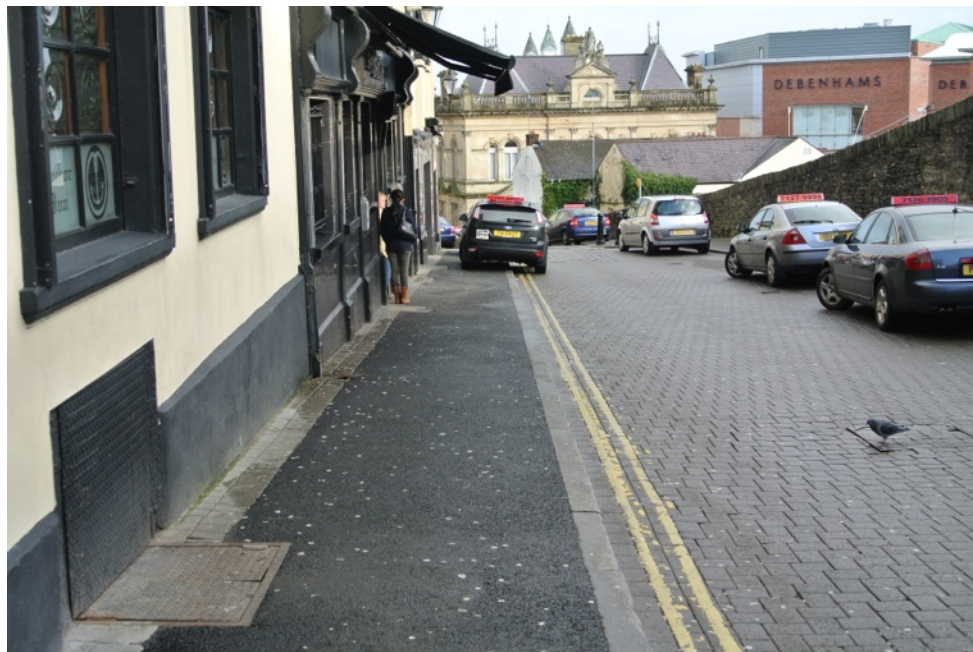
- 28 Vehicles parked on pavements restrict access on Market Street.

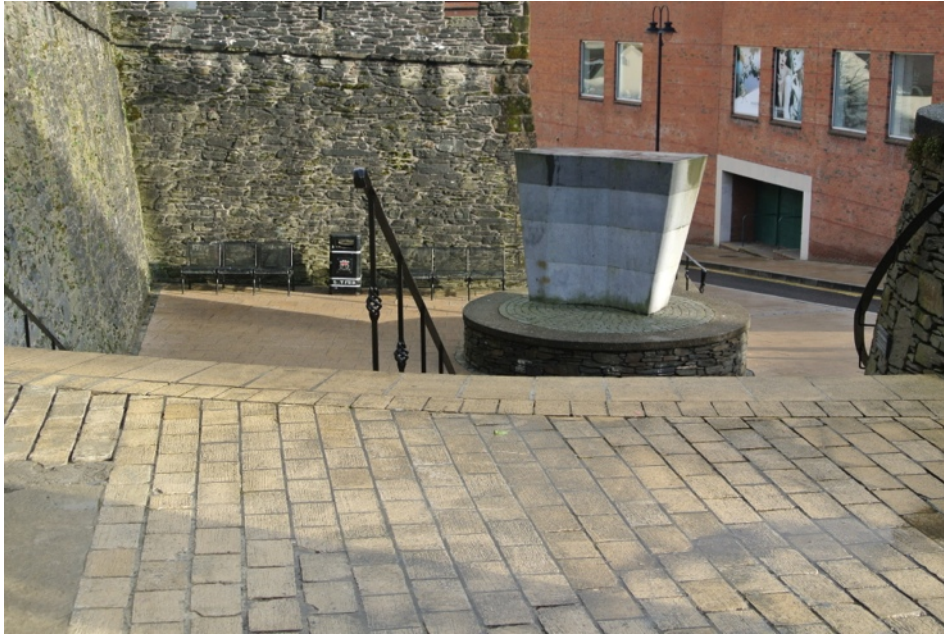
- 29 There are steep steps adjacent to Ferryquay Gate. These steps have no corduroy hazard paving.

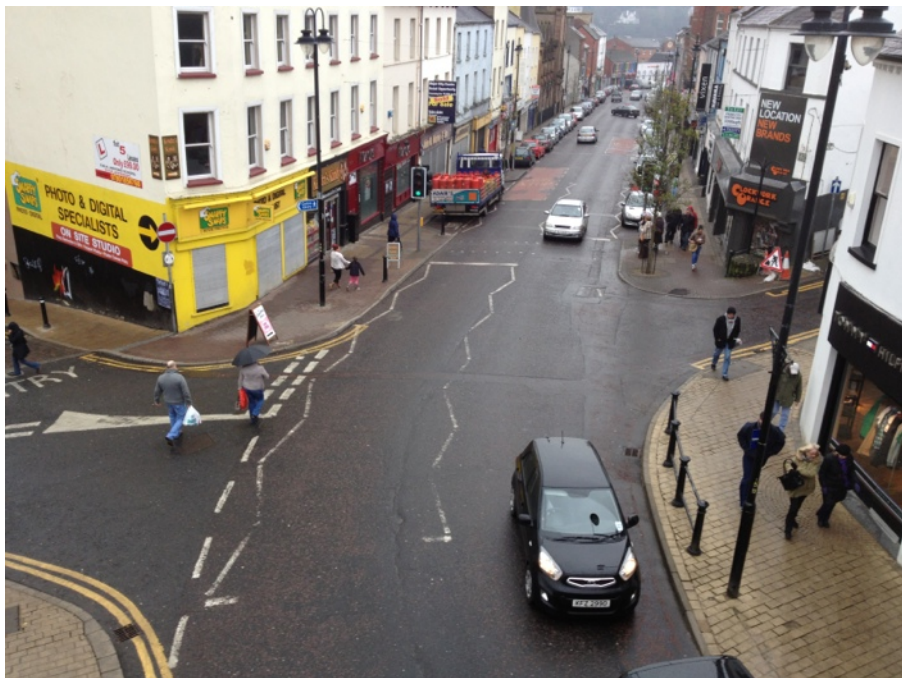
- 30 At Ferryquay Gate Orchard Street, Bridge Street, Fountain Street, Carlisle Road and Ferryquay Street all meet in what is a very busy junction. Whilst there are dropped kerbs in the area there are problems with their alignment and none of the dropped kerbs have tactile paving

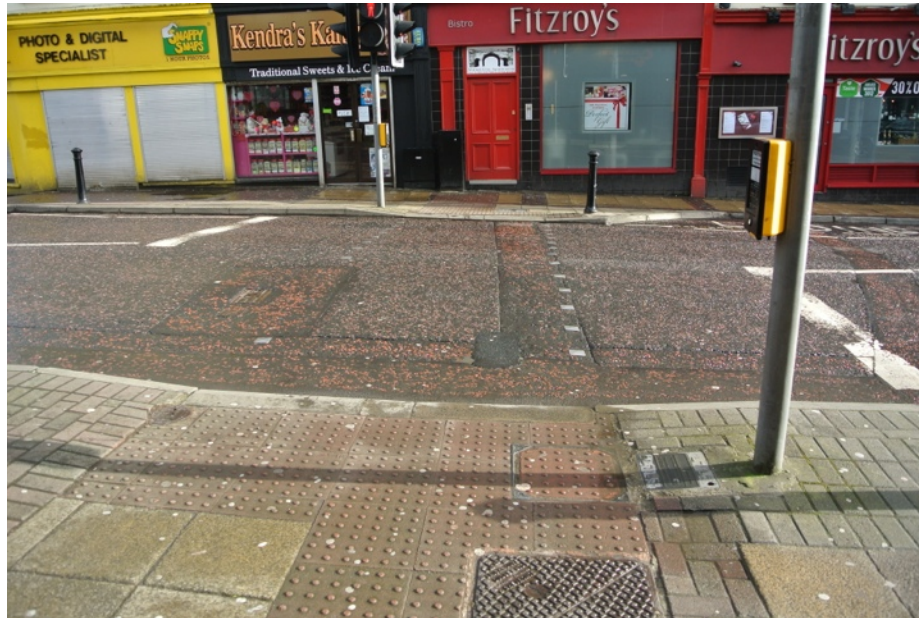
- 31 There is a good example of a controlled crossing at the northern end of Carlisle Road.

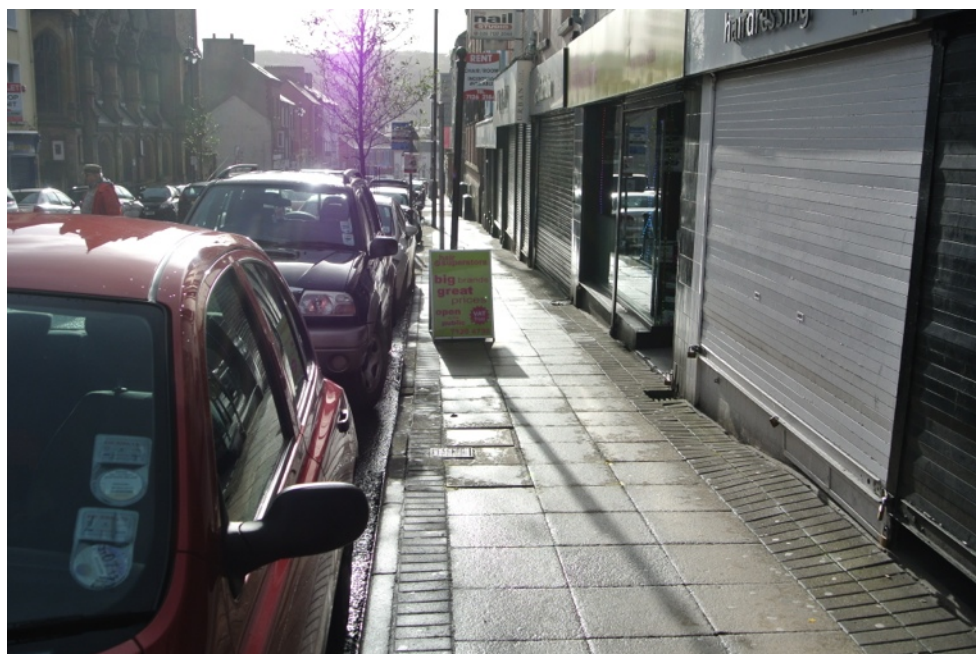
- 32 There are A-Boards on the pavement on Carlisle Road further restricting an already narrow pavement.

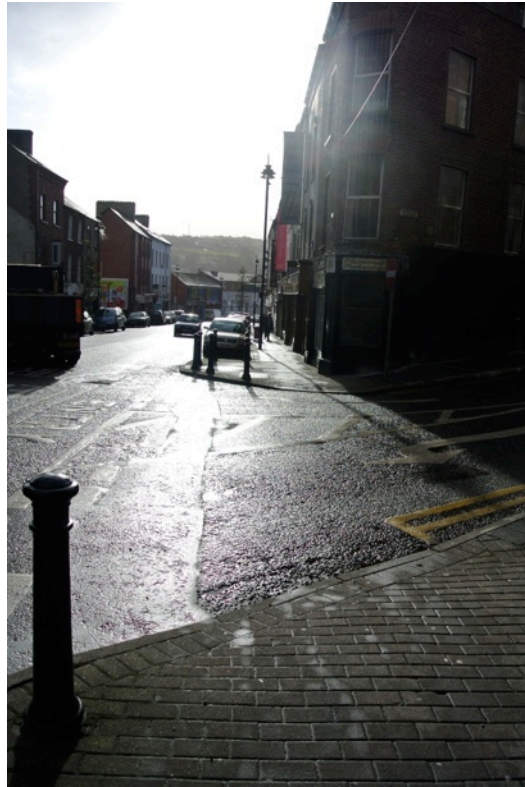
- 33 The in-line uncontrolled crossing at the junction with Horace Street has no tactile paving.

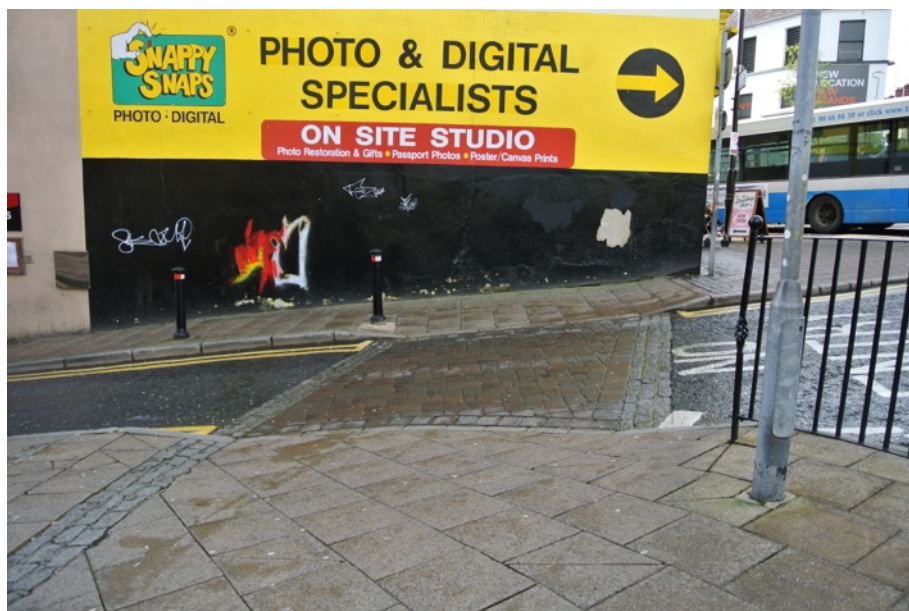
- 34 There is a raised in-line uncontrolled crossing at the junction of Bridge Street and Orchard Street. There is no tactile paving at this junction. Bollards have a red and white contrasting band.

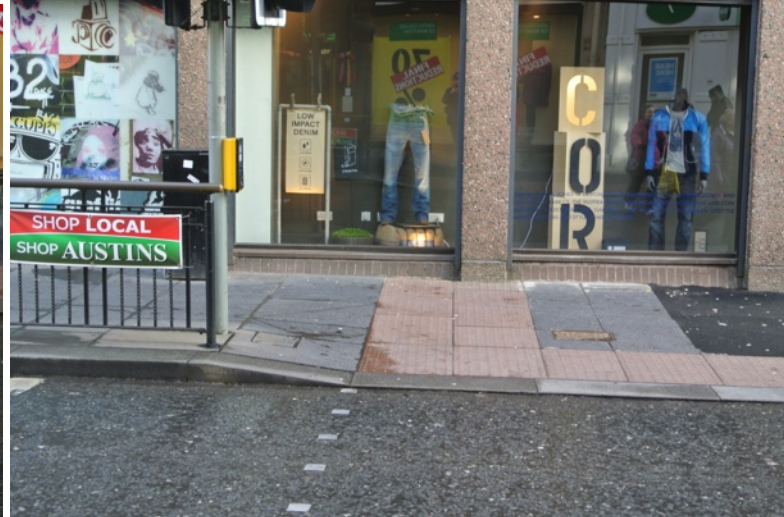
- 37 There is a controlled crossing at the northern end of Ferryquay Street (close to the Diamond). The control boxes on the crossings are too far from the tactile paving.

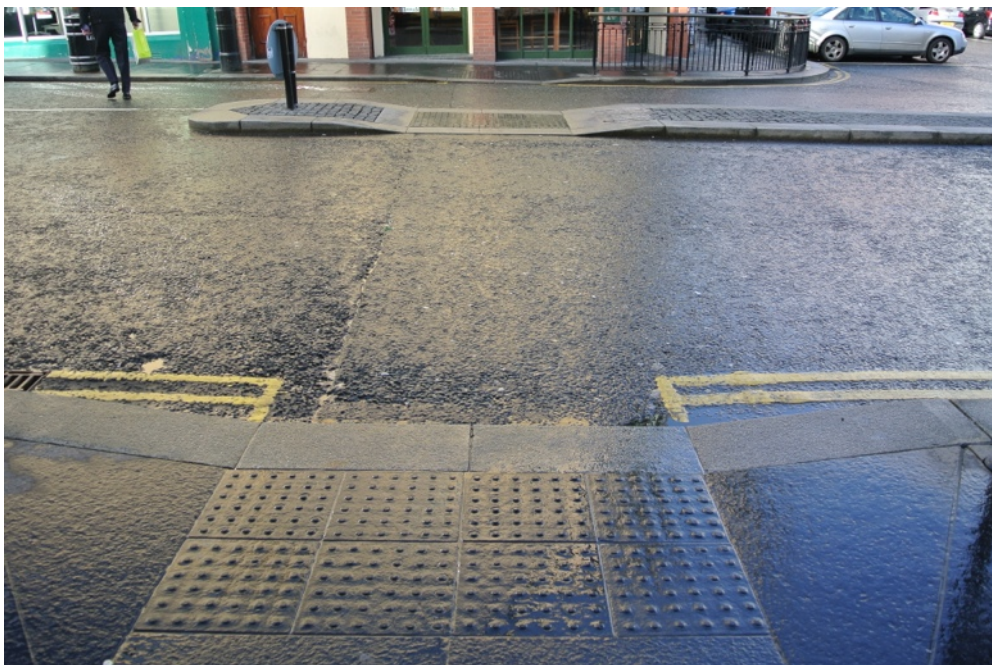
- 38 There is a good in-line uncontrolled crossing at the northern end of Bishops Street. However the tactile paving does not provide any contrast with the surrounding pavement.

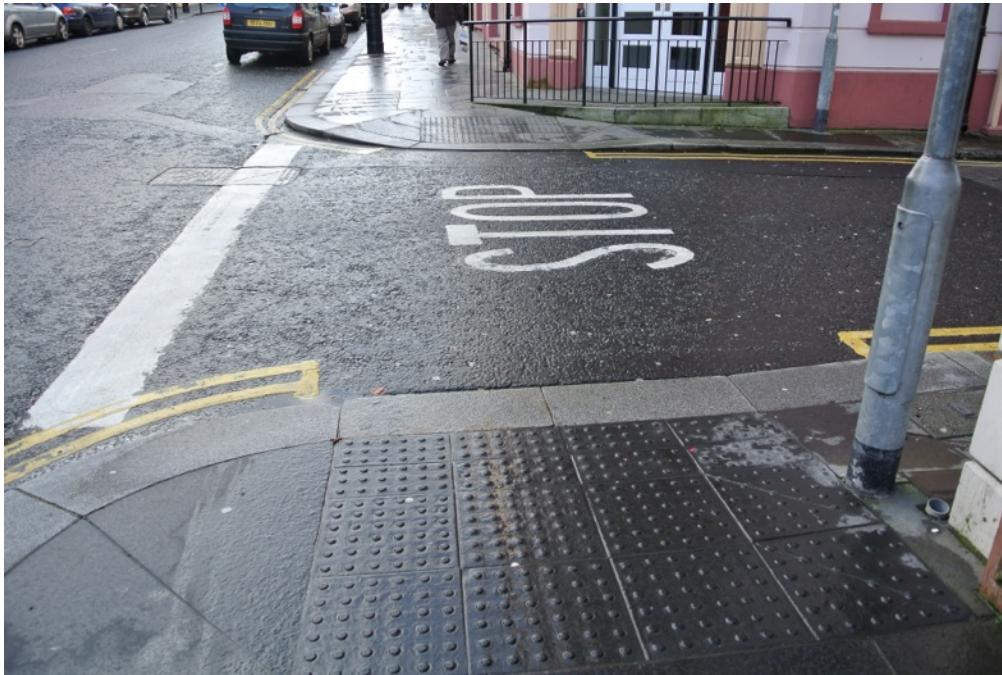
- 39 This issue is repeated with the in-line crossing at the junction with London Street.

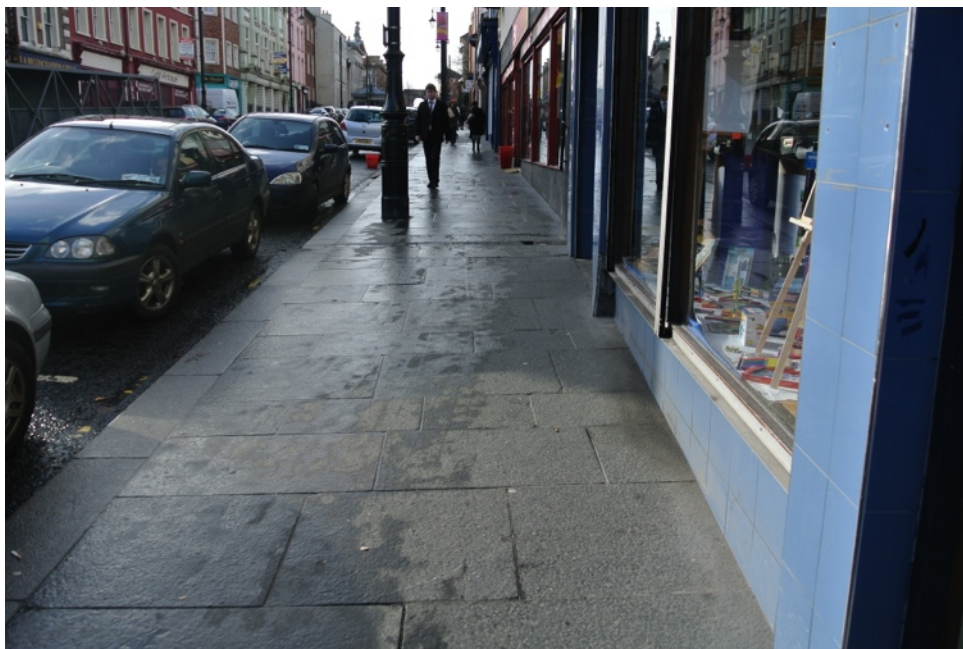
- 40 The pavements on Bishop Street are generally free of clutter. The use of dish drainage channels is not ideal.

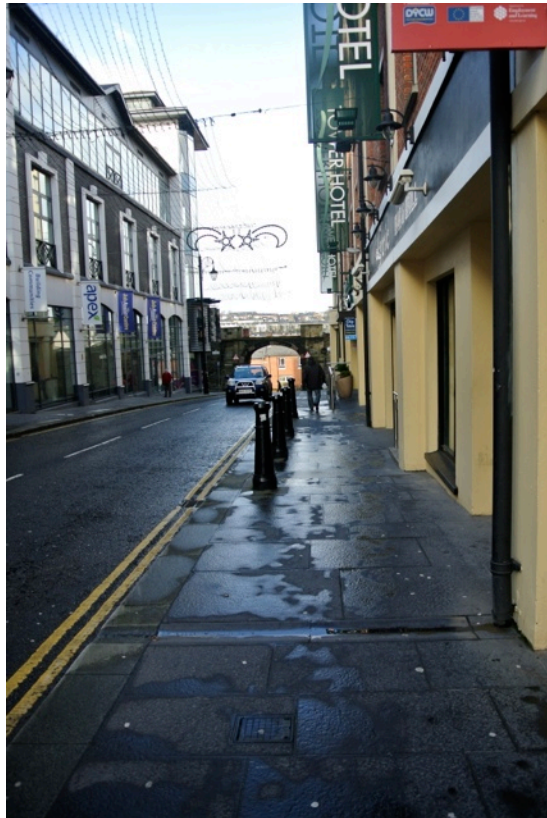
- 43 Bollards at the entrance to the Tower Hotel have no contrasting band and narrow the pavement.
