Report on Walking routes in Derry/Londonderry City Centre

July 2013

Audit of key routes

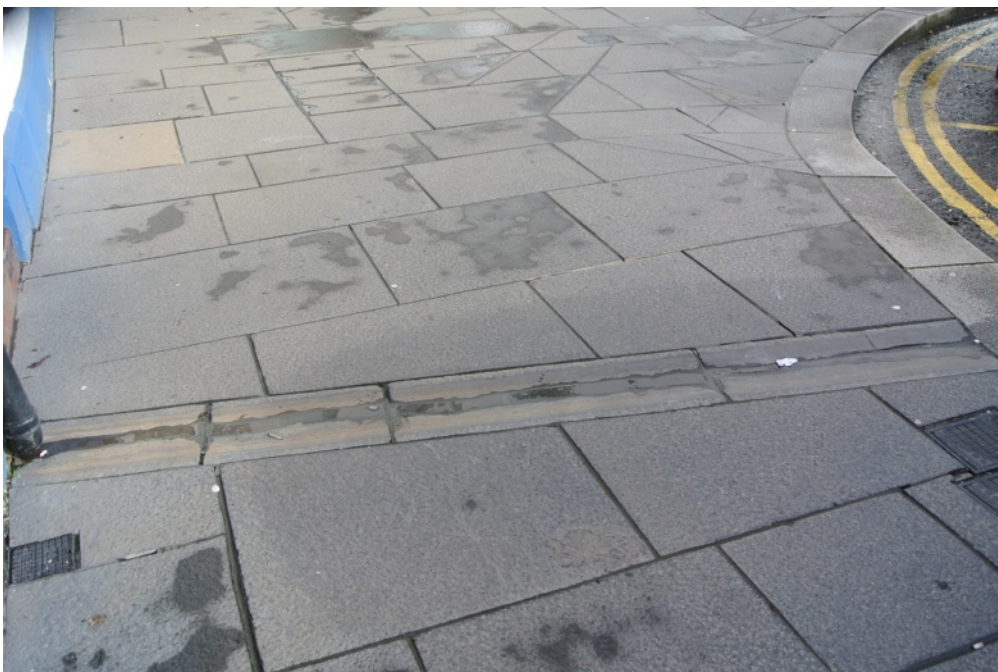
- 44 Dish drainage channels pose hazards in and around the Diamond.

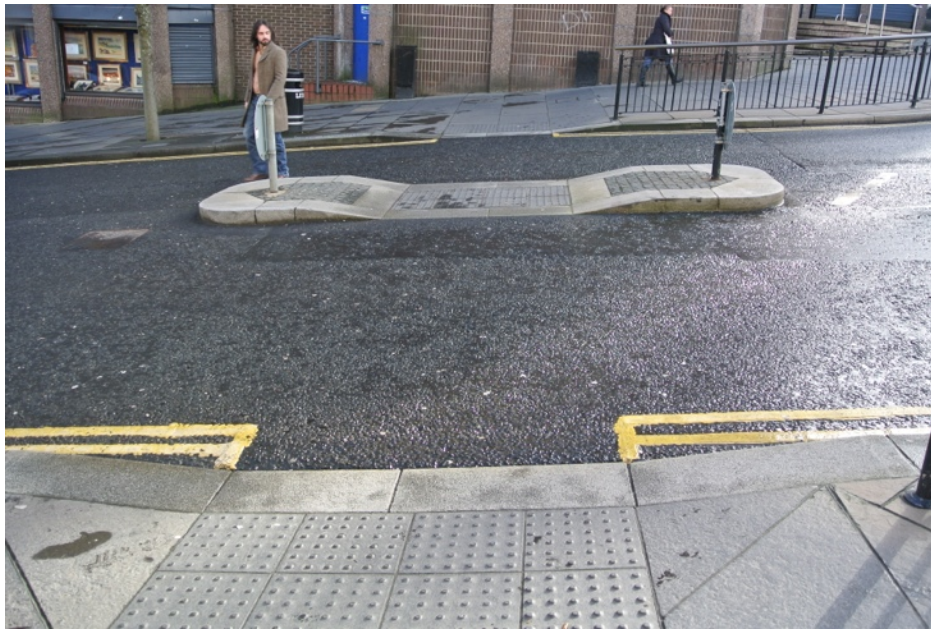
- 45 The in-line uncontrolled crossing at the junction with the Diamond uses tactile paving that does not contrast with the surrounding pavement.

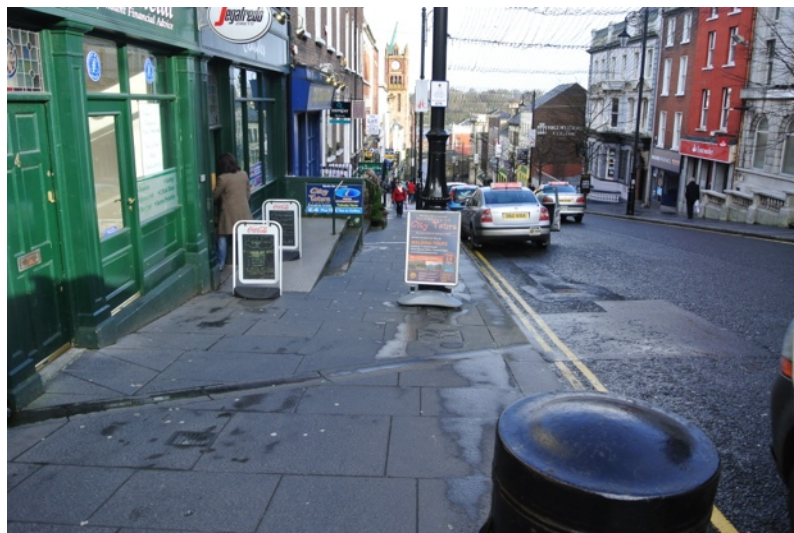
- 46 A-Boards, street furniture and lighting columns restrict pavement width on the street.

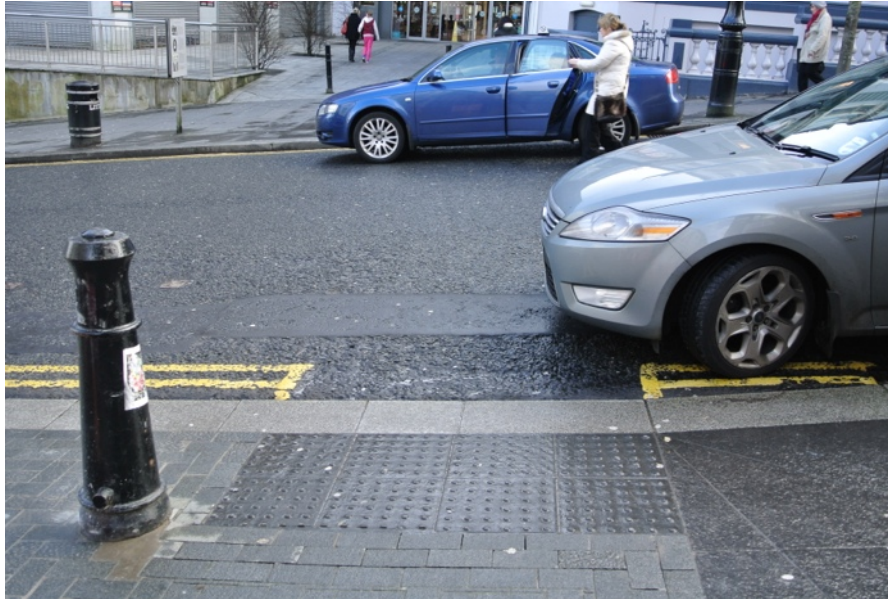
- 47 Access to the in-line crossing at the junction of Castle Street is restricted by bollards (no contrasting band) and parked cars. There is the same issue with contrast and tactile paving.

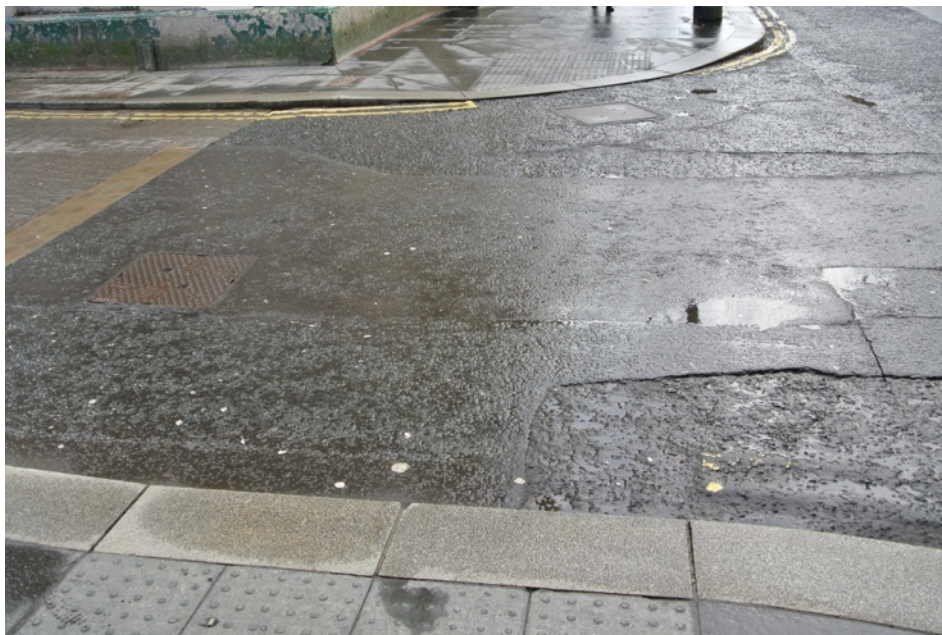
- 48 The issue with contrast and tactile paving is present at the junction with Union Hall Place.

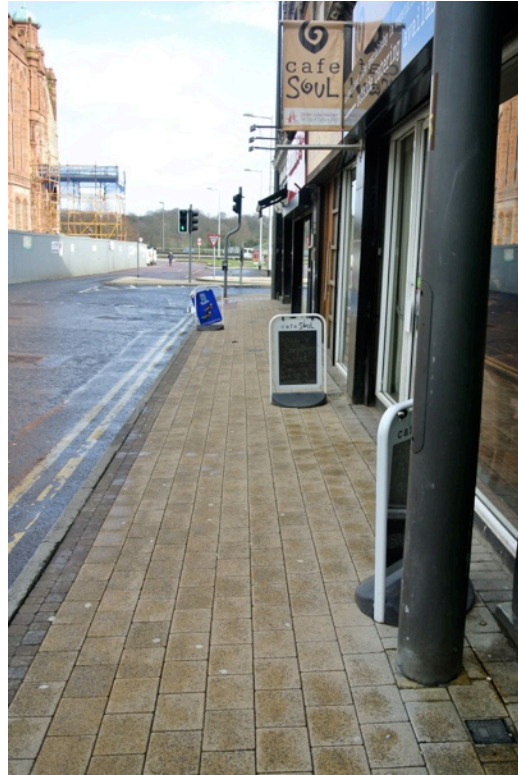
49 A-Boards are a problem on the pavement in this area.

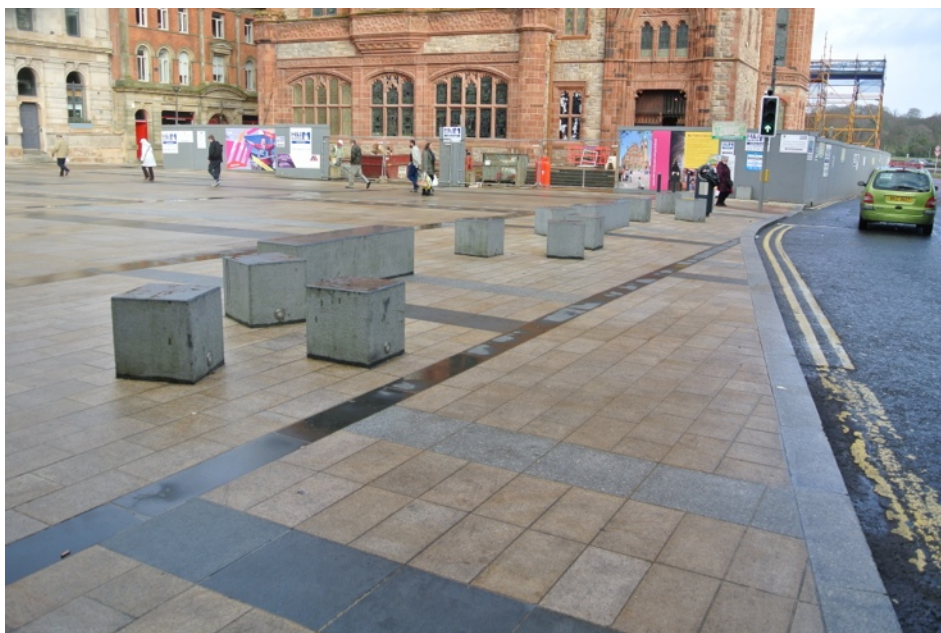
50 Random blocks are poorly contrasted and present numerous hazards for people with a visual impairment.

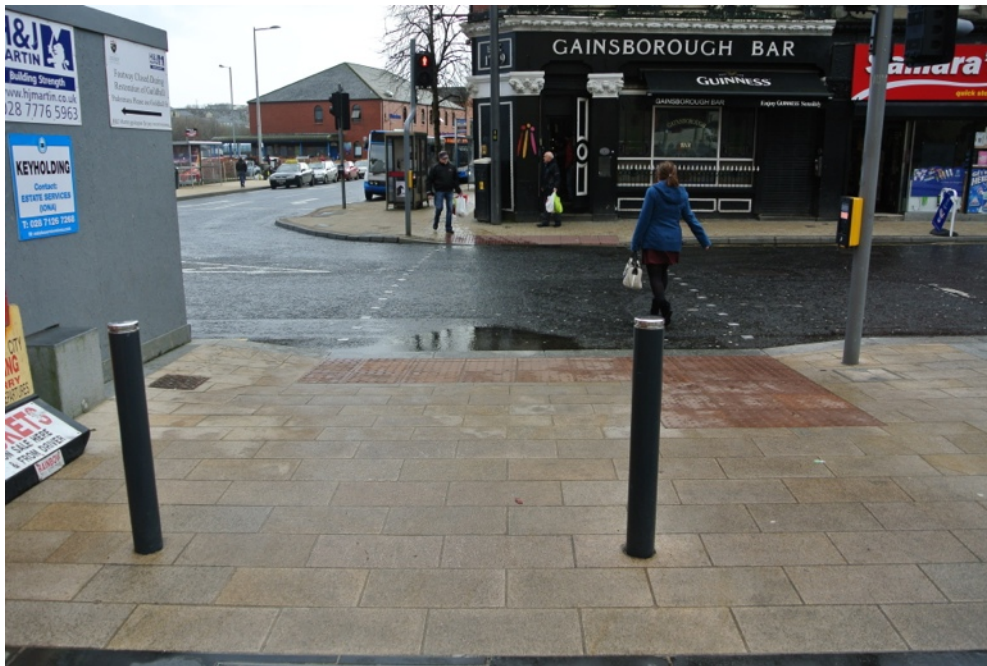
- 51 Bollards at the controlled crossing are poorly contrast and reduce the benefits of a well-designed crossing.

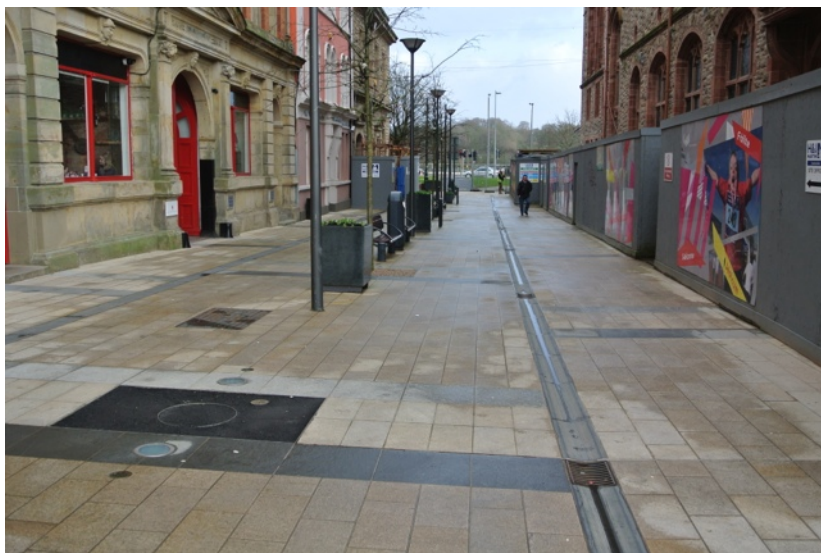
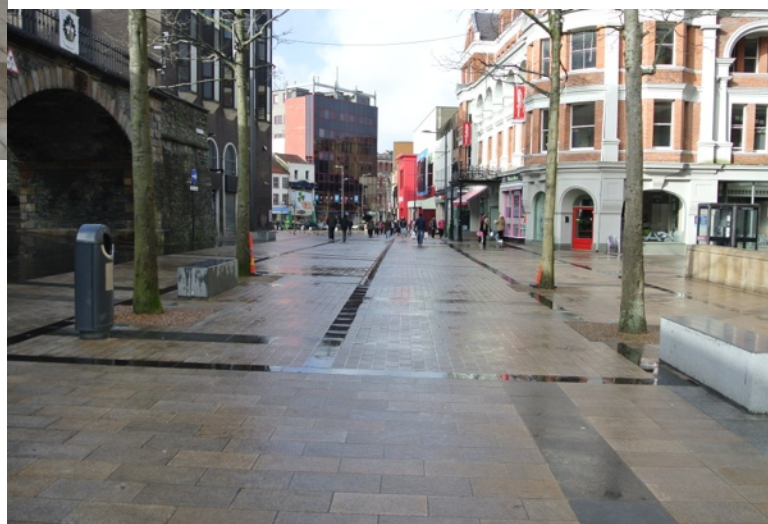
- 52 Street furniture is contained within clear lines in the area.

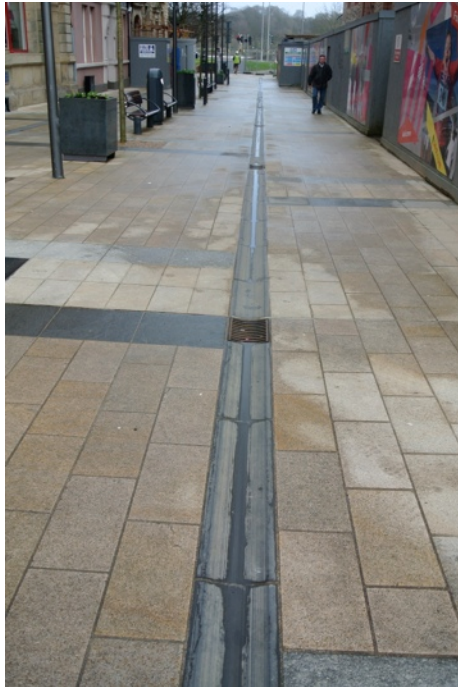
53 Dish drainage channels are deep and present a potential hazard.

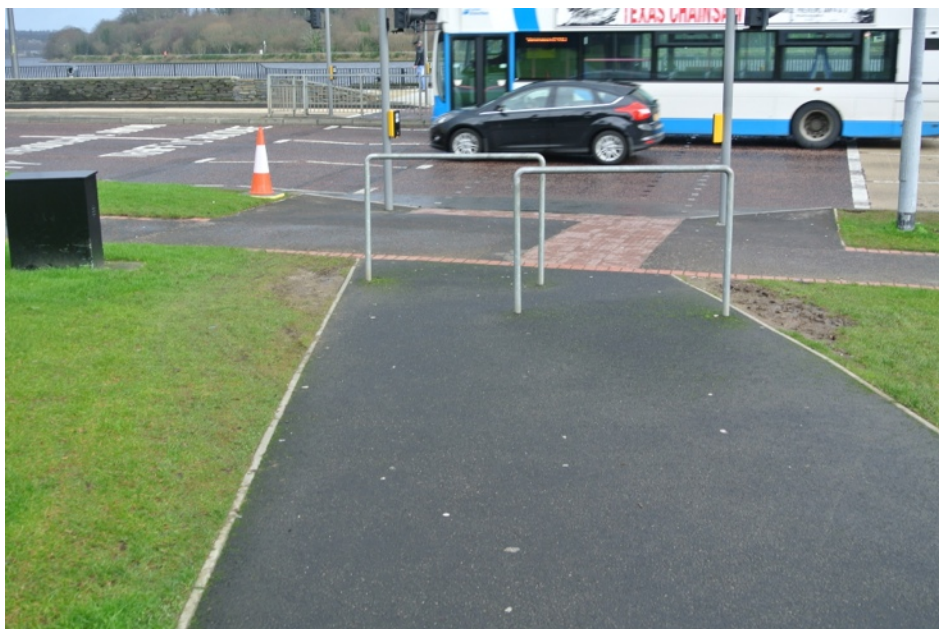
54 Barriers across the path leading from Guildhall Street to Foyle Embankment have been erected to enhance safety for cyclists and pedestrians approaching a busy road. These create difficulties for people with a visual impairment and other disabled people.

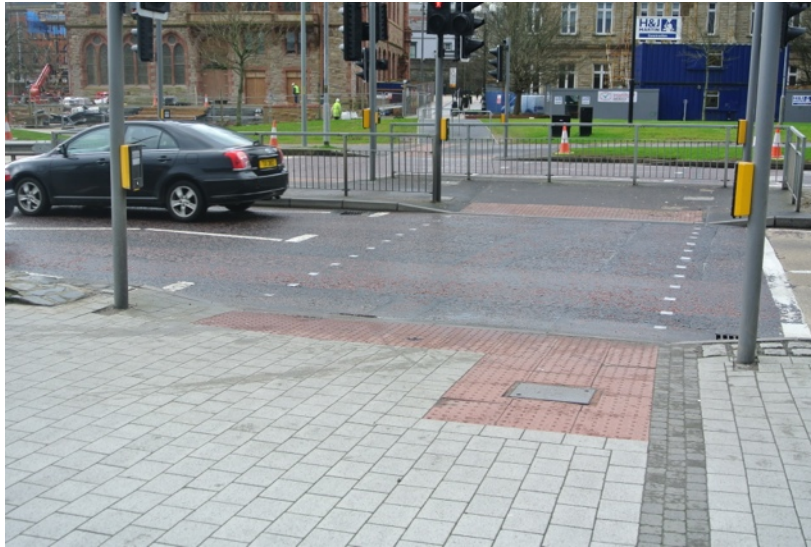
- 55 There is a good example of a controlled crossing on Foyle Embankment.

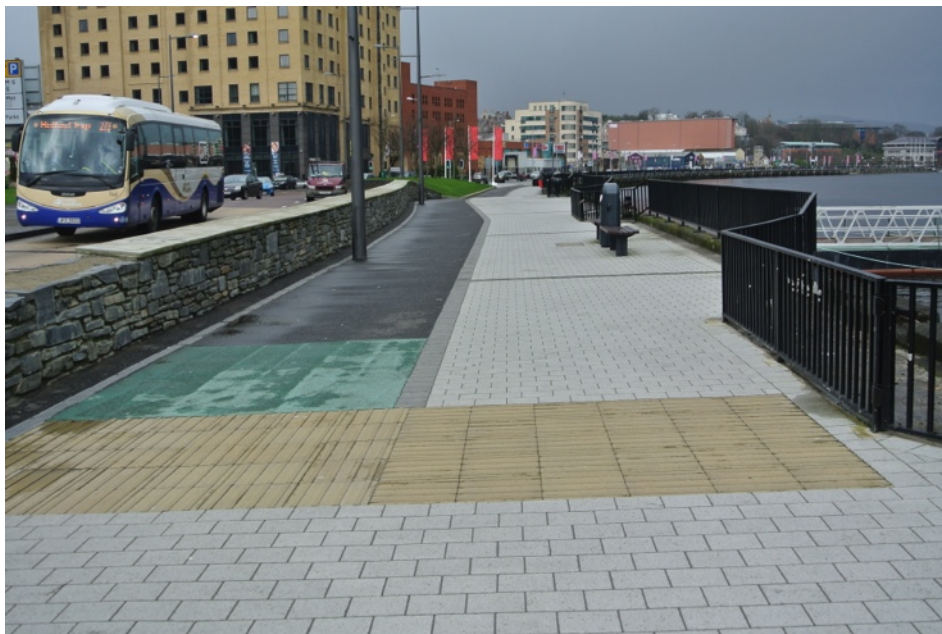
- 56 There is a broad shared use cycle/pedestrian path on Foyle Embankment with appropriate use of tactile surfaces.

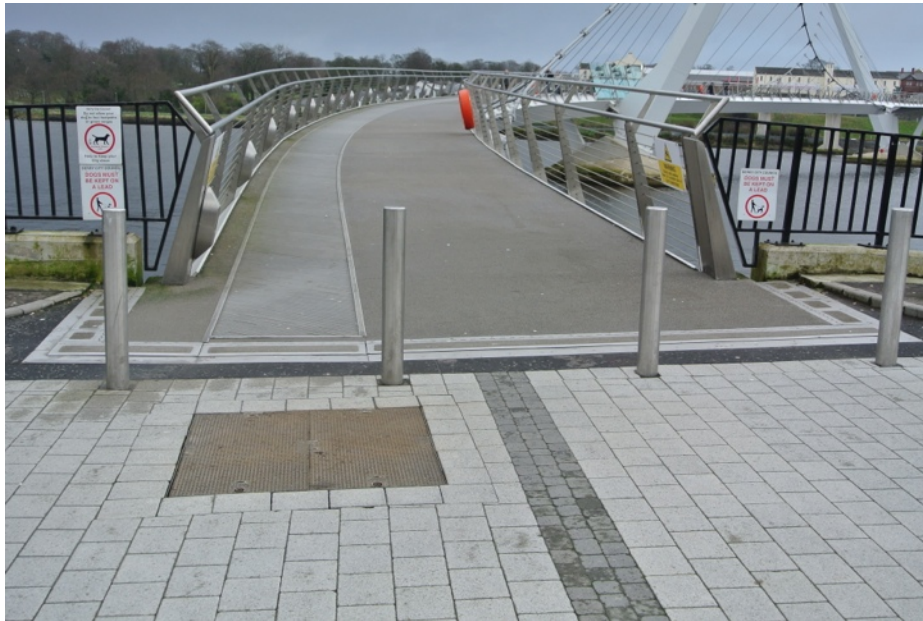
- 57 Bollards at the entrance to the Peace Bridge would benefit from the addition of a contrasting band.

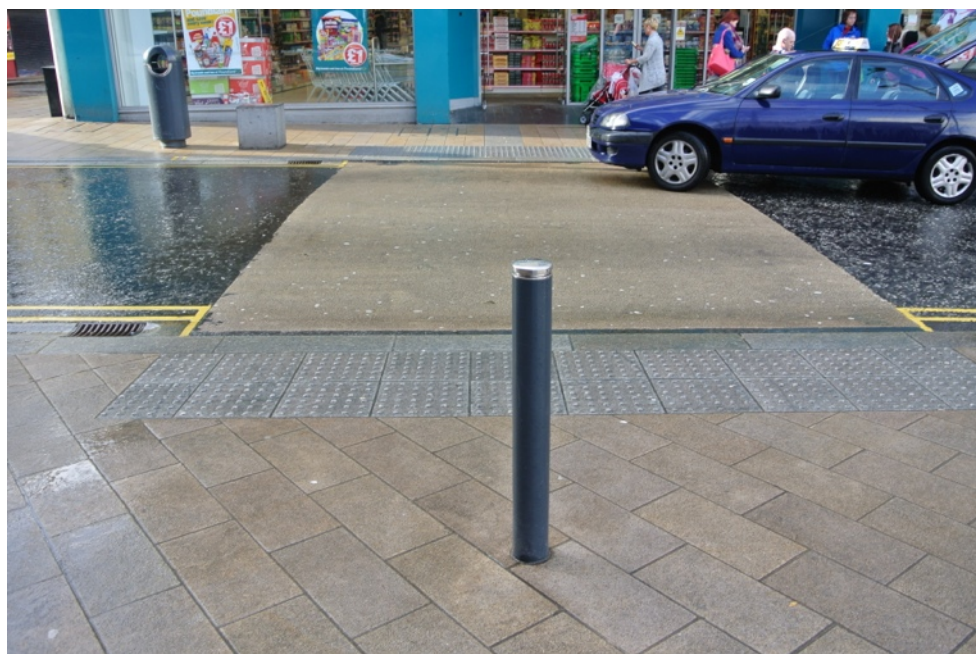
- 58 There is an in-line uncontrolled crossing. Contrast of tactile paving is again an issue. Other obstacles include bollards, stone cubes and inappropriately/illegally parked vehicles.

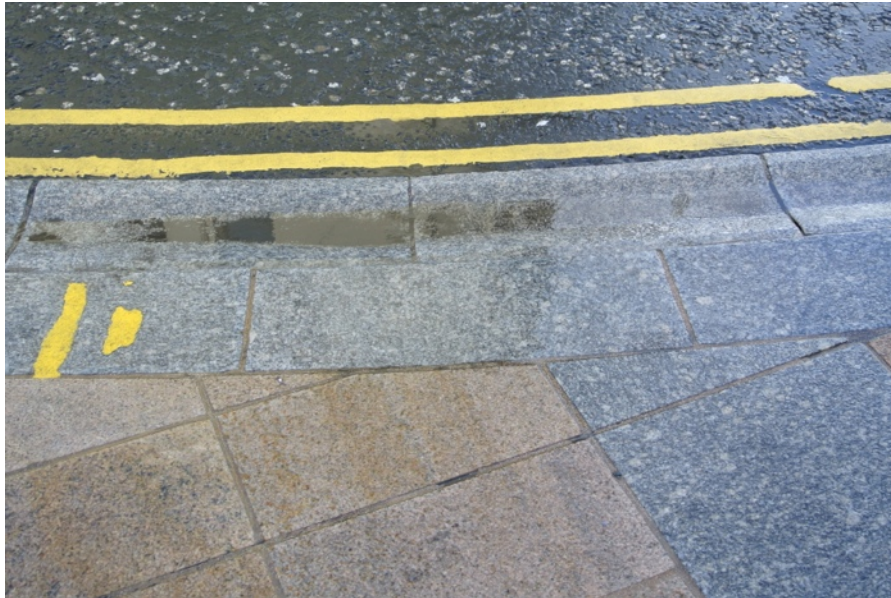
- 59 The use of dish drainage channels to demark the pedestrian and road surfaces in areas of Waterloo Place is not ideal but is preferable to no delineation.

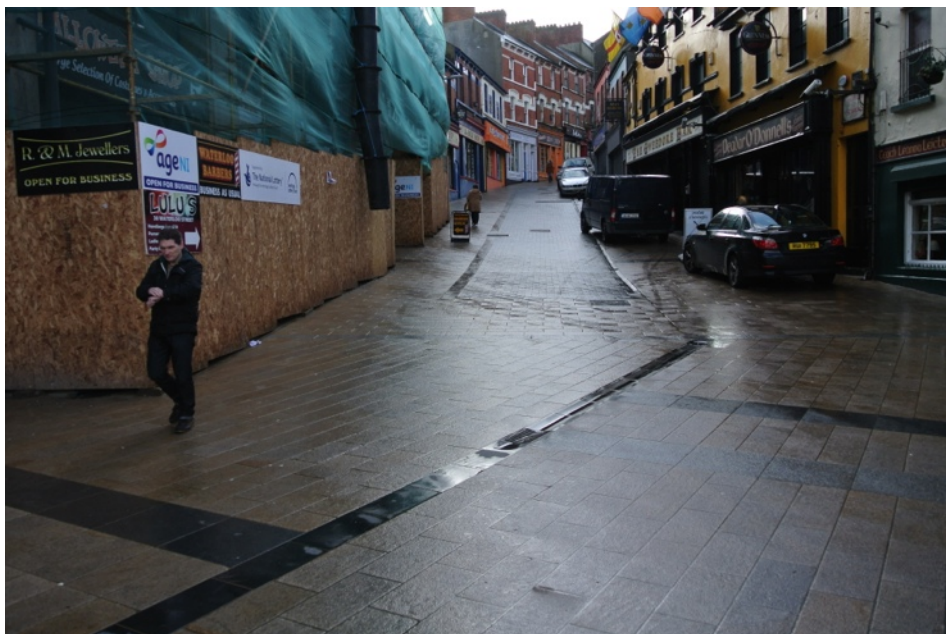
- 60 Moving and parked cars, as well as random clutter makes Waterloo Street a difficult place for people with a visual impairment.

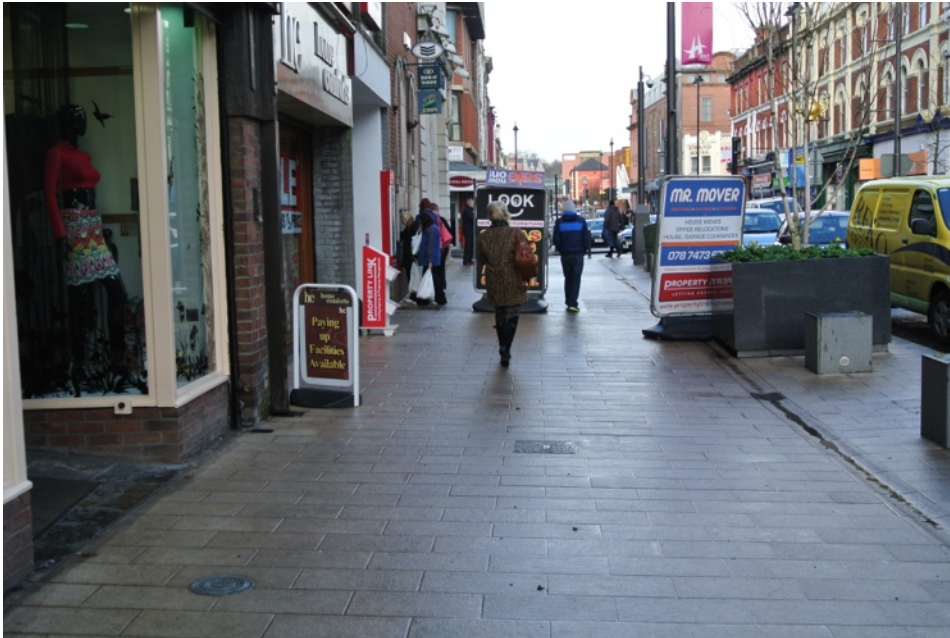
- 60 Clutter on the pavement is a problem at the southern end of Strand Road including some very large A-Boards.

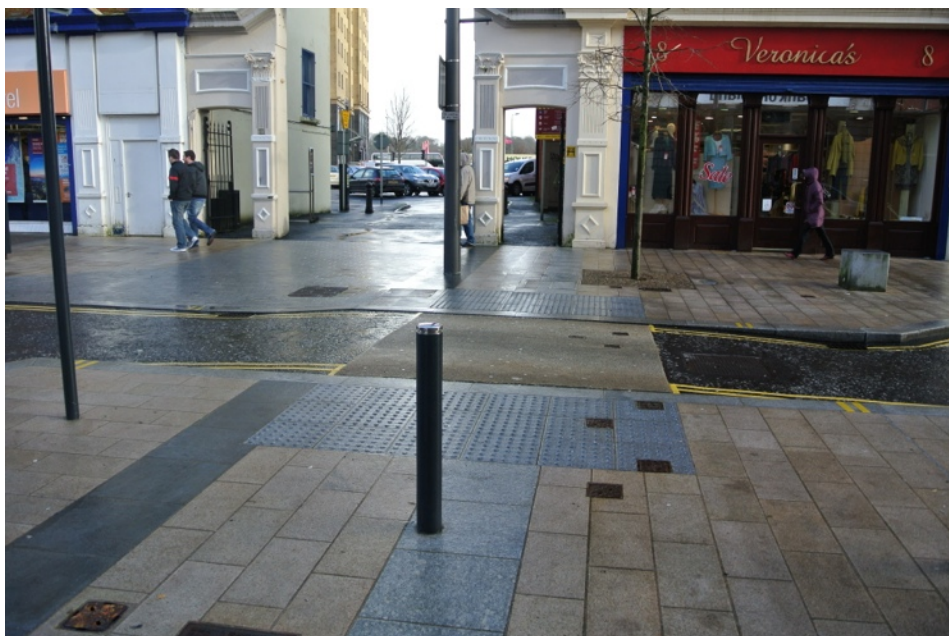
- 61 There is an in-line uncontrolled crossing at Victoria Market. Non-standard tactile paving is used. Poorly designed bollards restrict access.

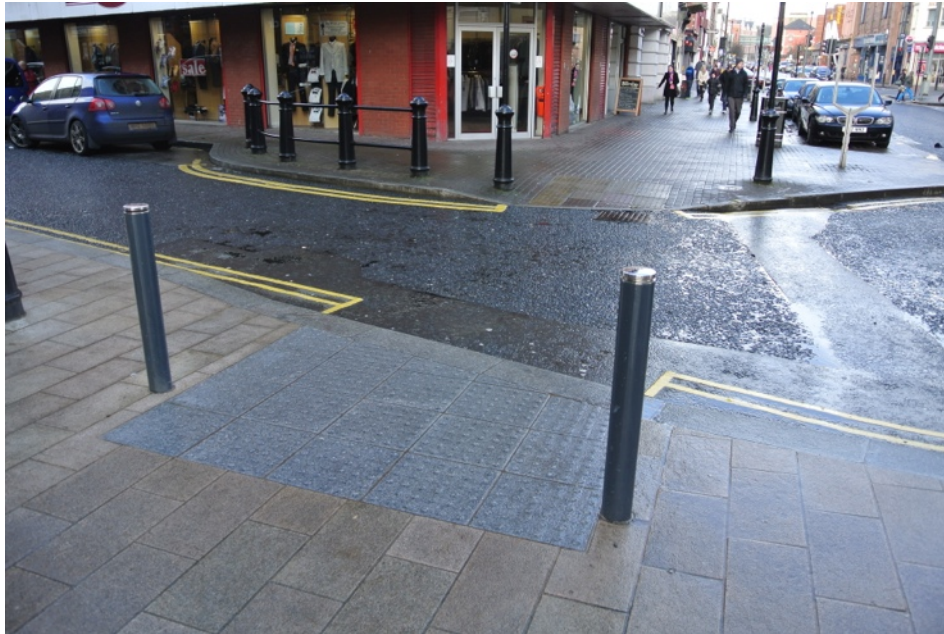
- 62 There is an in-line uncontrolled crossing at the junction with Sackville Street. Two different colours of tactile paving are used on one side, non-standard paving on the other. Bollards on one side present an additional obstruction.

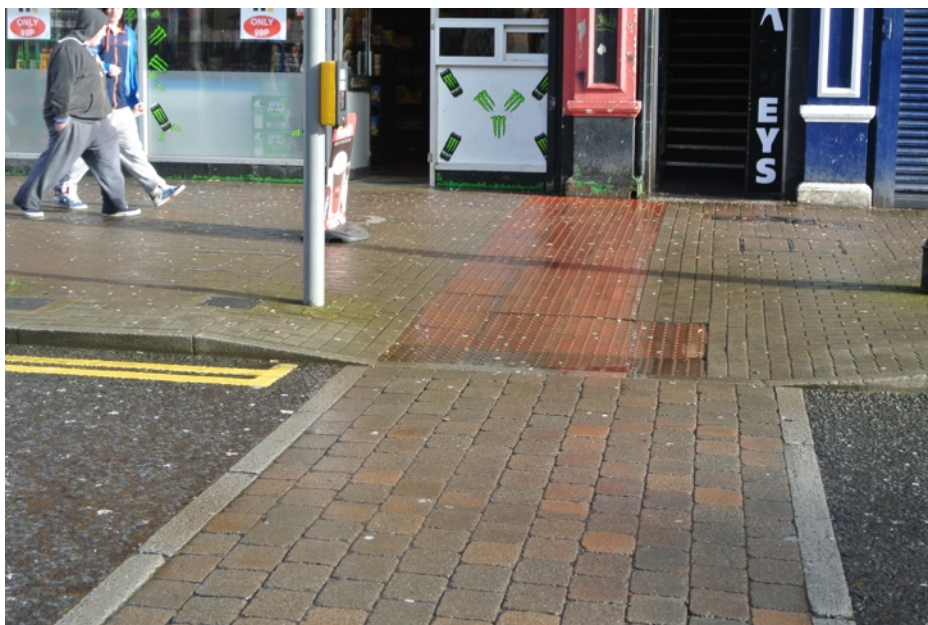
- 63 There is a controlled crossing on Strand Road between the junctions with Sackville Street and Great James Street. There is no contrast between the tactile paving and the surrounding surfaces.

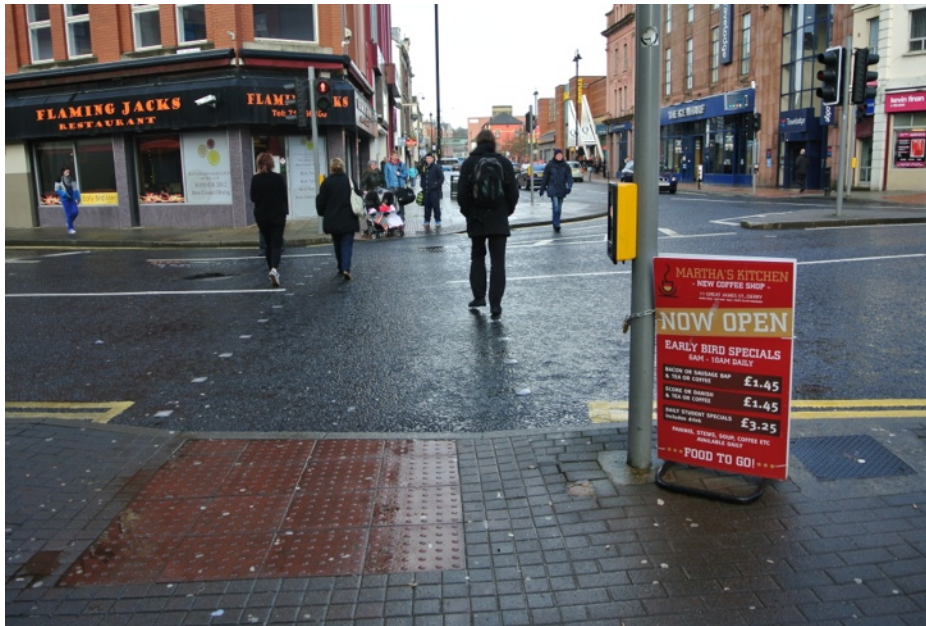
- 64 There are a series of controlled crossing at the junction with Great James Street. At the western end of Great James Street there is non-standard use of tactile paving and the control box is too far from the paving.

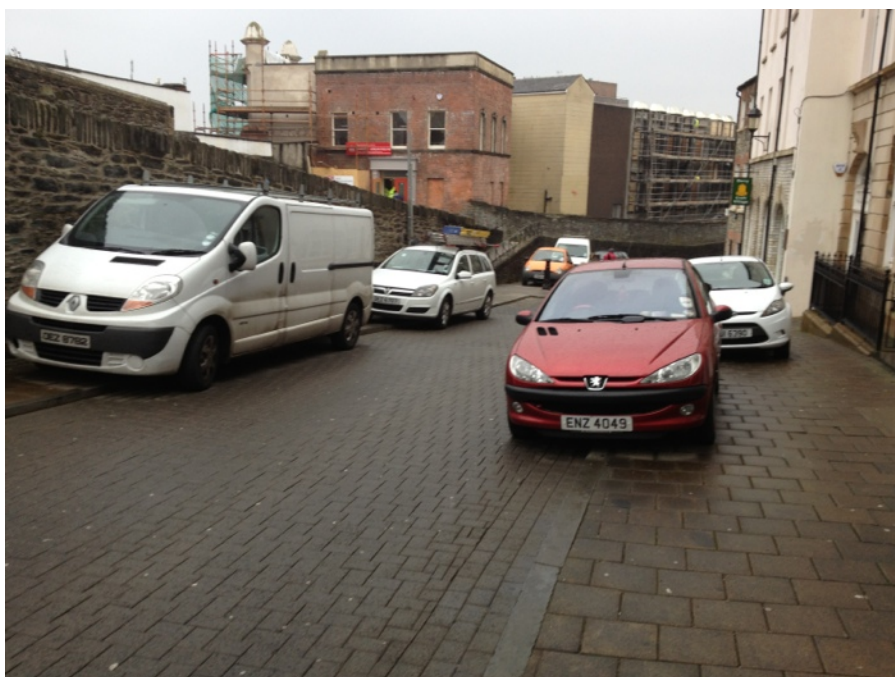
- 67 Parked vehicles on pavements reduces access for all pedestrians.

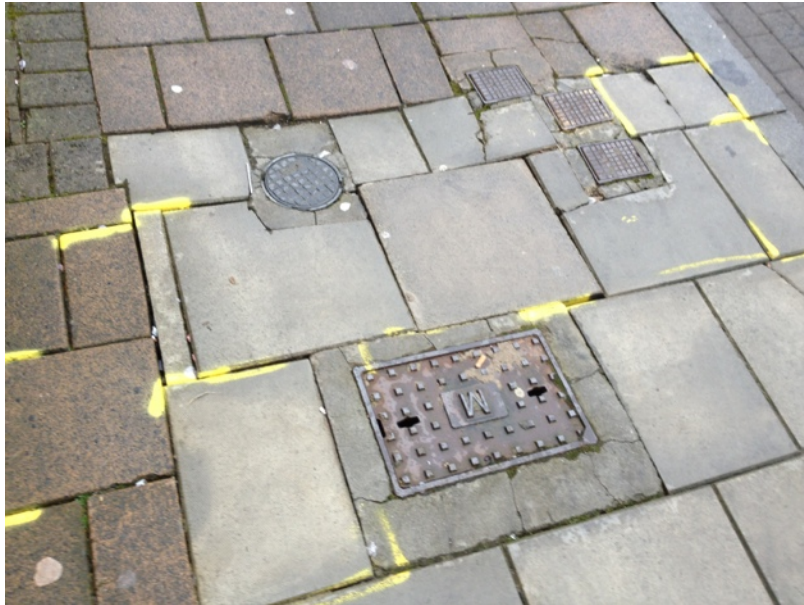
- 68 In general pavement surfaces in the area are of a lesser quality than in other parts of the city.

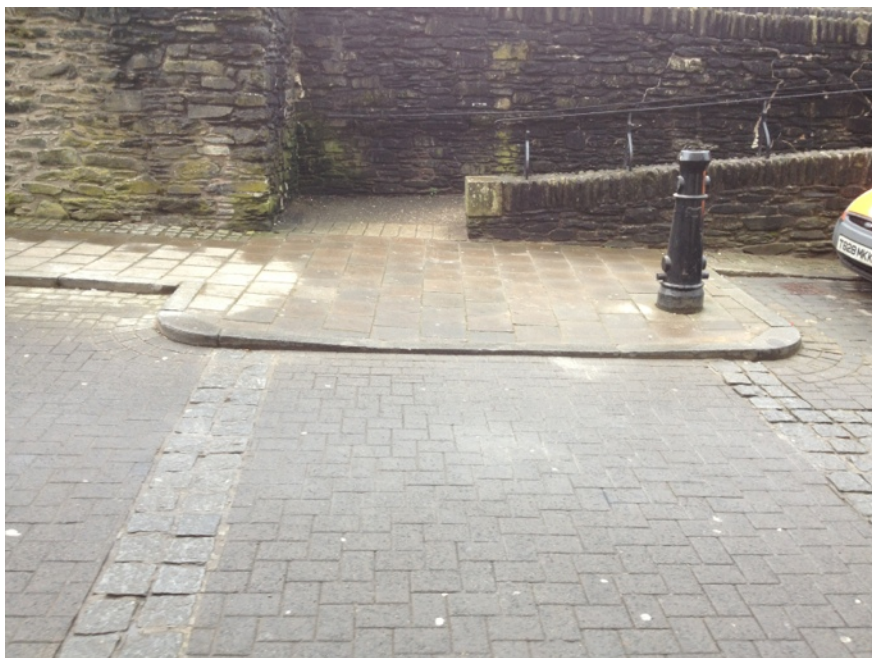
- 69 There are limited crossings in the area. A raised uncontrolled crossing does not have any tactile paving.

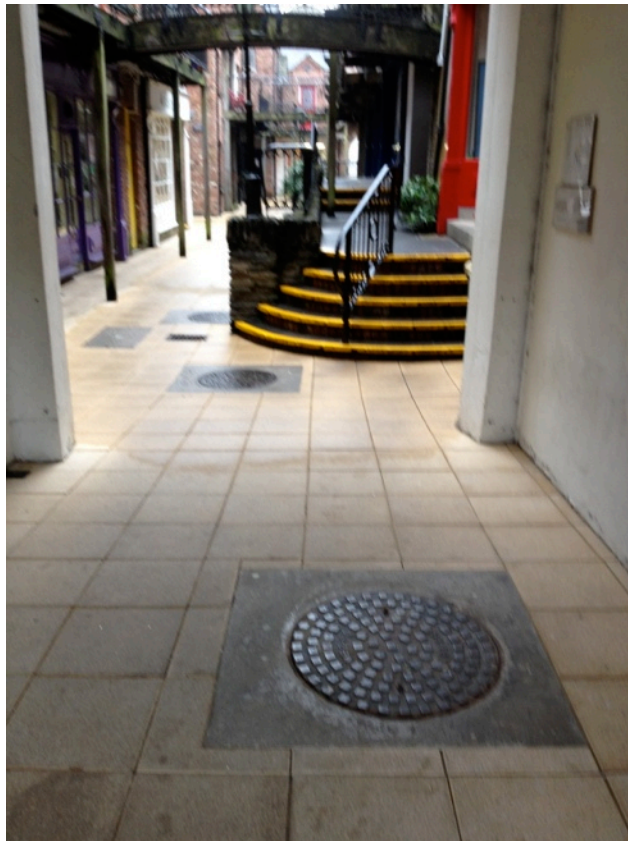
- 71 Contrasting bands have been added to the nosing of steps.

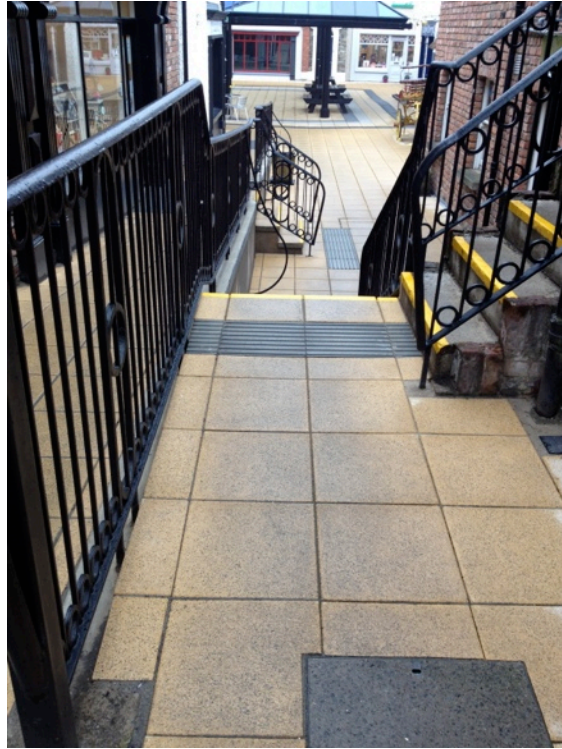
72 Corduroy hazard paving is included around steps.

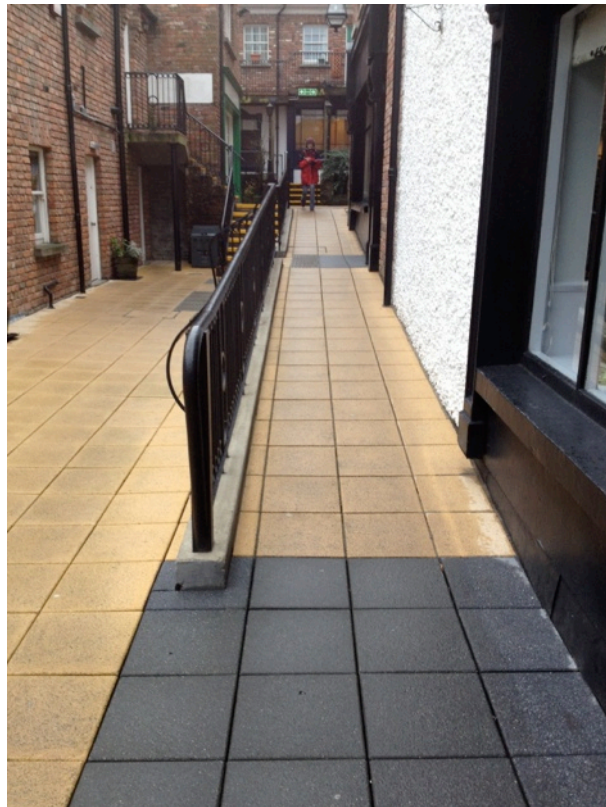
73 A ramp has been included to aid access between levels.

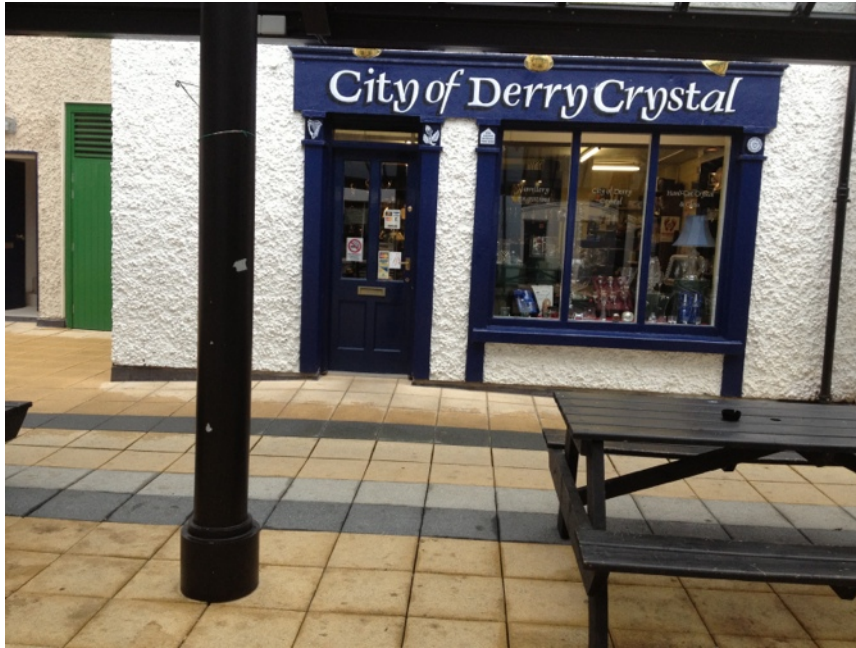
- 74 While not possible with every premise footway levels have been constructed to offer level access to a significant number.

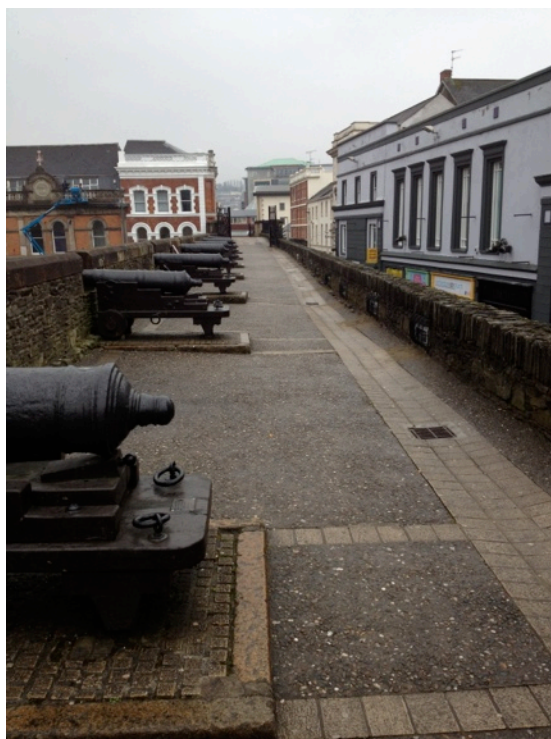
- 75 In general access to the walls is difficult for disabled people due to their status as an historic monument and the topography of the area which limit opportunities to make even reasonable improvements.
