**An assessment of facilities at the North West
Transport Hub**

(April 2020)

The initial phase of the the North West Hub was completed in late 2019. A site visit involving Imtac members and representatives from the Consumer Council took place on the 26th February 2020. This report details the findings from the site visit, assessing the provision at the new station against Imtac's recommendations and key inclusive design considerations. Because work on the approaches to the station including car parking and bus infrastructure is not complete this report is focuses on the station and its facilities only.

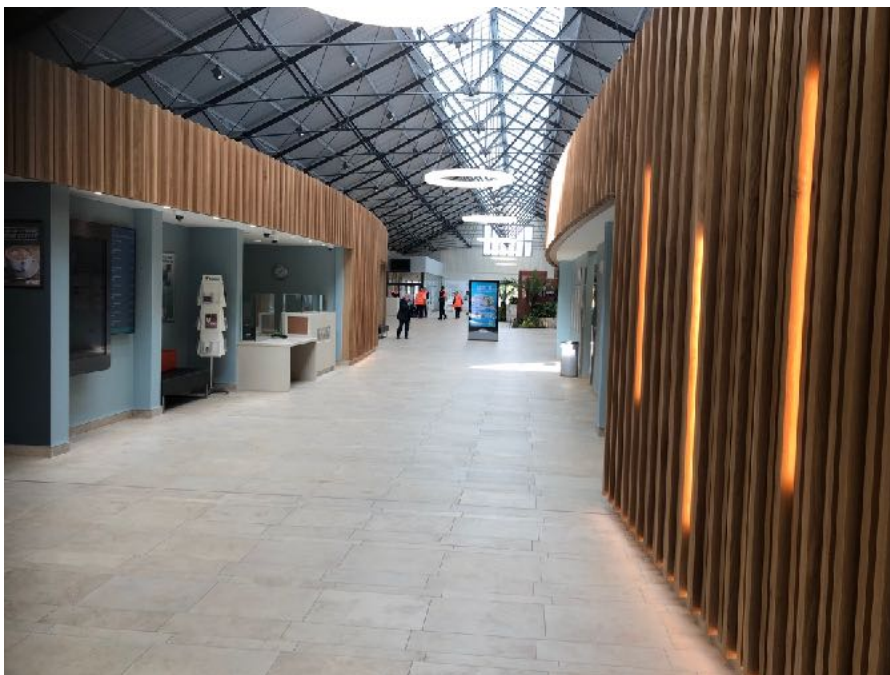
(Image shows interior of the station looking towards the access to platforms. Toilet facilities are on the right, ticket desk to the left)

All public facilities in the building are provided on the same level providing step free access from entrance to platform.

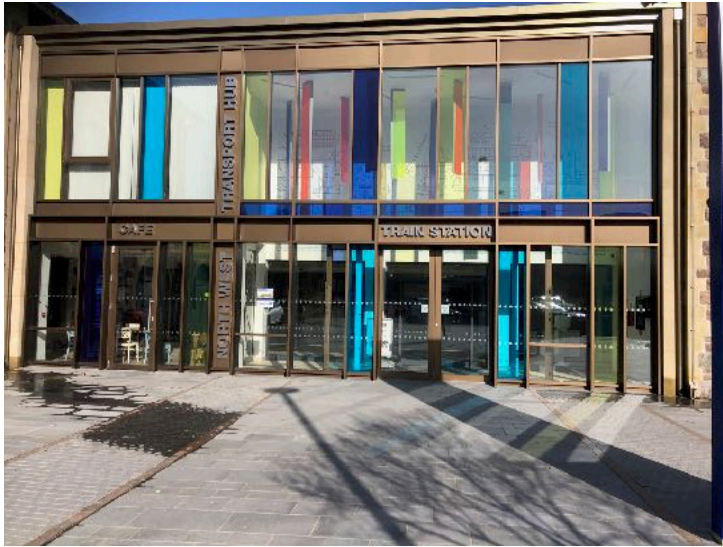
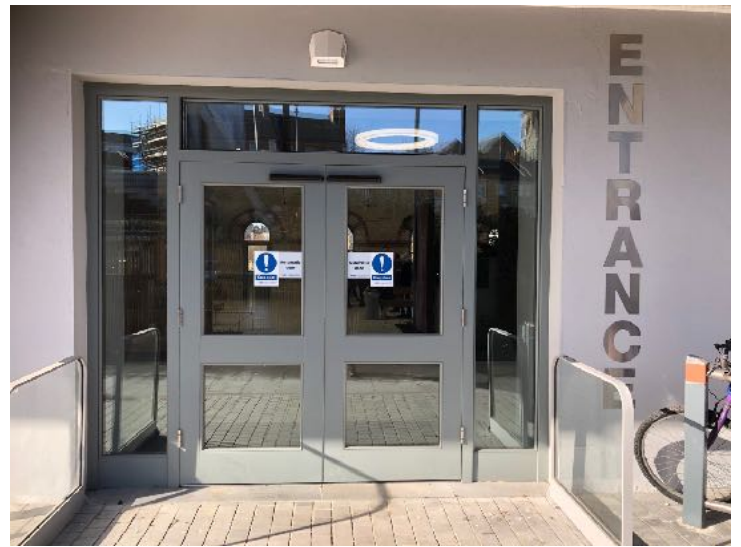
The main entrance / exit door and the access doors to platforms are fully automated. Side door access to the Greenway is semi-automated with push button controls.

(The image on the left shows the main entrance to the station. The image on the right shows the entrance to the station from the Greenway)

- Provide additional signage above the information/ticketing desk.
- Provide an additional signage totem in the central concourse close to the central seating area.
- Relocate current gender signage for toilets closer to the entrance points to toilets.
- Provide additional signage at the entrance to the station from the Greenway.
- Install perch type seating as soon as possible.

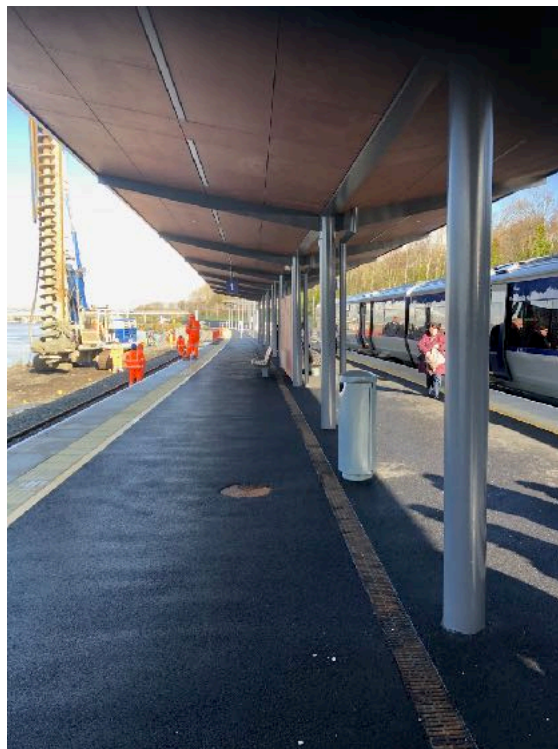
Platforms are wide with seating and other clutter located in a central line.

(The image shows the wide, unobstructed platforms at the Hub)

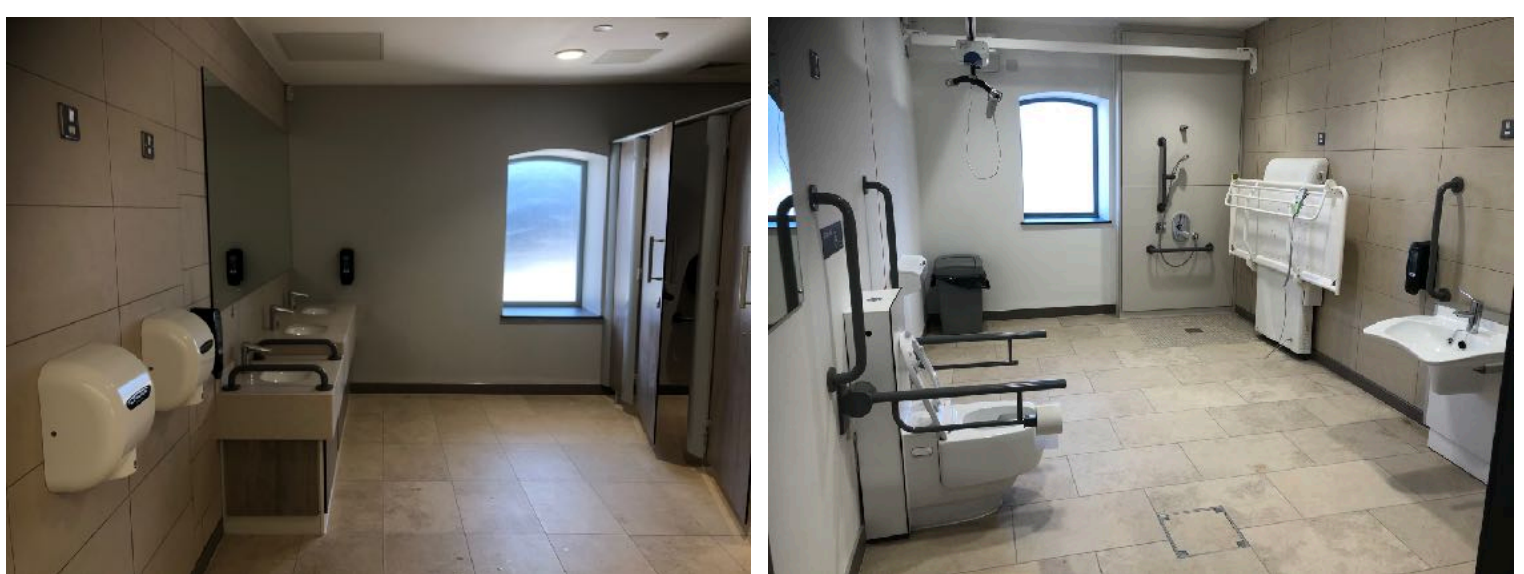
The North West Transport Hub provides the full range of toilet facilities including a Changing Places facility meeting design standards, a generous, separate accessible toilet, a generously proportioned parent / baby changing room and standard male and female facilities meeting inclusive design standards. The Committee believes the toilet provision at the station provides an exemplar and should be used as the benchmark for future new and refurbished Translink stations.

(The image on the left is the interior of the male toilets. The image on the right is the interior of the Changing Places facility.)

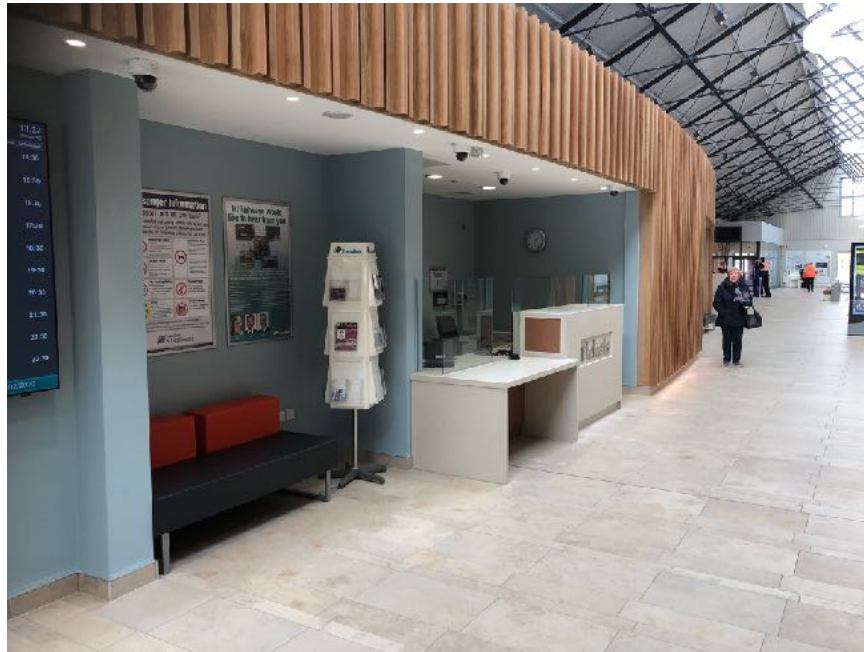
A ticket desk designed with the appropriate low-level counter and induction hearing loop system has been provided. Signage could be improved to make the location of the desk more obvious.

(The image shows the ticket / information desk in the Hub.)

- An additional wall mounted information sign (using blue and white) located above the ticket desk
- Relocating wall mounted signage in the male and female toilets closer to the toilet entrances
- Provision of additional standard (blue and white) signage at the entrance from the Greenway

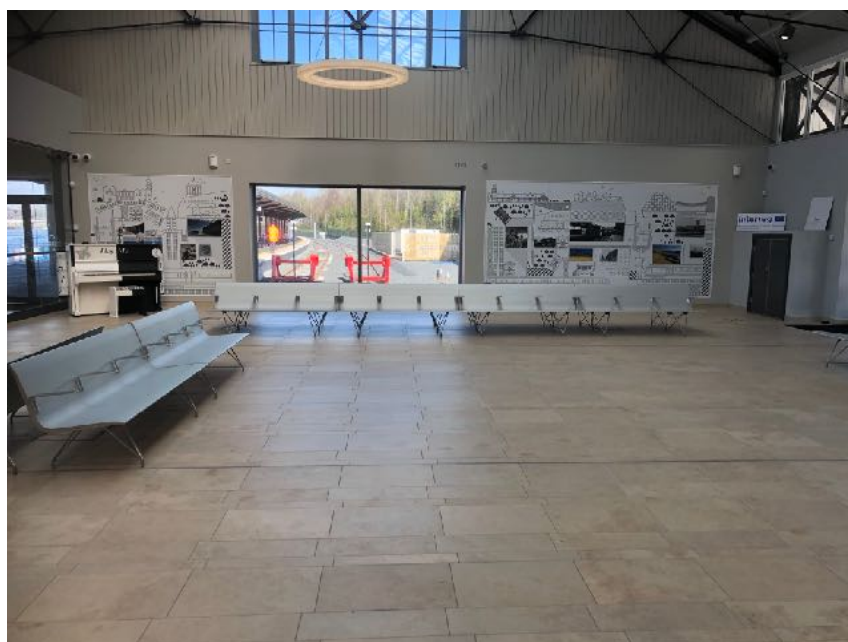
Seating has been provided both internally and on platforms at the station. All seating provided has armrests. There is a problem on some of the styles of seating with a lack of contrasting between armrests and the other parts of the seat.

(The image shows seating in the Hub with poor contrasting)

- Provide better contrasting on moveable seating currently located in the community space.

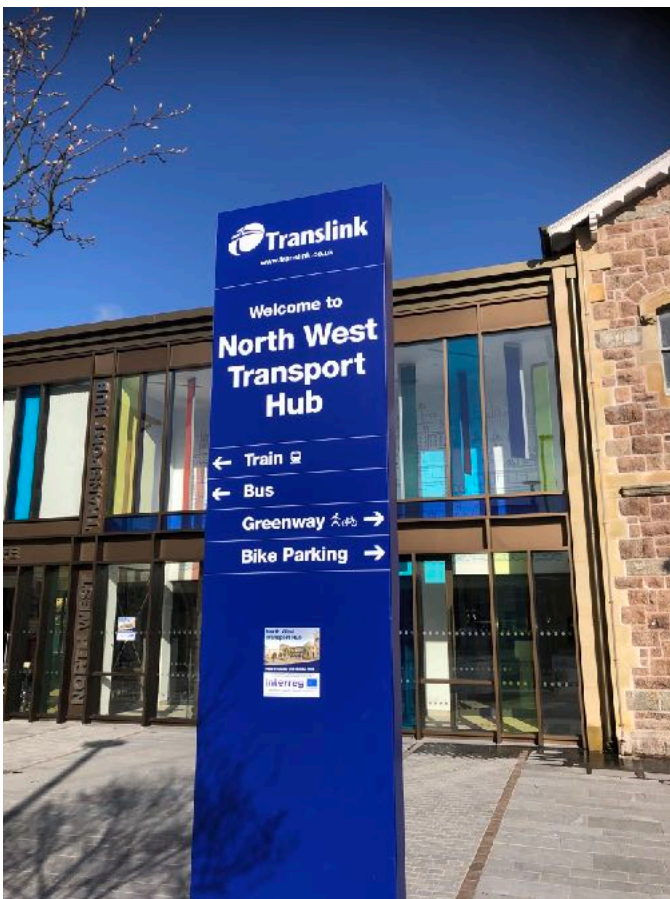
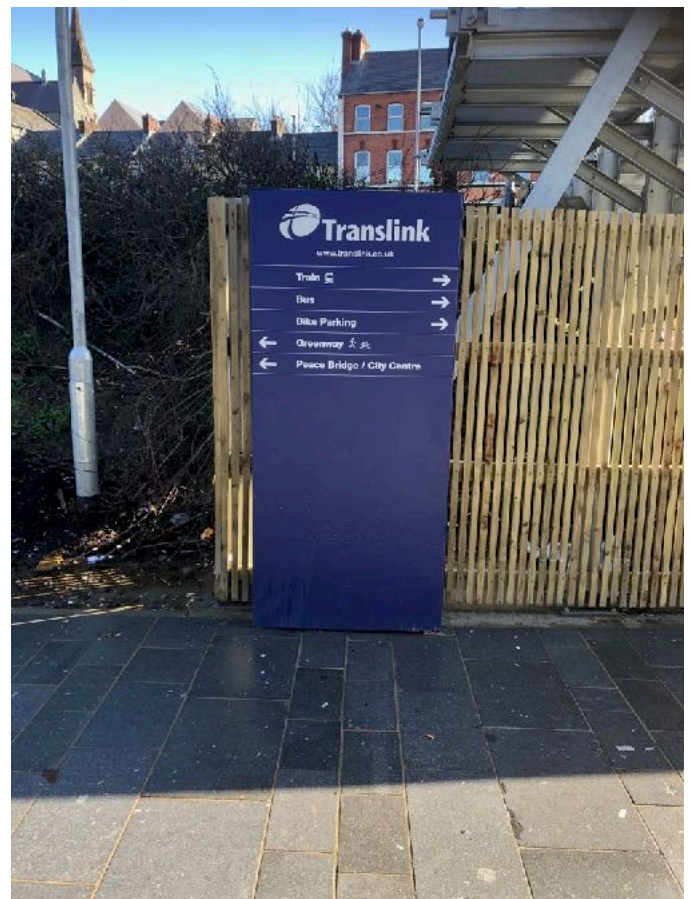
Totem directional signage has been provided externally outside the main entrance and the side entrance / exit to the Greenway. Again the design is good. Based on feedback it was felt a further totem could be provided within the concourse close to the main seating area.

(The image on the left shows the signage totem outside the main entrance. The image on the right the totem outside the Greenway entrance.)

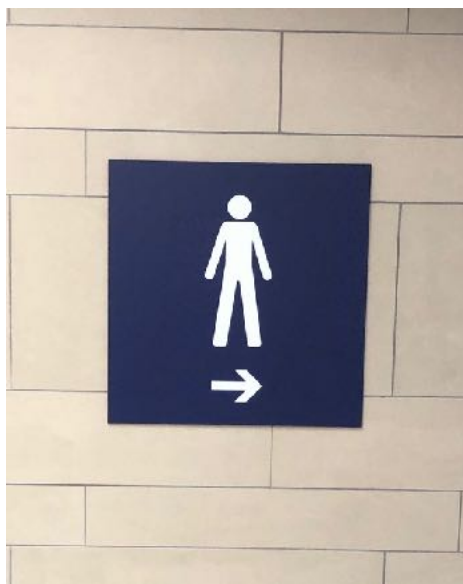
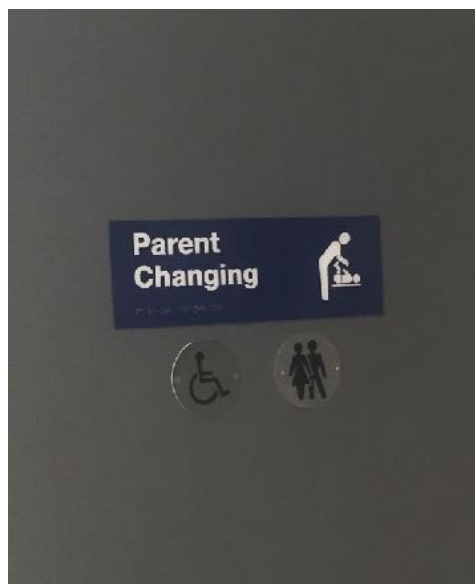
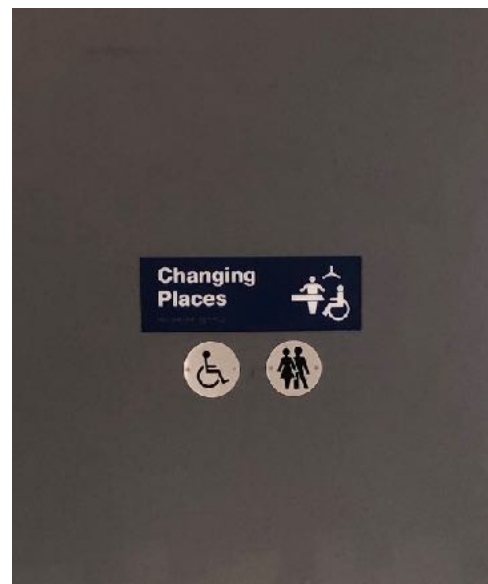
Signage has been provided on the doors of toilet facilities. This signage included tactile Braille lettering and generally meet good design standards. There are, however, some inconsistencies in the toilet signage at the Hub compared with other Translink destinations. Imtac recommends Translink develops an organisation wide policy around toilet signage to ensure consistent design and messaging across all facilities.

(The image on the left shows directional signage to the male toilet. The centre image signage on the Parent / Baby changing room door. The image on the right is signage on the door of the Changing Places facility.)

- Translink to develop an organisation wide policy around the provision of toilets including the design and wording of toilet signage to ensure consistency of provision across its infrastructure.
- Translink to develop a clear policy on the provision of assistance dog spending areas at their stations.

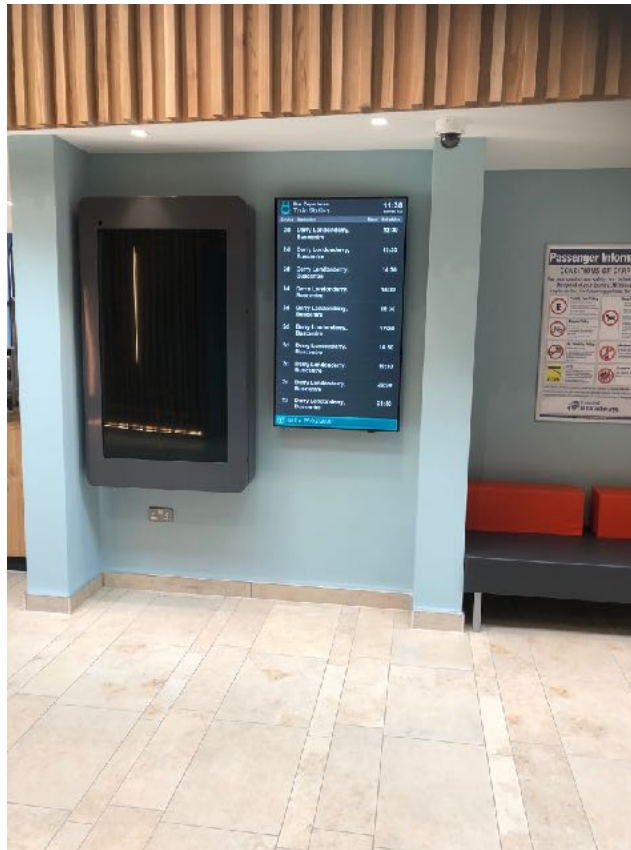
An additional screen has been provided close to the ticket desk providing information about bus departures and arrivals from the station. This provision is to be commended.

(The image shows the bus departures screen, alongside a train arrival / departure screen at the Hub)

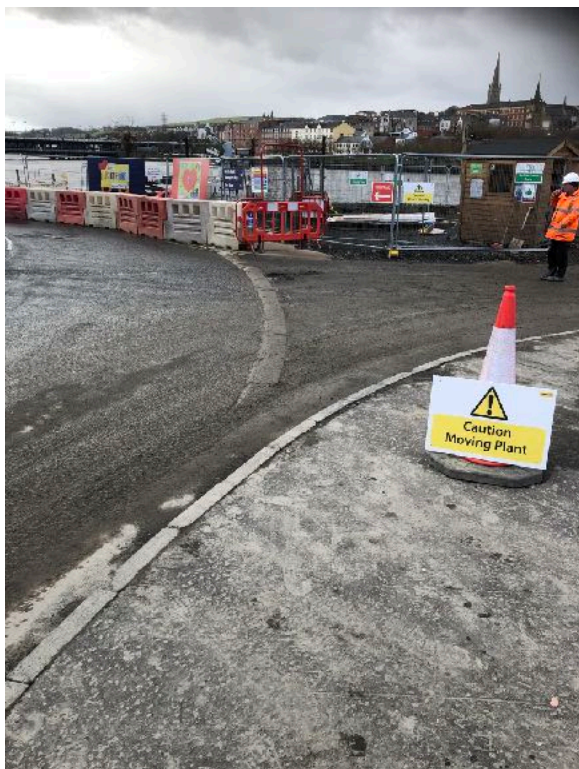
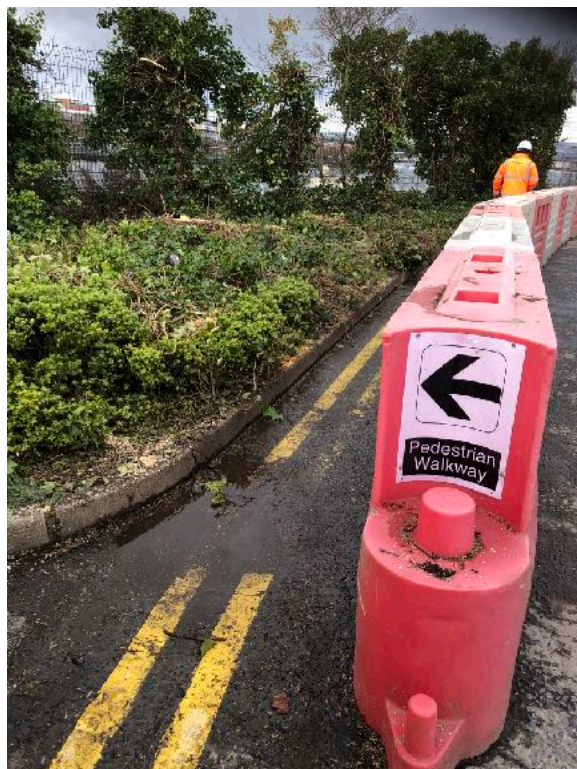
There was the opportunity on the day to look at temporary access arrangements to the station for people arriving by bus. To avoid passengers having to cross the busy and dangerous junction at the roundabout, a temporary, screened walkway has been provided. There were significant access issues with the provision on the day of the visit including:

- The temporary pedestrian route blocked on the day, forcing pedestrians to use the unsuitable crossing
- The temporary pedestrian route was too narrow to be used comfortably by a range of pedestrians
- The surfacing of the temporary pedestrian route was uneven in places, presenting potential hazards for pedestrians

(The image on the left shows the pedestrian walkway gated off on the day of the visit. The image on the right shows the other end of the walkway.)

Translink must take steps to ensure that measures are undertaken by contractor to ensure safe and accessible pedestrian routes to and from the station are maintained at all times.
