## **Report on Walking routes in Lisburn City Centre**

**May 2013**

## **About this report**

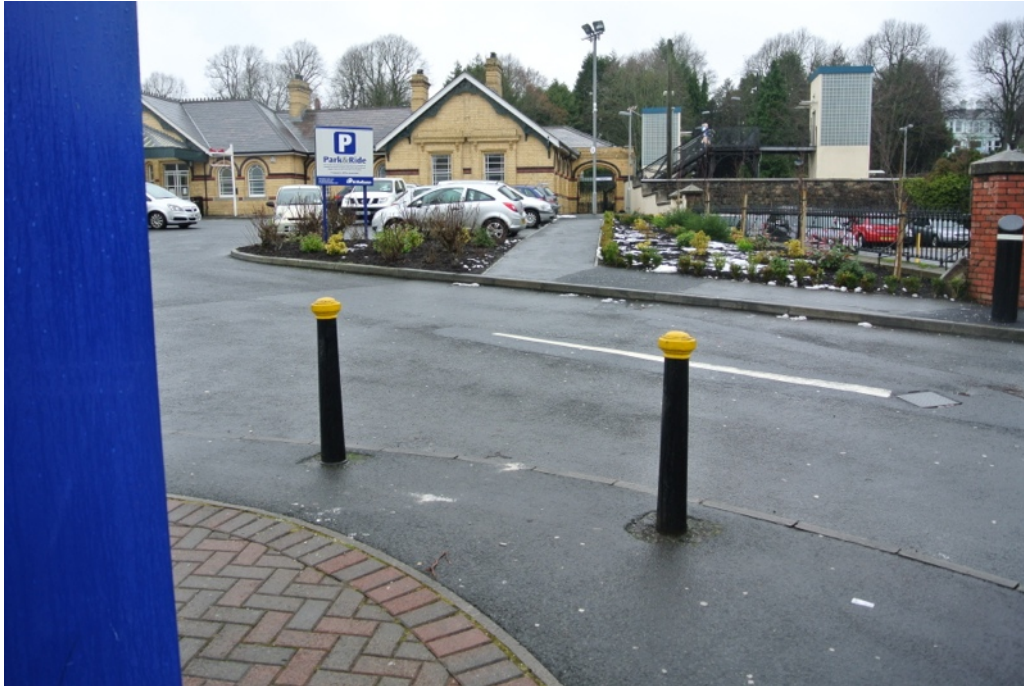
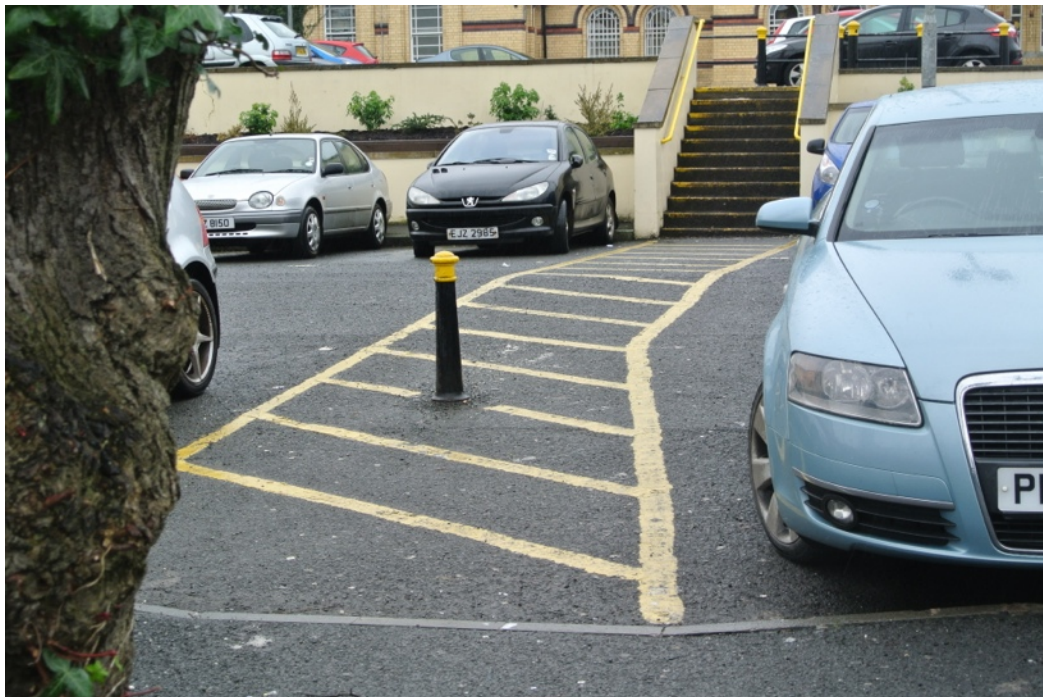
- 1 There is no safe, accessible pedestrian route across the forecourt and car park of Lisburn train station to Bachelors Walk. The only route with dropped kerb access is via a set of steps. The alternative route is via the road.

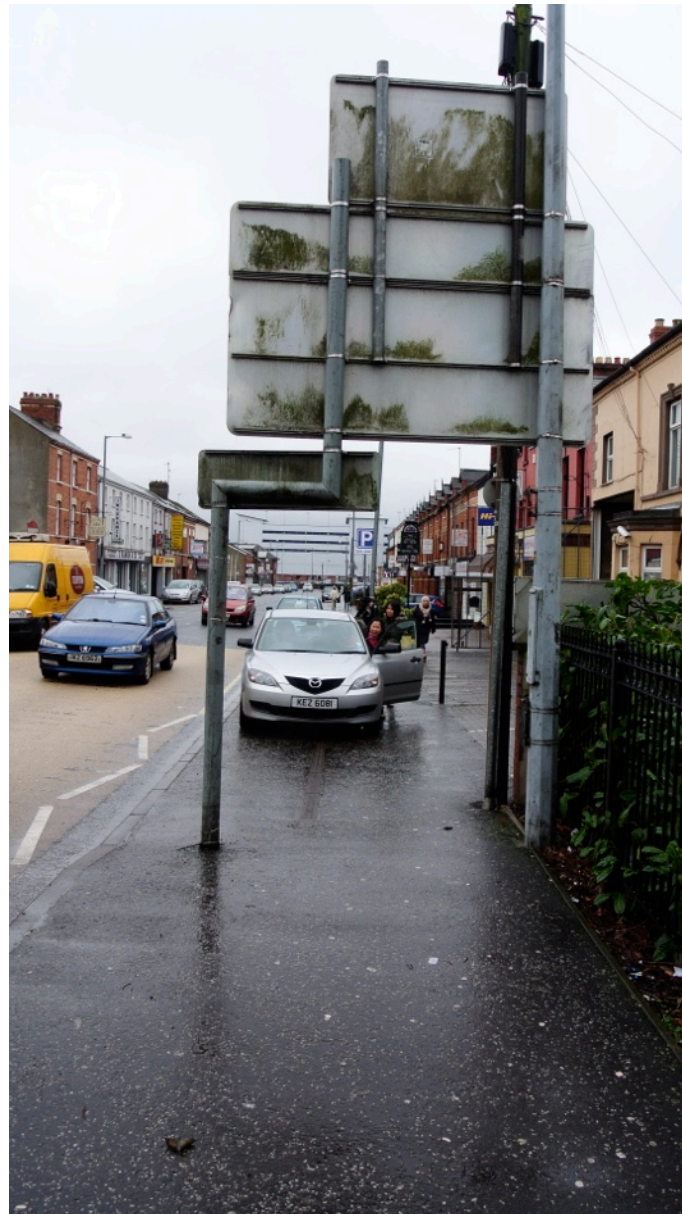
- 2 Parked cars obstruct the pavement on the station side of Bachelors Walk

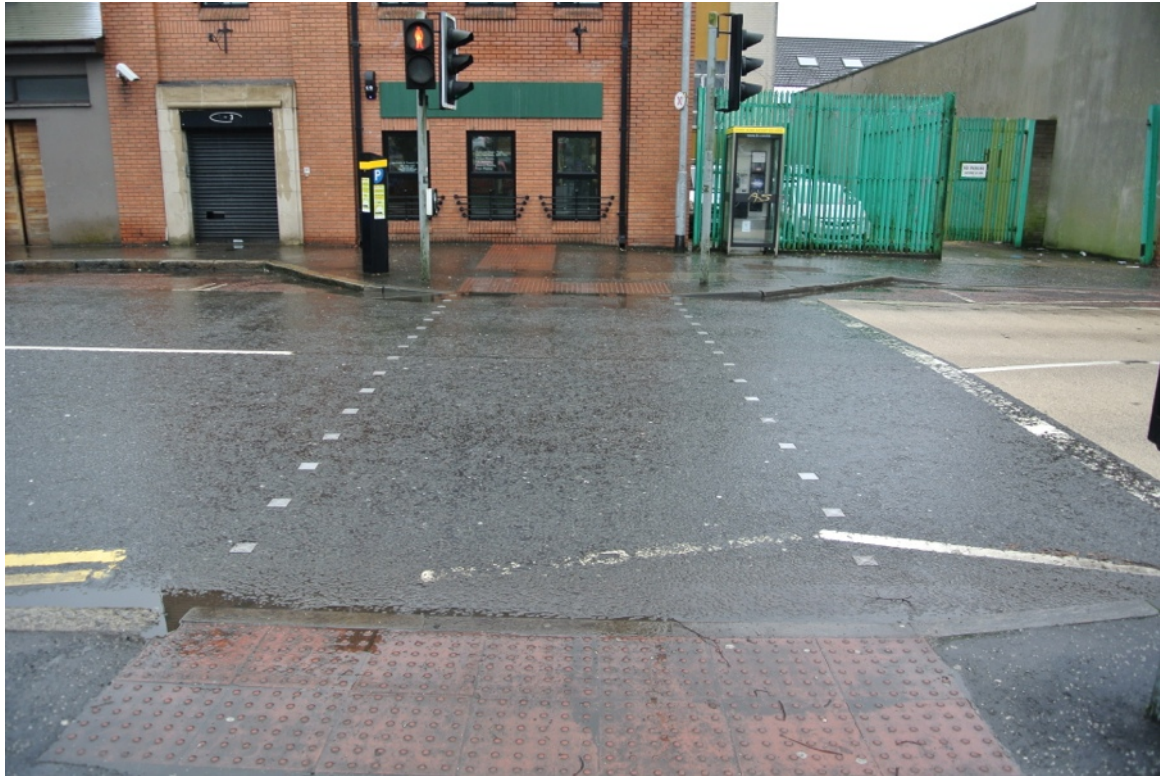
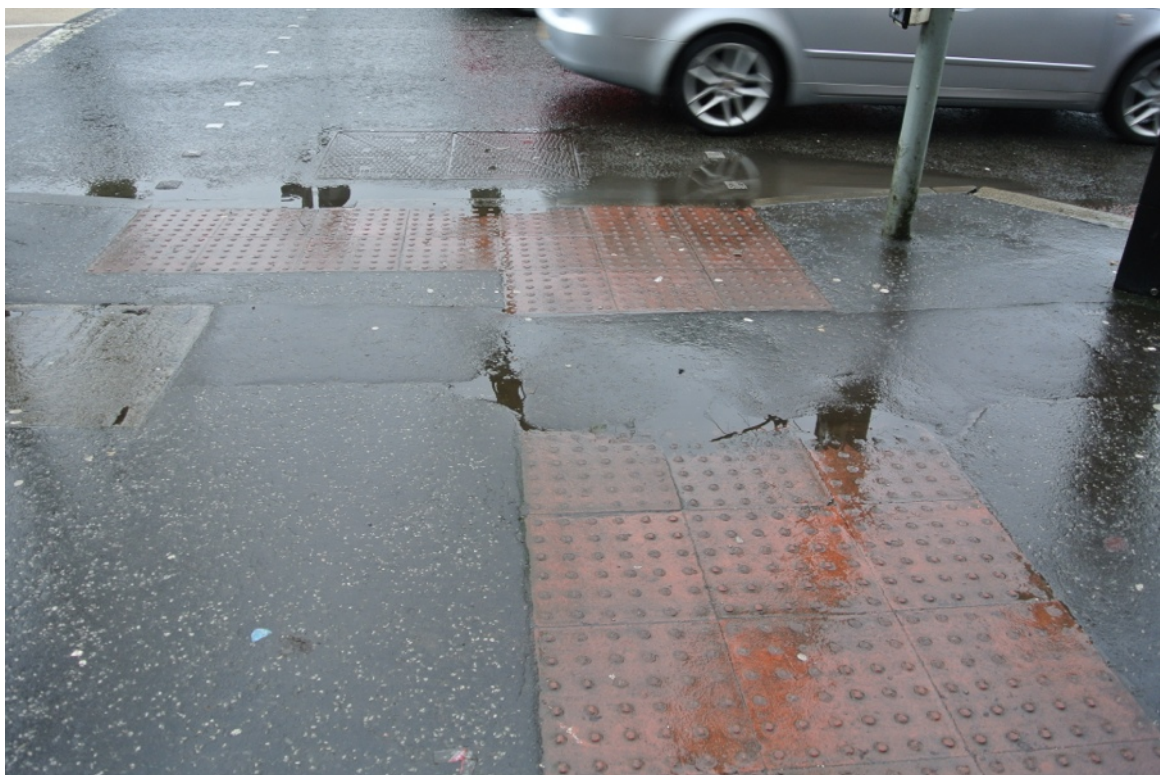
- 3 There is a controlled pedestrian crossing opposite the railway station. The crossing has no rotating cone and a section of tactile paving has been removed on one side following work by a utility company.

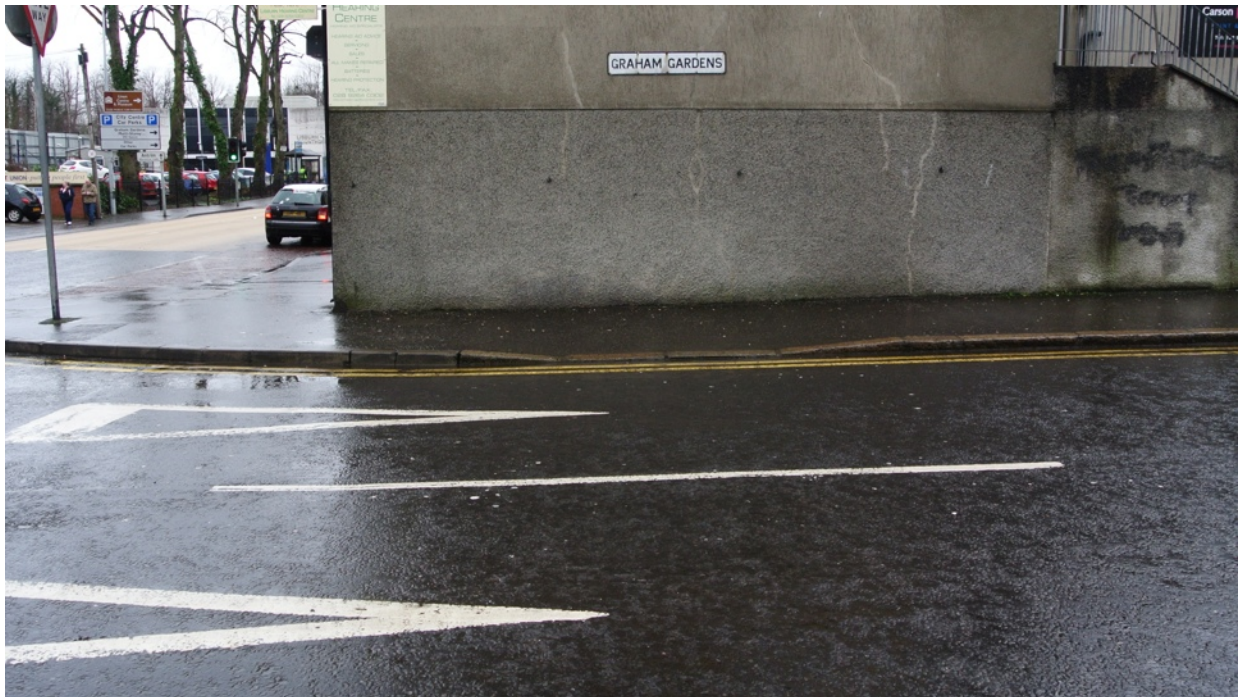
- 4 There is an in-line uncontrolled crossing at the junction of Graham Gardens and Bachelors Walk. However this is some way back from the junction and the absence of tactile paving makes it difficult for people with a visual impairment to locate.

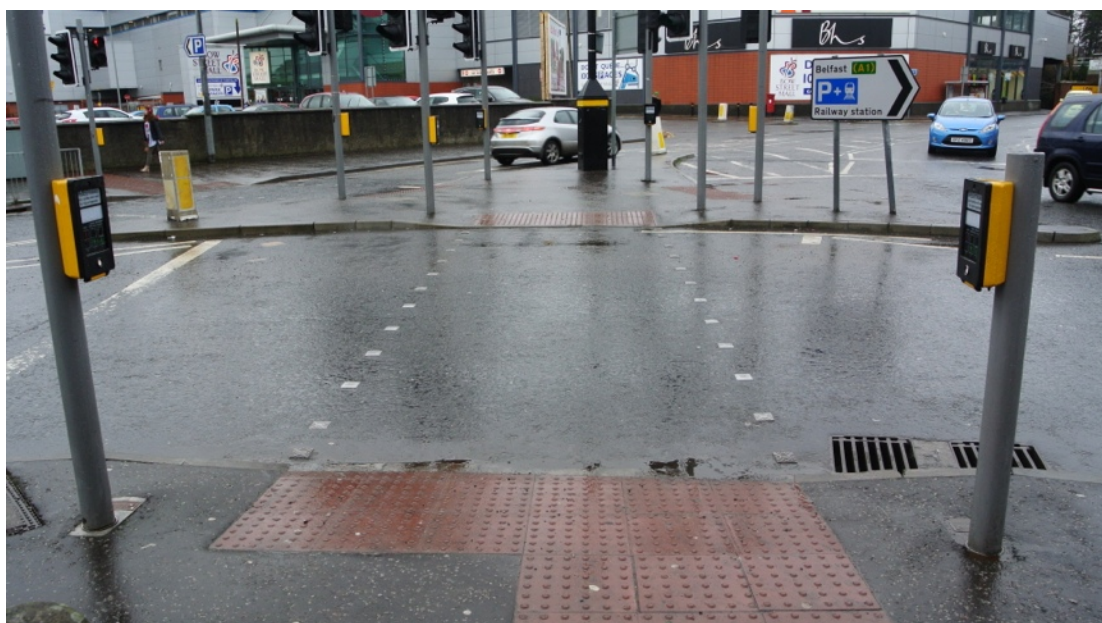
- 5 There are good examples of controlled crossings at the junction of Bachelors Walk and Antrim Street.

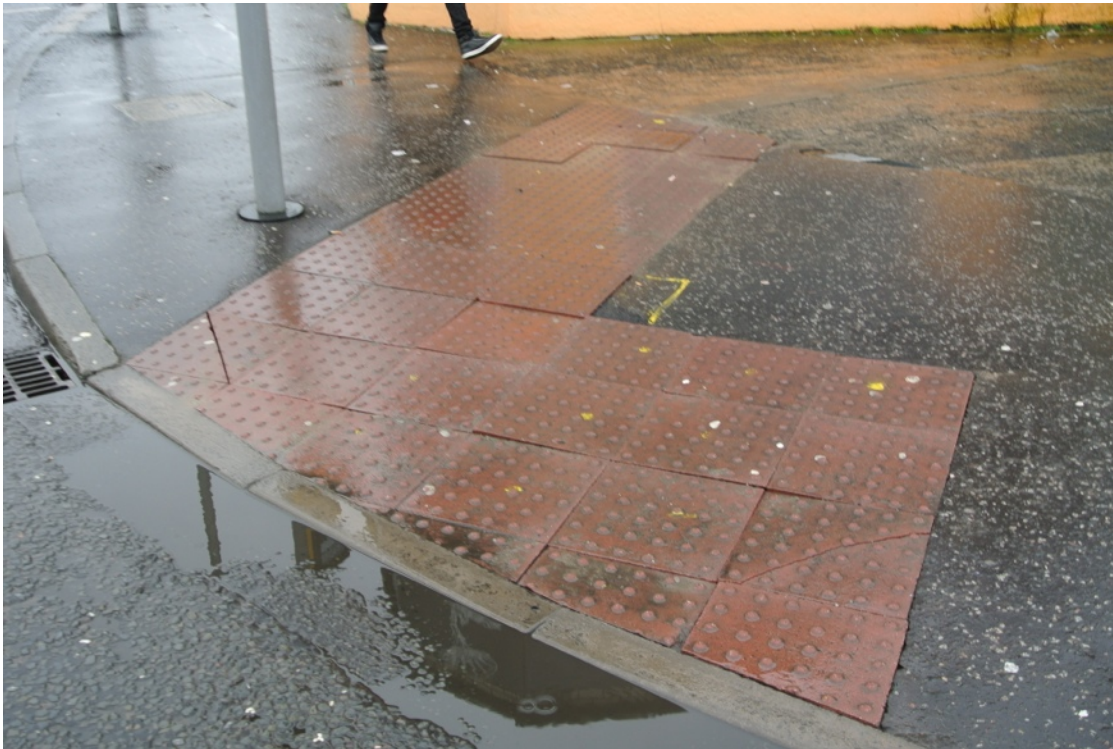
- 6 There is some damage to tactile paving at these crossing which appears to be marked for repair.

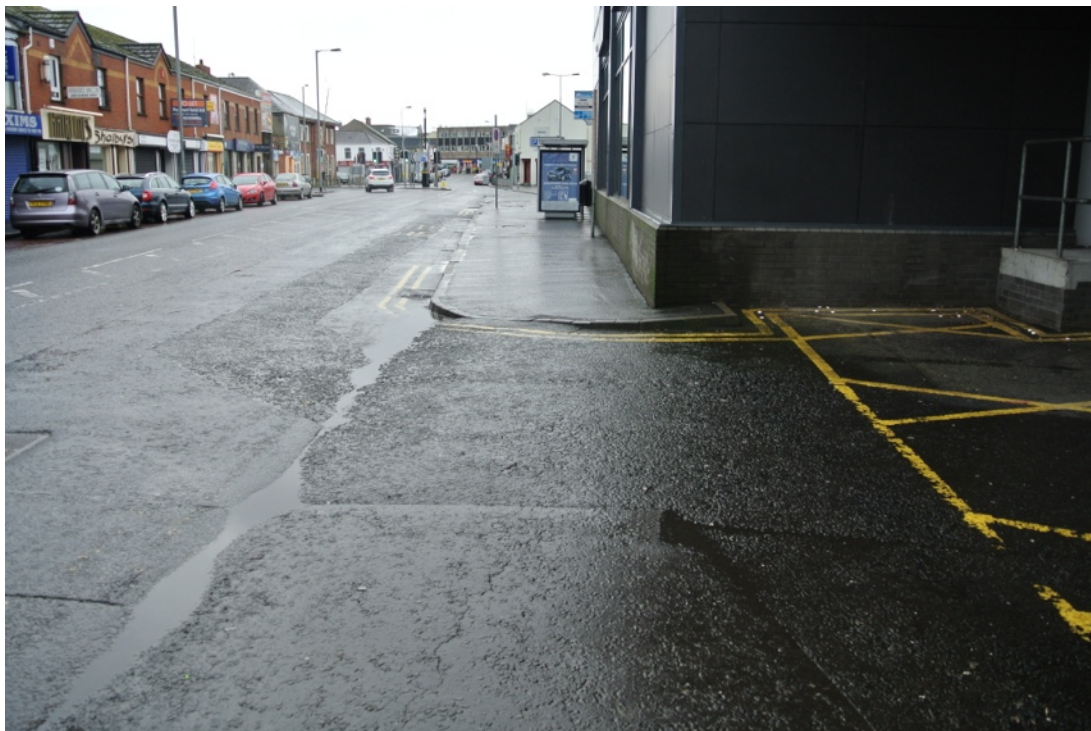
- 7 At the service yard to Bow Street Mall on Antrim Street there is no tactile paving or appropriate dropped kerb provision.

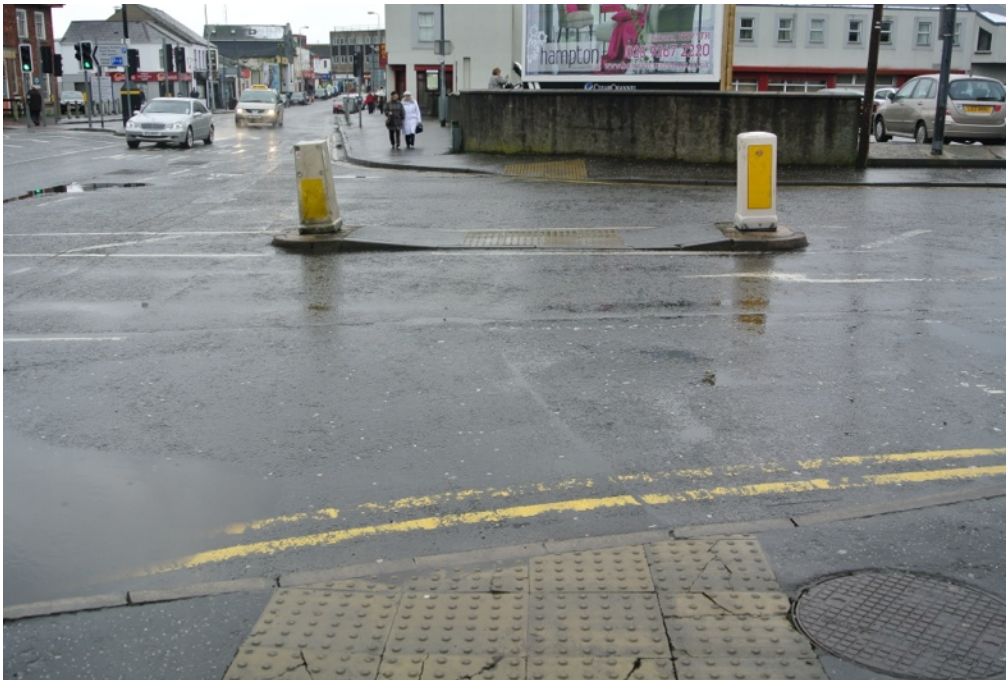
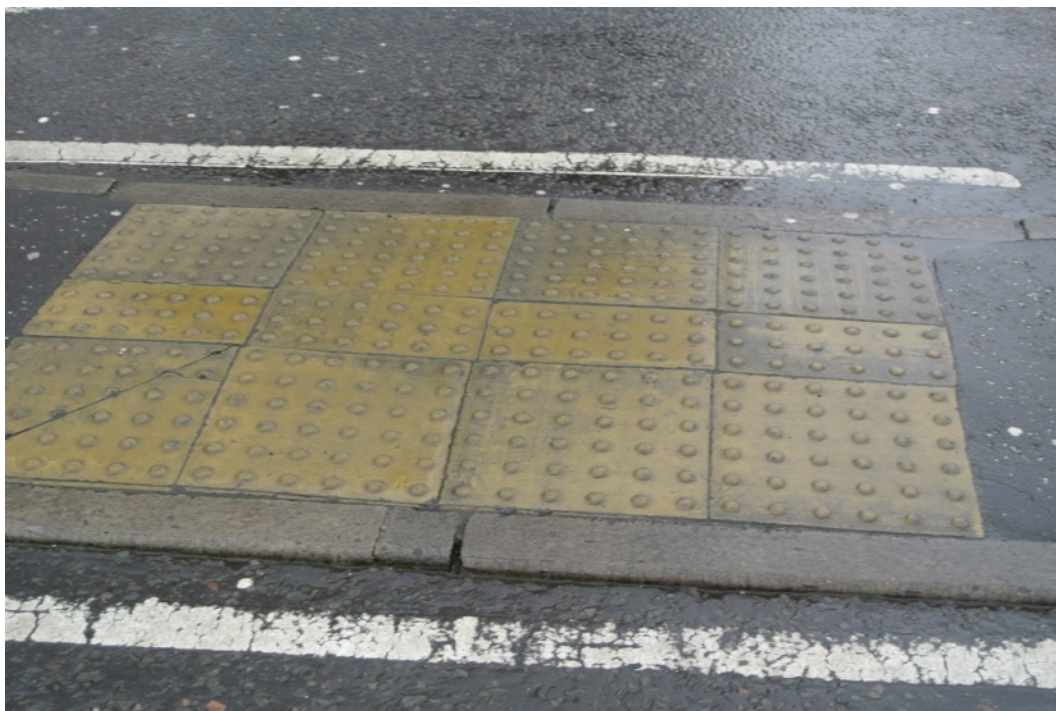
- 8 The uncontrolled crossing at the vehicle entrance to Bow Street Mall contains damaged tactile paving, there is a significant cross-fall on tactile on one side of the crossing and very narrow island in the middle of the crossing which is unlikely to accommodate for example a powerchair user, a person with a rollator or parent with buggy.

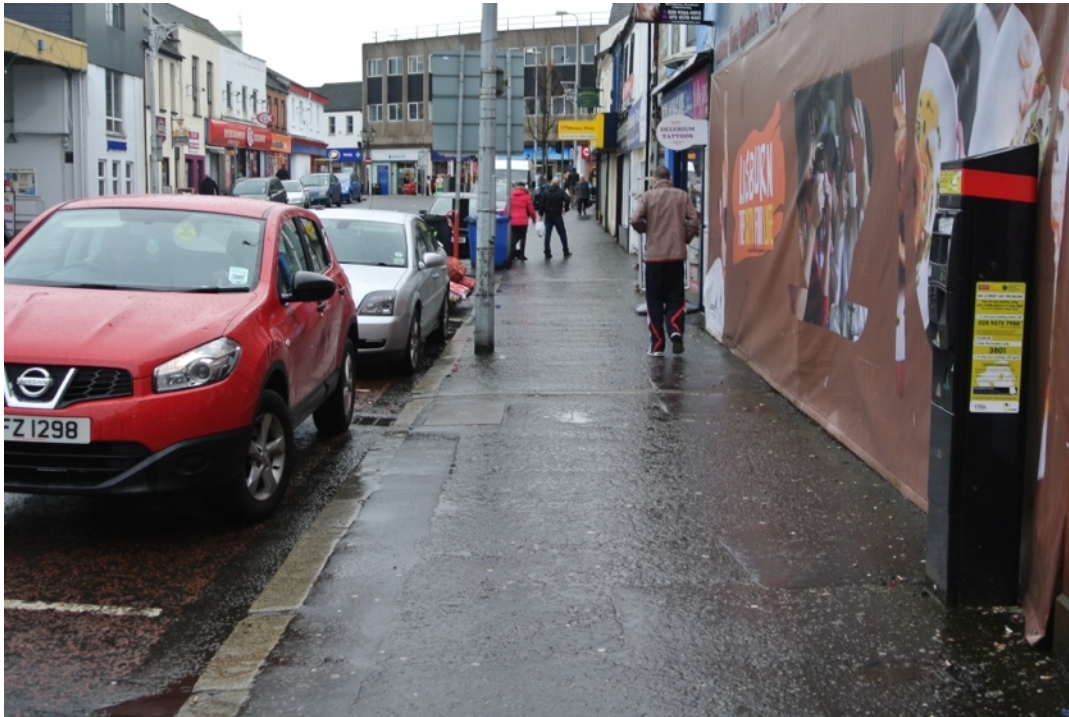
- 9 Shop displays have been placed on pavements in Antrim Street. This has the potential to create obstructions and restrict pavement widths .

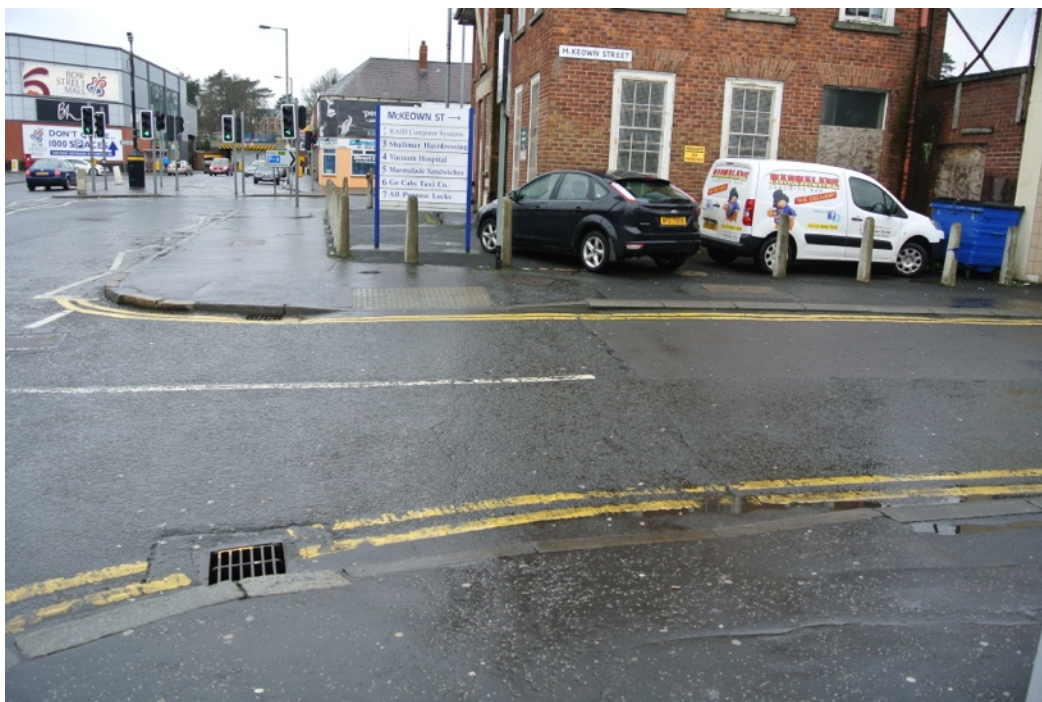
- 10 There is no tactile paving on one side of the uncontrolled crossing at the Antrim Street/McKeown Street junction.

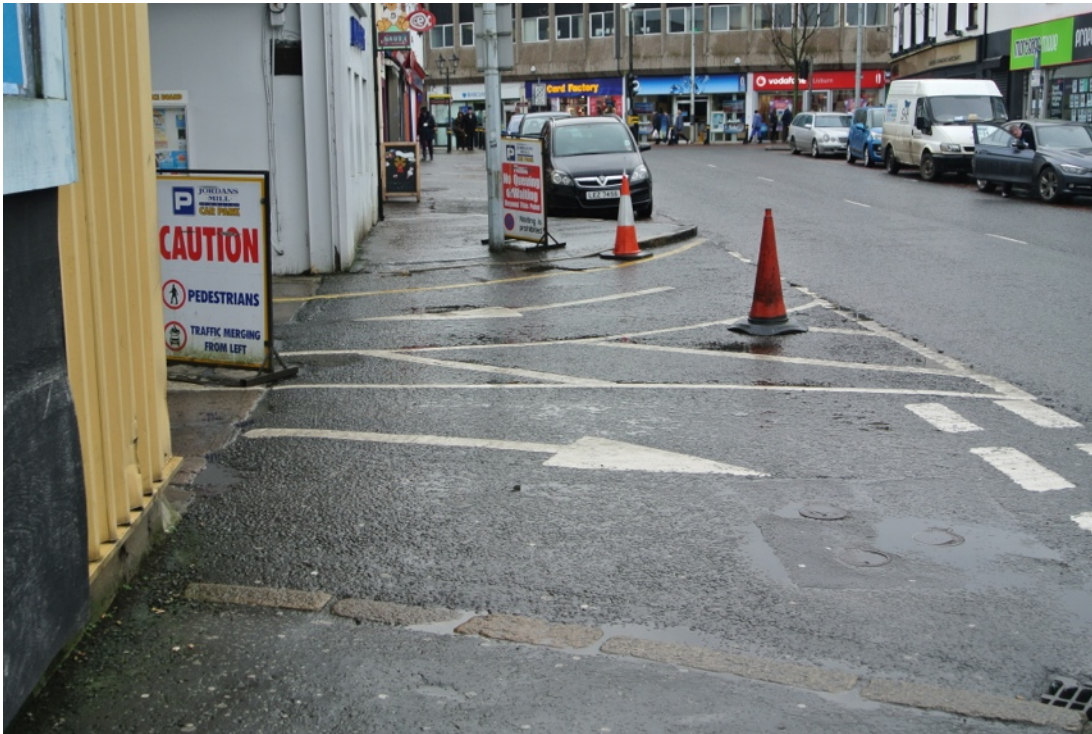
- 11 There is an entrance to a car park on Antrim Street. The entrance does not have tactile paving. Signage and posts narrows the pavement considerably on one side of entrance.

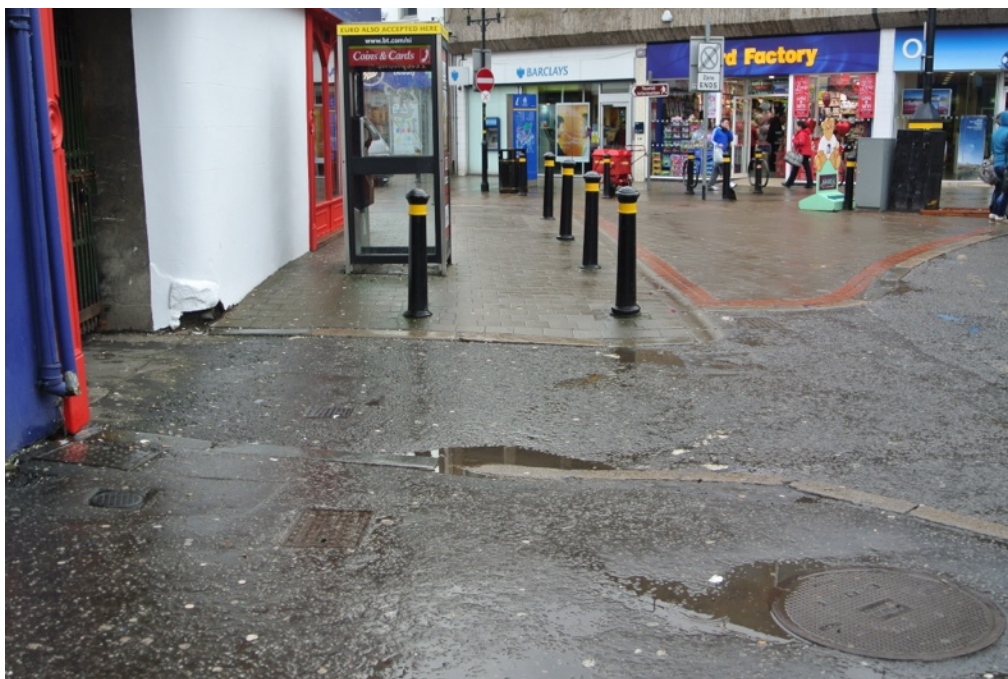
- 12 At the corner of Antrim Street and Bow Street there is a vehicle entrance. A number of obstructions restrict the pavement width in this area considerably.

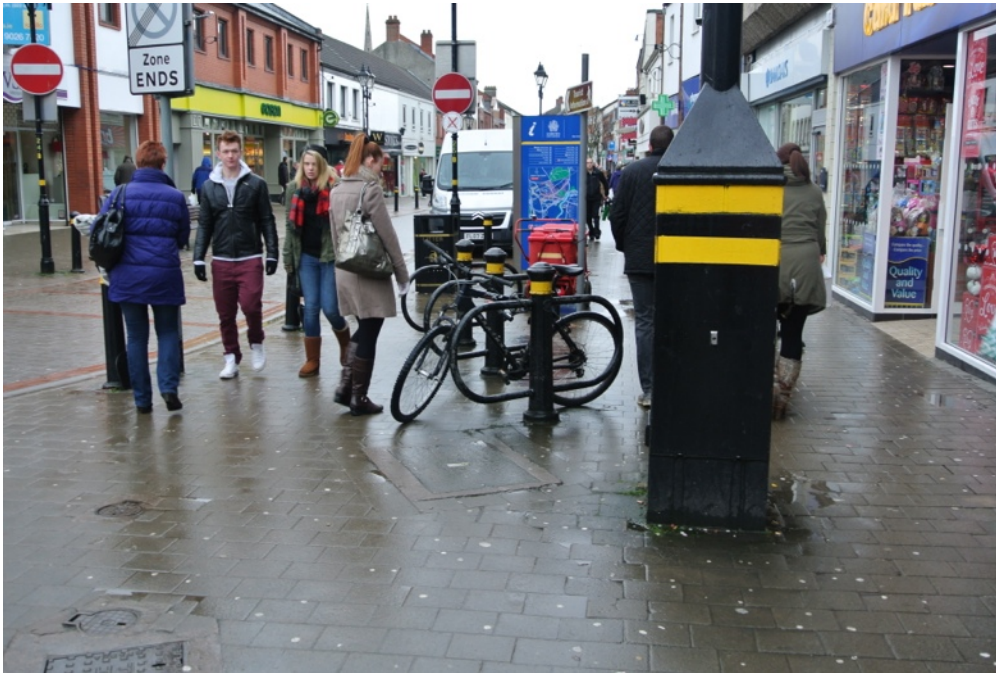
- 13 There is significant clutter at the end of the pedestrian zone.

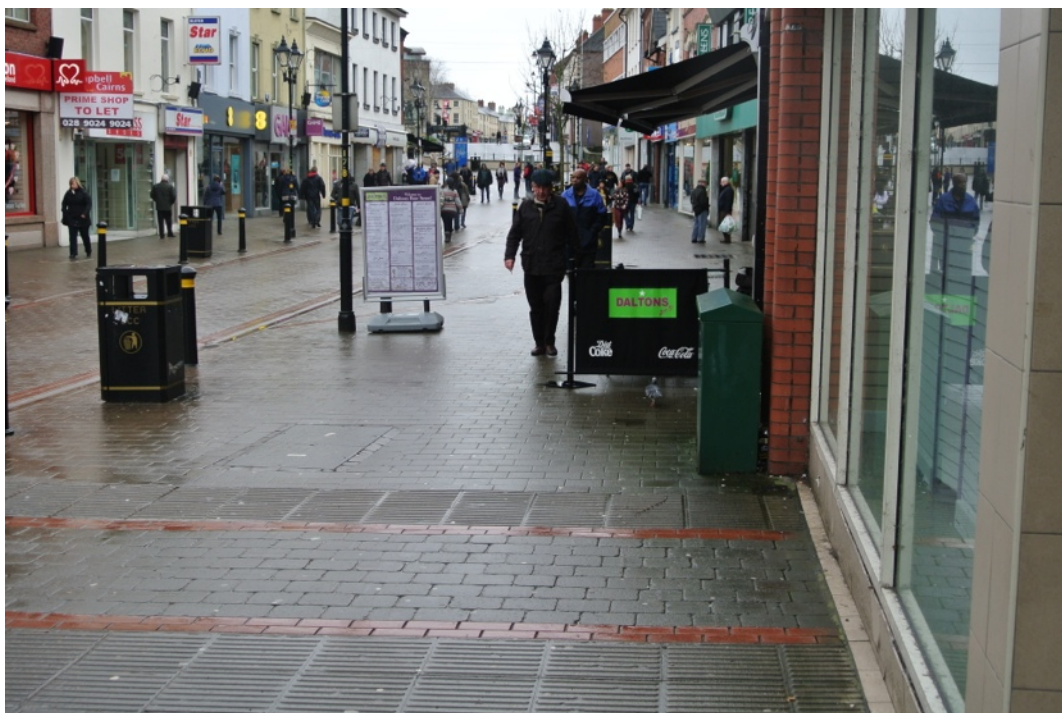
- 14 Whilst the pedestrian zone has clearly defined routes and furniture with visibility bands the sheer number of bollards and other obstructions including A-boards means the area is not particularly friendly for pedestrians.

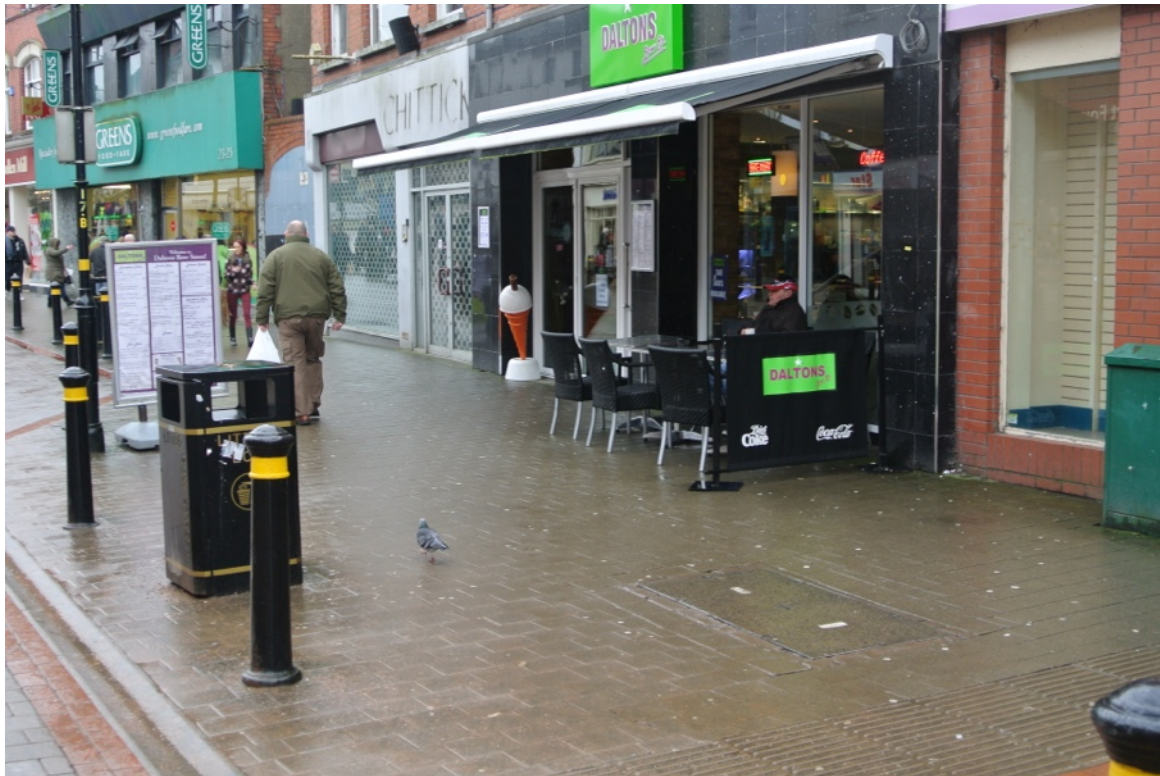
- 15 There are several pavement cafes in the area which would benefit from better screening.

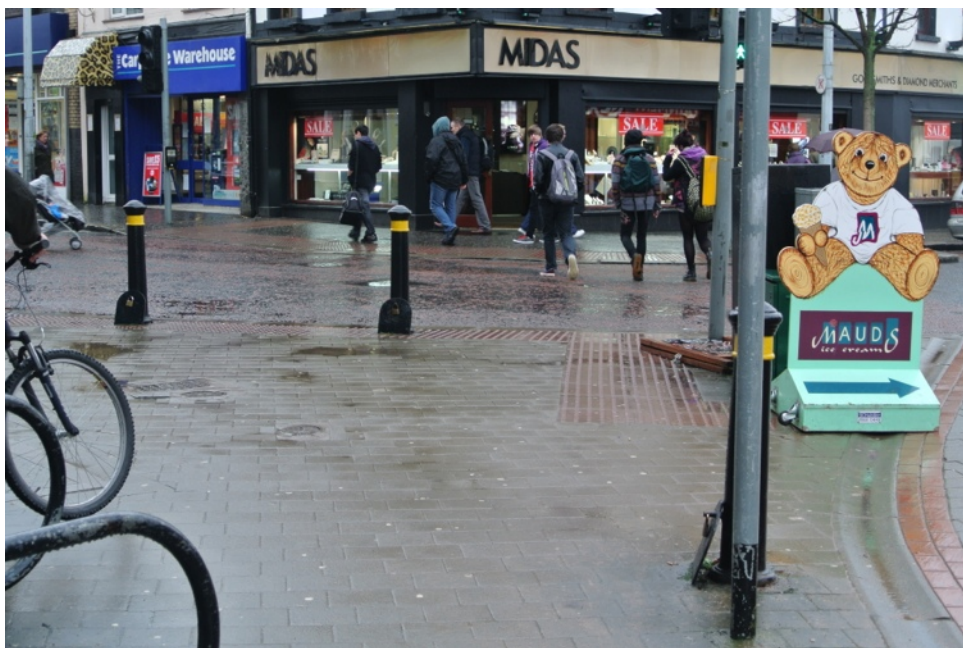
- 16 There is a wide pedestrian crossing at the end of the pedestrian zone – finding the control box is complicated by the placement of bollards and clutter.

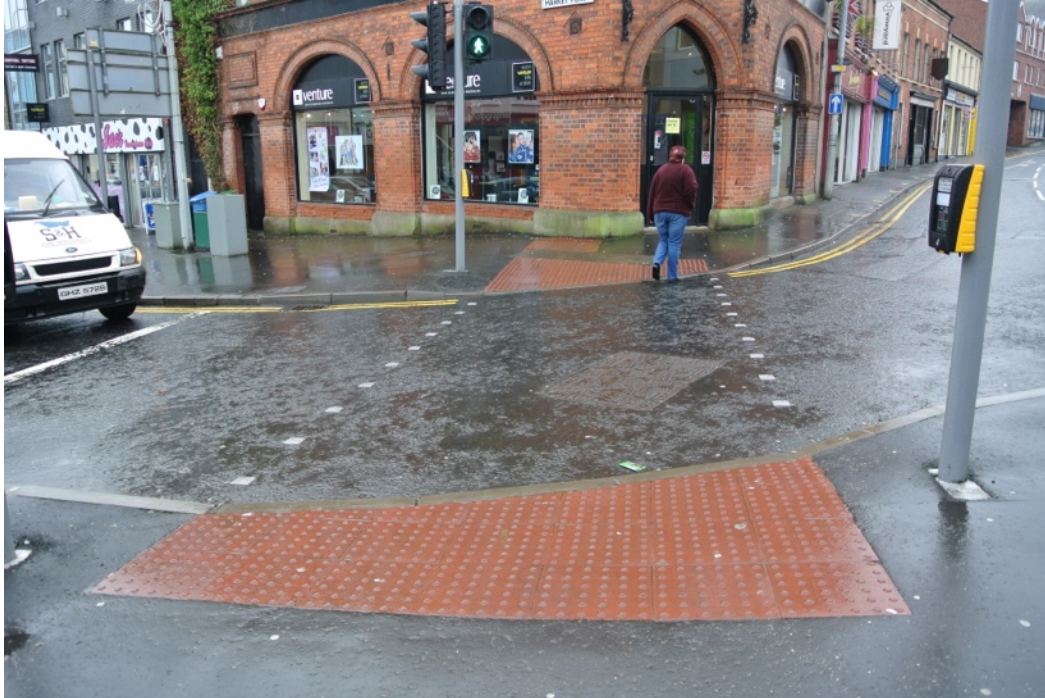
- 17 There are good examples of controlled crossings at the Bow Street/Chapel Hill/Market Place junction. Utility covers reduce the tactile paving on one area of the crossing.

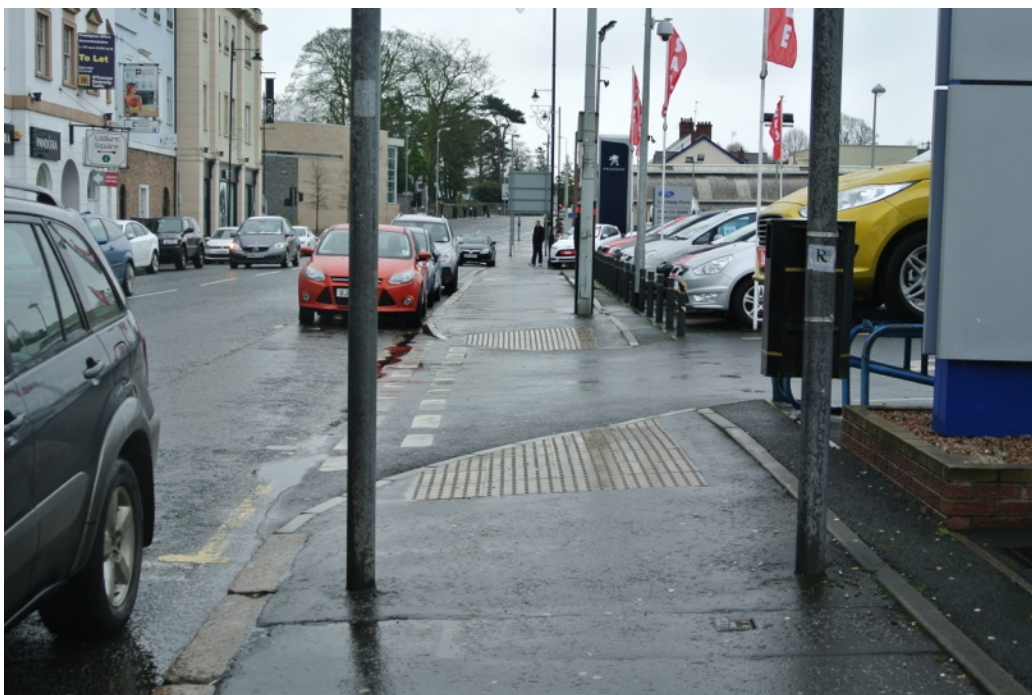
- 18 There are two good examples in line uncontrolled crossings on the west side of Market Place. Signage poles do introduce a potential hazard in this area.

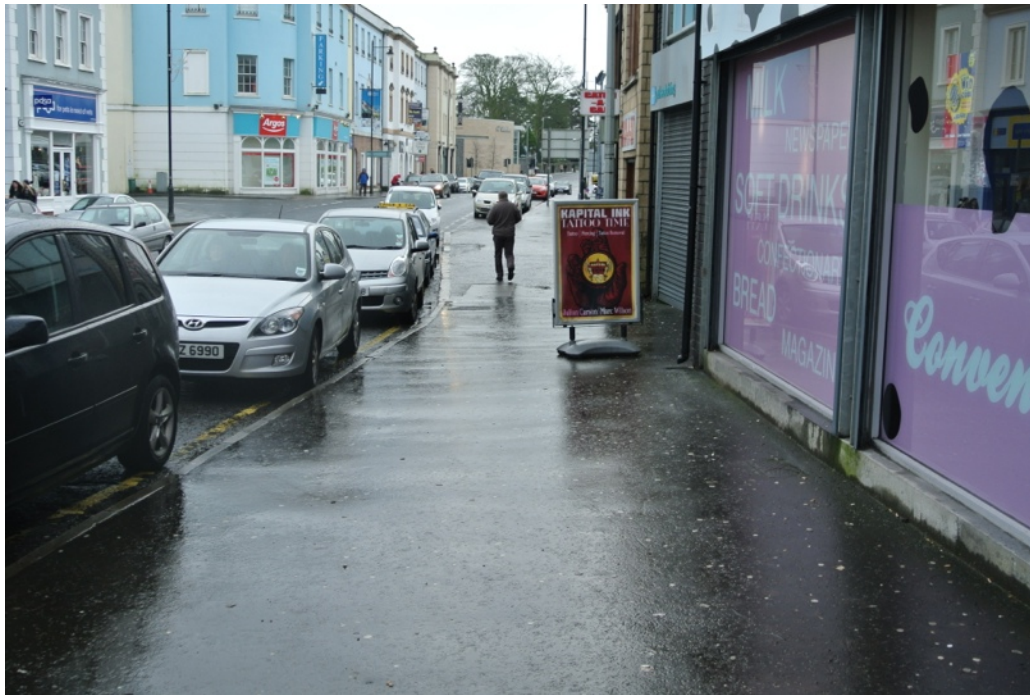
19 A-Boards are a problem in this area.

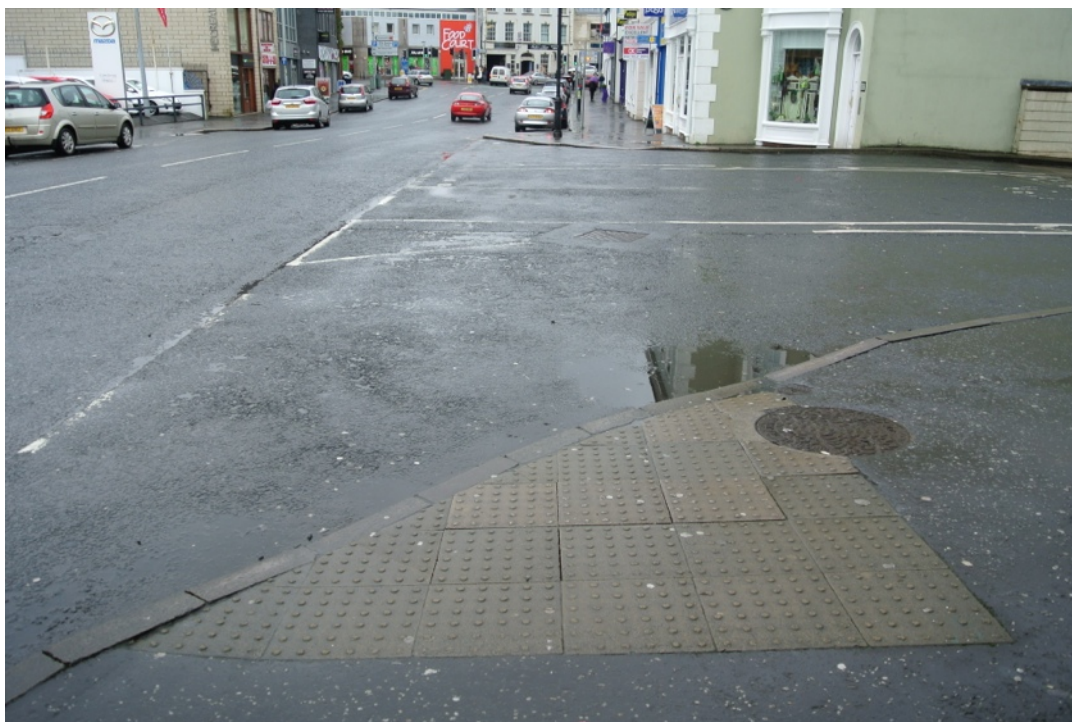
20 There is a very wide entrance to the Market Square car park. There is only dropped kerb provision on one side of the junction.

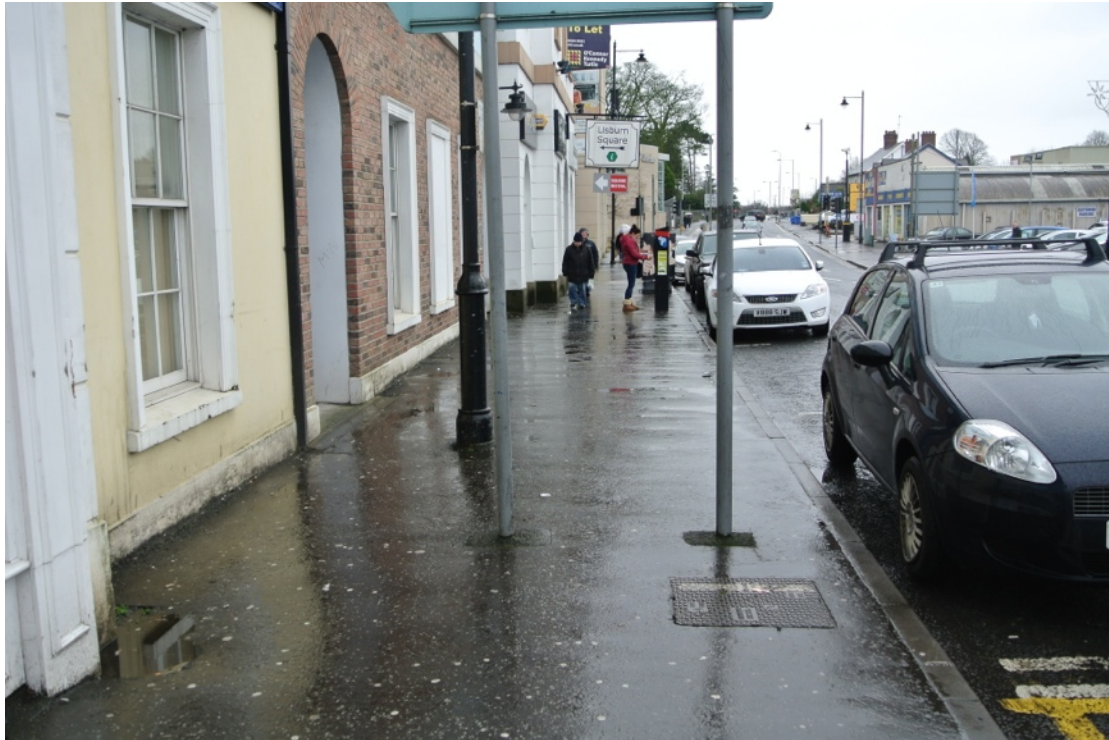
- 21 The benefits of the wide pavement towards the bus station on Market Place are reduced through the numerous obstructions including a series of street lighting and traffic signage poles.

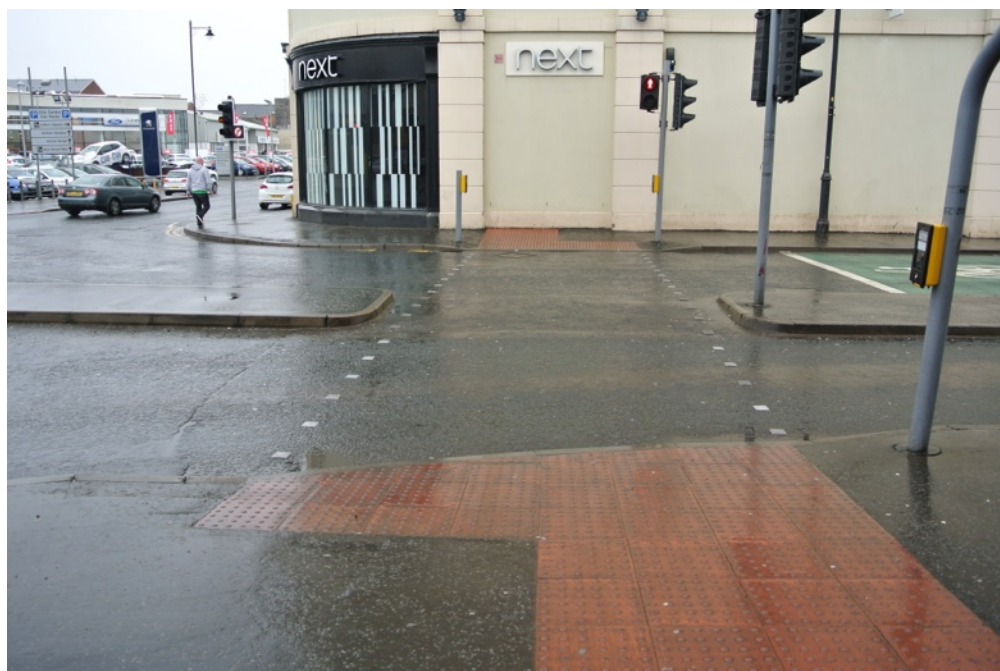
- 22 There are good examples of controlled crossings at the junction of Market Place and Smithfield Street.

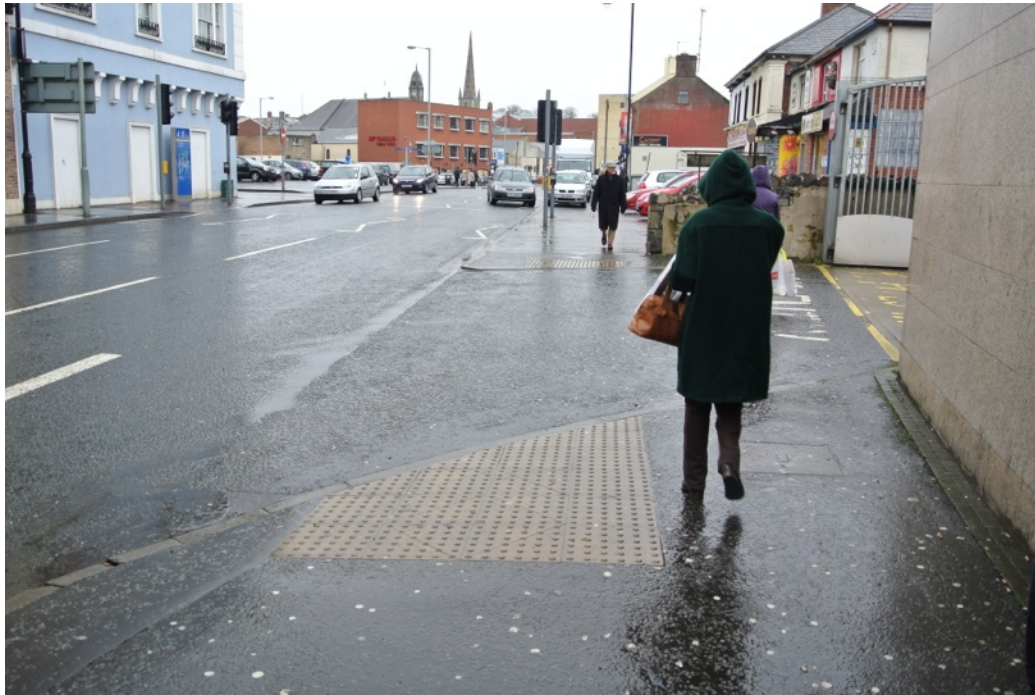
- 23 There is satisfactory in line uncontrolled crossing at the entrance to the bus station.

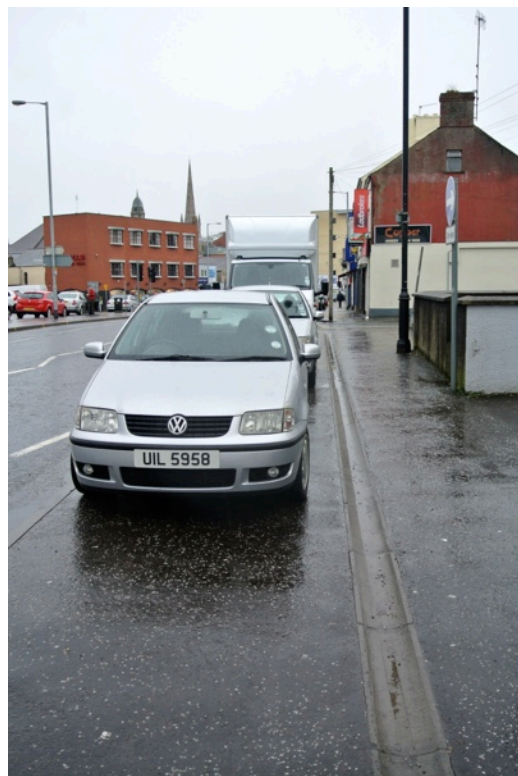
- 24 Pavement width is restricted in this area because of pavement parking.

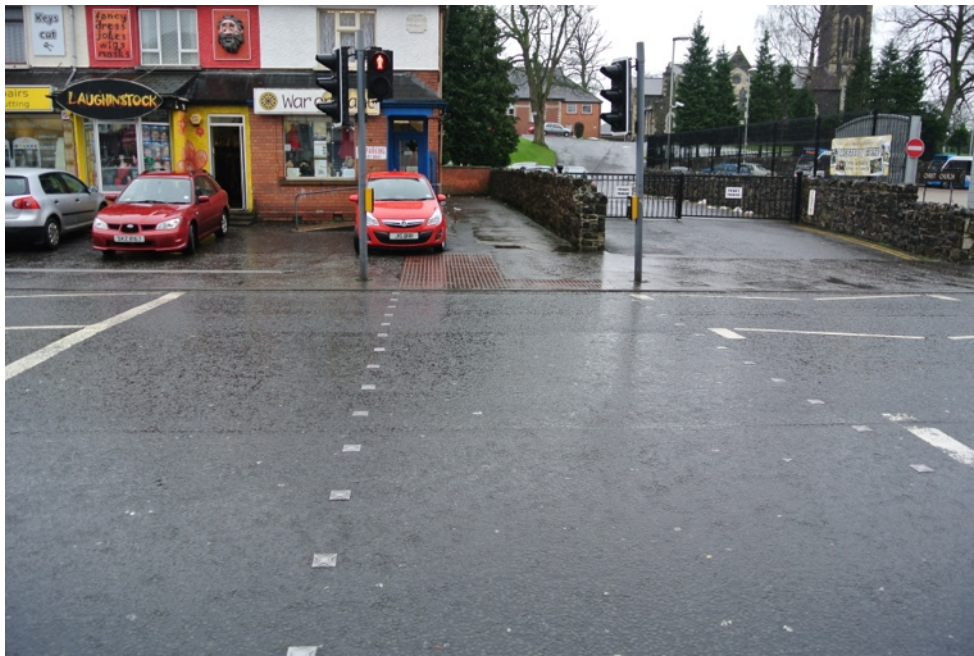
- 25 There is a good example of a controlled crossing on Smithfield Street near the bus station.

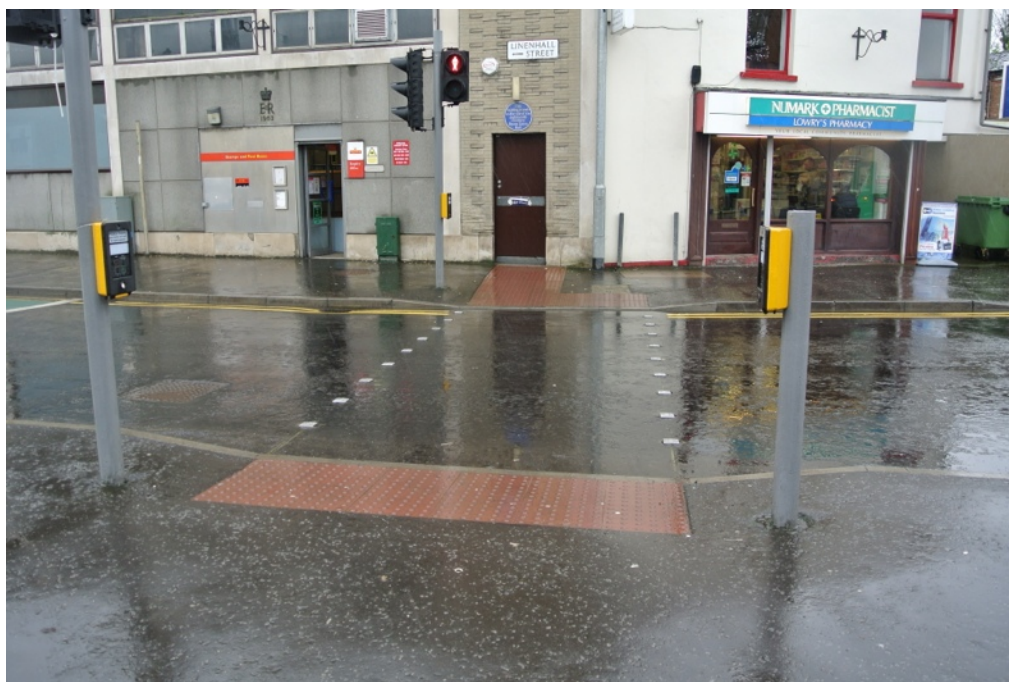
- 26 There are good examples of controlled crossings at the Smithfield Street/Market Street/Linenhall Street junction. Loose tactile paving does need to be repaired.
