## **Report on Walking routes in Lisburn City Centre**

**May 2013**

## **About this report**

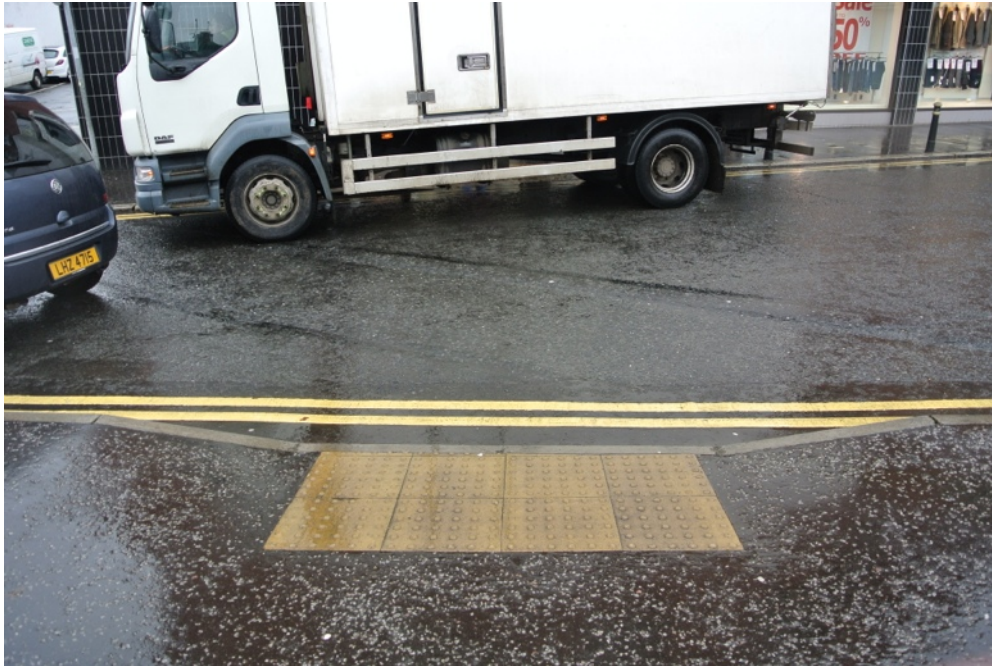
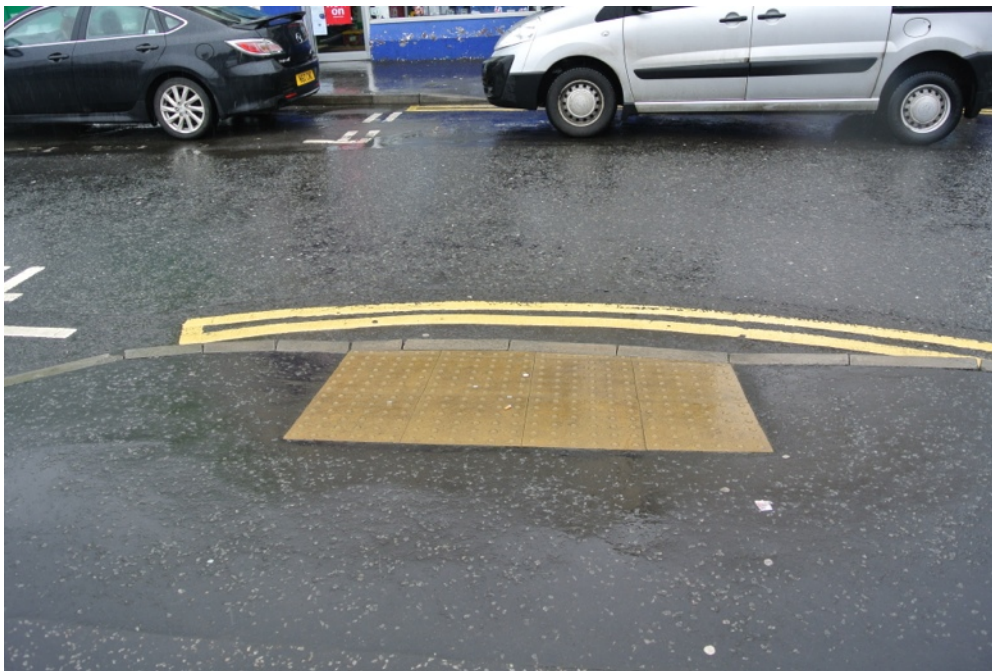
- 27 There are good examples of dropped kerb provision and in-line uncontrolled crossings in this area. However illegal parking and unloading across kerbs minimise the benefits.

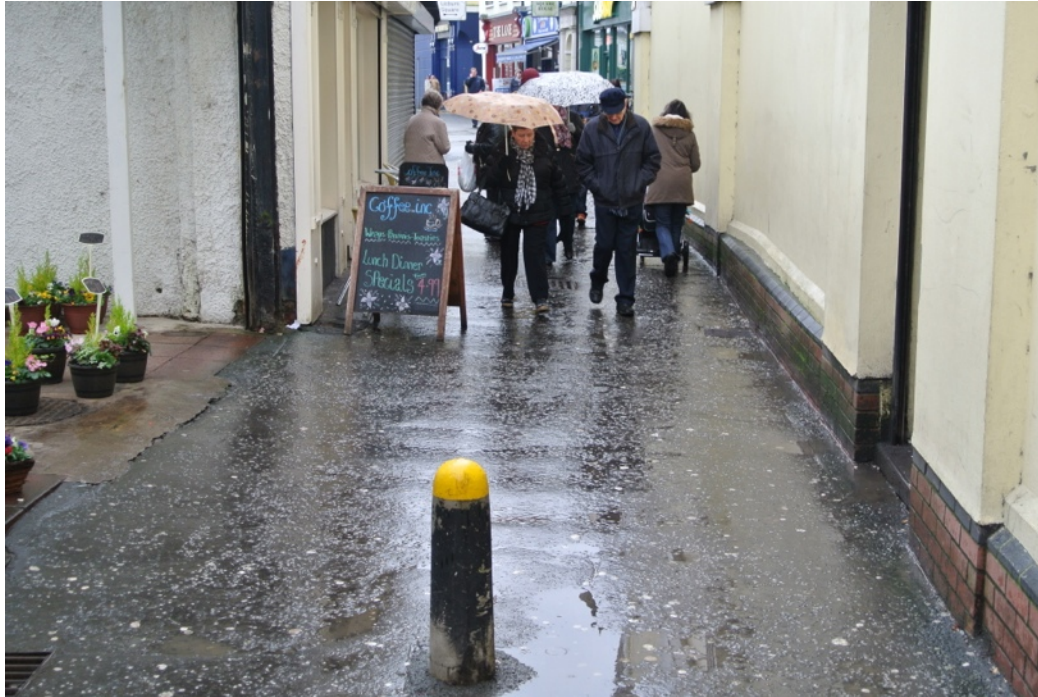
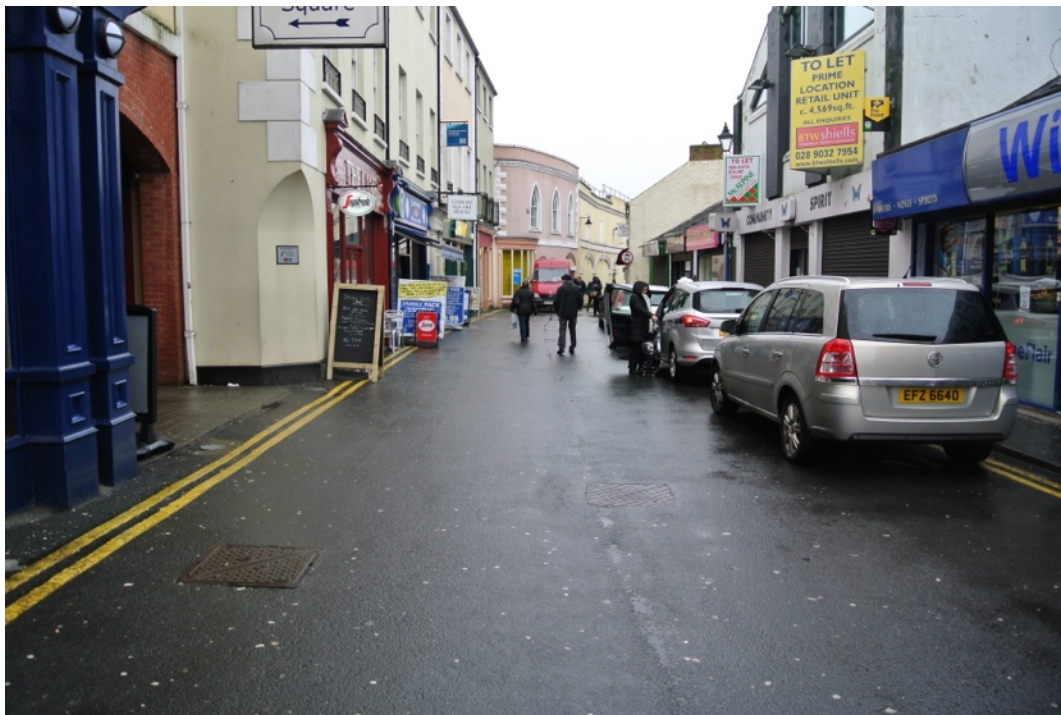
- 28 There are minimal footpaths in this area with a lot of vehicular movement and addition obstructions such pavement cafes, bollards and refuse bins.

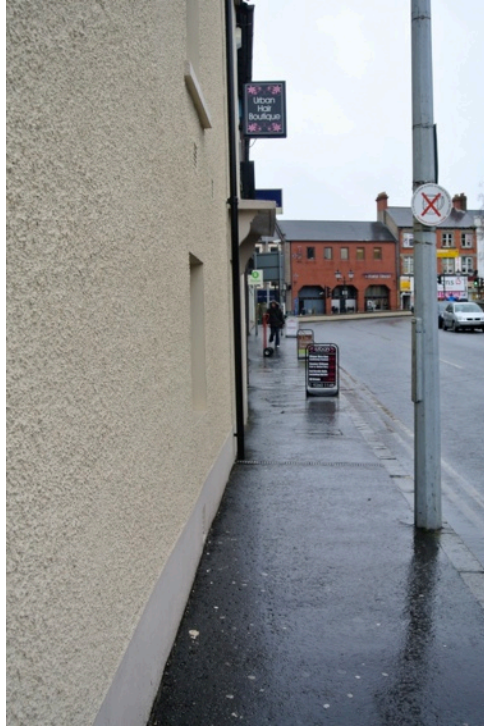
- 29 A-Boards cause obstructions and restrict pavement width on Market Street.

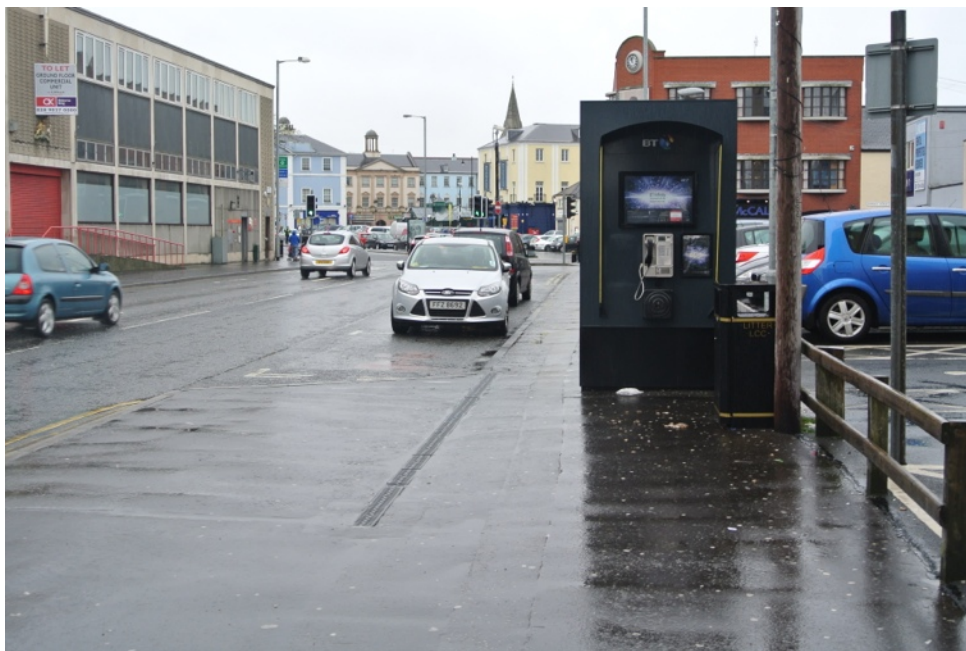
- 30 A BT Telephone kiosk restricts pavement width and causes an obstruction.

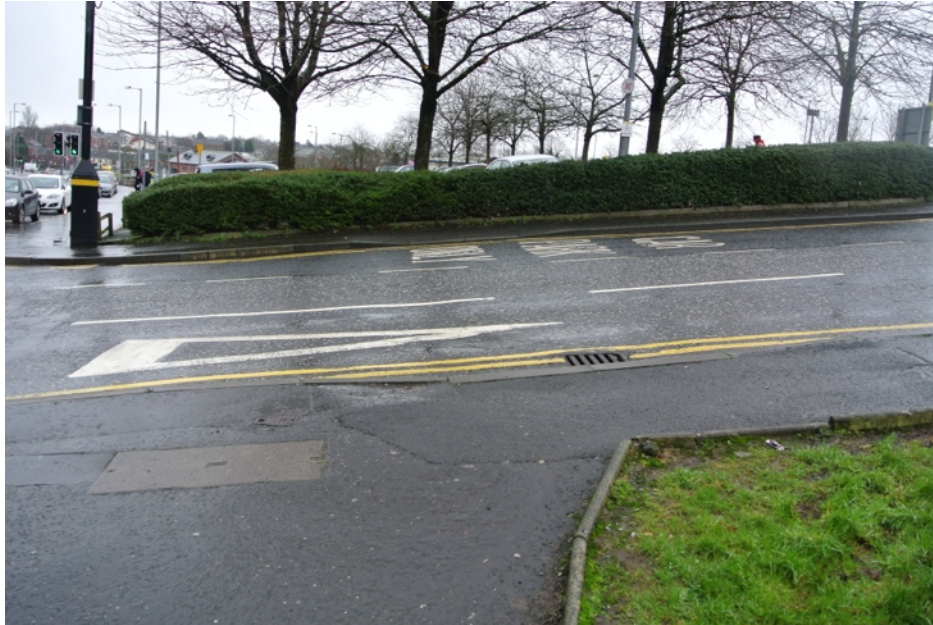
- 31 There is an uncontrolled crossing close to the Roads Service car park on Linenhall Street. The gradient of the road makes using this crossing difficult. There is no tactile paving.

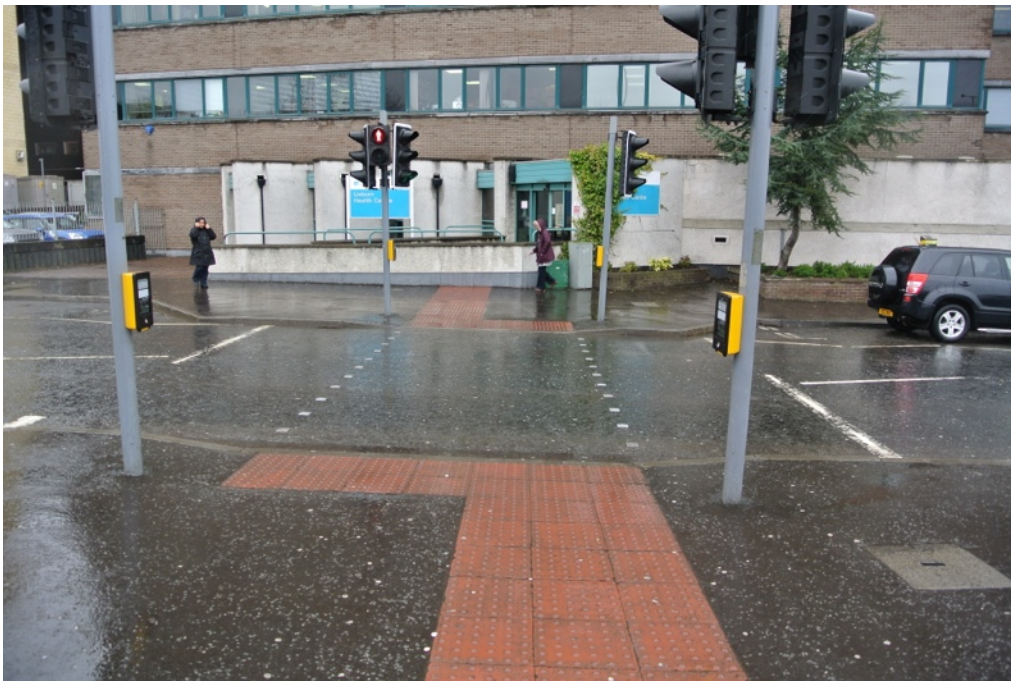
- 32 The controlled crossing at the health centre has no rotating cone.

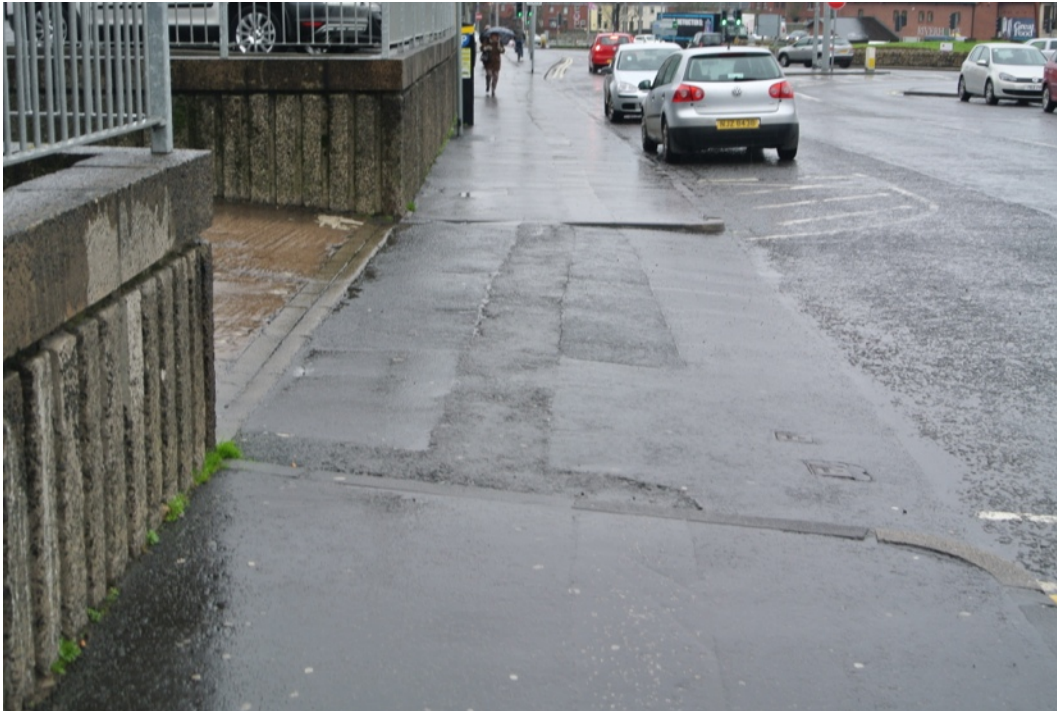
33 There is no tactile paving at the Health centre car park entrance.

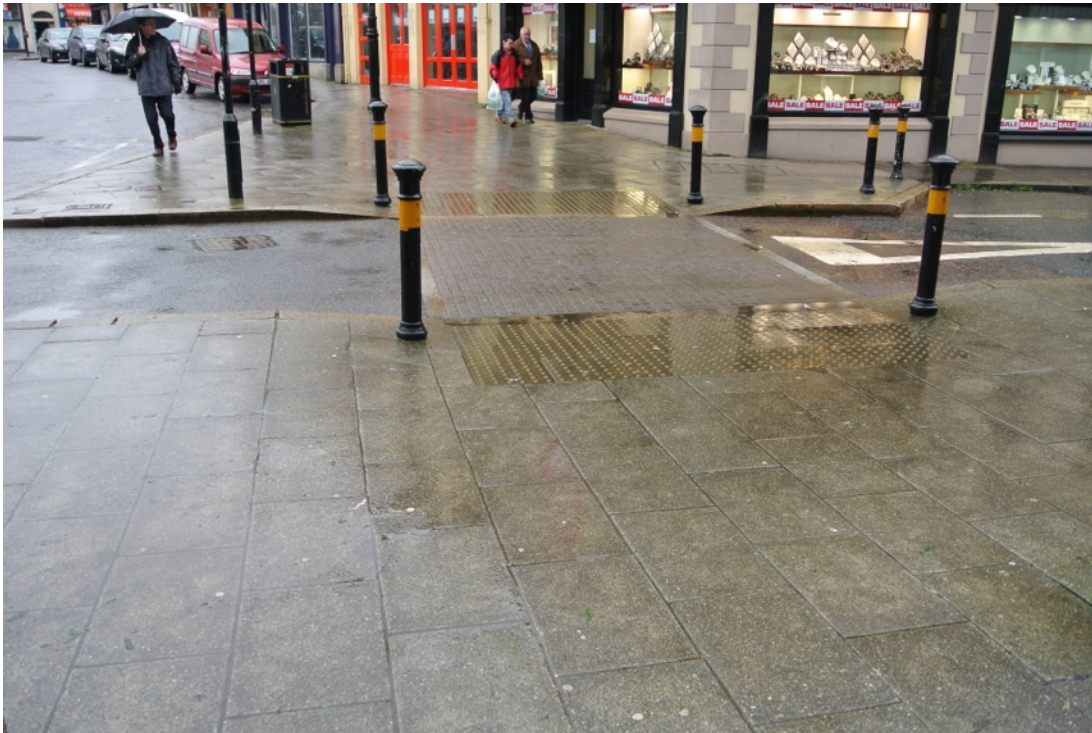
- 35 The tactile paving uncontrolled crossing at the junction of Bridge Street and Market Square is non-standard and does not provide good contrast.

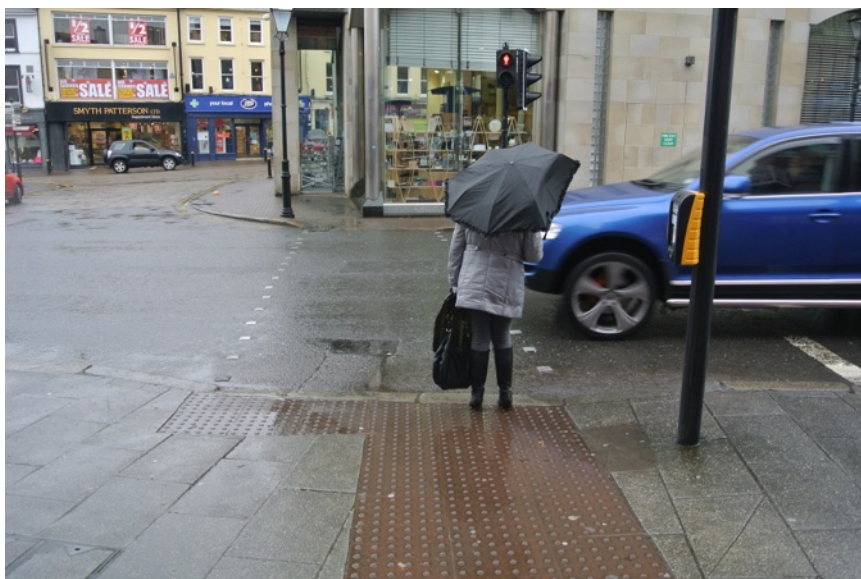
- 36 There is no tactile paving on the Linen Museum side of the controlled crossing on Market Square.

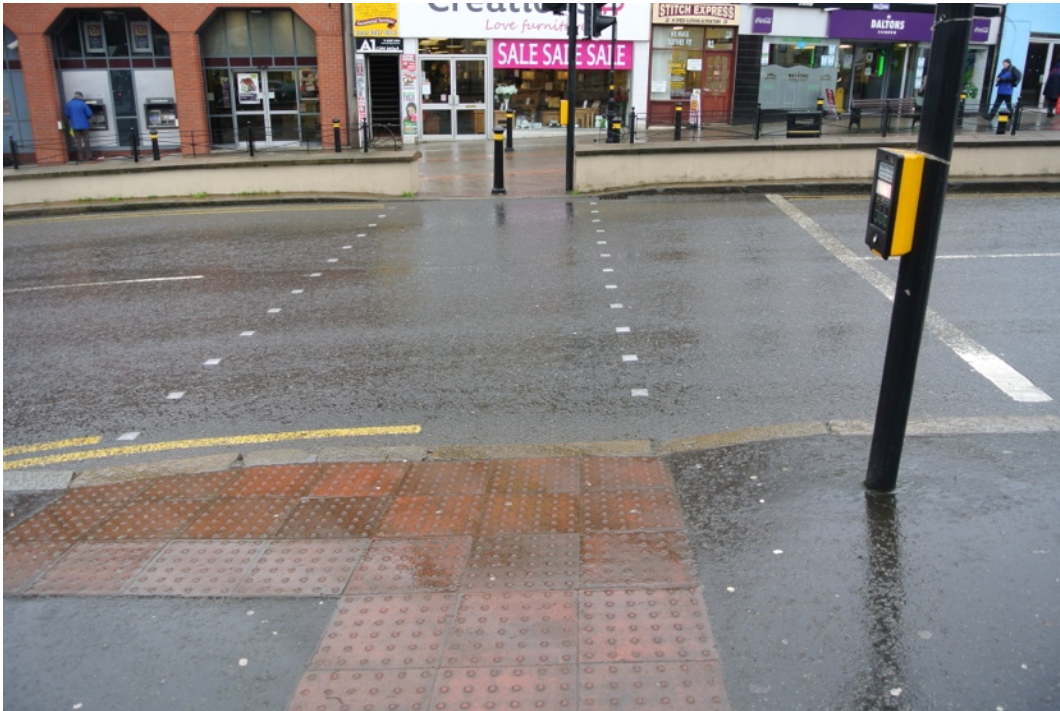
- 37 The control box is too far from the tactile paving at the controlled crossing at the east end of the pedestrian zone. Access on the far side is restricted by a bollard placed in the middle of tactile paving.

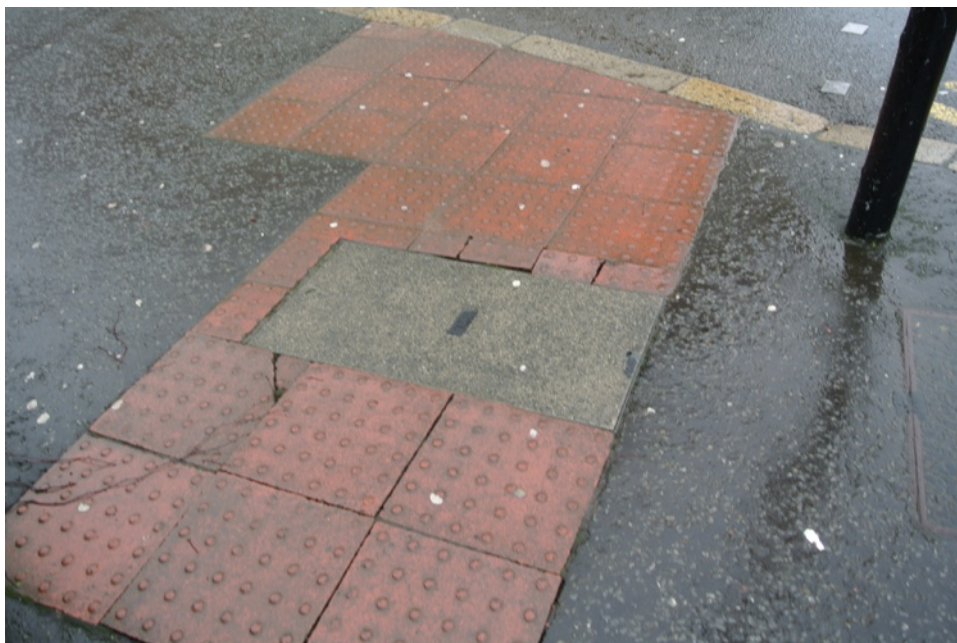
- 38 The tactile paving at the controlled crossing at the junction of Market Street and Market Square is damaged; there is also a significant crossfall and no rotating cone at this crossing.

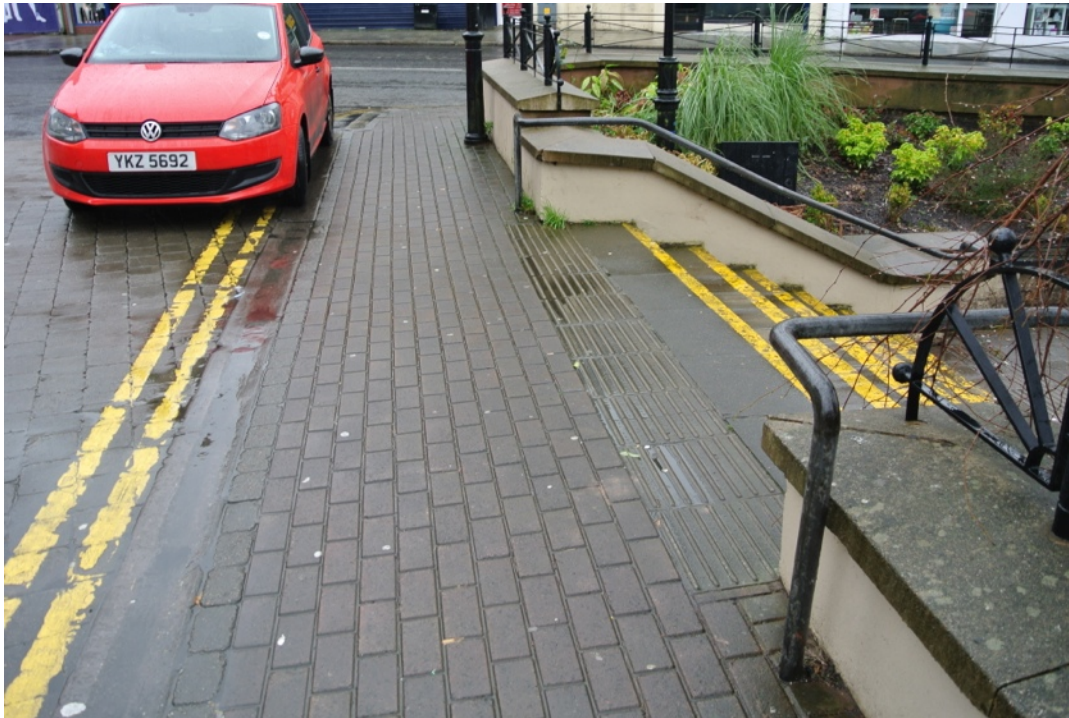
- 39 Steps around the Linen Museum gardens are fitted with the appropriate tactile corduroy hazard paving.

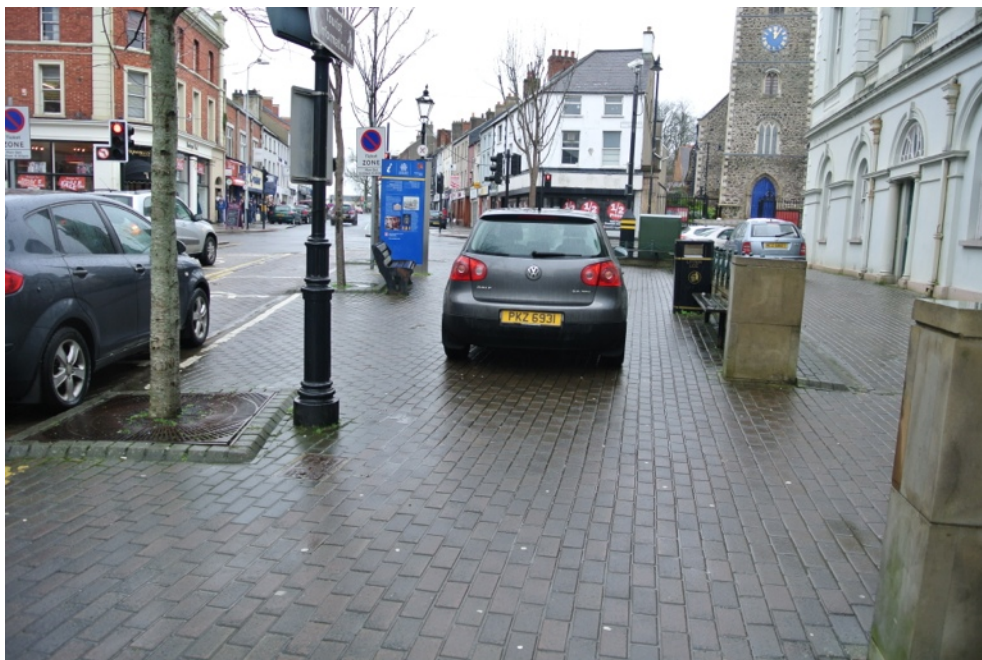
- 40 A car parked on the pavement in Market Square North is causing an obstruction.

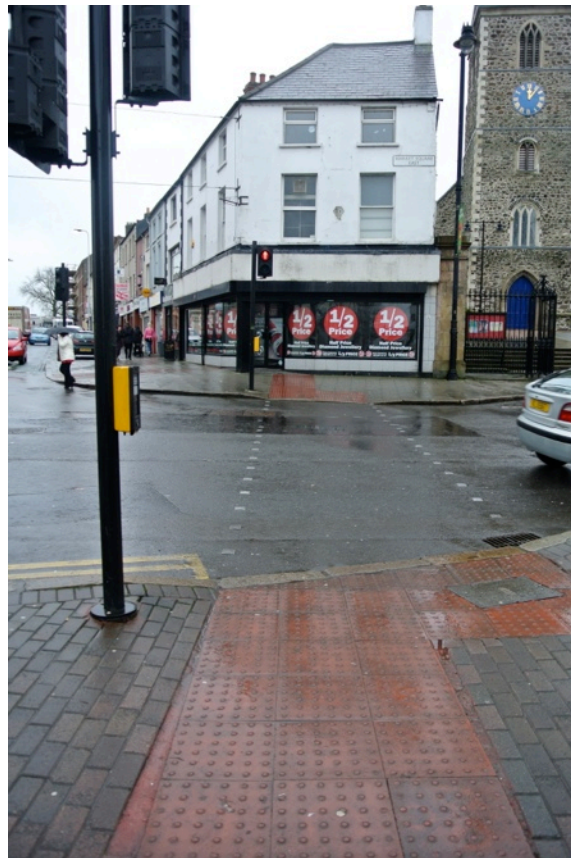
- 41 The dropped kerb at the controlled crossing between Market Square North and East is not flush and presents a trip hazard.

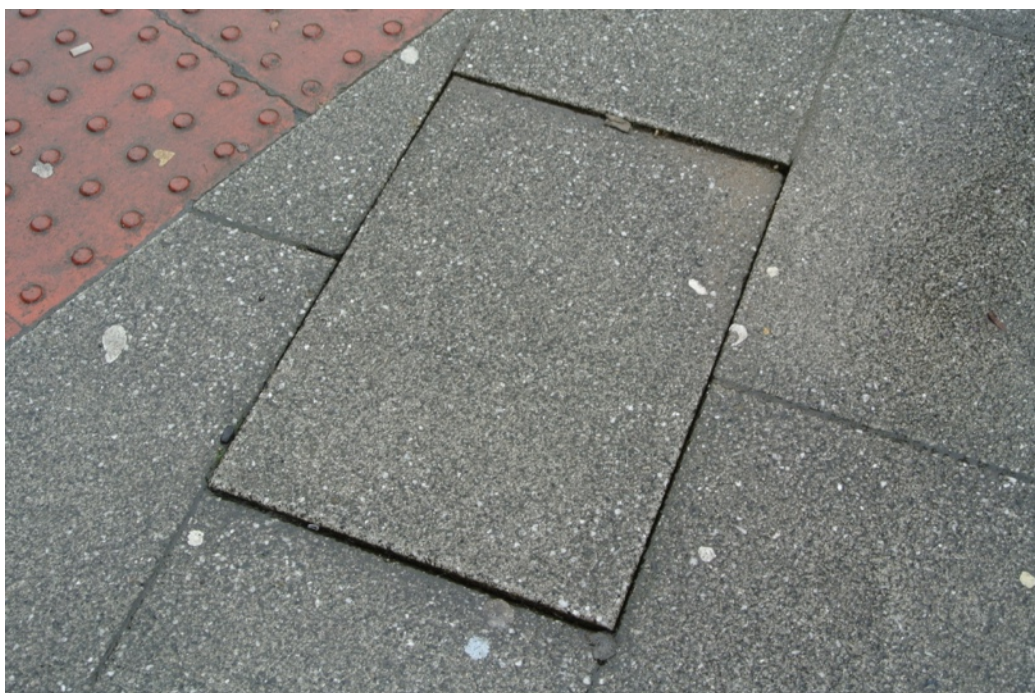
- 42 The granite paving on Market Square East is in poor condition with loose paving slabs presenting a number of trip hazards.

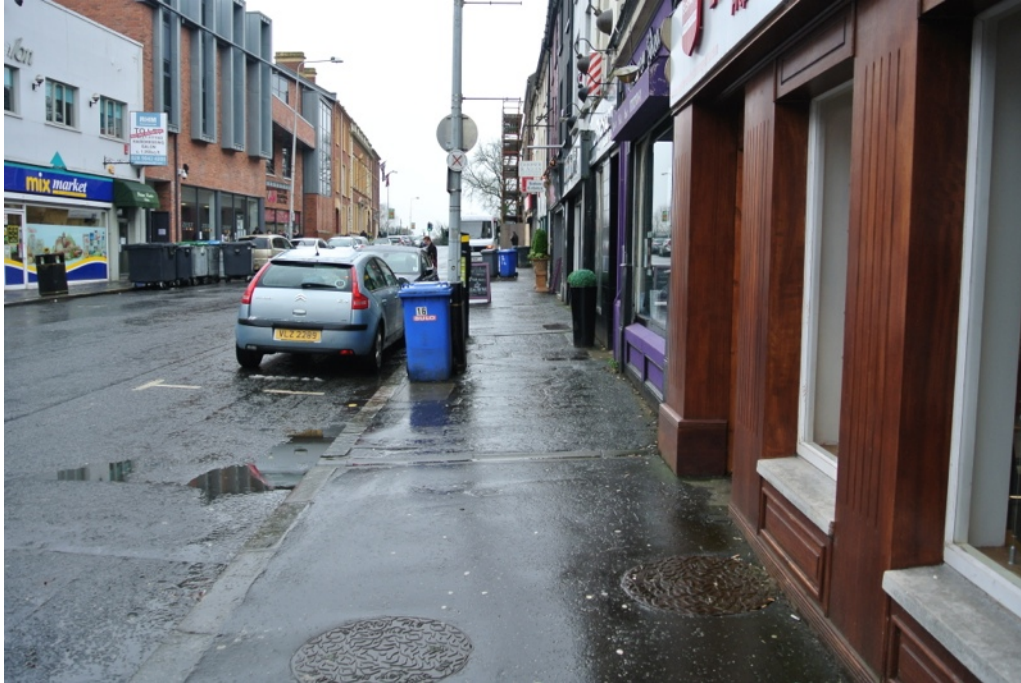
- 43 The pavement on Castle Street is uneven, dish drainage channels and clutter add to the problems.

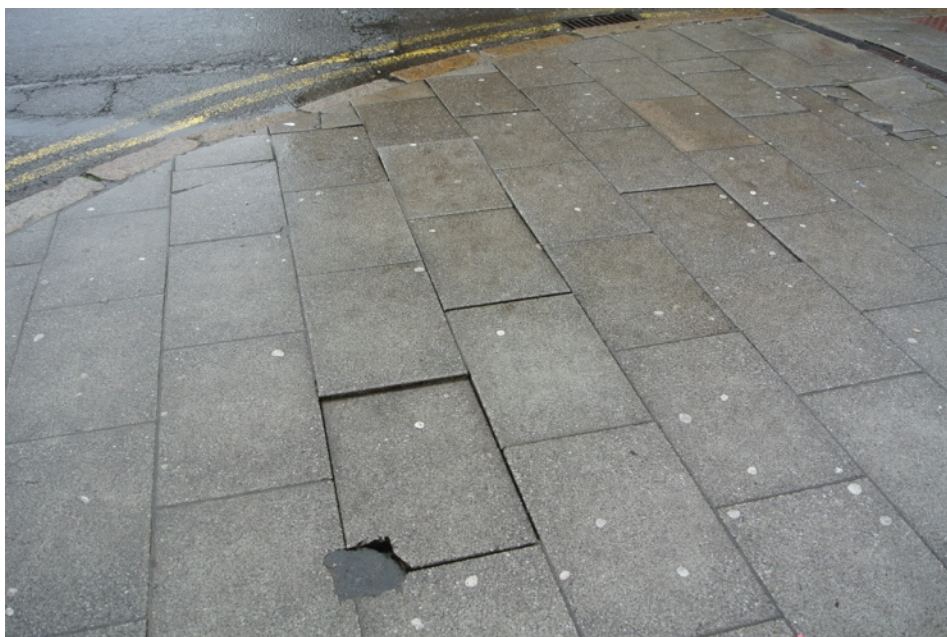
- 44 The granite paving around the controlled crossings on Castle Street/Railway Street/Market Square junctions is in a poor state of repair and present a tripping hazards. There is loose tactile paving on the crossing.

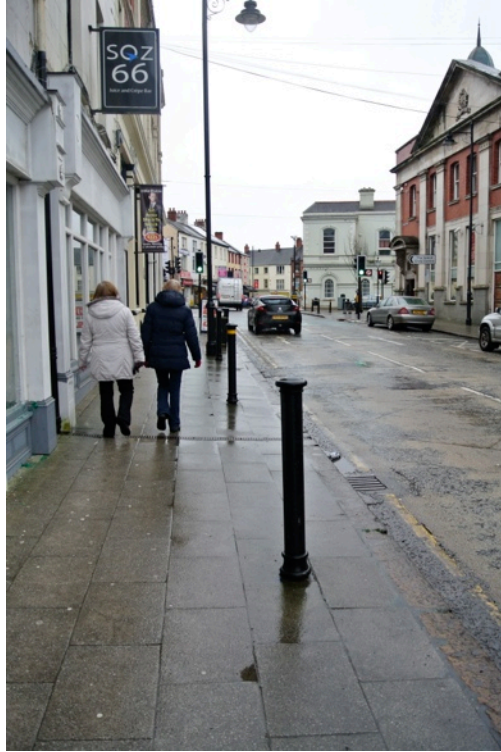
- 45 There are two “rogue” bollards on Railway Street without visibility bands.

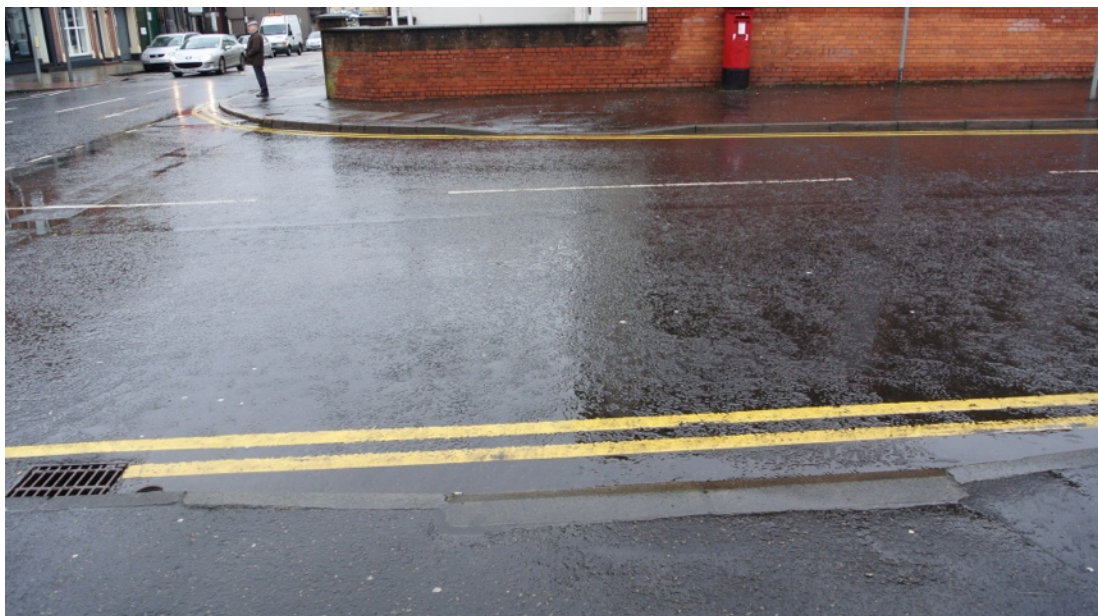
- 46 There is tactile paving missing from the uncontrolled crossing at the junction of Railway Street and Wallace Avenue. The crossing is not inline.

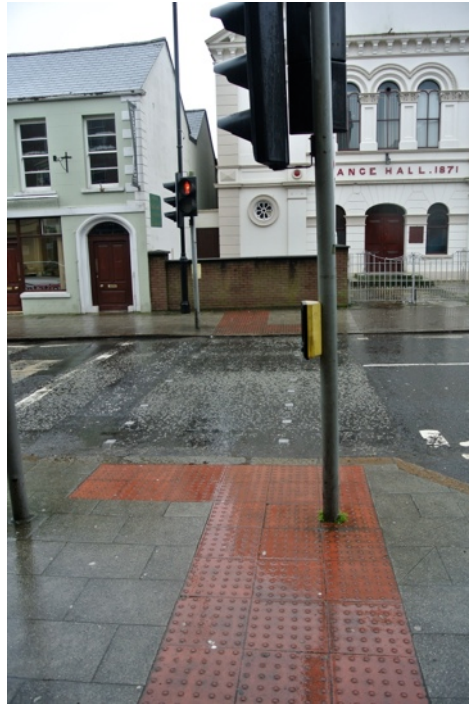
- 47 The controlled crossing on Railway Street does not meet good practice; the poles are located in the middle of the tactile paving, the control box is too high and has no rotating cone. The dropped kerb does not provide flush access.

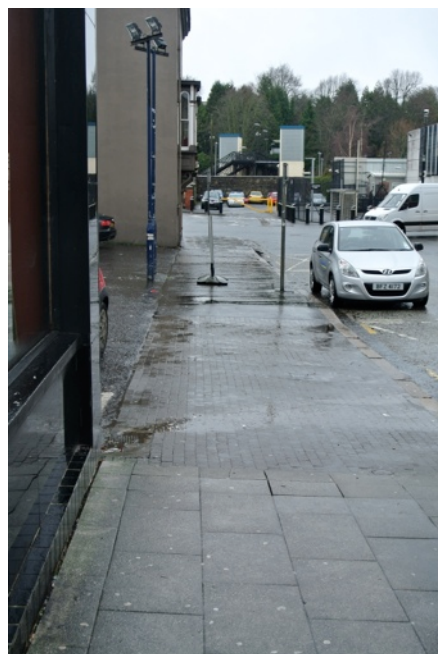
- 48 Tactile paving needs to be provided at vehicle entrances along Railway Street.

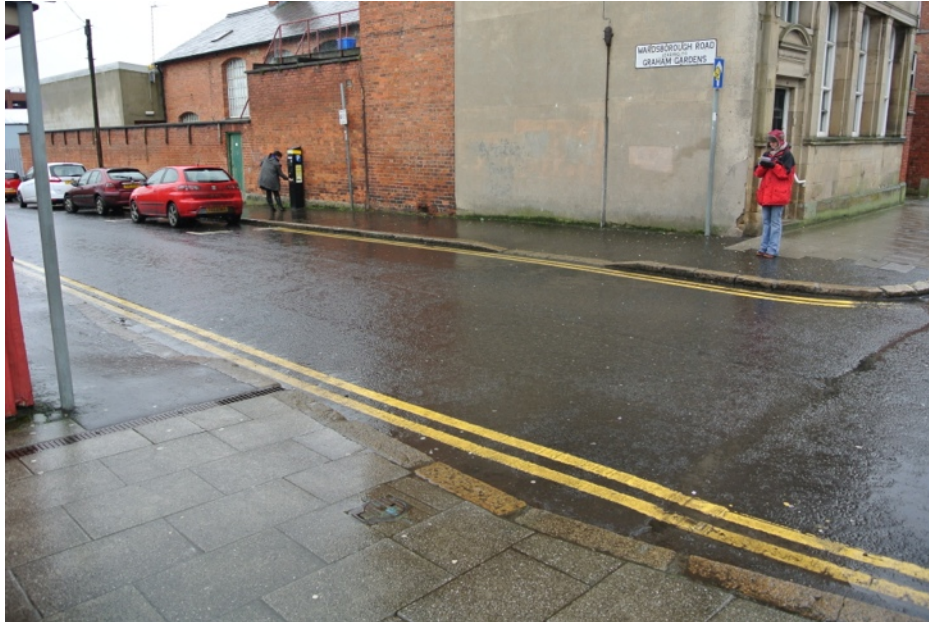
- 49 There is an inline uncontrolled crossing at the junction of Railway Street and Wardsborough Avenue. There is no tactile paving here. There are also restricted views for pedestrians on one side making it very difficult to see traffic coming from Railway Street onto Wardsborough Avenue. A very dangerous crossing.

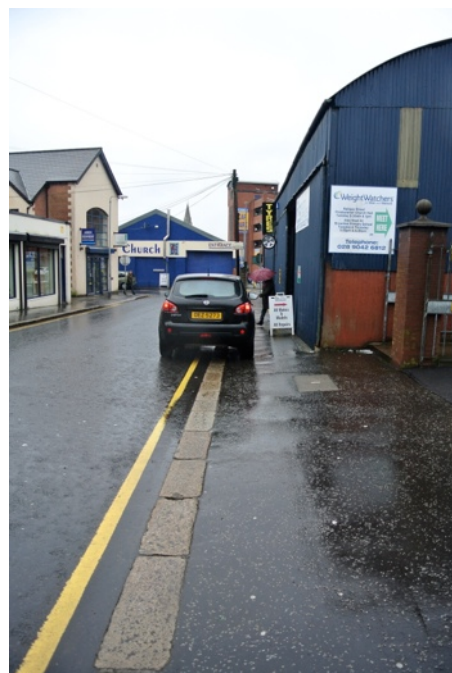
- 50 Cars parked on the pavement and A-Boards cause obstructions and restrict pavement width.

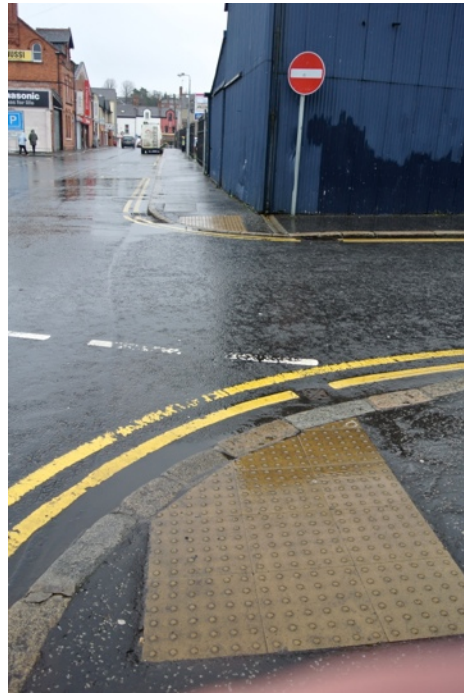
- 51 There is a good inline uncontrolled crossing at the junction of Wardsborough Avenue and Graham Gardens.

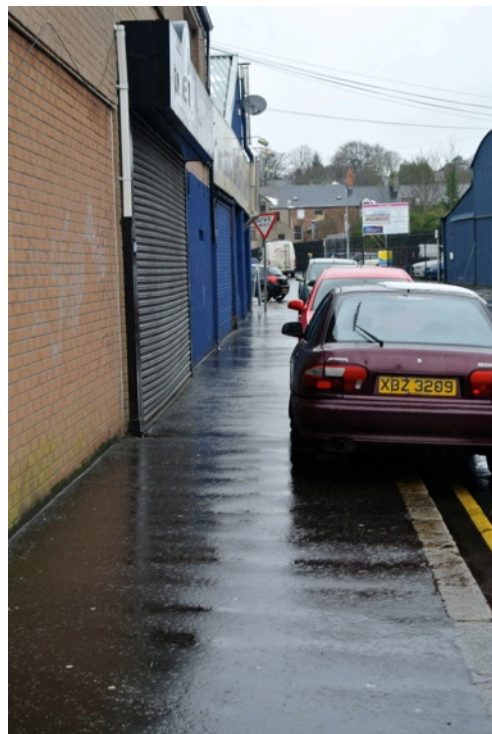
- 52 Pavement parking with cars displaying a Blue Badge restricts pavement width on Graham Gardens.
