Recommendations from Imtac on public realm proposals for Belfast Streets Ahead Phase 5

(November 2018)

Street audit findings

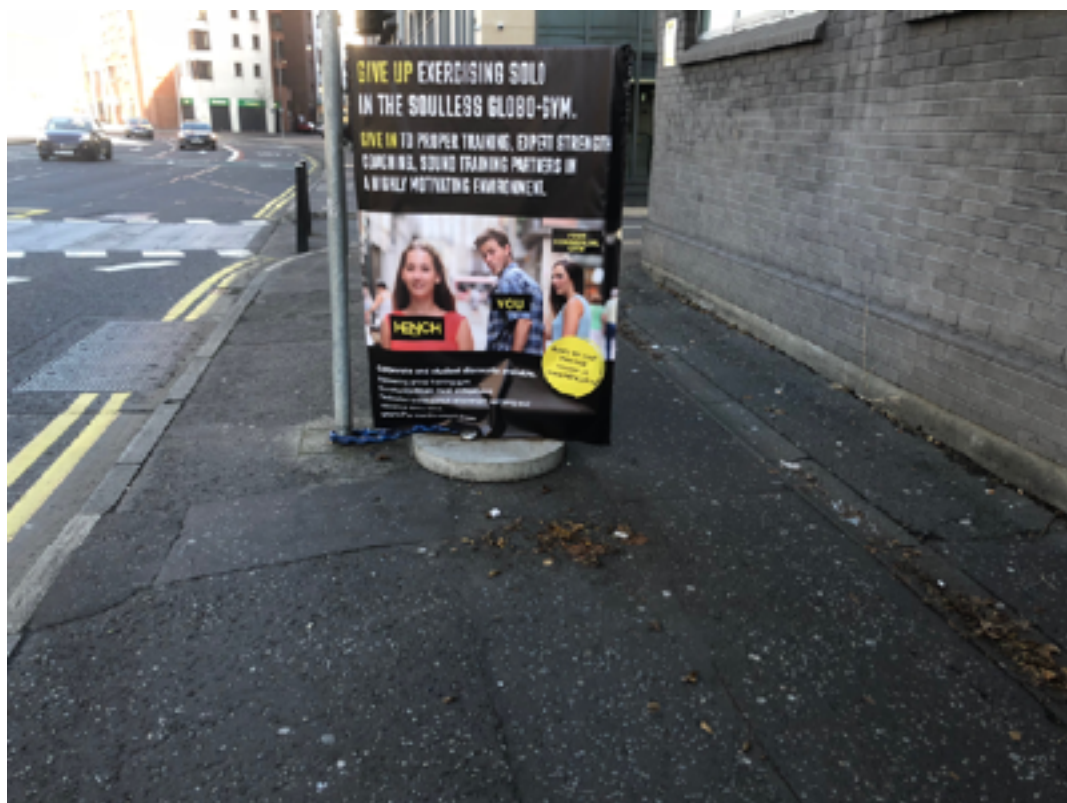
A large A-Board obstructs the eastern footway shortly after this crossing.

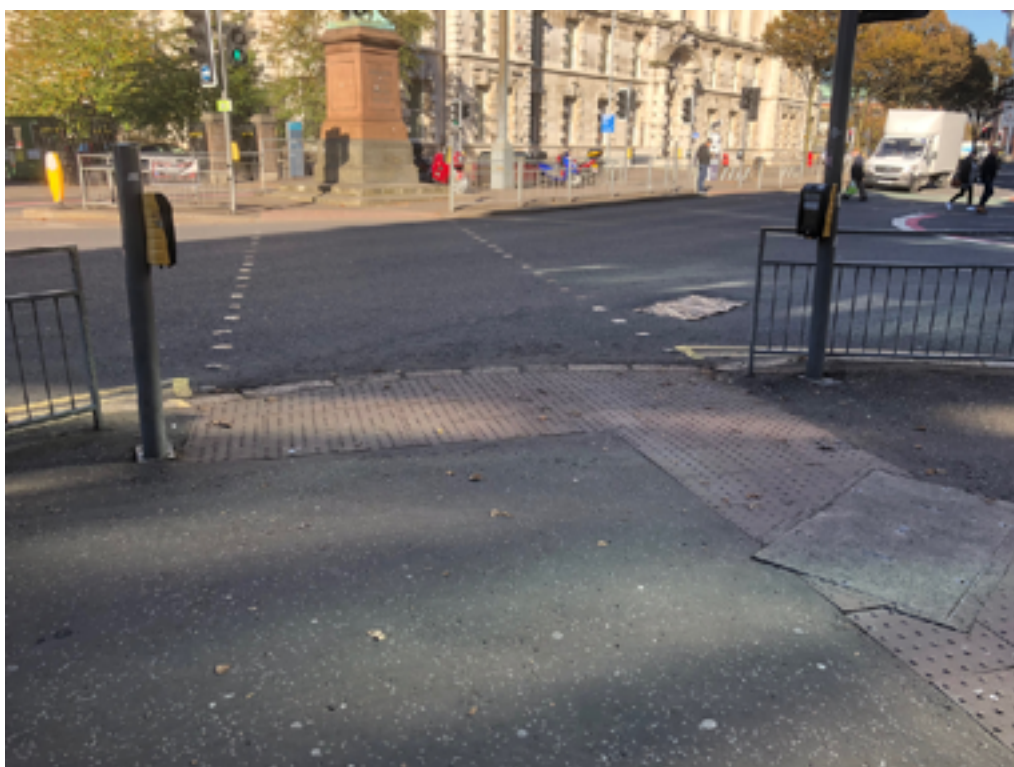
There is a second controlled crossing across the northbound lanes of College Square East to the large central traffic island. The use of tactile paving and control boxes is again good but some tactile paving is loose and unstable.

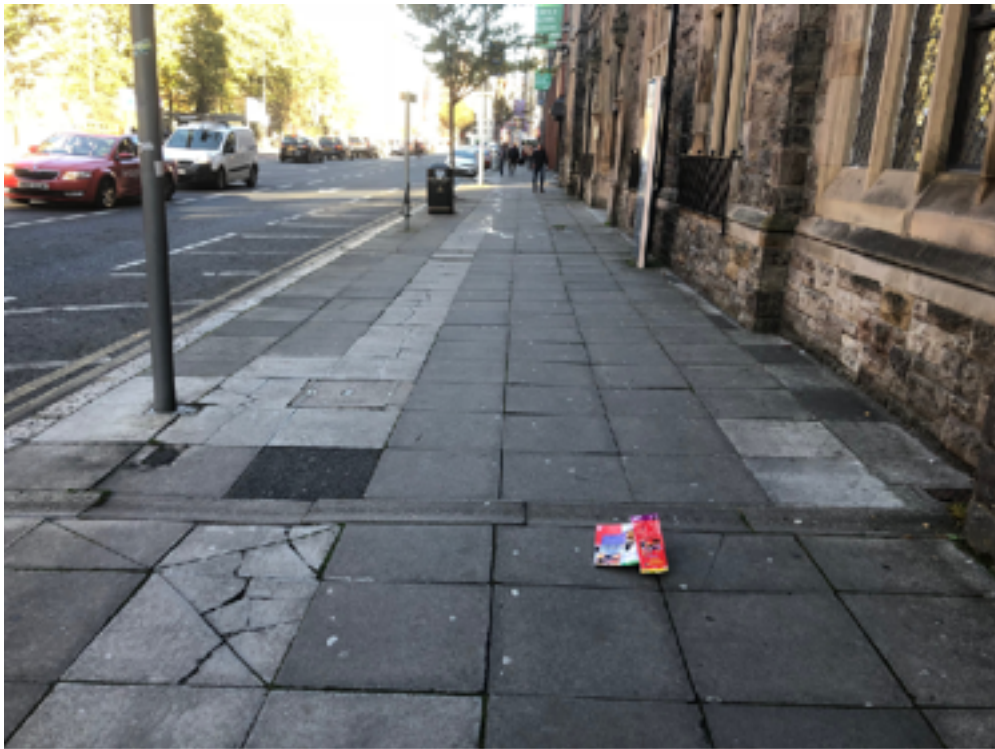
Although broad the footway between Fisherwick Place and Howard Street is damaged and uneven in parts. Deep dish drainage channels are used frequently.

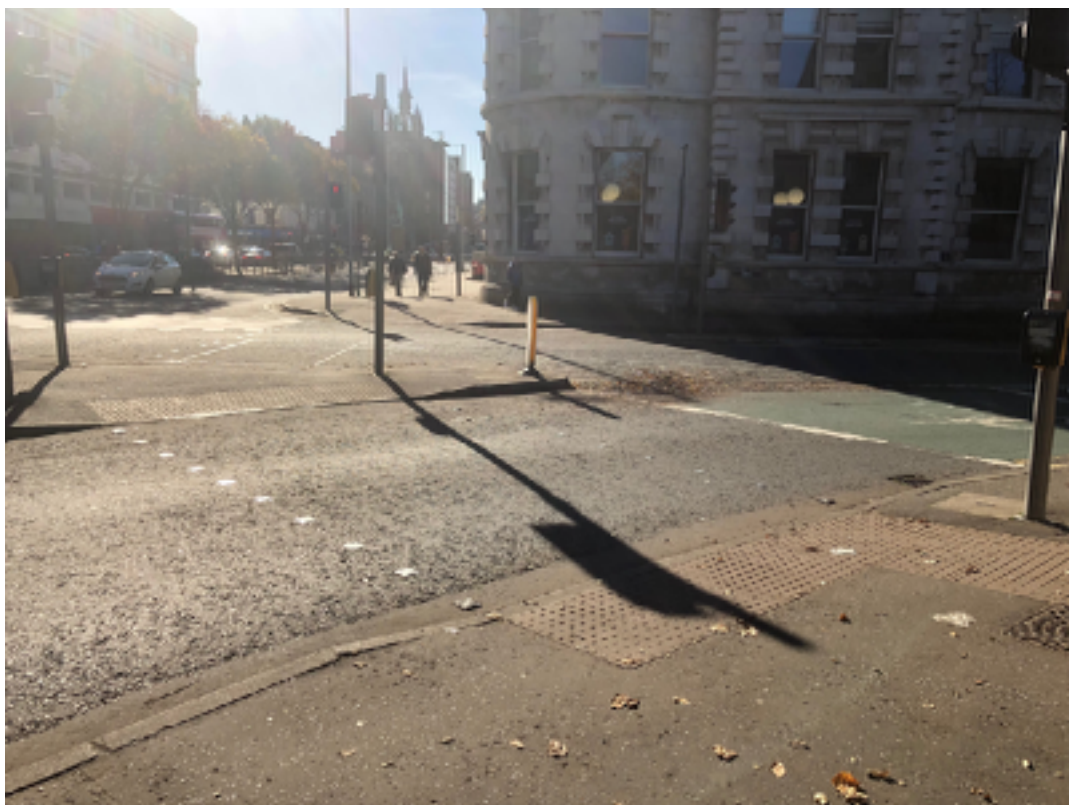
There is a staggered controlled crossing across via a small traffic island College Square North at its junction with College Square East. The positioning of control boxes on the island is problematic.

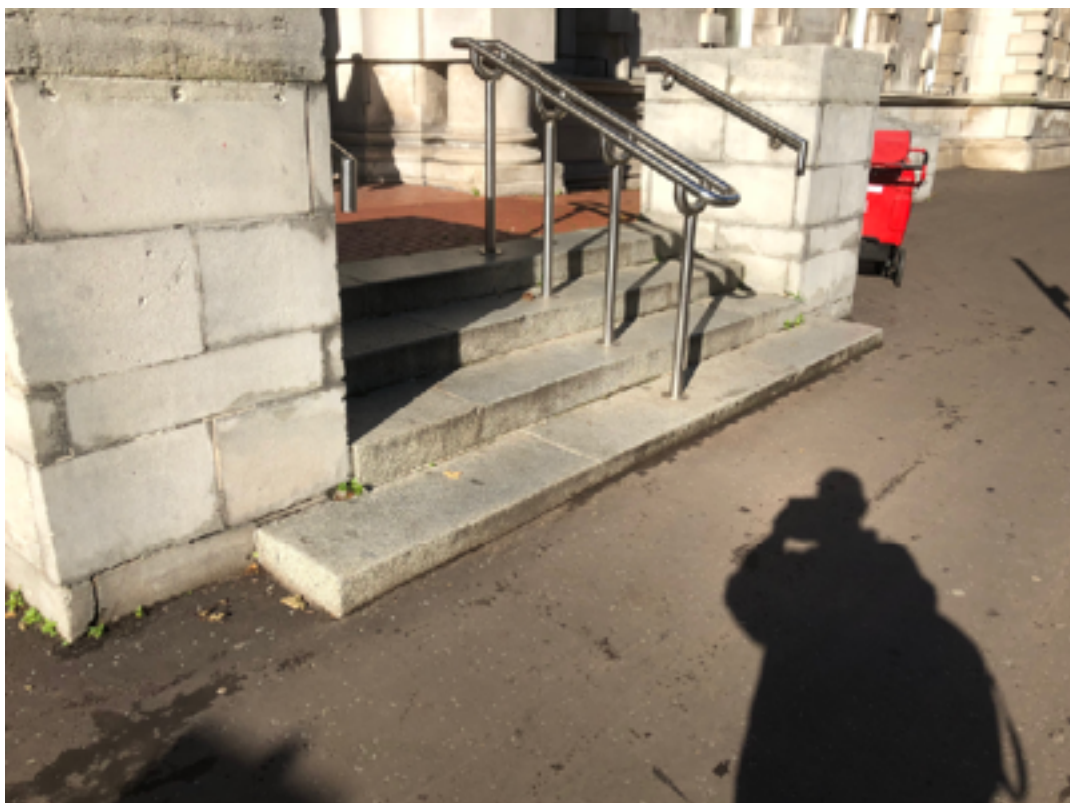
The steps at the entrance to John Bell House extend into the footway creating a potential hazard. Corduroy hazard paving has been provided at the top but not the bottom of the steps. A-Boards in the area can create an additional hazard.

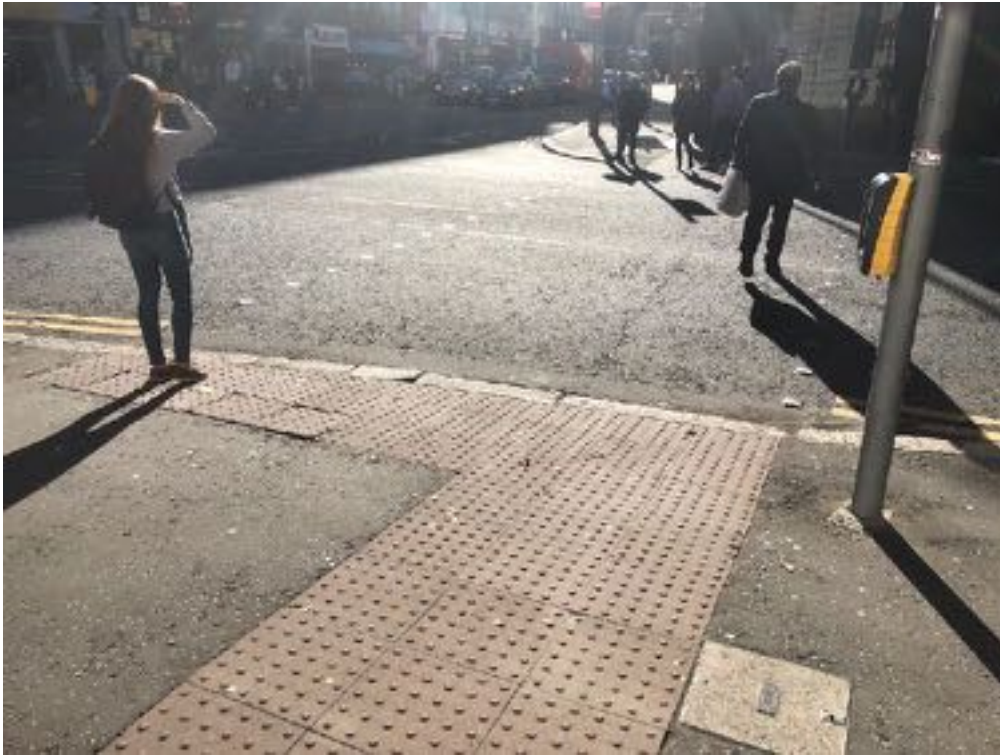
There is controlled crossing across the junction with Grosvenor Road providing access onto Great Victoria Street. Although laid correctly the tactile paving is damaged, loose and uneven in places on the northern side.

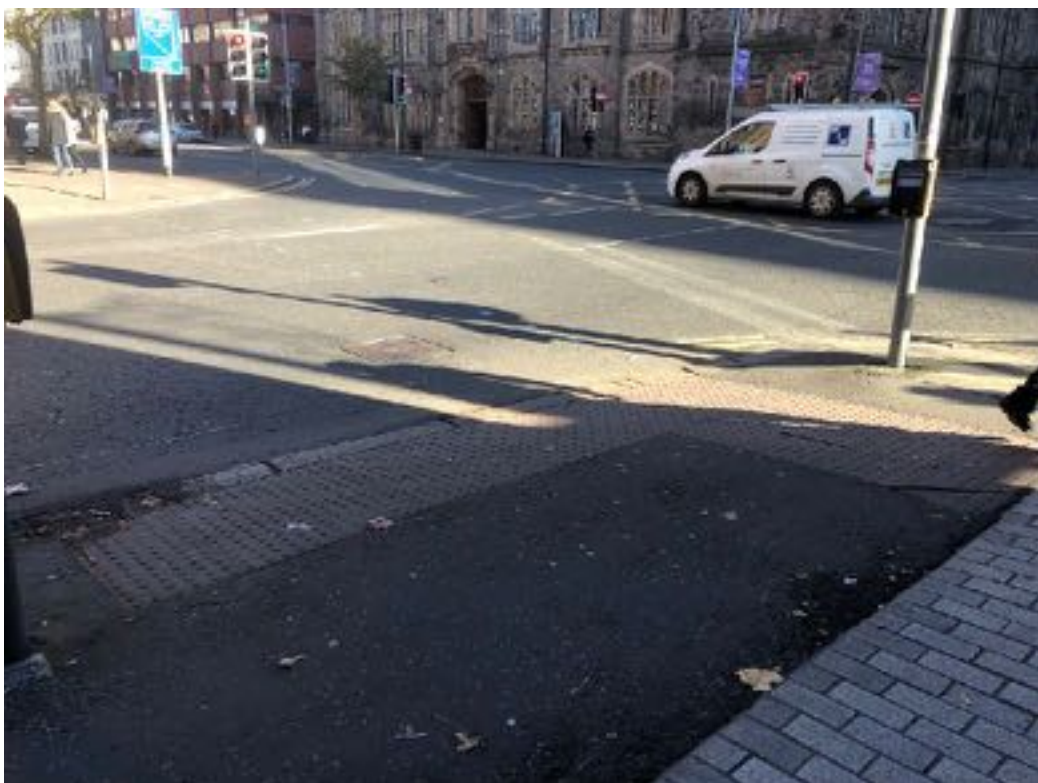
The tactile paving on the southern side of the controlled crossing across Grosvenor Road is again loose and uneven in places.

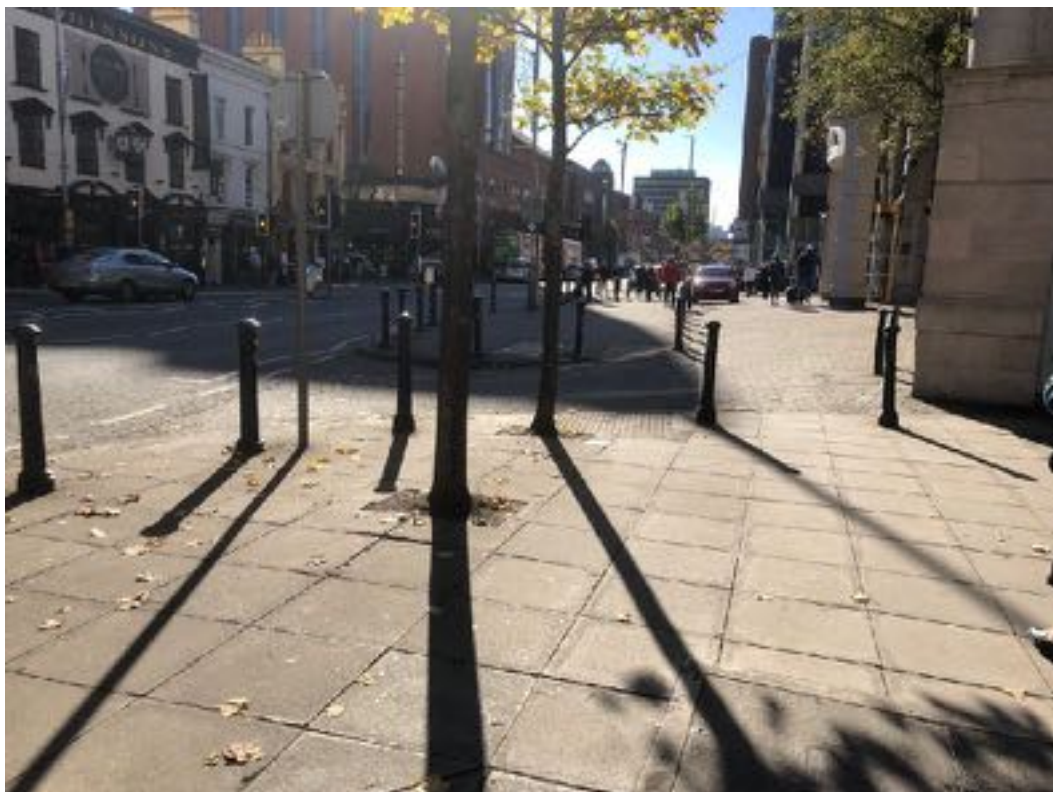
At the Europa Hotel there is a vehicle exit which includes an uncontrolled crossing with tactile paving. However there is a substantial area of flush surface without tactile paving. Bollards and trees create multiple hazards.

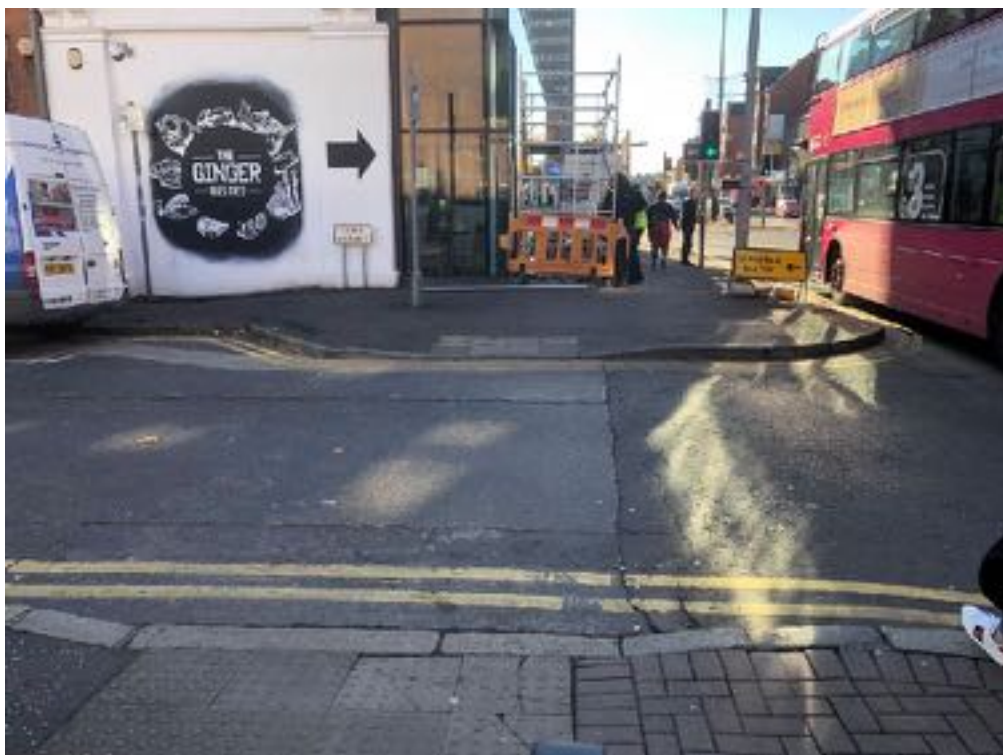
The footway on the eastern side of Great Victoria Street is obstructed by works to the building at its junction with Hope Street. There is an in-line uncontrolled crossing across Hope Street. Tactile paving is damaged and not sufficient in terms of depth. The dropped kerb on the southern side of the crossing is not flush with the carriageway.

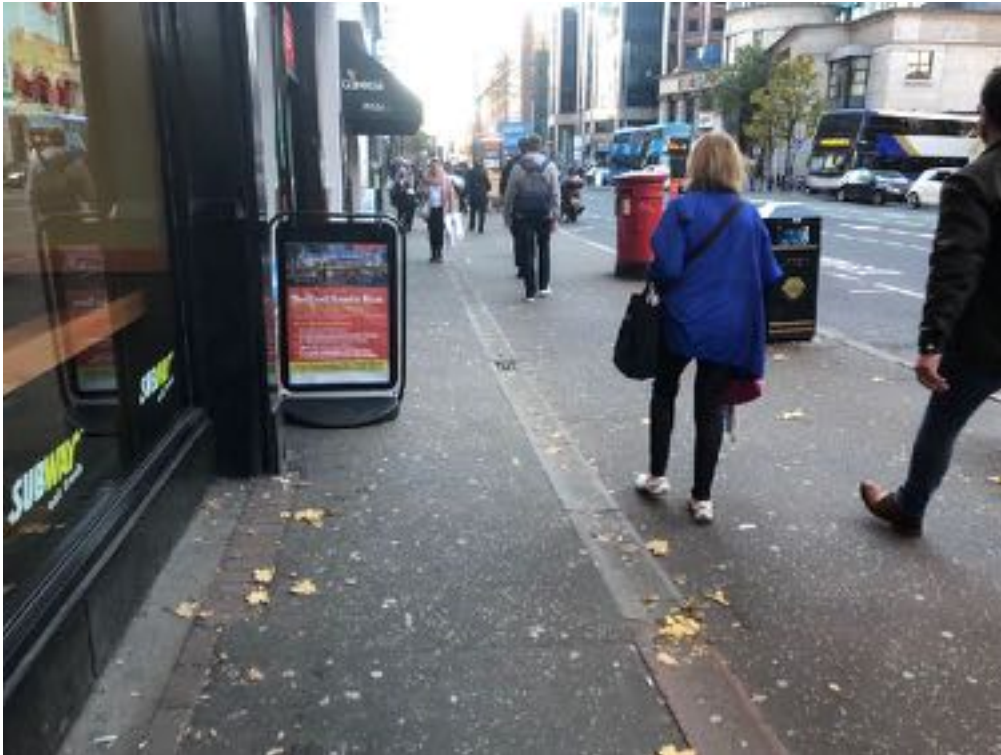
The eastern footway towards Howard Street is broad but very busy. A Boards are a frequent potential hazard along this section.

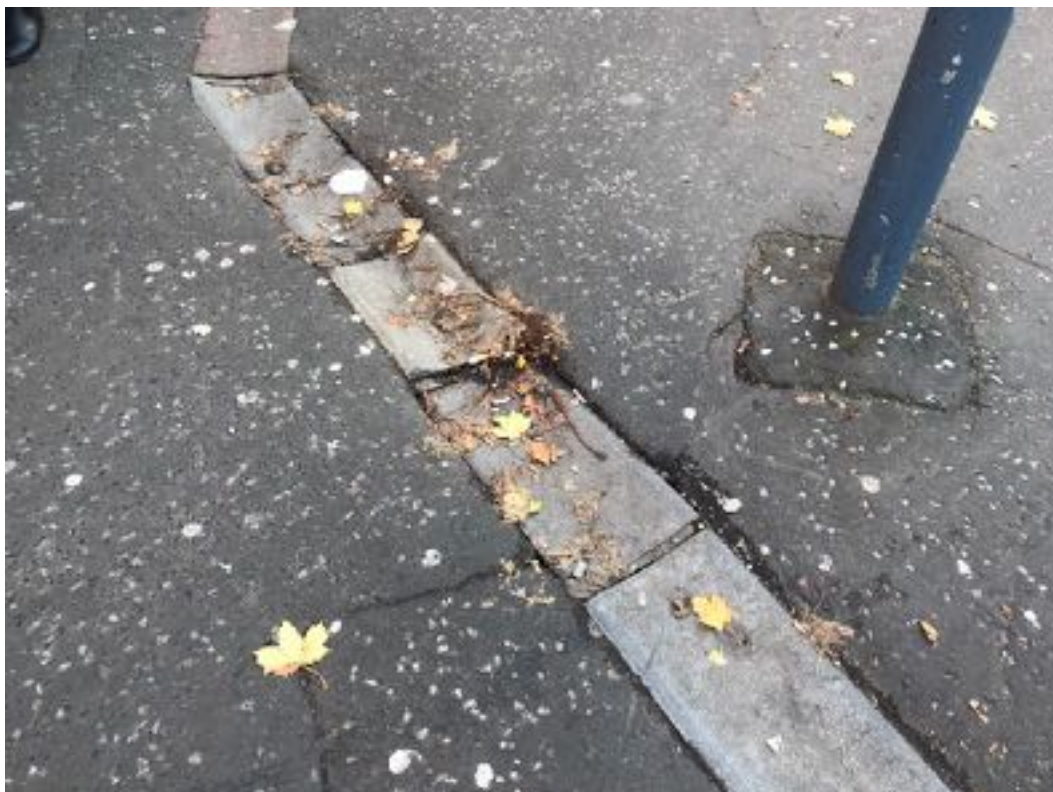
Dish drainage channels are used throughout this section presenting a significant potential trip hazard in some locations.

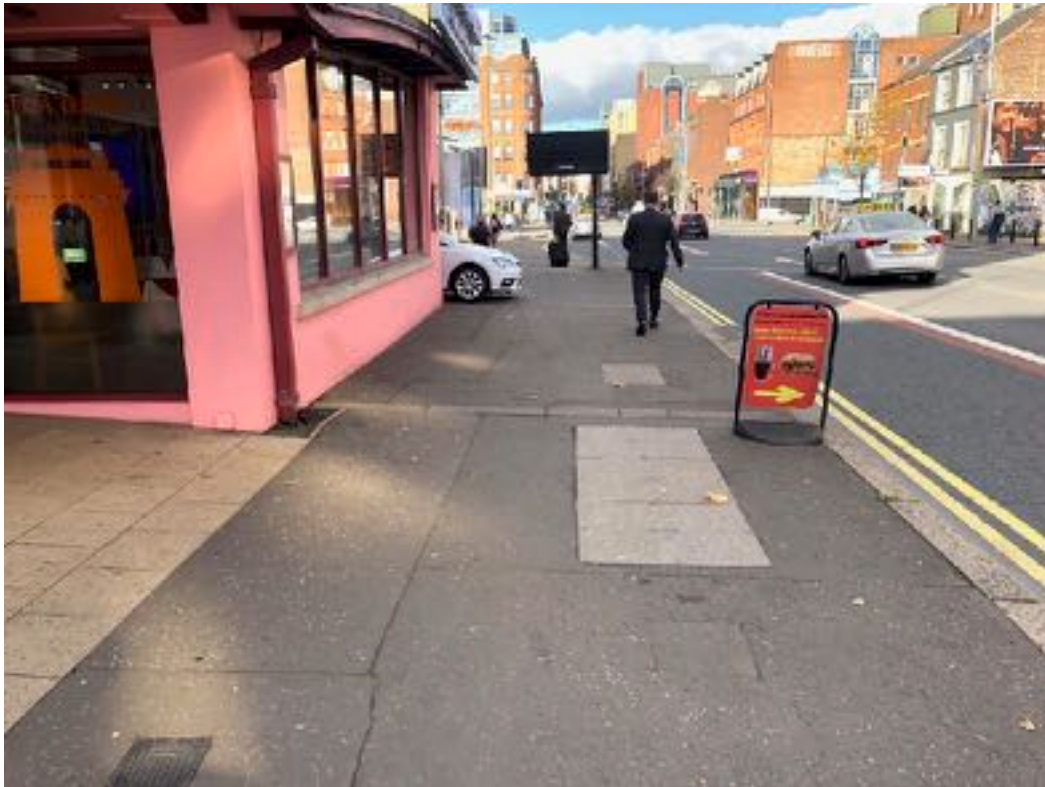
Although broad the footway is obstructed by parked cars and A-Boards. Dish drainage channels create additional potential hazards.

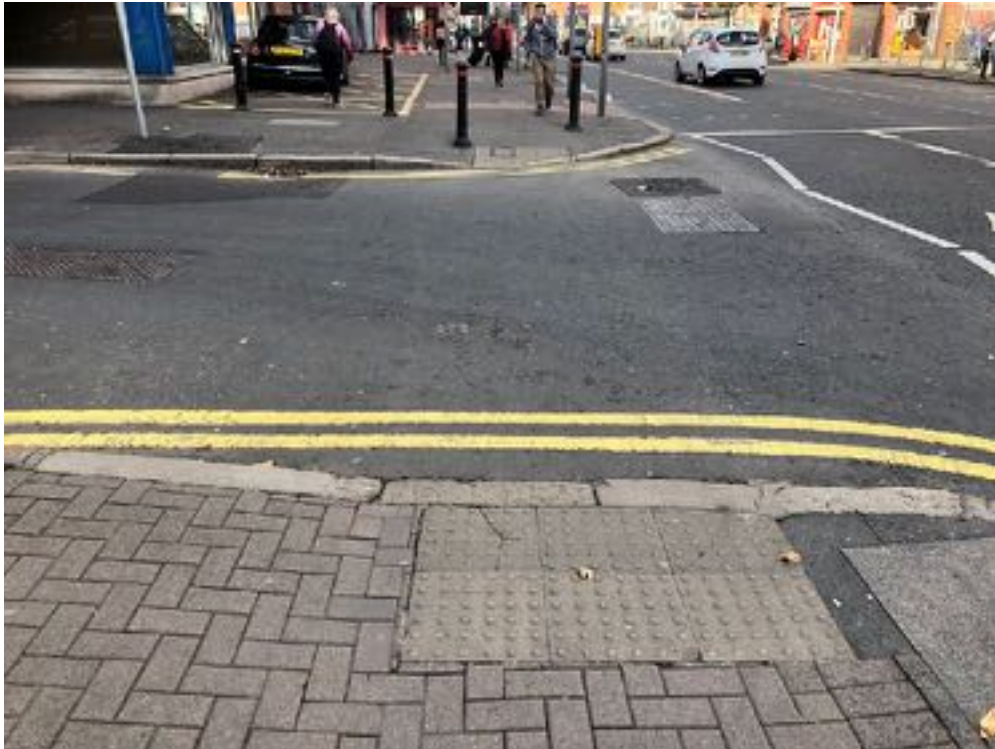
There is an in-line uncontrolled crossing across Wellwood Street. Bollards on the northern side create potential hazards. The depth of tactile paving is insufficient on both sides of the crossing and contrast is poor on the southern side.

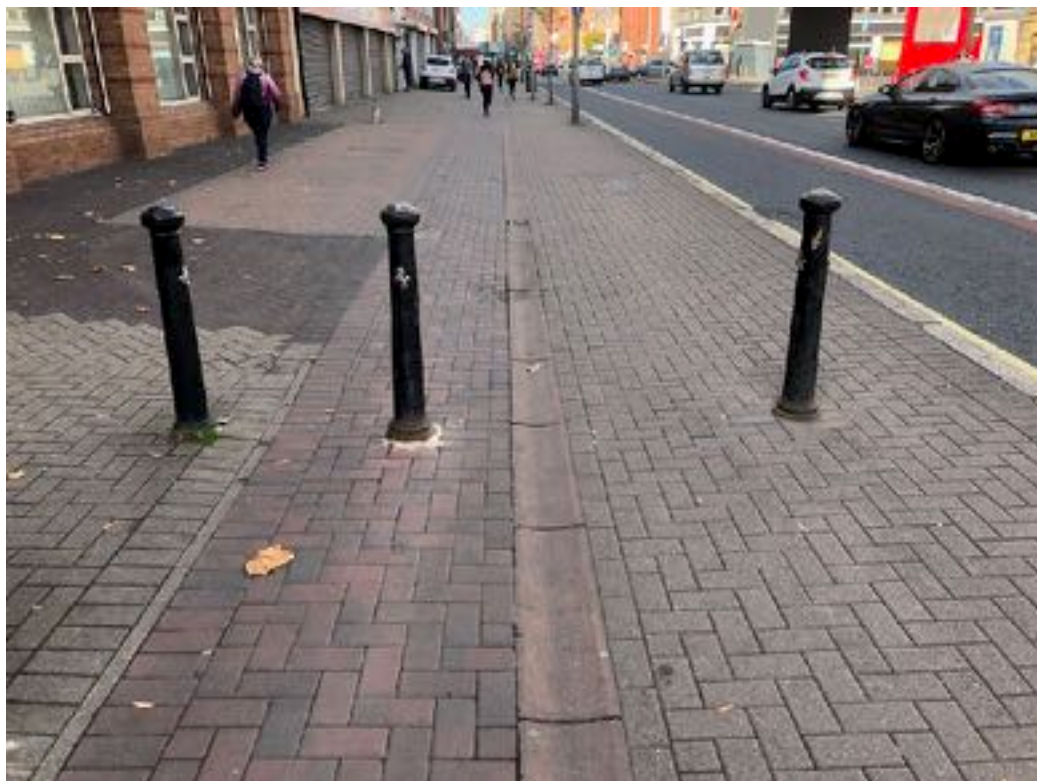
The footway beyond this junction is very broad but parked cars, A Boards and multiple bollards create potential hazards. There is also a significant cross fall on the footway and a central dish drainage channel along its length.

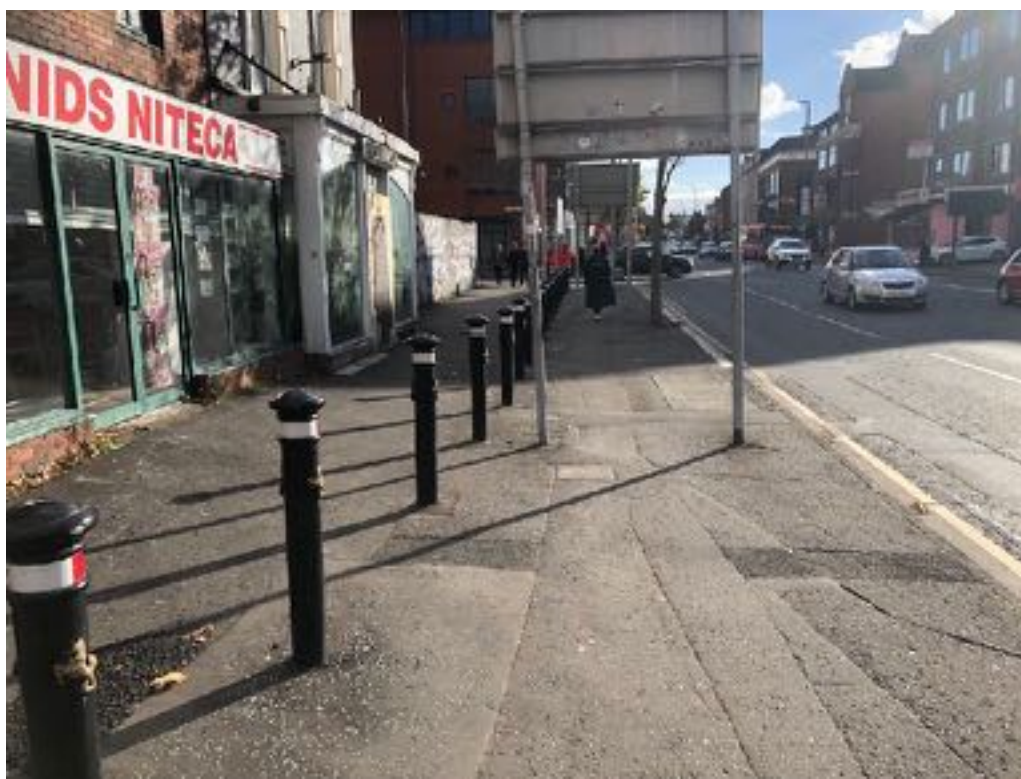
The broad eastern footway is narrowed significantly between Bruce Street and Ventry Street by a line of bollards (indicating a boundary between shop frontages and the adopted footway?). Trees and traffic signs create additional hazards.

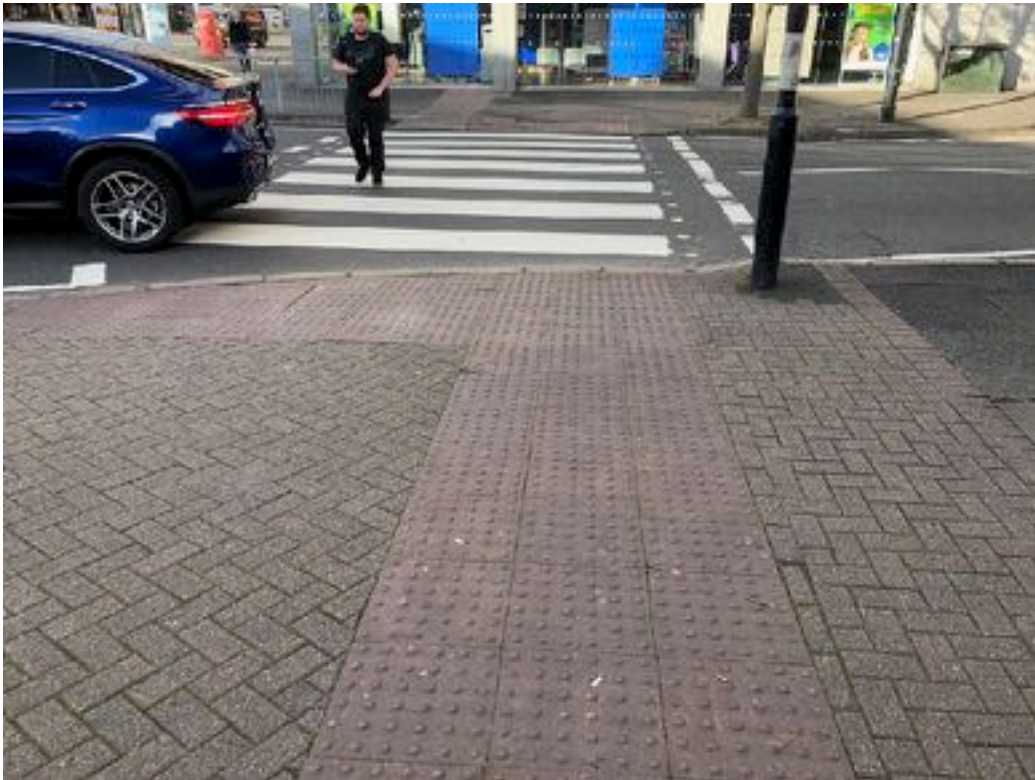
A Zebra crossing has been provided across Donegall Pass close to its junction with Shaftesbury Square and Botanic Avenue. The tactile paving is damaged, loose and uneven in places.

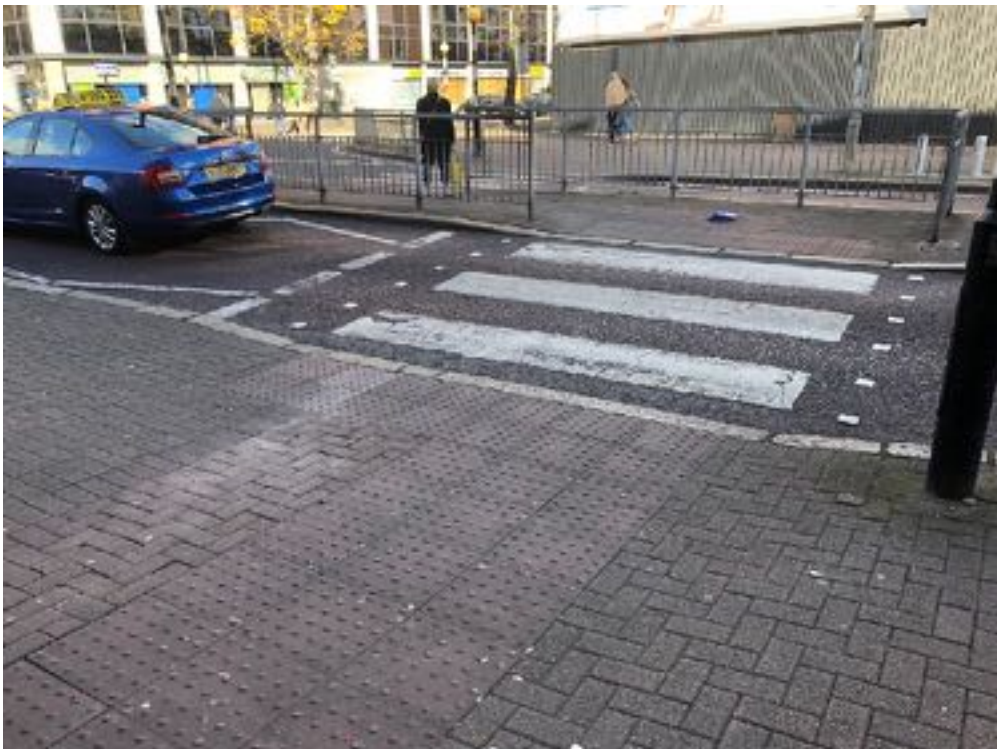
A staggered Zebra crossing has been provided across Botanic Avenue close to its junction with Donegall Pass and Shaftesbury Square. The tactile is damaged, loose and uneven in places and provides no contrast with surrounding paving.

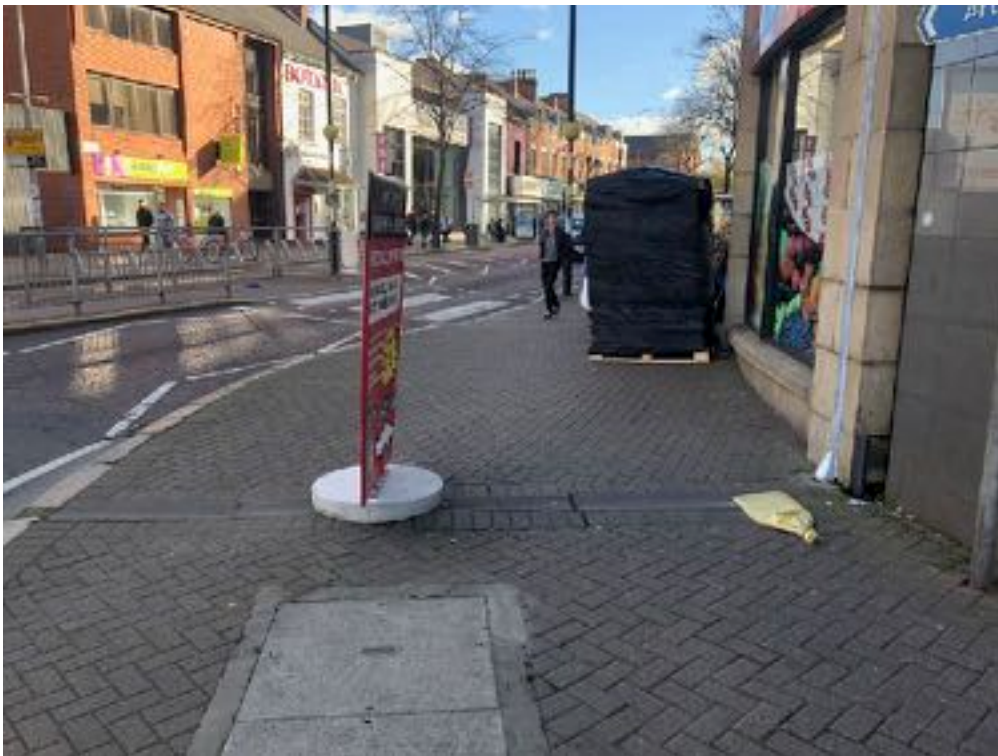
Obstructions on the footway including a large A-Board and delivery pallets associated with a nearby business create potential hazards for pedestrians travelling from Botanic Avenue along the southern footway on Shaftesbury Square towards Bradbury Place.

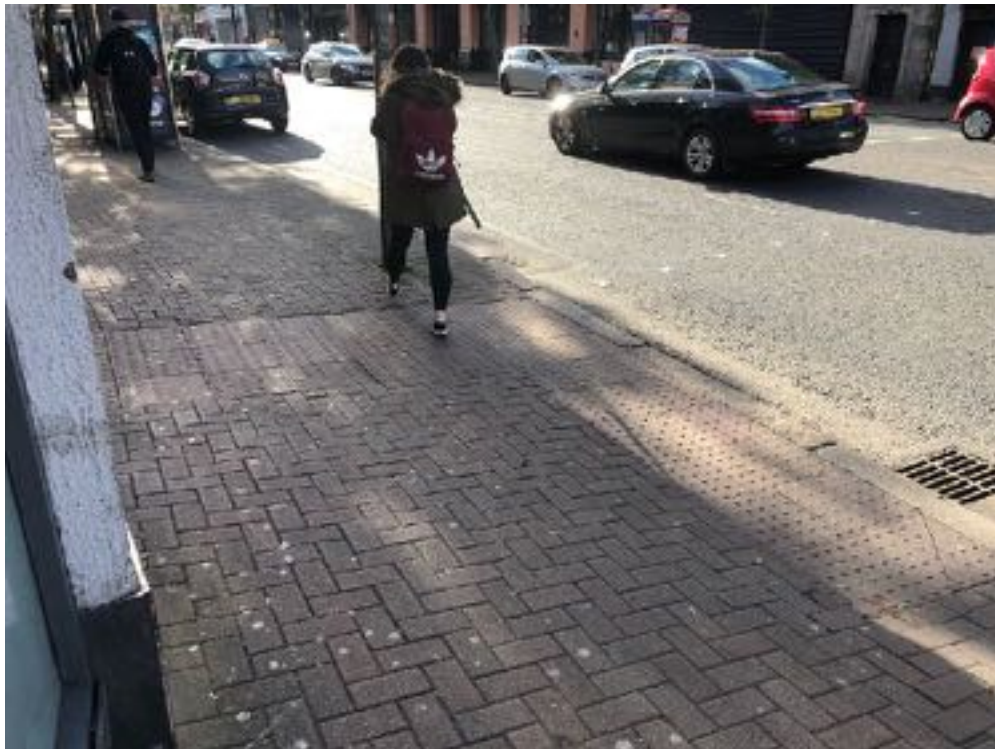
There is controlled crossing across the northern end of Bradbury Place just after this point. The tactile paving on the eastern footway does not contrast and is loose and uneven in parts. The tactile paving and control box have been positioned incorrectly.

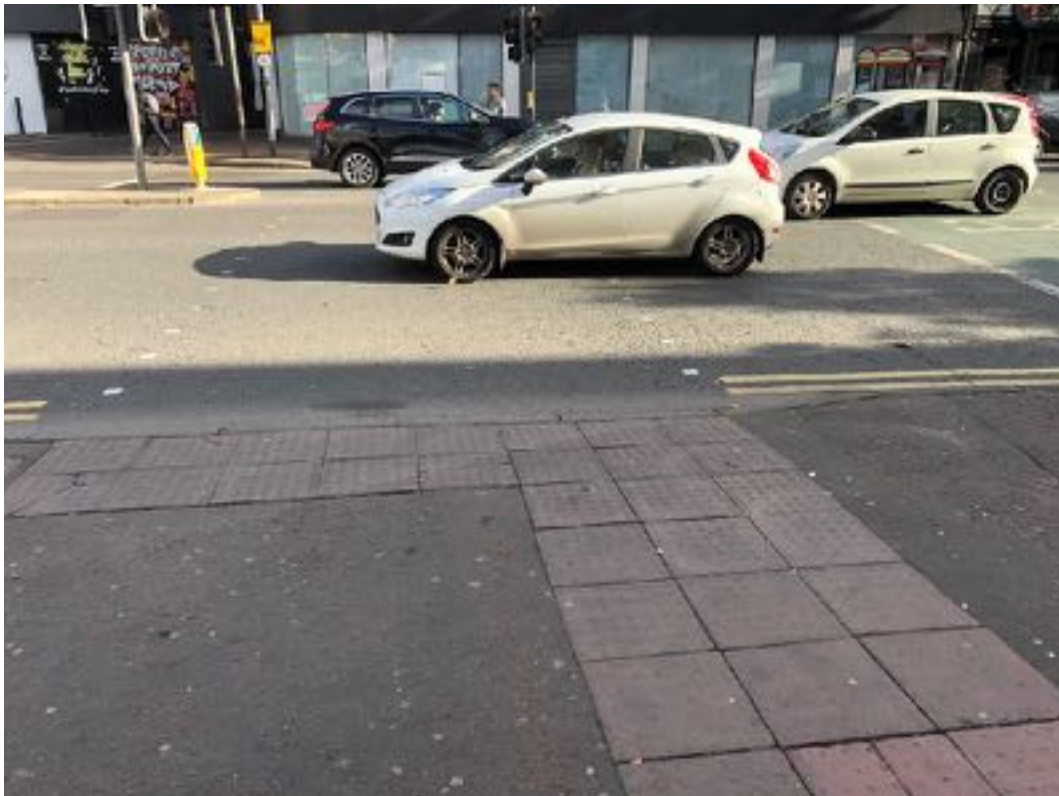
Tactile paving at the crossing across Bradbury Place is damaged, loose and uneven. The control box has been installed in the wrong location.

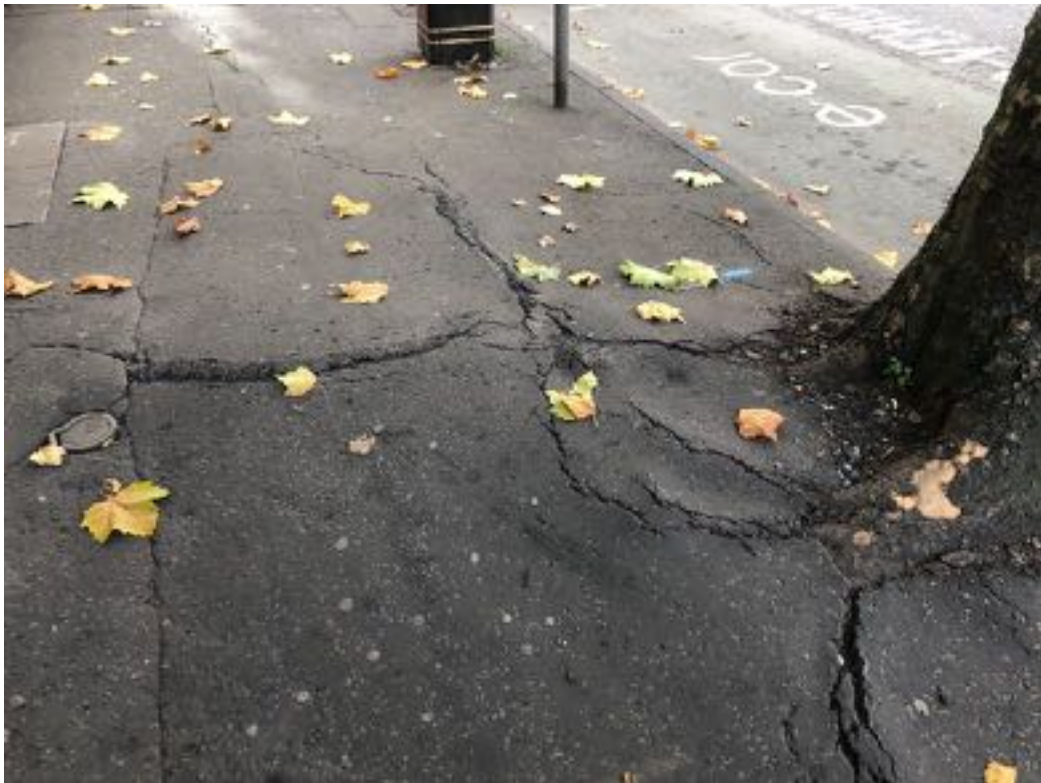
Tree roots have caused extensive damage to the footway in this section of footway, creating a hazard for all pedestrians.

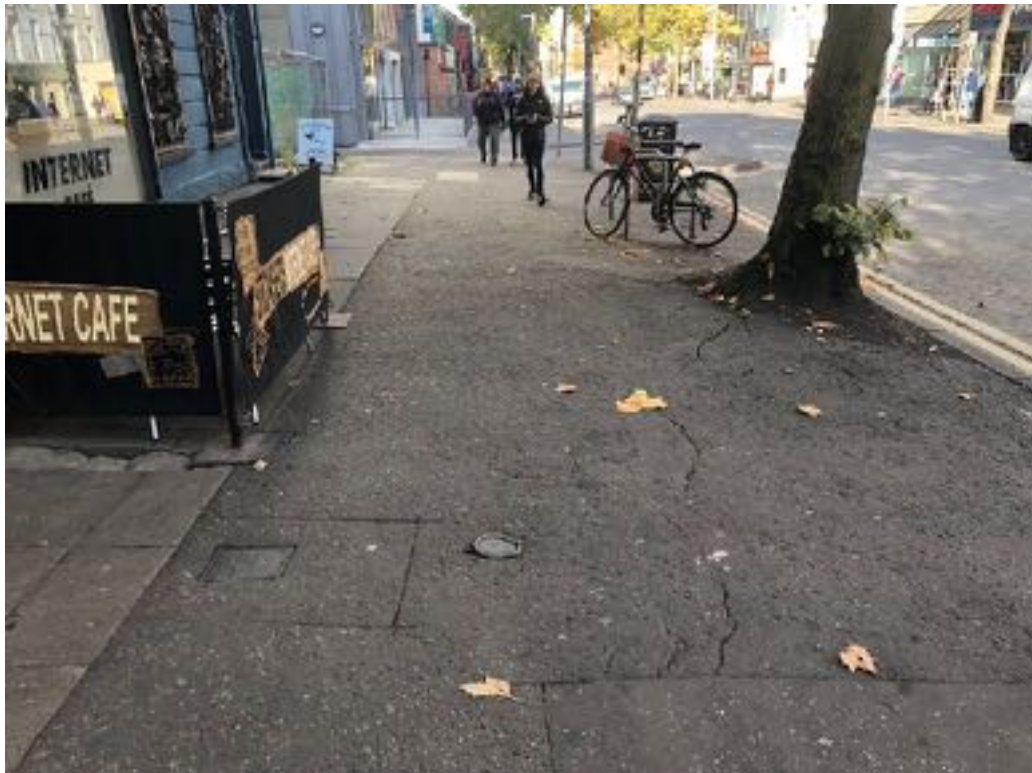
The orientation of cycle parking hoops creates unnecessary additional hazards on the footway.

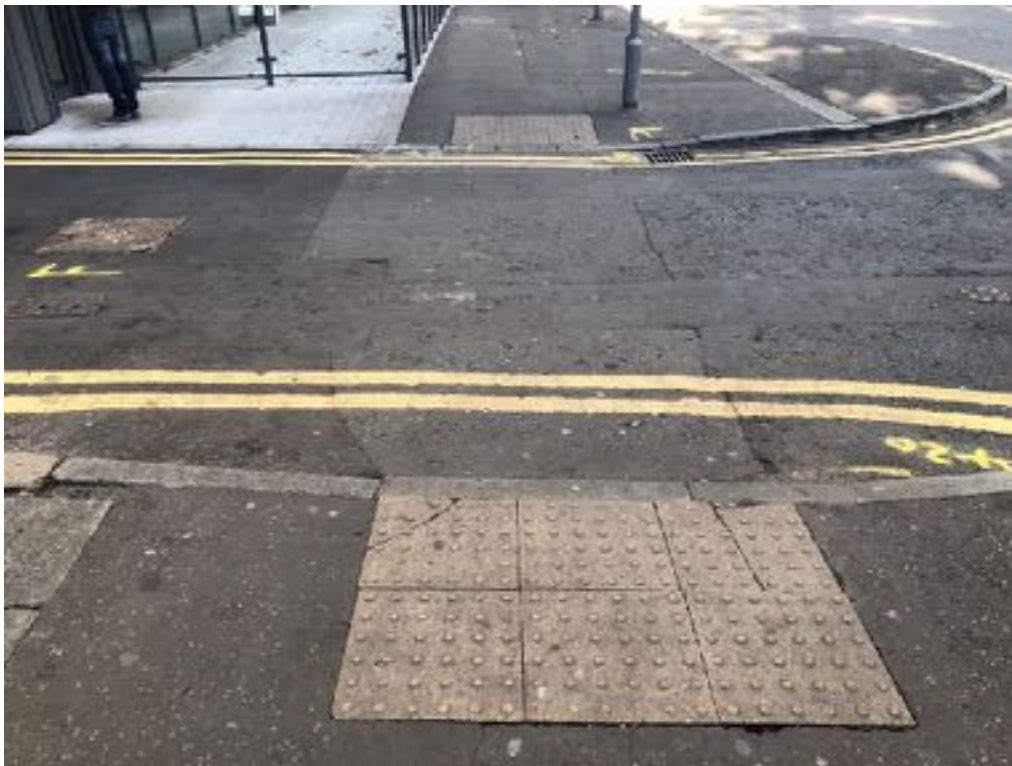
There is an in-line uncontrolled crossing across the southern junction with Ventry Street. The tactile doesn't extend the length of dropped kerbs and is of insufficient depth.

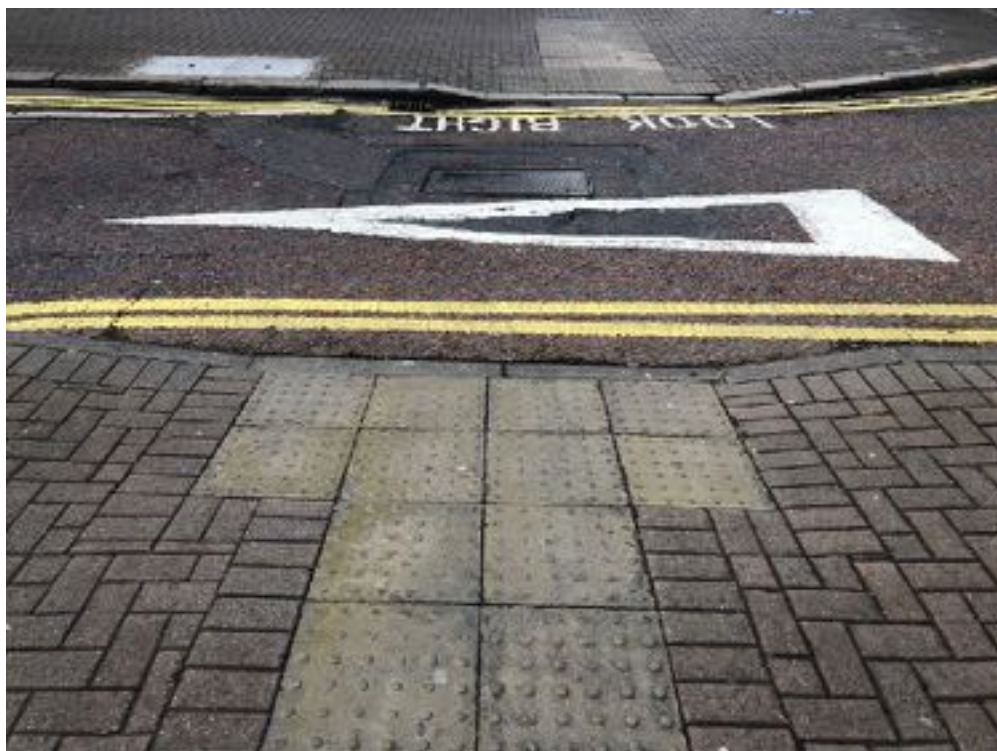
There is an uncontrolled crossing across the westbound lane of Ormeau Avenue. The tactile has been installed incorrectly and the crossing is not in line. Some of the tactile paving is loose and uneven.

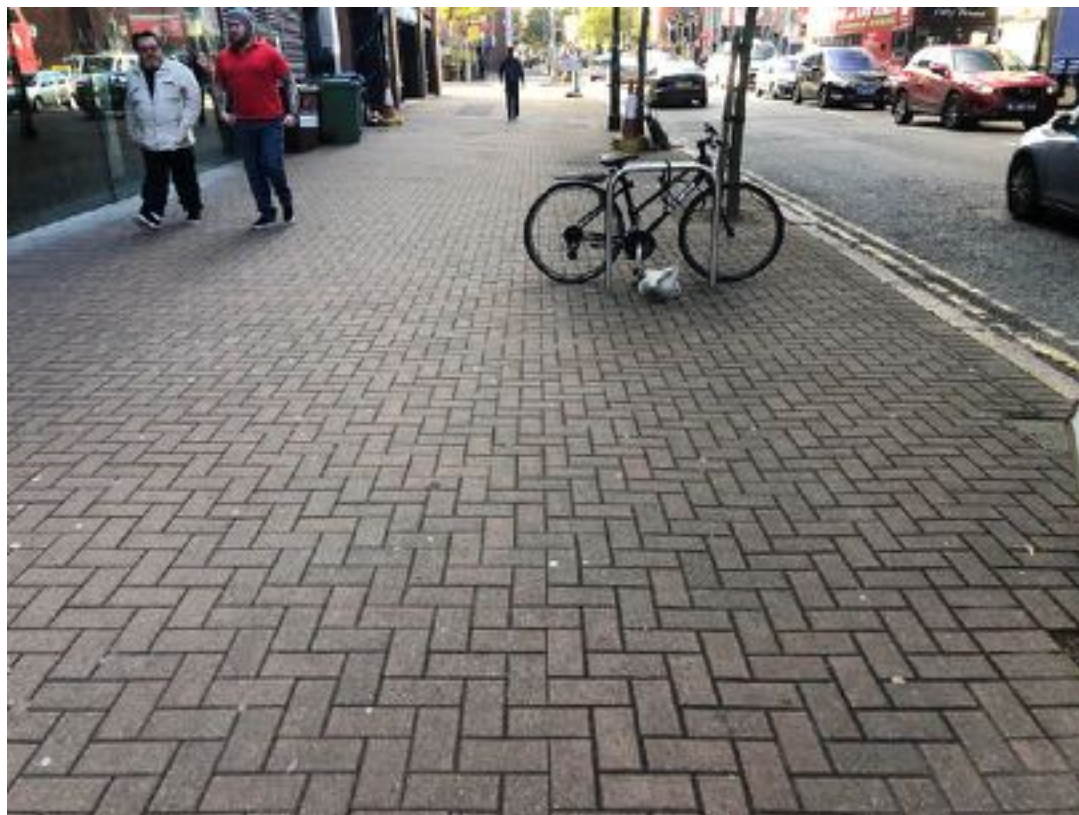
The eastern footway of Dublin Road is broad from Ormeau Avenue to Bankmore Street. The orientation of cycle parking hoops does create an unnecessary hazard.

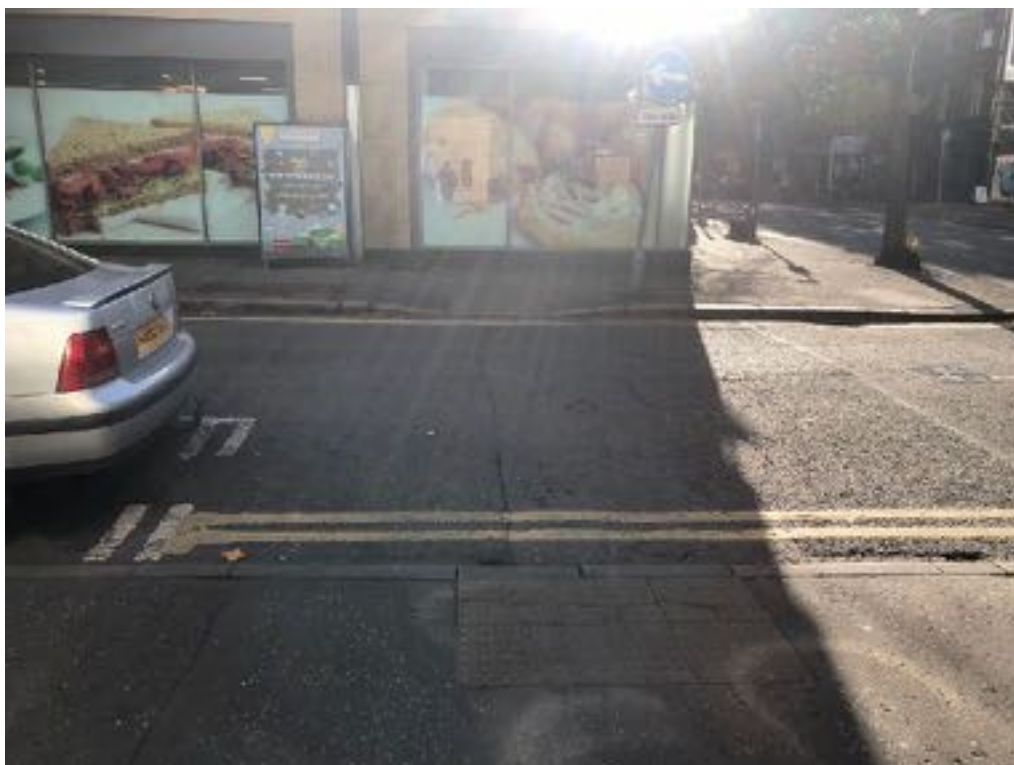
There is an in-line uncontrolled crossing across the junction with Salisbury Street. The crossing has been indented away from the radius of the junction. Tactile paving is damaged and there is a significant section of dropped kerb on the southern side without tactile.

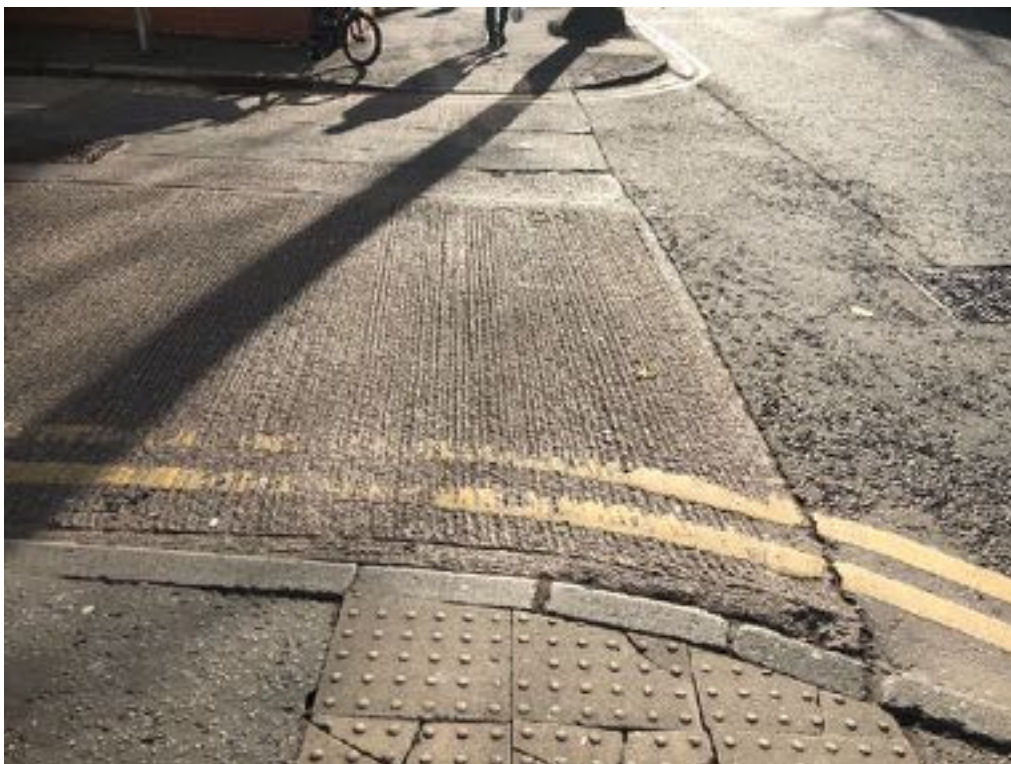
There is another in-line uncontrolled crossing across the junction with Hartington Court. Located on the radius of the junction the depth of tactile is problematic. Some tactile tiles are cracked and broken.
