Recommendations from Imtac on public realm proposals for Belfast Streets Ahead Phase 5

(November 2018)

Street audit findings

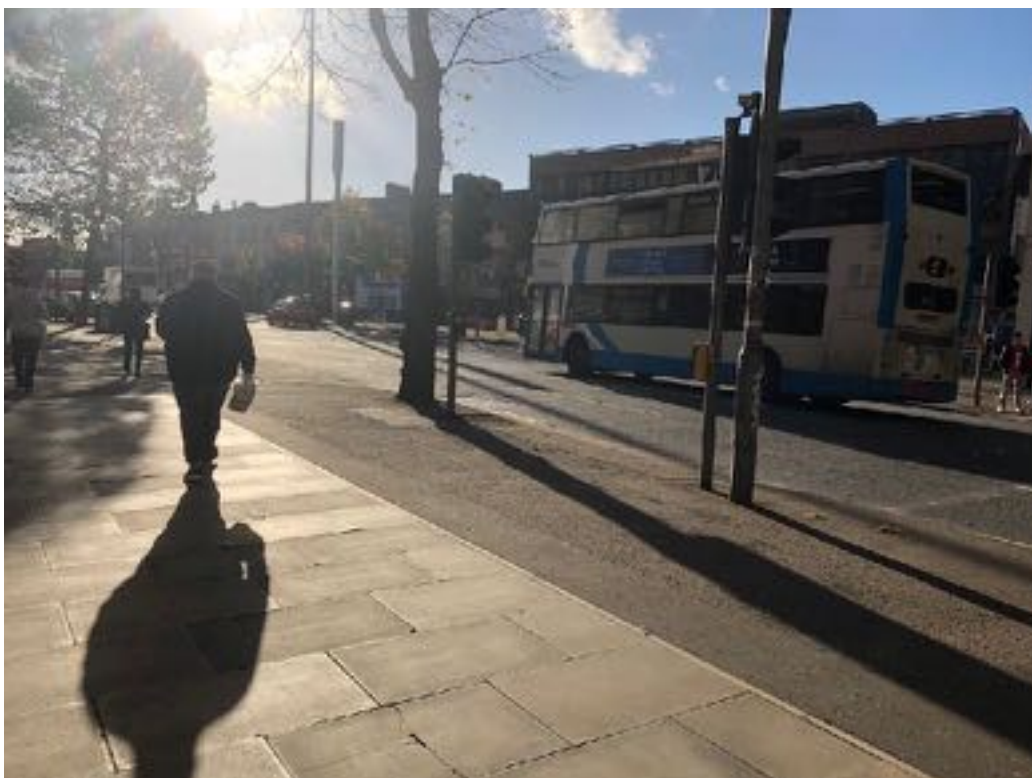
Approaching the junction with Shaftesbury Square the condition of new paving associated with student accommodation contrasts starkly with the poor condition of existing footway surface.

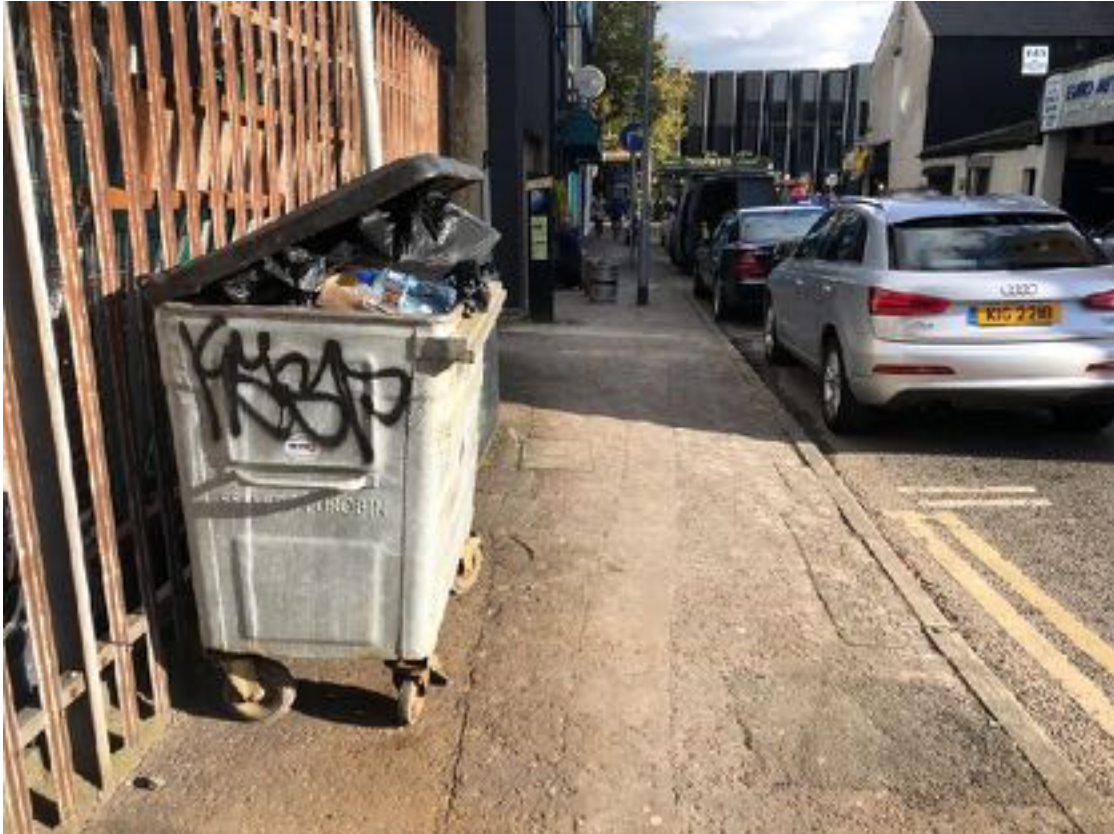
The northern footway continues to be narrowed by bins and other obstructions. Traffic and lighting columns create additional potential hazards.

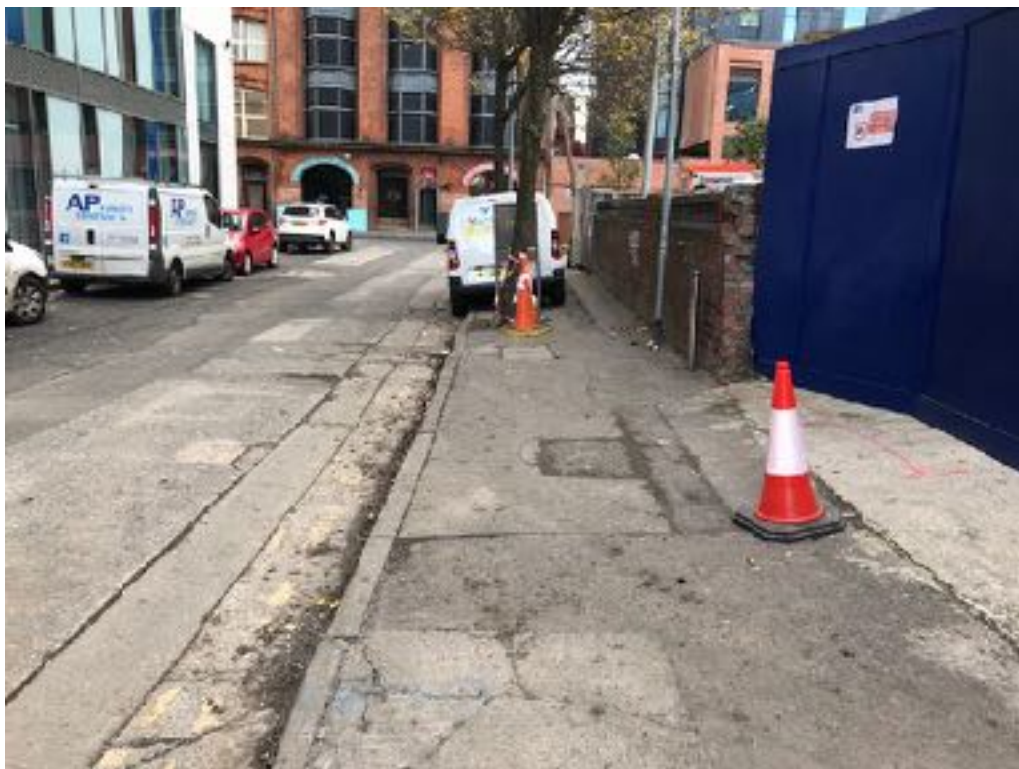
A van blocks the already narrow eastern footway approaching the junction with Franklin Street.

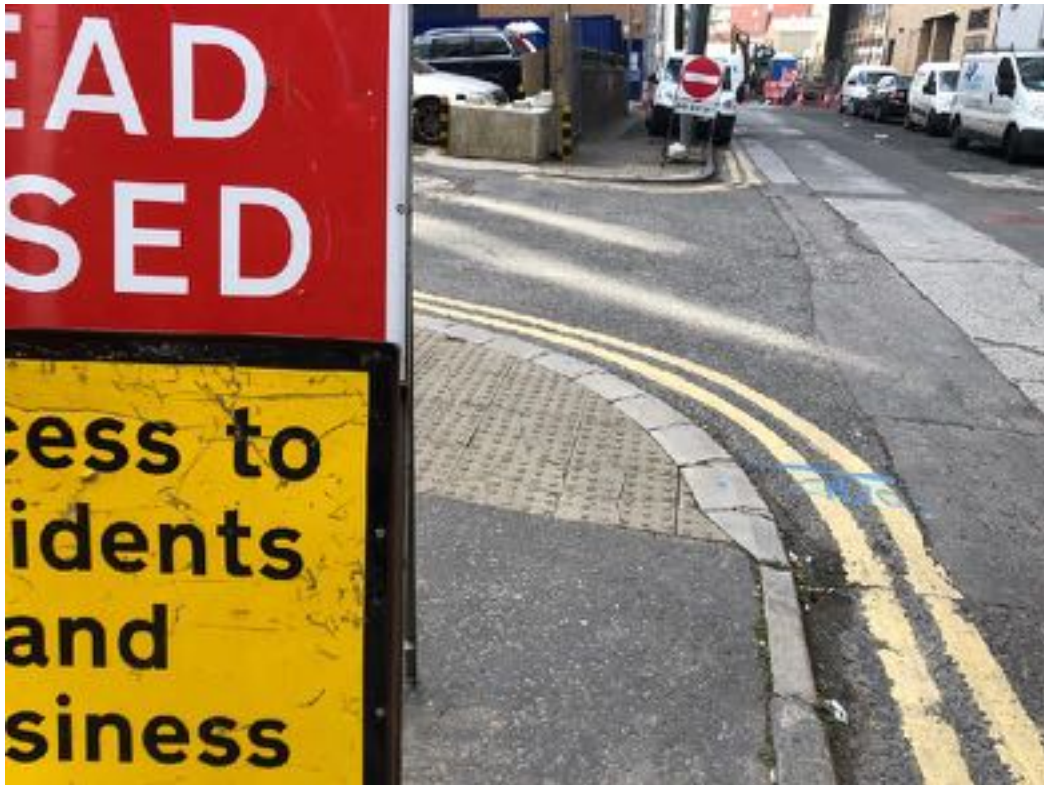
Signage provides a further obstruction adjacent to the entrance to the second car park. The depth and condition of tactile paving are again issues at the entrance.

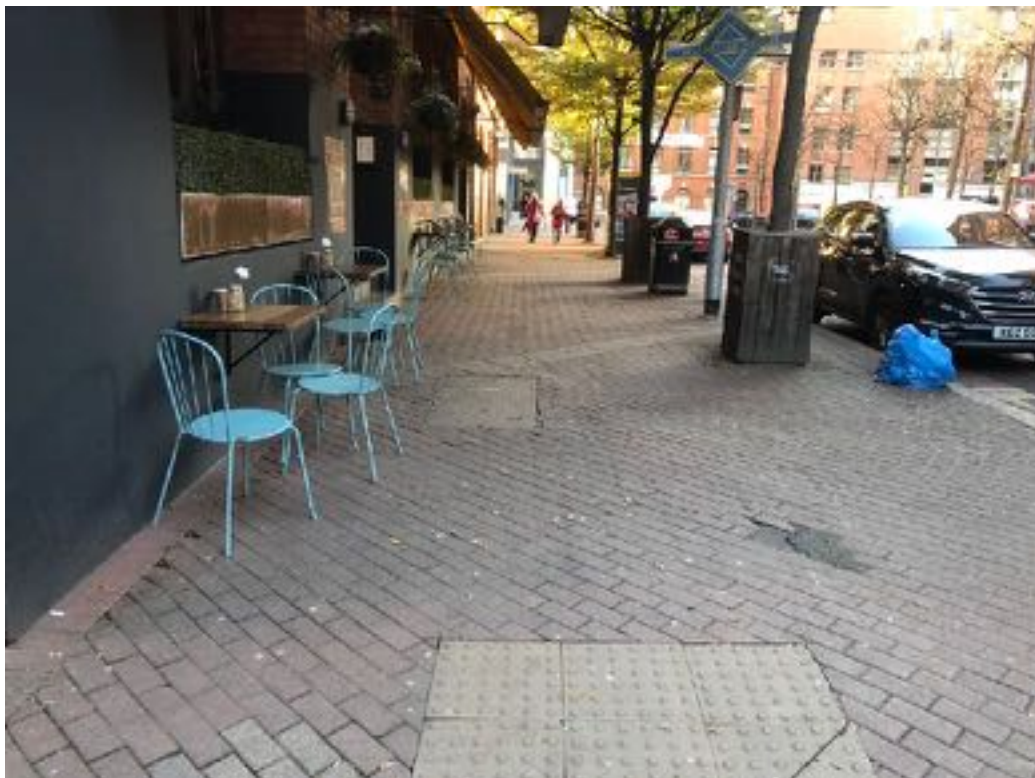
The eastern of footway Brunswick Street is broad but tables and chairs which are not screened do represent a hazard.

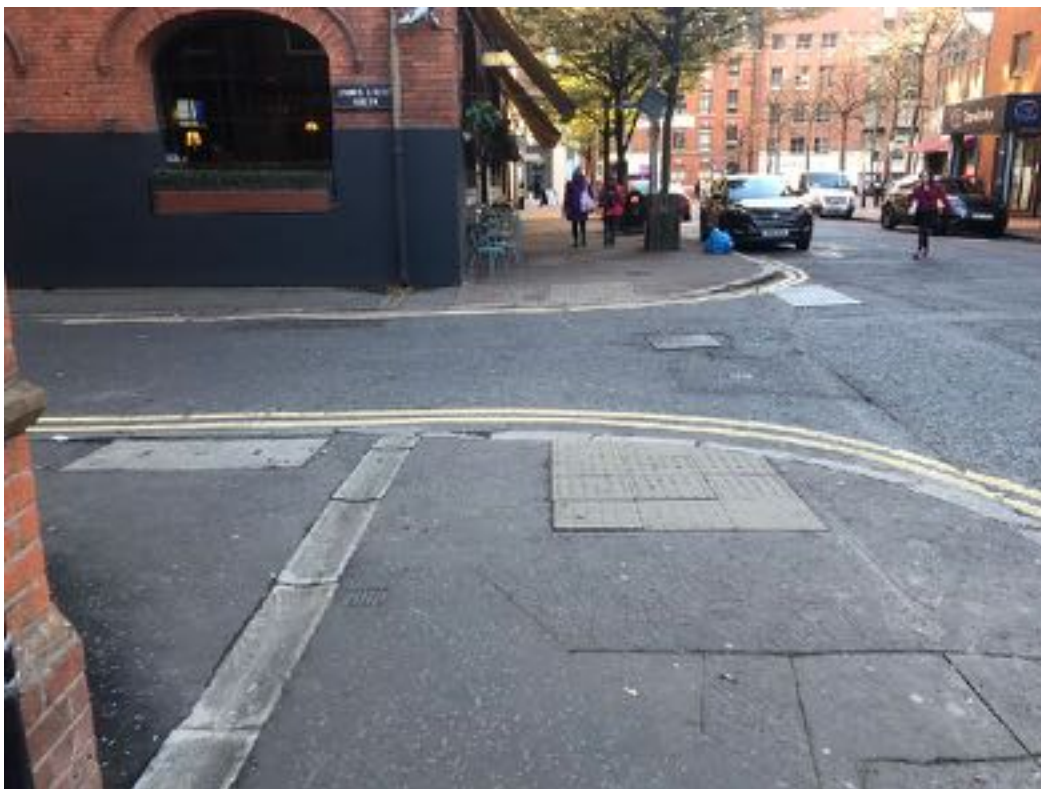
There is an in-line uncontrolled crossing across t James St South. Low kerb heights on southern side beside the crossing extending beyond the tactile paving are a hazard.

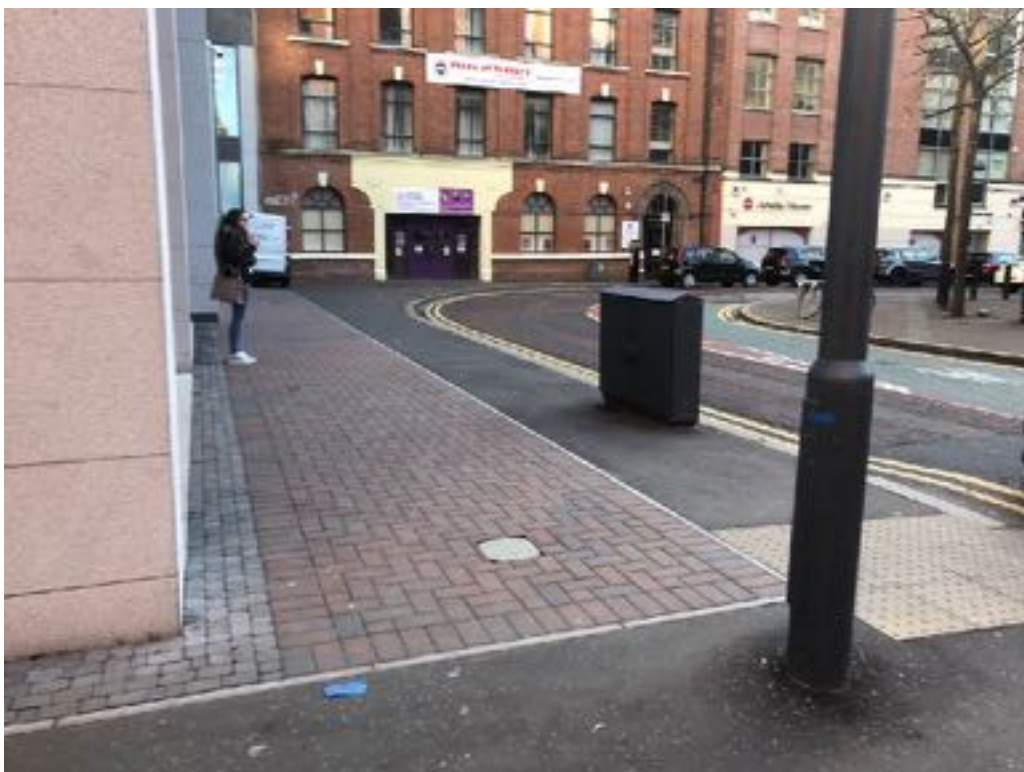
The eastern footway on Amelia Street is broad and has been recently upgraded as part of a hotel development. The positioning of a CCTV column creates a potential hazard in a very busy pedestrian location.

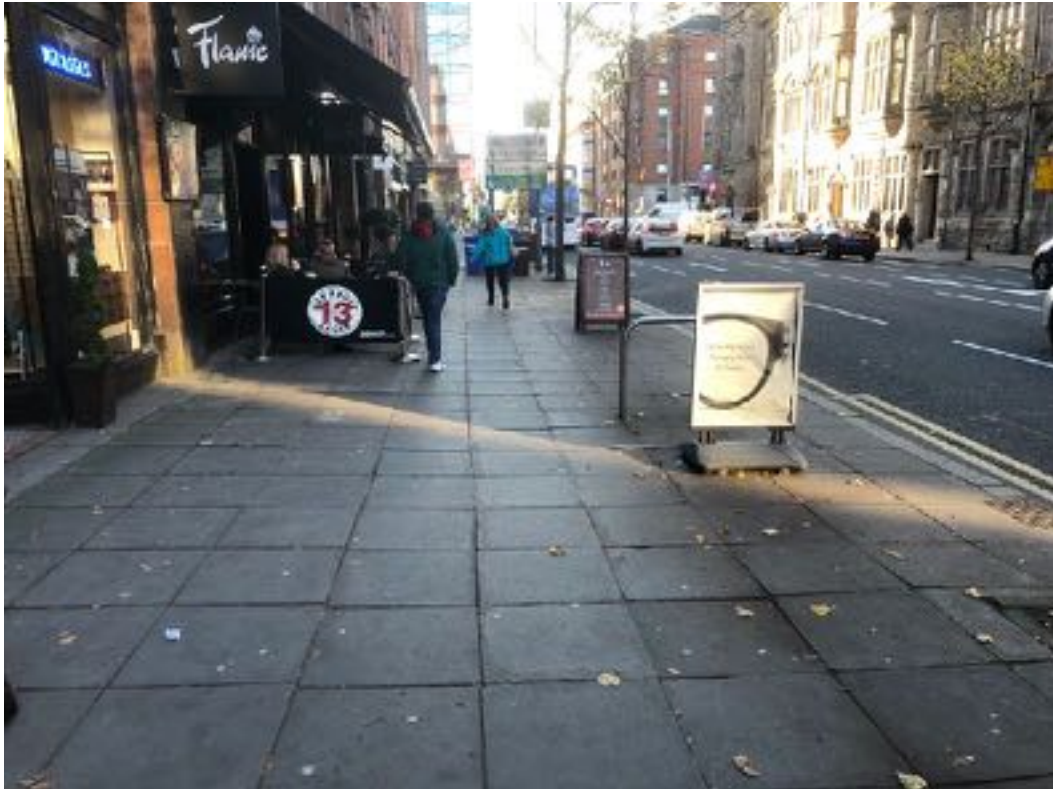
The orientation of a cycle parking hoop creates an additional hazard on an already cluttered footway.

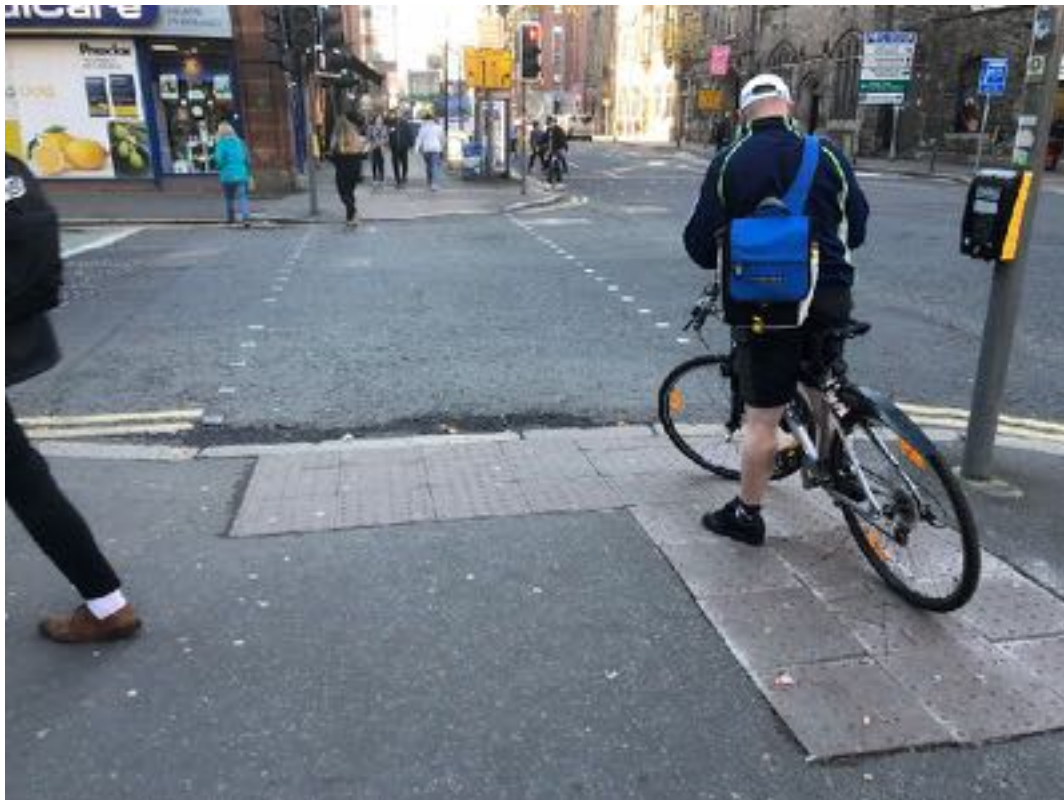
There is a controlled crossing across the junction with Brunswick Street. Tactile paving is damaged, loose and uneven in places.

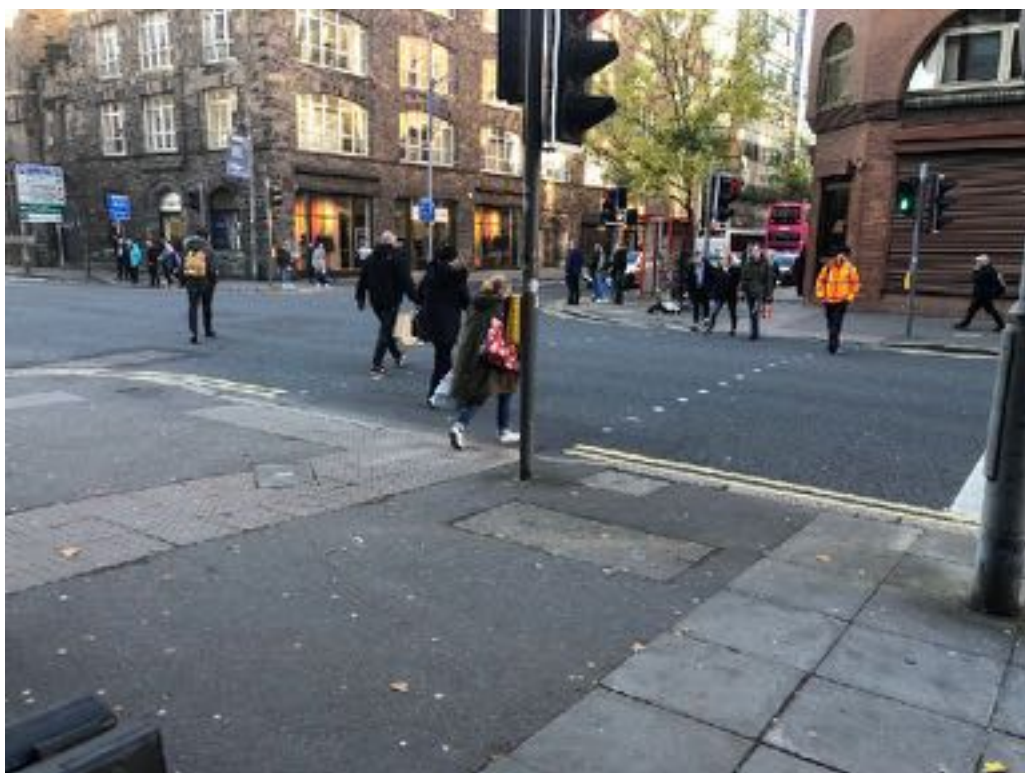
There is a further controlled crossing across Howard Street across the eastern arm of its junction with Brunswick Street and Upper Queen Street. Tactile paving is damaged loose and uneven in places.

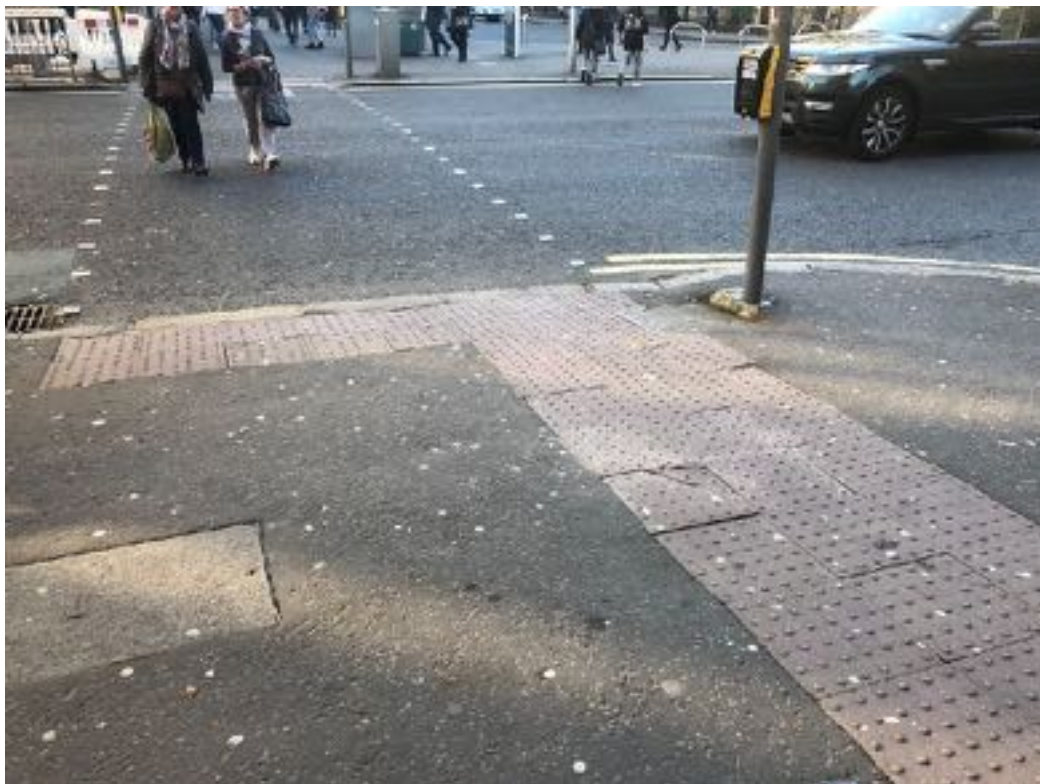
There is a controlled crossing across Howard Street at the junction with Bedford Street and Donegall Square West. Tactile paving is damaged, loose and uneven.

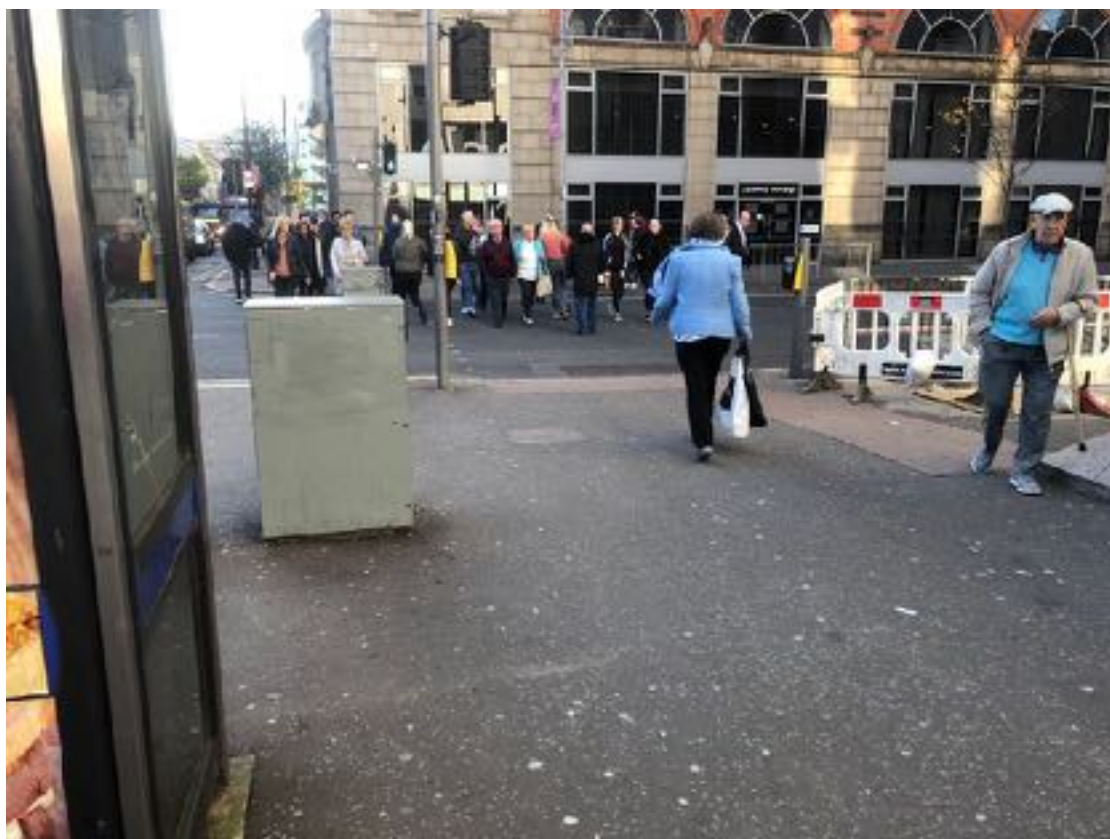
The section of Donegall Square West immediately surrounding this busy pedestrian crossing is extremely cluttered.

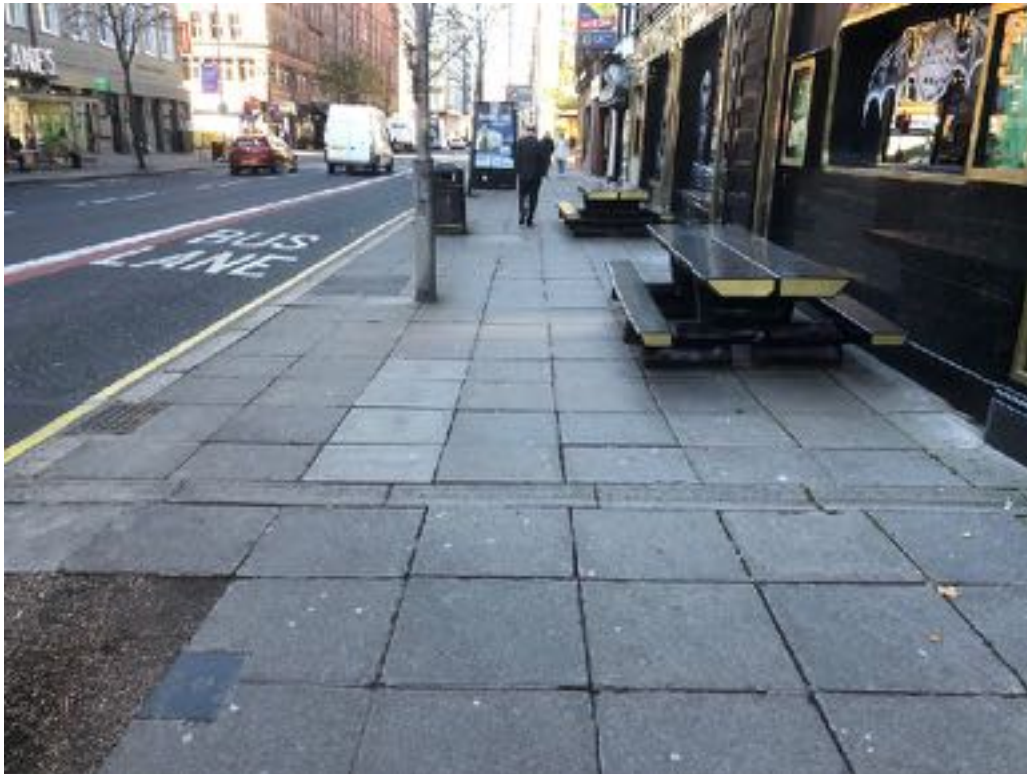
Large, unscreened tables on the northern footway on Howard Street pose a real hazard for people with a visual impairment. Deep dish drainage channels across the footway create additional hazards.

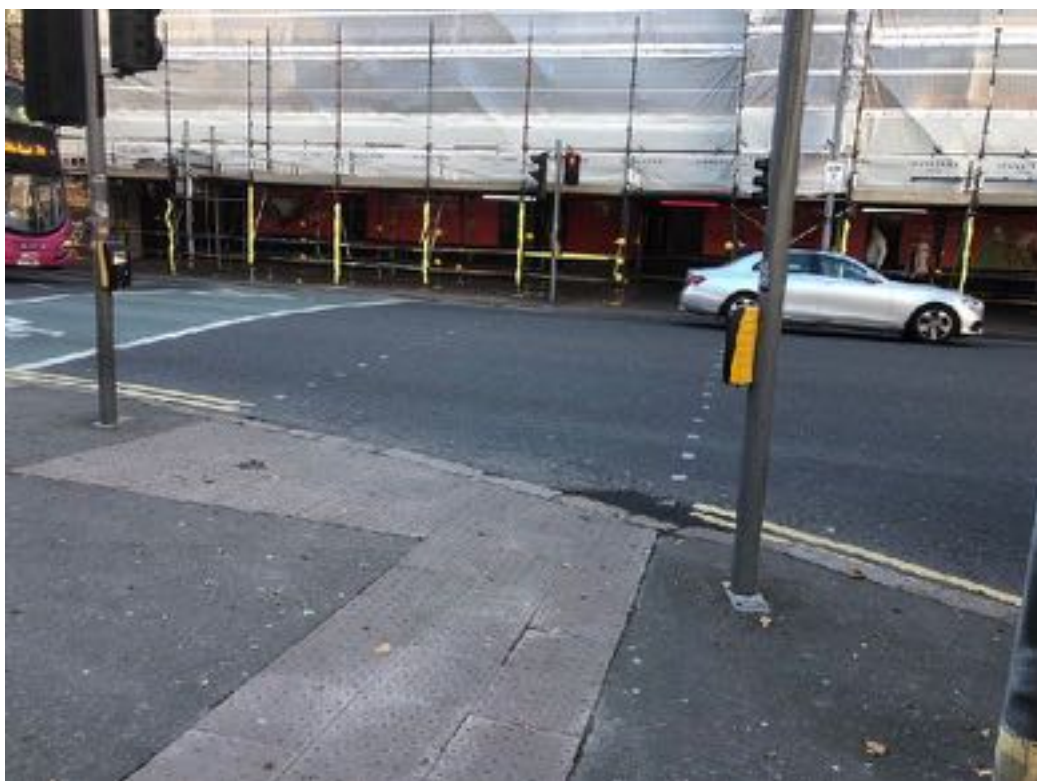
There is a controlled crossing across Donegall Square South at its junction with Bedford Street and Donegall Square West. Tactile paving is damaged, loose and uneven in places and the controlled box is obstructed by scaffolding on the southern side.

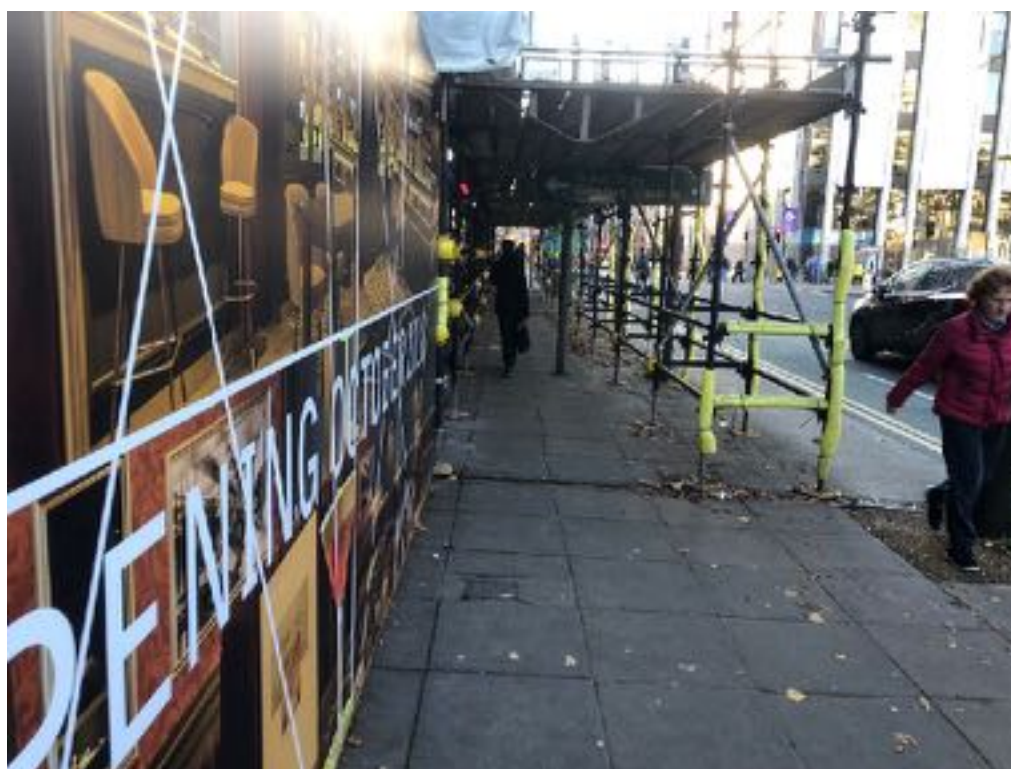
The scaffolding obstructs the southern footway with the positioning of a pole associated with traffic signage creating an obvious hazard.

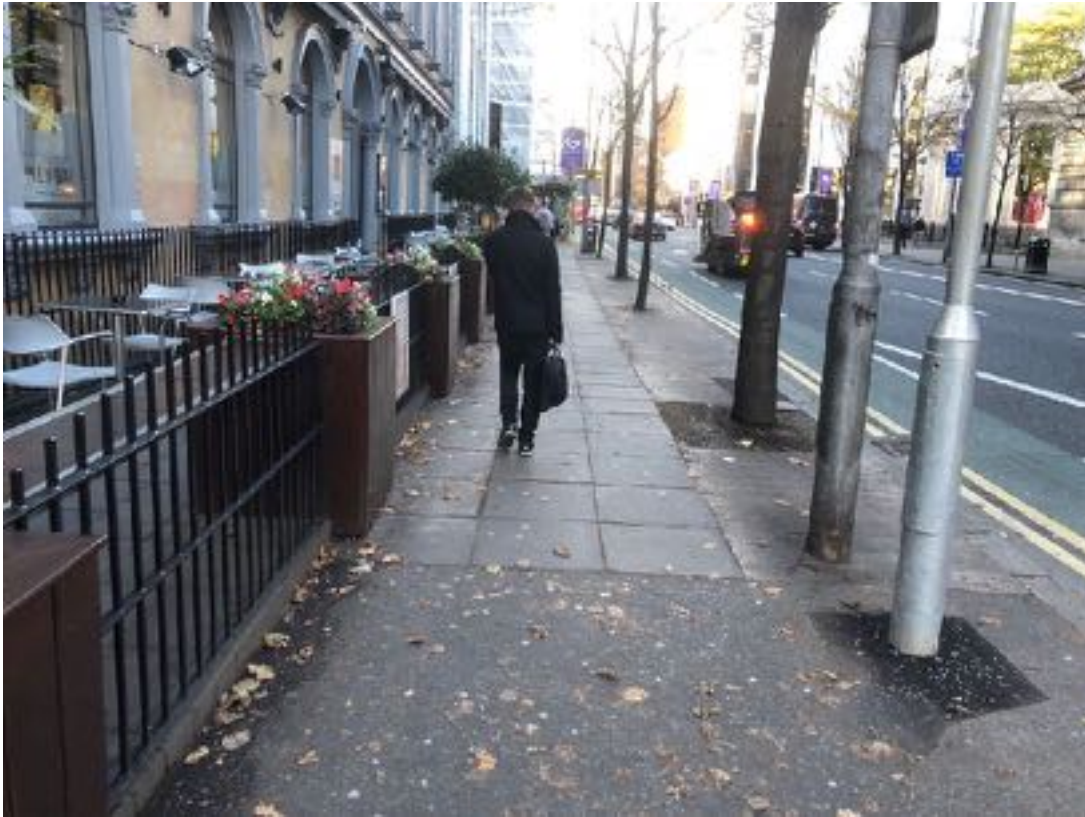
The footway is significantly narrowed by the outdoor seating associated with Ten Square which appears to be permanently screened.

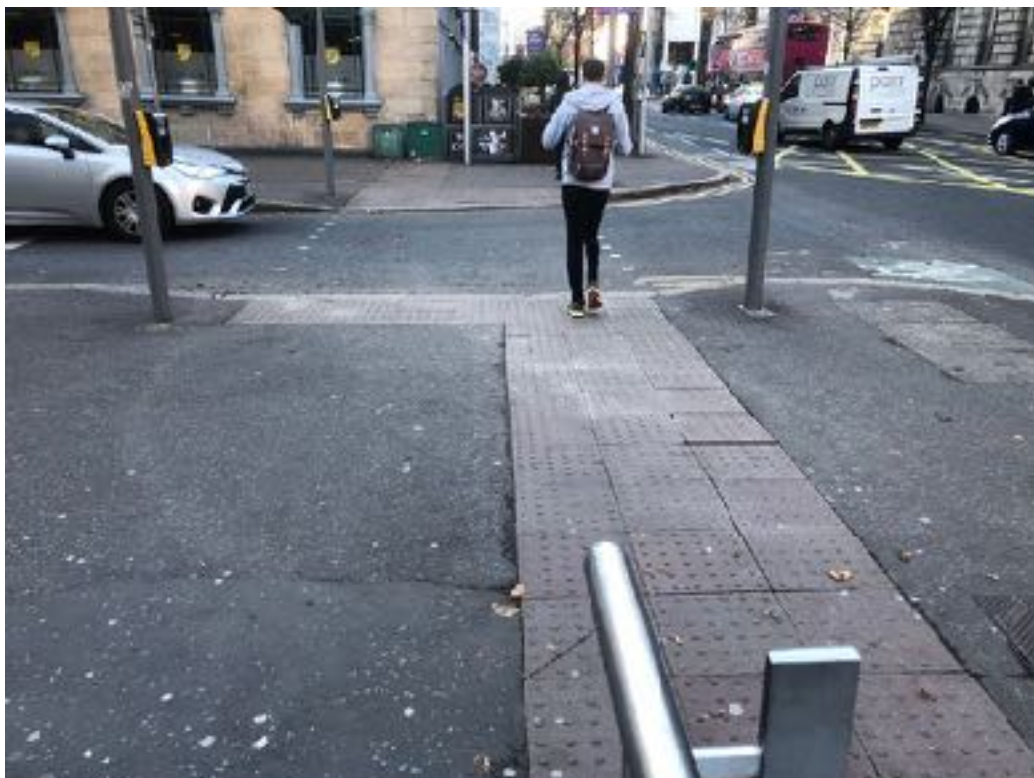
There is a controlled crossing across the junction with Linenhall Street. Tactile paving is damaged, loose and uneven in places. Tactile paving of the western side of the crossing leads directly into an obstruction.

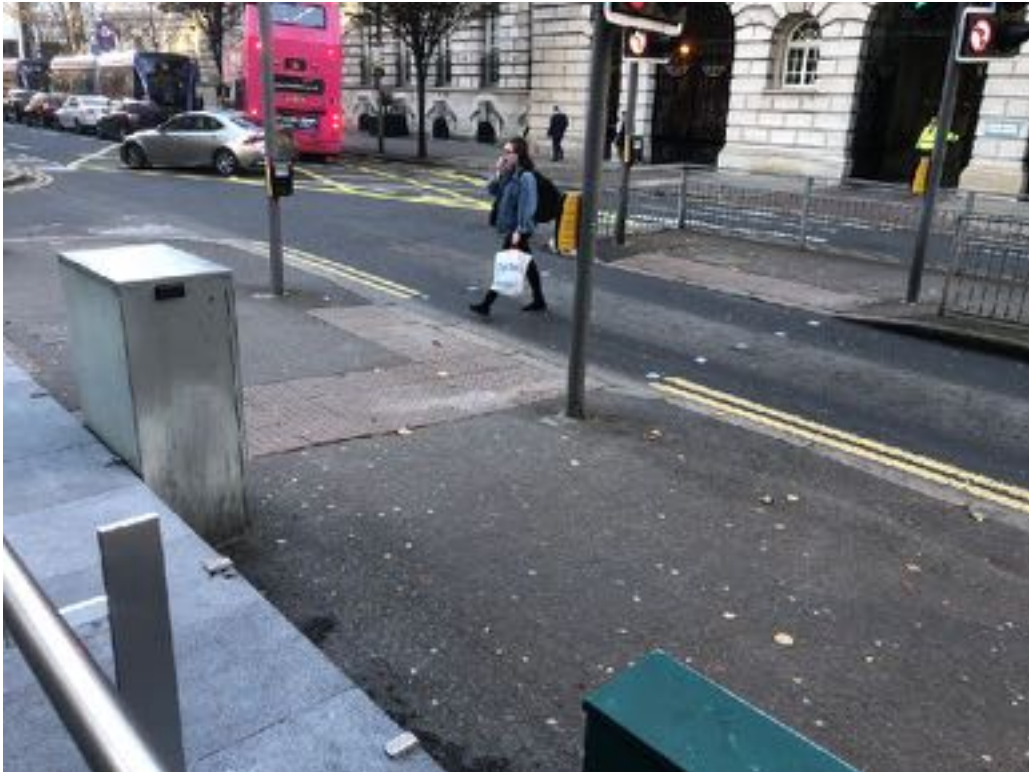
Tactile paving associated with the southern side of the staggered controlled crossing across Donegall Square South is damaged, loose and uneven in places.
