Walking Routes in Belfast City Centre - an update

February 2013

# About this paper

Since the previous audit there have been significant changes to the pedestrian environment in Belfast City Centre arising out of the Belfast on the Move project. A further audit was undertaken in October 2012 to identify whether progress has been made in reducing barriers identified by the previous report.

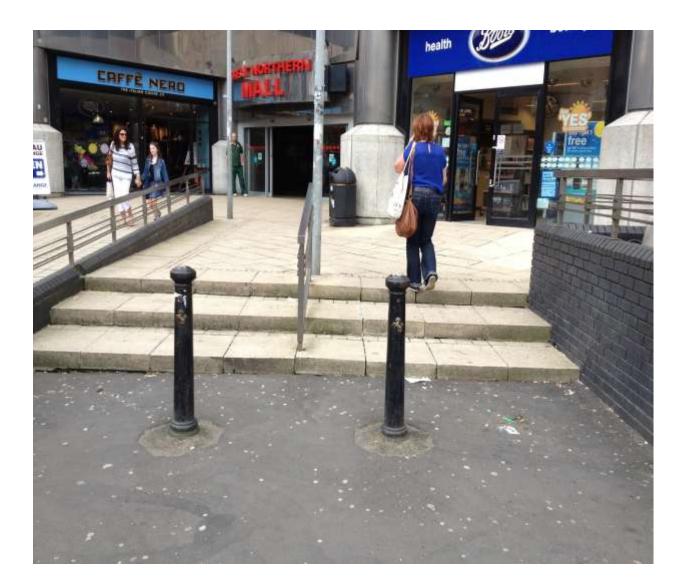
1 <u>Issue</u> - At the Great Northern Mall entrance there is no corduroy hazard warning paving at the top or bottom of steps and ramps. The provision of bollards (without contrasting bands) create hazards at the bottom of steps and ramps.

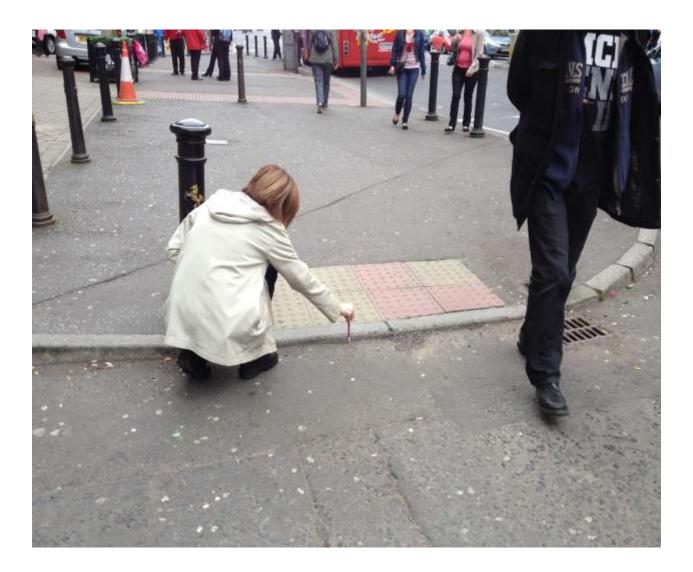
2 <u>Issue</u> - At the entrance to the Europa Hotel in line tactile paving is provided. However currently the paving is a mix of buff and red (it should be buff only). The paving should also be 3 slabs deep rather than the current 2. The current drop kerb height could present a trip hazard.

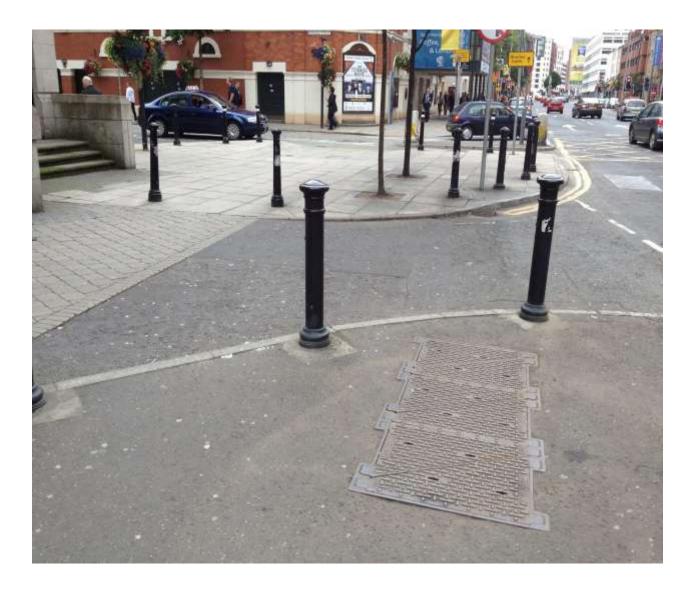
3 <u>Issue</u> - No tactile paving is provided at the exit to the Europa Hotel. The provision of unmarked bollards creates an additional hazard.

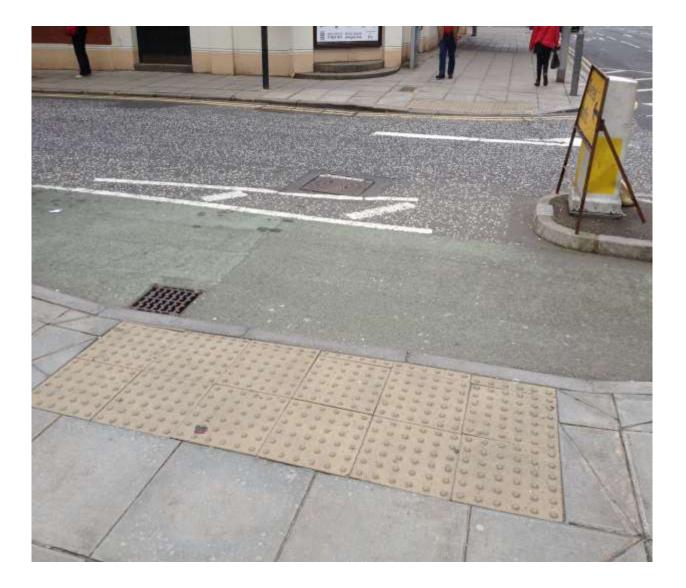
4 <u>Issue</u> - The tactile paving on the in line crossing at the junction of Great Victoria Street and Glengall Street should be three rather than two slabs deep.

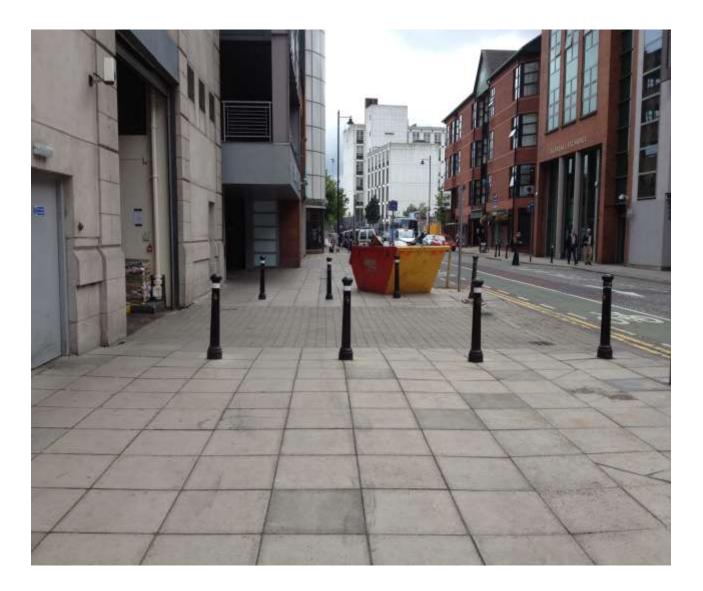
5 <u>Issue</u> - The station side footway on Glengall Street is blocked with cars. Bollards across the footway not have been fitted with an appropriate contrasting visibility strip.

<u>Progress</u> – Bollards have been fitted with white visibility strip. Obstructions on the pavement remain an issue.

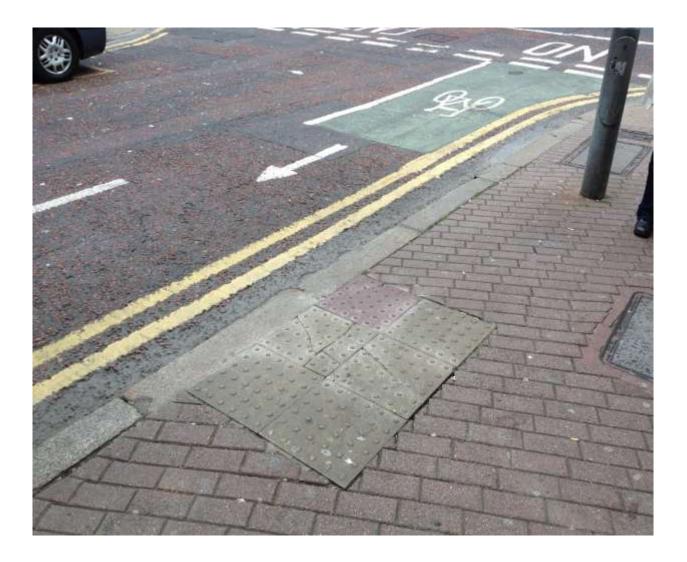
7 <u>Issue</u> - On Amelia Street there appears to be tactile paving relating to a redundant offline crossing which needs to be removed.

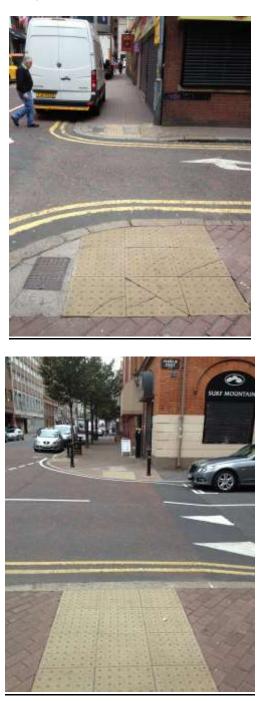
8 <u>Issue</u> – Lack of tactile paving around inline crossings around Blackstaff Square and no crossing facilities at the junction of Franklin Street

<u>Progress</u> – Significant improvements have been made in the area with tactile paving included on inline crossings and a new high quality uncontrolled crossings incorporated around Franklin Street.

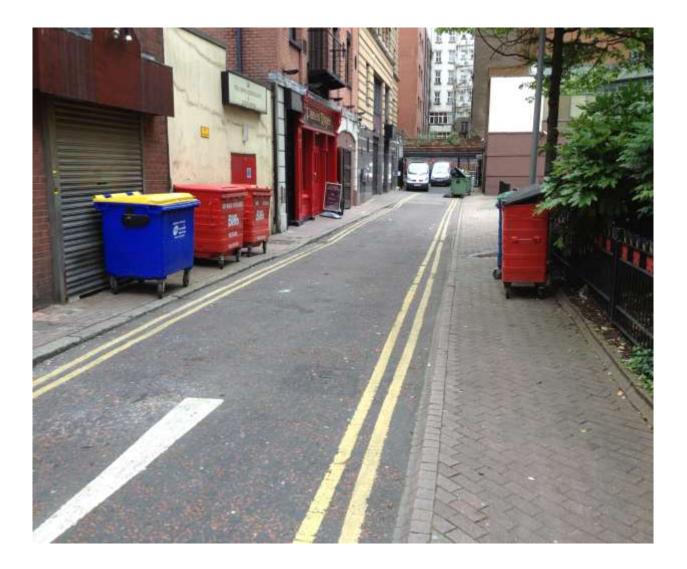
9 <u>Issue</u> - Bins and vehicles parked on the footway create additional hazards on Blackstaff Square.

Progress – Both remain a problem.

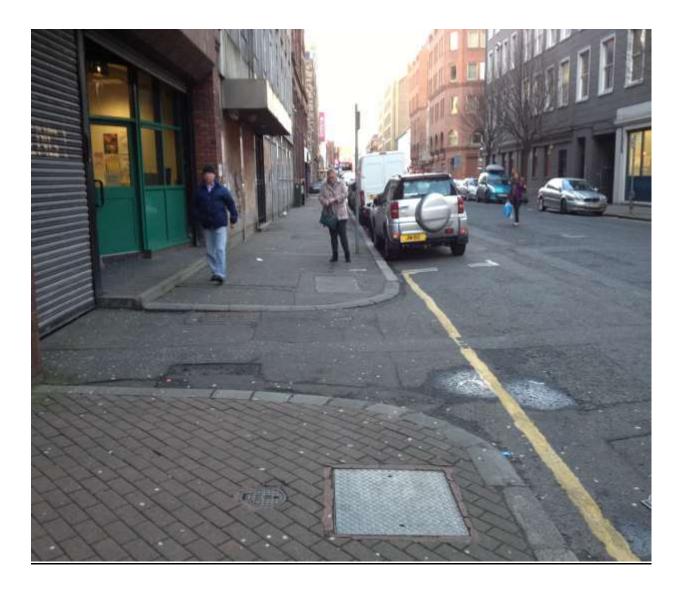
10 <u>Issue</u> – Vehicle entrances on Brunswick Street take precedence over the footway with no tactile paving. Drop kerbs are inconsistent in height.

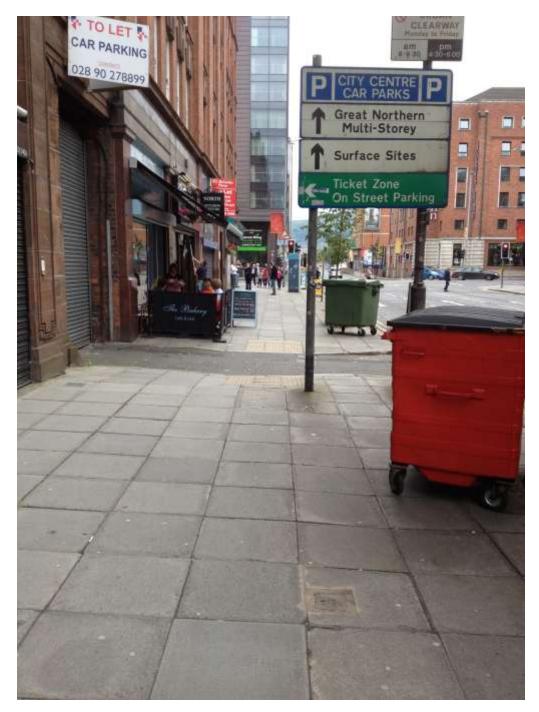
11 <u>Issue</u> - There is tactile paving on vehicle entrances on Howard Street but in one case the paving is aligned directly with a sign post.

Progress – None - bins left on the pavement create an additional hazard.

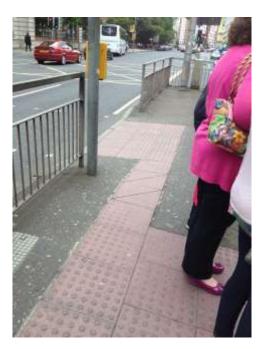
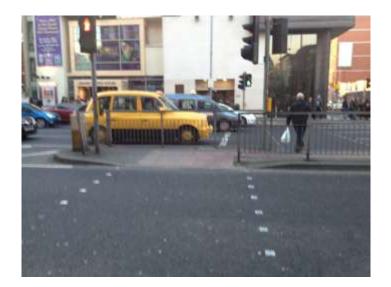
12 <u>Issue</u> - The controlled pedestrian crossing across Great Victoria Street at the Grosvenor Road/Howard Street Junction has a narrow traffic island. This would be exceptionally difficult to navigate in a wheelchair. The button on the traffic island is a long way from the edge of the tactile paving and the tactile paving has worn smooth. Footfall on this narrow crossing is high.

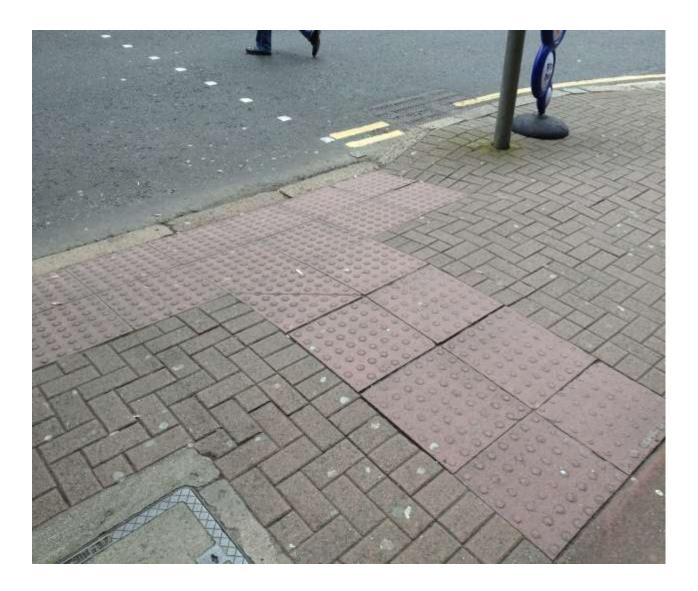
13 <u>Issue</u> - On the Howard Street side of this crossing the tail of the tactile crossing is incorrectly installed as it does not line the person up with the button. There is a lack of contrast between the paving and the tactile paving at this crossing.

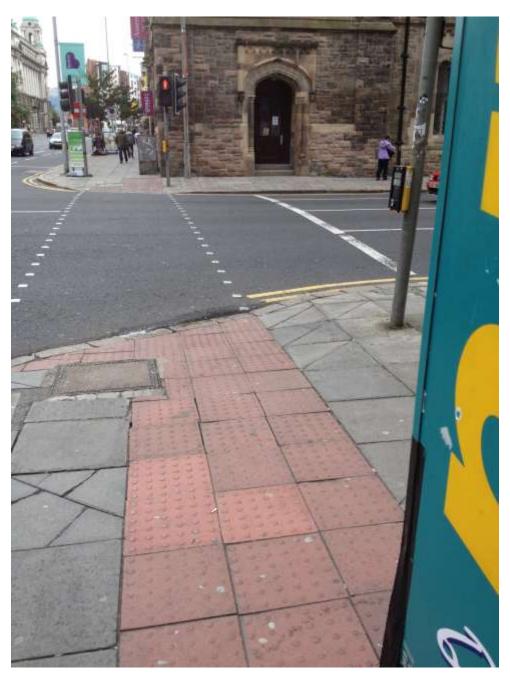
14 <u>Issue</u> - There is a controlled crossing across Howard Street (the Centra Store on GVS). Utility covers cut into the provision of tactile paving at this crossing potentially meaning a blind person could step into a very busy road. The button at the crossing is far away from the tactile paving and is obstructed by another pole.

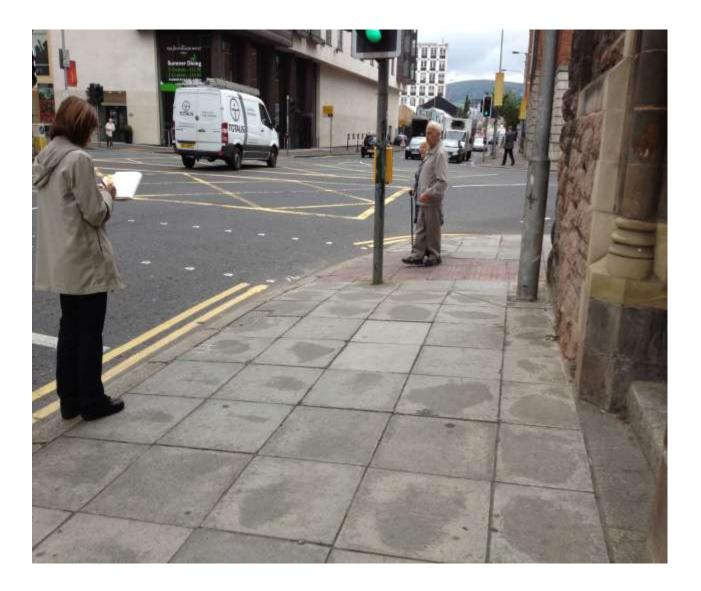
15 <u>Issue</u> - At the opposite side of the crossing on Howard Street (around the Spires) there is a step crossfall on the pavement.

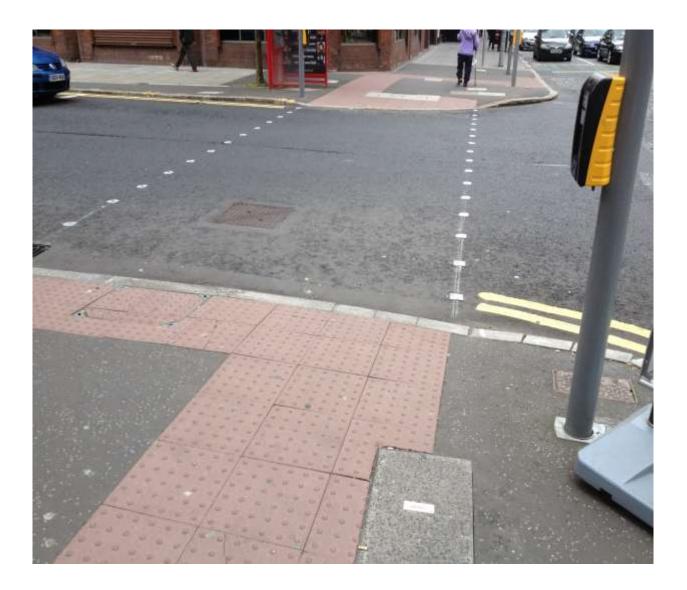
16 <u>Issue</u> – Controlled and uncontrolled crossings at the junction of Howard Street and Upper Queen Street had numerous issues including damaged paving and poorly dropped kerbs.

<u>Progress</u> – The junction has been upgraded to high quality controlled crossings.

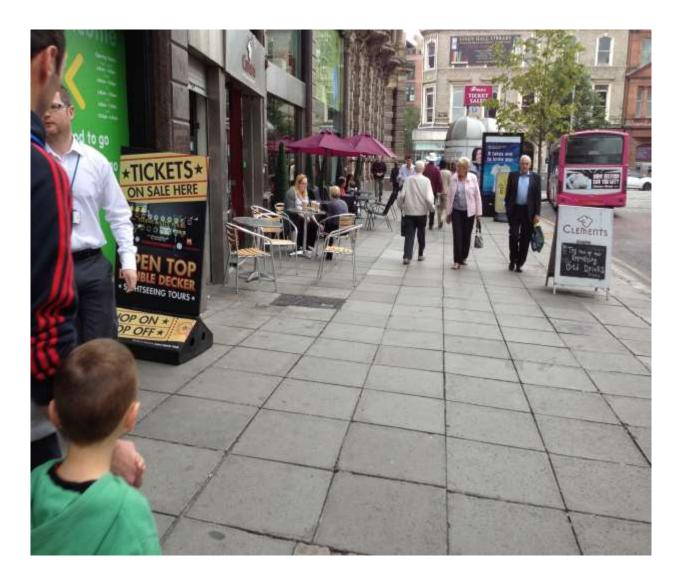
17 <u>Issue</u> - On Donegall Square West the pedestrian route is significantly narrowed by street furniture (including bus shelters) and tables and chairs from cafes. The unrestricted nature of the street clutter is a significant hazard.

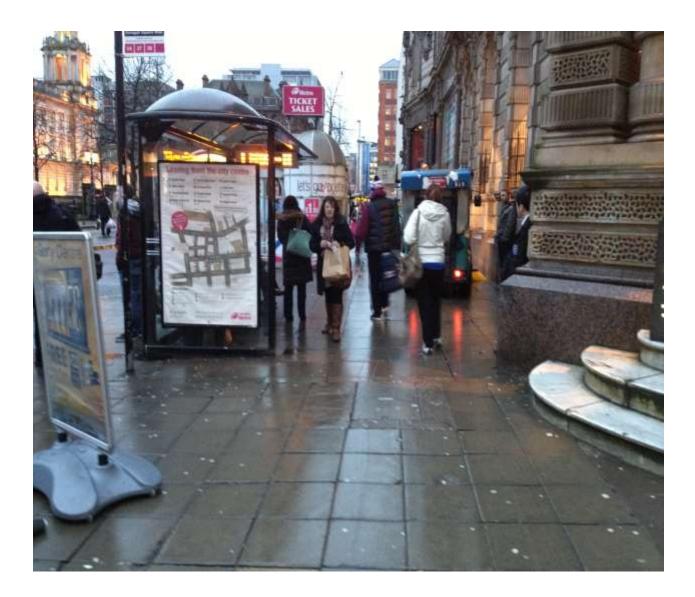
18 <u>Issue</u> - There is a significant pinch point at the northern end of Donegall Square West which could be resolved by realigning street furniture.

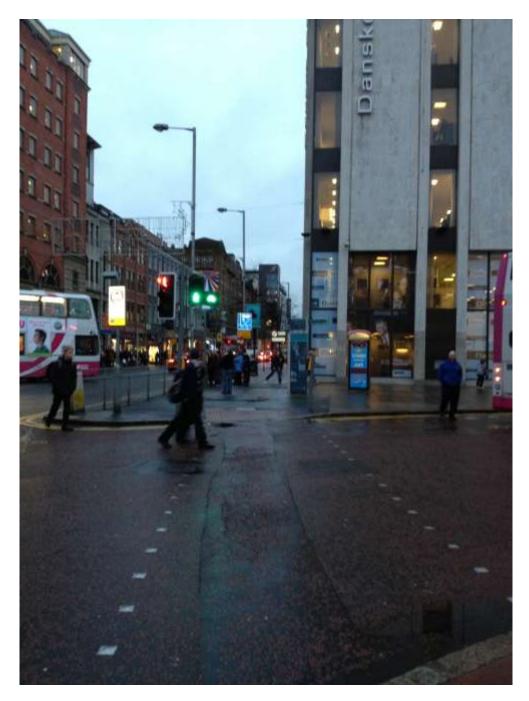
19 <u>Issue</u> - The previous audit highlighted the potential benefits of an additional pedestrian crossing at the southern end of Donegall Square West.

<u>Progress</u> - Pedestrian crossing has been provided at the southern end of Donegall Square West

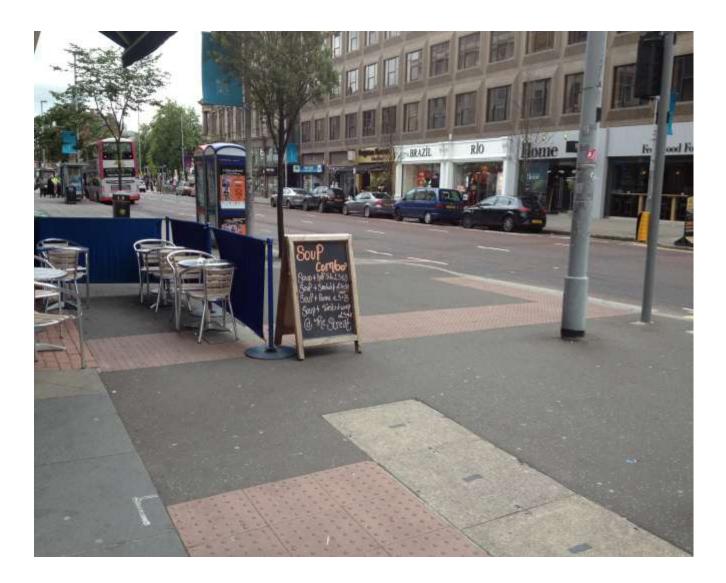
<u>Additional Progress</u> - Since the first audit the controlled crossing at Wellington Place (at Upper Queen Street and Queen Street) has been upgraded and meets best practice and represents an alternative route into the City Centre avoiding Donegal Square West. However the benefits of the improvements are reduced by street cafes at two corners of the junction.

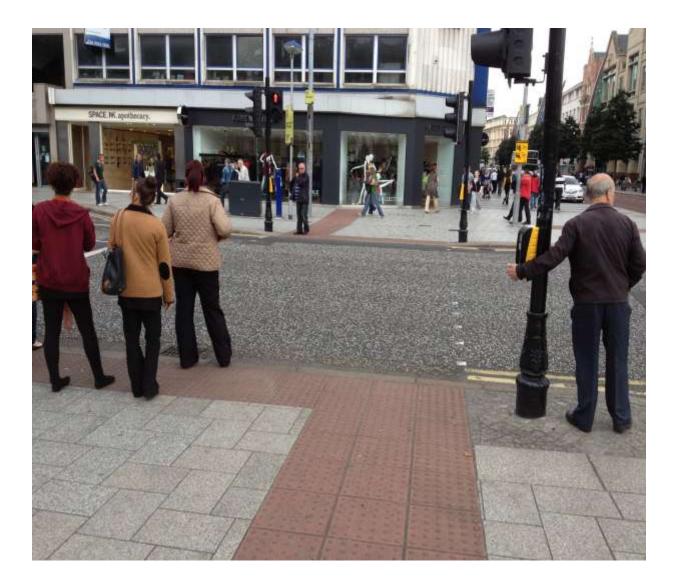
20 <u>Issue</u> - At the controlled crossing across Donegall Square North (towards Donegall Place) had issues with the alignment of tactile paving and the location of the button.

Progress – The crossing has been upgraded to a high standard

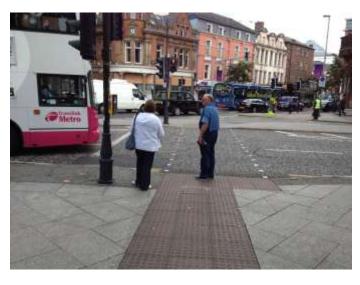
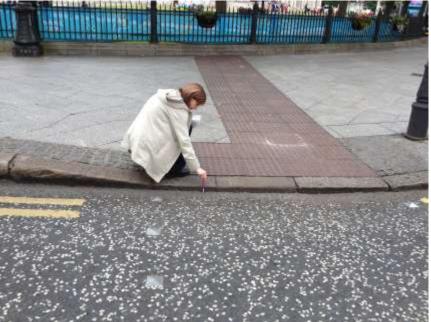
21 <u>Issue</u> - At the controlled crossing on the junction of Donegall Square North and East (City Hall side) the button is mounted too high on the pole and the pole is located to far from the tactile paving. There is a high drop kerb that would represent a significant trip hazard. There is use of non-standard tactile paving in this area. There is a high drop kerb on the eastern side of this crossing and the tactile paving is badly worn and needs replaced.

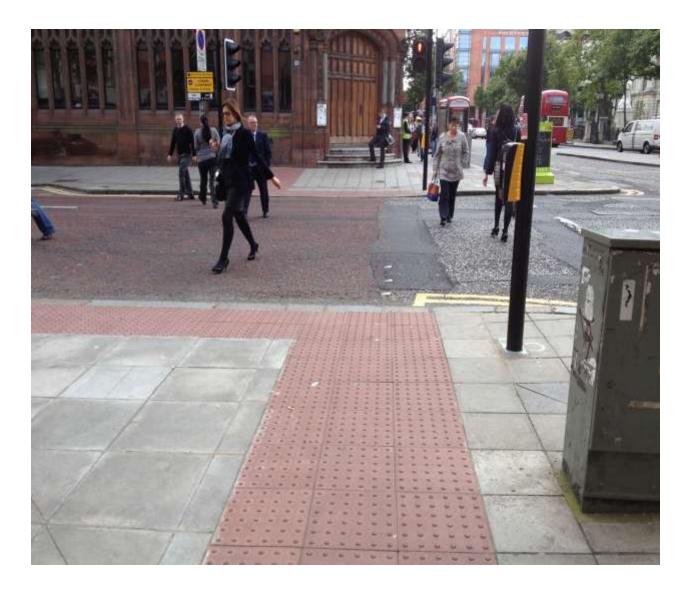
22 <u>Issue</u> - At the controlled crossing across Chichester Street (at Donegall Square) the use of the wrong coloured tactile paving and location of the buttons posed problems.

Progress – This crossing has been upgraded to a high standard

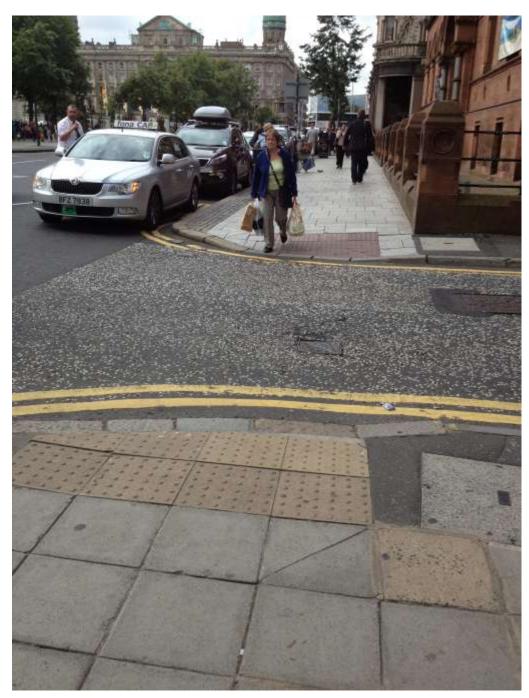
23 <u>Issue</u> - At the junction of Callender Street and Chichester Street the in line crossing has a mix of colour paving slabs (should be buff). Also there should be a depth of three slabs on the Café Nero side of the junction.

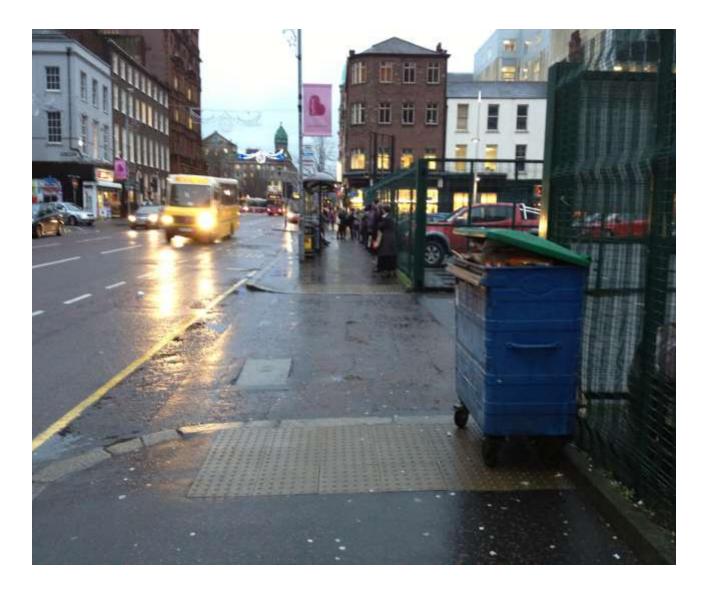
24 There is a good example of an inline crossing at the entrance to the surface car park on the corner of Arthur Street.

<u>Update</u> – Noted bin obstructing the pavement reducing the impact of good provision

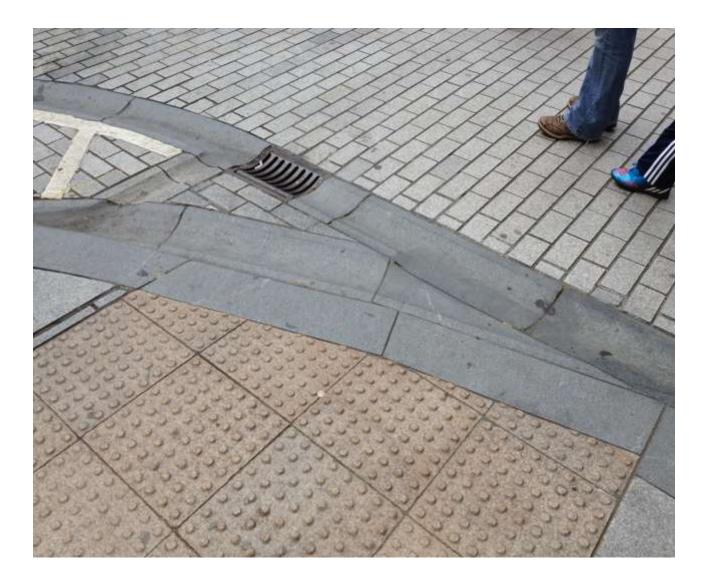
26 <u>Issue</u> - A dish drainage channel obstructs the in line crossing at the junction of Chichester Street and William Street South.

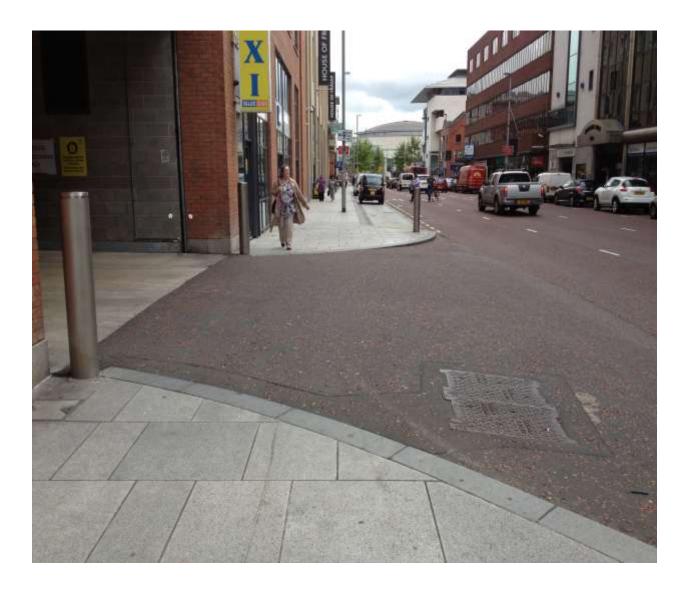
27 <u>Issue</u> - There is no provision of tactile paving on the entrance to the Victoria Square service yard on Chichester Street.

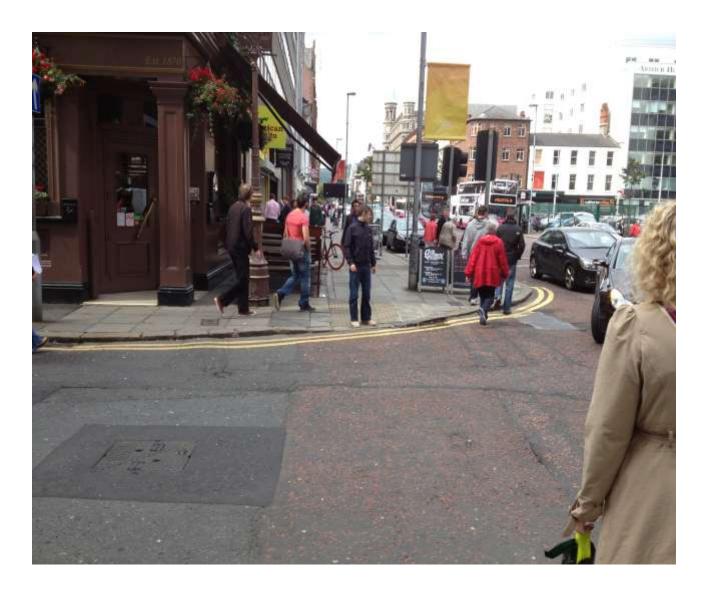
28 <u>Issue</u> - There is a good example of an inline uncontrolled crossing across Montgomery Street. Unfortunately clutter on the pavement reduces the accessibility of this crossing.

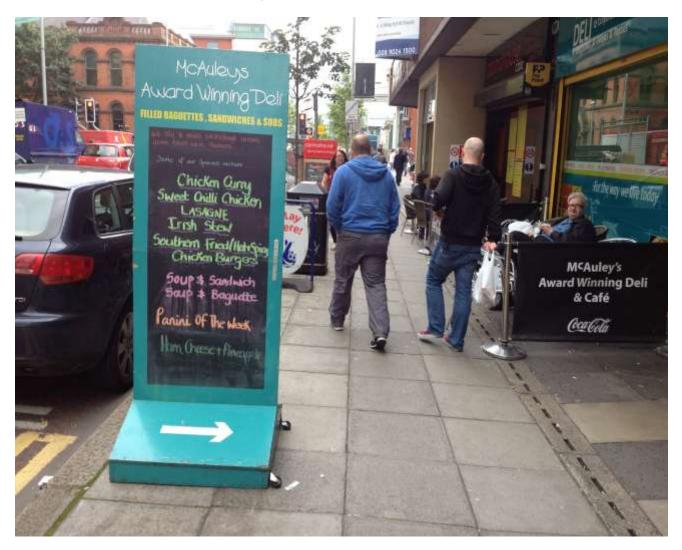
29 <u>Issue</u> - Accessible parking bays provided on Chichester Street do not meet the standard width. Drop kerb provision is limited and could be improved by dropping the entire length of bays.

Progress – None

<u>Additional update</u> -The route towards the law courts on Chichester Street is restricted by significant pavement clutter.

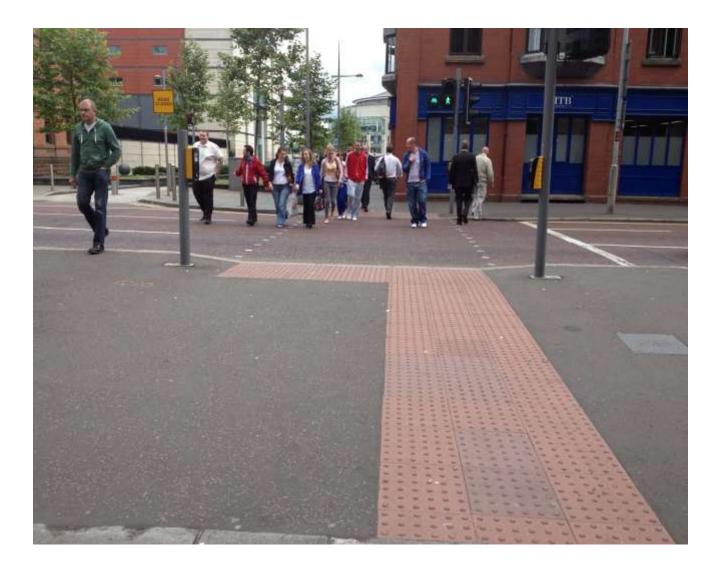
30 <u>Issue</u> - The controlled crossing on Victoria Street (towards the Law Courts) was good but could benefit from increased capacity.

<u>Progress</u> – The crossing has been improved to a high standard.

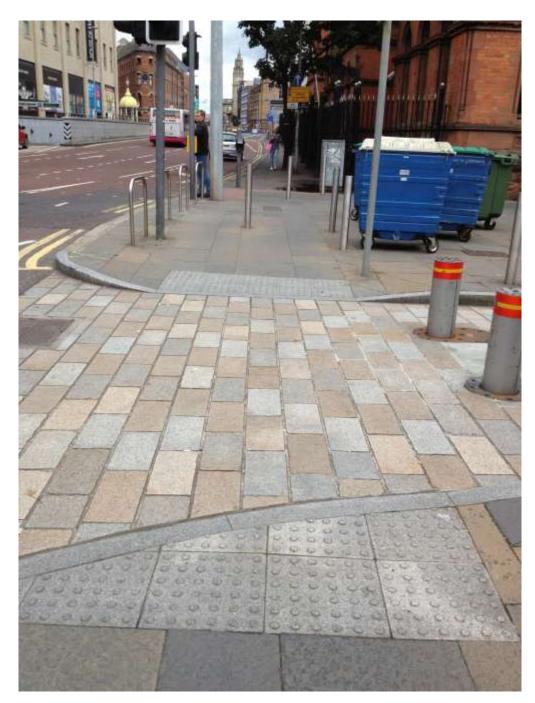
31 <u>Issue</u> - There is an inline crossing across Victoria Street at the entrance to the Law Courts (Lower Chichester Street). However there is no contrast between the paving and tactile and the paving should be extended to a depth of three slabs.

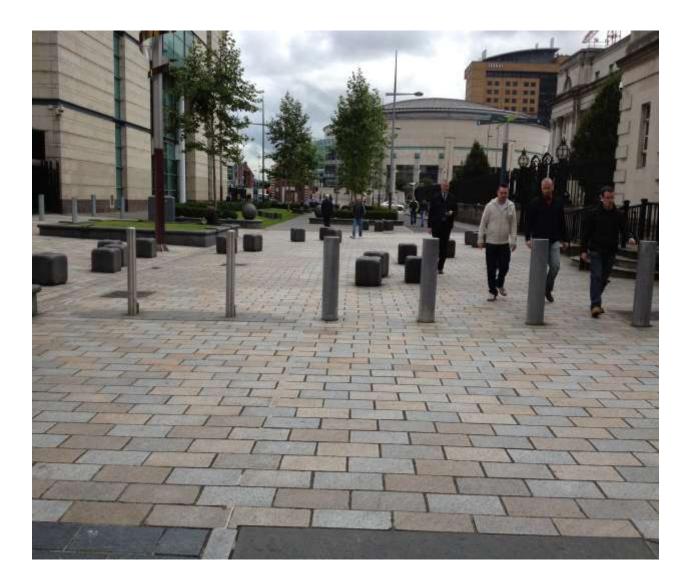
32 <u>Issue</u> - The walking route through the area in front of the law courts is fraught with difficulty. When open to traffic there is little to delineate between walking and traffic areas. The design of lighting columns represents a trip hazard as do the random placement of bollards in this area.

Progress – The area is no longer open to traffic

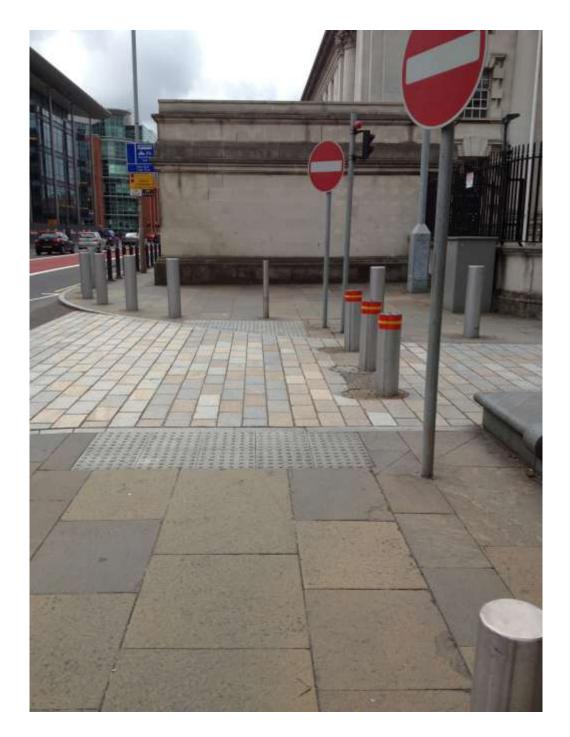
33 <u>Issue</u> - As with the opposite end the inline crossing across Oxford Street at the end of Lower Chichester Street has inadequate provision of tactile paving.

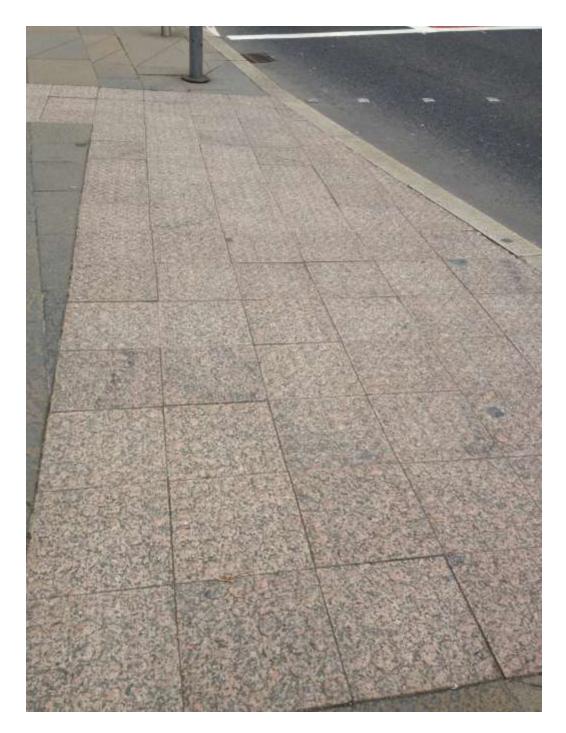
34 <u>Issue</u> - There is a controlled crossing across Oxford Street. On the Waterfront Hall side of Oxford Street. There is inadequate nonstandard tactile paving on the crossing which needs replaced.

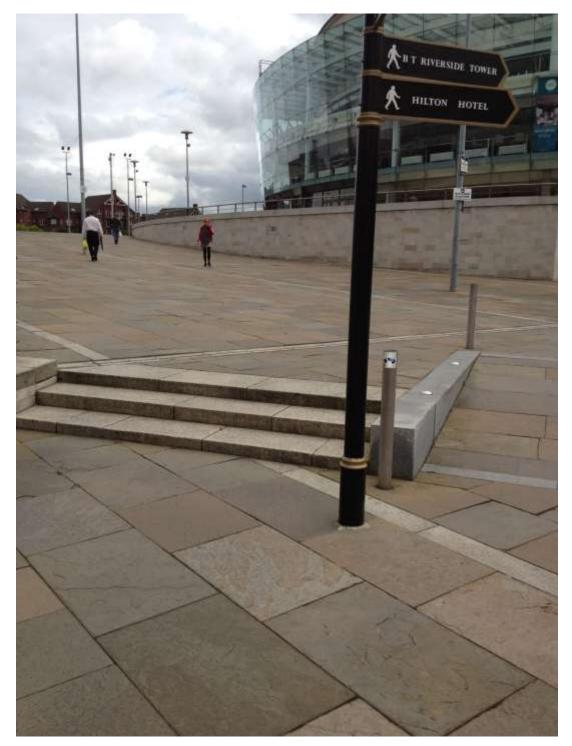
35 <u>Issue</u> - There are a series of steps and ramps around the Waterfront Hall which do not have corduroy paving or appropriate contrast.

Progress - none

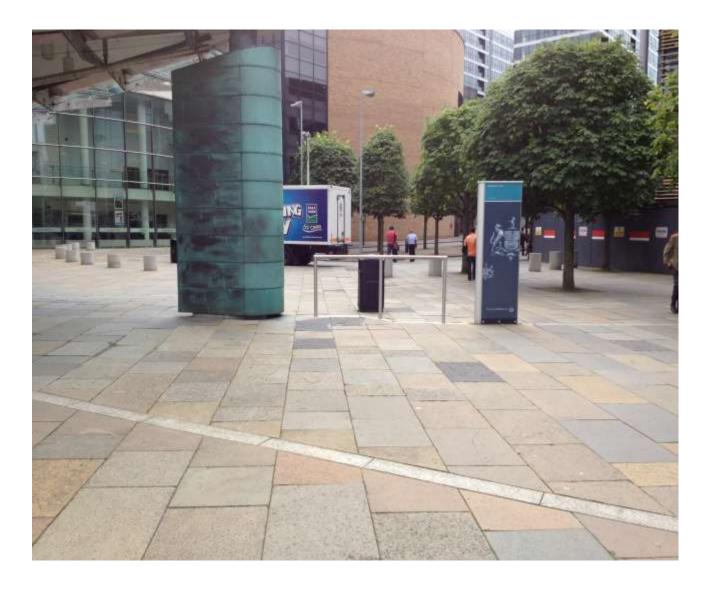
36 <u>Issue</u> - Unexpected changes in levels, bins, bollards and A-boards provide additional hazards in this area.

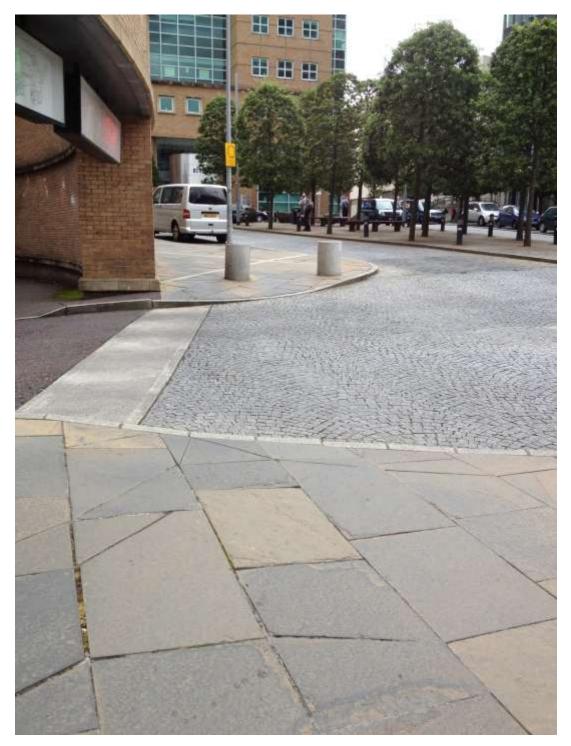
37 <u>Issue</u> - There is poor or no provision of tactile paving at crossings around the Hilton Hotel.

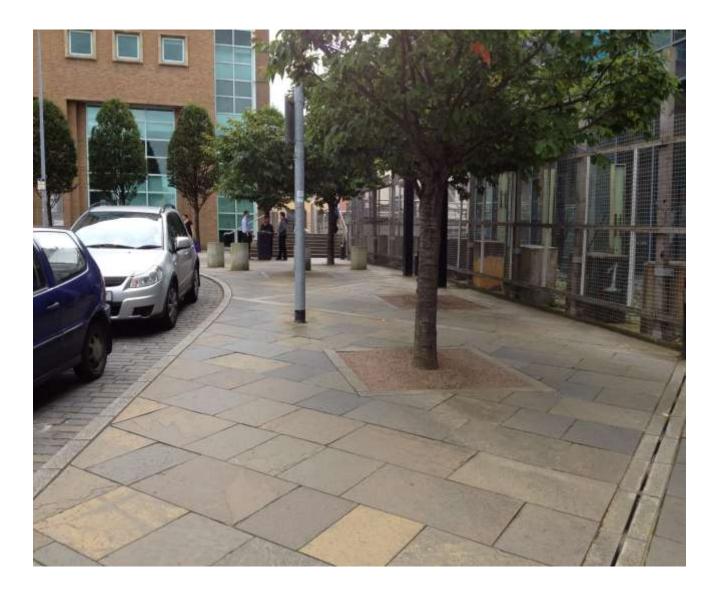
38 <u>Issue</u> - There are multiple obstructions in the area around the stepped access towards Central Station.

<u>Progress</u> – None

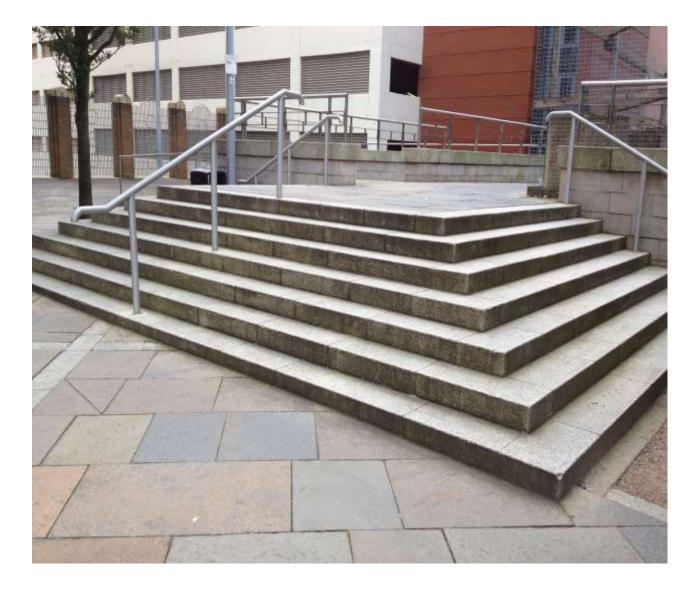
39 <u>Issue</u> - The design of the steps is poor with no corduroy paving. The short tread means the steps are very steep. In places steps descend into hazards such as trees. There are no handrails.

Progress – Handrails have now been added to the steps

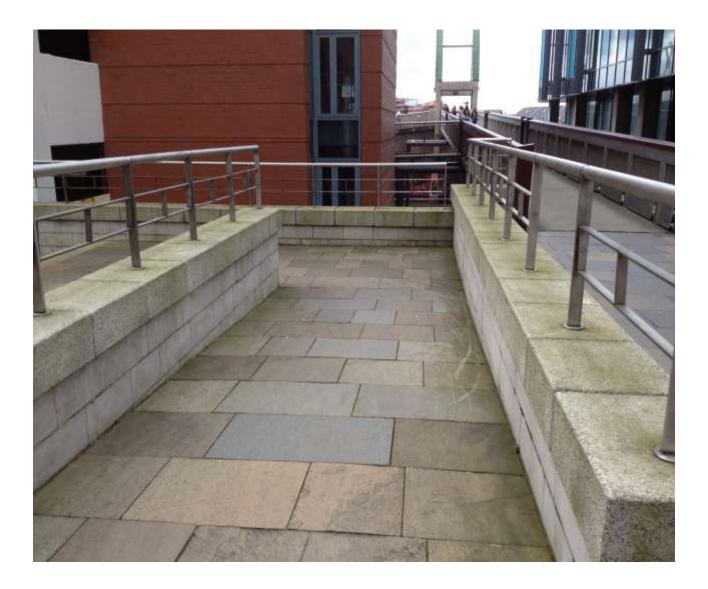
40 <u>Issue</u> - There is a long alternative ramp provided but no handrail or corduroy paving.

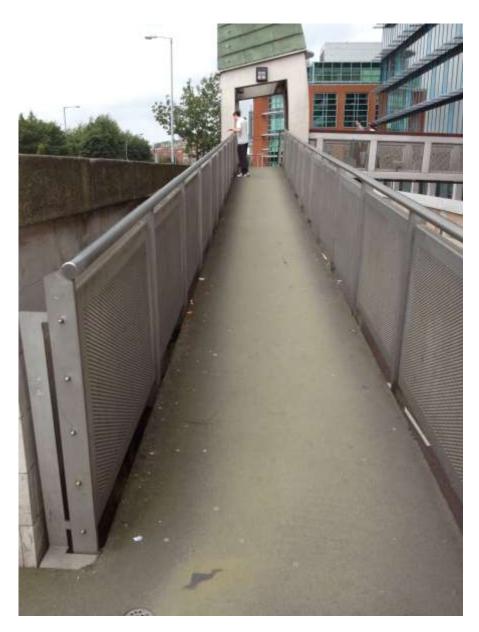
41 <u>Issue</u> - Access to East Bridge Street is via a ramp. The ramp is steep and long with no handrail or landings where people could rest. Steps at the top of the ramp providing access to the road have no corduroy paving, lack contrast and require a lower handrail. An alternative ramp is provided which is steep and has inadequate handrail. The base of the guardrail is open and does not provide adequate protection.

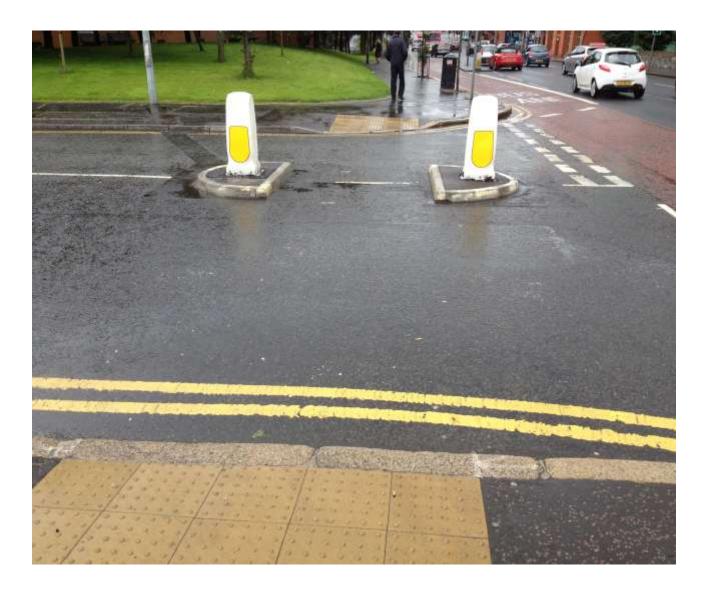
43 <u>Issue</u> - The depth of tactile paving needs to be increased at the junction of Stewart Street and East Bridge Street.

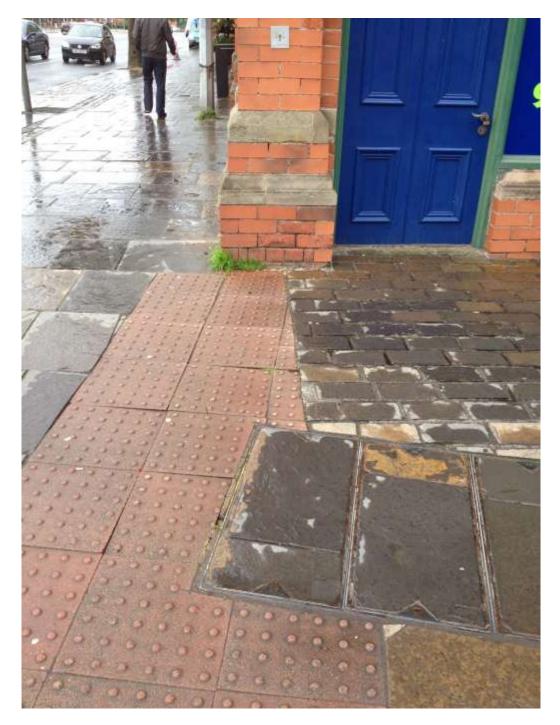
44 <u>Issue</u> - The tail of tactile paving at the controlled crossing on the corner of Oxford Street and East Bridge Street does not continue through covers for utilities.

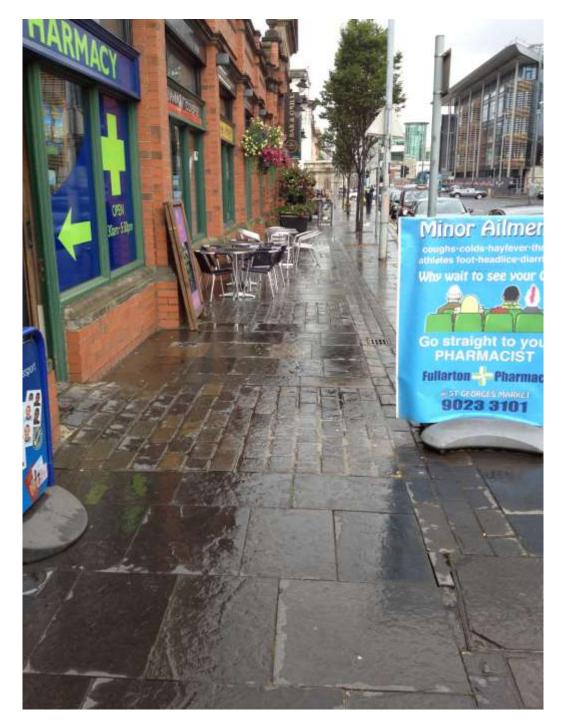
45 <u>Issue</u> - There are multiple obstructions on the footway on Oxford Street outside St Georges Market. There is also a significant crossfall.

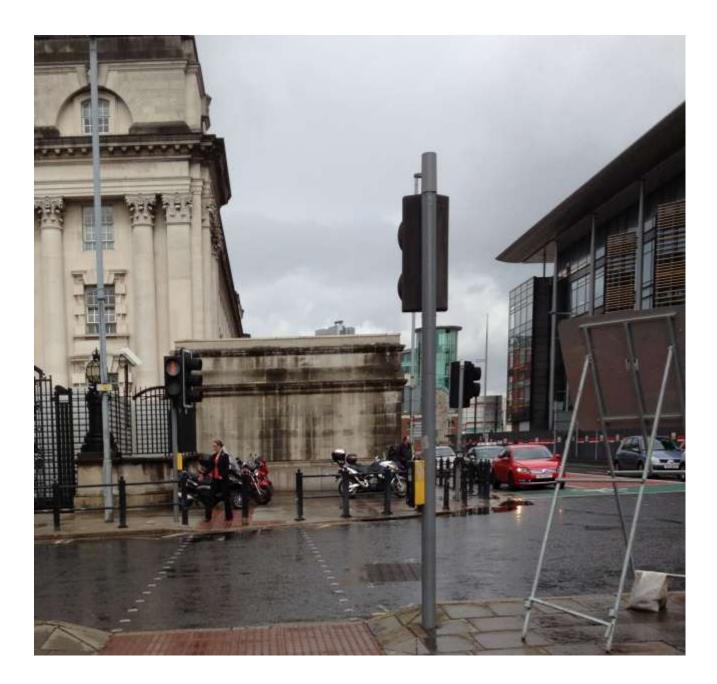
46 <u>Issue</u> - There are bollards placed in the middle of tactile paving at the controlled crossing across May Street. While these are there for security reasons they do create an unexpected hazard.

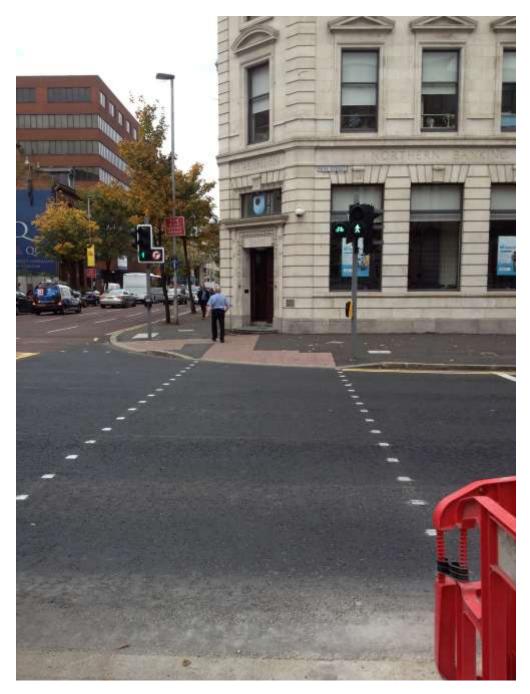
47 <u>Issue</u> - There are numerous issues with the controlled crossings at the junction of May Street, Cromac Street and Victoria Street including trip hazards, positions of columns and tactile paving not in line.

<u>Progress</u> – The junctions have been upgraded to provide high quality facilities.

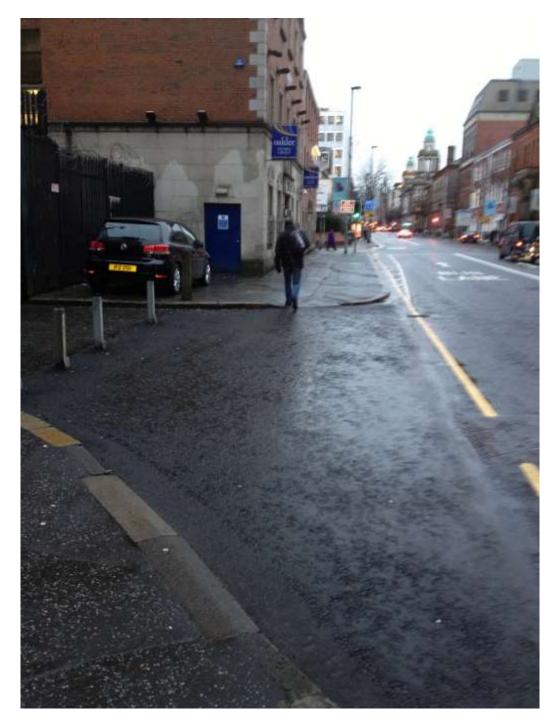
49 <u>Issue</u> - There are a series of vehicle entrances on May Street where no tactile paving has been provided. Pedestrian priority measures could resolve this.

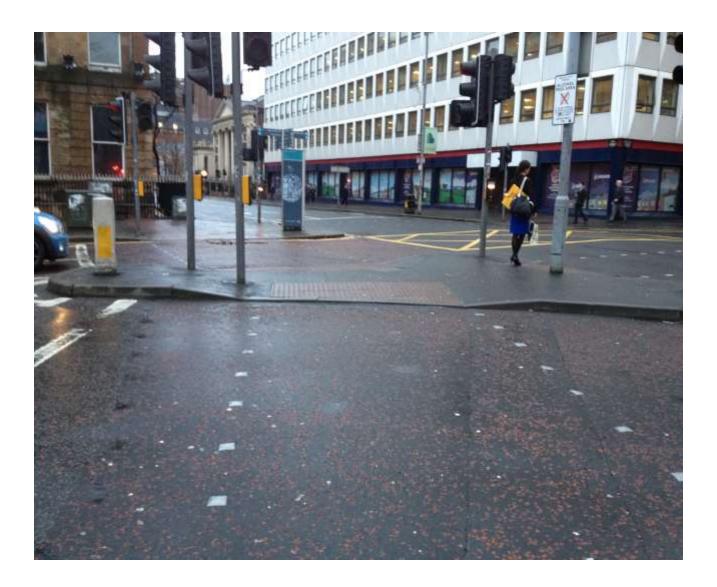
52 Issue -The dropped kerbs on the controlled crossings across Donegall square East are too high and represent a trip hazard.

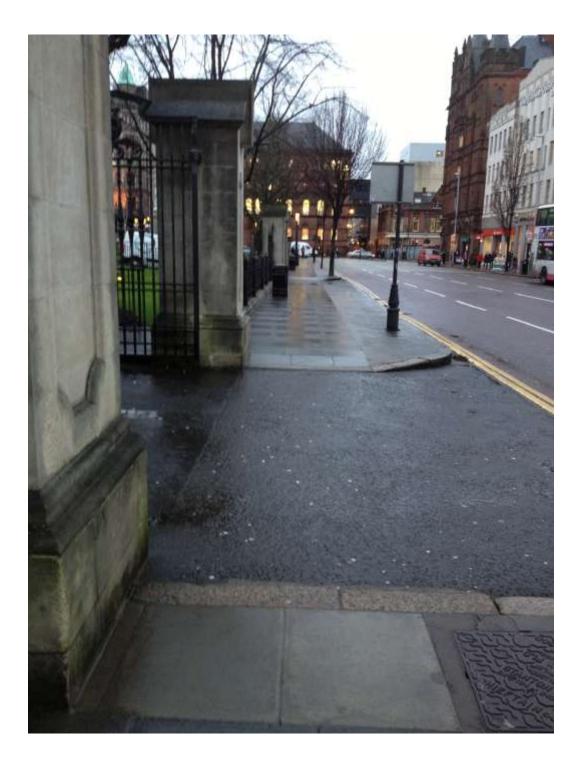
53 <u>Issue</u> – The entrances to City Hall on Donegall Square East have no dropped kerbs.

Progress – Kerbs have been dropped but no tactile paving included

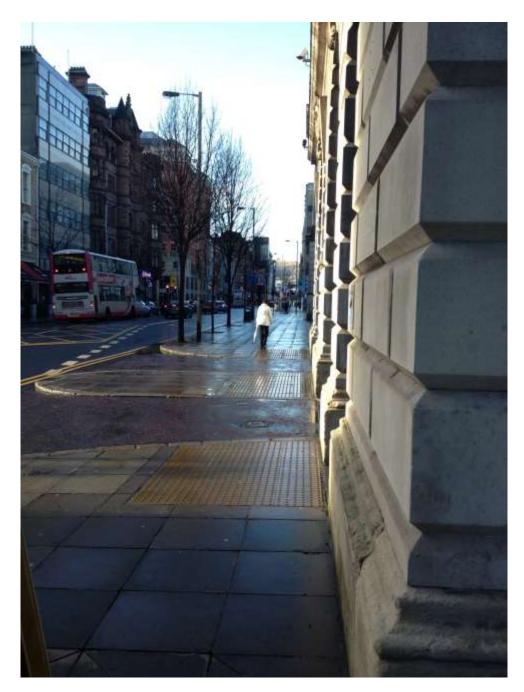
54 <u>Issue</u> - There are in line tactile paving at the vehicle entrances to City Hall on Donegall Square South. There is more paving used than is necessary.

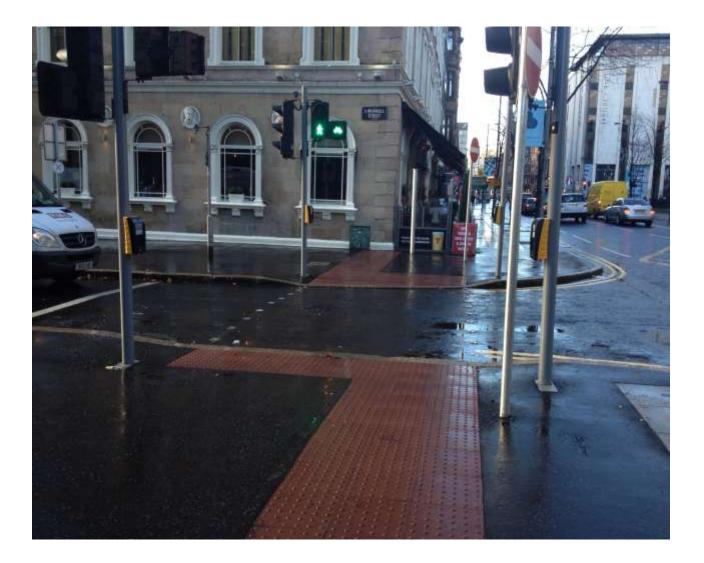
55 <u>Issue</u> – There is an acute crossfall at the junction of Linenhall Street and Donegall Square South making using the uncontrolled crossing difficult.

<u>Progress</u> – The junction has been upgraded to provide high quality controlled crossings.
