Walking Routes in Belfast City Centre - an update

February 2013

# About this paper

Since the previous audit there have been significant changes to the pedestrian environment in Belfast City Centre arising out of the Belfast on the Move project. A further audit was undertaken in October 2012 to identify whether progress has been made in reducing barriers identified by the previous report.

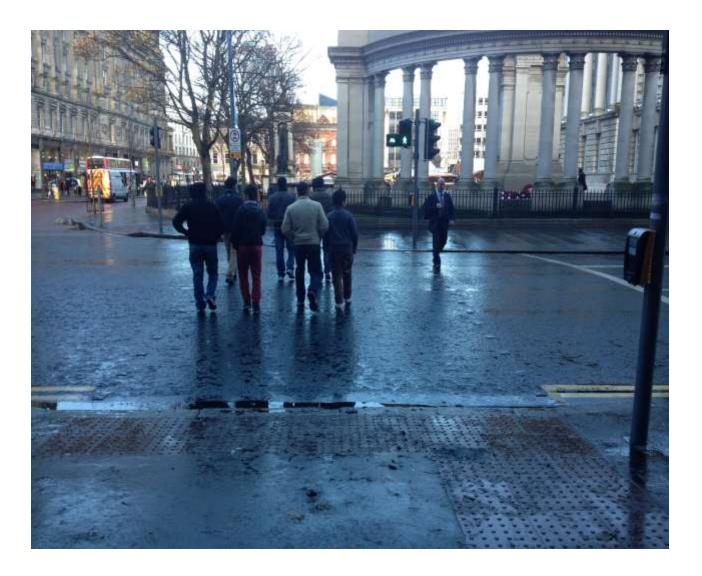
56 <u>Issue</u> – The controlled crossings at junction on Bedford Street/Howard Street/Donegall Square South are in a poor state of repair and would benefit from upgrading.

<u>Progress</u> – The junction has been upgraded to provide high quality controlled crossings
