Report on Walking routes in Newry City Centre

April 2014

This report is the fifth in a series of reports compiled by Imtac looking at the accessibility of key walking routes for disabled people and older people in town and city centres across Northern Ireland. The report was compiled following an inspection of Newry city centre in December 2013. It considers provision on key pedestrian routes in Newry measured against accepted accessibility standards¹. The report is a snapshot of current provision and seeks to identify potential barriers for disabled people and older people and recommends how these barriers could be resolved. The report also highlights examples of good practice in the city centre. A key aspect of the report is linkage between the pedestrian environment and the bus station in Newry. We have produced two reports, a text only version and a version with photographs used to highlight barriers and good practice.

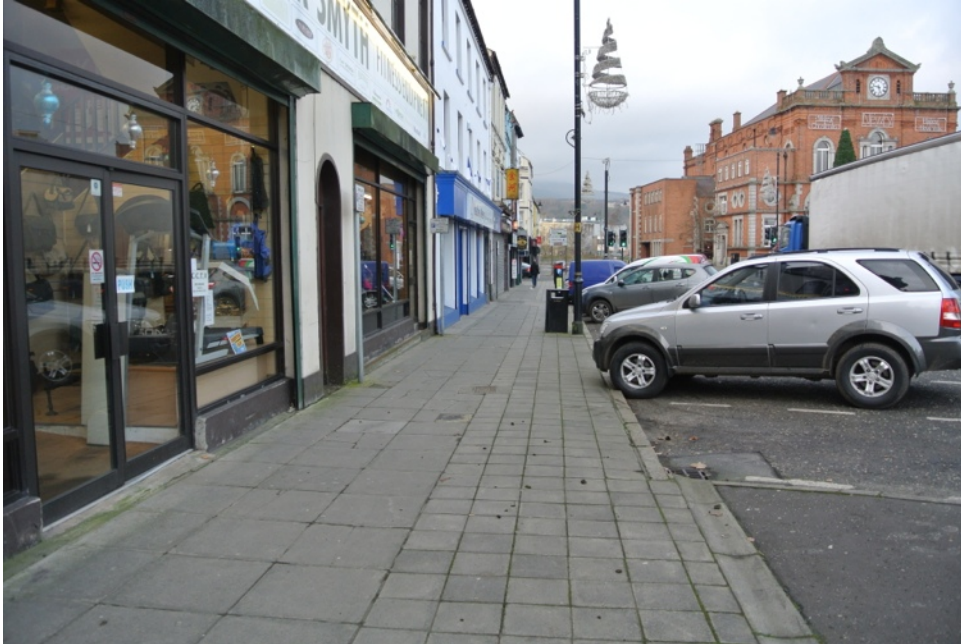
- 1 The pavements at the northern end and eastern side of Kildare Street are broad with furniture located in a line beside the kerb.

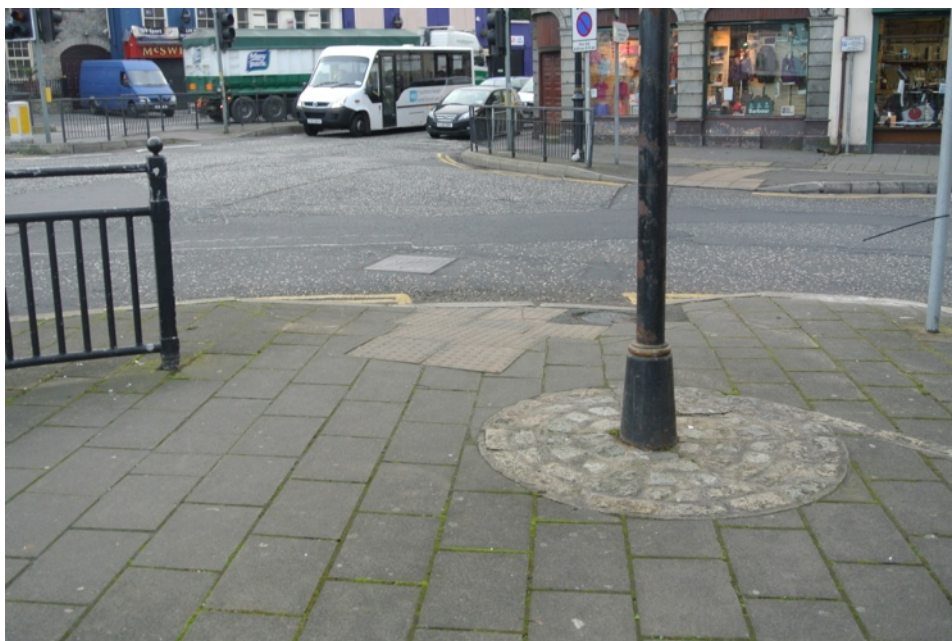
- 2 There is an uncontrolled crossing at the northern end of Kildare Street at its junction with Upper Water Street, Sugar Island and Trevor Hill. The tactile paving is incorrectly laid and in poor state of repair. Given the heavy traffic in the area using this crossing safely is likely to be challenging for some older and disabled people.

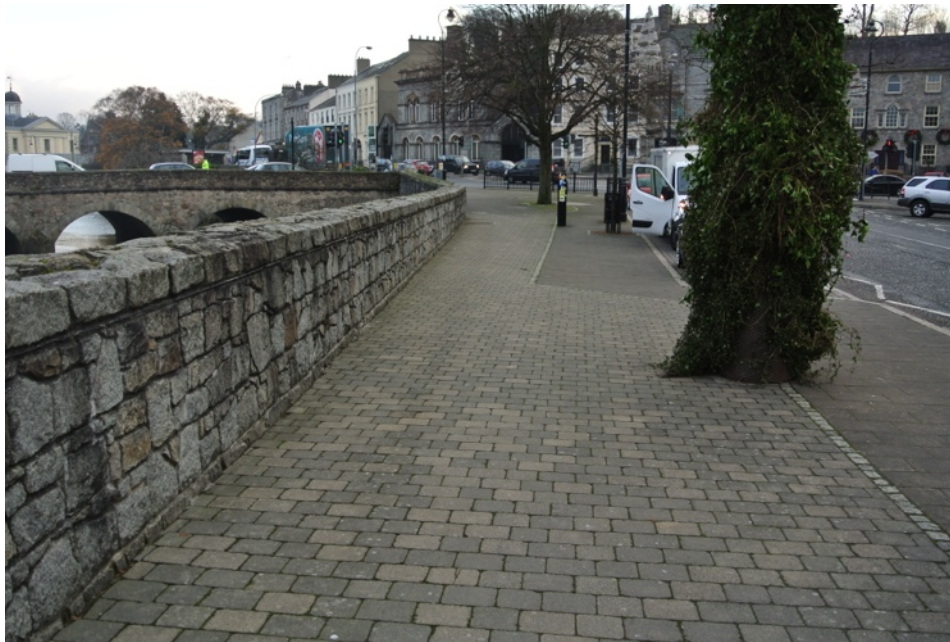
- 3 The pavement on the western side of Kildare Street adjacent to the canal is broad. However there are different surface types used in the area and the random location of furniture may make navigation difficult for people with a visual impairment.

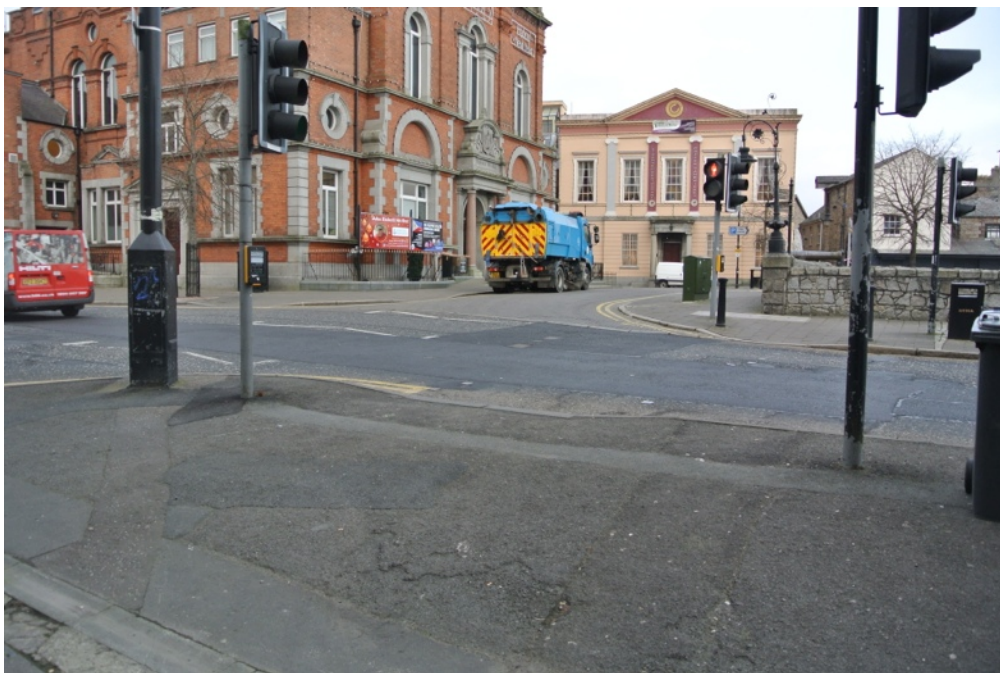
- 4 There is a controlled crossing at the junction of Kildare Street and Bank Parade. The crossing does not meet acceptable standards with no tactile paving provided at all, control boxes poorly located and no tactile rotating cone.

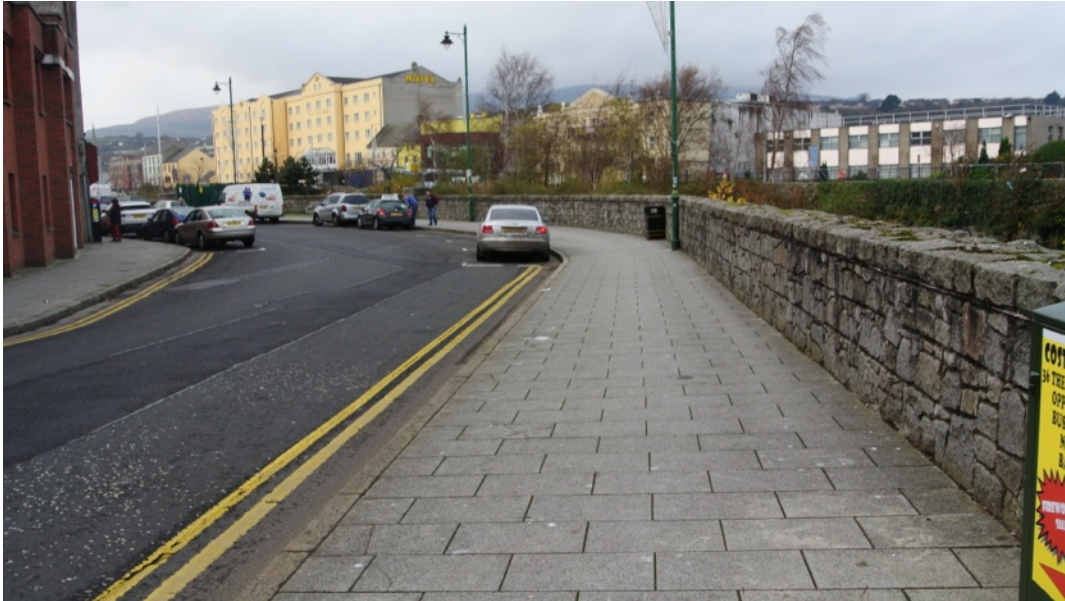
- 5 Proceeding south on Kildare Street the pavements are relatively broad and a good state of repair. There is a significant crossfall on the eastern side.

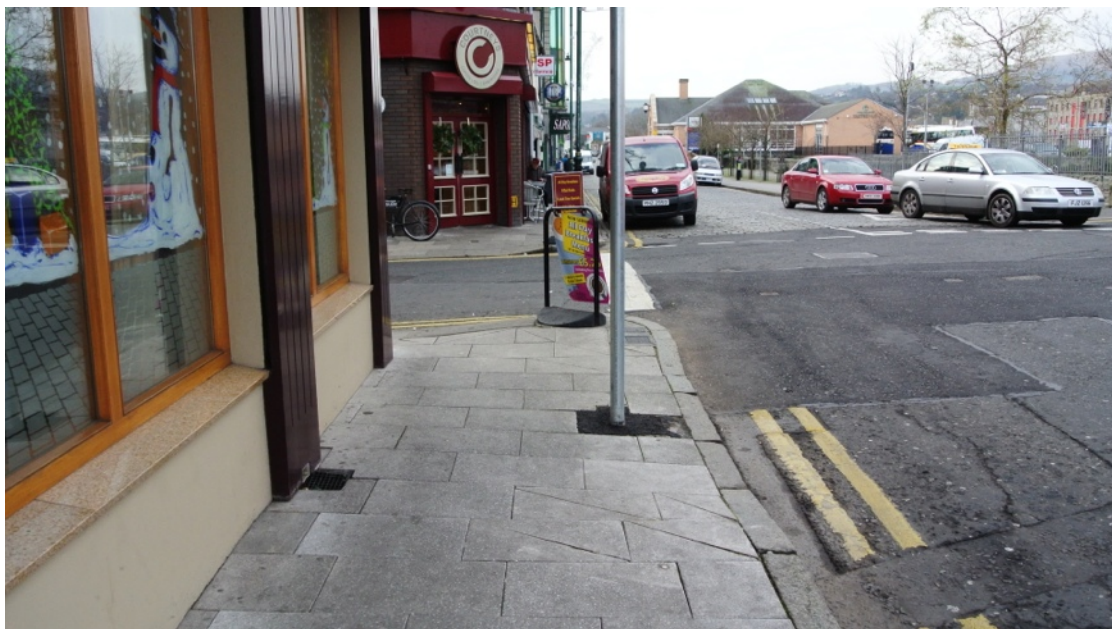
- 6 The pavement on the eastern side narrows considerably approaching the junction with Margaret Square. Dropped kerbs have been provided at this busy junction but no tactile paving included. Signage poles have been placed in the middle of the dropped kerb. Pavement cafes restrict an already narrow pavement.

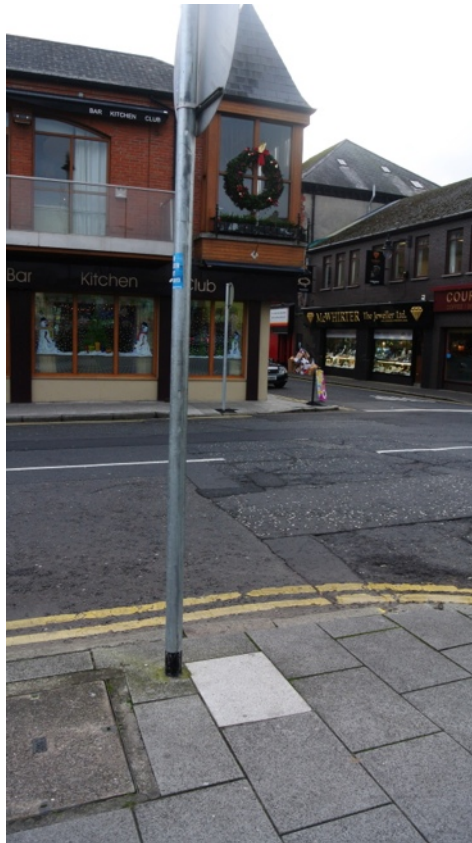
- 7 On the pavement at the western side of the Margaret Square there is no dropped kerb in line with the dropped kerb provided on the eastern side.

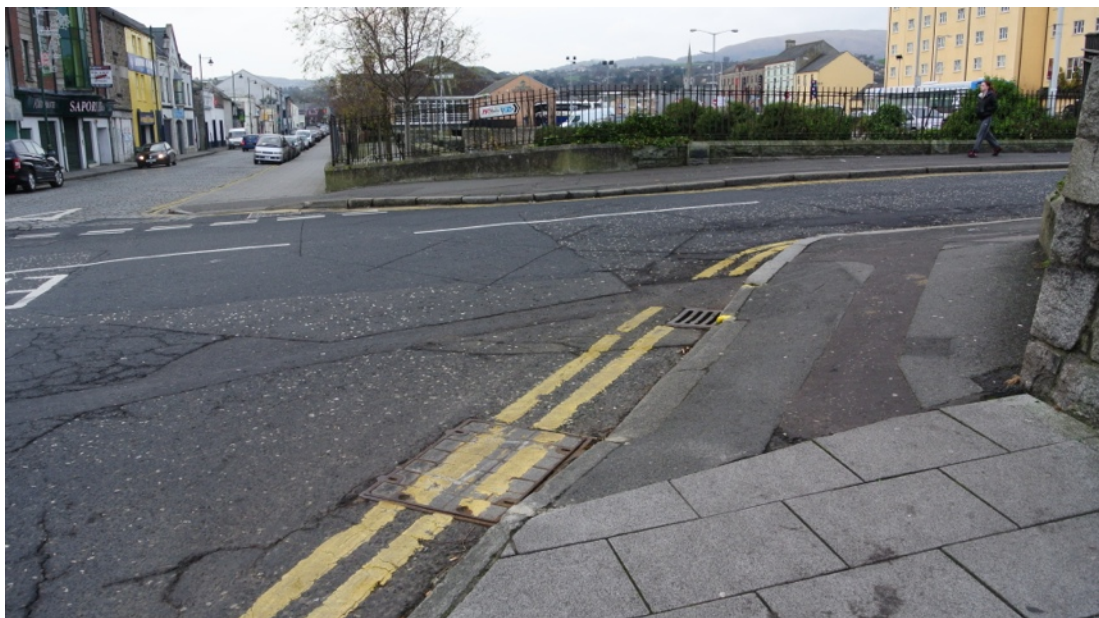
- 8 At the junction of the bridge linking Kildare Street with Monaghan Street dropped kerbs have been provided. These are not inline and have no tactile paving. The dropped kerbs direct people into the middle of a very busy junction and therefore represent a hazard.

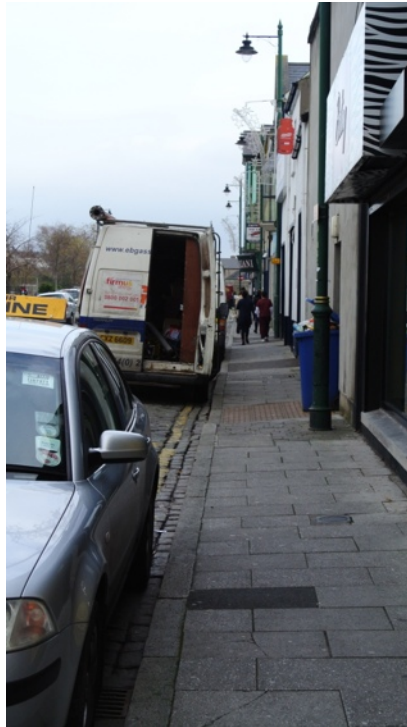
- 9 Proceeding in a southerly direction the pavement on the eastern side of Kildare Street narrows considerably following the junction with Margaret Square. Bins provide a frequent and random obstruction.

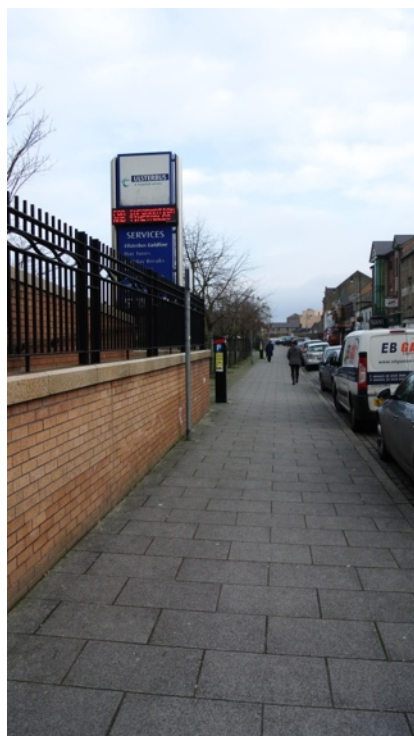
- 10 There is a wider pavement in good condition on the western side of Kildare Street approaching the bus station.

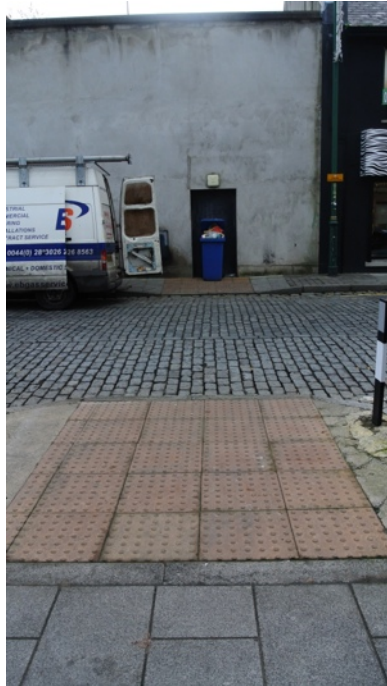
- 11 There is a good example of an uncontrolled crossing at the bus station. However there is a bin in the middle of the tactile paving on the eastern side and the open van doors extend into the crossing. The historic cobbled road surface in this area also makes using this crossing difficult for some disabled people and older people.

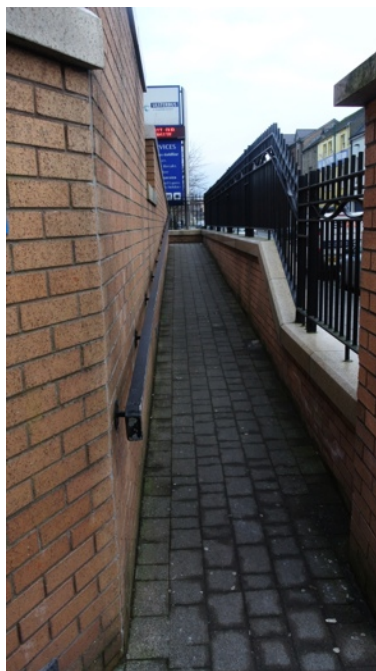
- 12 Access to the bus station from Kildare is via ramp or steps. The design of both are reasonable given there are constraints around the site. However the ramp is long and overly narrow in places. Both these issues are likely to cause difficulties for some disabled people.

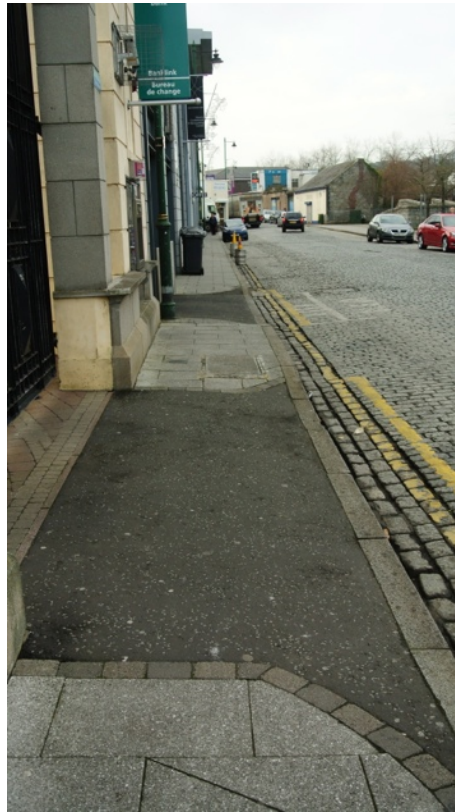
- 13 Bins continue to be a problem on the narrow eastern pavement on Kildare Street. There are a number of vehicle entrances along this pavement with no tactile paving to indicate a potential hazard for visually impaired pedestrians.

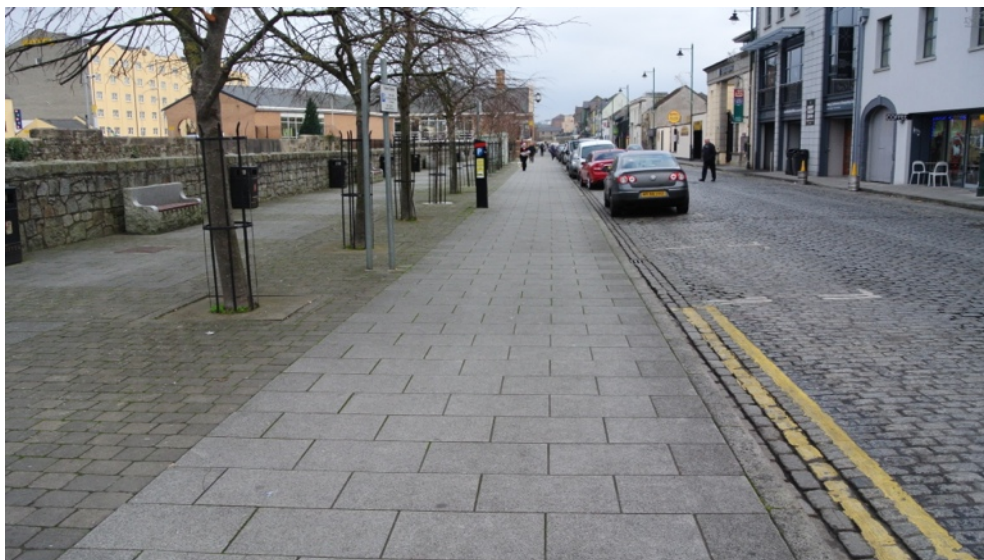
- 14 The pavement on the western side of Kildare Street continues to be broad and of a high standard.

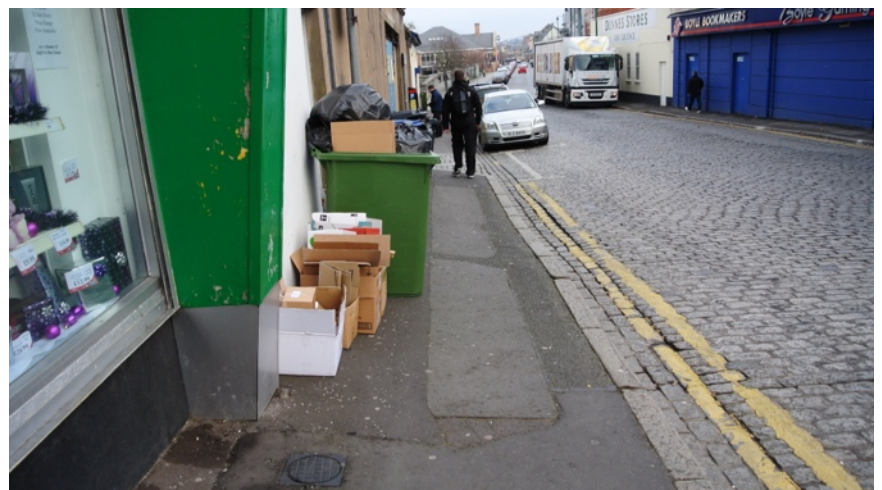
- 17 The junction at Kildare Street, Bridge Street and Mill Street is very busy. In-line Dropped kerbs have been provided across Kildare Street either side of the junction. However no tactile paving has been provided.

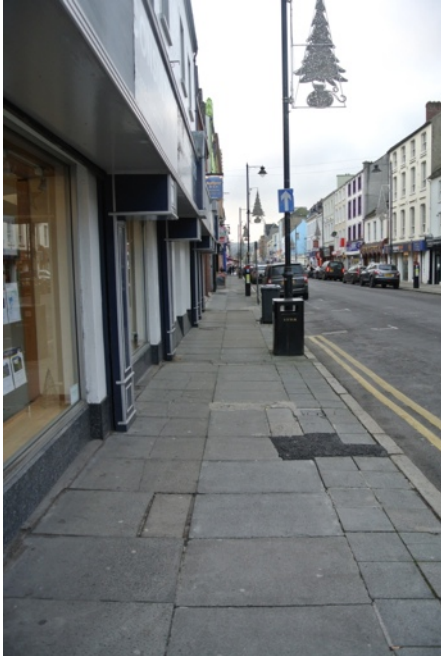
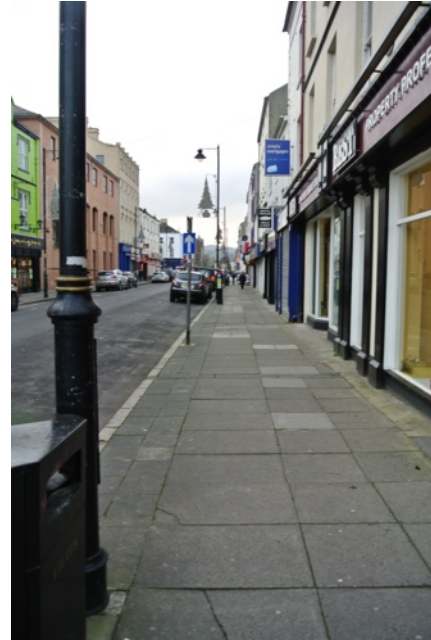
- 19 The pavements at the northern end of Hill Street are generally broad, of reasonable quality and generally clutter free. There is no accessible opportunity to cross Hill Street at the junction with Kildare Street or along Hill Street until the junction with Margaret Square.

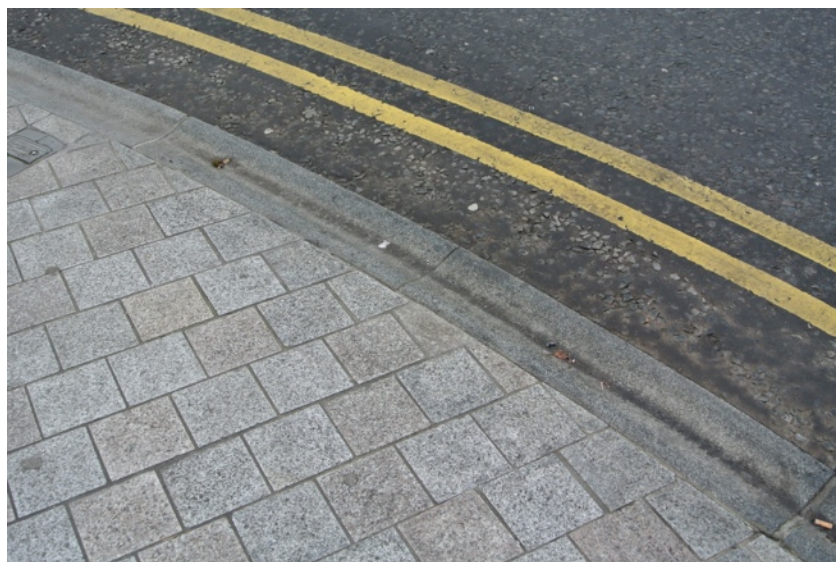
- 20 A recent public realm scheme has improved surfaces around Margaret Square. The square is busy with parking for taxis and cars. There are no kerbs in the area with dish drainage channels used to delineate between the flush road and pedestrian surfaces. This type of delineation is not something Imtac would recommend.

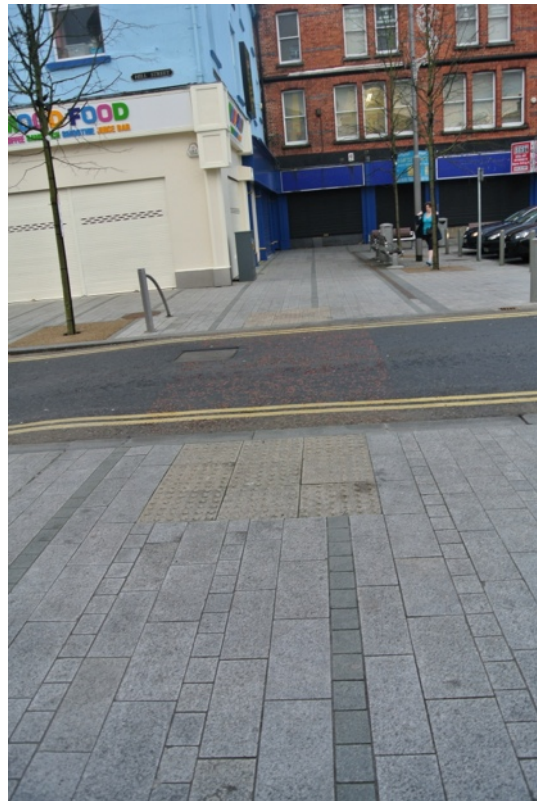
- 21 There are four in-line controlled crossings on the square. These follow good practice in relation to the provision of this type of crossing. However given the “shared” nature of the area consideration should be given to extending the length of the tactile paving at these crossings.

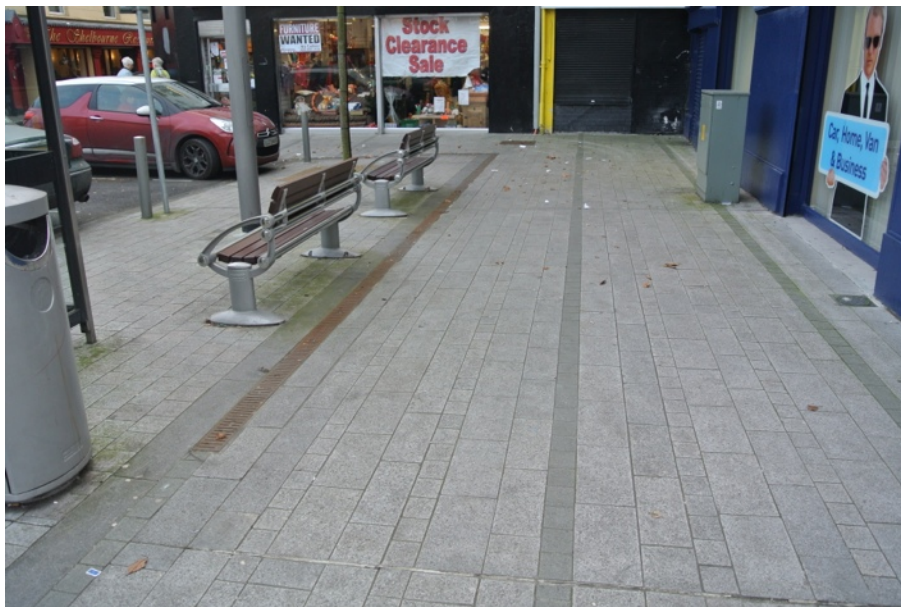
- 22 Street furniture has been used to mark out clear pedestrian routes in the square. However accessibility and safety in the area would be enhanced by the inclusion of visibility bands on bollards and other furniture.

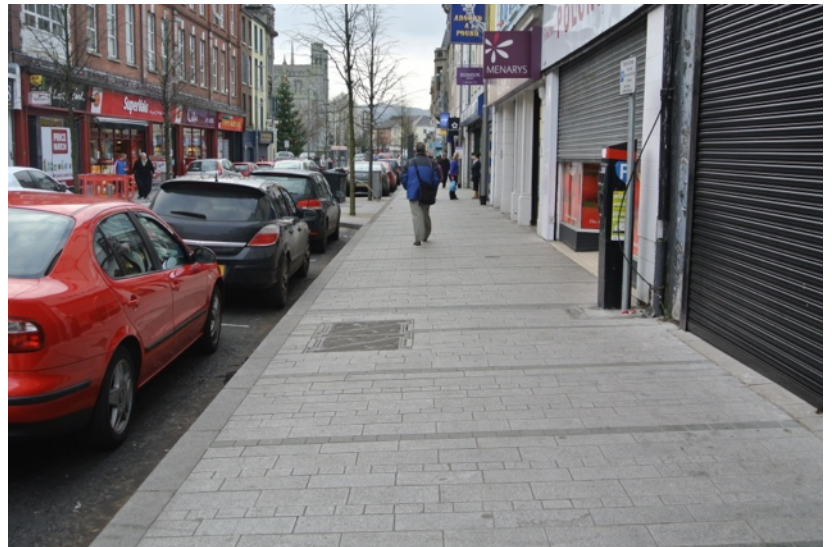
- 23 Proceeding up Hill Street towards Marcus Square the pavement on both sides provides a broad high quality walking surface. The kerb has been reintroduced at this point. There is a lack of consistency in the location of street furniture with parking meters located at the building line and kerb line in different locations.

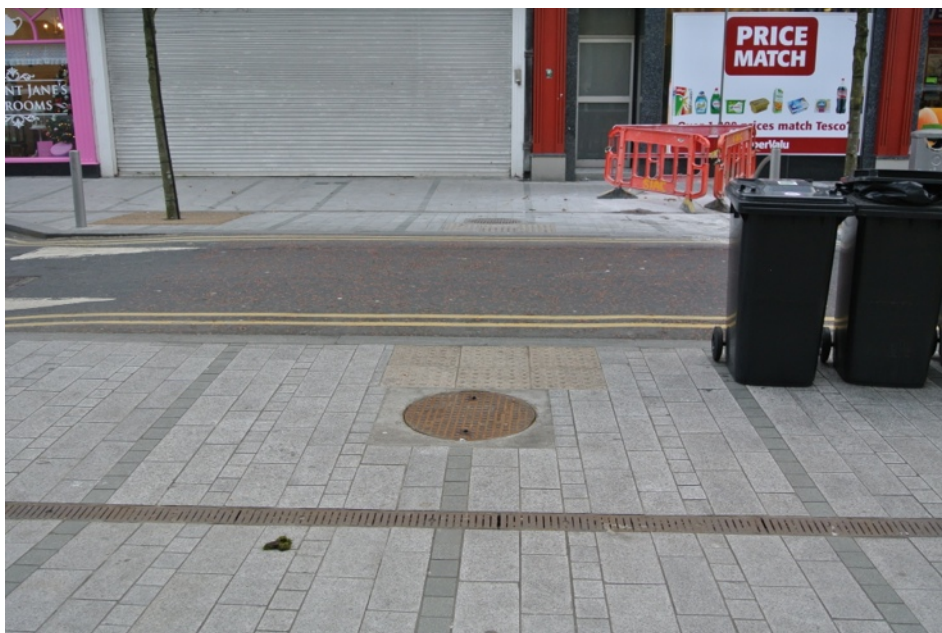
- 24 There is an in-line raised uncontrolled crossing on this section of Hill Street. Once again there is an opportunity to enhance pedestrian accessibility at this crossing by extending the length of the tactile paving. Bins and maintenance work are potential obstructions at this crossing.

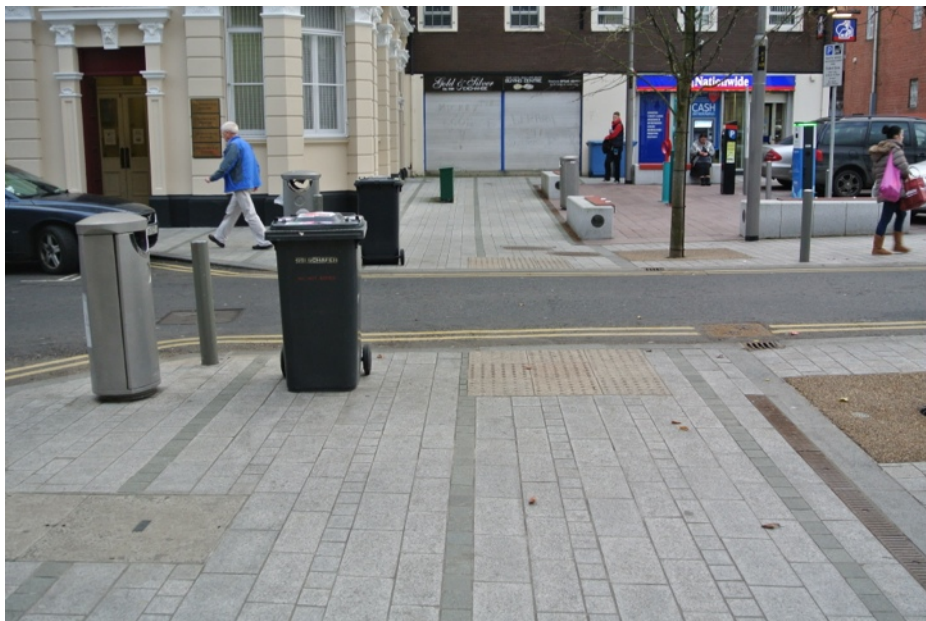
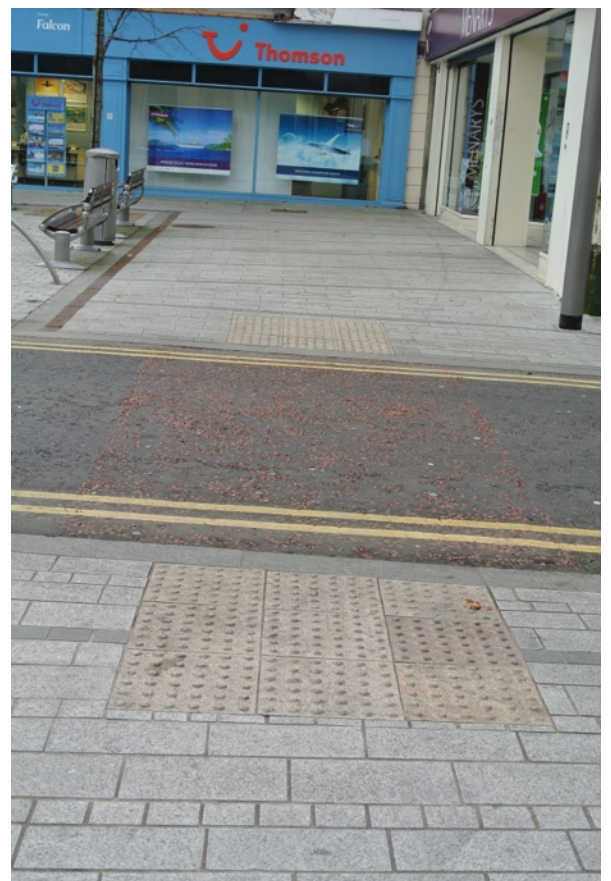
26 As with Margaret Square in-line uncontrolled crossings have been provided. Once again pedestrian accessibility could be improved by extending the length of the tactile paving over the width of the crossing.

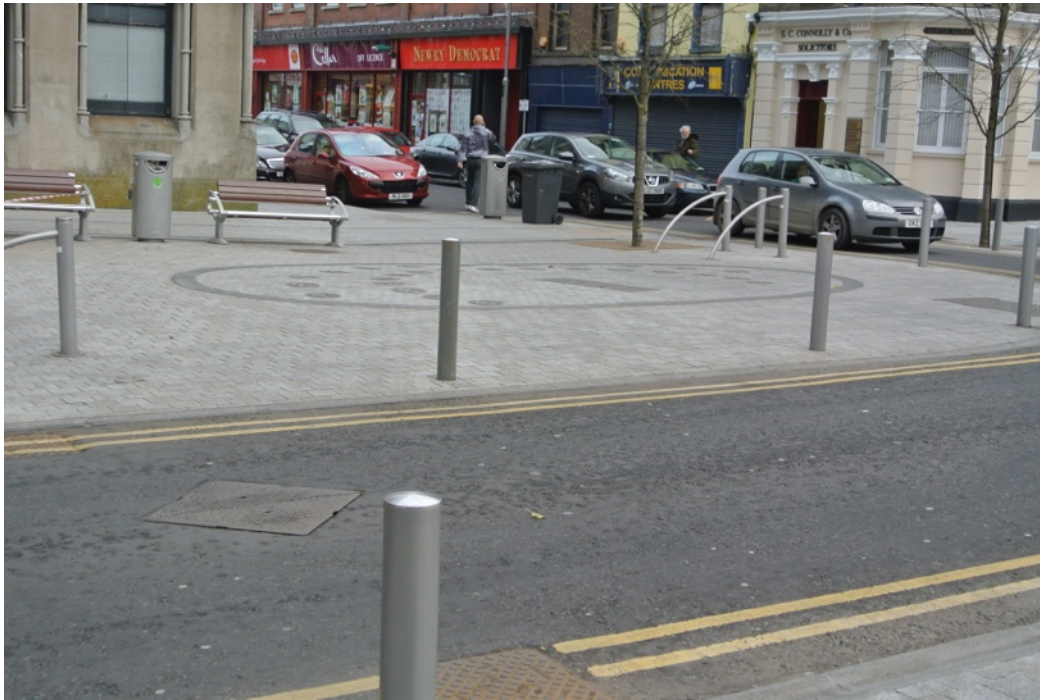
- 27 As with Margaret Square the design attempts to use street furniture to mark out pedestrian routes. However accessibility and safety in the area would be enhanced by the inclusion of visibility bands on bollards and other furniture.

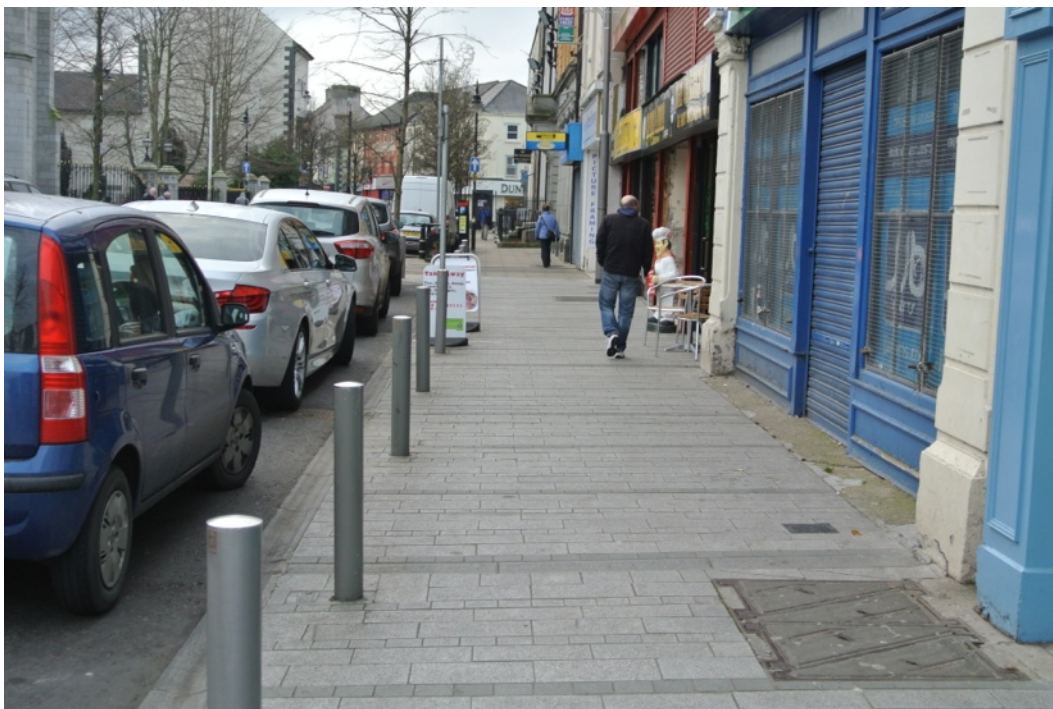
- 28 The flush surface between pavement and road continues for a short distance along Hill Street. Unmarked bollards and a dish drainage channel provide a less than satisfactory delineation.

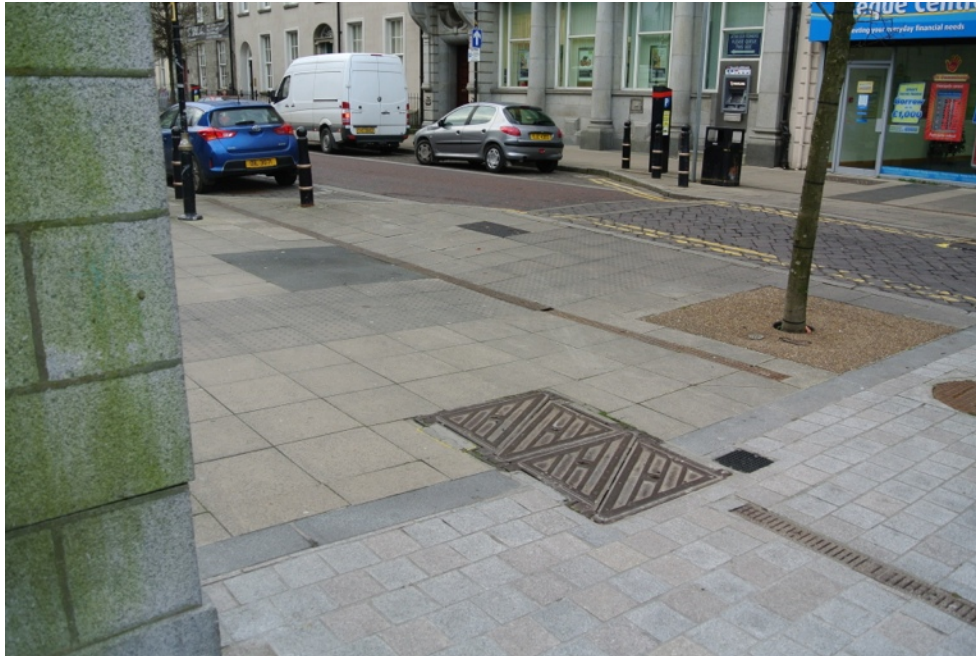
- 29 Approaching the cathedral on Hill Street the public realm scheme ends. At this point there is an inline flush uncontrolled crossing. The use of tactile paving at this crossing is incorrect and there is no contrast between the tactile and surrounding paving. A kerb is reintroduced after this crossing.

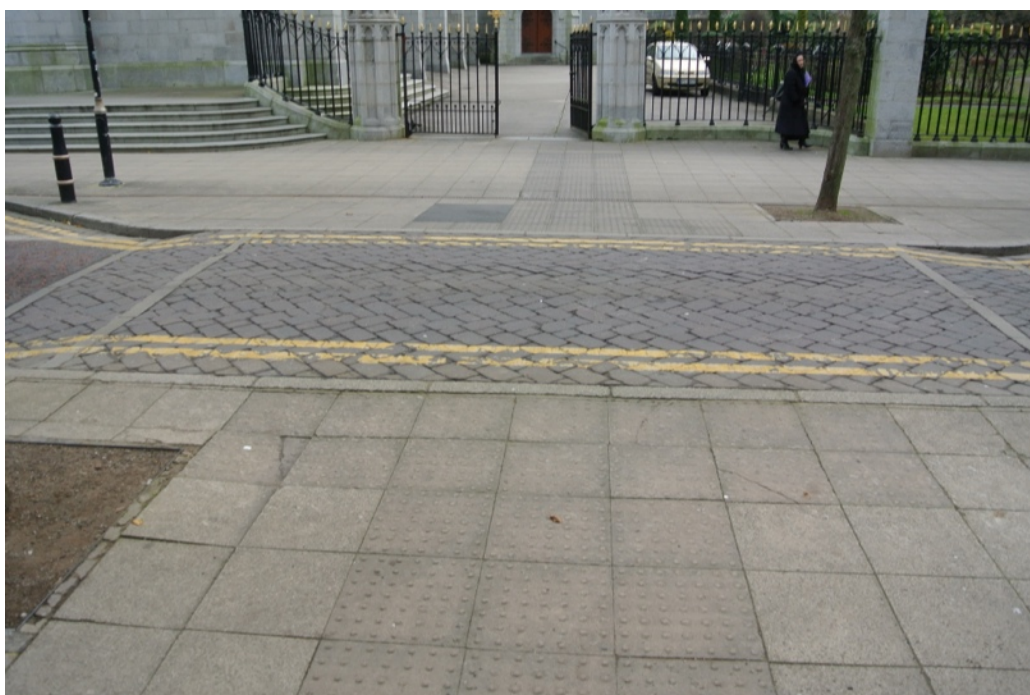
- 30 There is another inline flush uncontrolled crossing at the entrance to the Cathedral. The use of tactile paving at this crossing is incorrect and there is no contrast between the tactile and surrounding paving. The paving in this area is in a poor state of repair.

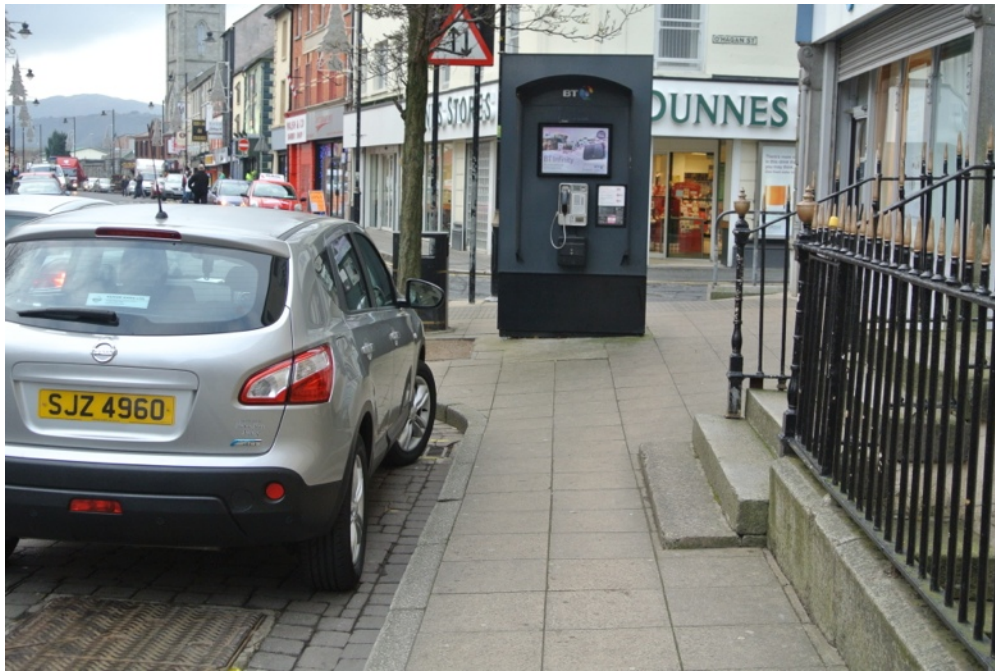
- 31 Towards the junction of Hill Street and O'Hagan Street a telephone kiosk represents a major obstacle. There is also a significant crossfall on the pavement.

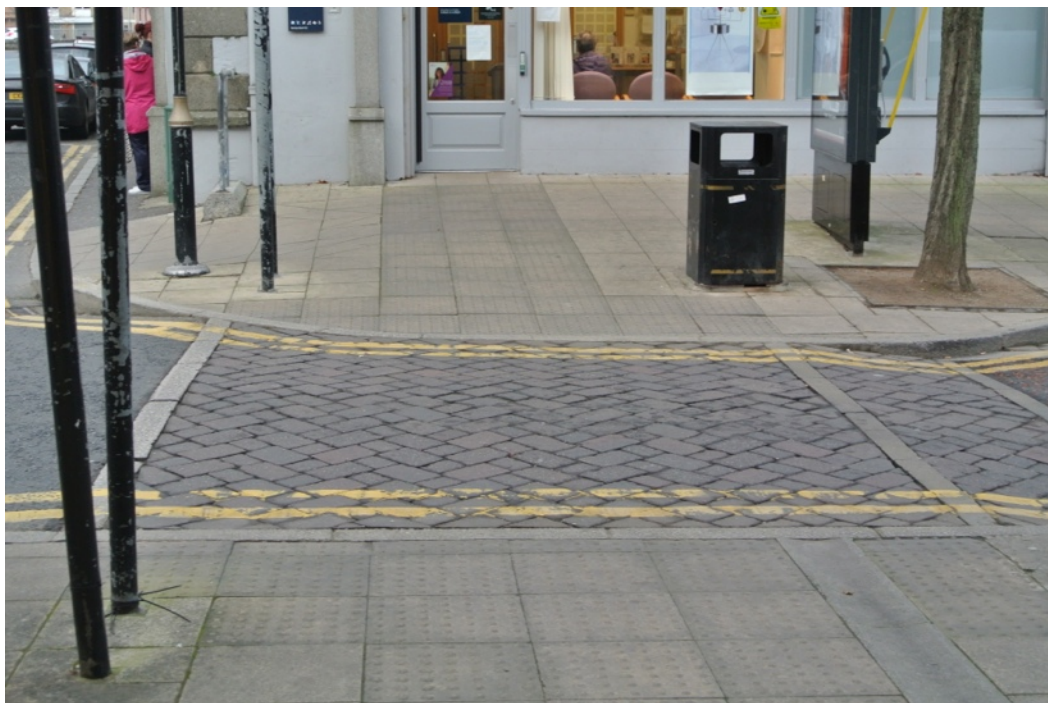
- 32 Approaching this junction there is another in-line flush uncontrolled crossing. The issues reflected in paragraphs 30 and 31 are present here. In addition, the location of street furniture presents numerous obstacles for users of the crossing.

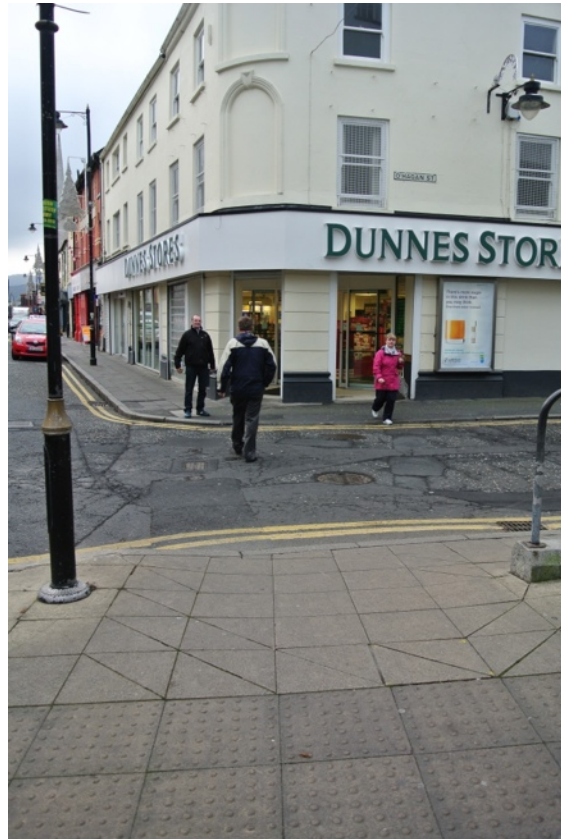
- 33 There are dropped kerbs at both sides of the junction between O'Hagan Street and Hill Street. However no tactile paving has been provided.

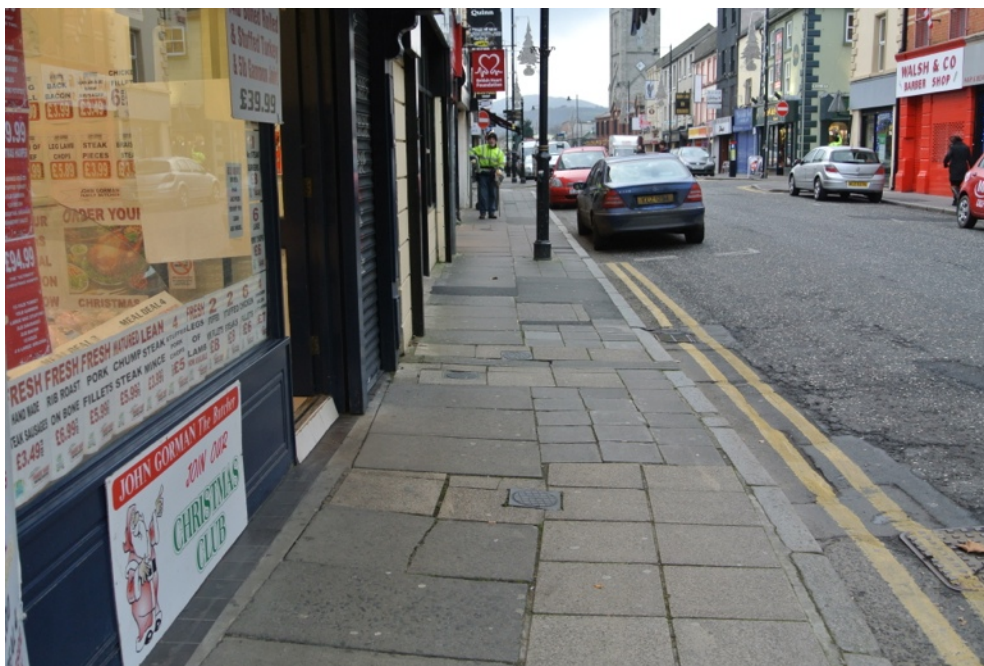
- 34 Paving surfaces in this area of Hill Street are of poor standard.

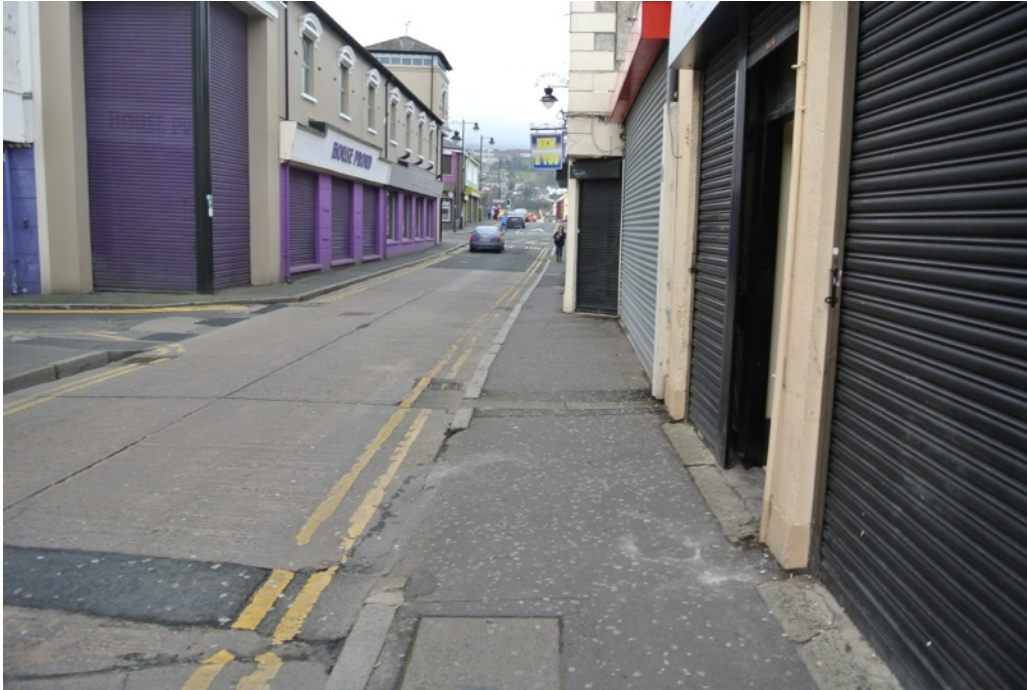
37 The pavements on Mill Street are narrow in places.

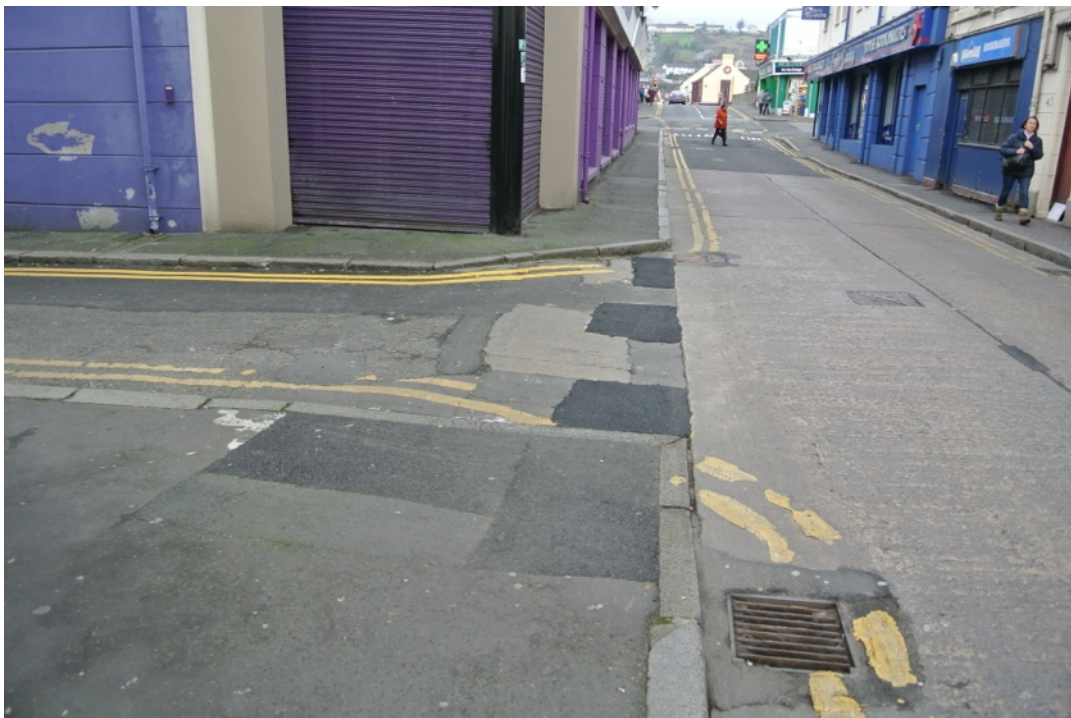
38 The absence of dropped kerbs means there is no accessible opportunity to cross Mill Street at the junction with Georges Lane. The pavement surfaces are poorly maintained.

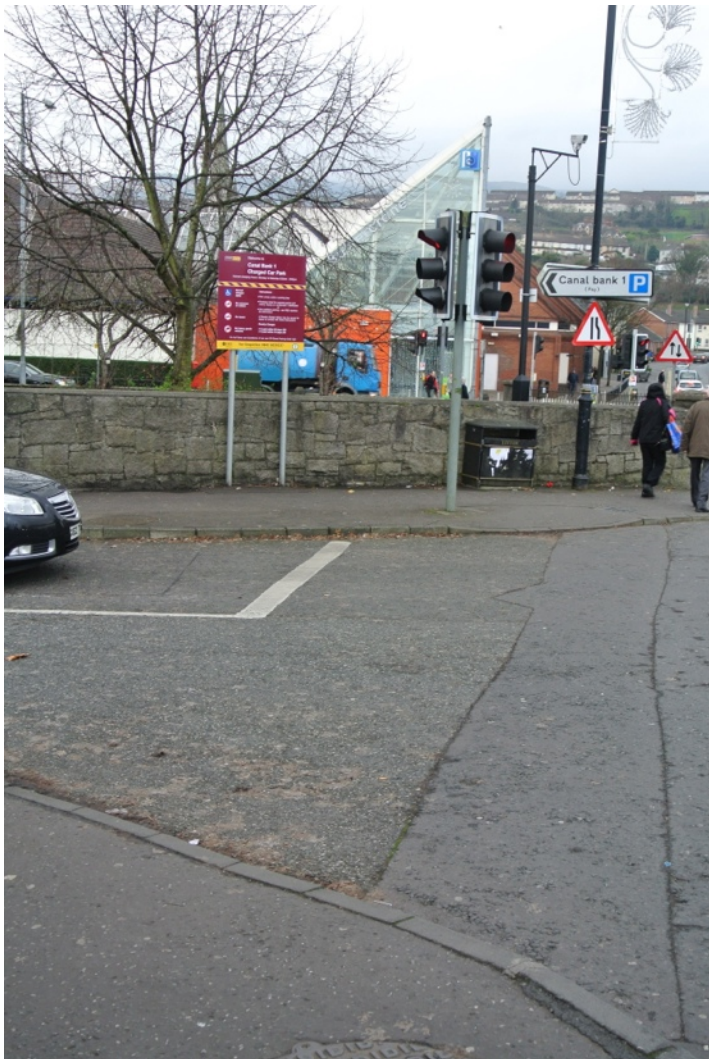
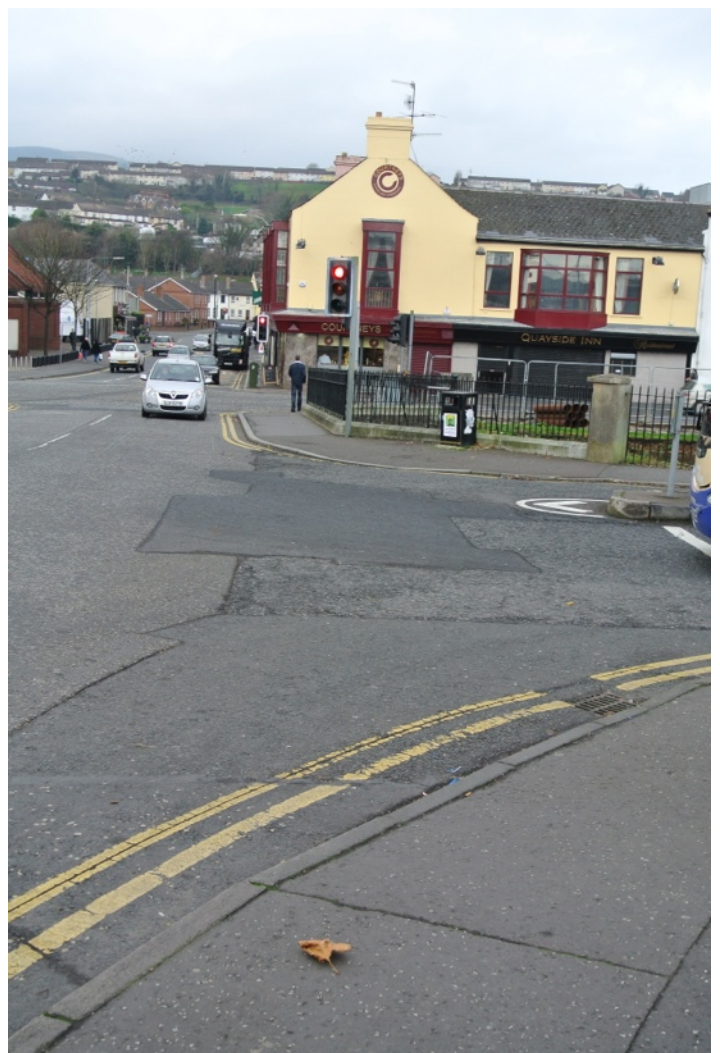
- 39 There are traffic lights mid way along Bridge Street at the entrance to the Roads Service car park on the southern side and the exit of the bus station on the northern side. No provision has been made for pedestrians at these traffic lights and whilst dropped kerbs are in place no tactile paving has been provided. An extremely hazardous junction for some disabled people.
