Report on Walking routes in Newry City Centre

April 2014

This report is the fifth in a series of reports compiled by Imtac looking at the accessibility of key walking routes for disabled people and older people in town and city centres across Northern Ireland. The report was compiled following an inspection of Newry city centre in December 2013. It considers provision on key pedestrian routes in Newry measured against accepted accessibility standards¹. The report is a snapshot of current provision and seeks to identify potential barriers for disabled people and older people and recommends how these barriers could be resolved. The report also highlights examples of good practice in the city centre. A key aspect of the report is linkage between the pedestrian environment and the bus station in Newry. We have produced two reports, a text only version and a version with photographs used to highlight barriers and good practice.

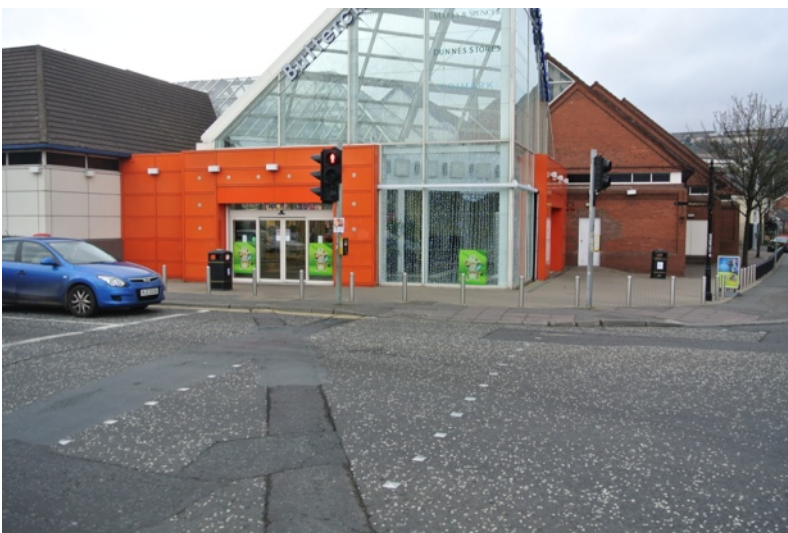
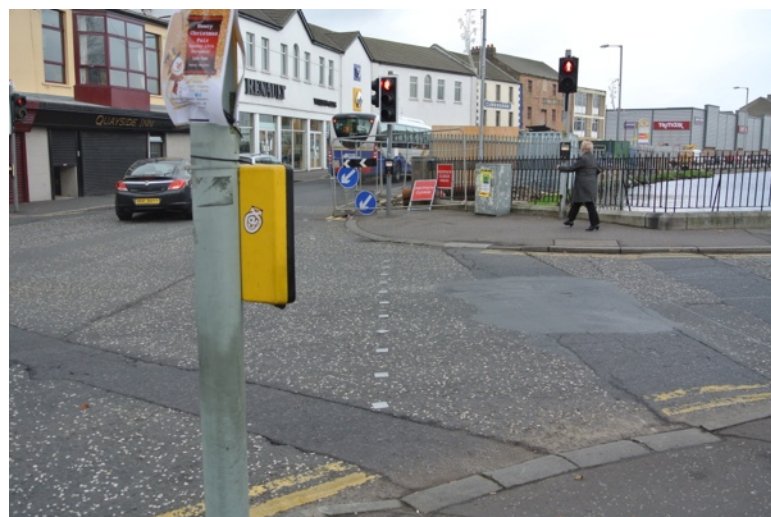
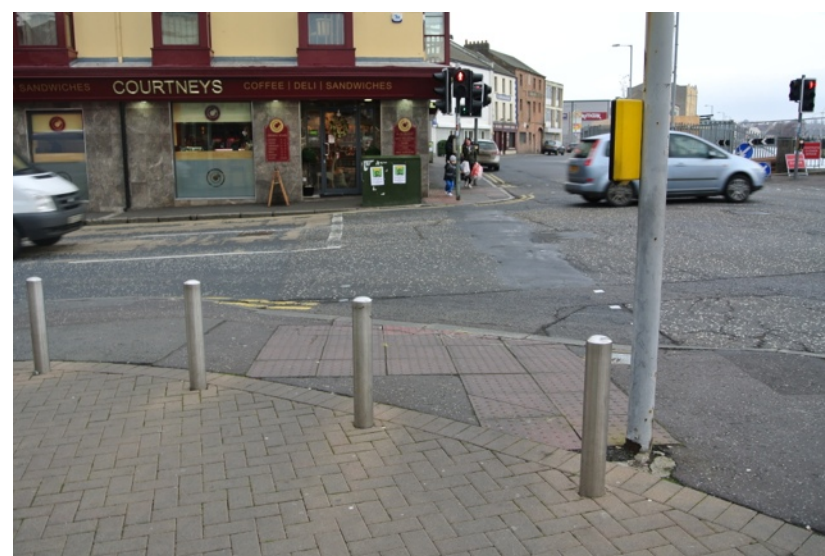
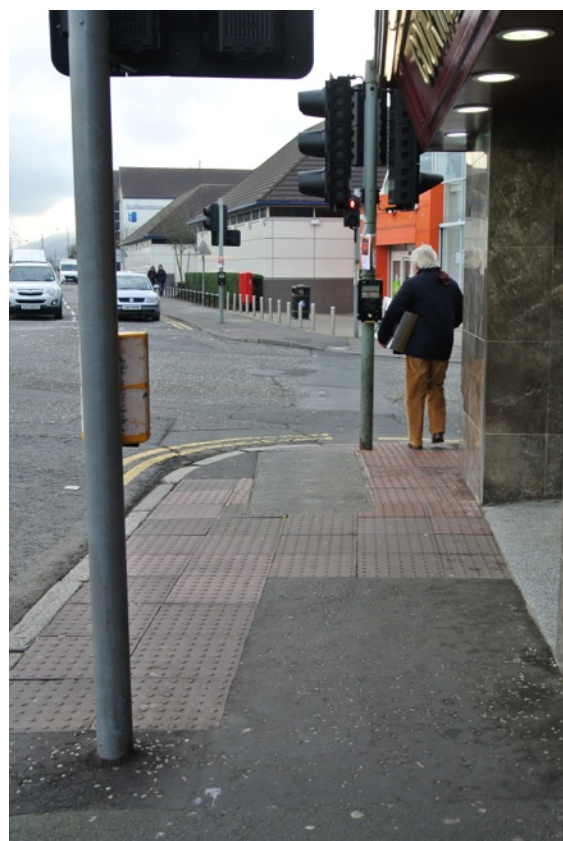
- 40 At this junction there is controlled crossing. This junction has some of the poorest quality provision for pedestrians ever encountered by Imtac. Issues include the absence of appropriate tactile paving or dropped kerb provision, the inappropriate use of tactile paving, the inappropriate location of control boxes and poles and the absence of tactile rotating cones. The junction is in urgent need of improvement as current provision for pedestrians is wholly inadequate and for some disabled people and older people hazardous.

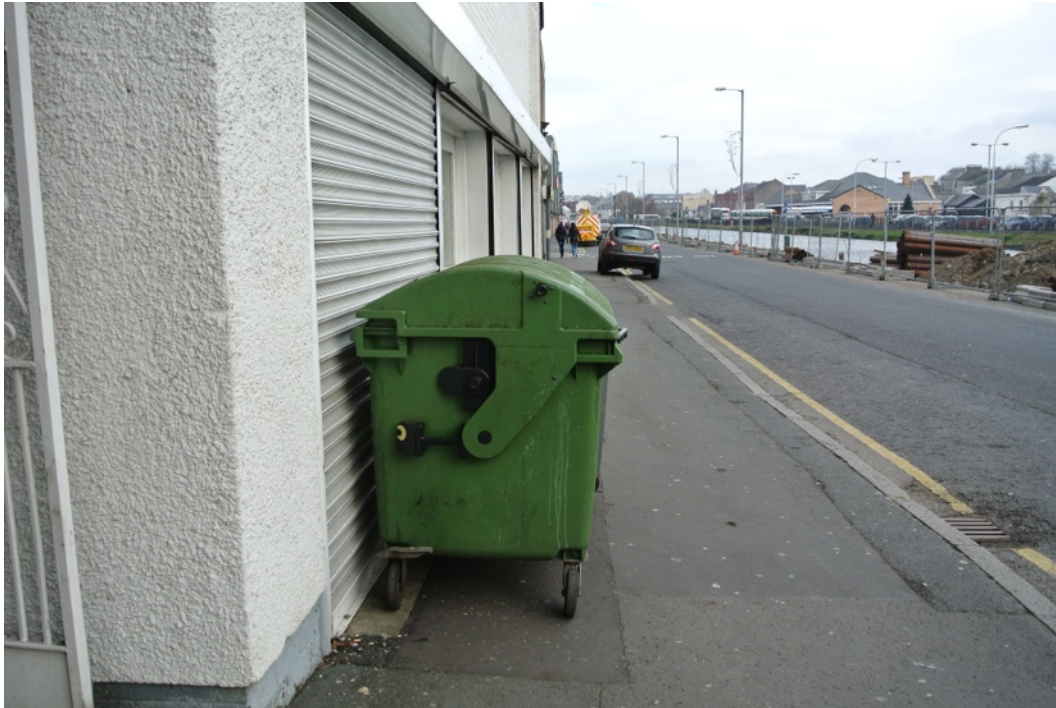
41 Bins create obstructions on the pavement.

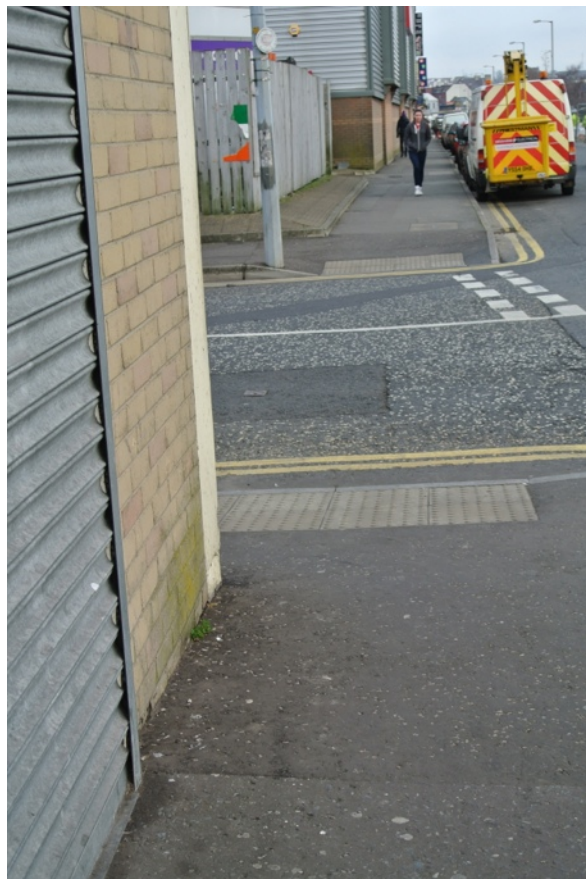
42 There is a good example of an in-line uncontrolled crossing at the junction leading to Cornmarket.

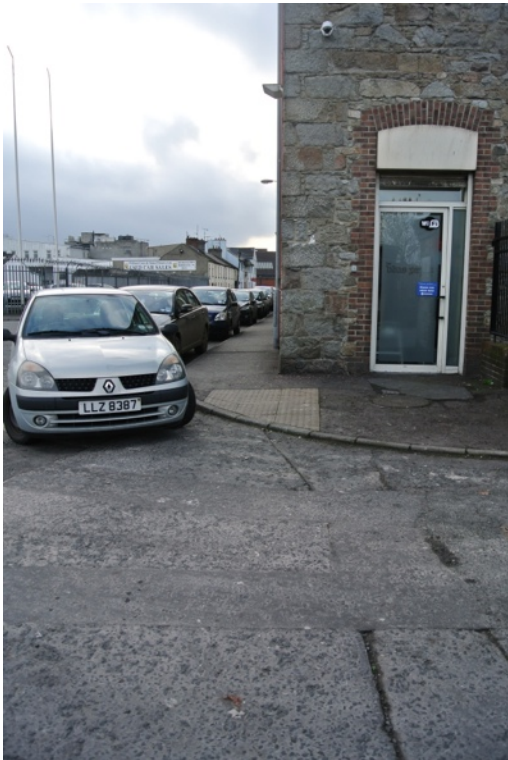
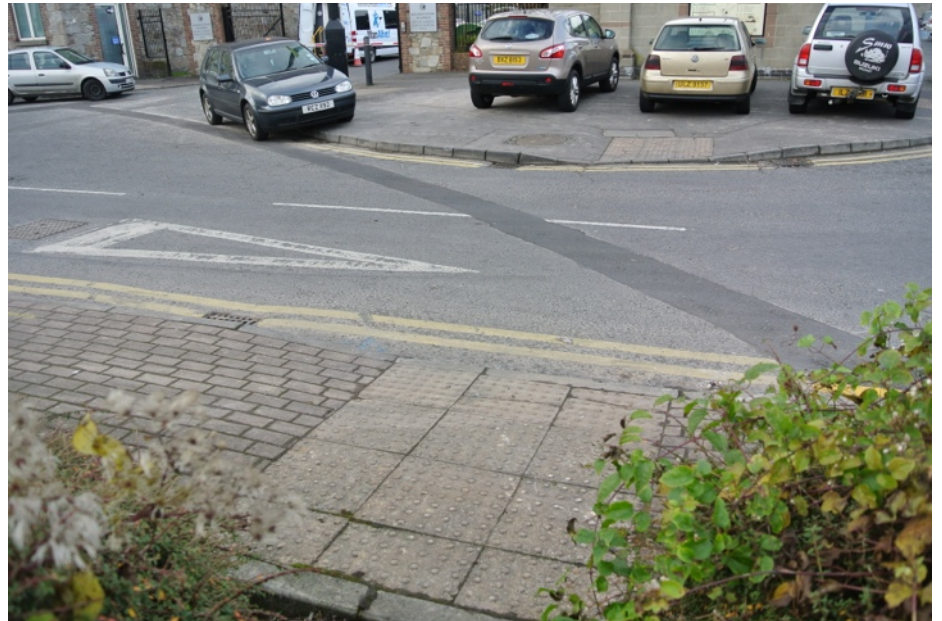
- 43 Parked cars restrict access to dropped kerb provision at the roundabout at Cornmarket. Tactile paving has been damaged by parked vehicles.

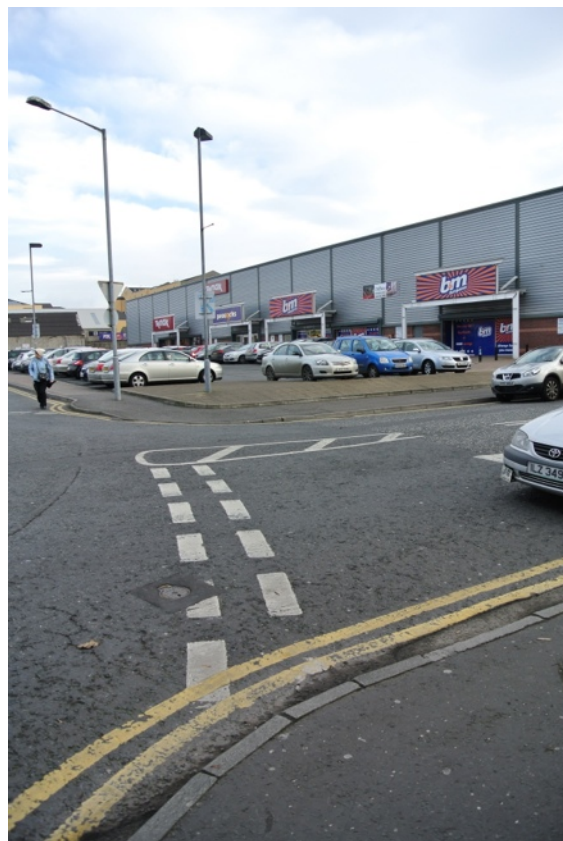
- 44 There is no appropriate access across road to the retail park approaching the Cornmarket roundabout. The pedestrian route through the retail park is difficult.

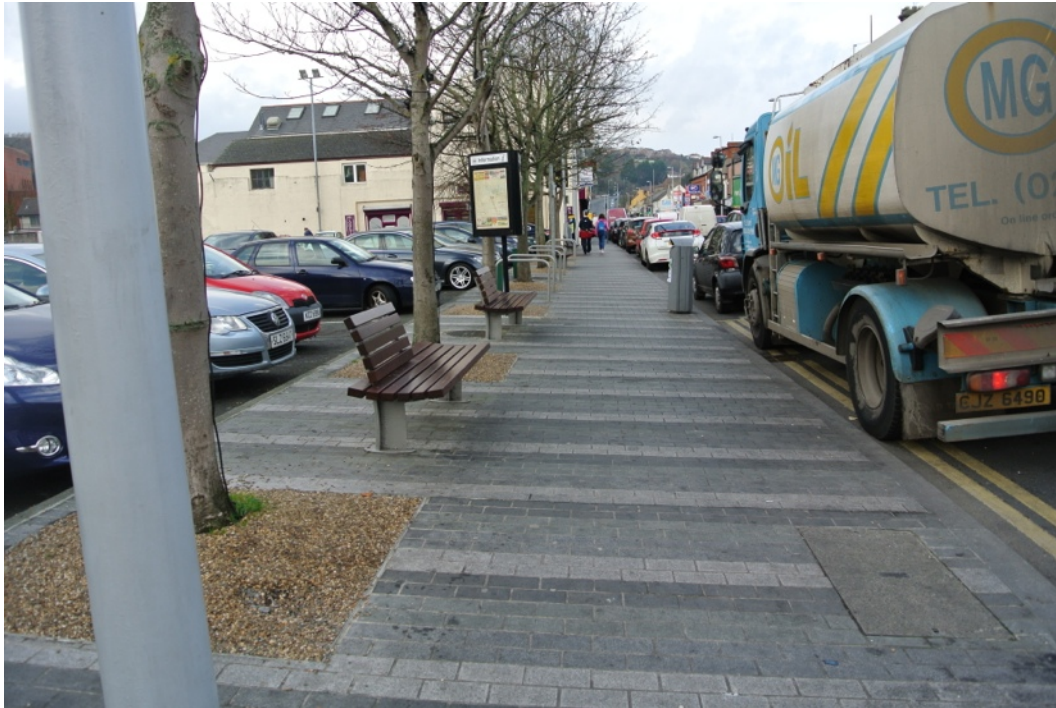
- 47 The walking surface on the pavement on the southern side of Monaghan Street is broad, high quality and furniture has been located in a single line.

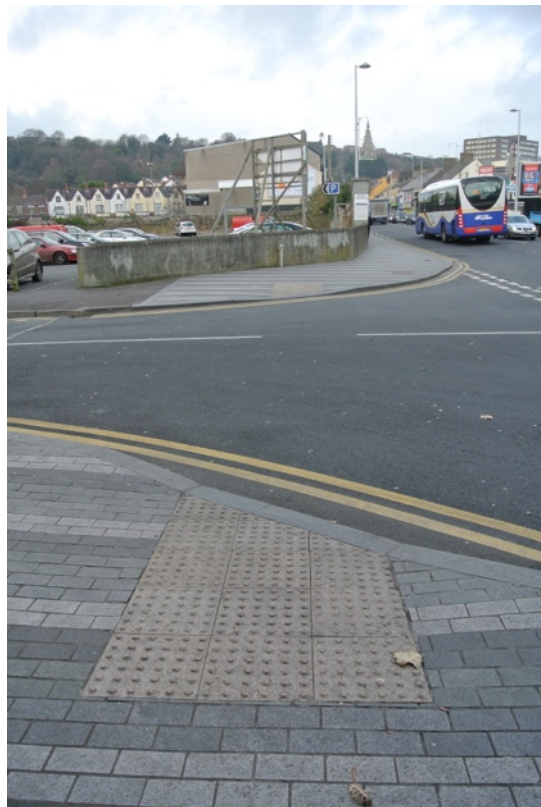
- 48 There is a good example of an in-line uncontrolled crossing across the next junction on the southern side of Monaghan Street.

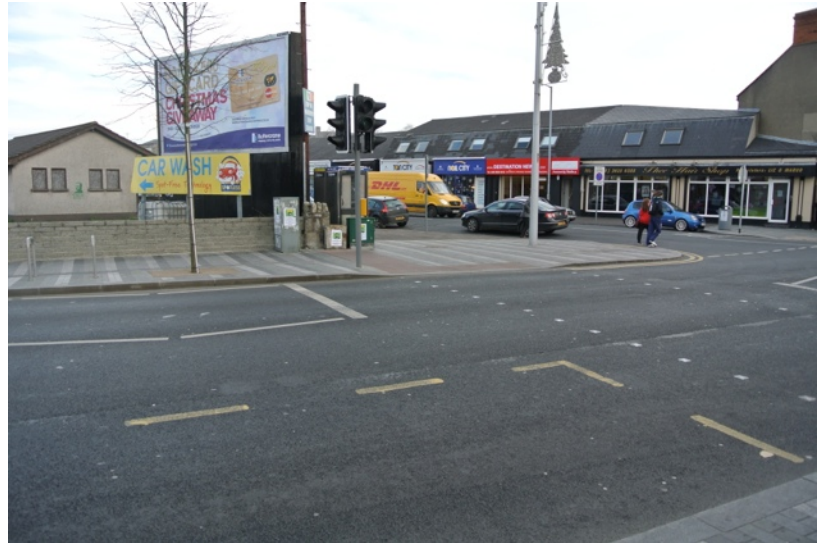
- 49 There is a good example of controlled pedestrian crossing close to the junction with Railway Avenue and Monaghan Street.

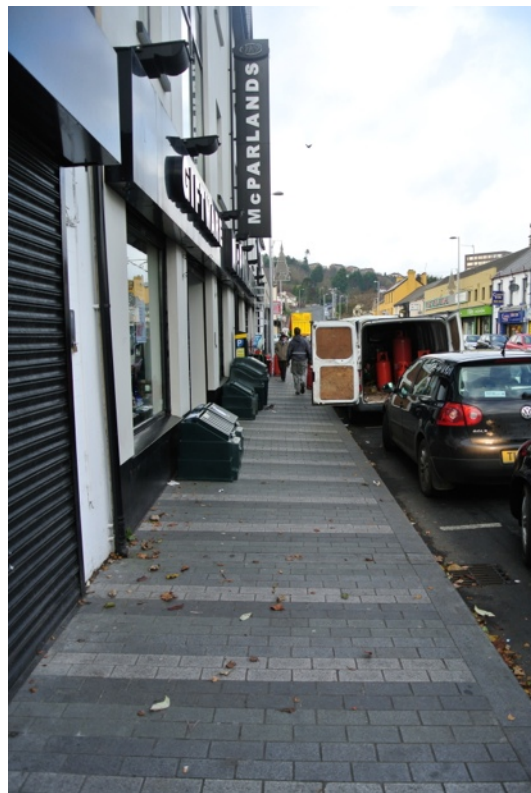
- 50 Continuing in a westerly direction on the southside of Monaghan Street shop displays restrict pavement widths.

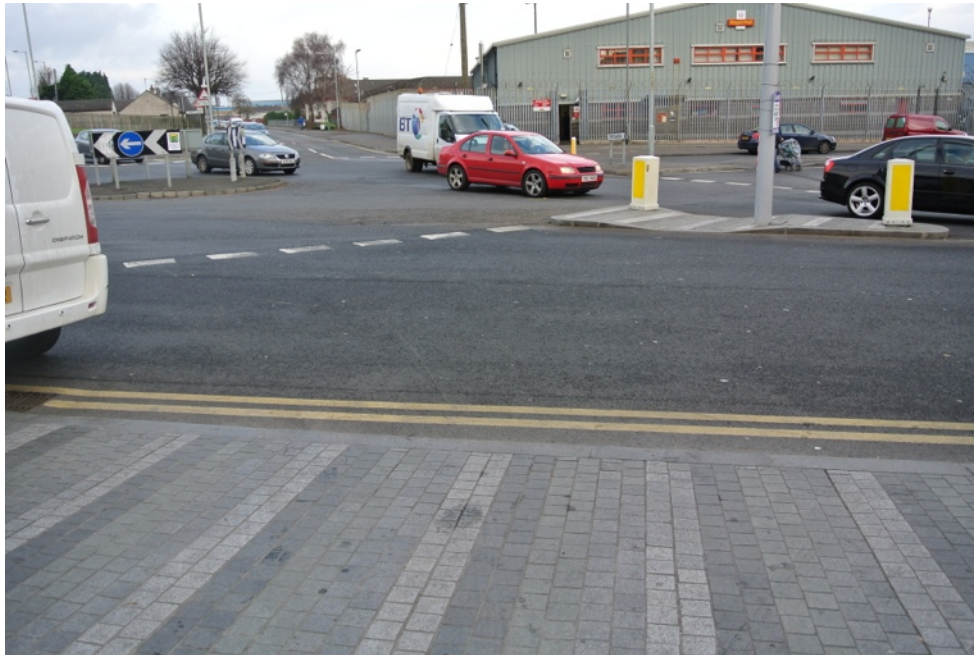
- 53 There is an opportunity to cross Monaghan Street approaching its junction with the roundabout. Whilst there are dropped kerbs no tactile paving has been provided.

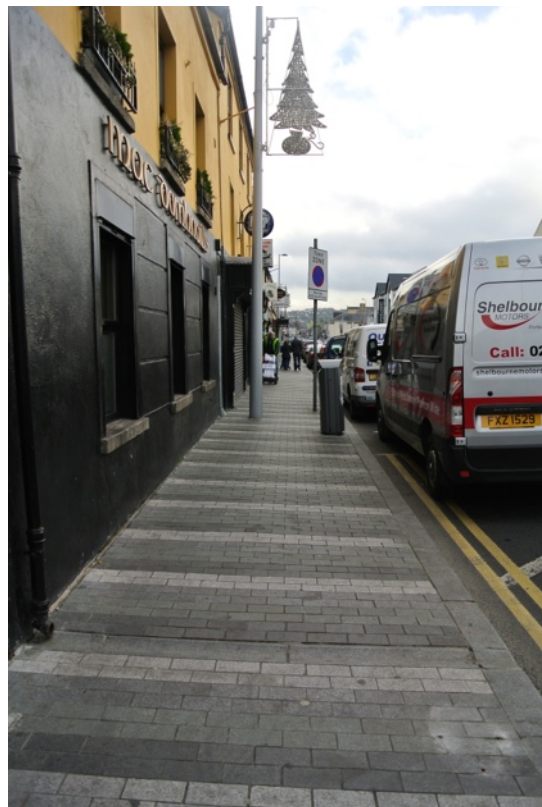
- 54 On the northern side of Monaghan Street there are examples of inconsistencies in the placement of street furniture. This creates additional obstacles and restricts good pavement width.

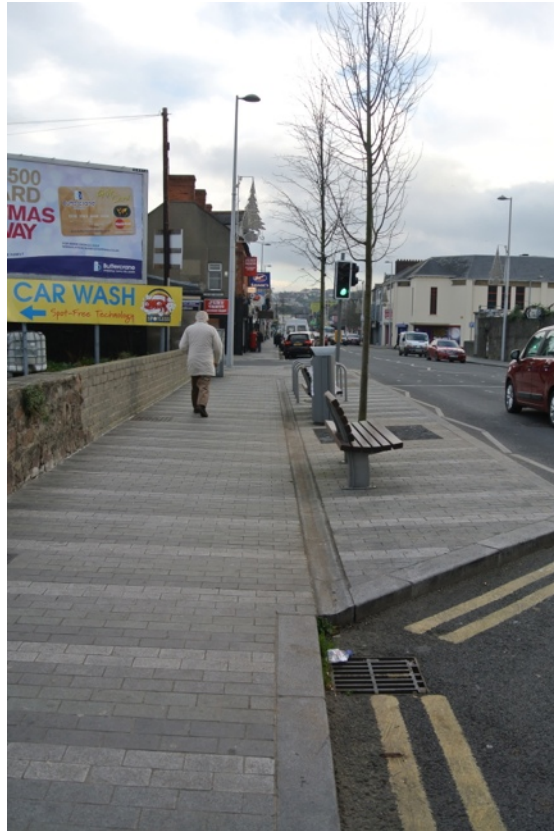
- 55 Further up the northern side of Monaghan Street furniture is better located providing a clutter free pedestrian route.

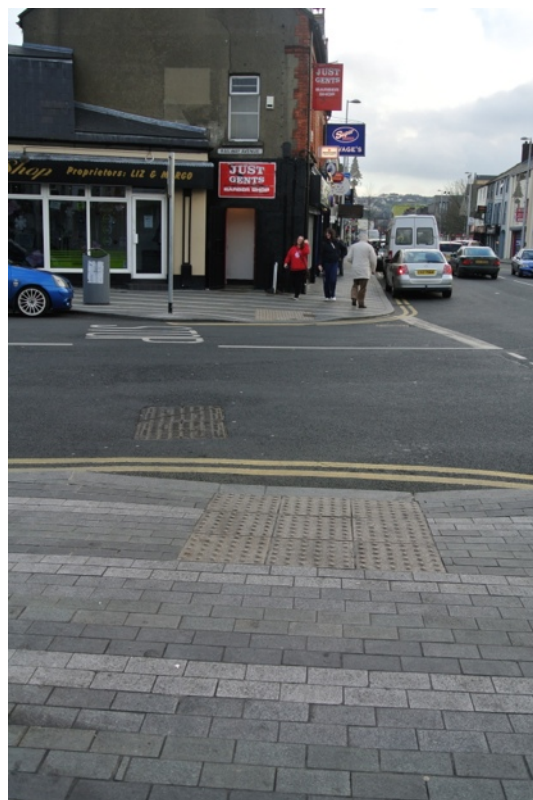
- 56 There is a good example of an in-line uncontrolled crossing at the junction with Railway Avenue.

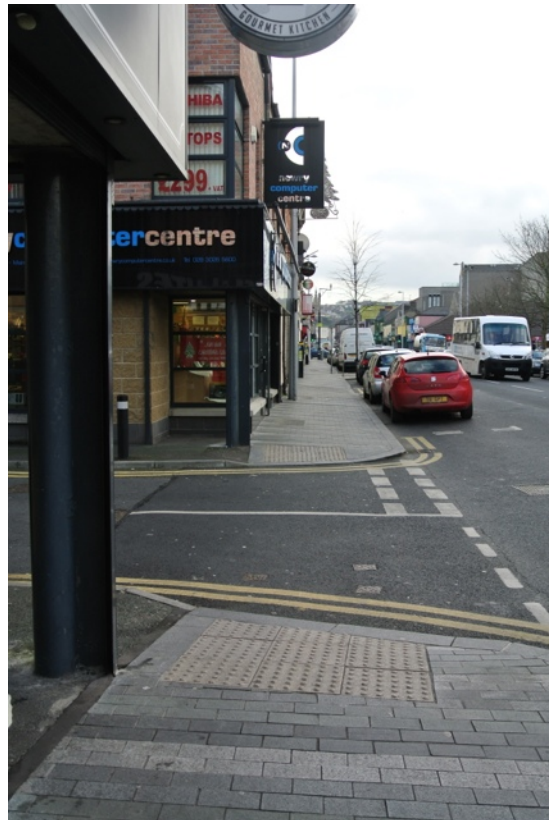
- 57 There is another good example of an inline uncontrolled crossing at the vehicle entrance further down the north side of Monaghan Street.

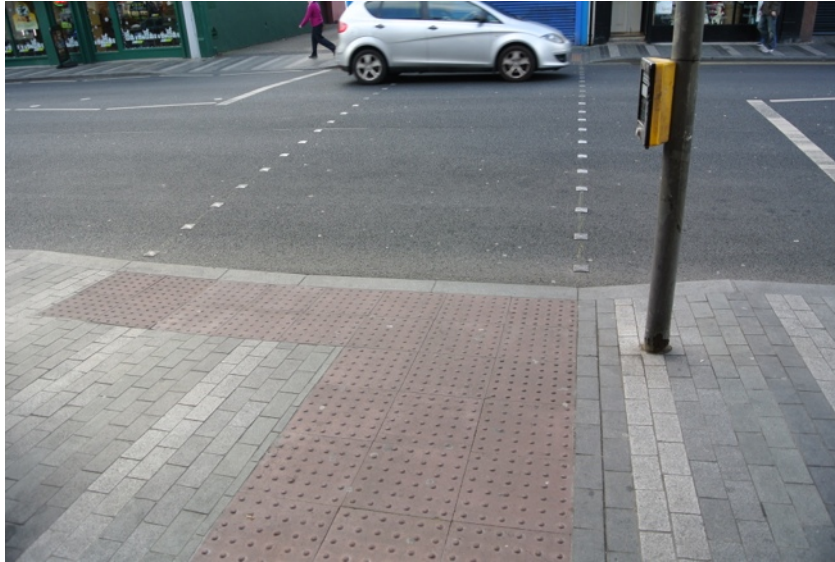
- 59 There is a reasonable example of a controlled pedestrian crossing just after the Kilmorey Street junction. Whilst the paving has been renewed and correctly installed the signals have not and have no tactile rotating cones.

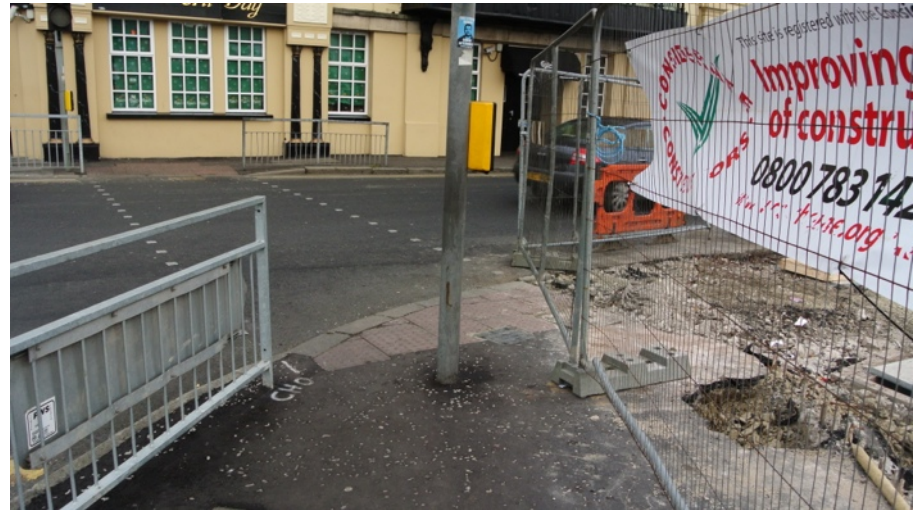
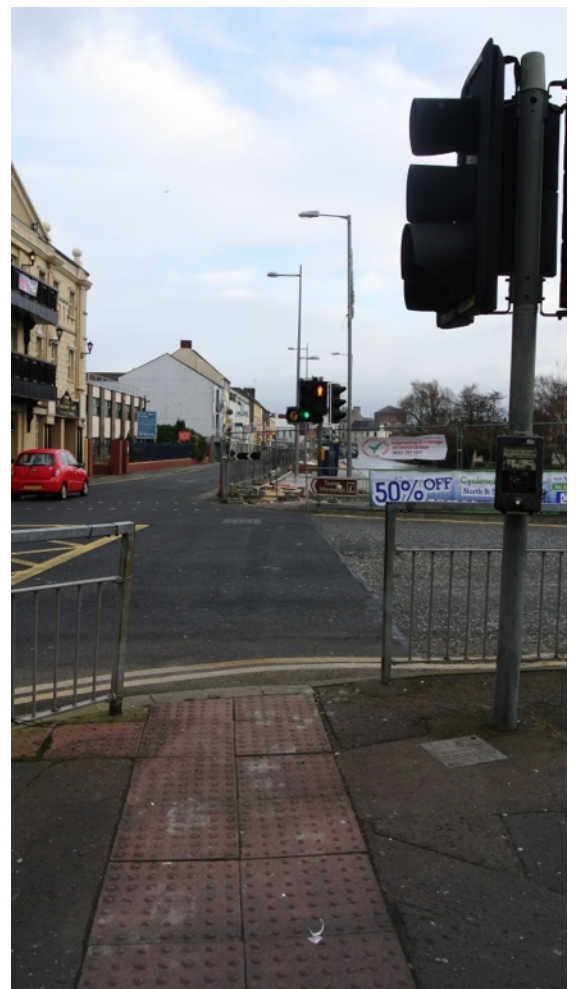
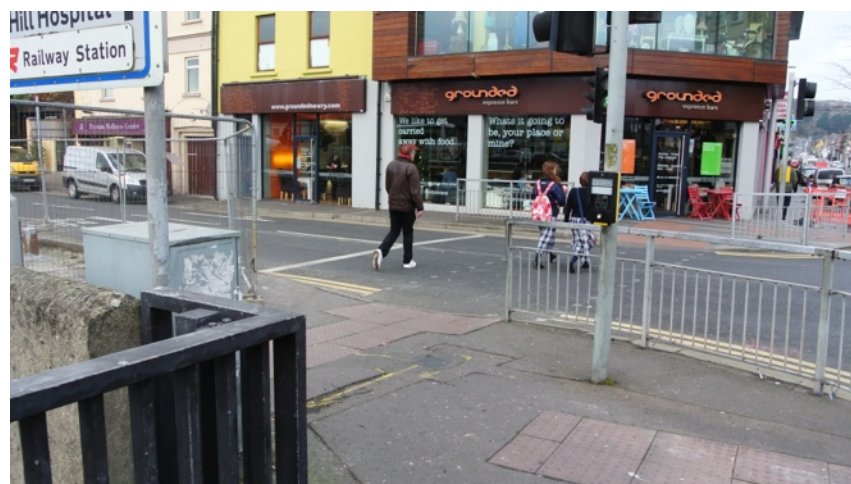
- 63 There are further controlled crossings across Merchant Quay and across Margaret Street. The provision at these crossings is very poor with inappropriate use of tactile paving, poor locations for control boxes and no rotating tactile cones. There are public realm improvements in the vicinity so it would be hoped that problems with the pedestrian facilities will be addressed.

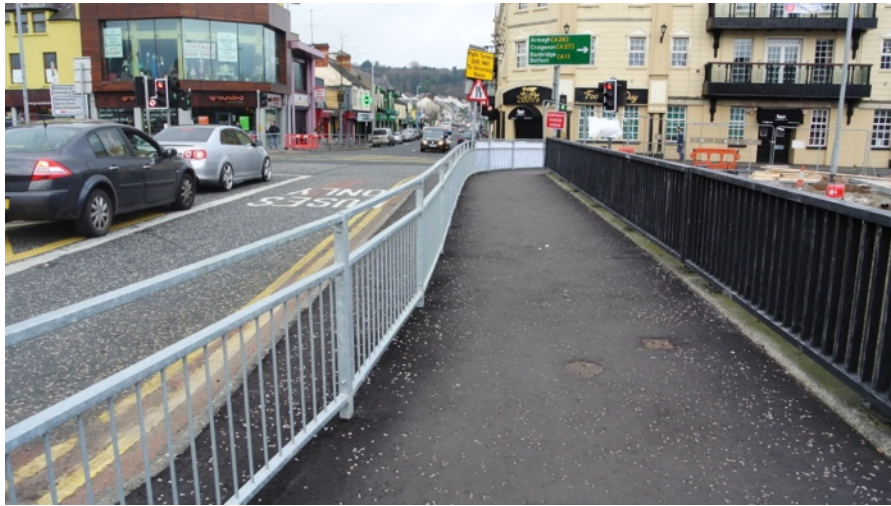
- 64 Pedestrians on Margaret Street are “corralled” by extensive railings in the approaches to the junction. This reinforces the perception that this junction is not a safe place for pedestrians.

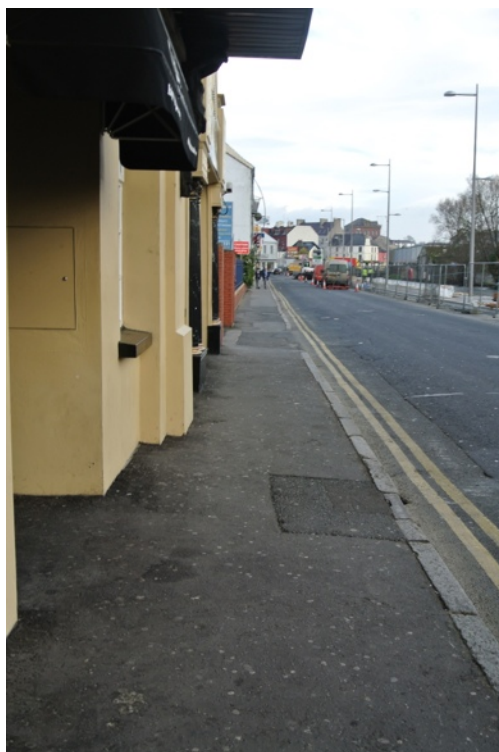
- 65 The eastern side of this section of Merchants Quay is currently undergoing public realm improvements. This will hopefully improve what is currently a poor pedestrian environment. The pavement on the western side of Merchants Quay here is narrow and in poor condition in places.

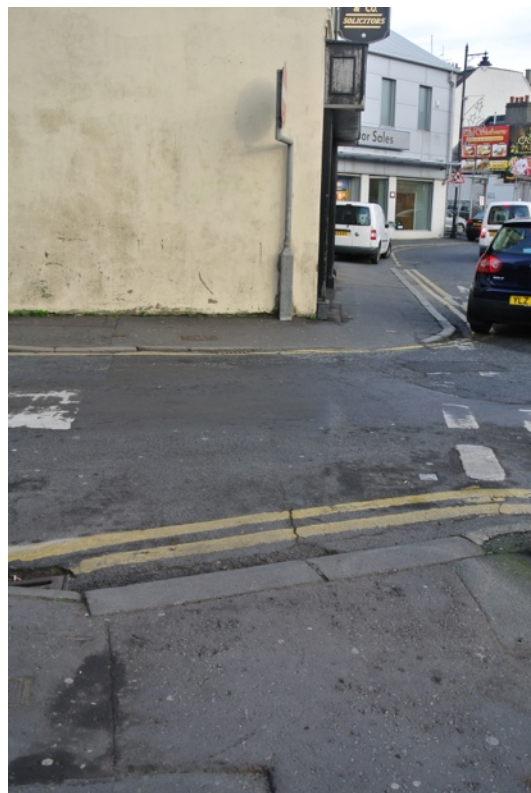
- 67 At the busy junction with Edward Street there are dropped kerbs but no tactile paving.

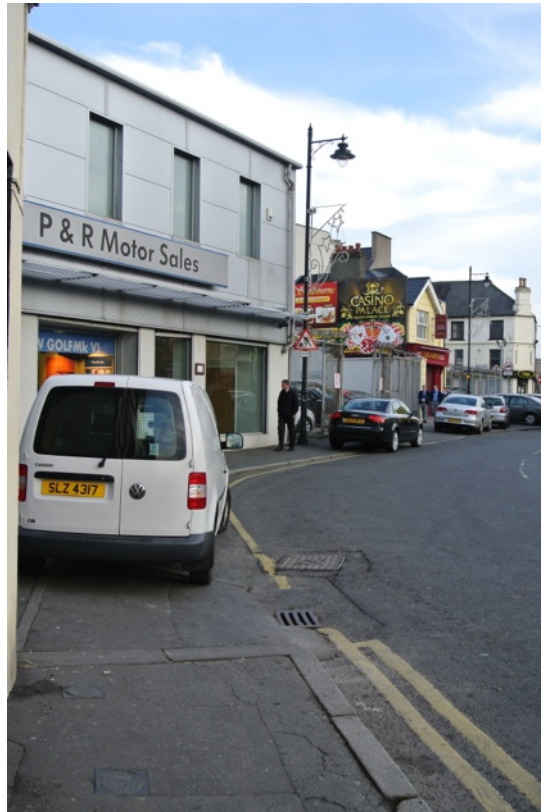
68 Cars block the pavement around a car showroom.

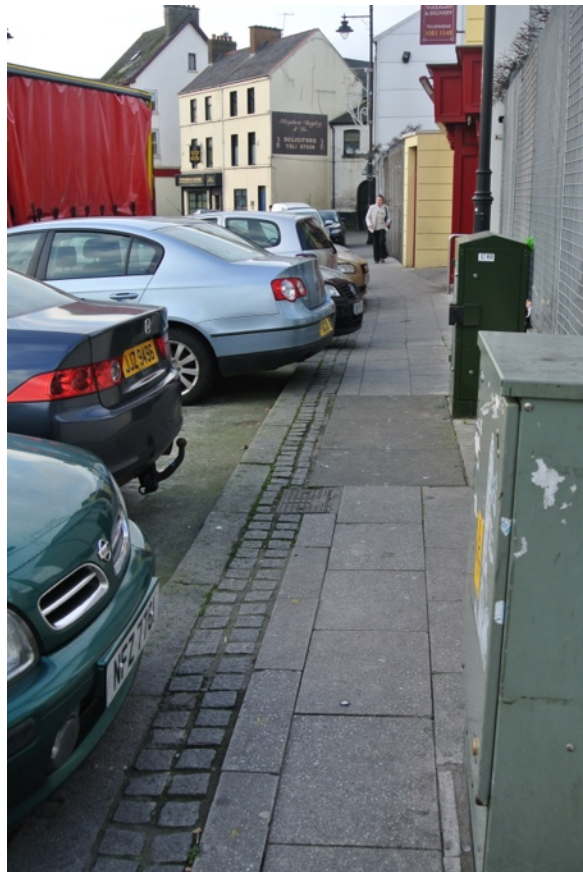
69 Parked cars extend onto the pavement creating a series of obstacles on what is already a narrow footway which is further restricted by utility equipment.

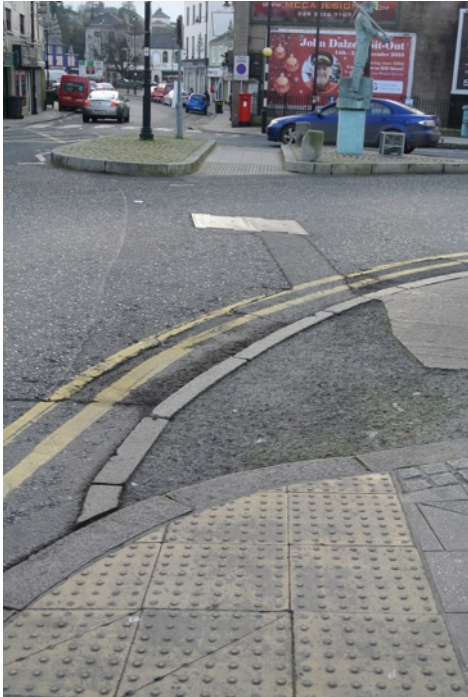
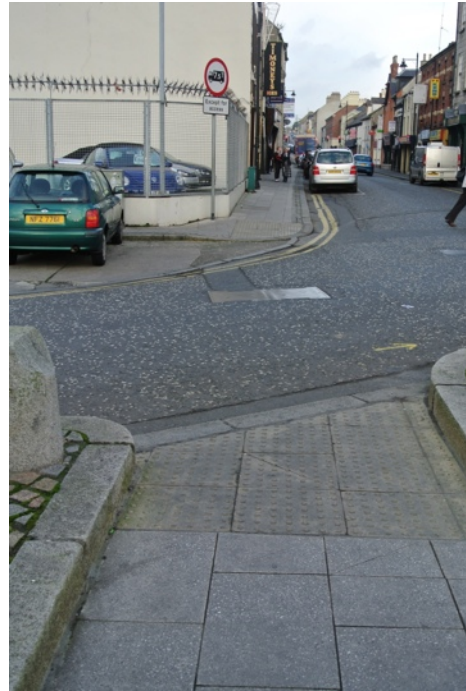
- 70 There is a non-standard in-line controlled crossing at the junction of Merchants Quay and Sugar Island. The tactile paving on the northern side of the road do not appear to lead to the end of the pavement which is narrower than the tactile. This is confusing and potentially hazardous for people with a visual impairment.

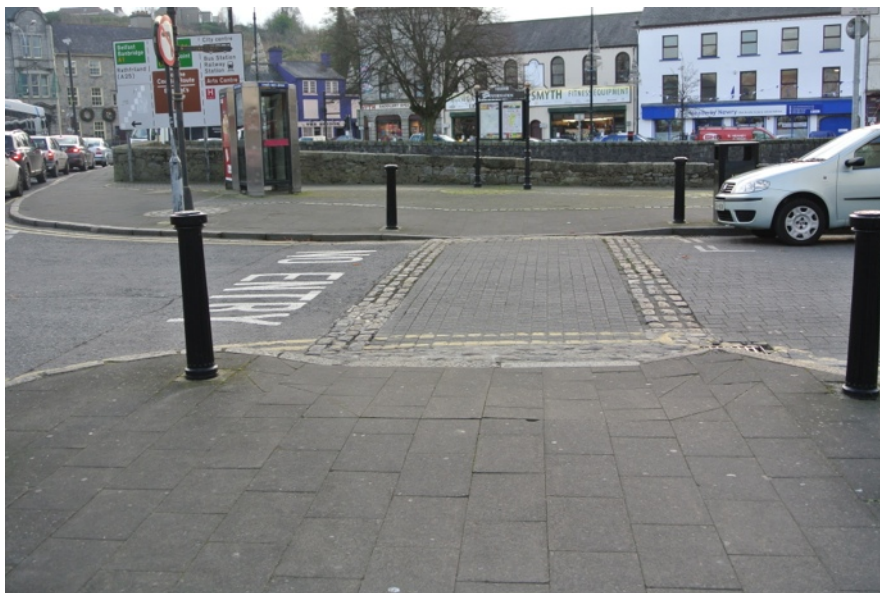
- 73 There is a broad raised in-line uncontrolled crossing around the junction between Bank Parade and Sugar Island. No tactile paving is provided.

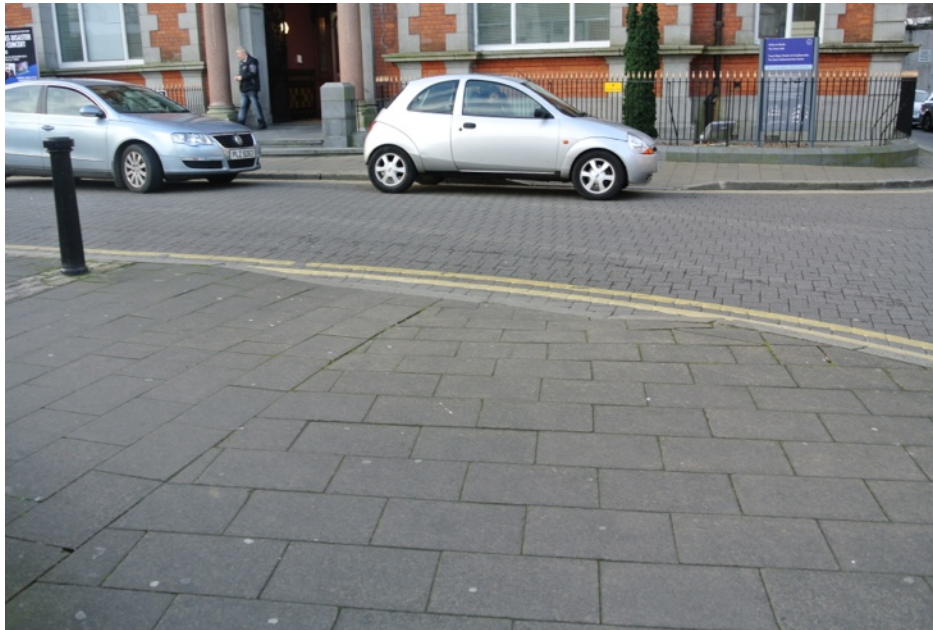
- 74 There is a further crossing opportunity outside the entrance to the Council offices. Again no tactile paving has been provided. Parked cars block one side.

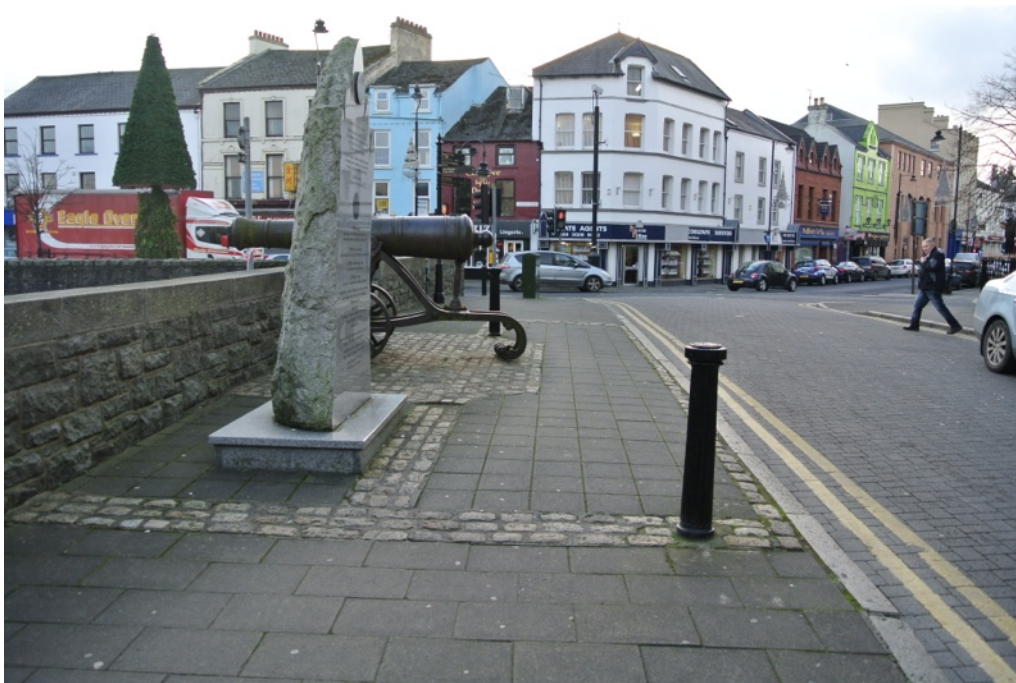
- 75 Unmarked bollards opposite the Council Office restrict pavement width and represent a potential obstacle as does the carriage of the cannon.

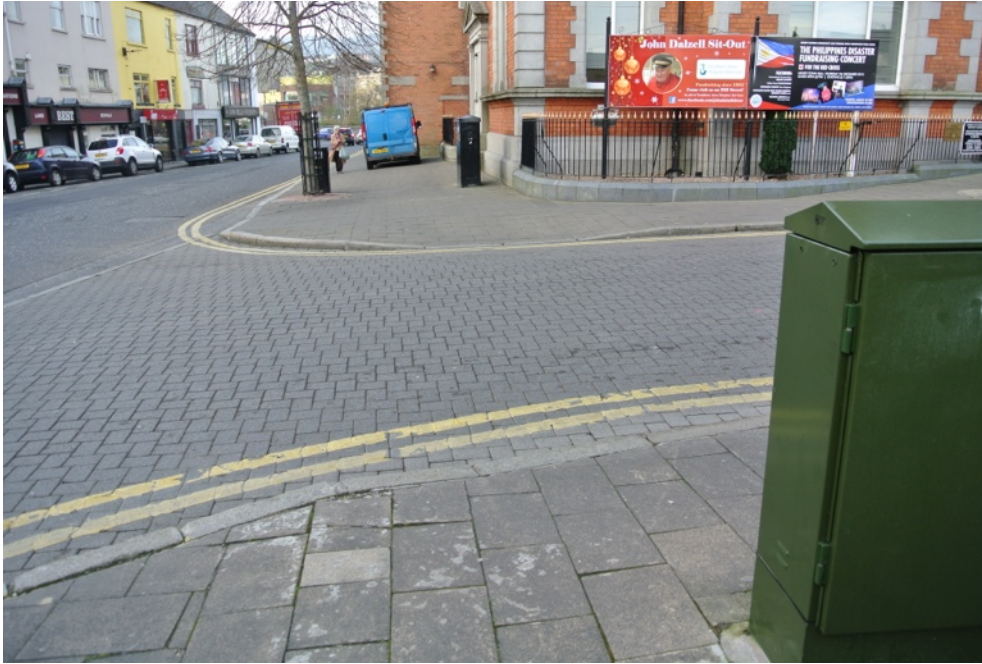
- 76 An in-line uncontrolled crossing opportunity is provided close to the junction with Kildare Street. The kerbs have been dropped but no tactile paving has been provided.
