Report on Walking routes in Omagh Town Centre

October 2013

The report was compiled following an inspection of Omagh in August 2013. It considers the provision of pedestrian facilities in the town measured against accepted accessibility standards<sup>1</sup>. The report identifies potential barriers for disabled people and older people and recommends how these barriers could be resolved. The report also highlights examples of good practice. A key aspect of the report is linkage between the pedestrian environment and the bus station in Omagh. We have produced two reports, a text only version and a version with photographs used to highlight barriers and good practice.

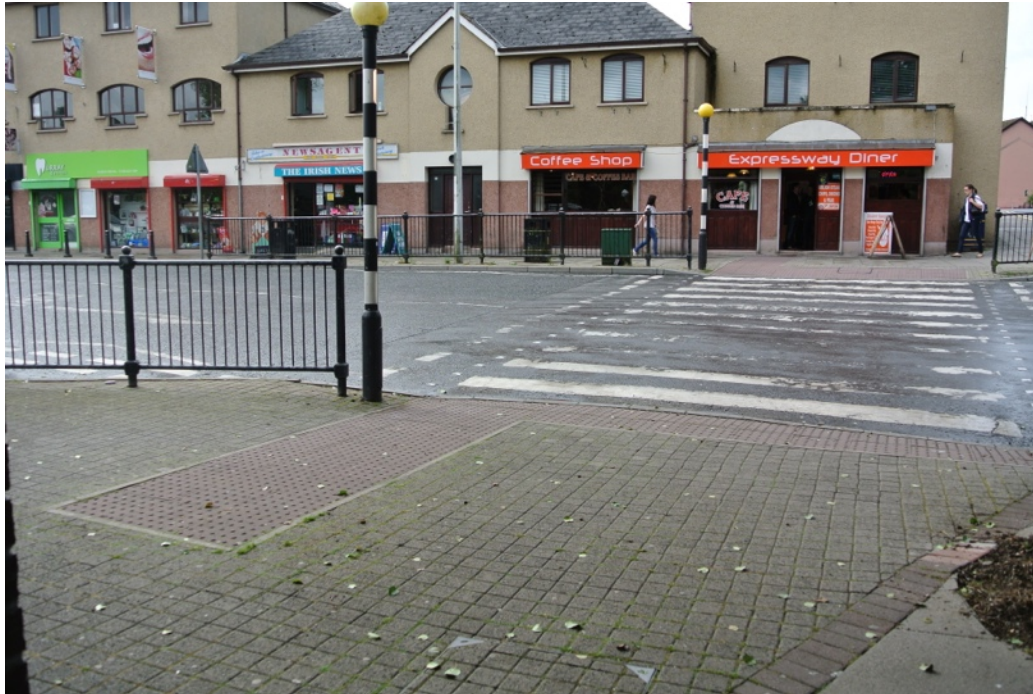
- 1 There is a good example of a Zebra crossing at the entrance/exit to the bus station on Mountjoy Road.

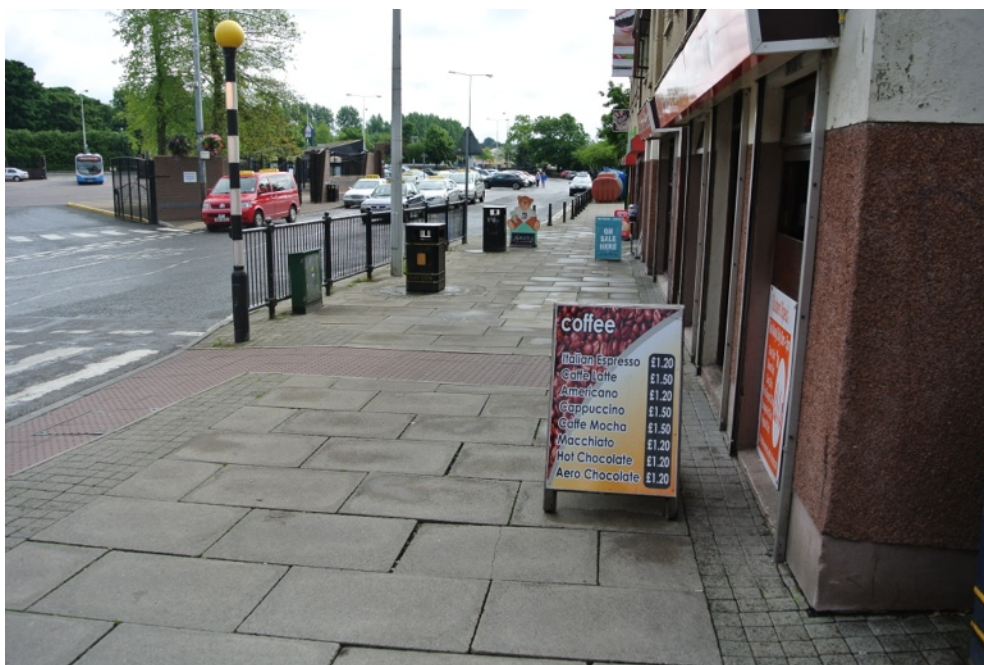
- 2 A-boards present potential hazards on the pavement across the road from the bus station.

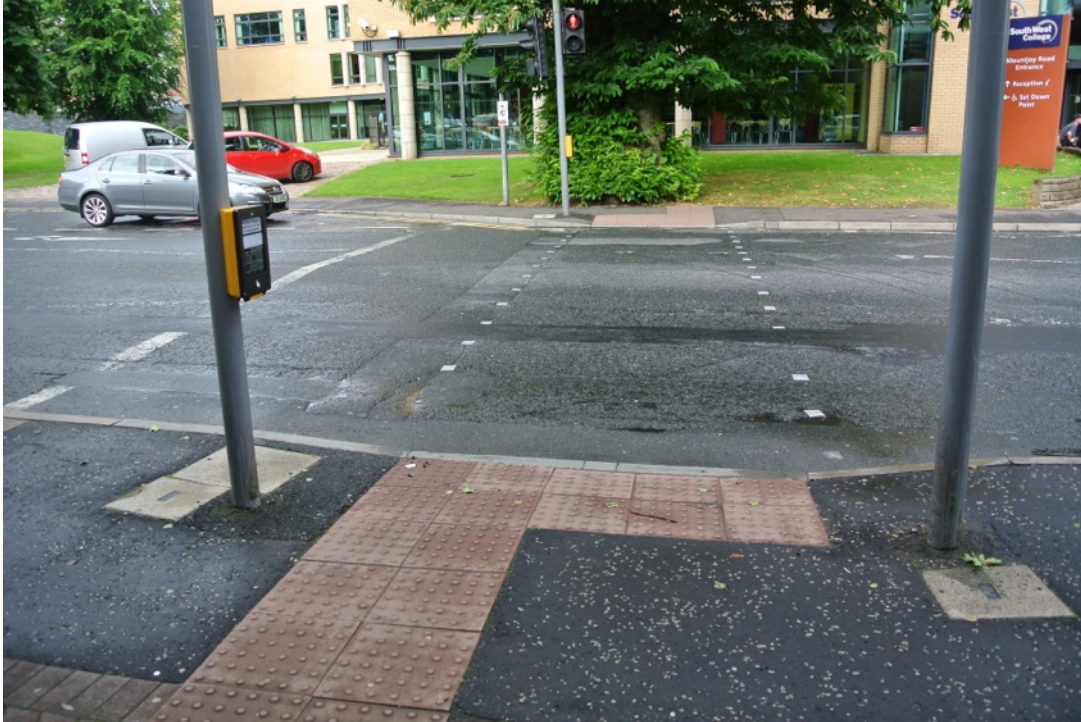
- 3 There is a controlled crossing at the entrance to the bus station on Bridge Street. The tactile paving and control boxes are incorrectly installed.

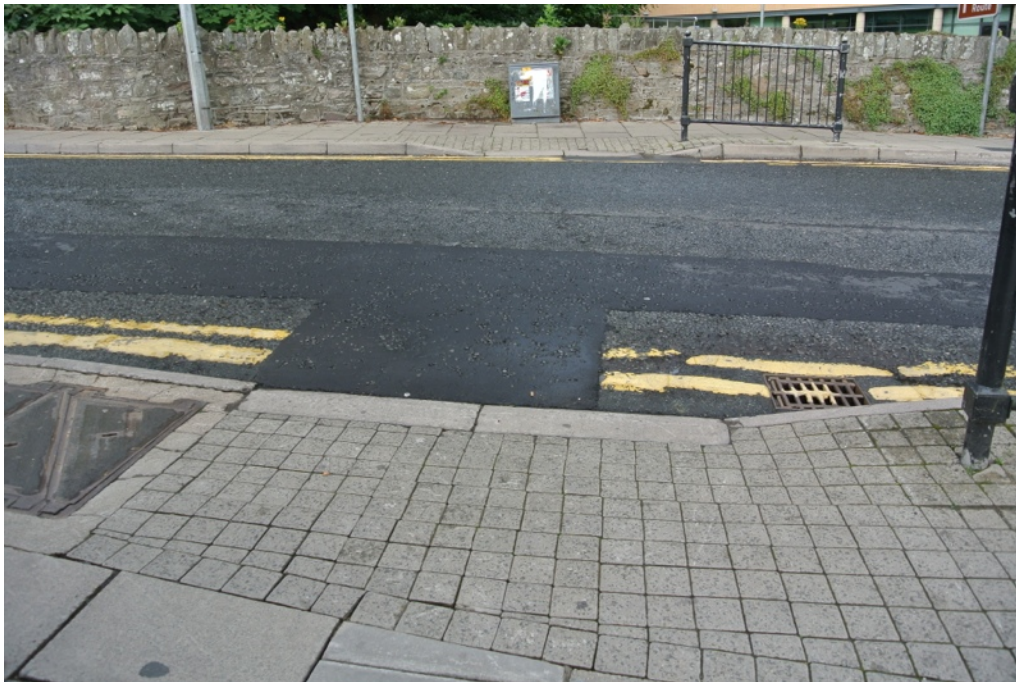
- 4 There are dropped kerbs along Bridge Street towards the town centre. However no tactile paving has been provided.

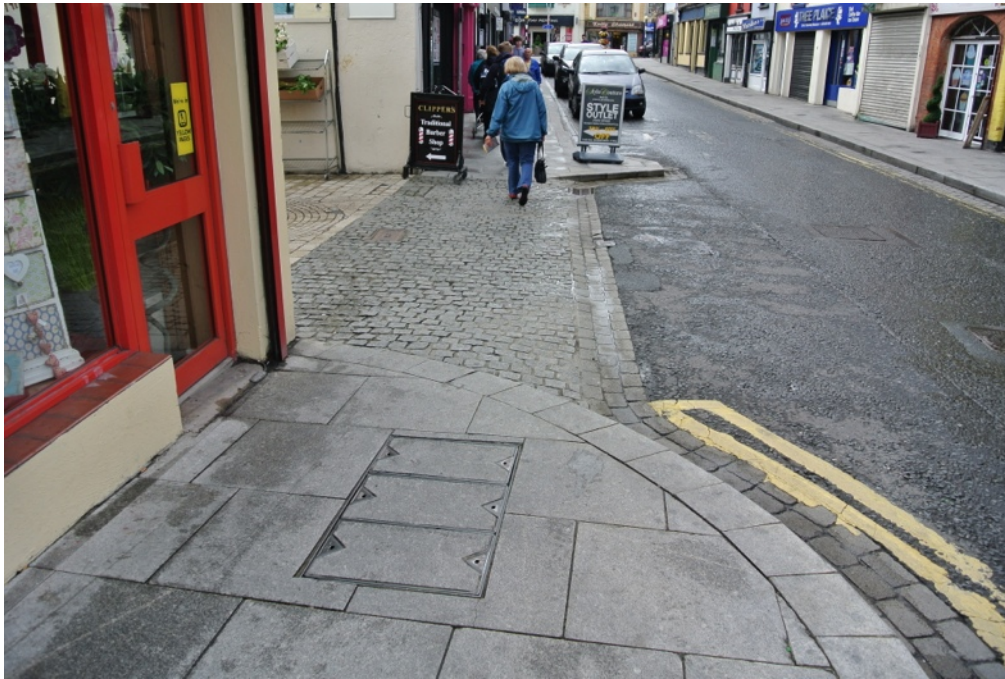
- 5 Over the bridge there is an entrance to Market Square on the eastern pavement. Although the pavement is flush with the entrance, tactile paving should be provided as a warning of potential vehicle movements in the area.

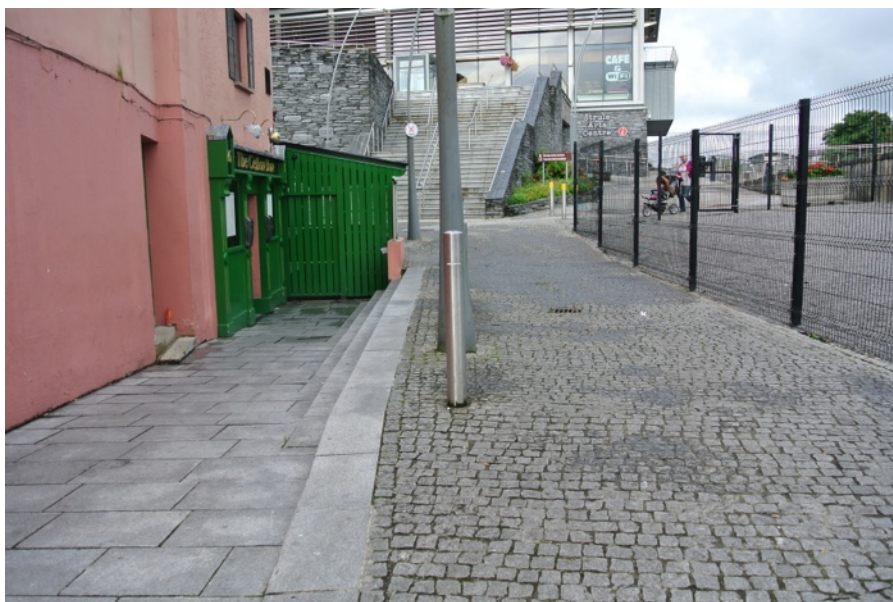
- 6 On the western pavement there is a pedestrian entrance to the Strule Arts Centre. The types of paving materials used are not ideal for some disabled people including wheelchair users. Bollards and lighting columns have no clear visibility strip and present a hazard to people with a visual impairment as do steps in the area that have no corduroy hazard paving to indicate their presence.

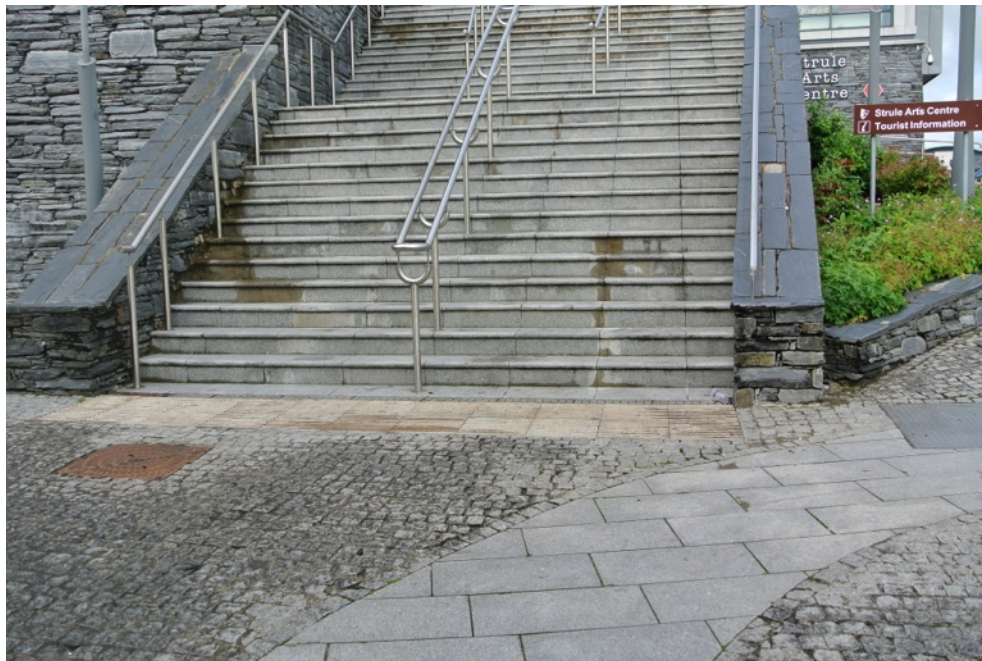
- 7 Stepped access to the Arts Centre does include corduroy hazard paving.

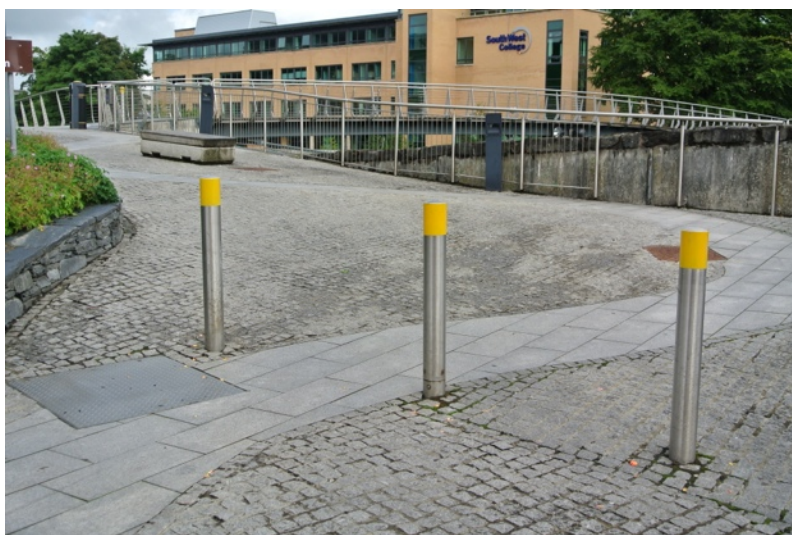
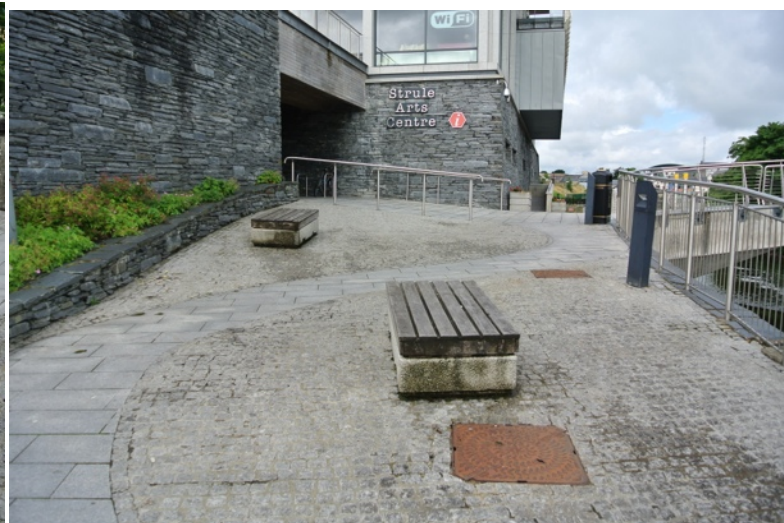
- 8 There is a level and flat alternative walking route to the Arts Centre and bollards in the area have a strong visibility band. However other surfaces and seating in the area are not ideal for some disabled people.

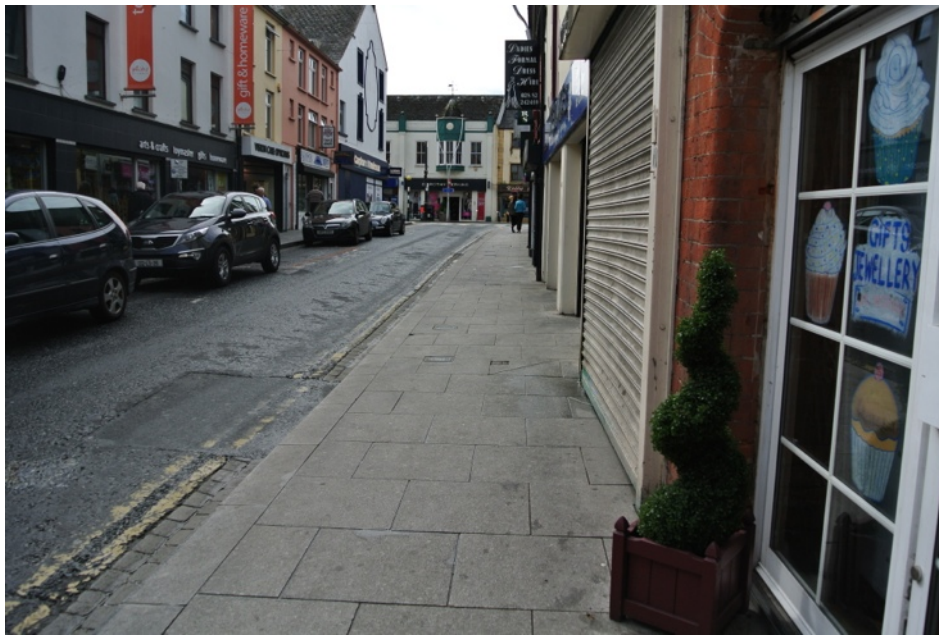
- 9 The pavement along the remainder of Bridge Street towards High Street is of good quality and free of obstruction.

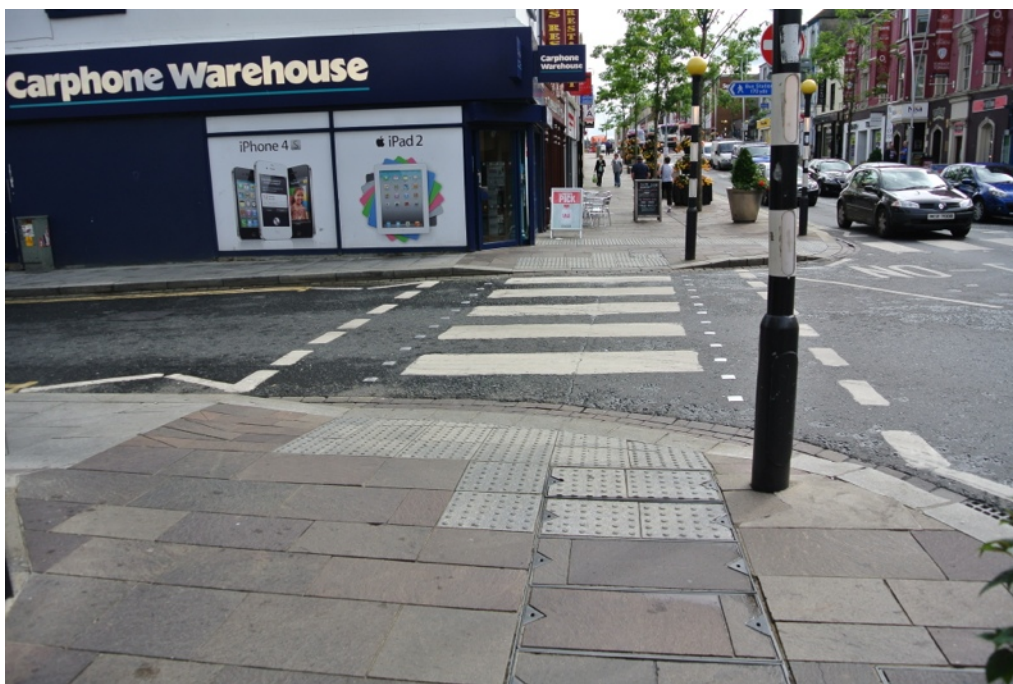
- 10 There is a zebra crossing at the end of Bridge Street with the junction of High Street. Non-standard tactile paving has been used.

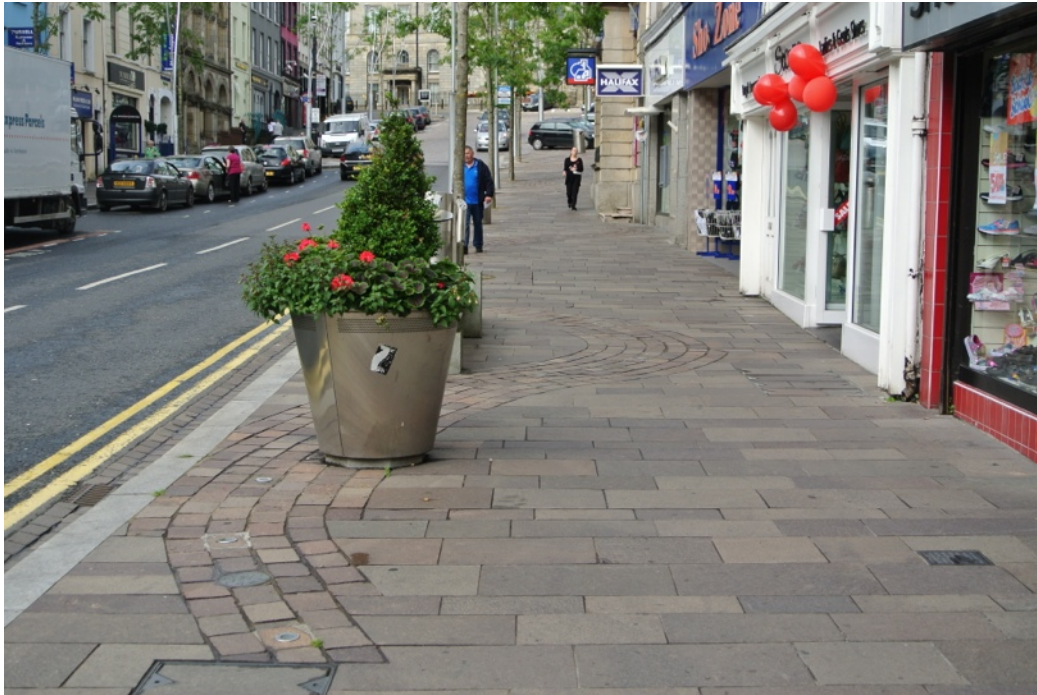
- 11 The pavement on the northern side of High Street (towards the courthouse) is of good quality and width. Street furniture has been placed in a line towards the kerb.

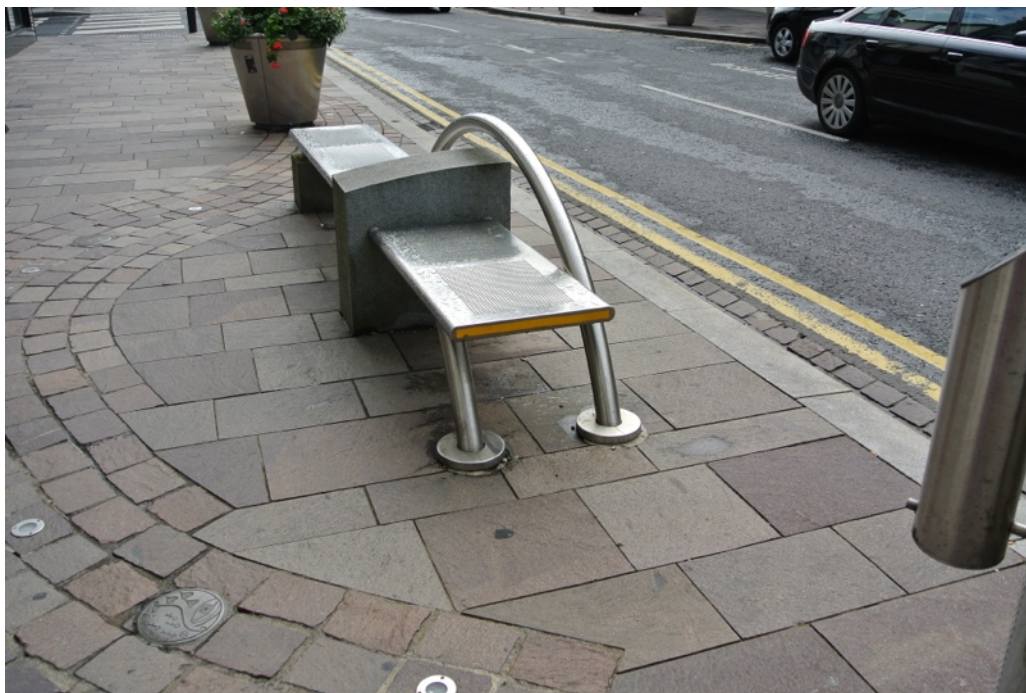
- 12 Efforts have been made to make the chrome materials used for seating more visible.

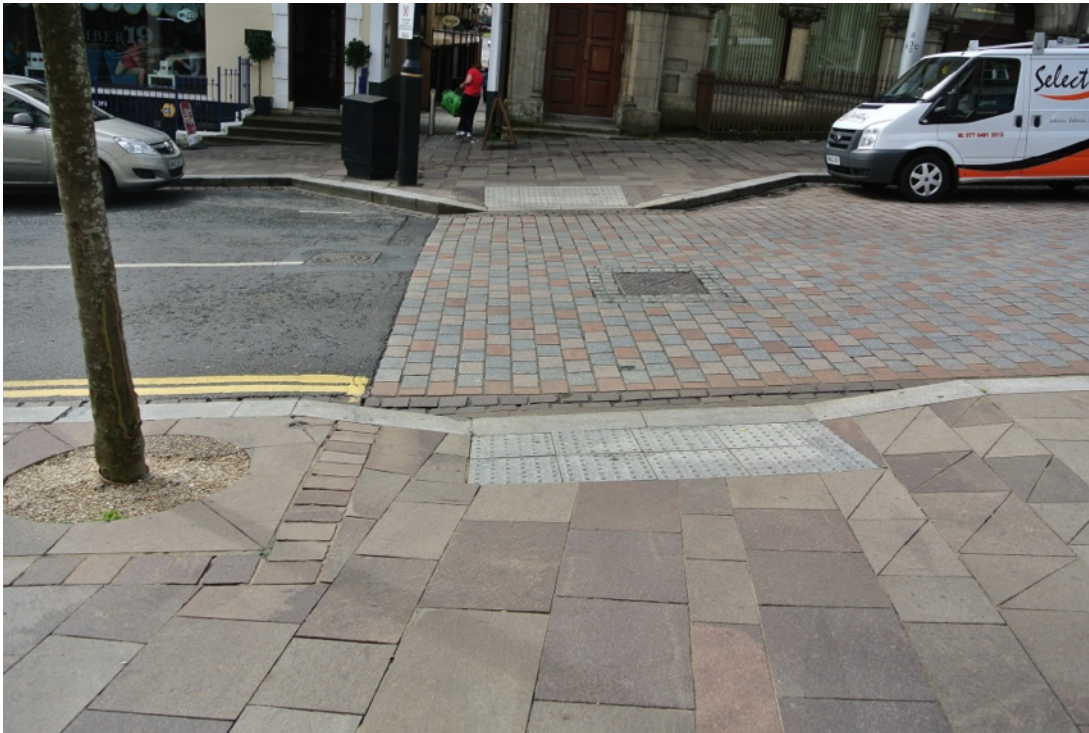
- 13 There is a good example of an in-line uncontrolled crossing across High Street. Non-standard tactile paving has been used.

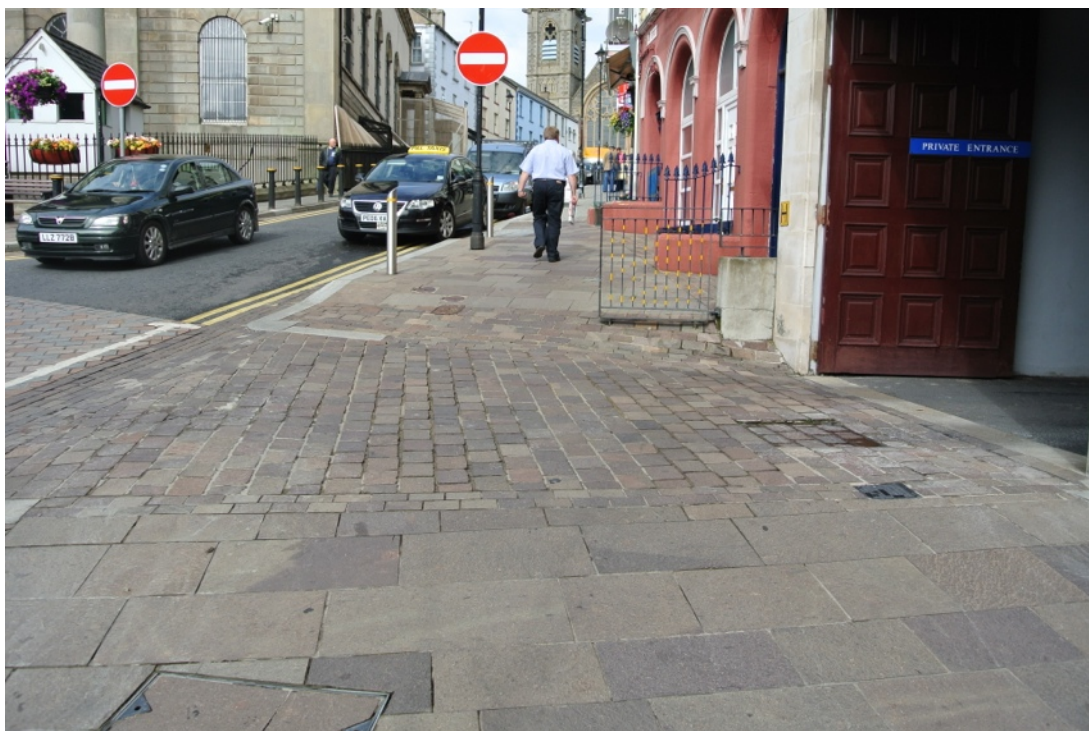
- 14 Vehicle entrances give pedestrians priority.

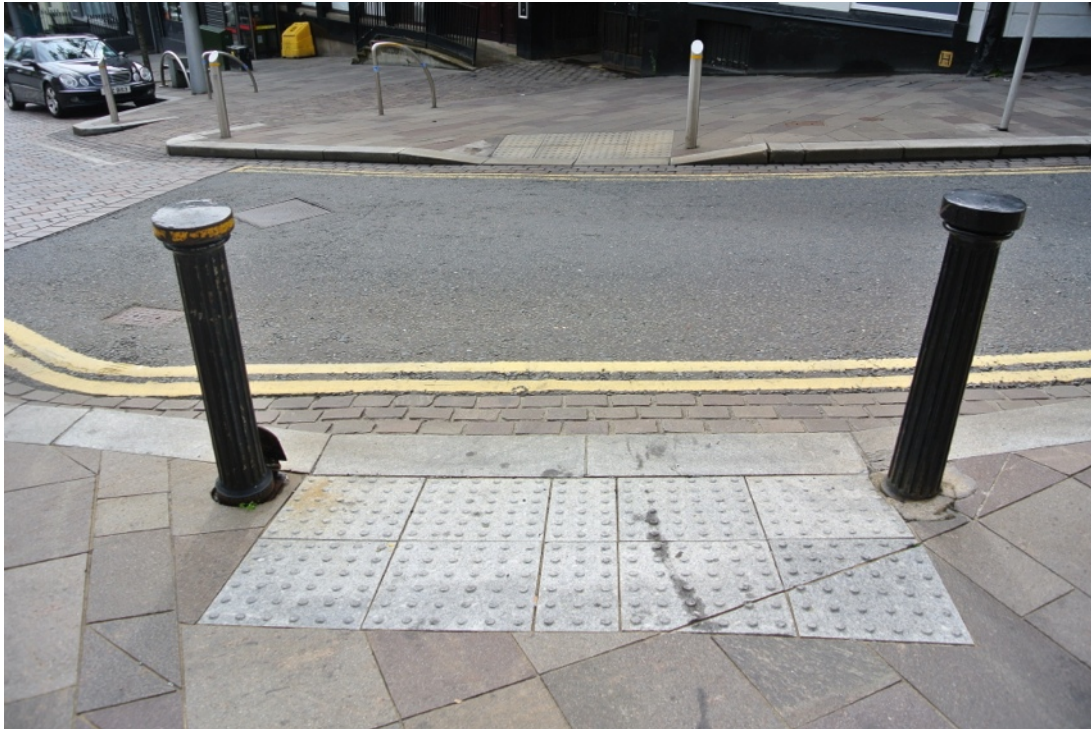
- 15 There is an uncontrolled crossing across High Street outside the Courthouse. Bollards on the Courthouse side require a stronger visibility strip.

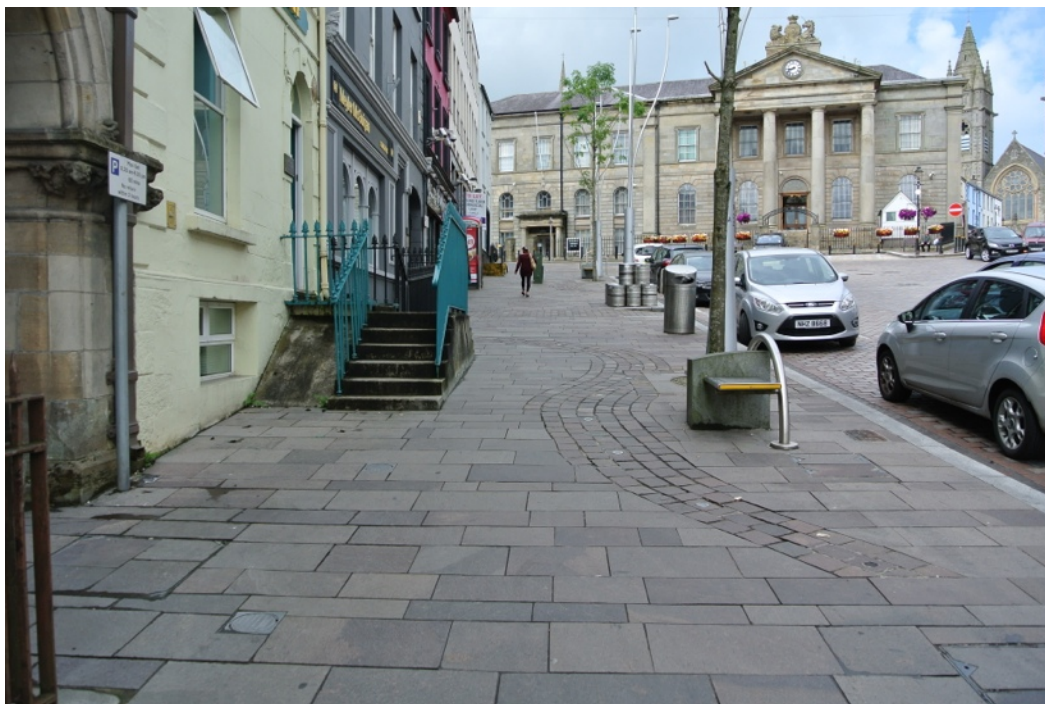
- 16 On the Southern side of High Street (near the Courthouse) the pavement is of good quality with furniture in a line.

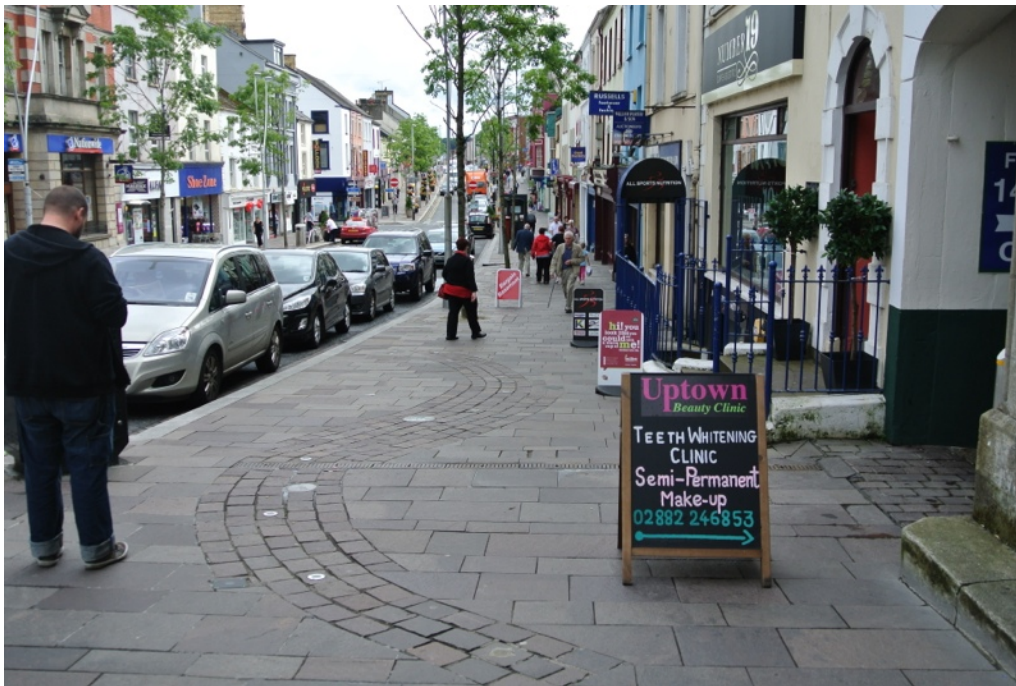
- 17 A-boards and clutter increasingly become a problem on the southern pavement approaching the town centre.

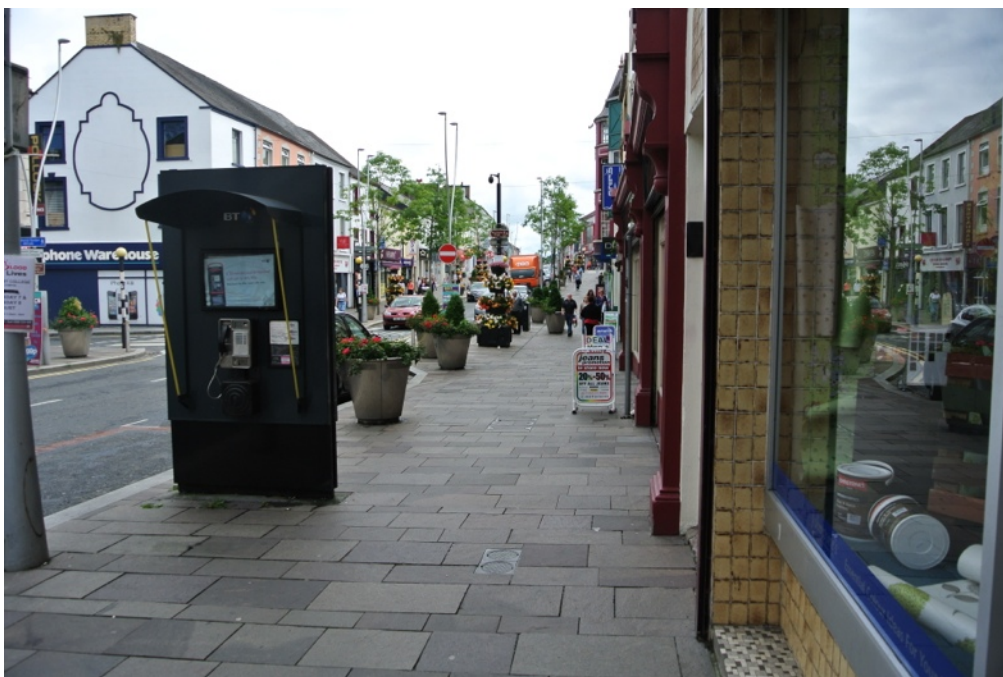
- 18 Floral displays and clutter narrow pavement widths and create obstacles around the controlled crossing across High Street at the junction of Bridge Street.

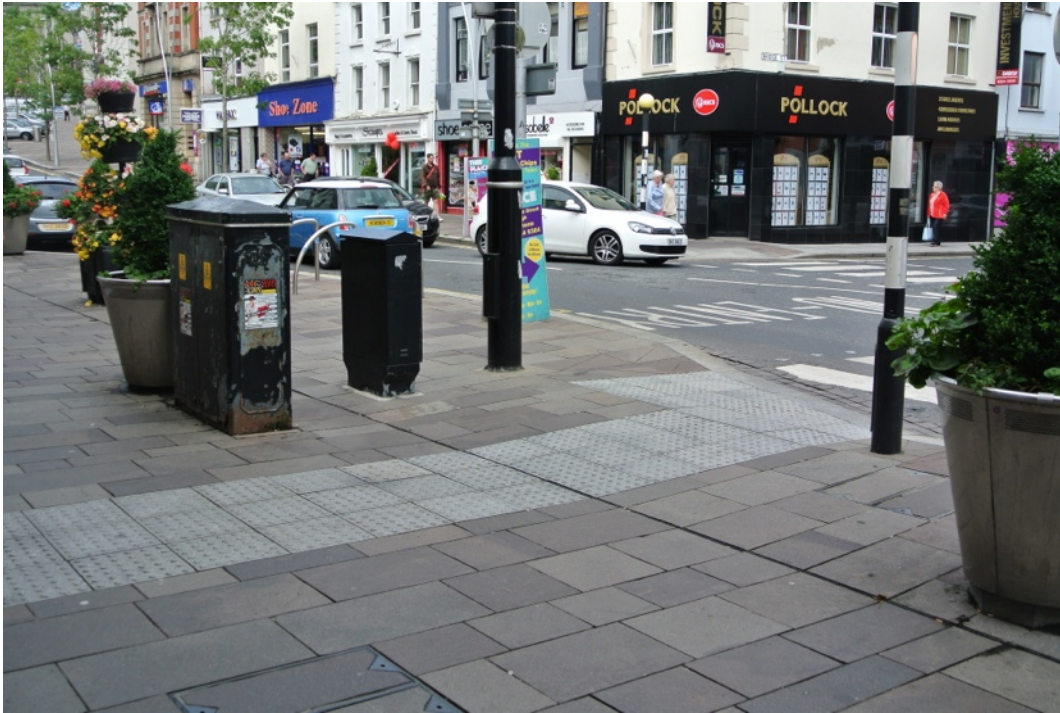
- 19 There is a Zebra crossing across High Street. Non-standard tactile paving has been used.

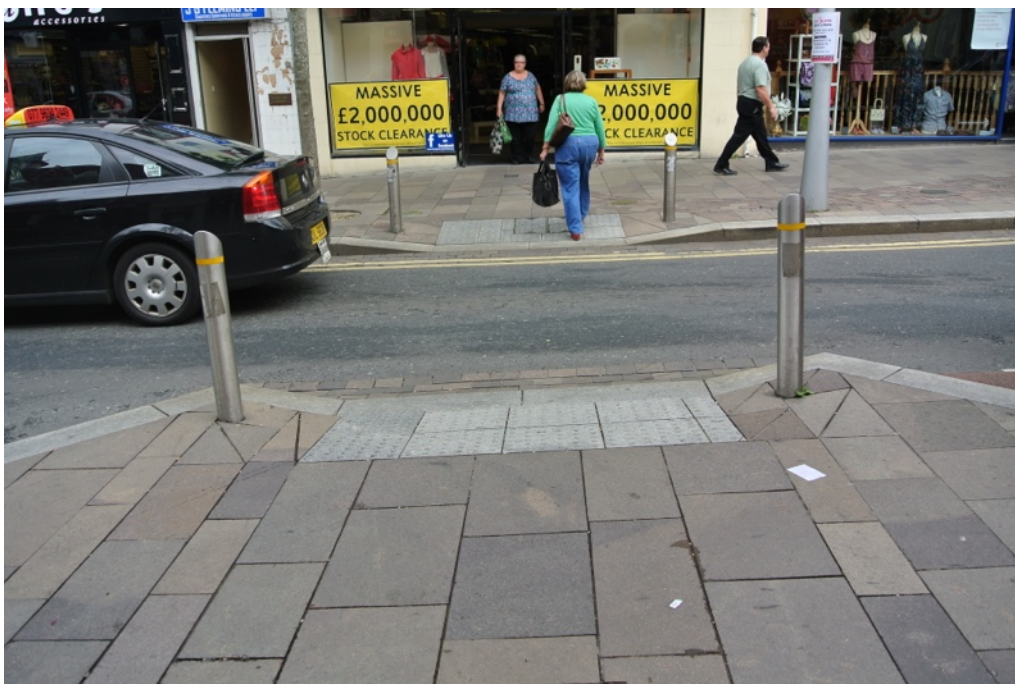
- 20 There is a good example of an inline uncontrolled crossing further along High Street. Again non-standard tactile paving has been used.

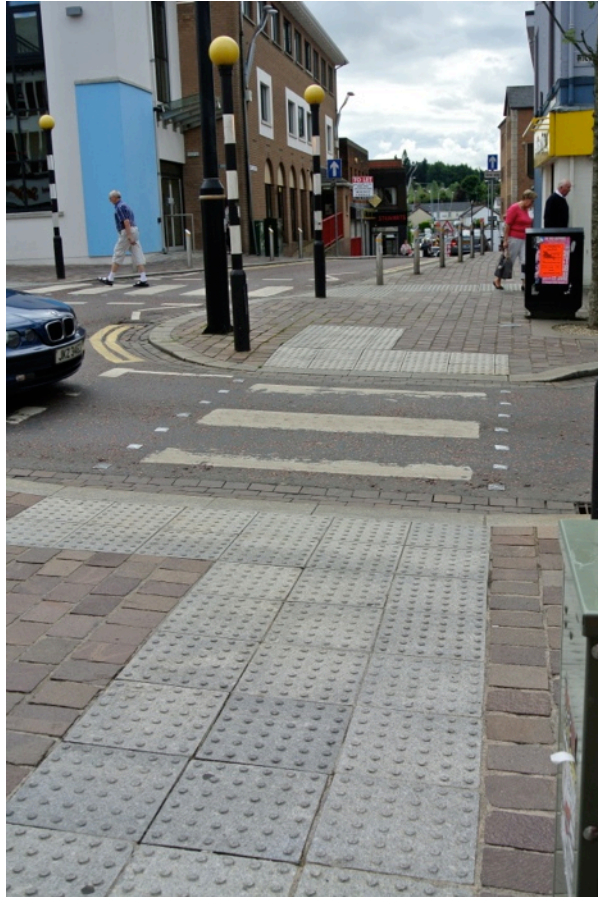
- 21 There is a Zebra crossing on High Street at the junction of Street/Scarffe's Entry. Non-standard tactile paving has been used. Market

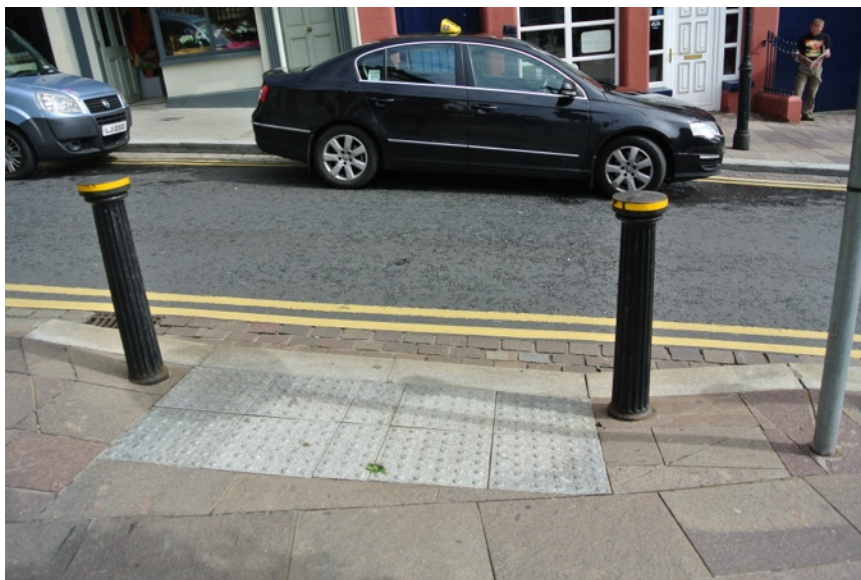
- 22 There is an inline uncontrolled crossing at the junction of George's Street and High Street (beside Courthouse). Non-standard tactile paving has been used and a parked car blocks access to one side of the crossing.

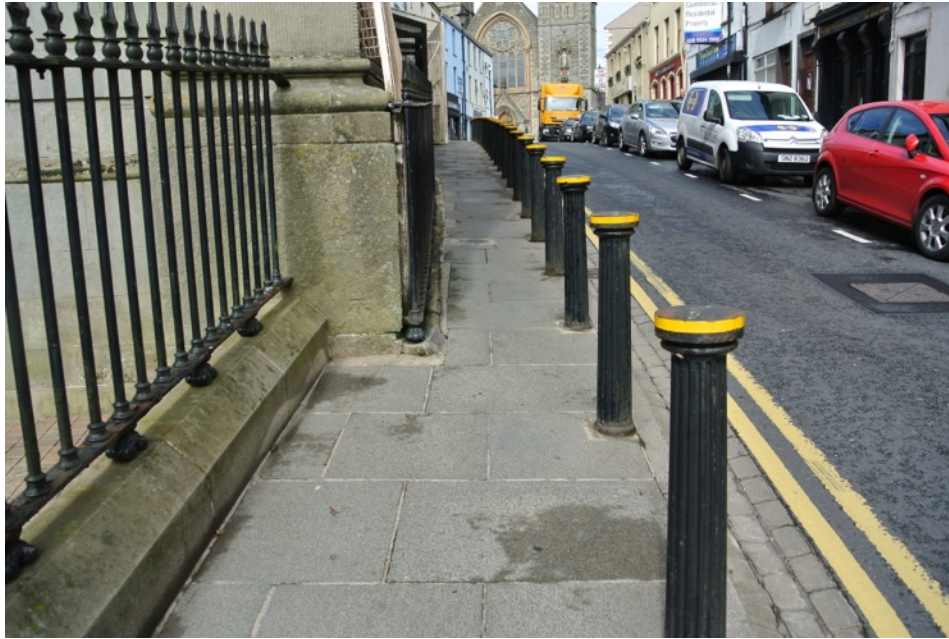
- 23 The pavement alongside the Courthouse on George's Street is restricted by a line of security bollards. These bollards include a clear visibility strip.

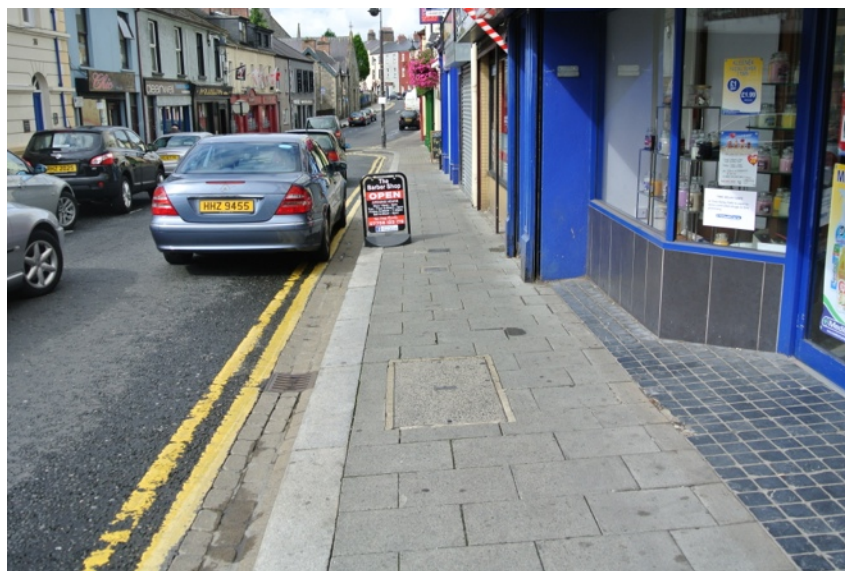
- 24 The pavement in John Street is narrow. Width is further reduced in places by A-boards and shop displays.

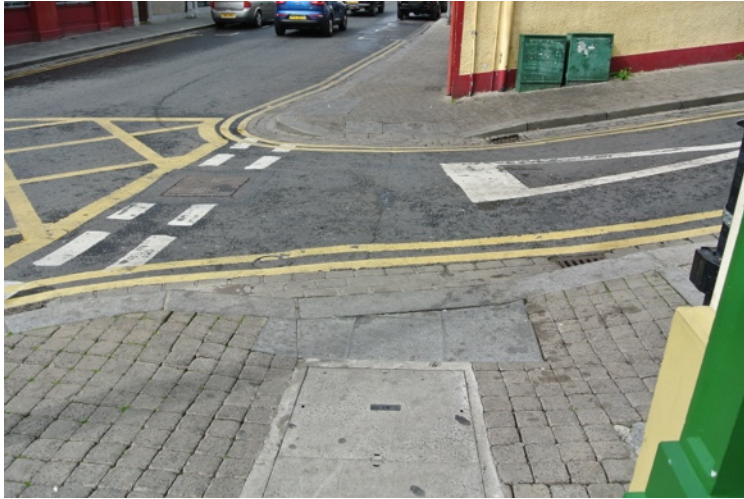
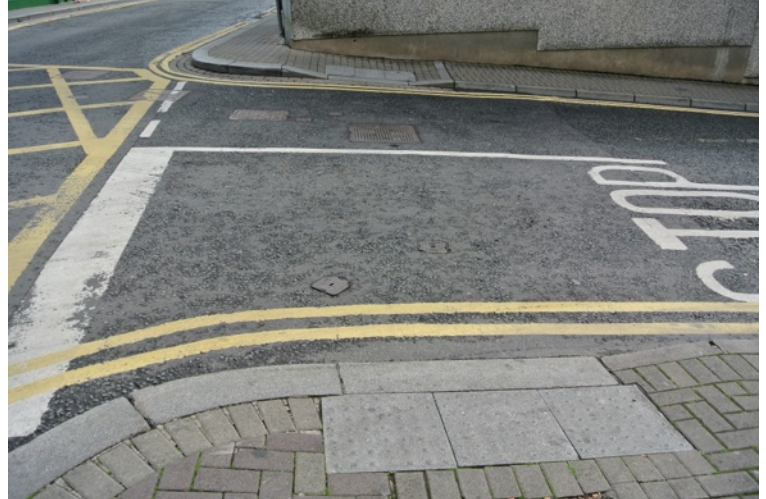
- 25 There are four uncontrolled crossings at the junction between John Street and Kevlin Road. The tactile paving is non-standard and should be two rather than one slab deep at all the crossings.

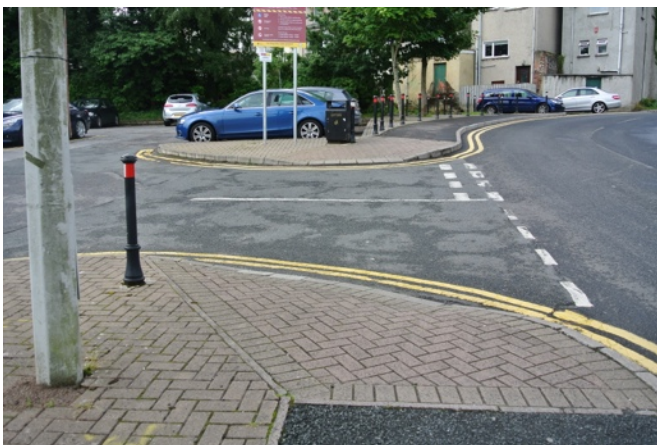
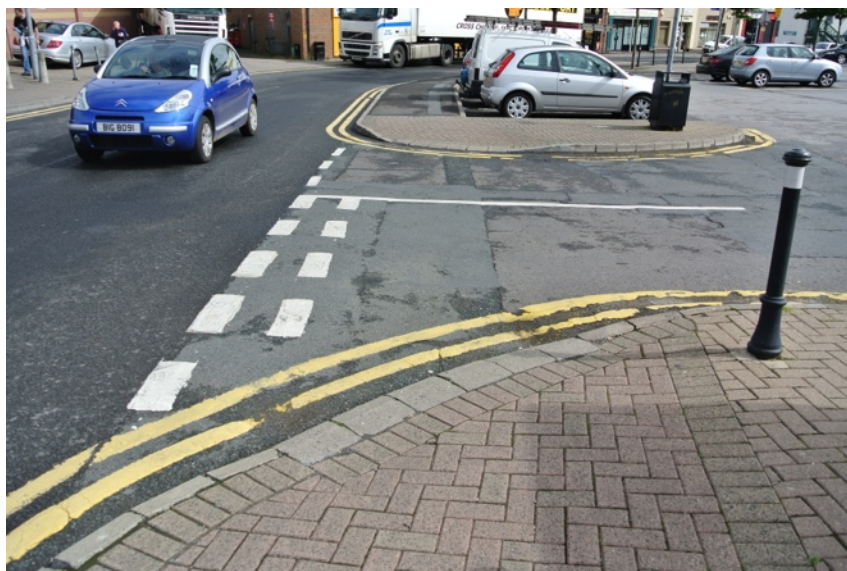
- 26 There is no tactile paving at the entrances to the Roads Service car park on Kevlin Avenue.

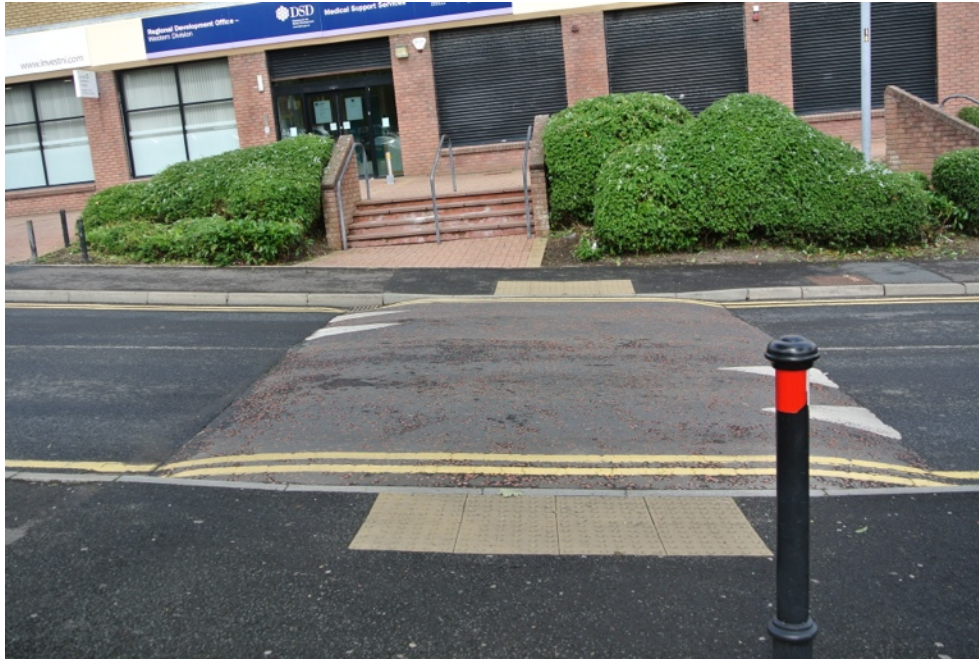
- 27 There is good example of a raised in-line uncontrolled crossing across Kevlin Avenue at the DSD offices.

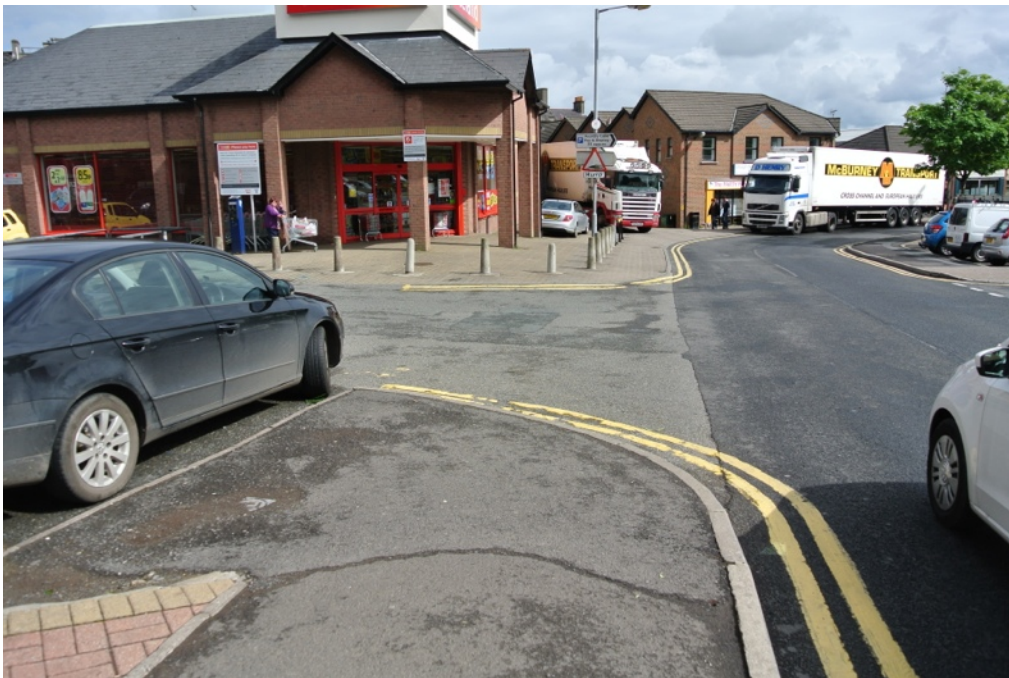
- 28 On the northern side of Kevlin Avenue there is no dropped kerb at the entrance to Iceland.

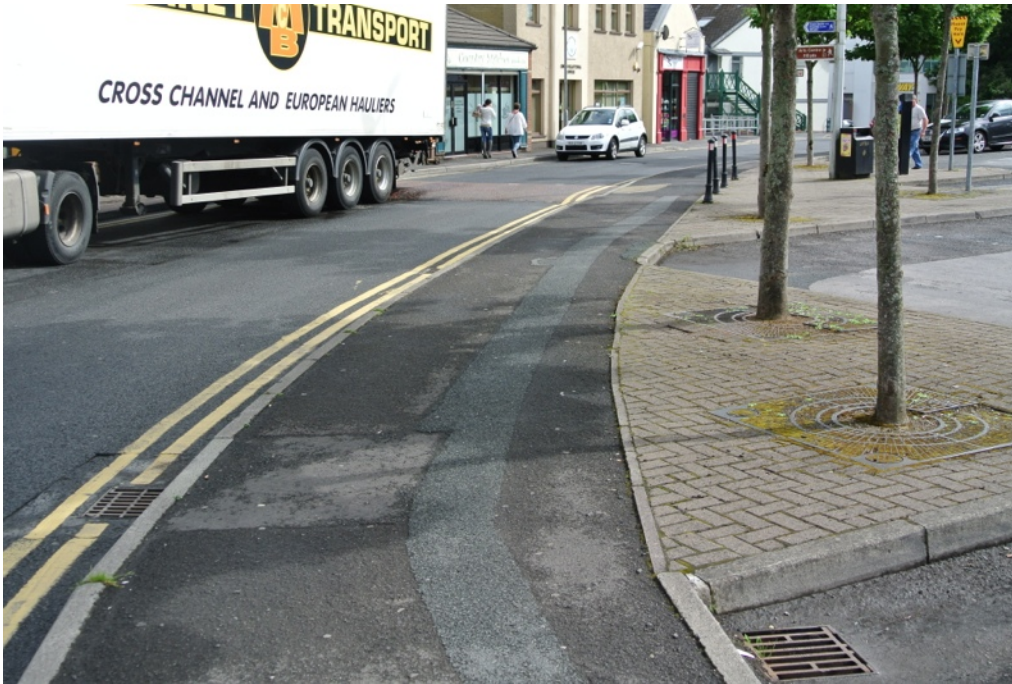
- 29 There is a step free route along the southern pavement of Kevlin Avenue.

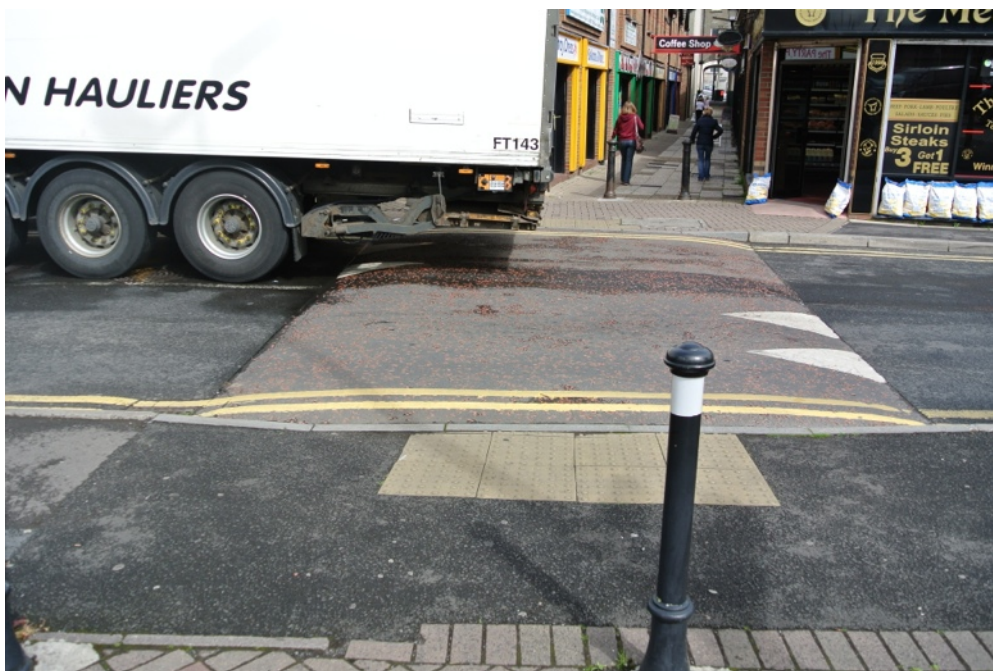
- 30 There is a good in-line uncontrolled crossings across Kevlin Avenue providing access to the lane between Kevlin Avenue and High Street.

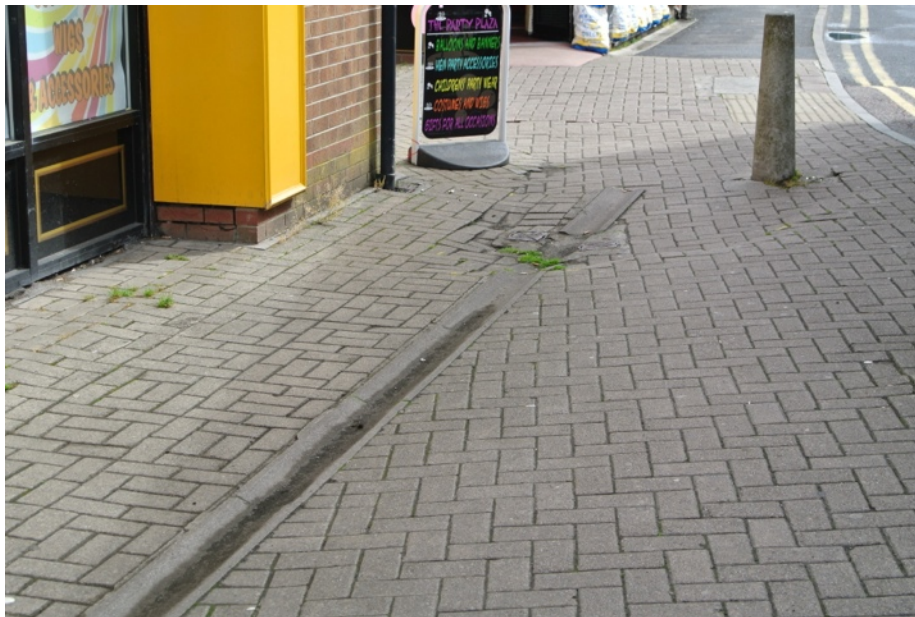
- 31 The pedestrian surface on the northern side of Kevlin Avenue in this location is in poor condition.

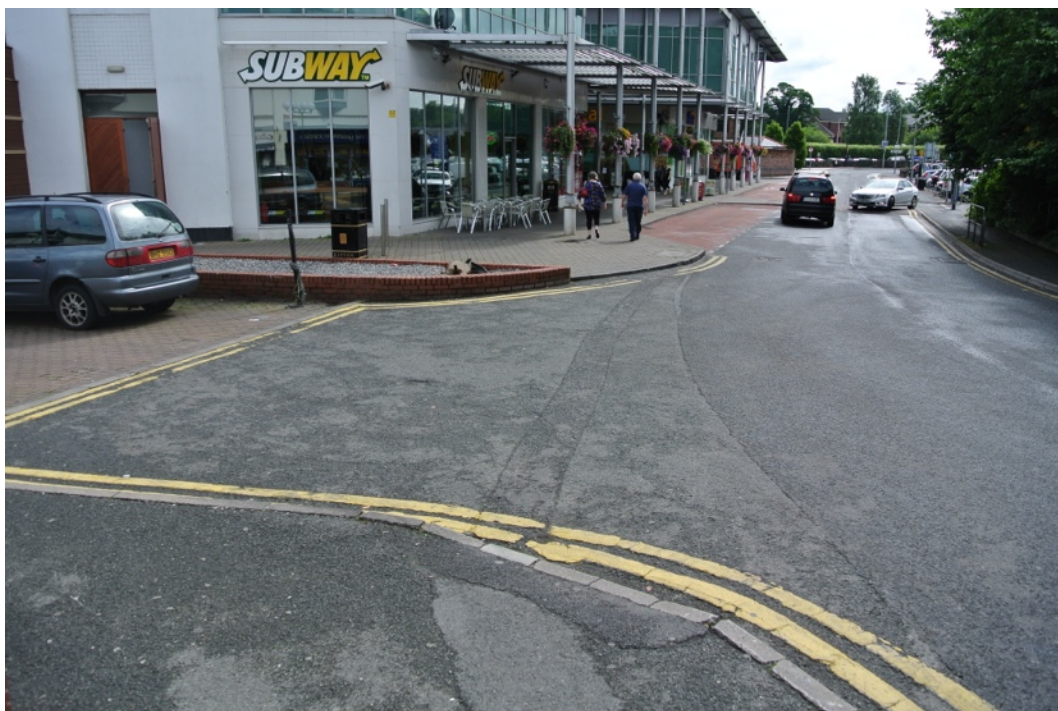
- 32 There is no step free access to Main Street shopping centre on the northern side of Kevlin Avenue as the kerbs have not been dropped on the shopping centre side.
