Report on Walking routes in Omagh Town Centre

October 2013

The report was compiled following an inspection of Omagh in August 2013. It considers the provision of pedestrian facilities in the town measured against accepted accessibility standards<sup>1</sup>. The report identifies potential barriers for disabled people and older people and recommends how these barriers could be resolved. The report also highlights examples of good practice. A key aspect of the report is linkage between the pedestrian environment and the bus station in Omagh. We have produced two reports, a text only version and a version with photographs used to highlight barriers and good practice.

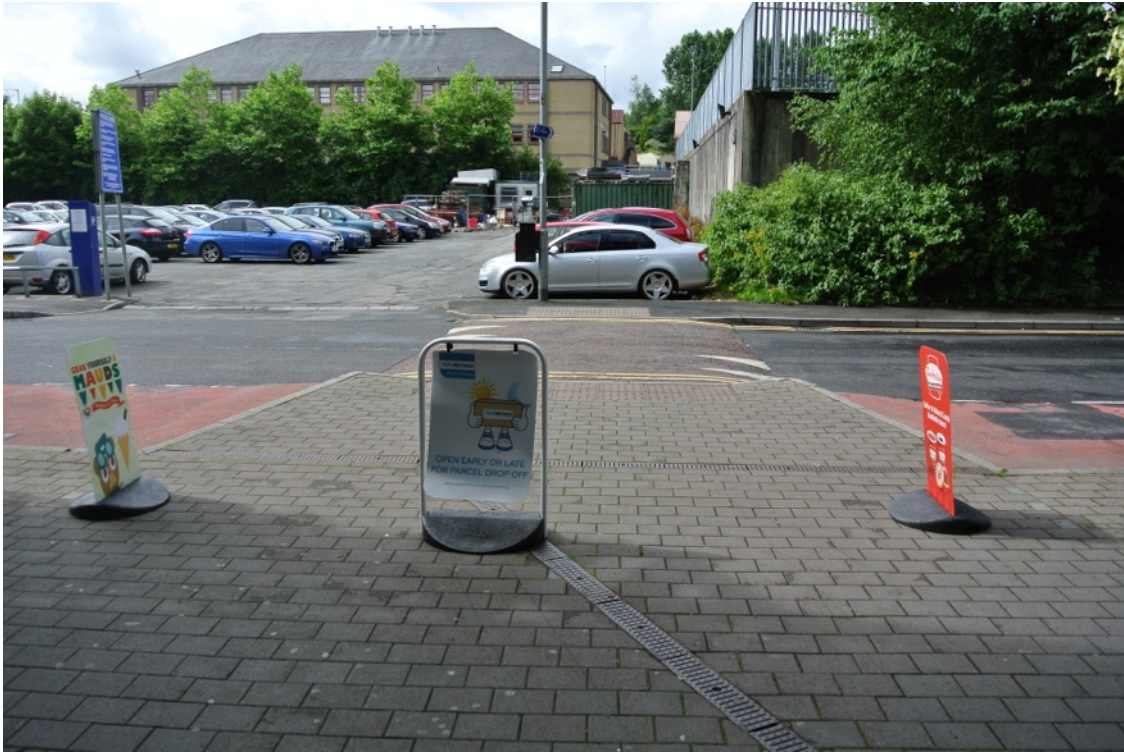
- 33 There is step free access via the southern pavement and a good inline controlled crossing. However A-boards provide obstacles on the western side of the crossing.

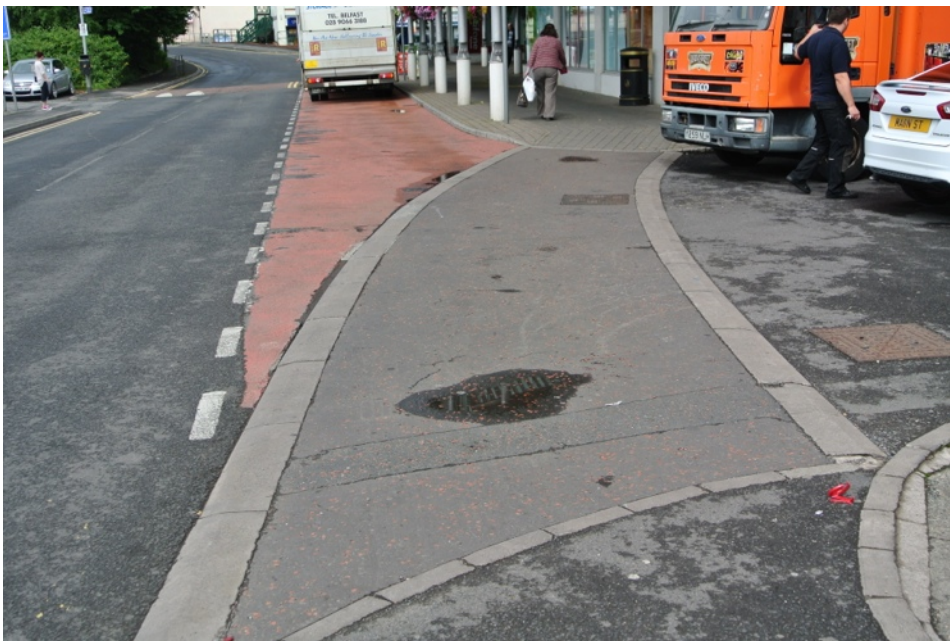
- 34 There is a service yard entrance on the Northern pavement beside Main Street shopping centre. Although level with the pavement tactile paving should be provided to warn people of potential vehicle movements.

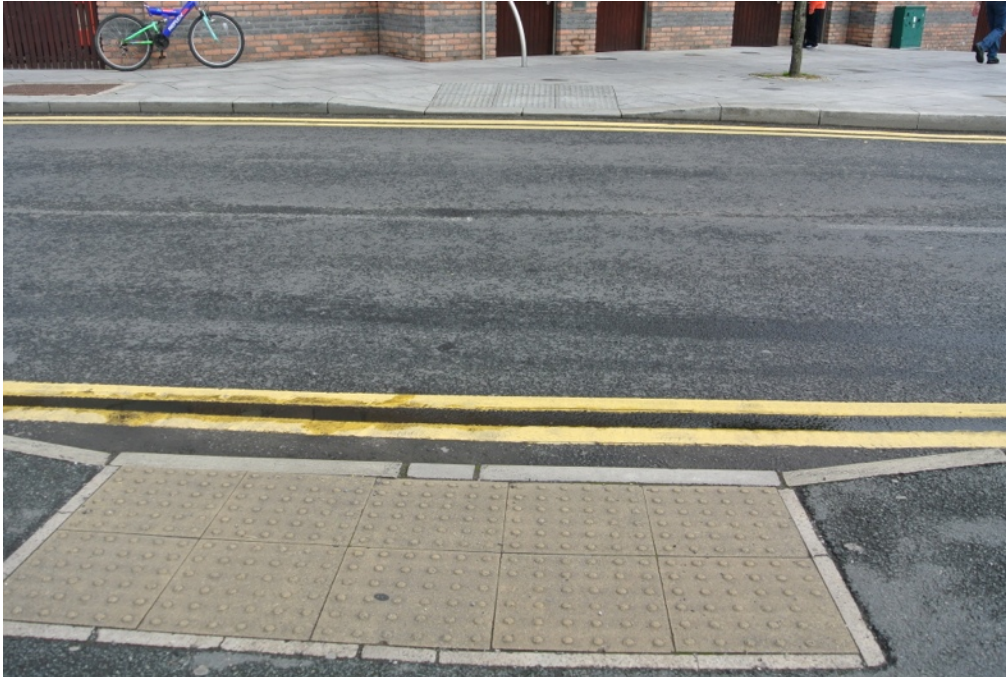
- 35 There is a good in-line uncontrolled crossing across Kevlin Avenue between the public toilets and the Roads Service car park. Non-standard paving has been used on the western side and does not provide sufficient contrast with the surrounding pavement.

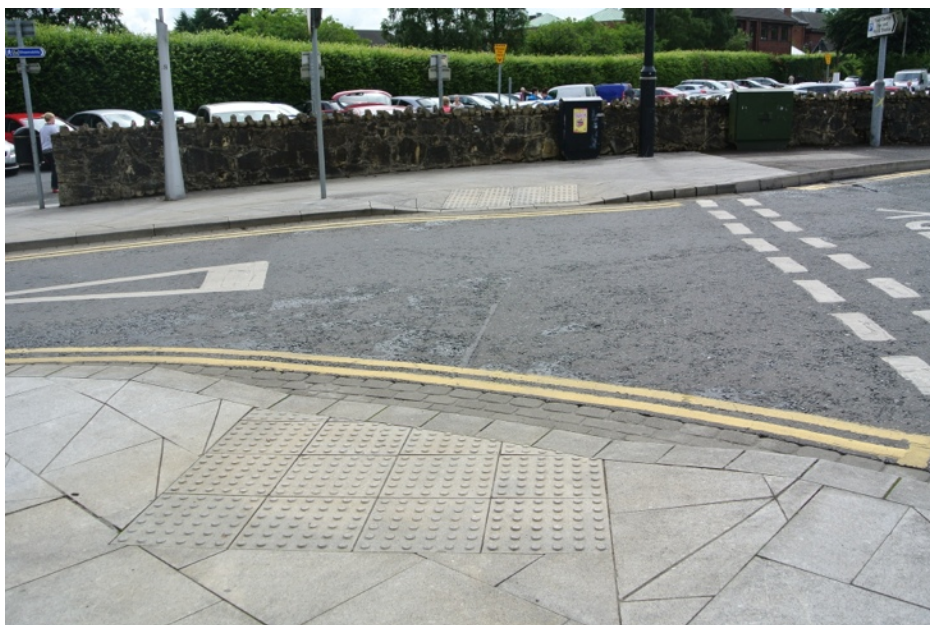
- 36 There is a good example of an in-line uncontrolled crossing across Scarffe's entry at the junction with Kevlin Avenue. Non-standard tactile paving has been used and does not provide sufficient contrast with the surrounding pavement.

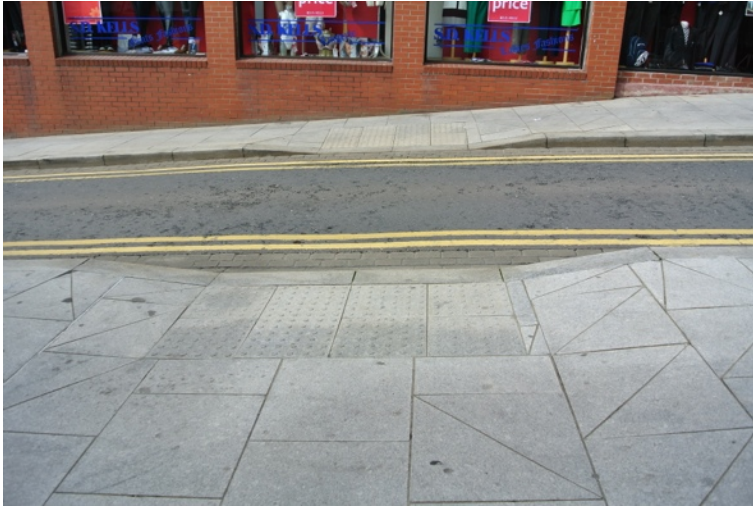
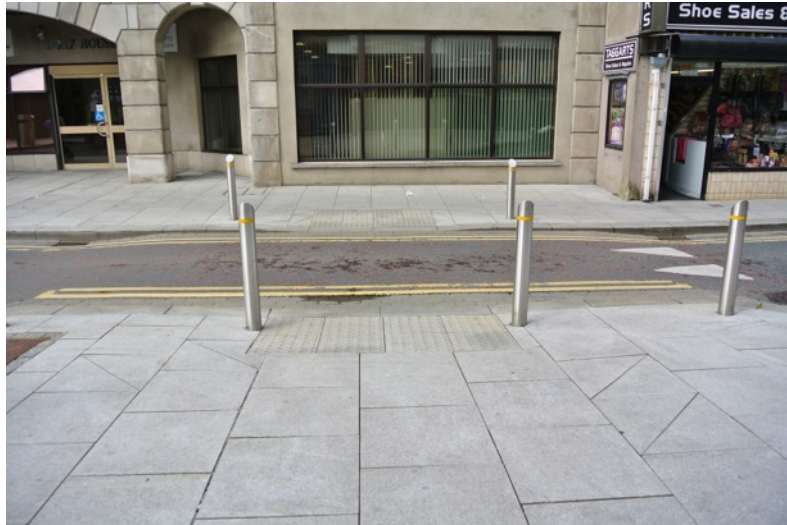
- 37 There are two further reasonable examples of in-line uncontrolled crossings across Scarffe's entry further along the street. Non-standard tactile paving has been used and does not provide sufficient contrast with the surrounding pavement.

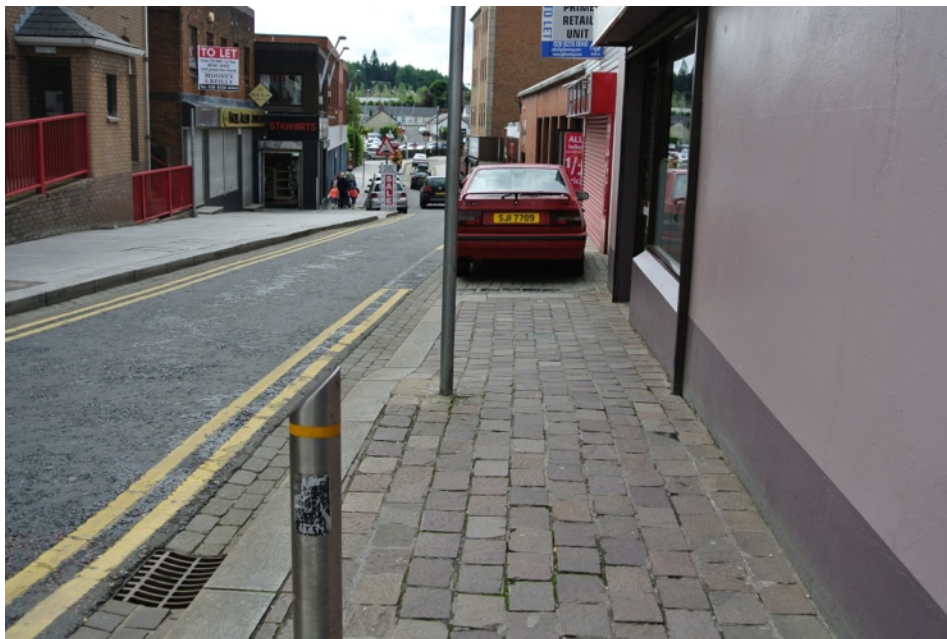
- 38 A car parked at a vehicle entrance blocks the pavement on the western side of Scarffe's entry.

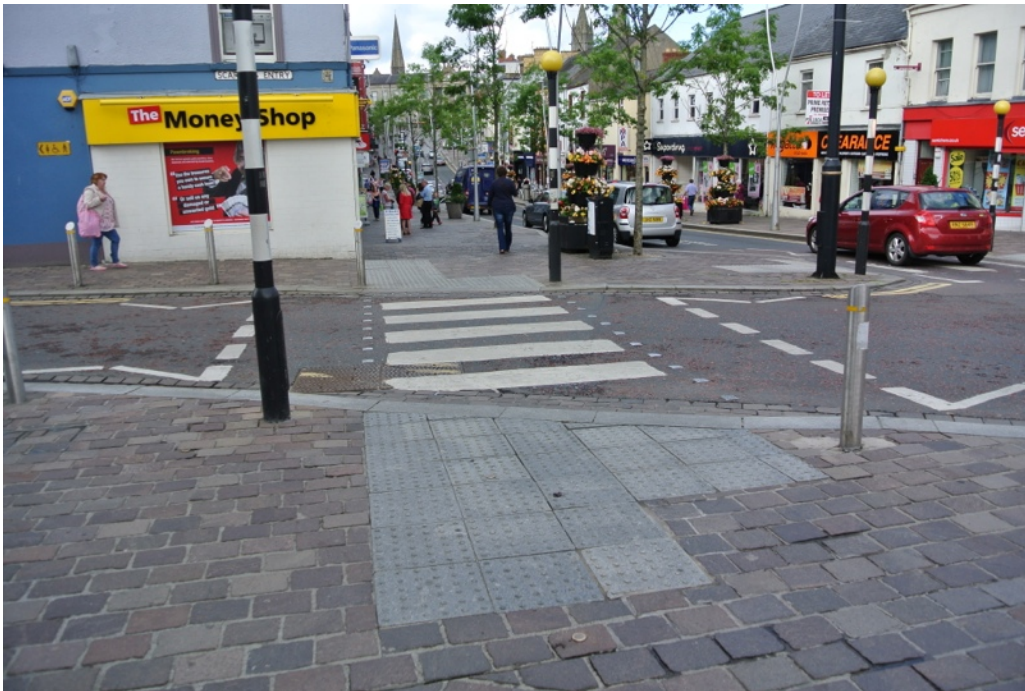
- 39 There is a Zebra crossing on Scarffe's Entry at the junction with High Street and Market Street. Non-standard tactile paving has been used.

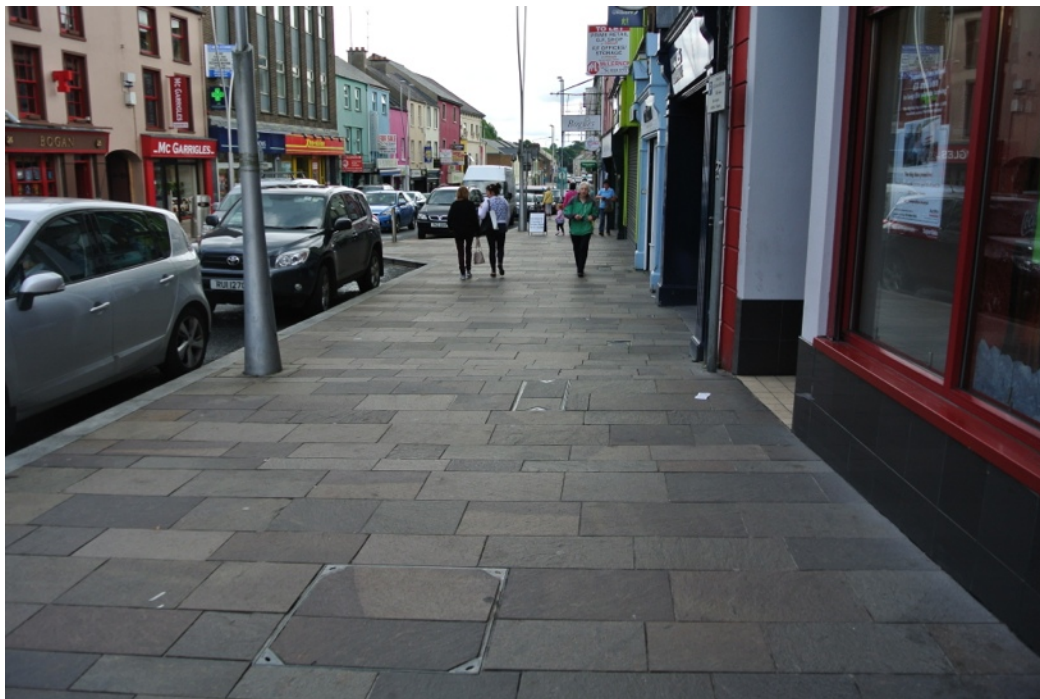
- 40 The pavements on the southern pavement of Market Street are good quality, broad and generally clutter free.

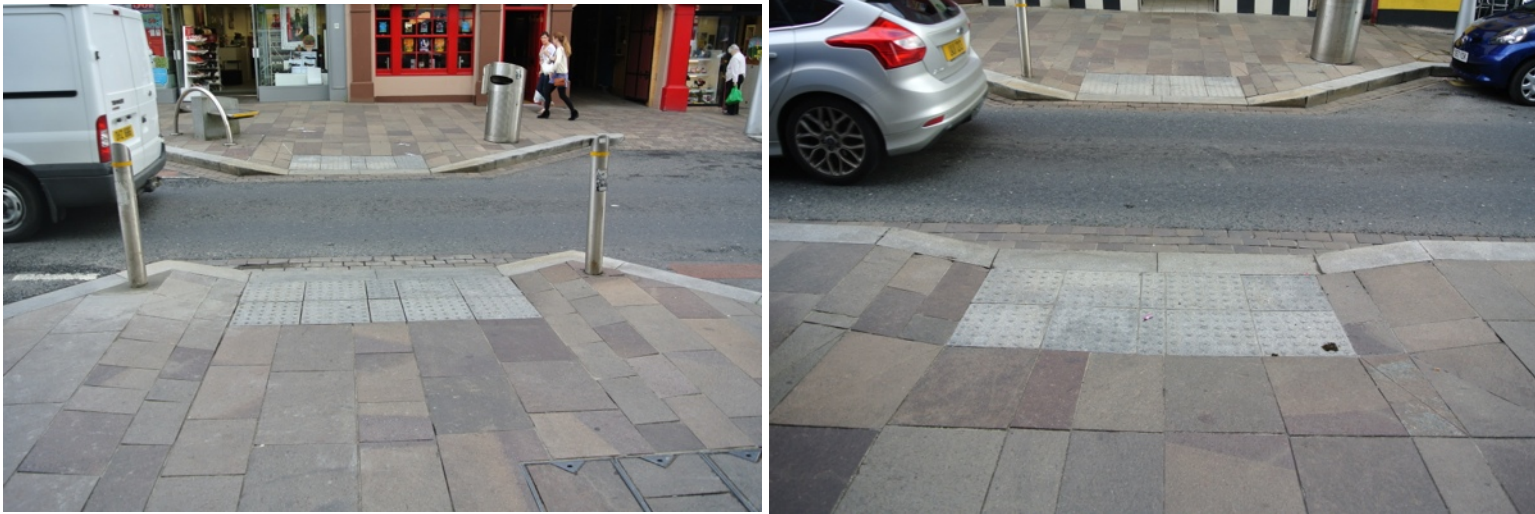
41 There are two good examples of in-line uncontrolled crossings across Market Street. Non-standard tactile paving has been used.

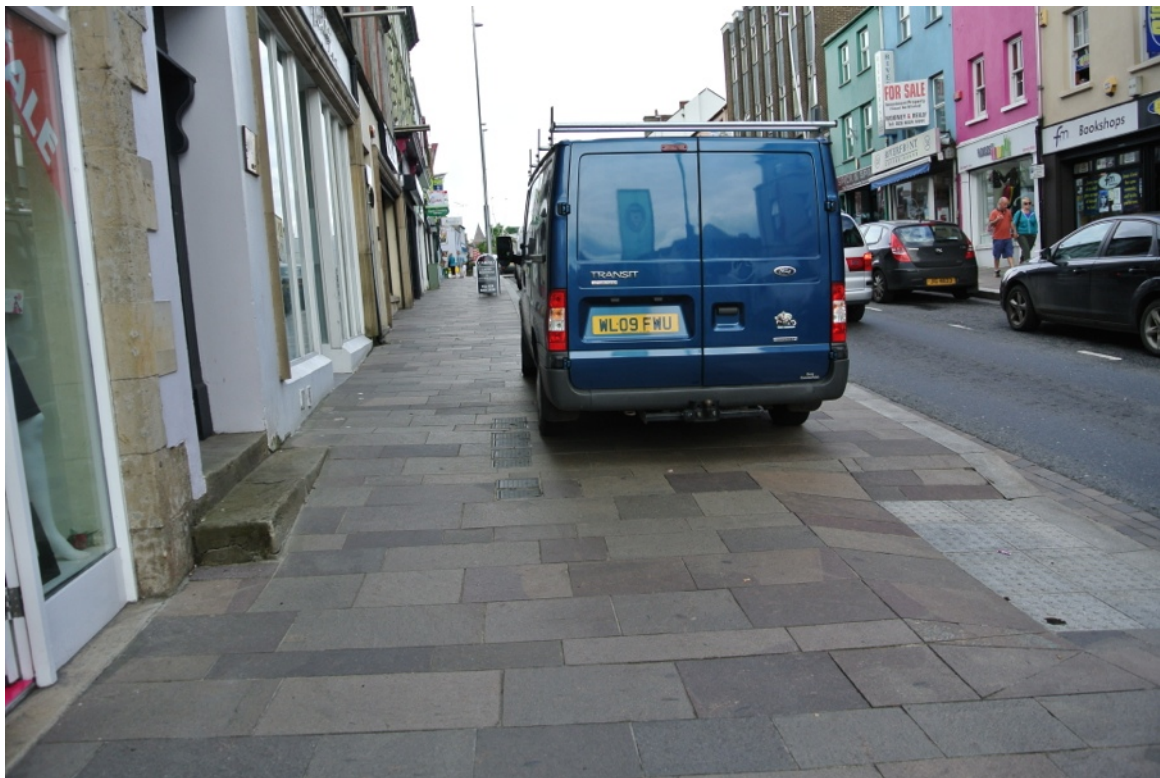
42 A vehicle parked on the pavement close to the junction with Dublin Road presents a potential hazard.

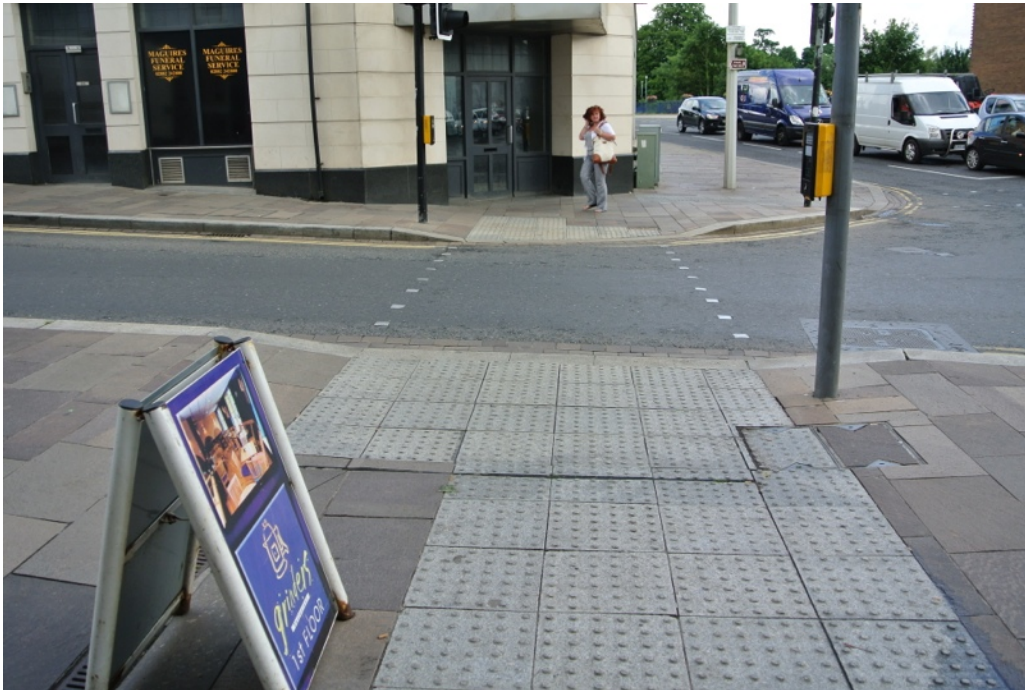
- 43 There is a good controlled crossing across Market Street at the junction with Dublin Road. However an A-board is an obstacle. Non-standard tactile paving has been used.

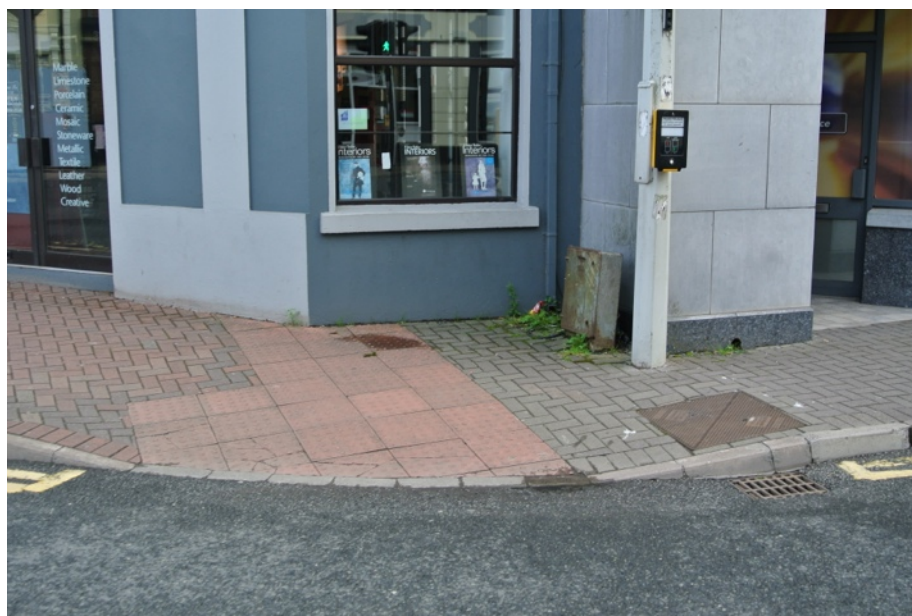
- 44 There is a controlled crossing across Dublin Road. The control box on the eastern side is mounted too high on a lighting column and too far from the tactile tail.

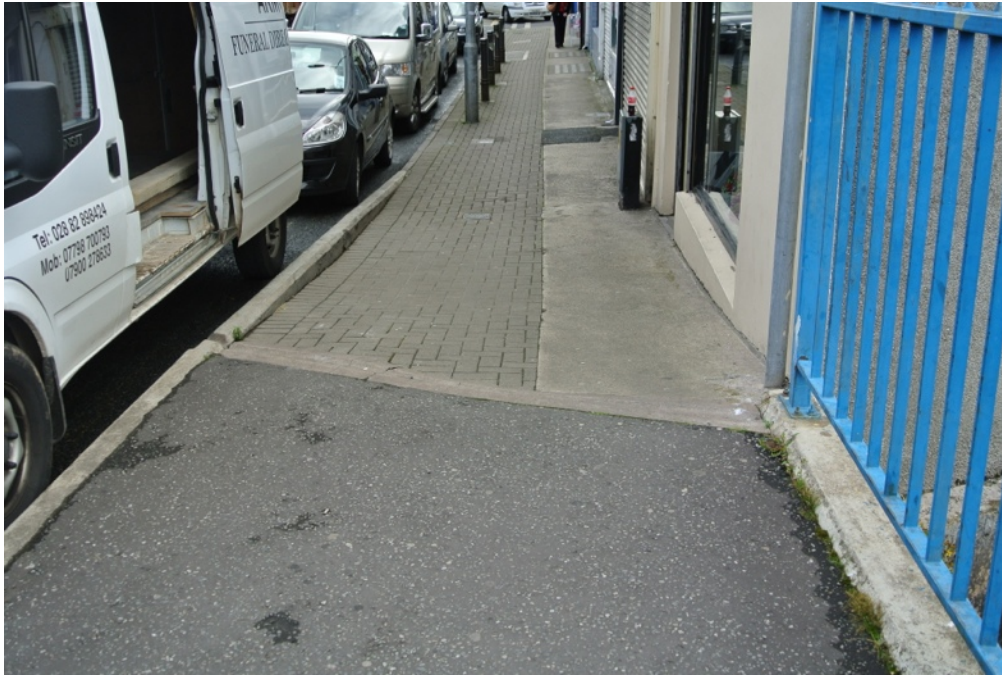
- 45 The southern pavement on Market Street has a significant crossfall after the bridge. This is an obstacle for some disabled people including wheelchair users.

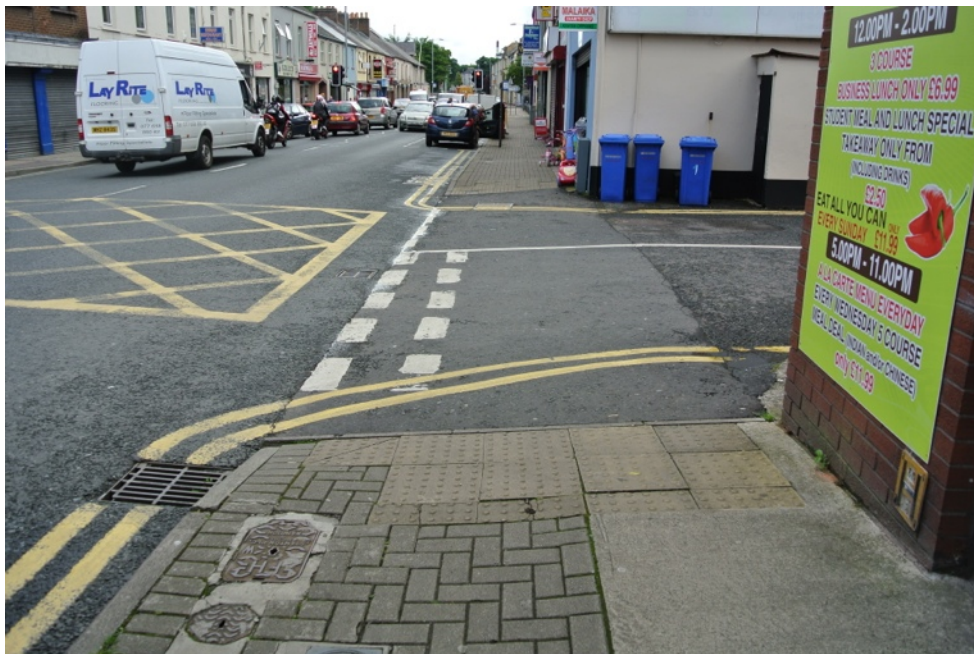
- 46 There is an in line uncontrolled crossing at the junction with Campsie Drive. The tactile paving is in need repair.

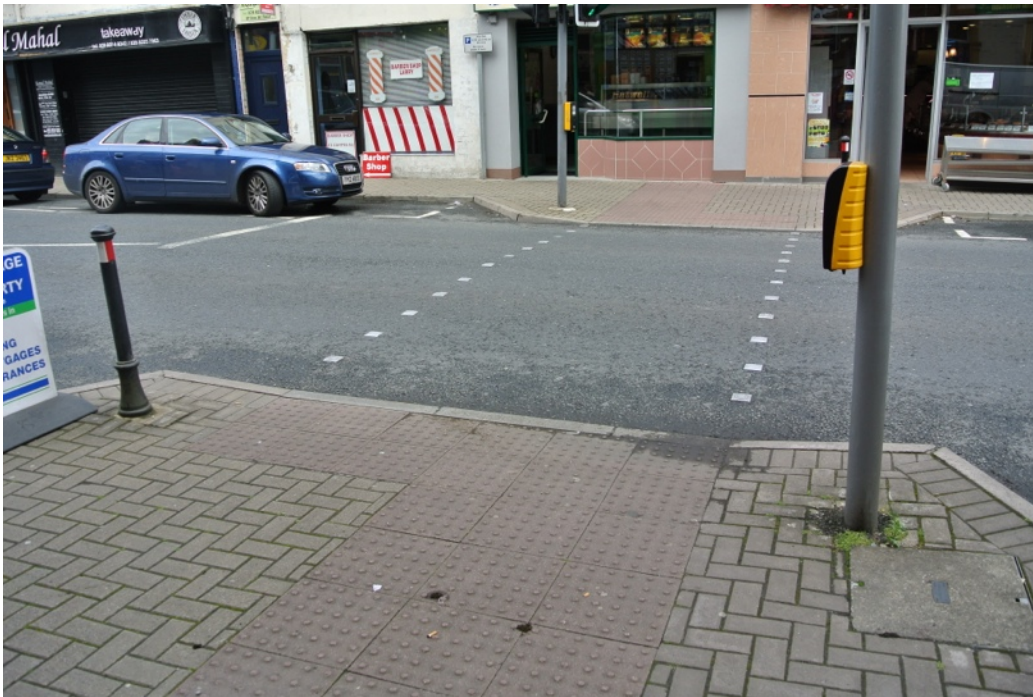
47 There is a good example of a controlled crossing across Market Street.

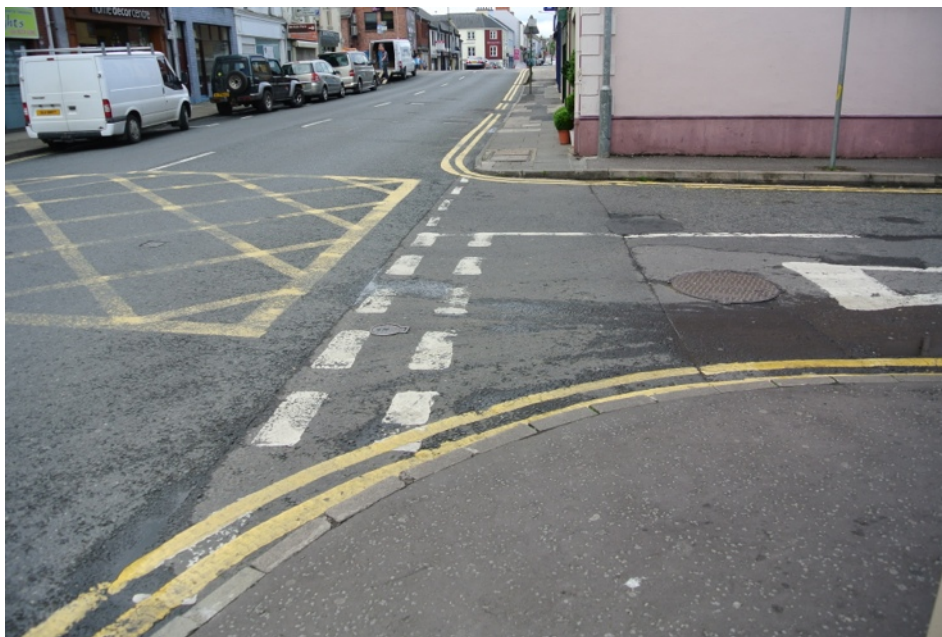
48 Heading back towards the town centre on the northern pavement there is no provision, such as dropped kerbs, for crossing made at the junction with Campsie Avenue.

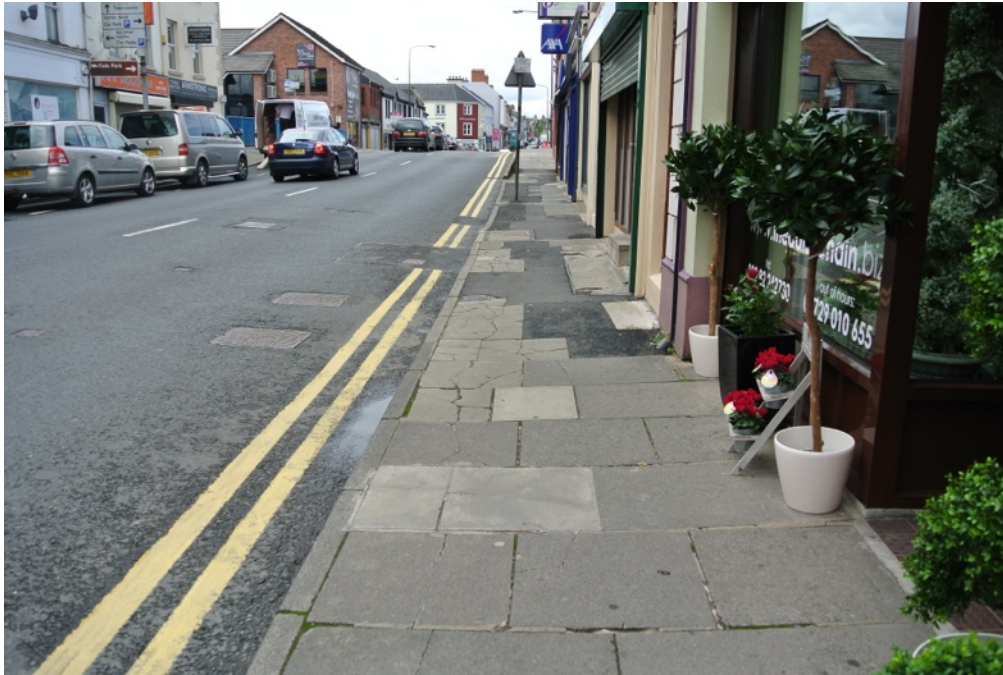
- 49 The pavement on the northern side of Market Street is in a poor state of repair in places.

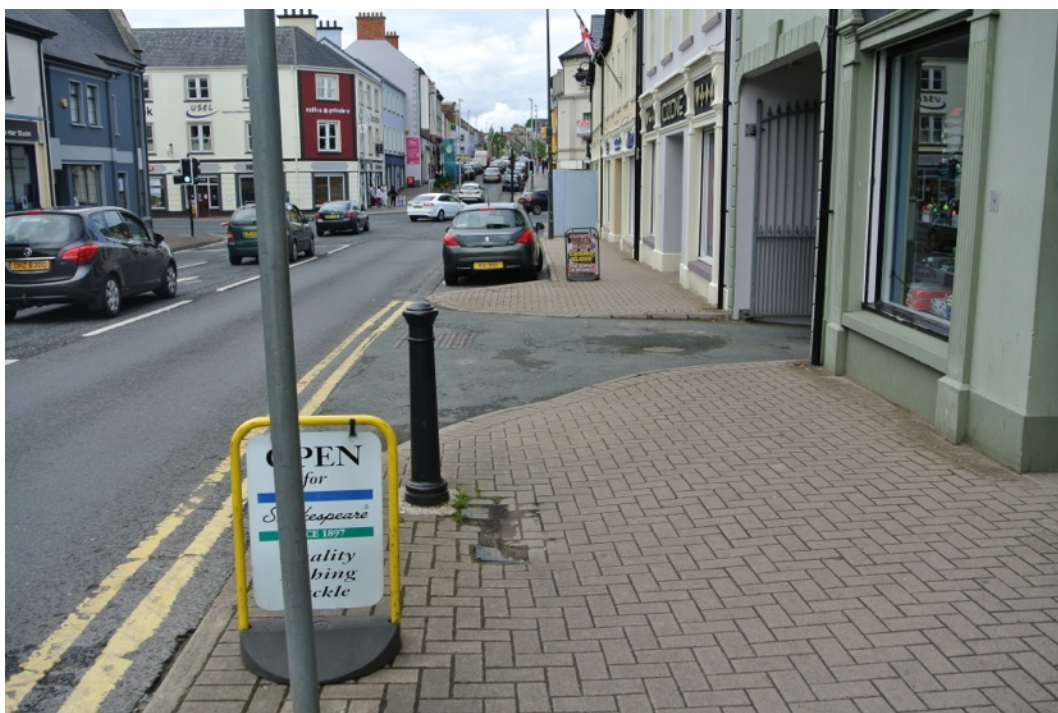
- 50 Vehicle entrances do not provide pedestrians with priority and no tactile paving has been provided.

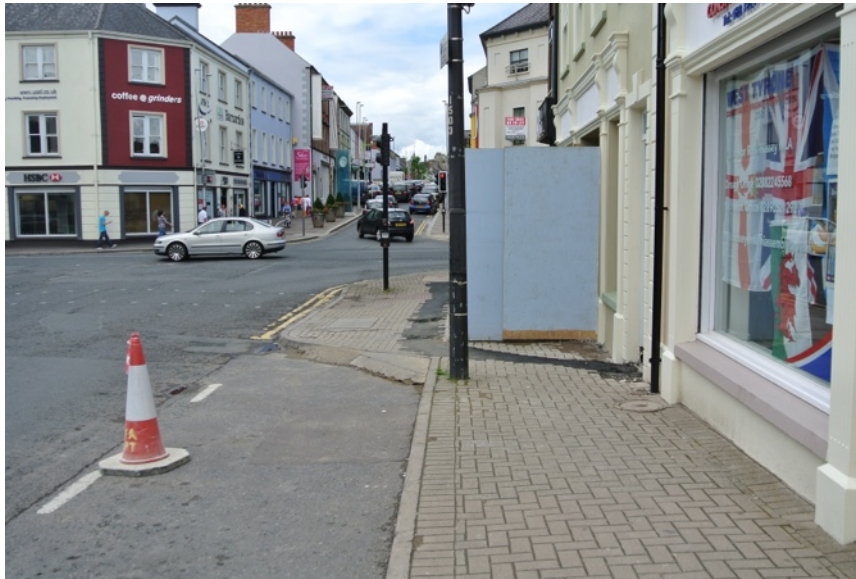
- 51 Building work restricts pavement width and has damaged tactile paving around the junction between Market Street and Drumragh Avenue.

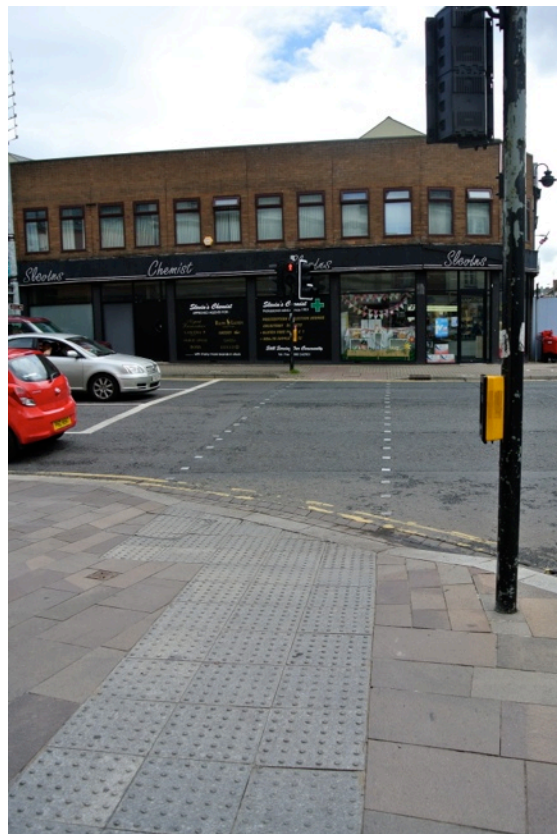
- 52 A good example of a controlled crossing is in place at the junction of Market Street and Drumragh Avenue. Non-standard tactile paving has been used on one side.

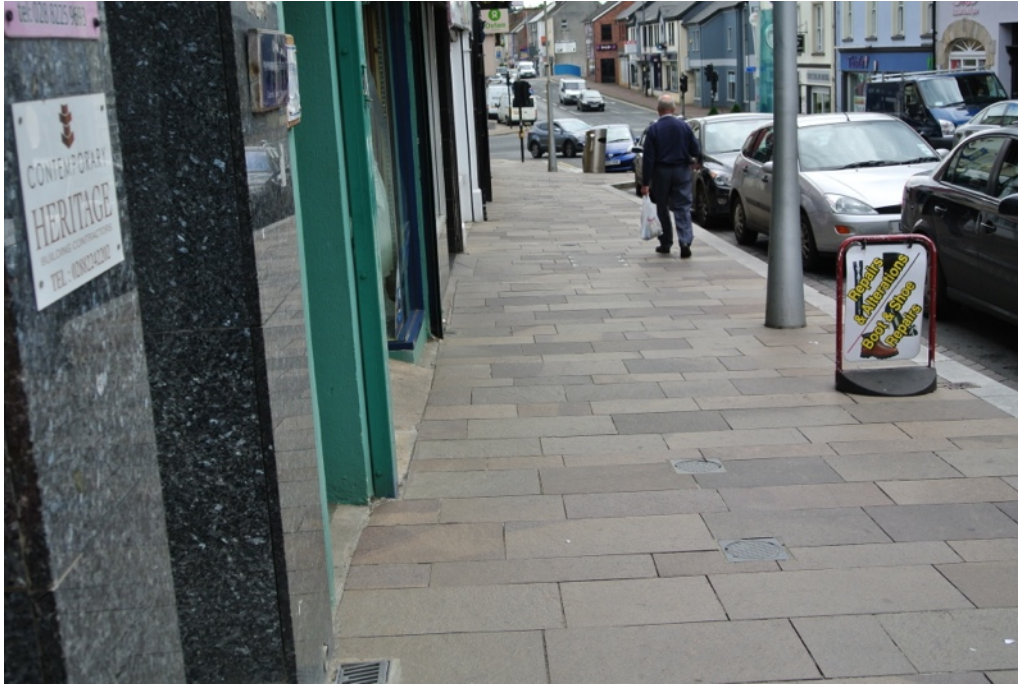
- 53 There are good quality, wide pavements on the northern pavement of Market Street towards the centre of town. A-boards present an obstacle but are located in the furniture line.
