**Report on Walking routes in Portrush Town Centre**

**(April 2017)**

The report was compiled following an inspection of Portrush town centre in February 2017. It considers the current provision of pedestrian facilities on streets that form part of the proposed public realm scheme measured against accepted accessibility standards<sup>1</sup>. The report identifies potential barriers for disabled people and older people. A key aspect of the report is linkage between the pedestrian environment and bus and rail facilities in Portrush. Two reports have been produced, a text only version and version where photographs have been used to highlight barriers and good practice.

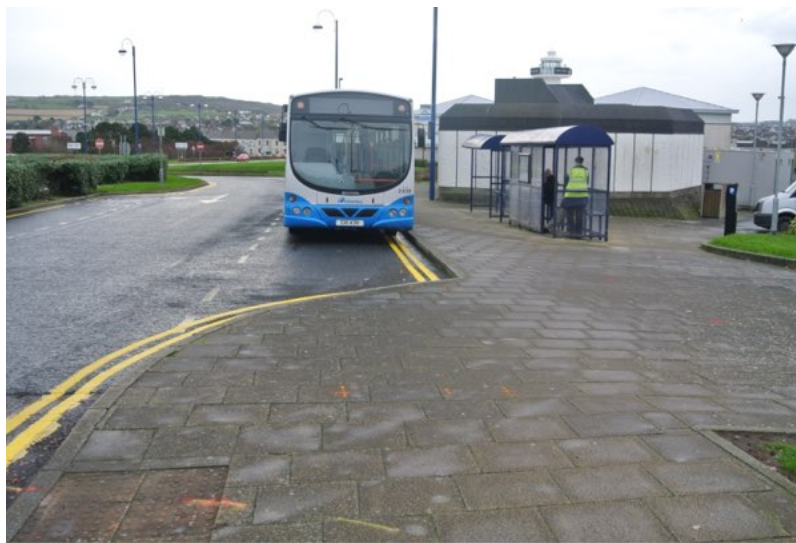
- 1 Buses servicing the town terminate on the western side of Dunluce Avenue. Basic facilities, including shelter from the elements, have been provided. However there remains a considerable distance from the bus stop to the main attractions in the town, a distance that will be difficult or impossible for many older people and disabled people to manage.

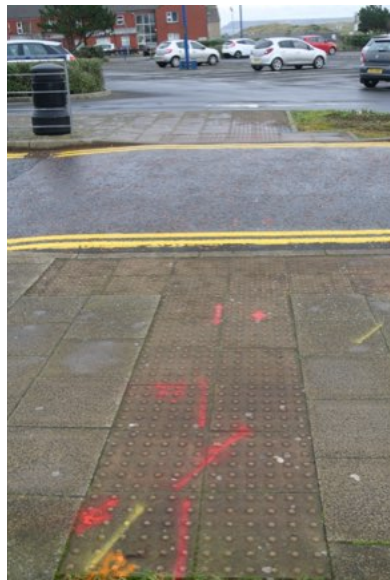
- 2 One of the main car parks for the town is located directly opposite the bus stops. An uncontrolled crossing is provided from the car park to the footway on the western side of Dunluce Avenue. Tactile paving has been laid incorrectly and fails to provide an adequate contrast with the surrounding paving.

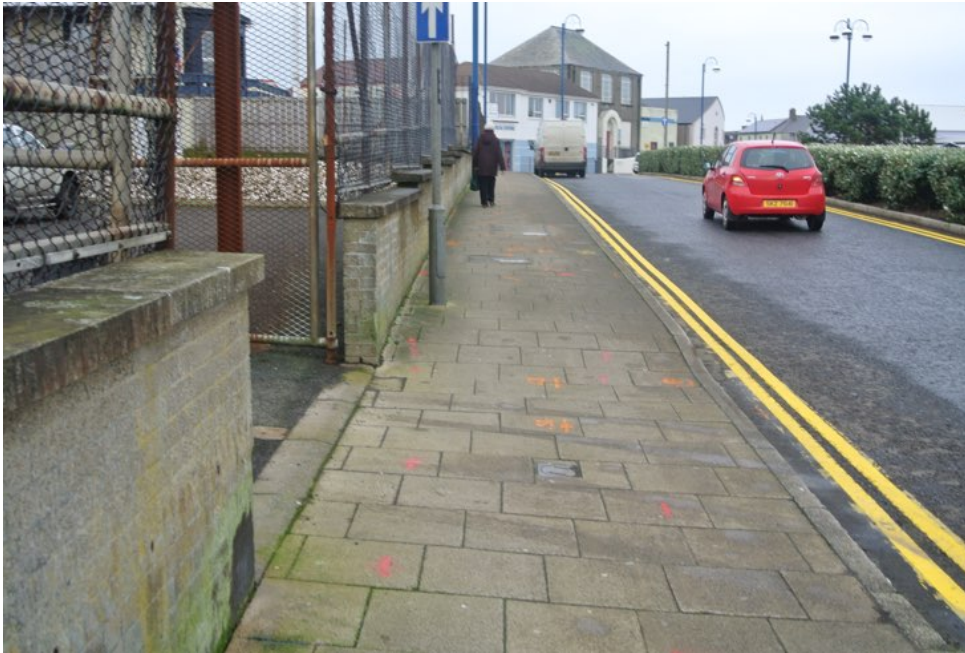
- 3 The footway towards the town is narrow but relatively uncluttered.

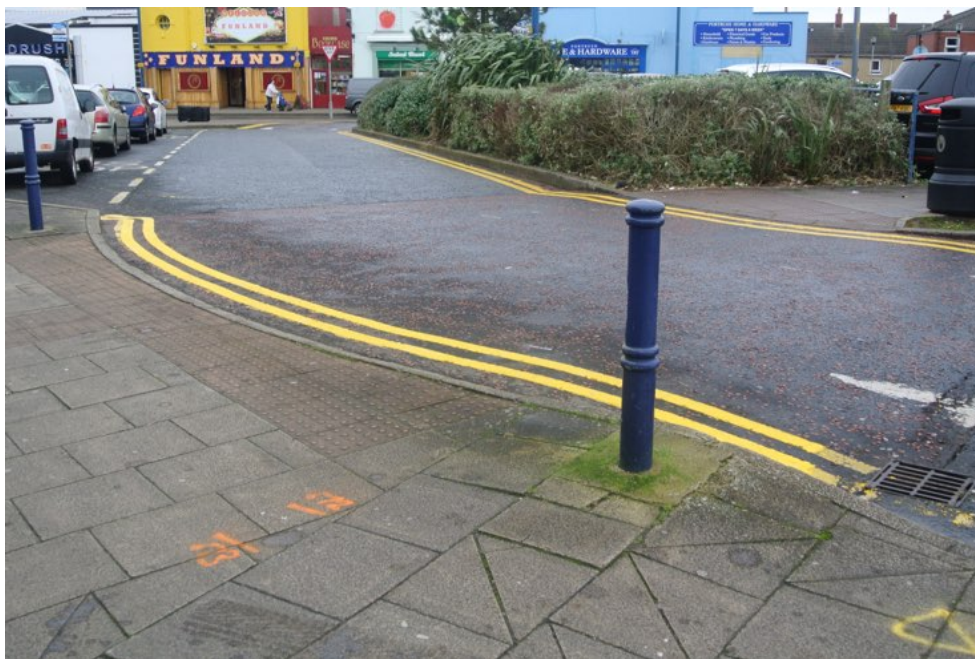
- 4 The footway broadens around the health centre on Dunluce Avenue. An uncontrolled crossing is provided here with access to the car park. The tactile paving does not contrast sufficiently with the surrounding paving. The positioning of a bin partially blocks the crossing on the car park side.

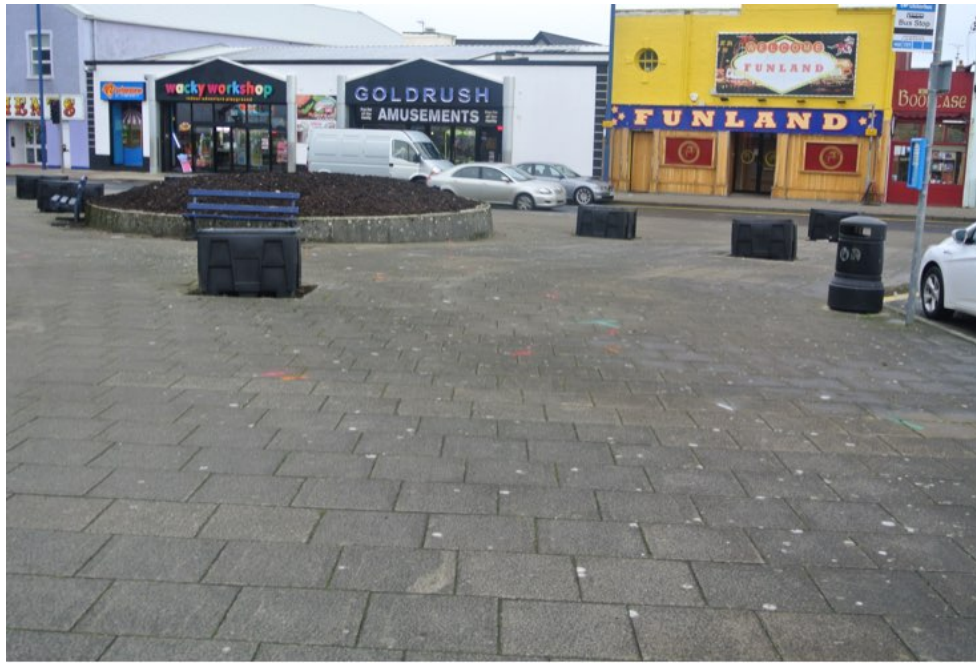
- 5 The pavement broadens further as Dunluce Avenue turns towards the town. The random positioning of large planters in this area creates the potential for hazards for people with a visual impairment.

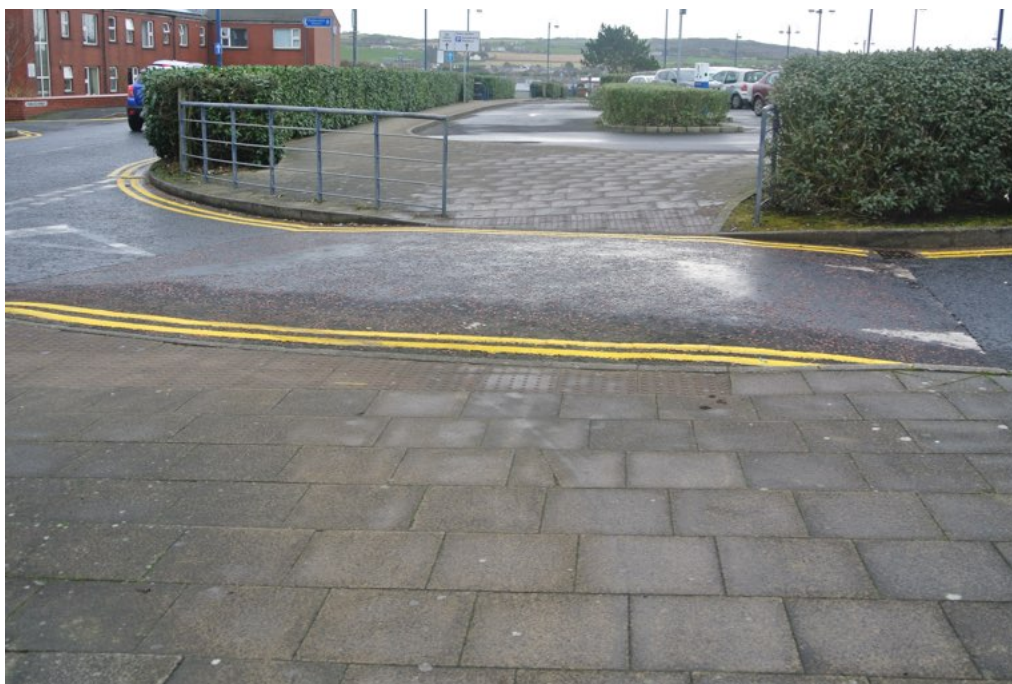
- 6 There is another uncontrolled crossing at this point providing access to and from the car park. The tactile paving does not contrast sufficiently with the surrounding paving.

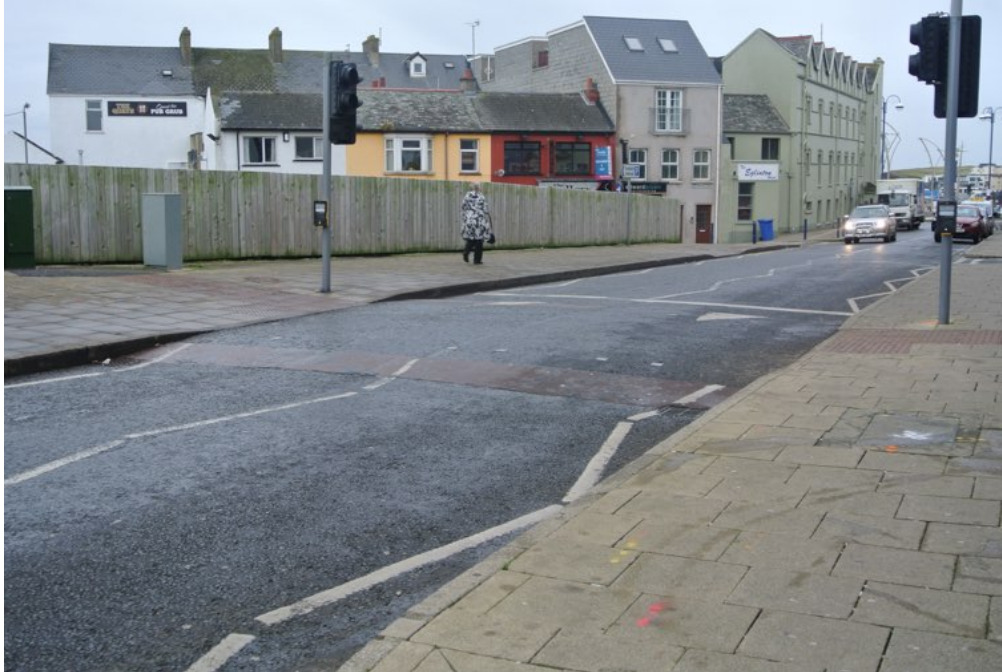
- 7 There is a controlled crossing providing access to the eastern footway on Dunluce Avenue. The tactile paving has been installed incorrectly on this crossing and the contrast with the surrounding paving could be improved.

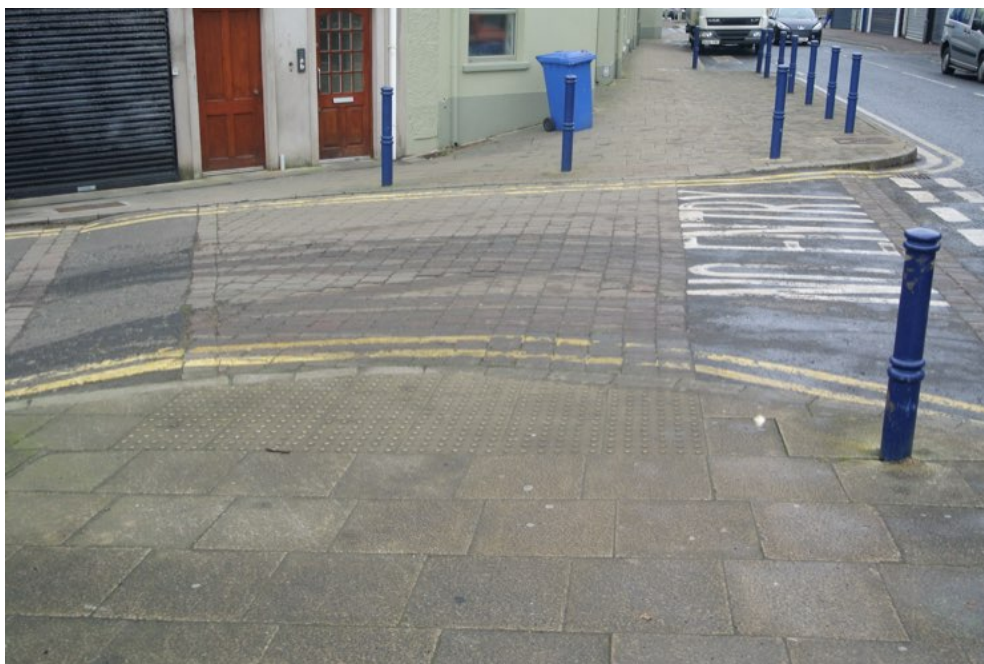
- 8 The broad footway continues along the western side of Dunluce Avenue until a side street is reached. An uncontrolled crossing has been provided with tactile paving. However multiple bollards (designed to prevent pavement parking) create significant hazards for people with a visual impairment in particular. The pavement narrows considerably after this point.

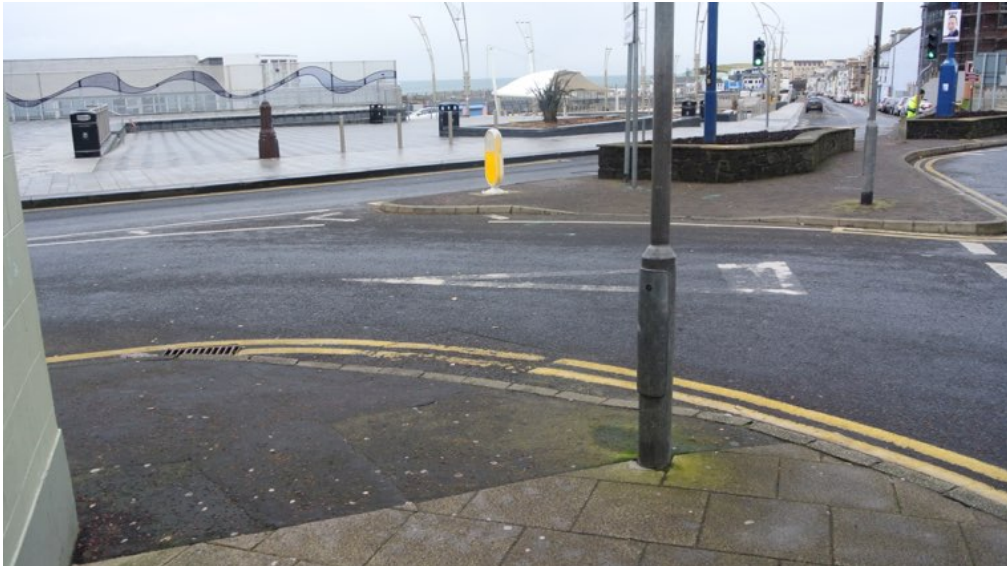
- 9 At the junction with Eglinton Street there is a section of dropped kerb providing access to the traffic island between Kerr Street and Eglinton Street. There is no tactile paving provided at this uncontrolled crossing.

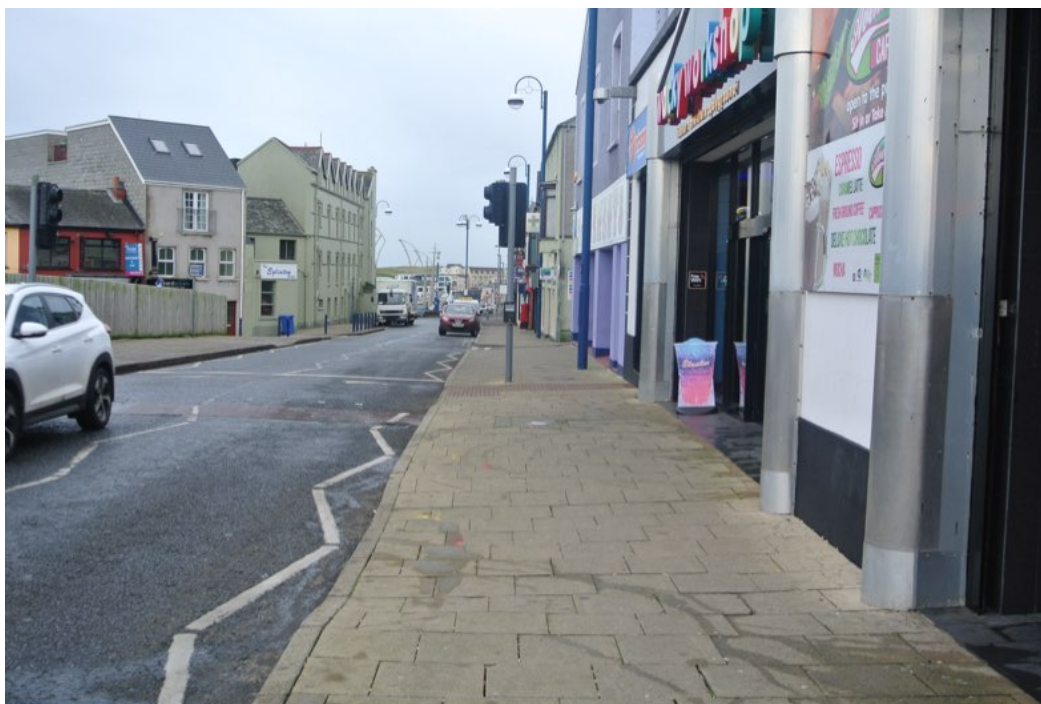
- 10 The footway on the eastern side of Dunluce Avenue is quite wide and was relatively uncluttered during the site visit.

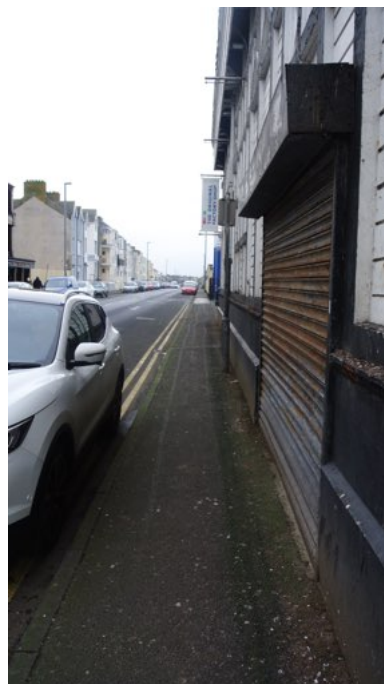
- 12 A lack of footway width is a major issue on the western side of Eglinton Street from the exit of the railway station to Station Square.

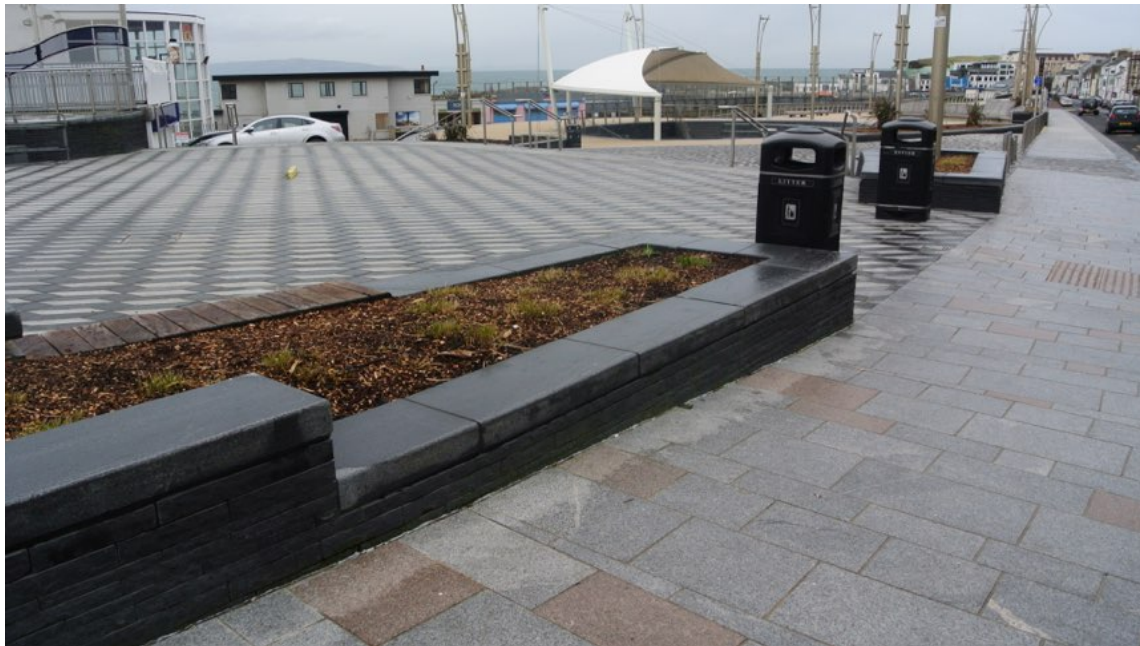
- 13 The footway broadens out at Station Square. Station Square has benefitted from recent public realm improvements.

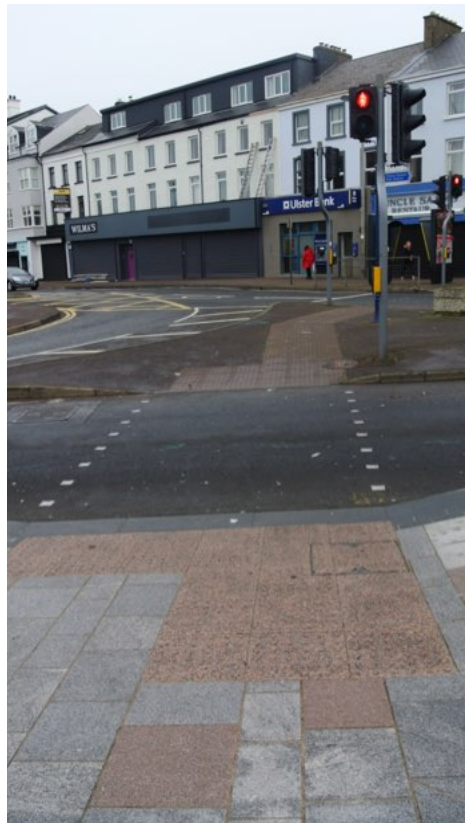
- 14 A controlled crossing has been provided from Station Square across Kerr Street to a traffic island. Tactile paving has been installed incorrectly on this crossing.

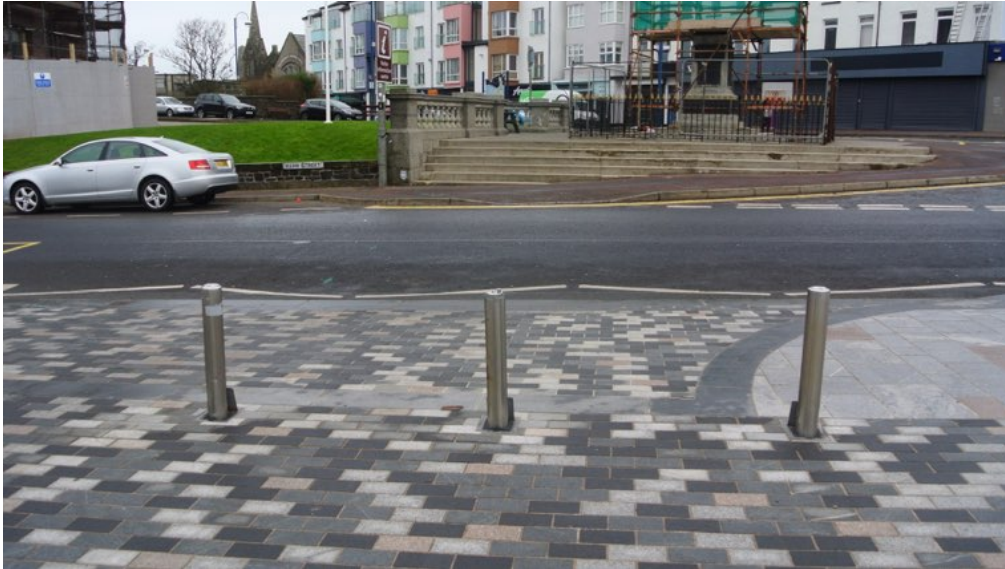
- 15 There is another “informal” uncontrolled crossing from Station Square across Kerr Street to the war memorial. The kerb is dropped here, but no tactile paving has been provided.

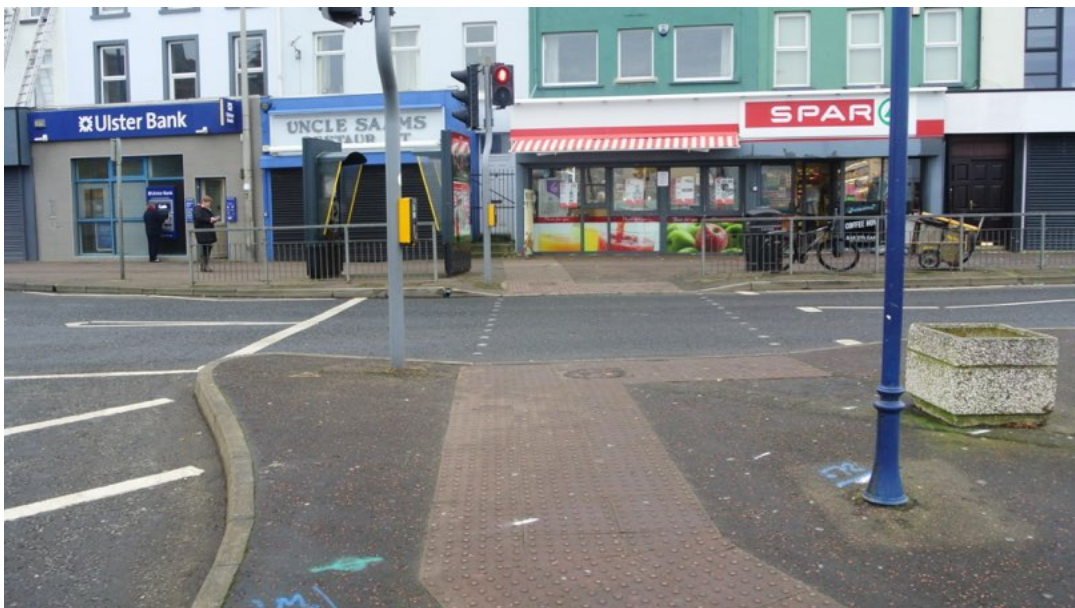
- 16 A further controlled crossing is provided from the traffic island to the eastern side of Eglington Street opposite to the Spar. Tactile paving has been installed incorrectly on this crossing.

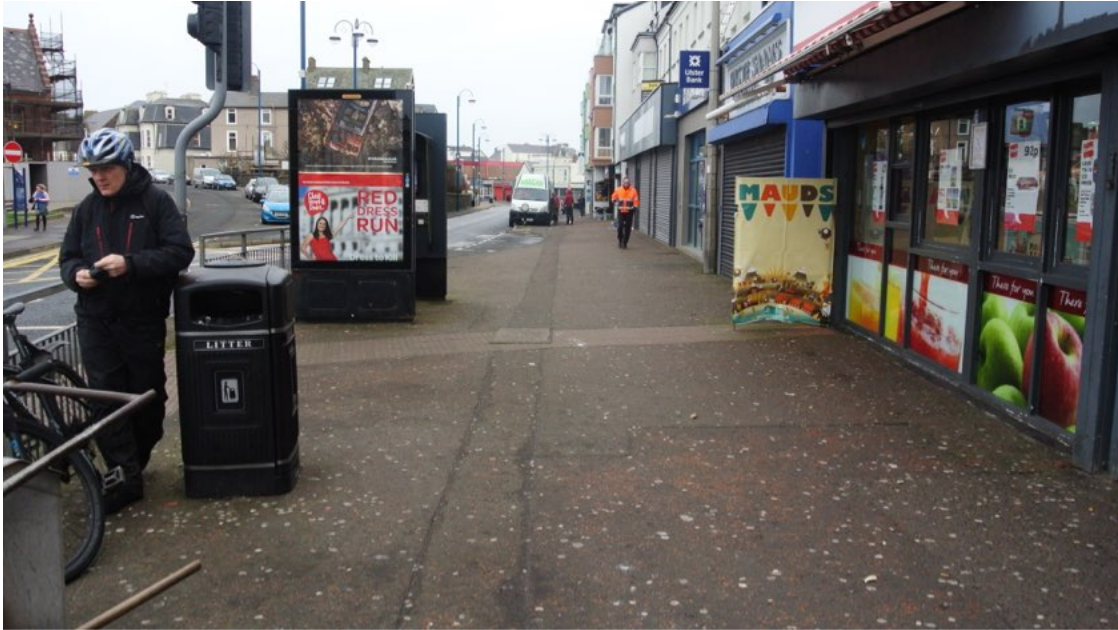
- 17 BT telephone kiosks on the footway on Eglington Street obstruct sight lines for pedestrians and drivers at this crossing. The pavement is relatively broad in this section of the street.

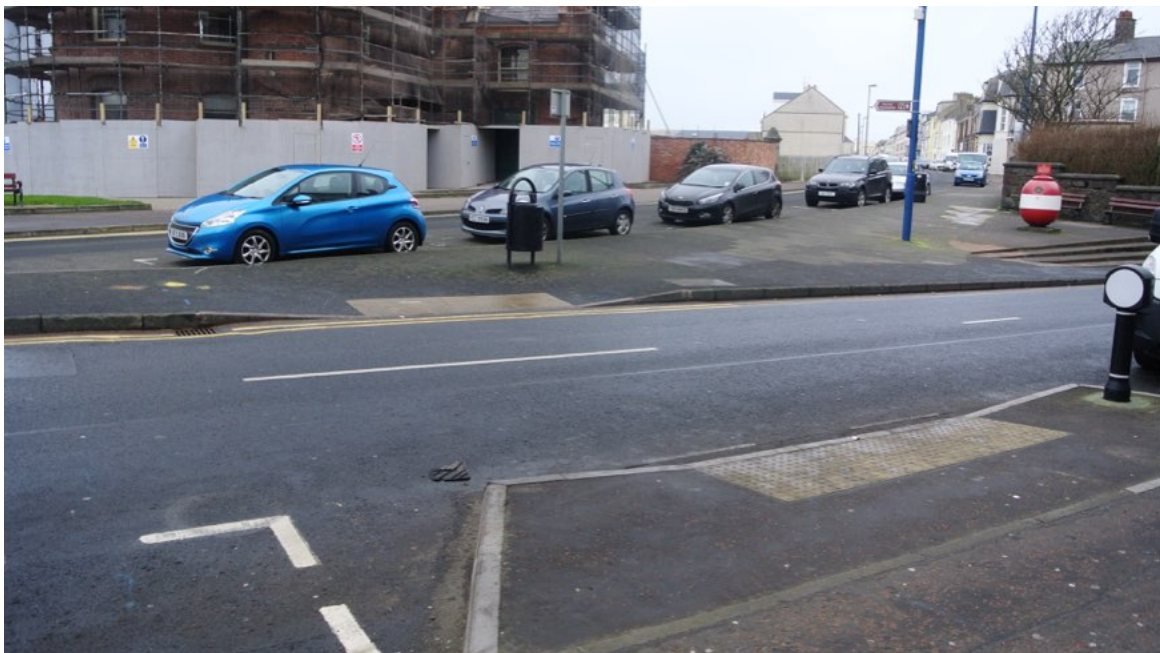
- 18 An uncontrolled crossing has been provided to enable people to access the western footway and Mark Street further along Eglington Street. This is a good example of an uncontrolled crossing although parking does obstruct sight lines for pedestrians and drivers.

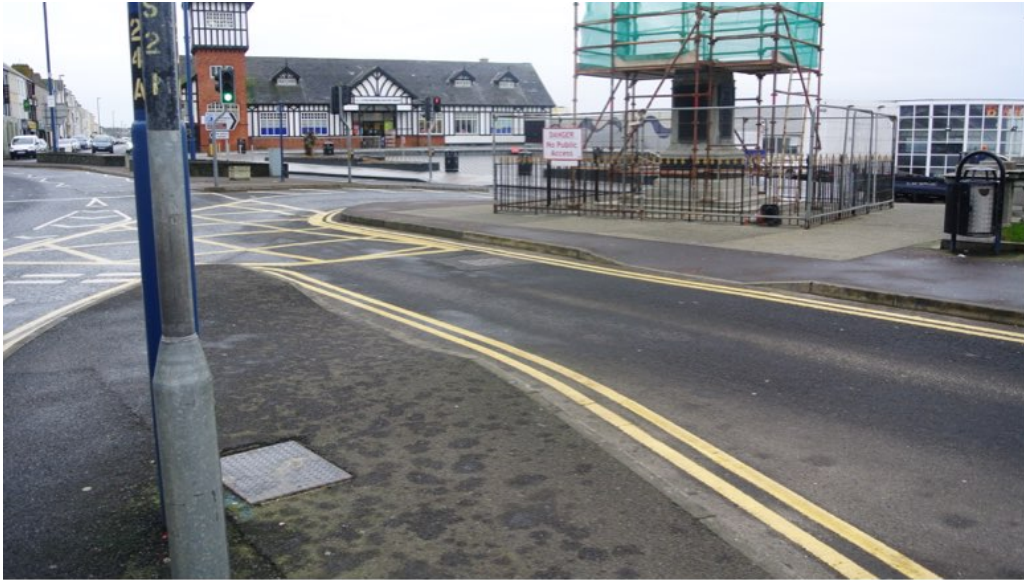
- 19 On the western side of Eglinton Street there is a further uncontrolled crossing across Mark Street towards the war memorial. No tactile paving has been provided at this crossing.

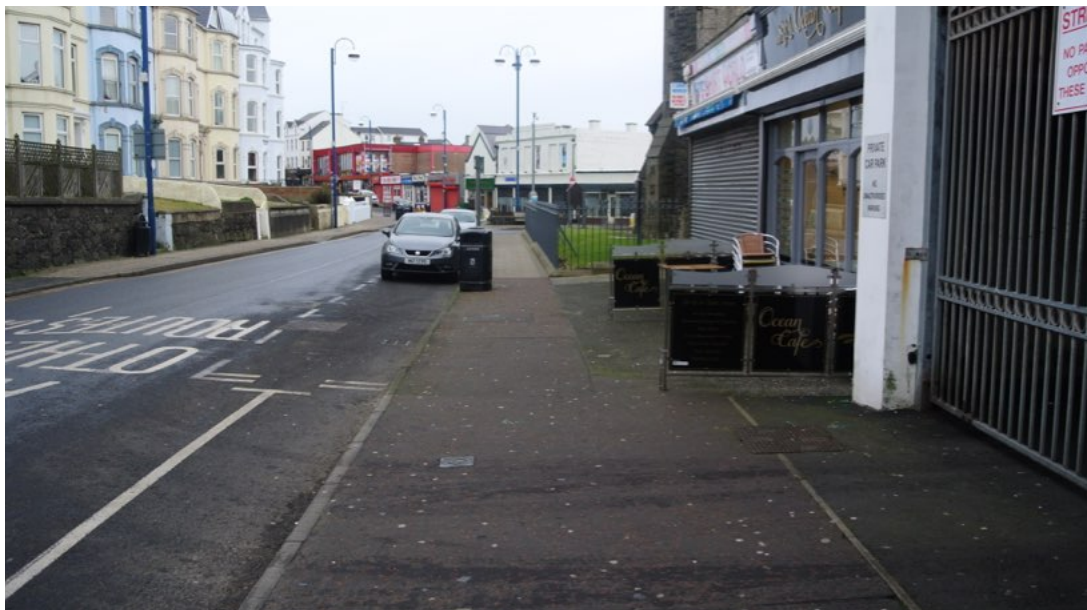
- 20 The pavement on the eastern side of Eglinton Street narrows towards Main Street and Causeway Street. There is an indication that pavement cafes and shop displays may reduce pavement width further during summer months. The location of bins further reduces pavement width at points.

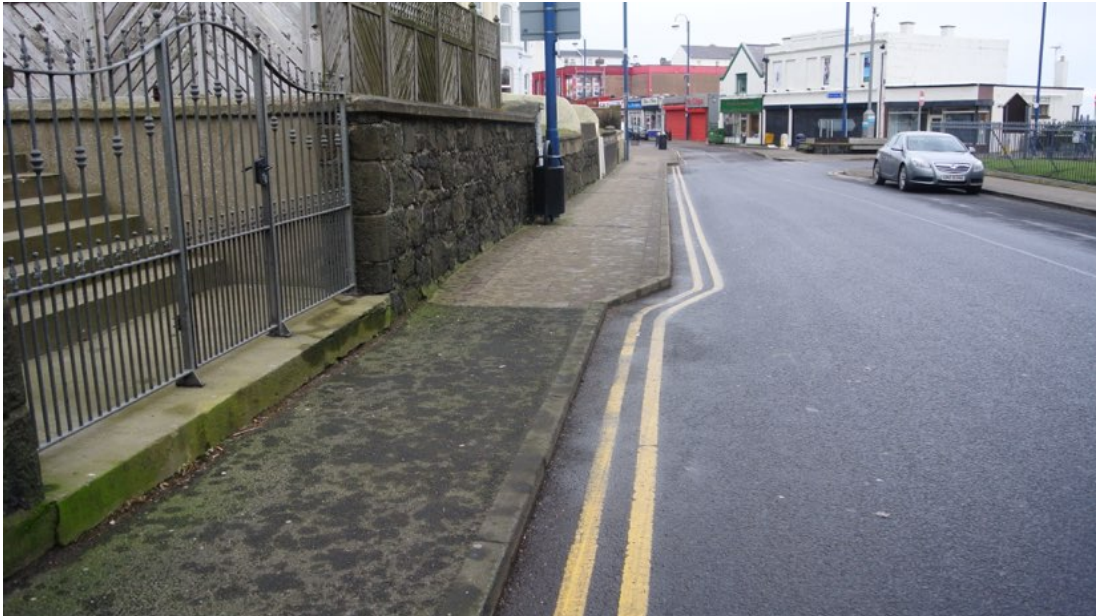
- 21 The pavement on the western side of Eglinton Street is exceptionally narrow at points.

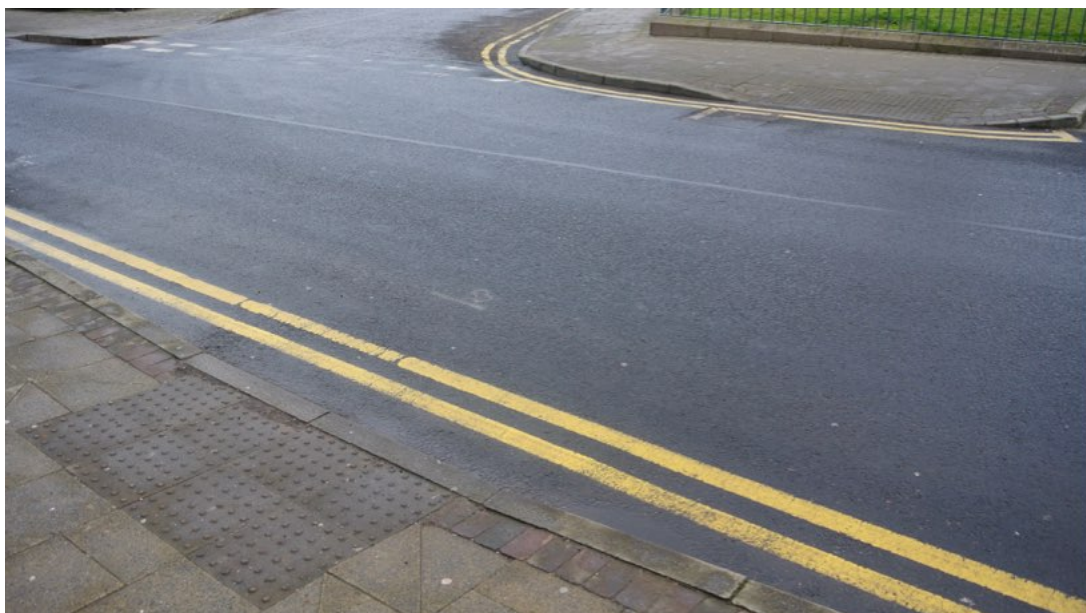
- 22 There is an uncontrolled crossing across Eglinton Street just before the junction with Causeway Street and Main Street. The tactile paving does not contrast sufficiently with the surrounding paving.

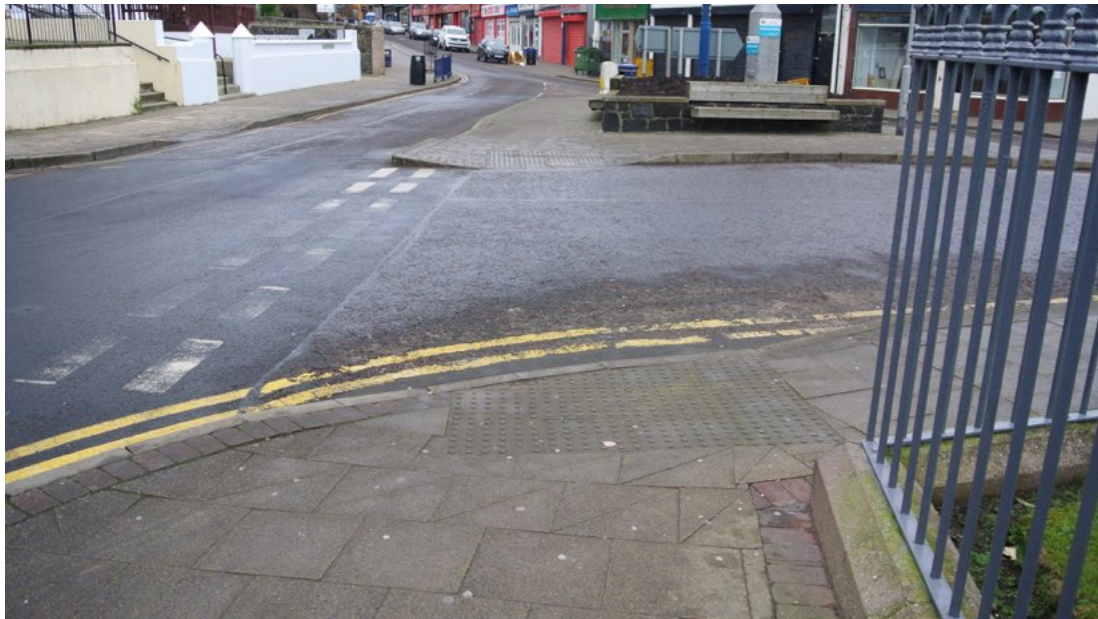
- 23 At the junction of Eglinton Street, Causeway Street and Main Street there is a traffic island. Although dropped kerbs with tactile paving have been provided to enable pedestrians to cross between these streets this is less than satisfactory as it is extremely difficult for people with visual impairment to navigate safely.

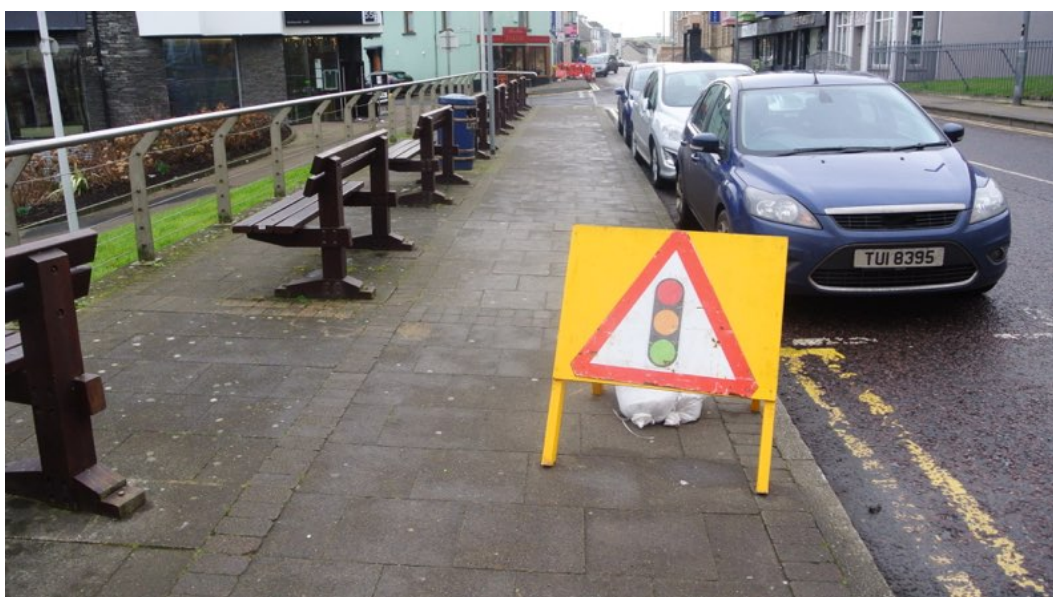
- 24 The footways on both sides of Causeway Street are relatively narrow. Signage associated with road works obstructed the eastern footway at the time of the survey.

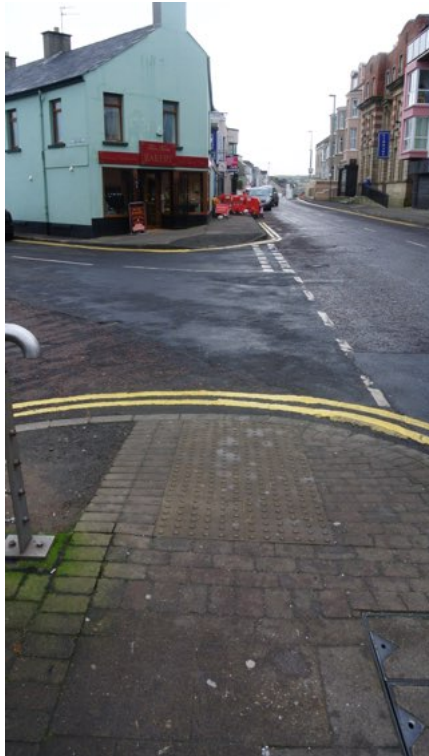
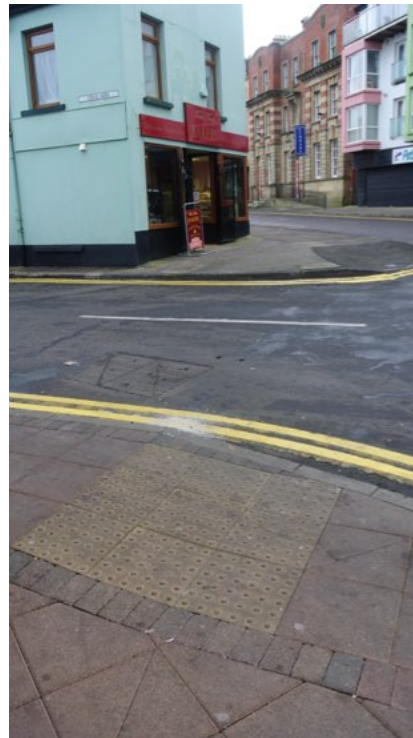
- 25 On the eastern footway there is a junction with Craig Vara . Provision for crossing this street is confusing and in need of upgrading.

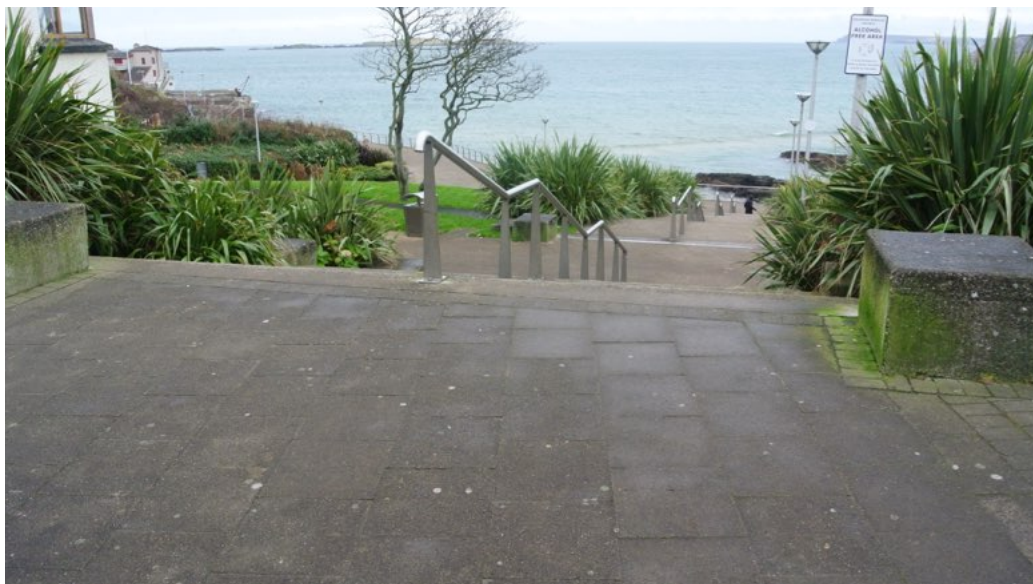
- 26 There are steps provided from the eastern footway of Causway Street providing access to the promenade. There is no corduroy tactile paving provided at the steps to indicate a potential hazard for people with a visual impairment.

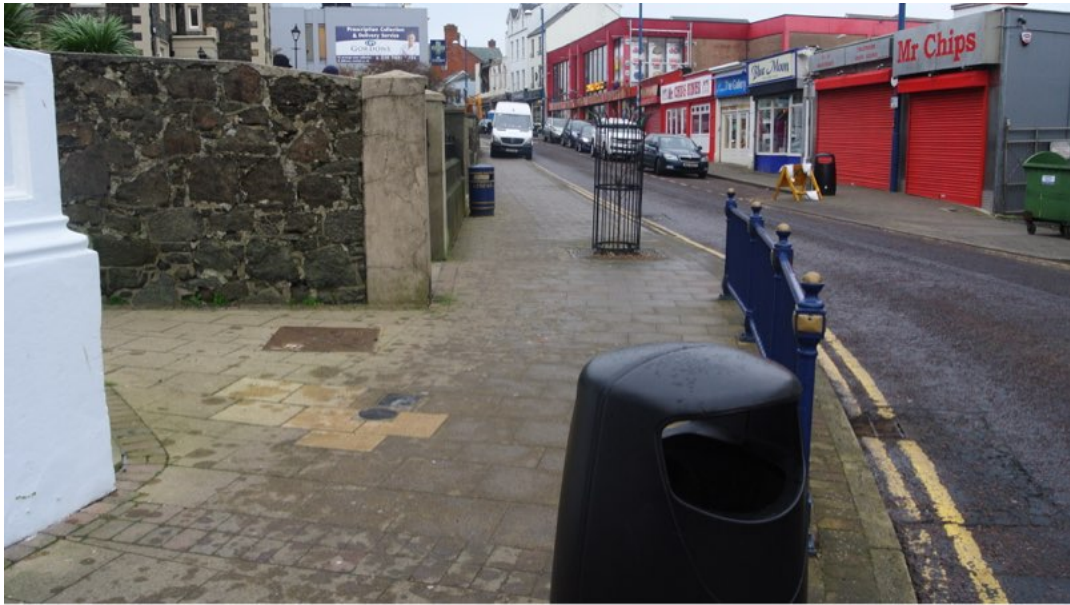
- 27 The footway on the western side of Main Street close to the junction with Eglington Street is relatively narrow. The location of bins and trees further restricts width. A van parked on the pavement creates a major barrier for all pedestrians.

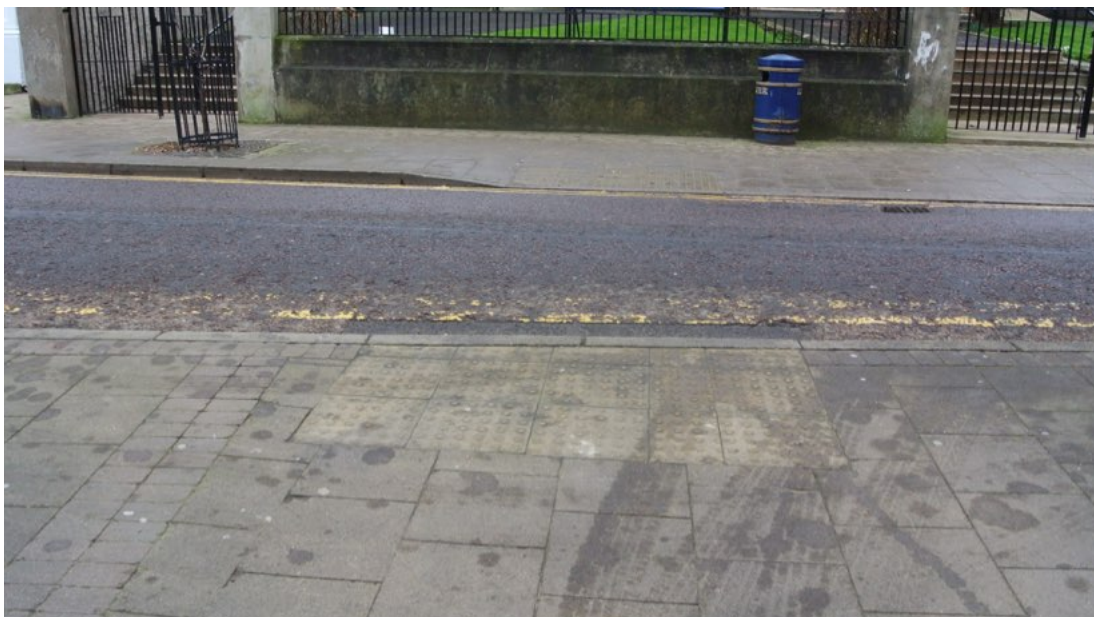
- 28 There is an uncontrolled crossing at the church to the eastern side of Main Street. Tactile paving is provided but does not contrast sufficiently with surrounding paving.

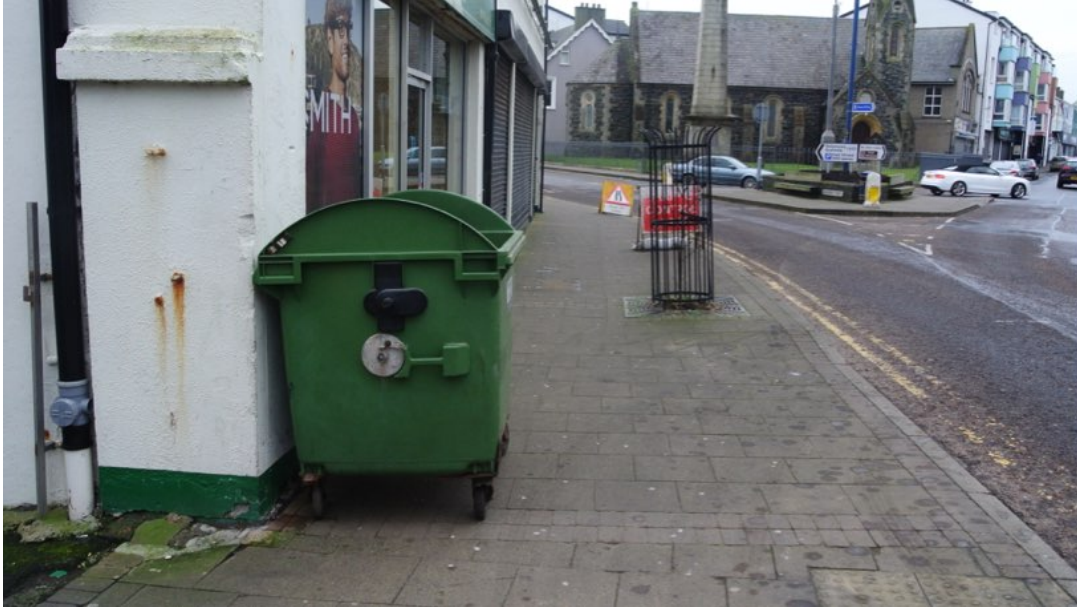
- 29 The footway on the eastern side of Main Street near the junction with Causeway Street is narrow. A variety of clutter including large refuse bins narrows the footway further.

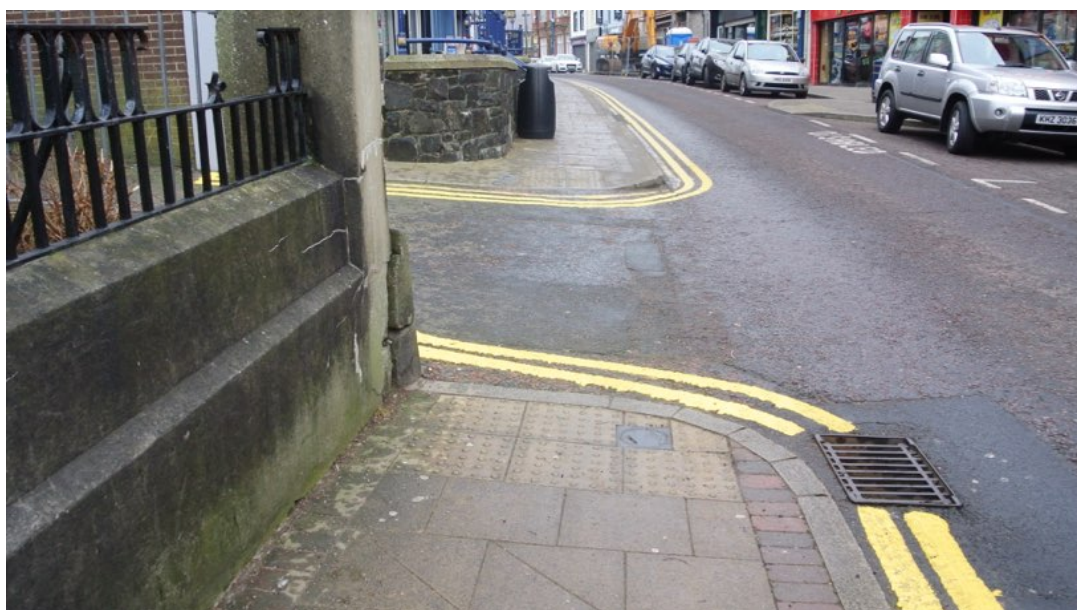
- 30 An uncontrolled crossing is provided across the junction with Manse Avenue on the western side of Main Street. Lack of contrast and tactile paving is again an issue as is the location of litter bins as is a cross fall on the footway.

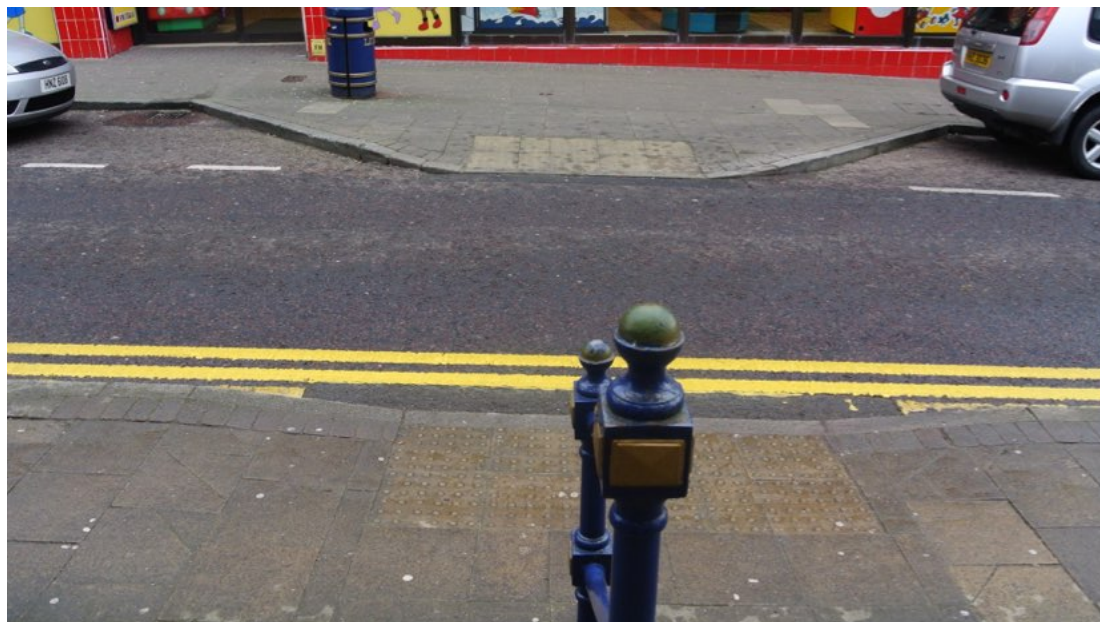
- 31 A well designed uncontrolled crossing (other than tactile paving contrast) across Main Street is provided just after Manse Avenue.

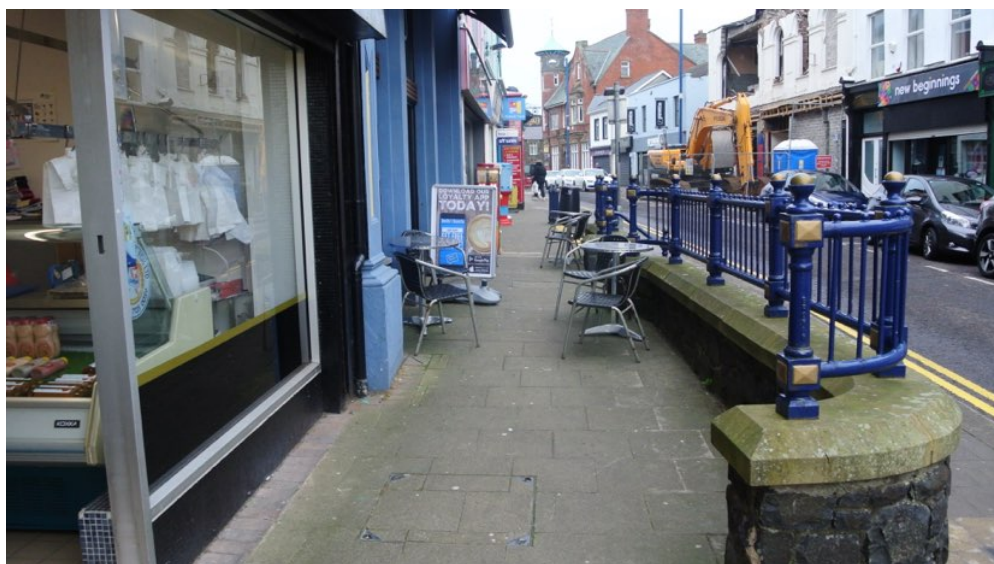
- 32 At this point on the western footway is a series of shops (including a chemists) only accessible via steps or a ramp. The ramp has a reasonable gradient but is completely obstructed by a pavement café and associated A boards. The ramp also has a section with an unprotected edge. Although attempts have been made to improve the visibility of this section it remains a potential hazard for people with visual impairment.

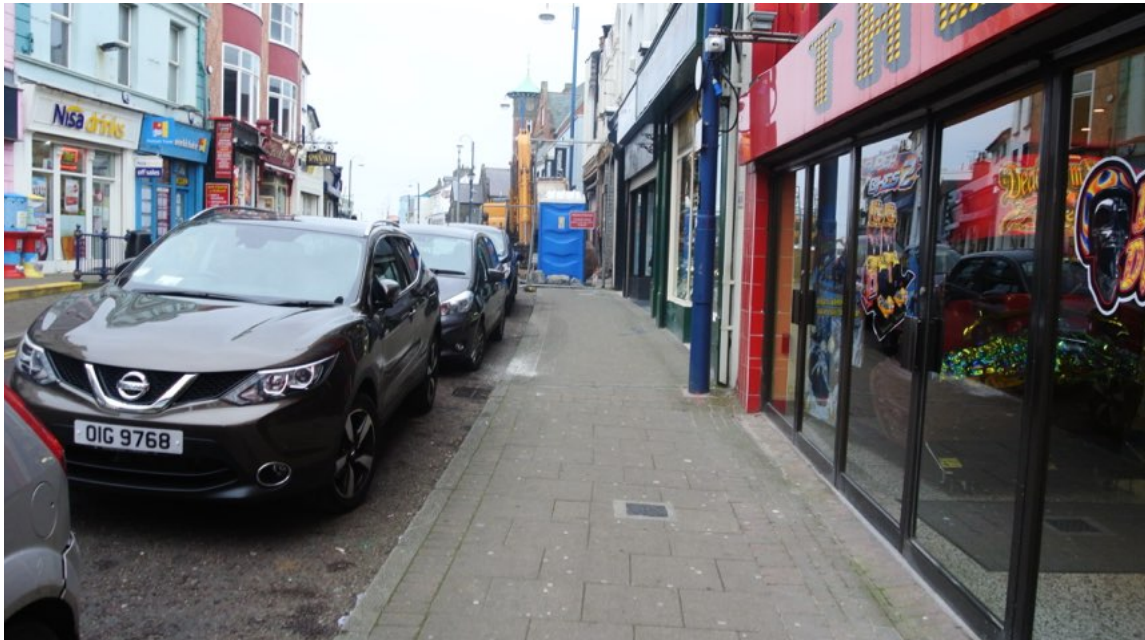
- 33 On the eastern footway at this point a major building project blocks the footway entirely. No provision has been made to provide an accessible route around the obstruction.

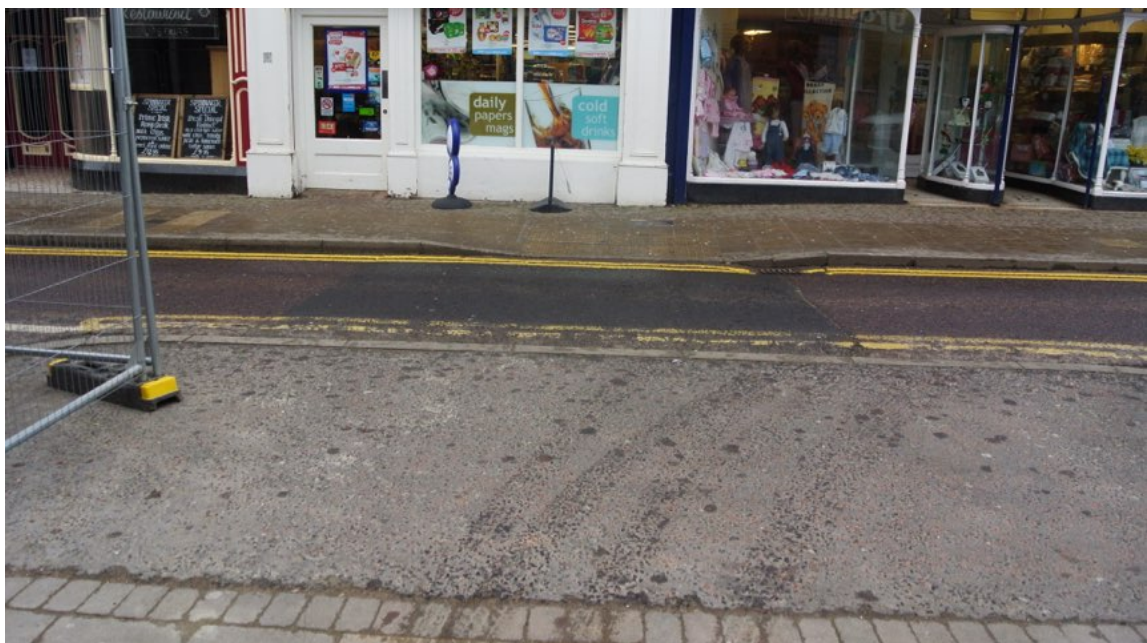
- 34 There is another uncontrolled crossing across Main Street just after this point. No tactile paving has been provided on the eastern footway.
