**Report on Walking routes in Portrush Town Centre**

**(April 2017)**

The report was compiled following an inspection of Portrush town centre in February 2017. It considers the current provision of pedestrian facilities on streets that form part of the proposed public realm scheme measured against accepted accessibility standards<sup>1</sup>. The report identifies potential barriers for disabled people and older people. A key aspect of the report is linkage between the pedestrian environment and bus and rail facilities in Portrush. Two reports have been produced, a text only version and version where photographs have been used to highlight barriers and good practice.

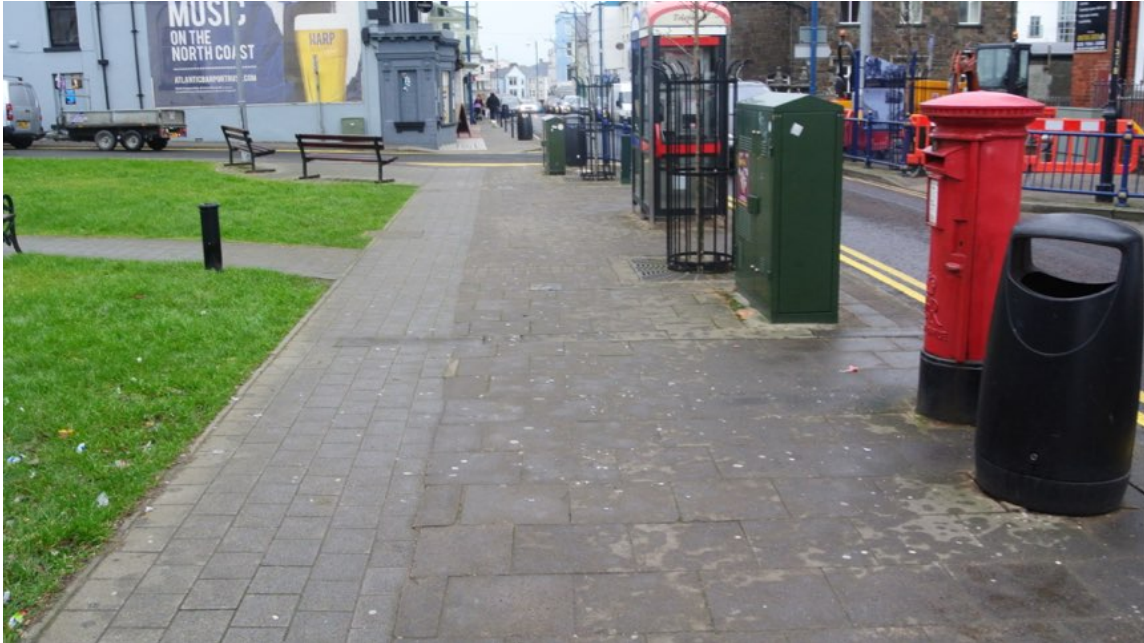
- 35 Approaching the junction with Atlantic Avenue on the western side there is a collection of street furniture. Although in a consistent line the area would benefit from reducing the amount of clutter.

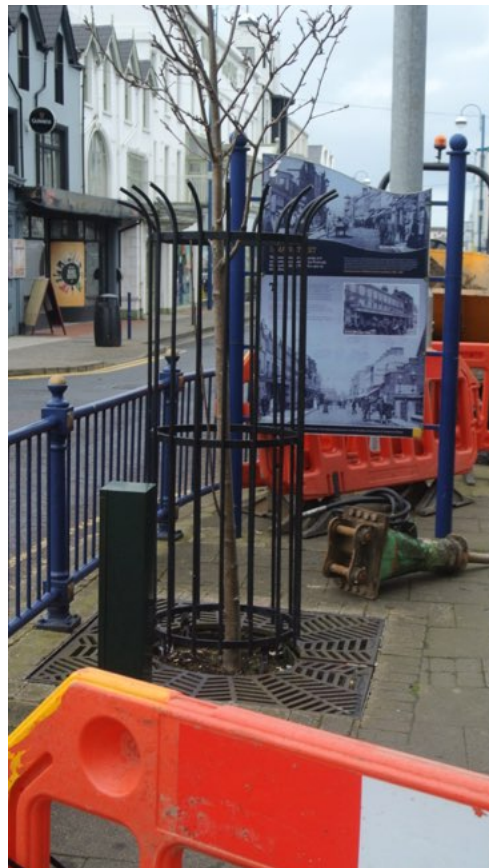
- 36 The eastern footway there is similar clutter. The provision of pedestrian railings on both sides of the road does appear to be unnecessary.

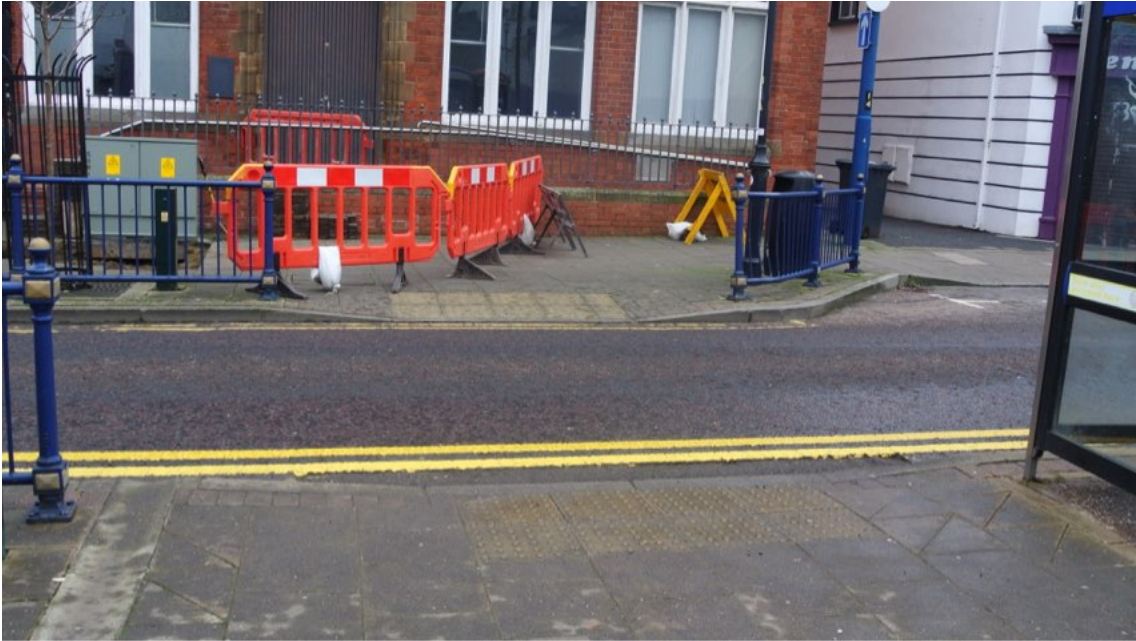
- 37 An uncontrolled crossing across Main Street is provided before the junction with Atlantic Avenue.

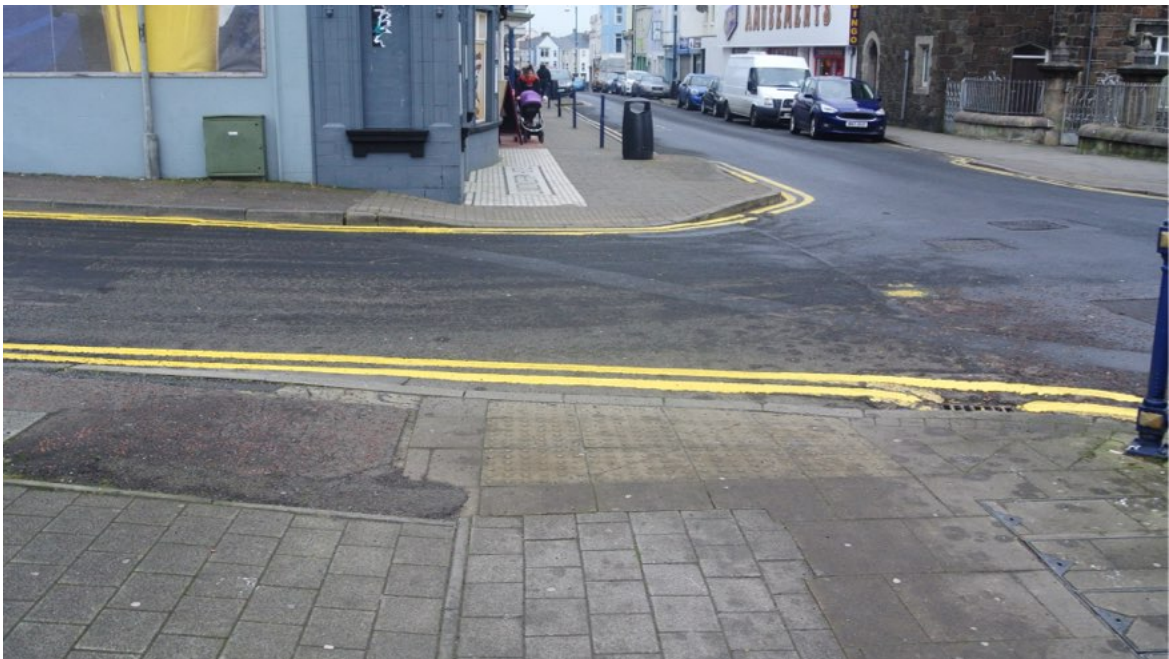
- 38 There are uncontrolled crossing across Atlantic Avenue on the western footway and Church Pass on the eastern footway. Although adequate the area would benefit from improved surfaces and stronger contrast between tactile paving and the surrounding paving.

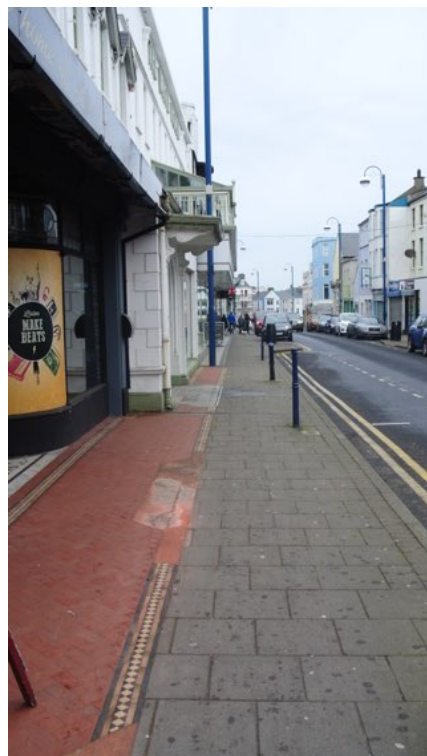
- 40 The footway narrows on the western side after the junction. Bollards create additional obstructions.

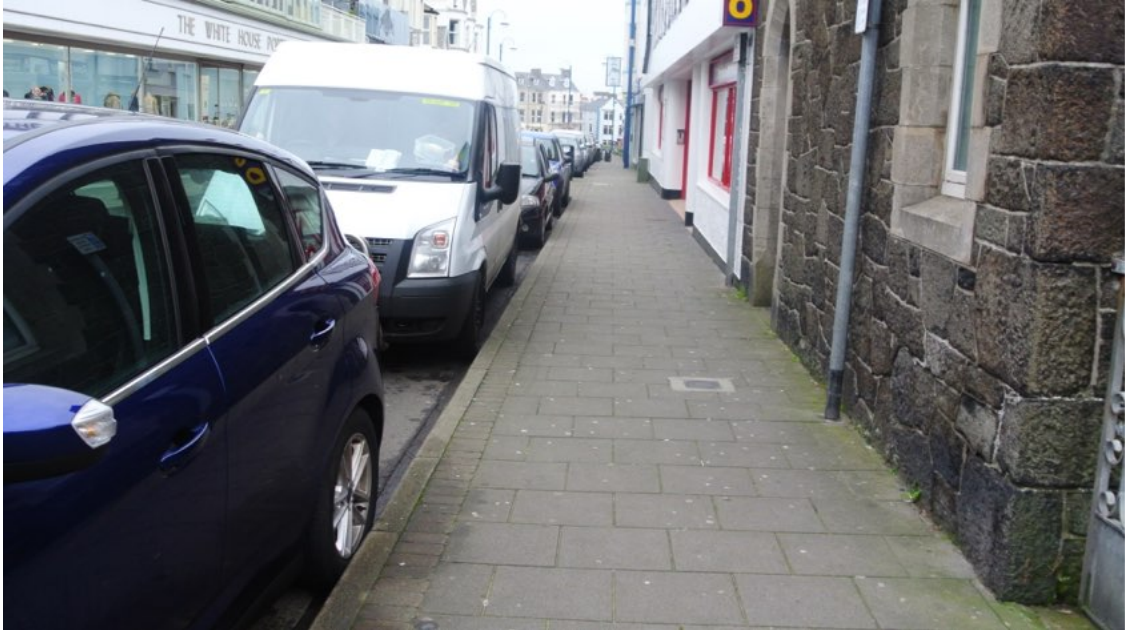
- 41 The footway on the eastern side is relatively narrow but also uncluttered in this area.

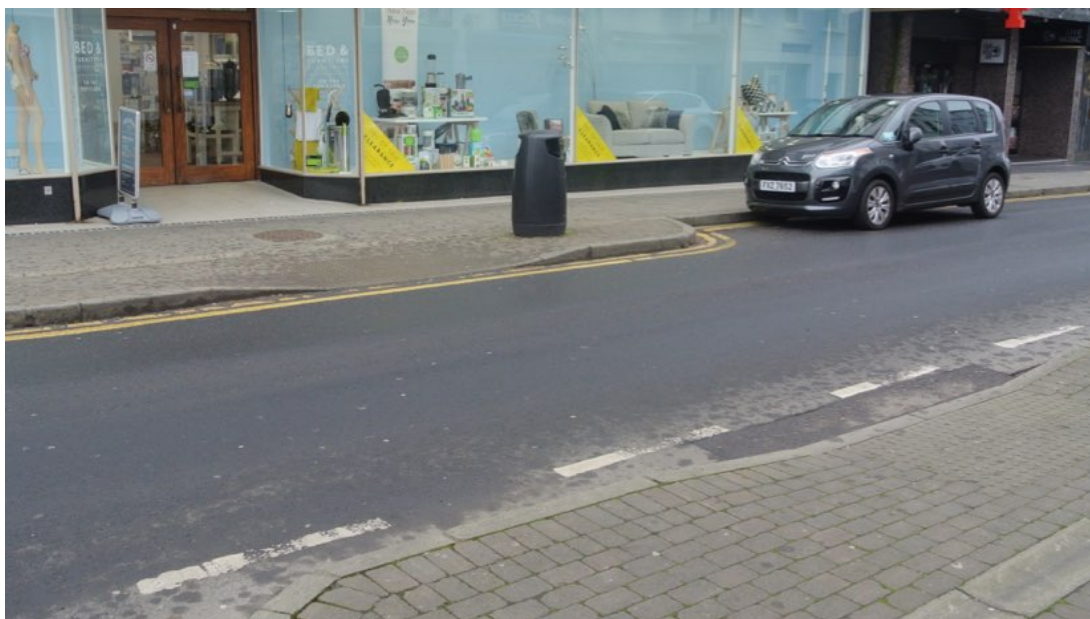
- 42 An uncontrolled crossing across Main Street is provided outside the White House. The tactile paving does not contrast sufficiently with the surrounding paving.

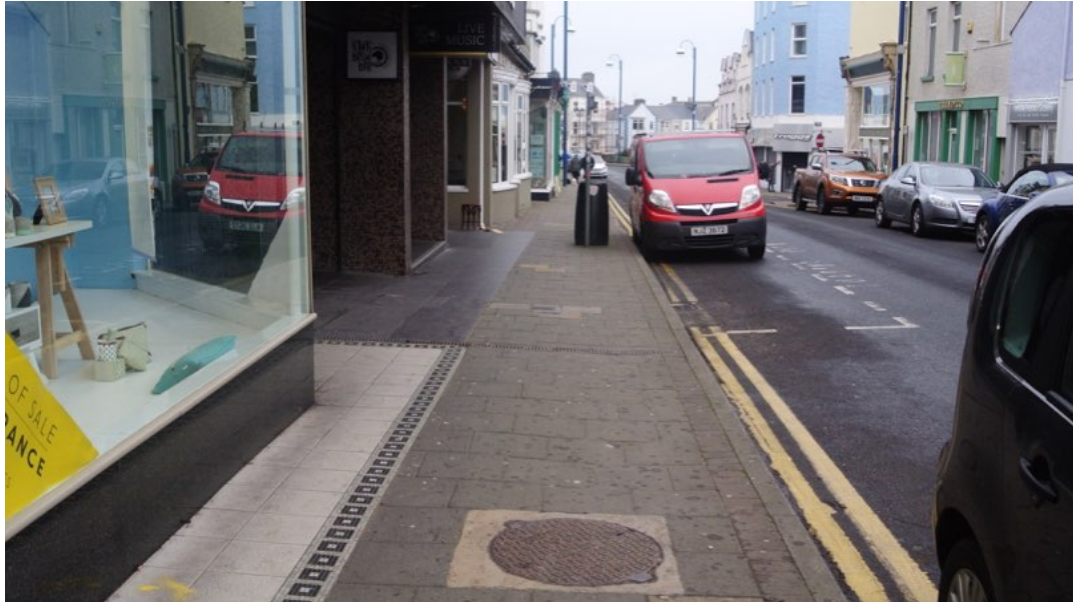
- 43 Traffic sign poles and bins create obstructions on an already narrow western footway at this point.

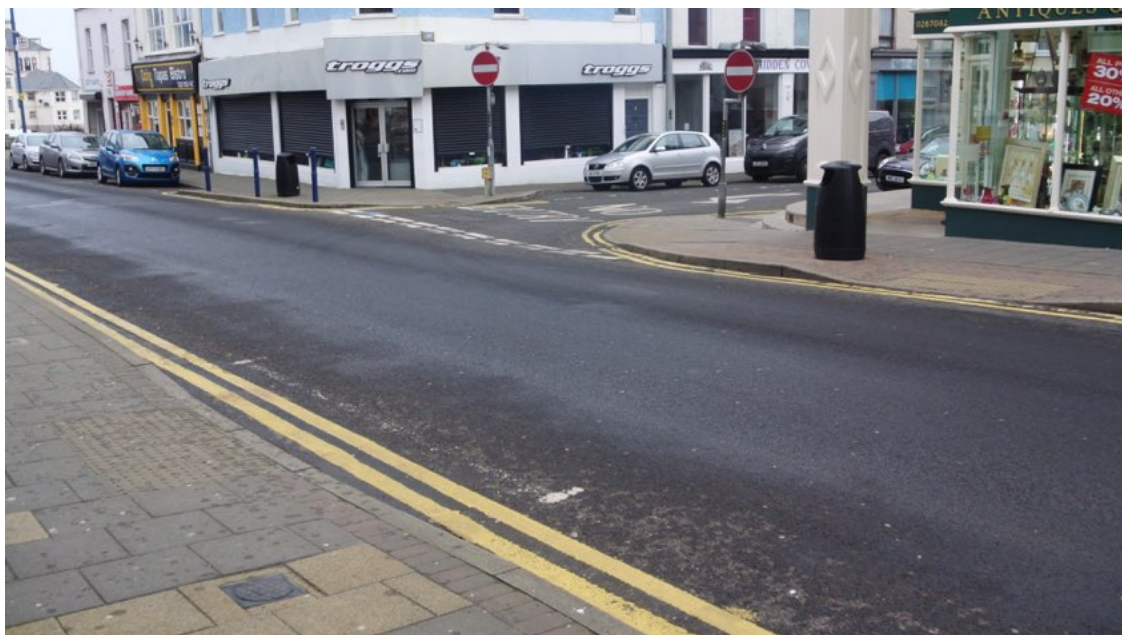
- 44 An uncontrolled crossing across Main Street is provided approaching the junction with Bath Street. The tactile paving does not contrast sufficiently with the surrounding paving.

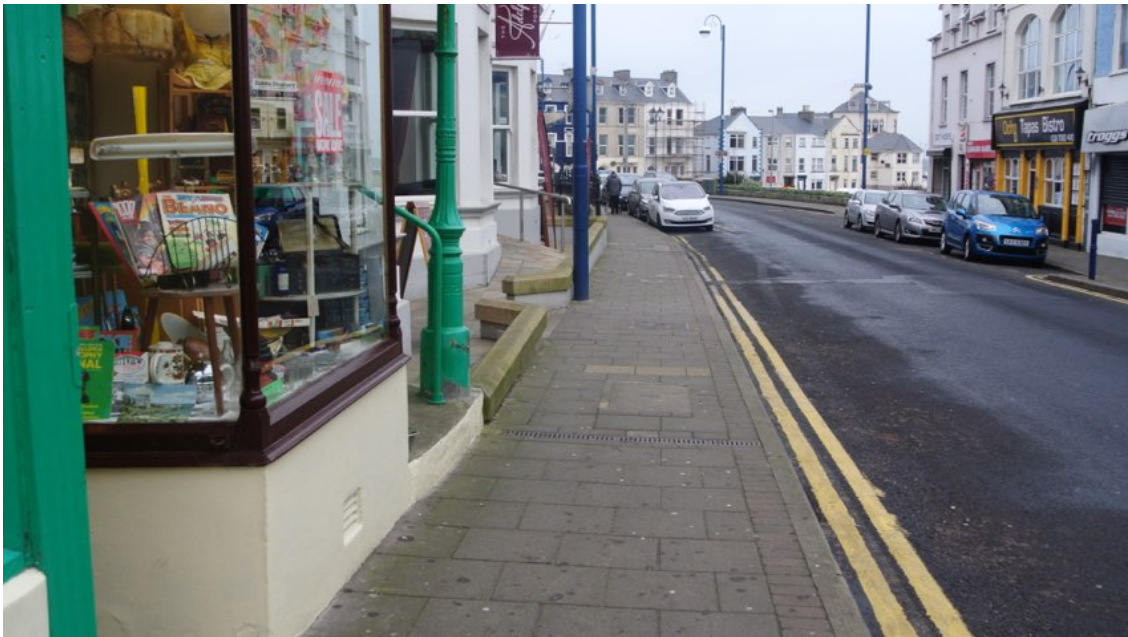
- 45 The footway on the western side of Main Street continues to be narrow but relatively uncluttered.

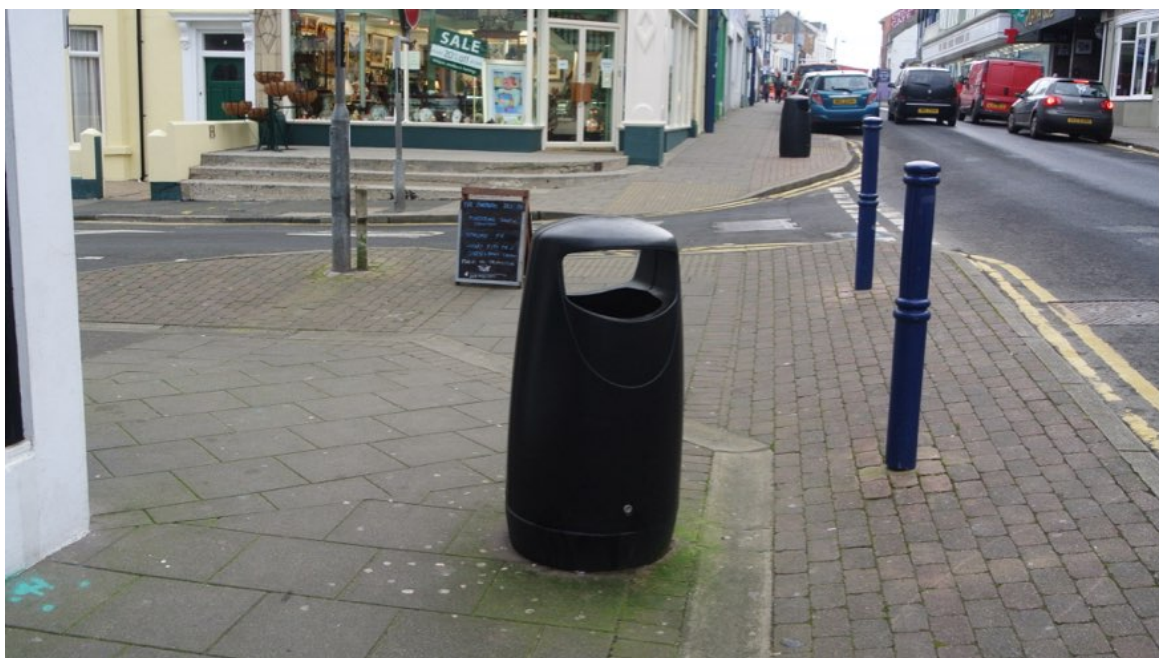
- 46 An uncontrolled crossing is provided across the junction with Bath Street. There are significant crossfalls on the footway around this junction. Bins and A Boards obstruct narrow pavements on Main Street after the crossing.

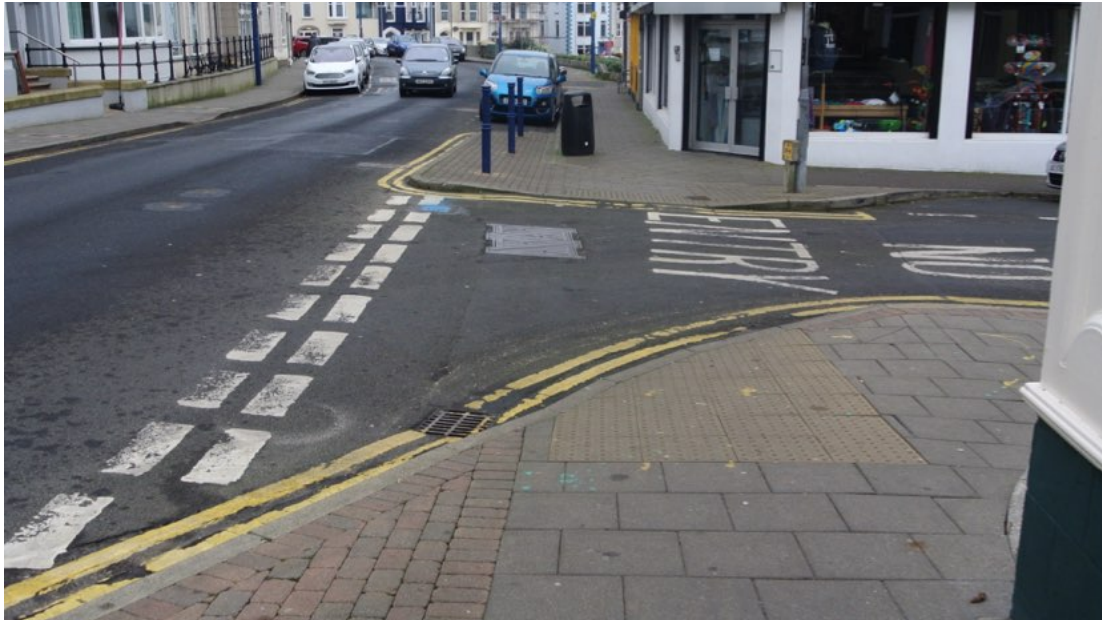
- 47 Just after this point a dropped kerb is provided on the western footway of Main Street but not on the eastern footway. This could be confusing and dangerous to someone with a visual impairment.

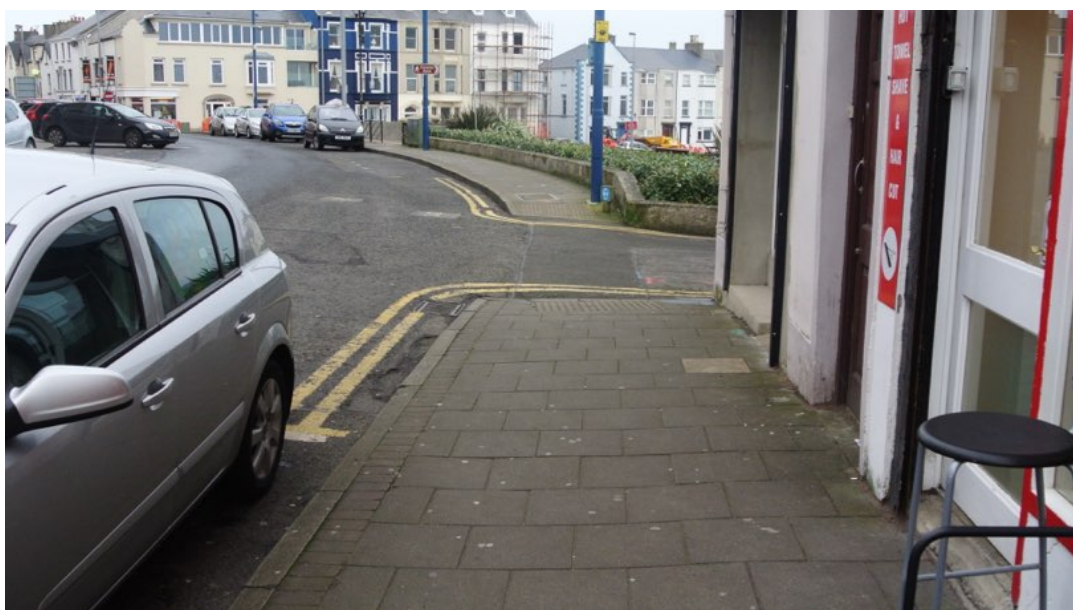
- 48 An uncontrolled crossing is provided across the junction with Antrim Gardens on the eastern footway. The footway narrows after this point.

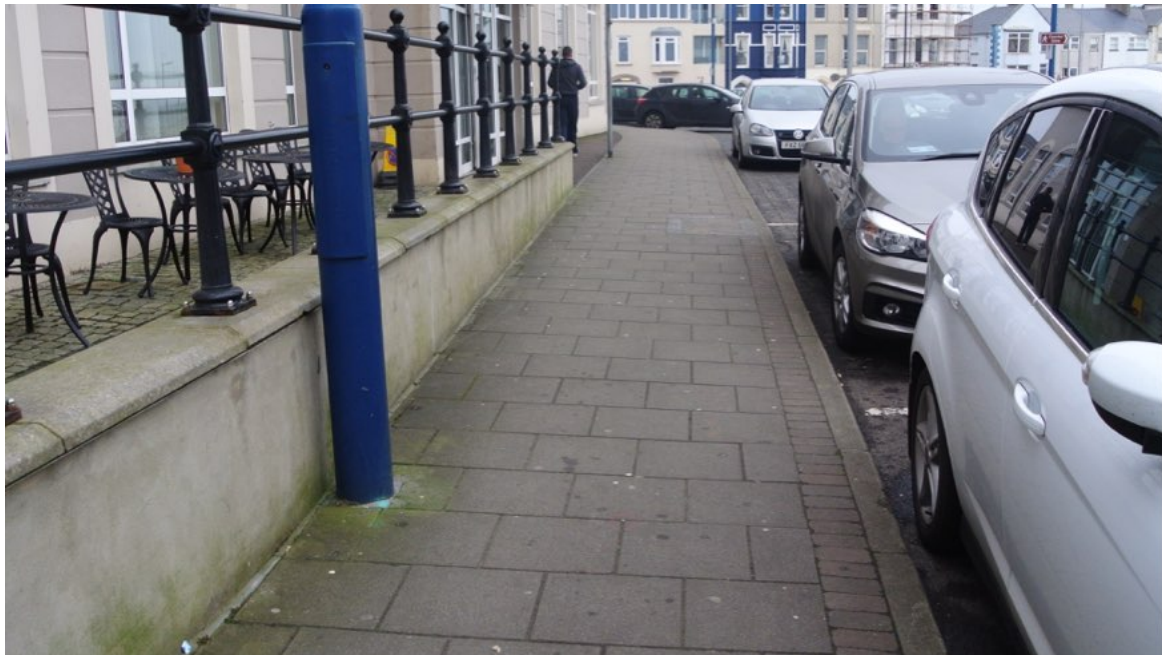
49 The footway on western side remains narrow but uncluttered.

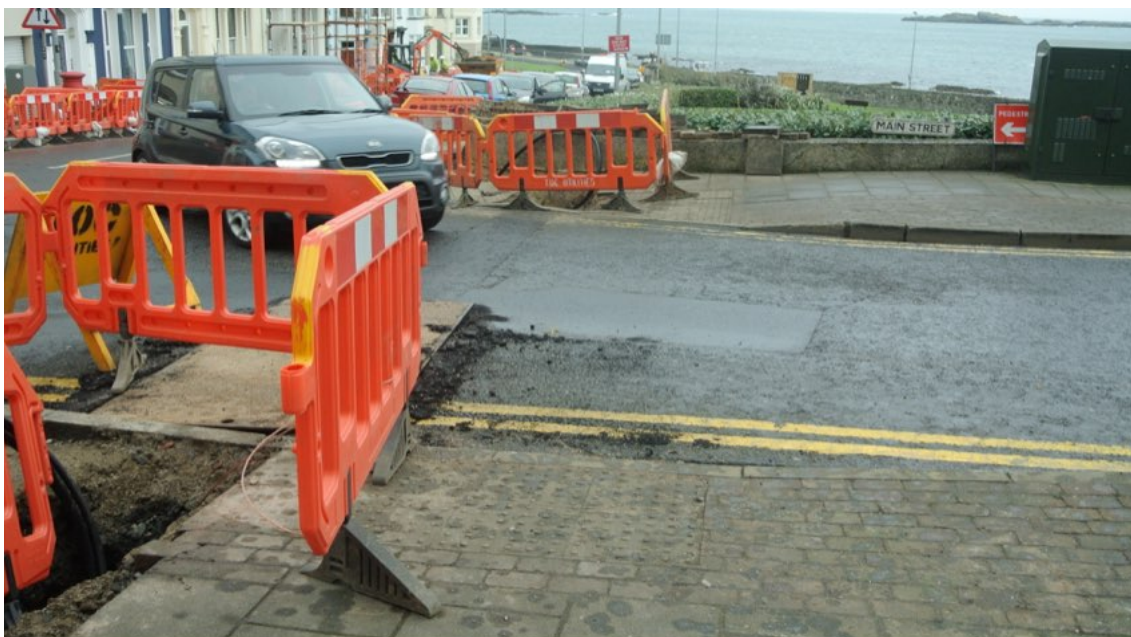
50 There is an uncontrolled crossing across Main Street just before the junctions with Causeway View and Mark Street. The tactile paving does not contrast sufficiently with the surrounding paving.

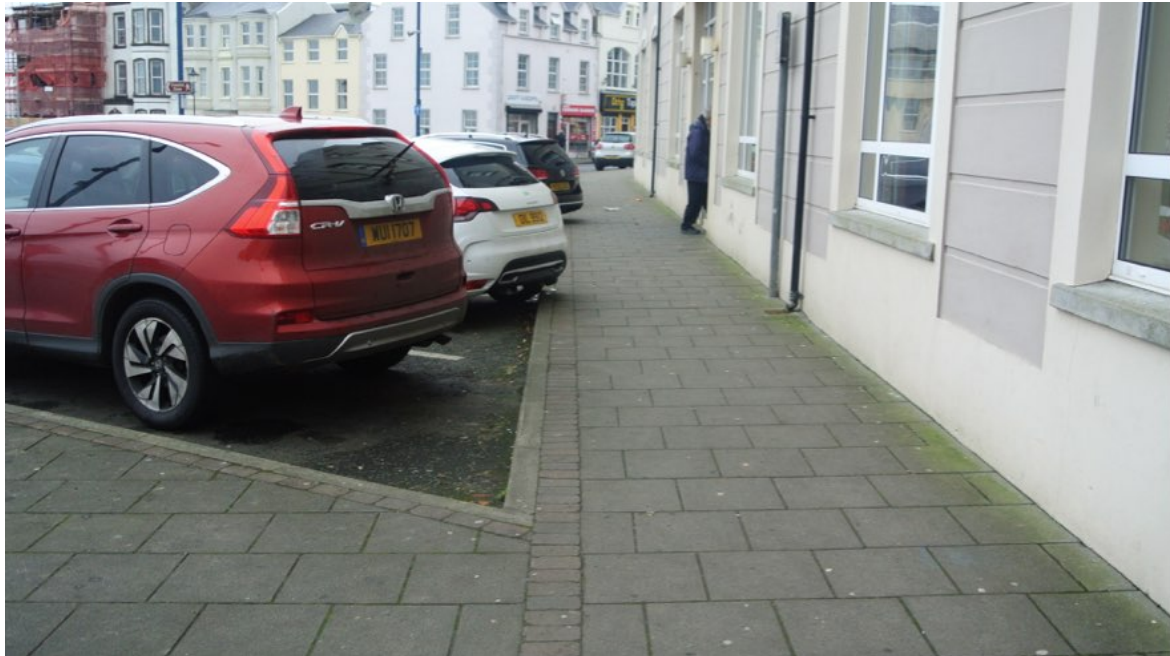
- 51 Vehicles parked at the hotel on Main Street overhang the footway reducing available width and create potential hazards for people with visual impairment.

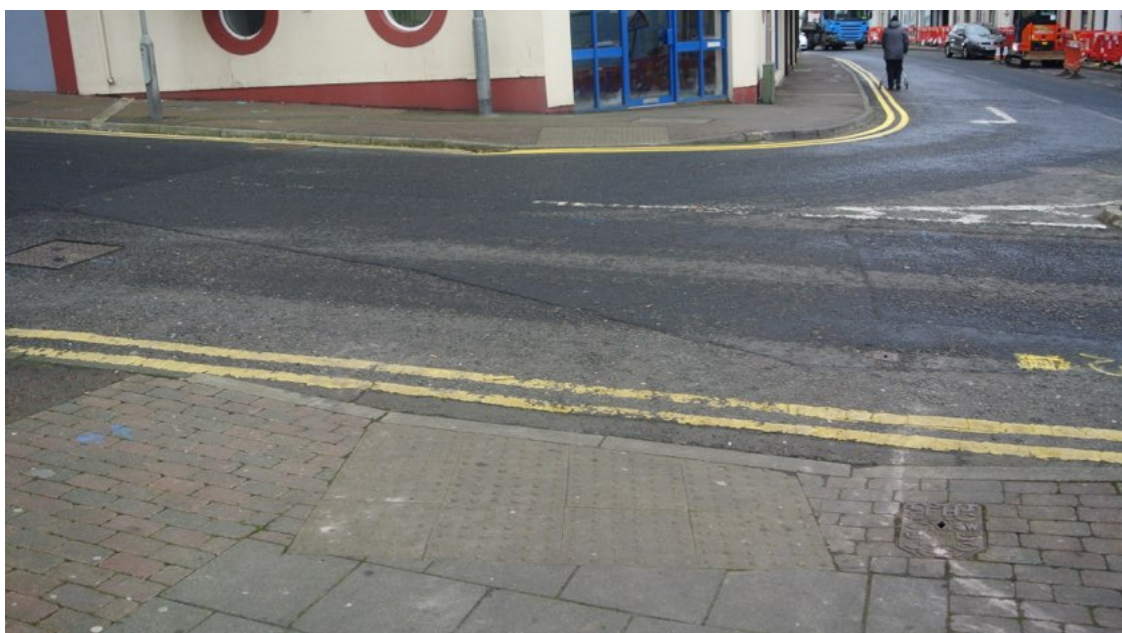
- 52 Uncontrolled crossings have been provided across both Mark Street and Causeway View to enable pedestrian access to the remainder of Main Street. The tactile paving does not contrast sufficiently with the surrounding paving.

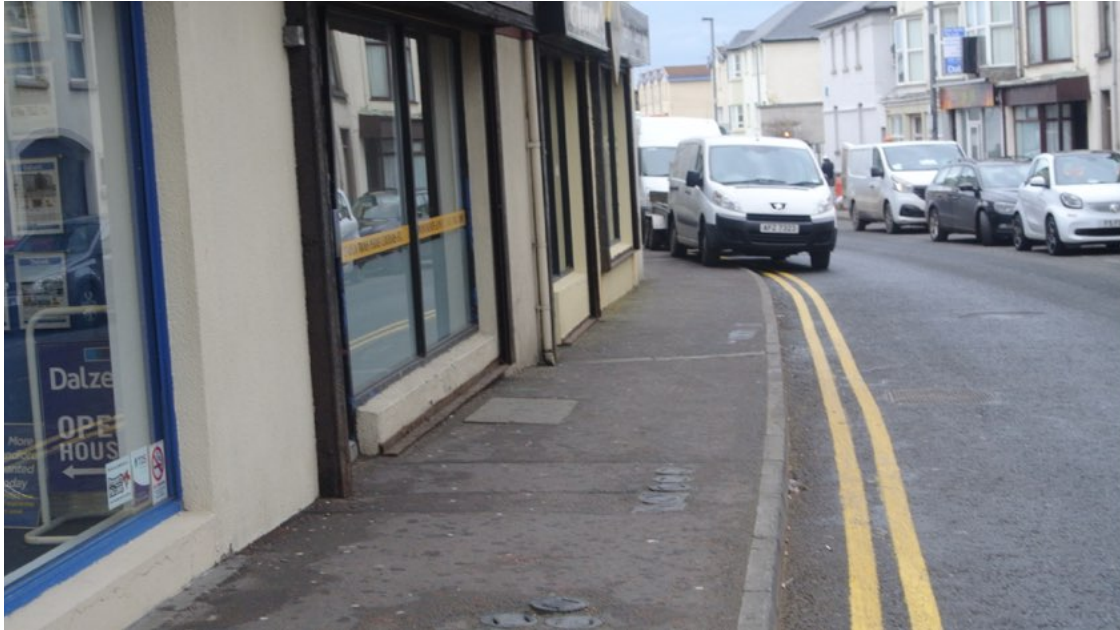
- 53 Utility works were taking place on Main Street in this area so a proper assessment could not be made. However vehicles parked on the western footway created obstructions along the street.

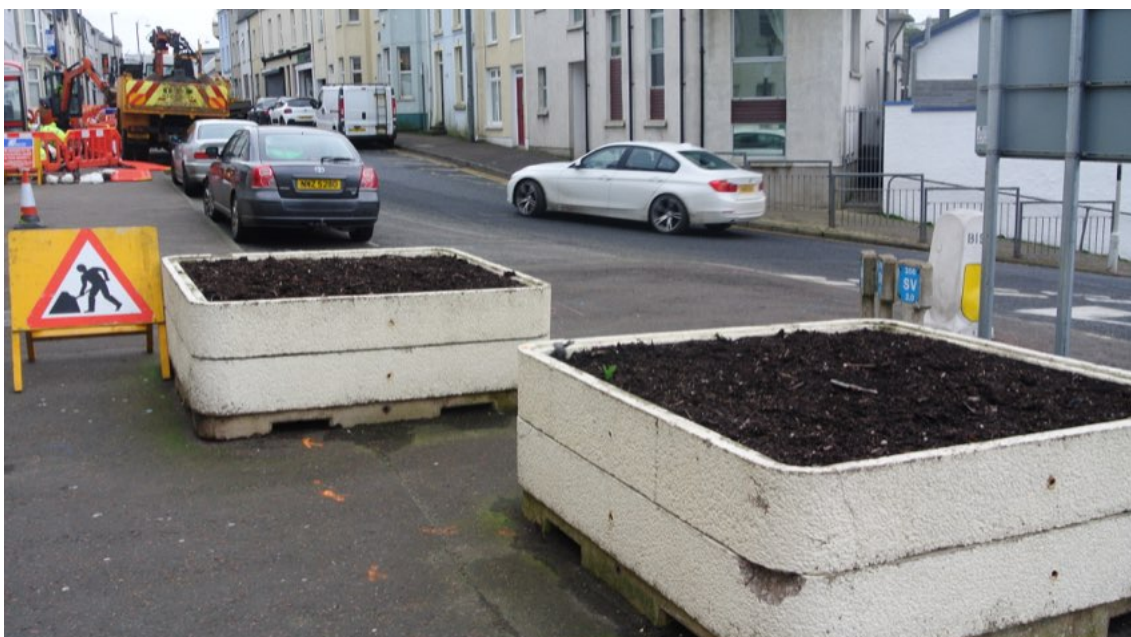
- 54 There are limited opportunities to cross Main Street along the section from Mark Street to Kerr Street. Difficulties are particularly acute at the harbour end of the road at its junction with Kerr Street where there are no safe, accessible routes to cross. This needs to be rectified. As this is a link with the Coastal Way the lack of basic pedestrian access is a major concern.

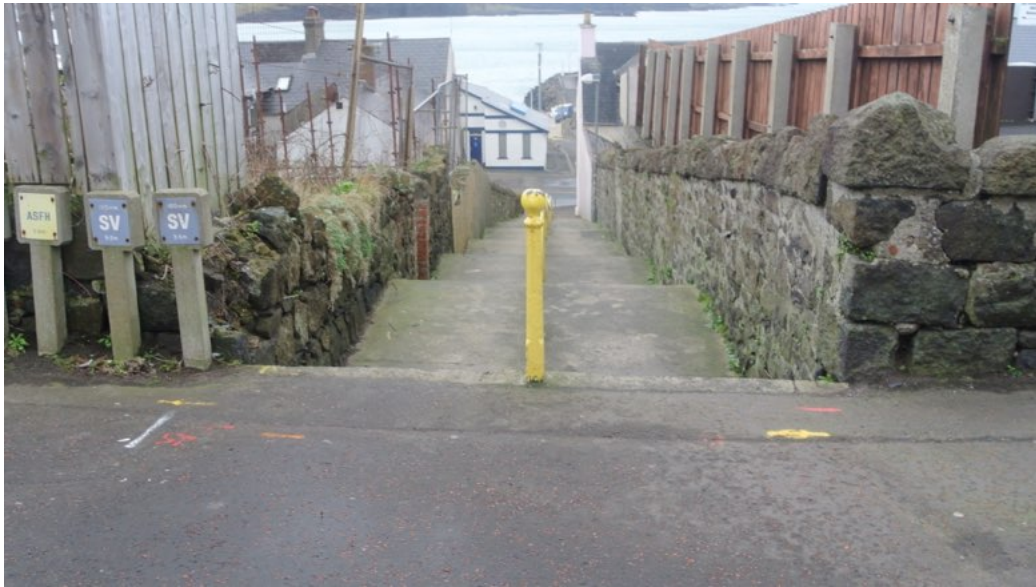
- 55 Atlantic Avenue and Church Pass provide a crucial link between the east and west strands in the town. Pedestrian access to West Strand is via a set of steps between Mark Street and Kerr Street. The steps are currently inaccessible, with no corduroy tactile paving provision, limited handrails and are extremely unattractive.

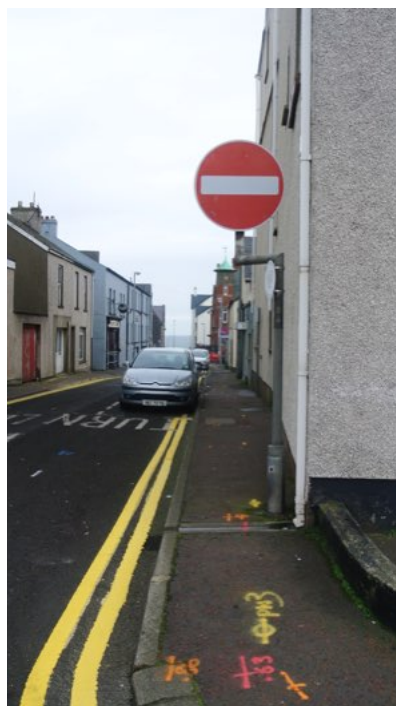
- 56 The footways along Atlantic Avenue are extremely narrow with a number of vehicle access points. There street would benefit significantly from enhancing pedestrian facilities including broader footways and pedestrian priority at vehicle entrances.

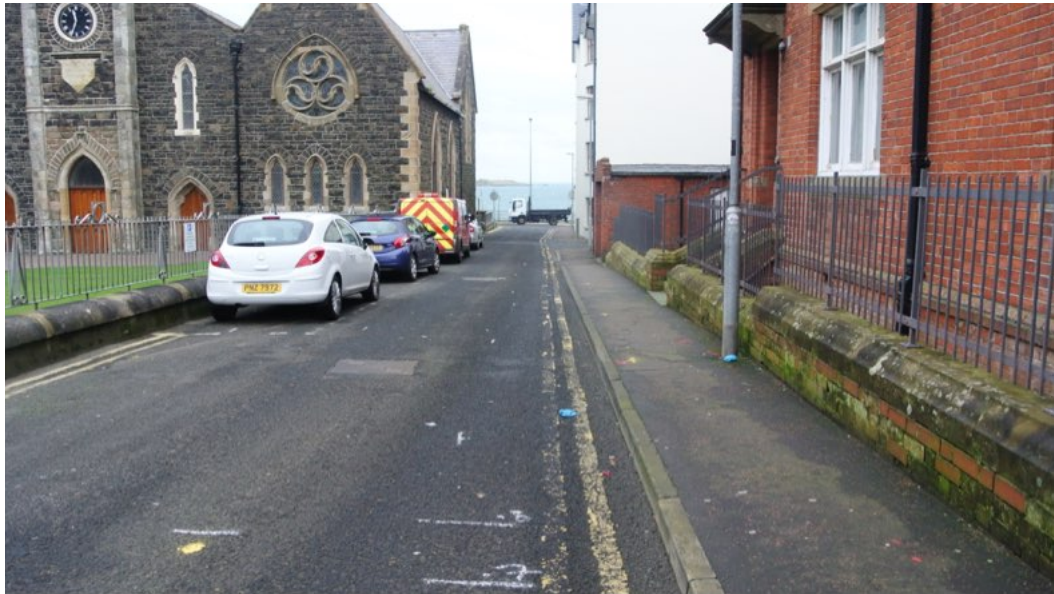
- 57 Church Pass currently only has a narrow footway on the southern side of the street. As with Atlantic Avenue pedestrians would benefit from enhanced provision and priority at vehicle entrances along the street.

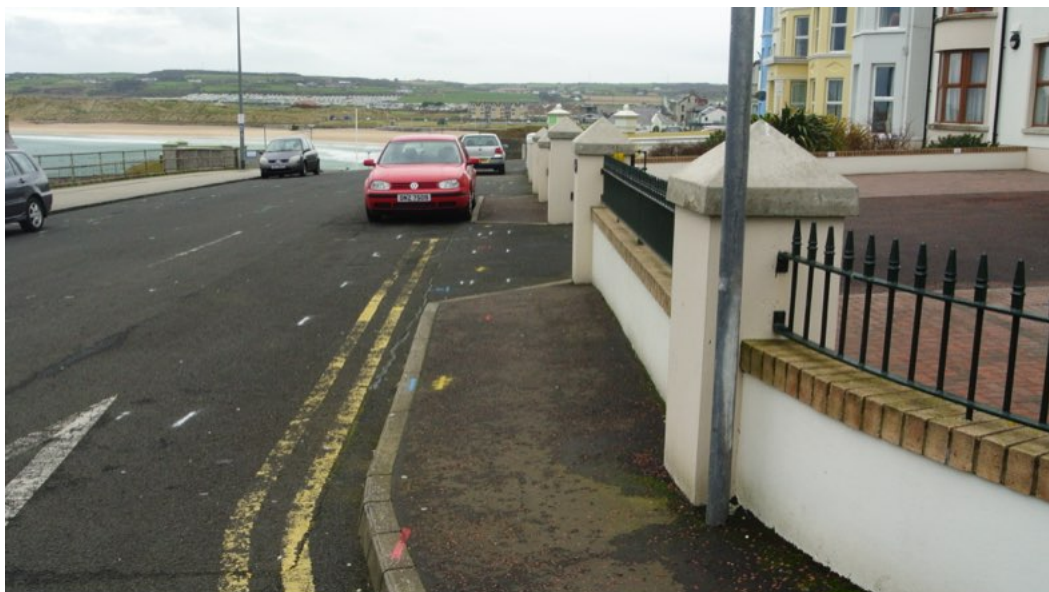
- 58 Bath Terrace and Bath Street will provide important linkages to the proposed extended promenade on the west on the town.

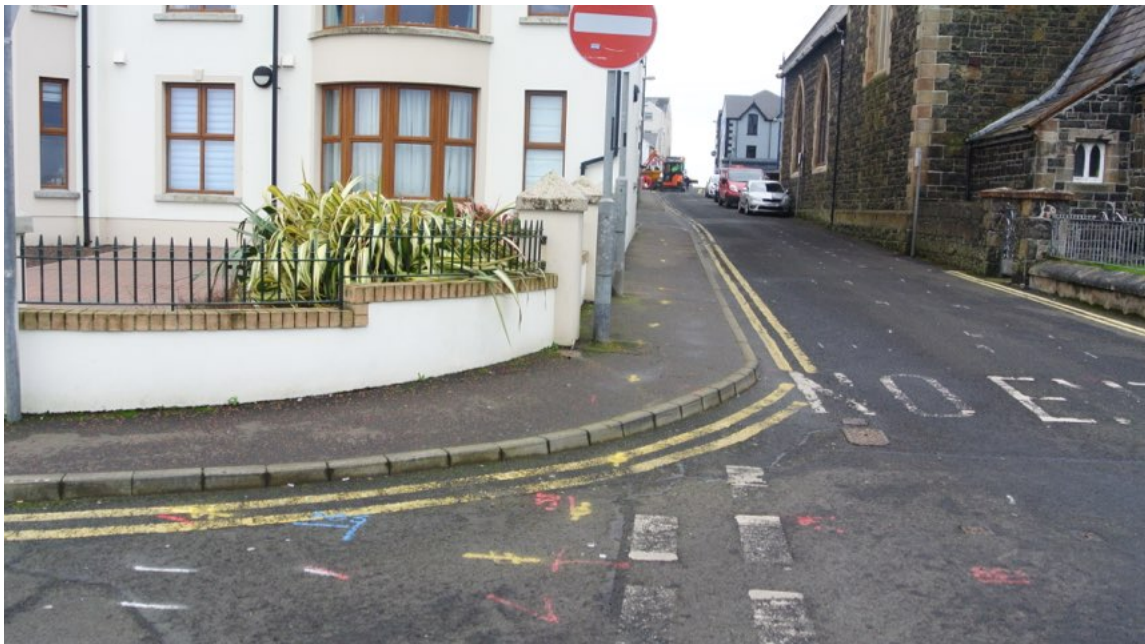
- 59 Safe and accessible opportunities for pedestrians to cross to the promenade from Church Pass are required.

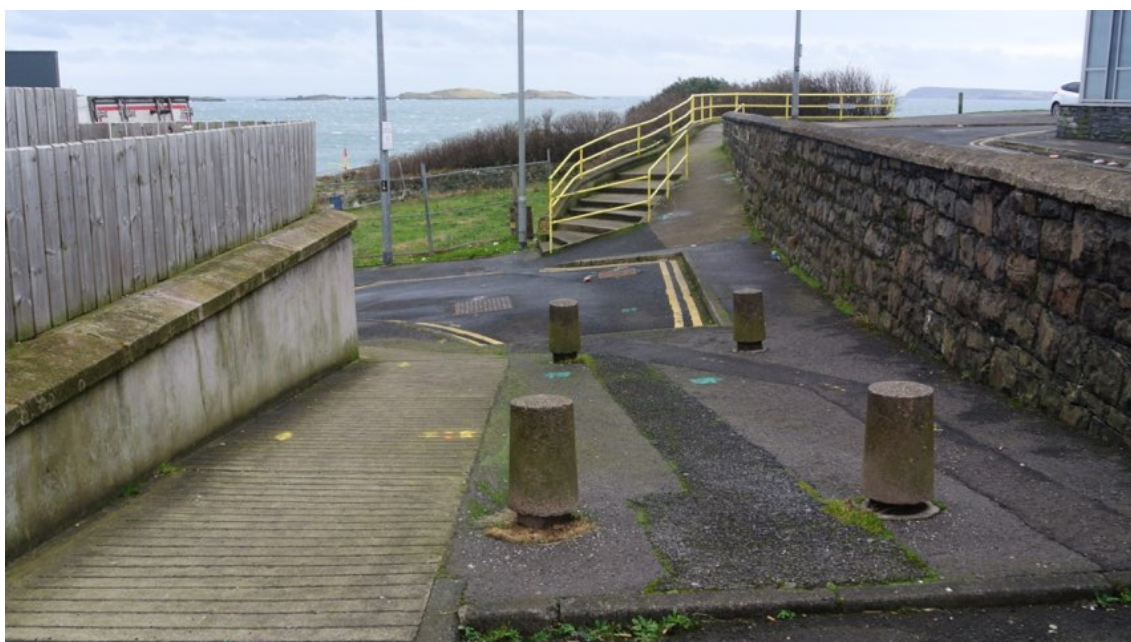
- 60 There are major access issues with the changes in levels between Bath Terrace, Bath Street and Bath Road. If the proposed promenade is to be a space for all solutions must be found to make this space inclusive.

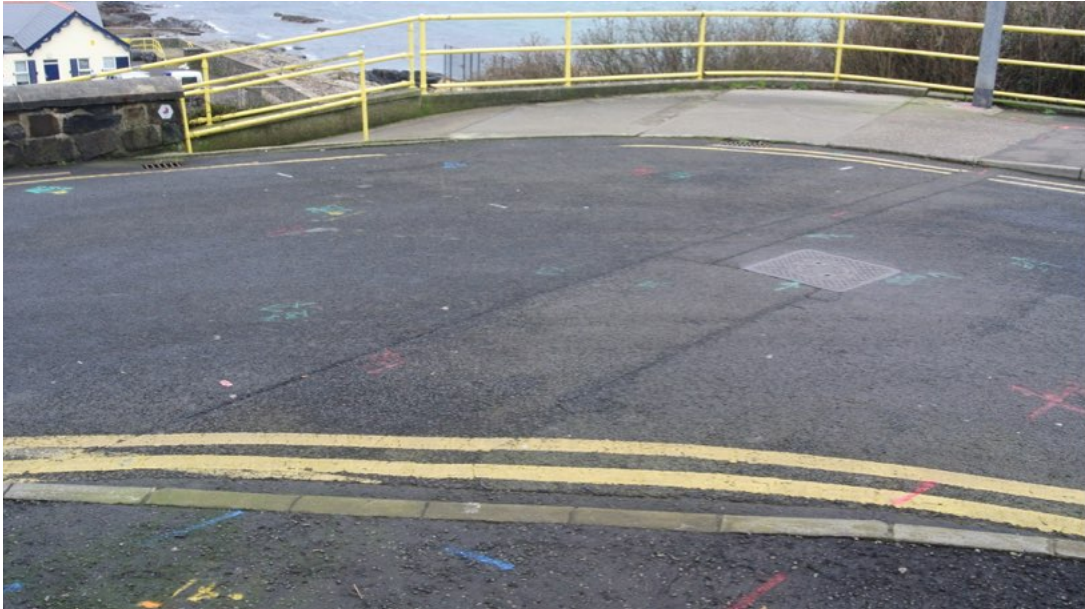
- 61 Current crossing facilities at the corner of Bath Street/Terrace are in need of upgrading including correctly installed tactile paving.

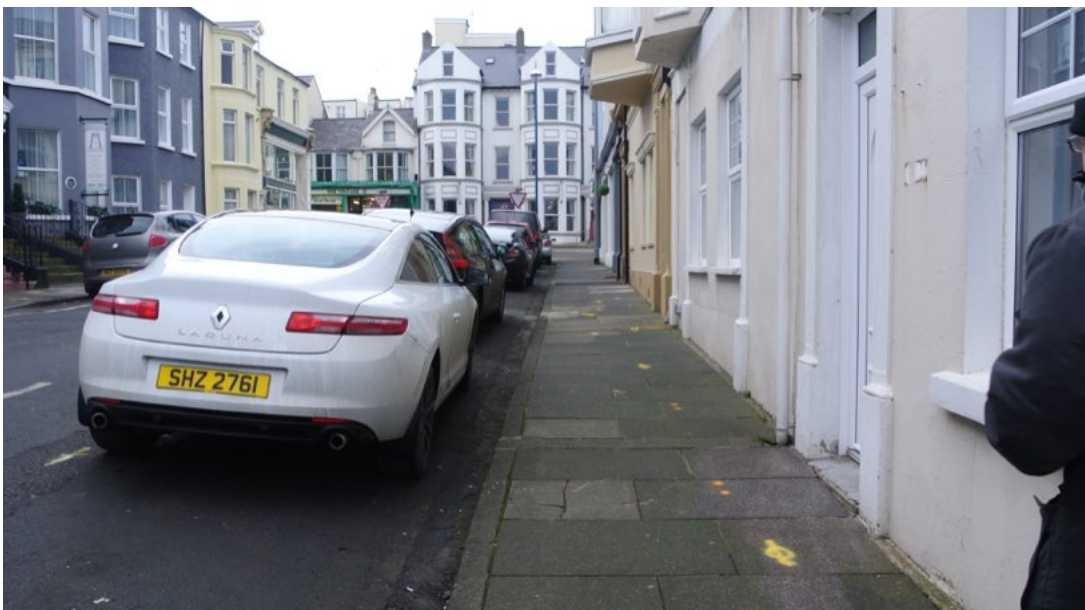
- 62 The surfacing of footways along Bath Street are generally poor and in need of an upgrade.

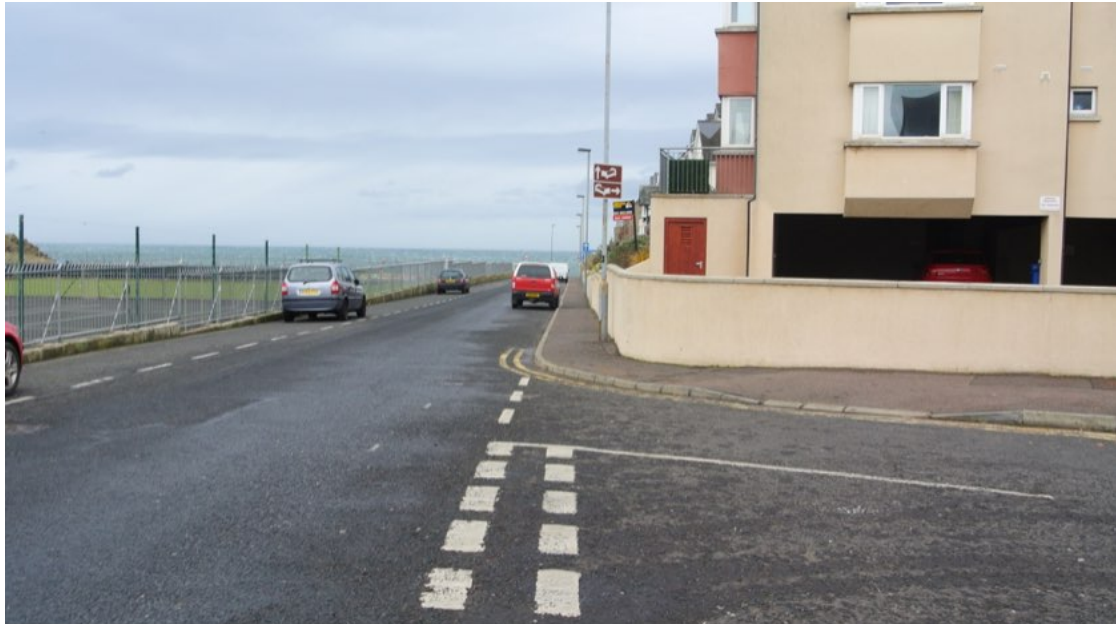
- 63 Currently Ramore Avenue has footway on the southern side only. This footway is narrow and junctions and crossings are in need of upgrading to include correctly installed tactile paving.

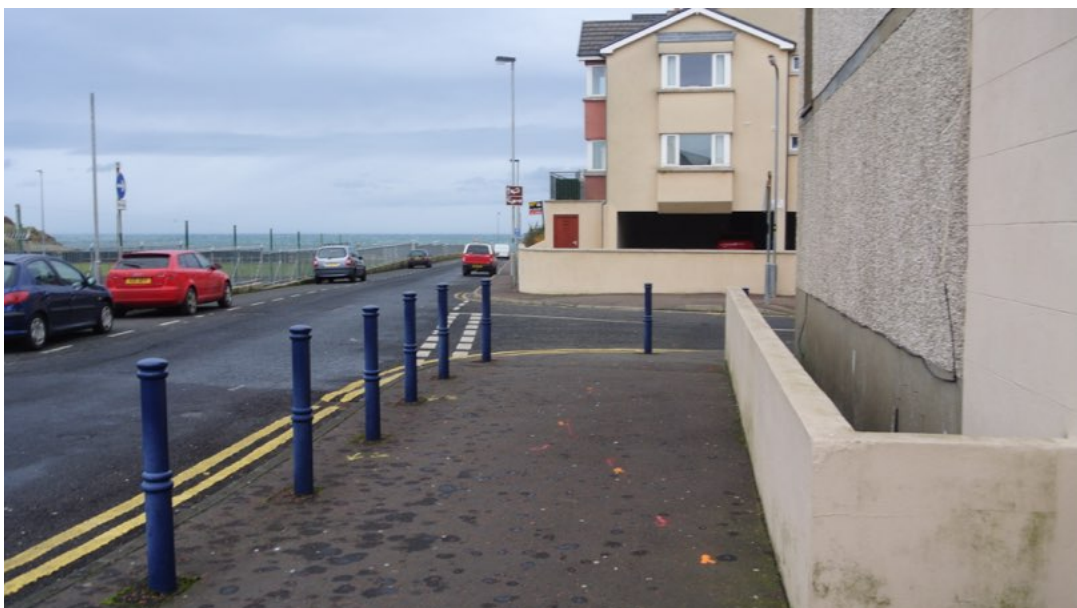
- 64 Proposals to create a footway on the northern side on the street linking with the promenade are to be welcomed. The scheme must include opportunities to cross Ramore Avenue and other improvements such as well-designed crossings at junctions on the southern side of the street.
