Recommendations from Imtac on public realm proposals for Banbridge town centre

(October 2019)

Street audit findings

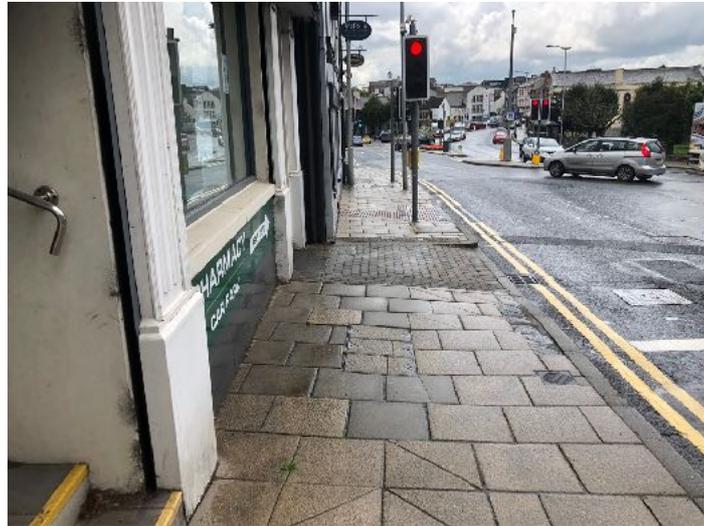
The eastern footway of Dromore Street approaching its junction with Church Square and Church Street is relatively narrow but uncluttered. There is a vehicle entrance on the footway meaning surfaces are not consistently level. This is a significant issue throughout the town centre.

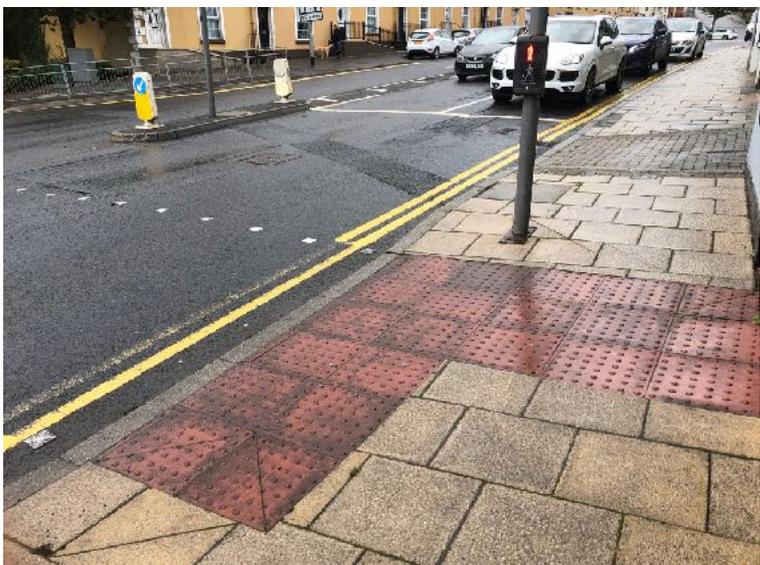
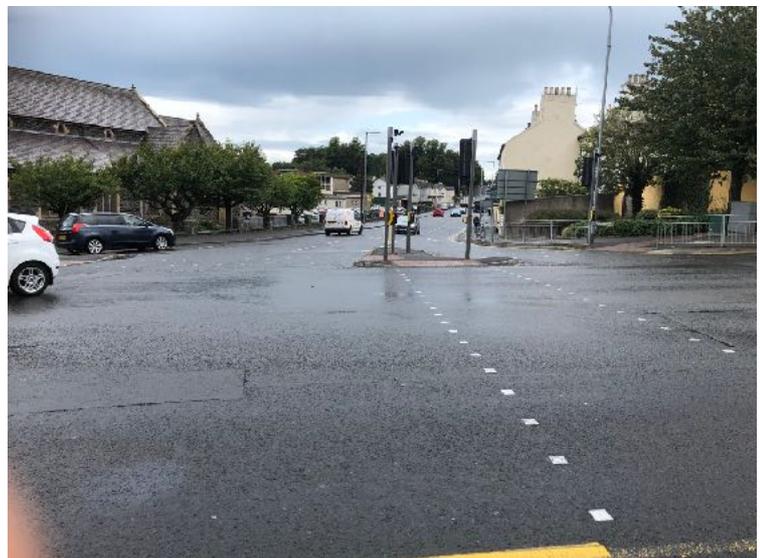
There is a controlled crossing across Dromore Street at the junction with Church Street/Church Square. Access to the western footway is via a small triangular traffic island which will very difficult for some disabled people to use independently. Tactile paving and control boxes have been positioned correctly.

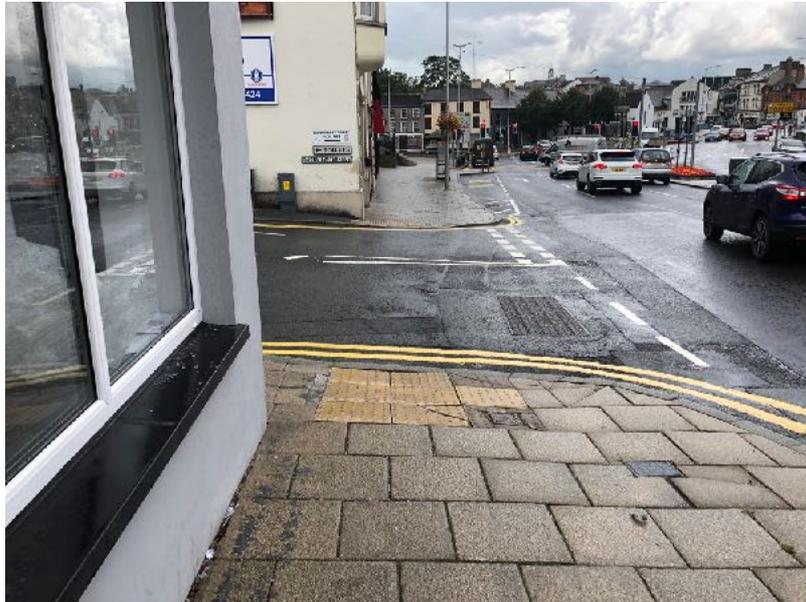
There is an uncontrolled crossing at the junction with Burnview Terrace. The tactile paving is laid correctly but damaged in places. There are sections of dropped kerb without tactile paving presenting a potential hazard for people with visual impairment. Contrast between the tactile paving and surrounding pavement could be improved.

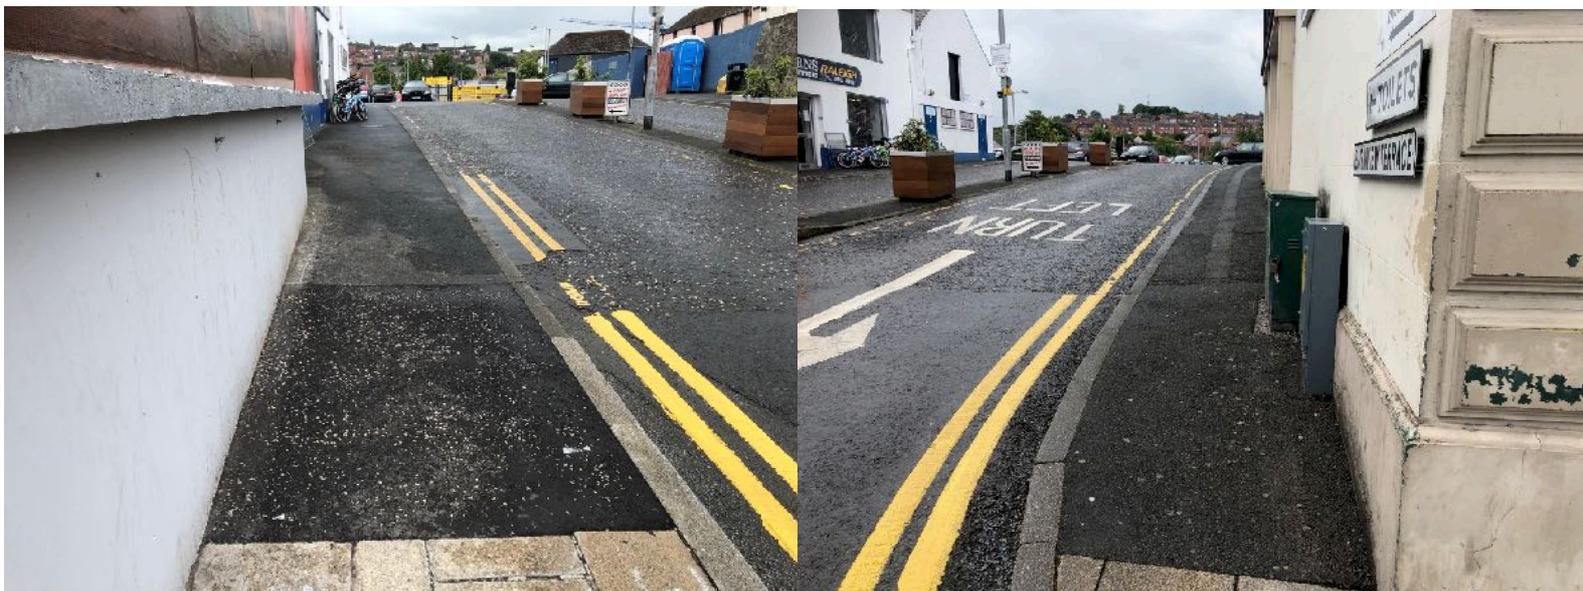
The footways on Burnview Terrace linking to the car park are narrow and in poor condition. Shop displays create obstructions on the northern side.

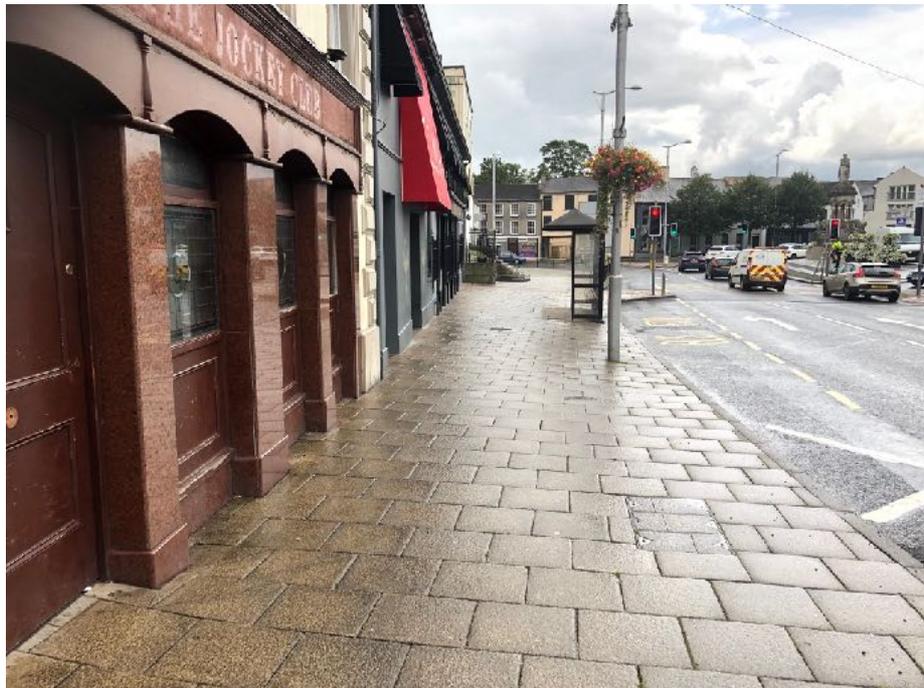
The eastern footway on Church Square broadens close to The Coach public house. One of the main bus stops for services from Belfast is located at this point.

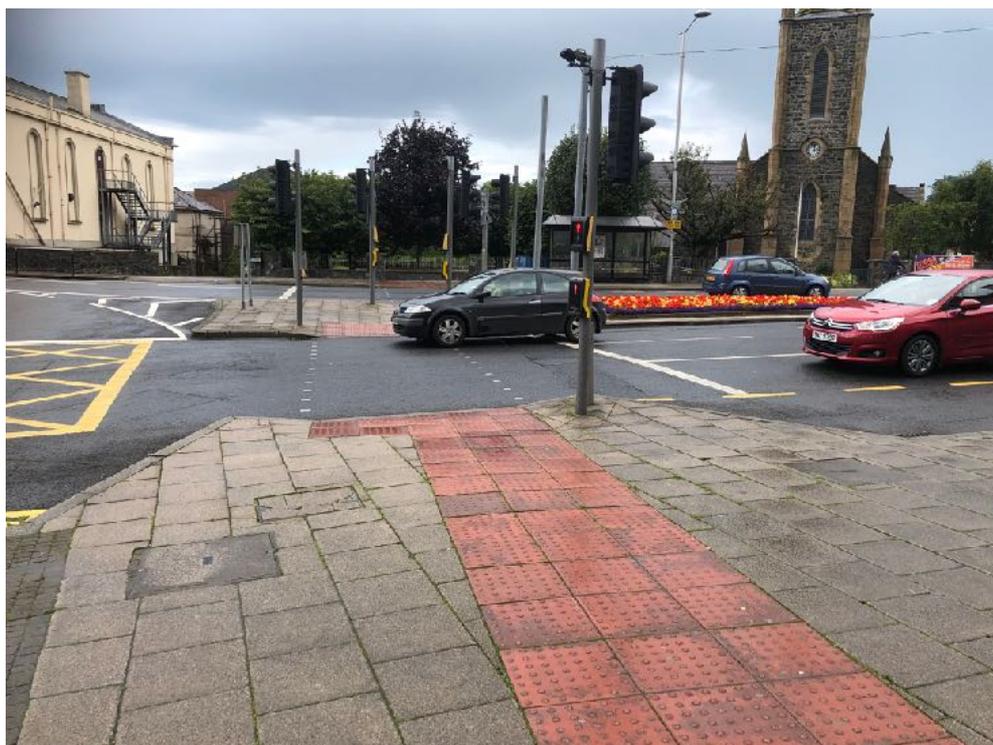
There is a controlled crossing across Church Square approaching its junction with Windsor Terrace (leading to Castlewellan Road). The crossing is staggered with a traffic island at the midpoint. Tactile paving and control boxes have been correctly positioned at the crossing.

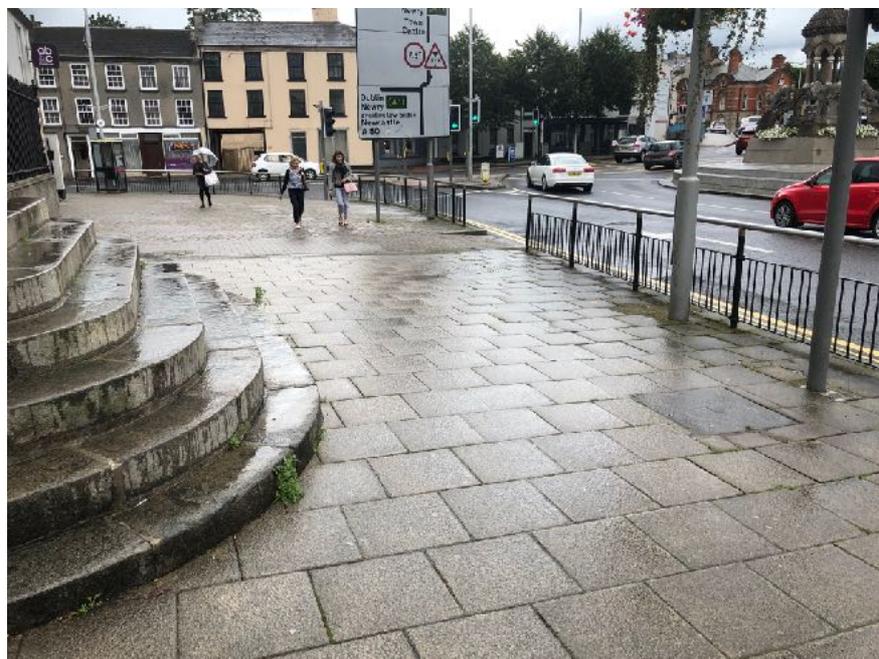
Although the footway is broad approaching the junction with Windsor Terrace steps to a B1 listed building and a vehicle entrance present potential hazards to people with visual impairment. Pedestrian railings along the kerb line suggest traffic levels impact significantly on the amenity of this area.

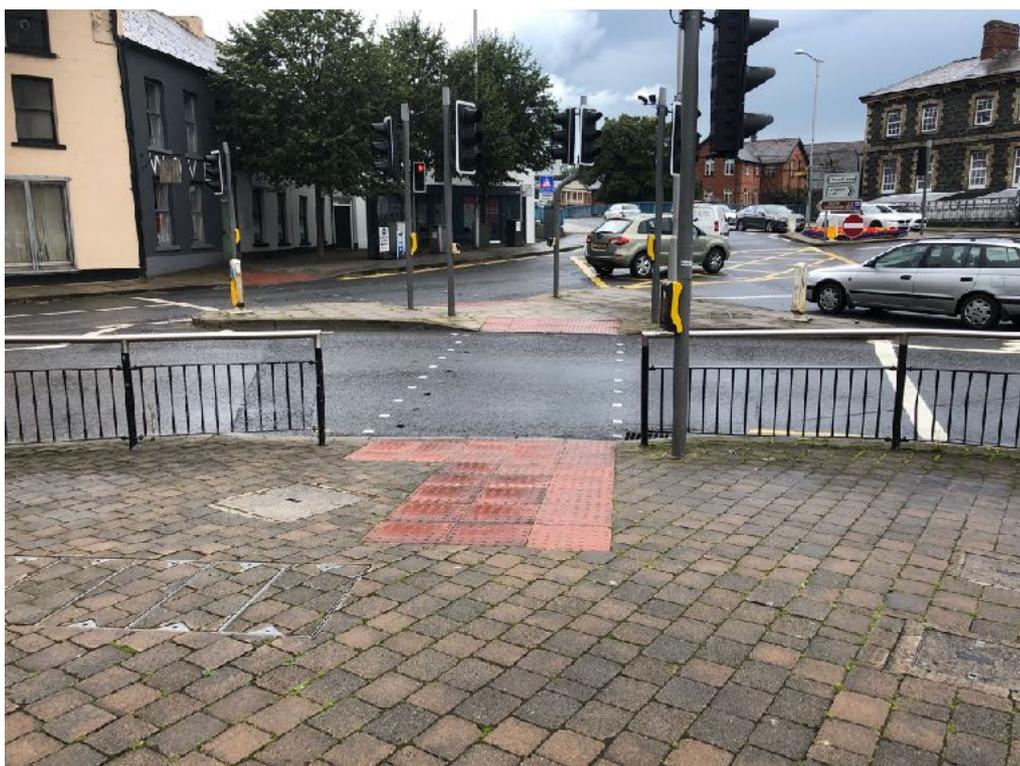
There is a controlled crossing at the junction of Church Street and Windsor Terrace. The crossing is split with a traffic island at its mid point. Tactile paving and controlled crossings have been positioned correctly, although the tactile tail at the northern side does not extend to the building line.

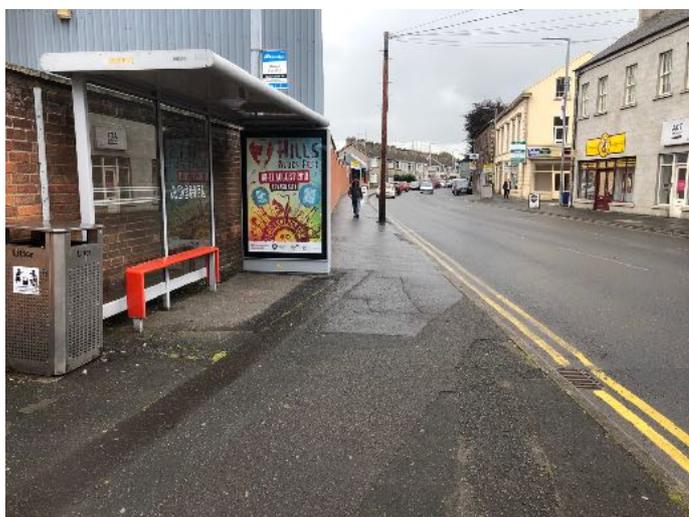
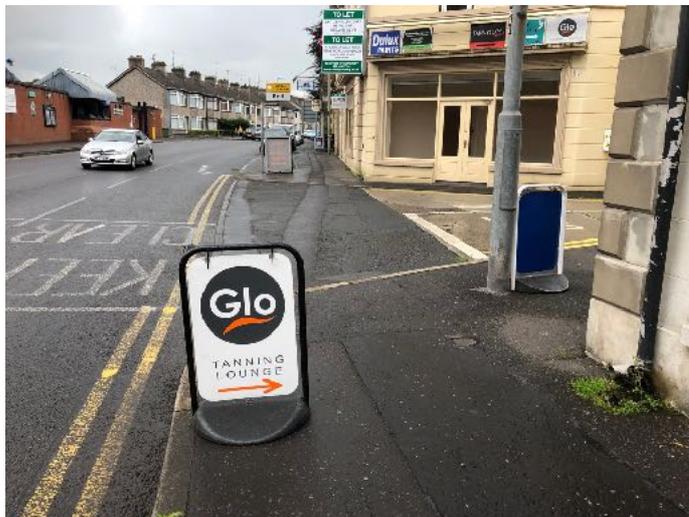
Footways on Windsor Terrace are narrower and in poorer condition compared to Church Square. A junction without tactile paving and A Boards create potential hazards on the southern footway.

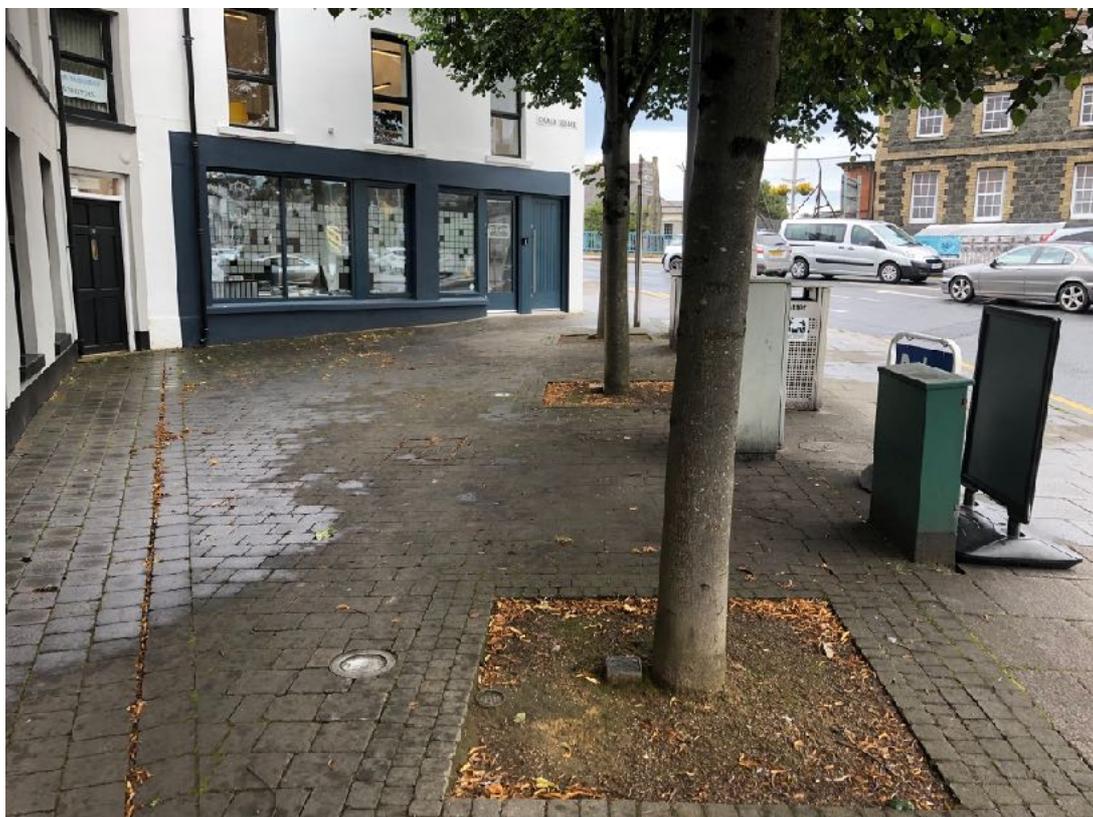
There is a wide section of footway approaching the bridge on the eastern side of Church Square. The positioning of street furniture including trees does little to make this a welcoming or accessible space.

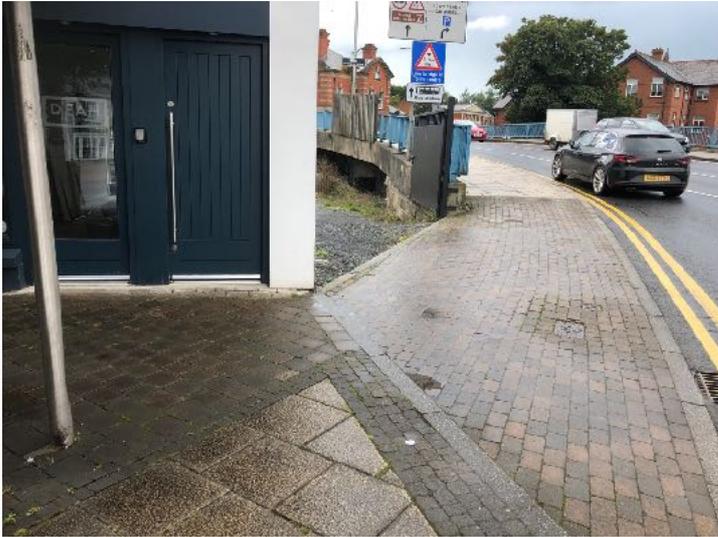
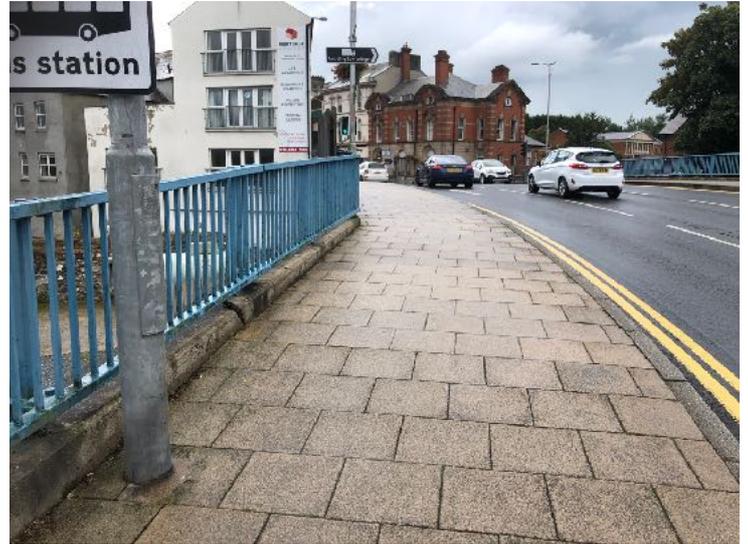
There is another vehicle entrance approaching the bridge on Church Square. The absence of tactile paving presents a potential hazard for people with a visual impairment. The footway on the bridge itself is wide and uncluttered.

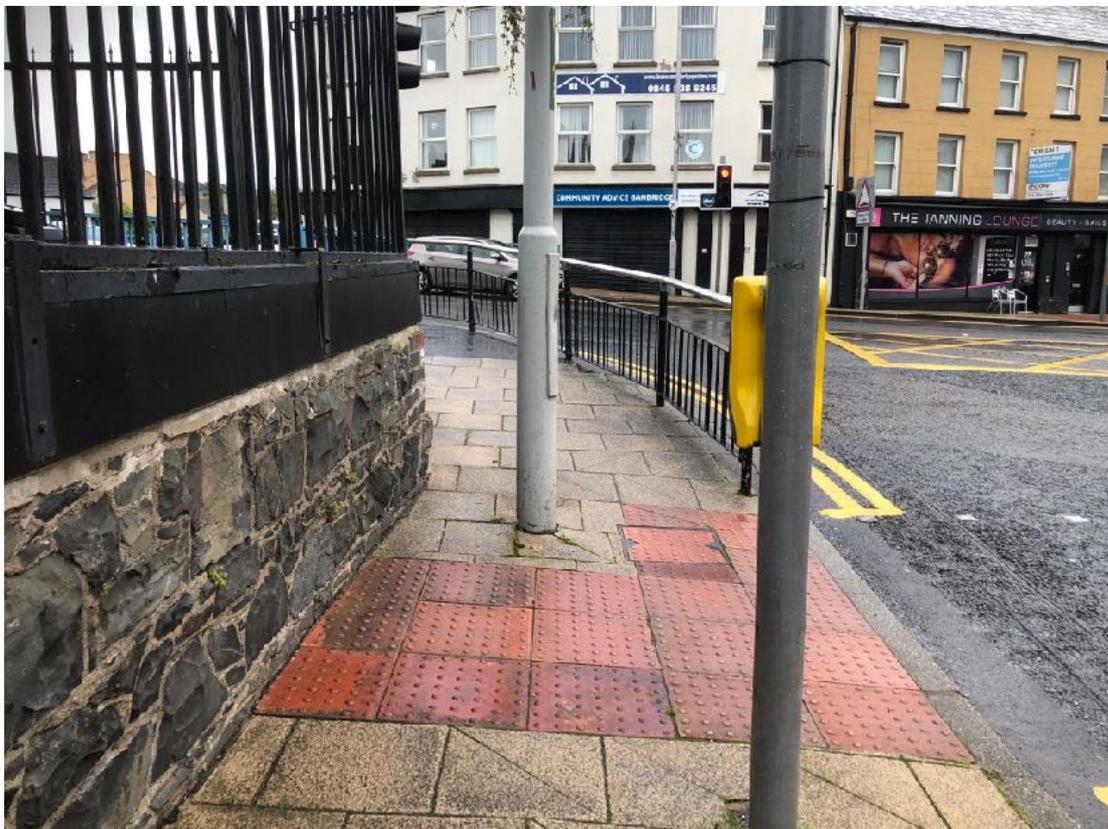
There is a controlled crossing across Huntly Road at its junction with Bridge Street and Church Square. The positioning of a lighting column on the northern side of the crossing obstructs access towards Church Square. Pedestrian railings emphasise the impact of traffic in the area.

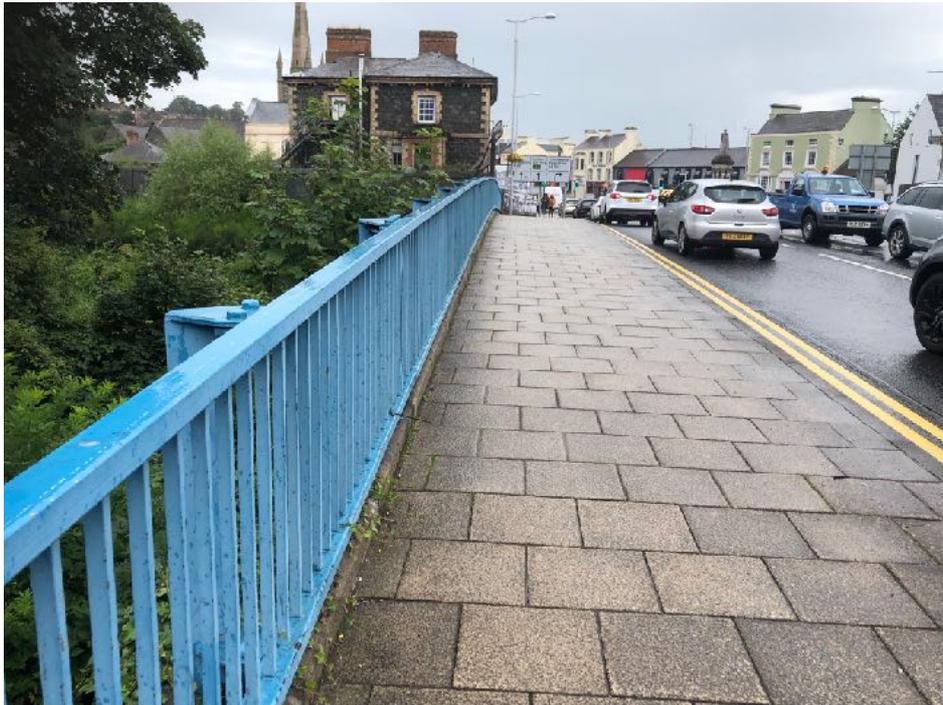
The footway on the bridge on the western side of Church Square is broad and uncluttered.

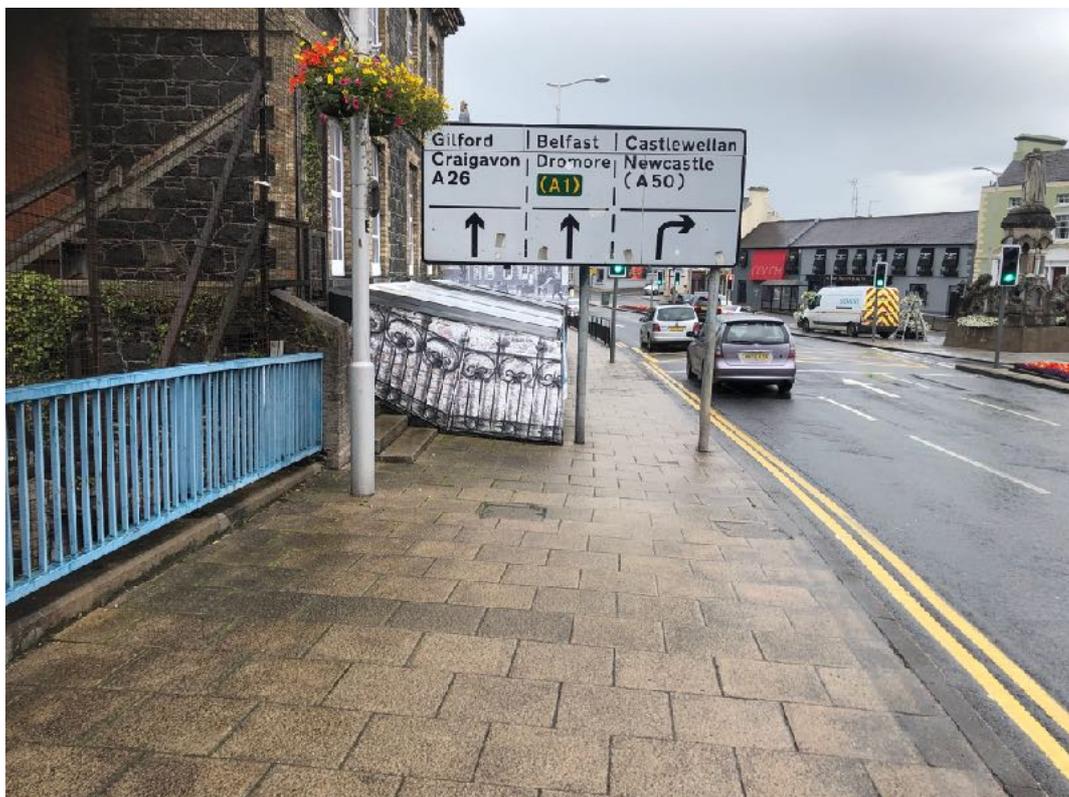
The western footway is significantly narrowed by building works after the bridge. This is no ideal on what is a very heavily trafficked area. Traffic signage poles create additional hazards.

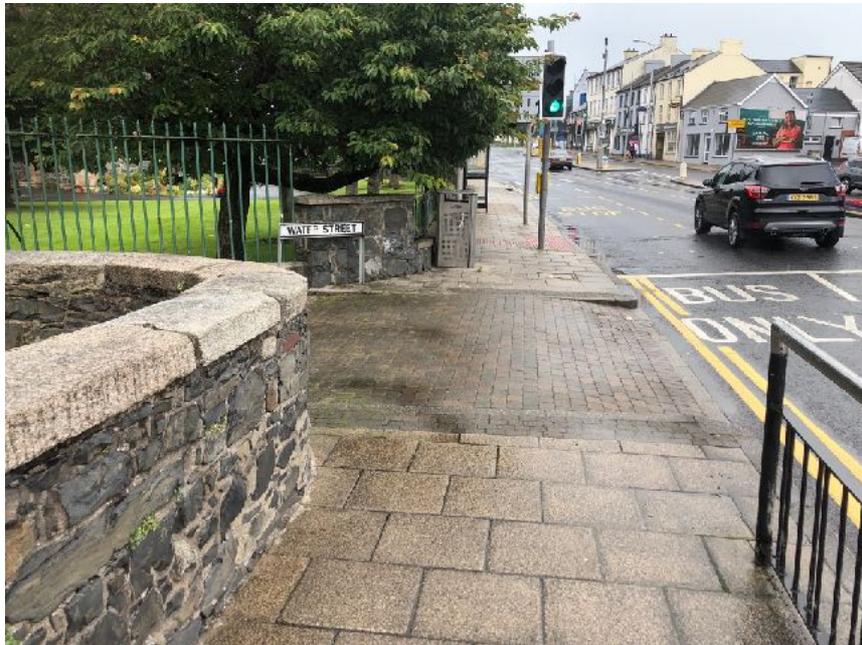
Pedestrian railings reappear approaching the controlled crossing across Church Square. The entrance to Water Street means there is a kerb show on the footway by the carriageway. This is replicated at the entrance to Seapatrck Parish Church.

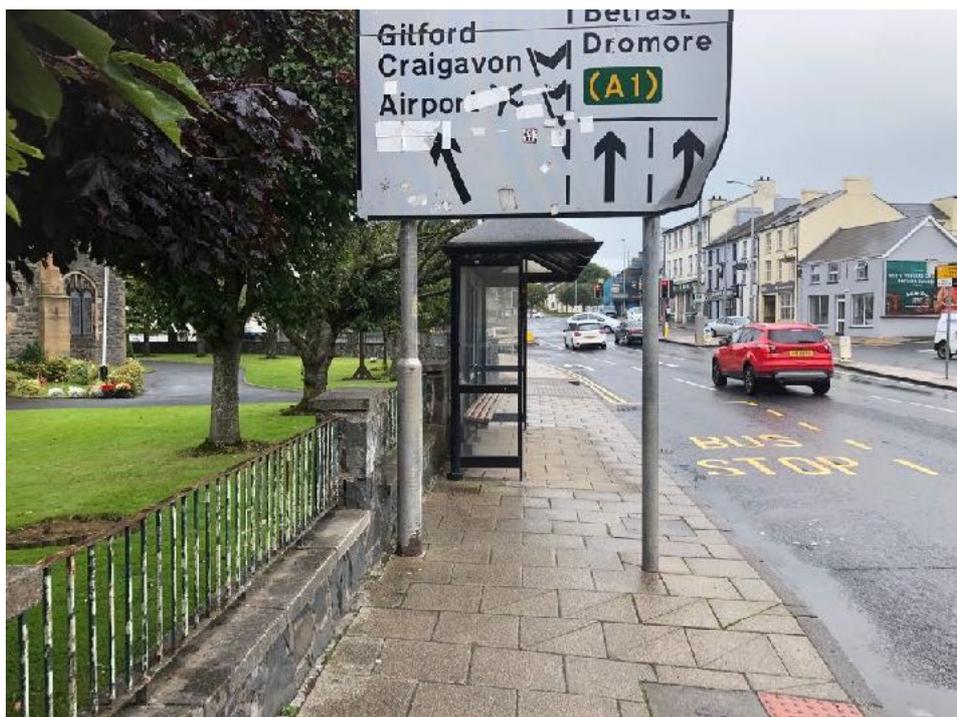
There is a bus stop shortly after this point on Church Square serviced by buses travelling to Belfast. Given the importance of this service the current footway width is narrow. The location of the traffic sign support obstructs a straight line access.

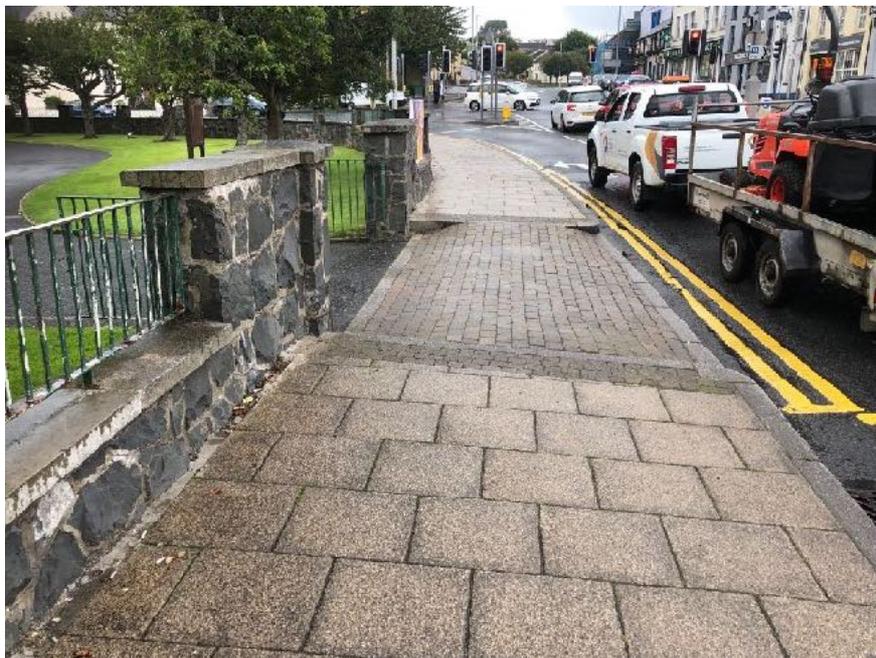
The vehicle entrance to Seapatrck Parish Church near the junction with Church Street has been constructed with a raised table with variable kerb shows at either side of the footway and no tactile paving, presenting significant hazards for disabled people.

The treatment of many vehicular accesses (eg at Seapatrick Parish Church) with a raised paved table to create a section of level footway having ramped vehicle approaches on one or both sides. This results in trip hazards on either side of the footway. At most, if not all, of these accesses there is no tactile indication for people with a visual impairment that the footway may be shared with vehicles.

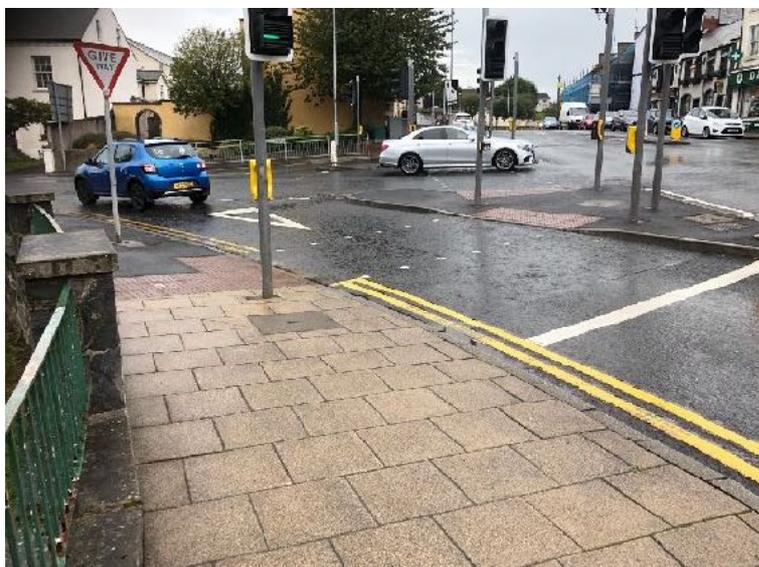
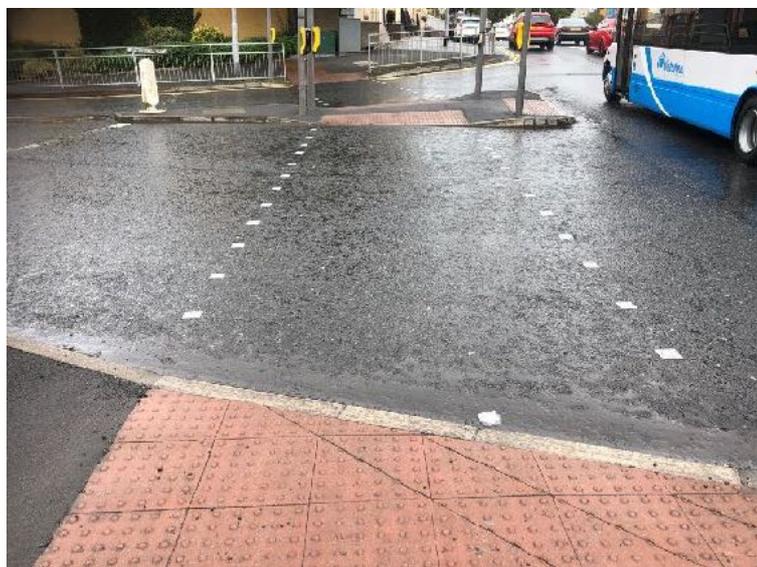
There are a series of complex controlled pedestrian crossings across Church Street at its junctions with Church Square and Dromore Street. Although tactile paving and control boxes have been installed correctly, the angular design of crossings at the junction means some disabled people will find using it very difficult or impossible without assistance.

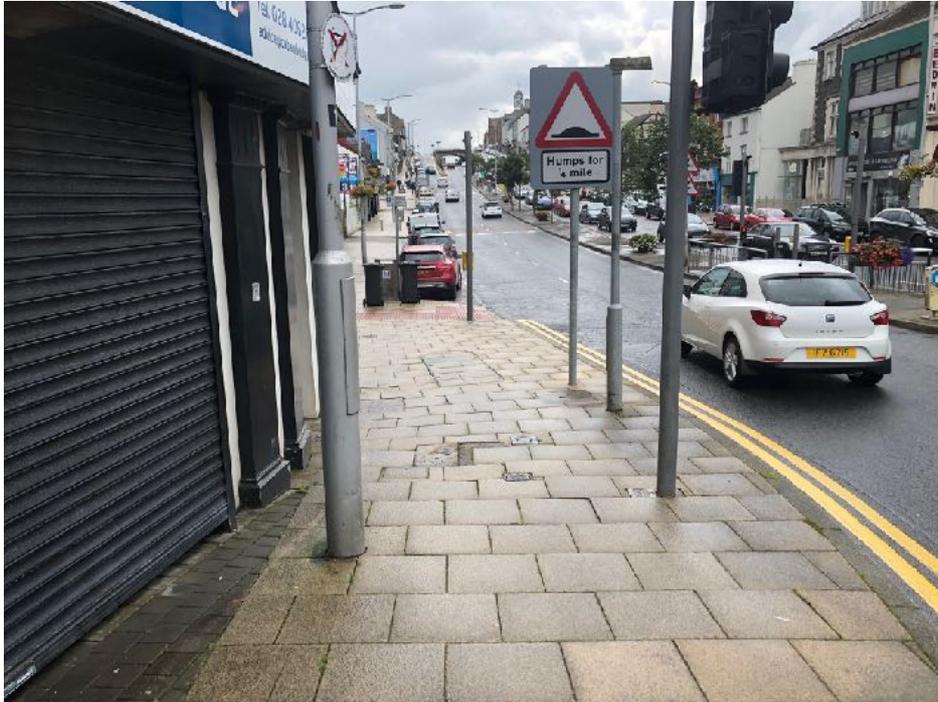
The eastern of footway of Bridge close to the junction with Church Square is cluttered with street signage poles, some of which appear to be redundant.

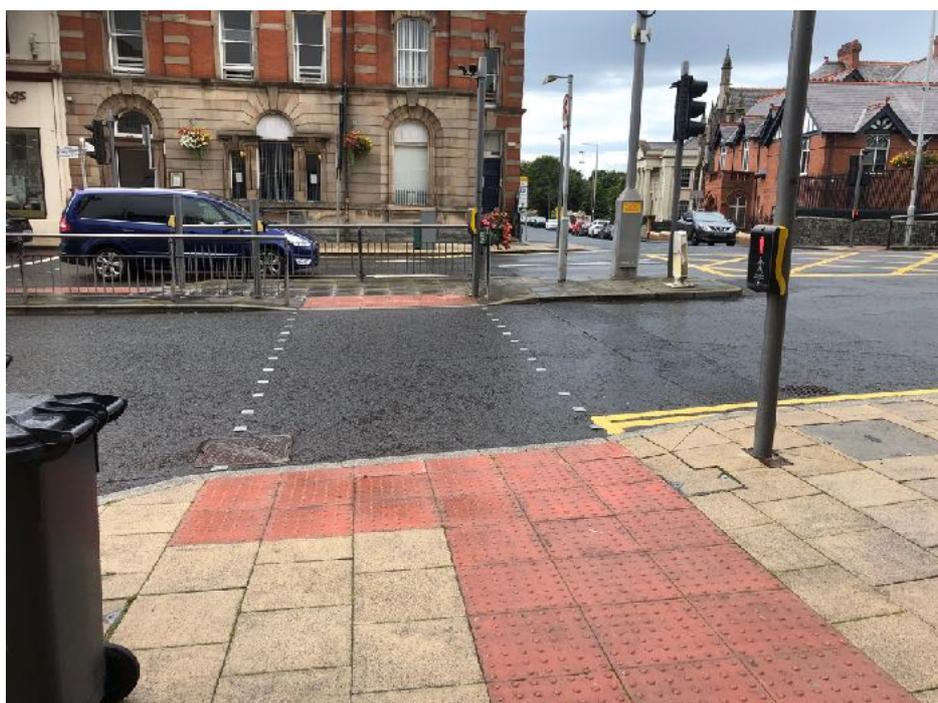
There is a controlled crossing across Bridge Street close to the junction with Church Square. The crossing is staggered with a traffic island at its mid point. Pedestrian railings have been provided on the island. Tactile paving and control boxes have been installed correctly.

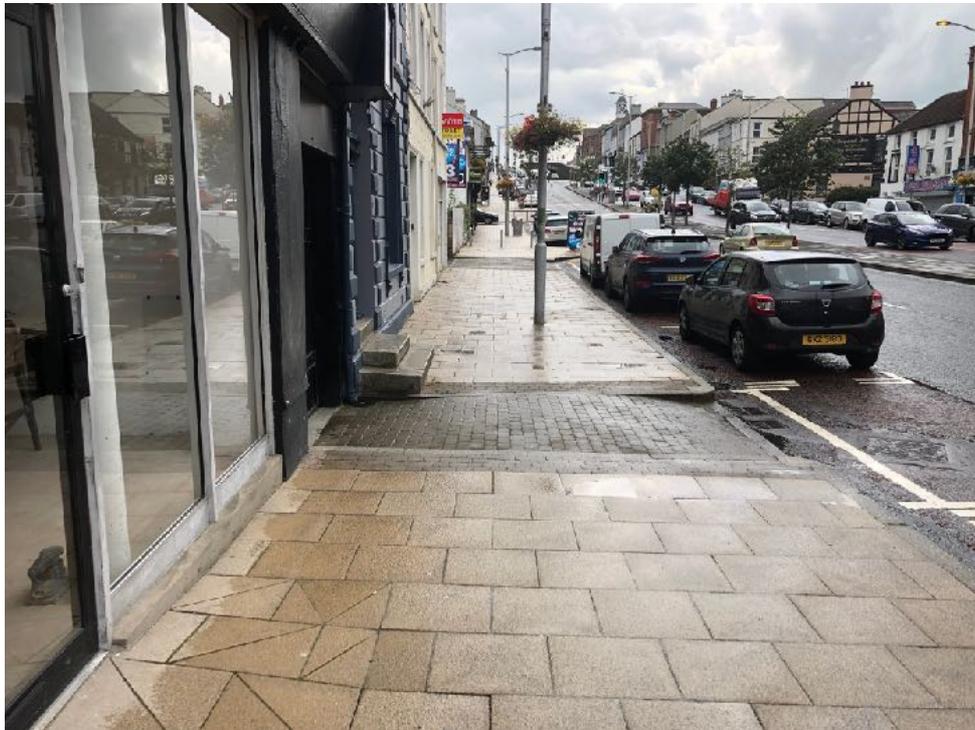
Although the eastern footway is broad the lack of consistency in the location of street furniture including bollards and lighting columns as well as vehicle entrances with kerb shows close to the carriageway create potential hazards for people with visual impairment.

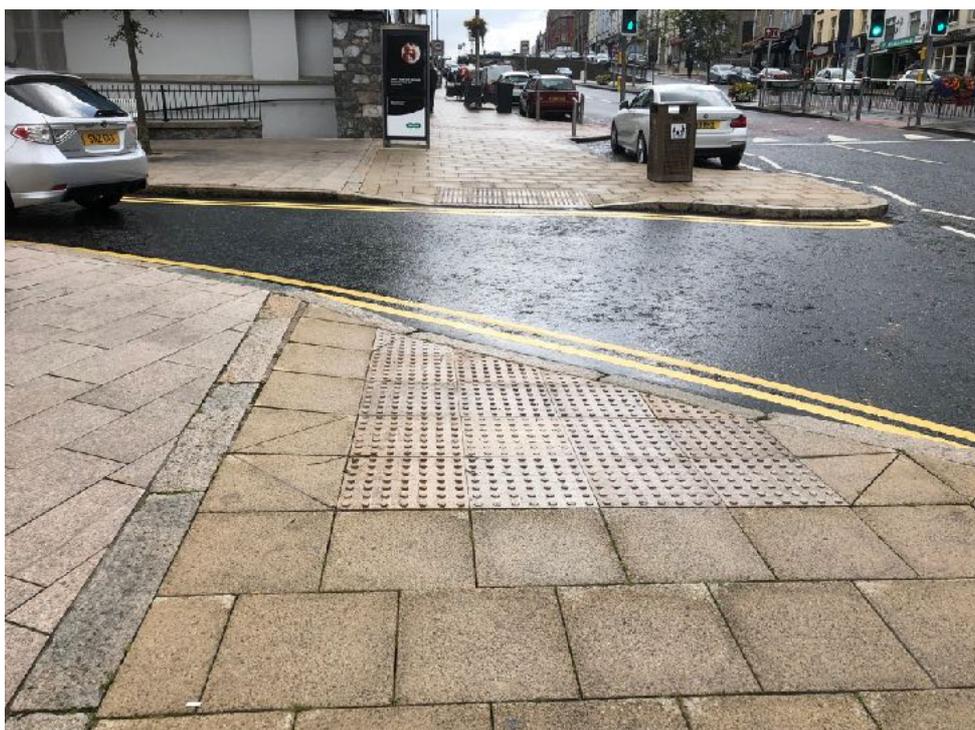
There is an uncontrolled crossing across the junction with Bridge Street East. The tactile paving does not contrast sufficiently with the surrounding pavement and lacks sufficient depth of tile on the southern side of the junction.

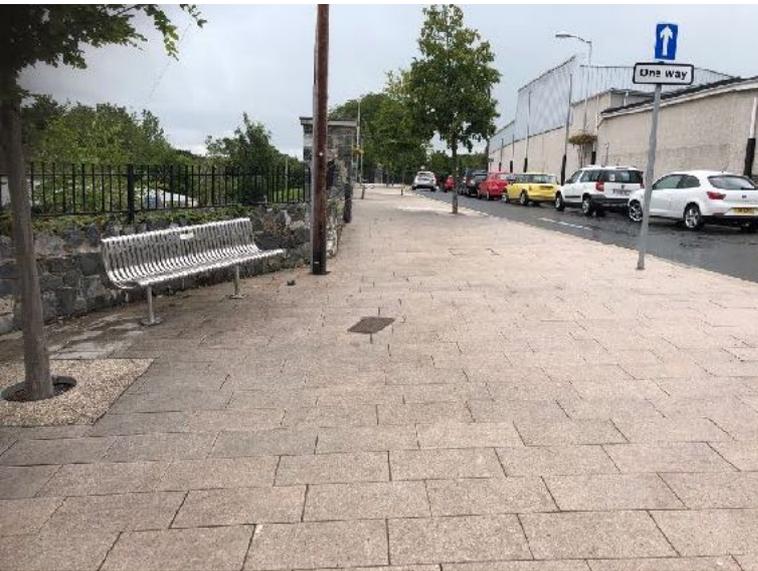
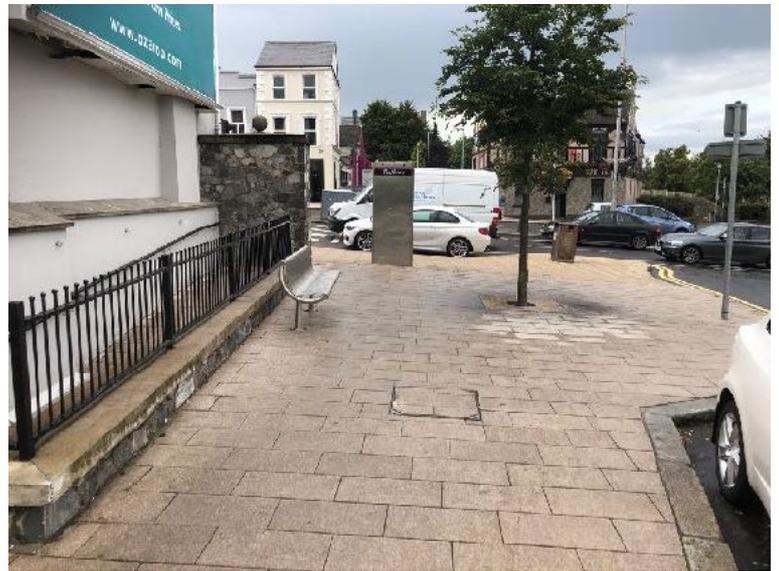
The surfaces on the footways on Bridge Street East are good. The provision seating and trees provide attractive links to and from Solitude Park and a nearby off-street car park. A mix of seating types would make the area more inclusive.

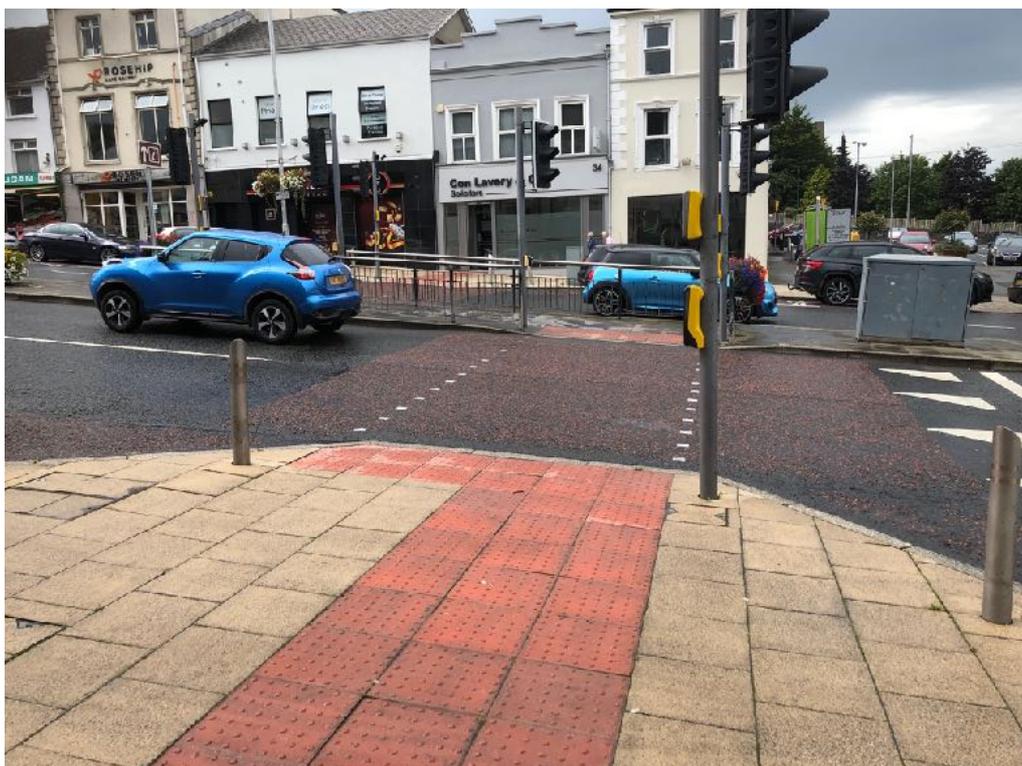
Shortly after this junction there is a controlled crossing across Bridge Street. The crossing is staggered with a traffic island at its mid point. The traffic island includes pedestrian railings. Tactile paving and control boxes have been installed correctly.

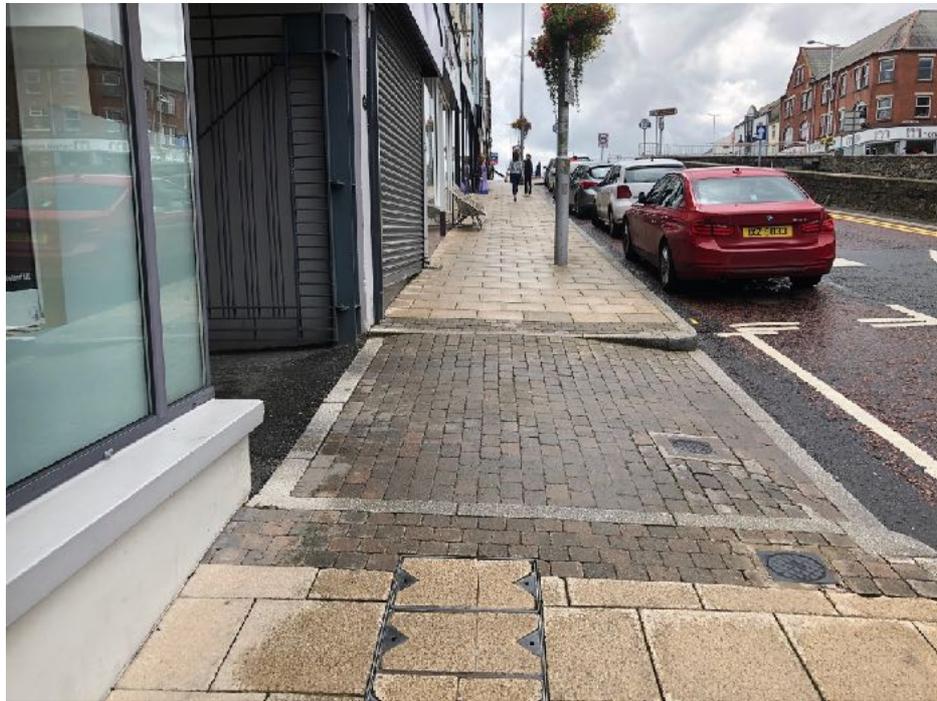
The gradient of the footway increases significantly after this point, approaching the historic bridge. A vehicle entrance with some kerb show and clutter from shops create potential hazards and the position of street lighting columns impact on clear footway width.

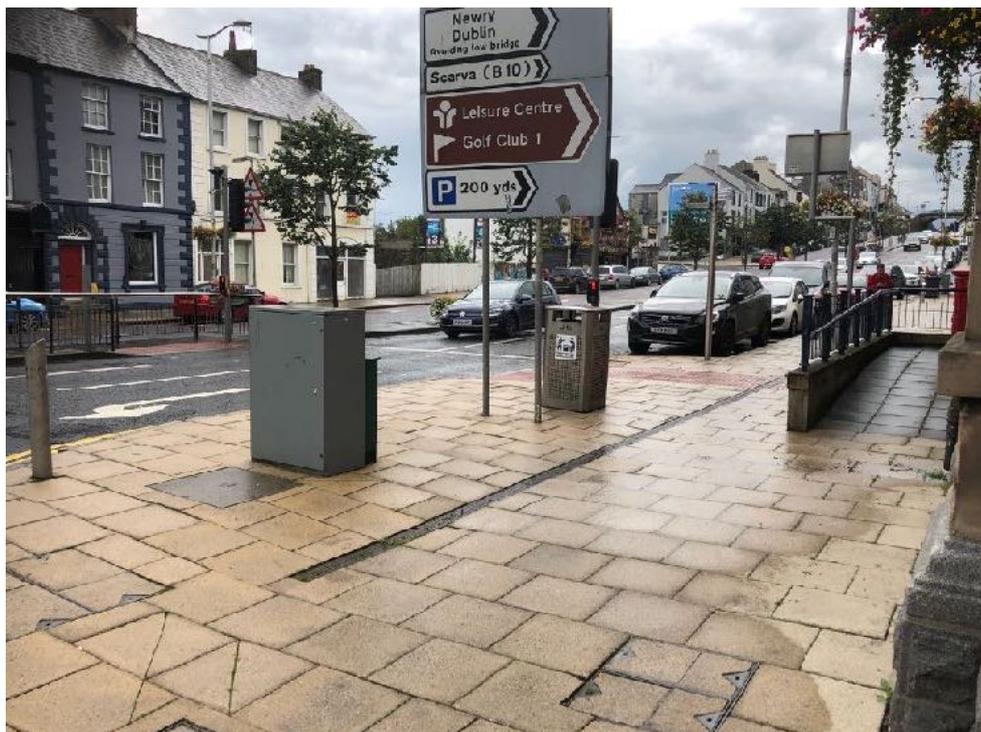
The western footway on Bridge Street is partially obstructed by ramped access to a B1 listed building close to the junction with Huntly Road and Church Square. Further street clutter impacts on access in the area.

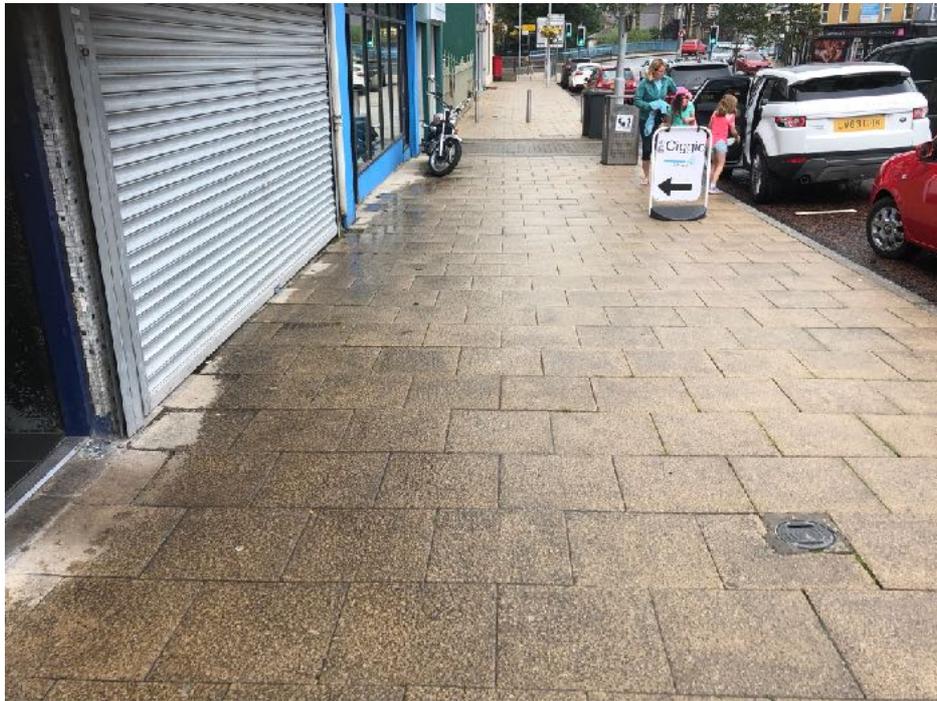
Bollards, a vehicle entrance, a parked motorbike and an A Board all create hazards for people with a visual impairment on the western footway.

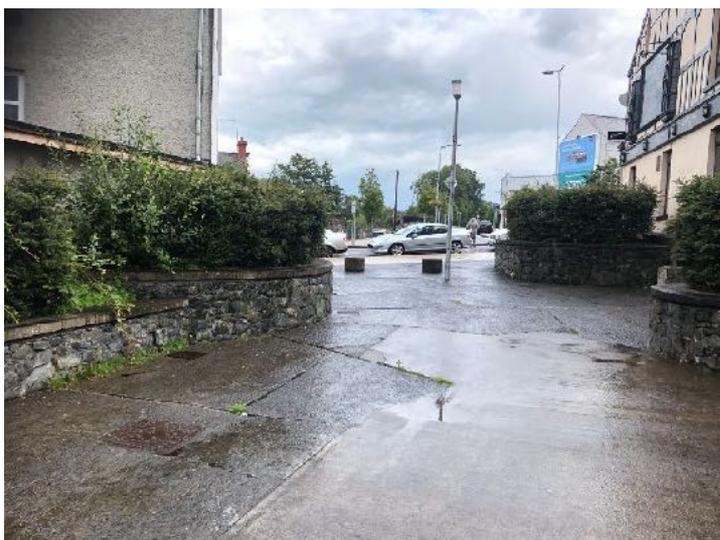
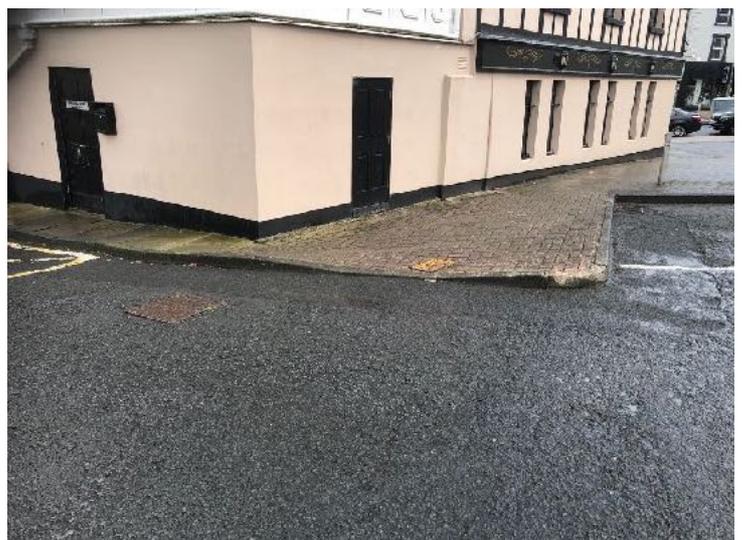
Two linkages either side of the Imperial Public House provide access to the Downshire Place off street car park. The area is dated with poor surfaces and in need of improvement. One access point to the car park is stepped although a step free alternative is available via a dropped kerb without tactile paving provided.

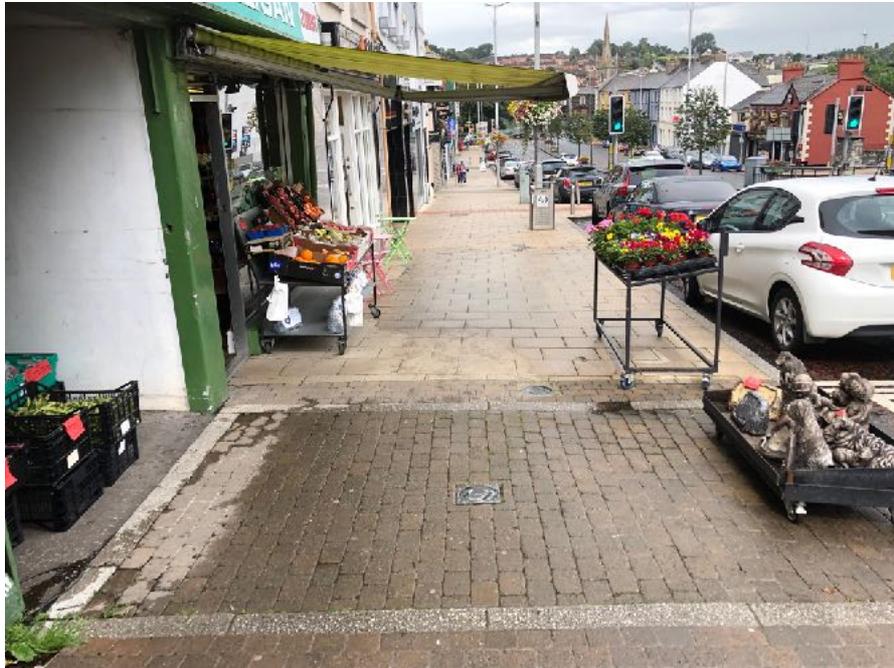
The gradient of the western footway increases approaching the bridge. Vehicle entrances, a pavement cafe and shop displays on the pavement create potential hazards for people with a visual impairment.
