Recommendations from Imtac on public realm proposals for Banbridge town centre

(October 2019)

Street audit findings

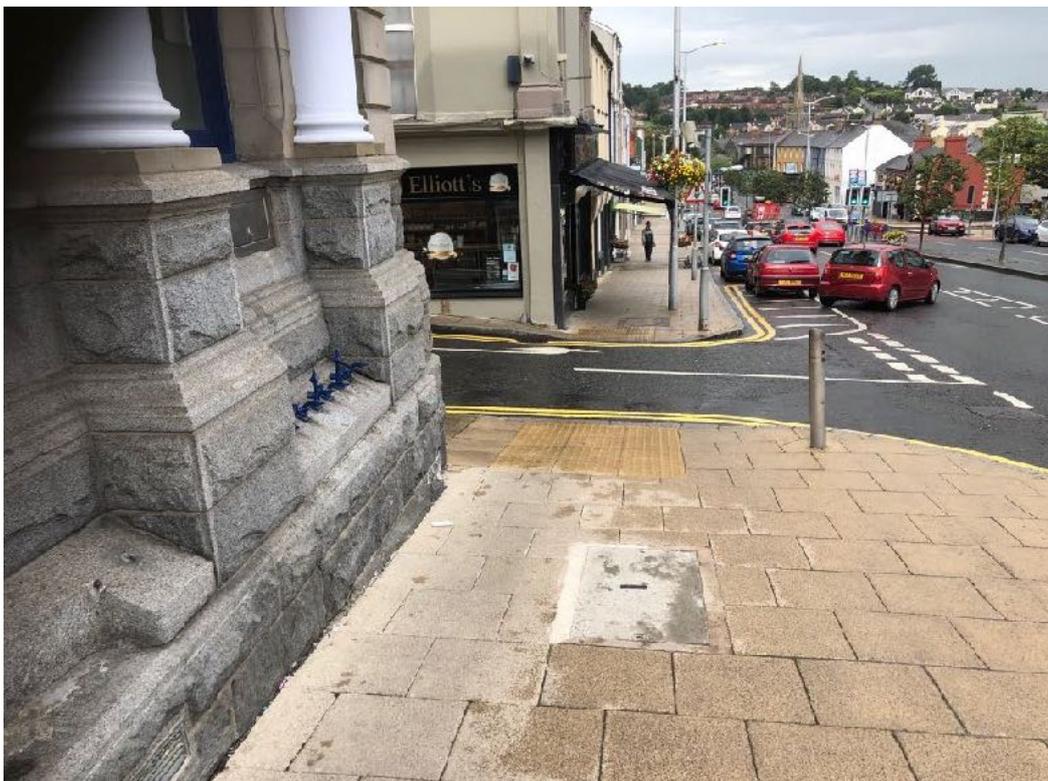
There is an uncontrolled across Bridge Street at the junction with Victoria Street. Although tactile paving has been installed correctly, it does not contrast sufficiently with surrounding paving.

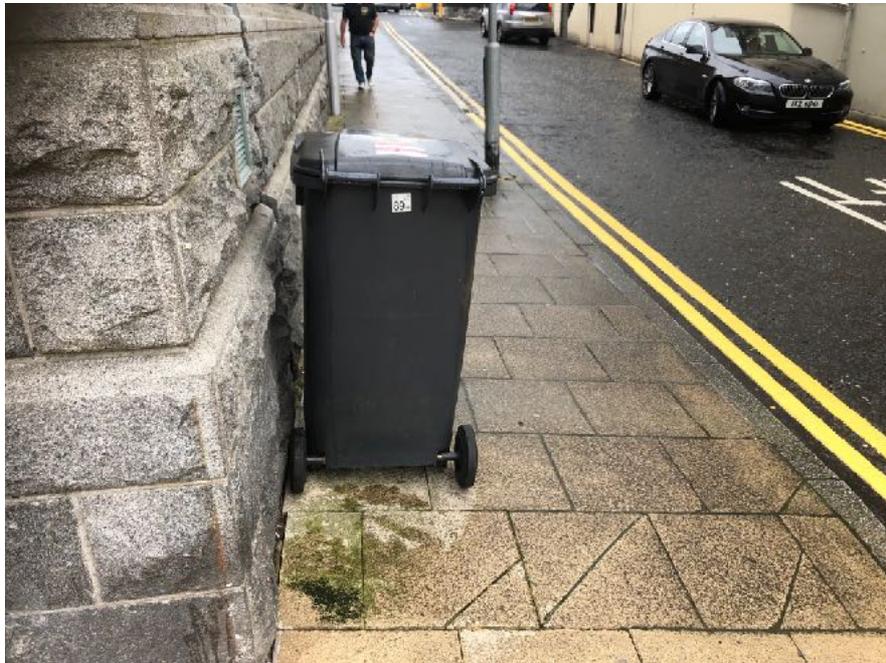
Victoria Street provides a linkage to the off street car park. A footway is provided on the southern side only and was obstructed on the day of the audit by a bin.

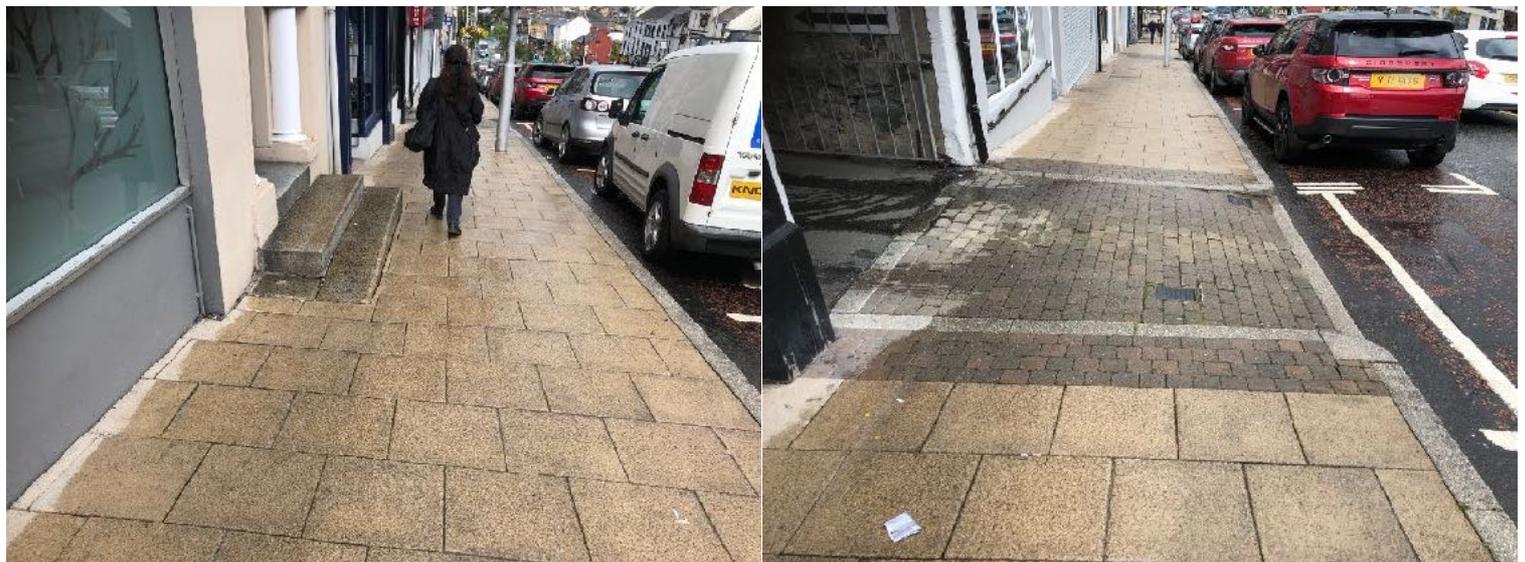
The gradient of Bridge Street increases significantly after this point. Vehicle entrances and steps into building create potential hazards for people with a visual impairment.

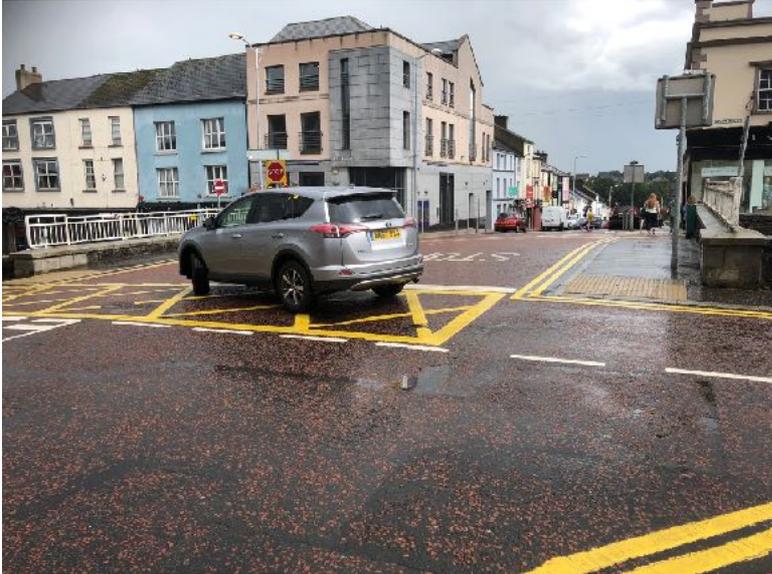
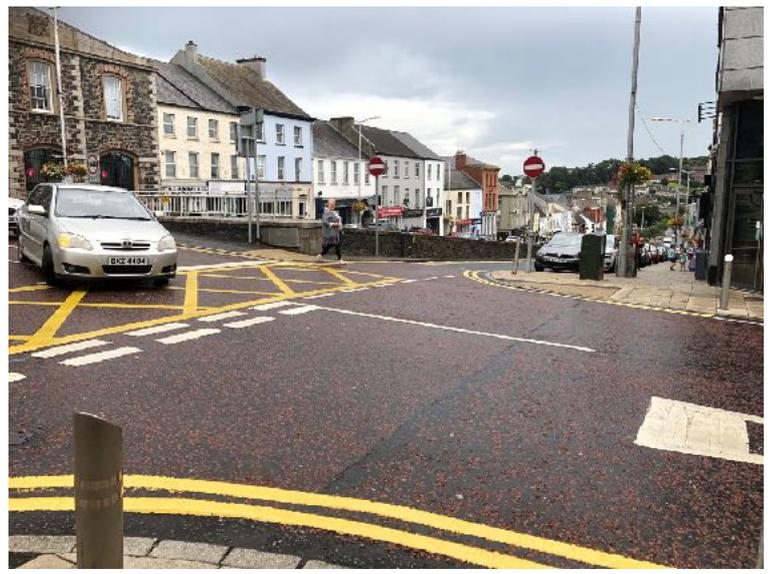
Bridge Street, Newry Street, Rathriland Street and Scarva Street all converge at the top of Downshire Bridge. The area is heavily trafficked and a raised table as been created on the bridge to slow traffic which has resulted in no kerb delineation in the area. Pedestrian sight lines are poor in places due to parked cars.

The area around the B1 Listed Downshire Bridge exemplifies the issues created by topography, built environment and traffic and is particularly problematic. The area is very heavily trafficked with many vehicles seemingly using the bridge and the surrounding streets to avoid the town centre or to circulate looking for a parking space. There is generous provision of on-street parking in the streets around Downshire Bridge to the detriment of pedestrian sight lines in places. Inadequate, poorly designed, uncontrolled crossings have been provided in and around the bridge. High traffic levels and poor design mean many disabled people struggle to navigate the area without assistance. In an effort to slow constant traffic movement a raised table has been installed over the top of bridge. This has effectively created a shared surface in the area with no delineation between footway and carriageway. In summary the entire area around the bridge is extremely challenging for pedestrians in general but is a hostile environment for older and disabled pedestrians in particular.

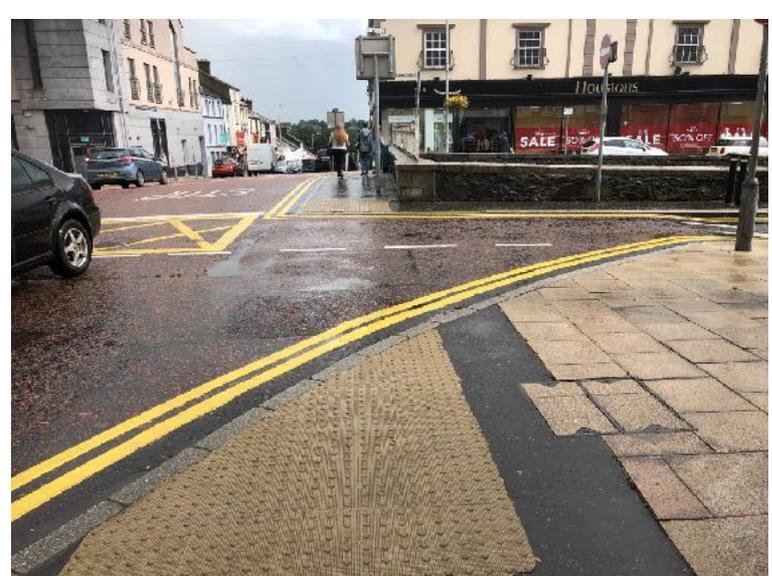
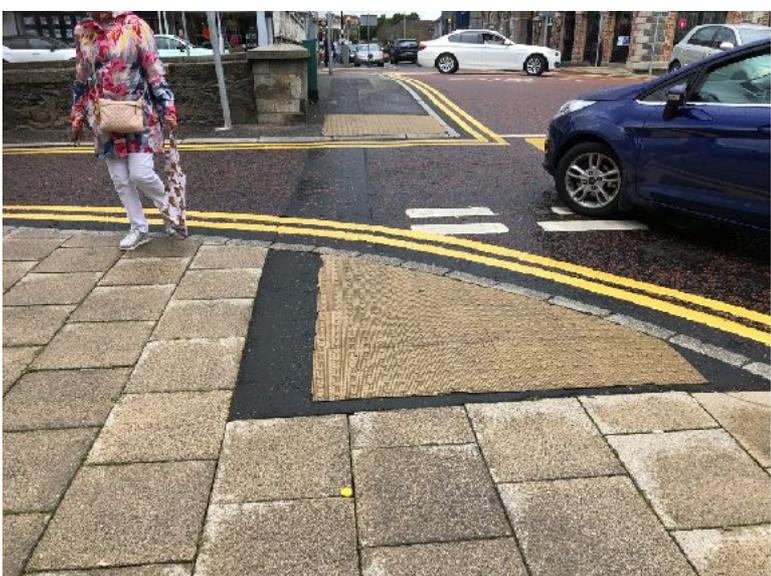
A series of uncontrolled crossings have been provided for pedestrians to cross the streets adjacent to the bridge. Stick down tactile tiles have been used on the bridge because of its listed status.

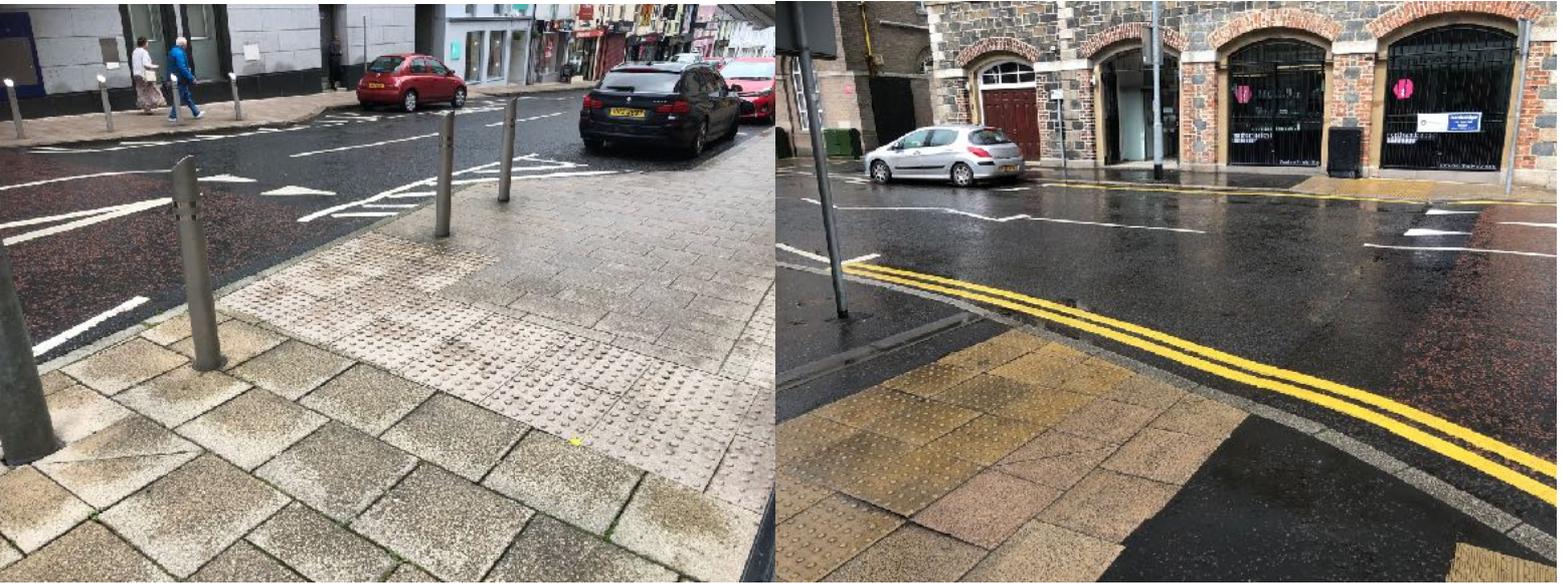
Uncontrolled crossings have been provided across Scarva Street and Rathfriland Street. Tactile paving layout does not meet standards. The tactile paving does not sufficiently contrast with surrounding pavements in places. The associated bollards do not include a strong visibility strip.

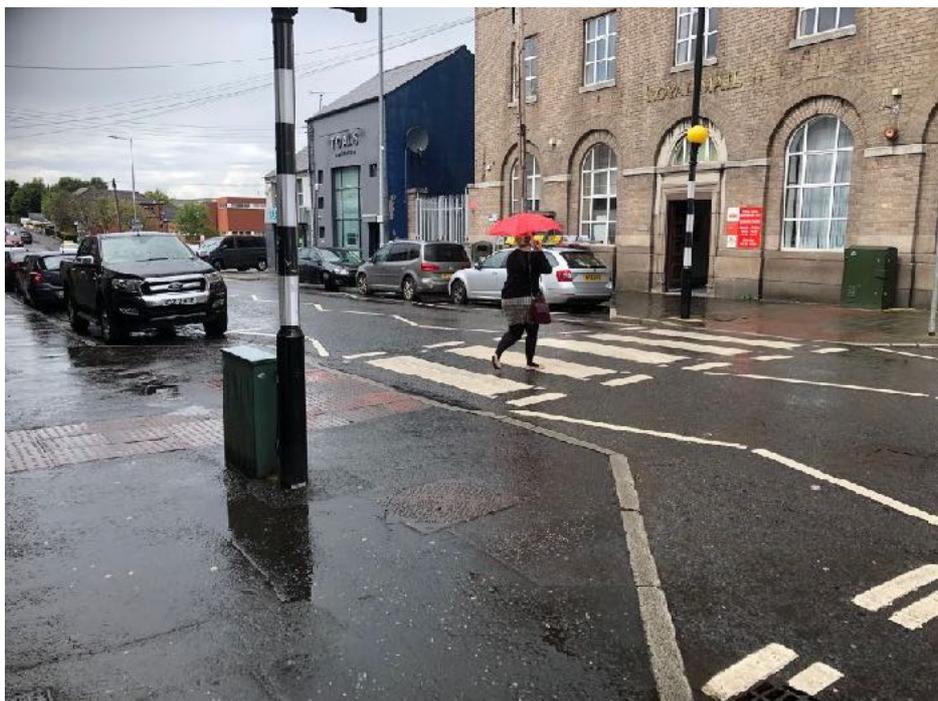
There is a Zebra crossing close to the Post Office on Scarva Street. The footway and tactile paving condition is not as good as on other streets in the town centre.

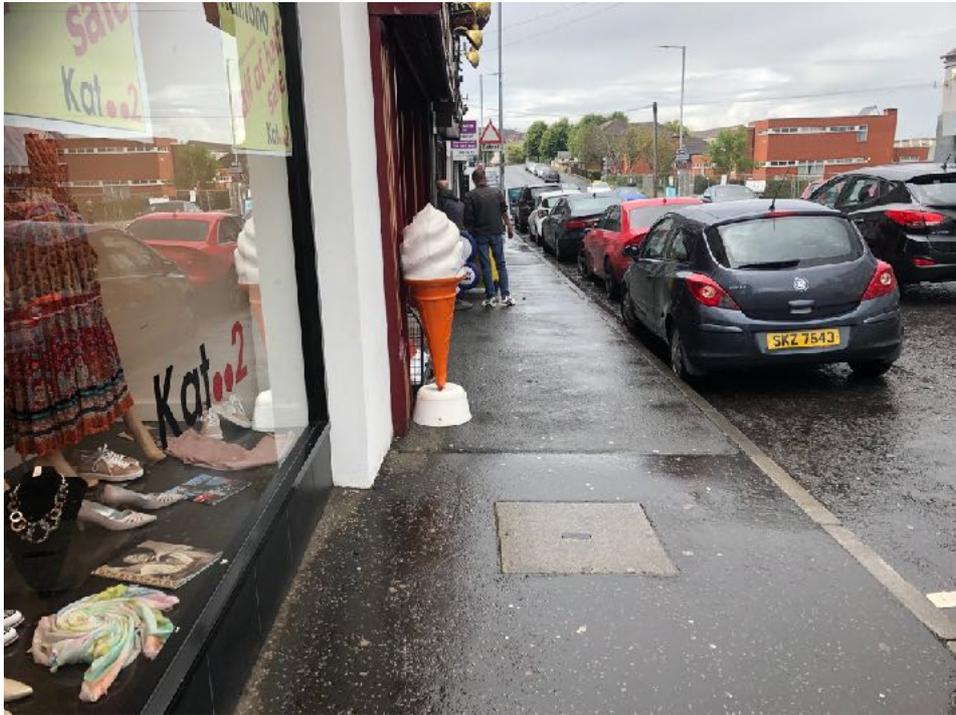
The southern footway on Scarva Street is narrow and uneven in places. Bins and shop displays on the pavement create potential hazards.

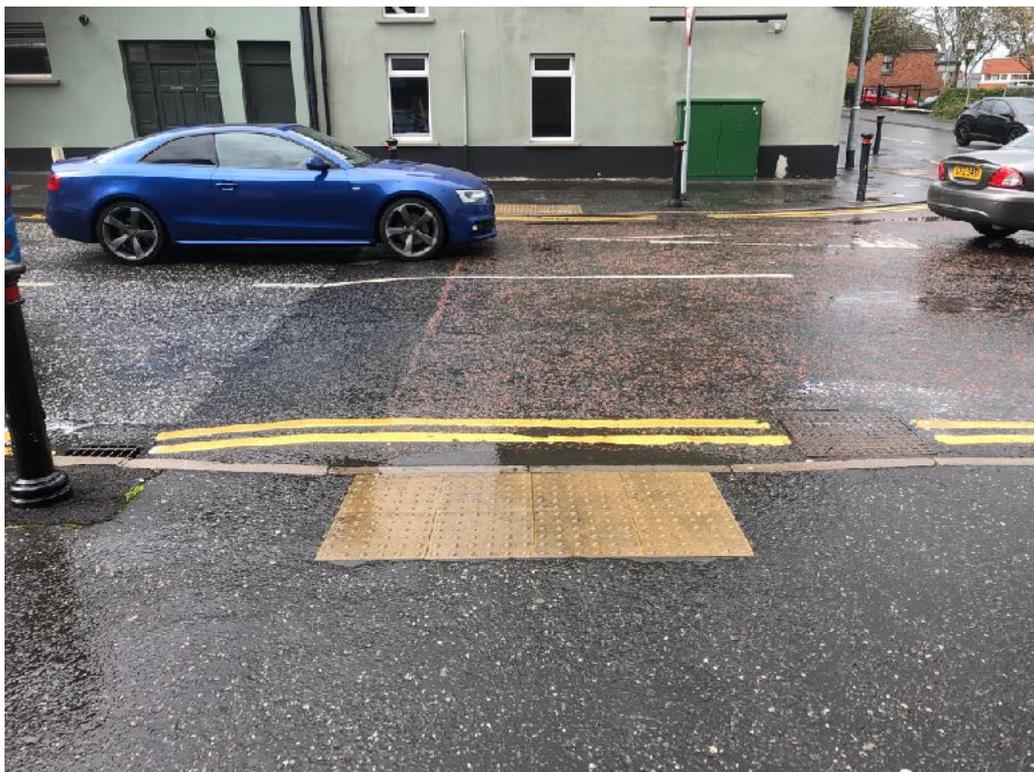
There is an uncontrolled raised table crossing at the junction with Commercial Road. Tactile paving is of insufficient depth and only partially covers the section of flush surface between footway and carriageway. The design of the junction makes it inaccessible to some disabled people.

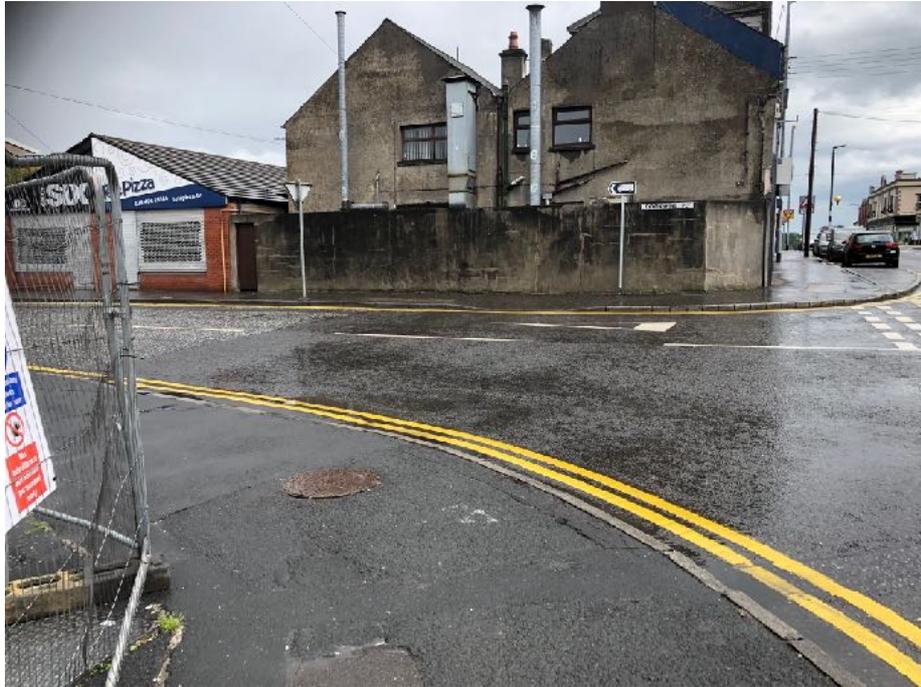
On the northern footway there is no uncontrolled crossing across Downshire Place. No dropped kerbs or tactile paving has been provided at this junction.

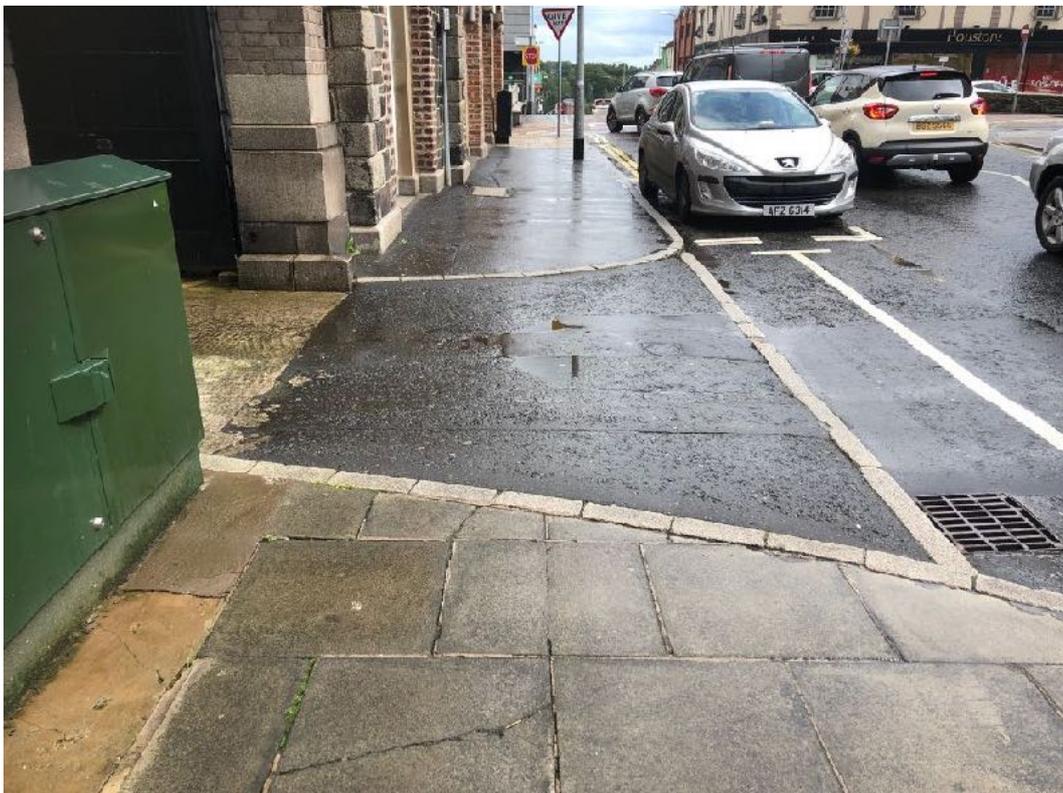
The northern footway is narrow and uneven in places. There are a number of vehicle entrances associated with the post office but no tactile indicators for people with a visual impairment.

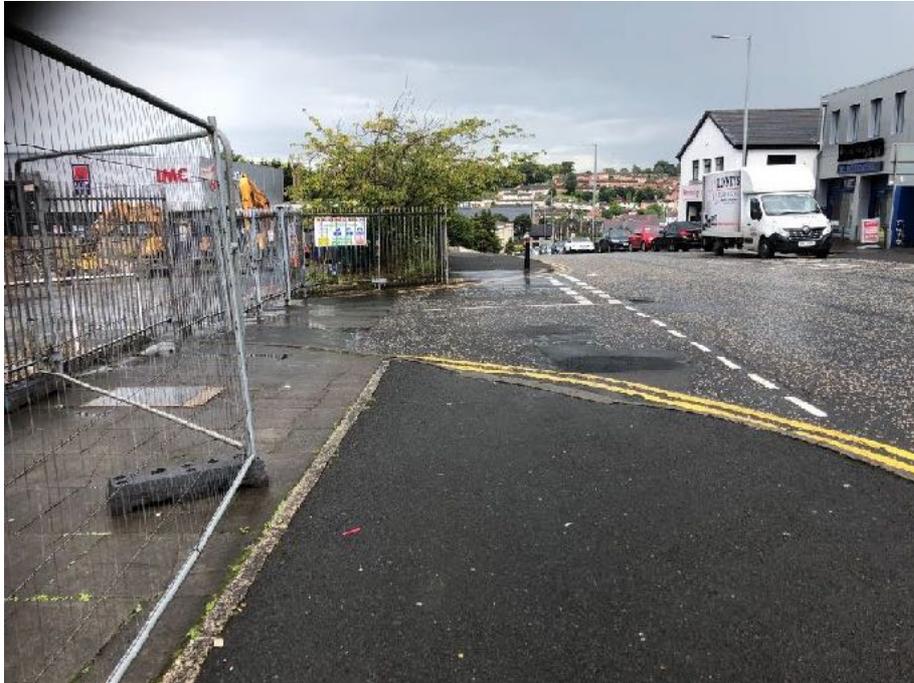
The footway on the western side of Downshire Place is uneven in places. There is a redundant uncontrolled crossing at a building site entrance without tactile paving.

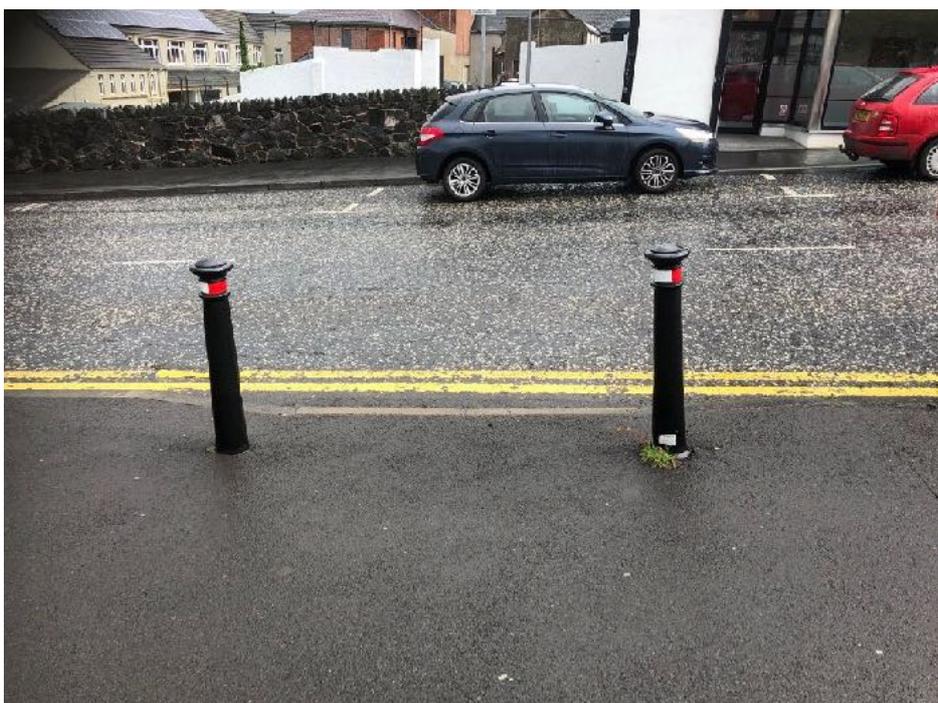
There is a dropped kerb without tactile paving on the western footway level with the entrance to the car park on eastern footway. A parking bay on the eastern carriageway obstructs access to the dropped kerb on the eastern footway.

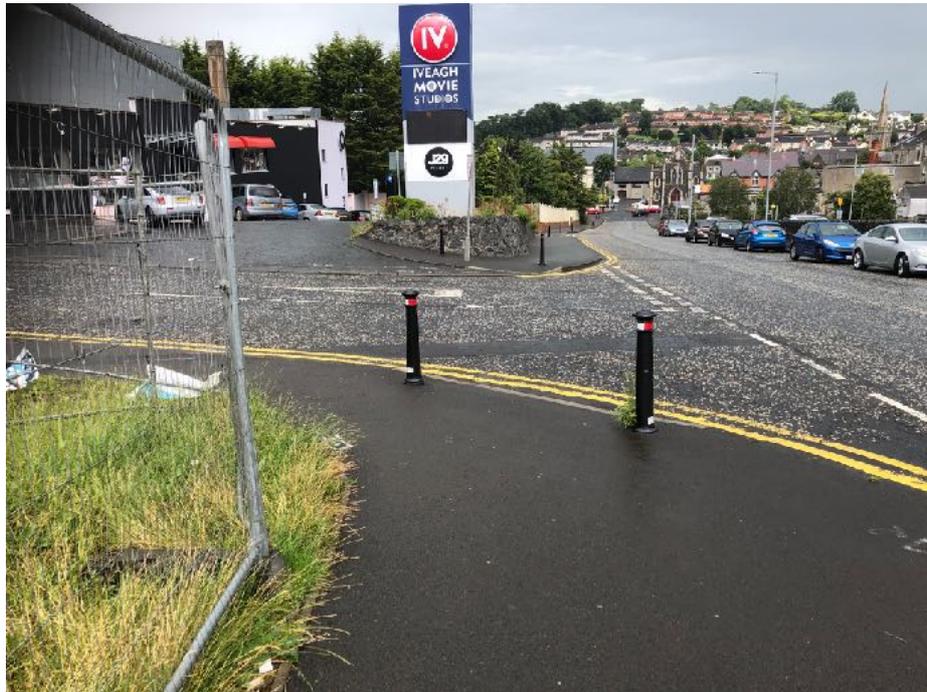
There is an uncontrolled crossing across the junction with Victoria Street. No tactile paving has been provided and the entrance to cinema on the northern side of the crossing obstructs access.

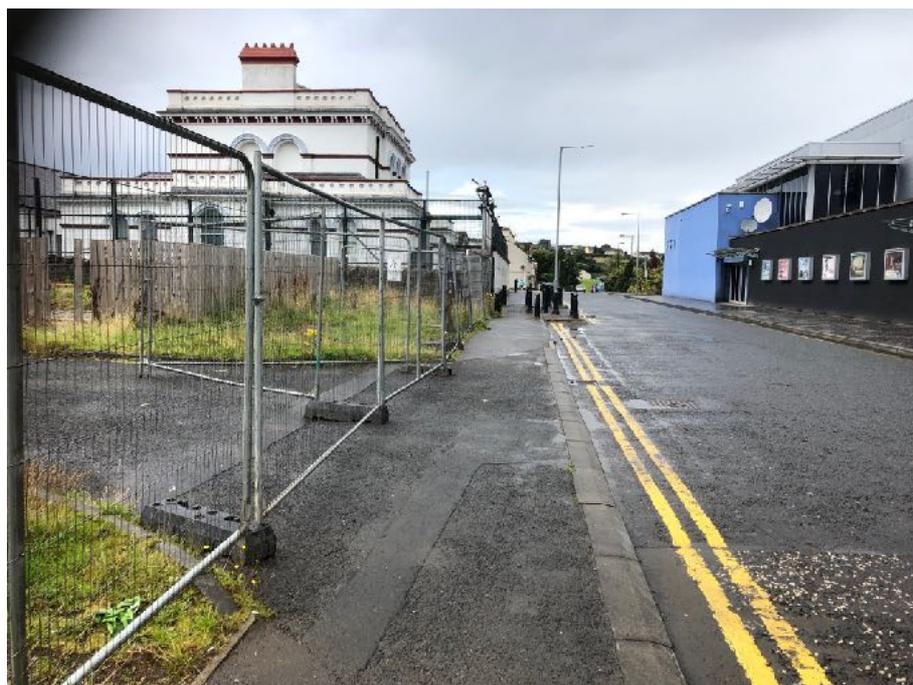
The northern footway on Victoria Street is wide and uncluttered. The southern footway is uneven and obstructed by security bollards around the old courthouse building.

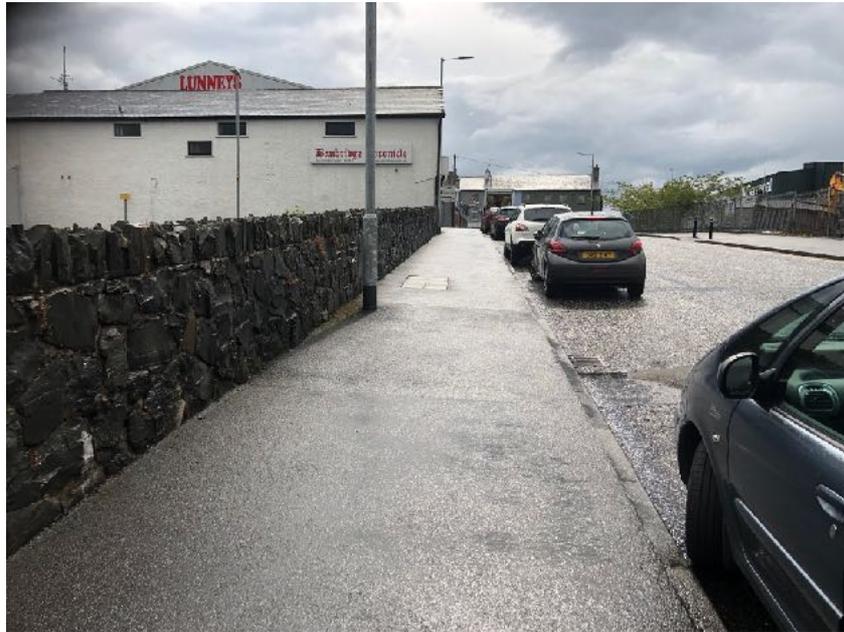
The eastern footway of Downshire Place is wide and uncluttered. However there is a significant gradient on the footway adjacent to the off street car park.

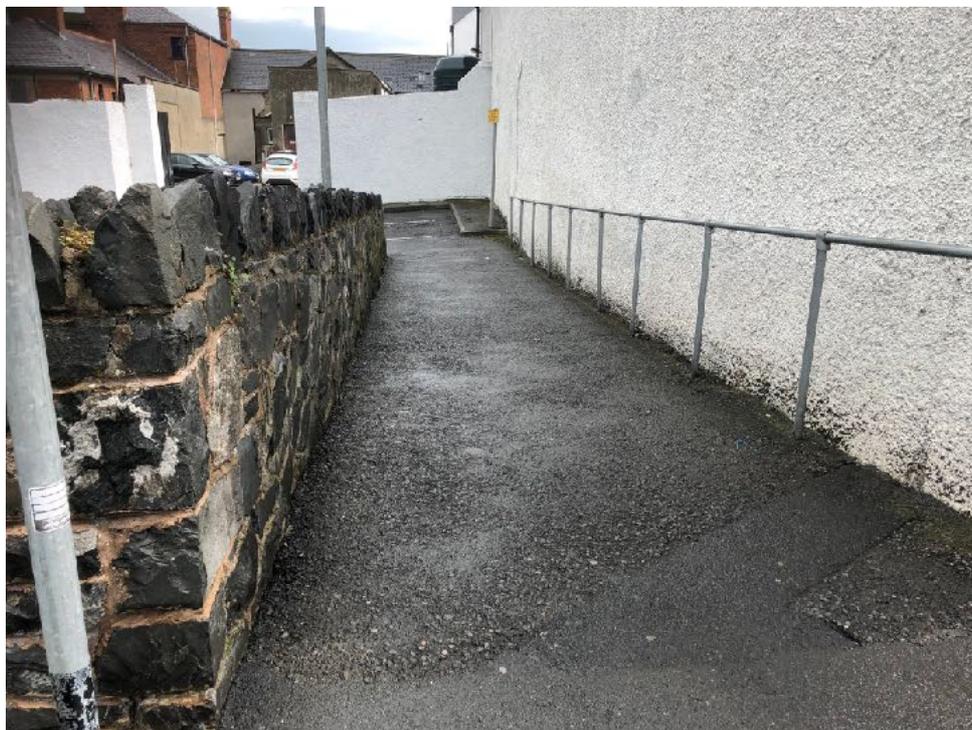
Ramped pedestrian access to the car park is provided close to this point. A handrail has been provided on one side but the surfacing and gradient of the ramp should be improved.

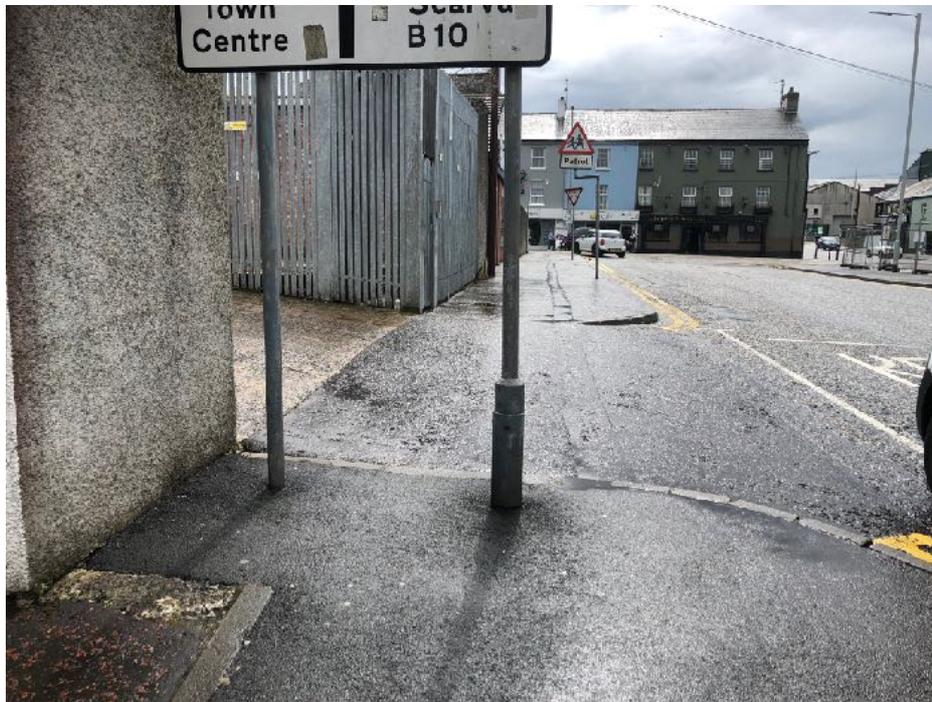
The positioning of traffic signage and a vehicle entrance to the post office are potential hazards for people with visual impairment on the eastern footway close to the junction with Scarva Street.

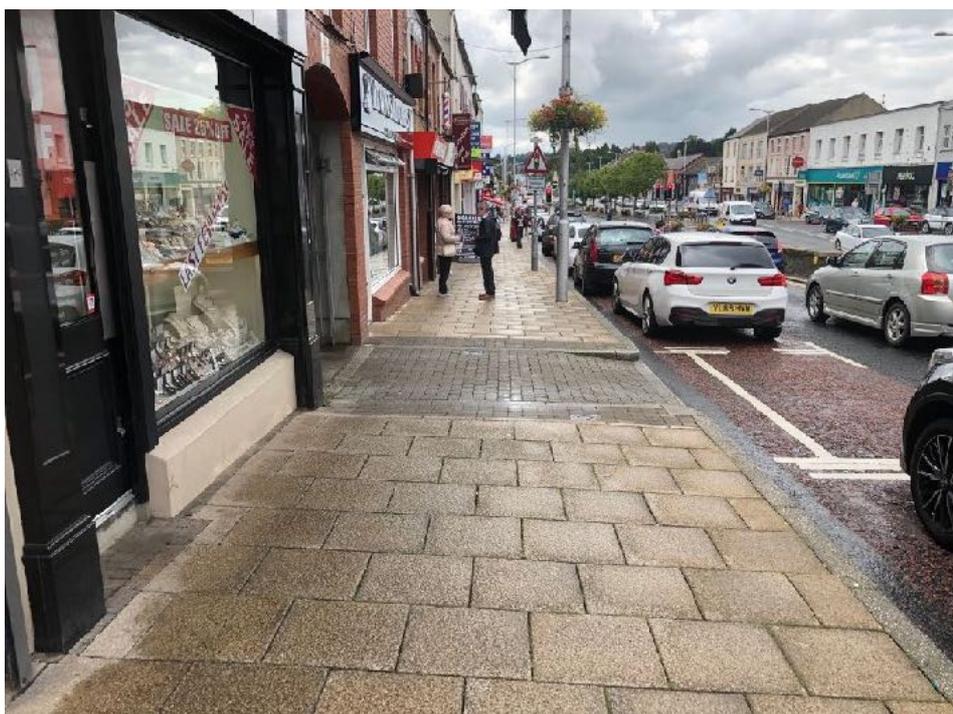
Vehicle entrances and A Boards create potential hazards for people with a visual impairment on the eastern footway of Newry Street close to the junction with Rathriland Street.

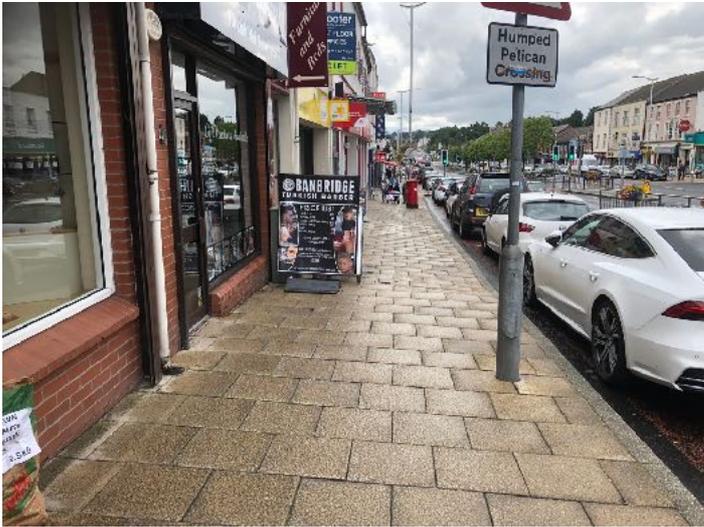
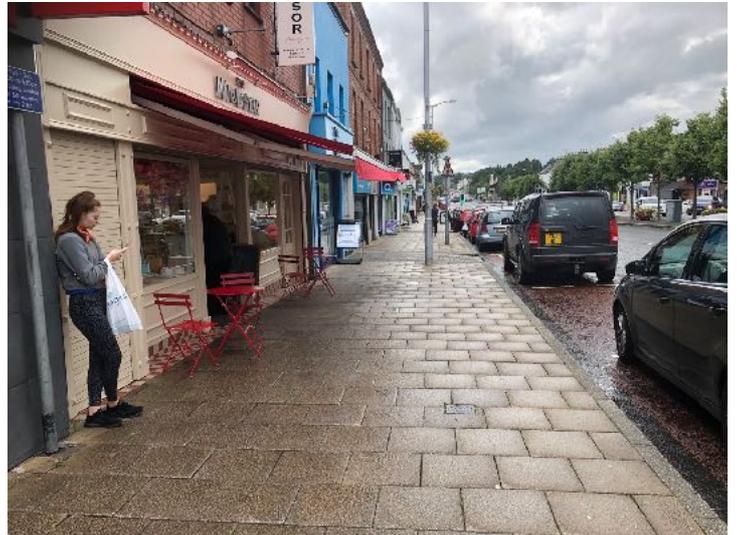
A Boards and unscreened pavement cafes are potential hazards along the eastern footway, although some effort has been made to locate these close to the building line.

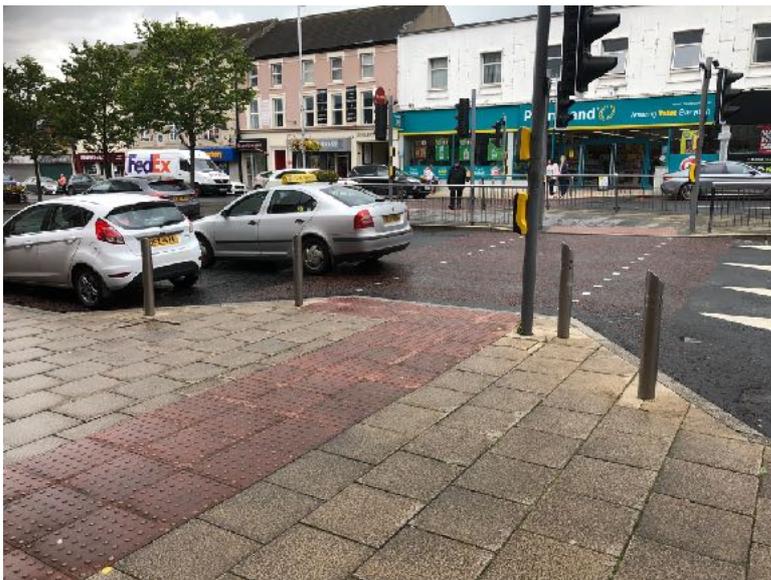
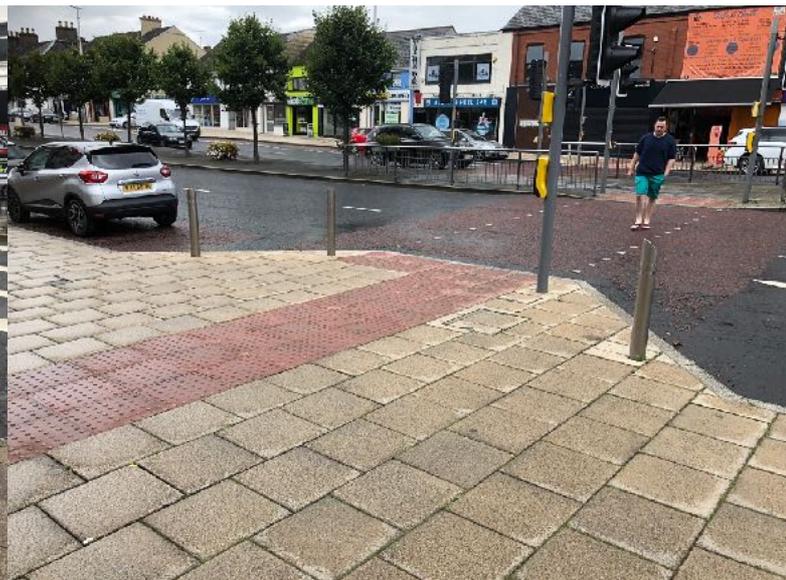
There are two controlled crossings across Newry Street. Both are staggered with pedestrian railings provided on the island. Tactile paving and control boxes have been installed correctly. The surface of the carriageway has been raised on both crossings providing level access for pedestrians but also leaving some sections of the footway flush with the carriageway without tactile paving.

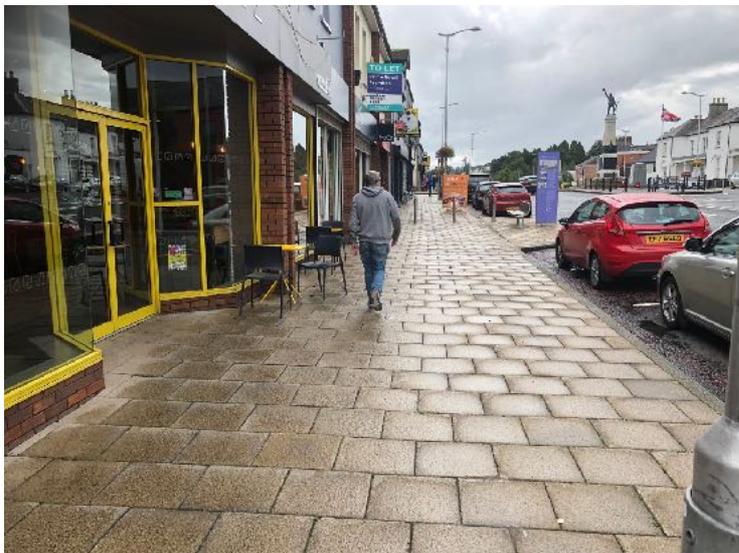
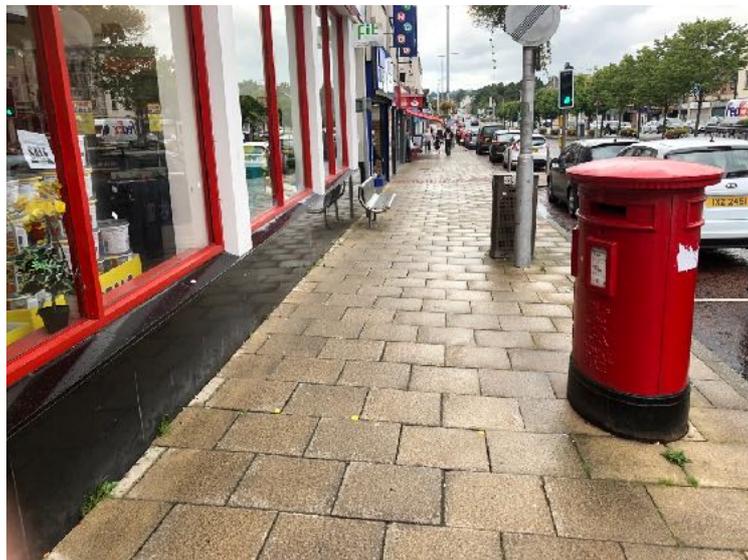
Some seating has been provided along the eastern footway. Whilst welcome greater thought is required into the design and positioning of seating and other street furniture away from pedestrian desire lines.

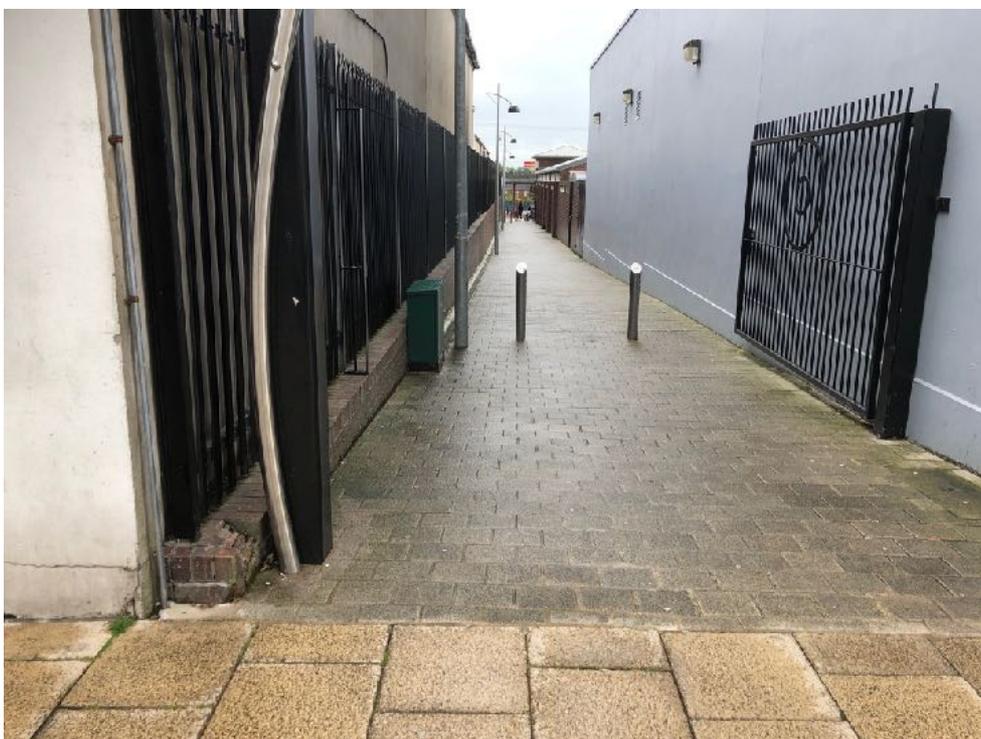
There is a gated alleyway (Poplar Row) linking the eastern footway from Newry Street with the bus station. Bollards with no visibility strips have been placed to prevent vehicle access.

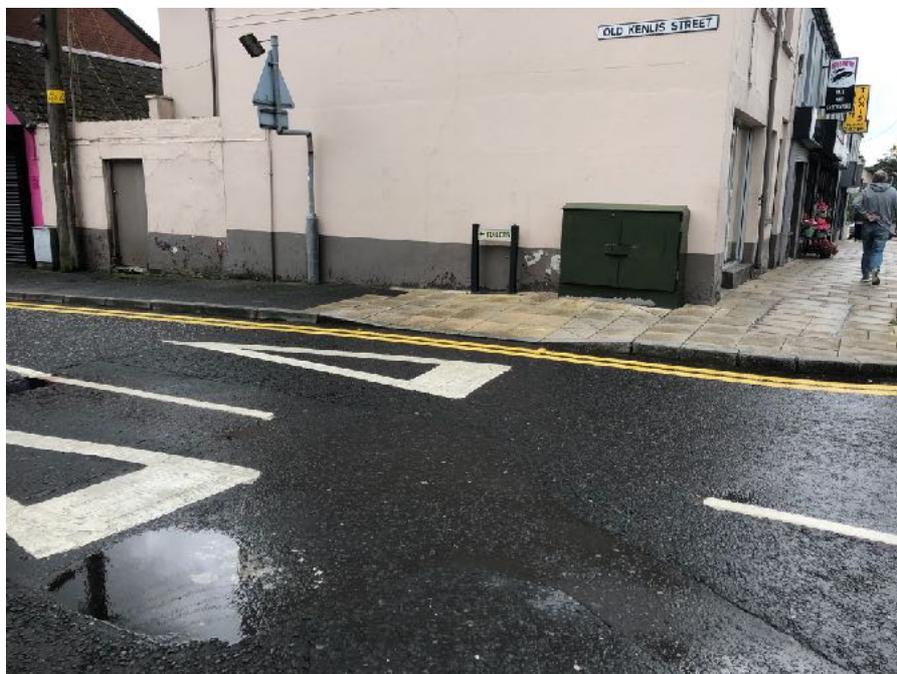
There is an indented uncontrolled crossing across Old Kenlis Street. Appropriate tactile paving has been provided. However this does not contrast sufficiently with the surrounding pavement.

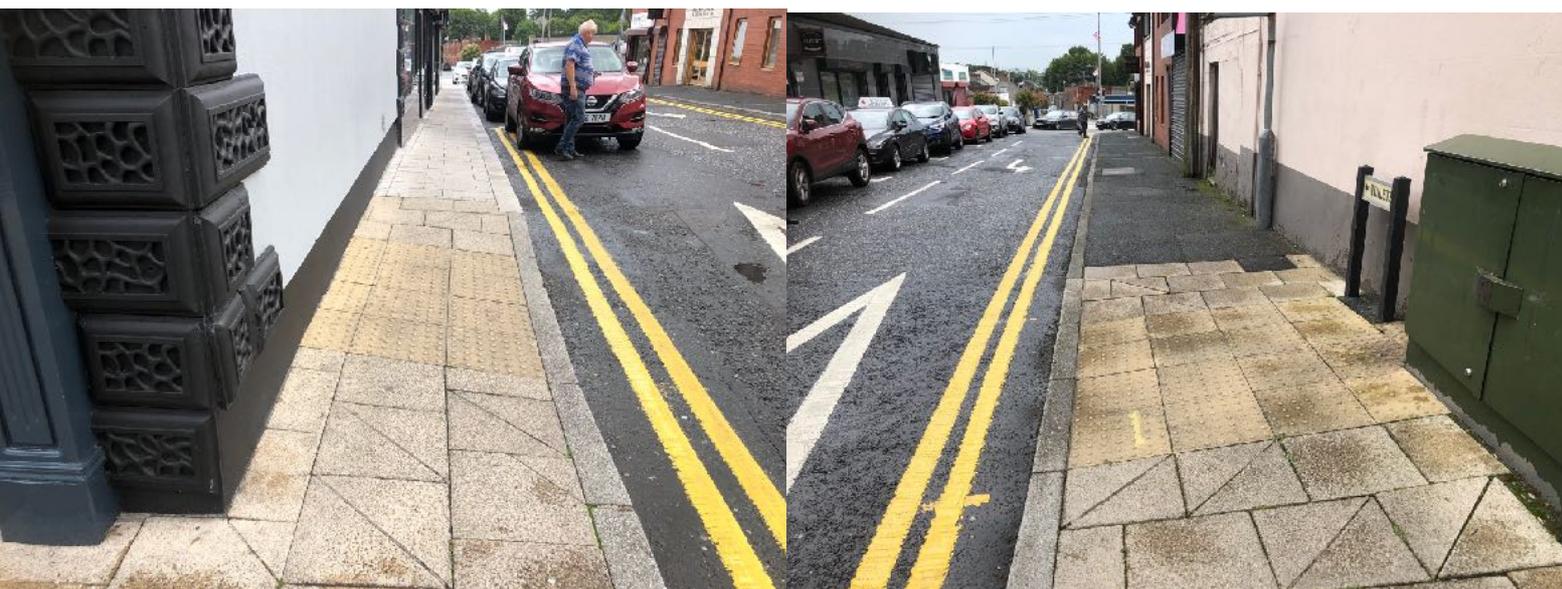
Old Kenlis Street links to the bus station. Its footways are very narrow and in poor condition on the southern side.

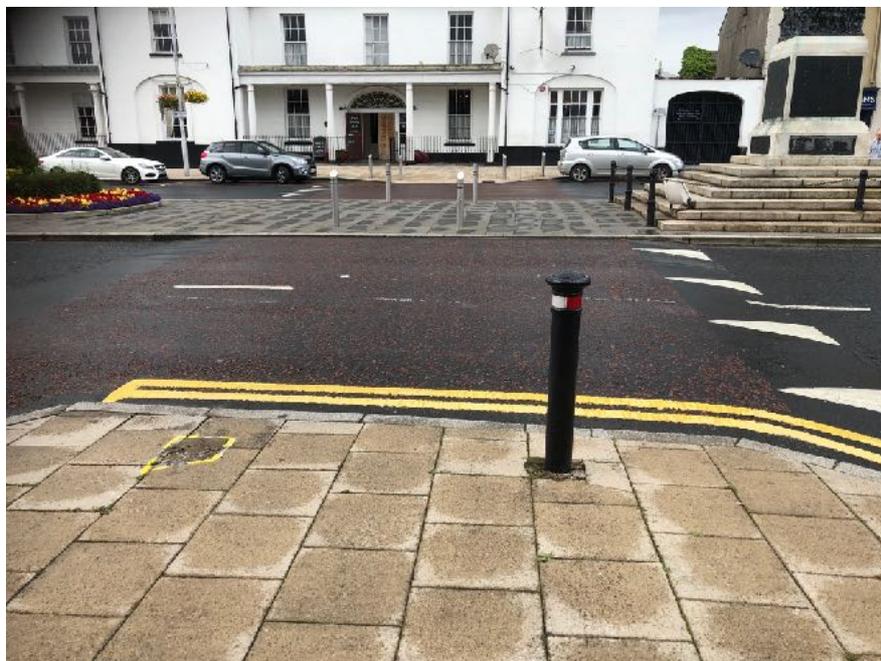
On Newry Street the carriageway is raised flush with the footway close to the Cenotaph, giving the impression this is an uncontrolled crossing. However no tactile paving has been provided making this a potentially hazardous place for people with a visual impairment. The visibility strip on bollards needs to provide a stronger contrast.

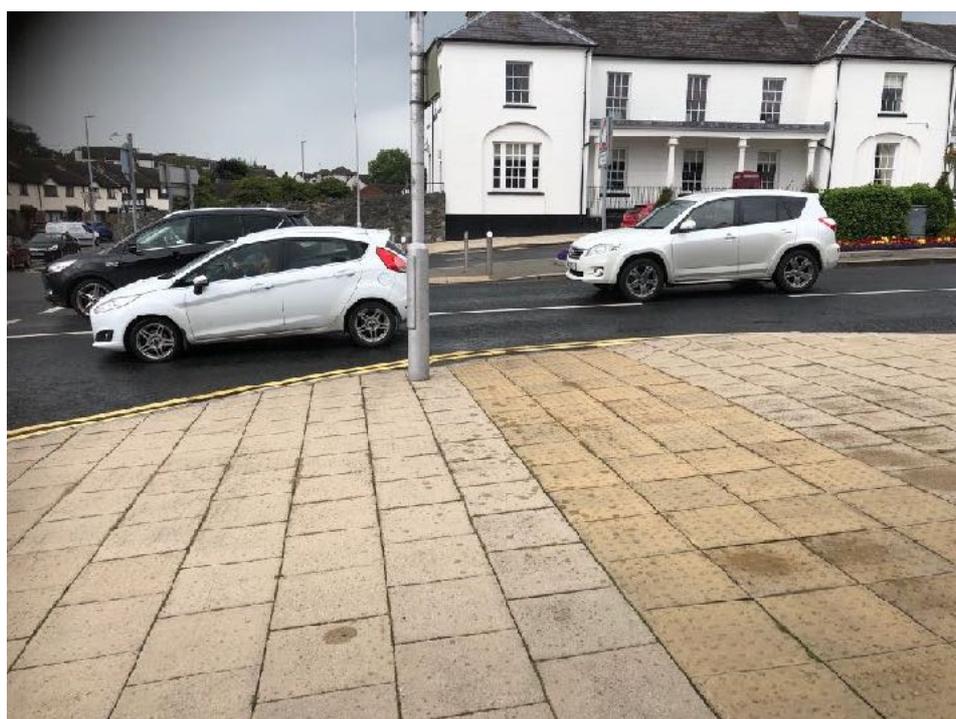
There is an uncontrolled crossing close to the roundabout at the end of Newry Street. The paving has not been laid to standard as it extends to the building line. The tactile paving does not sufficiently contrast with the surrounding pavement.

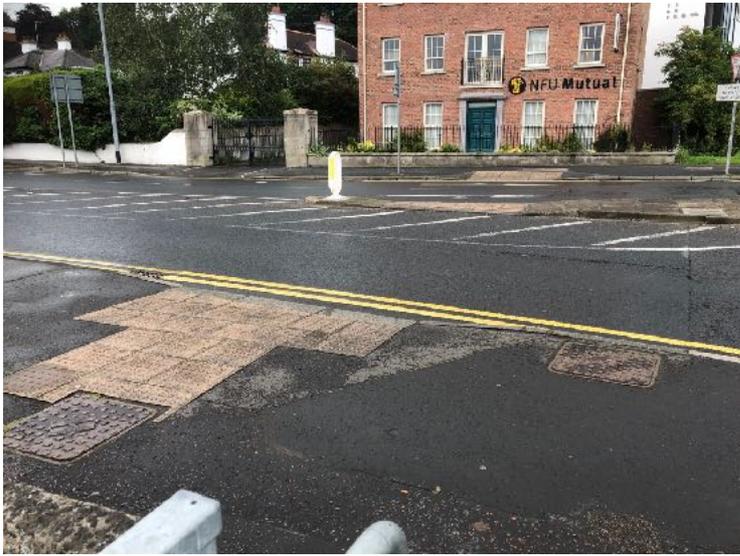
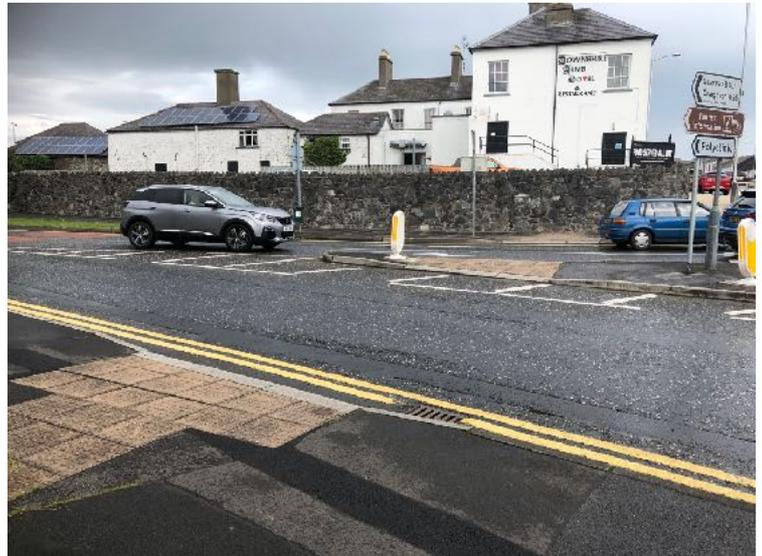
There is a series of uncontrolled crossings including a central refuge across Kenlis Street, Newry Road and Commercial Road close to the roundabout. The tactile paving is not be laid in accordance with standards. Even it was the heavy traffic levels at the roundabout means many disabled people cannot cross without assistance.
