Recommendations from Imtac on public realm proposals for Banbridge town centre

(October 2019)

Street audit findings

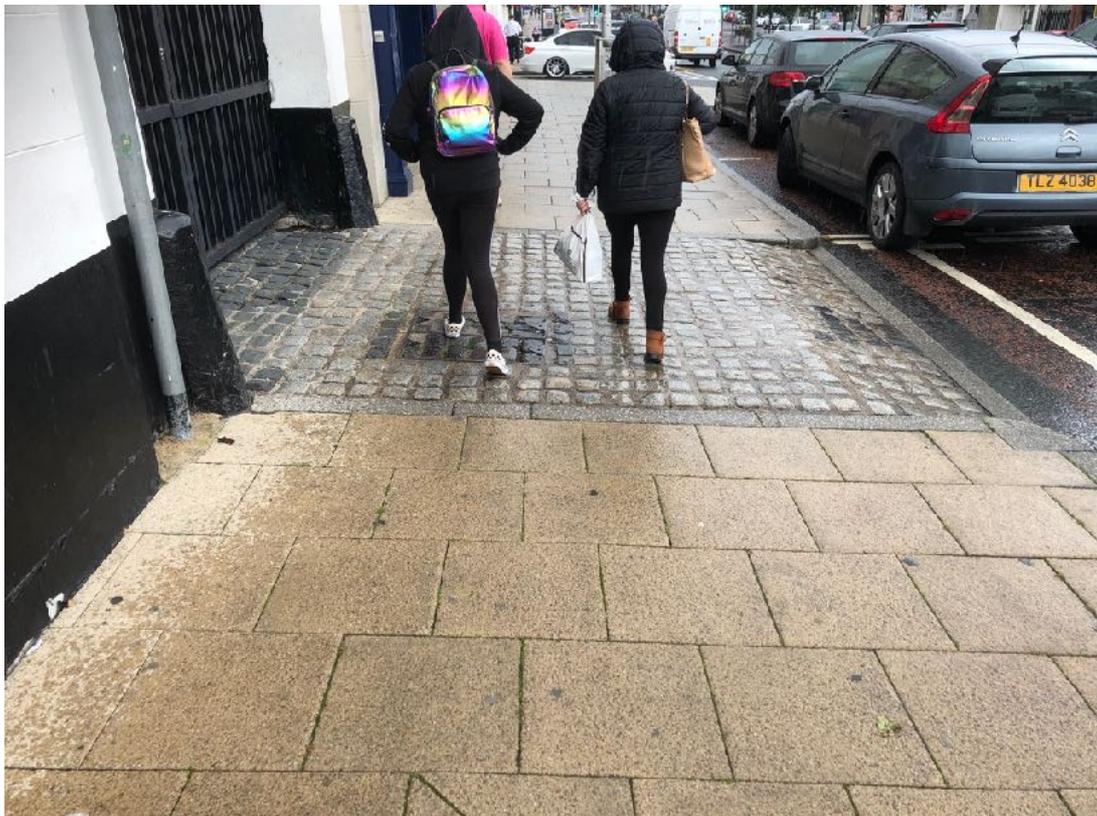
On the western footway at the Downshire Arms Hotel (B1 Listed building) there is a vehicle entrance with a rough cobbled surface.

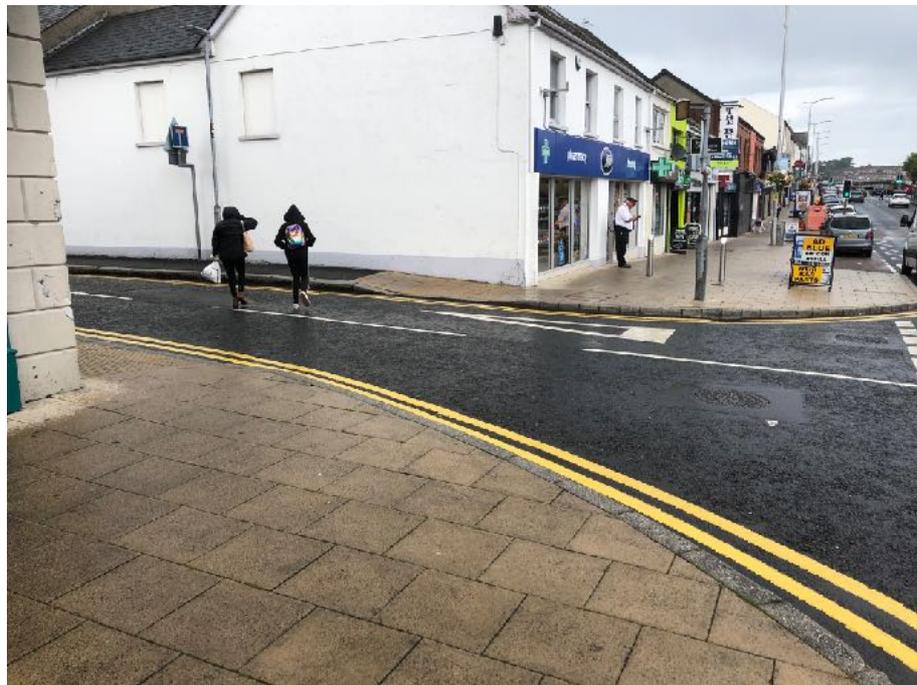
There is an indented uncontrolled crossing across the junction with Linenhall Street. Although the tactile paving has been installed correctly it does not contrast sufficiently with surrounding pavement.

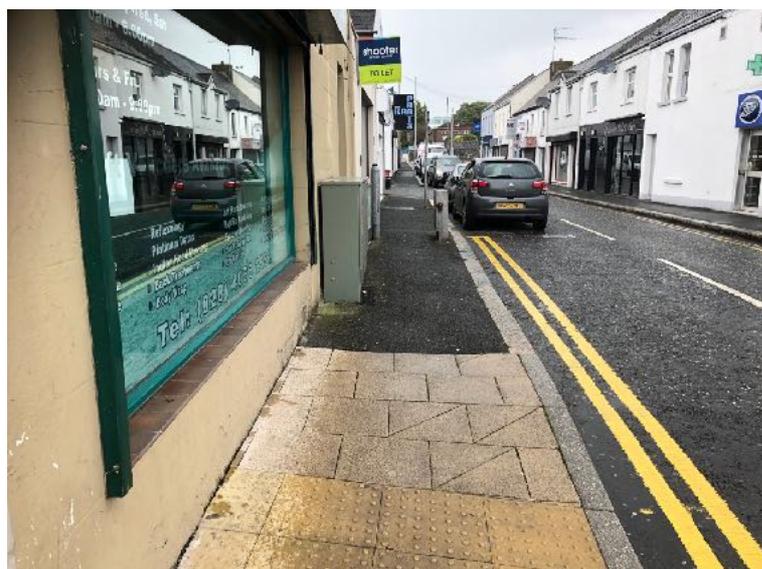
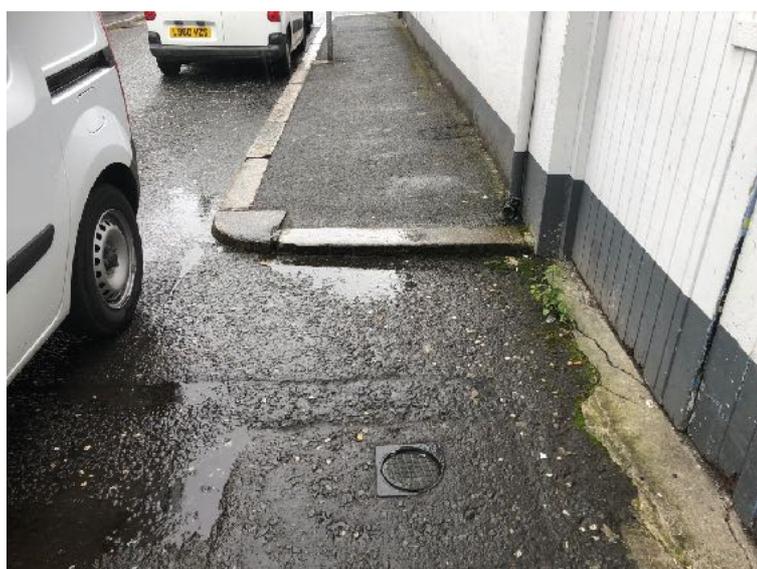
The footways on Linenhall Street are narrow, with street furniture on both sides further reducing available width, and in poor condition. There is no step free access along the length the southern footway.

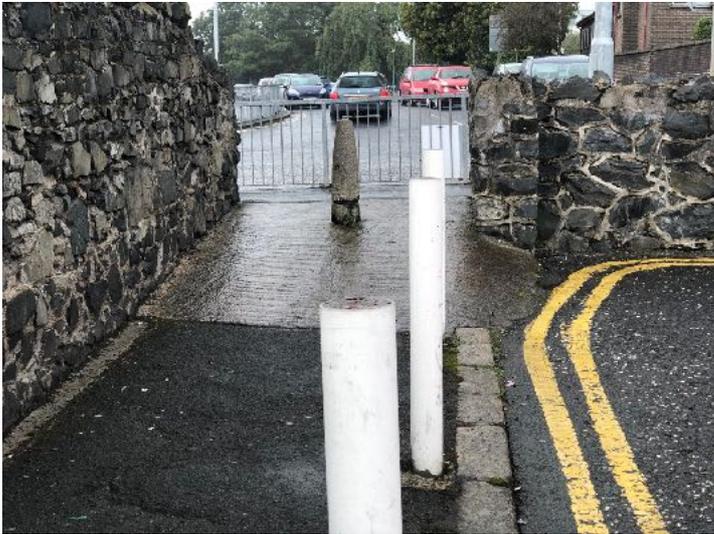
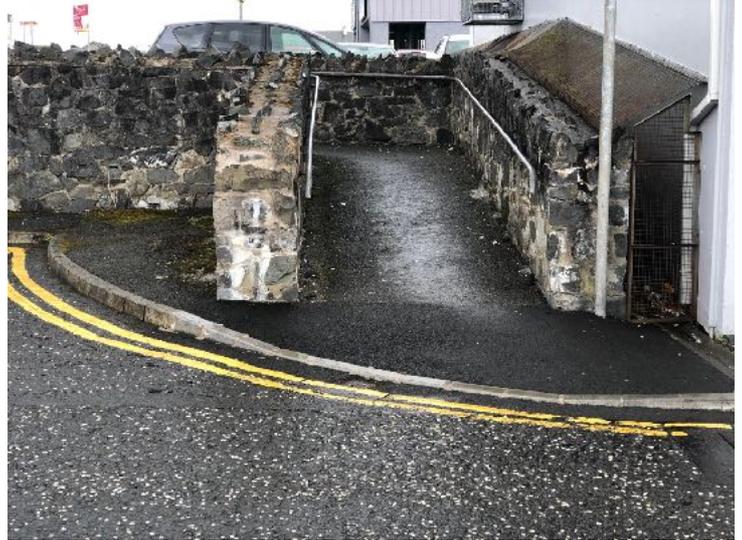
There is ramped pedestrian access to Commercial Road and to the adjacent car park. Provision of both ramps falls short of acceptable inclusive design standards. The presence of bollards illustrates the significant numbers of vehicles using Linenhall Street despite it being a no through road.

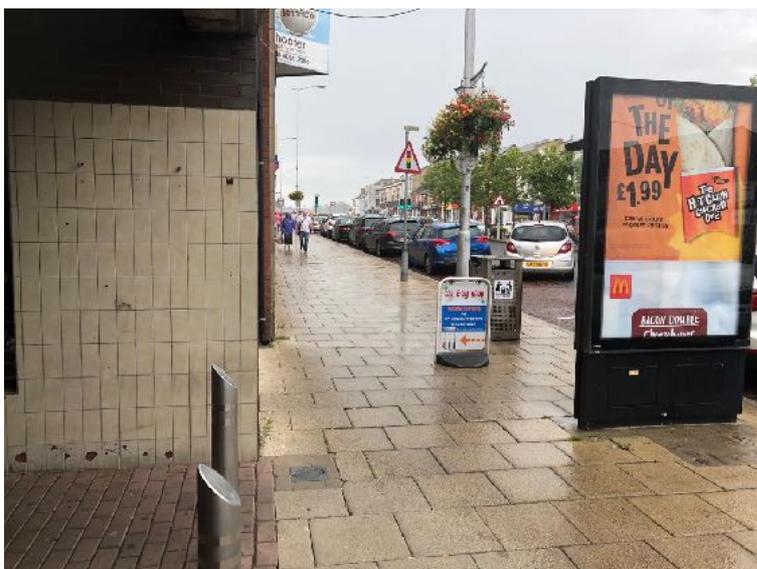
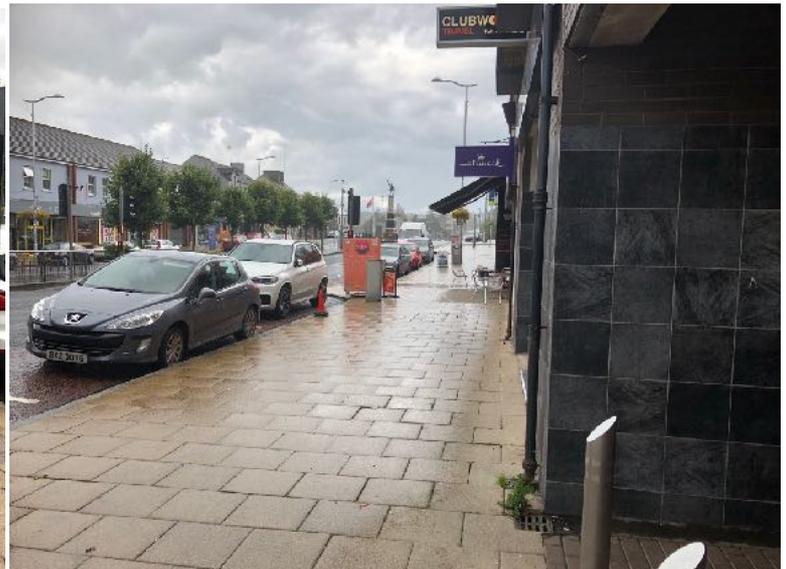
The western footway of Newry Street close to the junction with Linenhall Street is cluttered with A Boards, unscreened pavement cafes and street furniture, all potential hazards to be people with a visual impairment.

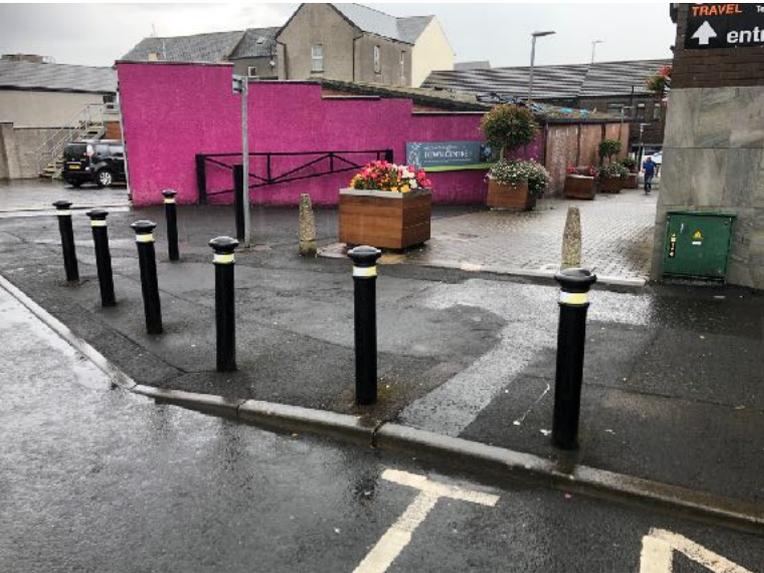
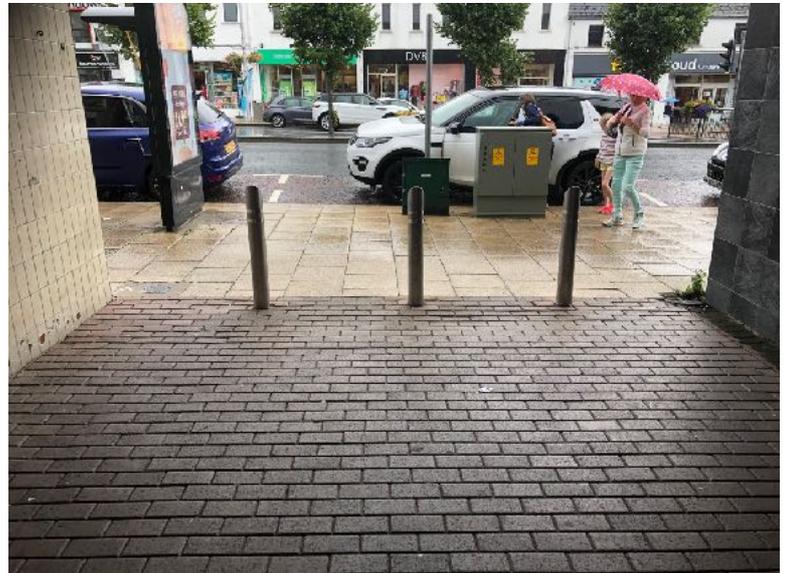
The Mall provides a linkage between the car park on Commercial Road and Newry Street. Currently the area is uninviting (despite floral displays). Surfaces are uneven in places and bollards at the Newry Street end do not include a visibility strip.

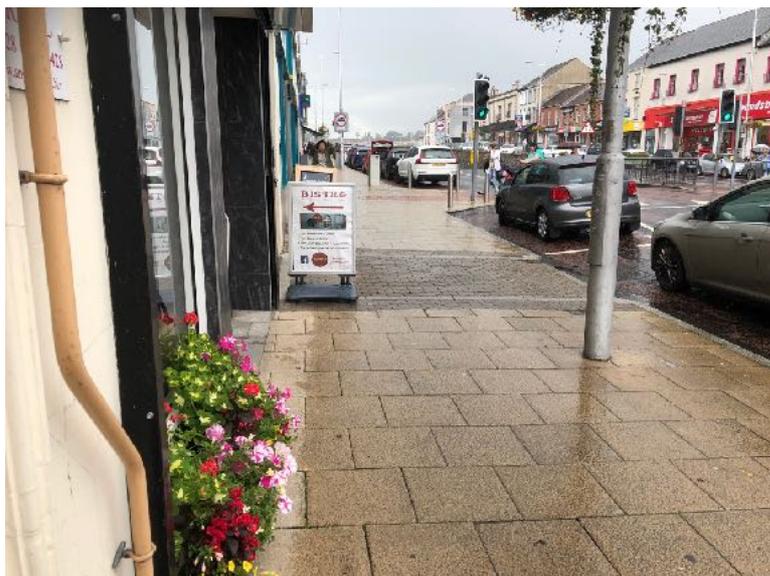
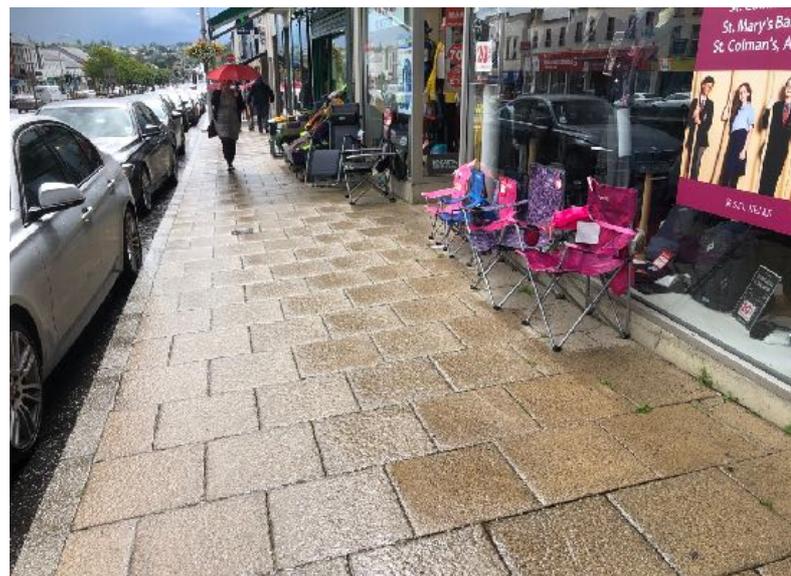
A Boards, shop displays and a vehicle entrance are potential hazards for people with visual impairment on the western footway of Newry Street approaching the bridge. The gradient of the footway increases significantly at this point approaching Downshire Bridge.

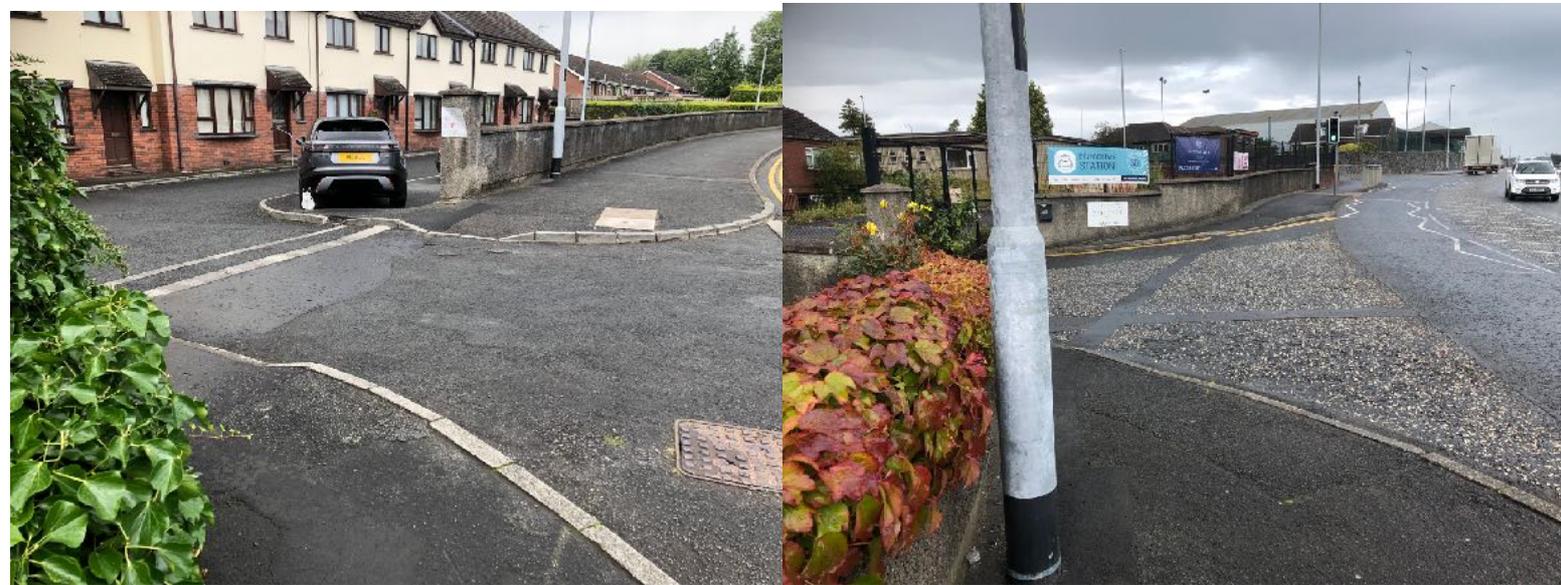
There are two vehicle entrances along the western footway of Commercial Road. Although the kerbs are dropped no tactile paving has been provided.

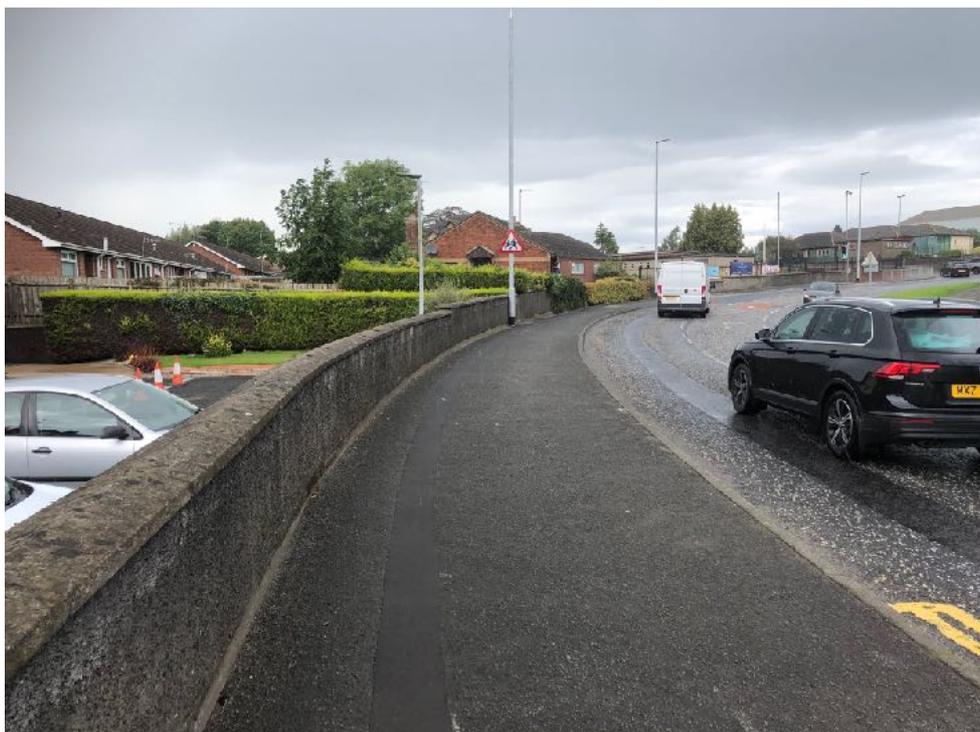
The footway is broad but uneven in places. Traffic calming measures are an indication of the high traffic levels in the area.

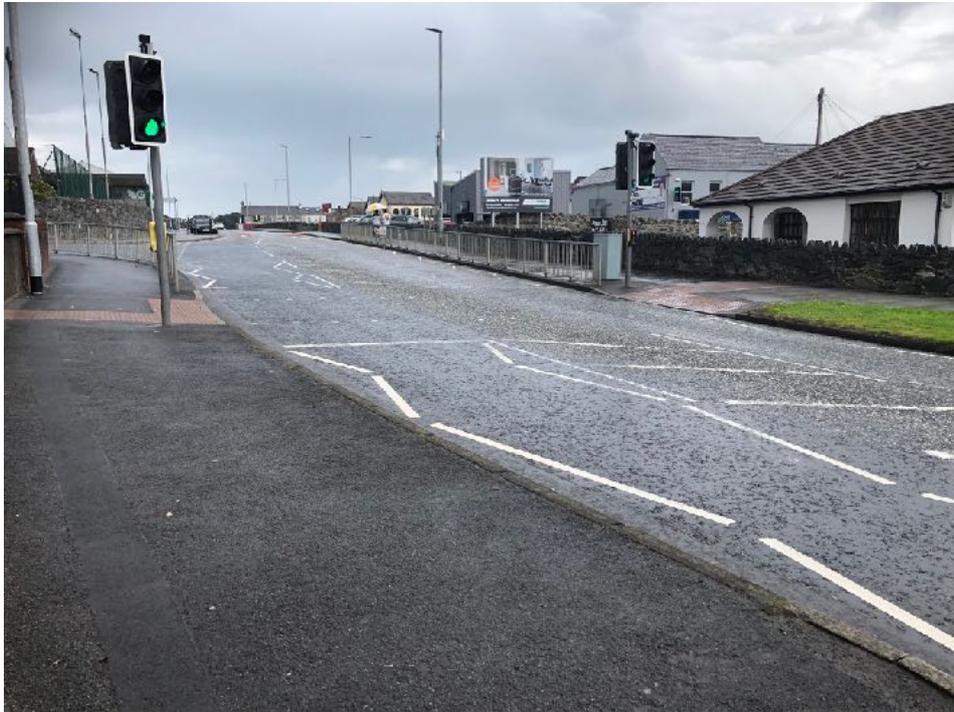
There is a pedestrian crossing across Commercial Road close to the junction Linenhall Street. Tactile paving and control boxes are installed correctly. Pedestrian railings around the crossings again indicate the impact of high traffic levels in the area.

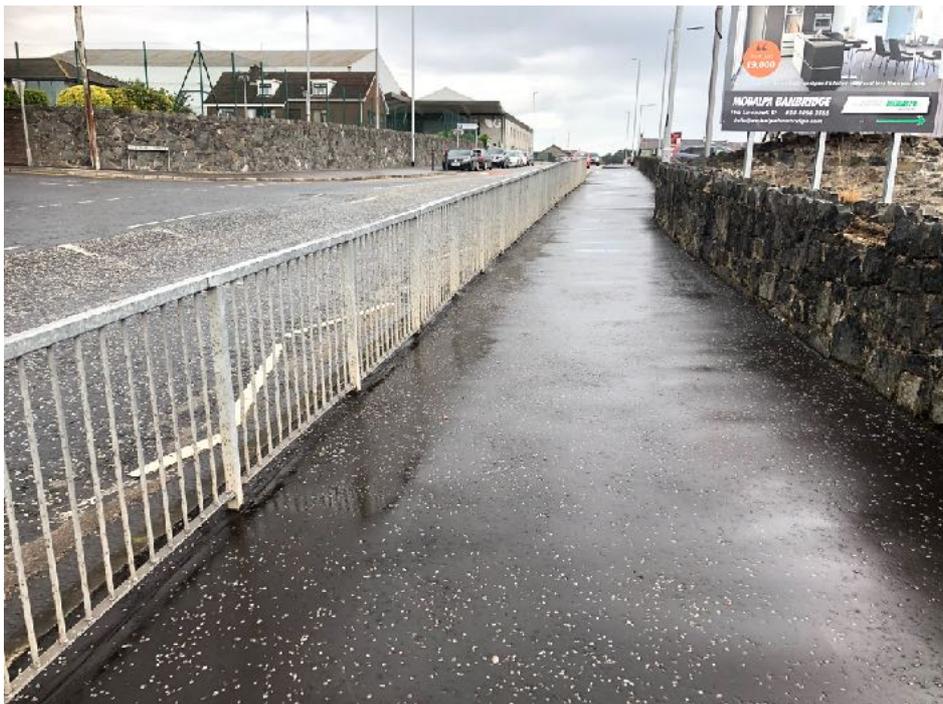
Pedestrian railings continue for a significant distance on the eastern footway of Commercial Road approaching the entrance of the car park.

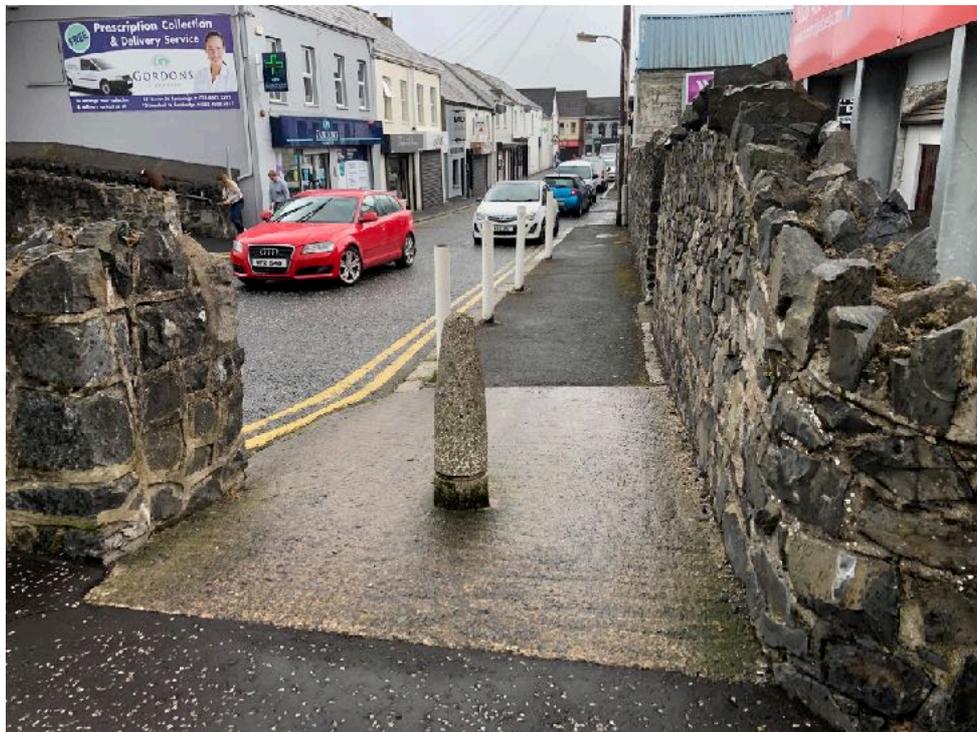
There is ramped access from Commercial Road onto Linenhall Street. Although this is step free it does not meet acceptable inclusive design standards.

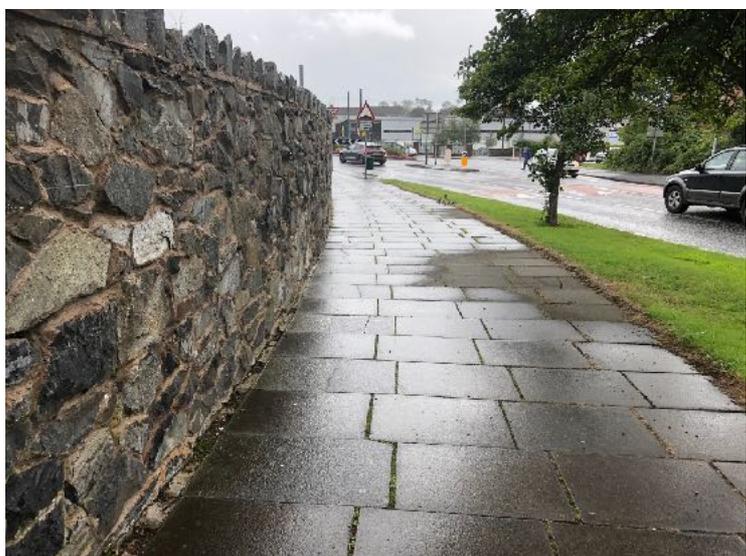
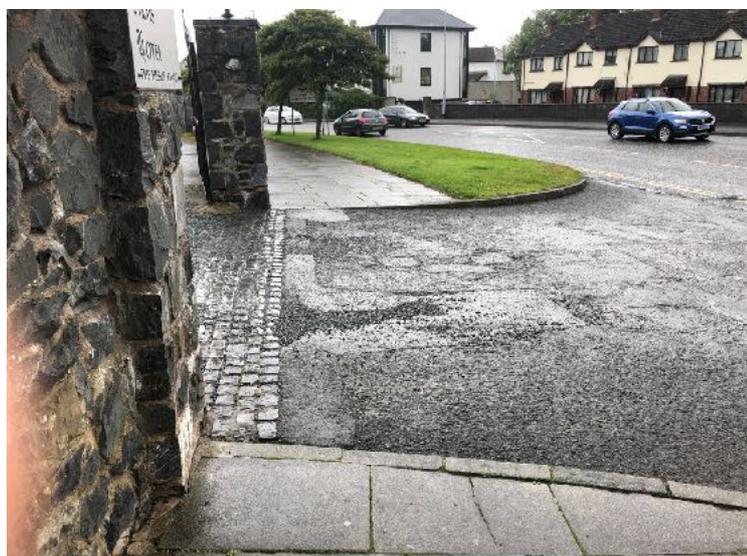
There is a broad paved footway on the eastern side of Commercial Road. Grass and trees provide a buffer from traffic levels on this side of the street. There is a vehicle entrance to the Downshire Arms Hotel on this footway - the dropped kerb is not completely flush, no tactile paving has been provided and the surfacing at the entrance is rough and uneven particularly along the pedestrian desire line.

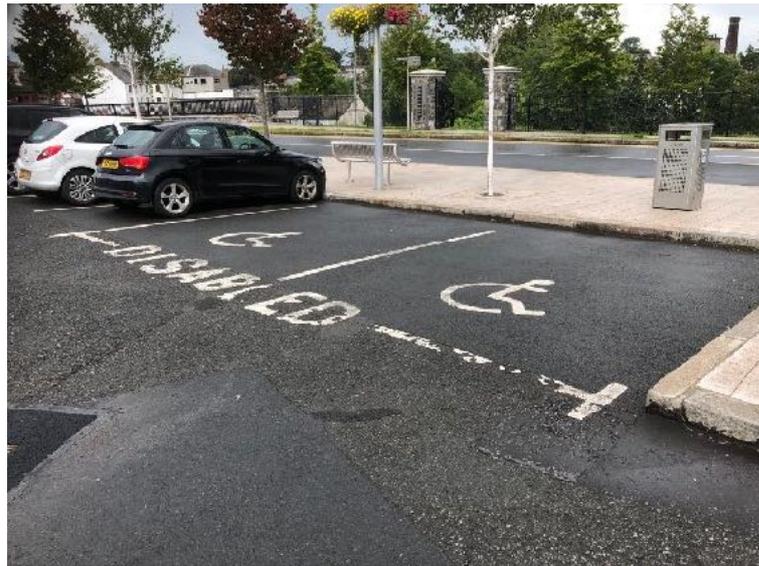
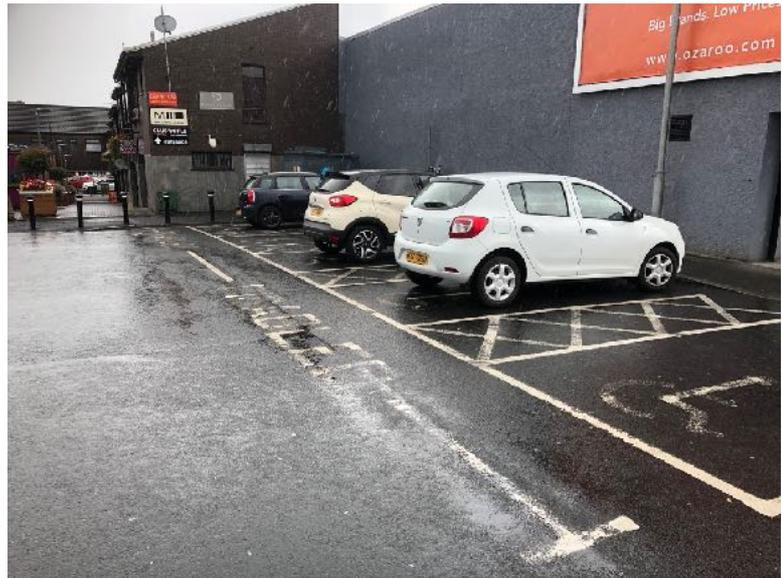
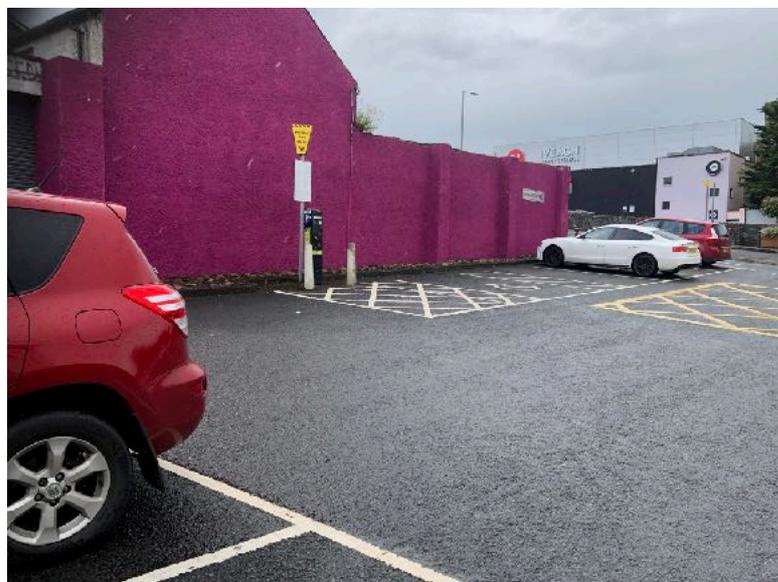
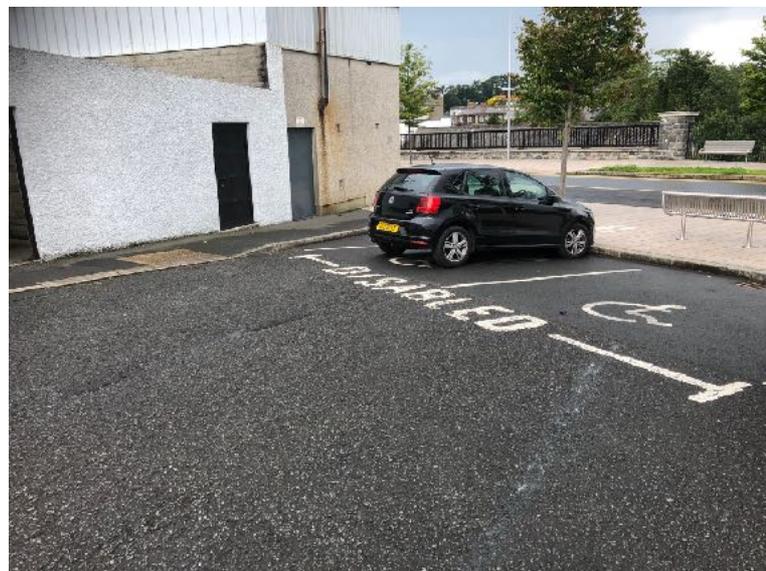
There are four off-street car parks, operated by the Council, located on the periphery of the main town centre streets associated with the scheme. All these car parks have accessible parking bays, although these are not designed to modern inclusive design standards with regard to dimensions and markings. Car parks are all pay & display.

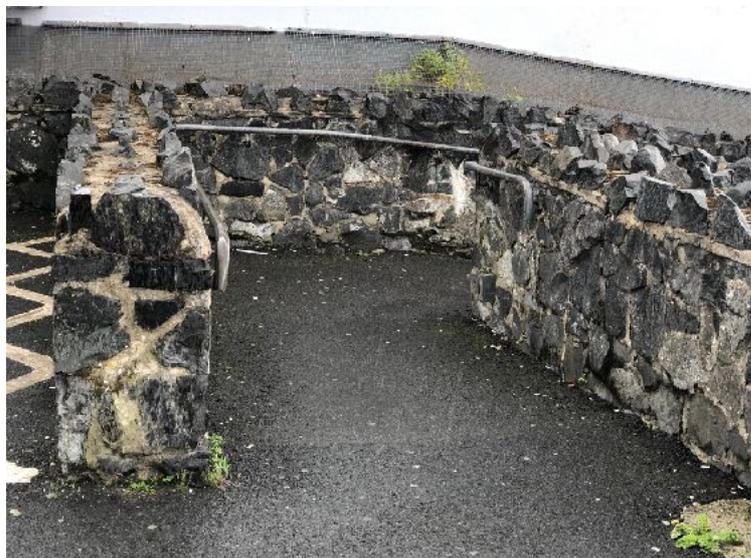
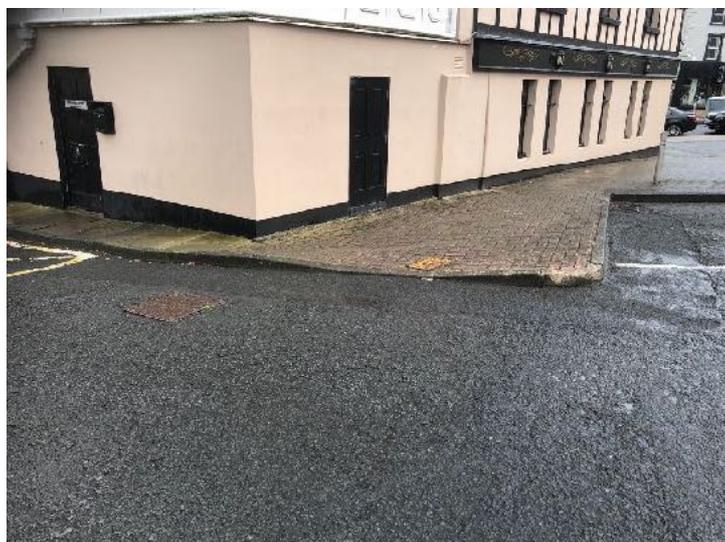
Although step free access is available to and from all the car parks, surface finish and ramp provision is generally far from ideal, falling short of inclusive design standards.

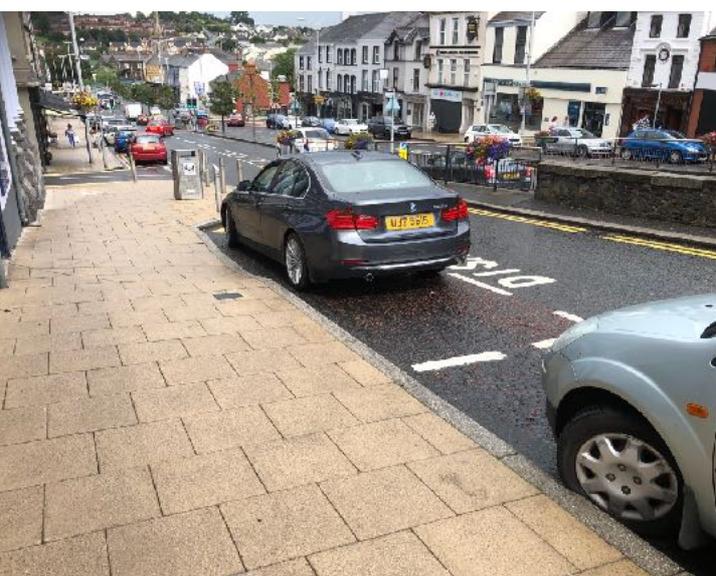
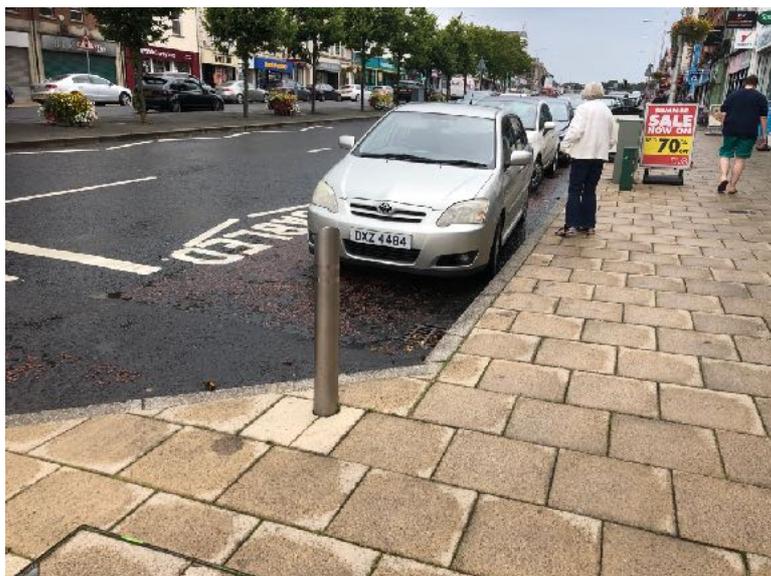
There are a significant number of free on-street parking bays in the town centre streets. A small proportion of these bays are designated accessible parking. For the most part accessible bays have included a dropped kerb although others rely on proximity to a controlled crossing for access to the footway.

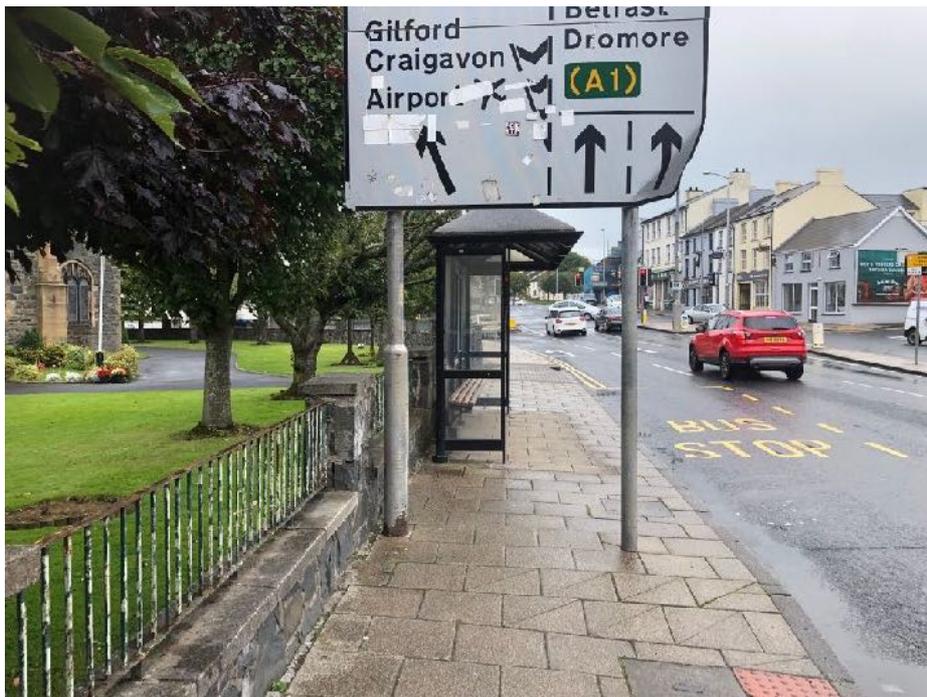
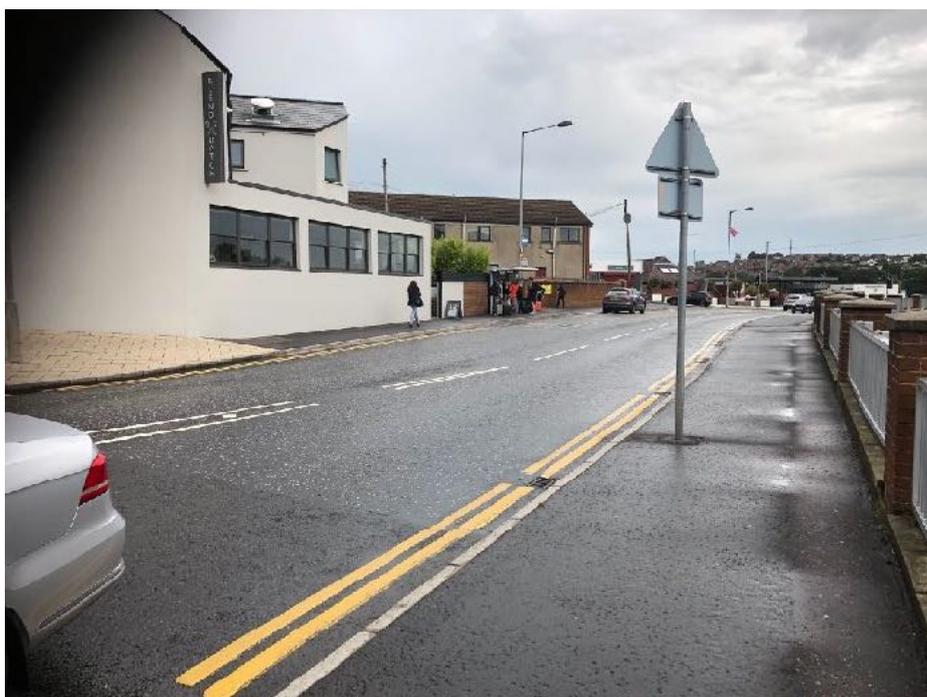
Banbridge is served by local town services and regular bus services that operate between Belfast and Newry, as well as services to Dublin. Currently bus stops are located at either end of the town (Church Square and Kenlis Street) with the bus station located at the junction of Kenlis Street and Townsend Street. The bus station is connected to Newry Street via Poplar Row and Old Kenlis Street. The stops on Church Square and Kenlis Street are located on narrow footways, completely unsuited to the volume of passengers using the services.
