## **Report on Walking routes in Bangor Town Centre**

**July 2013**

This report is the fourth in a series of reports compiled by Imtac looking at the accessibility of key walking routes for disabled people and older people in town and city centres across Northern Ireland. The report was compiled following an inspection of Bangor town centre in May 2013. It considers the provision of pedestrian facilities in Bangor measured against accepted accessibility standards<sup>1</sup>. The report is a snapshot of current provision and seeks to identify potential barriers for disabled people and older people and recommends how these barriers could be resolved. The report also highlights examples of good practice in the town centre. A key aspect of the report is linkage between the pedestrian environment and the bus and rail station in Bangor. We have produced two reports, a text only version and a version with photographs used to highlight barriers and good practice.

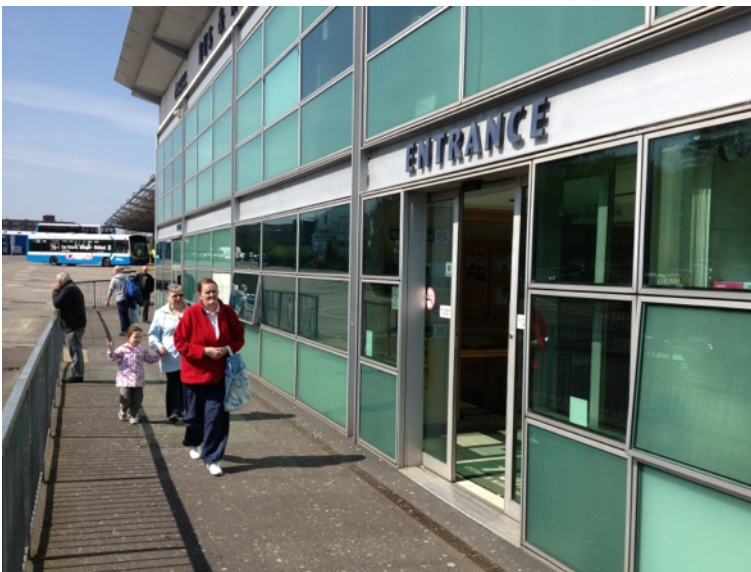
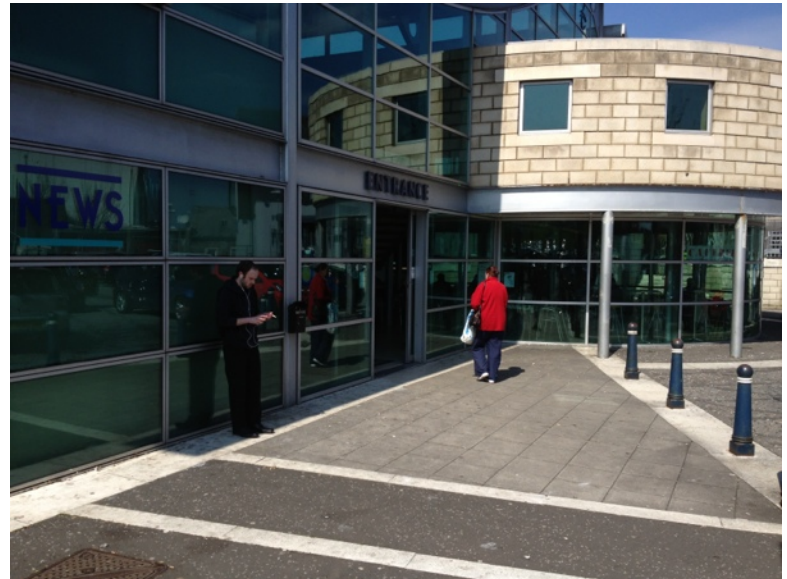
- 1 Both entrances to the station offer wide and generally uncluttered pavements.

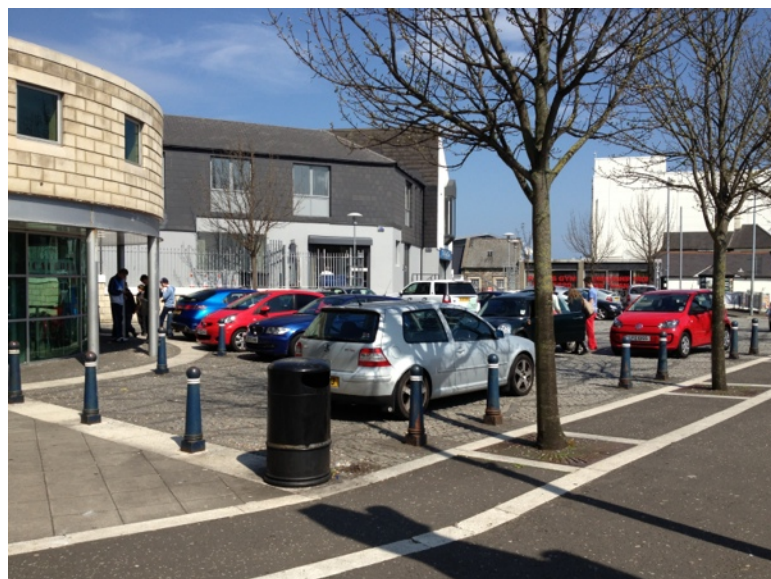
- 2 The station forecourt is cobbled and has constant vehicle movements. Signs encourage pedestrians not to use this area. Bollards mark out the boundary between the forecourt and pedestrian routes. The bollards would benefit from a stronger contrasting band.

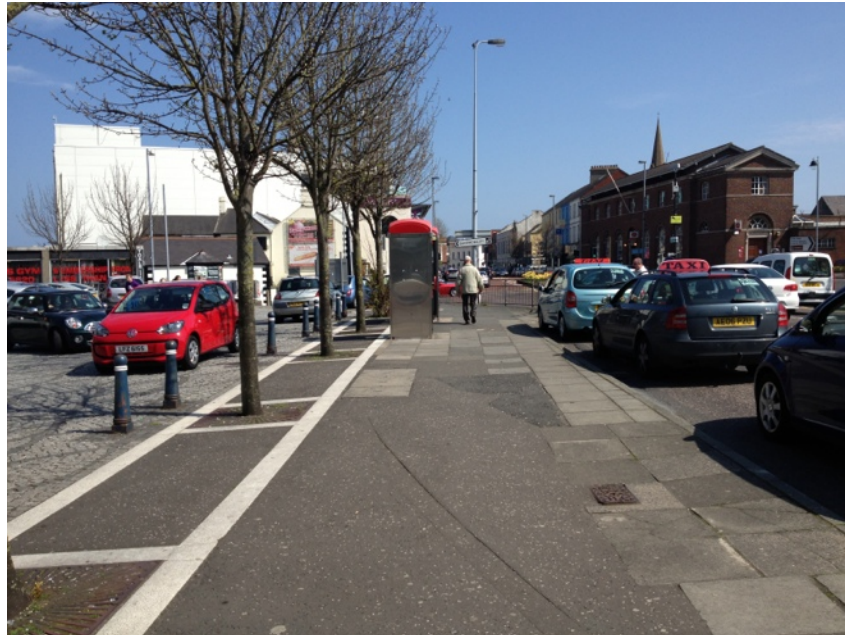
- 3 Bins, trees and telephone boxes restrict pavement width in the footway bounding the station forecourt. The surface is uneven in places.

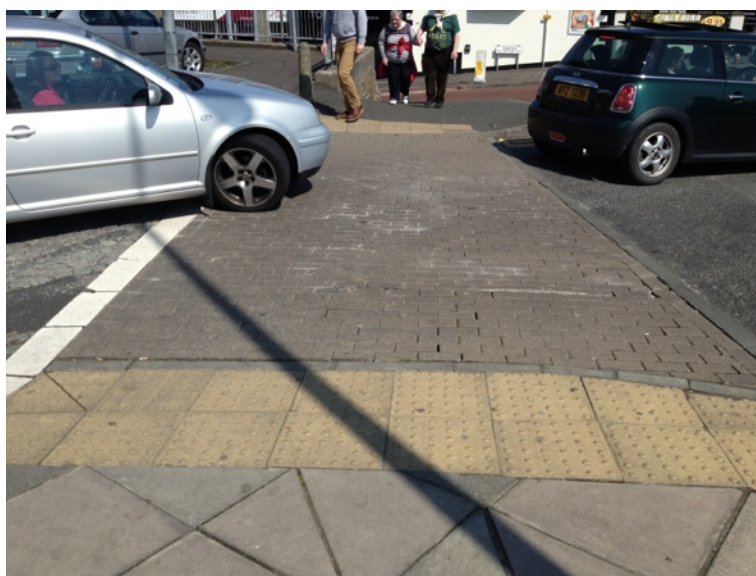
- 4 There is a good example of an in-line uncontrolled crossing at the entrance to the station forecourt. The high traffic levels make this a difficult crossing to use.

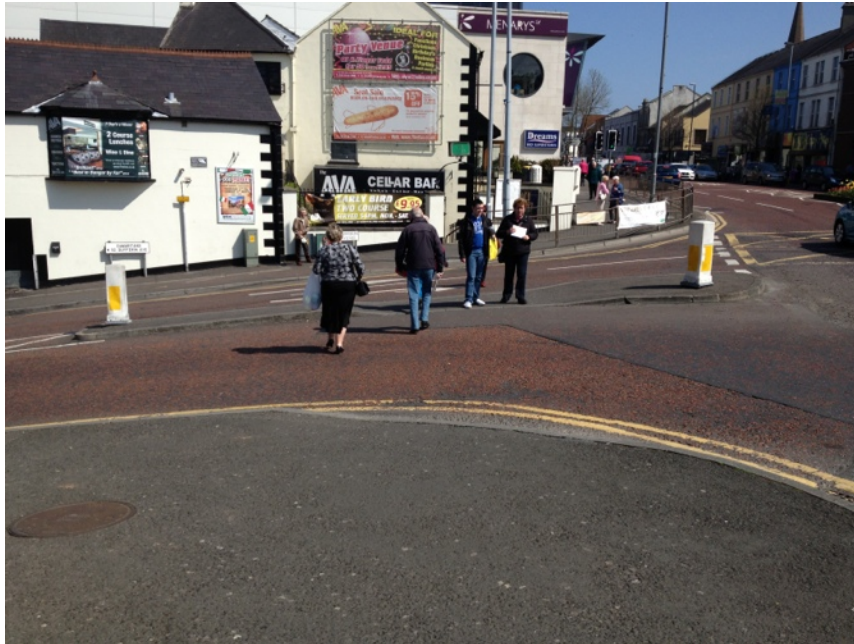
- 5 There is an uncontrolled crossing at the top Dufferin Avenue. The kerb is dropped but no tactile paving is provided. The steep cross fall at this junction will present difficulties for some disabled people.

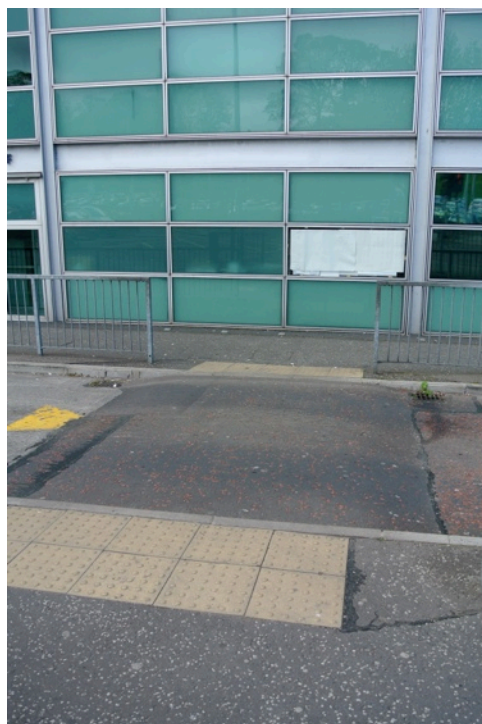
- 6 A safer alternative route is available by crossing the road using controlled crossings at the side entrance of the station.
- 7 There is a good example of an in-line uncontrolled crossing between the pedestrian entrance of the station across the exit for buses.

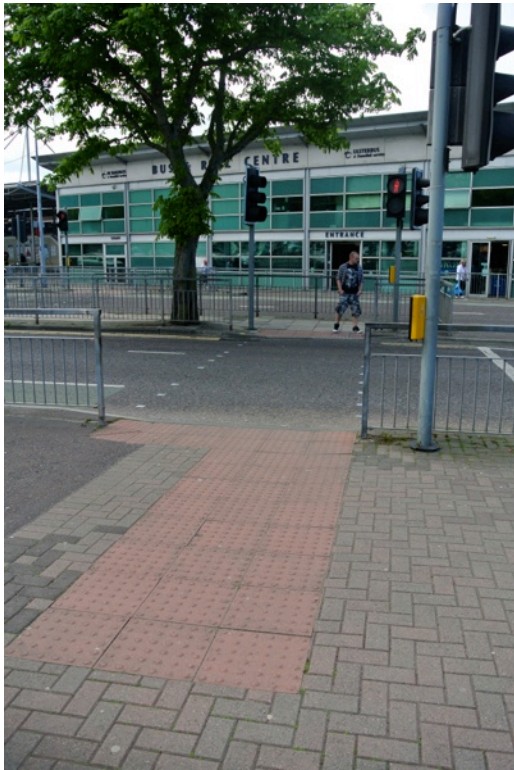
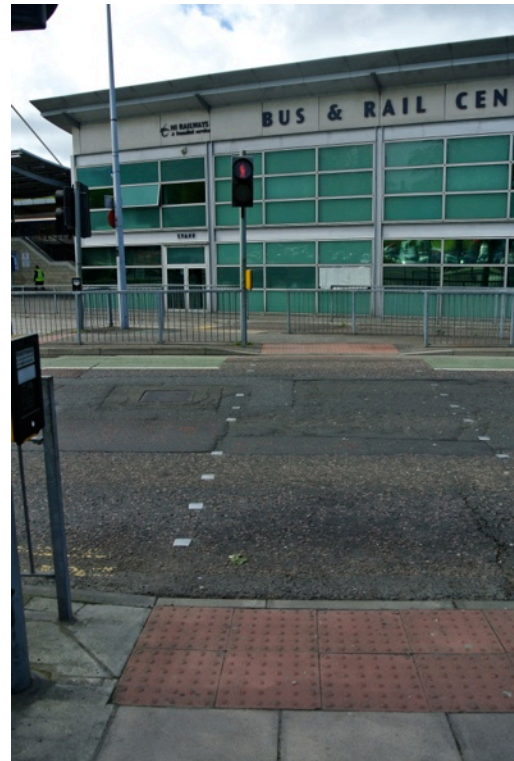
- 8 There are good examples of controlled crossings across Abbey Street linking the station to the Park and Ride/Roads Service car park.

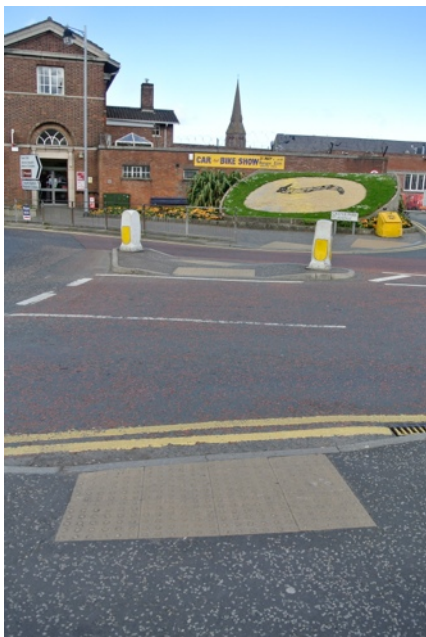
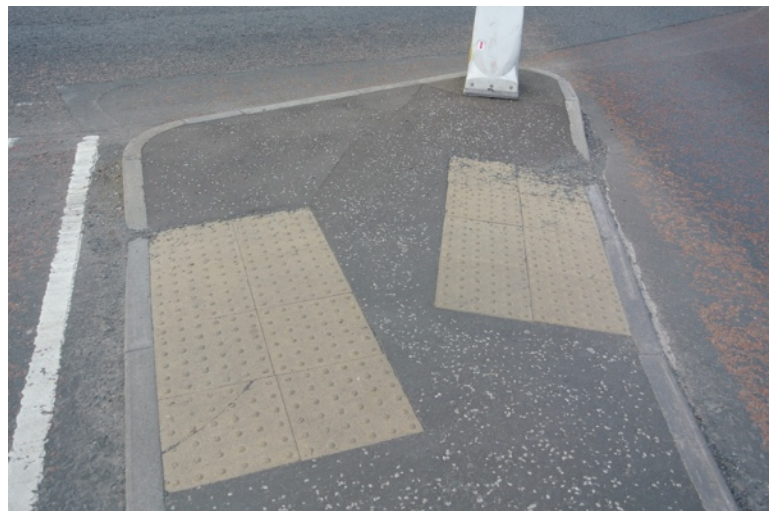
- 9 There is a broad pavement towards Castle Park Avenue.
- 10 At the junction with Castle Park Avenue there is an in-line uncontrolled crossing with a traffic island. The tactile paving on the island are laid incorrectly and are potentially dangerous.

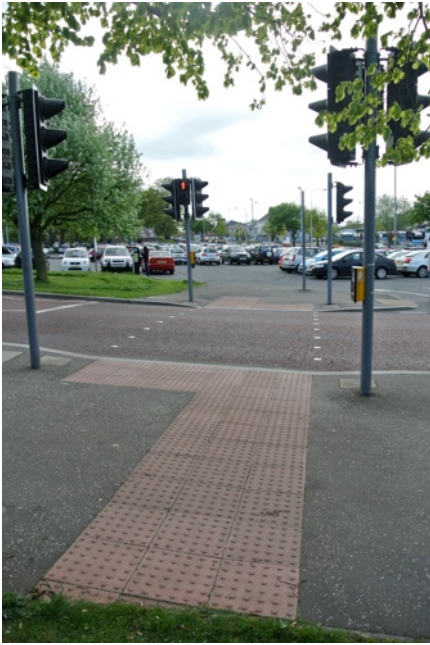
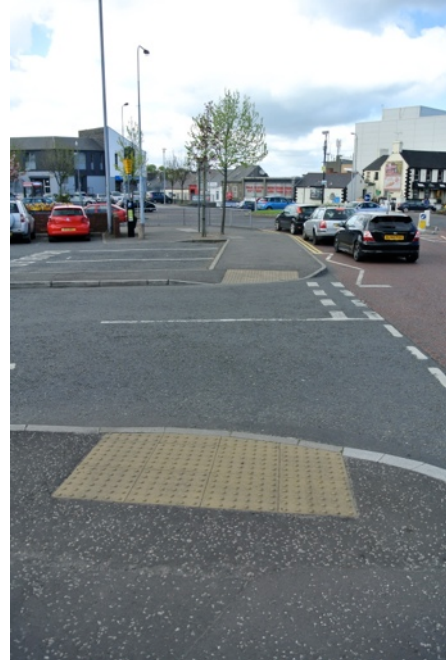
- 11 There is a good example of a controlled crossing on Castle Park Avenue. This is reached via the entrance to the Roads Service car park. The entrance includes well-designed in-line uncontrolled crossings including tactile paving.

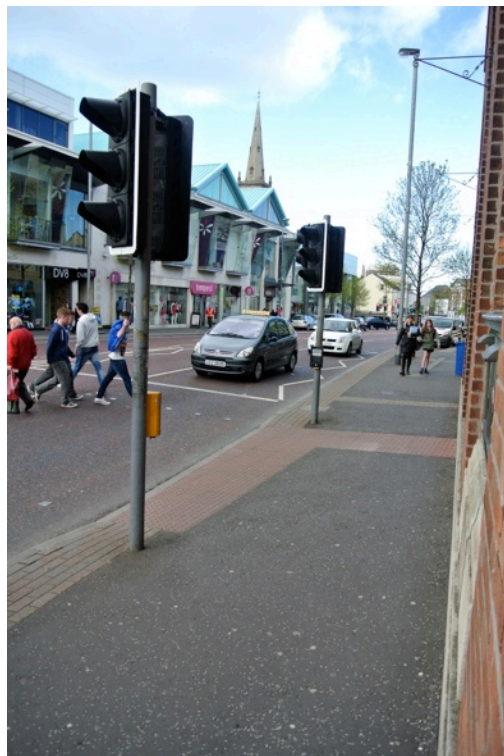
- 12 There is a good example of a controlled crossing at the Post Office.

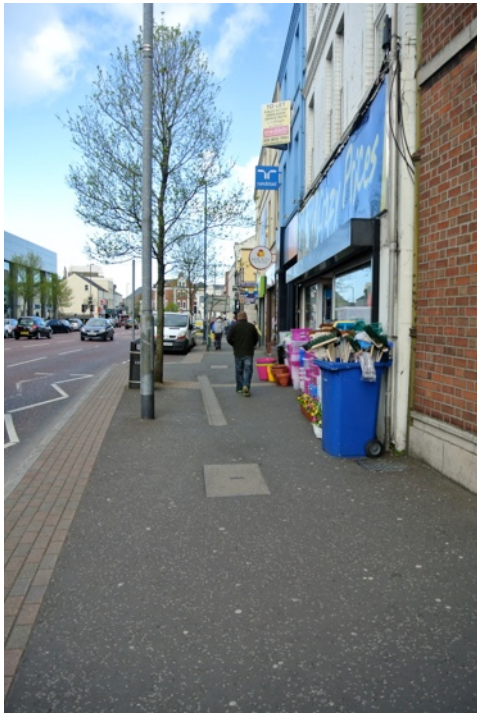
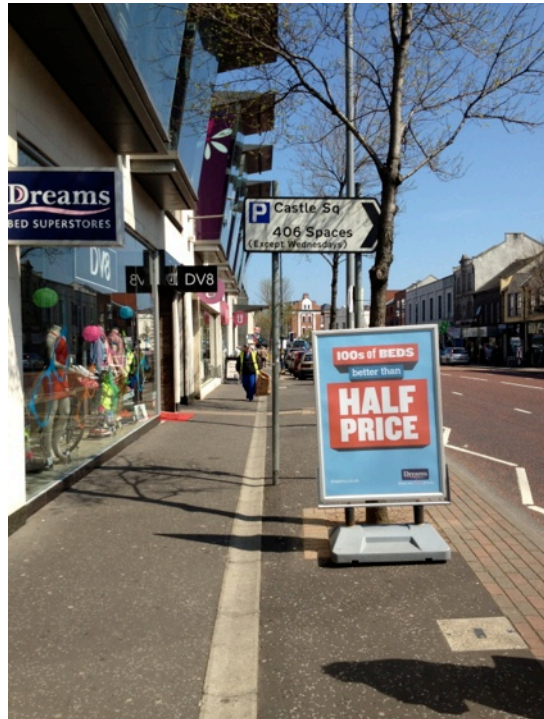
- 13 A-Boards, pavement cafes and shop displays create barriers along both sides of Upper Main Street.

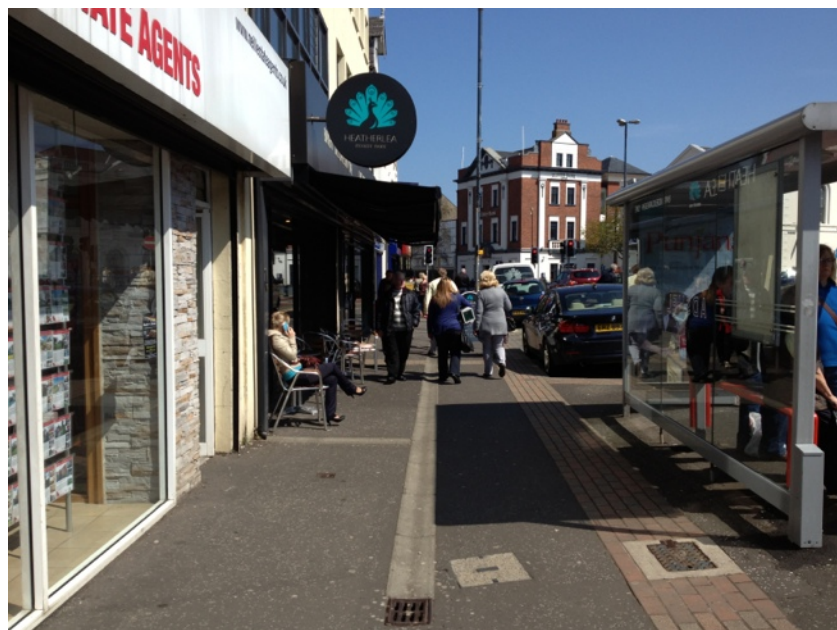
- 14 Dish drainage channels create additional hazards in the area.

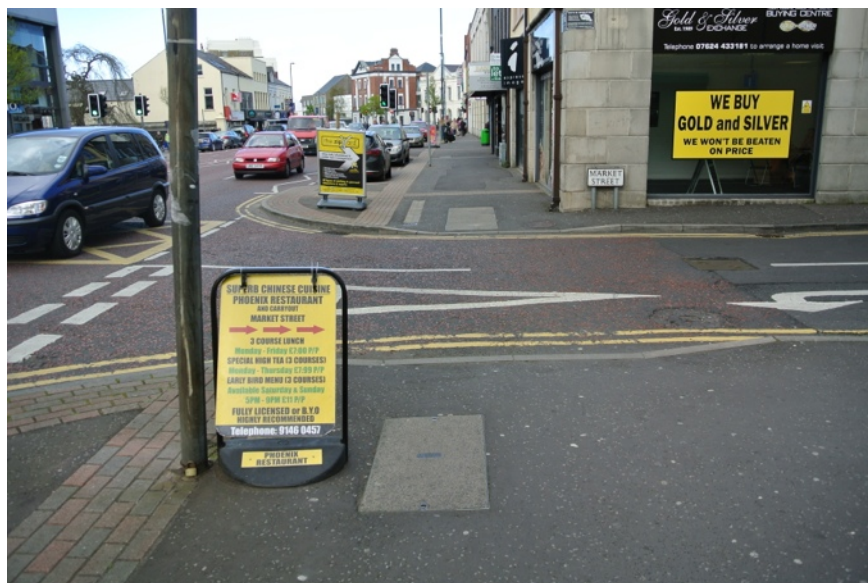
- 15 There is an in-line uncontrolled crossing at the junction of Market Street. A dropped kerb is provided but there is no tactile paving.

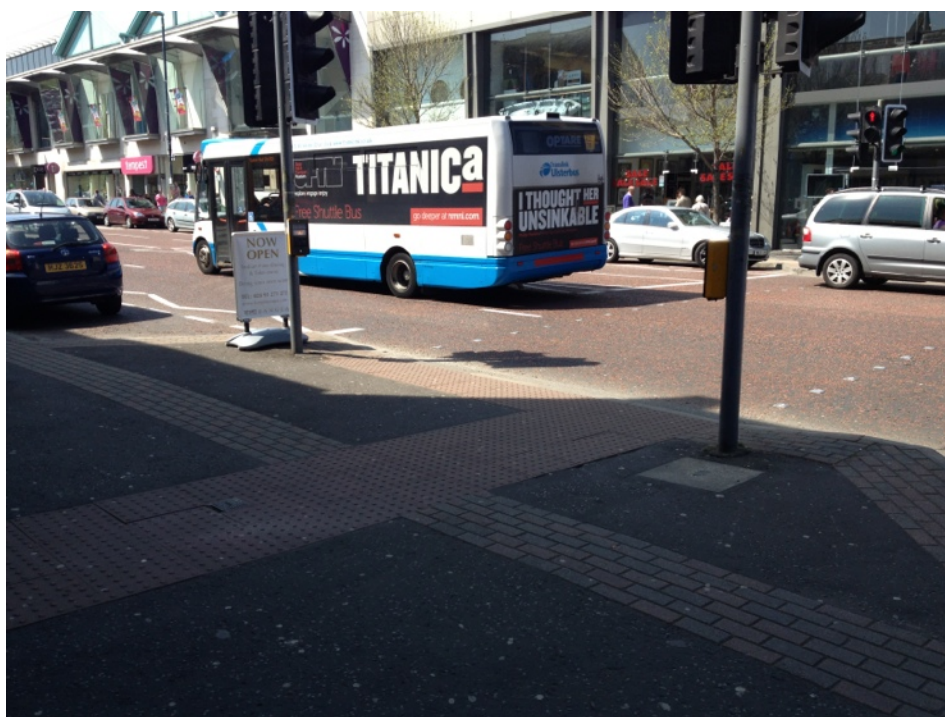
- 16 There is a good example of a controlled crossing at Asda supermarket. A-Boards in the area restrict access.

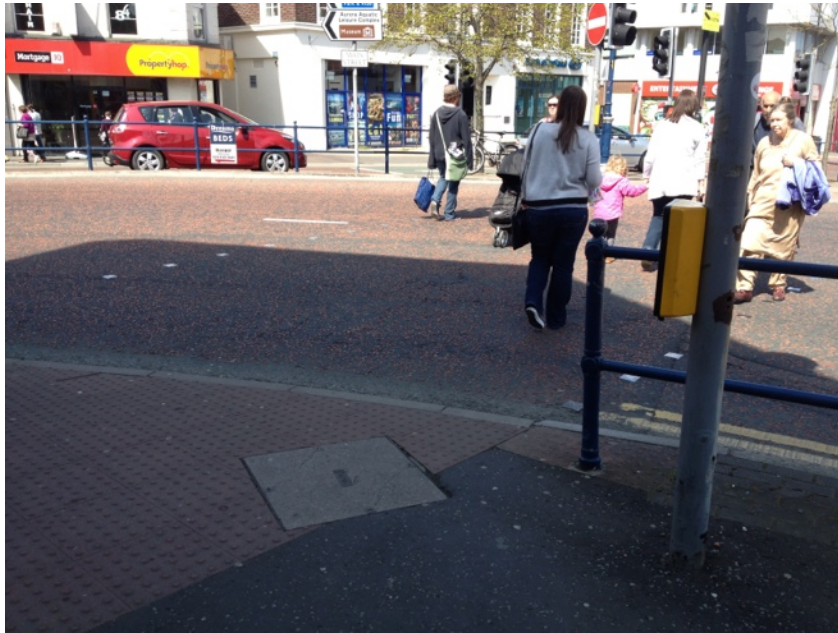
- 17 There is controlled crossing at the junction with Castle Street/ Hamilton Road. The control box at the crossing at the end of Upper Main Street is too far from the tactile paving. There is also loose tactile paving presenting a potential trip hazard.

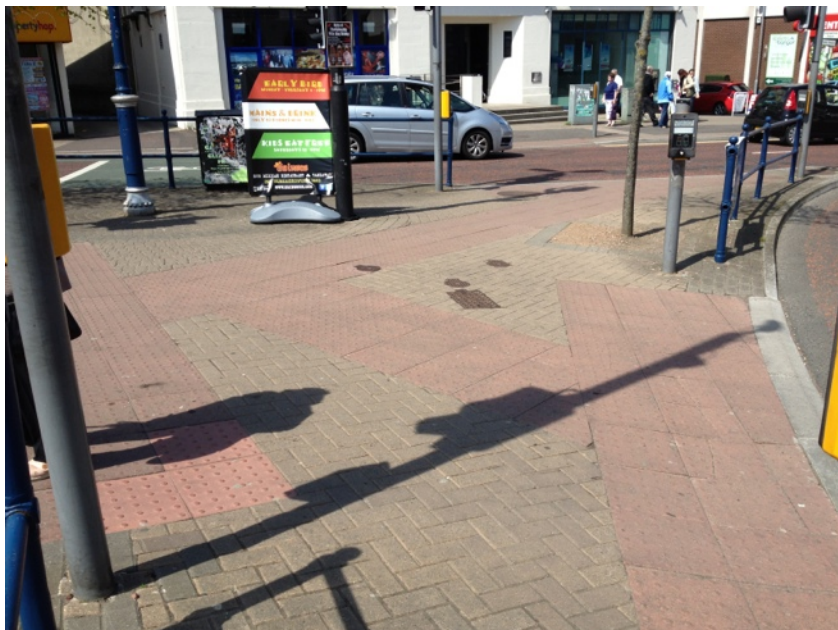
- 18 There is a traffic island at this crossing. The use of tactile paving here is unconventional and could be confusing for people with a visual impairment. Again some tactile paving is damaged and loose.

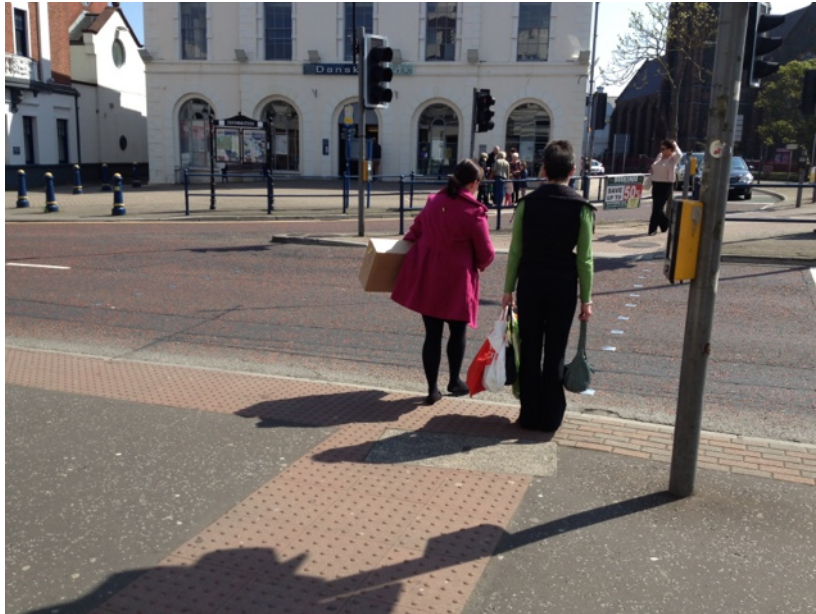
- 19 The controlled crossing at eastern side of Upper Main Street is adequate. However there are issues with the use of tactile paving on the traffic island (see 18).

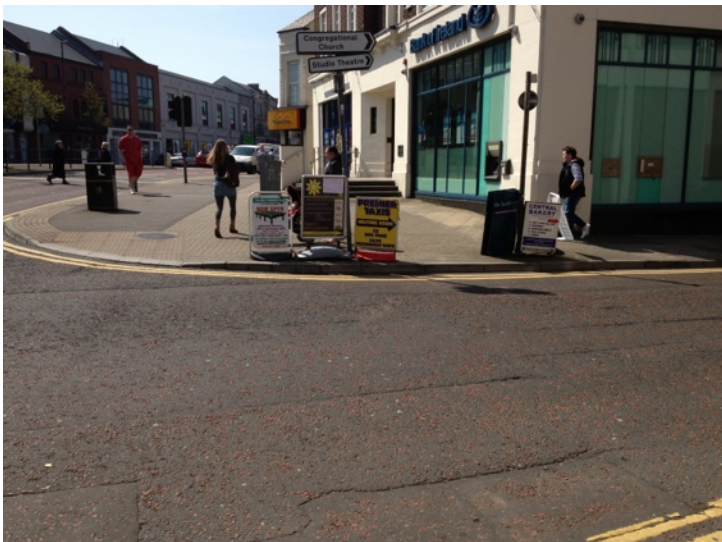
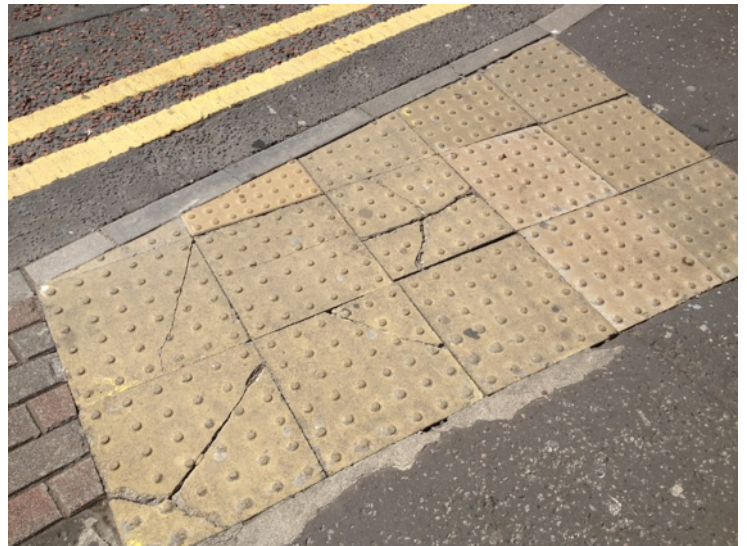
- 20 There is an in-line uncontrolled crossing at the junction of Central Avenue. The tactile paving is badly damaged on one side of the crossing. The positioning of A-Boards makes this area potentially hazardous.

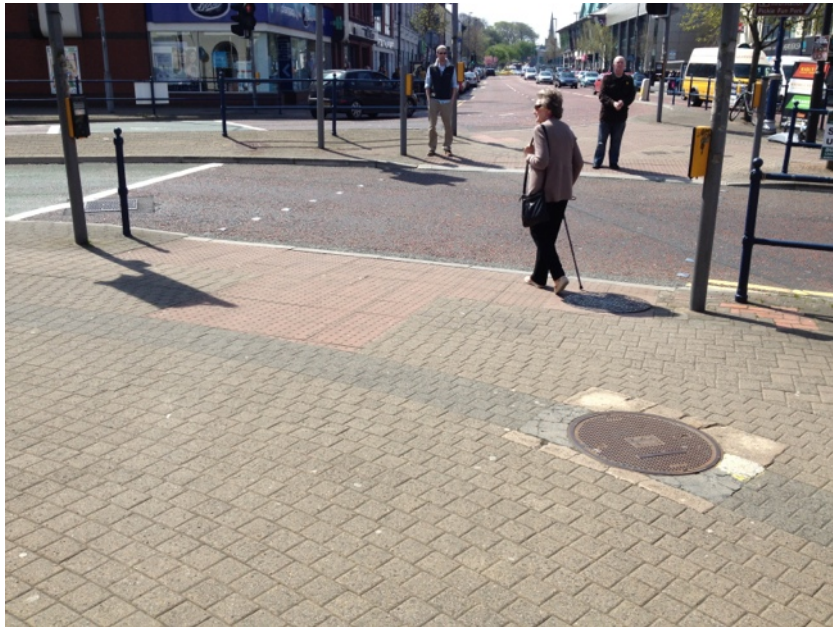
- 21 There is a controlled crossing at the junction with Hamilton Road. There is non-standard use of tactile paving at this crossing which has the potential to create confusion for people with a visual impairment and unnecessary discomfort for other disabled people.

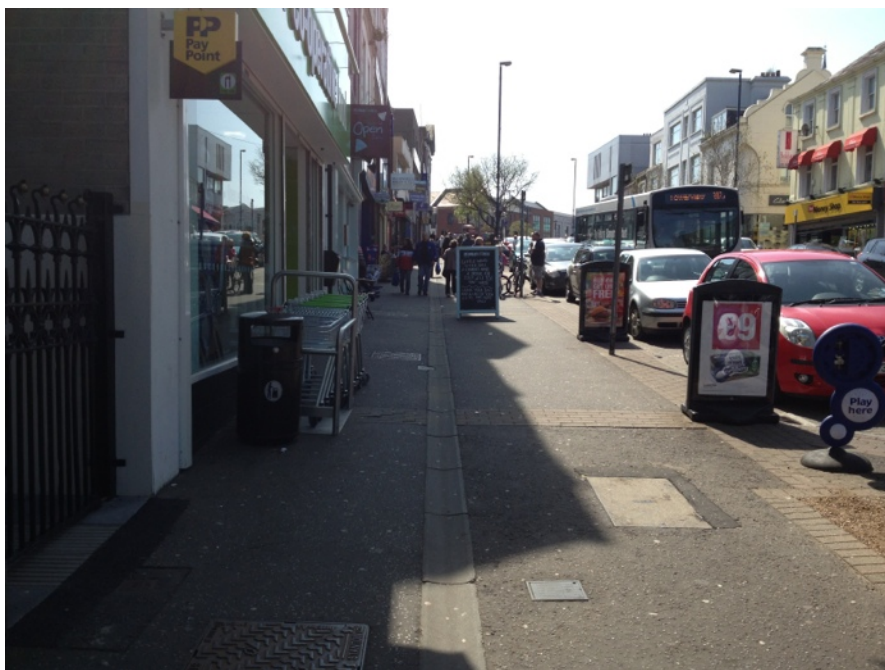
- 22 Pavement clutter is particularly severe on the eastern side of the street.

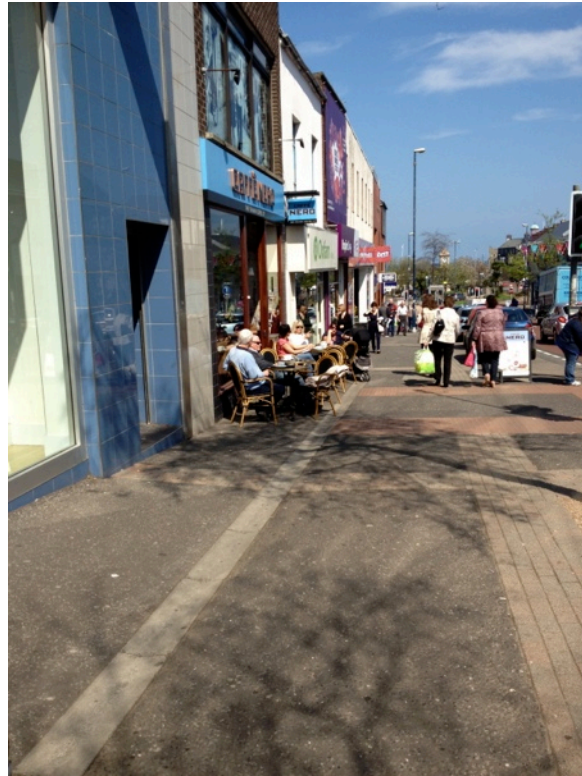
- 23 A-boards and a pavement café create barriers on the western side. Screening the café would help reduce hazard although it still encroaches on the pavement.

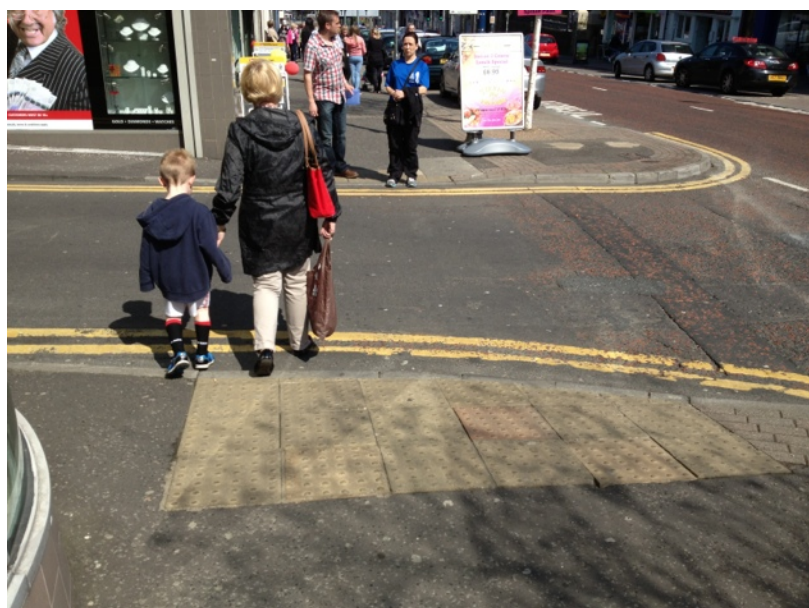
- 24 There is an in-line uncontrolled crossing at the junction with King Street. There is damage to the tactile paving and a mix of coloured slabs used. A-Boards restrict access at the junction.

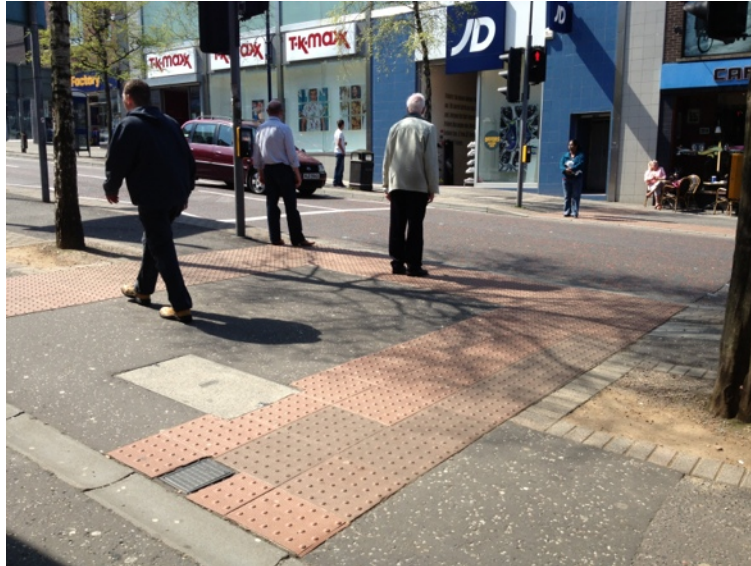
- 25 There is a controlled crossing midway down the street. There is non-standard use of tactile paving with the potential to create confusion for people with a visual impairment and unnecessary discomfort for other disabled people.

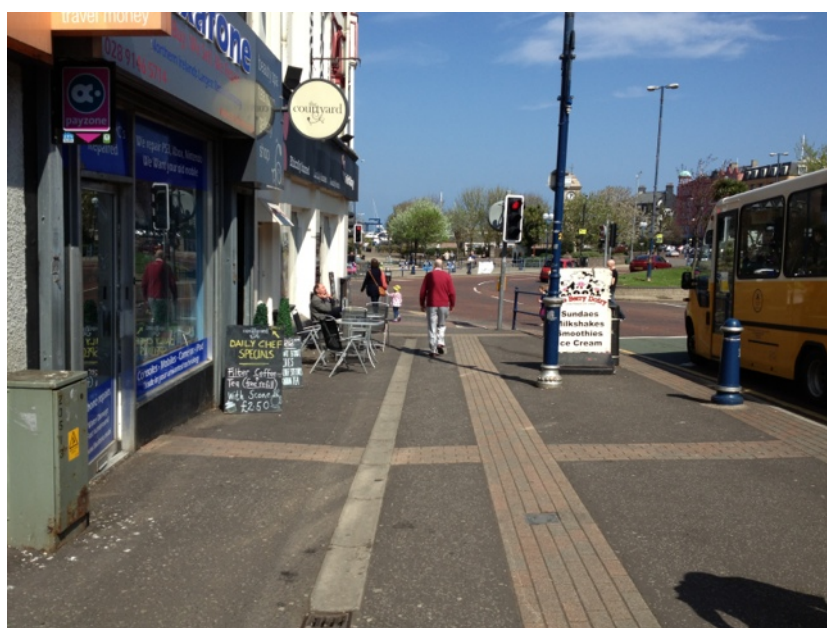
- 26 There is an unscreened pavement café and A-Boards at the northern end of Main Street.

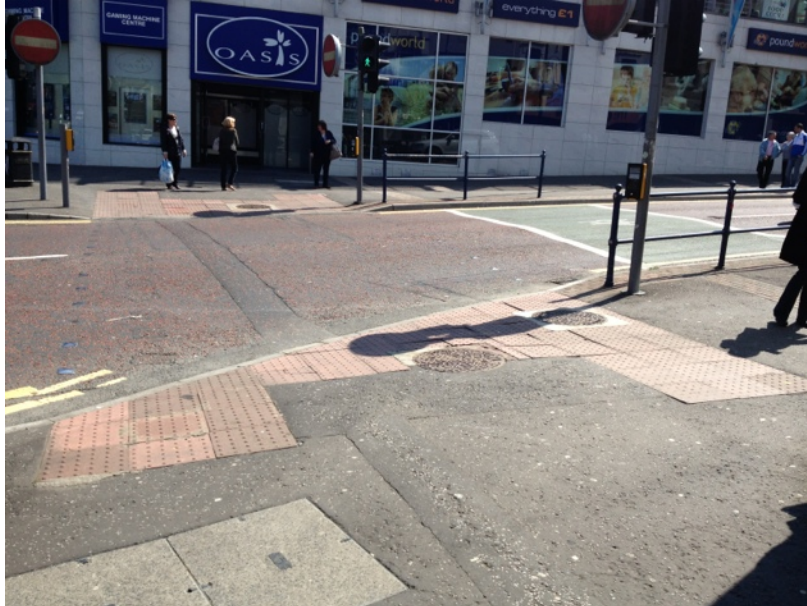
- 27 There is a controlled crossing at the northern end of Main Street. There is non-standard use of tactile paving as well as damage to the paving slabs presenting a potential trip hazard.

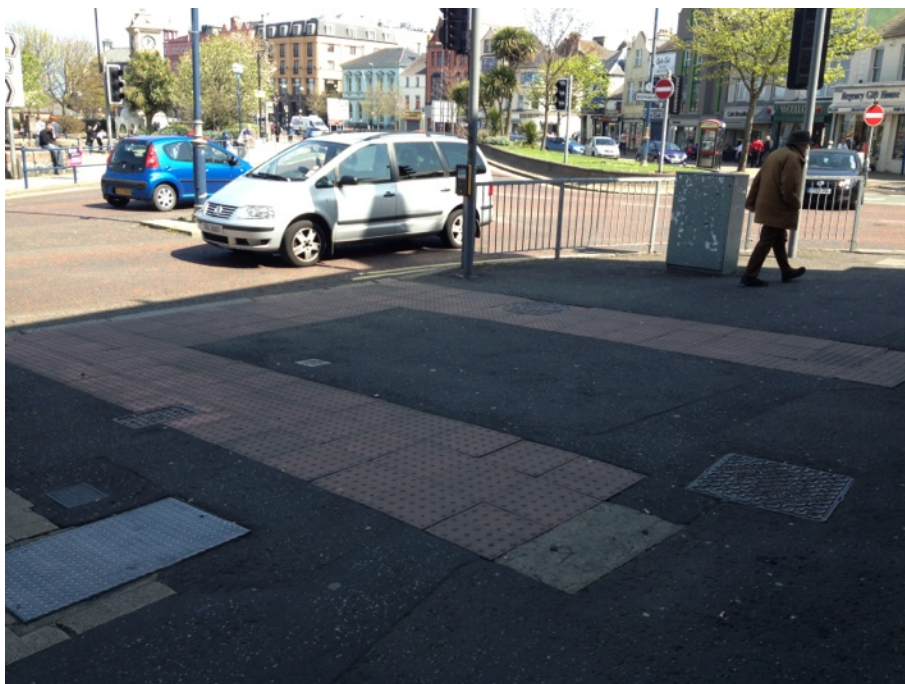
- 28 There is a controlled crossing at the eastern end of Queens Parade. There is non-standard use of tactile paving as well as loose slabs at this crossing.

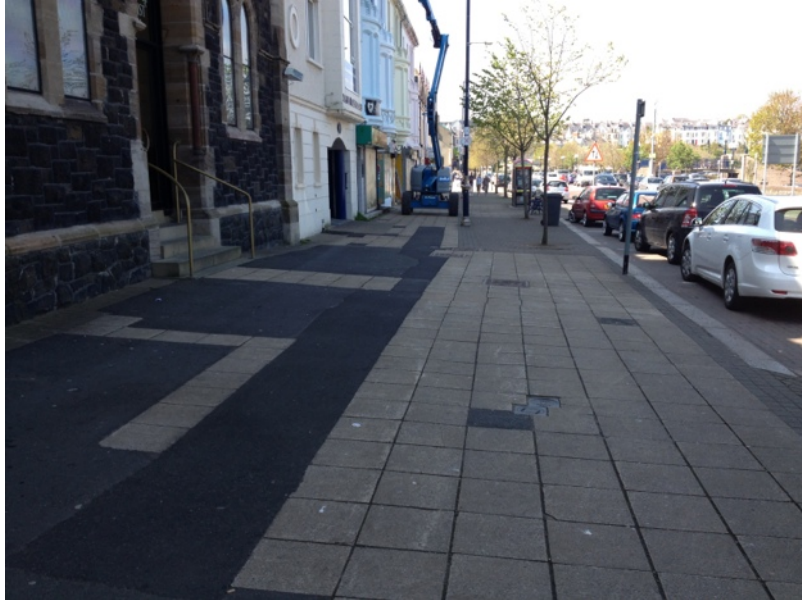
- 29 The surface quality of the pavement on the southern side of Queens Parade is poor in places creating potential trip hazards particularly for people with visual impairment.

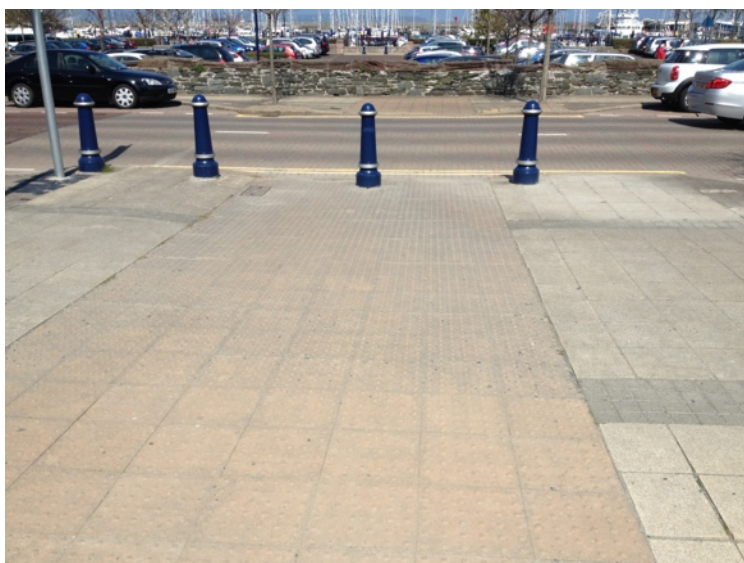
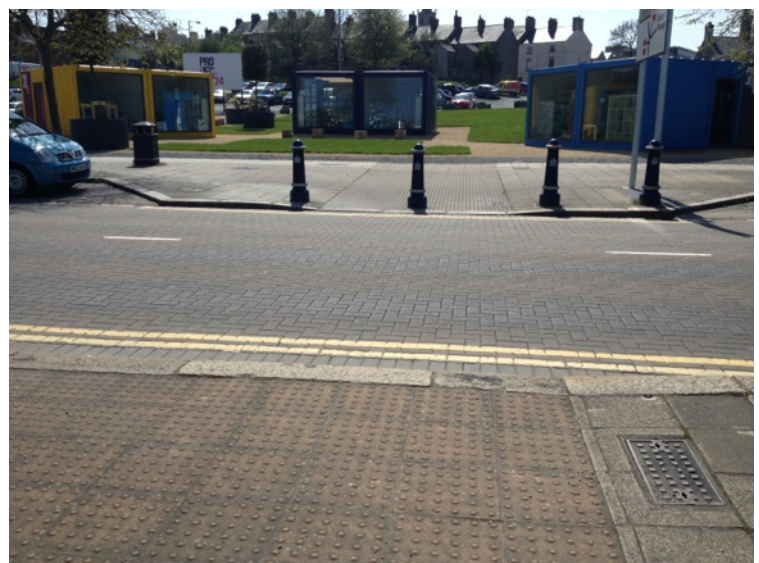
- 30 There are a number of in-line uncontrolled crossings across Queens Parade. There is overuse of tactile paving on these crossings with little contrast with the surrounding paving. Bollards placed on the southern side restrict access and would benefit from a stronger contrasting band. This has the potential to create confusion for people with a visual impairment and unnecessary discomfort for other disabled people.

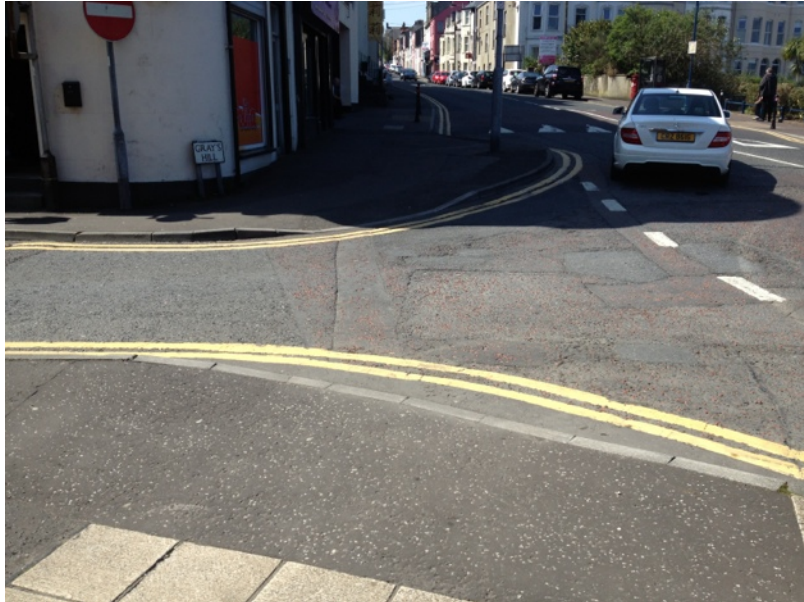
- 31 At the junction of Southwell Road/Greys Hill dropped kerbs have been provided. However these are not in-line and no tactile paving has been provided.

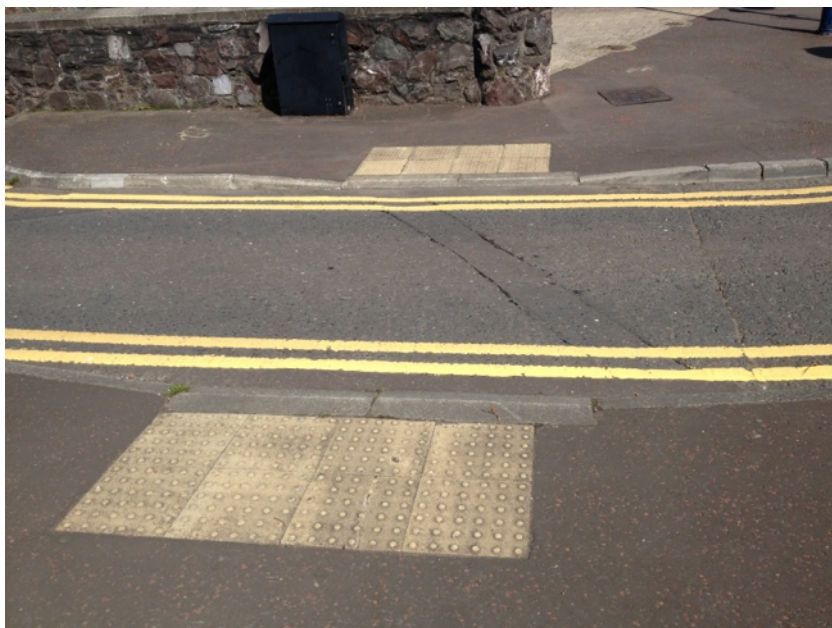
- 32 There are good examples of in-line uncontrolled crossings at the Eastern end of Greys Hill.

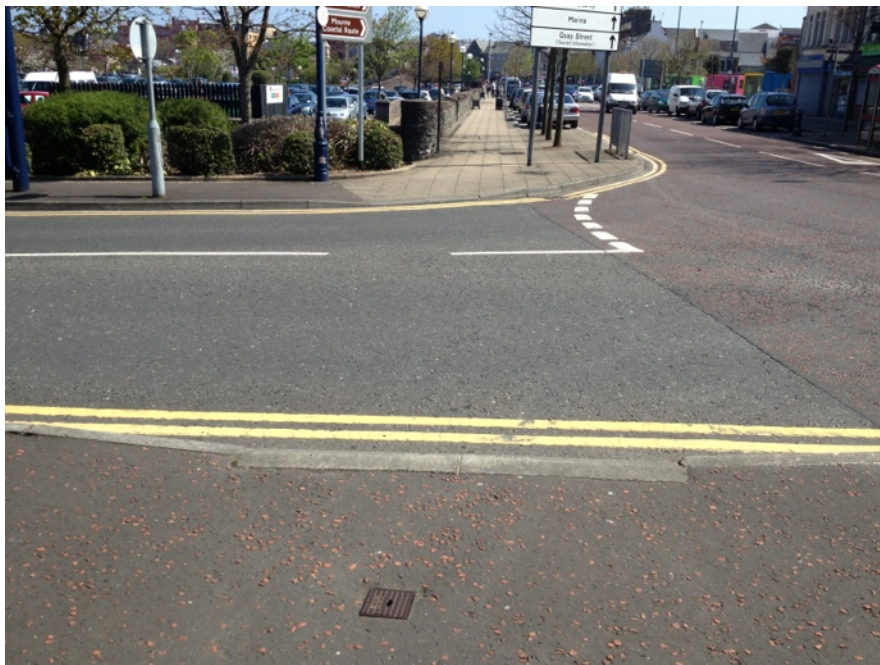
- 33 There is no tactile paving on the in-line crossing at the entrance to the car park on Queens Parade.

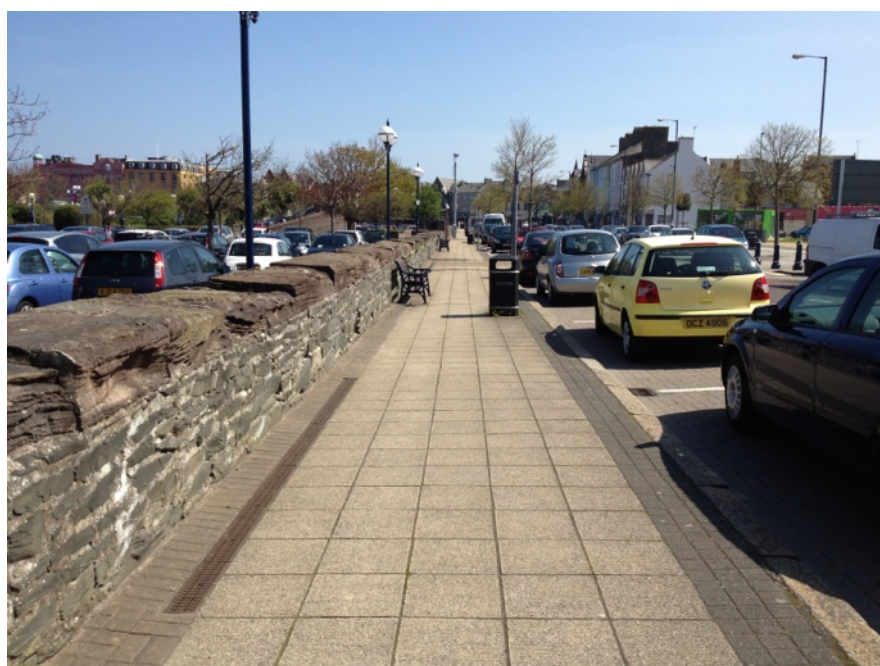
- 34 The location of street furniture (seating and bins) on the Northern side of Queens Parade restricts what is a wide pavement. Locating street furniture in a line would reduce this impact.

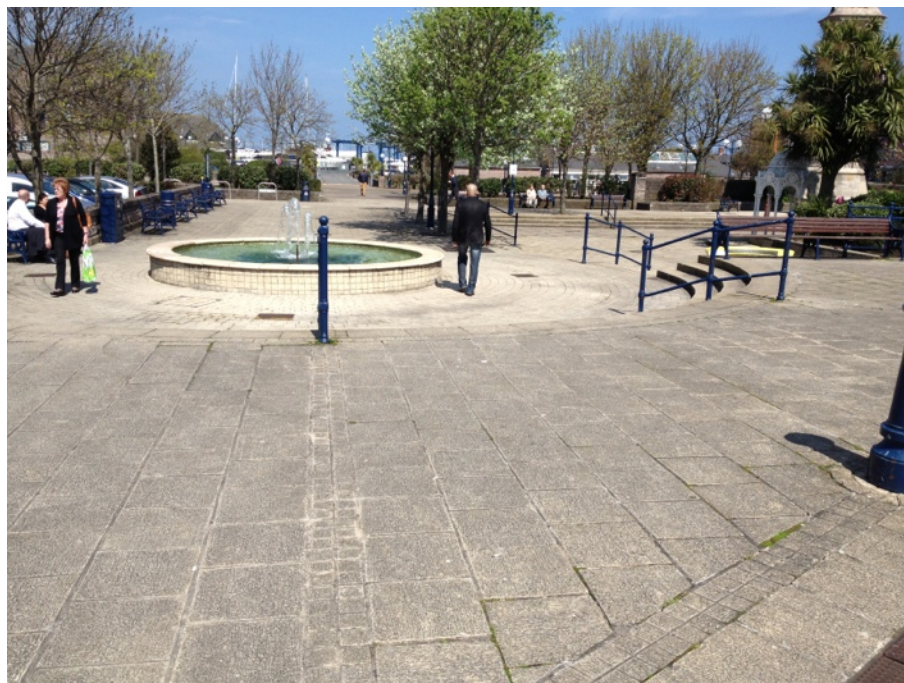
- 35 There are steps down to the sunken gardens at McKee Clock. Corduroy warning paving should be provided.

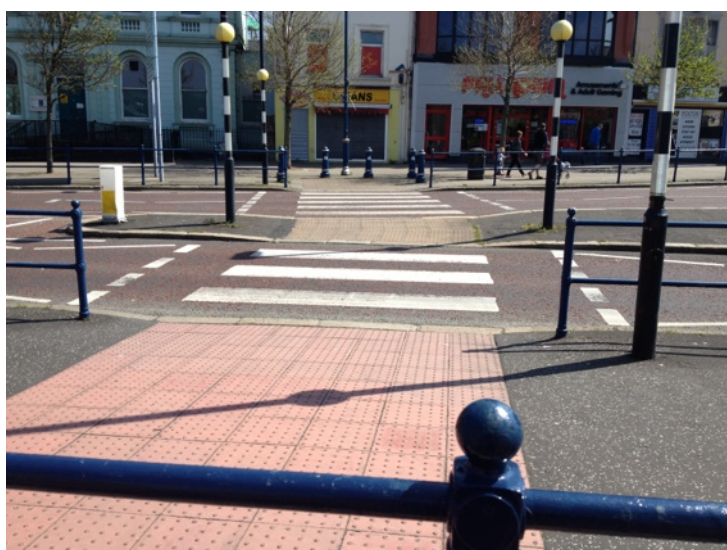
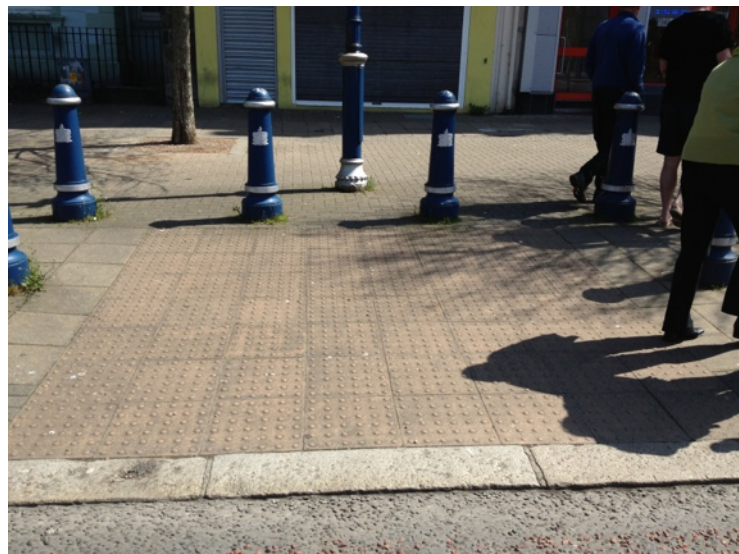
- 36 There is a controlled Zebra crossing on Quay Street. There is non-standard overuse of tactile paving on this crossing. There is also non-standard use of different coloured paving. The crossing on the eastern side is further restricted by bollards.

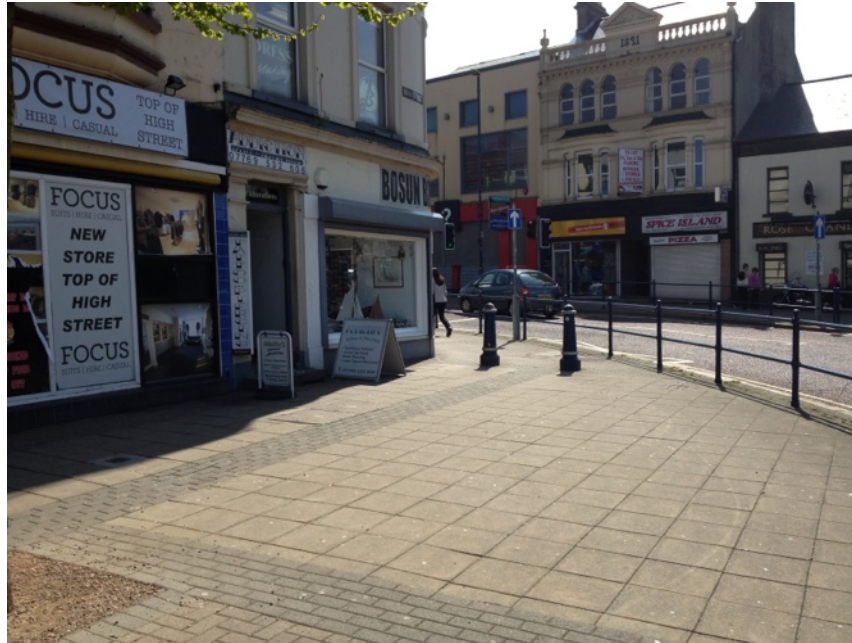
- 37 Access at the junction with High Street is restricted by A-Boards and bollards.

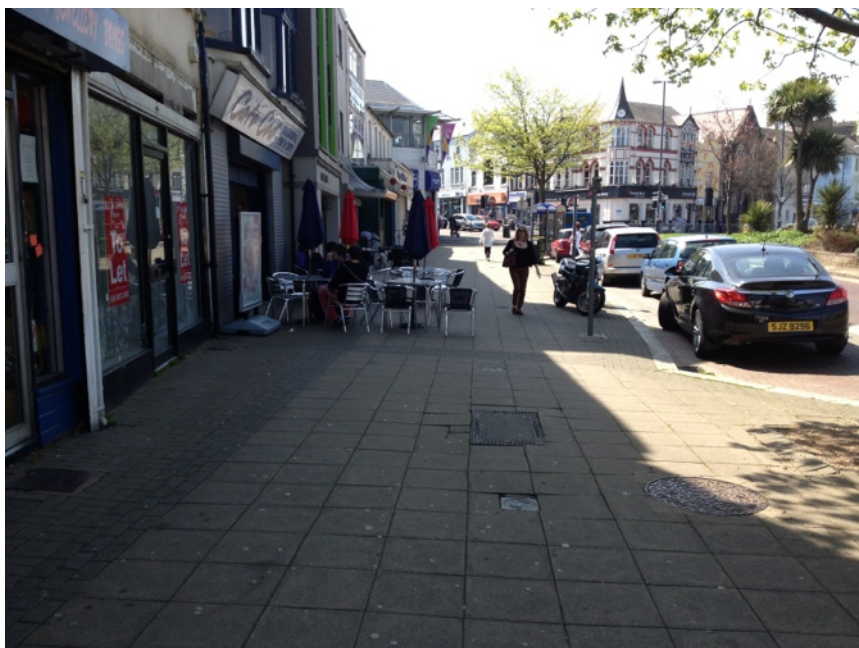
- 38 Unrestricted pavement cafes and parked motorcycles create significant hazards on Bridge Street.
