## **Report on Walking routes in Bangor Town Centre**

**July 2013**

This report is the fourth in a series of reports compiled by Imtac looking at the accessibility of key walking routes for disabled people and older people in town and city centres across Northern Ireland. The report was compiled following an inspection of Bangor town centre in May 2013. It considers the provision of pedestrian facilities in Bangor measured against accepted accessibility standards<sup>1</sup>. The report is a snapshot of current provision and seeks to identify potential barriers for disabled people and older people and recommends how these barriers could be resolved. The report also highlights examples of good practice in the town centre. A key aspect of the report is linkage between the pedestrian environment and the bus and rail station in Bangor. We have produced two reports, a text only version and a version with photographs used to highlight barriers and good practice.

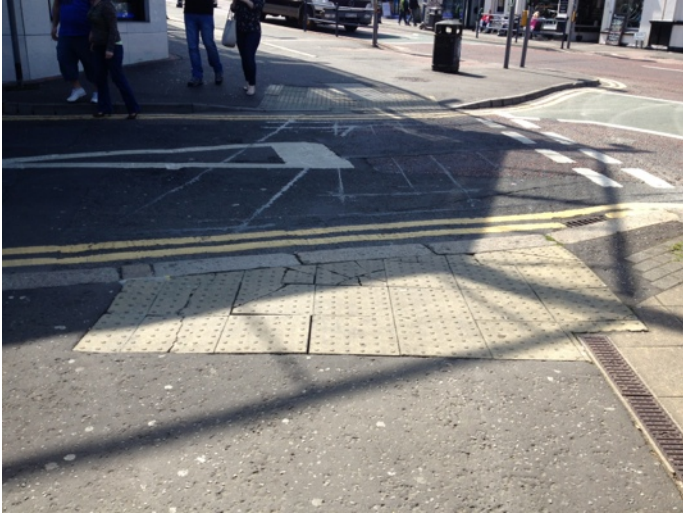
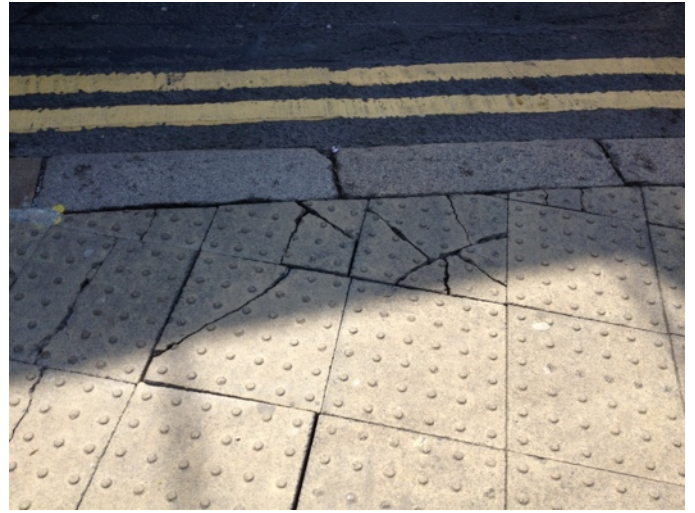
- 39 There is an in-line uncontrolled crossing at the southern end of Bridge Street at the junction with Mill Row. The tactile paving is badly damaged.

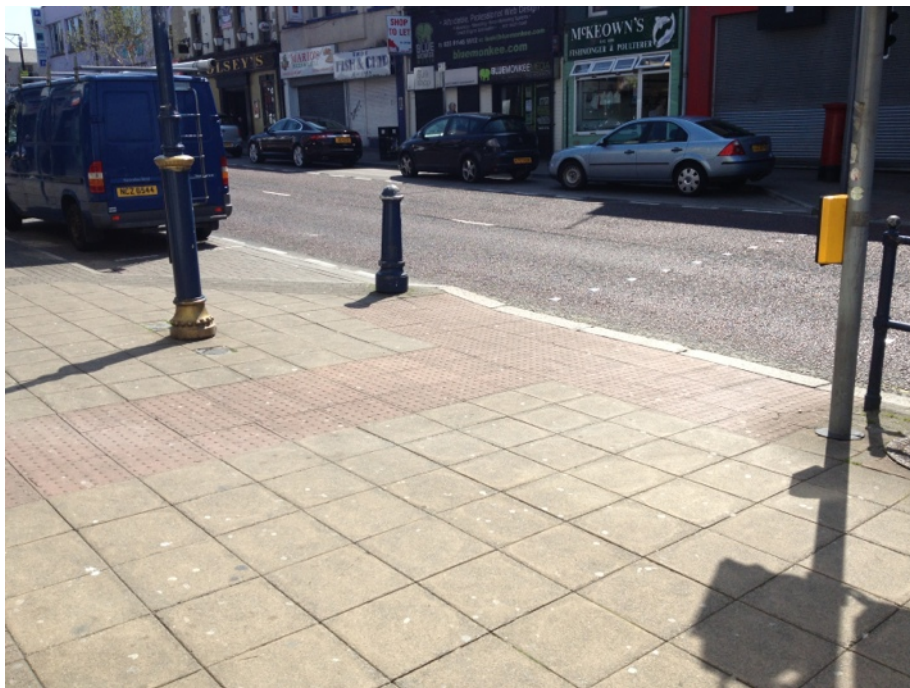
- 40 There is a controlled crossing at the western end of High Street. There is non-standard use of tactile paving at this crossing.

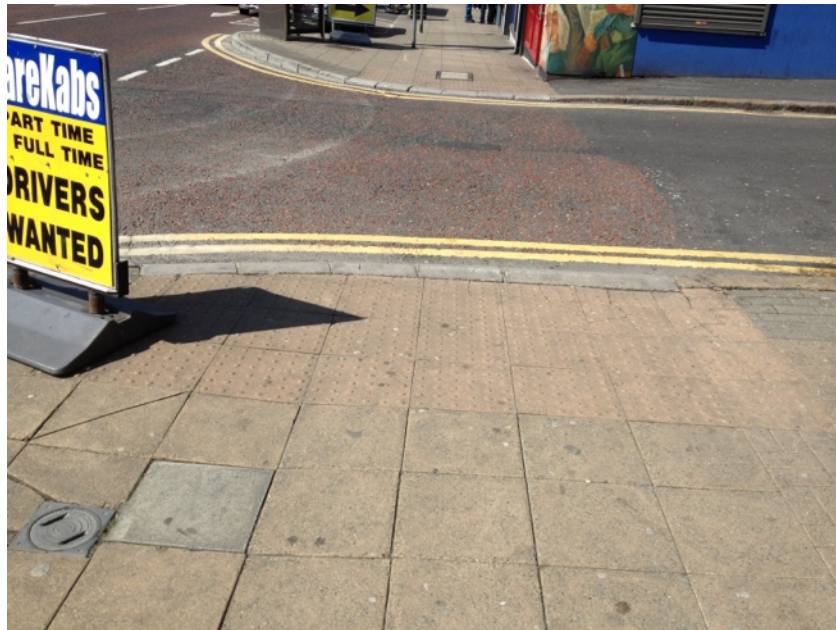
- 41 A-boards restrict access to what is a reasonable in-line uncontrolled crossing at the junction with Albert Street. The tactile paving does not however contrast with the surrounding pavement.

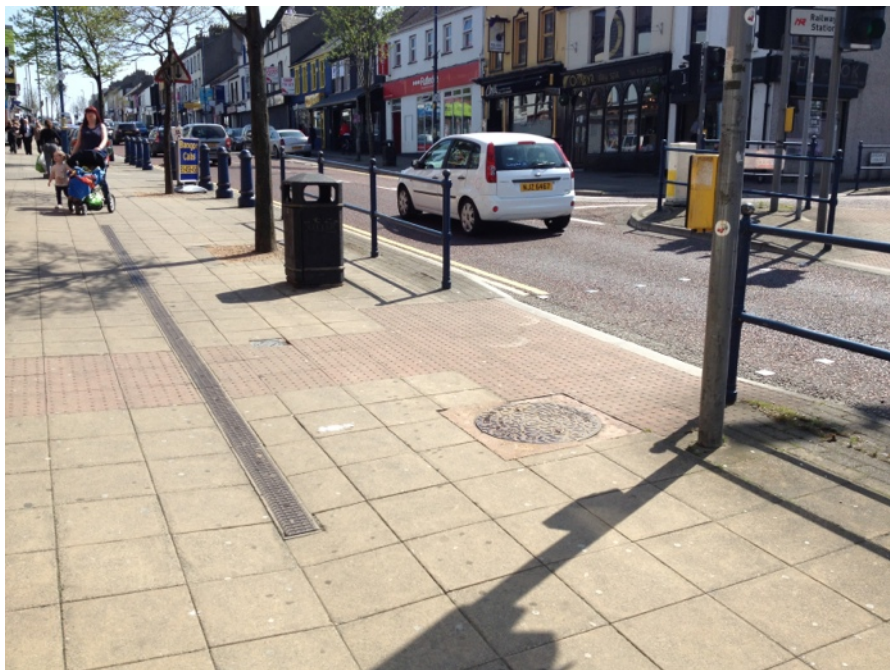
- 42 There is a controlled crossing midway up High Street. There is non-standard use of tactile paving at this crossing.

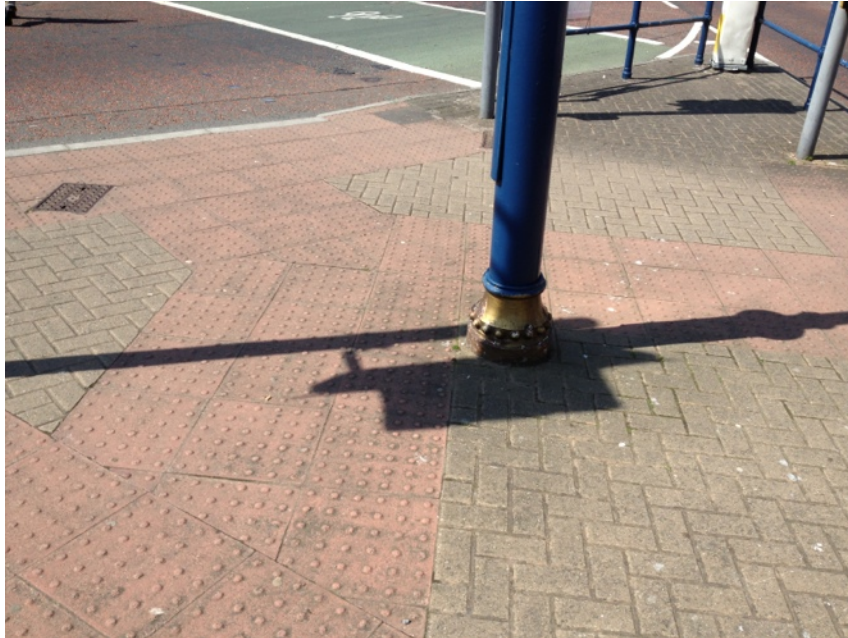
- 43 This crossing leads to a traffic island where incorrect use of tactile paving will make navigating this crossing difficult for people with a visual impairment.

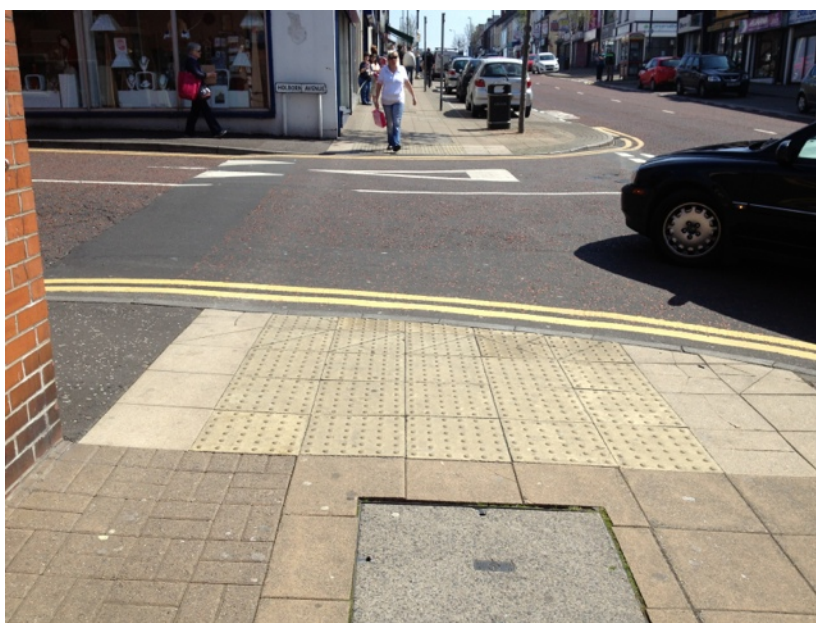
- 44 There is a good example of an in-line uncontrolled crossing at the junction of Holborn Avenue.

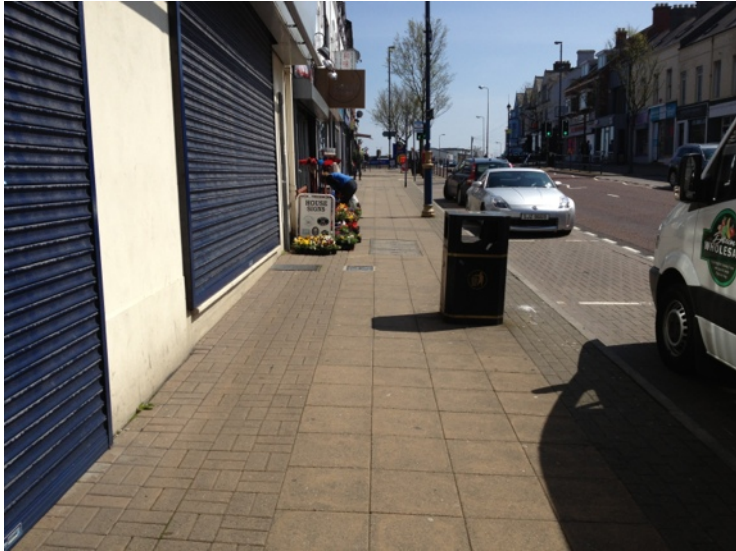
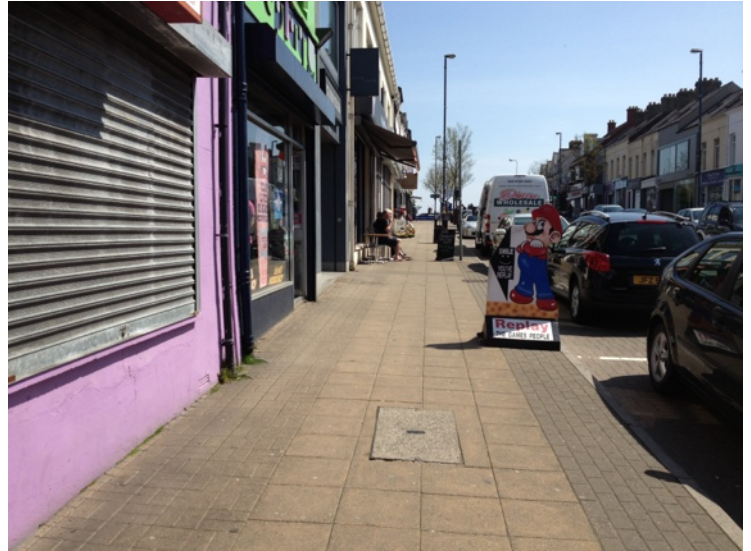
- 45 A-Boards, shop displays and tables and chairs restrict pavement width along High Street.

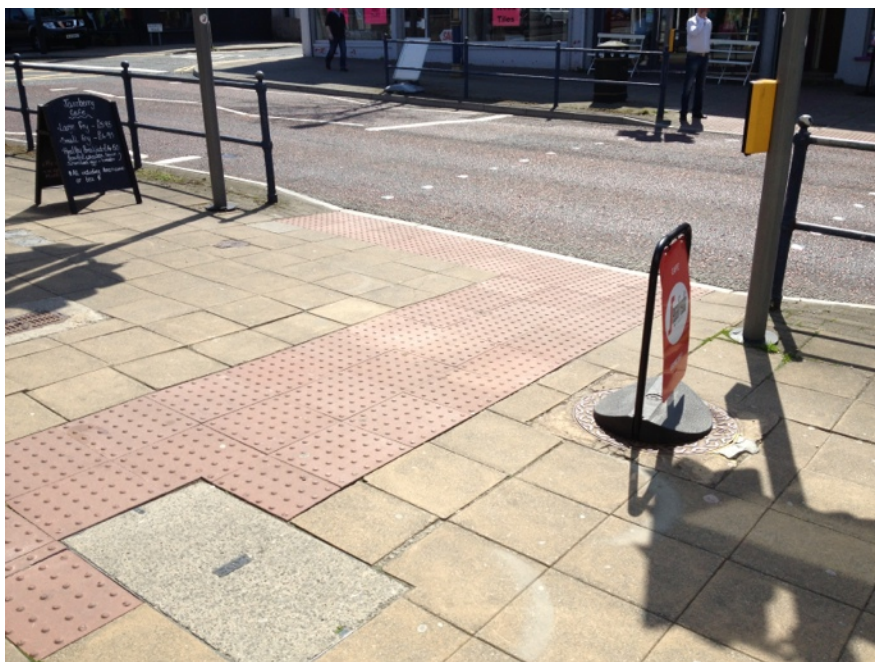
- 46 There is a good example of a controlled crossing at the eastern end of High Street. The benefits of the crossing are reduce by the placement of A-Boards.

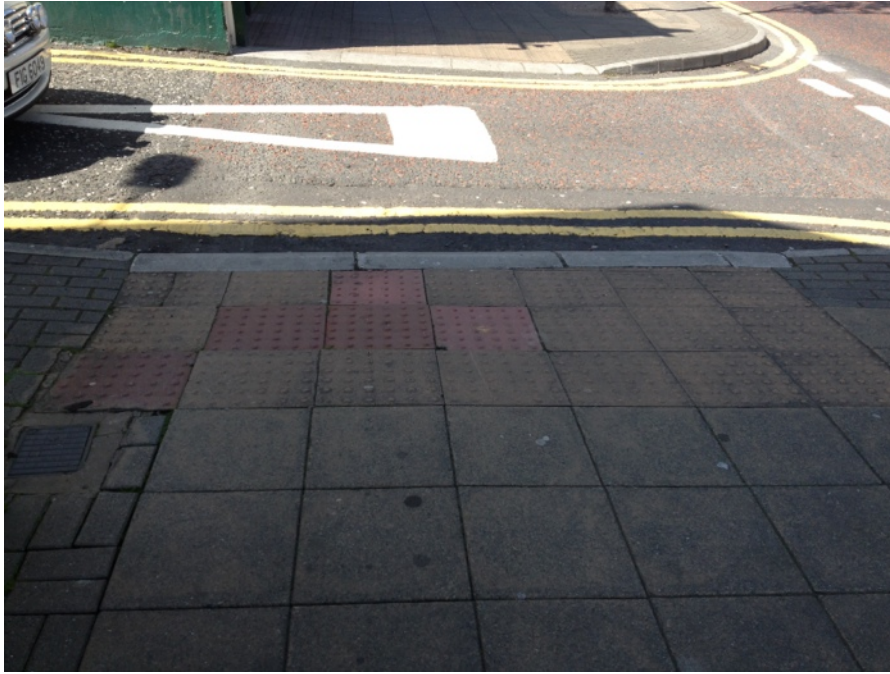
- 47 There is an in-line uncontrolled crossing at the junction with Beatrice Avenue. There is a lack of contrast between the tactile paving and the pavement surface. Also a variety of coloured tactile paving has been used.

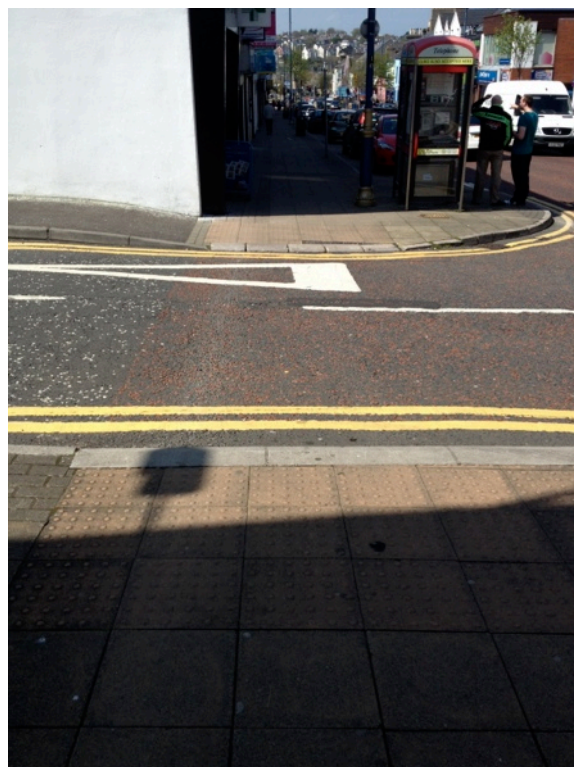
- 48 The same issues are present at the in-line uncontrolled crossing at the junction with Alfred Street.

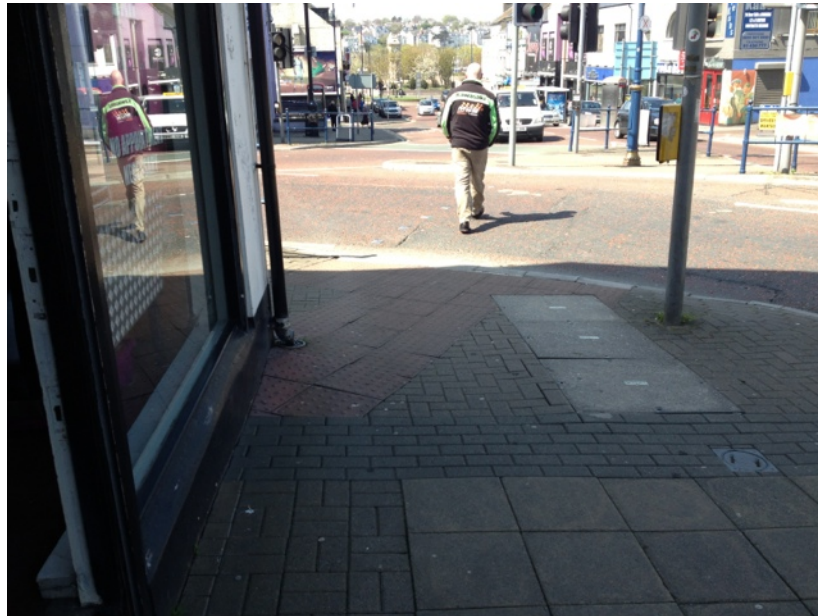
- 49 There is a controlled crossing at the junction with Bingham Street. There is a non-standard use of tactile paving. There are problems with the use of tactile paving on the associated traffic island (see 43).

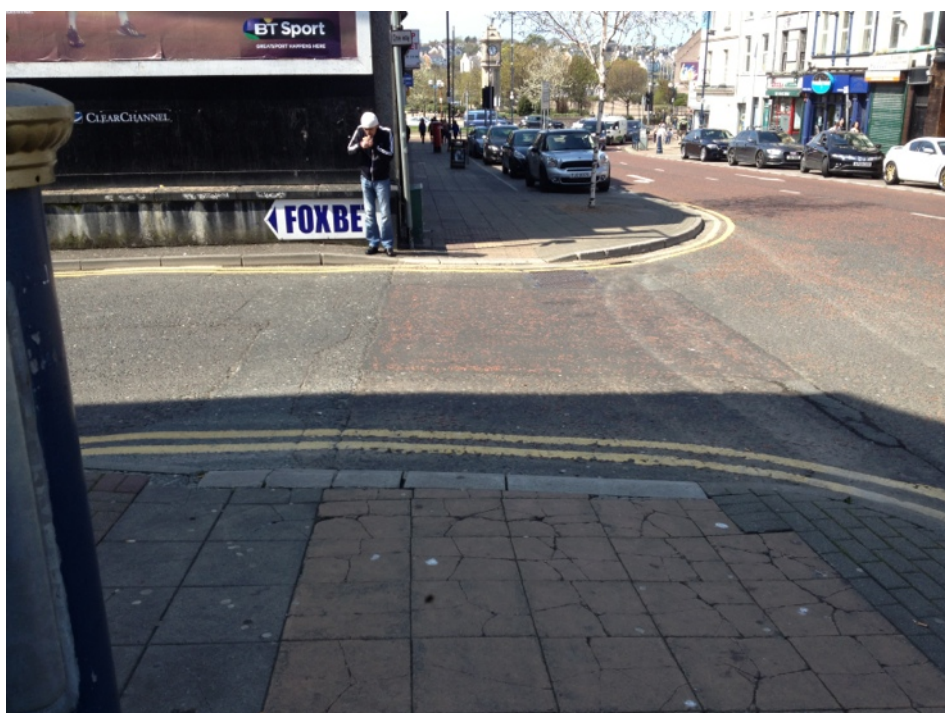
- 50 There is an in-line uncontrolled crossing at the junction with Mill Row. There is non-standard (over) use of tactile paving. There is significant damage to the tactile paving suggesting illegal or inappropriate pavement parking which potentially obstructs pavement width on occasions.
