**Report on Walking routes in Moira village**

November 2013

The report was compiled following an inspection of Moira in August 2013. It considers the provision of pedestrian facilities in the village measured against accepted accessibility standards<sup>1</sup>. The report identifies potential barriers for disabled people and older people and recommends how these barriers could be resolved. The report also highlights examples of good practice. A key aspect of the report is linkage between the pedestrian environment and the railway station in Moira. We have produced two reports, a text only version and a version with photographs used to highlight barriers and good practice.

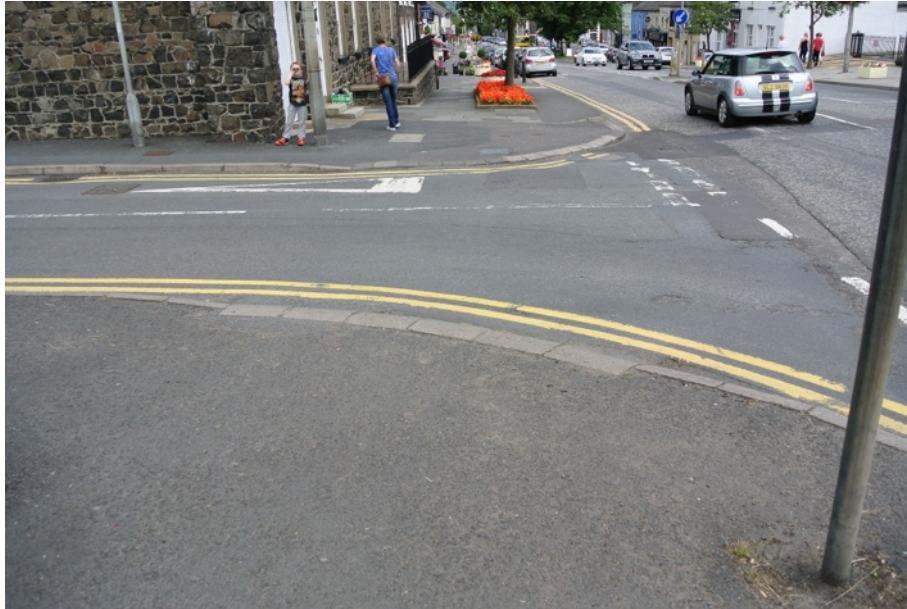
- 1 At the junction of Main Street and the entrance to the Library car park there is an uncontrolled crossing. The kerb is dropped at this point but no tactile paving is in place.

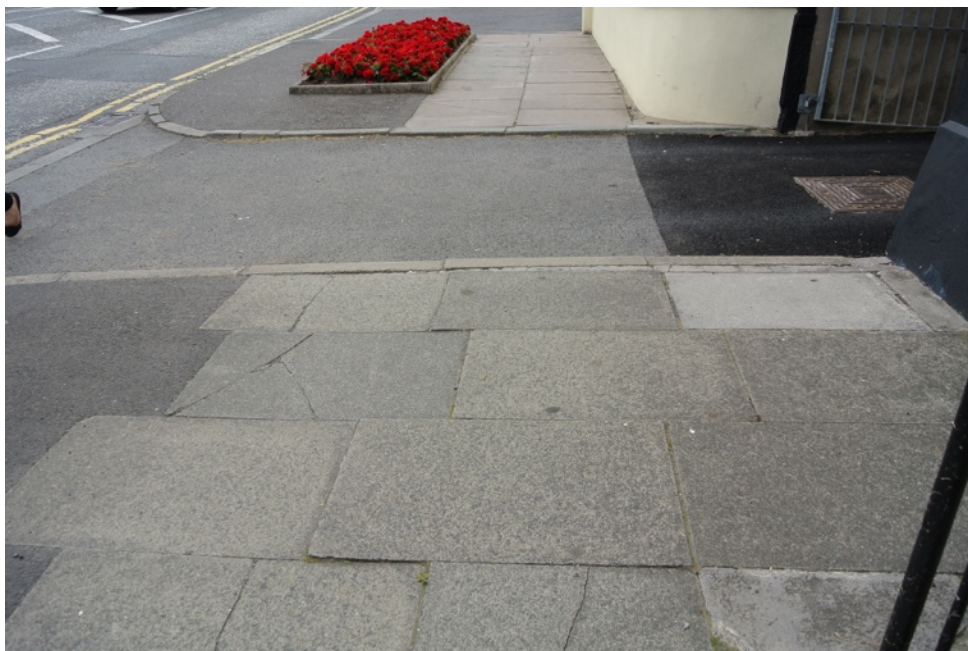
- 2 There are a number of vehicle entrances along Main Street that potentially make using the pavement difficult for some disabled people including wheelchair users. These areas would benefit from enhanced pedestrian priority.

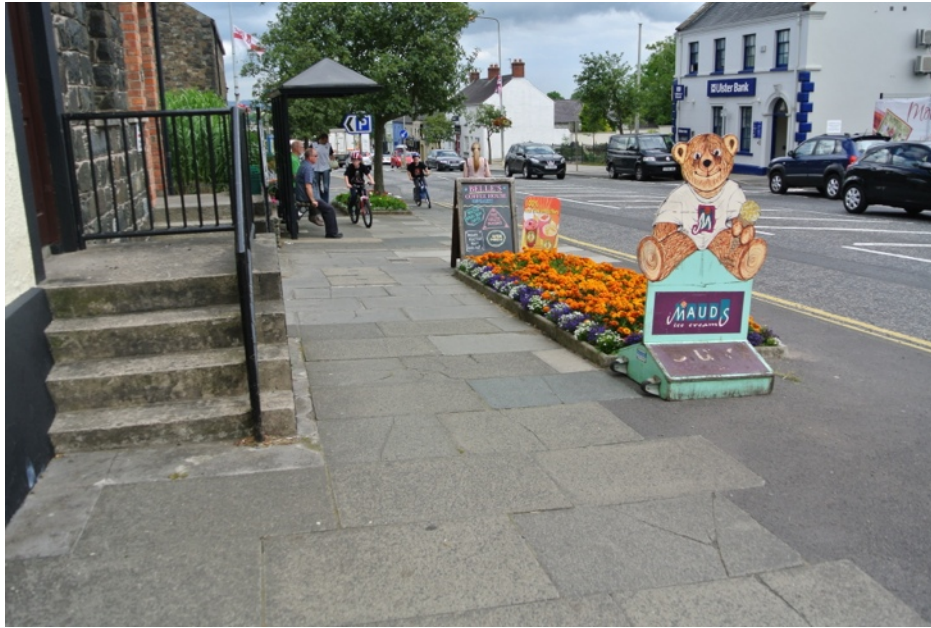
- 3 There is a bus stop on the northern side of Main Street. The pavement here is restricted by flowerbeds and A-boards. Some effort has been made to ensure that clutter is included in a line. However the area does present significant hazards particularly for people with a visual impairment.

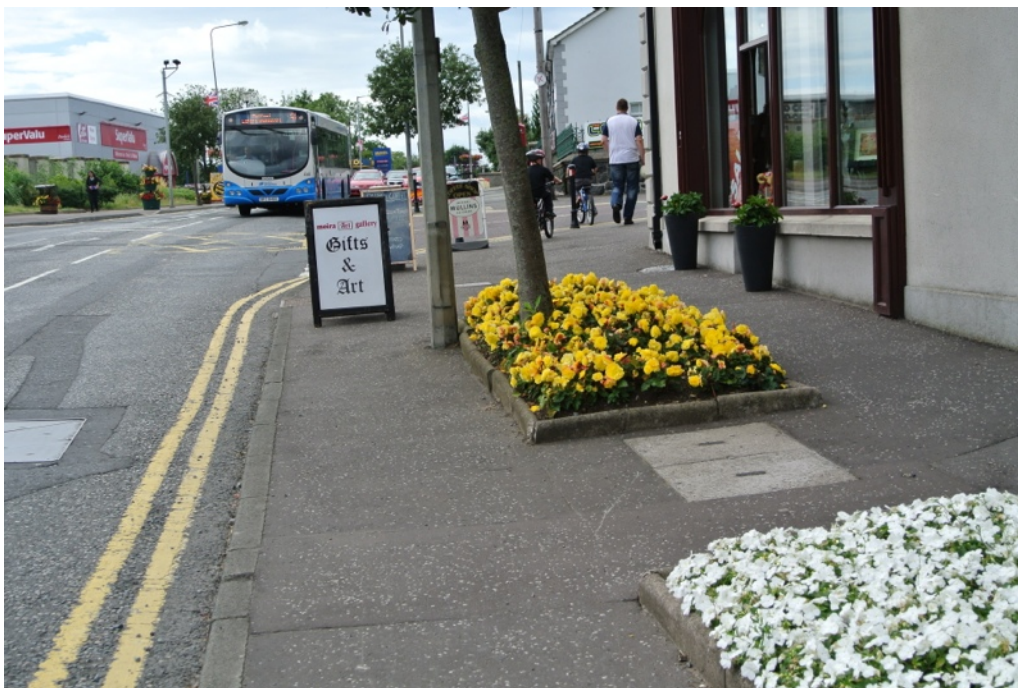
- 4 Flower beds, A-boards and other clutter continue to present hazards on the approach to the junction with Blackwood Road.

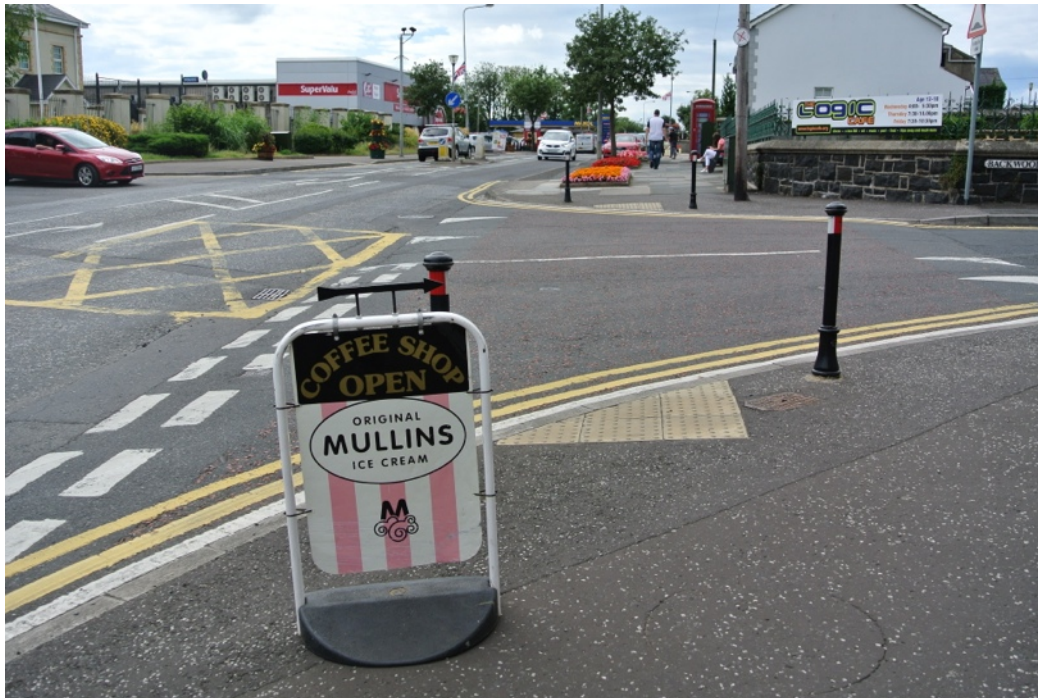
- 5 There is an in-line uncontrolled crossing at the junction with Blackwood Road. The tactile paving is less than one slab deep in places making identifying the crossing more difficult for people with a visual impairment. An A-board presents a further hazard.

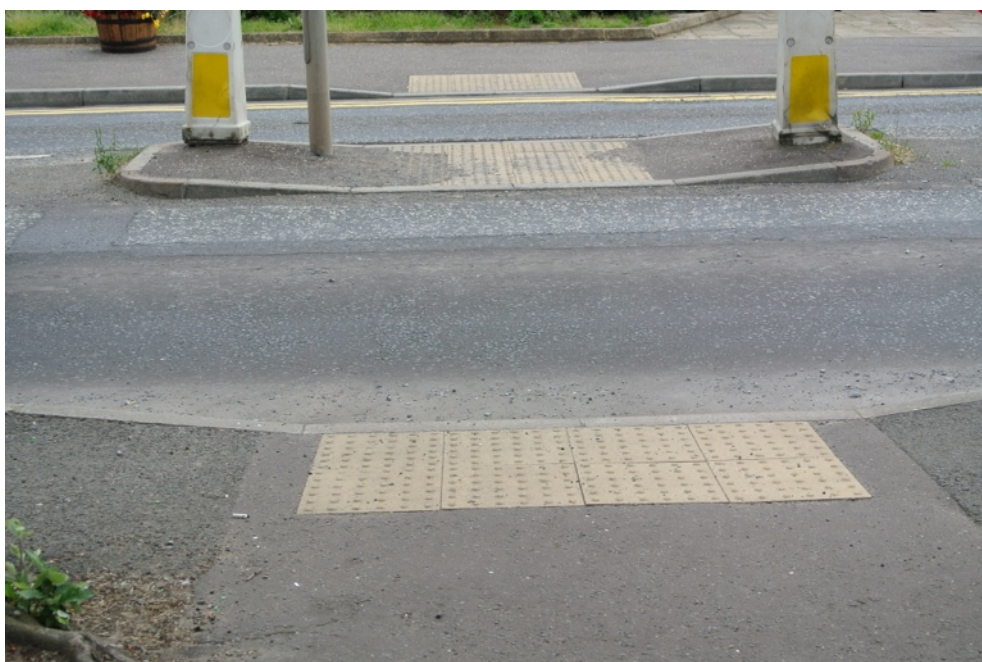
- 6 There is a good in-line uncontrolled crossing across to the southern side of Main Street (at the police station).

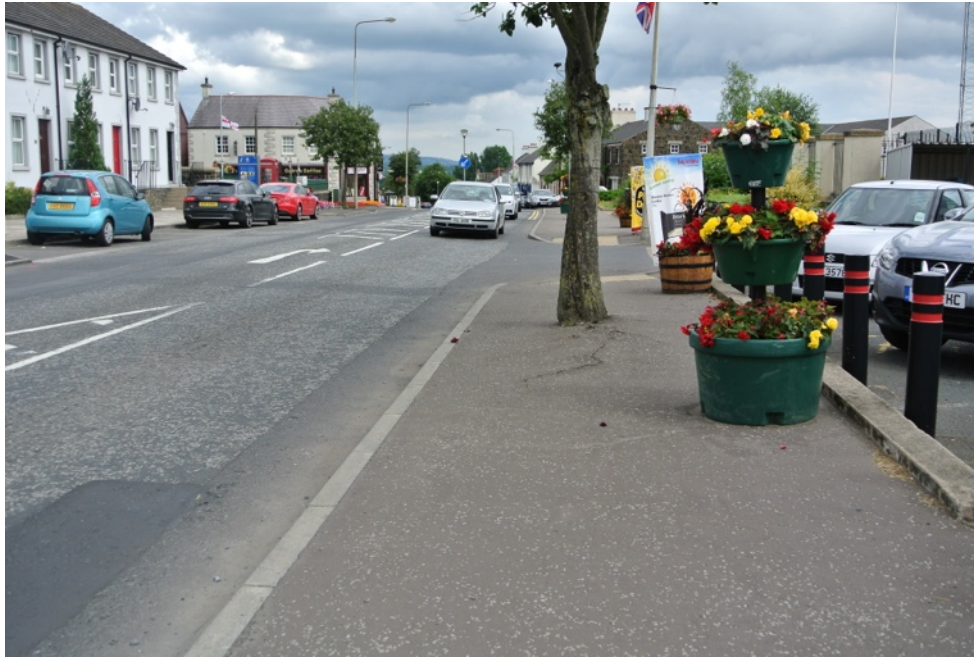
- 7 Planters and trees present significant obstacles on the route to the garage and Supervalu supermarket on the southern side of Main Street.

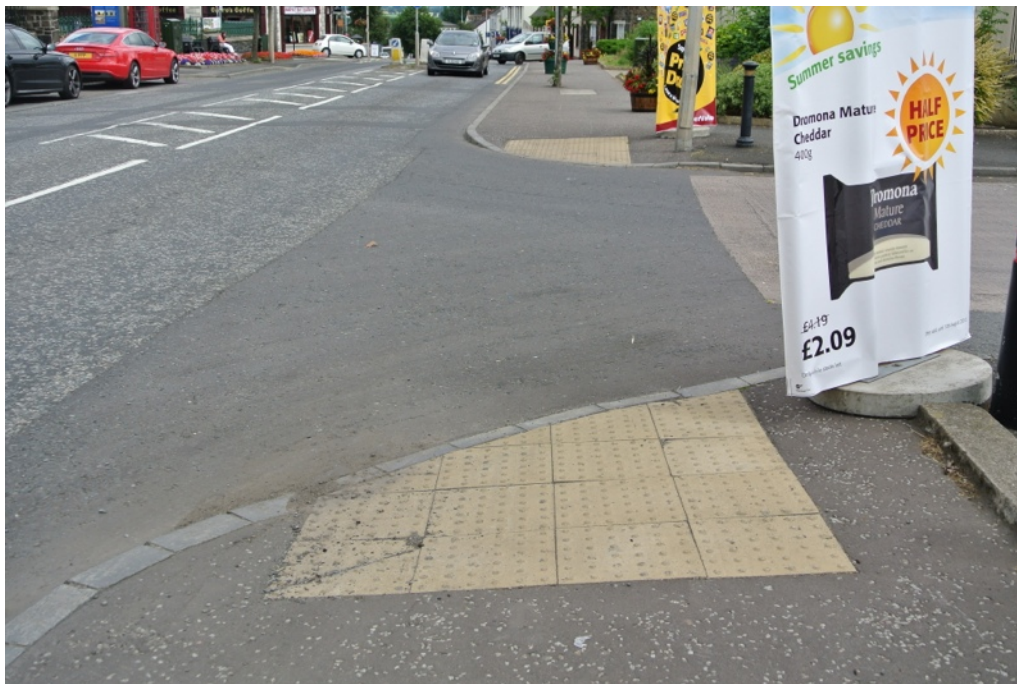
- 8 A good example of an in-line uncontrolled crossing is in place at the entrance to the garage/supermarket.

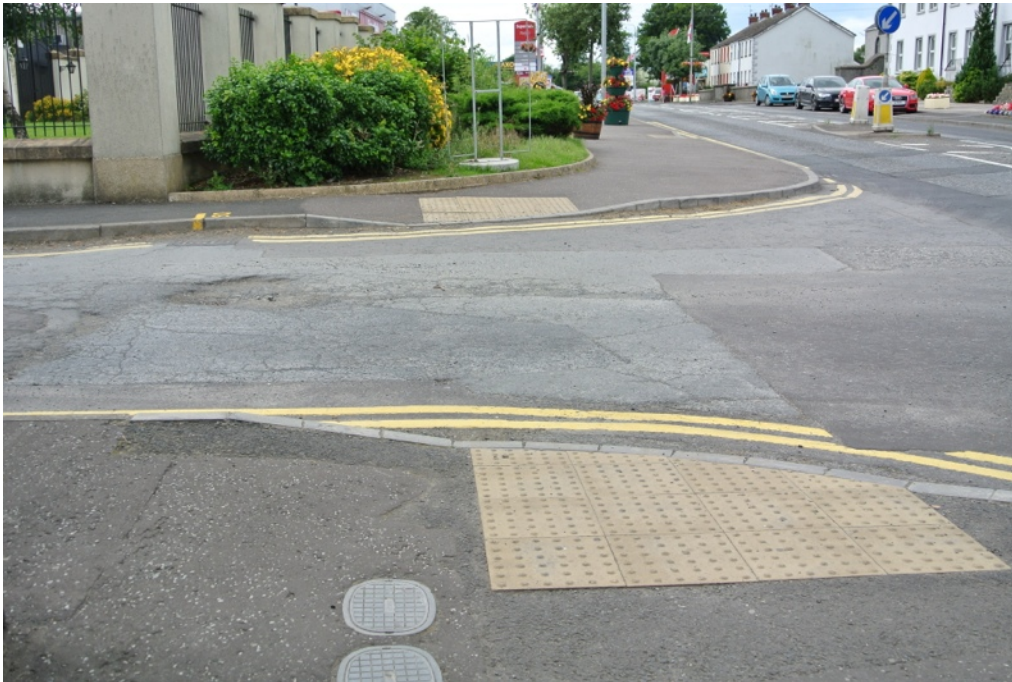
- 9 Returning towards the centre of the village there is a junction on the southern side of Main Street just after the police station. There is a good example of an in-line uncontrolled crossing at this point.

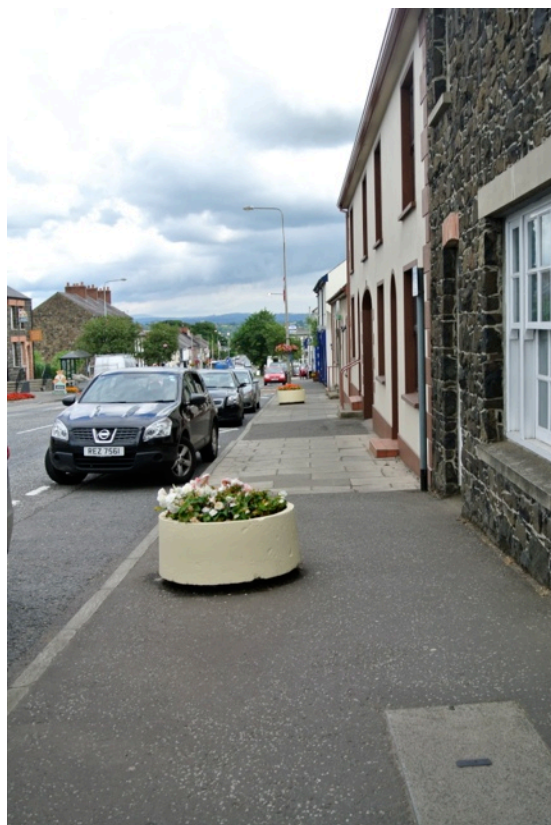
- 10 Low-level planters present hazards for people with a visual impairment along the route towards the village centre.

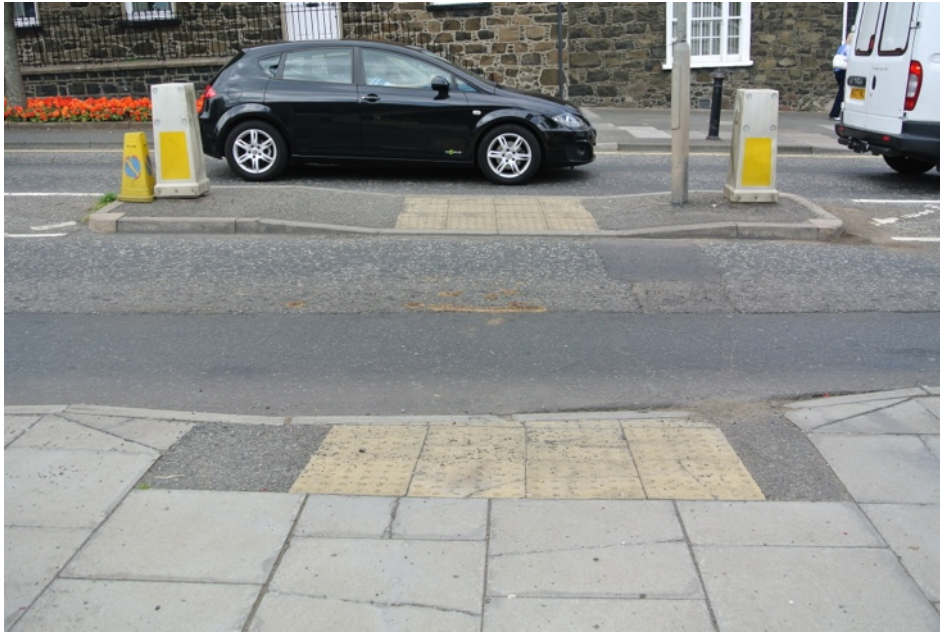
- 11 There is a good example of an in-line uncontrolled crossing across main street close to the Ulster Bank.

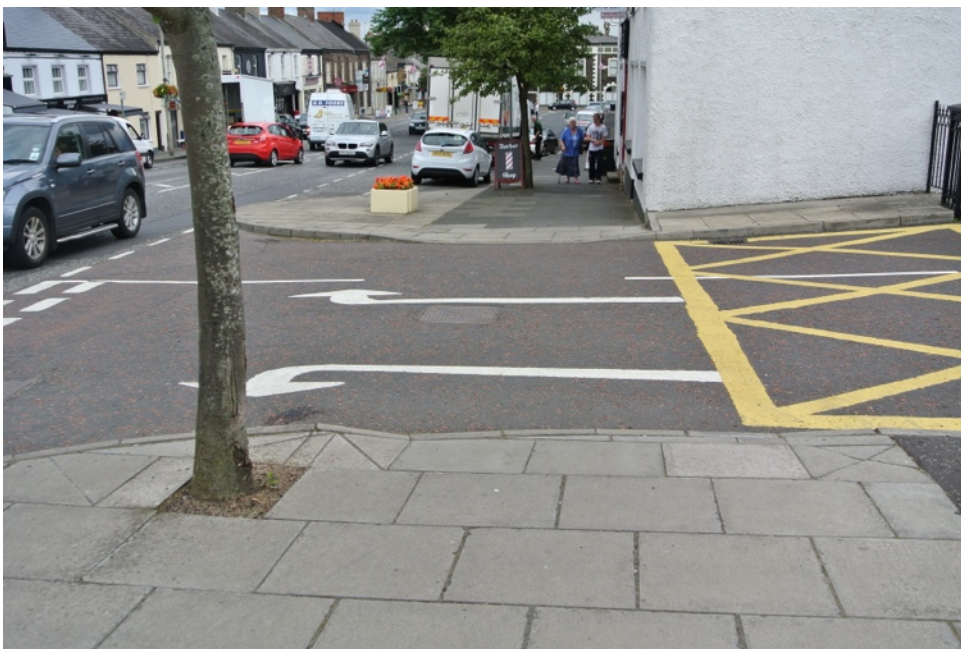
- 12 At this point on the southern side of Main Street there is an entrance to St John's Parish Centre. While the kerb has been dropped there is no tactile paving.

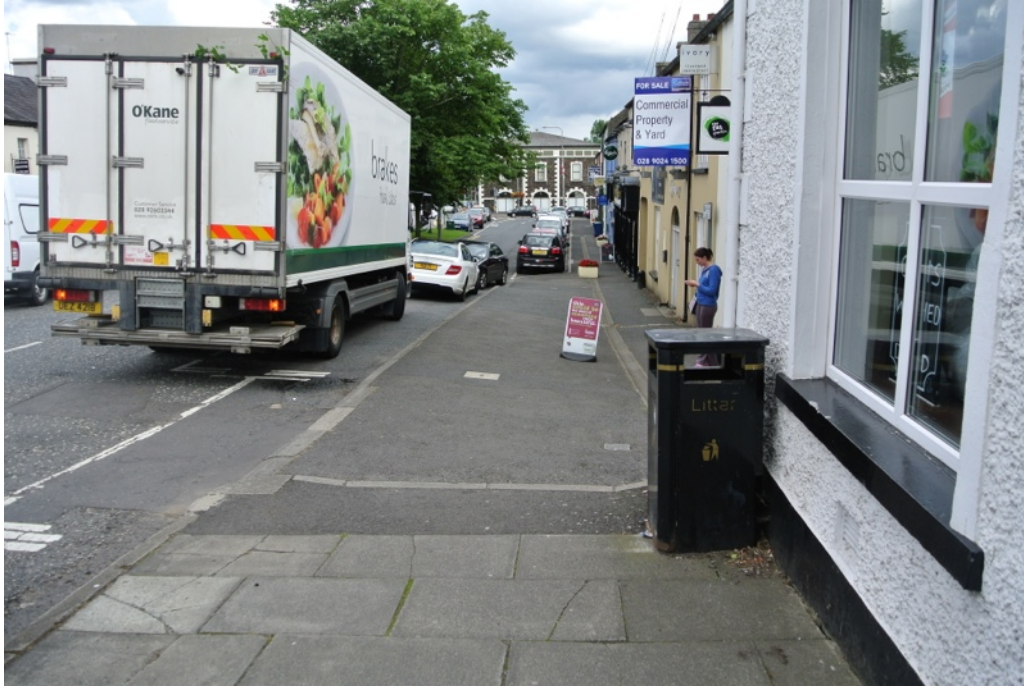
- 13 At this point the pavement slopes significantly. The cross-fall poses significant challenges for some disabled people including wheelchair users. The dish drainage channel creates an additional hazard.

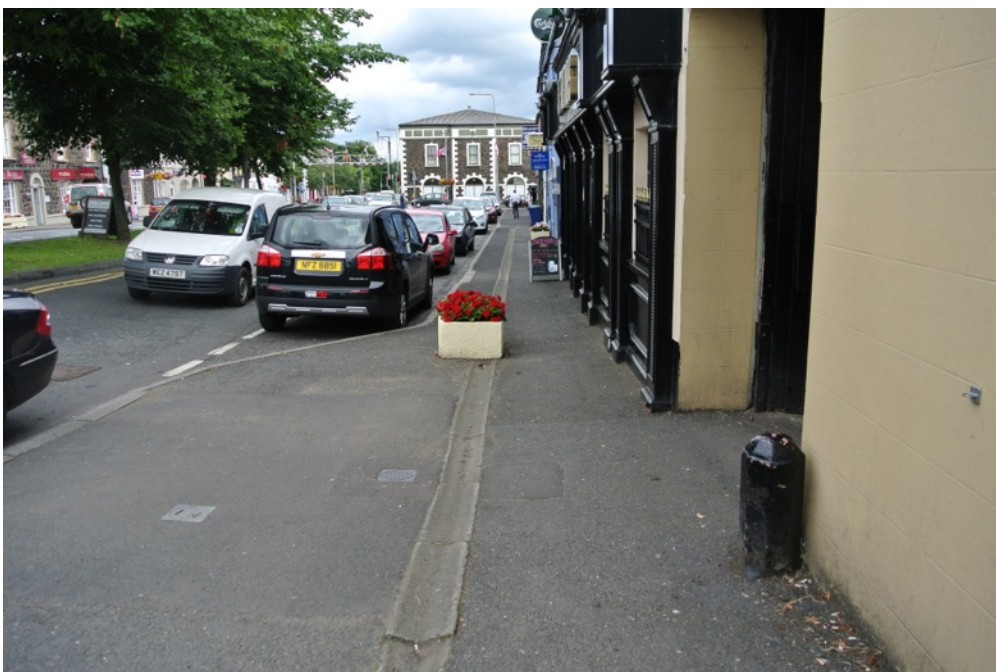
- 14 Proceeding along the southern side of Main Street the pavement narrows considerably. Planters, A-boards and the dish drainage channel make navigating this area a challenge.

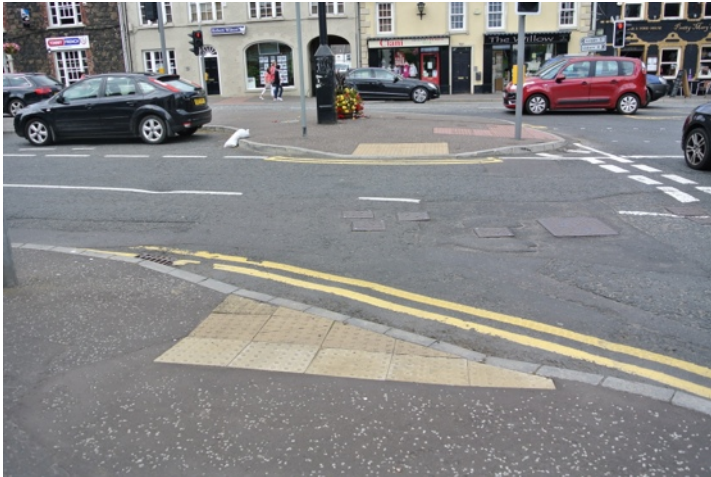
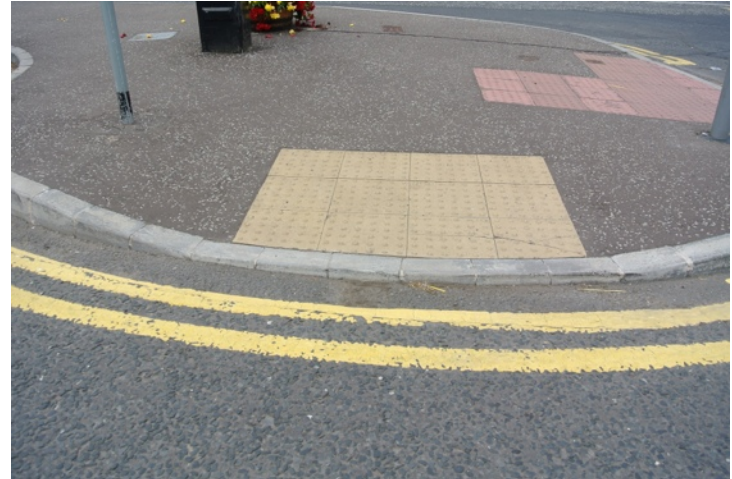
- 15 At the junction between Main Street and Meeting Street there is an in-line uncontrolled crossing leading to the island containing the controlled crossing for the junction. The kerb on the far side of the crossing is not flush and could present a tripping hazard. The tactile paving on the opposite side would benefit from an additional line of tiles.

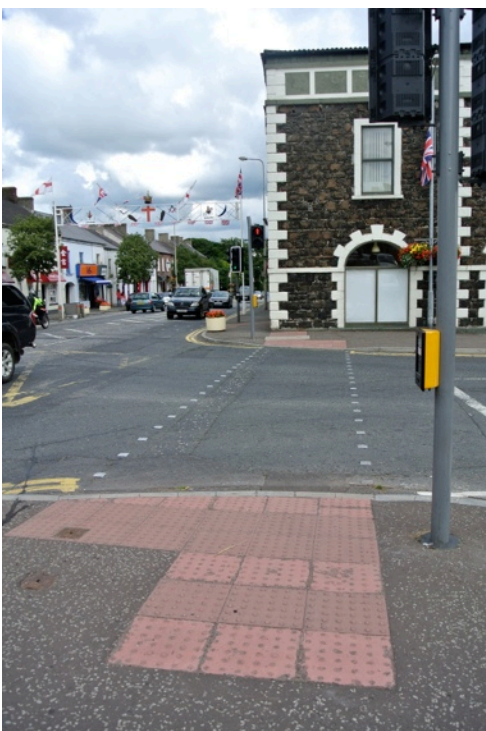
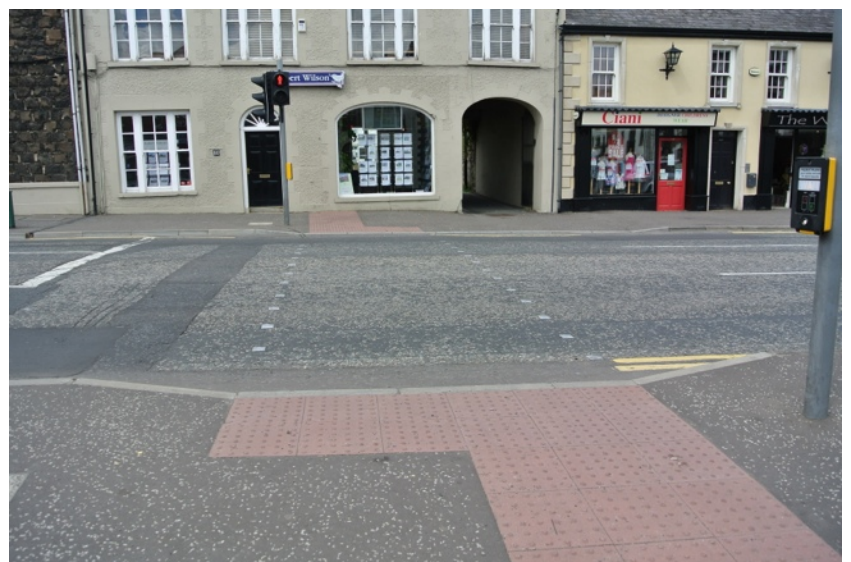
- 16 There is a good example of a controlled crossing here allowing access both across Meeting Street and Main Street. This is the last safe and accessible place to cross Main Street in the village. Consideration should be given to providing other crossing opportunities further along Main Street towards the railway station.

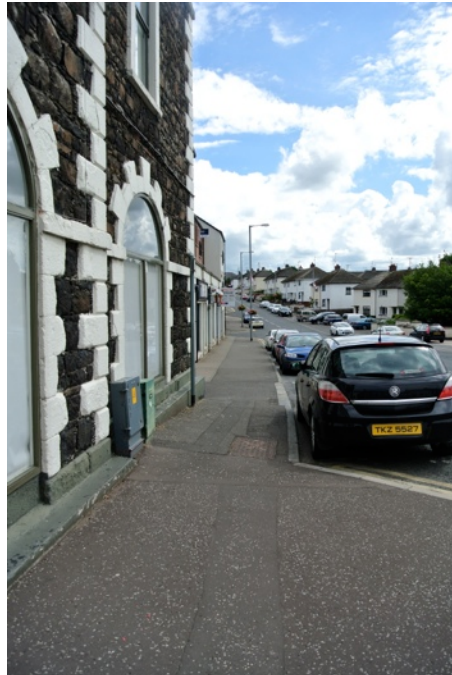
- 17 There is a clear uncluttered pavement around the retail units on Meeting Street.

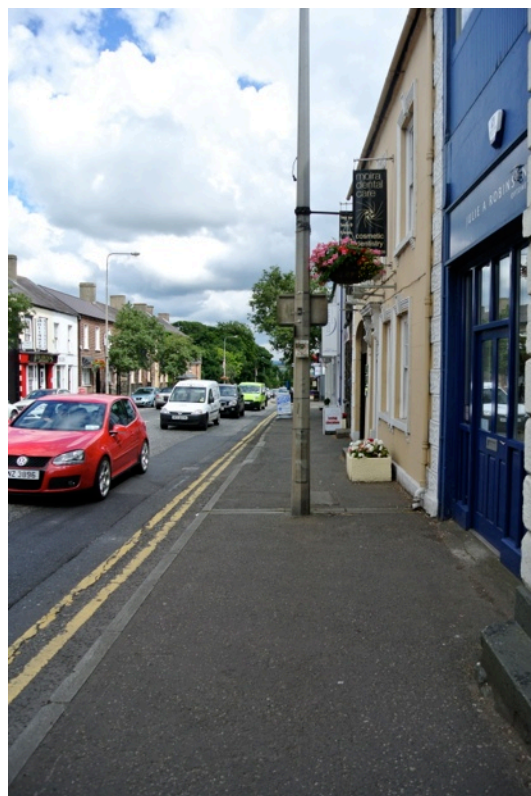
- 18 Pavement width is restricted by A-boards, planters and lighting columns continuing along southern side of Main Street.

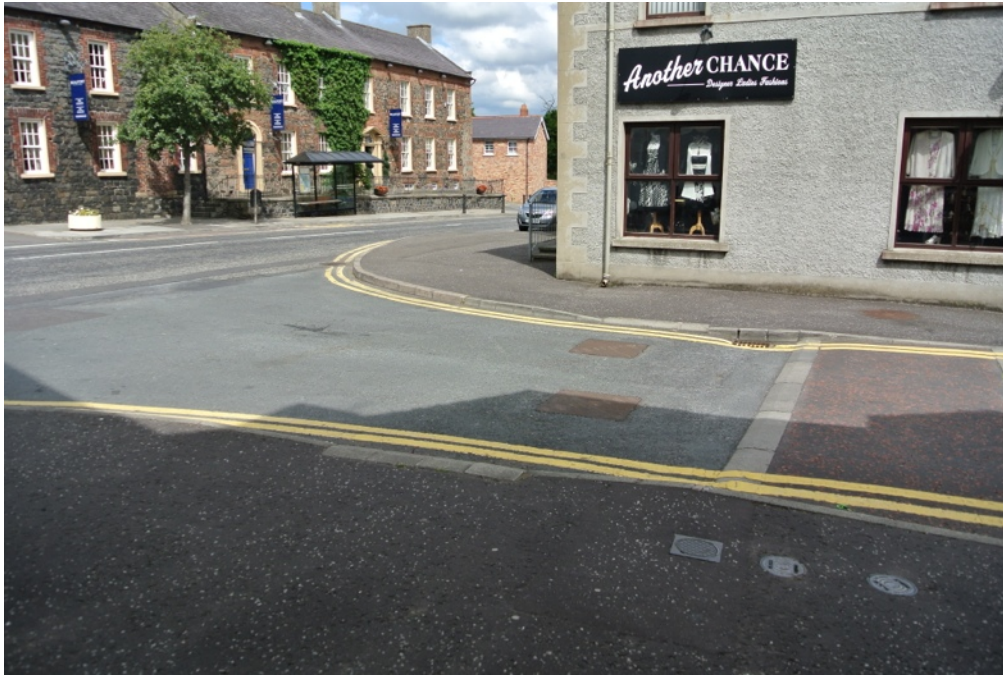
- 19 At the junction with Tanners Court the kerb has been dropped but no tactile paving has been provided.

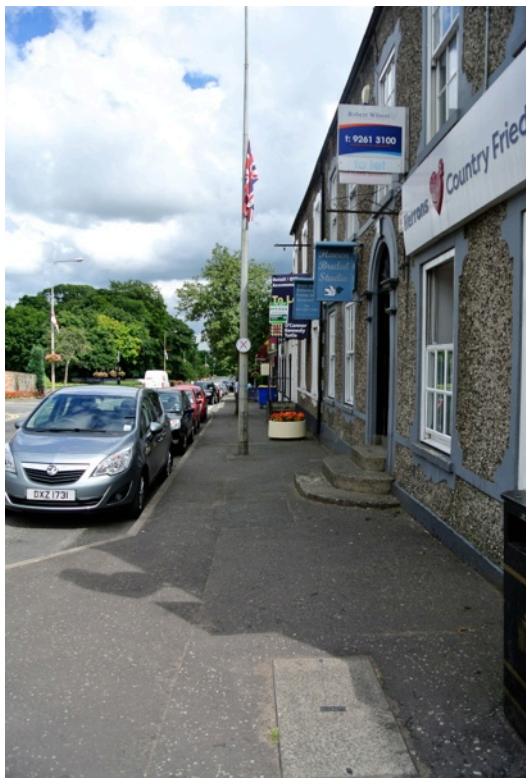
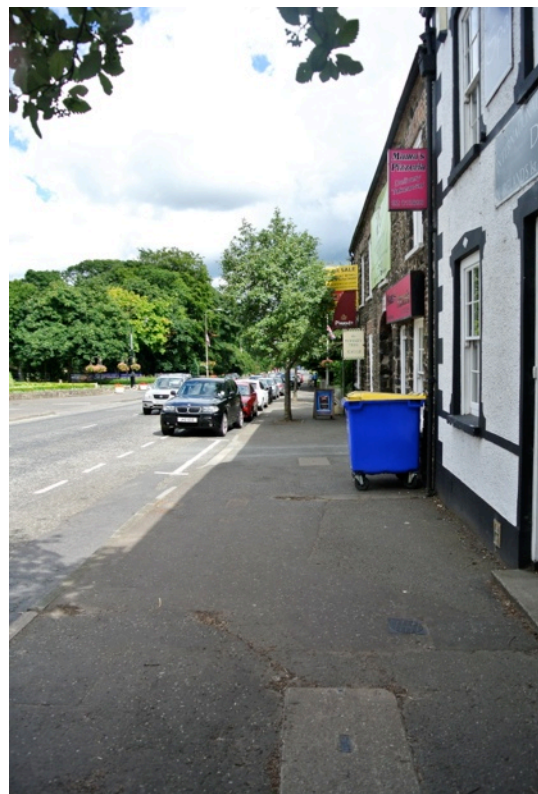
- 20 Continuing along the southern side of Main Street obstructions on the pavement continue to restrict width and present hazards.

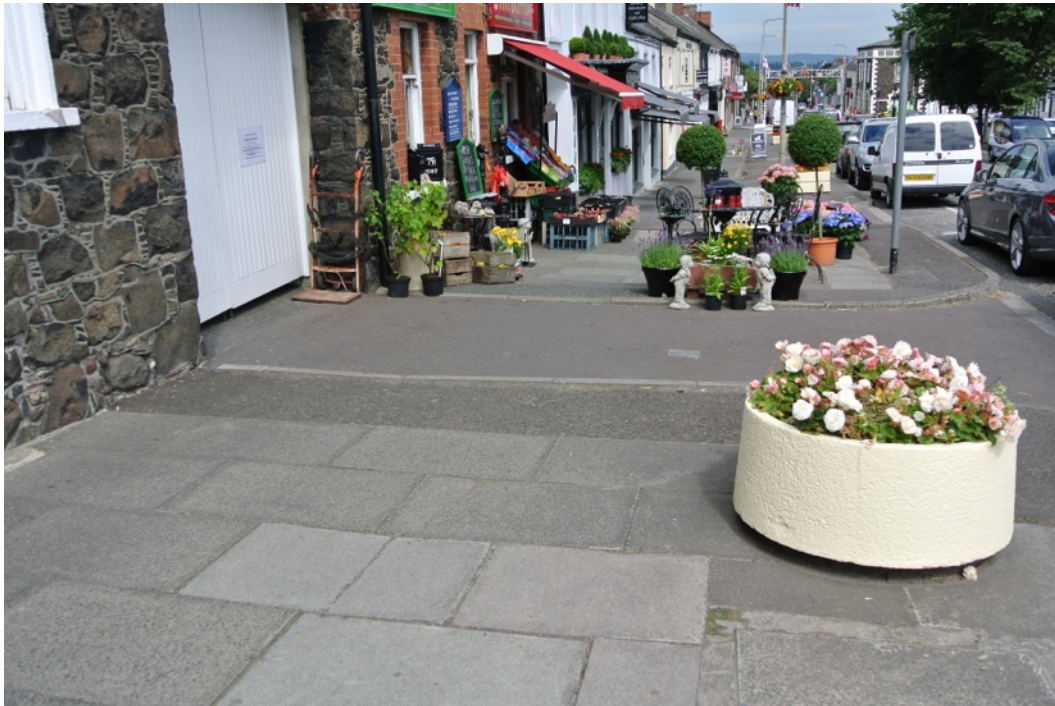
- 21 Returning to the Northern side of Main Street a shop display significantly restricts the pavement on the route into the village centre from the library car park.

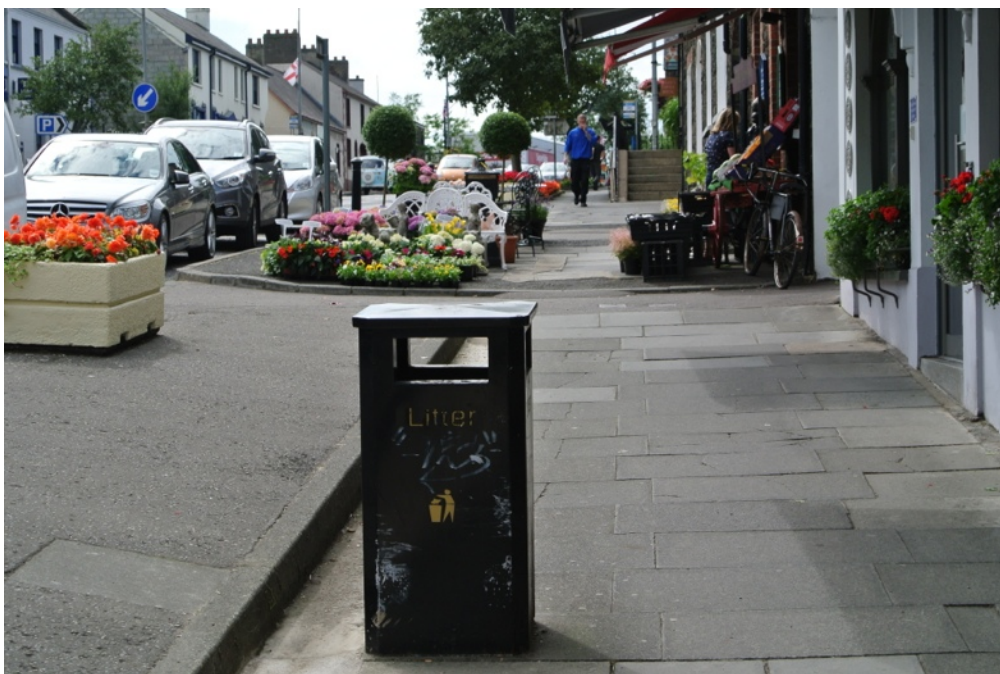
- 22 Continuing into the centre of the village the pavement is separated from the road by a tarmac area with high kerbs. This makes using on-street parking in the area a significant challenge for some disabled people including wheelchair users.

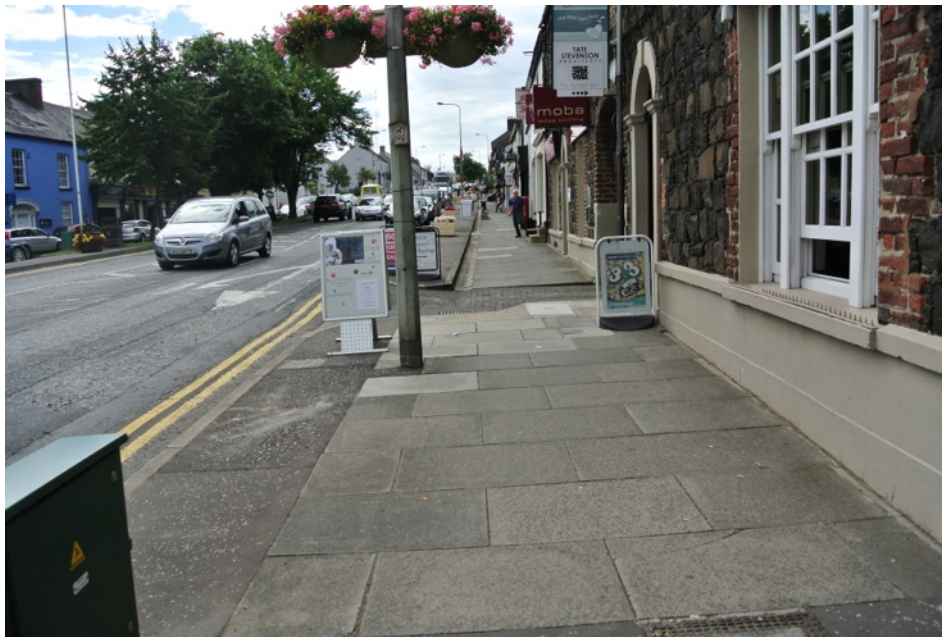
- 23 Clutter including A-boards, street furniture and shop displays create hazards in the area although some attempts have been made to keep these out of the main pedestrian route.

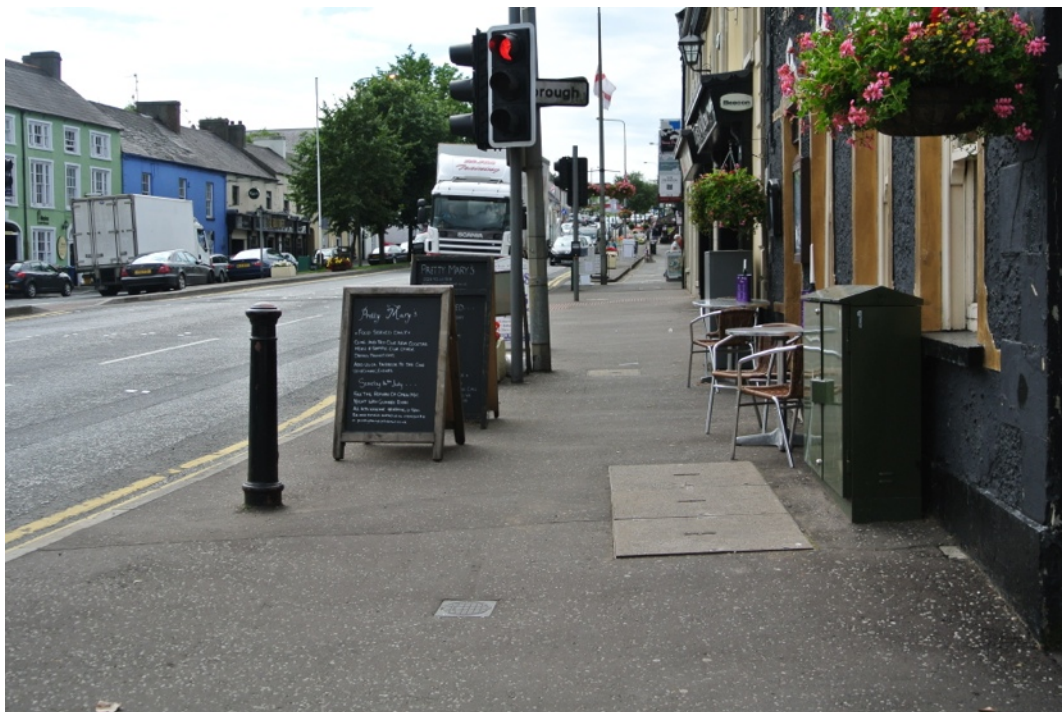
- 24 Around the controlled crossing at the junction of Meeting Street and Main Street the pavement is restricted by tables and chairs and A-boards. There is insufficient pavement width to effectively screen the table and chairs in this area.

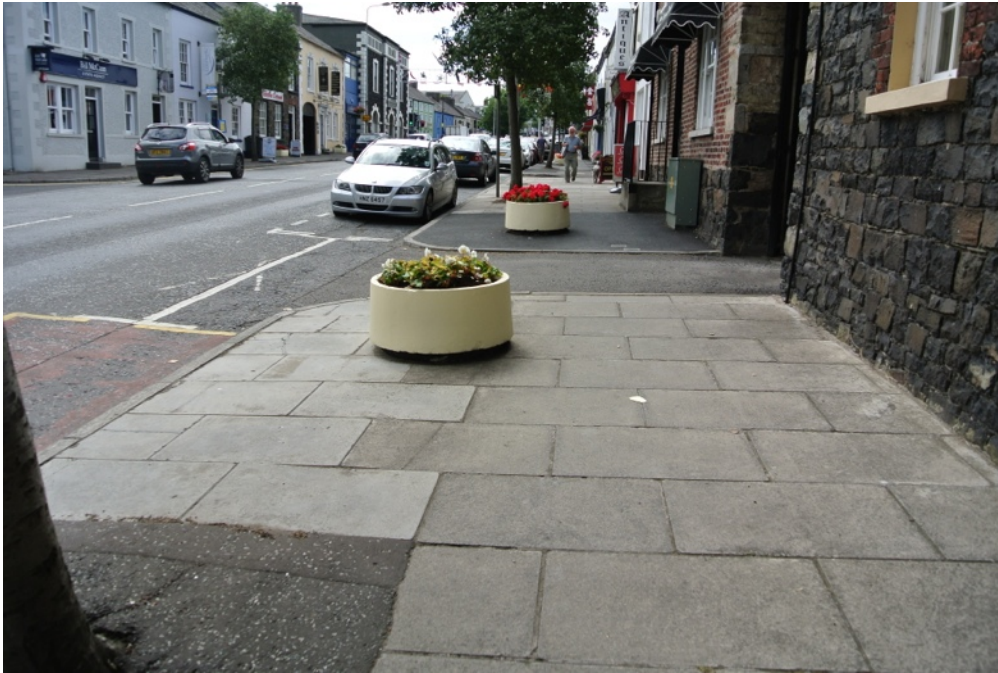
- 25 Continuing along the northern side of Main Street low-level planters and vehicle entrances create potential obstacles for disabled people.

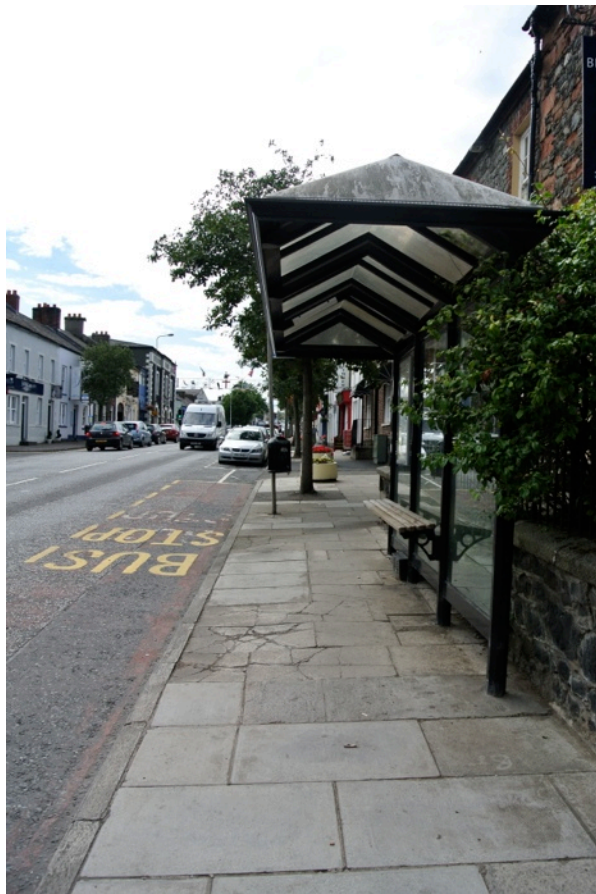
- 26 The pavement around the bus stop in this area is clutter free. However the pavement itself is in a poor state of repair.

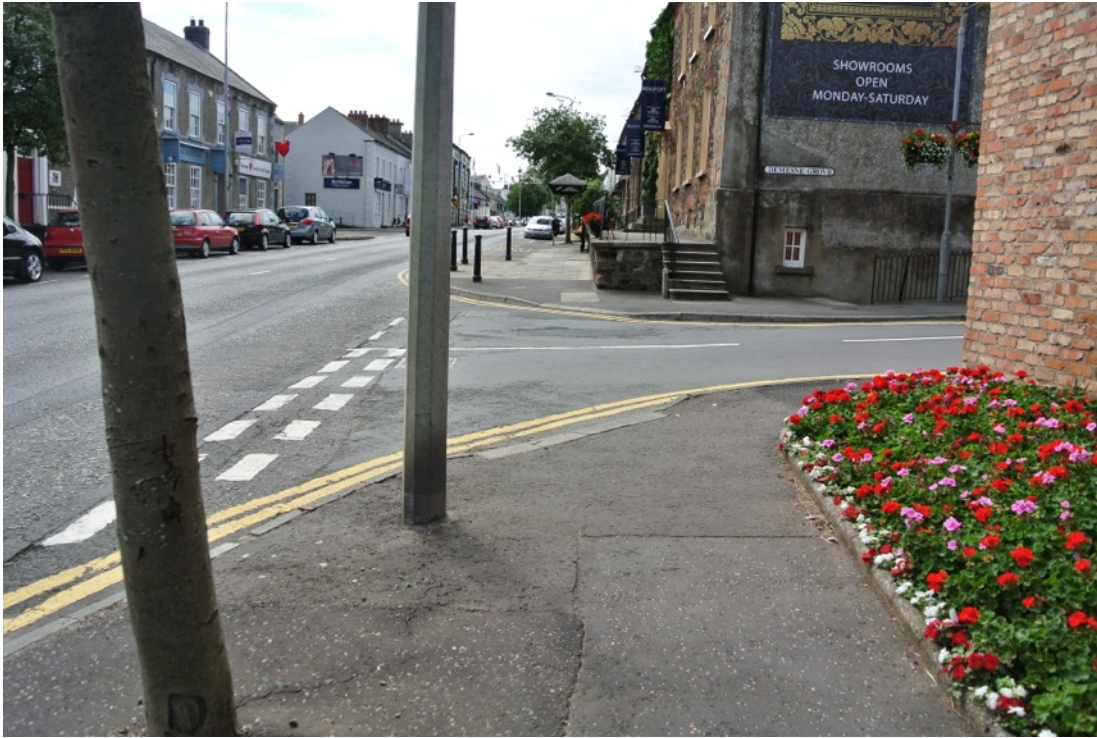
- 27 At the junction with Demesne Grove a dropped kerb has been provided but no tactile paving is in place.

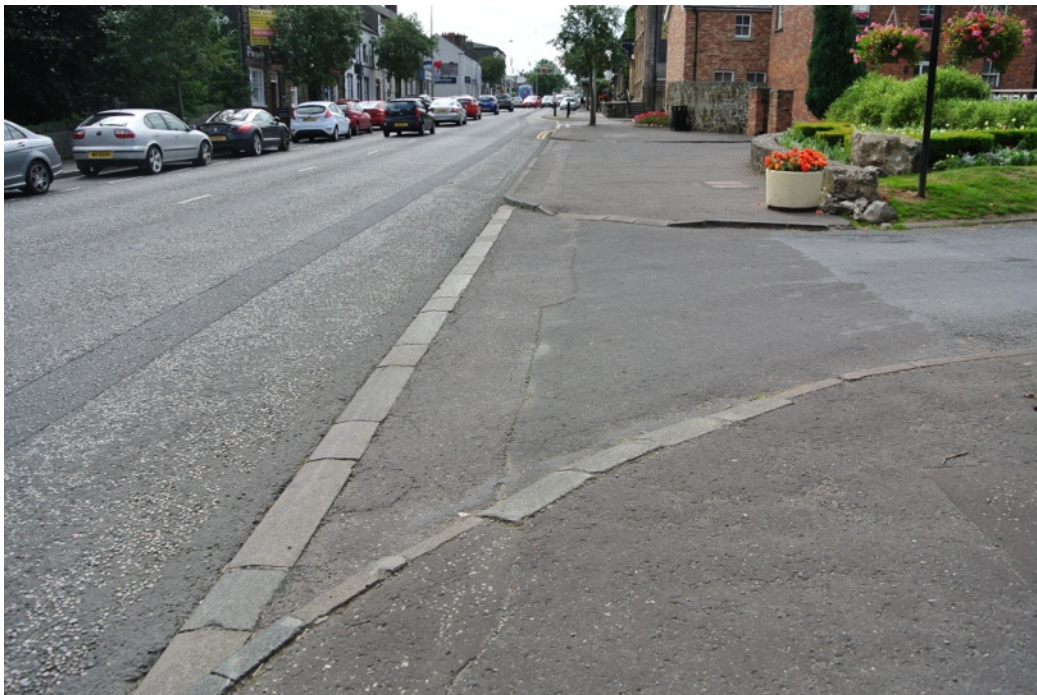
- 28 There is no tactile paving at the vehicle entrances to the Demesne.

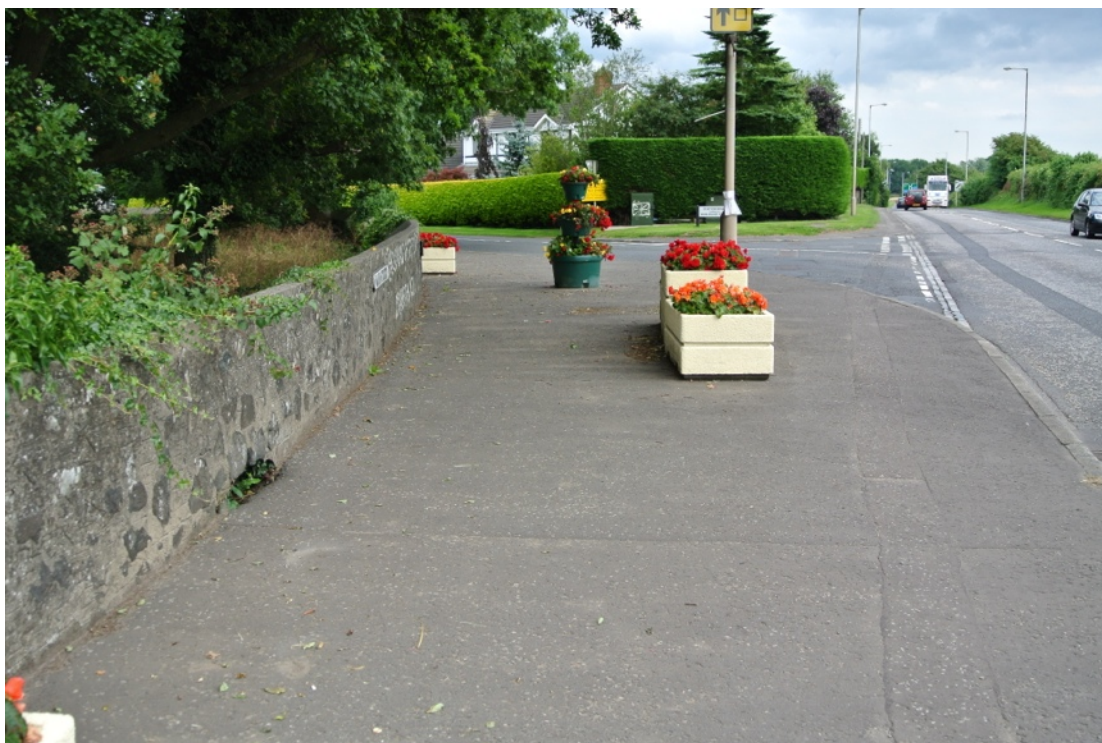
- 29 There is a wide pavement along Main Street approaching Station Road. However planters do present obstacles particularly approaching the junction.

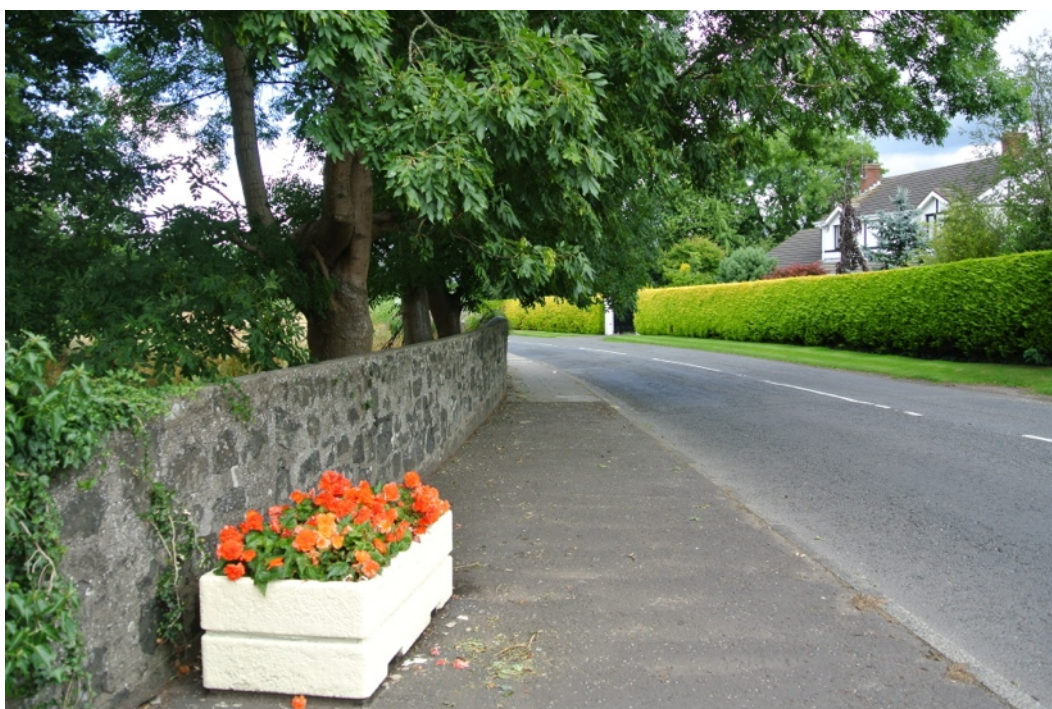
- 30 A narrow pavement provides access along one side of Station Road.

The railway station is an important transport link for Moira. As the station is some distance out of the village improvements are required now to improve the pedestrian route to and from the station and the village. Ideally this would involve widening the pavement on Station Road. However in the interim consideration should be given to ensuring hedges, trees and vegetation along the route is cut back, car parking on the pavement is enforced and the kerb at the junction of Drumbane Road is dropped.

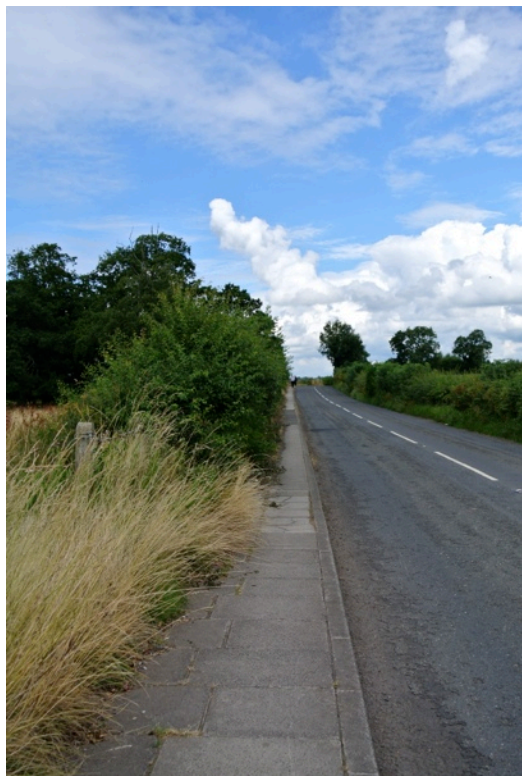
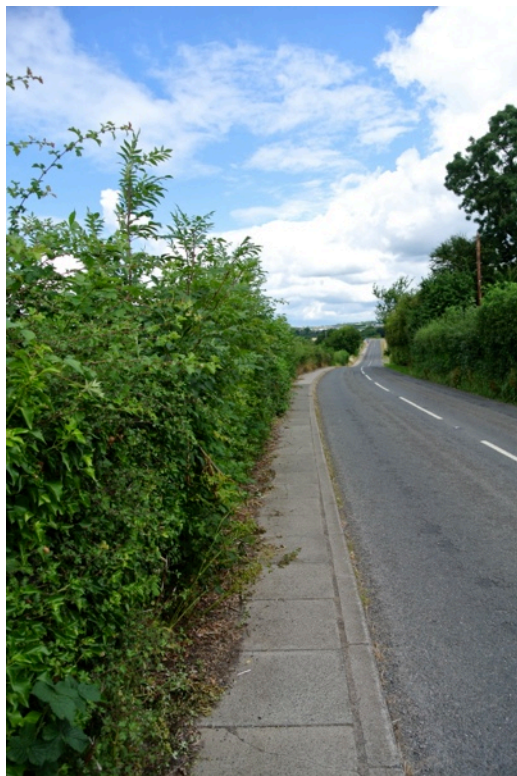
- 31 Stretches of the pavement are narrowed considerably by overgrown hedges. This means that pedestrians must often step onto the road to pass other pedestrians. For people with a visual impairment overgrown hedges present additional hazards with risk of injury from branches.

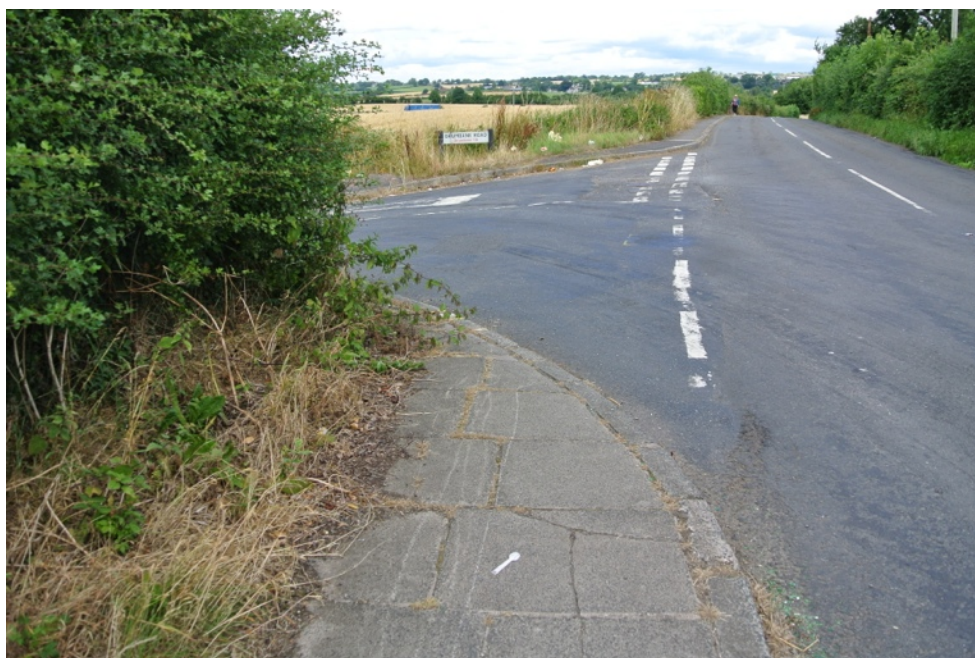
- 32 At the junction of Drumbane Road no dropped kerbs have been provided. This means the route to the station is not accessible to some disabled people including wheelchair users.
