**Report on Walking routes in Moira village**

November 2013

The report was compiled following an inspection of Moira in August 2013. It considers the provision of pedestrian facilities in the village measured against accepted accessibility standards<sup>1</sup>. The report identifies potential barriers for disabled people and older people and recommends how these barriers could be resolved. The report also highlights examples of good practice. A key aspect of the report is linkage between the pedestrian environment and the railway station in Moira. We have produced two reports, a text only version and a version with photographs used to highlight barriers and good practice.

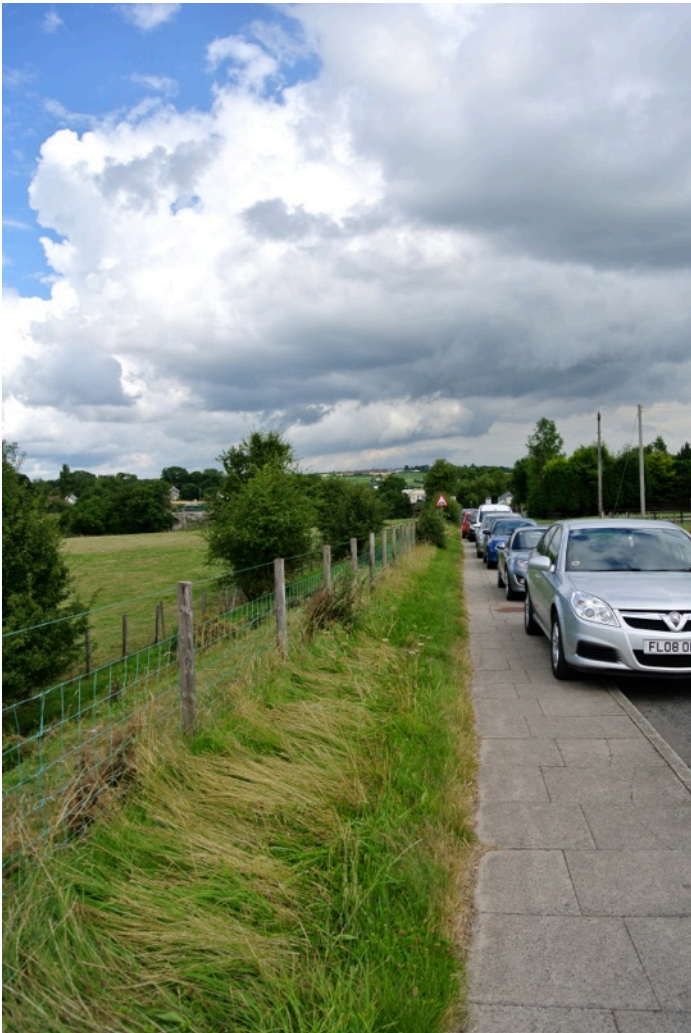
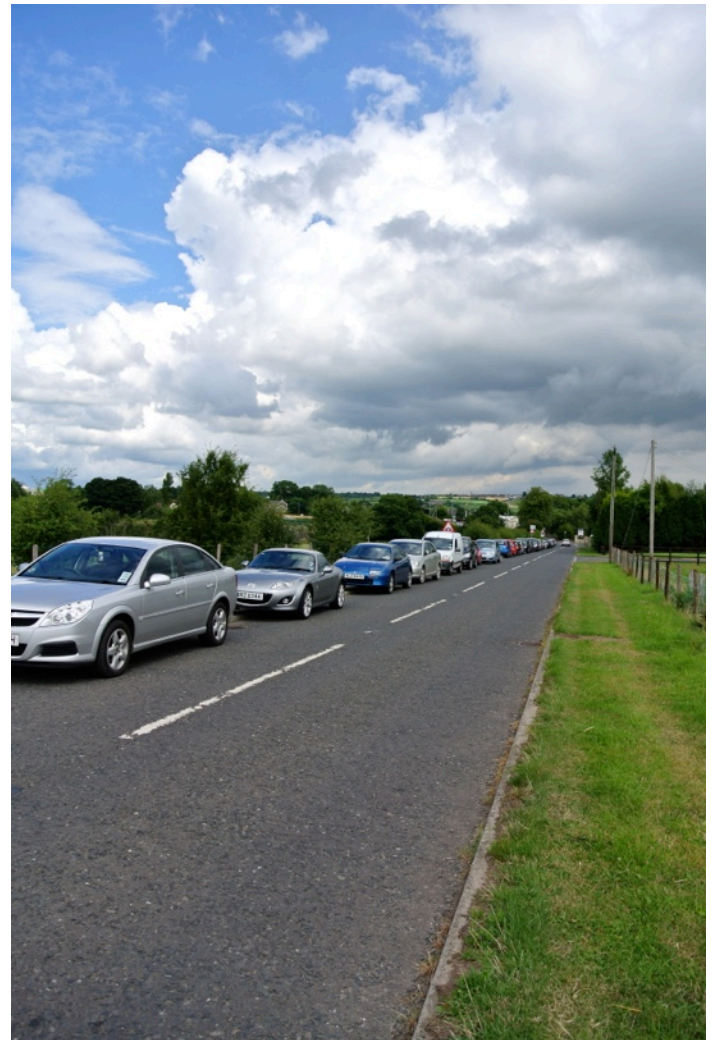
- 33 Approaching Moira railway station cars are parked on the pavement making the route to the station either extremely difficult or impossible for many pedestrians including disabled people and older people and parents with buggies. In this scenario pedestrians are forced to use the road.

The railway station is an important transport link for Moira. As the station is some distance out of the village improvements are required now to improve the pedestrian route to and from the station and the village. Ideally this would involve widening the pavement on Station Road. However in the interim consideration should be given to ensuring hedges, trees and vegetation along the route is cut back, car parking on the pavement is enforced and the kerb at the junction of Drumbane Road is dropped.
