Report on existing pedestrian environment in the streets that cover the proposed area for Belfast Streets Ahead Phase 3

July 2015

This report was compiled by Imtac to inform the design process around proposed public realm works in Belfast City Centre as part of Phase 3 of the DSD Streets Ahead project. The purpose of the report is to audit the existing public realm in the area and identify barriers for disabled people, older people and other pedestrians. The report broadly replicates the approach to similar reports undertaken by Imtac into pedestrian provision in a number of towns and cities across Northern Ireland. The report looks at provision in each street highlighting examples of good and poor practice as well as other issues. The report has been produced in two versions, one plain text, the other with photographs. Images have been used to illustrate issues identified. The report was compiled following a site visit to the streets covered by the project by Imtac members and other organisations on the 24th February 2015.

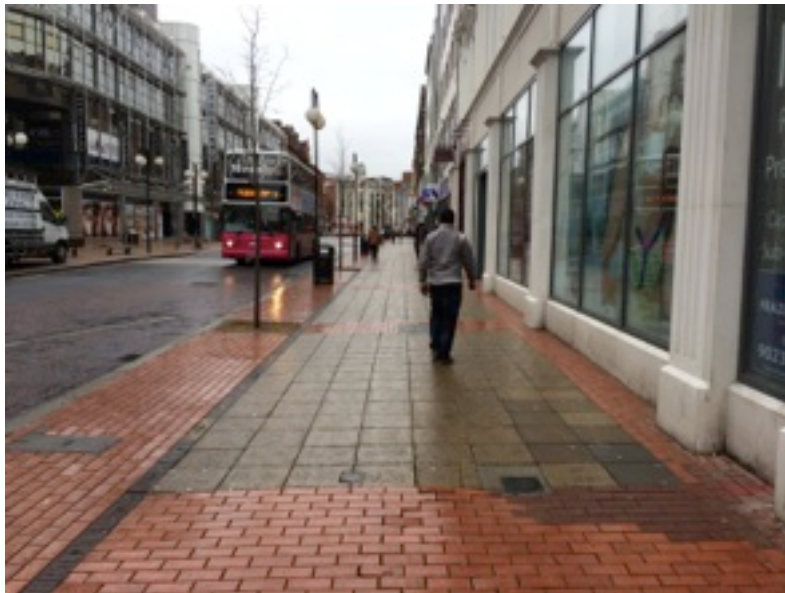
- 1 The public realm in the retail area of Royal Avenue is dated. In some areas the surfaces are uneven, an inevitable consequence of repairs over the years.

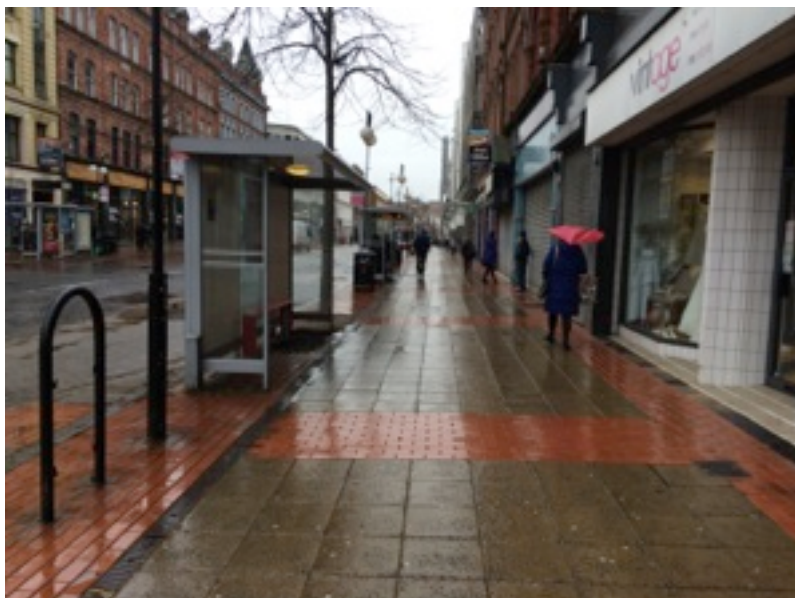
- 2 The pavements in the area are, however, wide and generally clutter free. Furniture, including bus stops, have been largely grouped in a line, minimizing impact on pedestrians and providing a buffer against traffic.

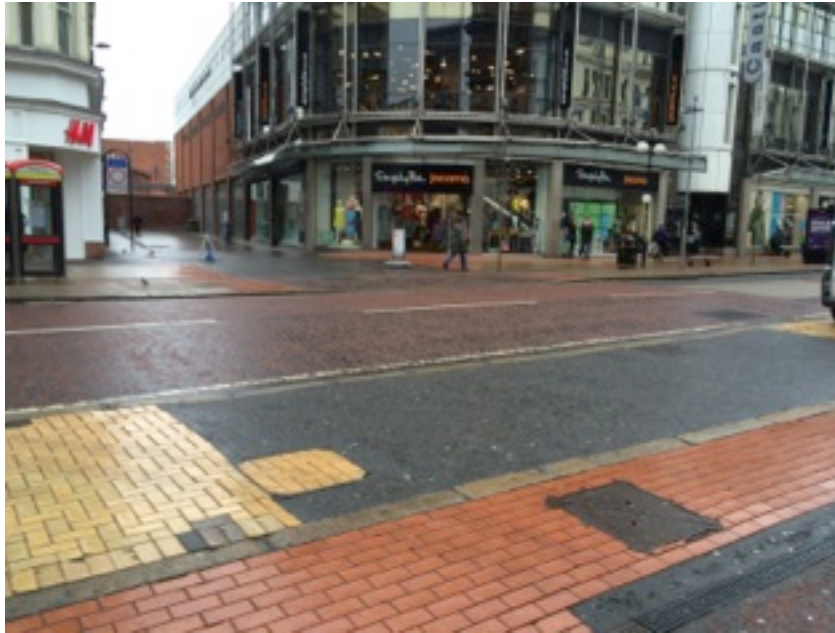
- 3 A major issue in the area is limited availability of opportunities to cross Royal Avenue. The number and location of bus stops in the areas makes provision of additional crossing opportunities difficult. None of the existing crossings have tactile paving.

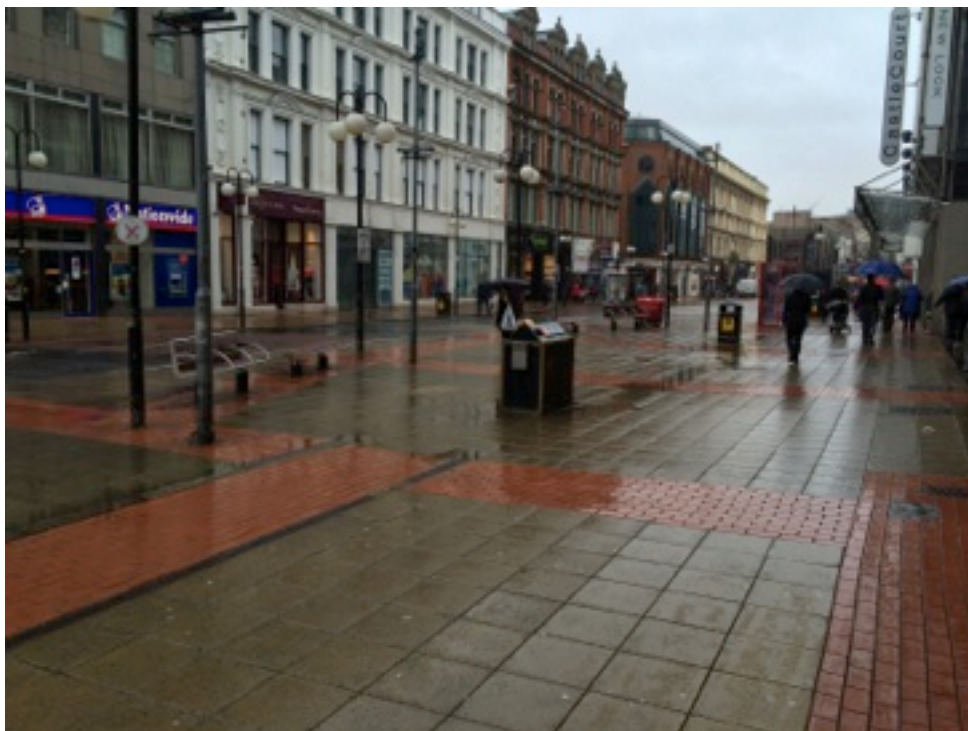
- 4 There is a crossing opportunity at the entrance to Castle Court. However poorly positioned street furniture and general clutter create unnecessary hazards in the area. There is no tactile paving at the crossing.

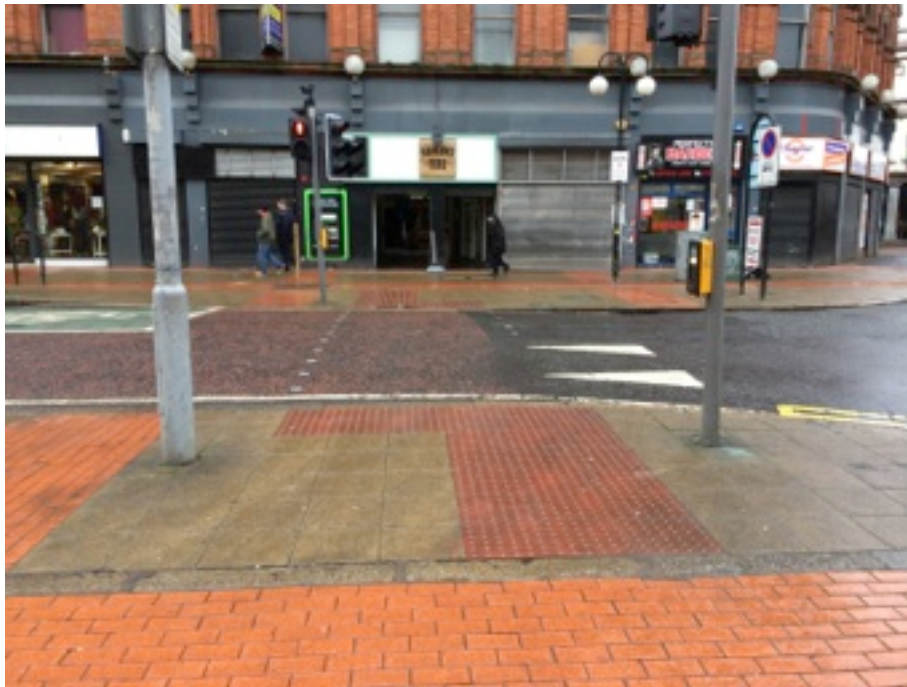
- 5 There is a good example of a controlled crossing across Royal Avenue close to the junction with North Street, although the tactile tail should extend to the building line.

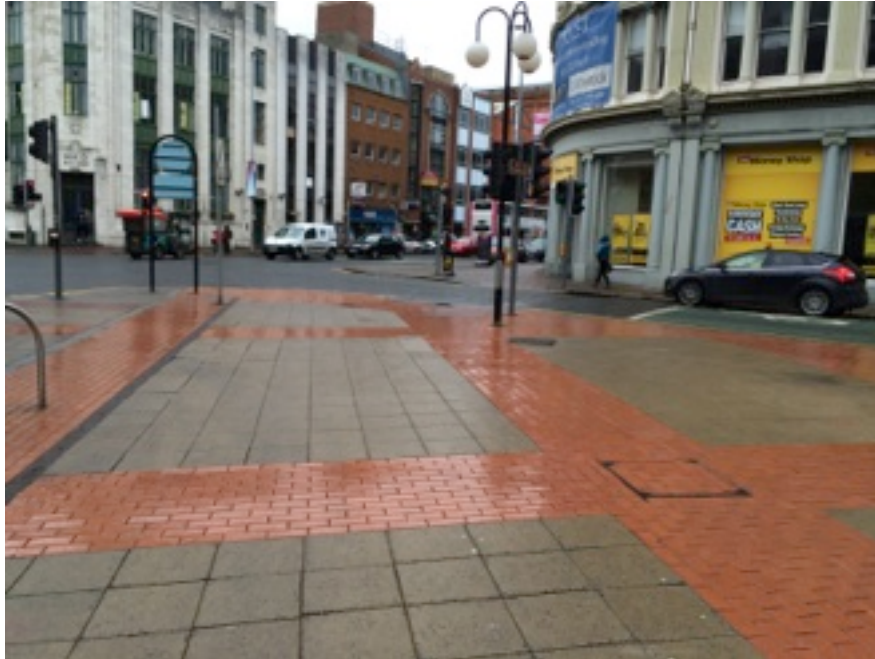
- 7 At the busy junction with North Street there are a series of controlled crossings. On the eastern side of Royal Avenue there is an open area of pavement. This coupled with the lack of contrast between general paving and the tactile surface makes locating the crossing across North Street a challenge for people with a visual impairment.

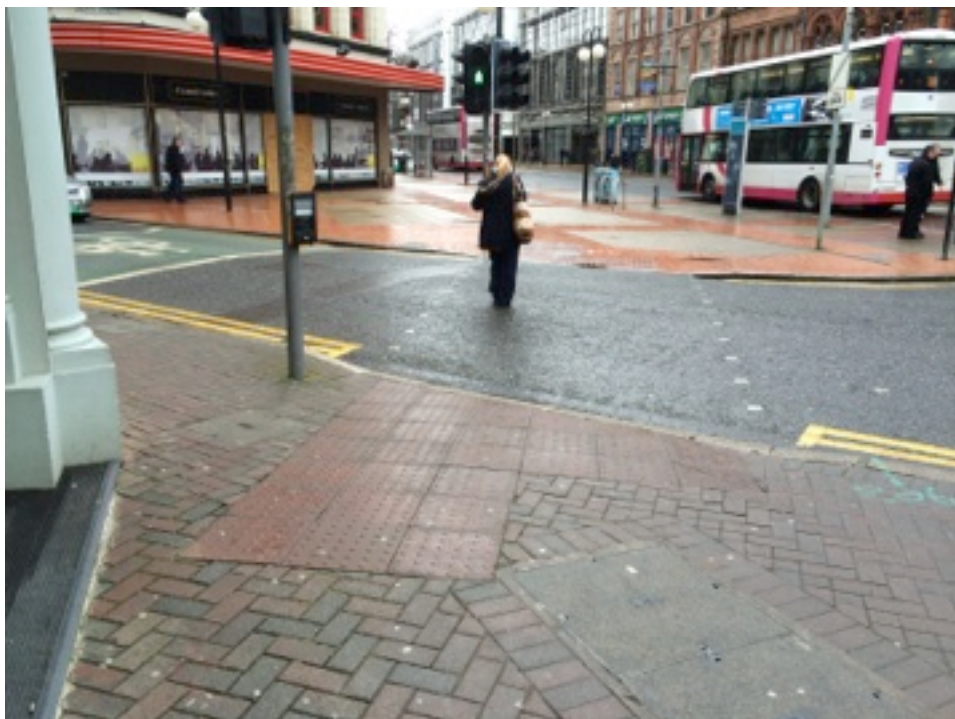
- 8 Contrast is also an issue on the far side of the crossing, heading towards Cathedral Gardens.

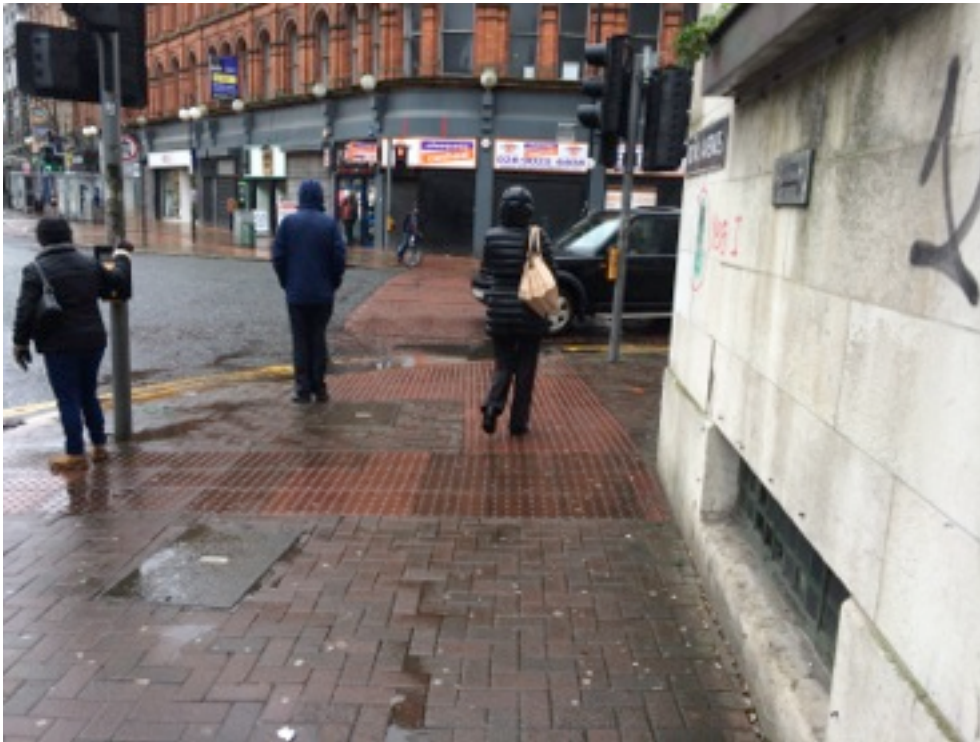
- 9 The controlled crossing across North Street on the western side of Royal Avenue is reasonable. However issues with contrasting and tactile paving persist and there is a problem with water pooling at the crossing.

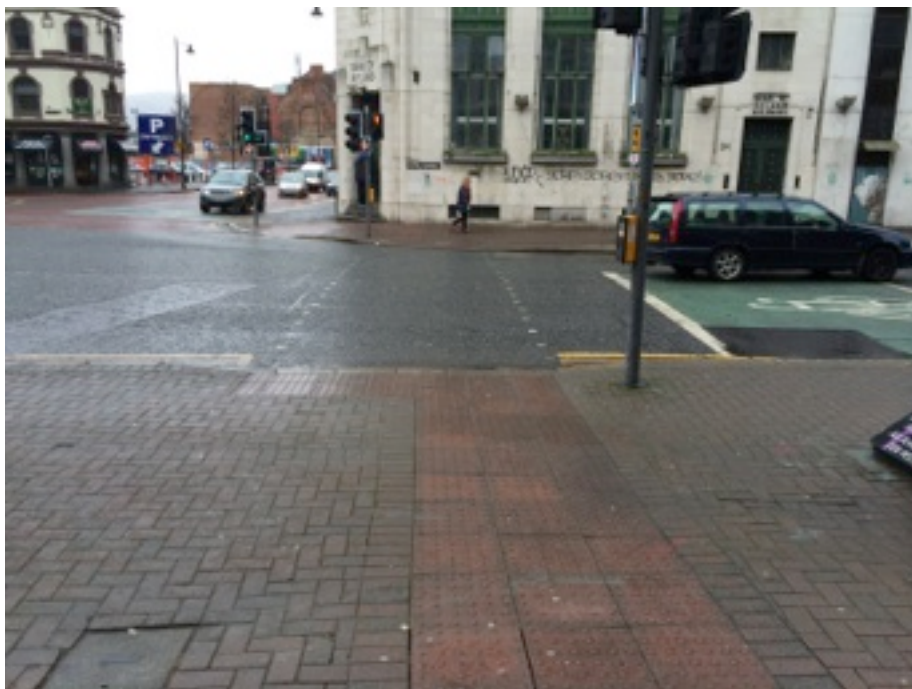
- 10 There is a controlled crossing across Royal Avenue at this point which is reasonable. However issues persist with contrasting of tactile paving and the surrounding pavement.

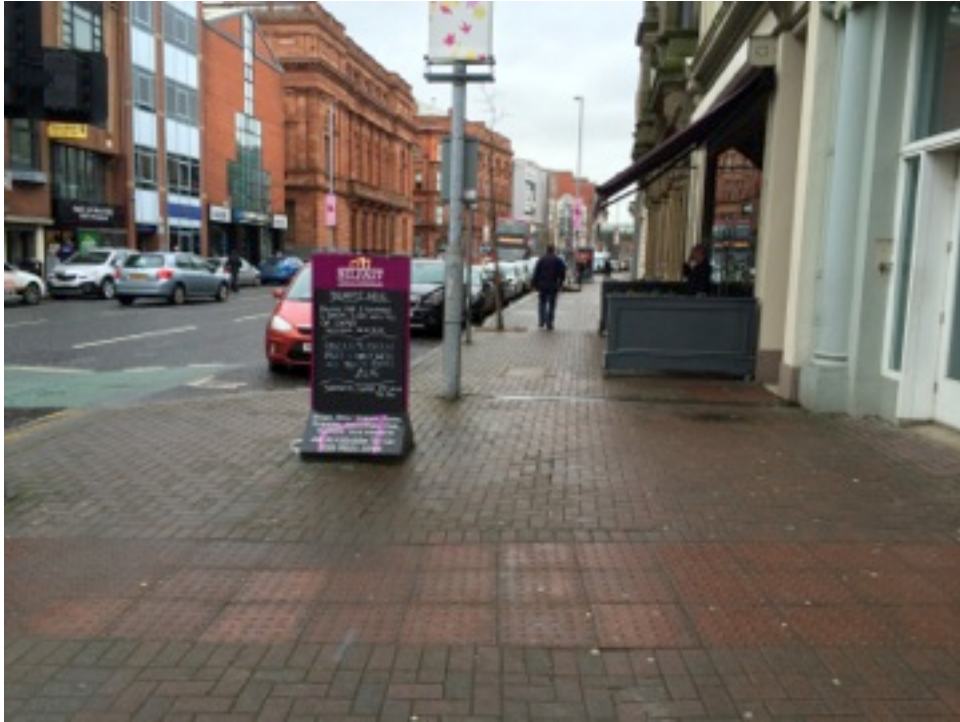
- 11 On the eastern side of Royal Avenue between North Street and Donegall Street a pavement cafe and associated a-board reduces pavement width considerably.

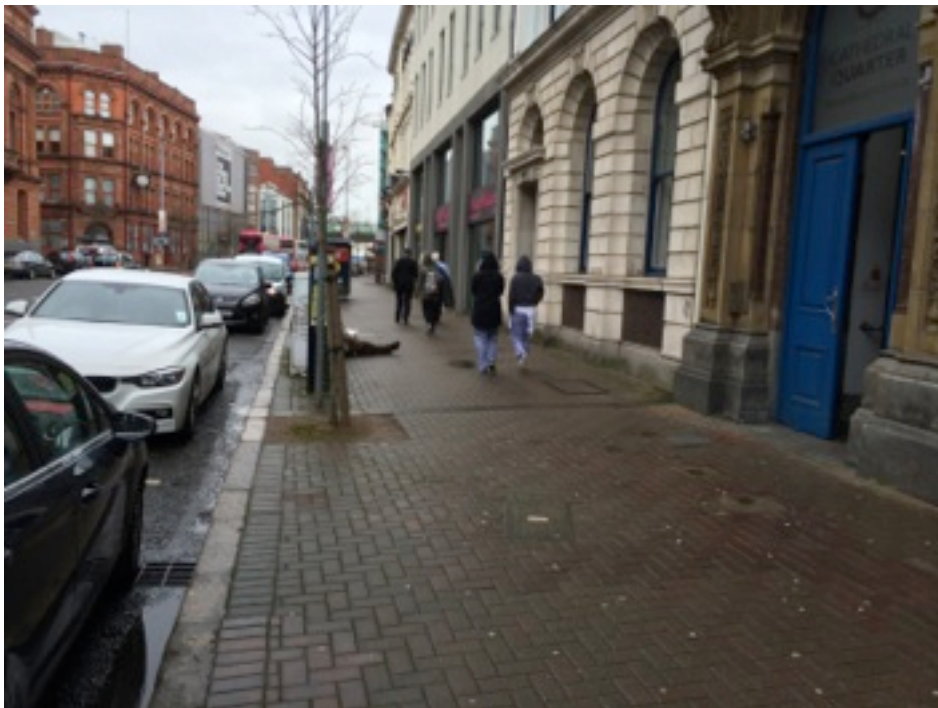
- 12 The pavement in this area is generally wide, however the surfaces in places are uneven and dish drainage channels are used.

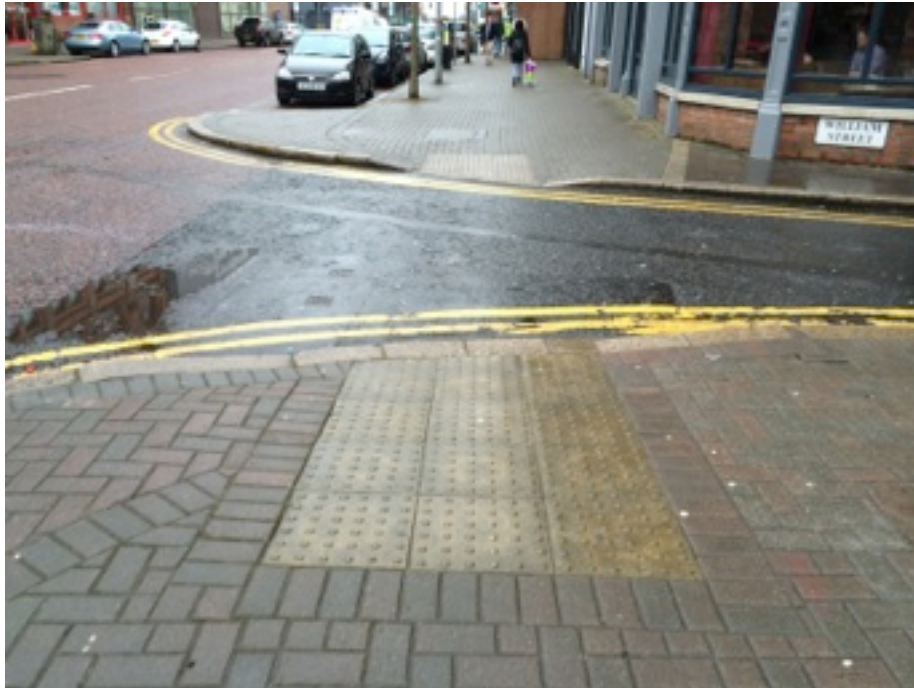
- 13 There is a good example of an inline uncontrolled crossing at the junction of William Street. Given William Street is a small side street enhancing pedestrian priority could be an option.

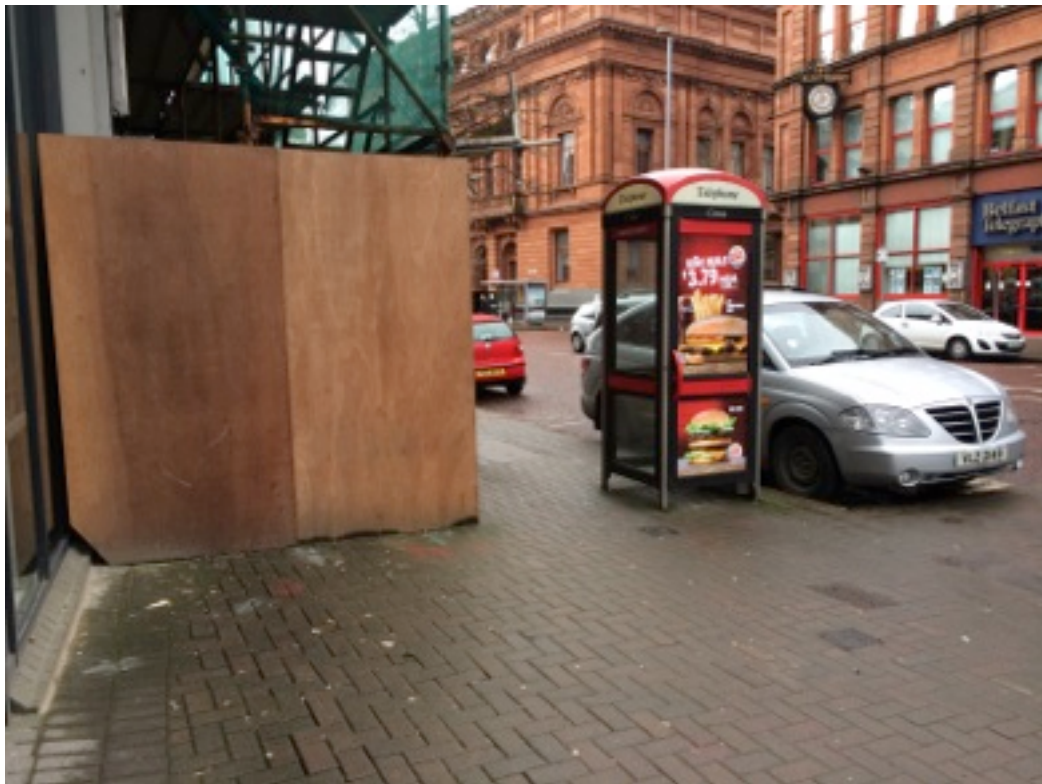
- 14 Close to the junction with Donegall Street on the eastern side hoardings around a building and telephone box create a very narrow pavement.

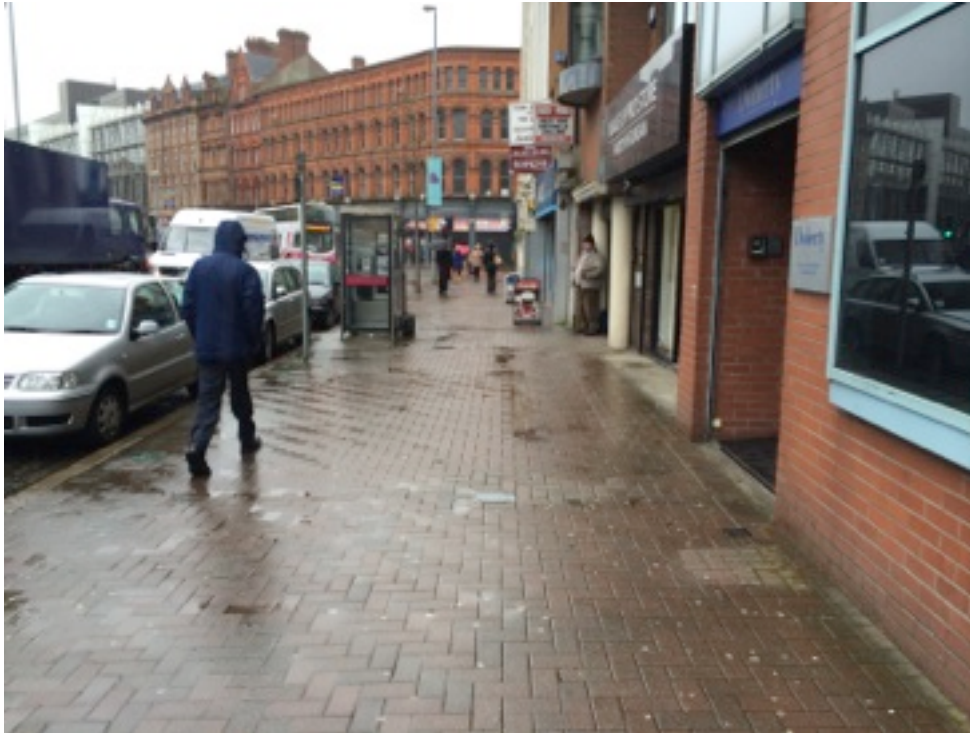
- 15 The pavement on the western side of Royal Avenue between North Street and Donegall Street is generally wide and, apart from a-boards, clutter free.

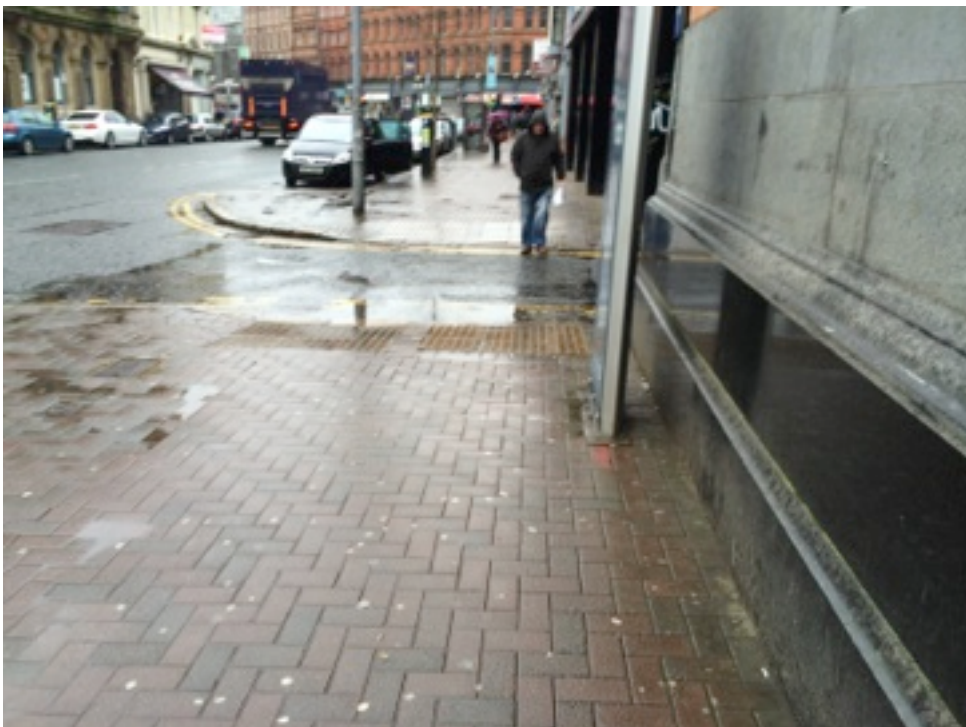
- 16 There is an uncontrolled crossing at the junction with Kent Street. Tactile paving has been laid incorrectly at this junction. The location of tourist signage in close proximity to the tactile paving creates a potential hazard.

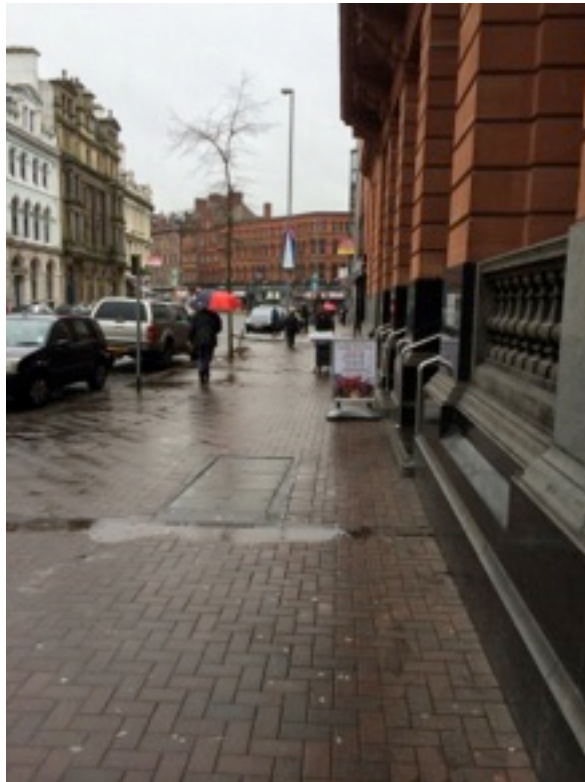
- 17 An a-board at the entrance to the Central Library creates an unnecessary hazard.

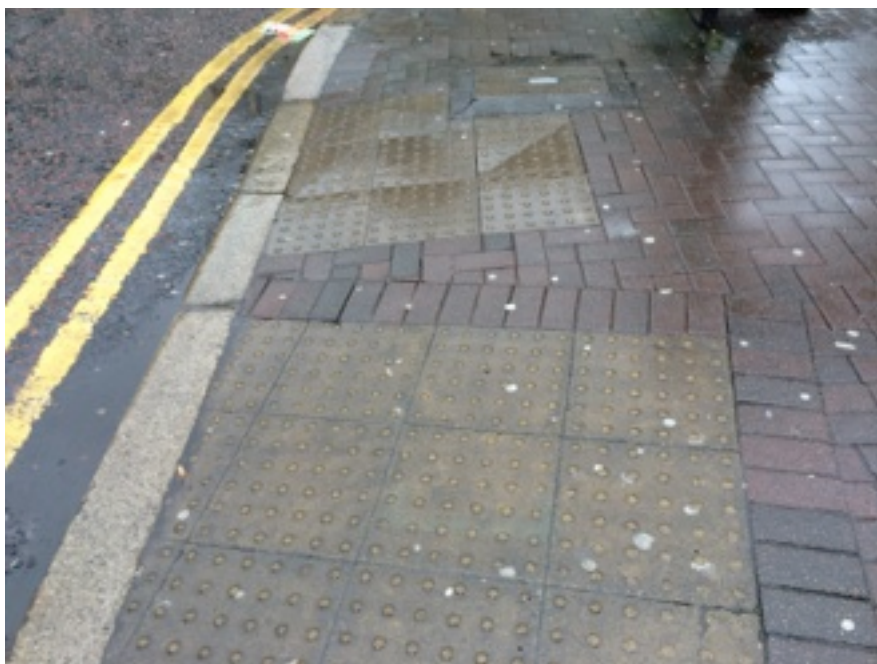
- 18 The inline uncontrolled crossing at the junction of Library Street has incorrectly laid tactile paving.

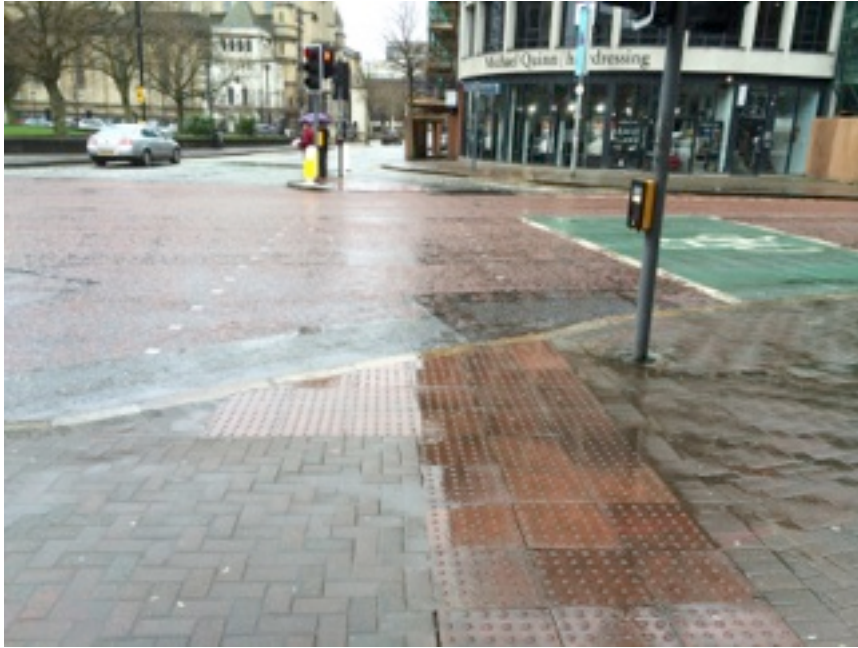
- 19 There is a very busy junction with Donegall Street and York Street which includes a reasonable controlled crossing across Royal Avenue.

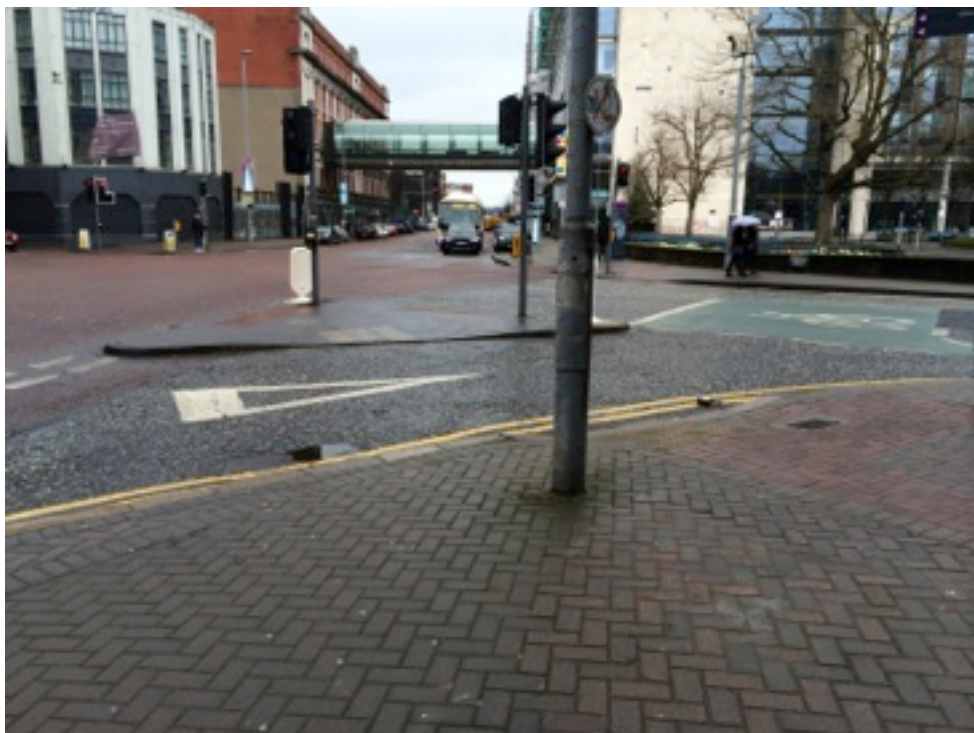
- 20 At the junction with Donegall Street on the eastern side of Royal Avenue there is an inline uncontrolled crossing that allows access to the controlled crossings across Royal Avenue and Donegall Street. With the volume of traffic at the junction the people with a visual impairment in particular will find using this uncontrolled section of the crossing challenging.

- 25 As with the issue previously raised in paragraph 20 an inline uncontrolled crossing on the western side of York Street at the junction of Donegall Street presents major challenges for people with a visual impairment and other disabled people at a very busy junction.

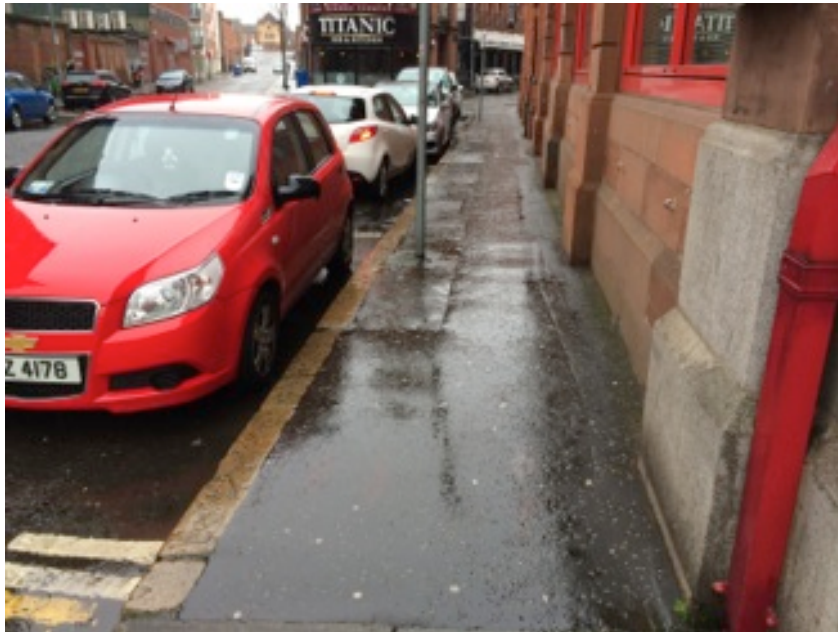
- 21 The footpaths in Library Street, Union Street and Little Donegall Street are narrow, with the area primarily used for pay and display on-street car parking.

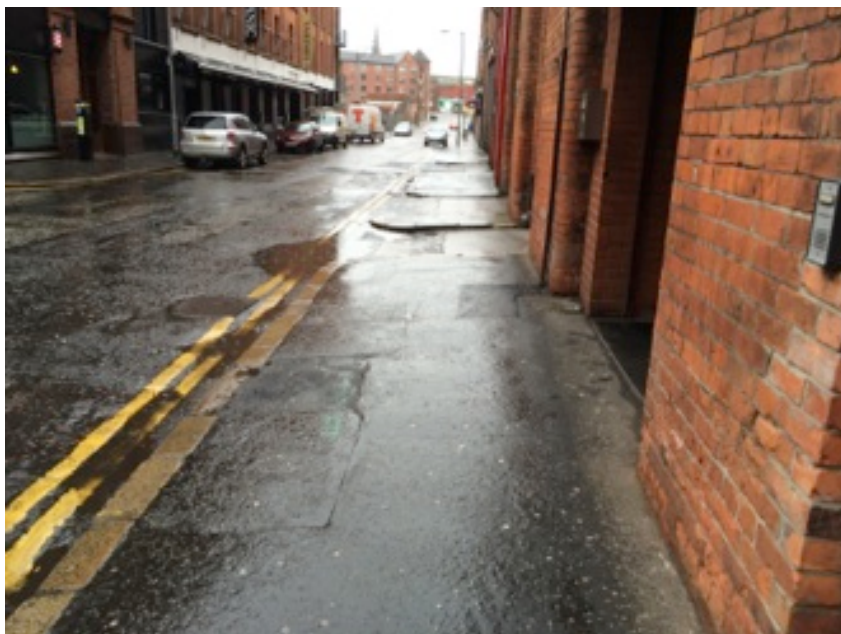
- 22 On both Library Street and Little Donegall Street servicing entrances take priority over pedestrians. The absence of dropped kerbs makes using the pavements difficult or impossible for some pedestrians.

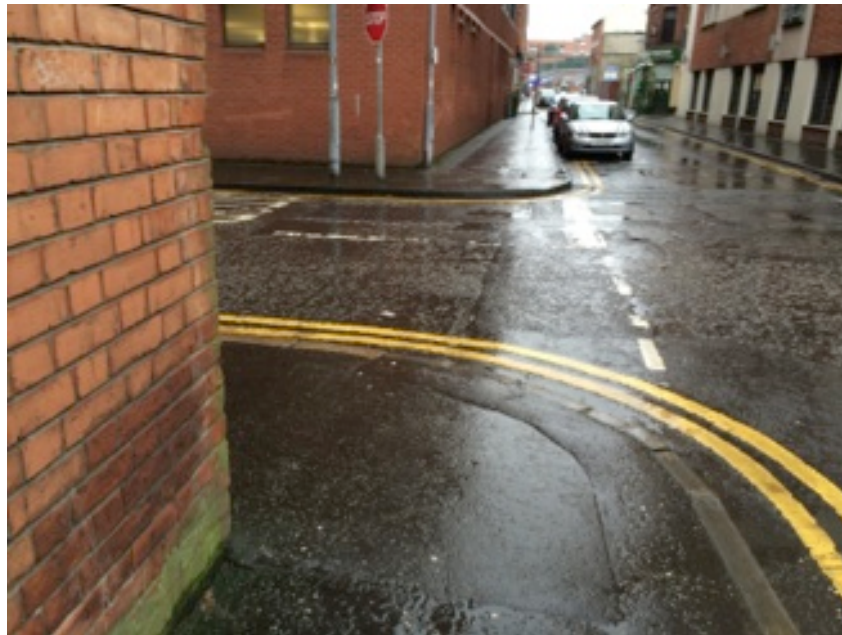
- 23 There are no appropriately designed crossing opportunities at the junctions between Union Street, Library Street and Little Donegall Street.

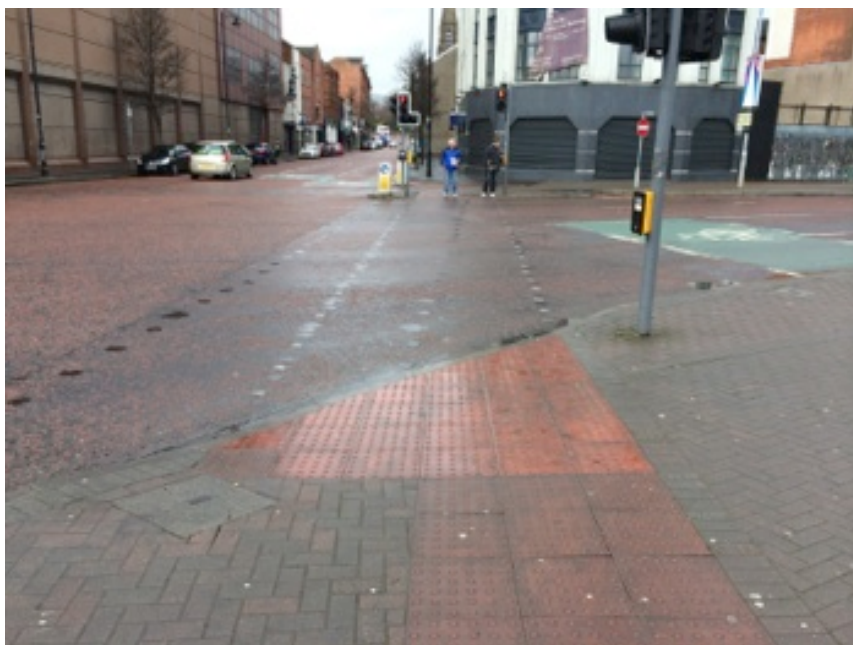
- 24 There is a reasonable controlled crossing across York Street at the junction with Donegal Street/Royal Avenue.

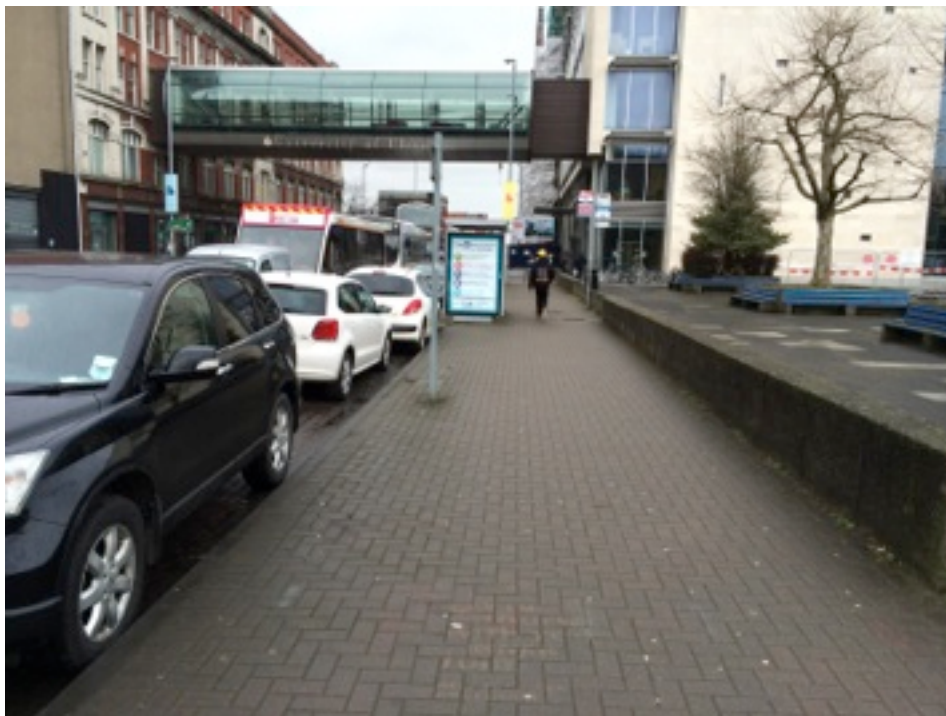
- 26 The pavement on the eastern side of York Street adjacent to Cathedral Gardens is of sufficient width and relatively clutter free.

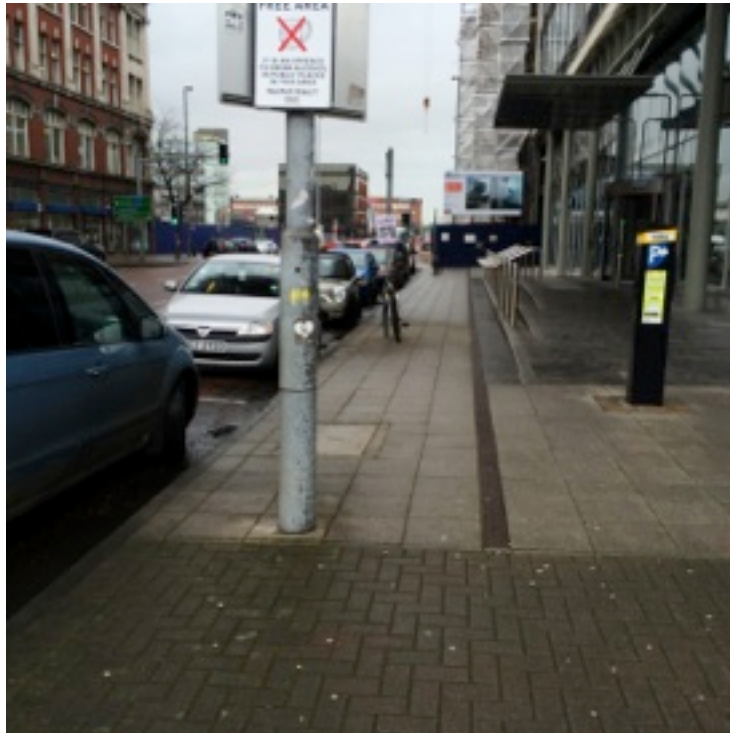
- 27 However the pavement narrows considerably at the University of Ulster Building. The steps into the building present a potential hazard to pedestrians due to poor contrasting and an absence of tactile hazard paving. The position of cycle parking also creates potential hazards.

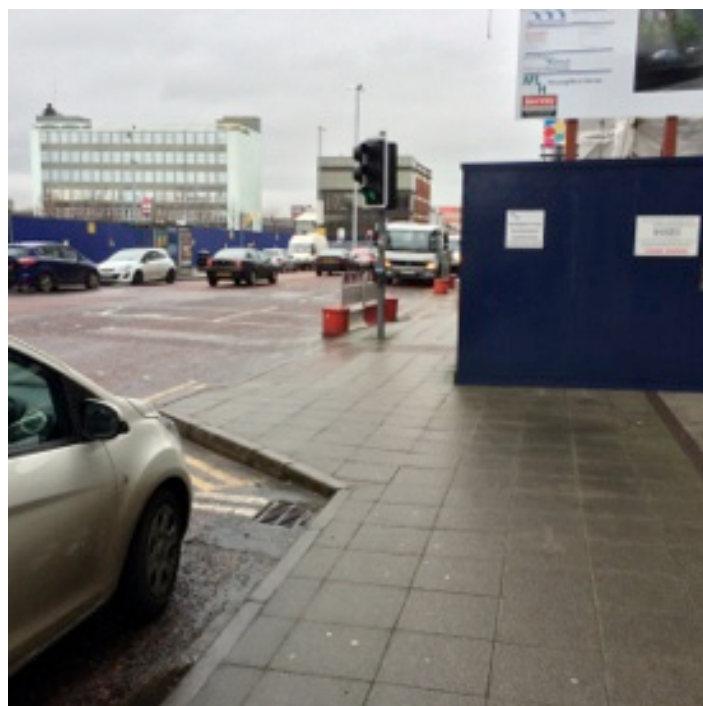
- 28 Continuing on the Eastern side of York Street construction works associated with the new university campus narrows the pavement considerably after this point. There is a controlled crossing at this point across York Street with no rotating cone.

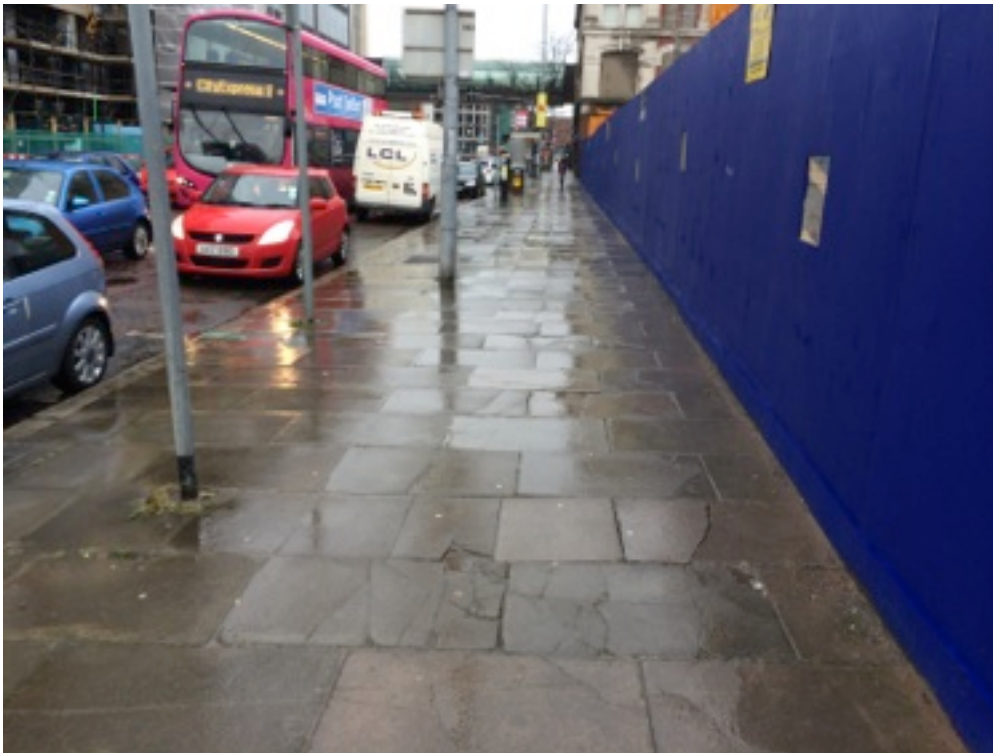
- 29 The pavement on the western side of York Street is broad but in poor condition in some locations.

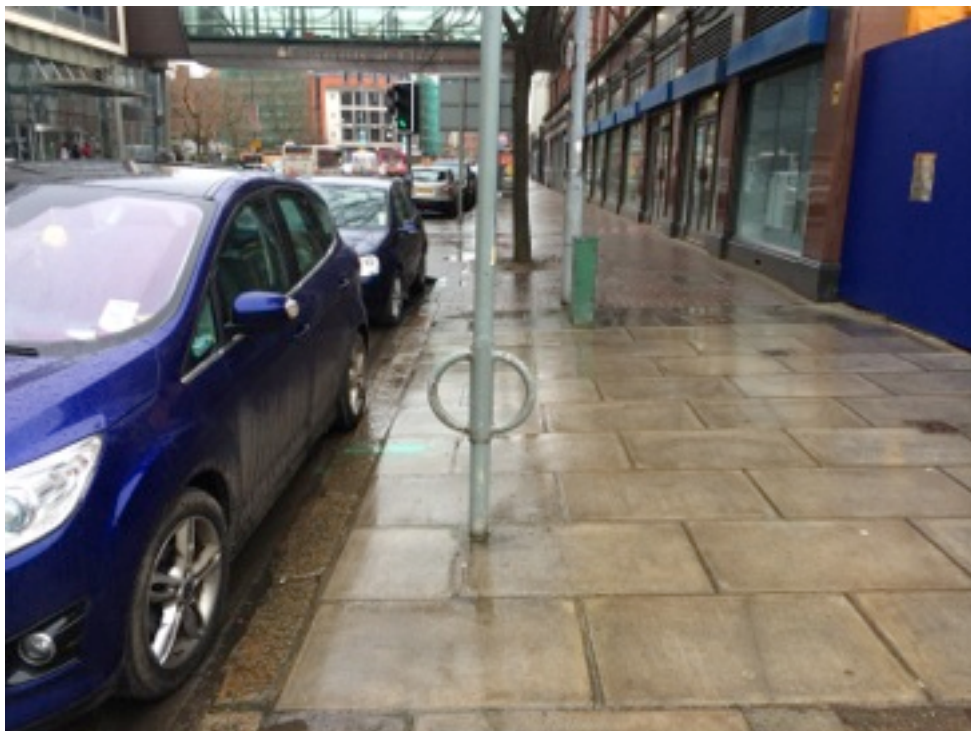
- 30 Bicycle parking infrastructure on York Street has been poorly installed, presenting a potential hazard. Colour contrasting would help reduce this hazard.

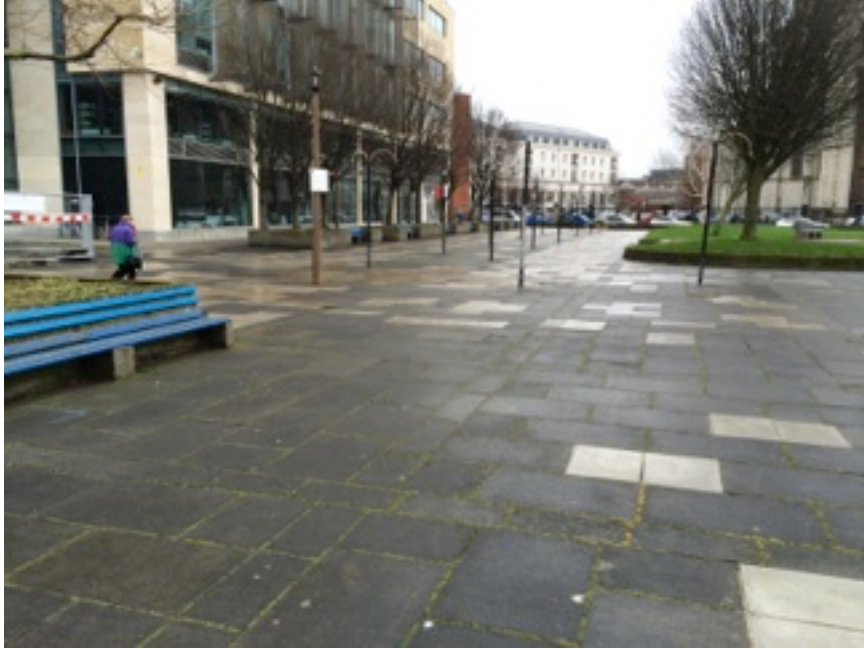
- 31 Cathedral Gardens is generally tired and dated. Poles and posts obstruct walking routes through the area.

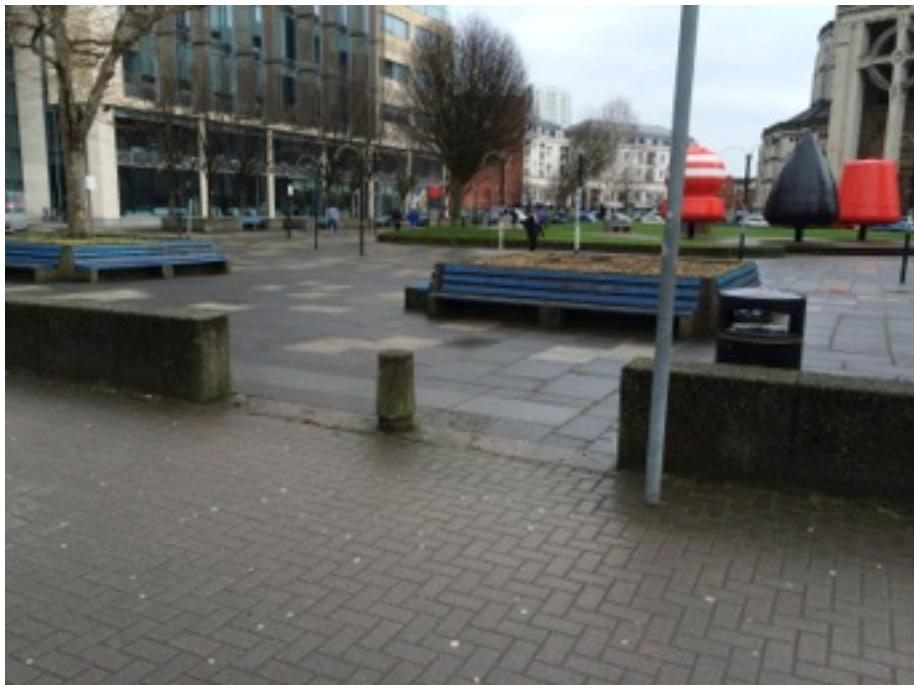
- 32 A low wall around the gardens and bollards at entrances do not provide a suitable contrast with the surrounding area, making access difficult for people with a visual impairment.

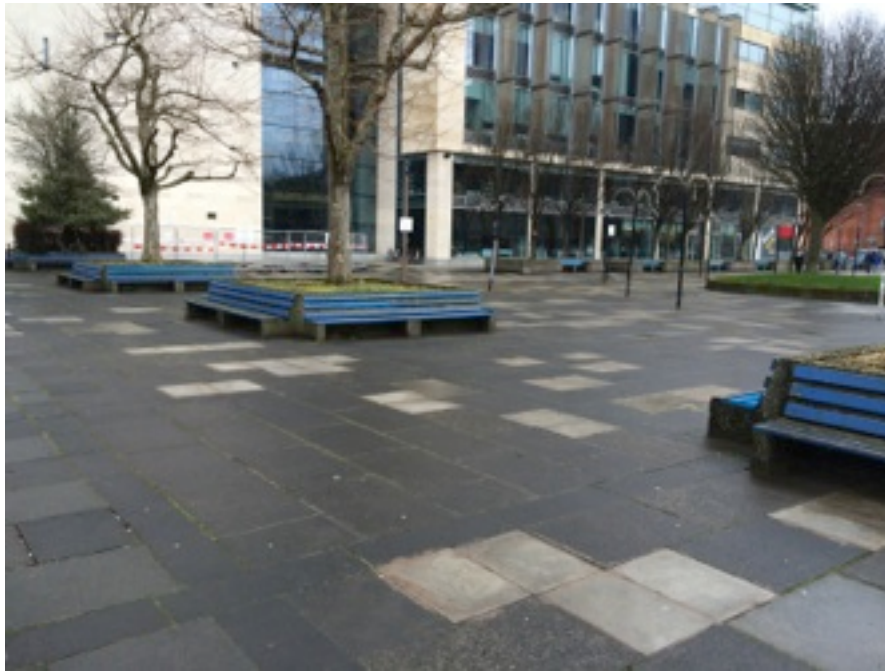
- 33 From a positive perspective seating is located to leave good access in and around the gardens.

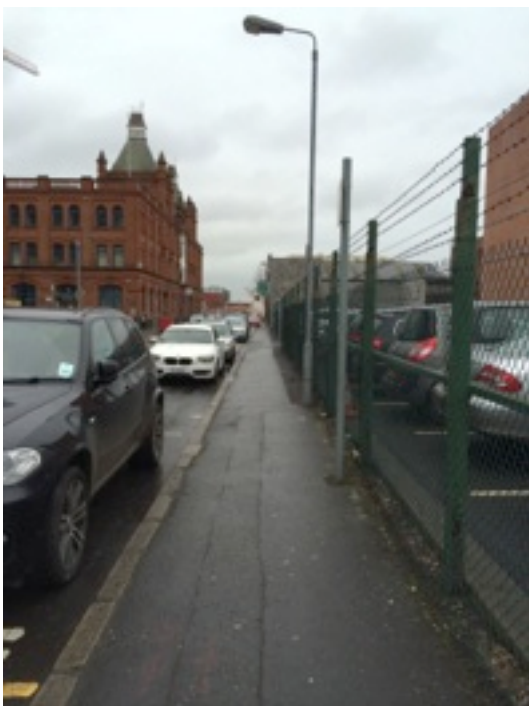
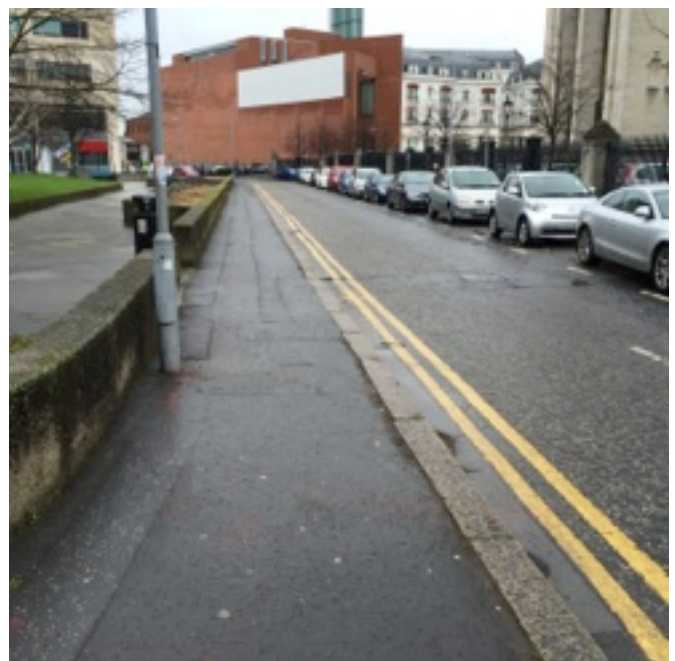
- 34 Academy Street has narrow pavements and is dominated by on-street parking.

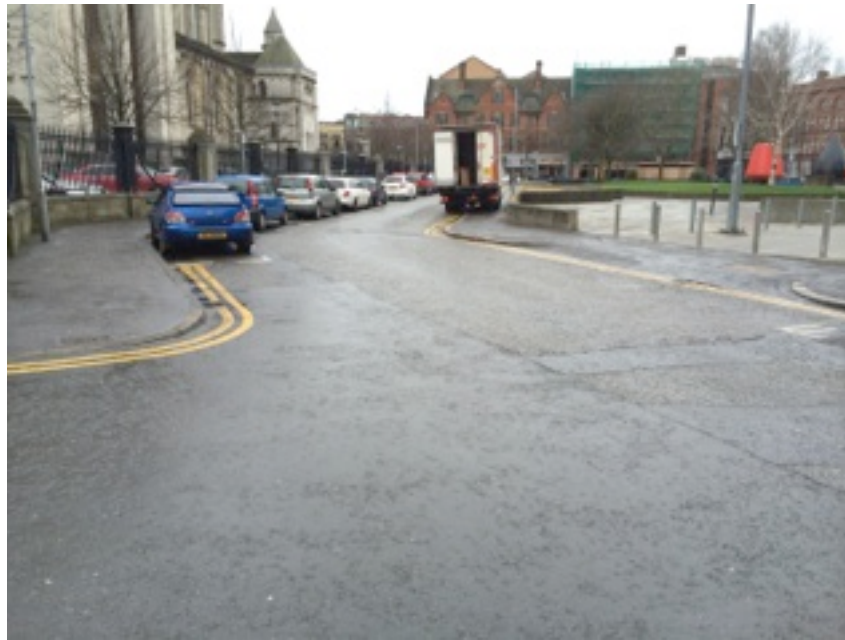
- 35 Crossing Academy Street presents real difficulties for some disabled people due to the absence of appropriately designed crossing opportunities.

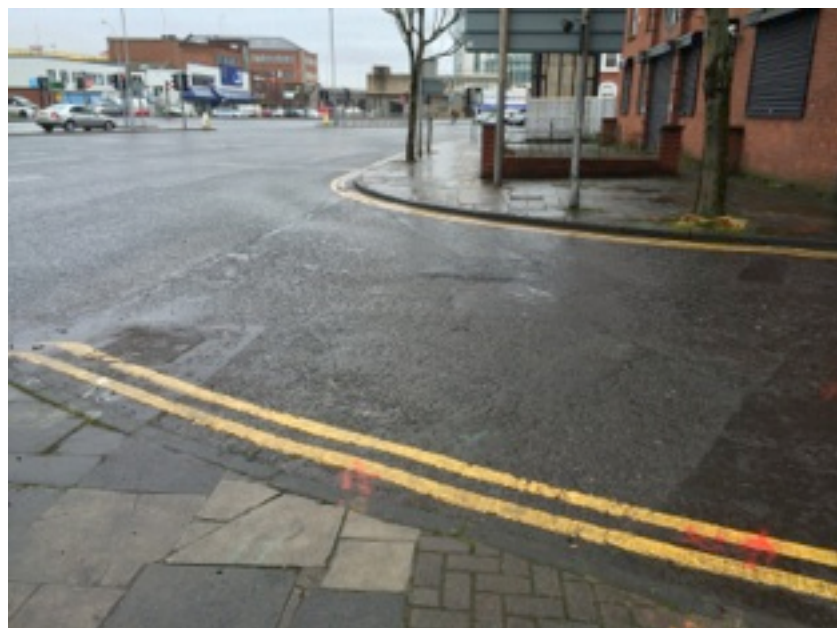
- 36 These problems increase at the northern end of Academy Street with no dropped kerb provision.
