Report on existing pedestrian environment in the streets that cover the proposed area for Belfast Streets Ahead Phase 3

July 2015

This report was compiled by Imtac to inform the design process around proposed public realm works in Belfast City Centre as part of Phase 3 of the DSD Streets Ahead project. The purpose of the report is to audit the existing public realm in the area and identify barriers for disabled people, older people and other pedestrians. The report broadly replicates the approach to similar reports undertaken by Imtac into pedestrian provision in a number of towns and cities across Northern Ireland. The report looks at provision in each street highlighting examples of good and poor practice as well as other issues. The report has been produced in two versions, one plain text, the other with photographs. Images have been used to illustrate issues identified. The report was compiled following a site visit to the streets covered by the project by Imtac members and other organisations on the 24th February 2015.

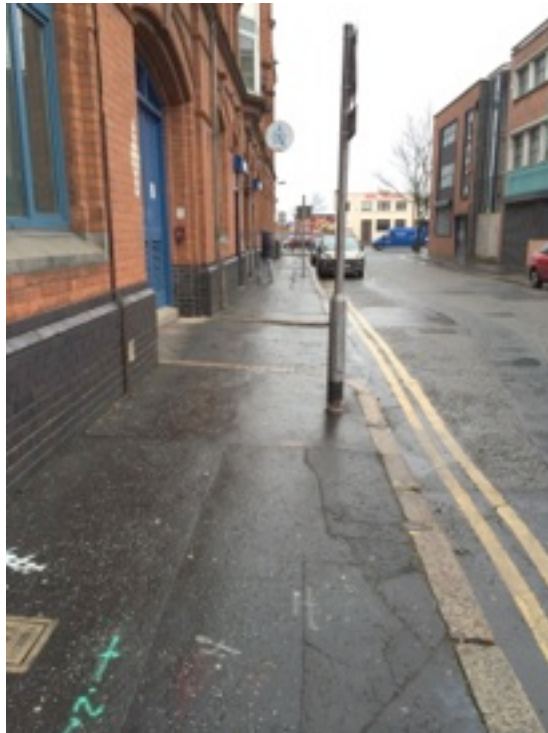
- 37 Vehicle entrances to buildings without dropped kerb provision in this area makes pedestrian access difficult or impossible.

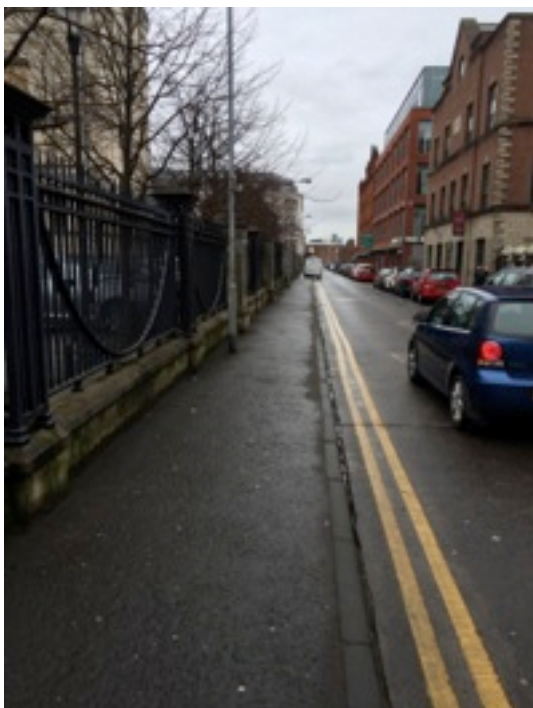
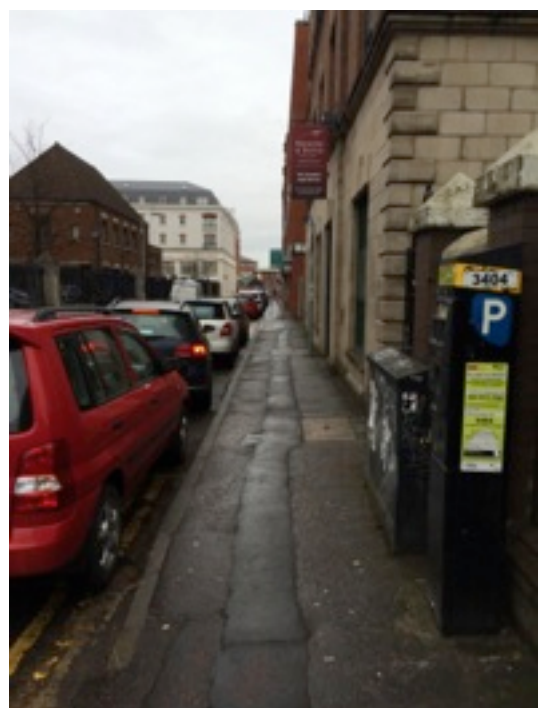
- 38 As with Academy Street pavements on Talbot Street are narrow.

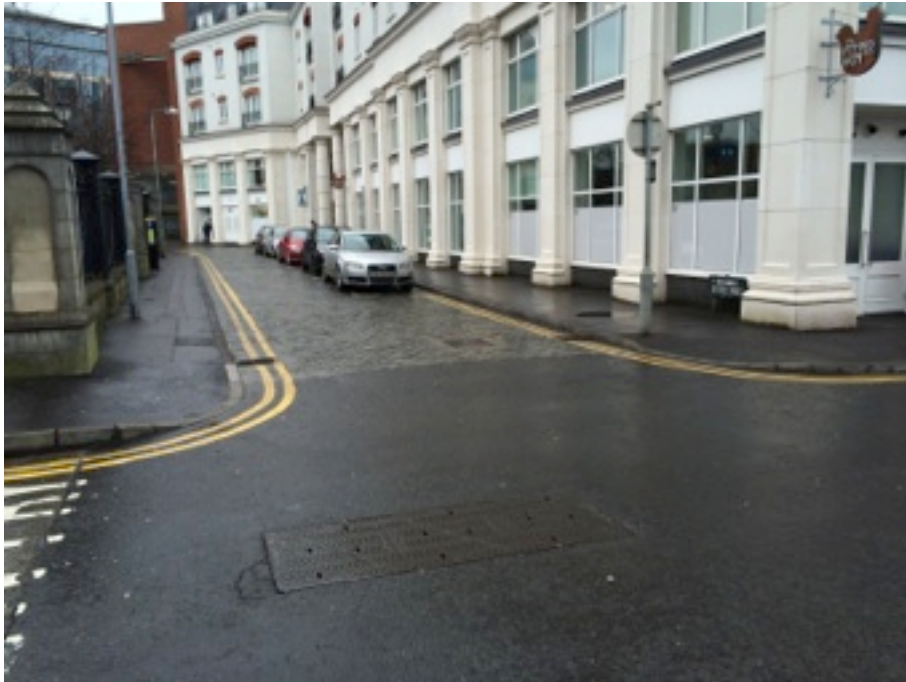
- 39 There are limited opportunities to cross Talbot Street. Provision for pedestrians at the junction with Hill Street and Exchange Street West is very poor. Much more needs to be done to enhance pedestrian accessibility and priority at this junction.

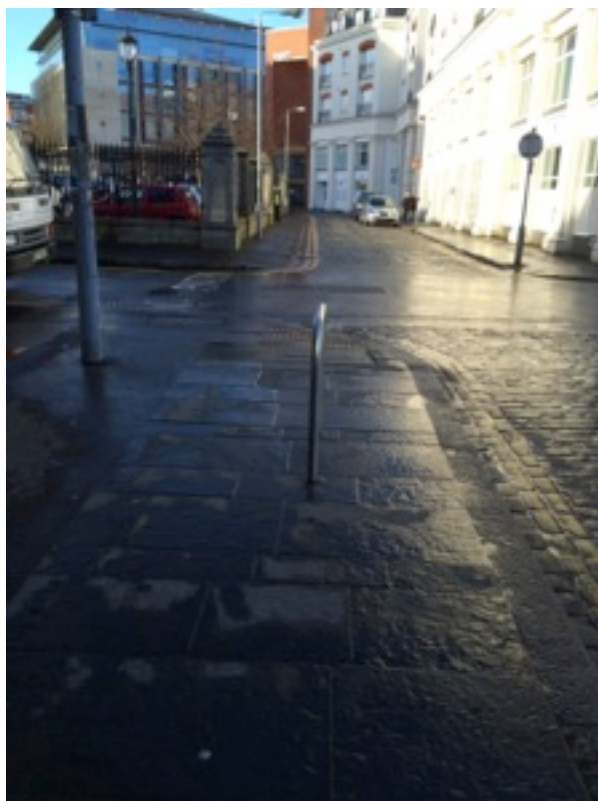
- 40 Also at this junction the positioning of a cycle stand on Hill Street obstructs the pavement and presents an obvious hazard to people with a visual impairment.

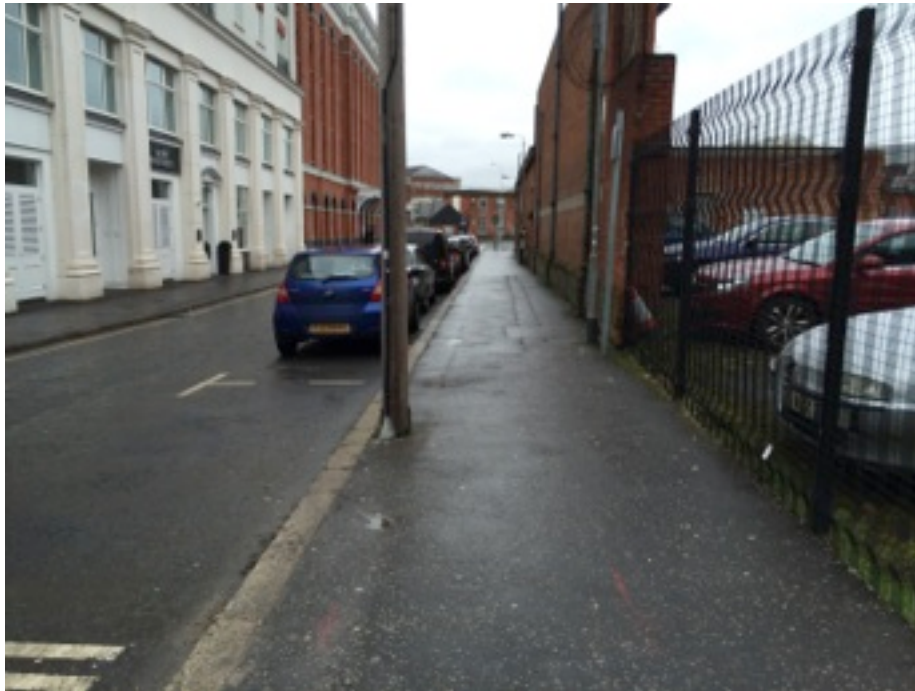
41 The pavements broaden towards the northern end of Talbot Street.

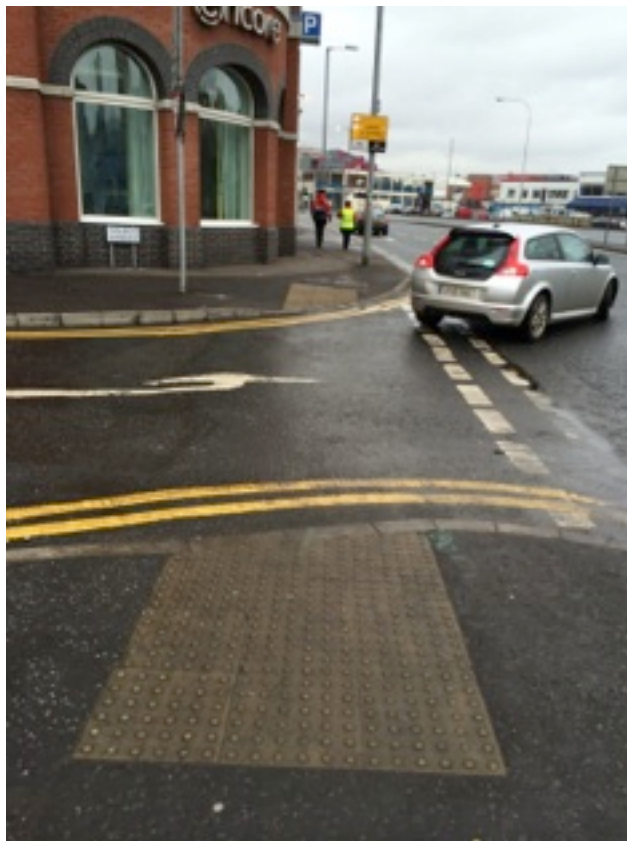
42 Appropriately designed inline uncontrolled crossings have been provide across Talbot Street at the junction with Dunbar Link.

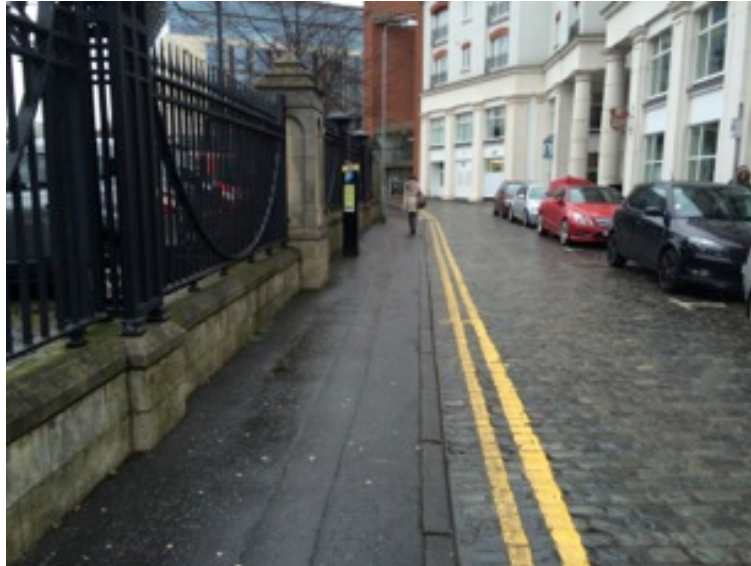
- 43 The pavements in the street are narrow with limited or no opportunities to cross the street. The uneven cobbled road surface enhances the perception of an area where pedestrian accessibility is not a priority.

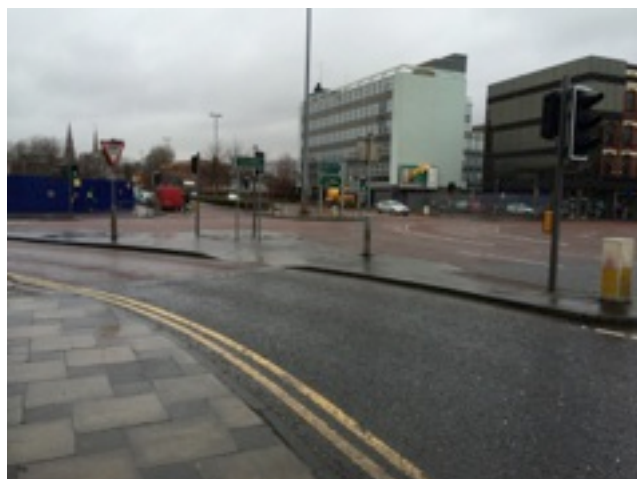
- 44 At the junction between York Street and Frederick Street there are a series of pedestrian crossings. Most of the crossings are controlled but there is an uncontrolled crossing which, in such a busy area presents a significant challenge to some pedestrians.

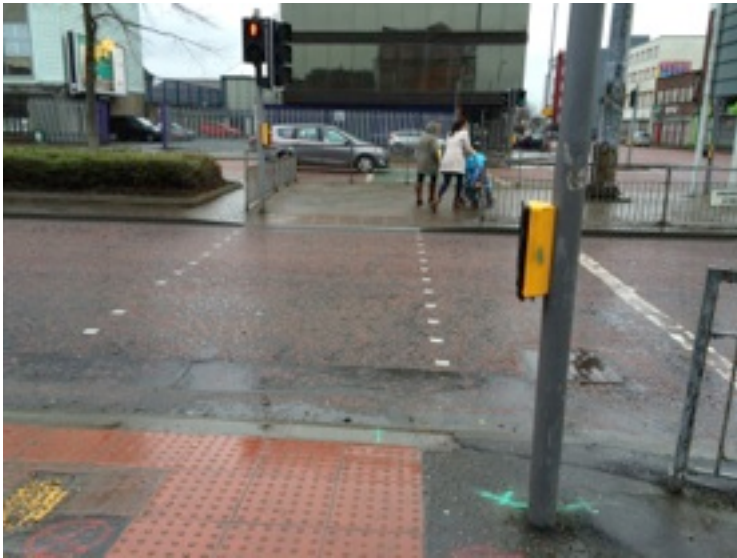
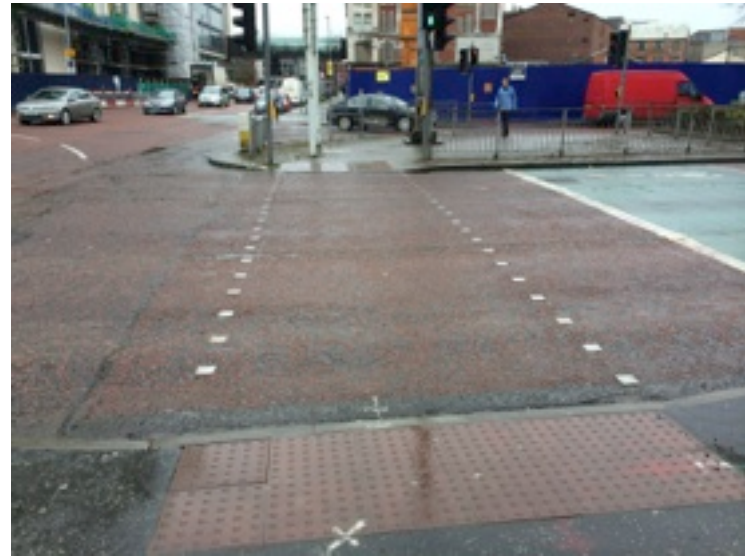
- 45 Due to the heavy 2-way traffic flow in the area access across Fredrick Street necessitates using two controlled crossings split by a traffic island. Whilst the design is generally reasonable the heavy traffic and the location of lighting columns make this a challenging area for pedestrians.

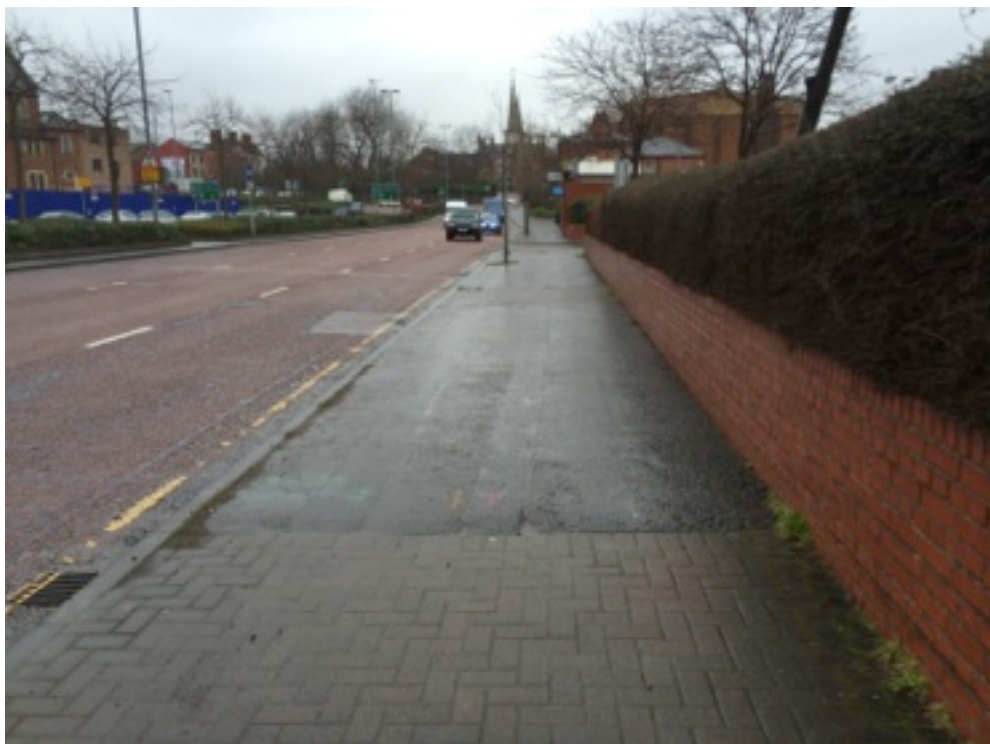
- 46 The pavement on the northern side of Frederick Street is broad but pedestrians are in close proximity to heavy traffic.

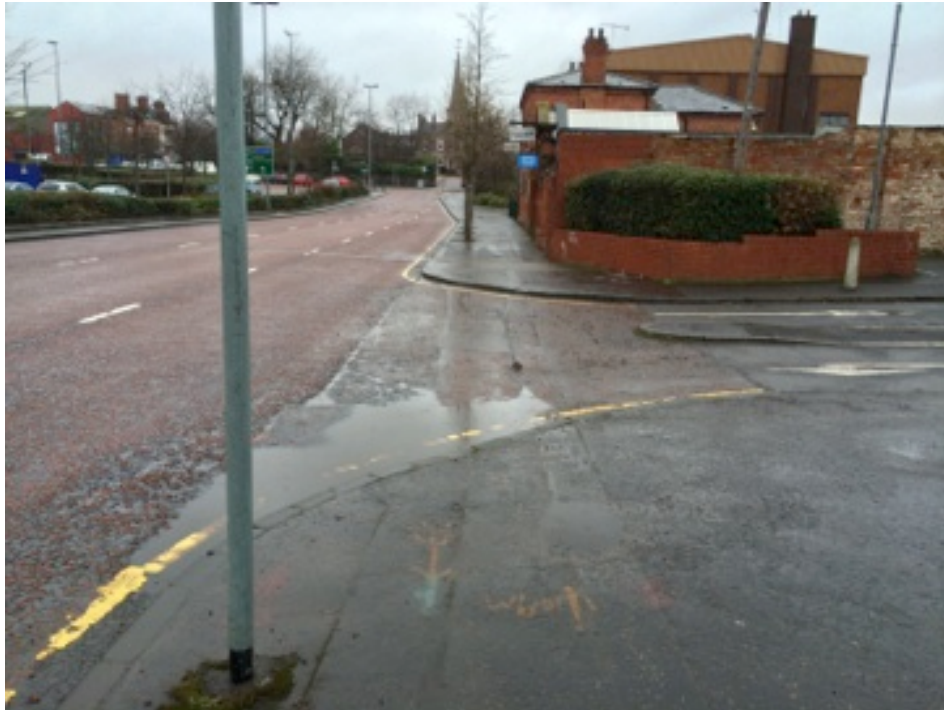
- 47 There are no dropped kerbs at the entrance to an off-street car park on the northern side of Frederick street.

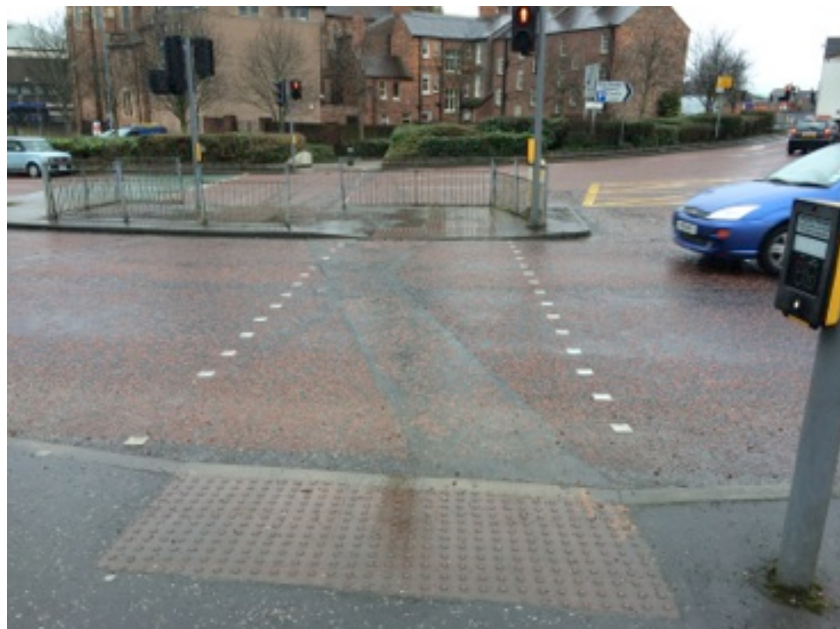
- 48 Access across Frederick Street at North Queen Street is via a split controlled and uncontrolled crossings. As with paragraphs 20 and 25 this will be challenging for people with a visual impairment. While the controlled crossings are generally satisfactory the tactile paving on the island has been incorrectly laid and the control boxes located in the wrong position.

- 50 There is a controlled crossing across North Queen Street at this junction which is reasonable. However as with paragraph 48 the inclusion of an uncontrolled crossing creates a challenge. The non provision of tactile paving is not satisfactory.

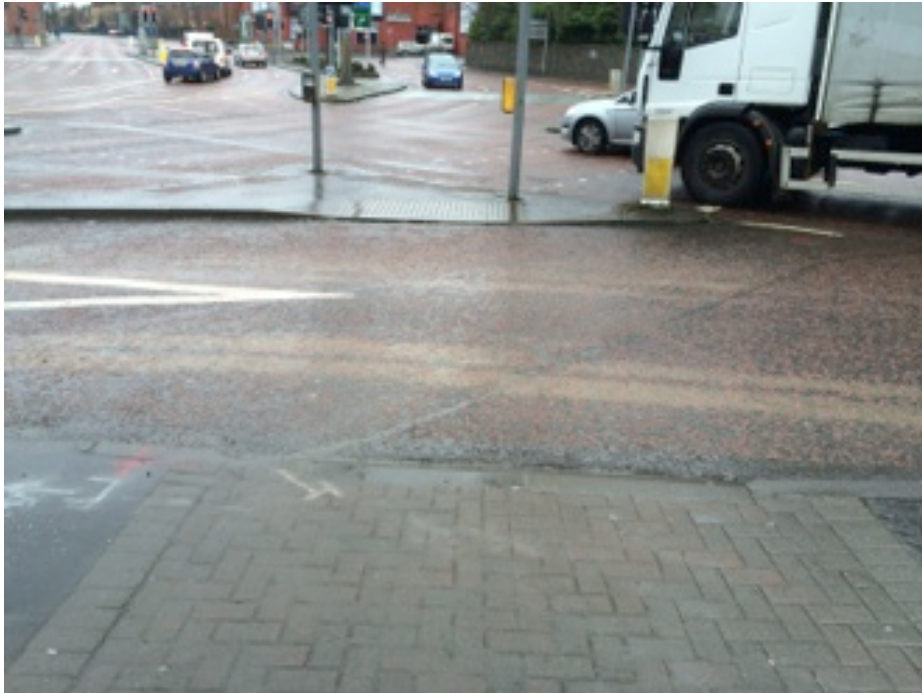
- 49 The uncontrolled crossing at Frederick Street at this location has no tactile paving on one side of the crossing.

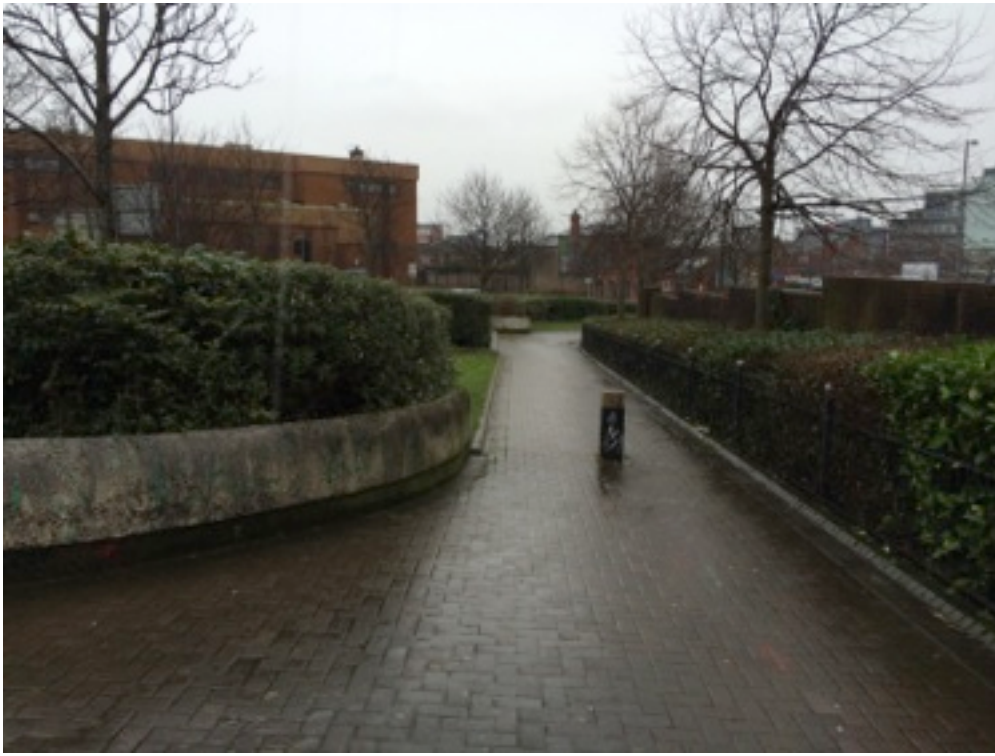
- 51 Access to southern side of Frederick Street is via a pavement separated from the traffic by a landscaped area. A bollard in the middle of the pavement creates an obstacle.

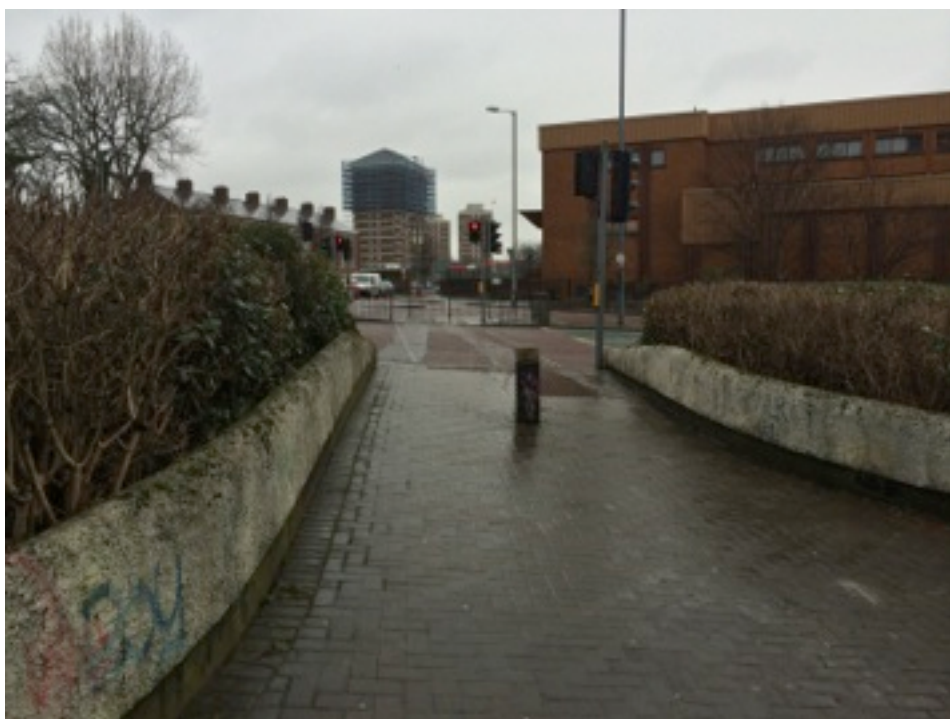
- 52 The pedestrian route splits with a pavement leading to the controlled crossing to North Queen Street. Again a bollard creates an obstruction close to the crossing.

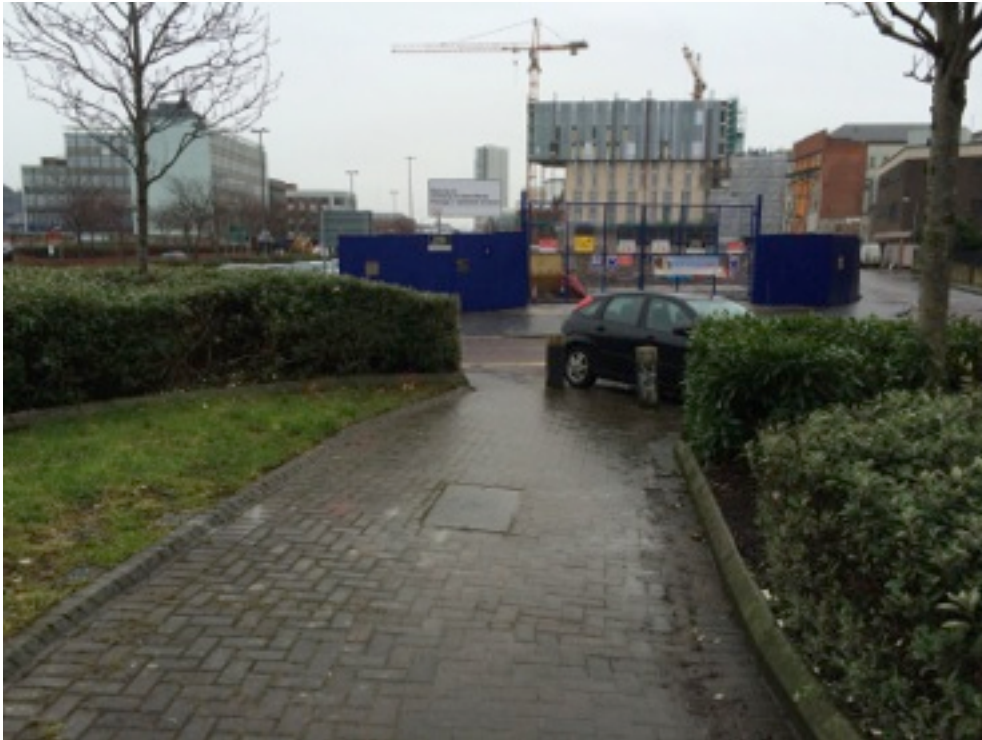
- 53 The remaining section of path continues down the south side of Frederick Street to York Lane at the start of the new University Campus. Here the crossing is blocked by two bollards and a parked car.

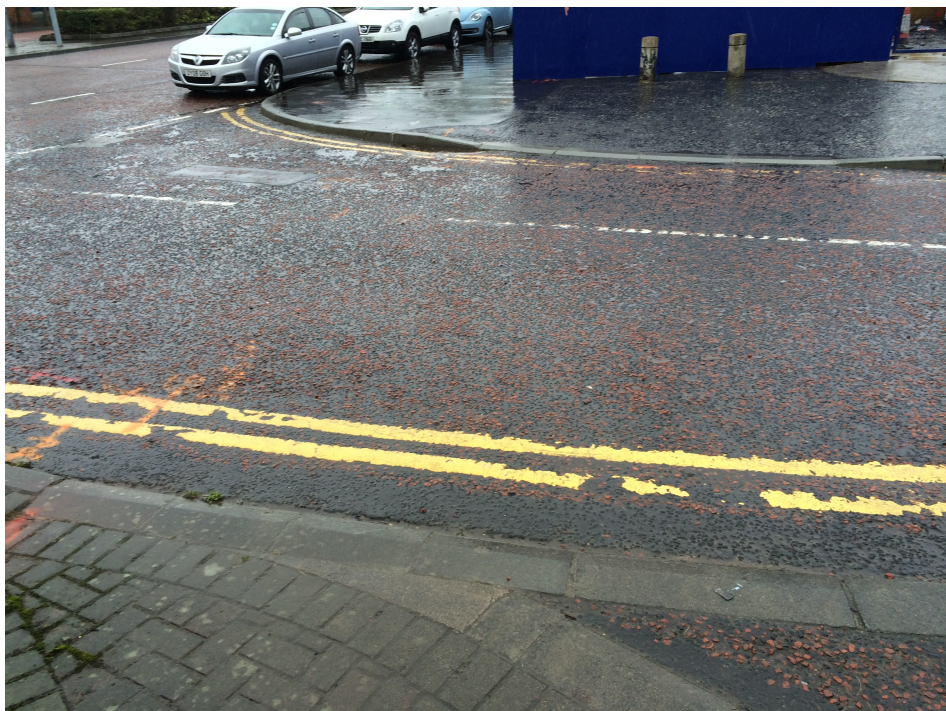
- 54 The kerb has been dropped at York Lane but no tactile paving provided.

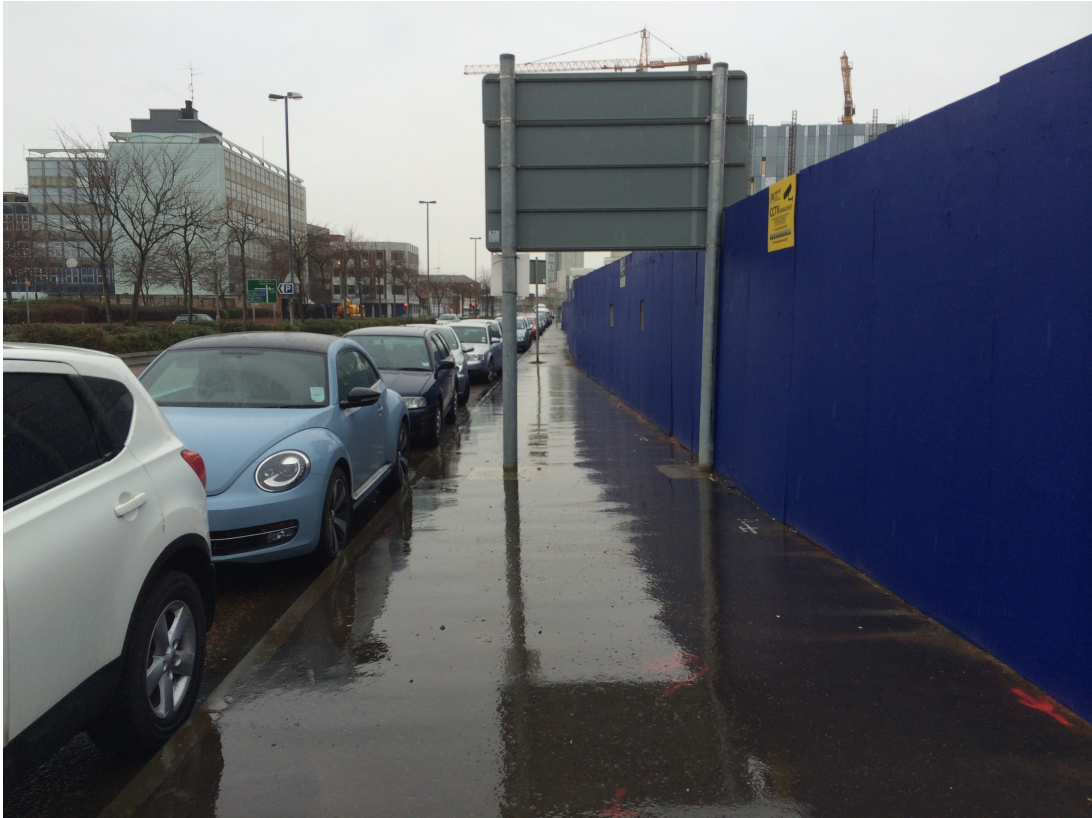
- 55 The pavement on the southern side of Frederick Street has been narrowed considerably as part of the building works associated with the new university campus. Poles associated with traffic signage create additional obstacles.
