Recommendations from Imtac on public realm proposals for the Clifton Gateway in Belfast

(November 2018)

About this report

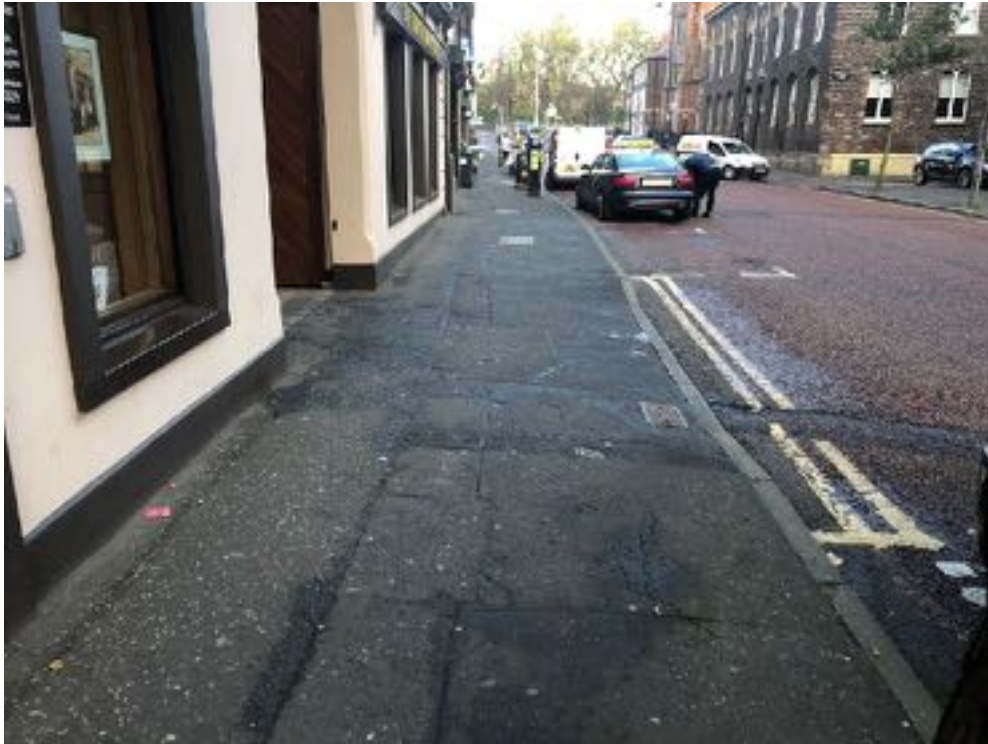
The western footway on Donegall Street continues along a section that is mainly clutter free, although there is a vehicle entrance to a funeral parlour.

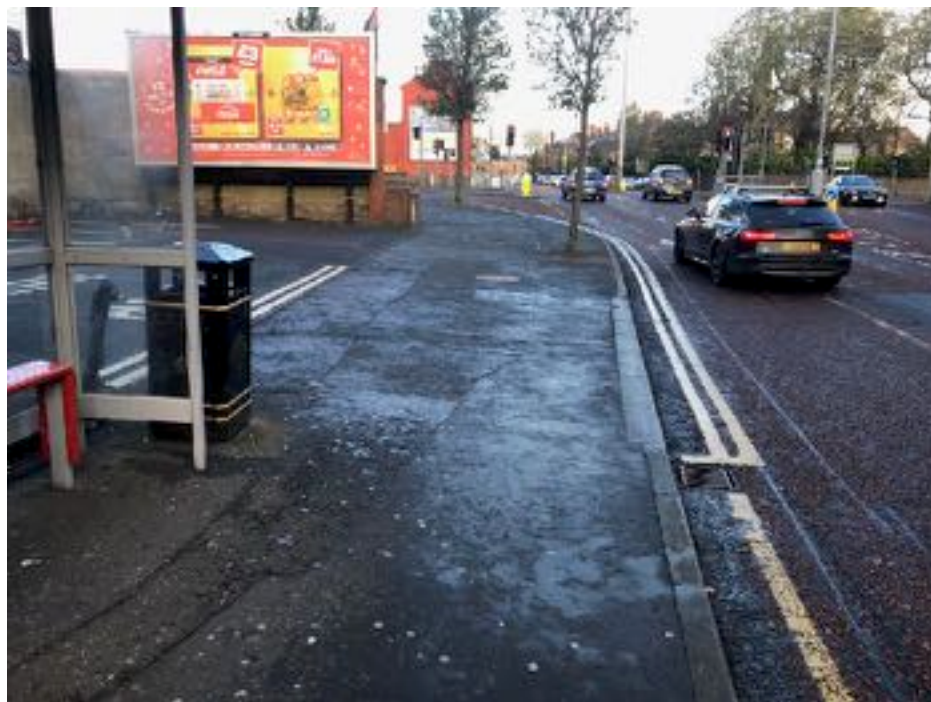
The footway broadens shortly after a bus stop, opposite St Patrick's Church. The footway surface here is rough and uneven.

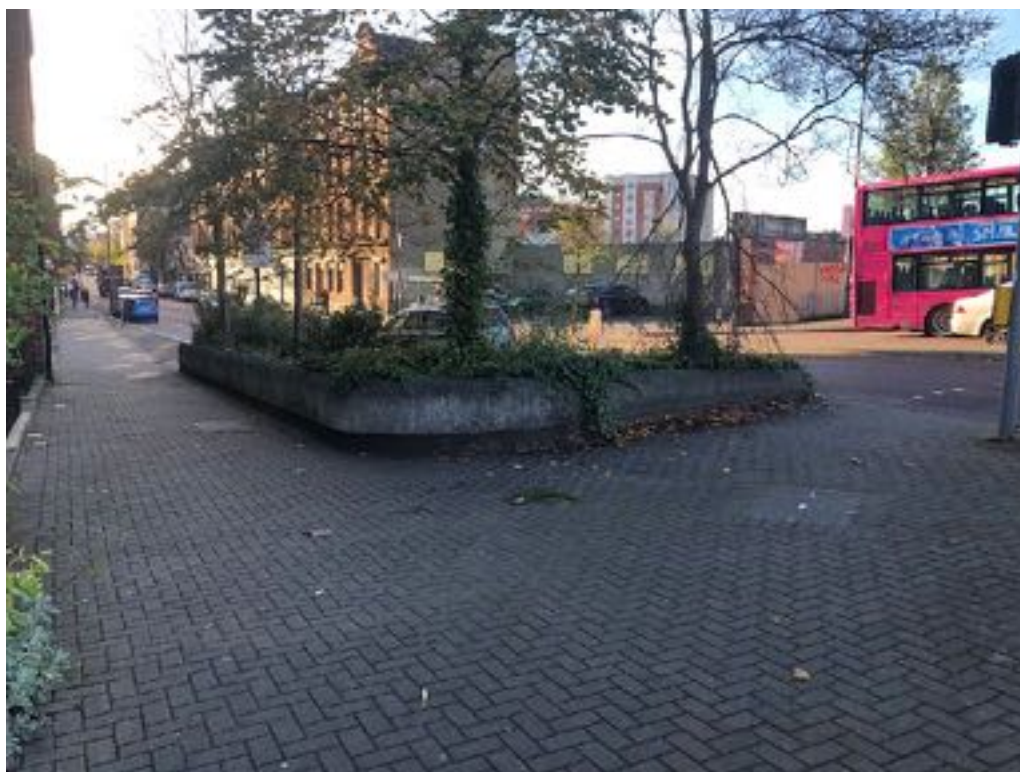
The eastern footway on Donegall Street is relatively wide and uncluttered at this point. Planting and a wall along the kerb line provides screening from what is a busy junction.

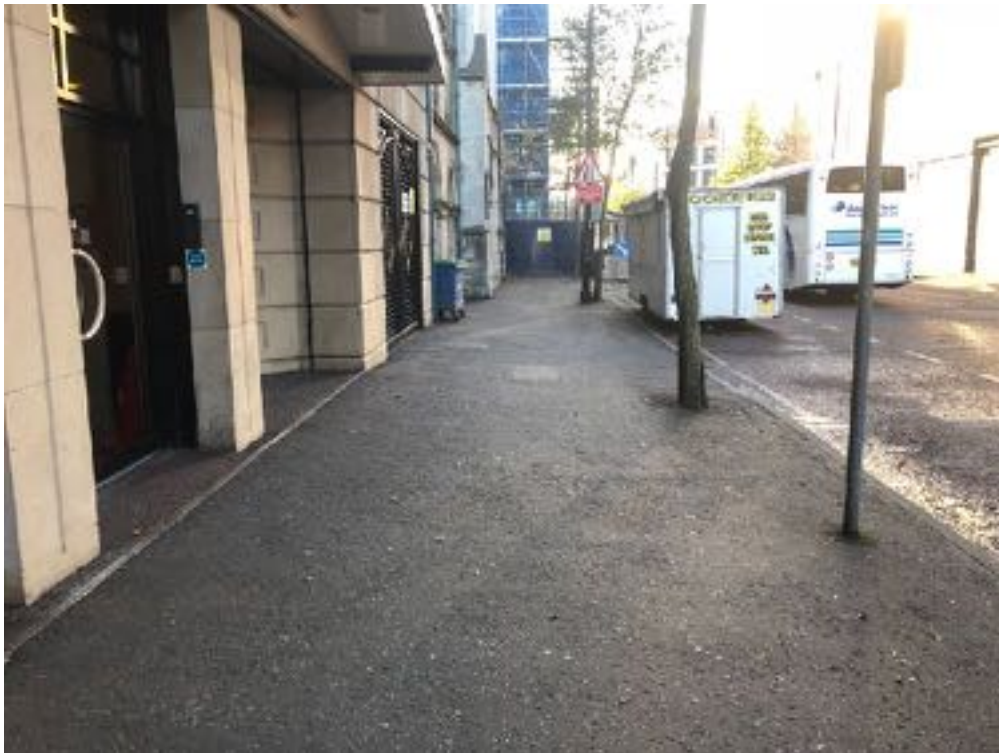
The footway after this turn is relatively clutter free with signage and trees located in a line close to the kerb.

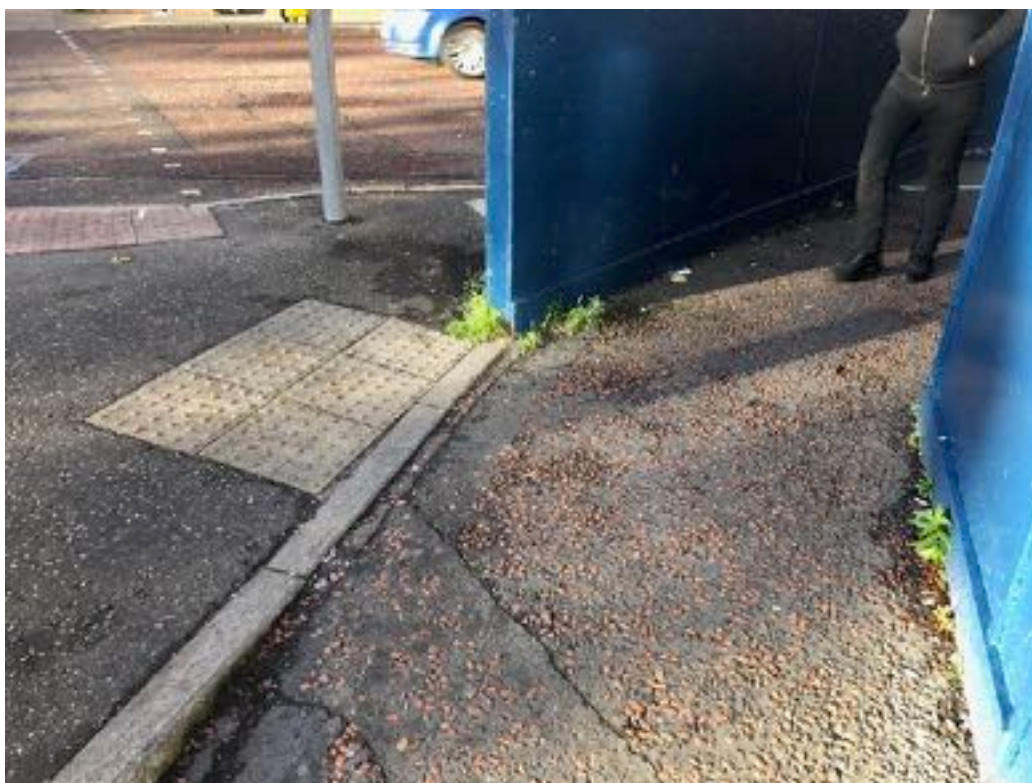
An existing dropped kerb provides access to the controlled crossing across the north section of Donegall Street at its junction with Royal Avenue. It should be noted that once works at the University is completed this will be an uncontrolled crossing for people travelling across Royal Avenue.

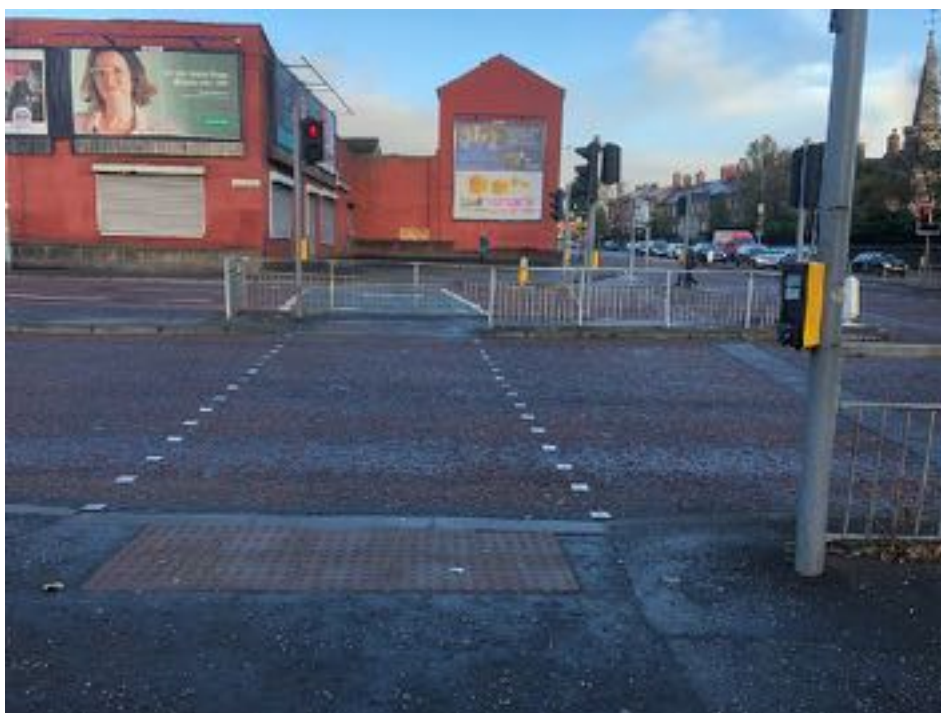
A staggered controlled crossing including a central traffic island is provided across Carrick Hill from the western footway of Donegall Street. The incorrect positioning of control boxes is problematic.

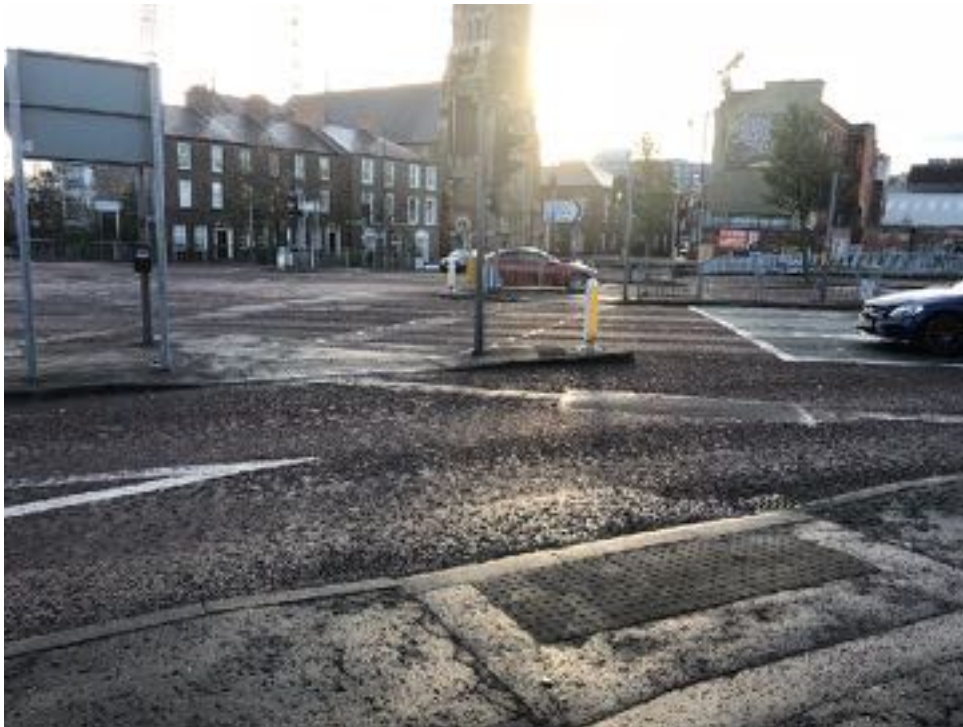
Completion of access on the western side of the northern footway of Carrick Hill is via another narrow traffic island and a uncontrolled crossing. This design incorporating controlled and uncontrolled crossing on one route is potentially confusing for a range of users.

- Uncontrolled crossings currently located at busy junctions such as on Carrick Hill/Donagall Street be replaced by controlled crossings.
- The small triangular traffic islands with a number of potential crossing opportunities are extremely confusing and therefore hazardous to some disabled people. The use of this type of infrastructure should be designed out of any new scheme.

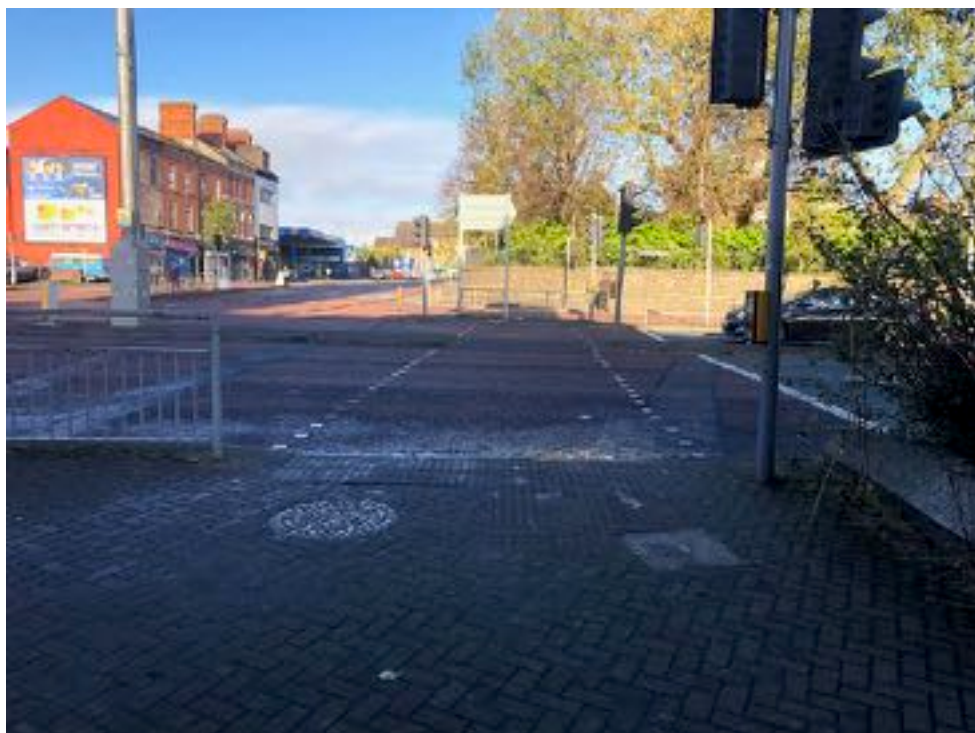
There is a staggered controlled crossing across Carrick Hill from eastern footway of Donegall Street. The crossing includes both a traffic island and refuge mid way between the footway and the island. The tactile paving and surrounding pavement do not contrast on the southern side of the crossing.

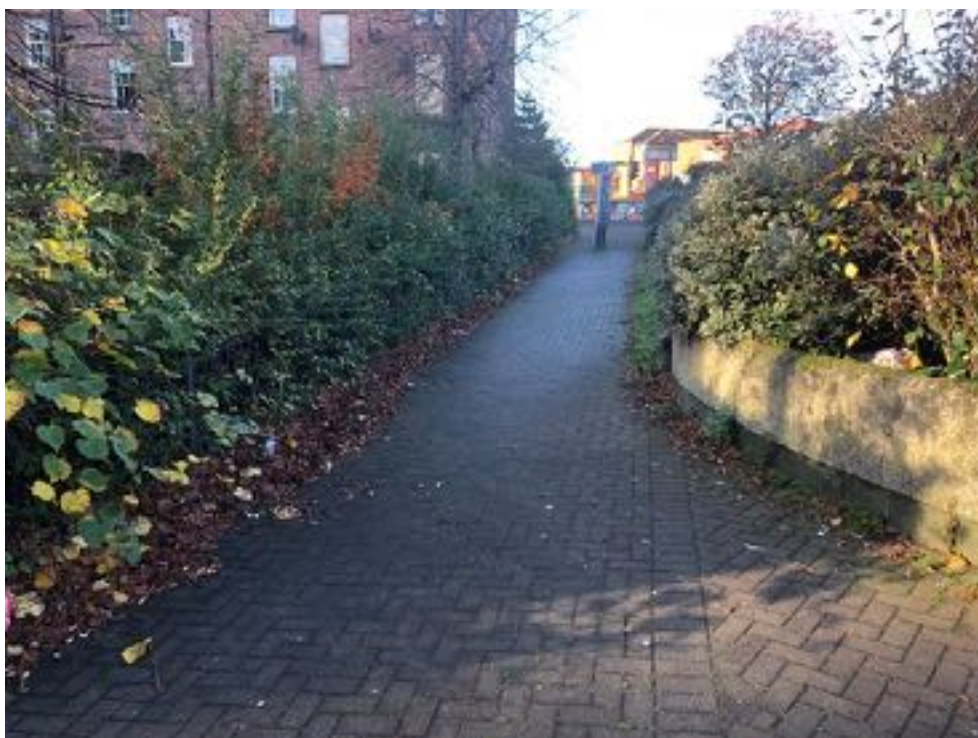
There is a footway along the southern side of Carrick Hill approaching its junction with Frederick Street. The area includes some green space which provides some protection from traffic but it is currently overgrown and uninviting.

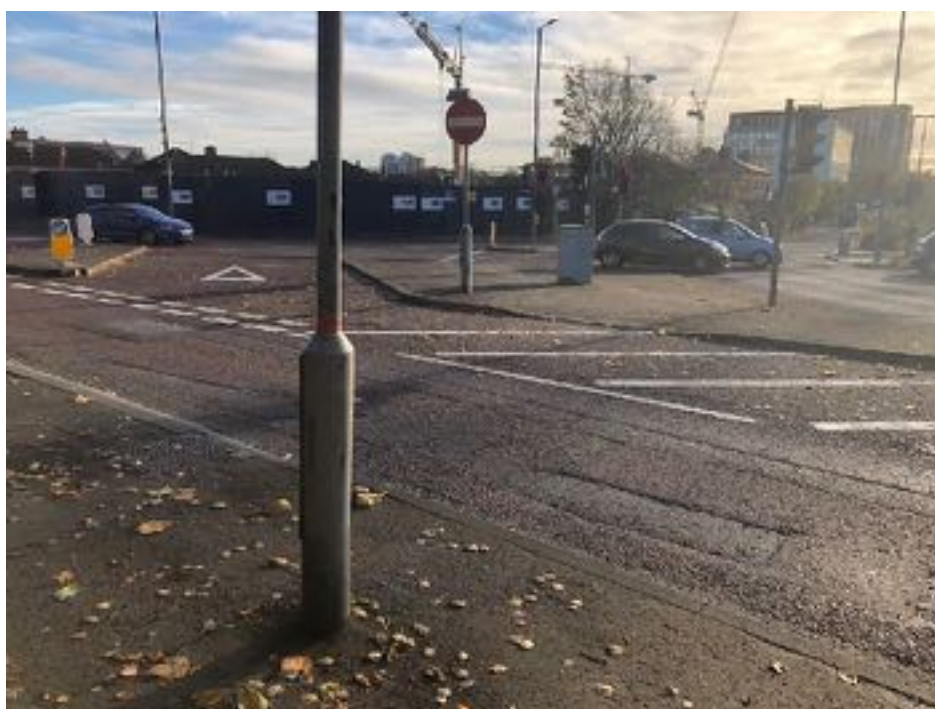
Access to the northern footway of Carrick Hill at this point is via a series of narrow, poorly designed traffic islands across its junction with North Queen Street. Although dropped kerbs have been provided, the absence of tactile paving means there is no safe or accessible way for people with a visual impairment to cross the westbound North Queen Street carriageway.

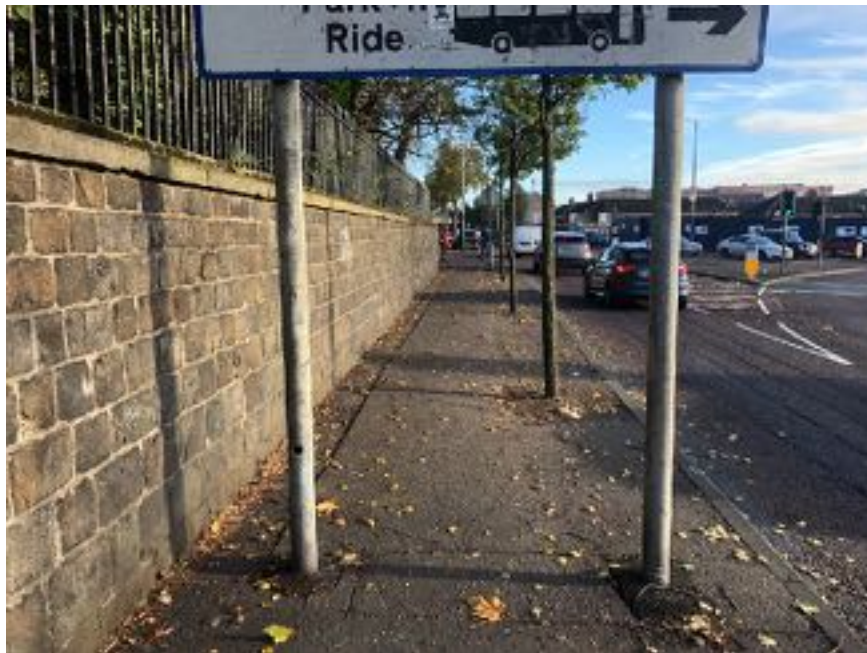
The footway along the northern section of Carrick Hill close to Clifton House is narrowed below acceptable standard by the positioning of trees and signage.

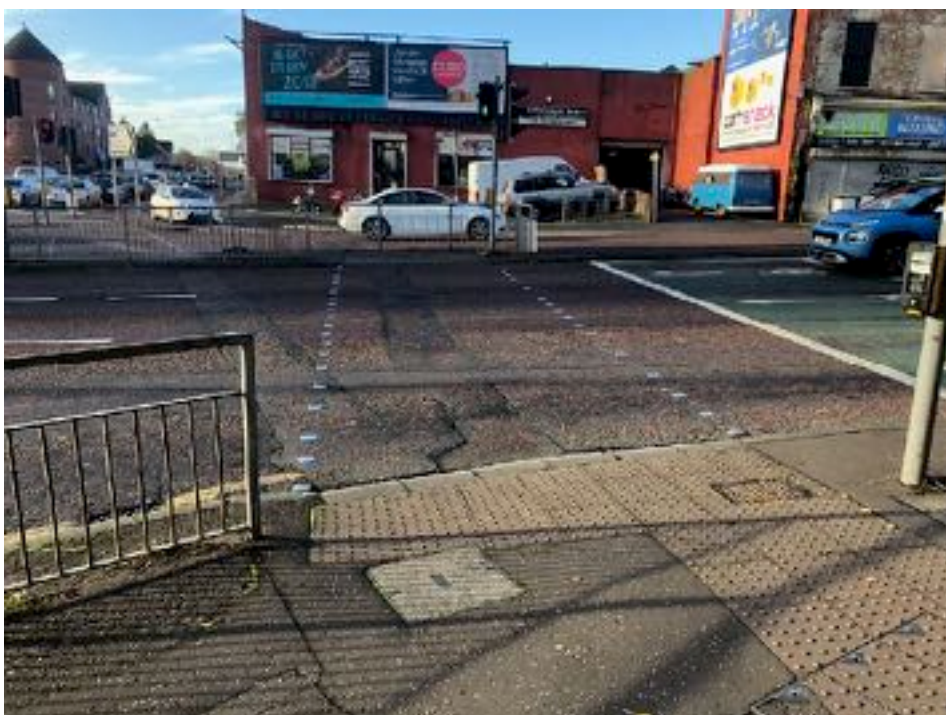
There is a staggered controlled crossing across Clifton Street at its junction with Carrick Hill. The incorrect positioning of control boxes on the traffic island is likely to create difficulties for people with visual impairment.

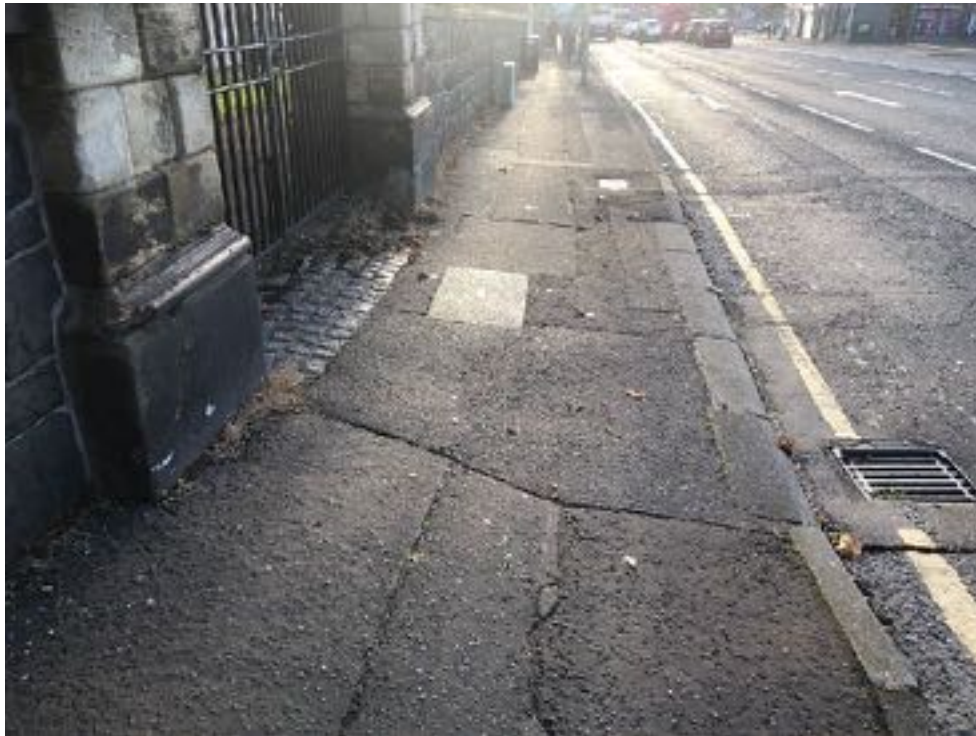
The footway surface on the eastern side of Clifton Street is rough and uneven and is narrowed below acceptable standards at points by the positioning of trees and street signs.

The proposed public realm scheme should address current issues with the condition of footways. New, level surfaces will immediately make the area more attractive and accessible. It is important that accessibility is particularly addressed around the many redundant and existing vehicle entrances on the routes. Materials used, including drainage solutions, must ensure a level surface is provided along the entire length of the footway.

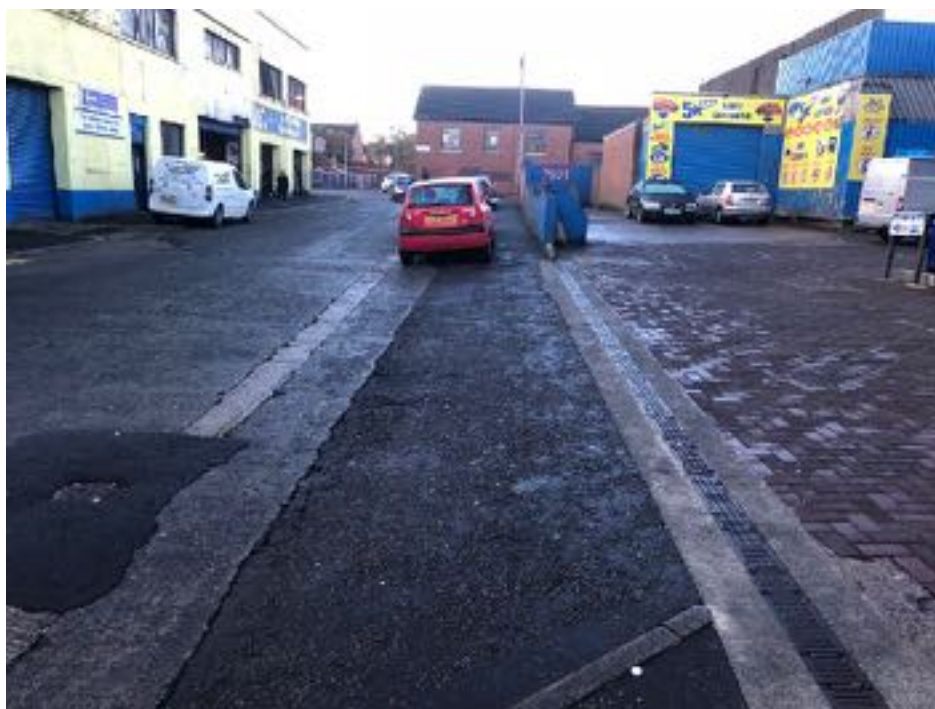
There is no footway on large parts of the northern section of Trinity Street because of the entrance to the garage with no tactile warning provided for pedestrians with a visual impairment. The section footway that is provided is obstructed by parked vehicles.

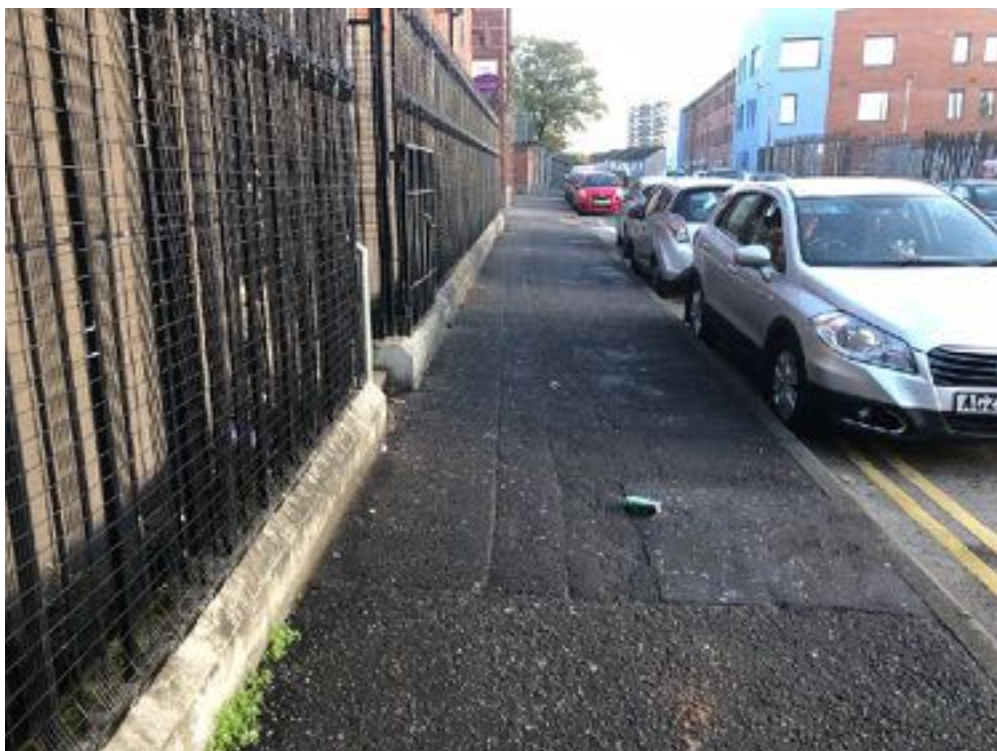
The northern section of footway along Henry Place is generally clutter free. The surface is rough and uneven.

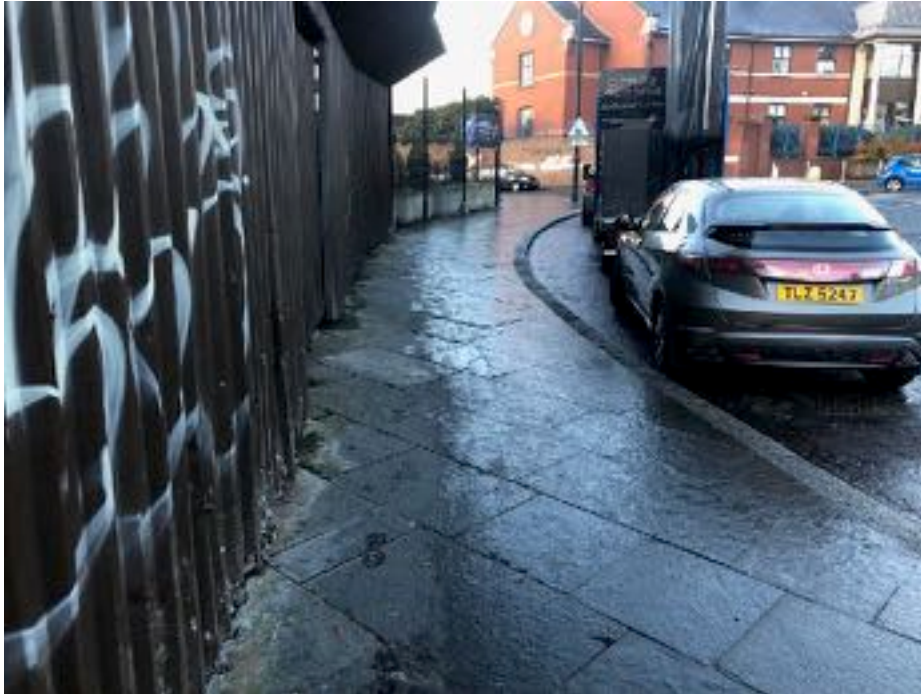
The quality of the footway surface improves in the area around Carlisle Circus. However the corrugated metal hoardings on the southern side narrows the footway and make the area uninviting.

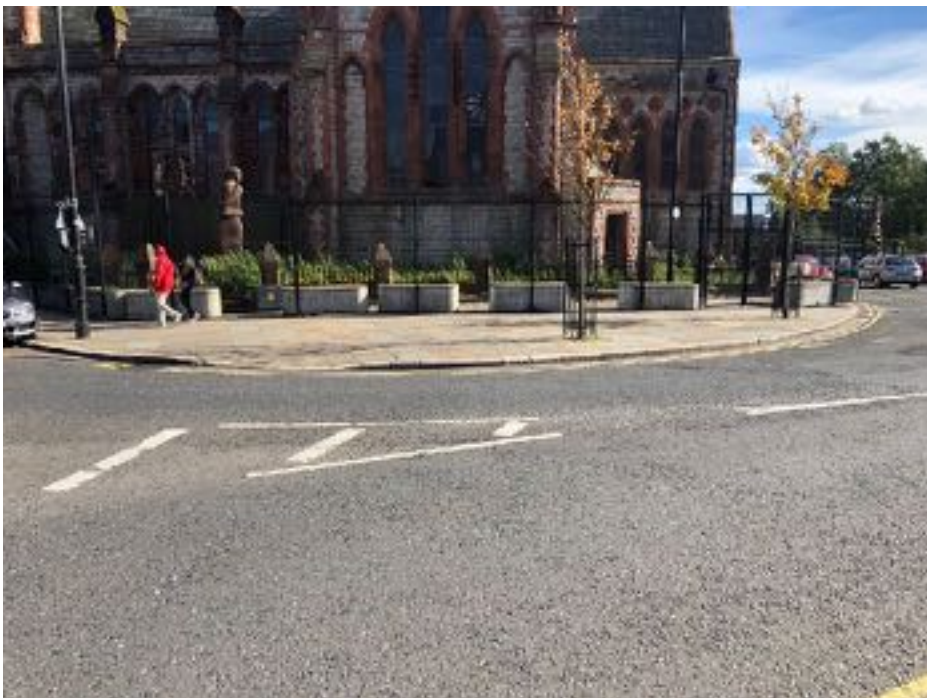
There is a wide section of footway on the southern side of the Denmark Street junction, partially screened off by security fencing. A parked car is partially obstructing the footway close to the uncontrolled crossing.

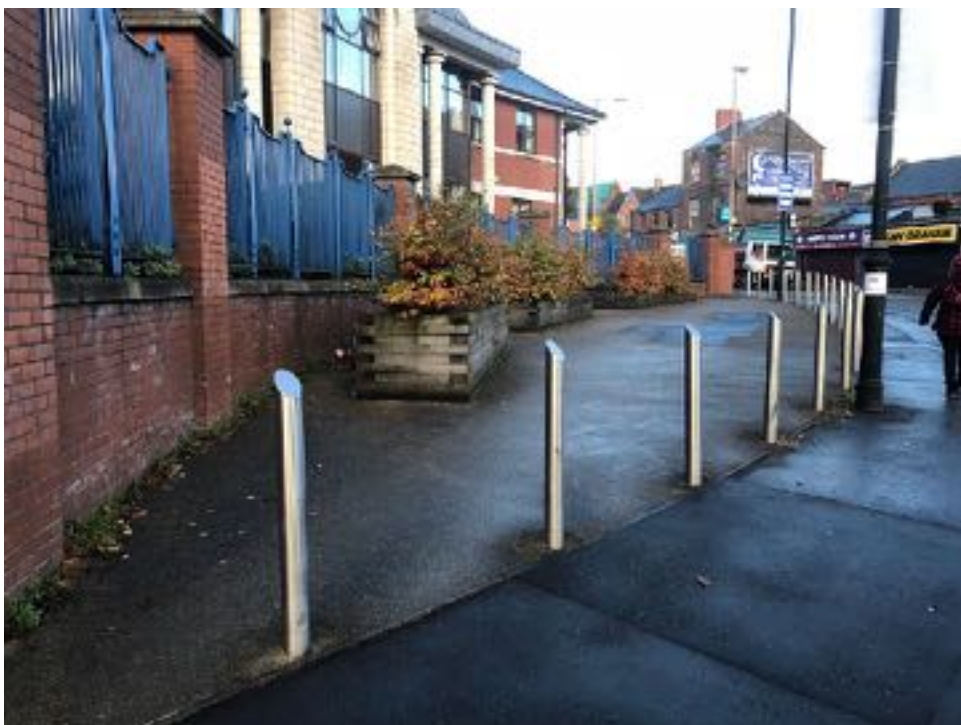
The footway on the western section between Denmark Street and Crumlin Road is broad and uncluttered. There is an under-utilised public space here containing planters and protected by a series of stainless steel bollards.

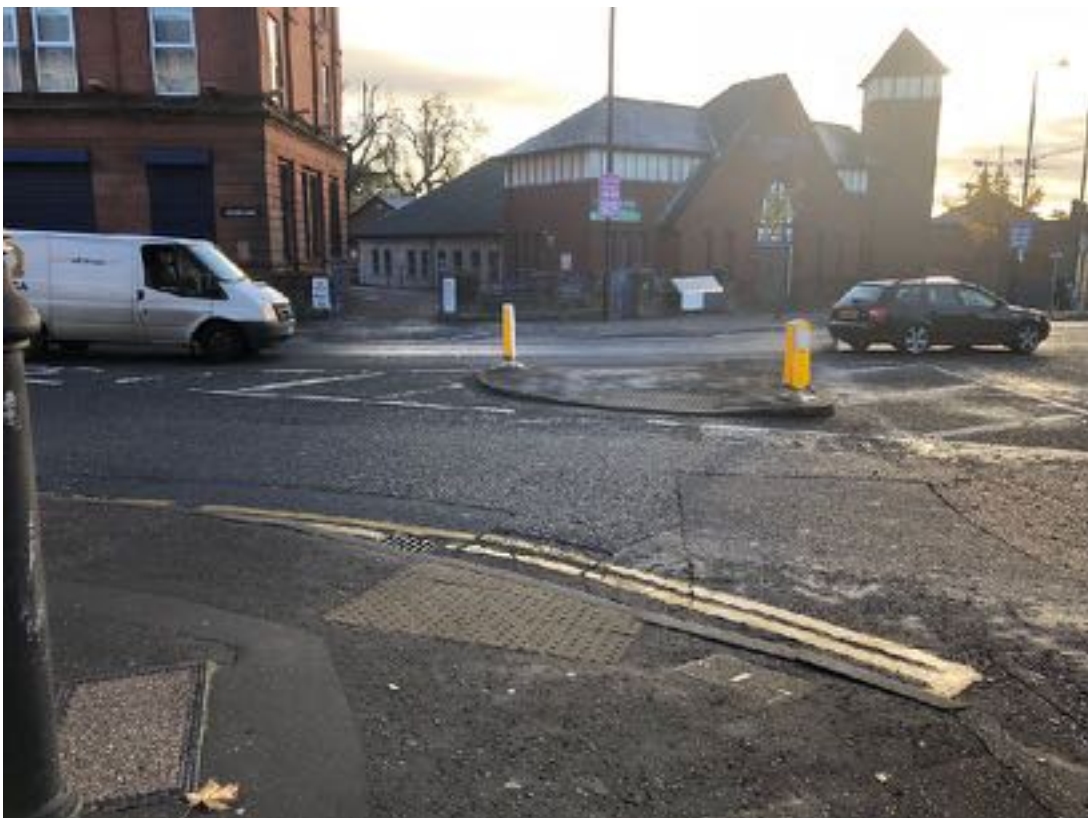
There is an uncontrolled crossing across the junction with Antrim Road which includes a central traffic island with appropriate tactile paving.

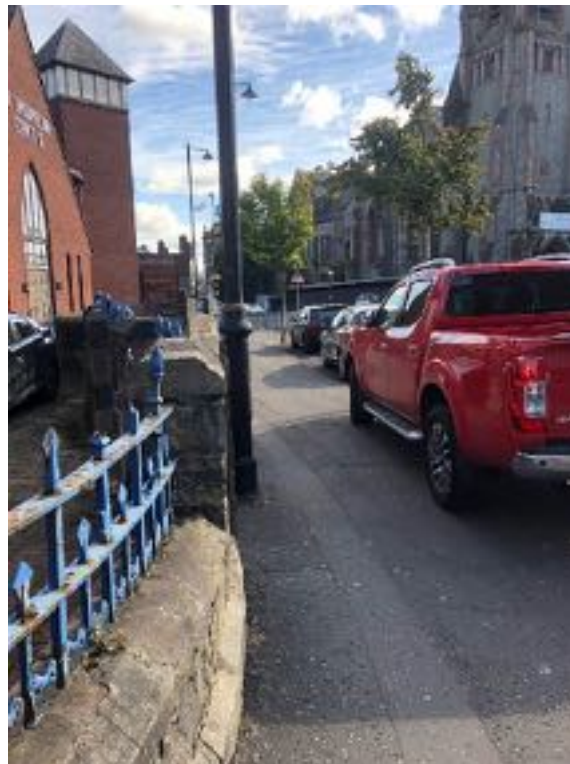
The footway on the eastern section of Carlisle Circus close to the Antrim Road is partially obstructed by a parked vehicle.

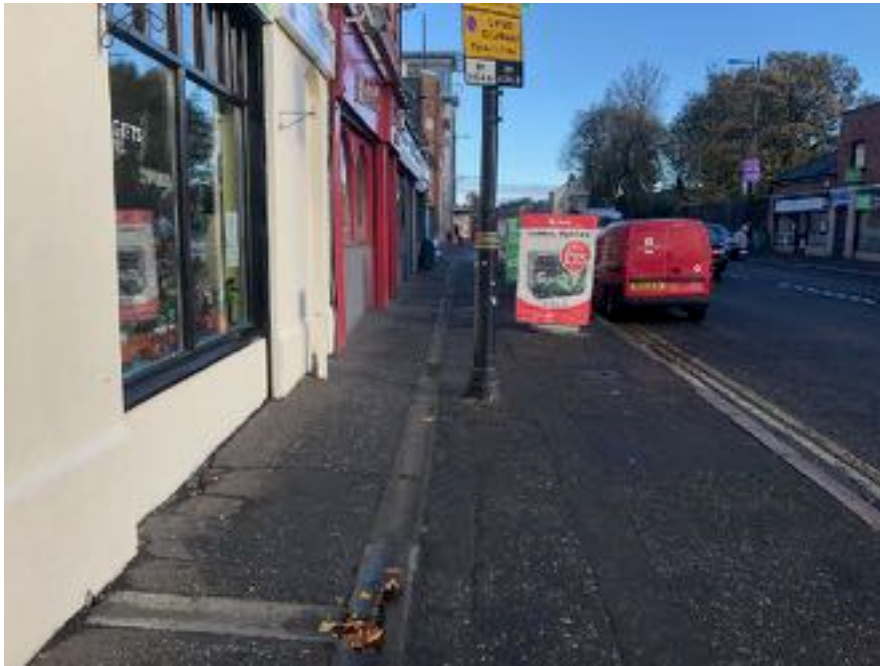
The footway on the western side of the Antrim Road close to Carlisle Circus is obstructed by the location of lighting columns and multiple large A Boards. It also includes a dish drainage channel running along the centre of the footway.

Other illegal clutter and obstructions also need to be addressed if the scheme is to be successful. Over the past number of years there has been an explosion in the use of A Boards across Belfast and beyond. As well as increasing in number the boards are also increasing in size. It is now time that agencies responsible adopt a zero tolerance to a practice which is illegal and creates a major hazard for older people and disabled people. Imtac recommends that Belfast adopt a city wide ban of the use of A Boards on pavements similar to that recently announced by Edinburgh City Council.

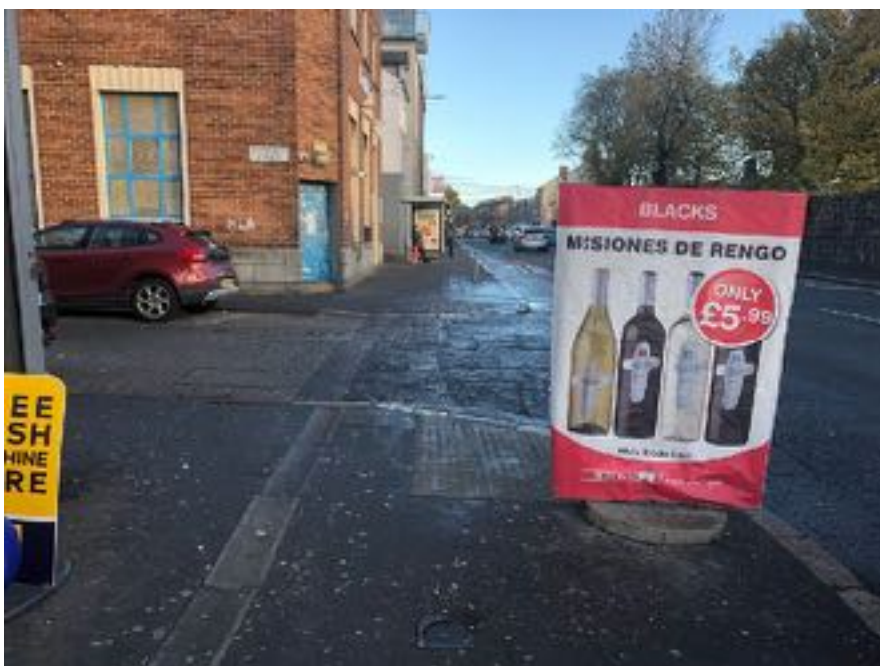
A-Boards partially obstruct an in-line uncontrolled crossing at the junction with Annesley Street. Sections of the footway are flush with the carriageway with no provision of tactile paving.

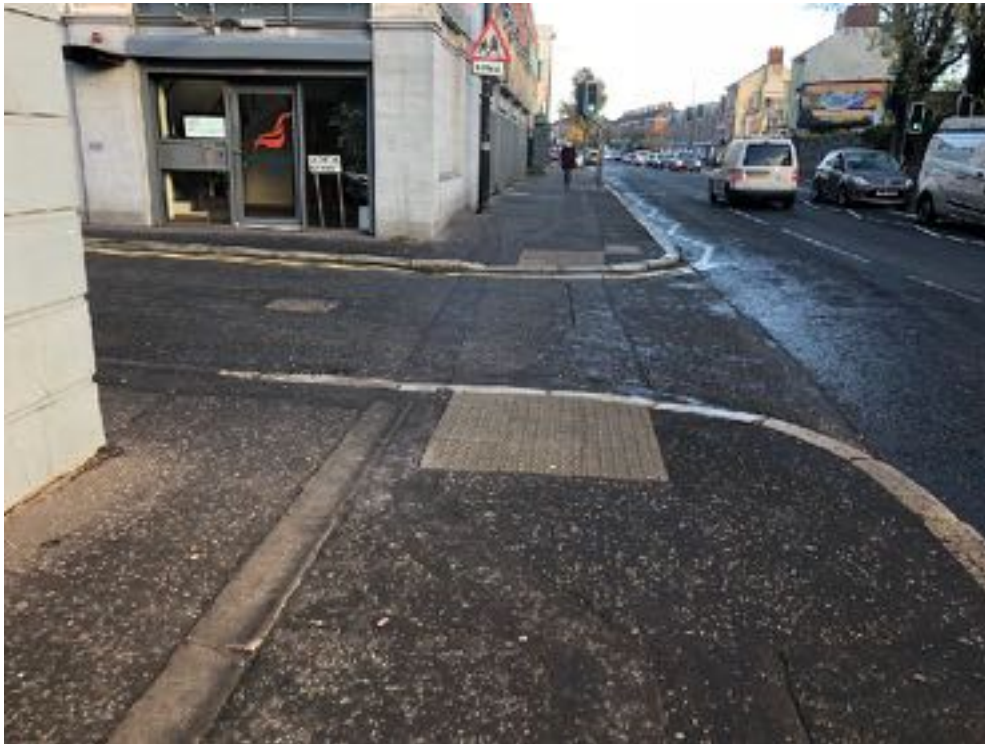
There is a further good example of an in-line uncontrolled crossing with appropriate tactile paving at the junction with Adela Street.

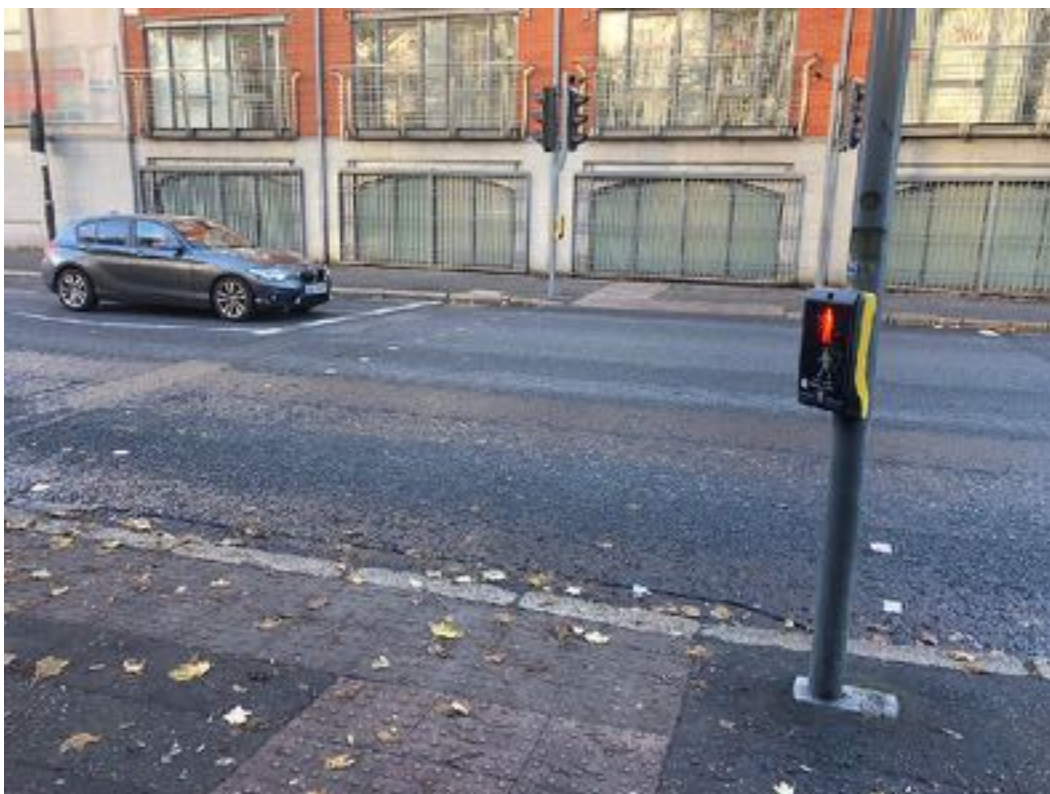
There is a well designed controlled crossing across Antrim Road north of Adela Street at this point with appropriate tactile paving and control box provision.

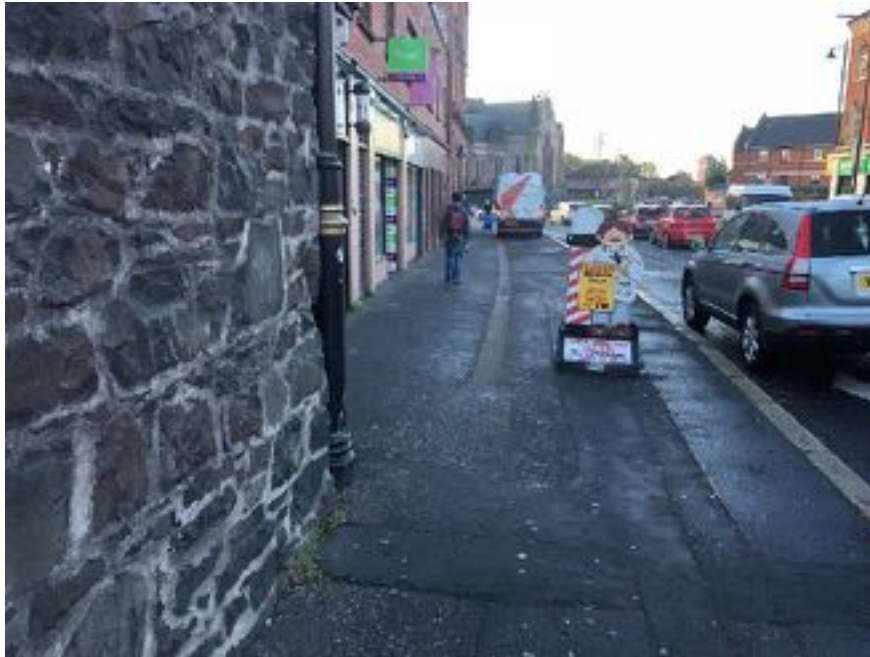
A-Boards, a dish drainage channel and footway parking create barriers on the footway around the shops approaching Carlisle Circus.

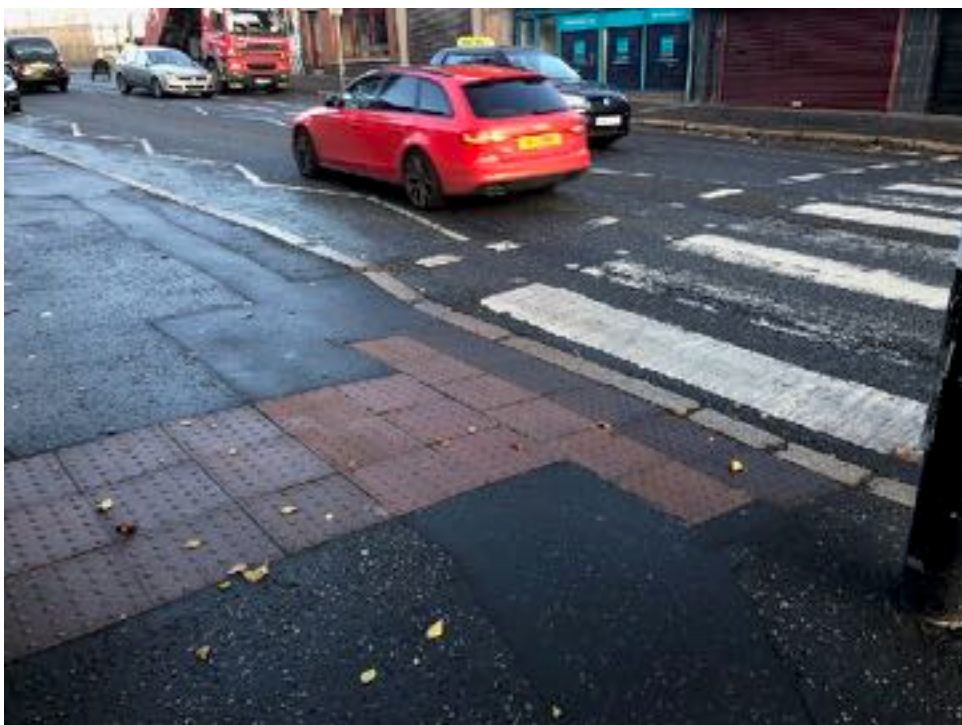
There is a Zebra crossing across Crumlin Road close to Carlisle Circus. The tactile paving has been laid incorrectly.

- Zebra crossings currently used in and around Carlisle Circus should be replaced with Puffin crossings.
- An additional control crossing should be considered close to the Crumlin Road Jail/Courthouse.

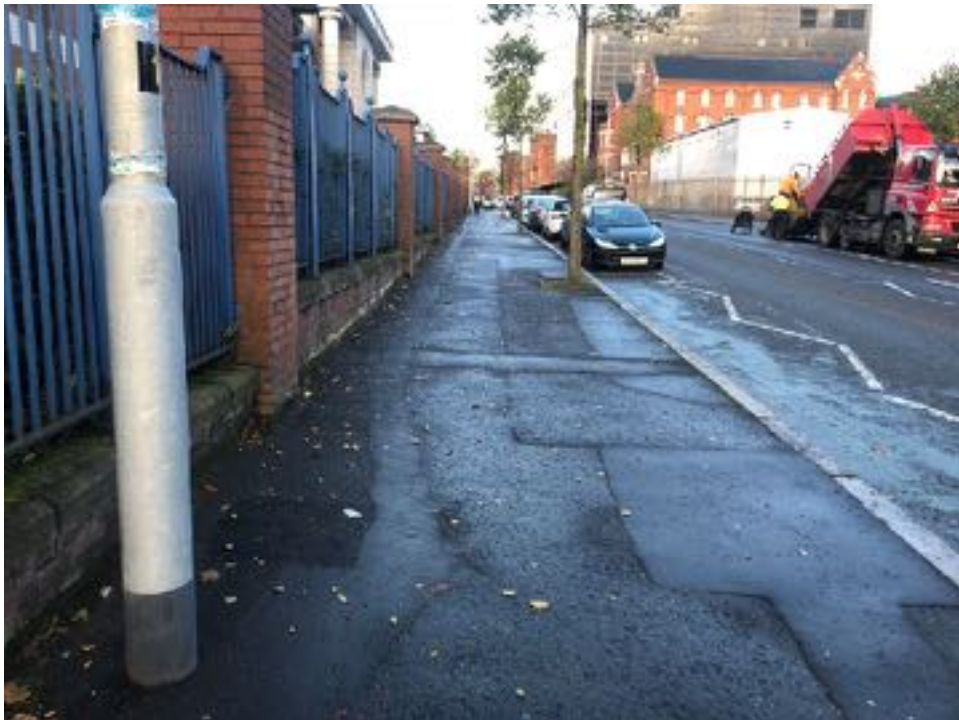
The surface of the footway on the southern side is rough and uneven but relatively clutter free.

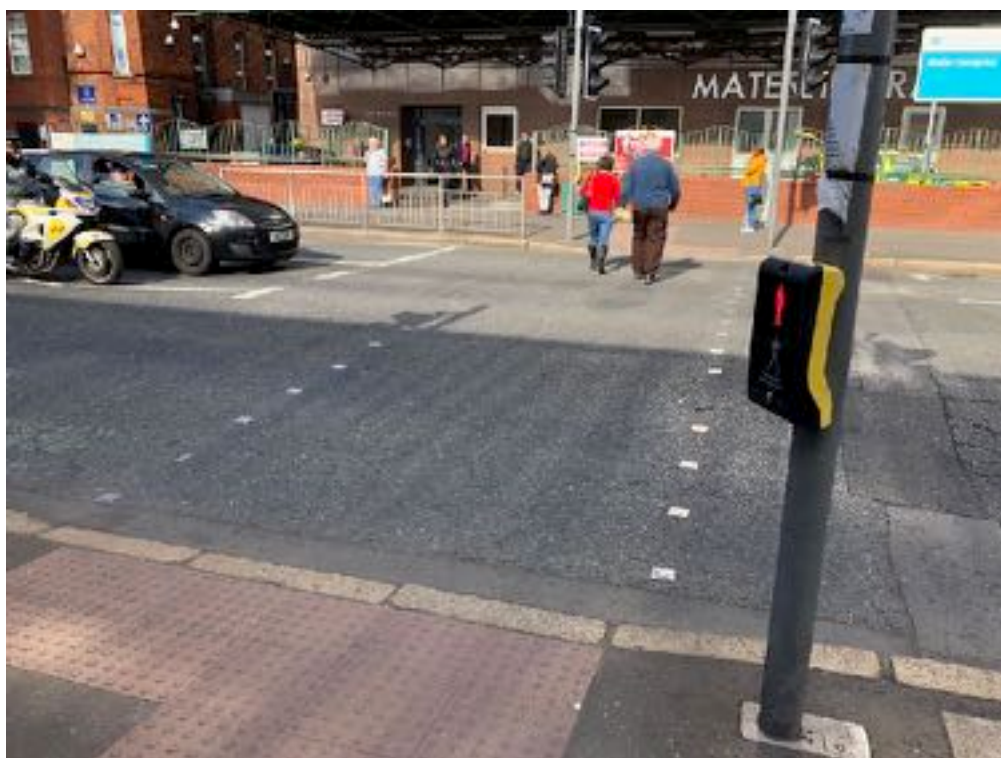
A good example of a controlled crossing is provided across Crumlin Road opposite the entrance to the Mater Hospital.

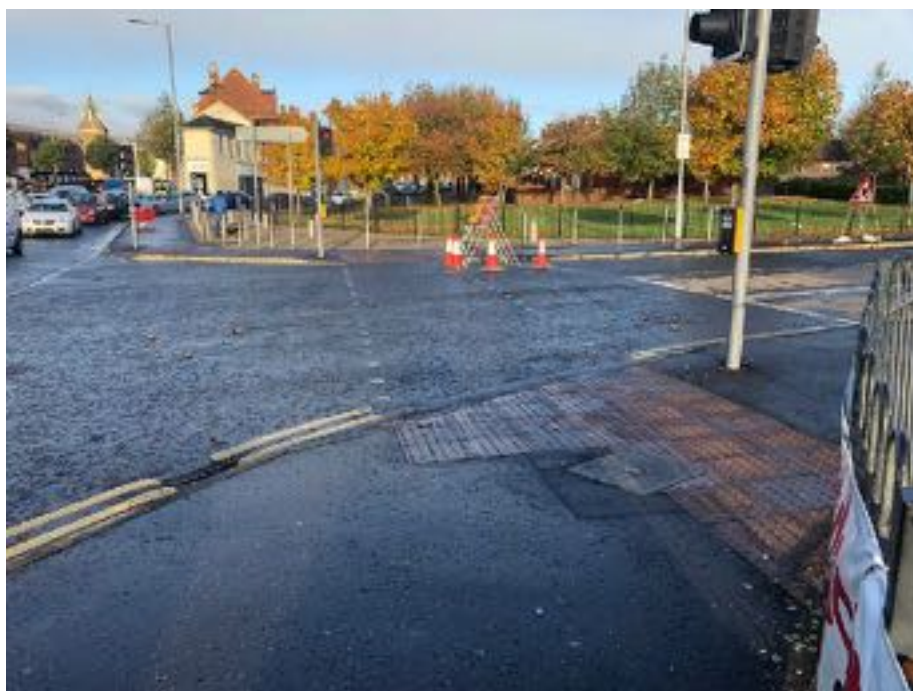
There is a good example of a controlled crossing on the eastern side of Crumlin Road across its junction with Clifton Park Avenue. Signs associated with road works partially obstruct the northern footway.

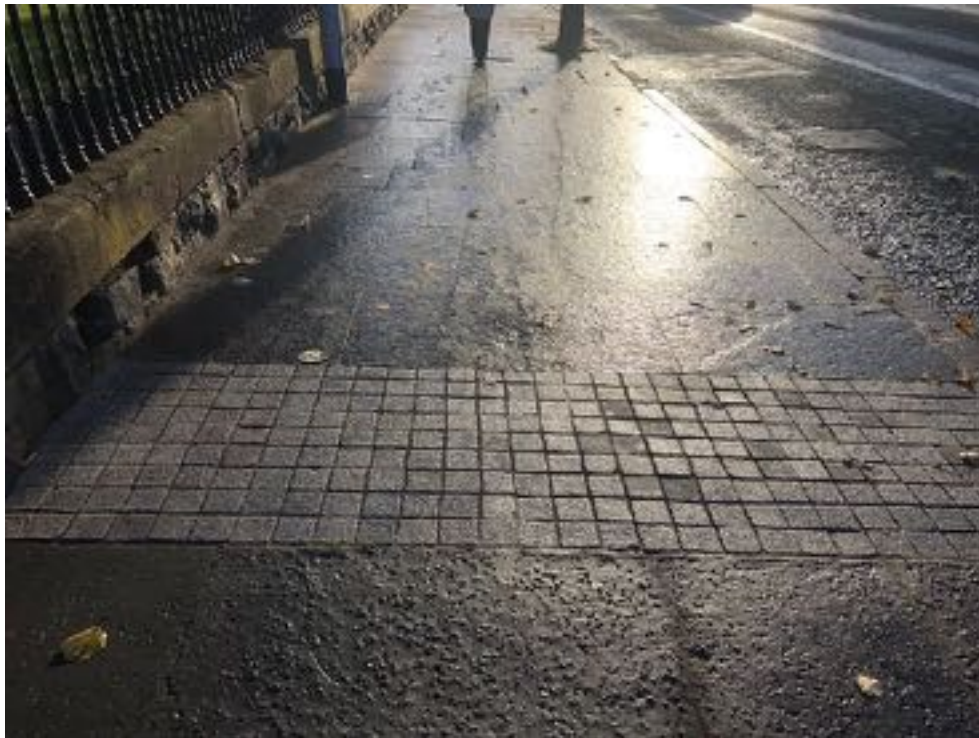
A newer smoother, level surface of paving has been used in the approach to the Gaol entrance.
