Recommendations from Imtac on public realm proposals for the Clifton Gateway in Belfast

(November 2018)

About this report

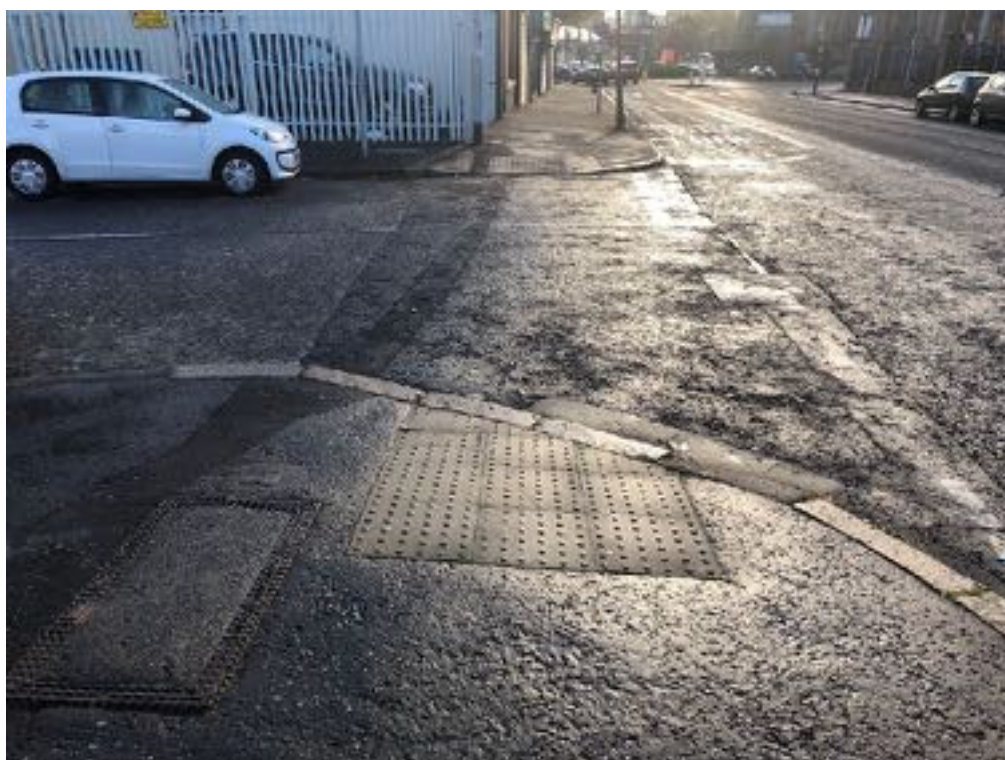
There is good example of an in-line uncontrolled crossing across the junction with Fleetwood Street.

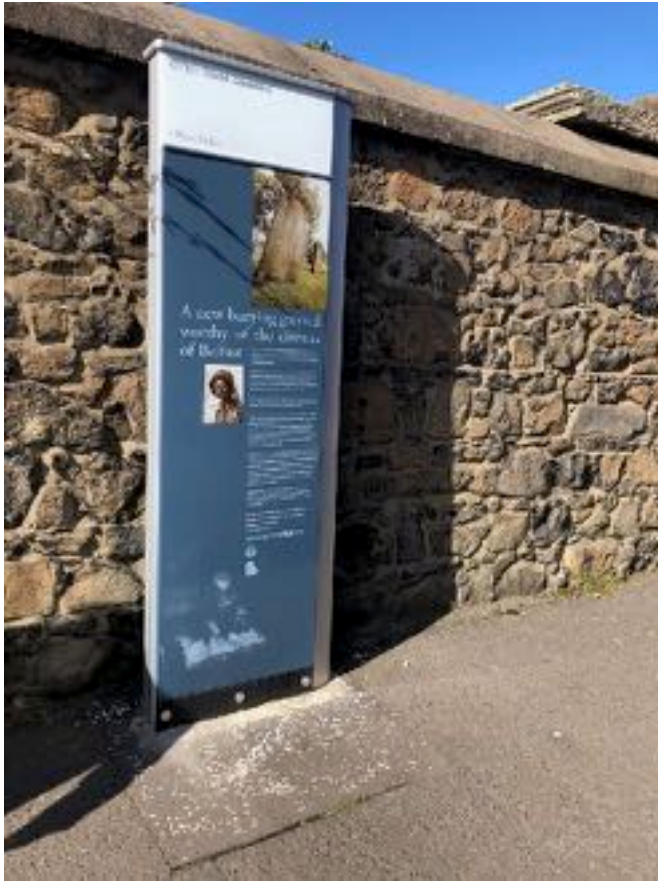
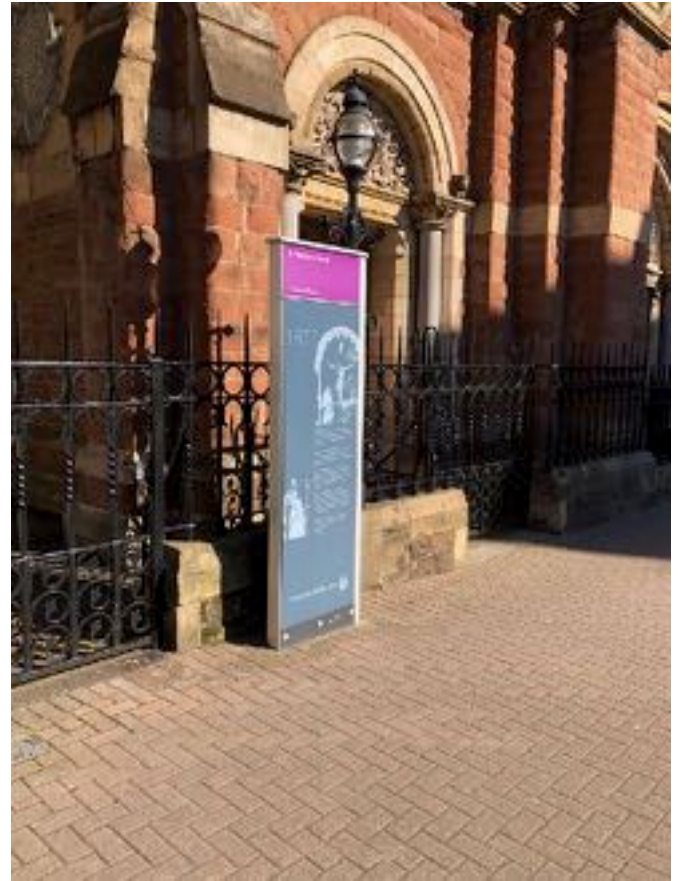
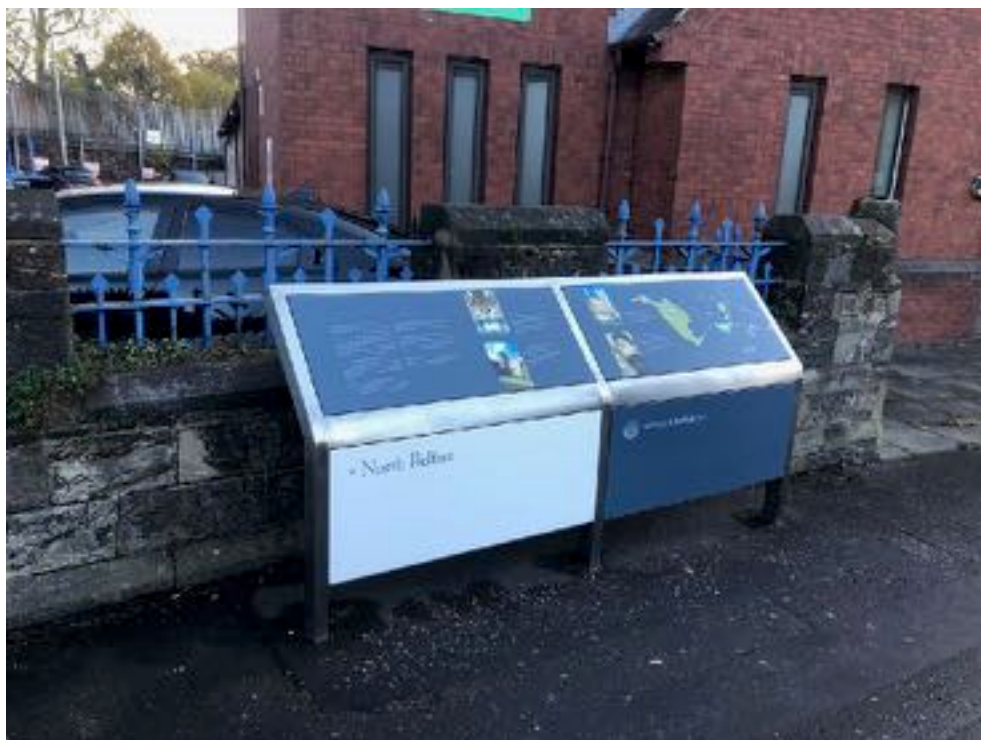
Many of the streets include wayfinding signage and information signage about the streets and key destinations. Whilst positioned in a way not to create obstructions there are issues around the use of contrasting colours and text size that limit the usefulness of this signage.

The report has also identified some issues with the accessibility of signage. As the Committee is aware this is a Belfast City Council city wide initiative, it recommends the Council undertake a review of current provision and specifically engage with disabled people and older people about improvements to accessibility.
