Report on Walking routes in Derry/Londonderry City Centre

July 2013

Audit of key routes

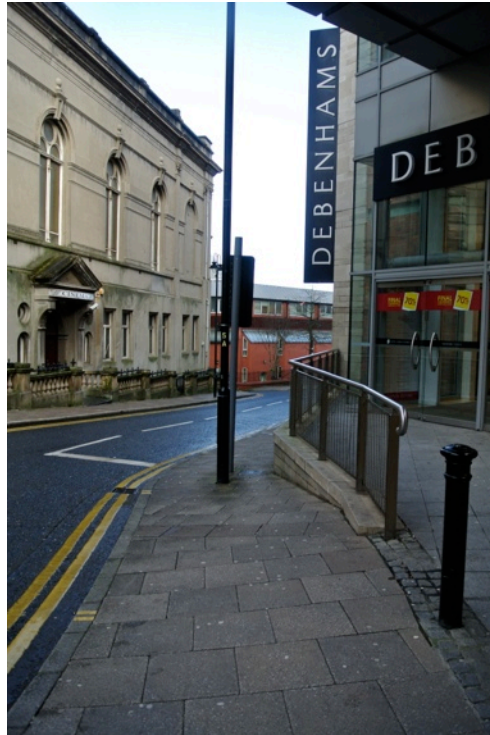
- 13 The pavement on the northern side of Orchard Street is narrow in places. Poles and pillars further restrict access.

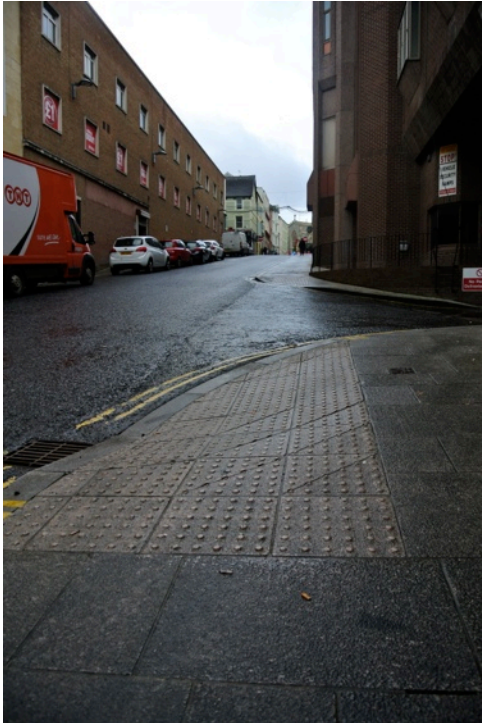
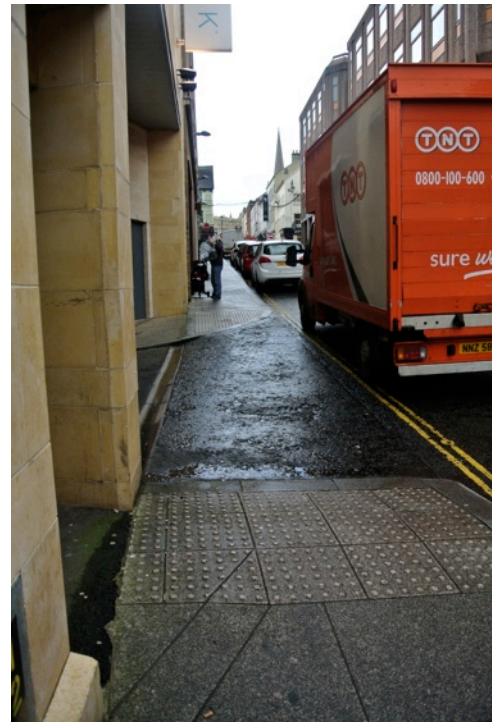
- 27 There are uncontrolled crossings at the service entrances on Linenhall Street. There is a problem with the alignment of the paving which may be confusing for people with a visual impairment.

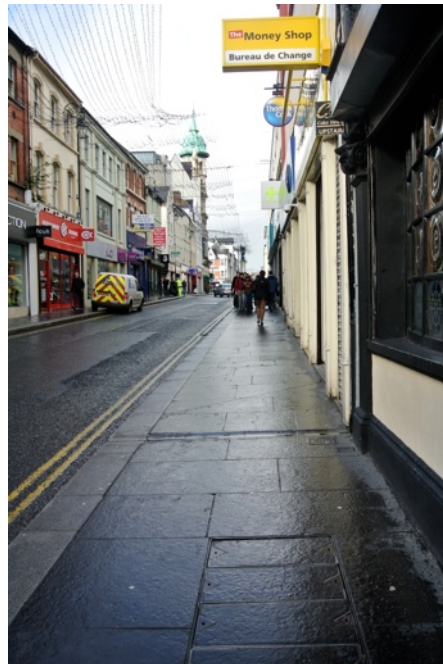
35 The pavements on Ferryquay Street are generally free of clutter.

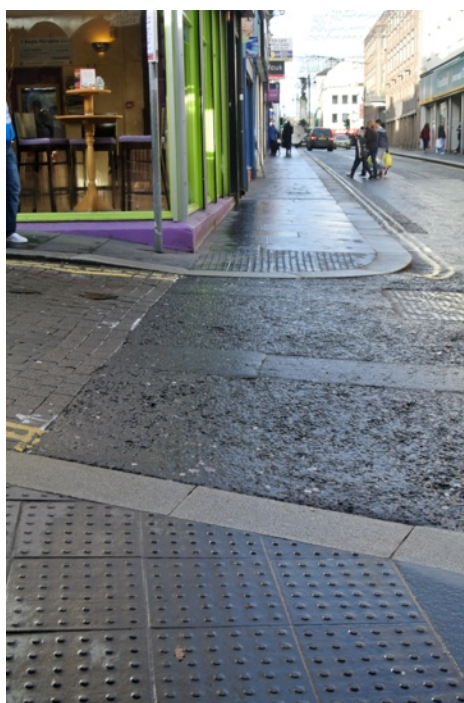
36 There are in-line uncontrolled crossings at the junctions with Artillery Street, Pump Street and Market Street. However the tactile paving is non-standard and provides no contrast with the surrounding paving. There are problems with the alignment of some of the tactile paving.

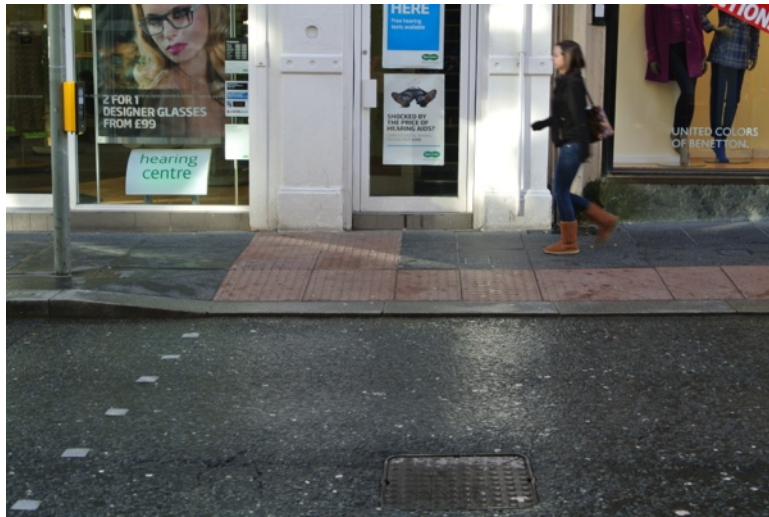
- 37 There is a controlled crossing at the northern end of Ferryquay Street (close to the Diamond). The control boxes on the crossings are too far from the tactile paving.

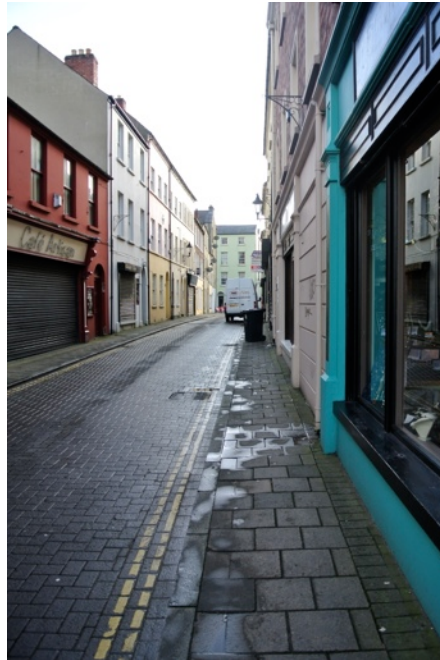
- 41 Parking and wheelie bins restrict an already narrow pavement on London Street. There is an absence of dropped kerbs in around London Street and Artillery Street. This significantly restricts access in and around this area for many disabled people including wheelchair users.

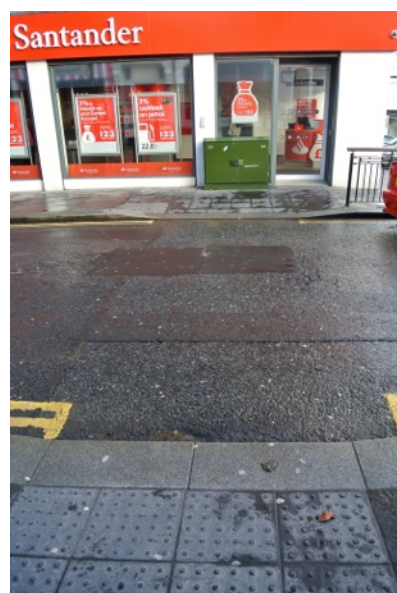
- 42 Issues with contrast and tactiles are replicated on Butcher Street.

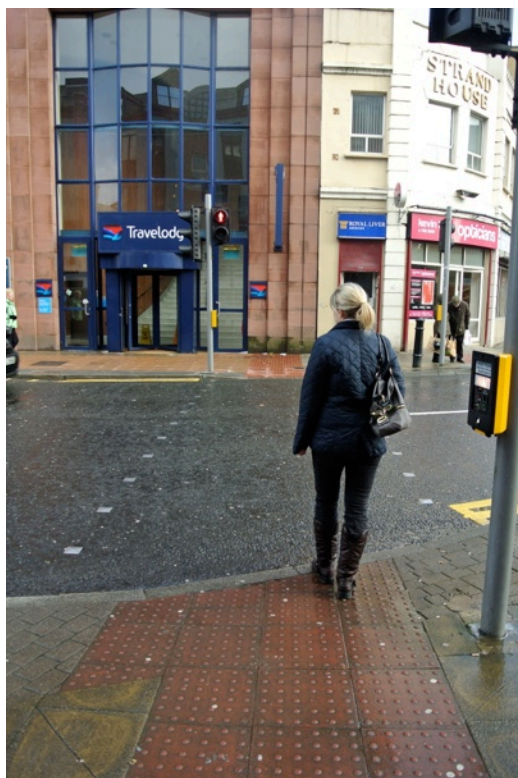
- 65 At the same junction there is a controlled crossing over Strand Road. Once again there is non-standard use of tactile paving and the control box is too far from the paving.

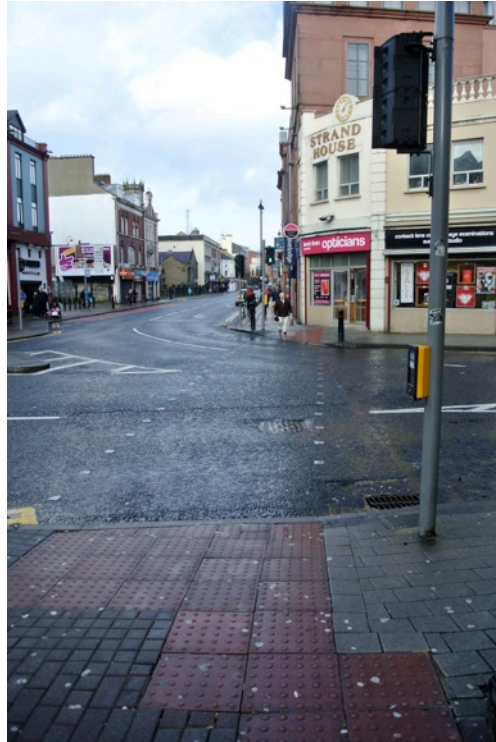
- 66 At the same junction there is controlled crossing at the eastern junction with Great James Street. Once again there is non-standard use of tactile paving and the control box is too far from the paving.

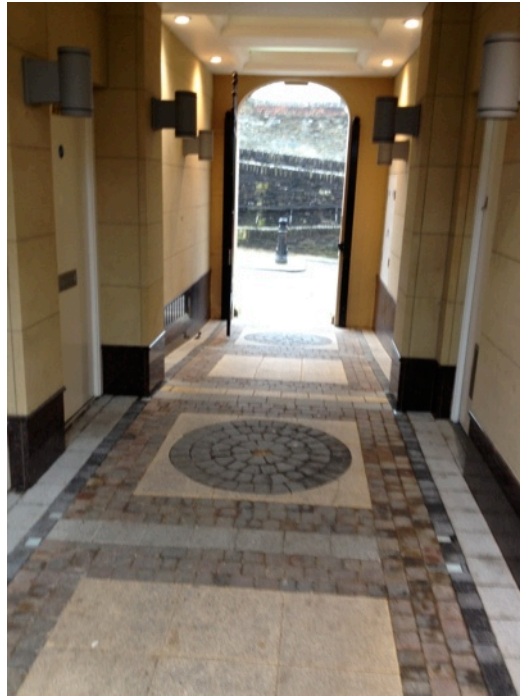
- 70 In general significant efforts have been made to improve pedestrian access to what is an historic area of the city centre.

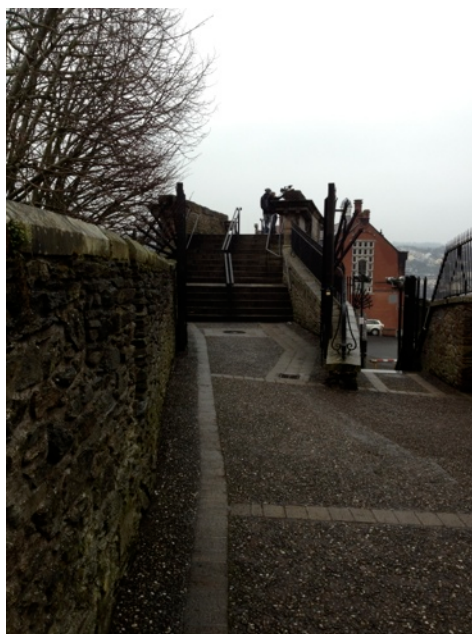
- 76 Conservation requirements appear to restrict those changes that could make the walls more inclusive by the inclusion of contrasting step nosings and hand rails as well as providing tactile surfaces. They also potentially limit opportunities to providing level and even surfaces.

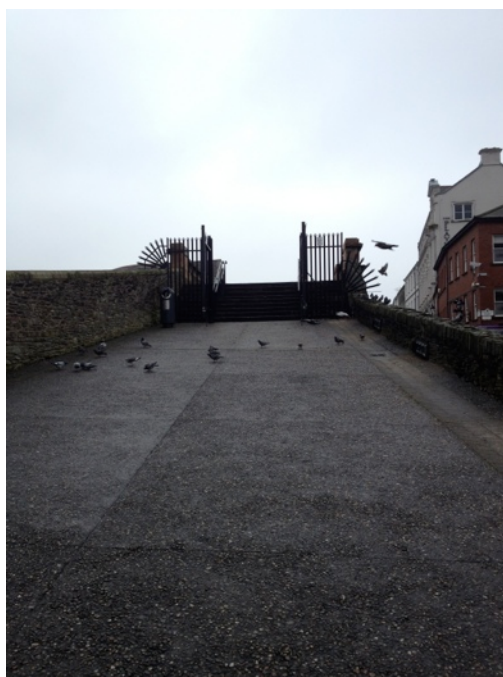
- 78 The sections of the wall between Newmarket Street and Bishops Gate are particularly challenging with very steep gradients and stepped access.

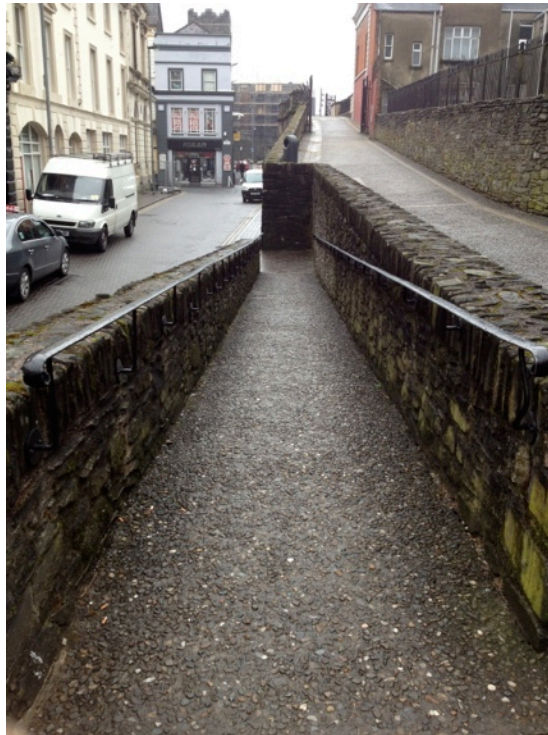
- 79 Other sections of the wall are less challenging and ramped access with handrails is provided in two locations (Magazine Gate & Castle Gate).
