Recommendations from Imtac on public realm proposals for Belfast Streets Ahead Phase 5

(November 2018)

Street audit findings

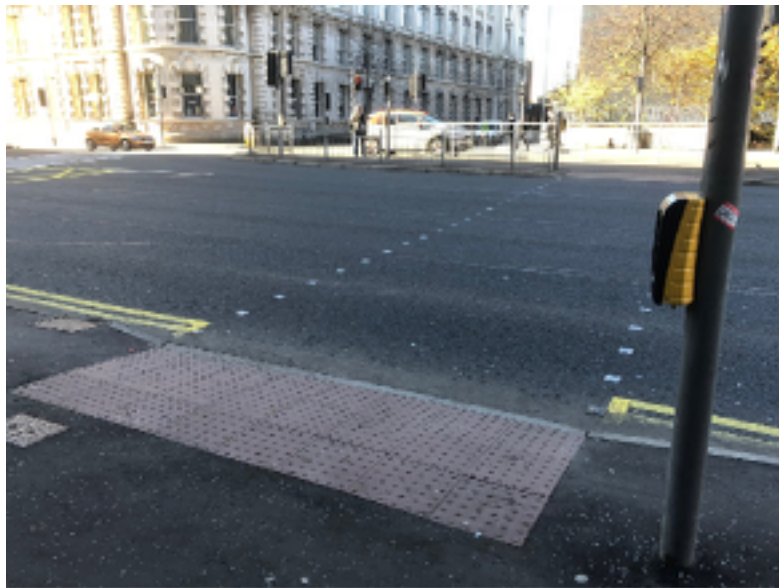
There is a controlled crossing at the northern end of College Square East with across College Avenue at the junction with College Street and College Square North. The crossing from the eastern footway leads to a central traffic island on this dual carriageway. The crossing should have a tactile tail leading to the building line.

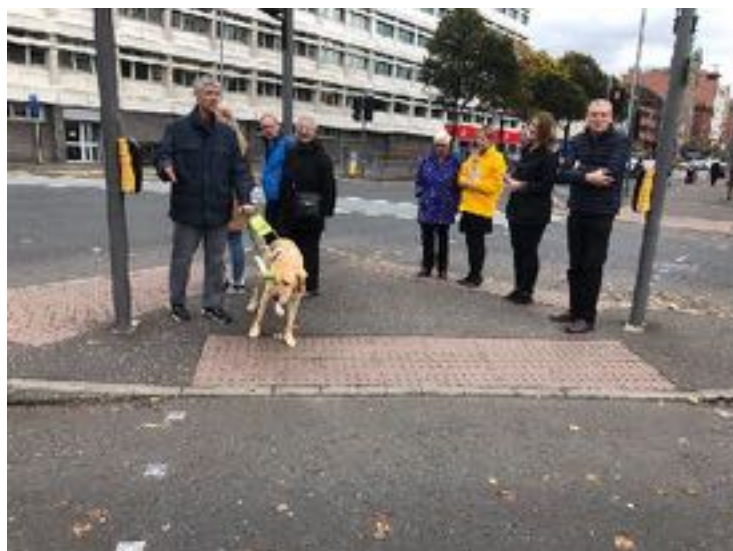
From the traffic island the crossing across the northbound traffic lanes leads to a smaller traffic island. This traffic island is also the island for the crossing of College Square North connecting to the western footway of College Square East to College Avenue. The size of this island, the positioning of control boxes and connection to multiple crossings make this a confusing and hazardous location for some disabled people.

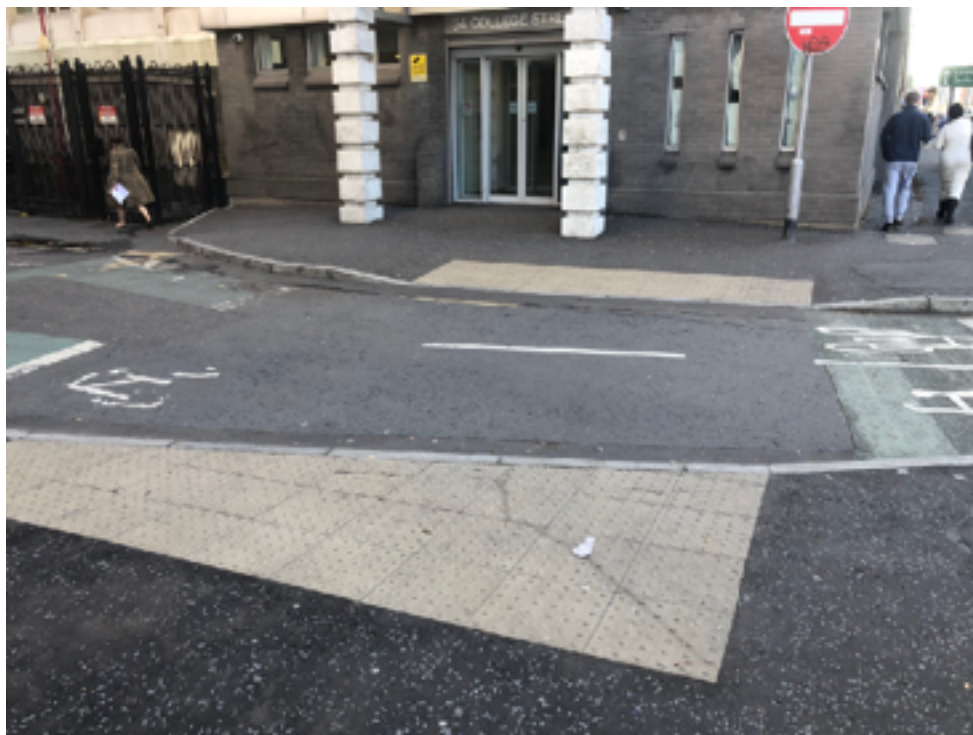
On the eastern footway there is a wide uncontrolled crossing across College Street. The radius of the kerb line means there is insufficient depth of tactile paving, particularly on the southern side.

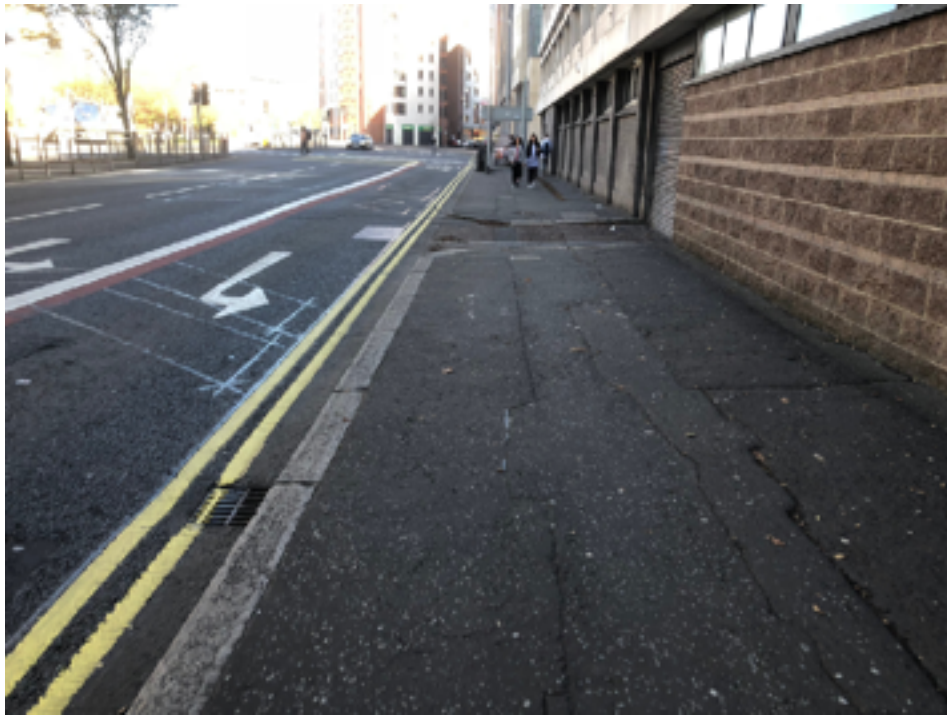
The footway surface is rough and uneven. Approaching the junction with Wellington Place a vehicle entrance without dropped kerbs interrupts step free access and creates a potential trip hazard.

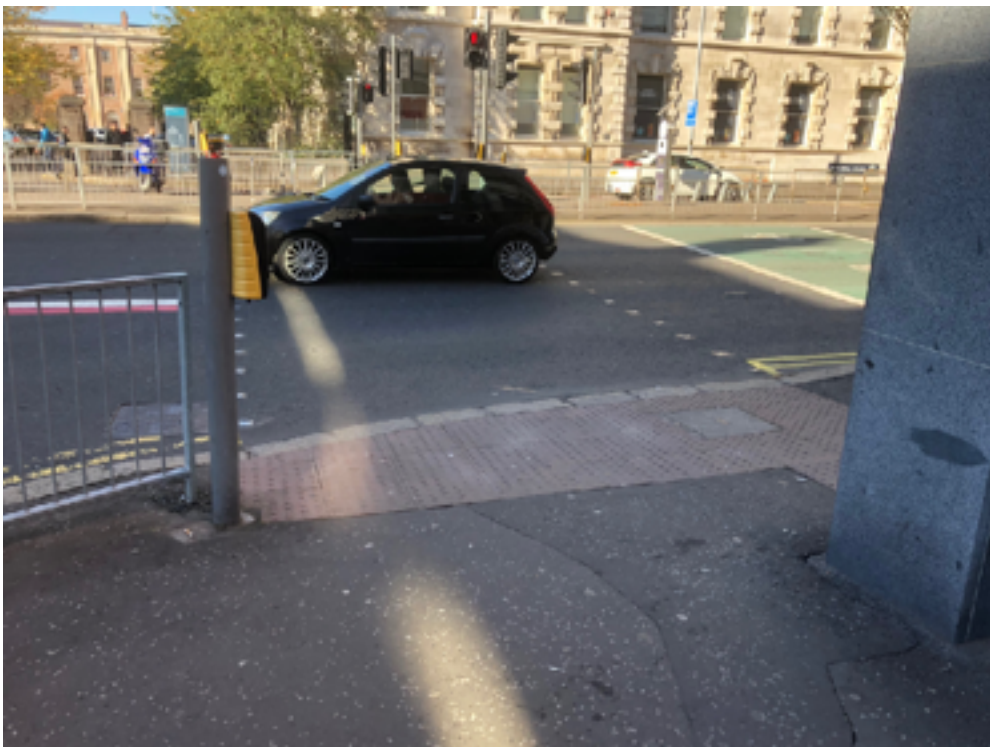
There is controlled crossing across the southbound lanes of College Square East at its junction with Wellington Place. It is part of a staggered crossing providing access to the western footway via a traffic island. On the eastern footway the positioning control box on the right hand side may make it difficult for people with a visual impairment to locate.

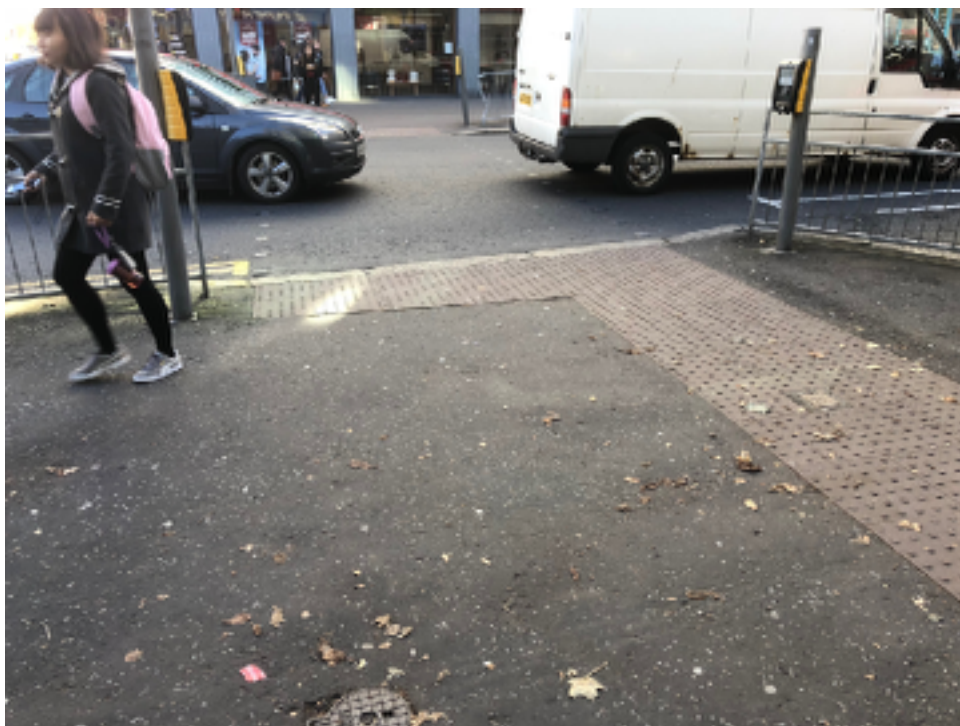
There is a control crossing across Wellington Place. Whilst the tactile paving and positioning of control boxes is good, some of the tactile paving is loose and unstable. Also during the audit vehicles repeatedly blocked the crossing during the pedestrian phase.

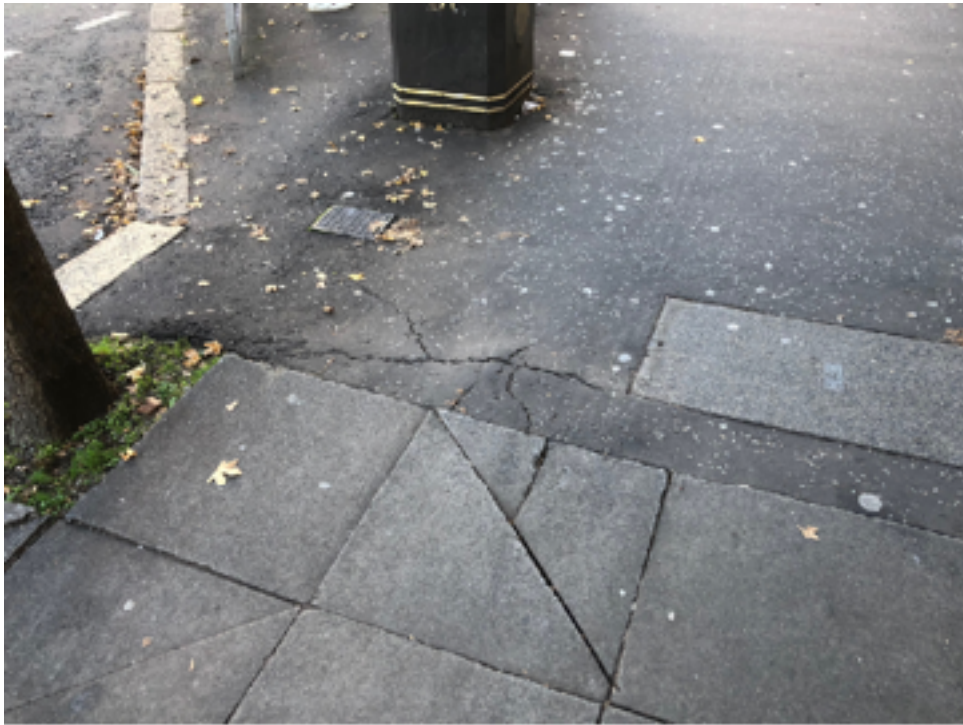
Trees roots have damaged the eastern footway and are a potential hazard.

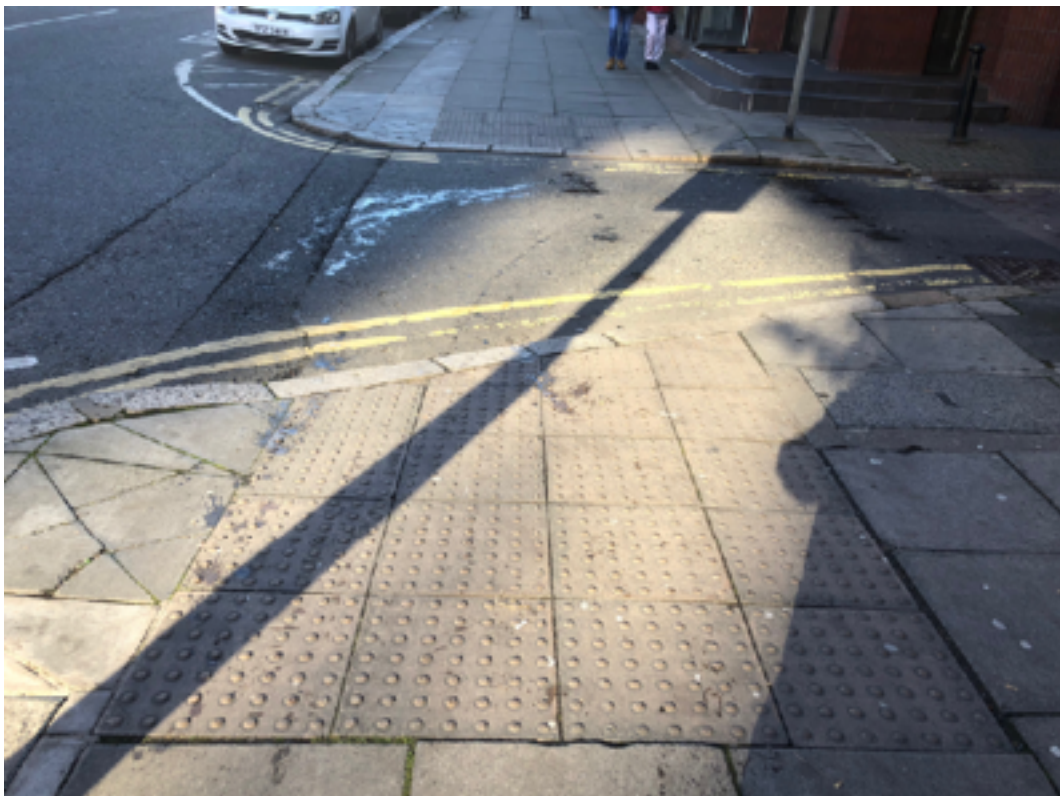
There is an in-line uncontrolled crossing across the junction with Wellington Street. The granite kerbing is not flush with the carriageway on the section of dropped kerb on the northern side of the crossing.

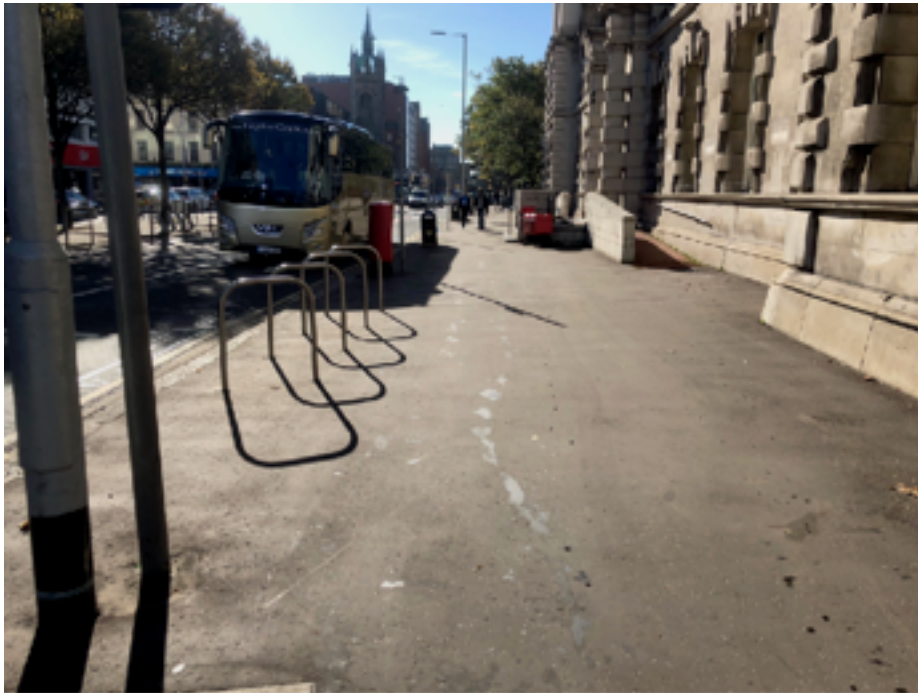
The footway in front of John Bell House is broad with street furniture located in a line. The orientation of cycle parking hoops could potentially create a hazard when cycles are parked and extend into the footway.

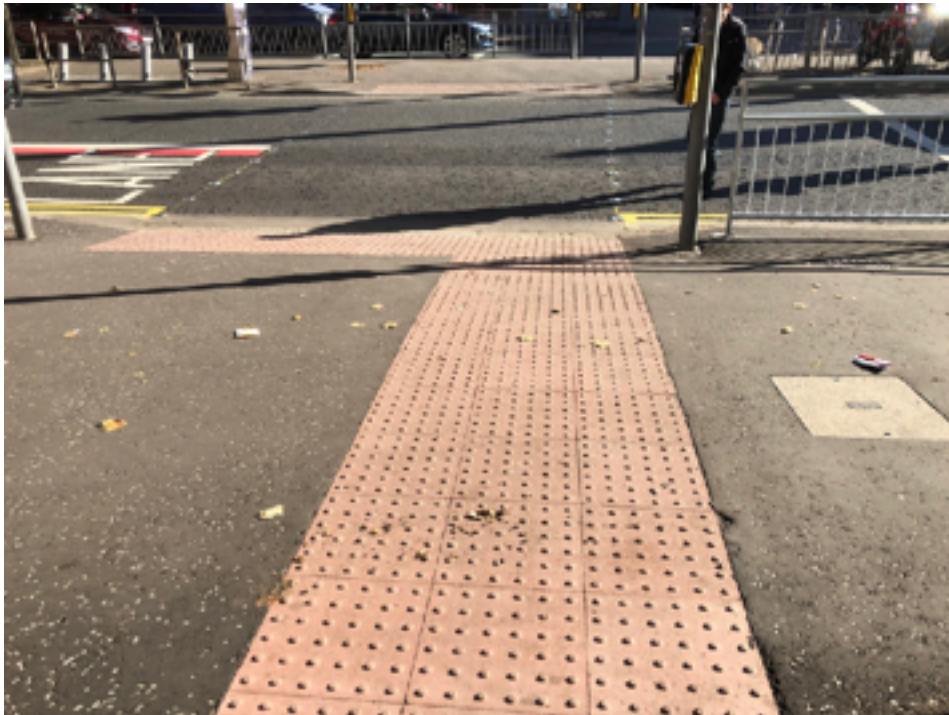
To the south of this point there adjacent to the entrance of RBAI is a controlled crossing across the northbound lanes of College Square East to the large central traffic island. Both the provision of tactile paving and location of control boxes is excellent at this crossing.

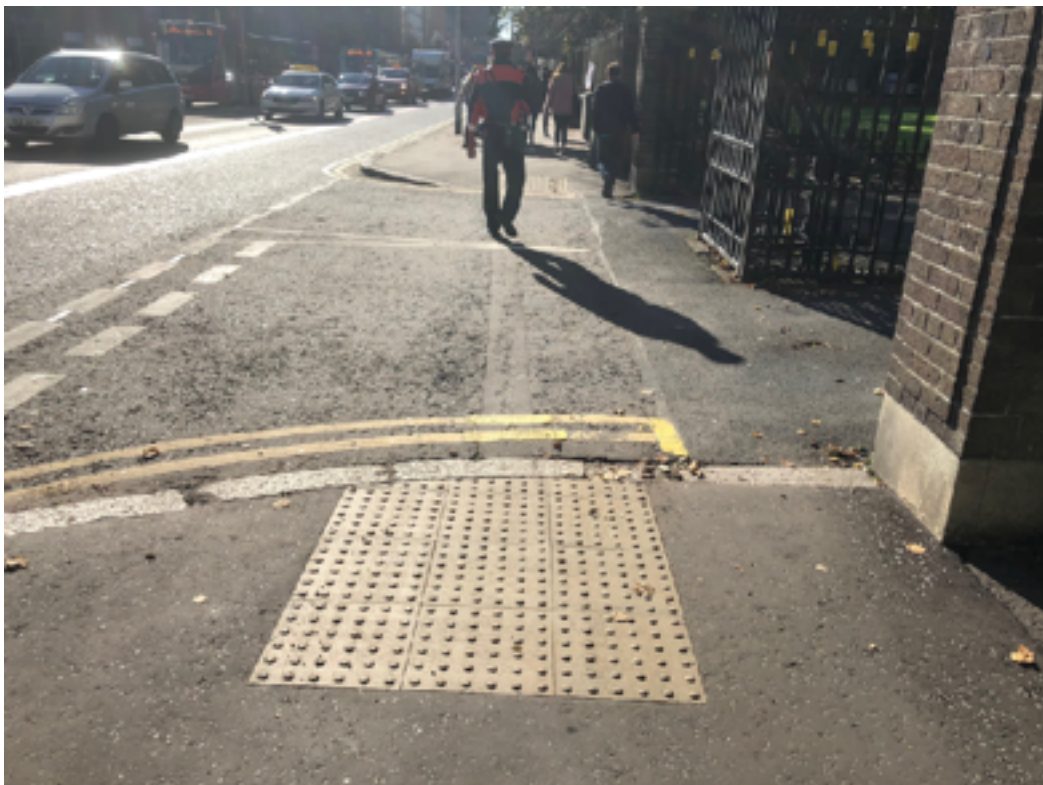
At the vehicle entrance to RBAI the kerb has been dropped and tactile paving provided. Although of sufficient depth the tactile paving does not extend the entire length of dropped kerb.

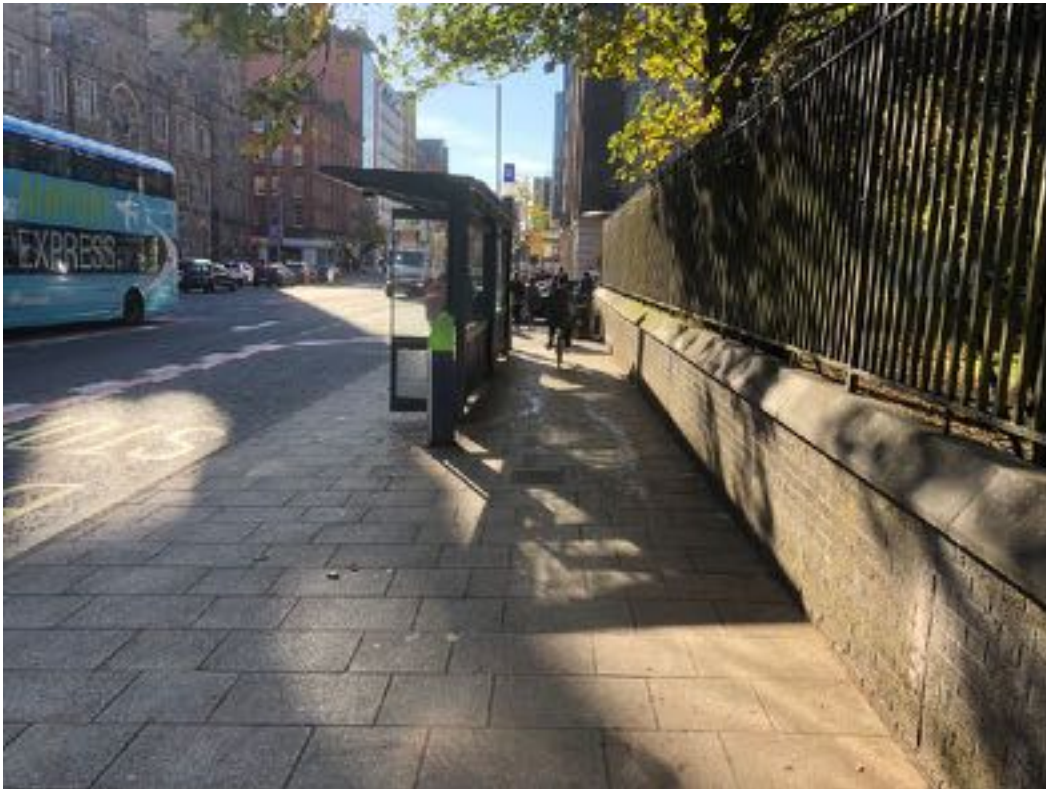
The broad footway has outside RBAI been narrowed by the recent installation of a Glider halt. However a clear path has been left to the rear of the halt.

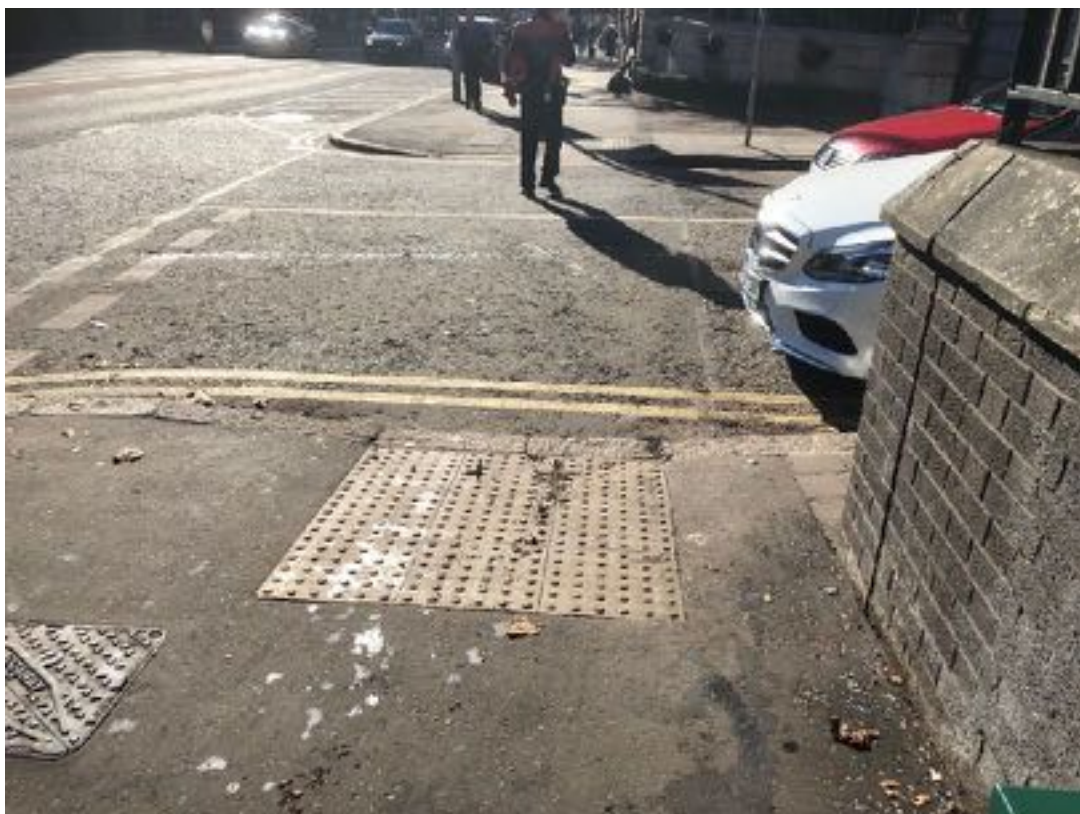
There is an in-line uncontrolled crossing across the junction with Murray Street. Although tactile paving has been provided it does not extend along the entire length of the dropped kerb.

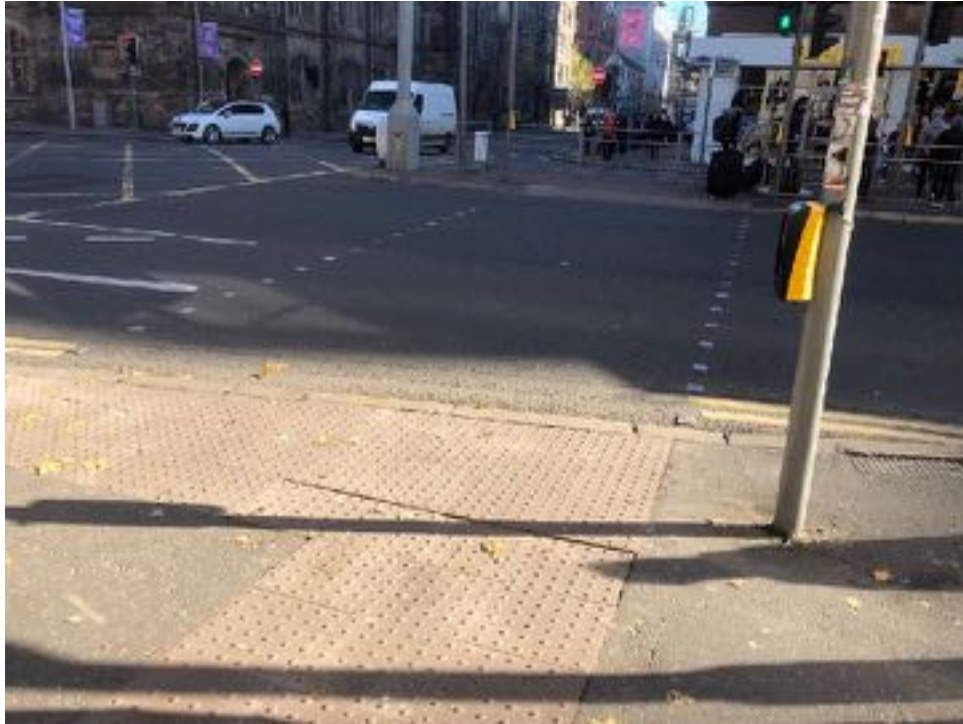
There is a staggered controlled crossing across Great Victoria including a traffic island. Although the tactile paving and control boxes have been installed correctly the tactile paving is loose and uneven in places. Although improved recently the traffic island is still narrow given the level of pedestrian usage.

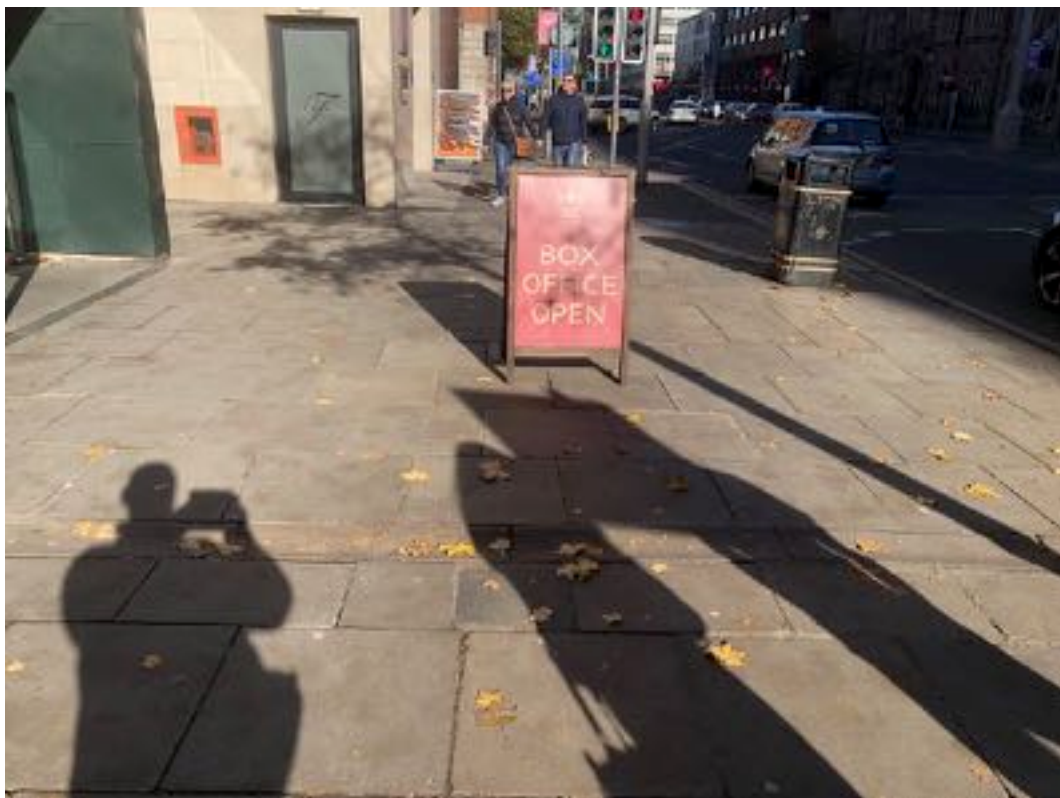
A-Boards associated with the Grand Opera House obstruct the western footway. Deep dish drainage channels are also an issue.

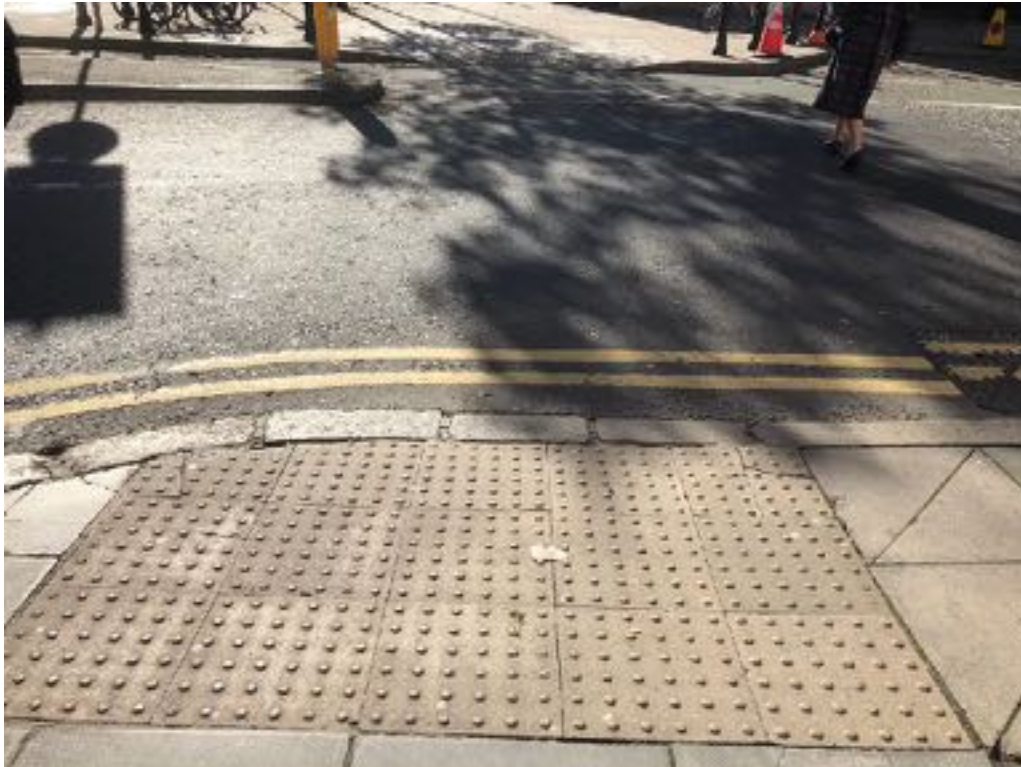
There is an in-line uncontrolled crossing across the junction with Glengall Street. A section of the kerb on the northern side is dropped without tactile paving.

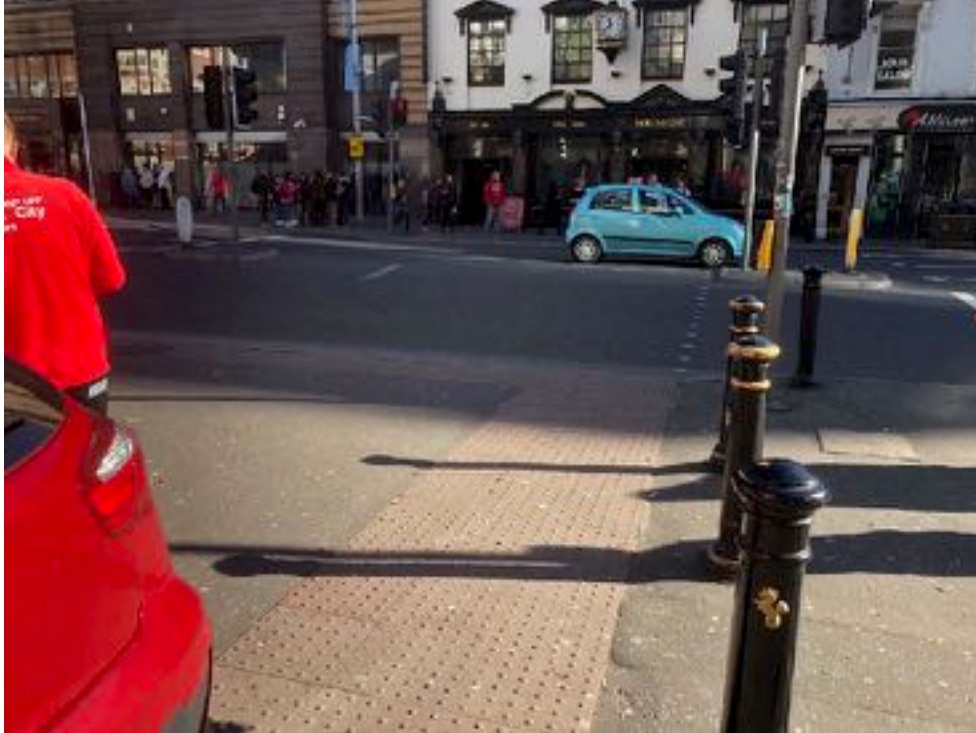
There is a wide controlled crossing across Great Victoria Street. The tactile paving and control boxes are installed correctly but paving is loose and uneven in places. Multiple bollards close to the crossing on the western footway create hazards. Participants in the audit felt crossing times at this busy crossing are insufficient.

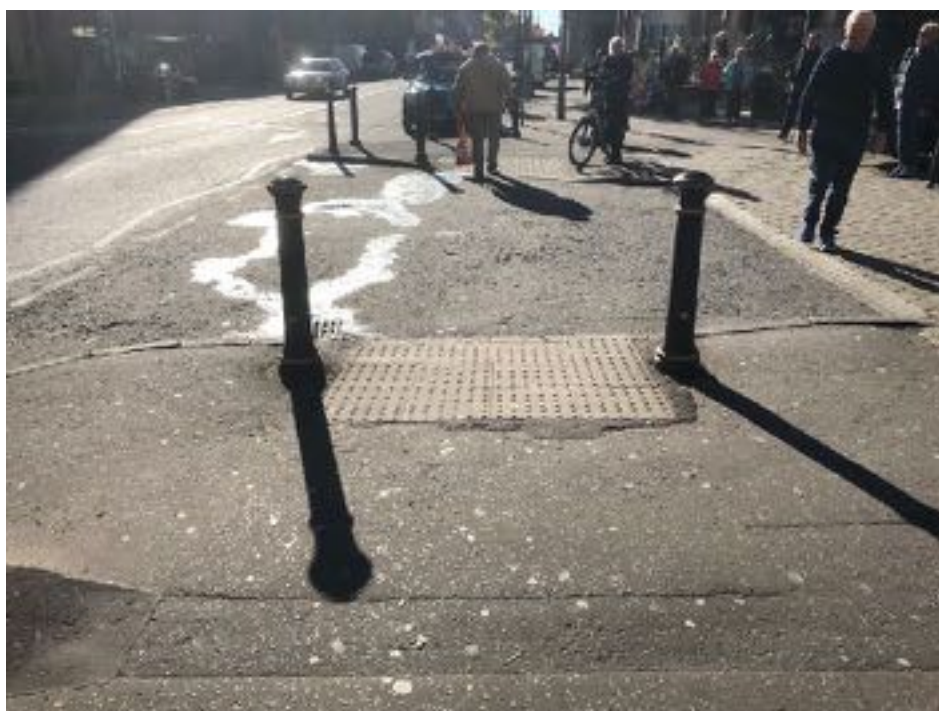
There is an uncontrolled crossing across the vehicle entrance to the Europa Hotel. Although the kerb has been dropped and tactile paving provided, bollards and general design does little to make this area attractive and accessible for pedestrians.

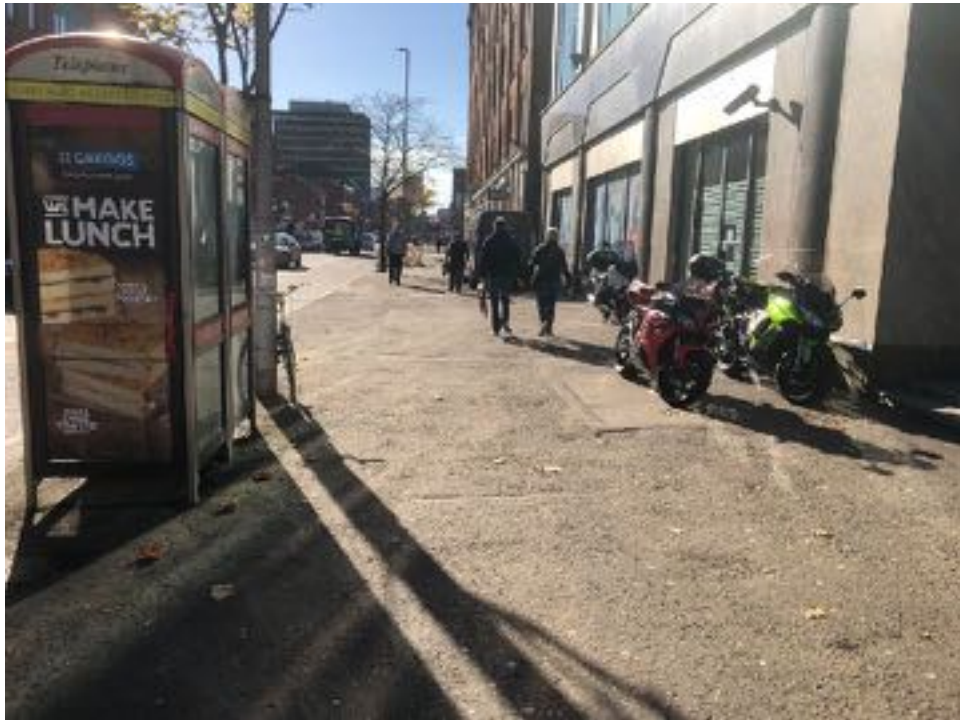
The footway on the western side of Great Victoria Street is broad, however its surface is rough and uneven. A van and motorcycles parked on the footway create potential hazards.

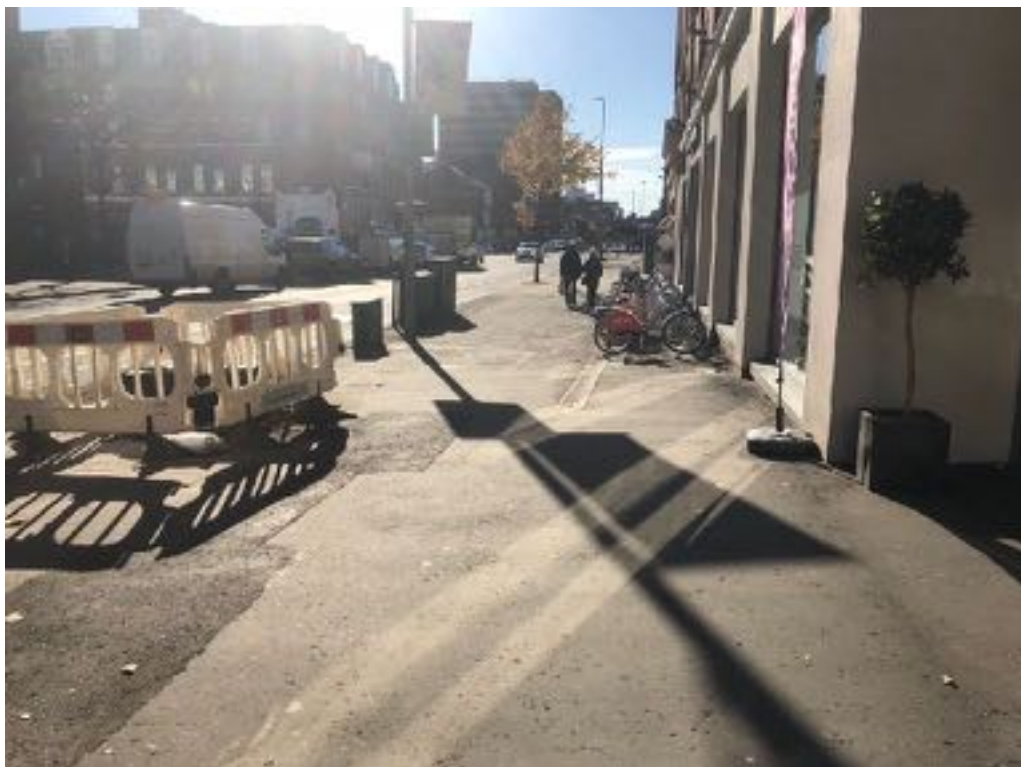
The footway outside the Lincoln Building has a considerable cross fall from the kerb to the building line which makes using it difficult for some disabled people.

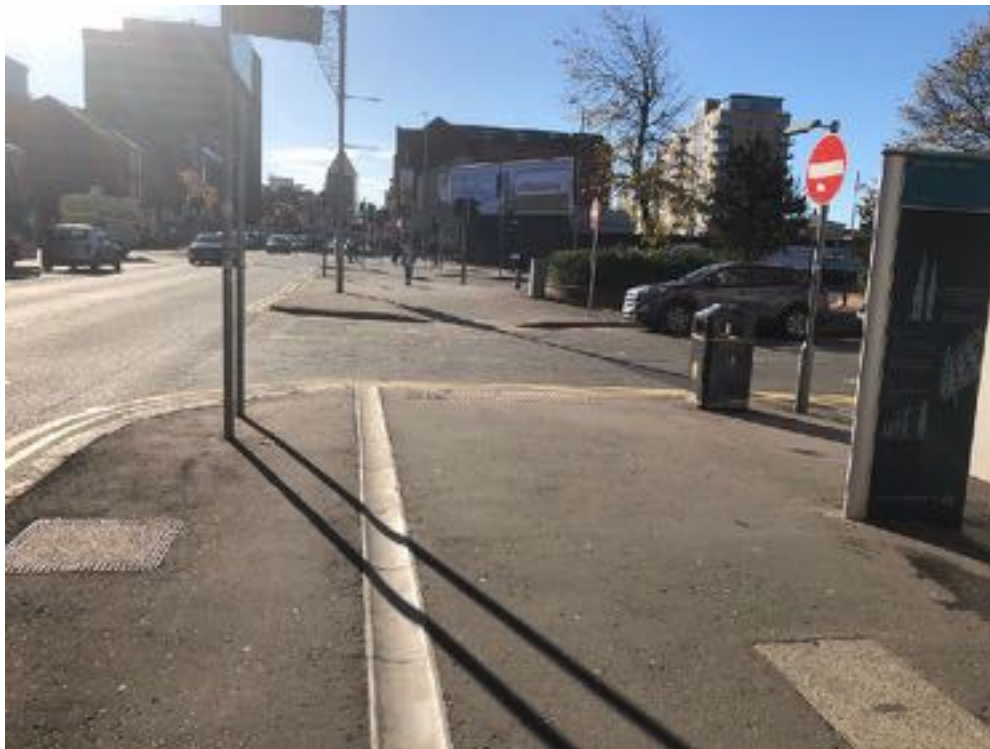
There is a deep dish drainage channel in the centre of the footway approaching the uncontrolled crossing at the junction with Hope Street. On the northern side there is a dropped kerb without tactile paving over its entire length. Greater depth of tactile paving should be provided on both sides of the crossing.

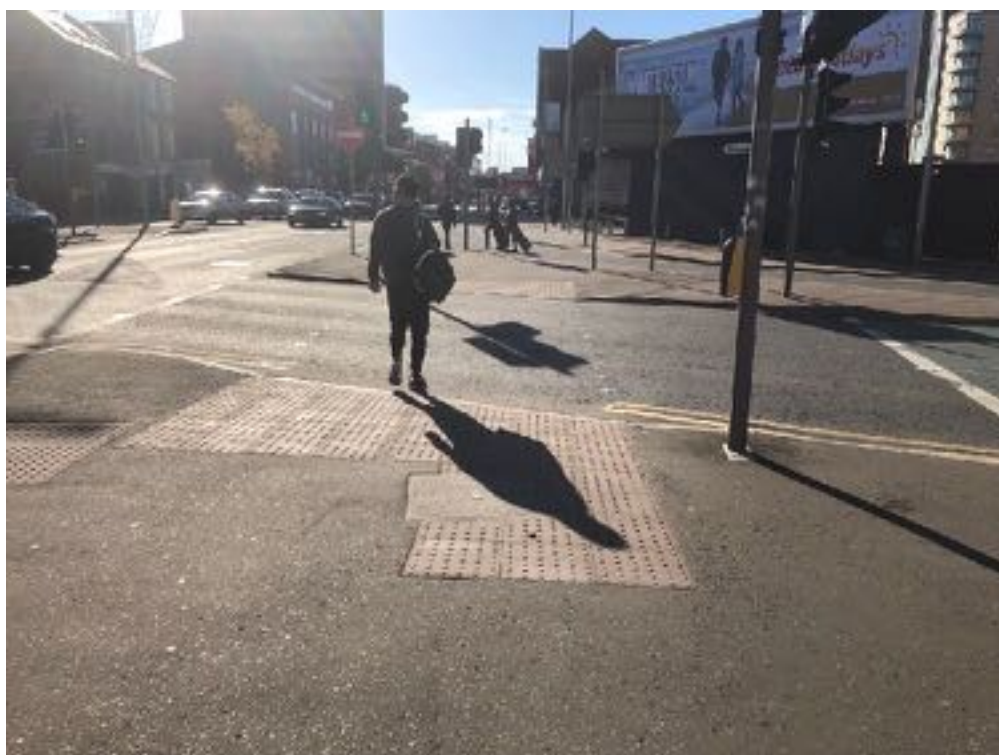
There is a controlled crossing across Bruce Street leading to a triangular traffic island. Tactile paving and control boxes have been installed correctly.

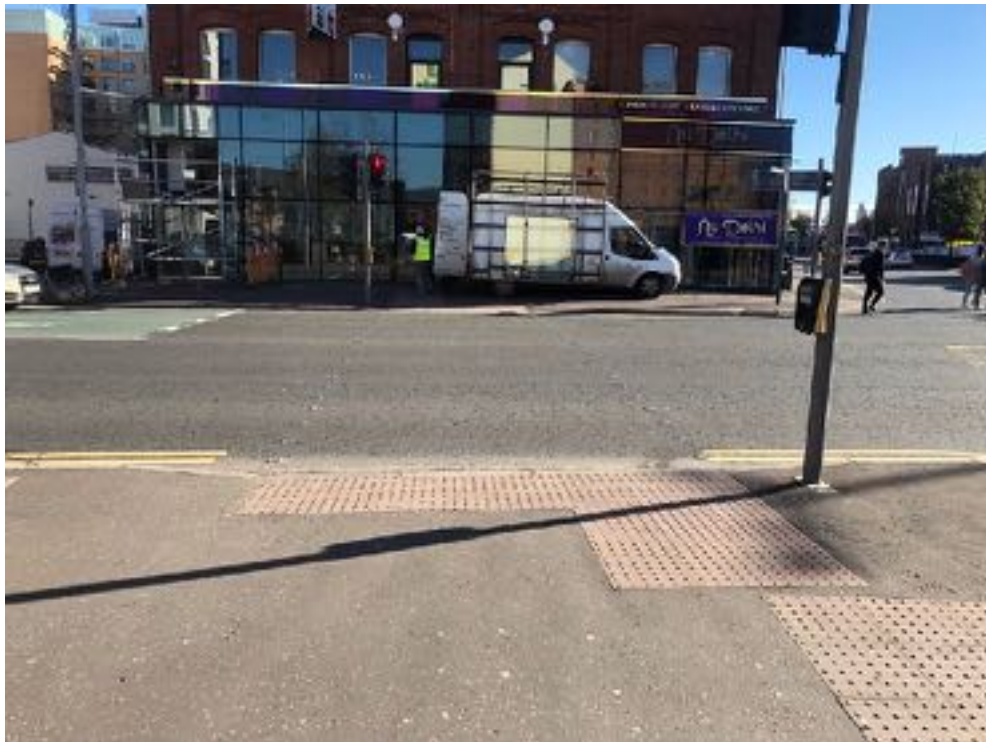
There is controlled crossing across Great Victoria Street at this point. Tactile paving and control boxes have been installed correctly. However a van parked on the footway on the eastern side obstructs the crossing.

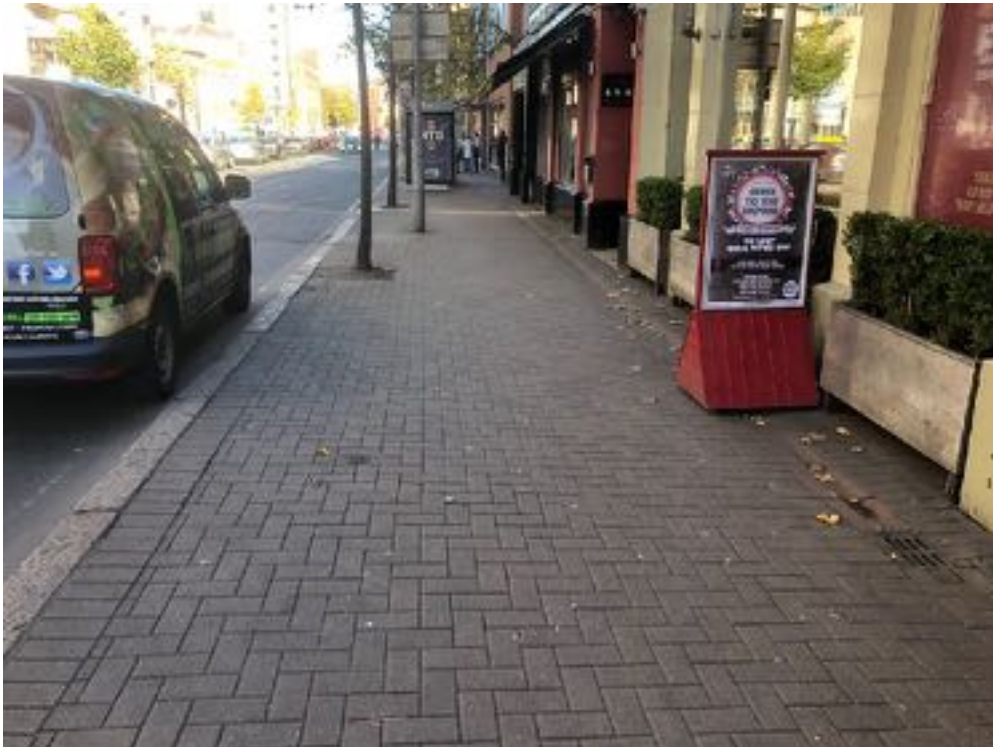
The eastern footway is broad from Hope Street to Amelia Street. A Boards and a dish drainage channel close to the building line create potential hazards.

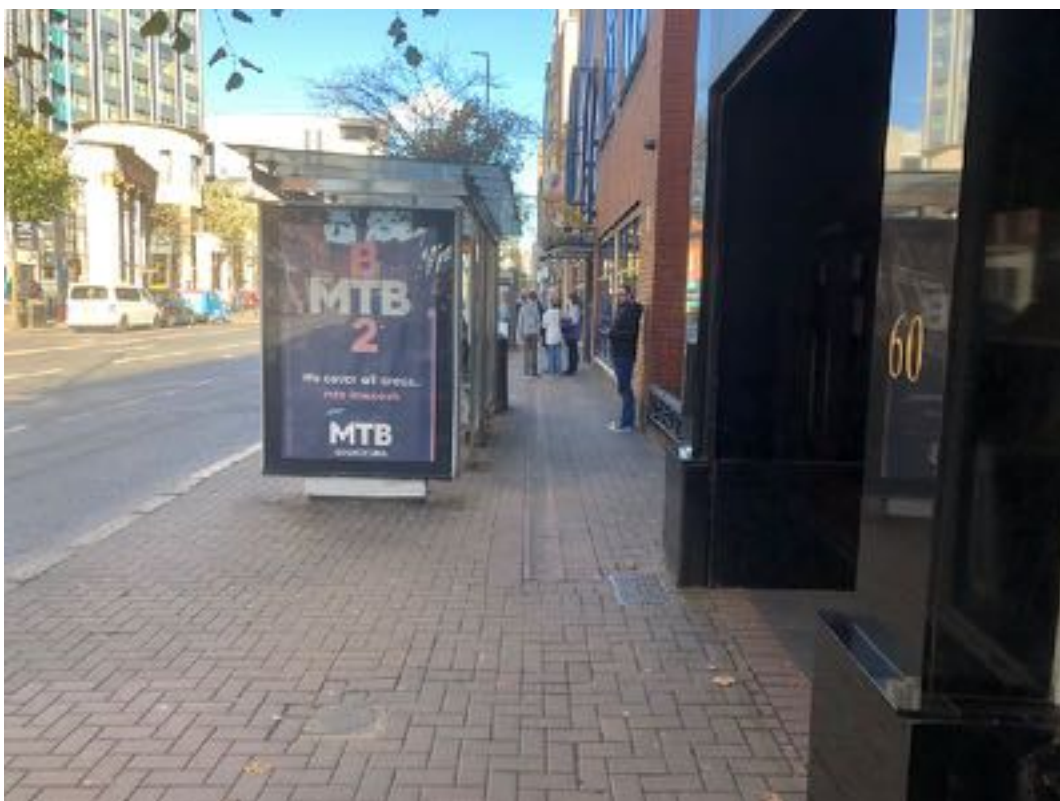
Bus stops outside Dorchester House narrow the footway significantly. A clear but narrow path is provided to the rear of the shelters, however a dish drainage channel means it is not obstacle free.

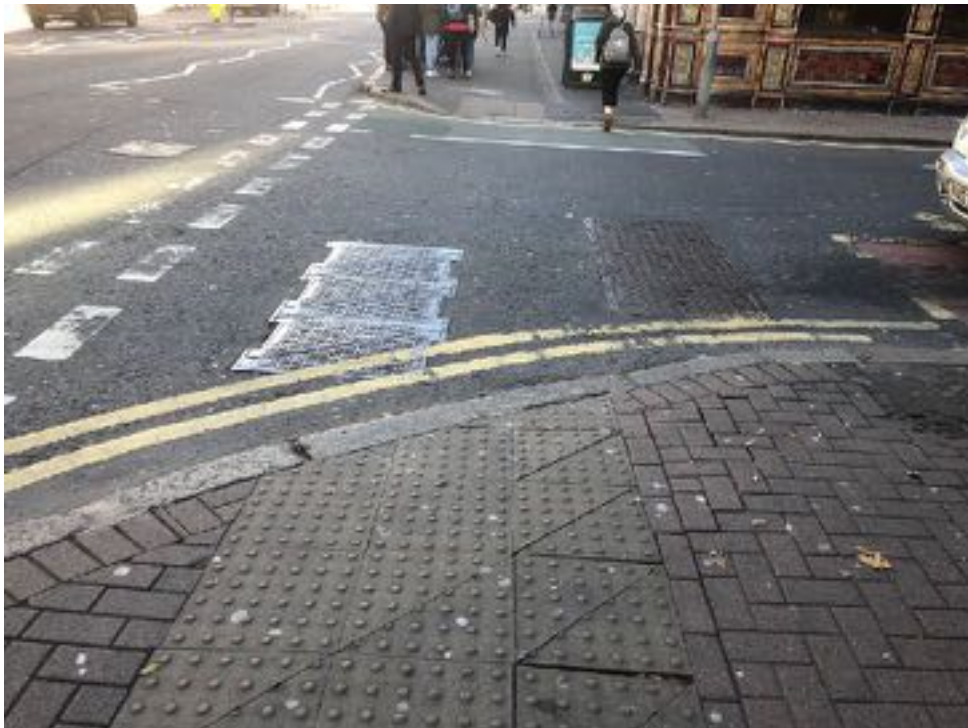
There is an in-line uncontrolled crossing across the junction with Amelia Street. Sections of the dropped kerb on both sides of the crossing have no tactile paving. An A Board associated with the Crown obstructs the footway on the northern side.

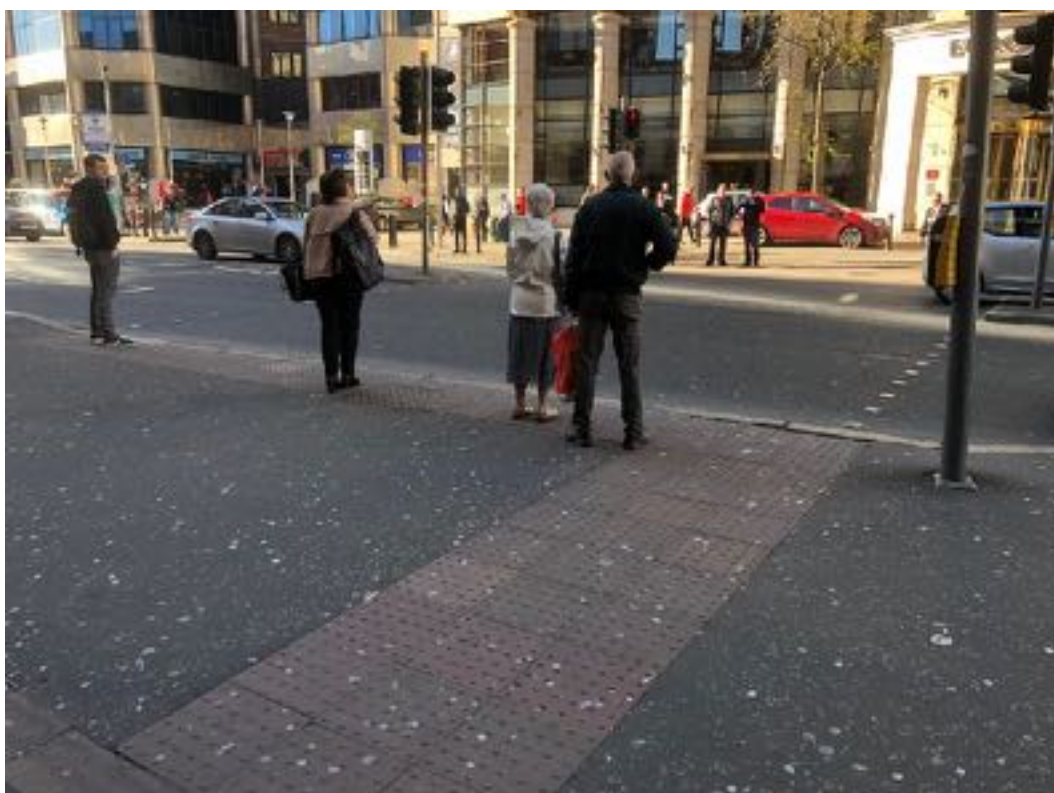
There is a wide controlled crossing across Great Victoria Street at this point providing access to the Europa Bus Station. Although installed correctly feedback from participants indicates crossing times are too short.

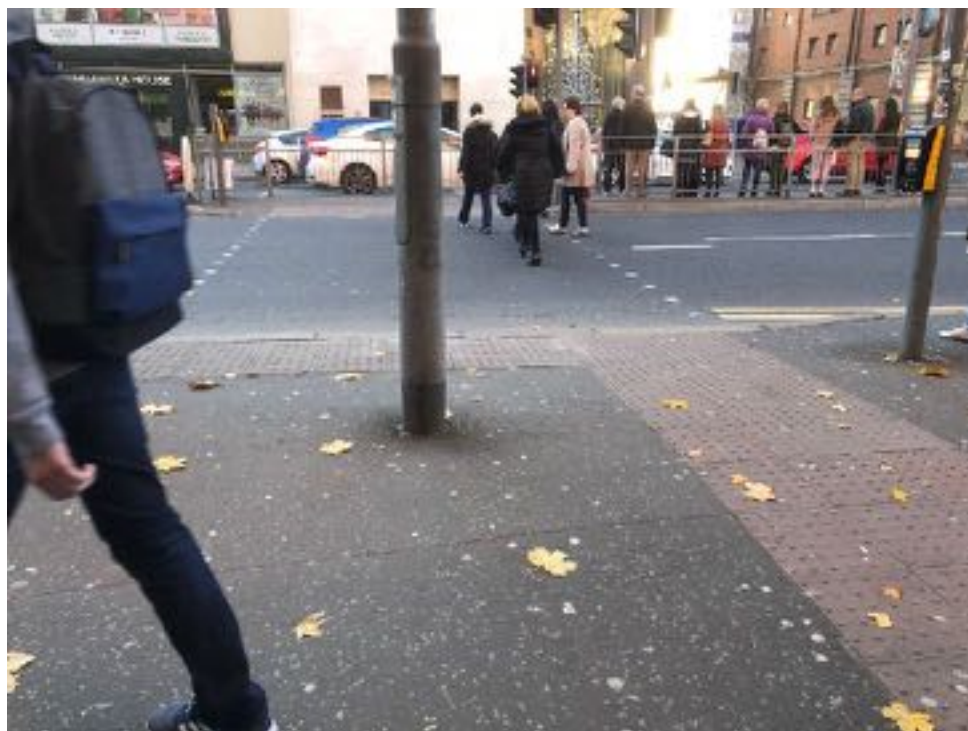
There is a staggered controlled crossing across Great Victoria Street close to its junction with Howard Street. Although installed correctly the location of a lighting column close to the centre of the crossing creates an obvious hazard. The traffic island is too narrow for the level of pedestrian usage.

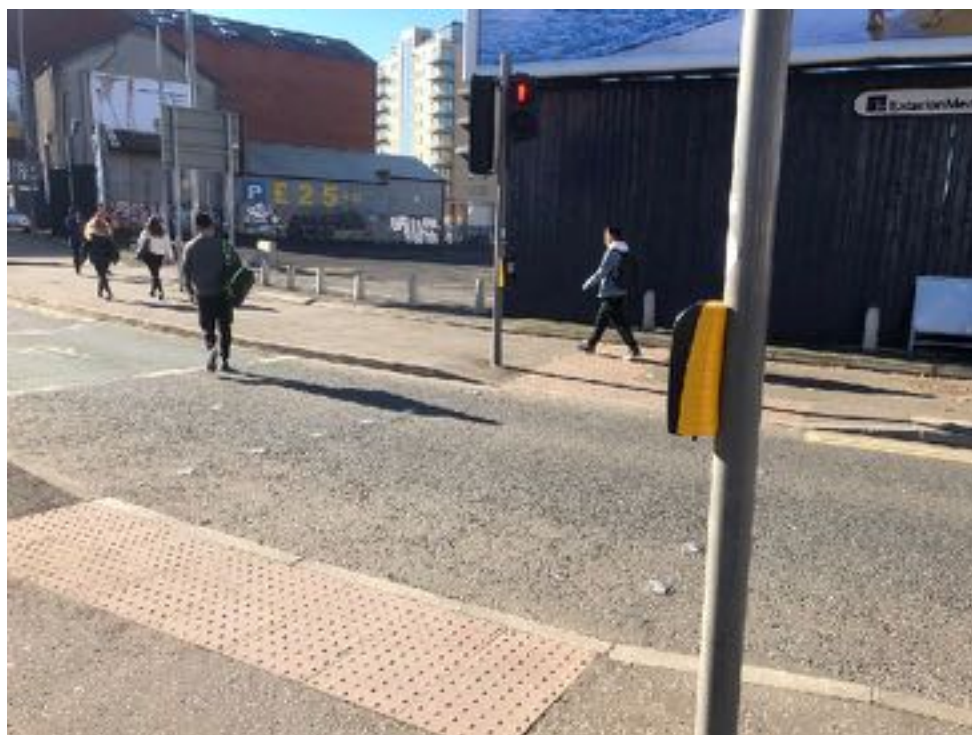
Returning to the western footway at the junction with Hope Street there is a controlled crossing from the triangular traffic island across the slip lane off Great Victoria Street onto Bruce Street. Tactile paving and control boxes have been installed correctly.
