Recommendations from Imtac on public realm proposals for Belfast Streets Ahead Phase 5

(November 2018)

Street audit findings

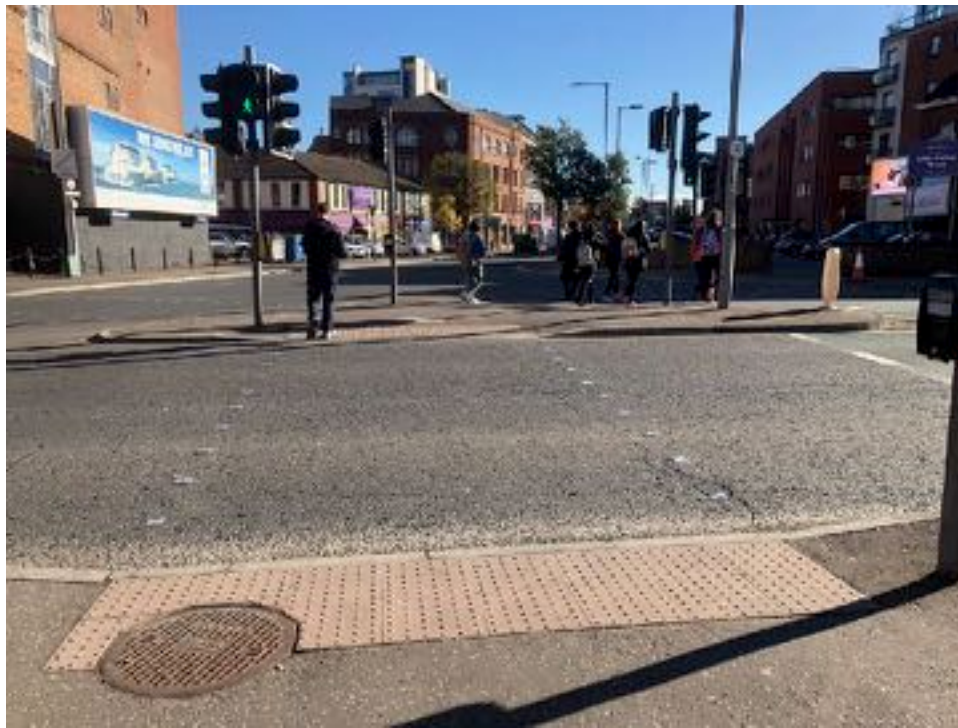
There is further controlled crossing across Great Victoria Street from this traffic island to a second triangular traffic island. Using this type of infrastructure creates a challenging environment for some disabled people. Due to the number of crossings in close proximity no audible signal is provided, although tactile cones are provided with control boxes.

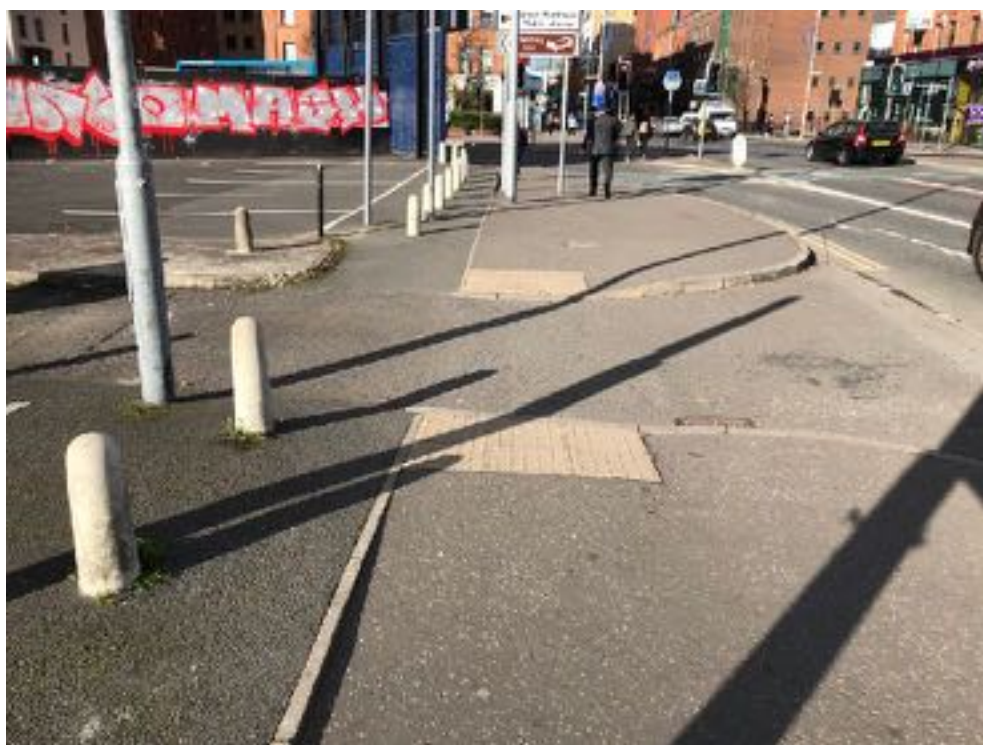
Continuing south towards Queens there is an in-line uncontrolled crossing across the entrance to a disused car park. This should be removed and a continuous footway provided.

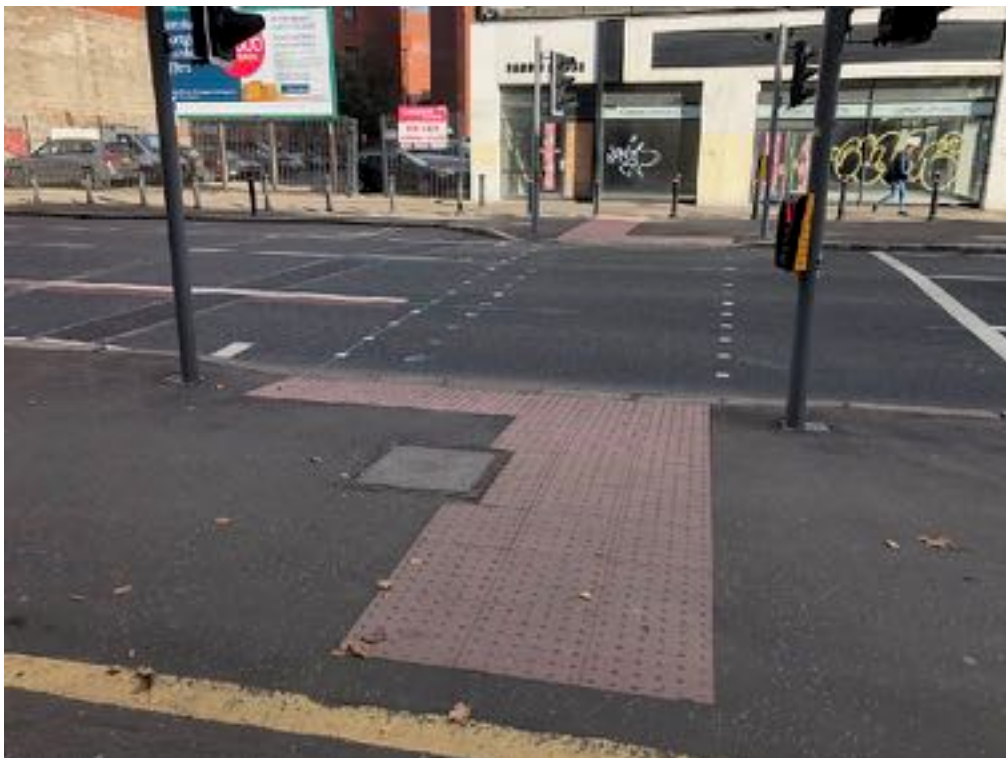
There is a controlled crossing across Great Victoria Street close to the junction with Wellwood Street. Tactile paving and control boxes have been installed correctly.

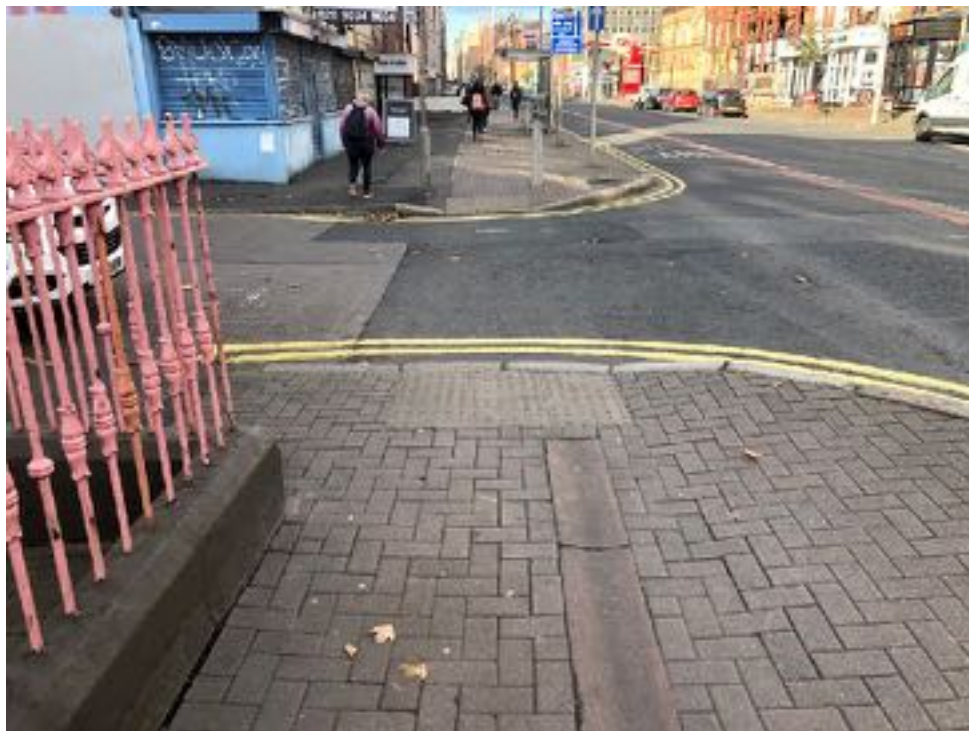
There is an in-line uncontrolled crossing across the junction with Stroud Street. A bollard creates an obvious hazard on the northern side. Contrast between the tactile and surrounding paving is an issue as is the depth of the tactile on both sides. A section of the kerb on the southern side is dropped without tactile.

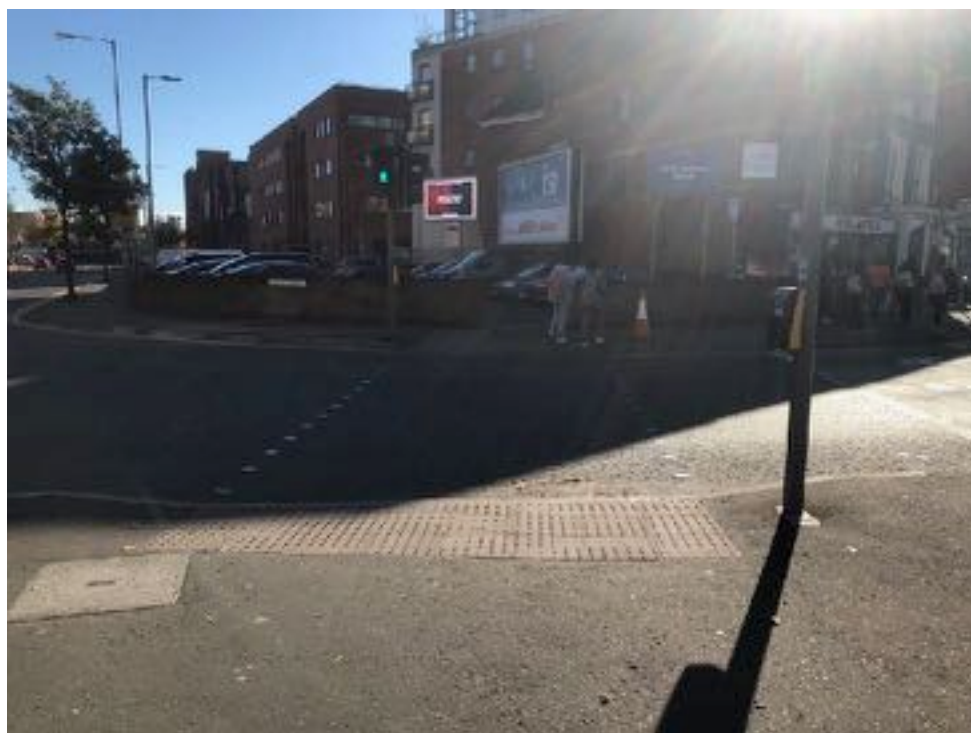
There is a controlled crossing from the triangular traffic island across Great Victoria street to the eastern footway at its junction with Bruce Street. Tactile paving and control boxes have been installed correctly.

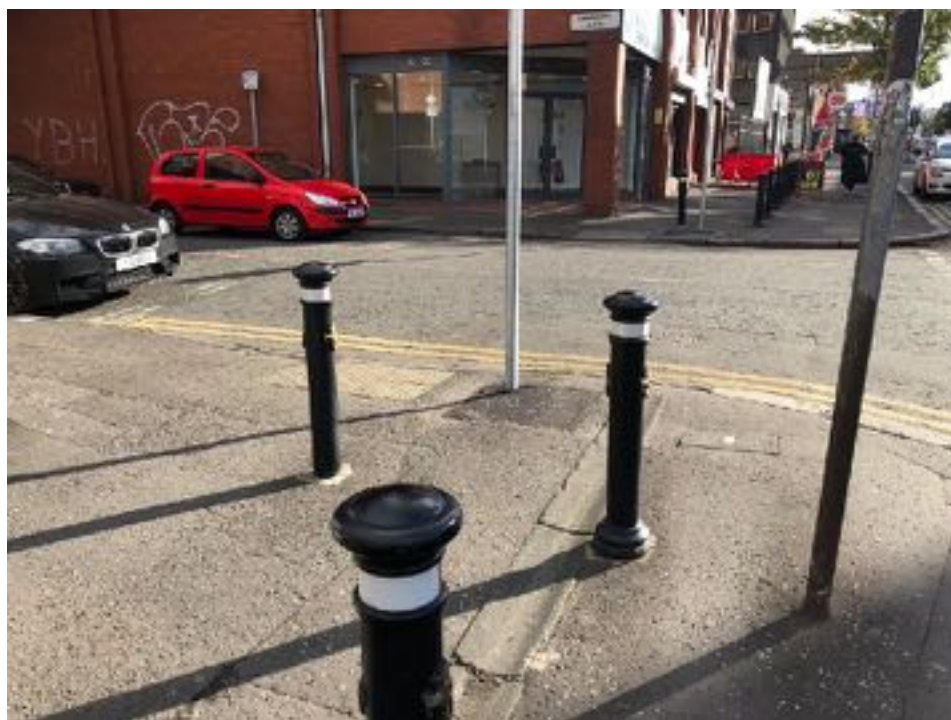
Bollards and traffic signs create multiple potential hazards approaching the in-line uncontrolled crossing across Downshire Place. Tactile paving depth is an issue at this crossing. The footway on the southern side is obstructed by bollards, a pavement cafe and A-Boards.

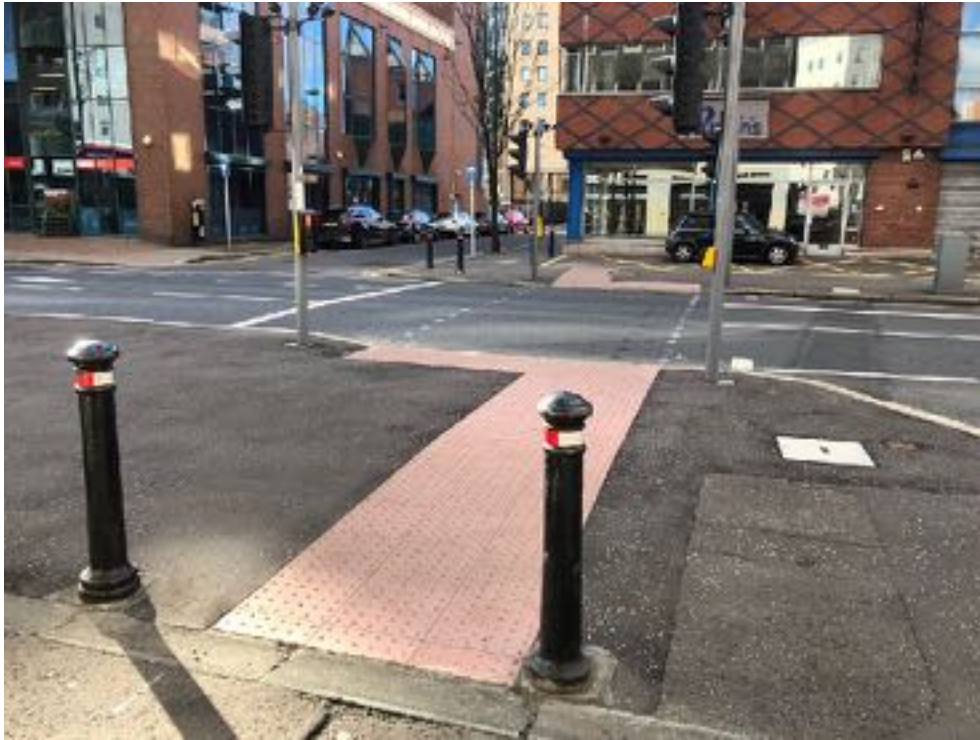
There is a controlled crossing across Great Victoria Street approaching its junction with Ventry Street. Although correctly installed bollards again create hazards.

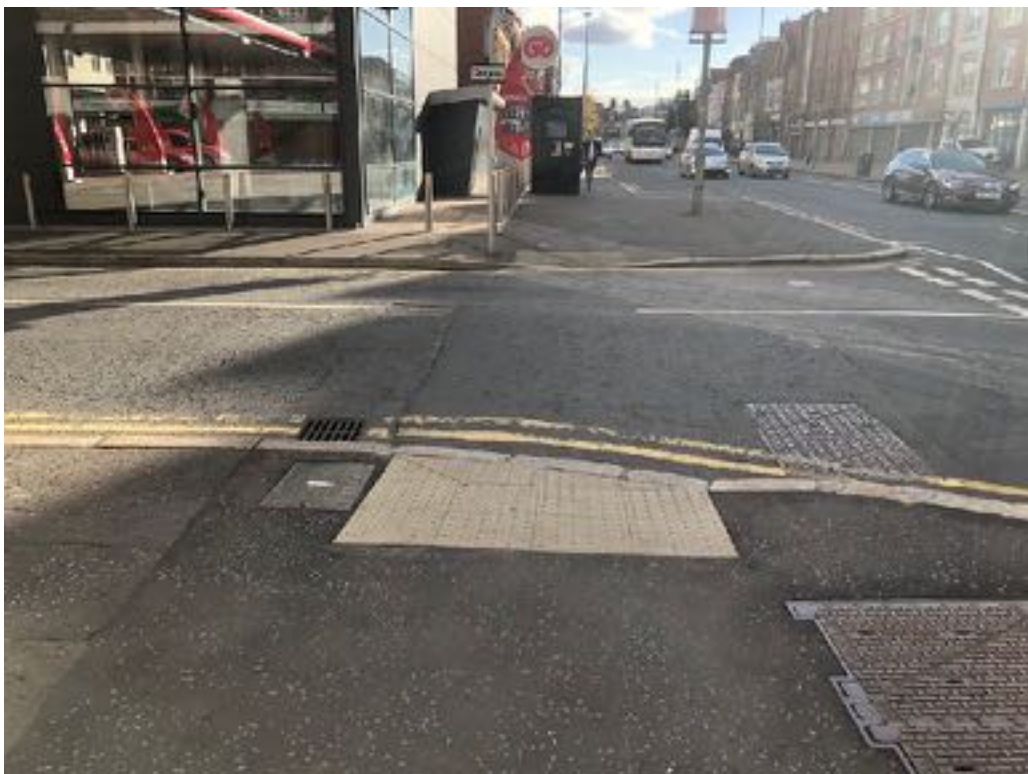
There is an in-line uncontrolled crossing across the junction with Ventry Street. Tactile paving depth is an issue. A BT kiosk obstructs all large part of the footway on the southern side of this crossing.

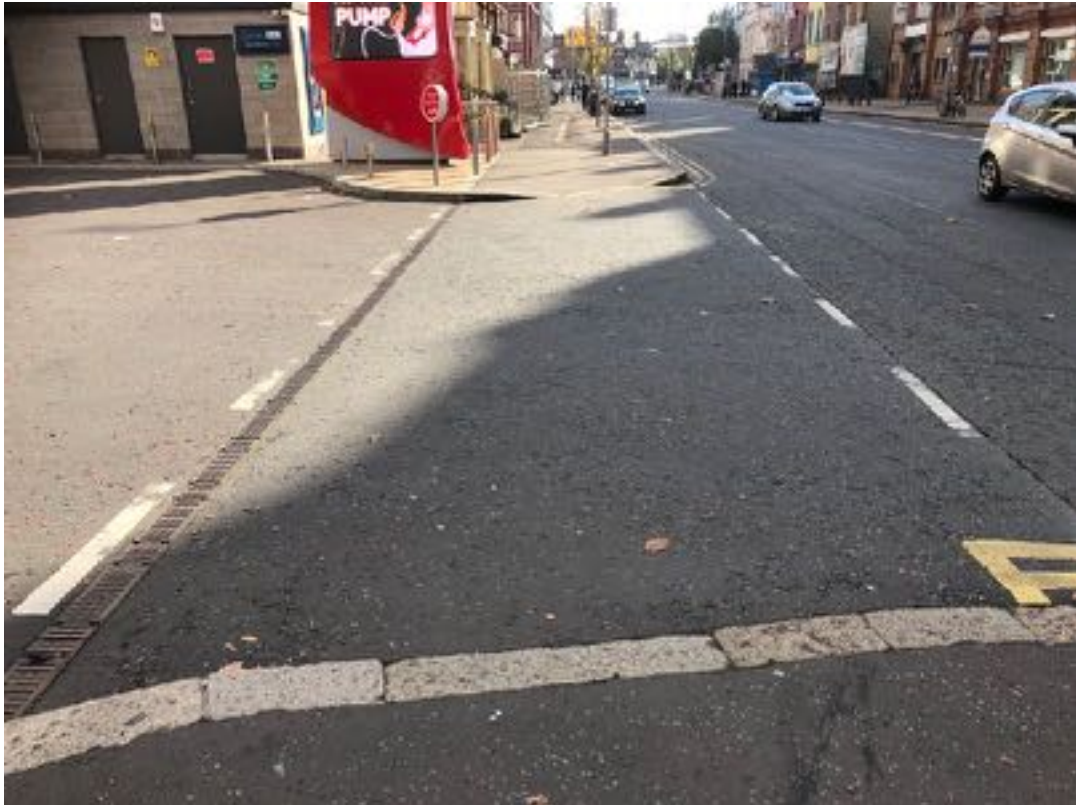
There is a wide entrance/exit to the filling station on Great Victoria Street. This entrance is flush with the footway but no tactile paving has been provided to warn pedestrians.

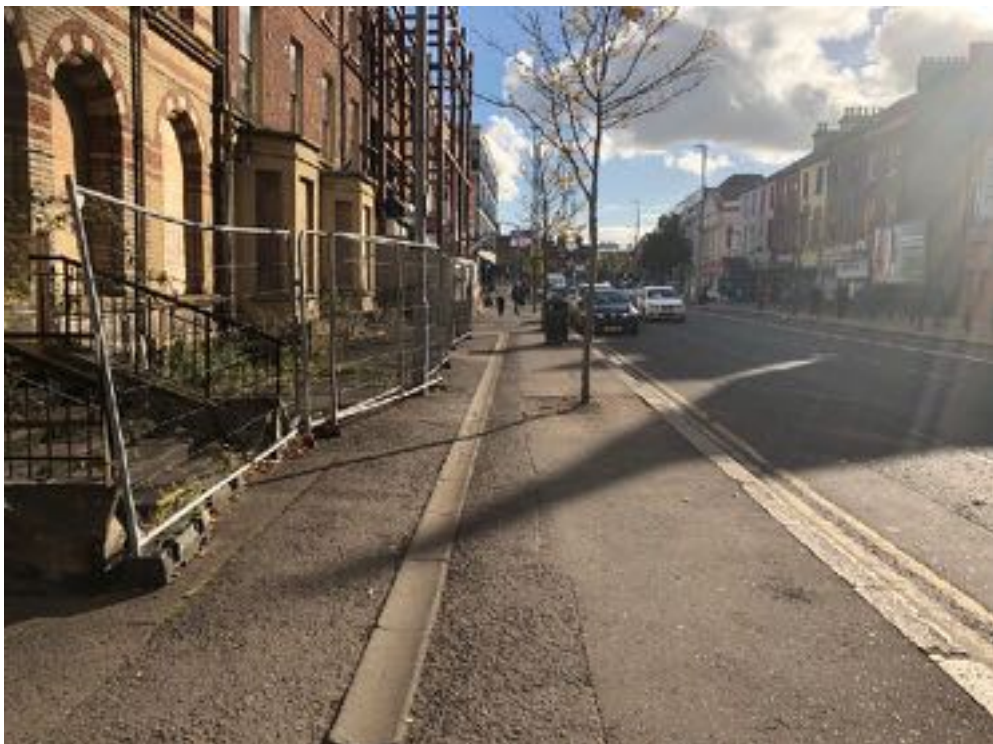
Continuing towards Shaftesbury Square the eastern footway is rough and uneven and a deep dish drainage channel runs up its centre. Derelict buildings with security fencing mean this area is unattractive. Participants in the audit felt they would avoid using this area.

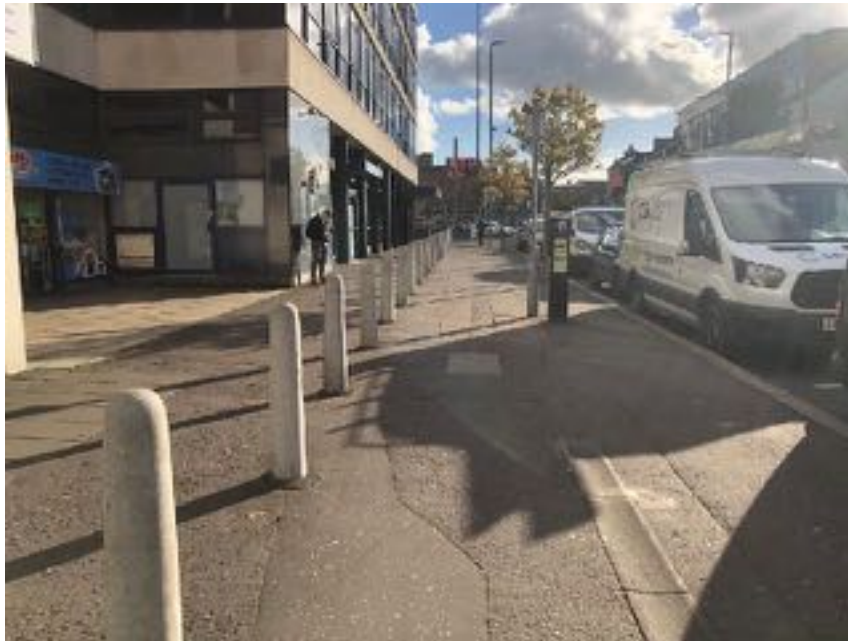
Bollards reappear to obstruct the footway on the approach to Shaftesbury Square which together with trees and street furniture reduce the useful pavement width.

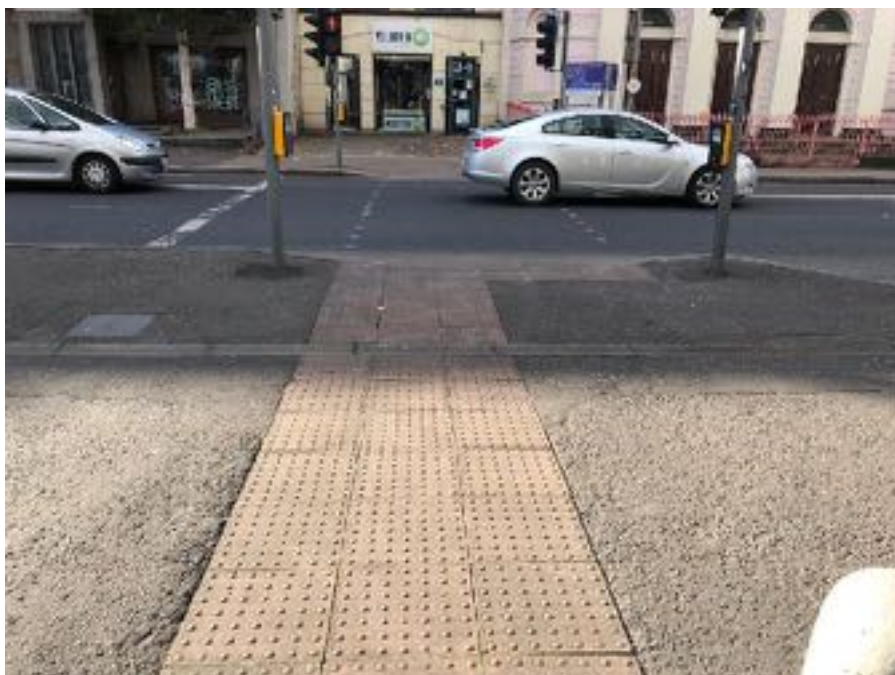
There is controlled crossing on the western side of Shaftesbury Square beside the offices of Volunteer Now. The tactile paving on both sides has been laid incorrectly with the tail to the left rather than the right, however control boxes are included on both left and right signal columns.

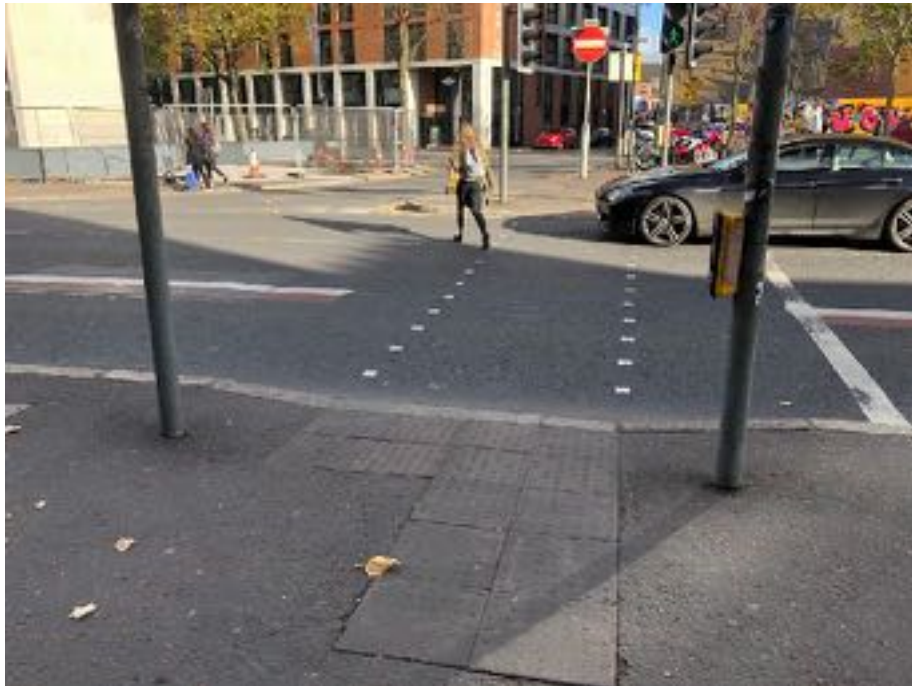
There is another controlled crossing from the western footway of Shaftesbury Square across the northbound traffic lanes to the large central traffic island. Again the positioning of the tactile paving is incorrect with the tail to the left.

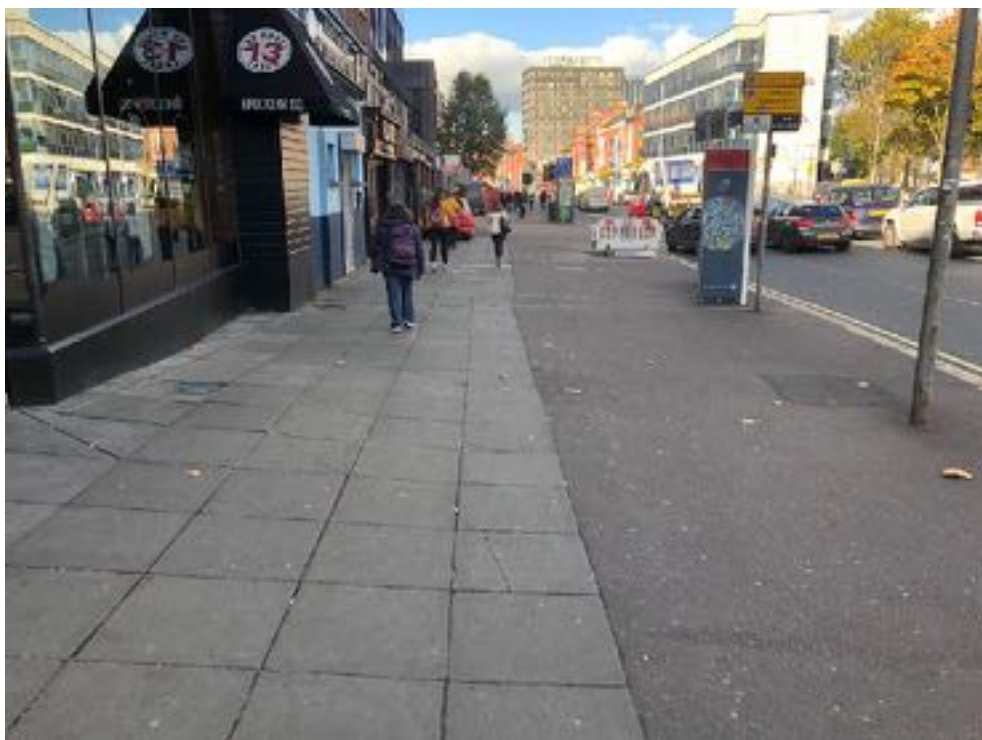
The western footway approaching the junction with Donegall Road is broad. The surface is rough and uneven. Parked cars, vans and a skip create potential obstructions.

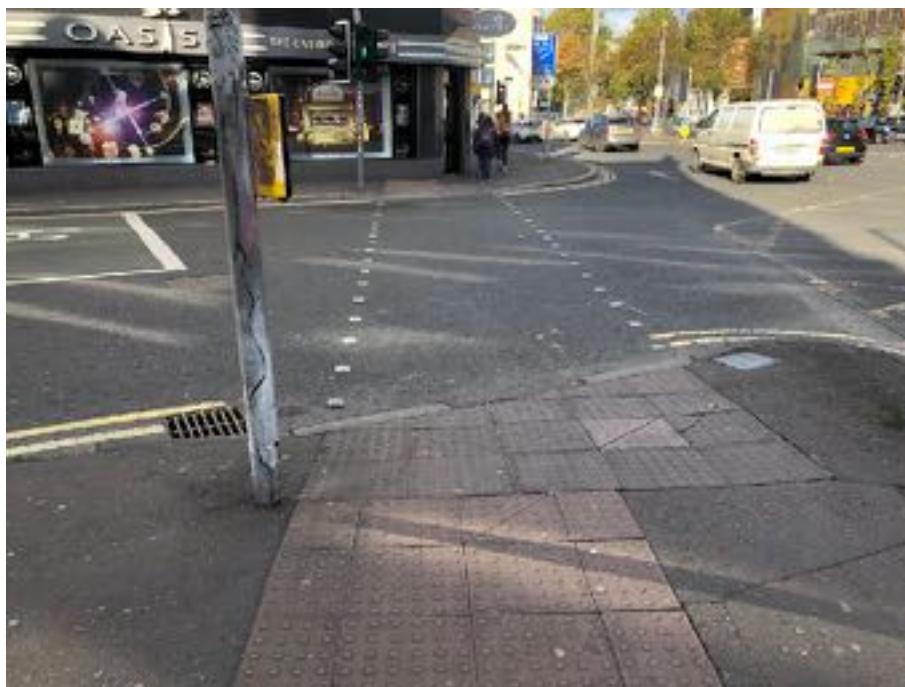
There is a controlled crossing between Shaftesbury Square and Bradbury Place at its junction with Donegall Road. The tactile paving has been laid incorrectly on the southern side and the control box incorrectly positioned on the southern side. The tactile paving is loose and uneven in places.

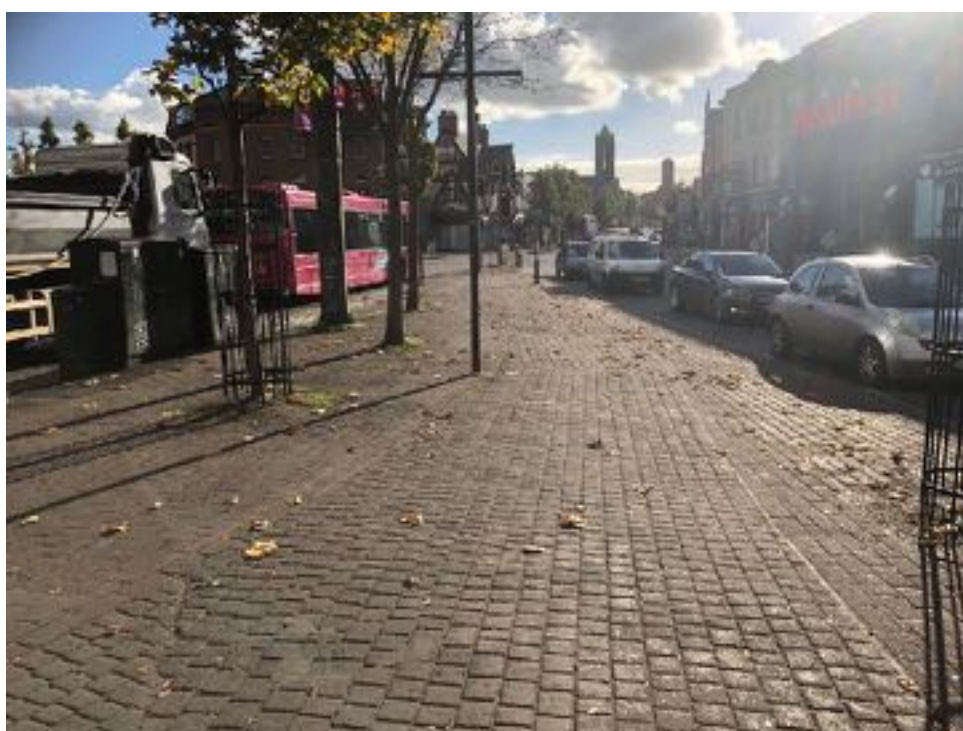
There are two large central traffic islands and several smaller island/refugees providing pedestrian access across Shaftesbury Square. These islands through a series of controlled and uncontrolled crossings provide pedestrian connections from the west and south footways to the northern and eastern footways. Navigating this space independently will be a challenge for some disabled people.

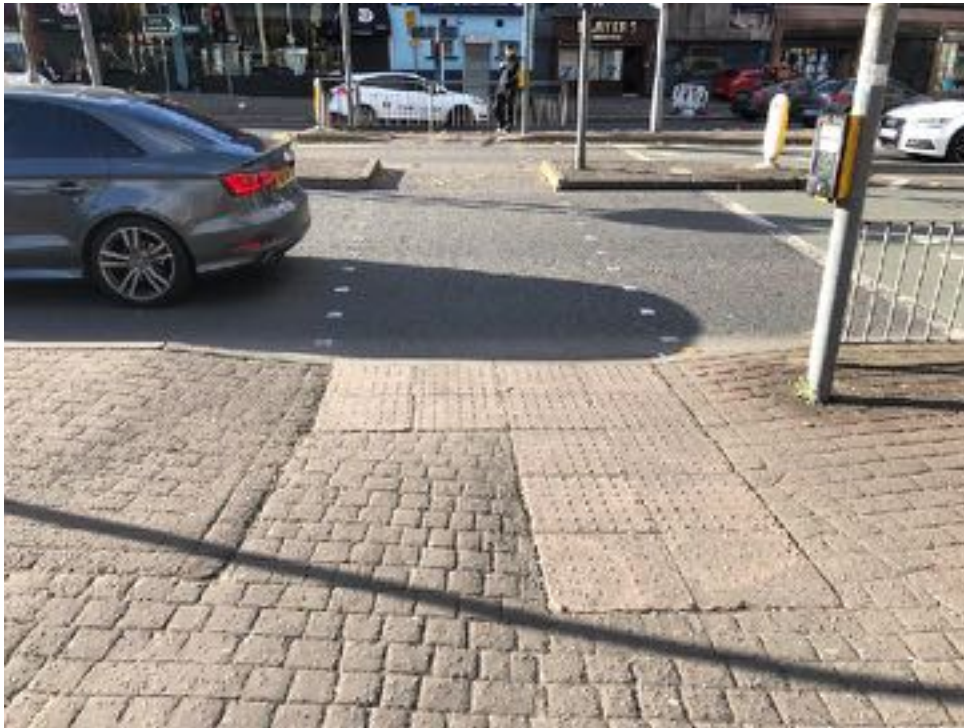
There is controlled crossing connecting the larger central islands. Tactile paving does not contrast with surrounding paving. Tactile paving and control box have been installed incorrectly on the western island.

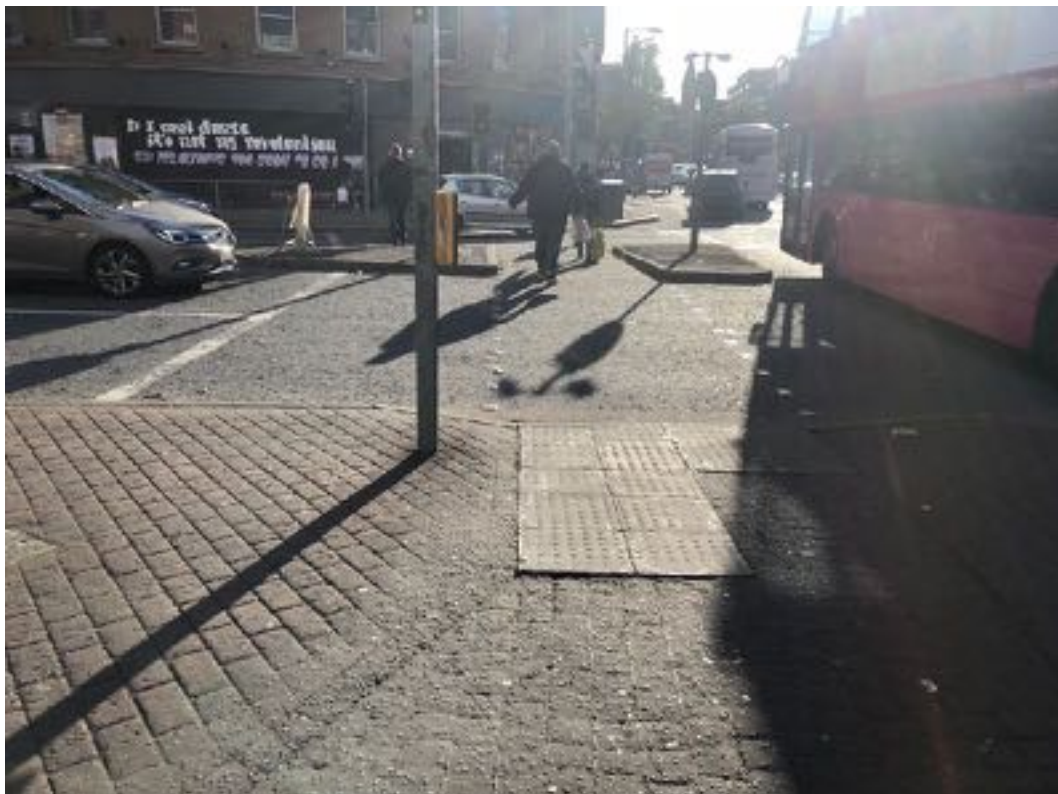
There is another controlled crossing connecting the eastern traffic island with the southern footway of Shaftesbury Square. Once again there is an issue with contrast and the positioning of tactile paving and the control box.

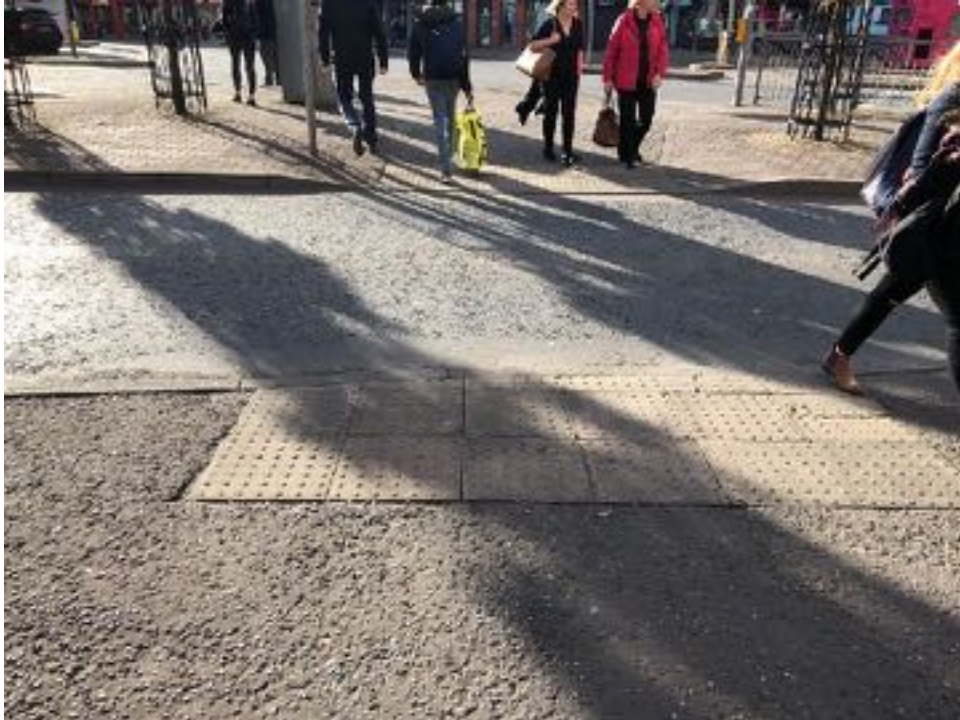
An inline uncontrolled crossing provides access between the eastern traffic island and the eastern footway of Shaftesbury Square. Condition of footways and tactile paving is poor.

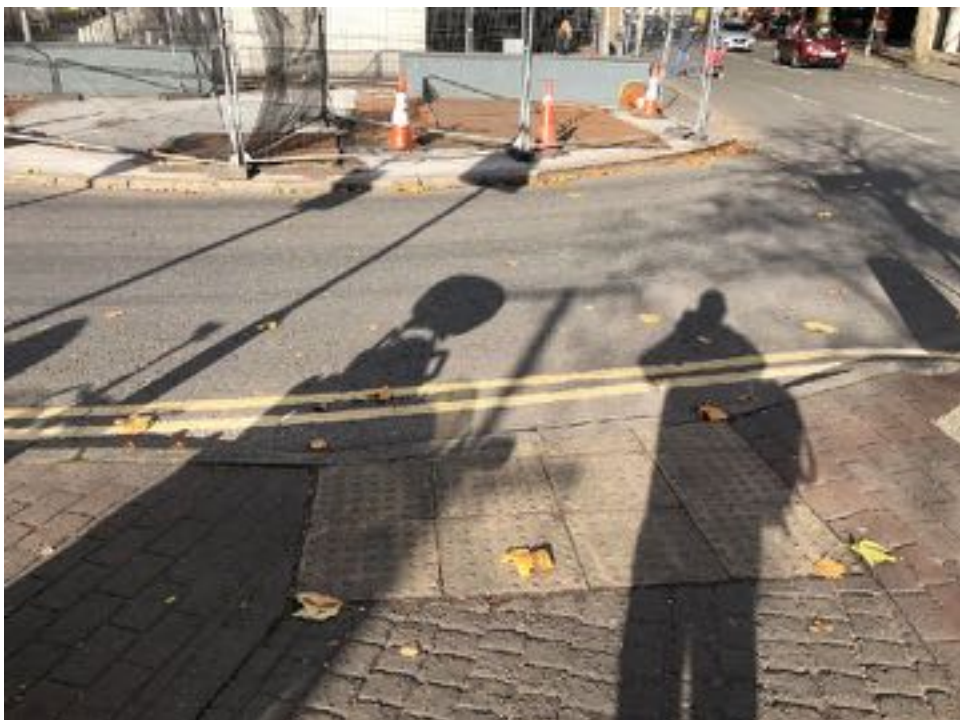
Access from the large western island is provided to the northern central footway of Shaftesbury Square via two inline uncontrolled crossings situated at each end of the single lane link road. One of these crossings has been blocked by development works.

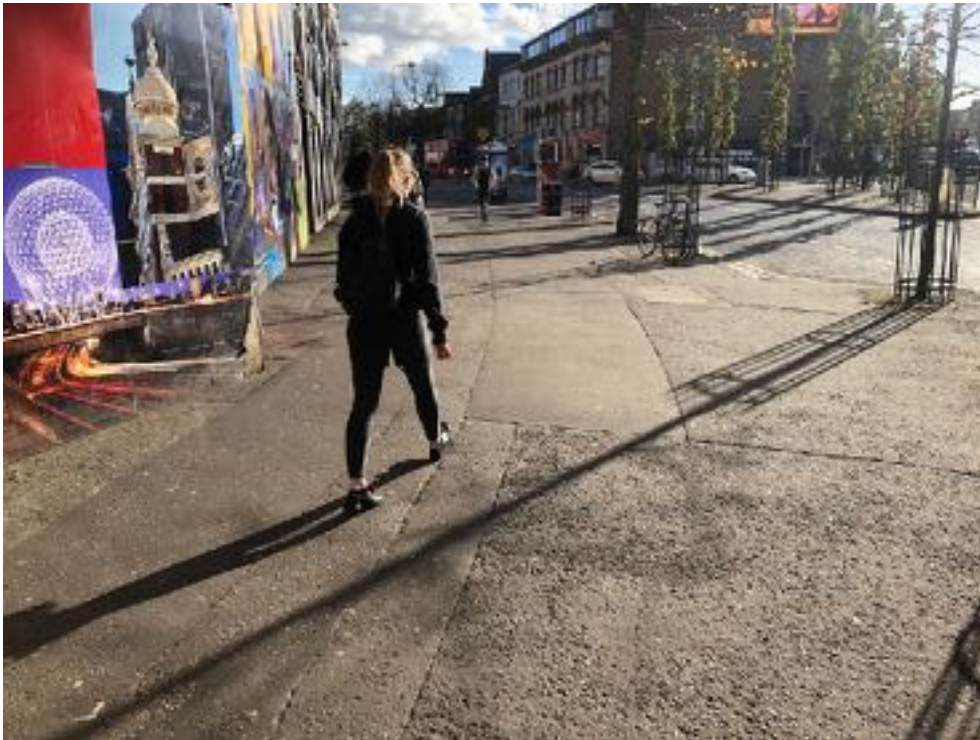
The footway on eastern side of Shaftesbury Square outside Equality House is broad although rough and uneven.

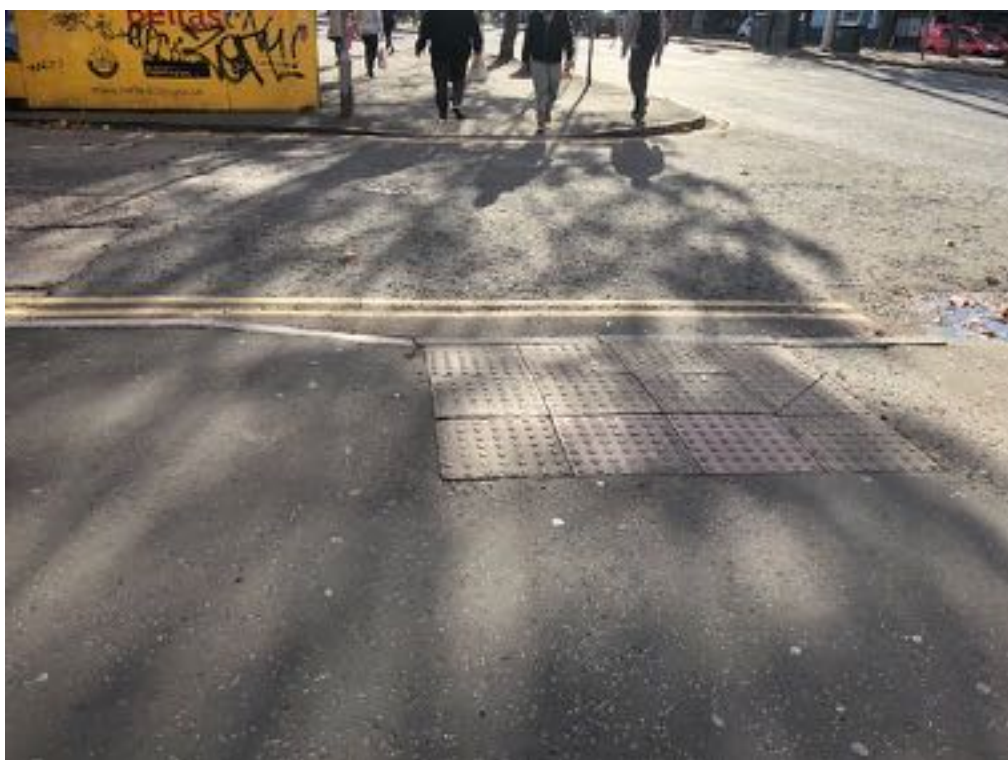
There is an inline uncontrolled crossing across the side street between the eastern footway of Shaftesbury Square and Dublin Road. Different colours of tactile paving slab have been used.

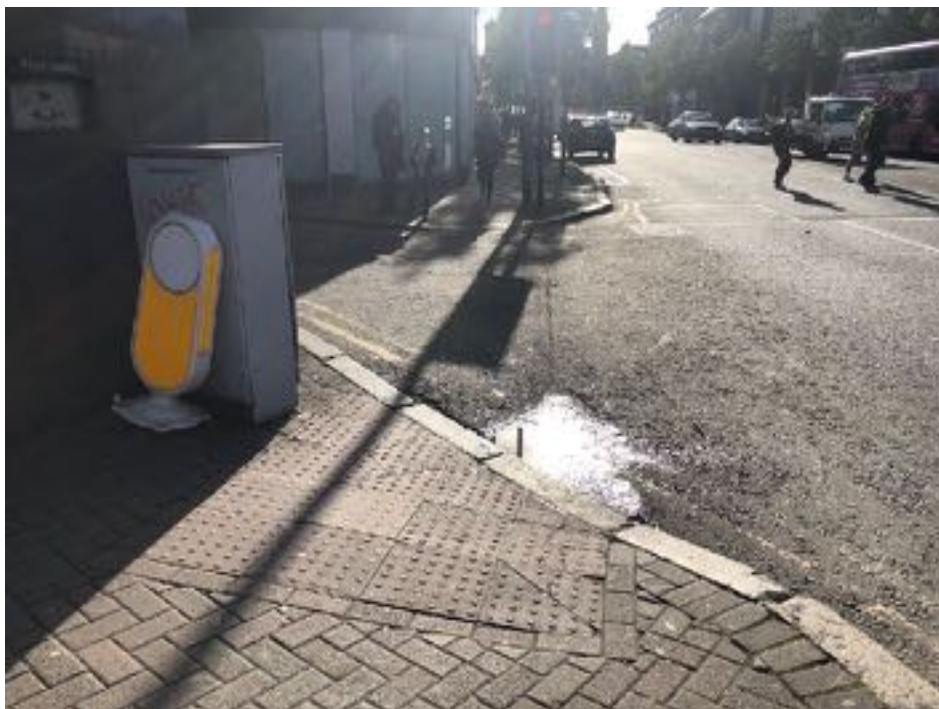
There is an uncontrolled crossing across Albion Lane at its junction with Bradbury Place. The tactile paving does not contrast and is not in line.

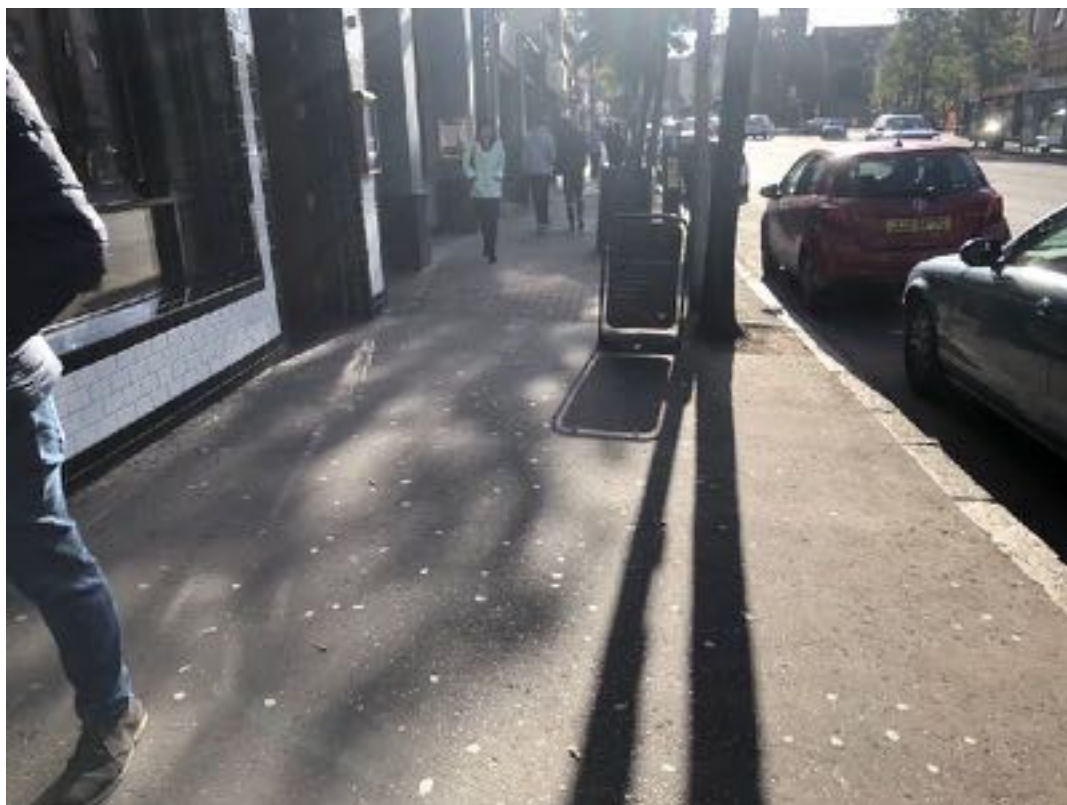
A-Boards restrict width on the busy eastern footway which also accommodates street furniture, trees and a bus shelter.

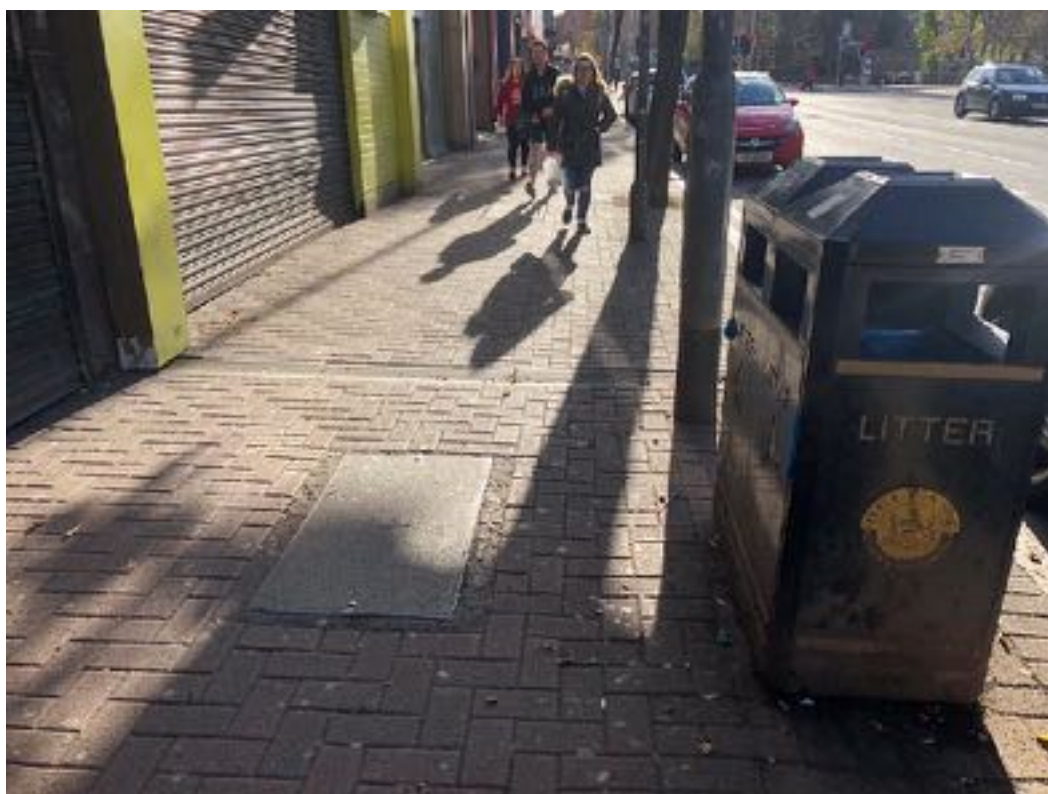
Deep dish drainage channels as used across the footway.

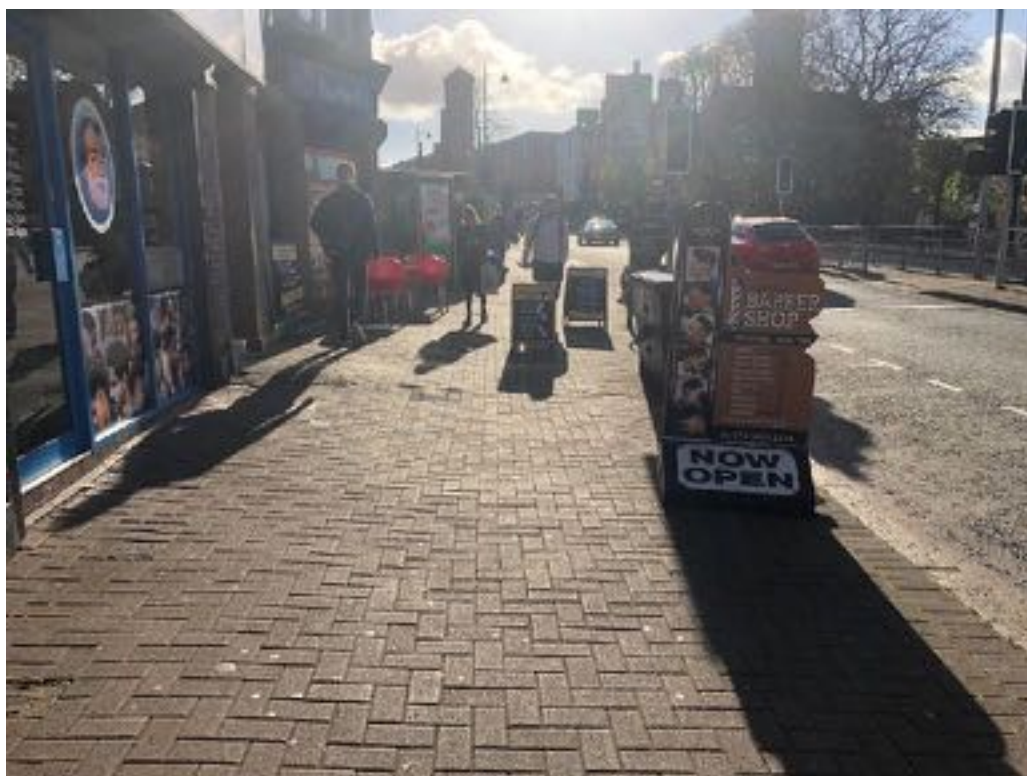
Problems with pavement clutter including numerous A-Boards intensify close to the crossing at the junction with University Road.

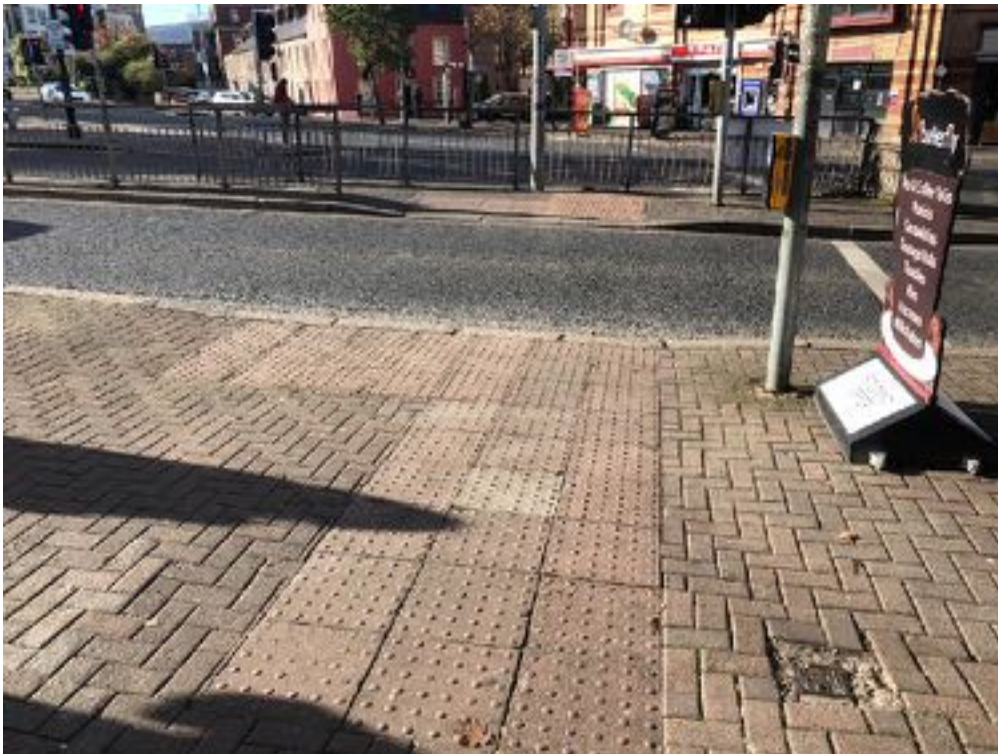
There is a staggered controlled crossing across Bradbury Place at its junction with University Road. The tactile and control box have been correctly installed on the eastern footway but not on the island. Contrast remains an issue.

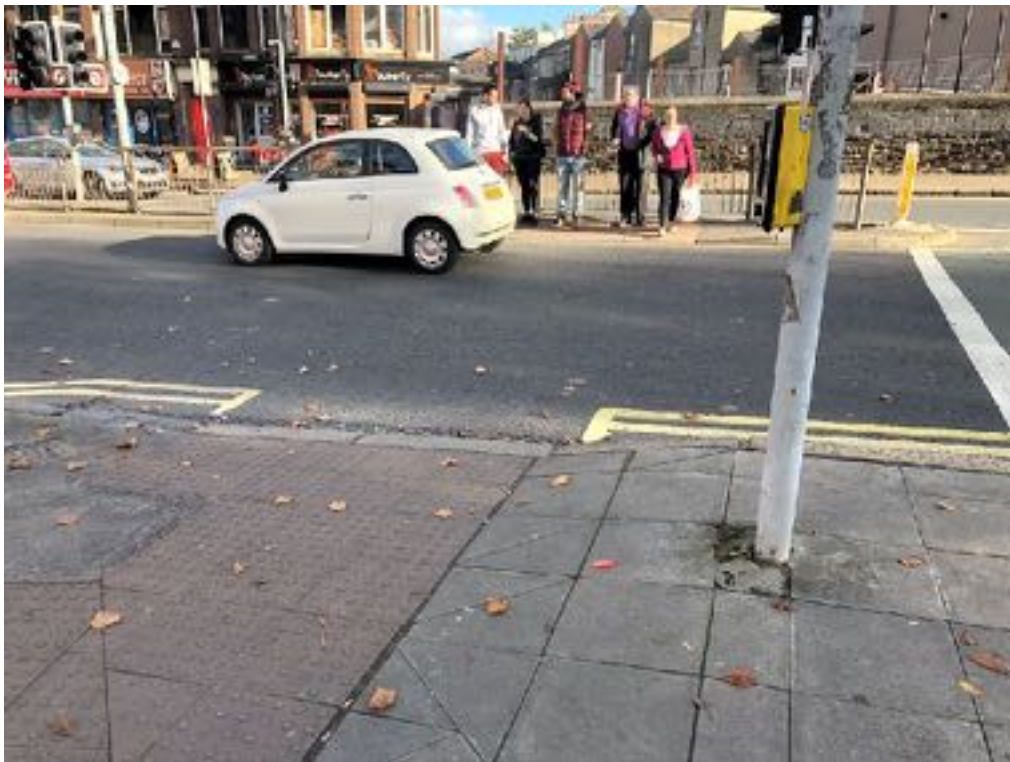
The positioning of control boxes and provision of tactile does not meet acceptable standards on the western side of the crossing.

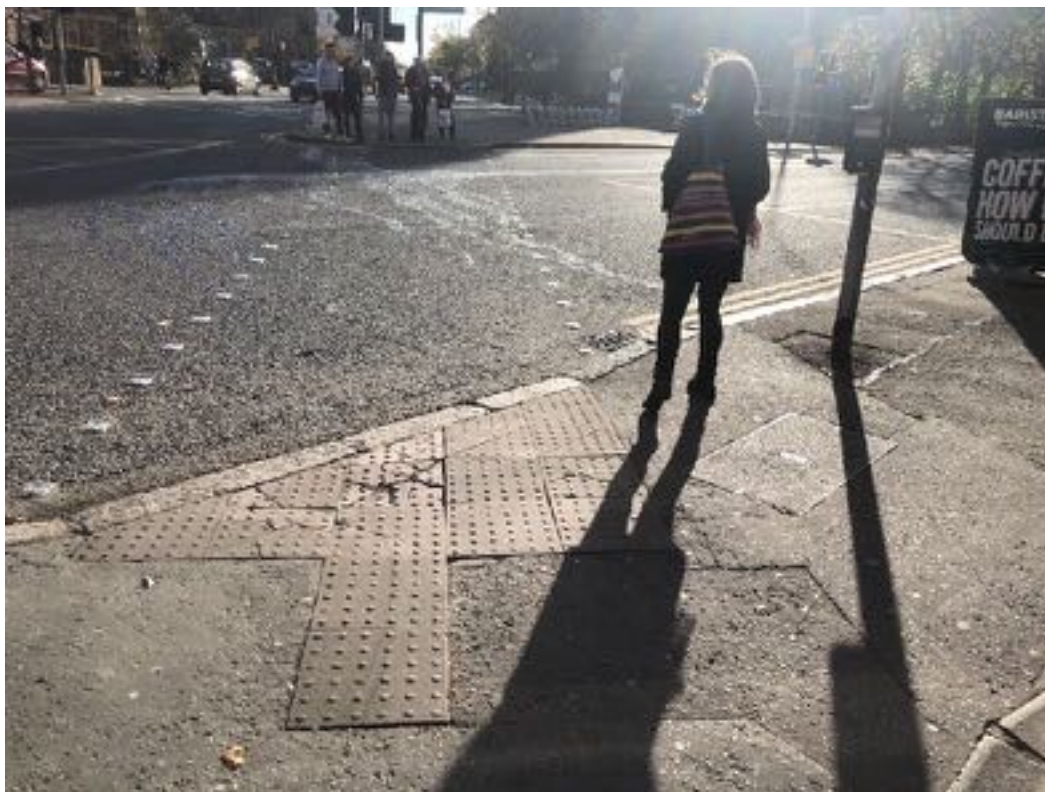
There is a controlled crossing across the junction with Lisburn Road providing access to the western footway of Bradbury Place. The provision of tactile paving and location control boxes is extremely poor at this crossing particularly on the southern side and does not meet acceptable standards.
