Recommendations from Imtac on public realm proposals for Belfast Streets Ahead Phase 5

(November 2018)

Street audit findings

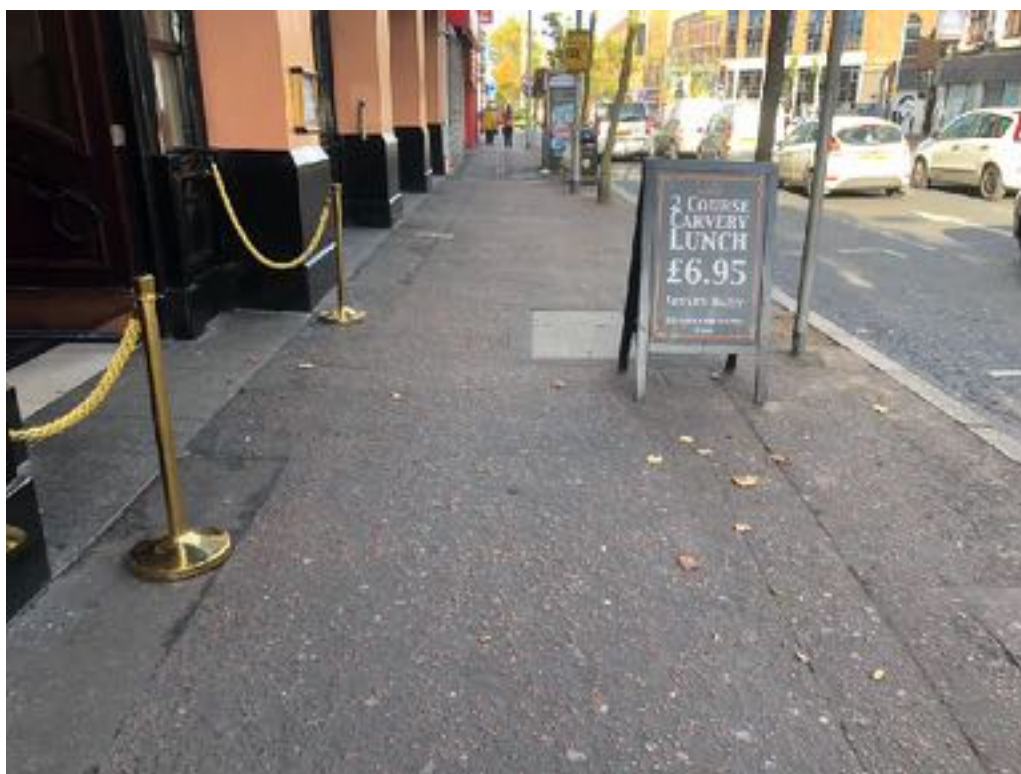
A-Boards in places reduce the broad footway width on the western side of Bradbury Place.

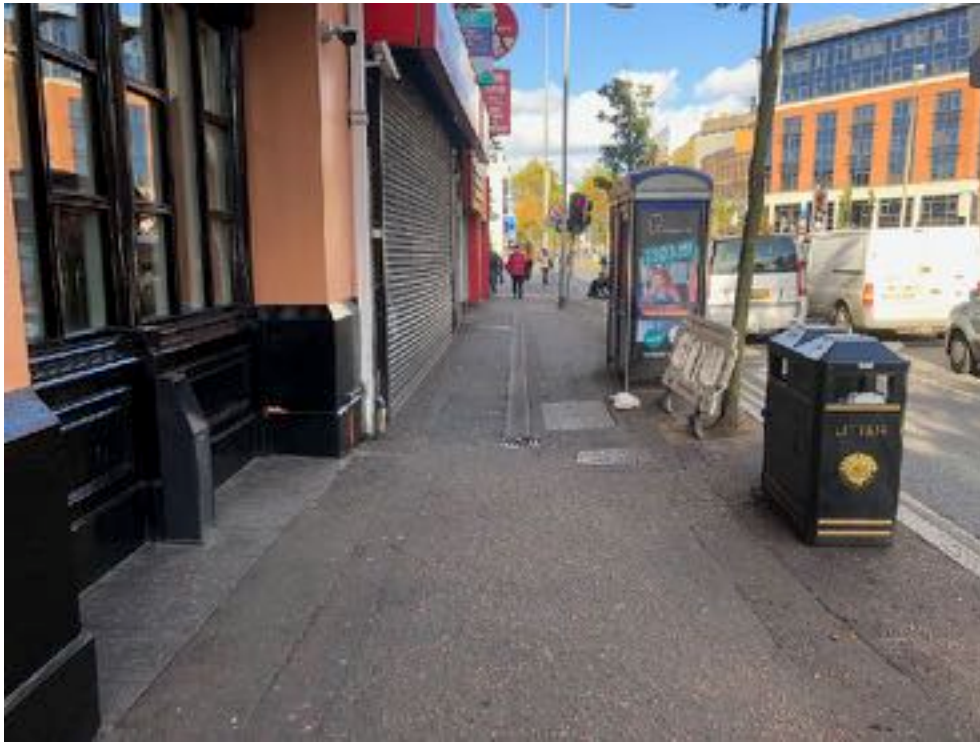
A deep dish drainage channel runs down the centre of the footway approaching the junction with Donegall Road.

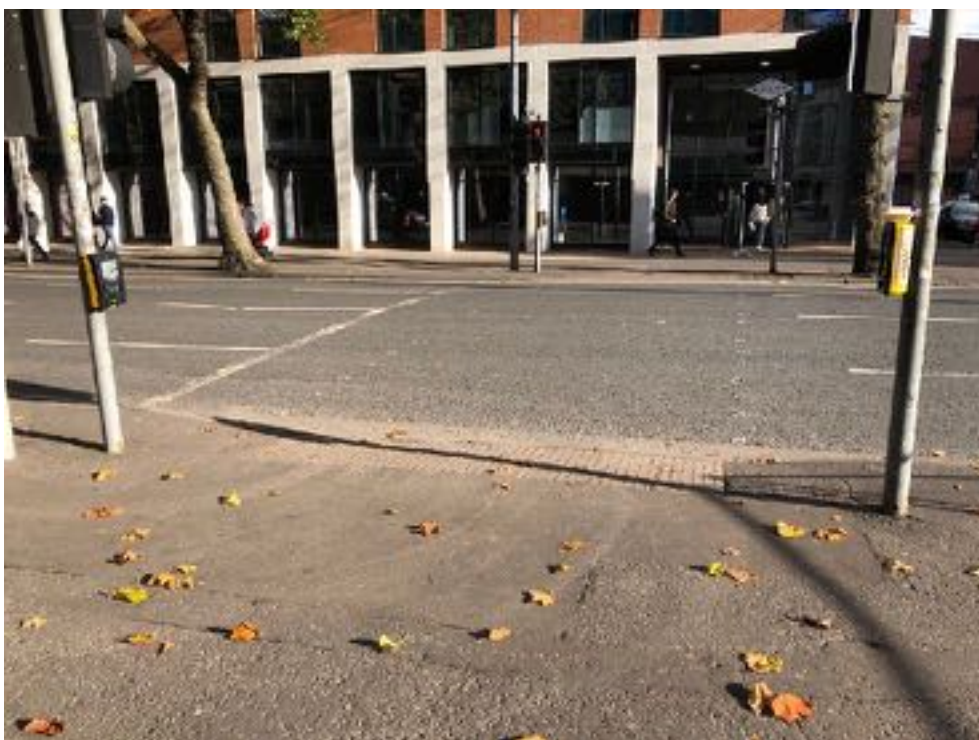
There is a controlled crossing across Dublin Road at its junction with Shaftesbury Square. There is no tactile tail on either side of the crossing.

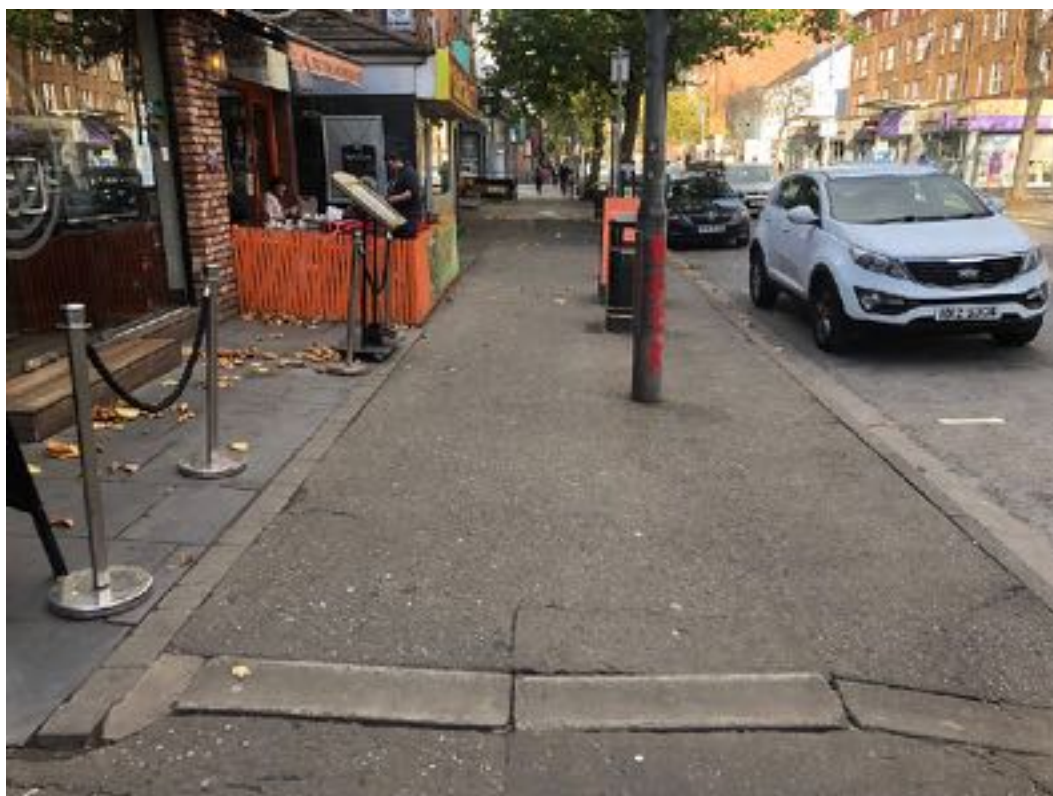
The footway on the western side is rough and uneven with deep dish drainage channels across the footway. The location of street furniture narrows the footway unnecessarily.

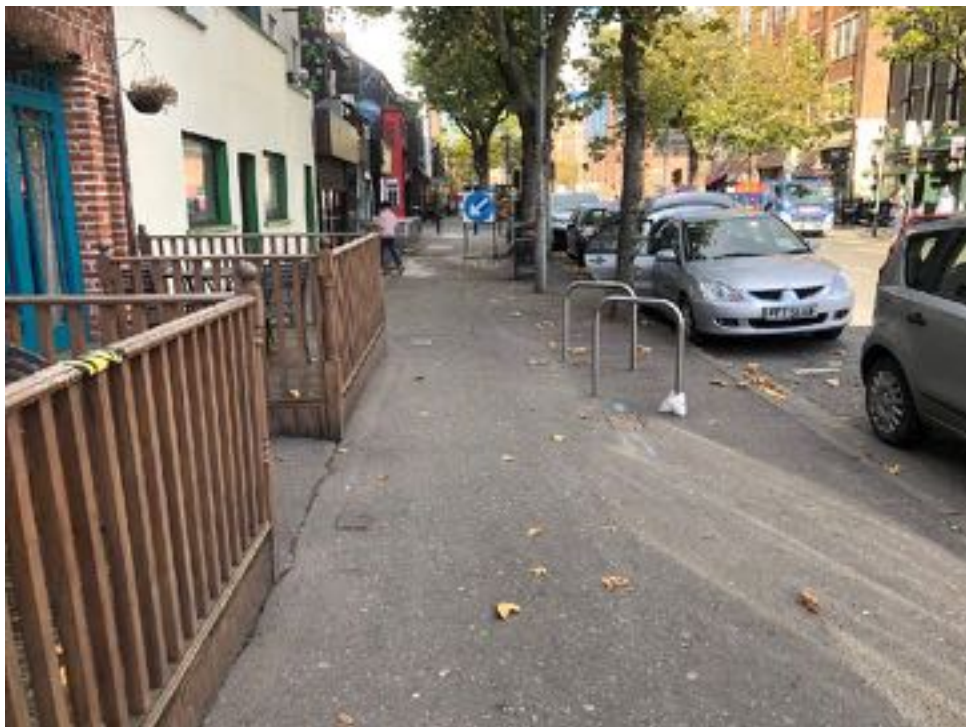
The orientation of cycle parking hoops and temporary road works signage create potential hazards on the footway.

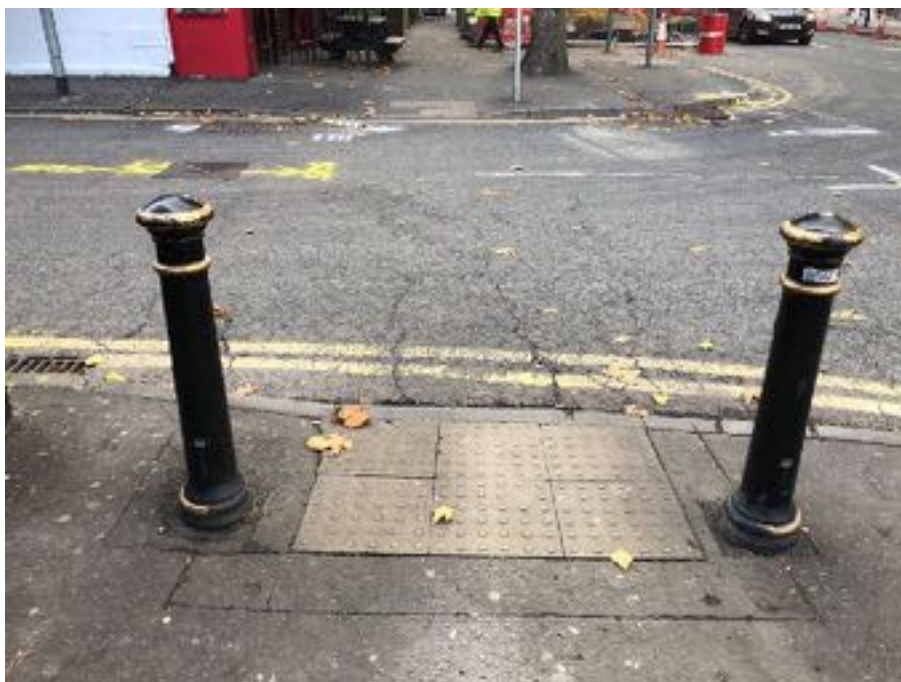
There is an in-line uncontrolled crossing across the northern junction with Ventry Street. Tactile paving is missing from the northern side and does not extend the full length of the dropped kerb. Depth of tactile is again a issue. A picnic bench on the northern footway creates a potential hazard as do bollards adjacent to the tactile paving.

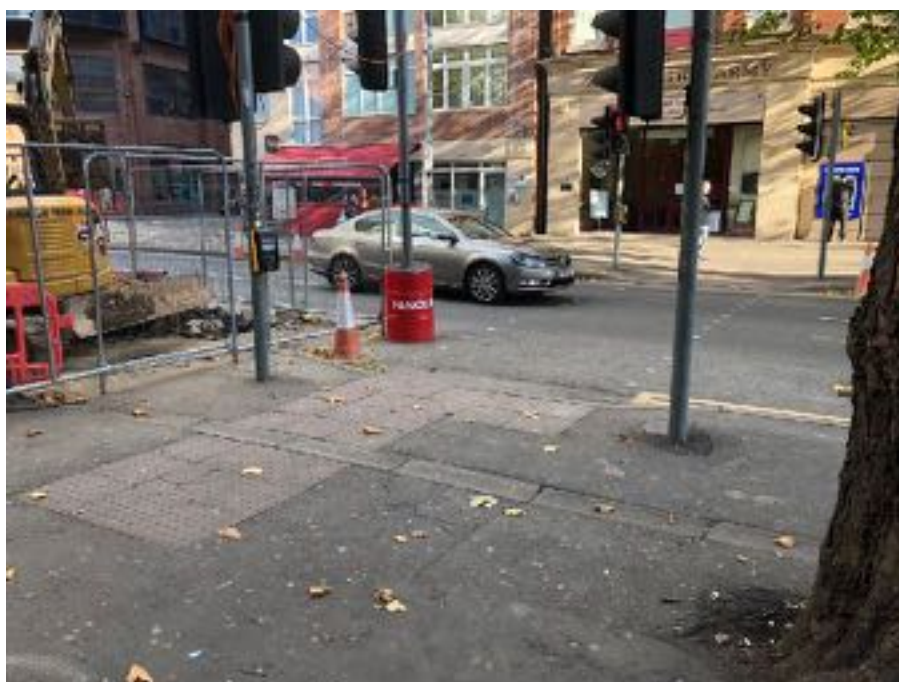
There is a controlled crossing across Dublin Road north of Ventry Street. Tactile paving and the control box have been installed incorrectly on the western footway. A deep dish drainage channel runs along the footway through the centre of the paving.

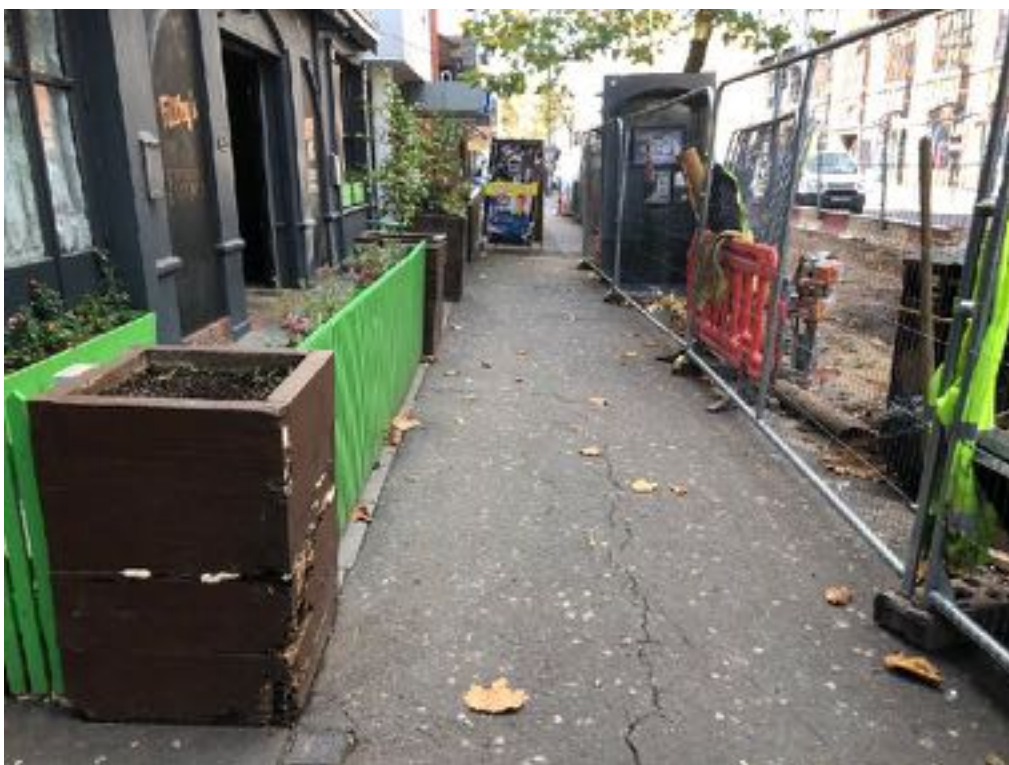
The western footway narrows considerably due to roadworks. A large A-Board almost completely obstructs the footway.

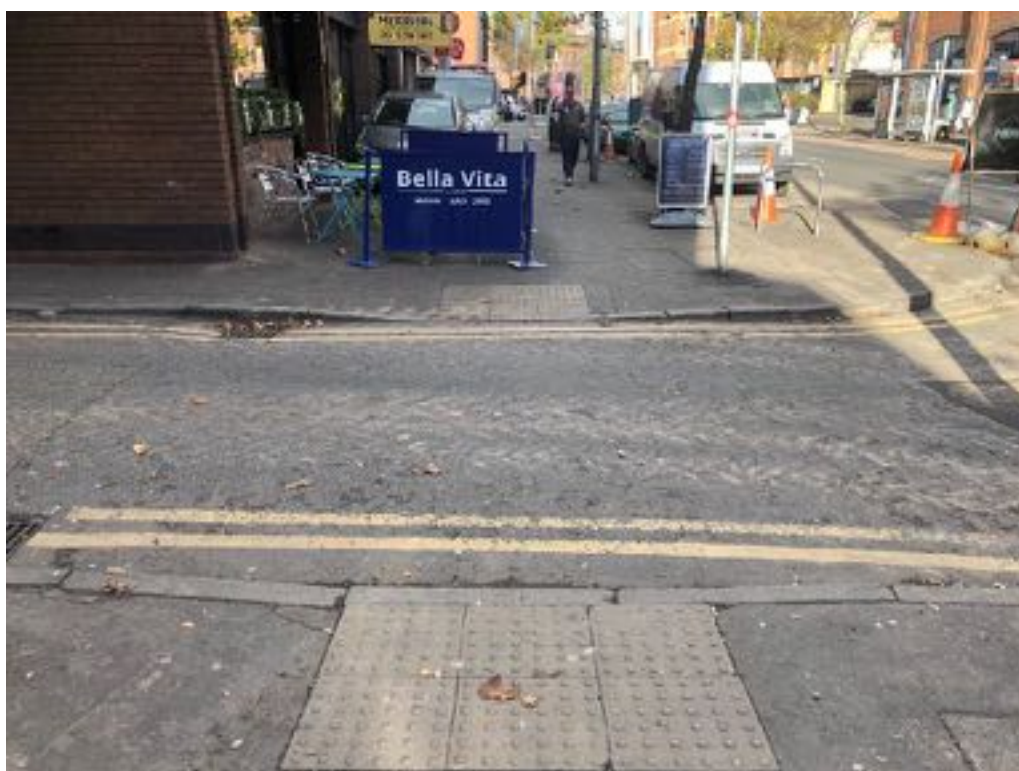
There is an in-line controlled crossing across Harmony Street. The depth of the tactile paving is an issue. There are multiple obstructions on the western footway including a pavement cafe, A boards and vehicles parked on the footway despite adjacent on-street parking.

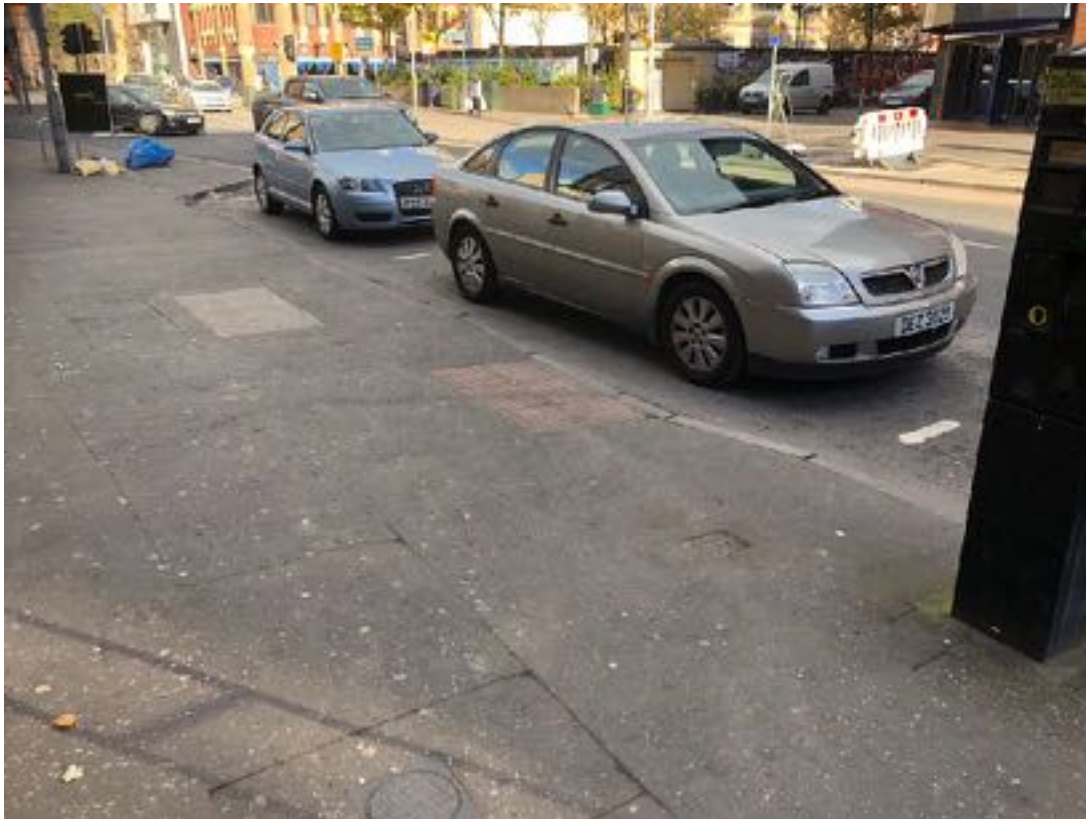
There is a single dropped kerb with tactile paving leading onto Dublin Road near the junction with Bruce Street. There is no similar arrangement on the eastern footway.

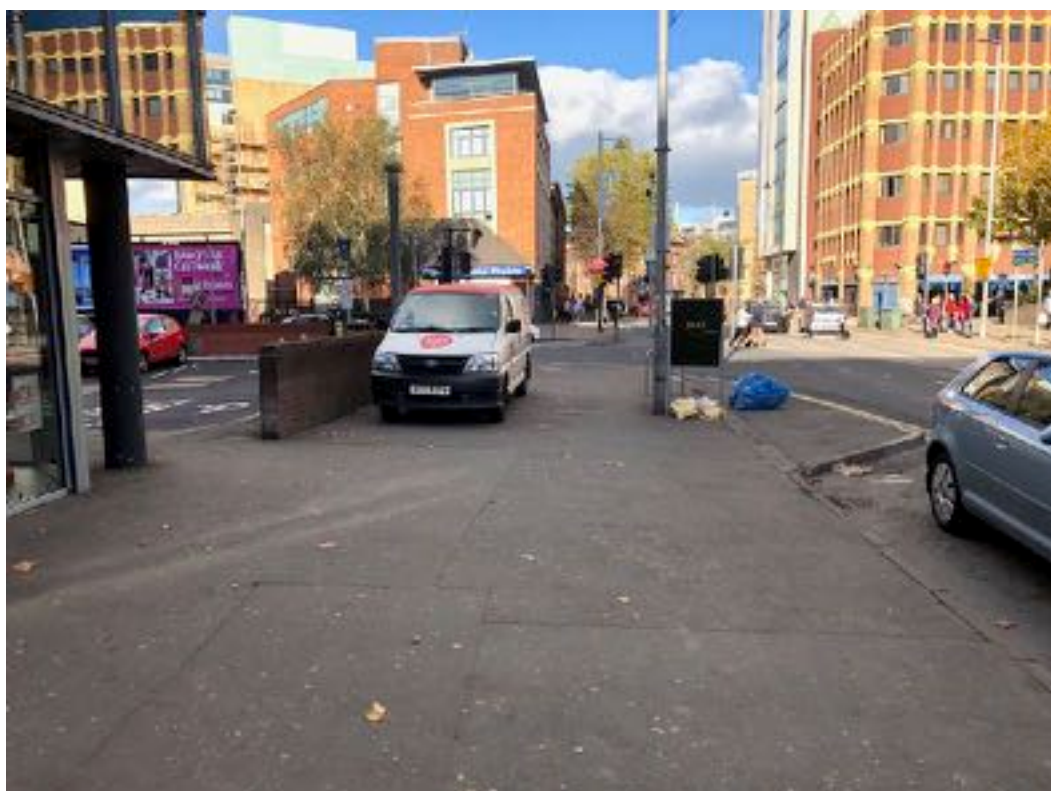
A van belonging to Chest, Heart & Stroke obstructs the footway approaching the junction with Bruce Street.

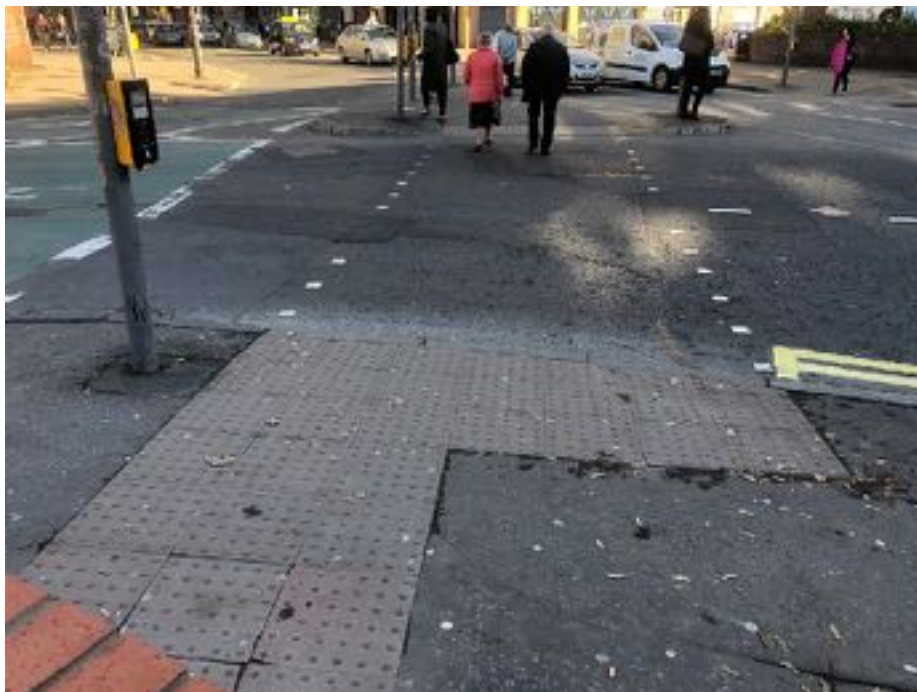
There are three controlled crossings across the junction of Bruce Street with the Dublin Road and to the eastern footway of Dublin Road. Access to the across Bruce Street and to the eastern footway is via a triangular traffic island. The installation of the control box and tactile paving on the southern part of the crossing on the western footway is incorrect.

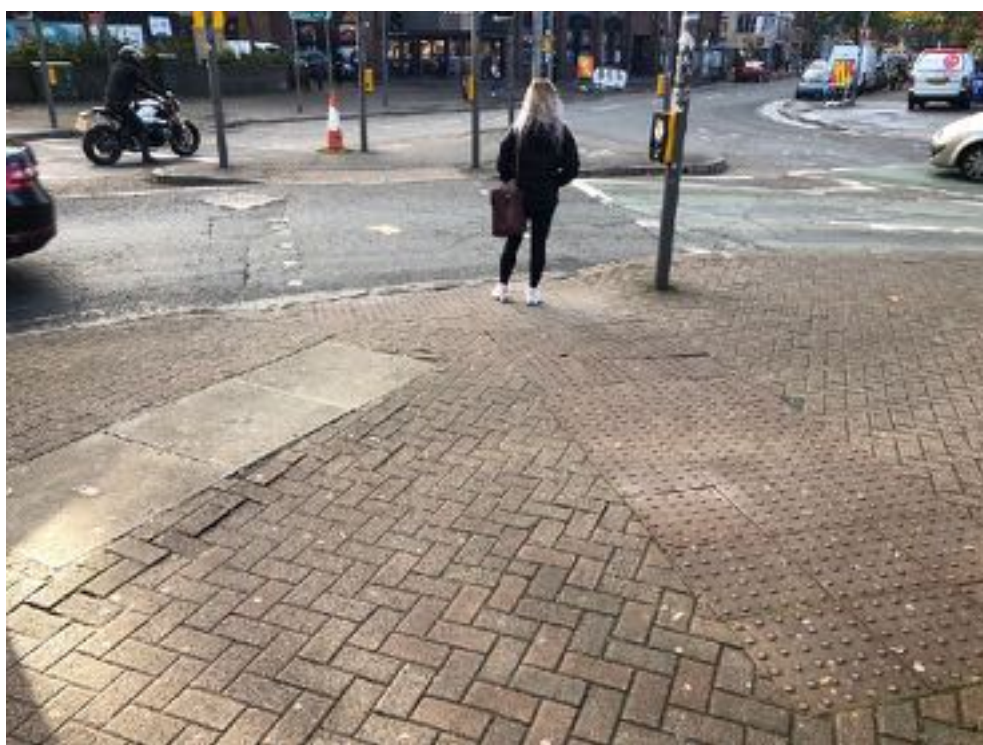
The crossing from the northern side of the western footway uses the correct arrangements for tactile paving and control box. However the paving does not contrast with tactile and the positioning of control boxes on the island is incorrect.

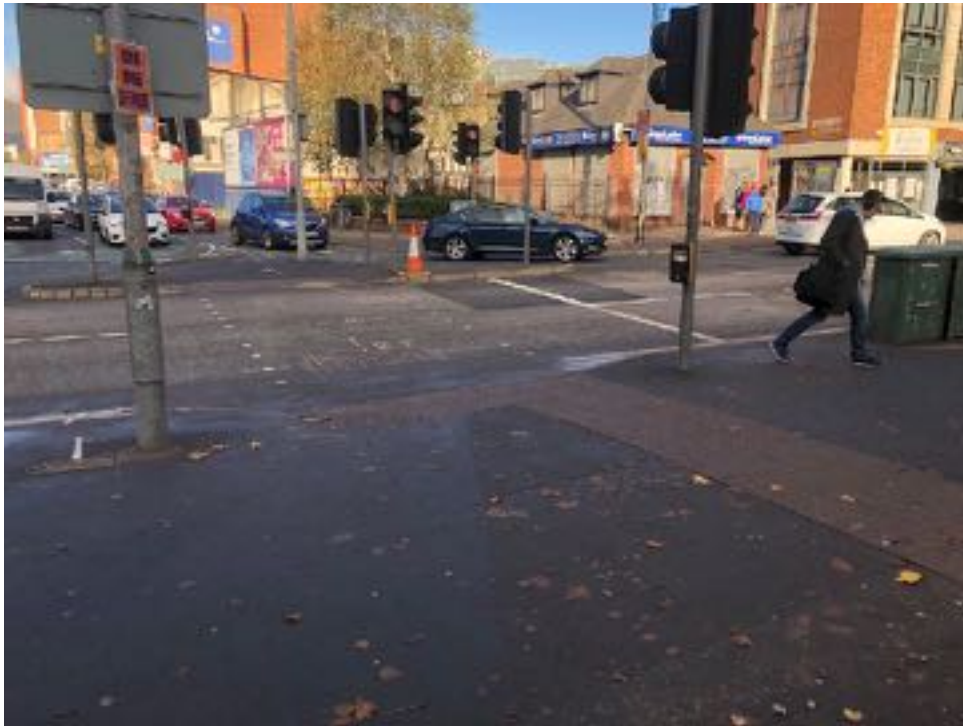
The tactile paving and control box on the crossing on the eastern footway have been installed correctly. However some tactile paving is damaged, loose and uneven.

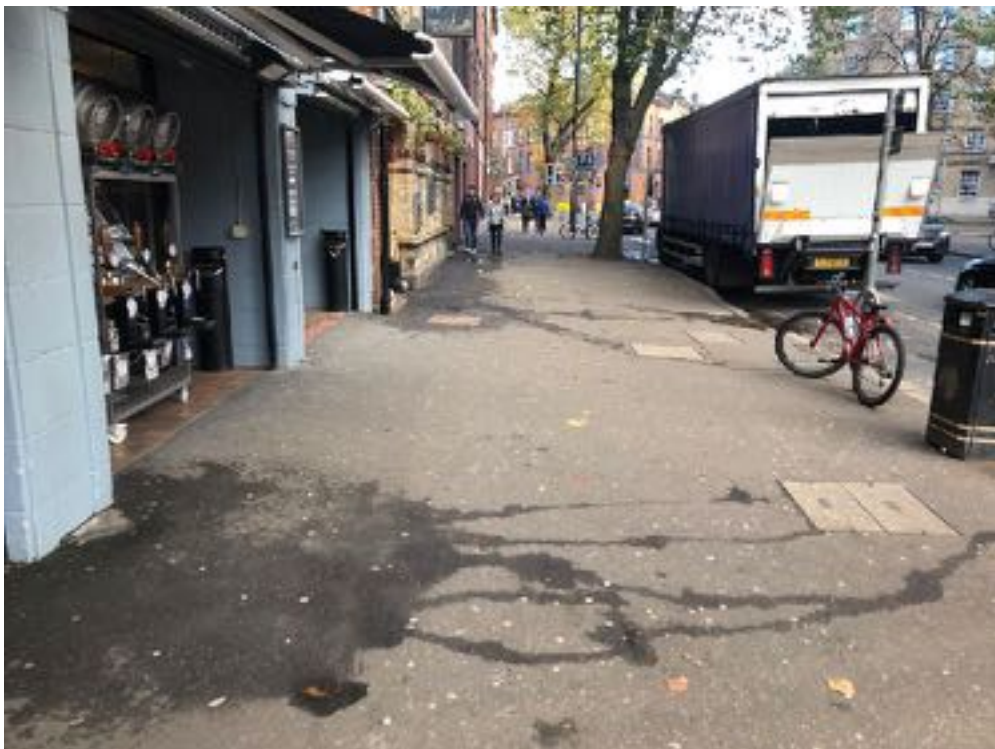
The footway around Wetherspoons is rough and uneven but provides a broad and uncluttered approach to the junction with Bedford Street.

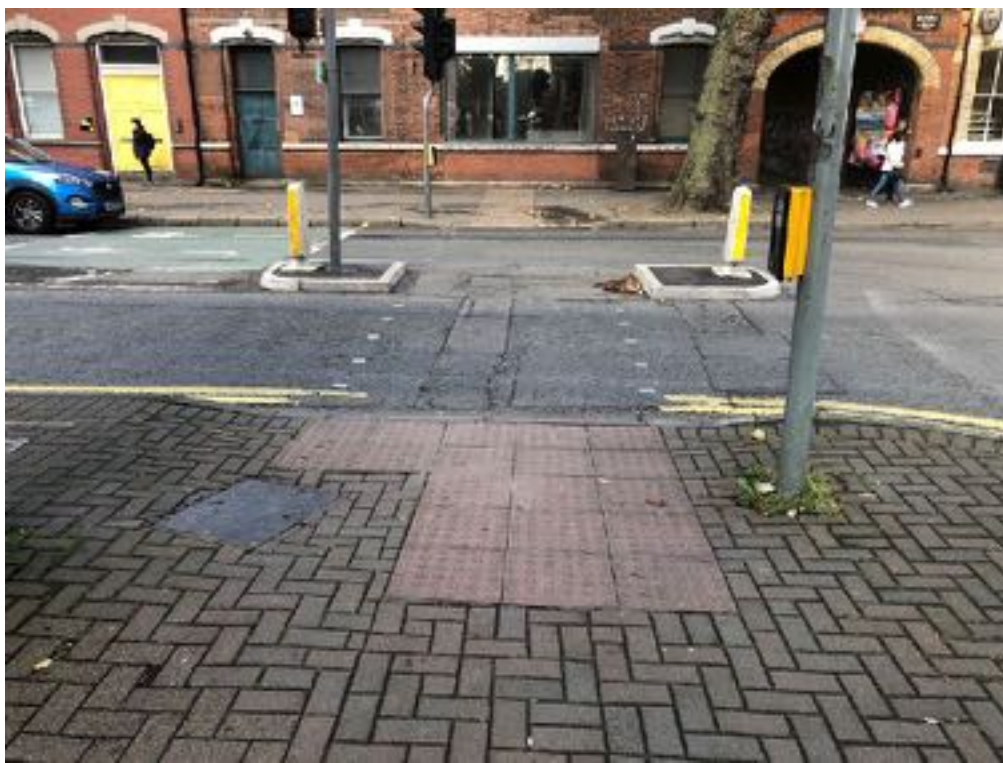
There is a controlled crossing across Dublin Road to a large triangular traffic island at its junction with Bedford Street and Ormeau Avenue. The crossing has by and large been installed correctly, however the tactile tail on the eastern side could extend further back from the kerbline.

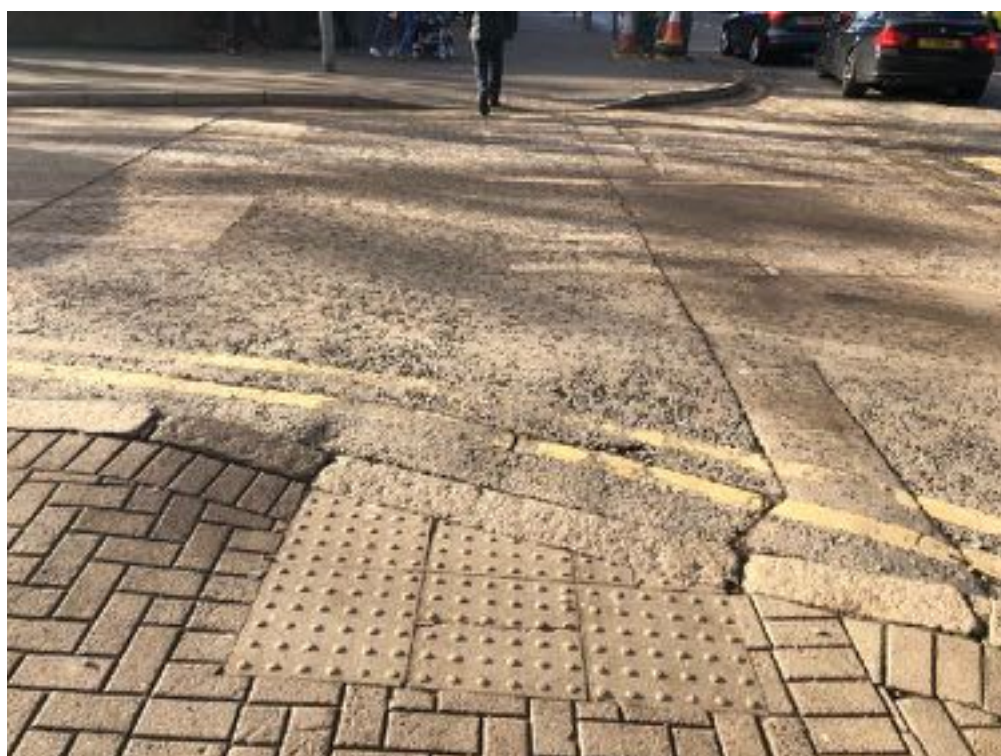
There is an in-line uncontrolled crossing across the junction with Bankmore Street. The depth of the tactile paving is an issue on both sides of the crossing as is the contrast on the northern side.

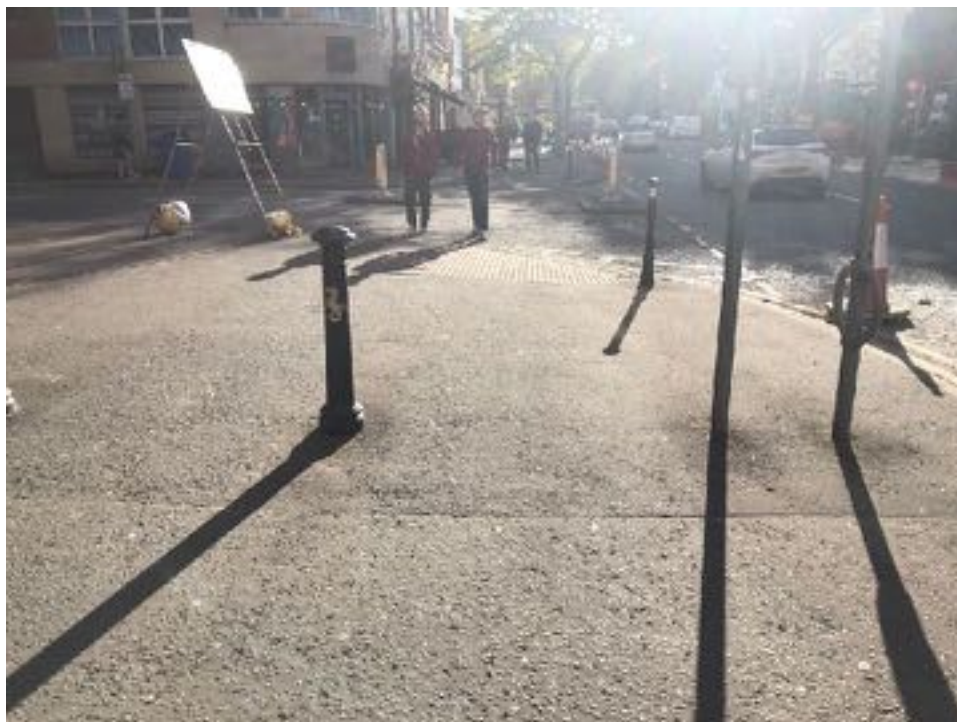
There is an in-line uncontrolled crossing on the eastern footway across Marcus Ward Street with a traffic island/refuge at the mid point. The positioning of the crossing on the radius of the junction reduces tactile depth in places. The position of bollards is also an issue.

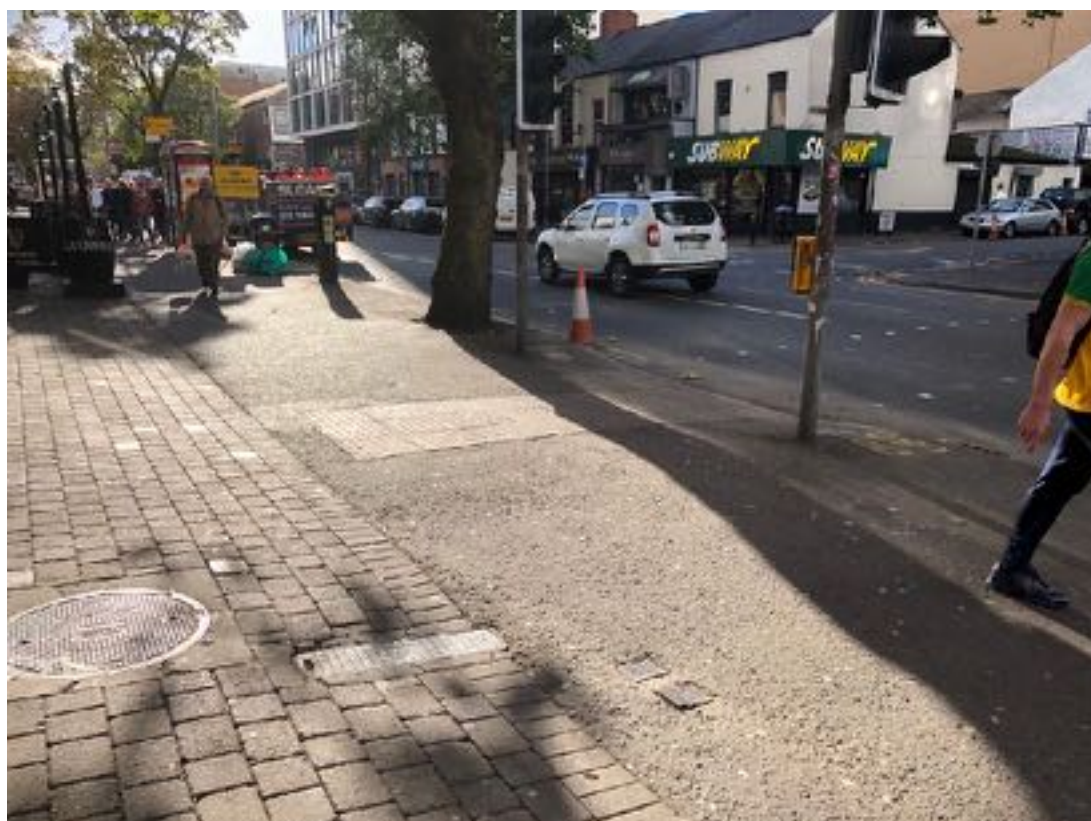
At the controlled crossing towards Shaftesbury Square the tactile paving and control box have been correctly installed.

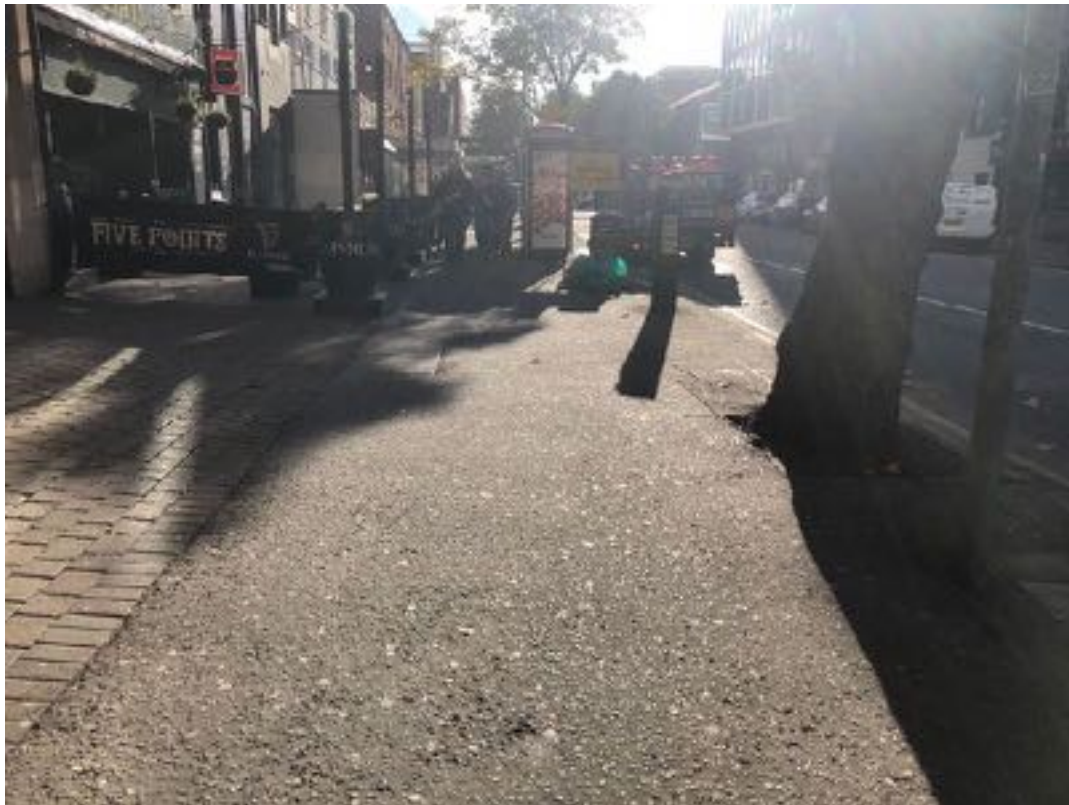
The busy footway between the crossing and Salisbury Street is narrowed significantly by outdoor seating and street furniture.

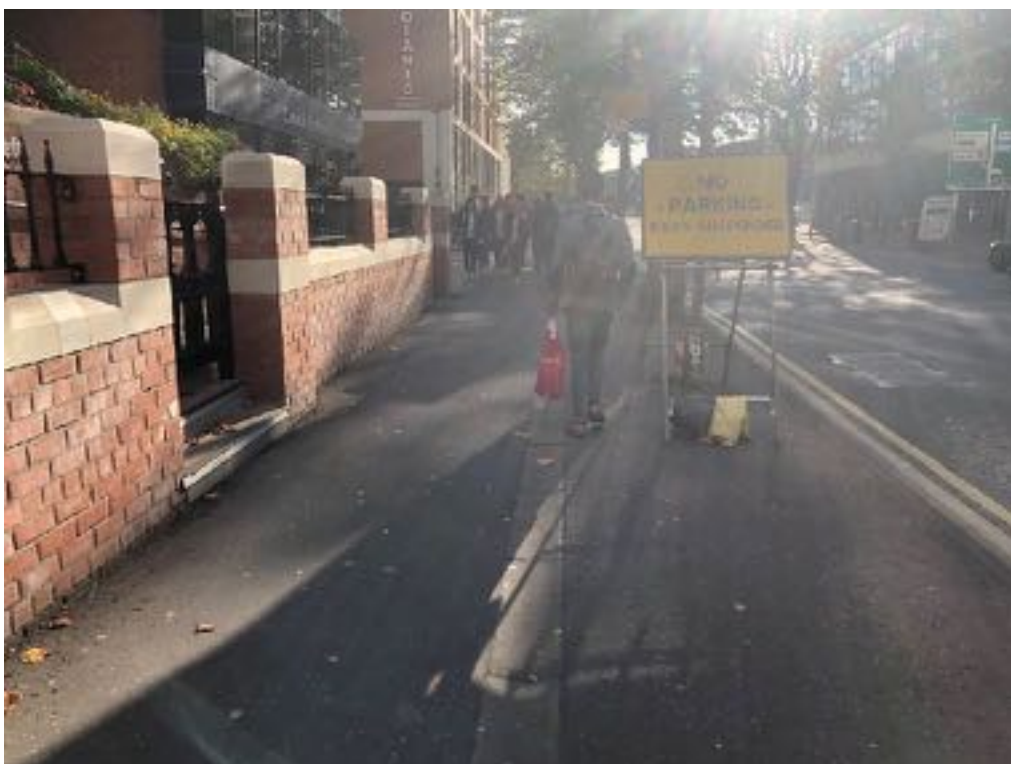
A-Boards and temporary traffic signage restrict footway width between Hartington Court and Pakenham Street. A large dish drainage channel also runs down the centre of the footway.

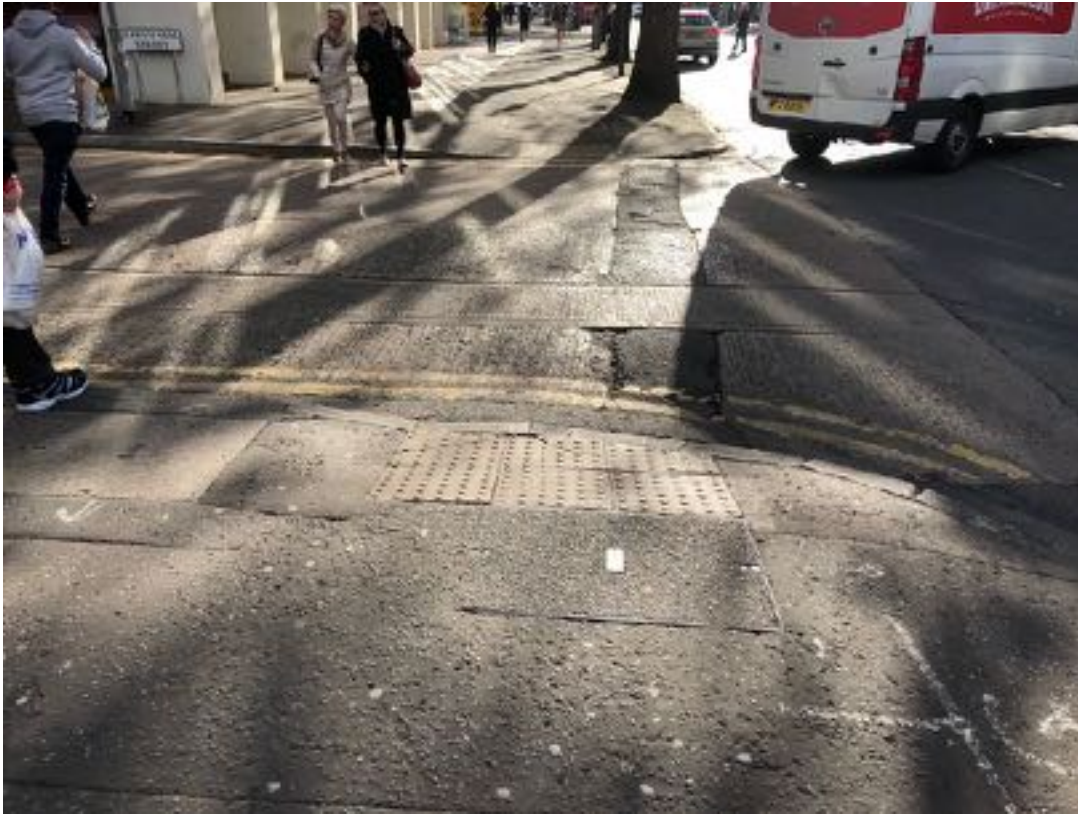
There is an in-line uncontrolled crossing across the junction with Pakenham Street. Again located on the radius of the junction the depth of tactile paving is an issue.

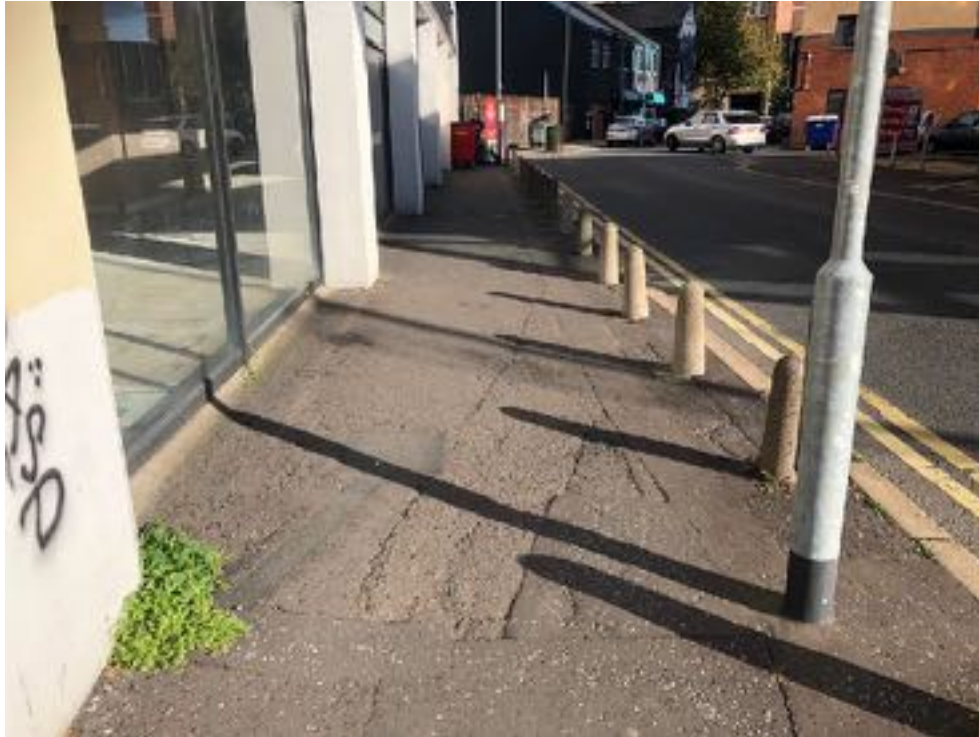
The surface of the northern footway is rough and uneven. Bollards line the kerb line adjacent to Fanum House and bins and rubbish obstruct the footway ahead going towards Dublin Road.

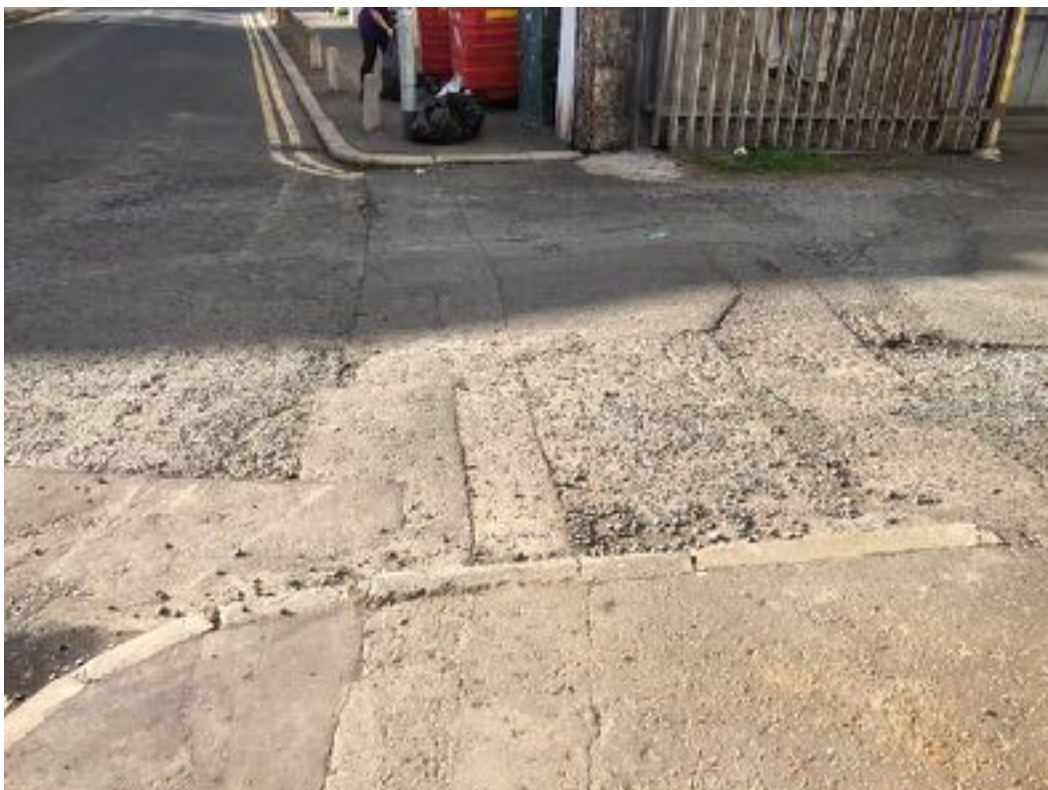
There is a car park entrance just after this point. The kerbs are not completely dropped and no tactile paving is provided to warn pedestrians.

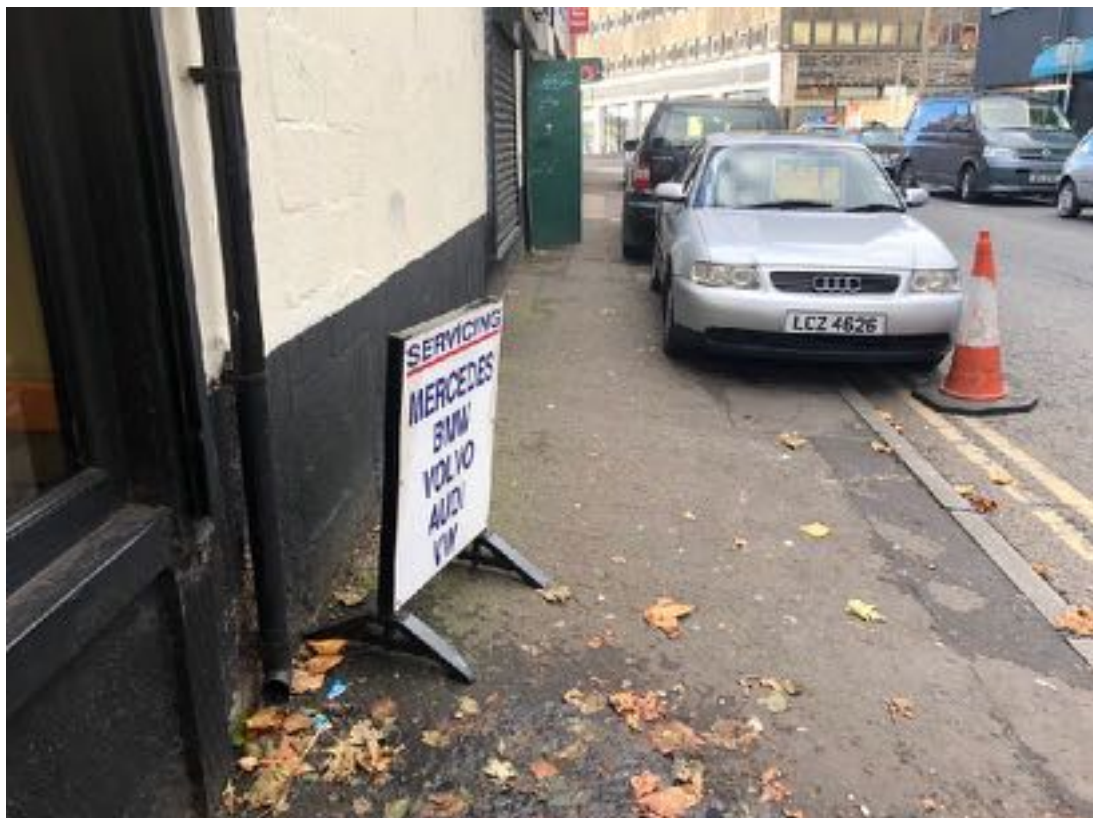
Parked cars and A-Boards obstruct the southern footway.

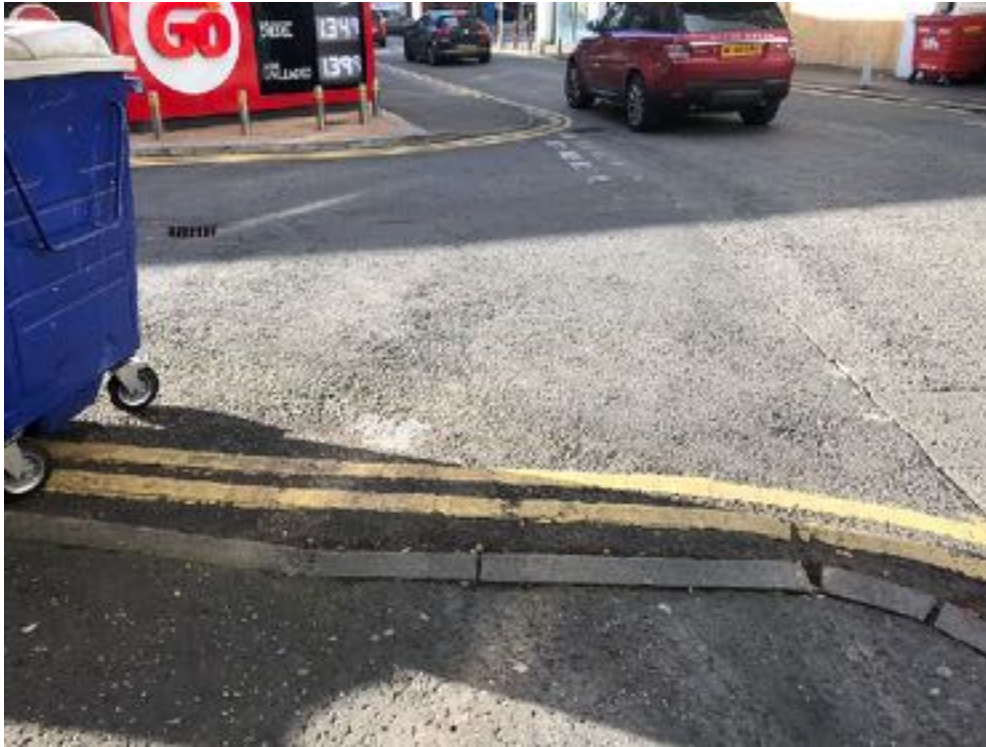
There is no in-line crossing with appropriate tactile paving across Ventry Street at the T junction approaching the garage. Continuing towards Great Victoria Street a section of the footway has been dropped beside the garage but no tactile paving provided to warn pedestrians.

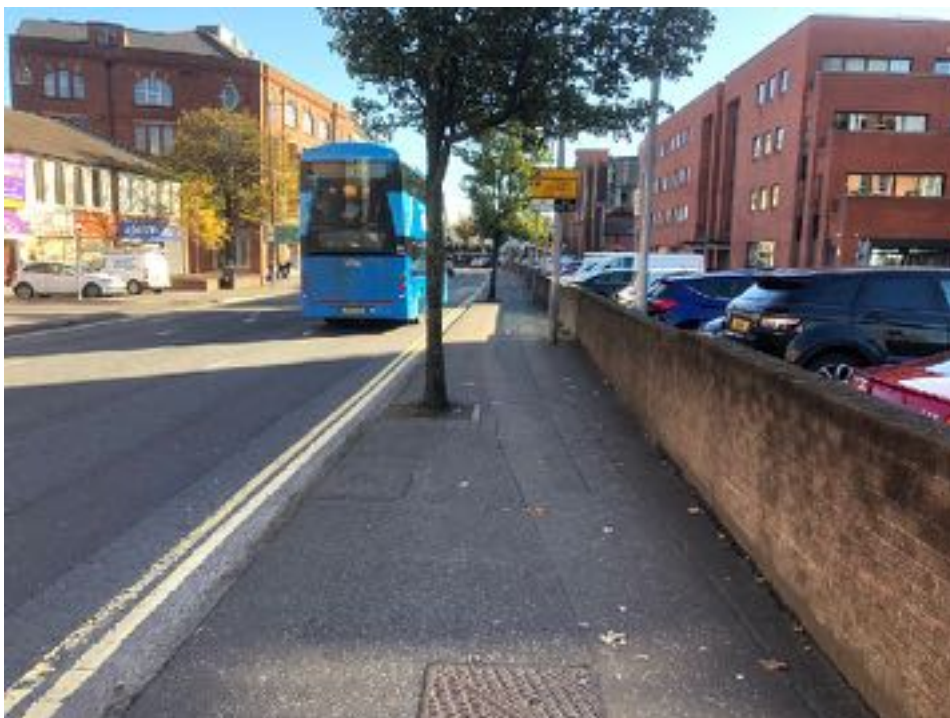
Footway width on the southern side of Bruce Street is obstructed by trees and traffic sign poles.

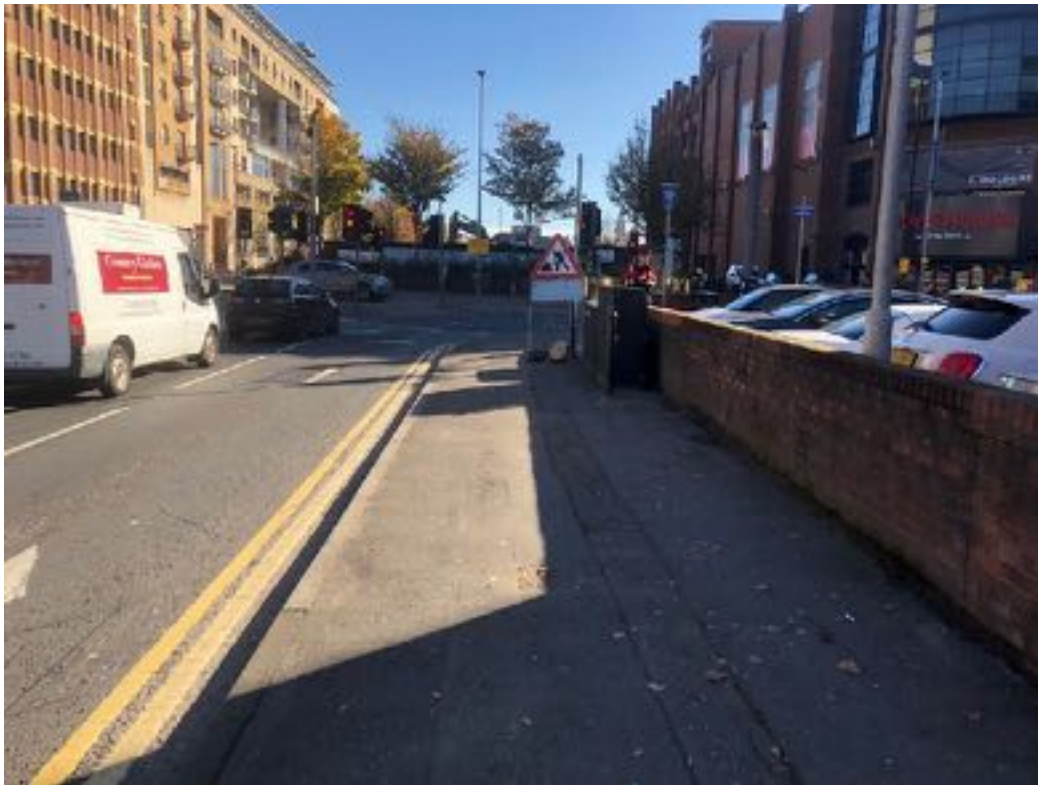
A road works signs is a further obstacle approaching the junction with Dublin Road.
