Recommendations from Imtac on public realm proposals for Belfast Streets Ahead Phase 5

(November 2018)

Street audit findings

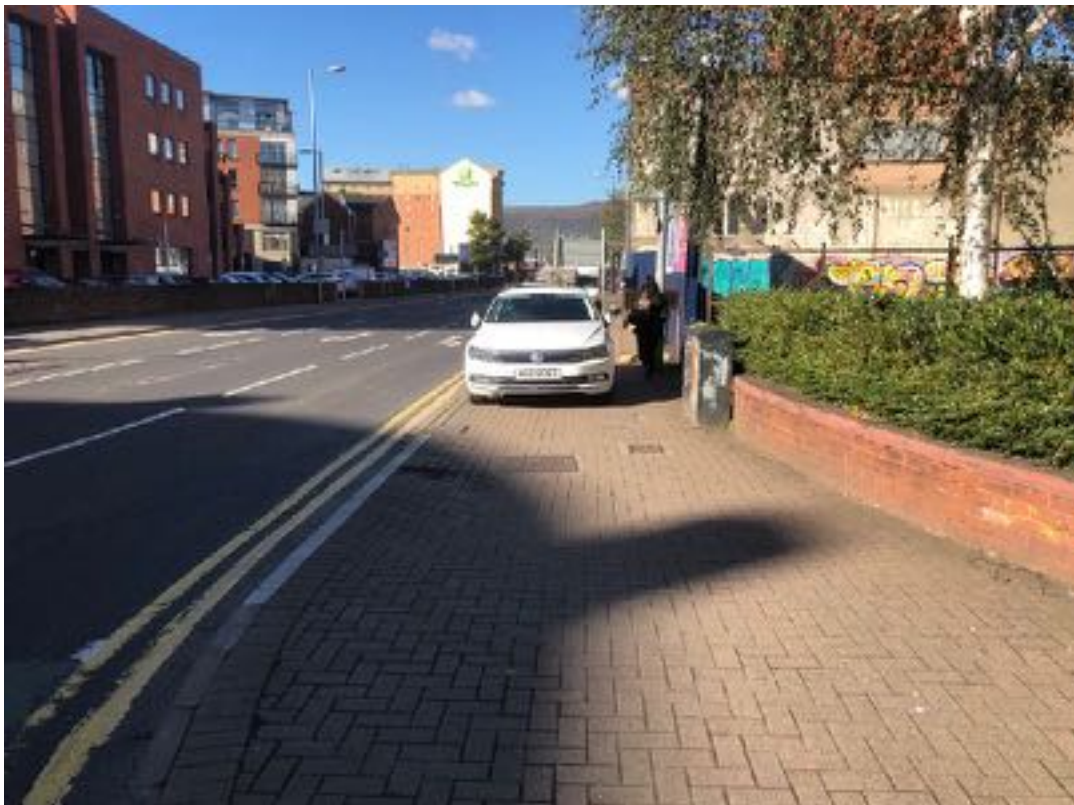
The footway on the northern side of Bruce Street is obstructed by a parked car and signage close to the junction with Dublin Road.

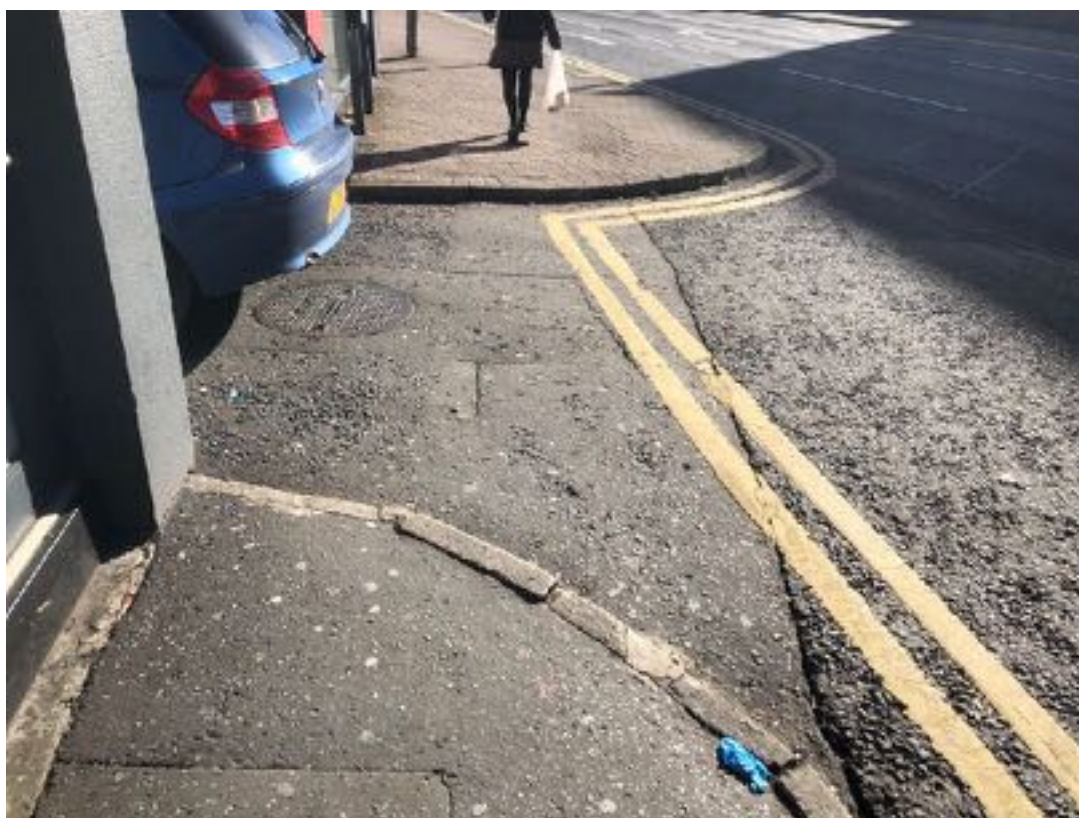
At the end of this wide footway there is a vehicle entrance with no dropped kerbs provided. The footway on the west side of the entrance narrows.

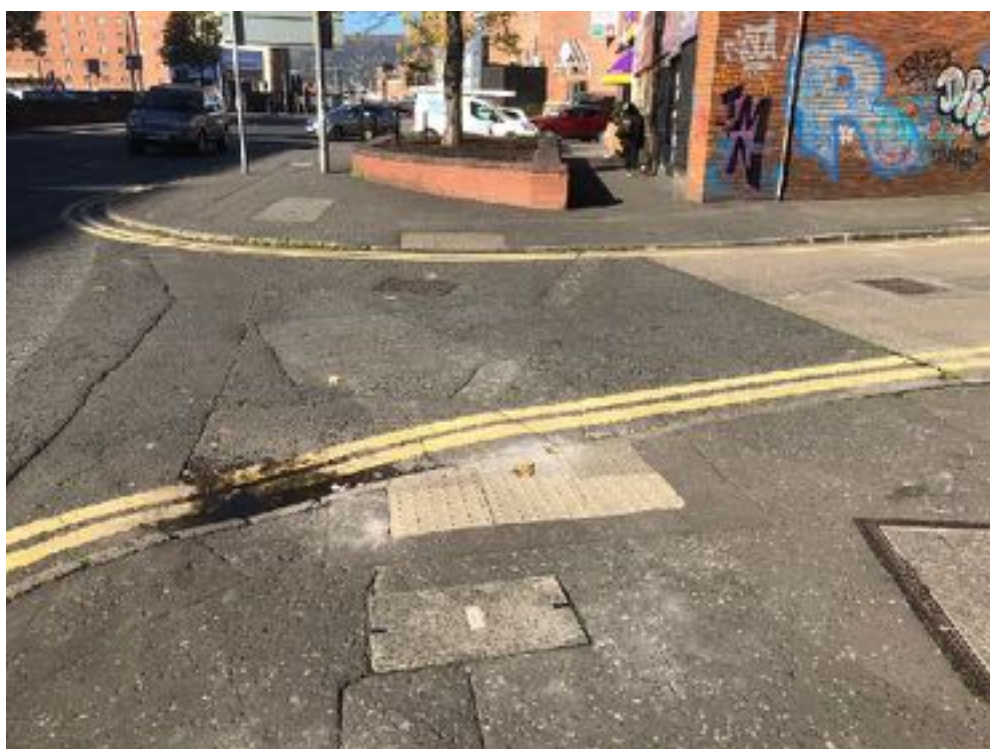
There is an in-line uncontrolled crossing across the junction with Holmes Street. Tactile paving depth is insufficient on both sides. Kerb heights are also an issue. Tactile paving leads directly into a large brick planter with footway either side.

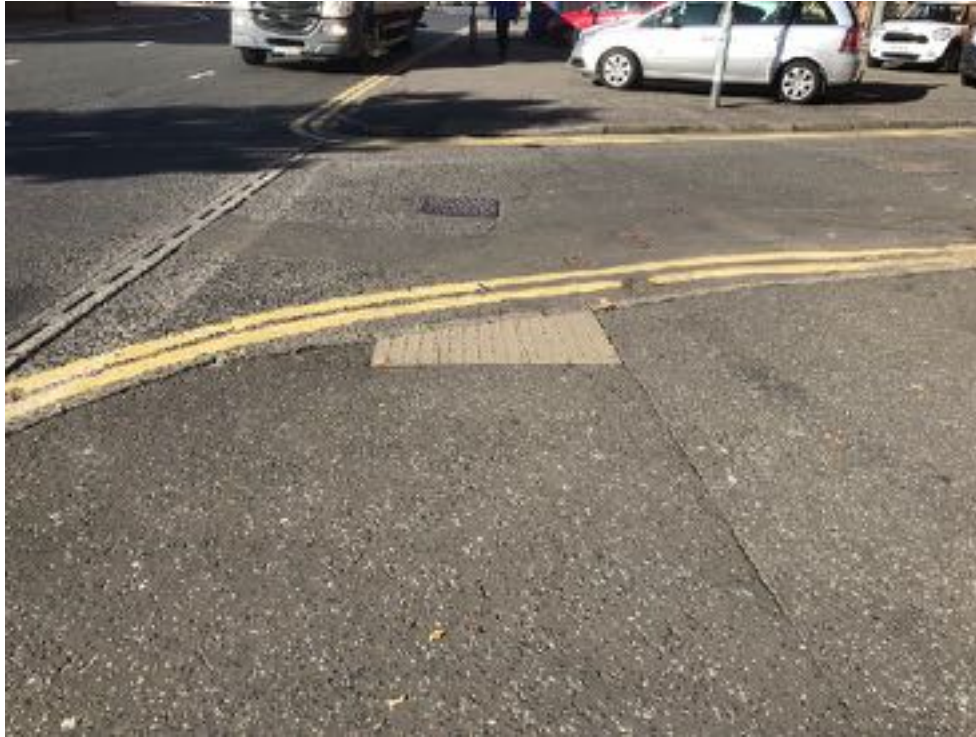
There is an in-line uncontrolled crossing across the junction with Hope Street. Located on the radius of the junction tactile paving depth is insufficient. Cars partially obstruct the footway on the western side approaching the junction with Great Victoria Street.

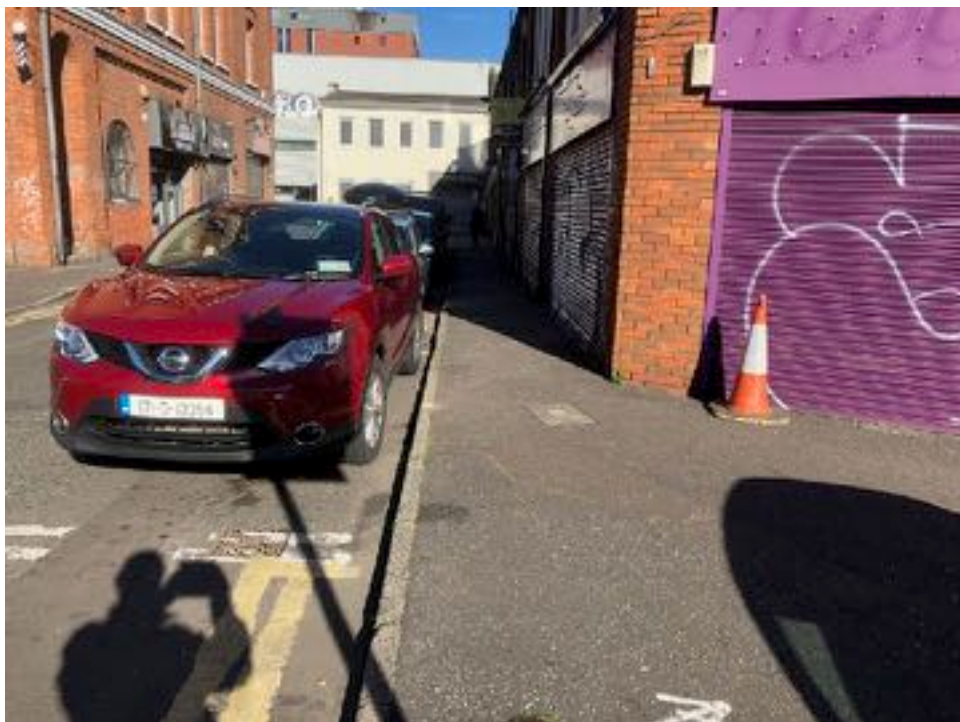
The footway on the eastern side of Hope Street is narrow but uncluttered.

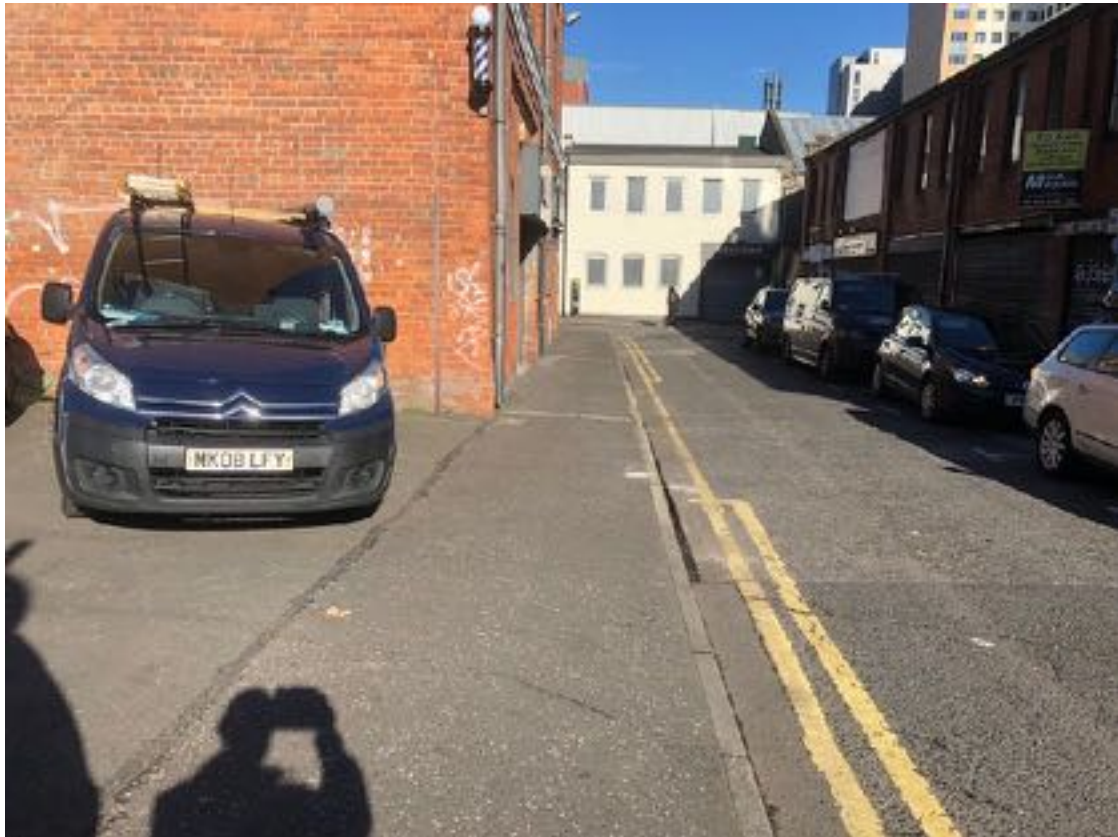
The footway on the western side is similar but includes dish drainage channels across the footway.

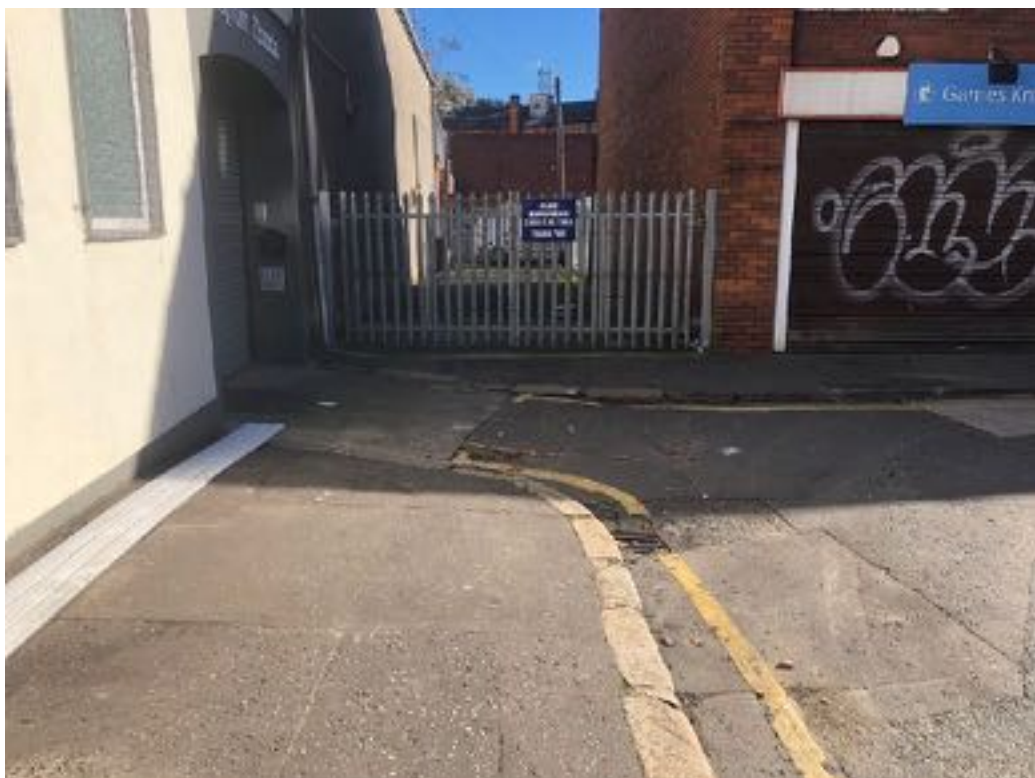
Hope Street turns sharply. Pedestrian access at a vehicle entrance at the corner of this turn are unsatisfactory.

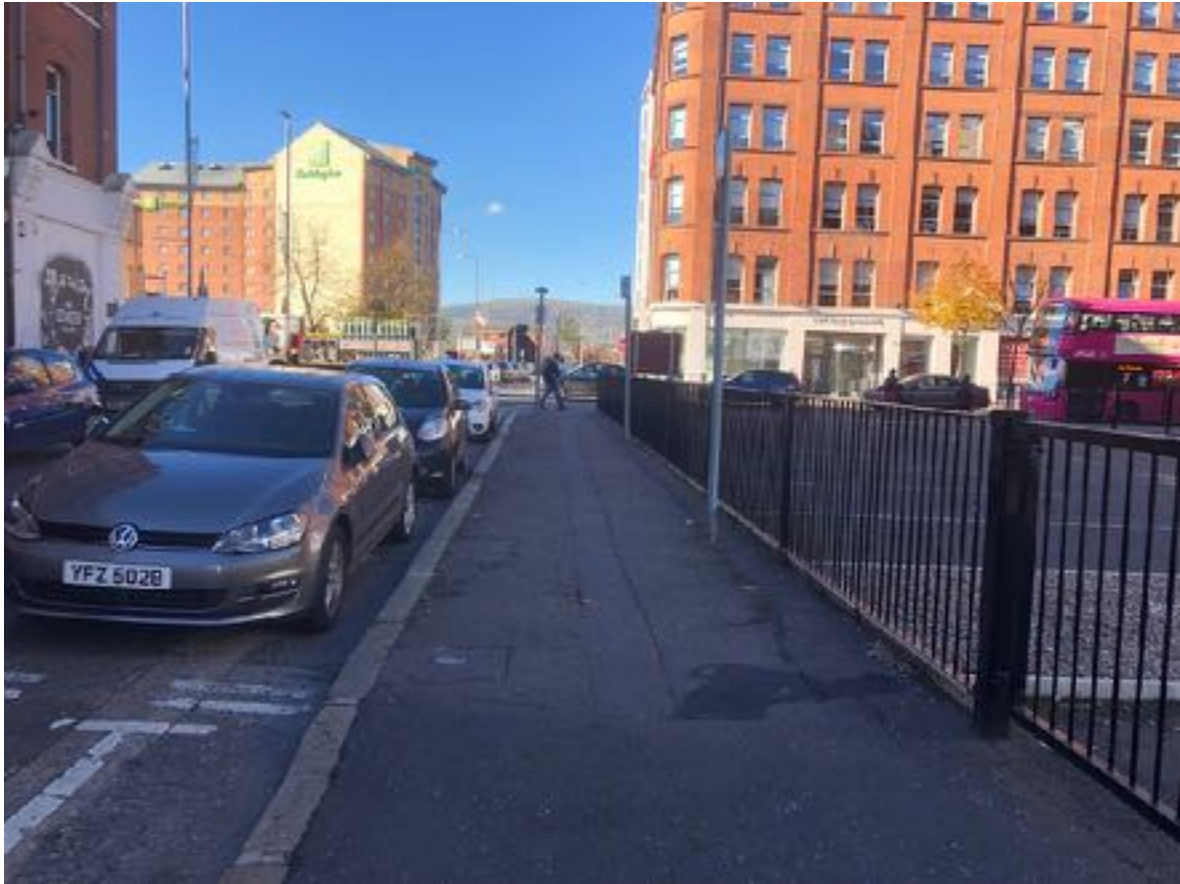
Although the surface is rough and uneven the remaining footway on the northern side of Hope Street is uncluttered.

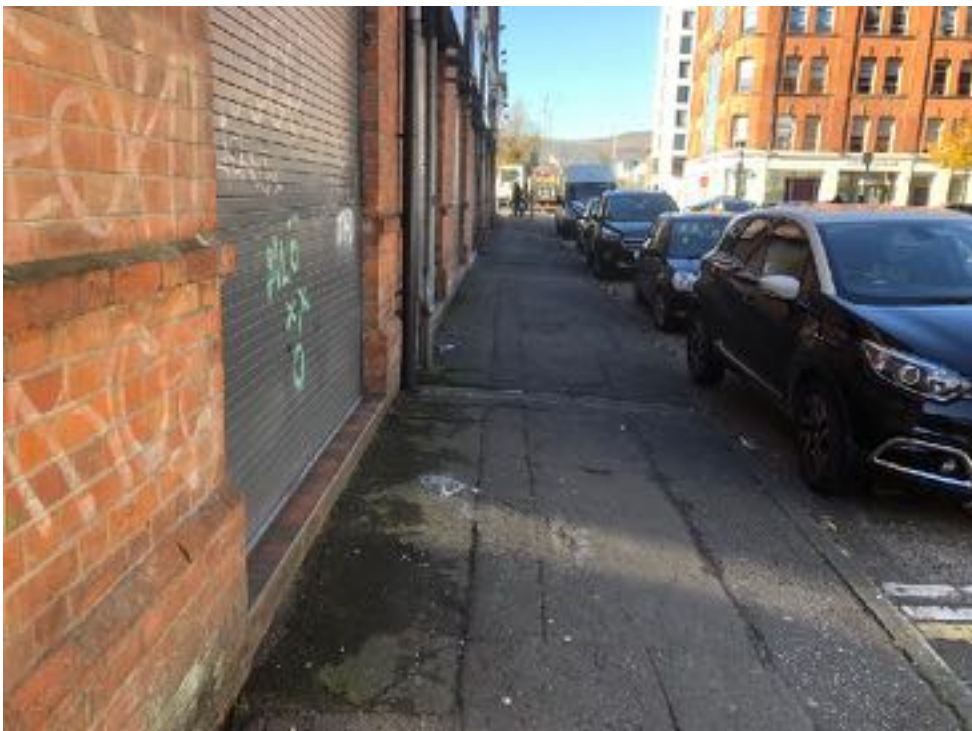
The footway on the southern side is again rough and uneven and contains deep dish drainage channels across the footway.

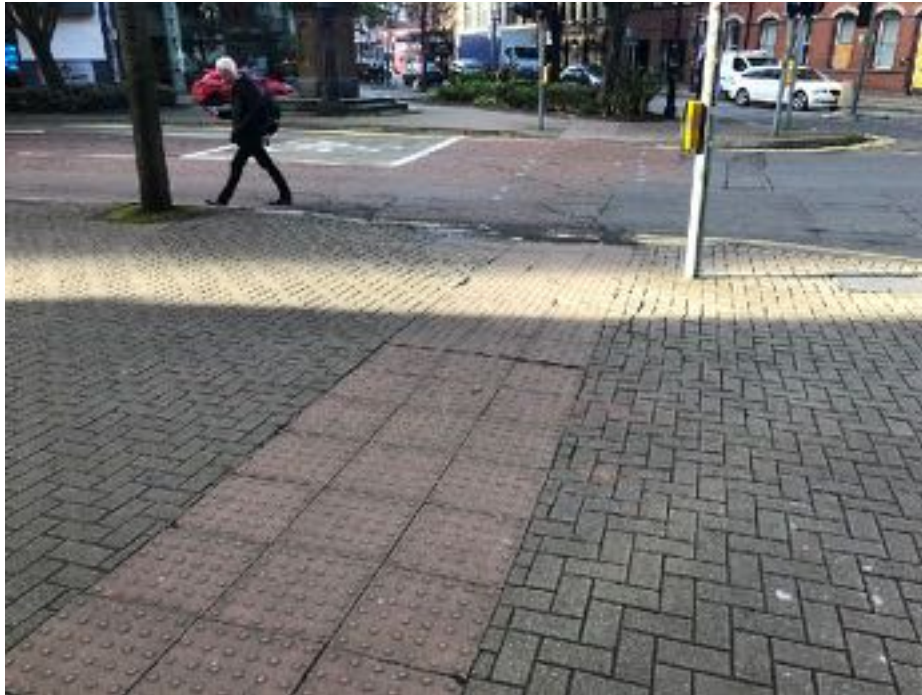
There is a controlled crossing across Ormeau Avenue to the traffic island linking the eastern footway on Bedford Street to Dublin Road. The tactile paving and control boxes have been installed correctly. However contrast between tactile and surrounding paving is poor and the tactile is loose and uneven in places.

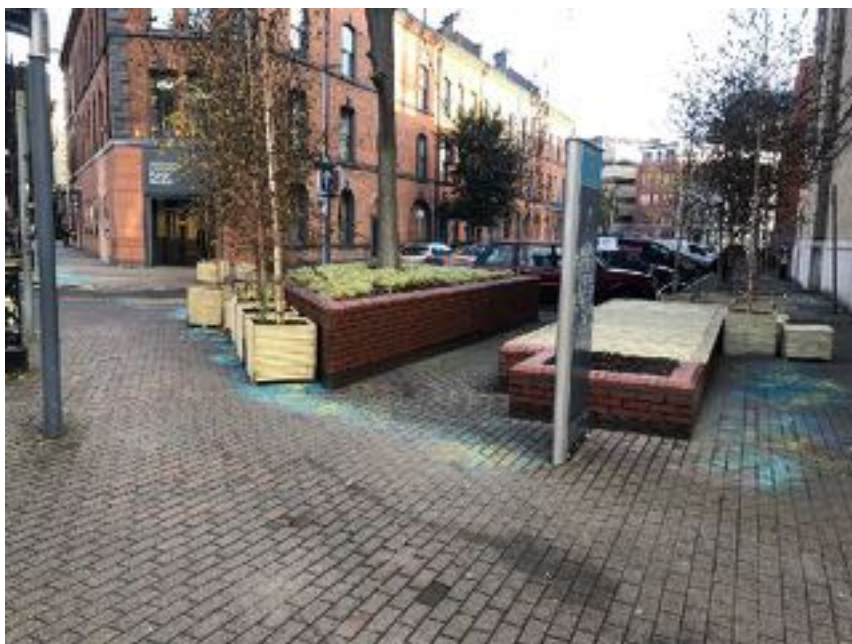
As part of Better Bedford Street some work has been undertaken to improve large brick planters beside the BBC building. The conversion of an existing planter to seating is welcome, however the location of trees in temporary wooden planters does narrow footway width.

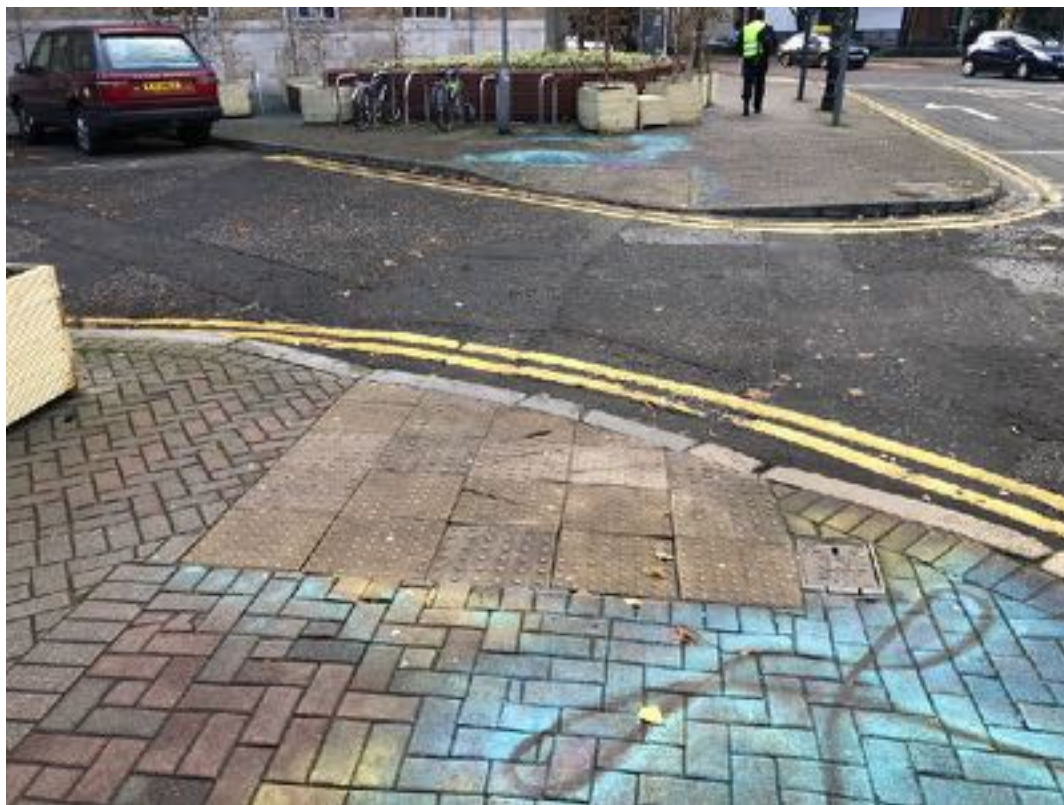
There is an in-line uncontrolled crossing across the junction with Linenhall Street West. Some of the tactile paving is loose and uneven. The radius of the junction reduces the depth of the tactile to unacceptable levels in places and contrast is poor.

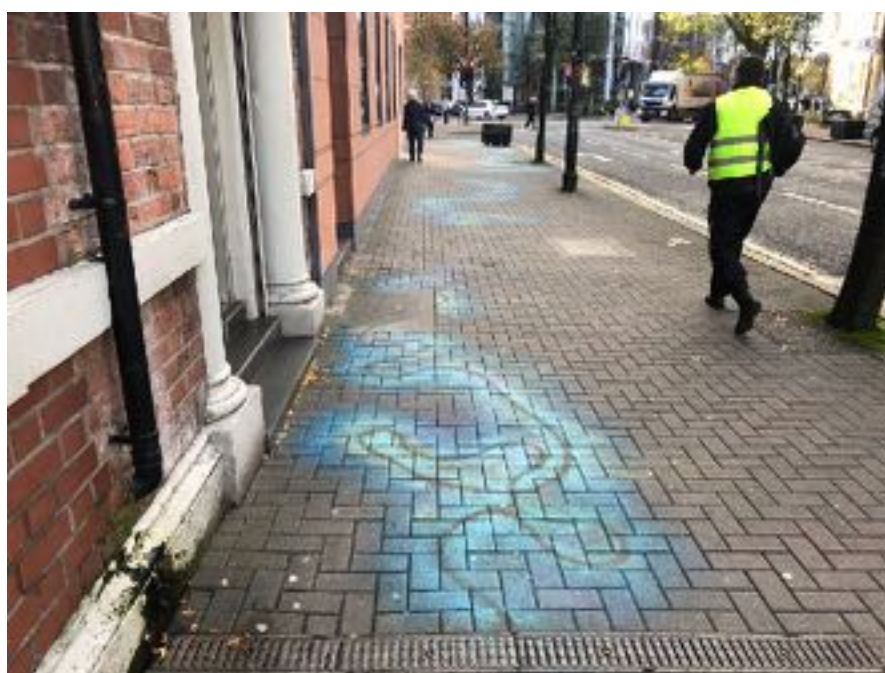
The footway between Linenhall Street West and Clarence Street is relatively broad and uncluttered. Participants in the audits were not complimentary about the pavement art with people with dementia in particular feeling it could make the street more confusing and difficult to navigate.

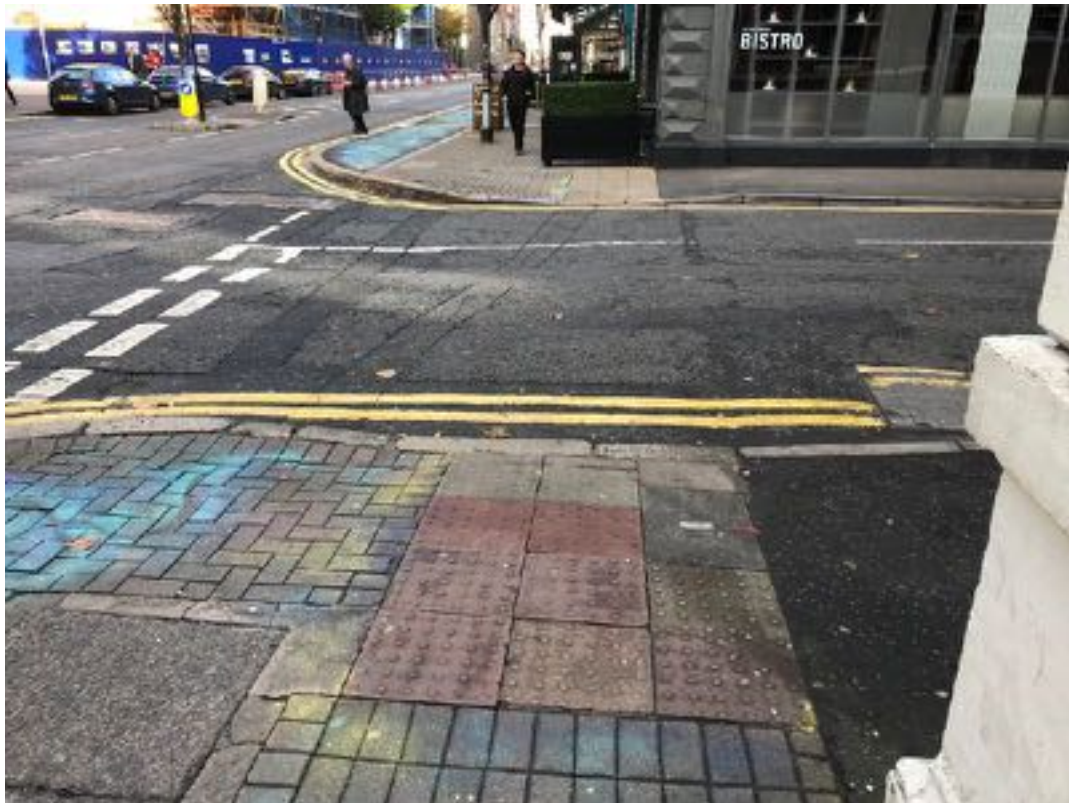
There is an in-line uncontrolled crossing across the junction with Clarence Street. Different colours of tactile paving is used on the southern side. On the northern side tactile leads directly into pavement cafe screening.

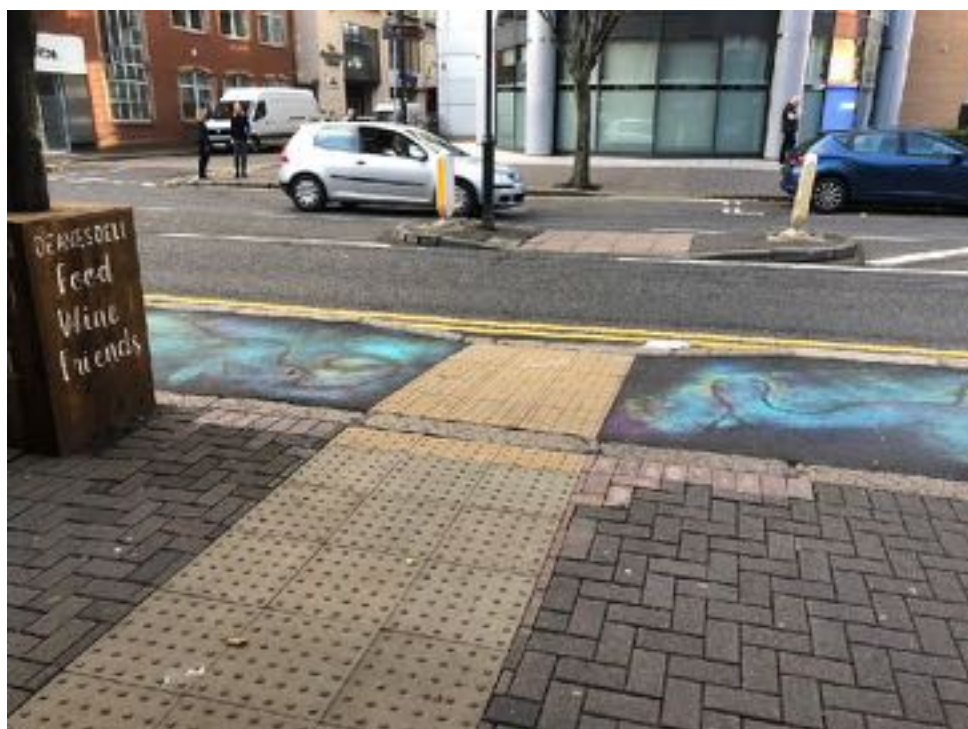
An in-line uncontrolled crossing is provided across Bedford Street outside Deane's includes a small traffic island midway. The tactile paving on the east side is laid incorrectly extending all the way to the building line. Contrast is poor on the western footway.

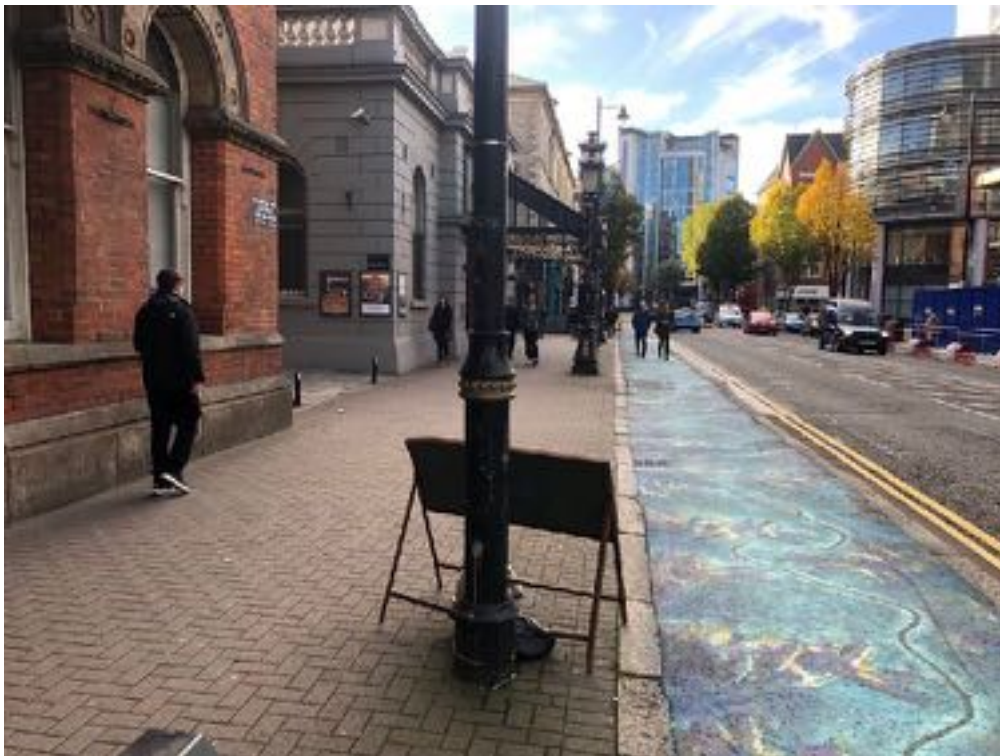
Participants in the audit welcomed the additional footway width provided as part of Better Bedford Street particularly around Harlem Cafe and the BT kiosk. However it was felt these benefits were to a degree reduced as street furniture was now located in the middle of the new footway.

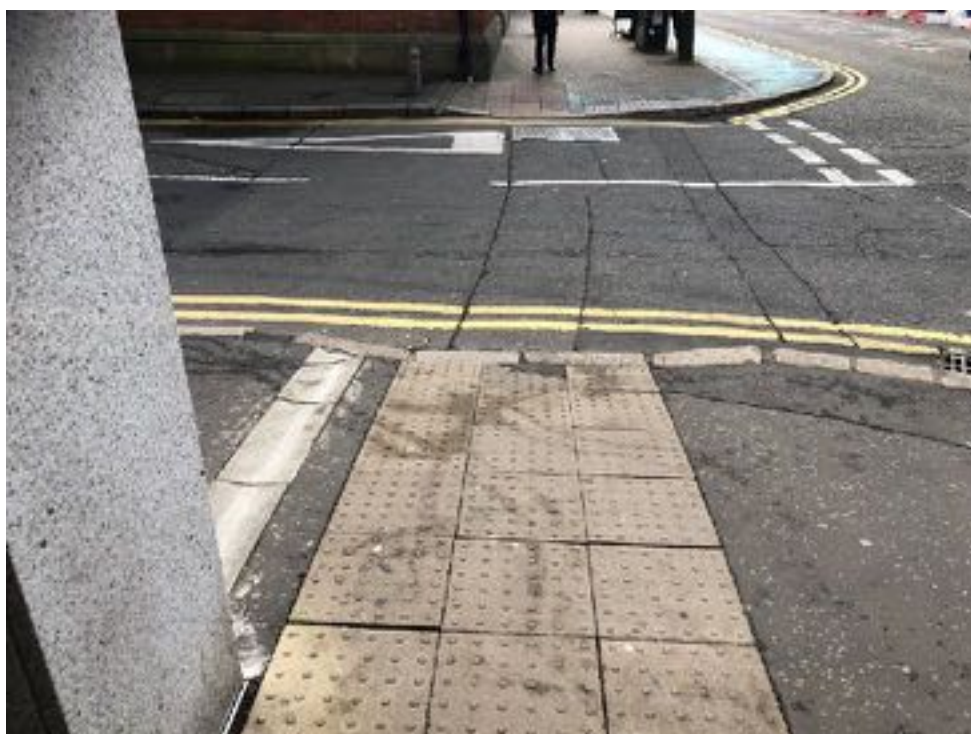
There is an in-line uncontrolled crossing across tFranklin Street. Tactile paving on the southern side is the wrong colour and there loose and uneven slabs. Dish drainage channels across the footway on Franklin Street is an issue.

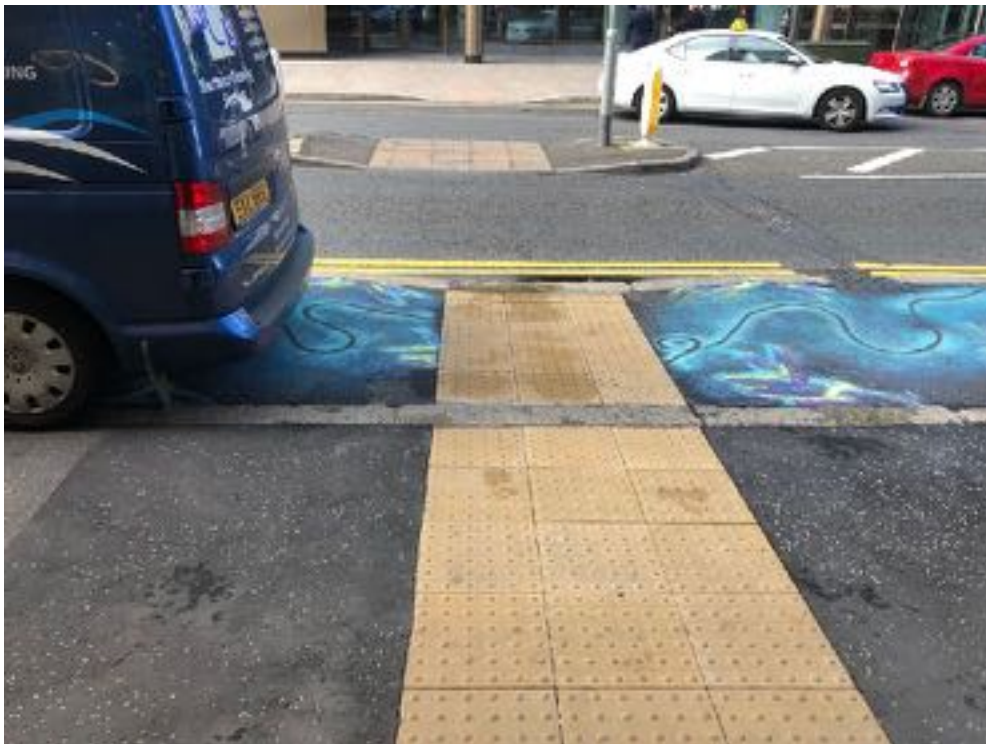
There is an in-line uncontrolled crossing across Bedford Street north of Franklin Street which includes a small traffic island. The tactile paving has been laid incorrectly on the eastern footway, extending to the building line. Although laid correctly outside the Grand Central contrast is not good.

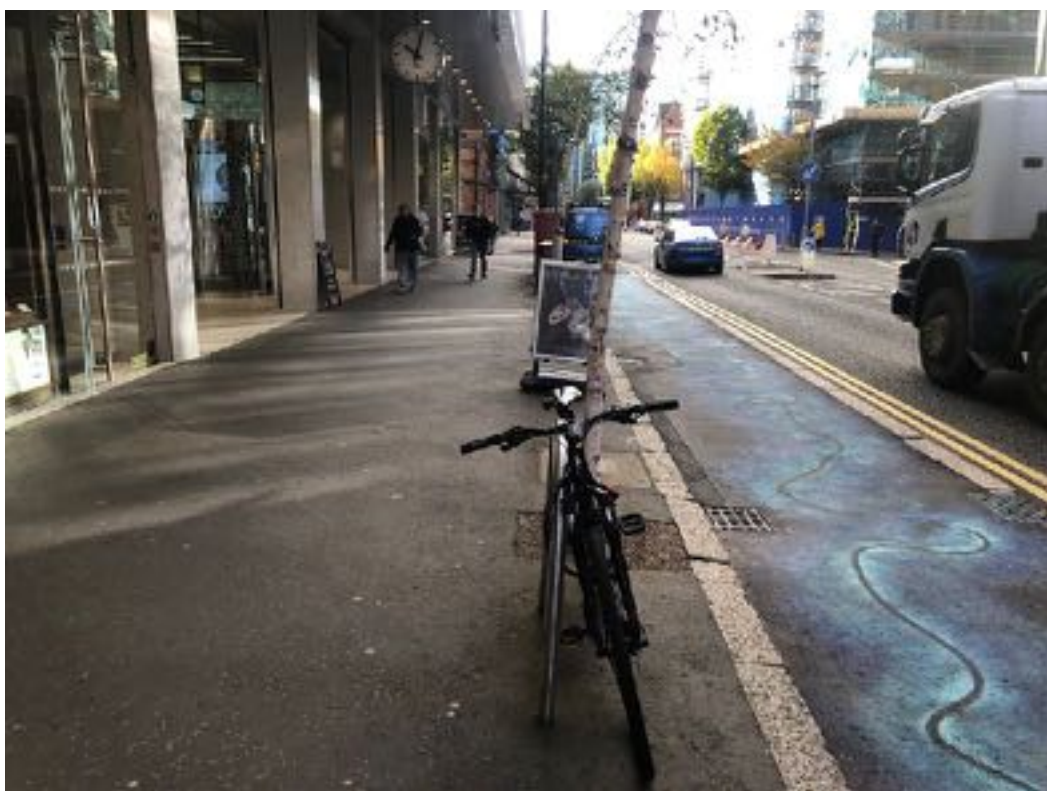
The eastern section of footway between Franklin Street and James St South is broad but obstructed in places by A-Boards and a parked vehicle.

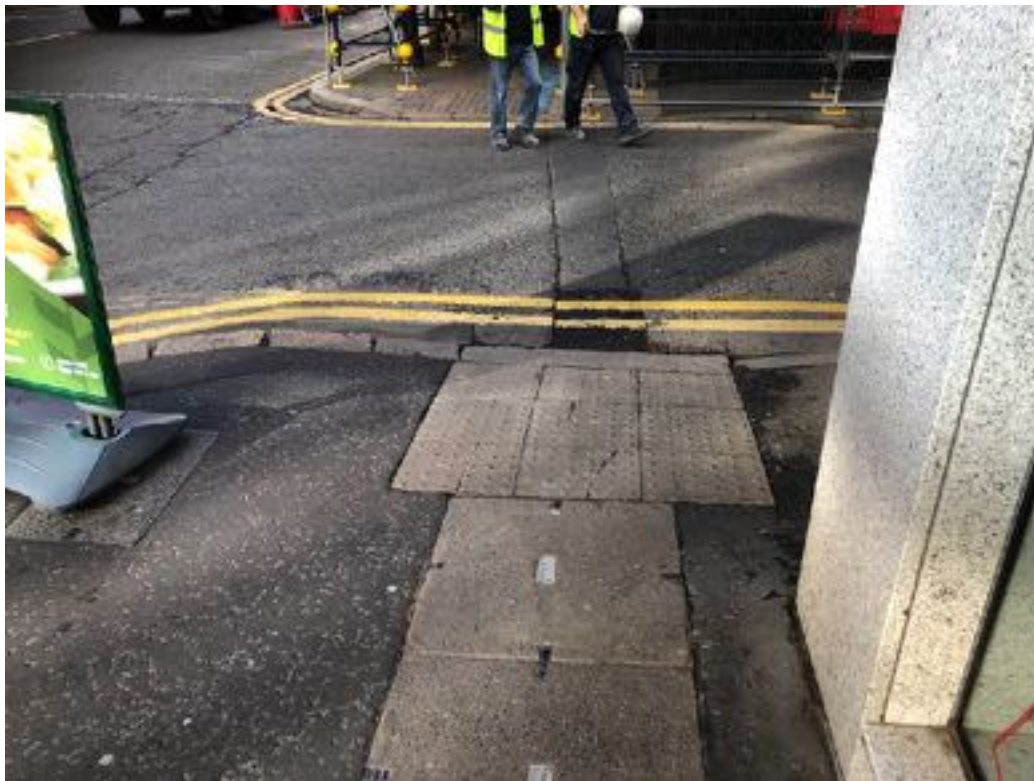
There is an in-line uncontrolled crossing across the junction with James Street South. The tactile on the northern side is obstructed completely by scaffolding although there is a section of the kerb has been dropped to provide temporary access.

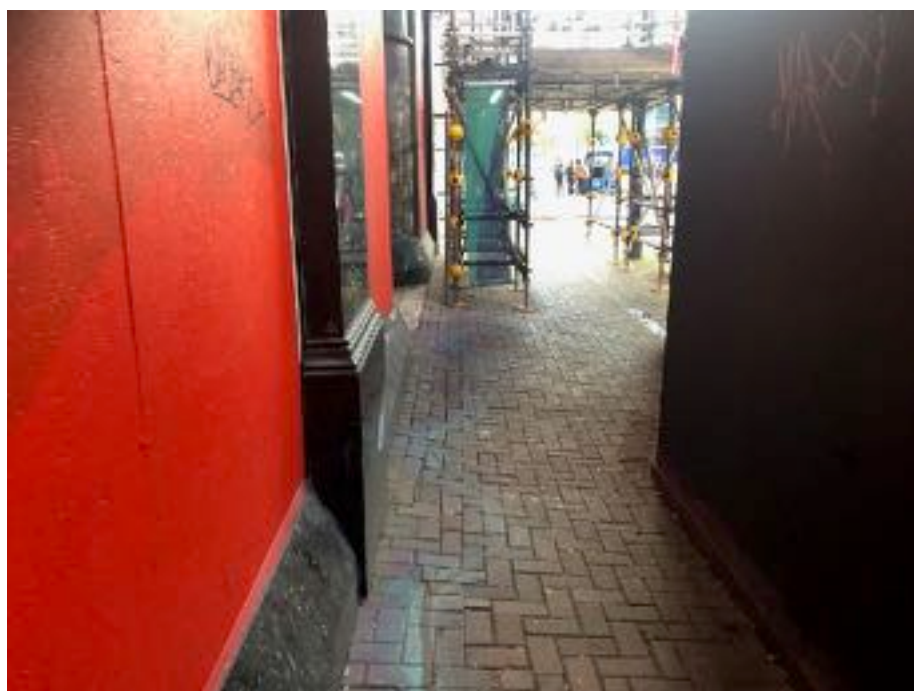
The remainder of the eastern footway on Bedford Street is narrowed considerably by scaffolding and hoarding associated with the hotel development. This area would be difficult for some disabled people to navigate through.

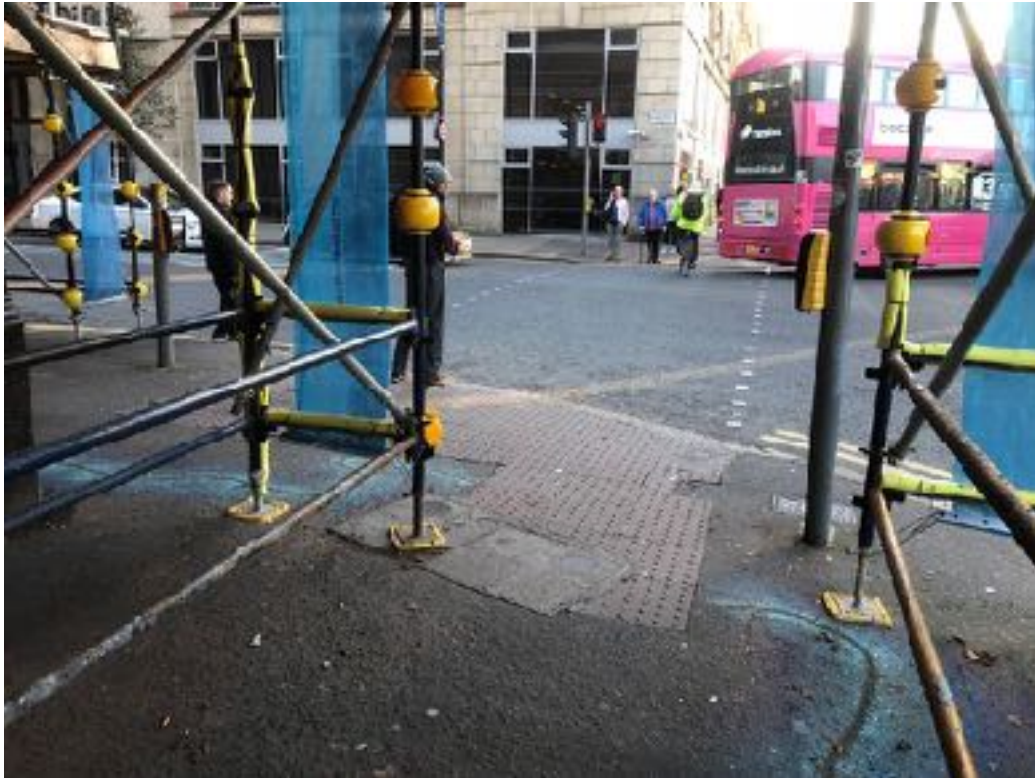
There is a controlled crossing across Bedford Street at its junction with Donegall Square South and Howard Street. The crossing from the eastern footway is partially obstructed by building works. The right hand control box should be closer to the kerbside.

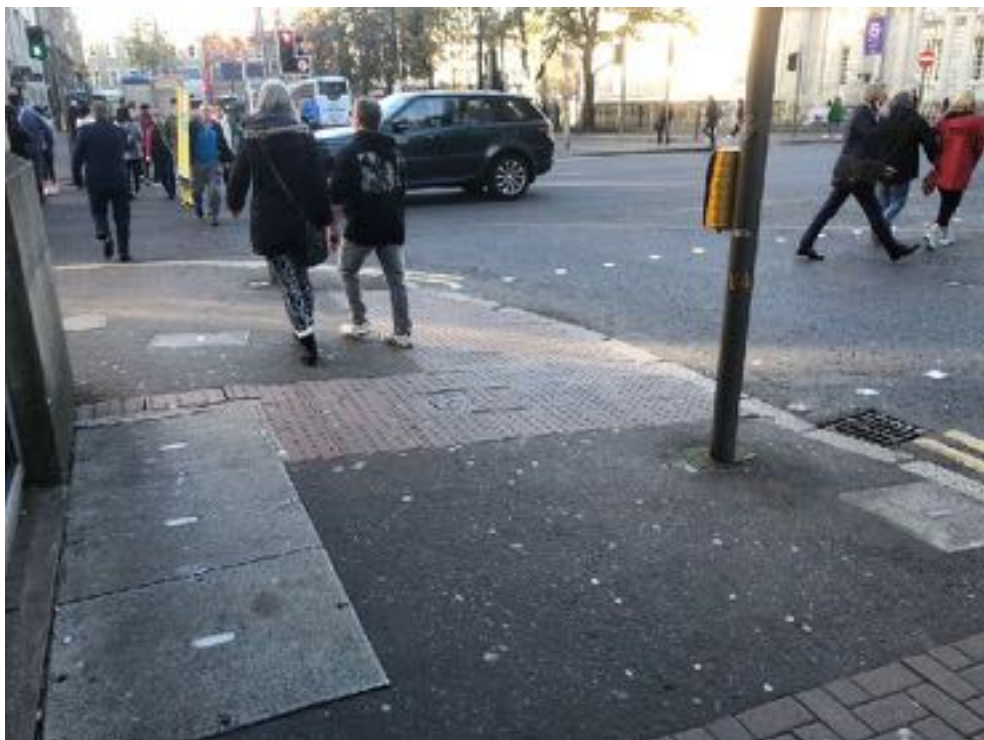
Tactile paving on the same crossing on the western footway is loose and uneven in places.

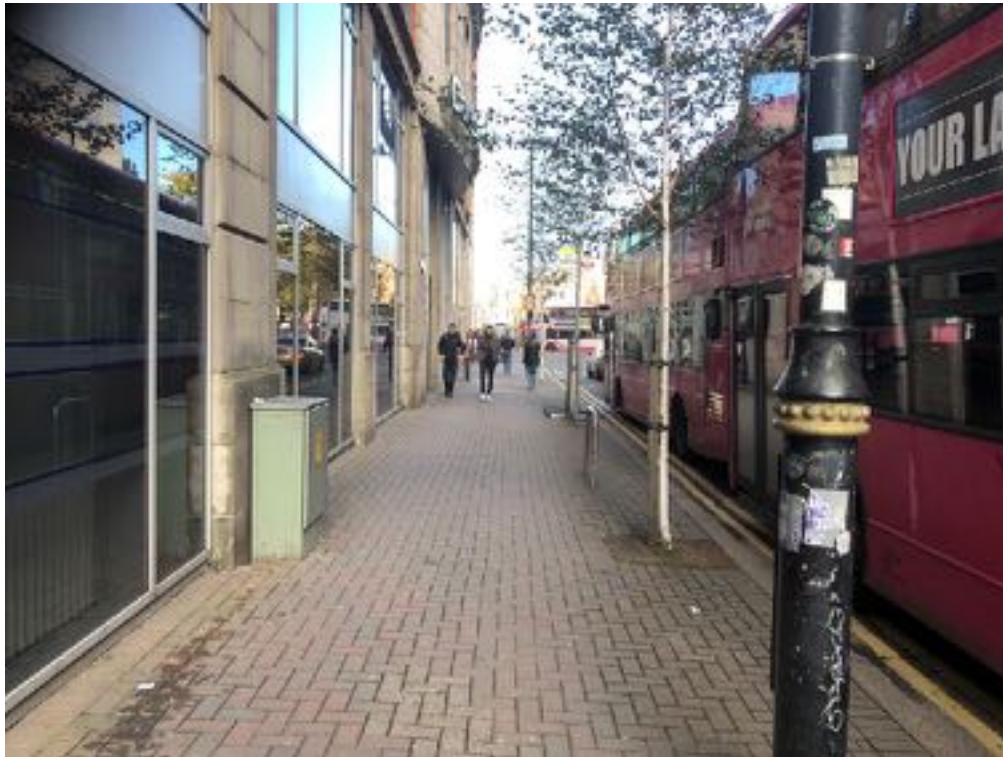
The section of footway between Howard Street and James St South is the main set down for many Metro and other bus services from outside Belfast. Frequently buses can access this stop and passengers must disembark onto the carriageway. Bus infrastructure is inadequate to meet the frequency of services using the street and the volume of disembarking passengers.

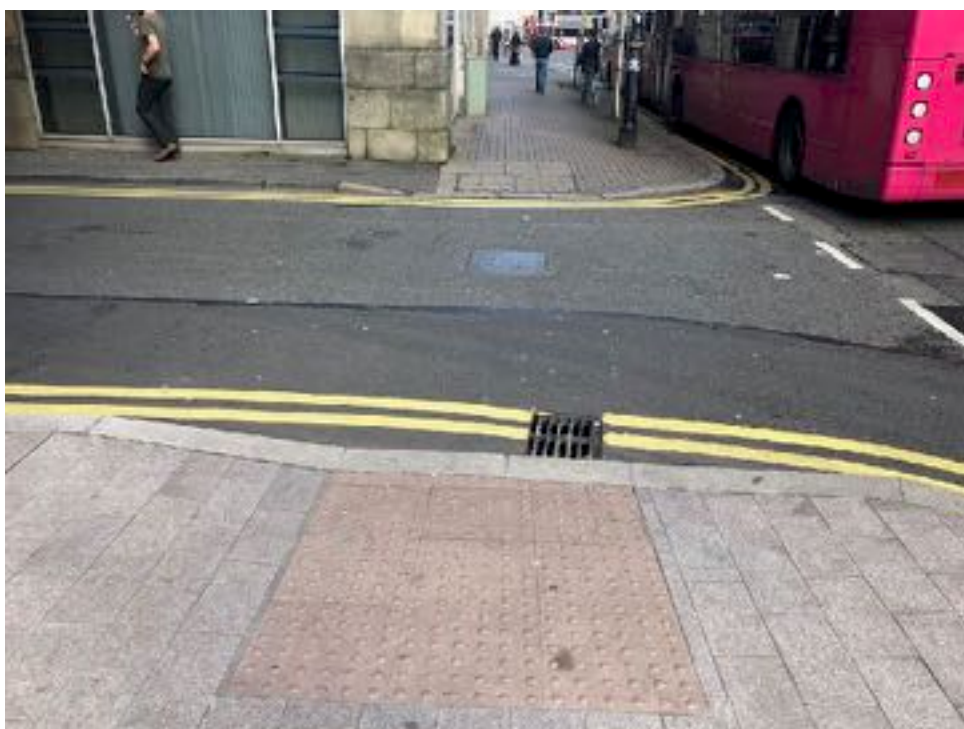
There is continuing along the western footway an in-line uncontrolled crossing across the junction with James Street South. Tactile paving and kerb levels are an issue on the northern side of the crossing.

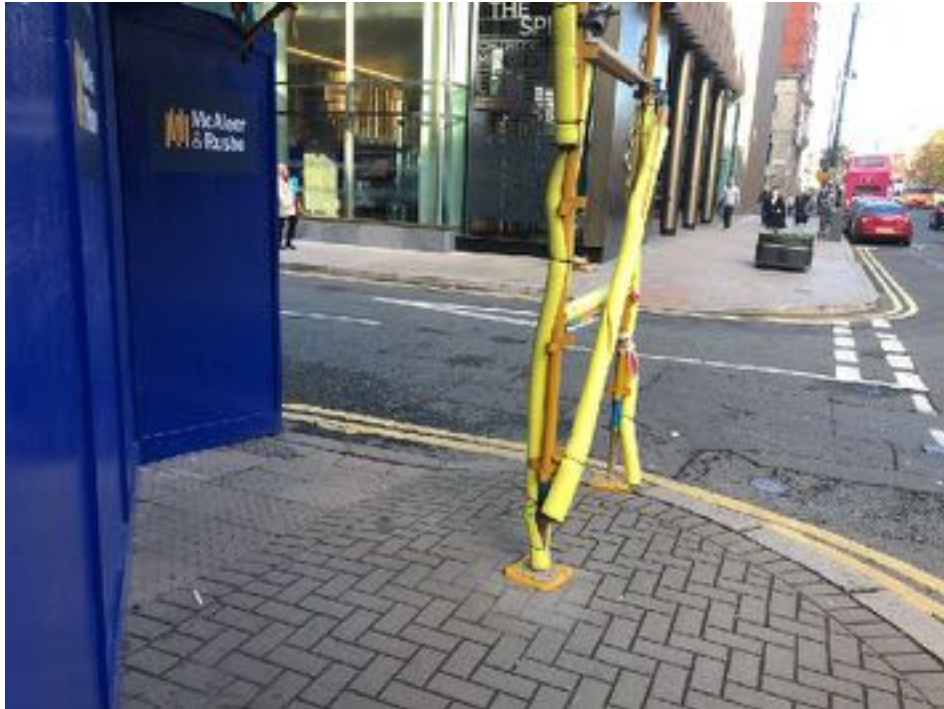
The footway around the new Grand Central Hotel has been upgraded to provide a high quality level surface. New tactile paving has been provided and correctly installed although contrast could be stronger. The in-line uncontrolled crossing across Franklin Street is partially obstructed by hoardings around works to the Ewart Building.

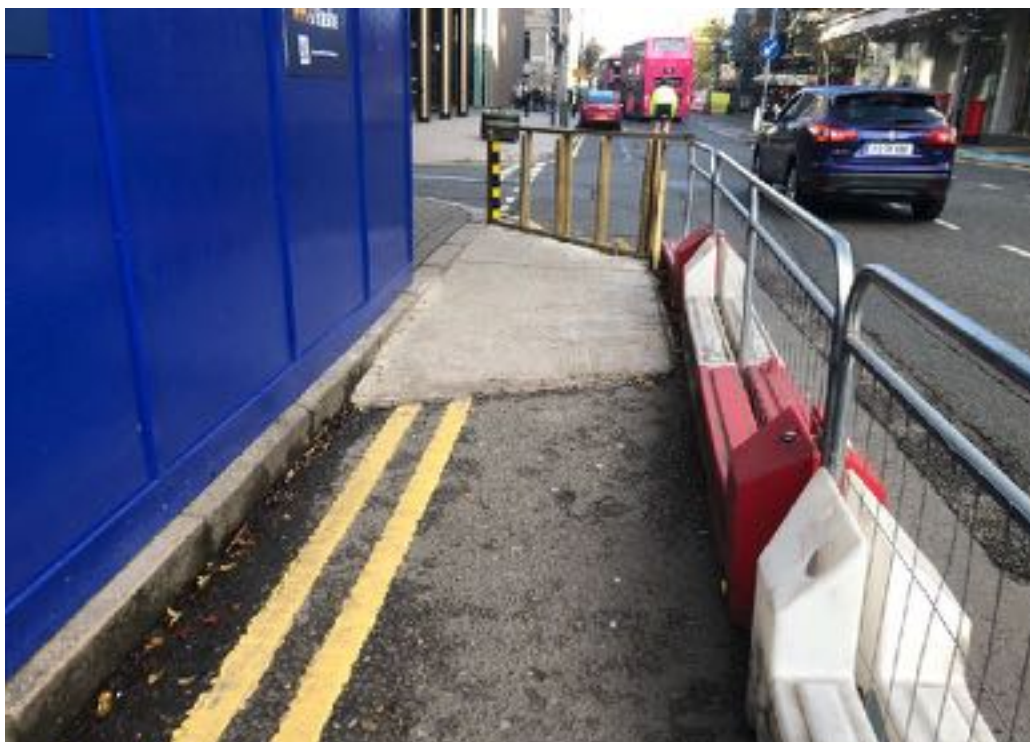
Temporary step free access has been provided for pedestrians around the Ewart Building. Although narrow this is an improvement on provision at many other city centre developments.

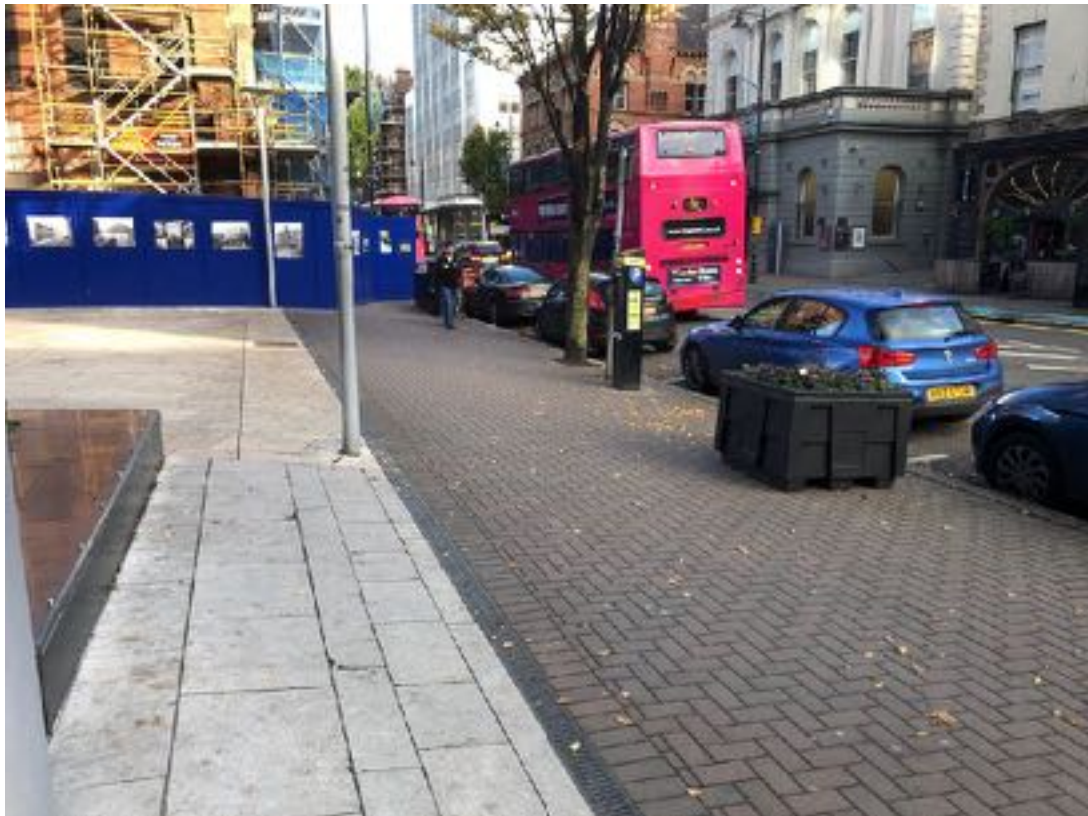
The footway beside the Invest NI building is broad and relatively clutter free.
