Recommendations from Imtac on public realm proposals for Belfast Streets Ahead Phase 5

(November 2018)

Street audit findings

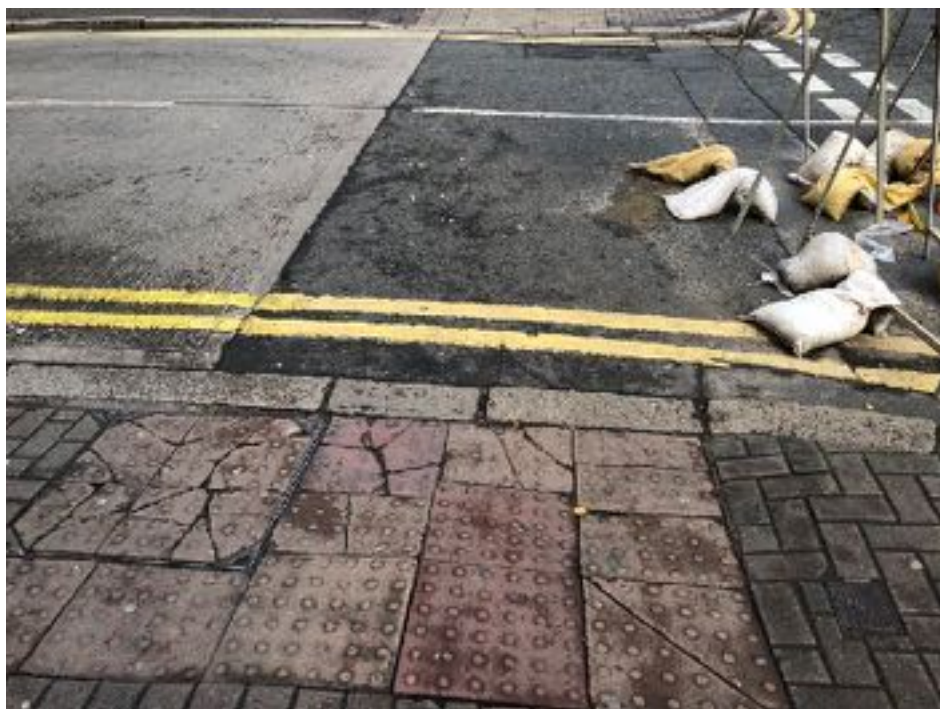
There is an in-line uncontrolled crossing across the junction with Clarence Street West. The tactile paving is damaged and uneven and different coloured tiles have been used.

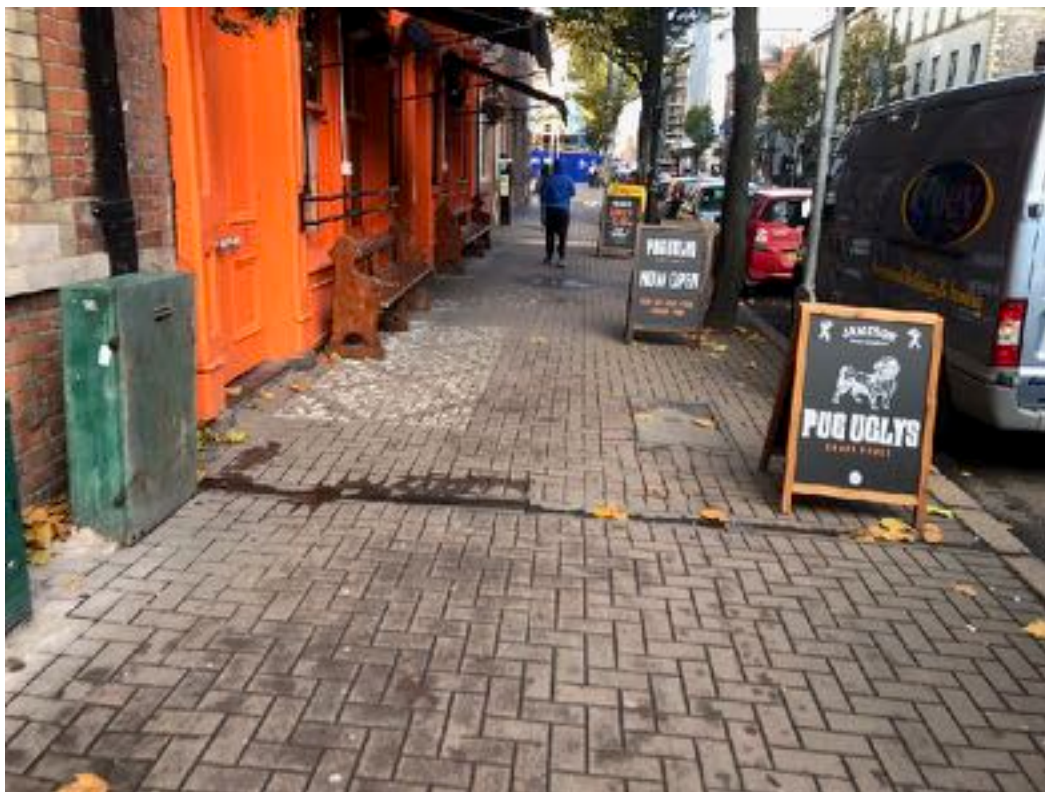
Frequent A-Boards, benches and a pavement cafe are major obstacles on the remaining section of Bedford Street.

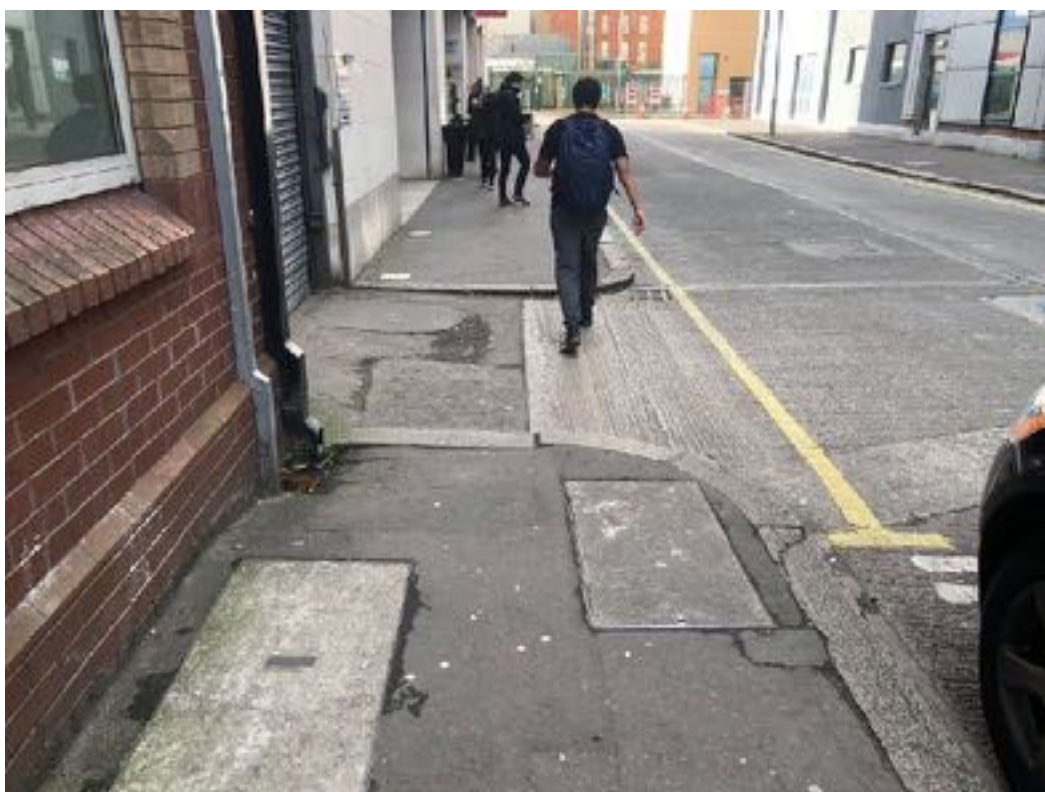
A vehicle entrance without dropped kerbs prevents step free access along the southern footway of Clarence Street West.

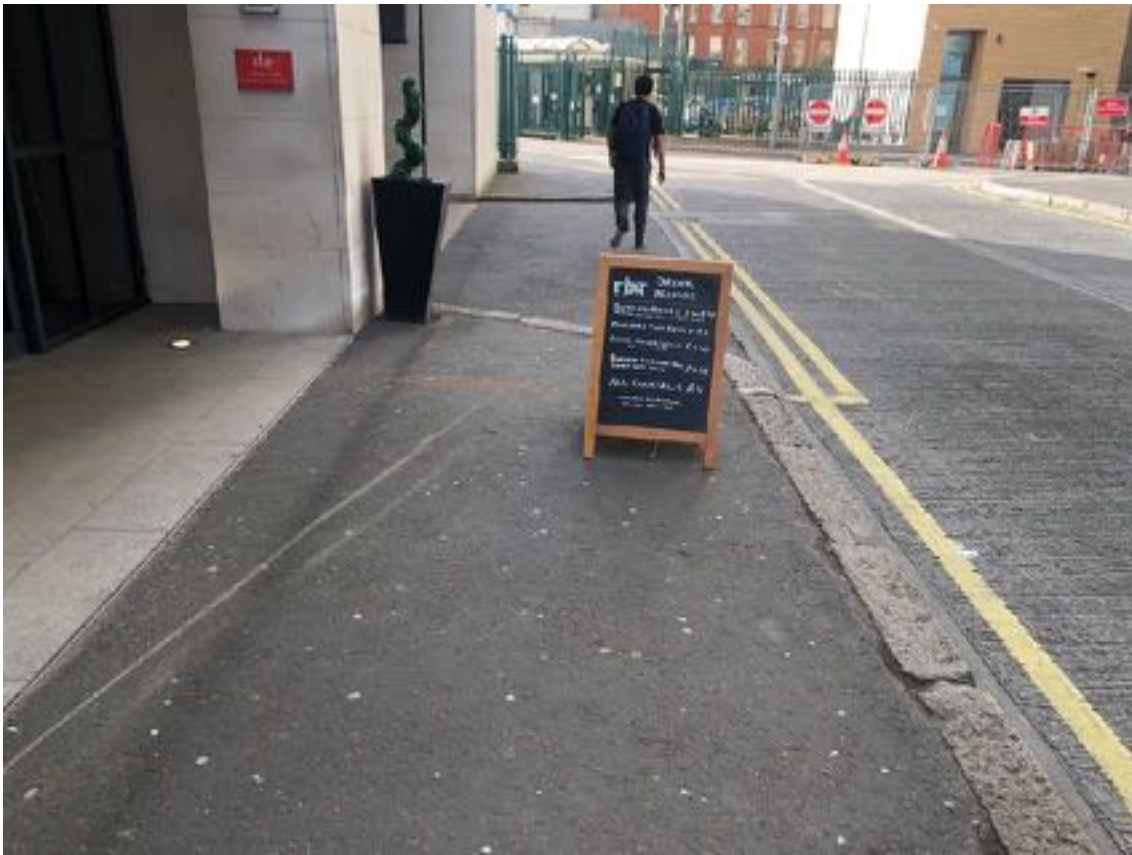
An A-Board, planters and another kerbed vehicle entrance create further obstruction along the footway.

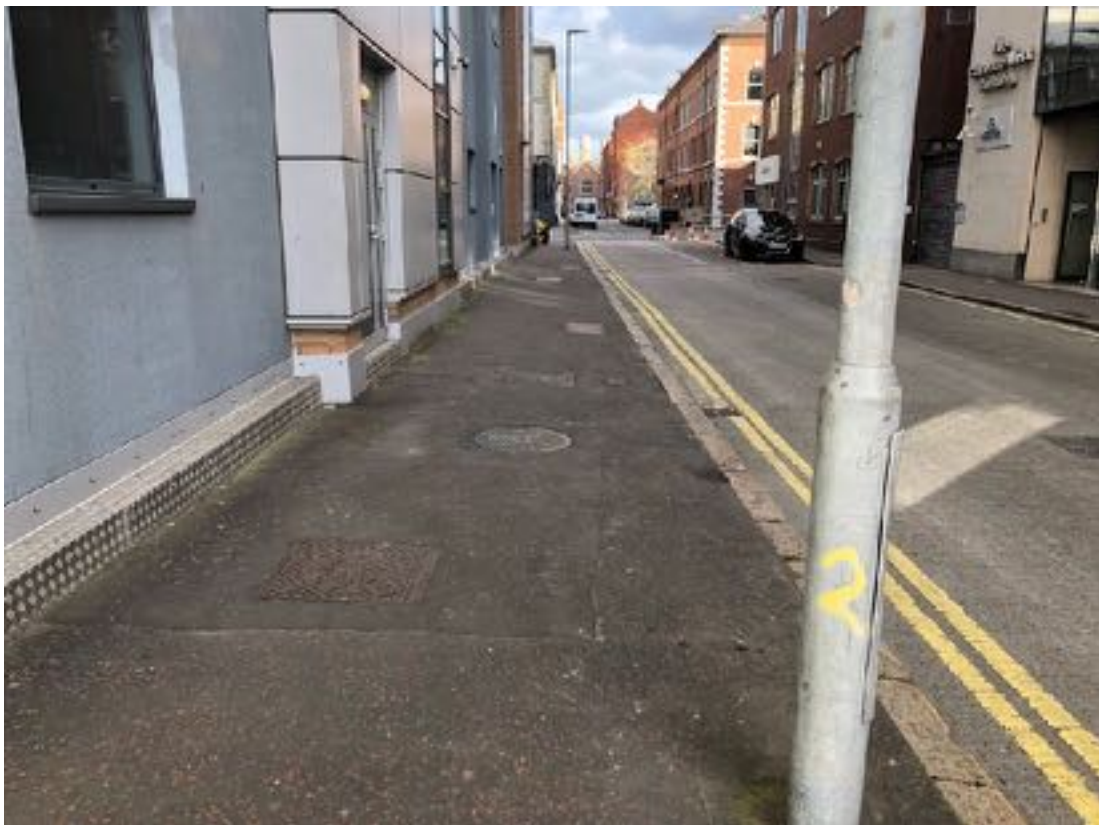
The northern footway is rough and uneven but largely clutter/barrier free.

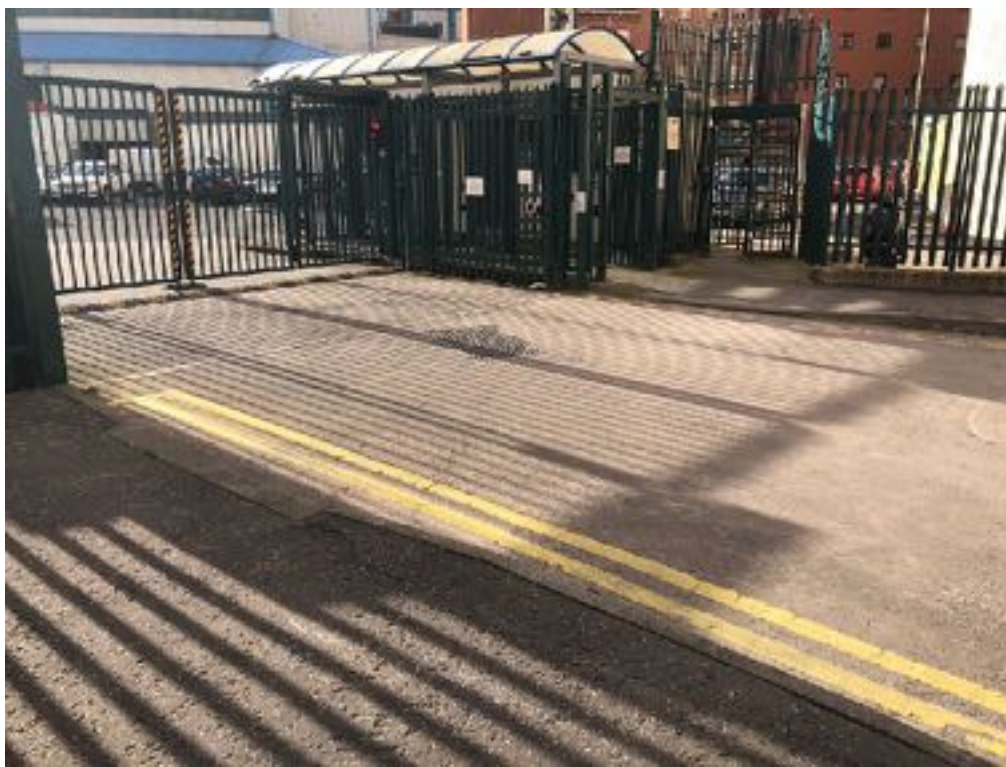
The entrance to the BBC Studios at the corner of Clarence Street West and McClintock Street has a partially dropped kerb with no tactile paving.

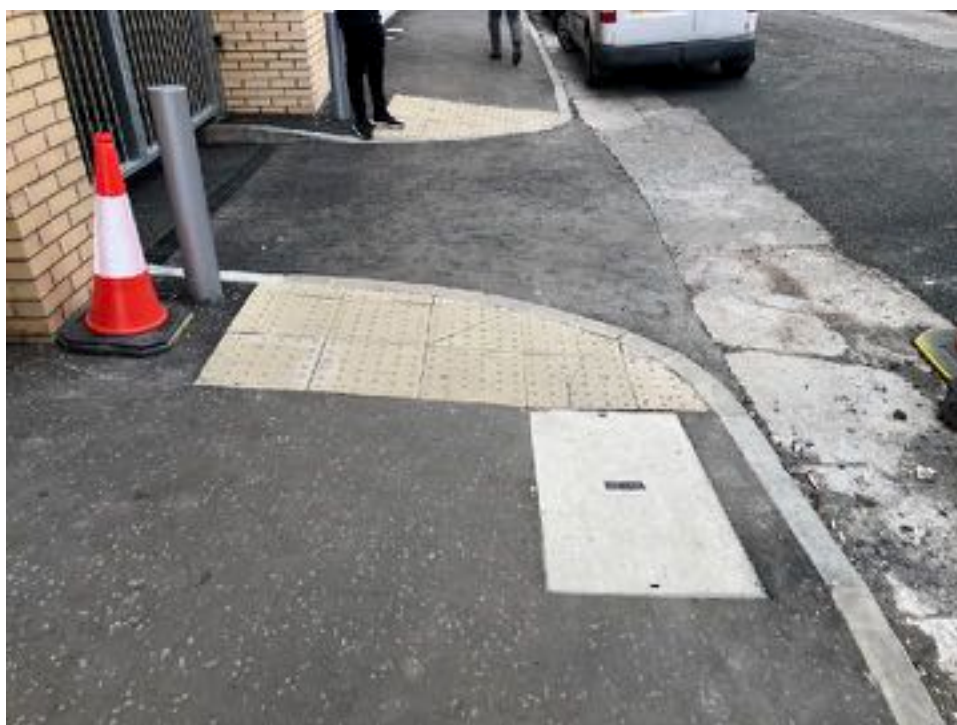
The western footway has been recently re-laid following a new development. Whilst the surface is improved tactile paving at the vehicle entrance lacks depth in place due to the radius of the kerb. The provision of bollards reduce footway width.

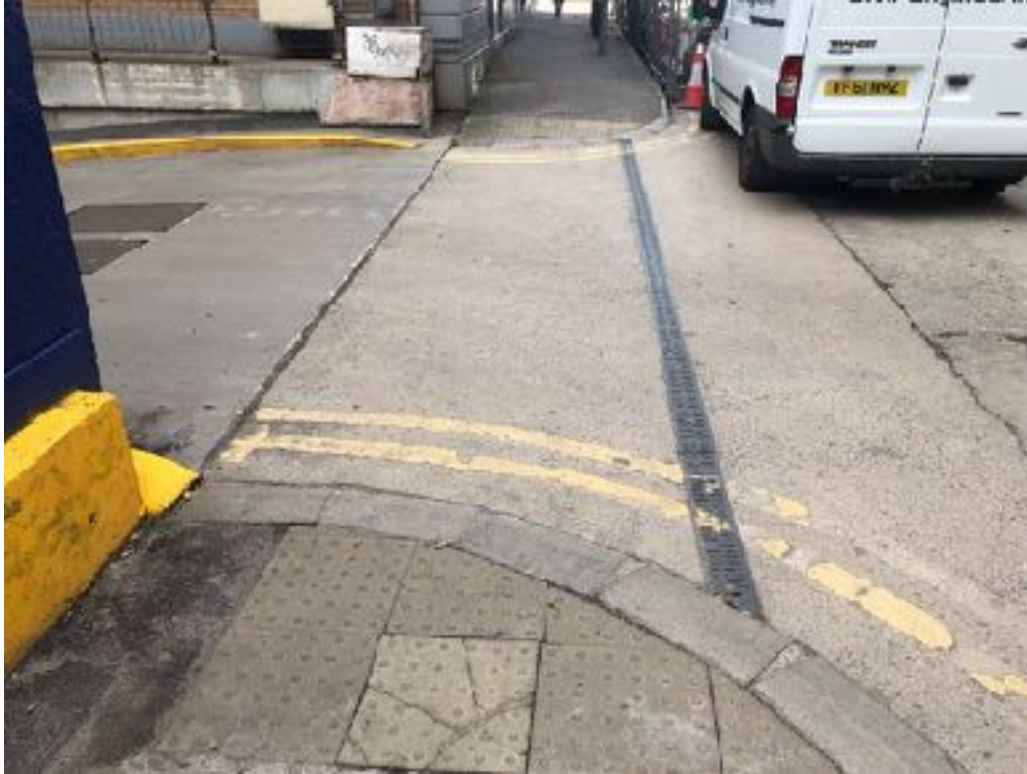
The surface of the eastern footway surface is rough and uneven. Trees and street furniture unnecessarily restrict footway width to a low standard. At the entrance to the underground car park a dropped kerb has been provided. However the tactile paving is damaged and lacks depth in places due to the radius of the kerb.

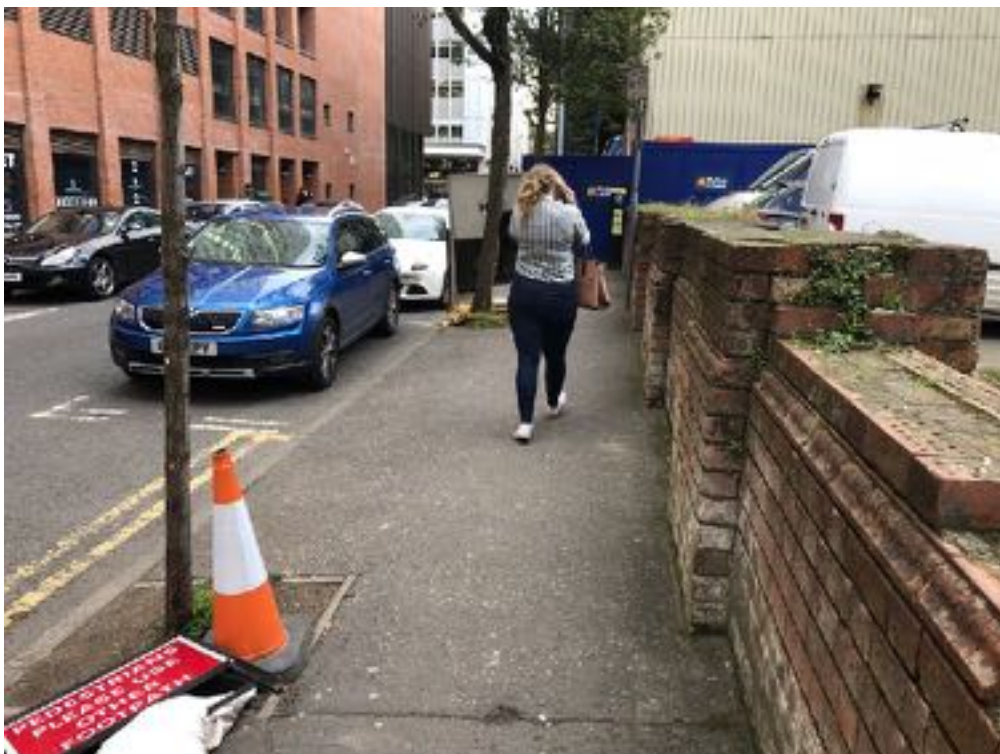
Parts of the southern footway have been closed due to the Ewart Building redevelopment.

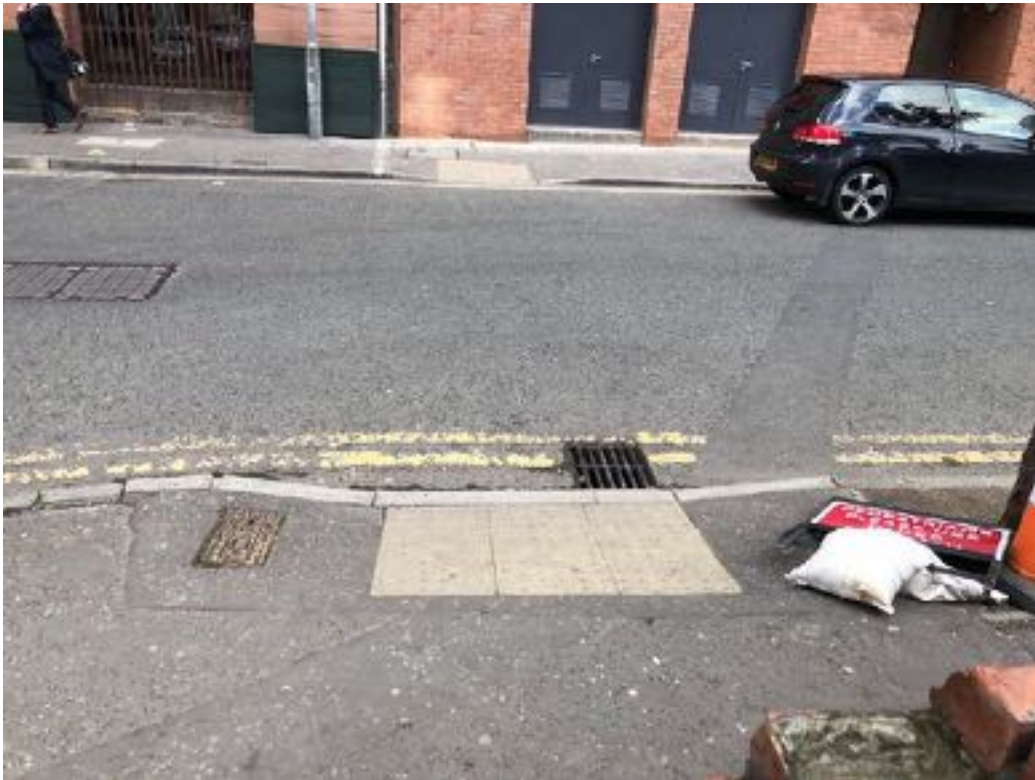
An in-line uncontrolled crossing has been provided to provide pedestrians with alternative step free access across to the northern footway on this section.

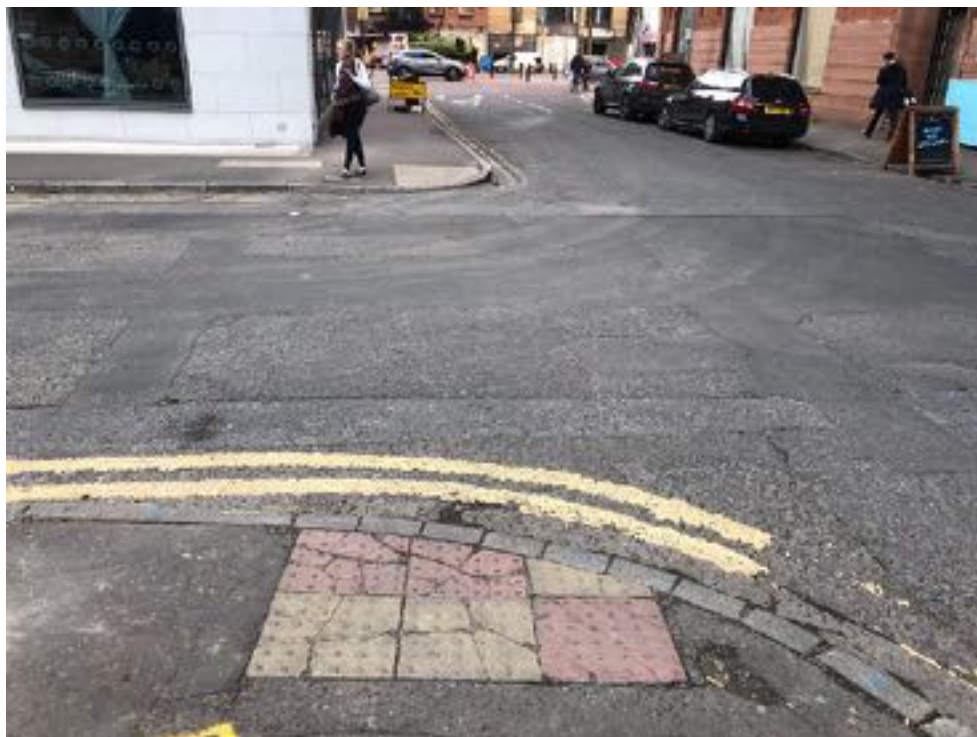
There is an uncontrolled crossing across the junction with McClintock Street. With damaged assorted coloured tactile paving on the eastern side and a significant kerb show on the eastern side as well as issues with tactile depth this is a very unsatisfactory crossing.

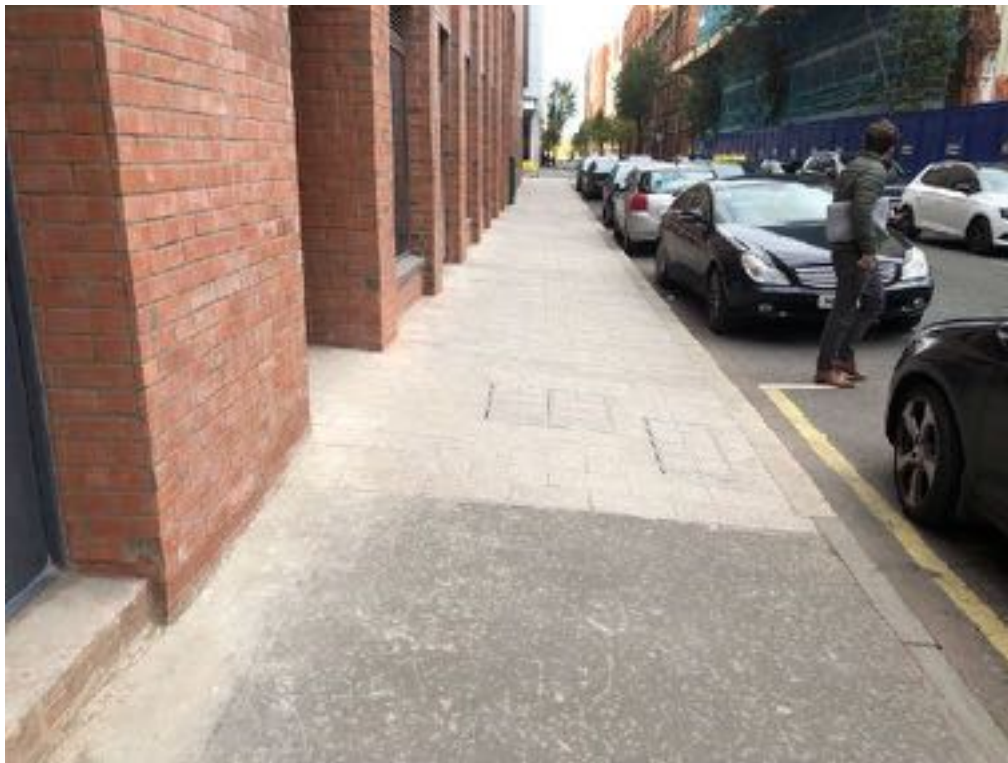
Part of the northern footway has been upgraded as part of the Grand Central Hotel development. There is a cross fall on the footway which become more significant along the footway towards Brunswick Square. This makes using the footway difficult for some disabled people.

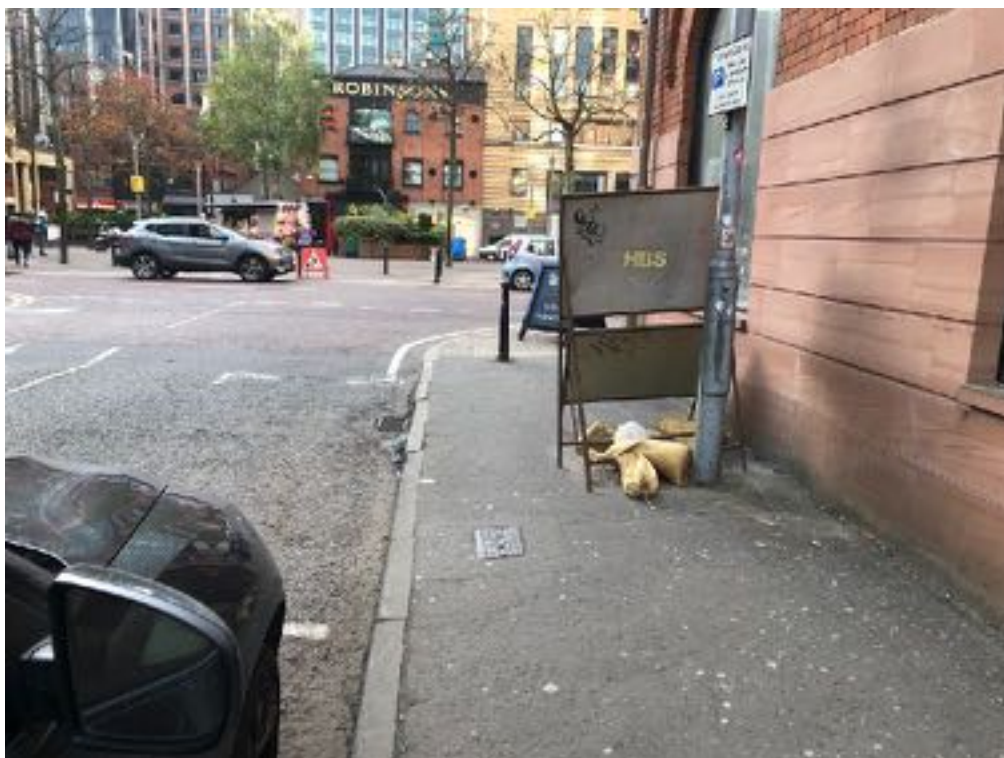
The remainder of the northern footway is rough and uneven. Traffic signs and an A-Board obstruct the footway approaching Blackstaff Square.

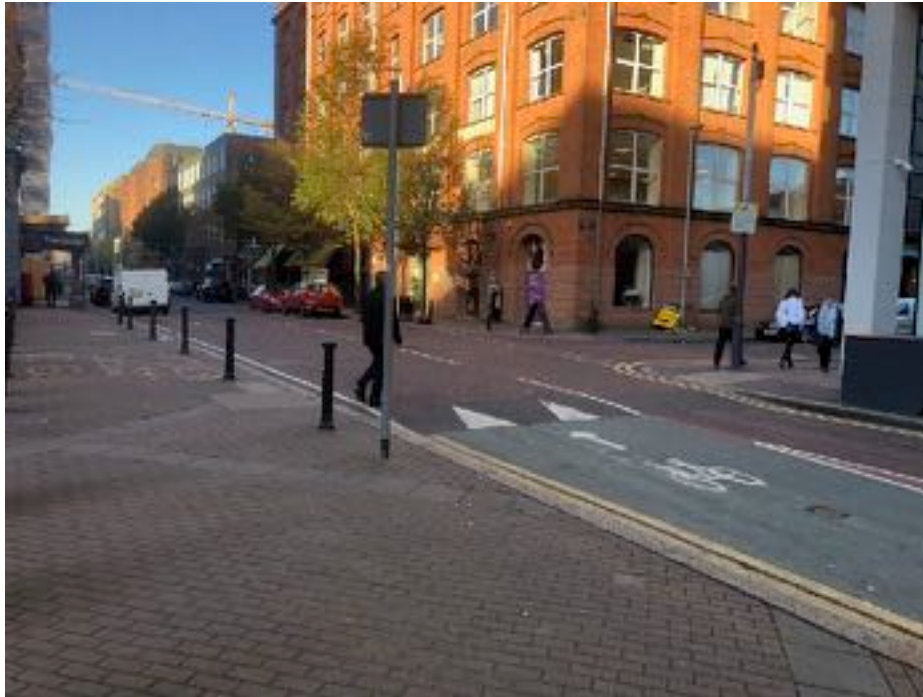
There is a table junction where Franklin Street, Amelia Street and Brunswick Street meet Blackstaff Square. Although tactile paving has been provided to highlight crossing points along the extremes of the raised table, there remain large sections of flush access between the footway and carriageway without any tactile surface.

- Replacing or repairing existing controlled crossings to ensure compliance with inclusive design standards
- Replacing uncontrolled crossings on heavily trafficked streets such as Bedford Street and Shaftesbury Square with controlled crossings
- Replacing Zebra crossing with Puffin crossings
- Replacing controlled and uncontrolled crossings on small triangular traffic island with a safe and accessible alternative
- Replacing or repairing existing uncontrolled crossings to ensure compliance with inclusive design standards
- Replacing the table junction at Blackstaff Square with a safe and accessible alternative

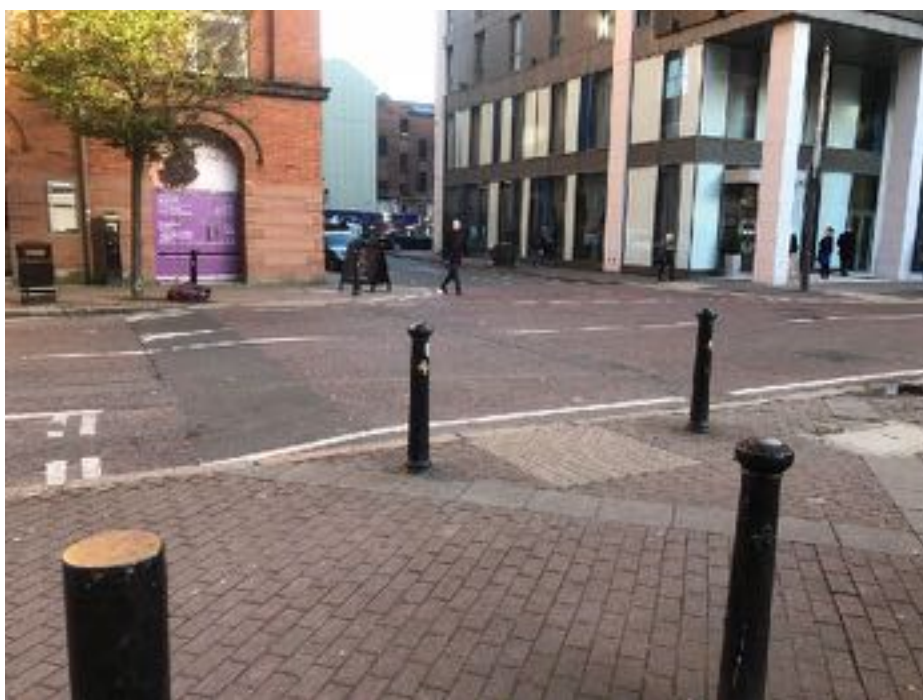
The design of the junction makes its safe use by people with a visual impairment difficult or impossible. Other participants in the audit felt the layout was confusing and unsafe.

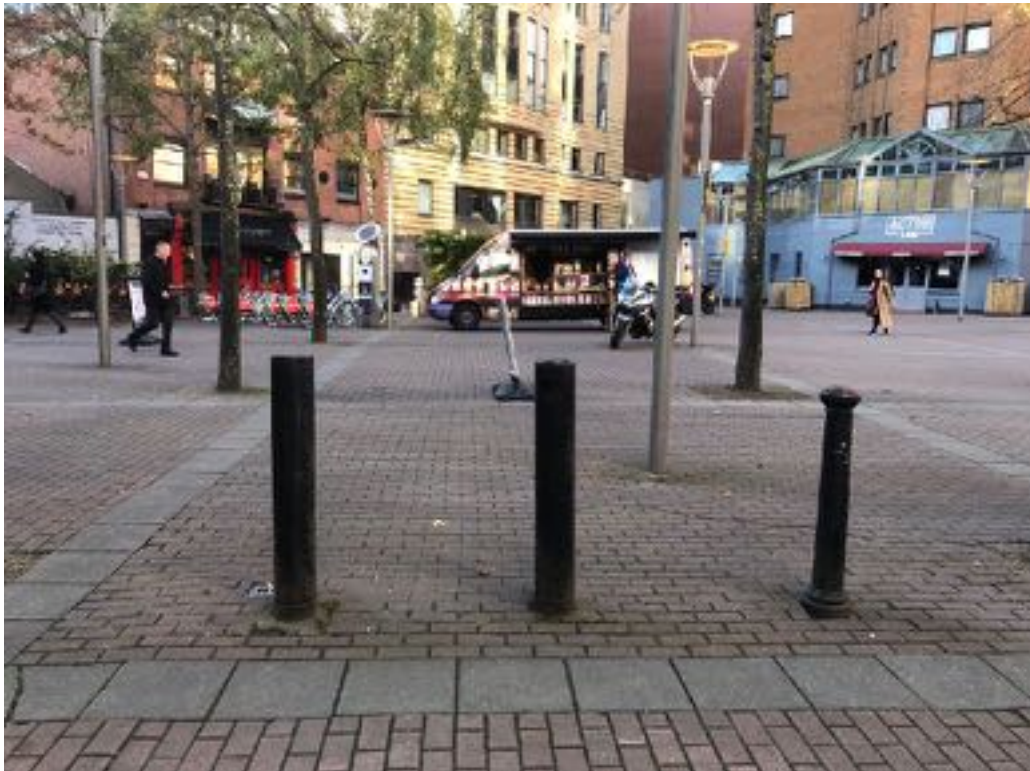
Blackstaff Square is one of a few public spaces in the city centre. Currently its layout is inaccessible and uninviting. All participants in the audit indicated it was not an area that felt safe.

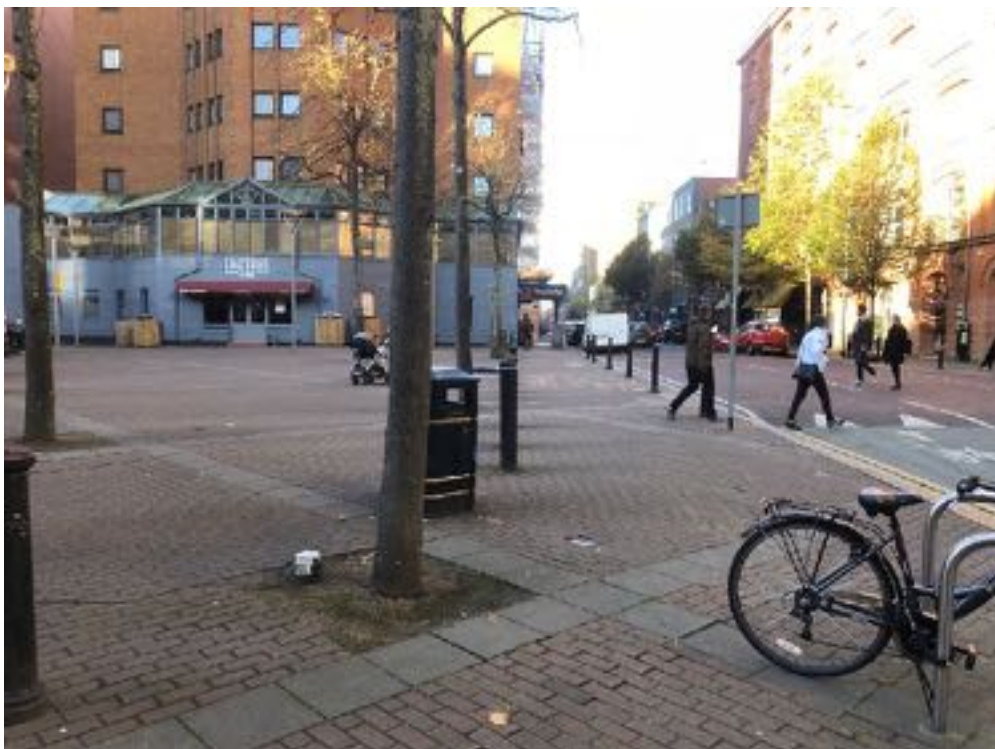
The Square is littered with obstructions including multiple bollards, trees, lighting columns, A Boards, bins and cycling infrastructure. There is no obstacle free route through the area. There is also no seating emphasising this is a space where people are discouraged from lingering.

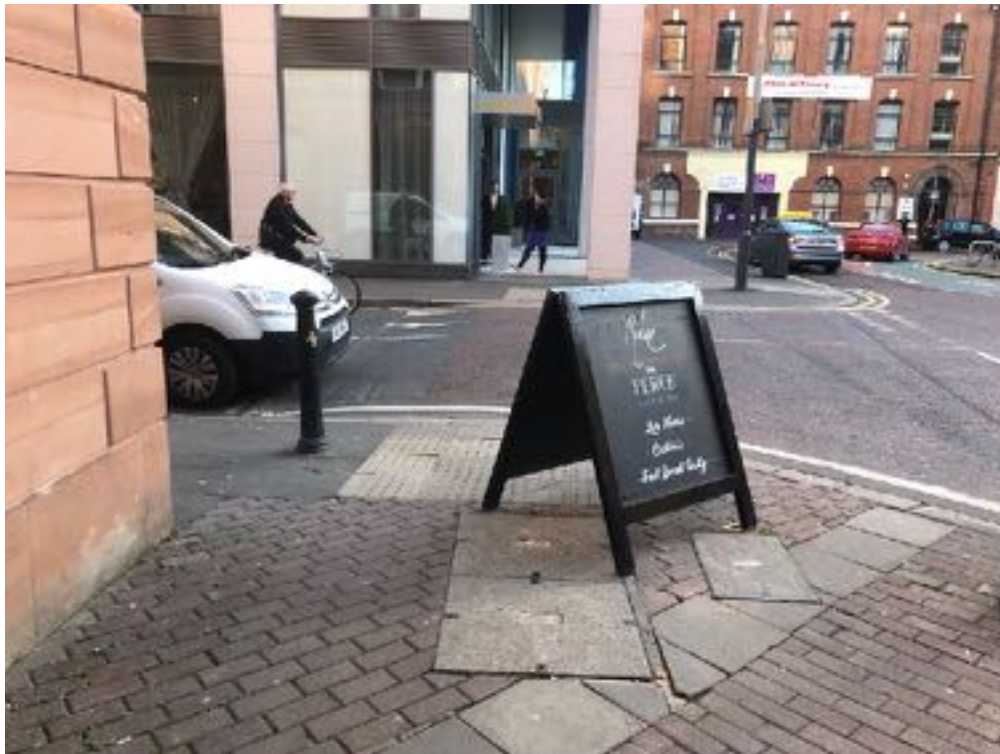
There is an inline uncontrolled crossing across Brunswick Street at its junction with Franklin Street. As well as issues previously highlighted about this table junction an A-Board has been positioned on the tactile on the northern footway.

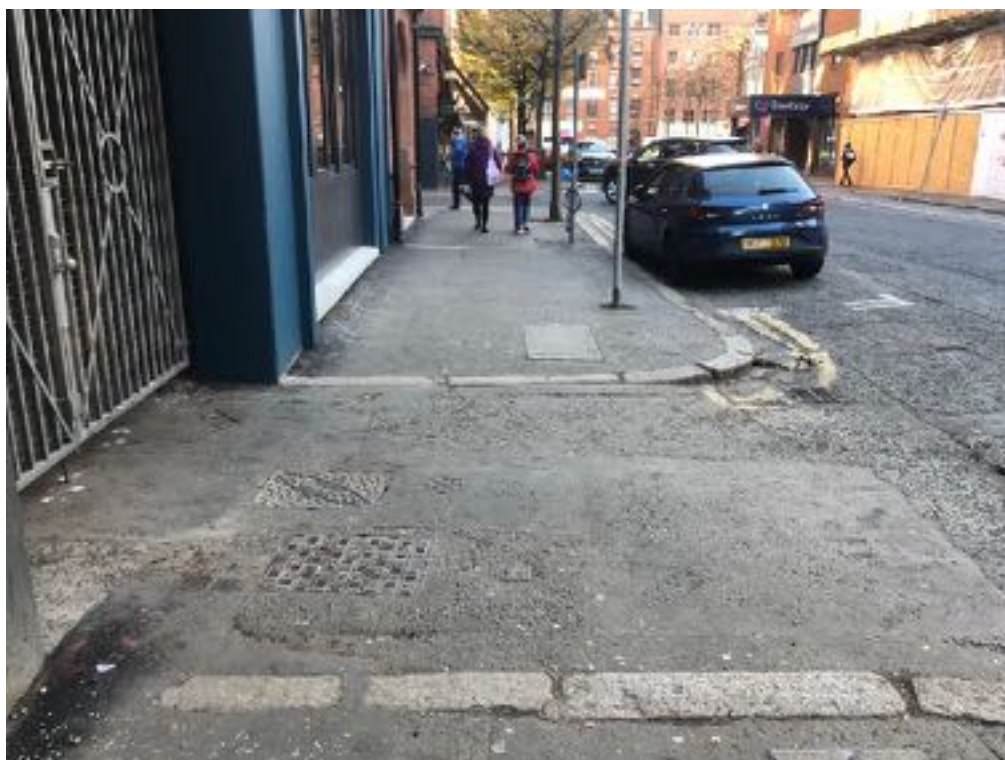
The remaining footway on the eastern side approaching Howard Street is broad but rough and uneven and includes dish drainage channels across the footway and a vehicle entrance with no tactile paving which appears to be in use.

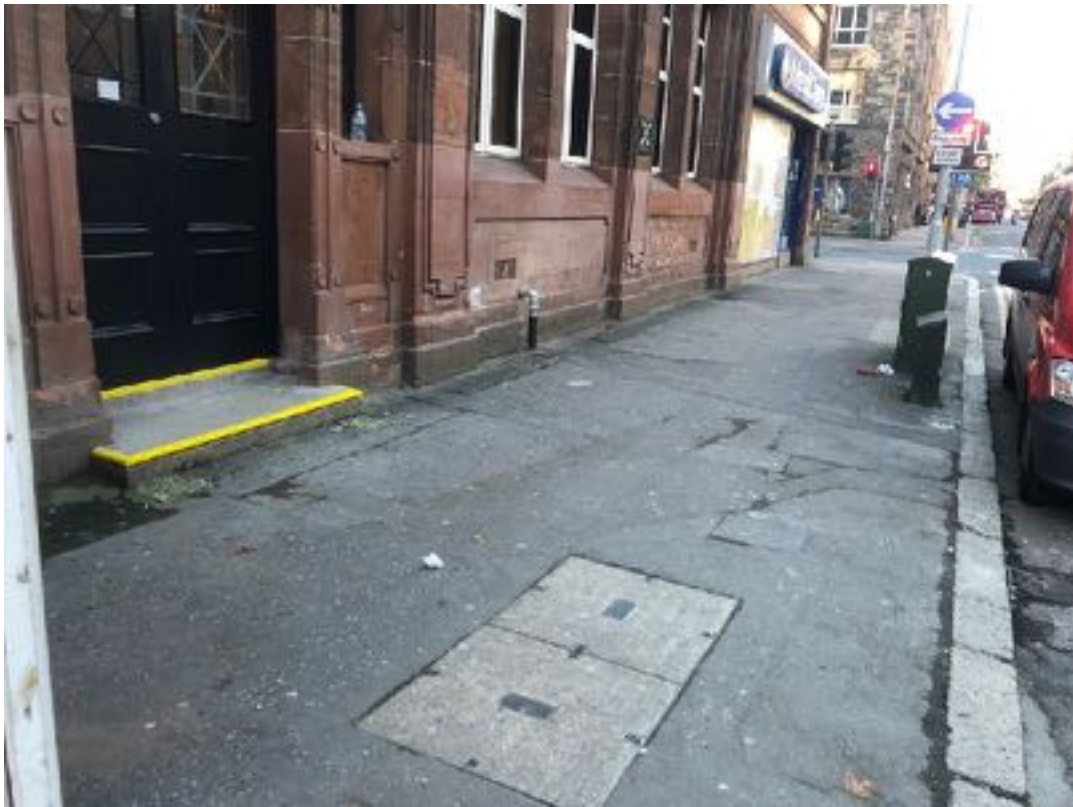
The footway on the western side is broad but rough and uneven in places.

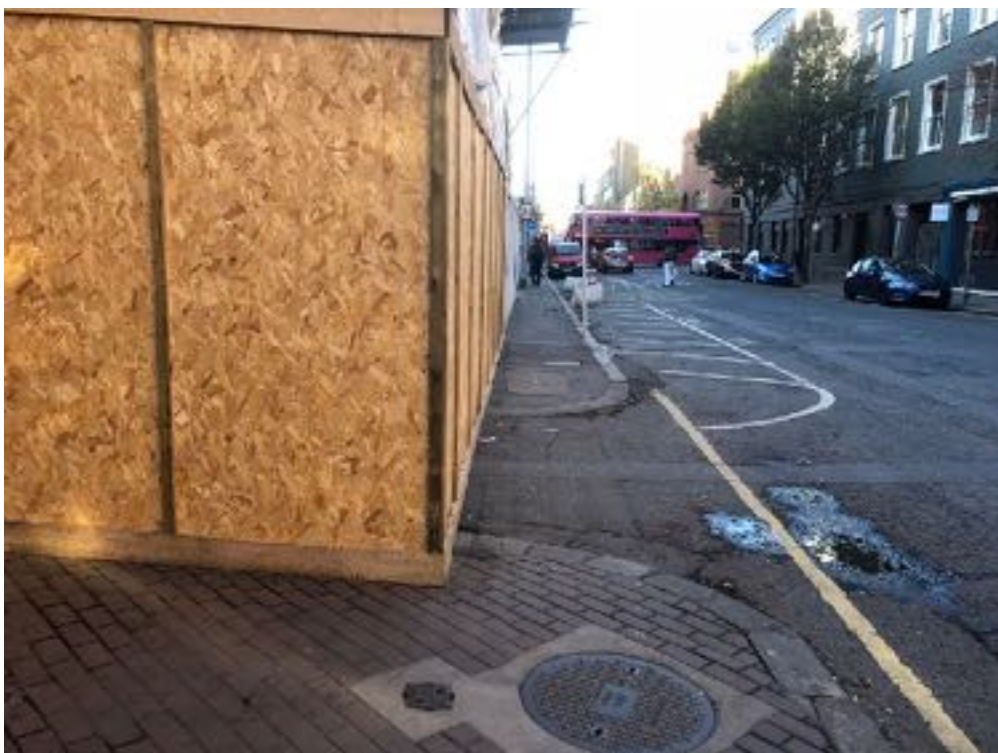
The western footway is narrowed considerably by hoardings associated with building works. An unused vehicle entrance includes only partially dropped kerbs.

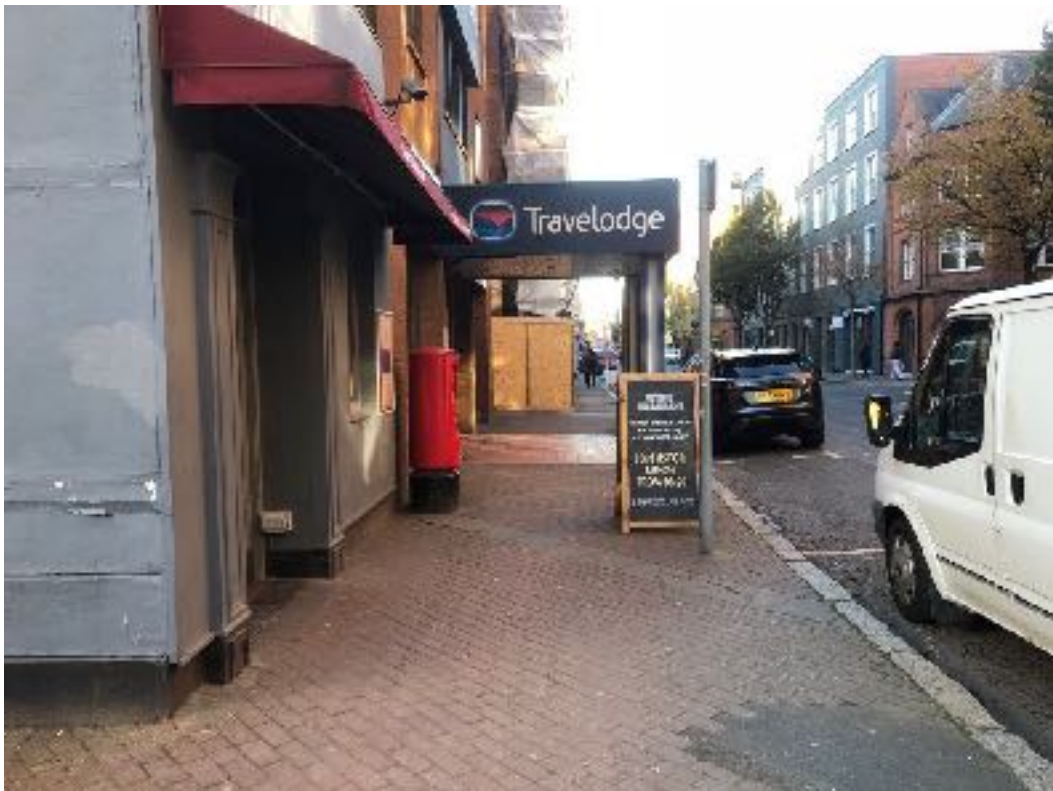
An A-Board obstructs the footway approaching Blackstaff Square.

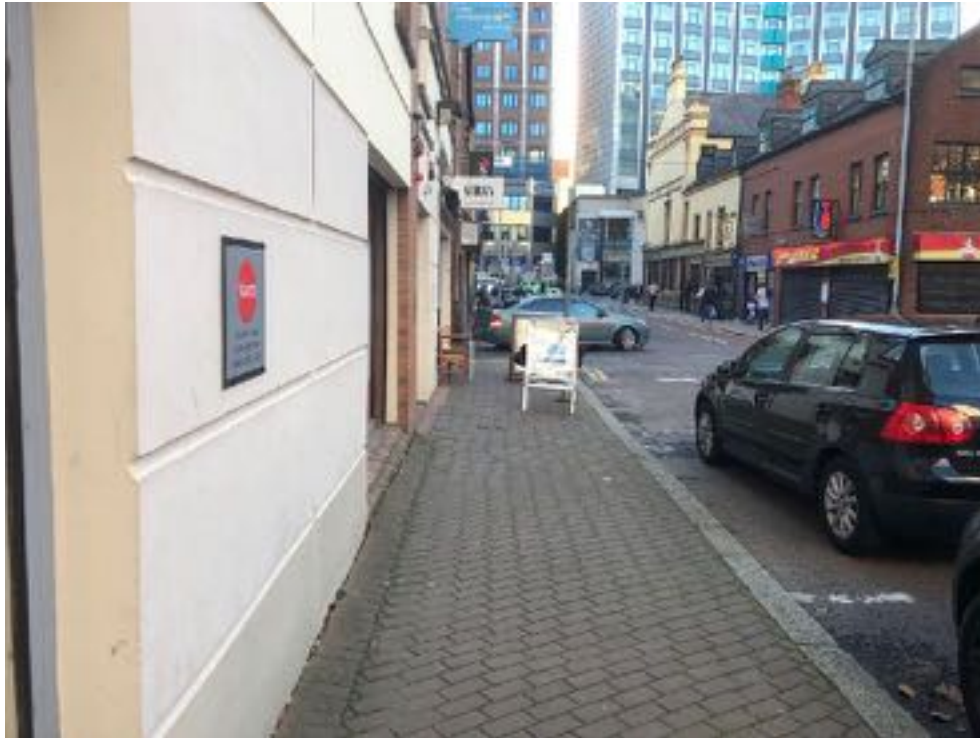
Amelia Street turns sharply. The southern footway narrows and is obstructed completely by A-Boards and a pavement cafe.

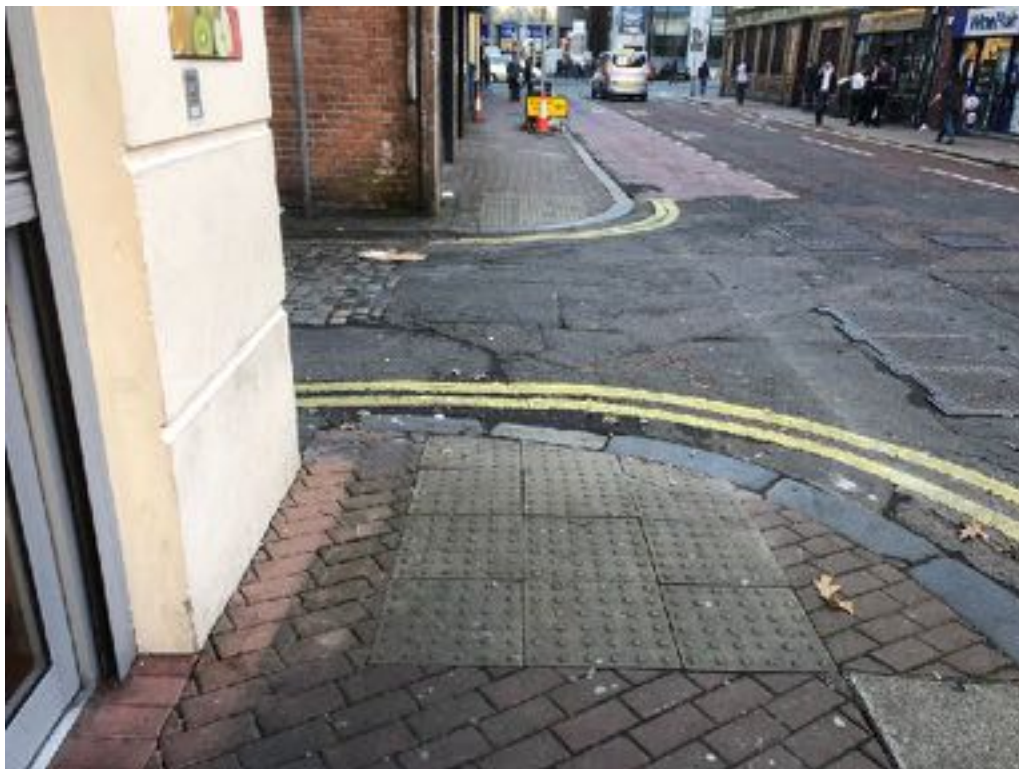
There is an in-line uncontrolled crossing across the junction with Bains Place. The carriageway surface is rough and uneven. Temporary road works signage narrows footway width approaching Great Victoria Street.

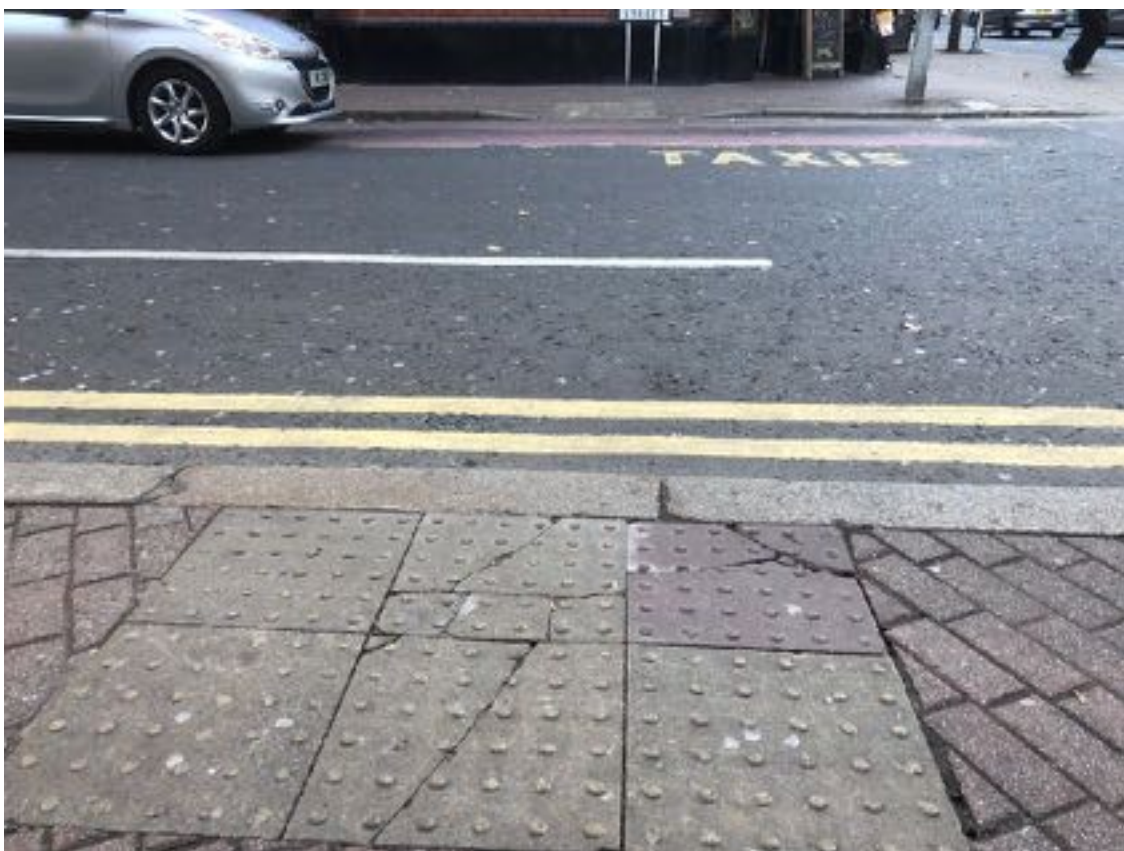
In addition to the uncontrolled crossing across the junction with Great Victoria Street another indented crossing has been provided. The kerb on the northern side has not been dropped and leads to the taxi rank on the southern side. Very confusing!

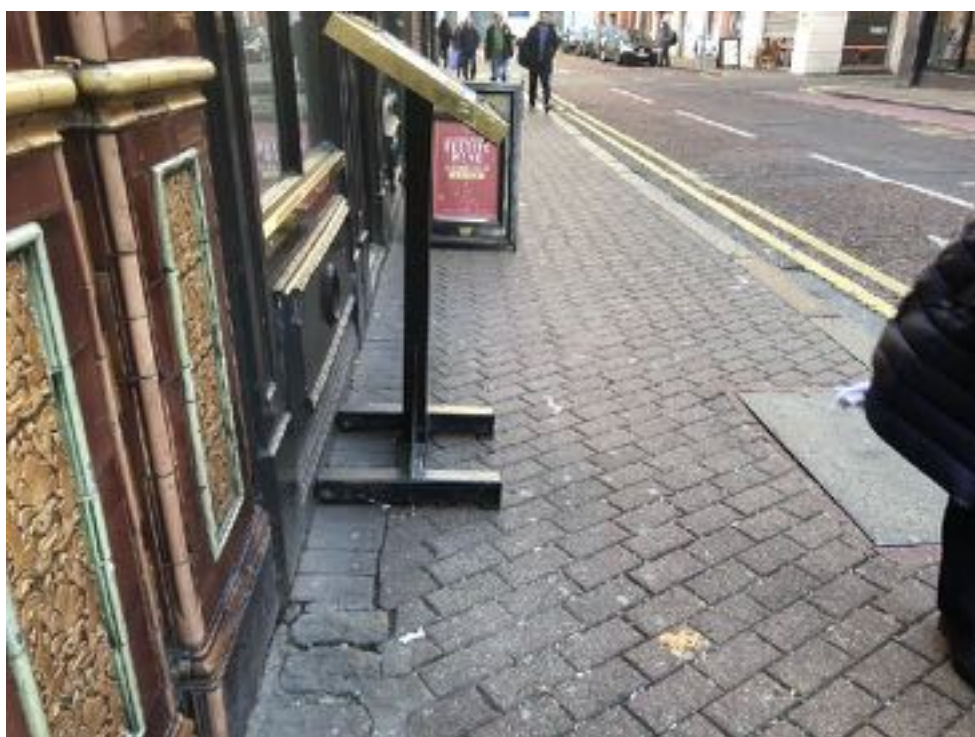
A-Boards obstruct the northern footway.

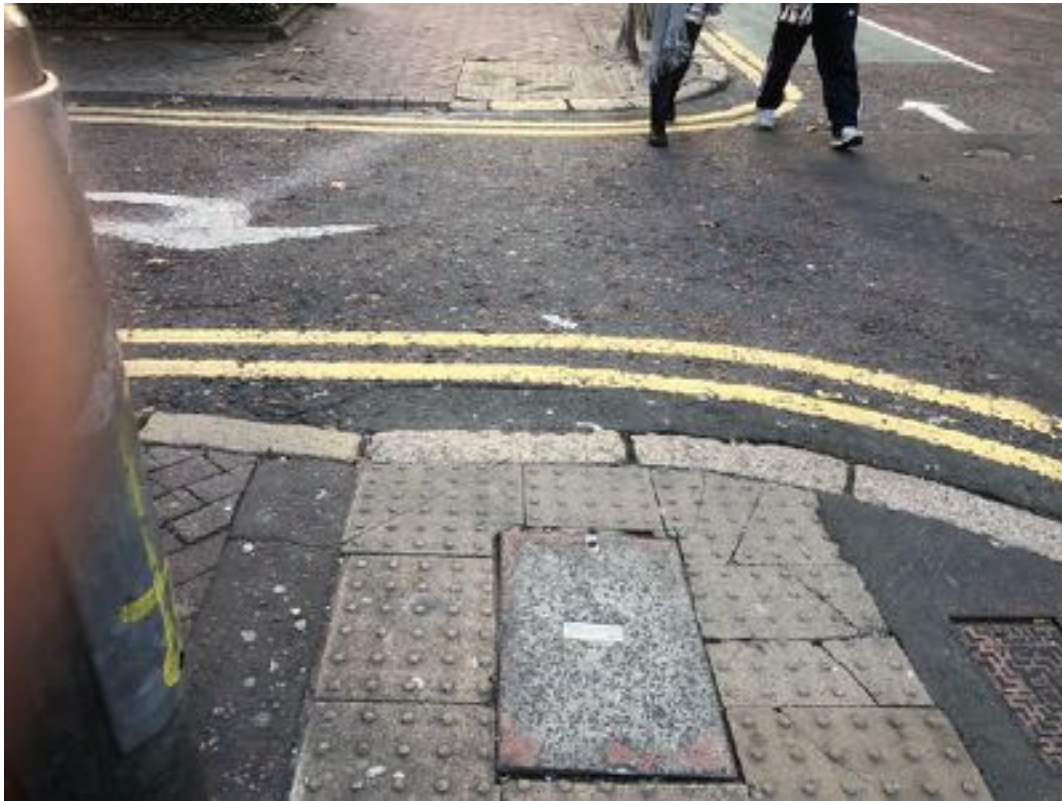
There is an in-line uncontrolled crossing across the side street between Amelia Street and Blackstaff Square. The condition of the tactile paving is poor and the depth of tactile paving is an issue on the eastern side.
