Recommendations from Imtac on public realm proposals for Belfast Streets Ahead Phase 5

(November 2018)

Street audit findings

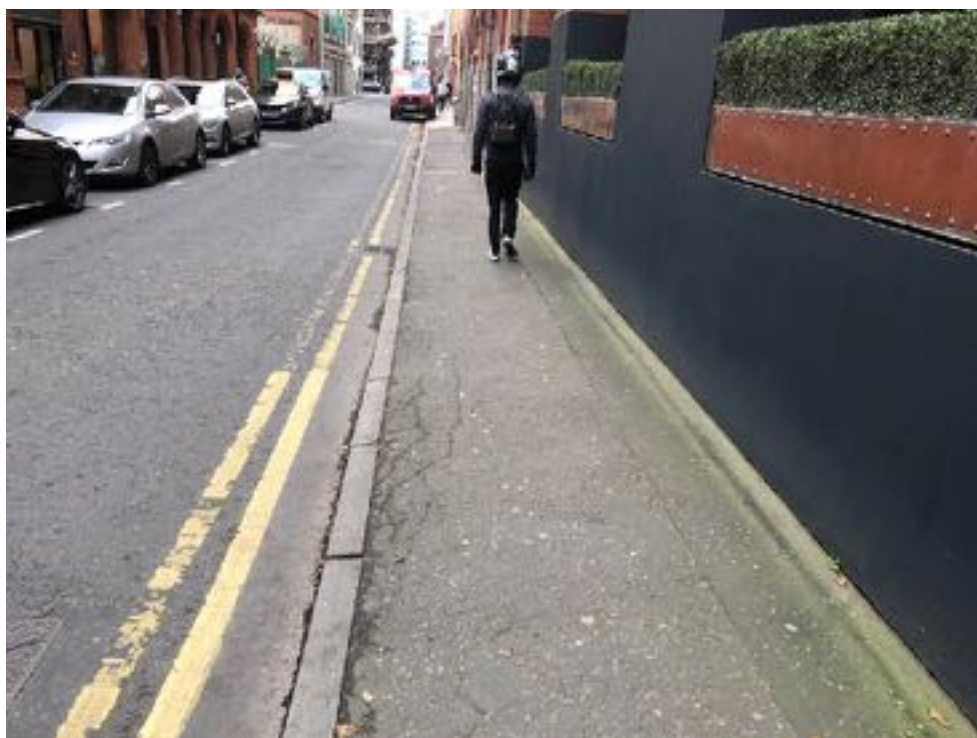
The southern footway is narrow but uncluttered. A van obstructs the footway approaching Bedford Street.

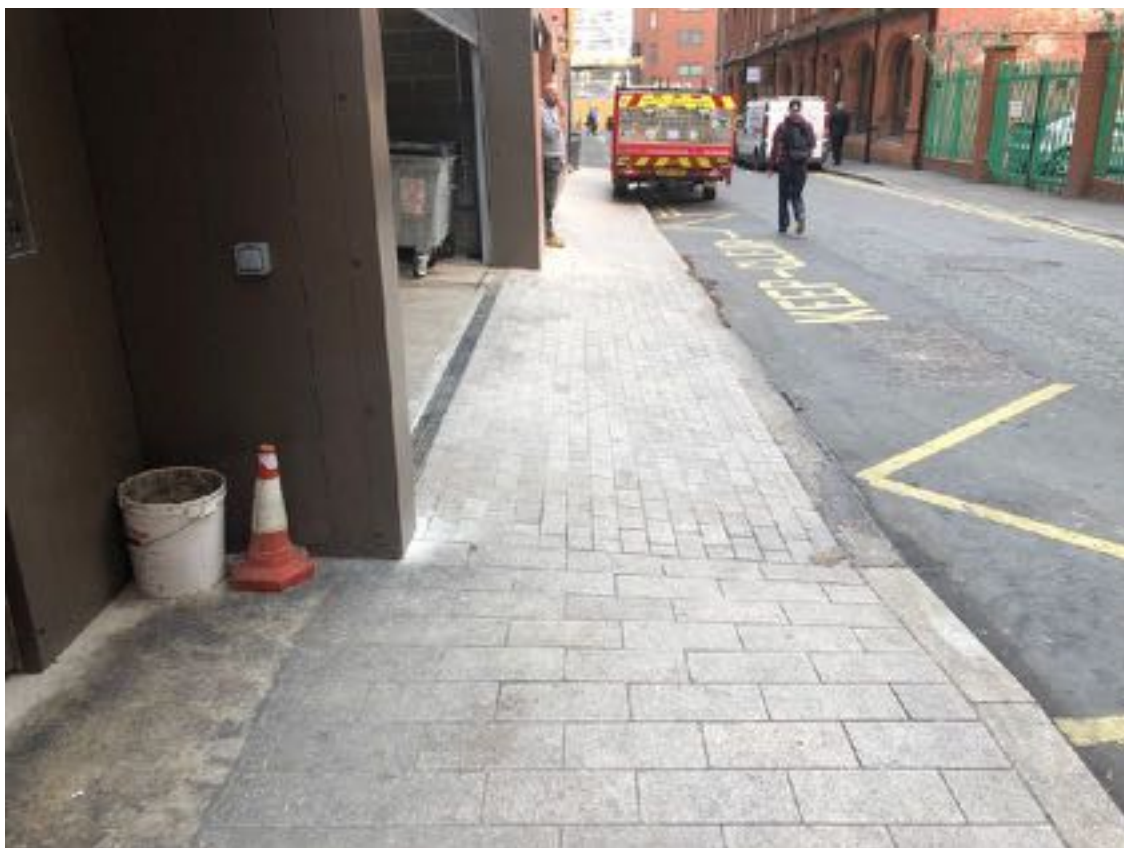
The footway around the Grand Central Hotel has recently been upgraded. There is a significant cross fall on the flush footway at service entrances.

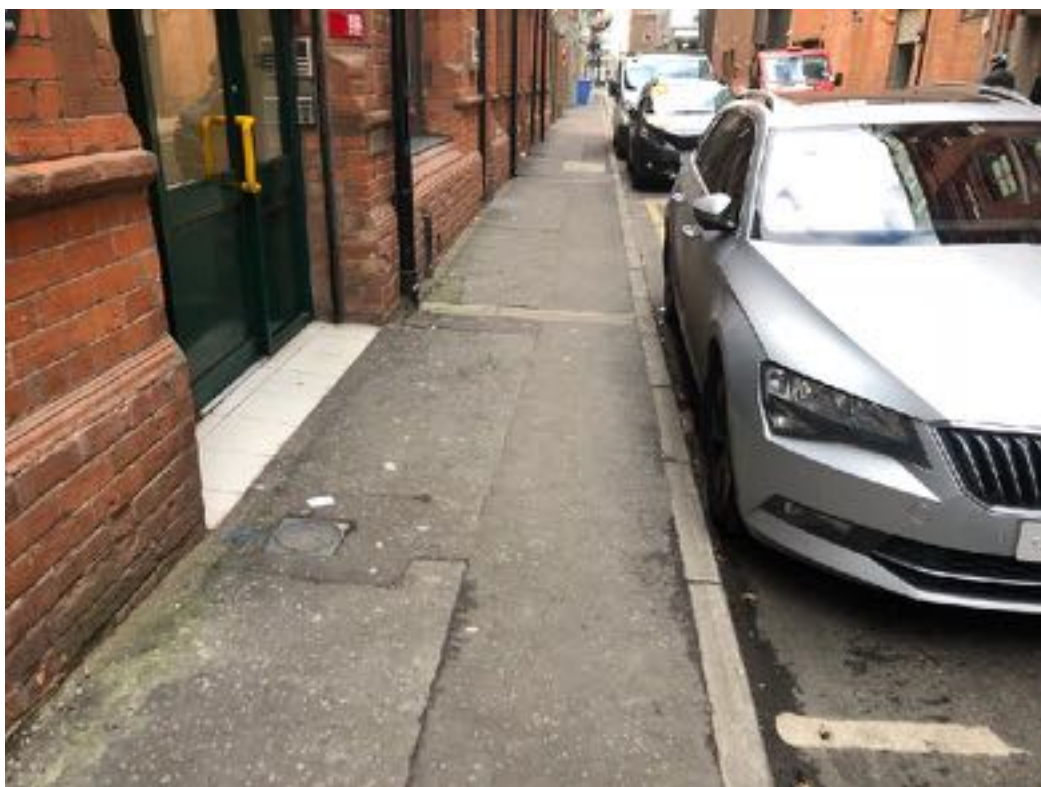
The northern footway is narrow, rough and uneven and contains frequent dish drainage channels across the footway. Bins obstruct the footway approaching Bedford Street.

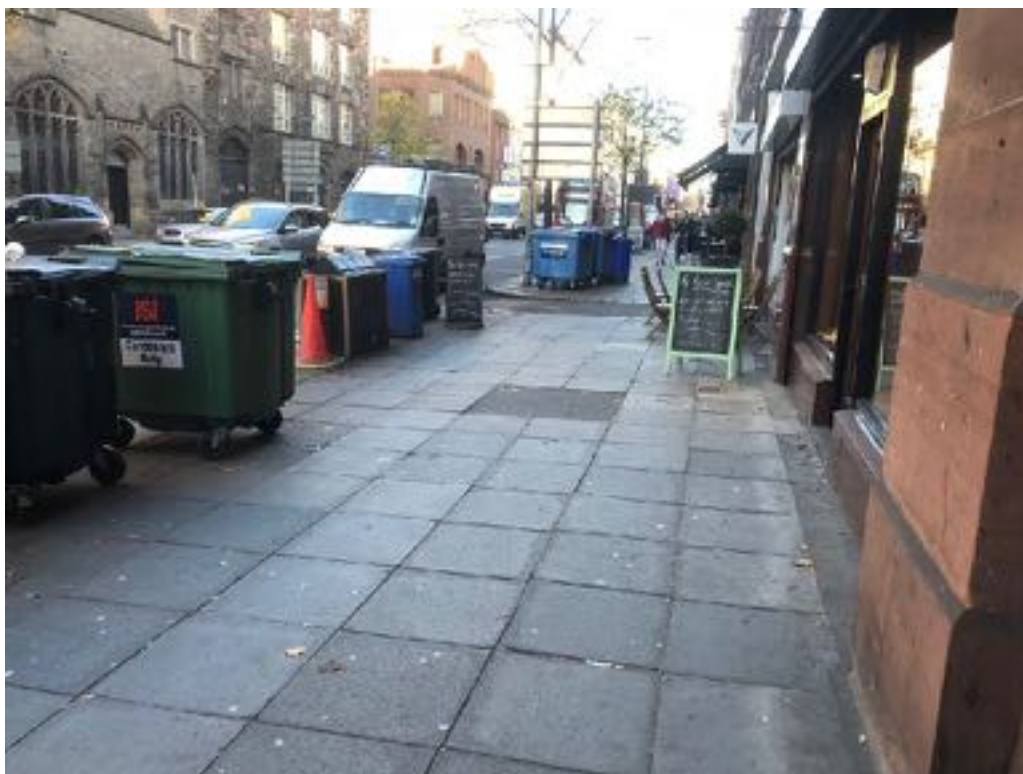
The surface of the southern footway between Great Victoria Street and Brunswick Street is rough and uneven. There are major issues with clutter including street furniture, businesses bins, A-Boards and pavement cafes.

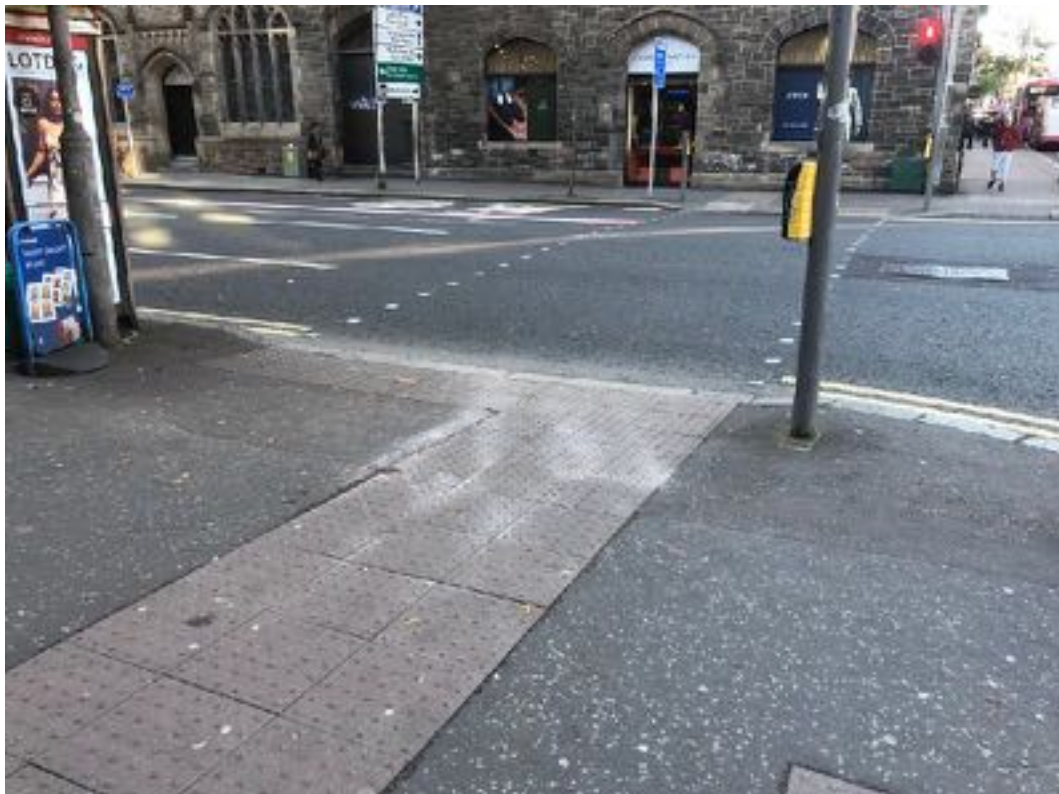
There is a good example of a controlled crossing across Howard Street at the western arm of its junction with Brunswick Street and Upper Queen Street.

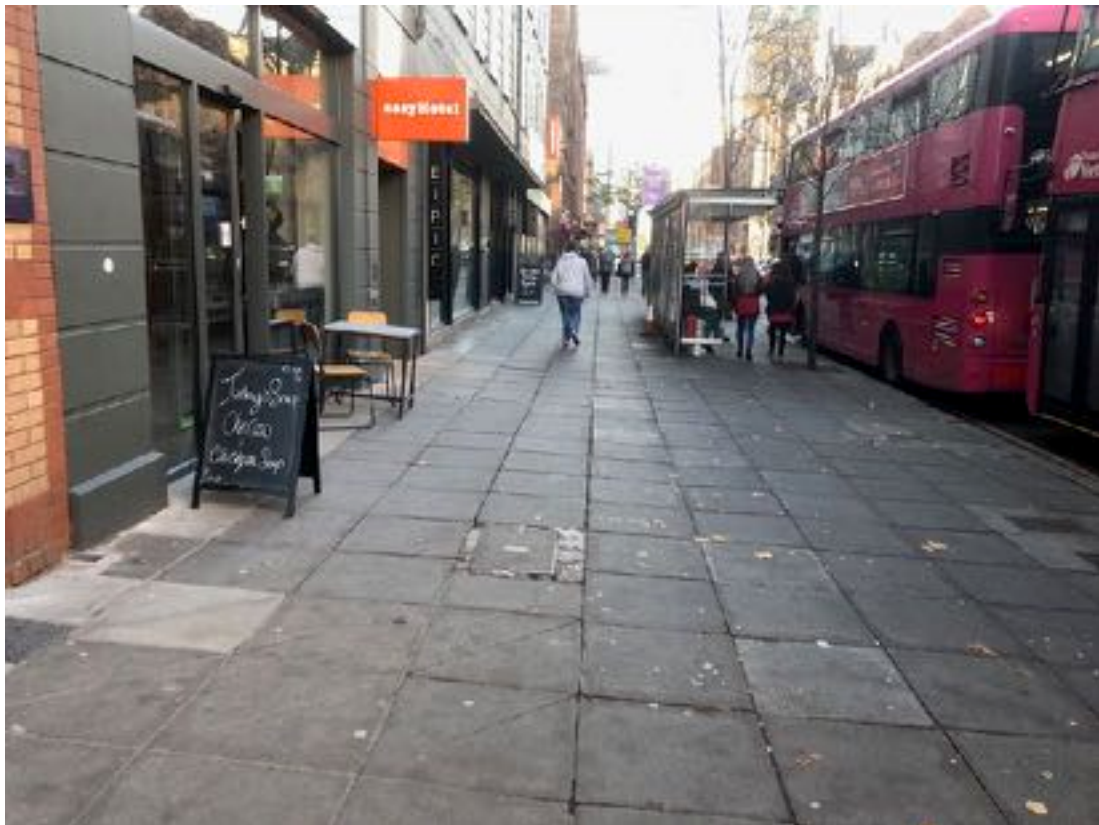
The very broad footway between Brunswick Street and Bedford Street is narrowed by bus shelters, a series of A-Boards and a pavement cafe.

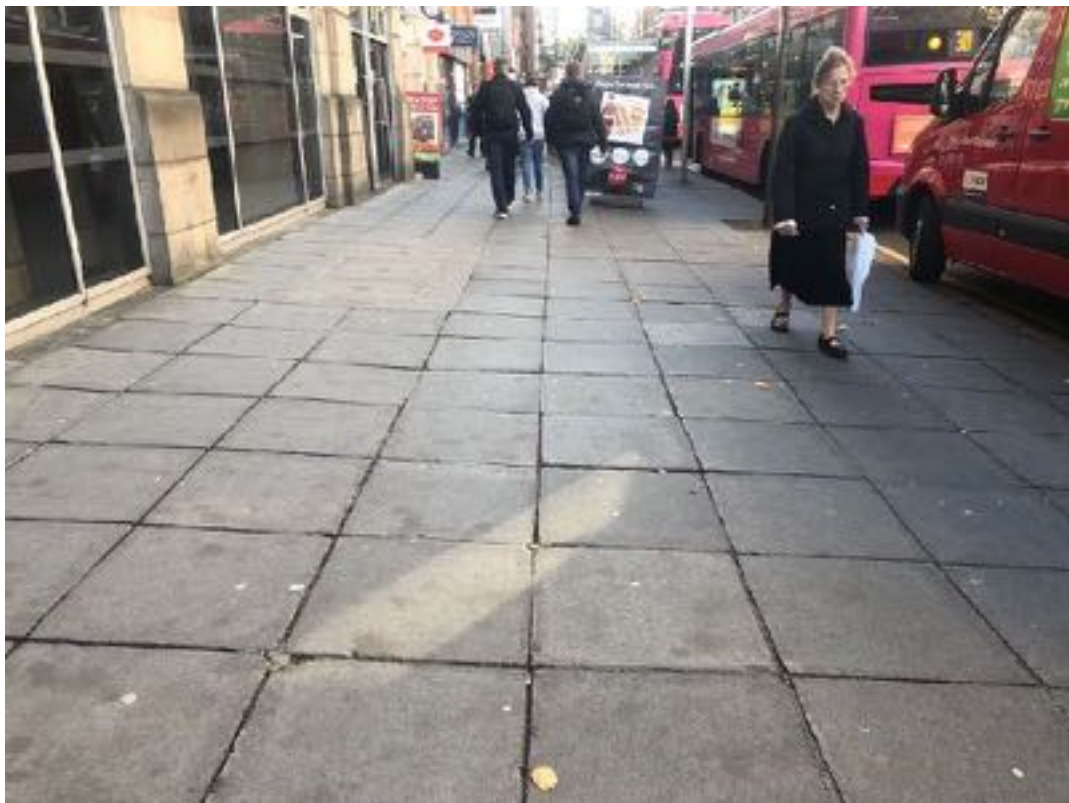
Large A-Boards continue to obstruct the footway approaching the junction with Bedford Street.

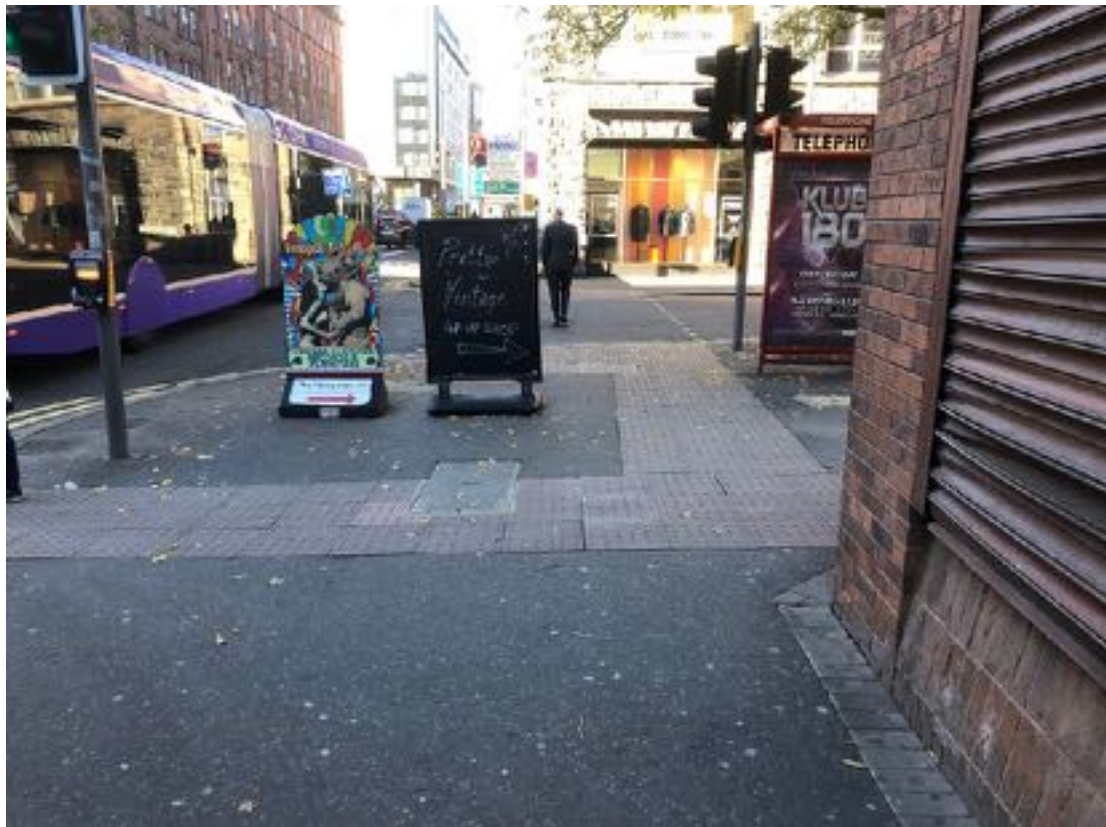
Large A-Boards obstruct the controlled crossing across the junction with Upper Queen Street.

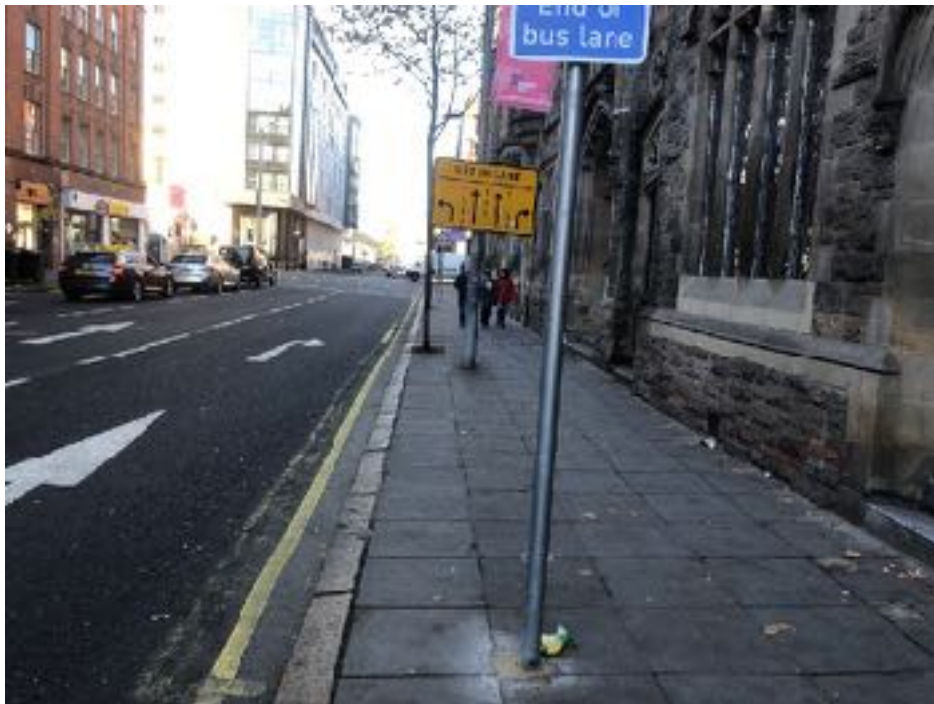
Poles associated with a myriad of traffic signage obstruct the footway approaching the junction with College Square East. Deep dish drainage channels are also an issue.

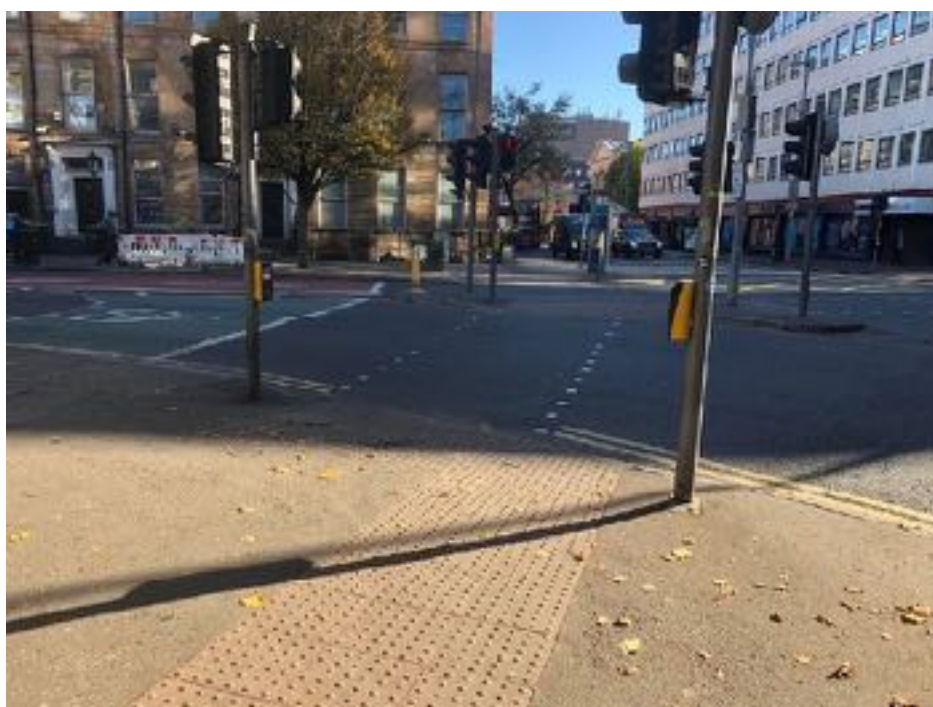
There is series of controlled crossings across Donegall Square South at its junction with Adelaide Street and Donegall Square East. Access to Donegall Square East and the northern footway on Donegall Square South is via a small triangular traffic island, the design of which is confusing for some users. The positioning of a CCTV column is particularly problematic.

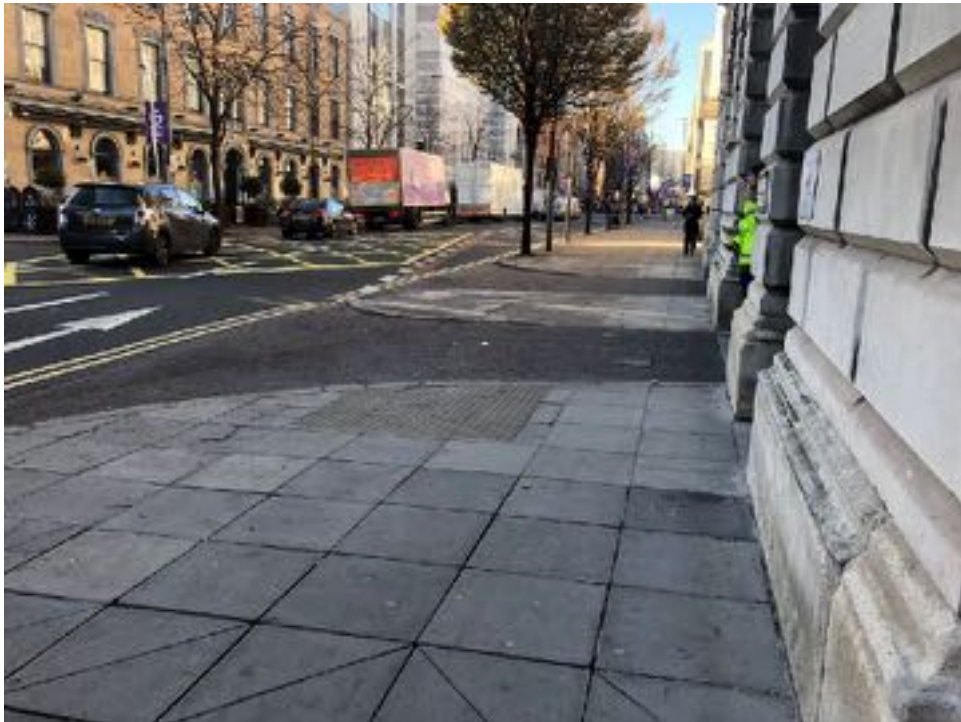
There are two vehicle entrances to the back of City Hall. Although long sections of the entrance kerbing are flush only partial tactile paving has been provided.

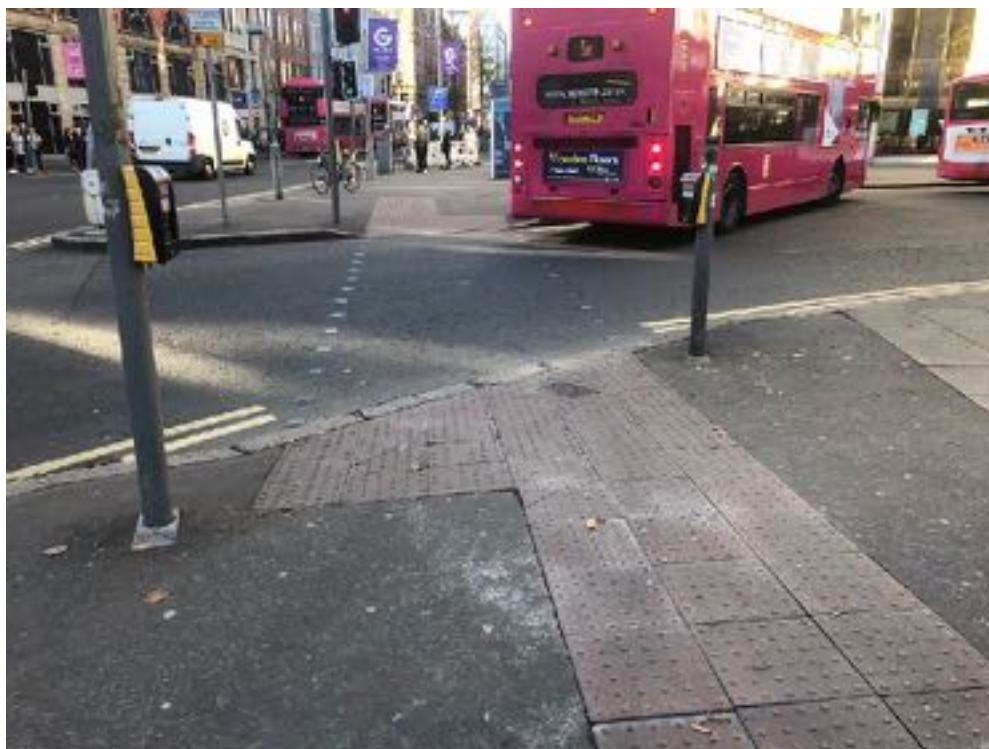
There is a controlled crossing across Donegall Square West. Tactile paving is loose and uneven in places. Clutter is an issue on the western side of the crossing.

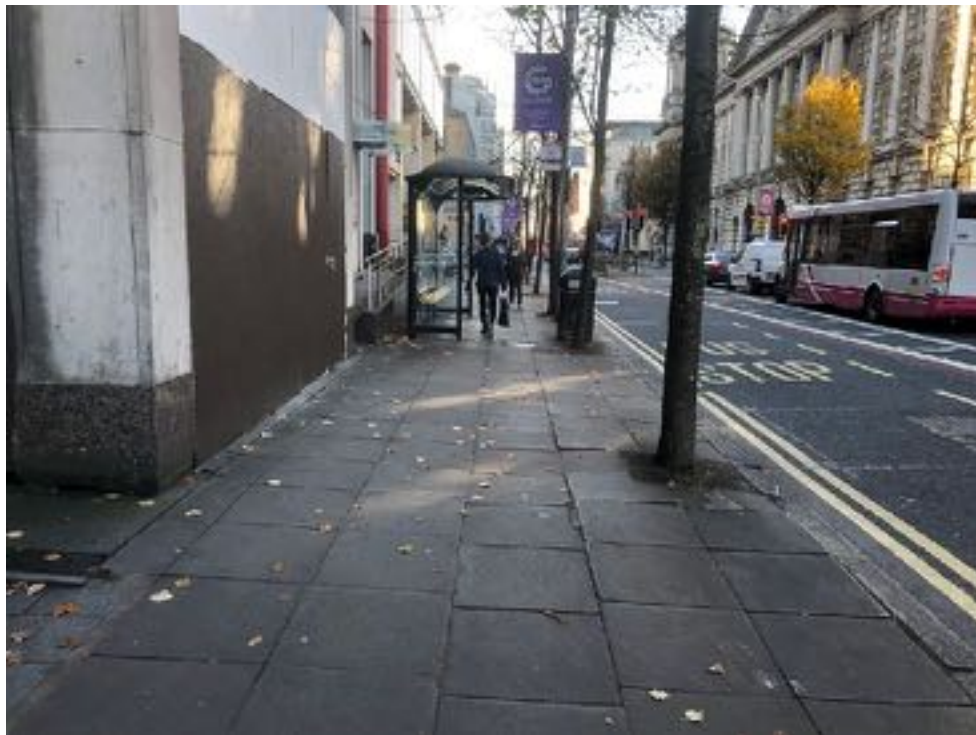
The remaining section of footway between Linenhall Street and Adelaide Street is uneven. A bus shelter significantly reduces available width.

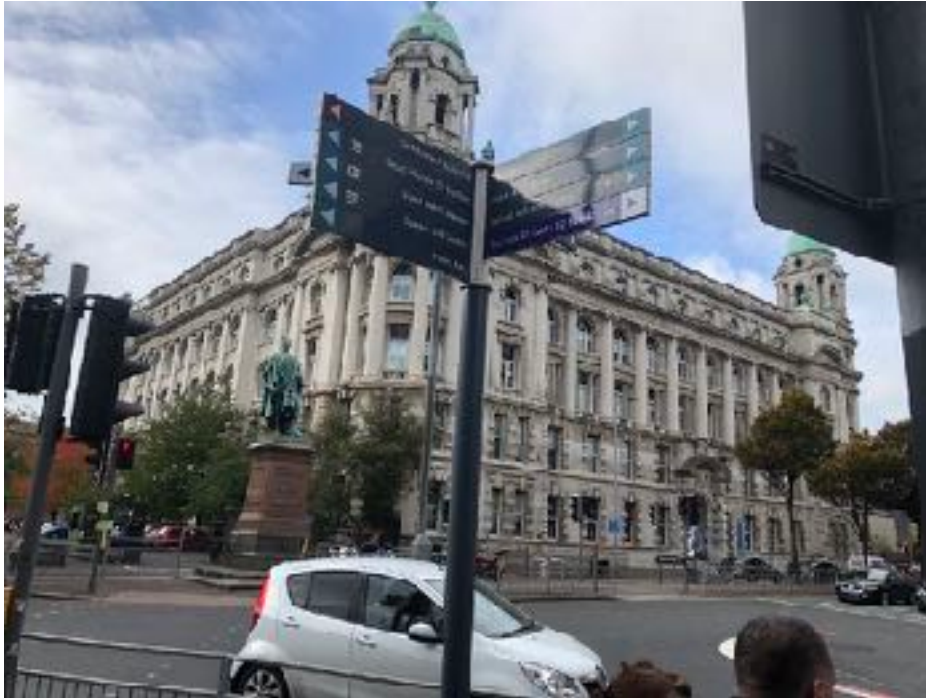
Distinctive wayfinding signage has been installed by Belfast City Council across all the street audited. Signage includes finger directional signs and site specific information and a combination of both.

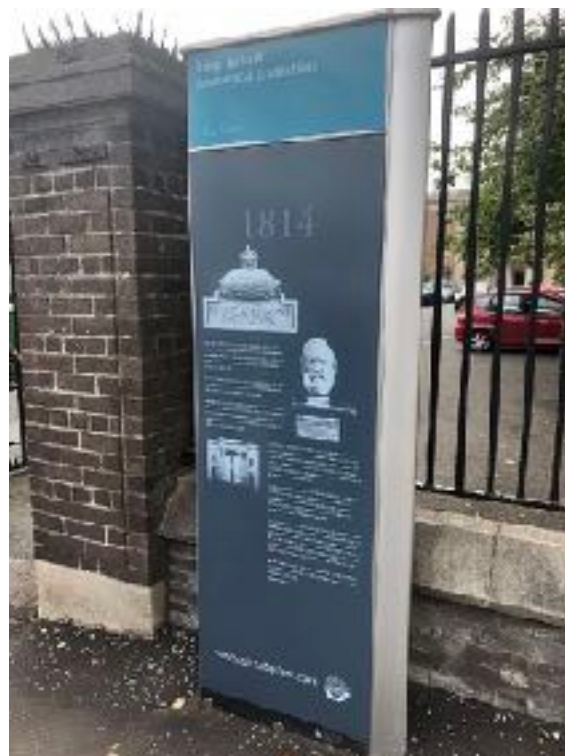
Participants in the audits felt that much of the directional signage was too high and the volume of information too much to be useful. No participants understood the relevance of the different coloured arrows used in signage.

Participants found the design of information signage problematic. The size of text used and the lack of good contrast between the writing, images and background made the information difficult to read.

Finally none of the participants found the current provision of wayfinding and information signage useful. This was largely due to design issues including the text size use and the lack of contrasting colours. It is important that Streets Ahead Phase 5 gives consideration to making signage and wayfinding in the city centre more inclusive.
