Walking Routes in Belfast City Centre - an update

February 2013

# About this paper

Since the previous audit there have been significant changes to the pedestrian environment in Belfast City Centre arising out of the Belfast on the Move project. A further audit was undertaken in October 2012 to identify whether progress has been made in reducing barriers identified by the previous report.

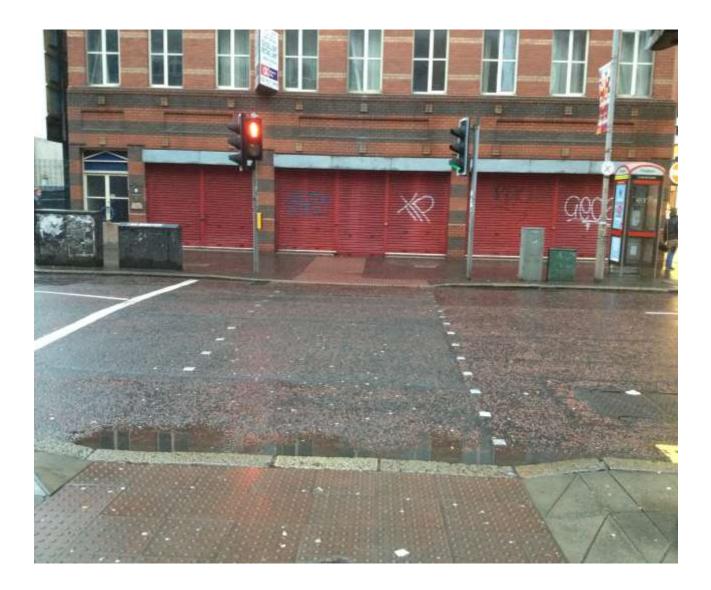
26 <u>Issue</u> - A dish drainage channel obstructs the in line crossing at the junction of Chichester Street and William Street South.

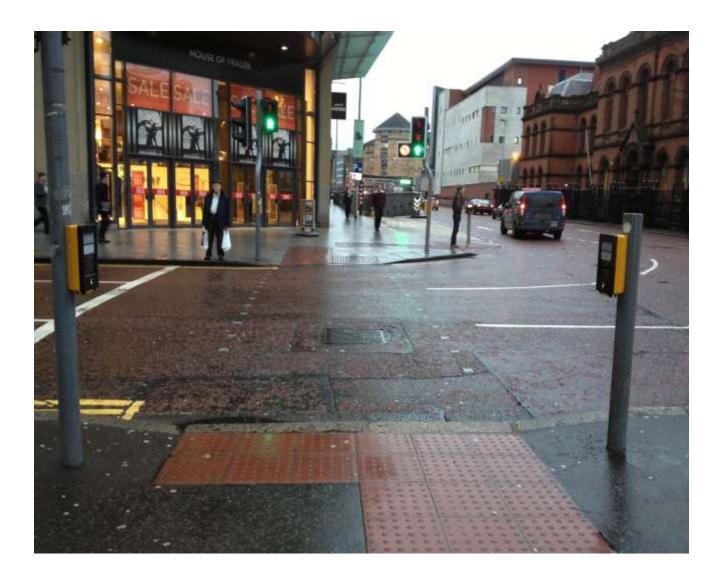
30 <u>Issue</u> - The controlled crossing on Victoria Street (towards the Law Courts) was good but could benefit from increased capacity.

<u>Progress</u> – The crossing has been improved to a high standard.

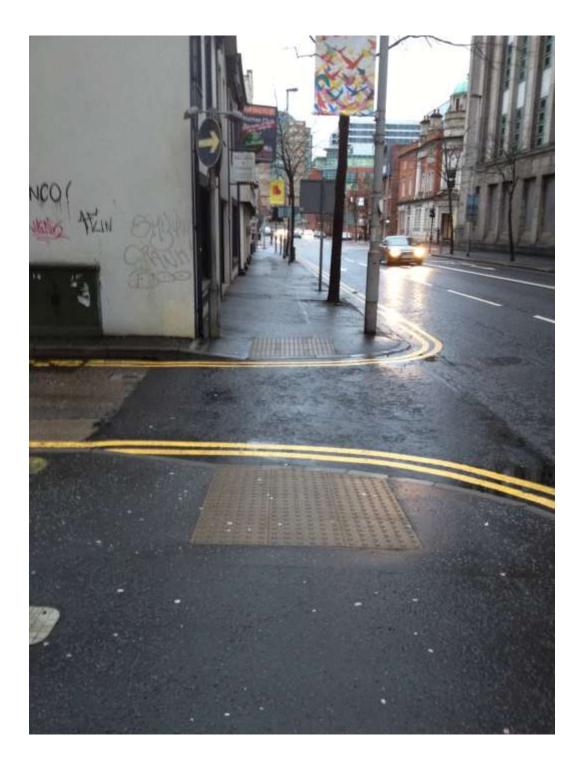
49 <u>Issue</u> - There are a series of vehicle entrances on May Street where no tactile paving has been provided. Pedestrian priority measures could resolve this.

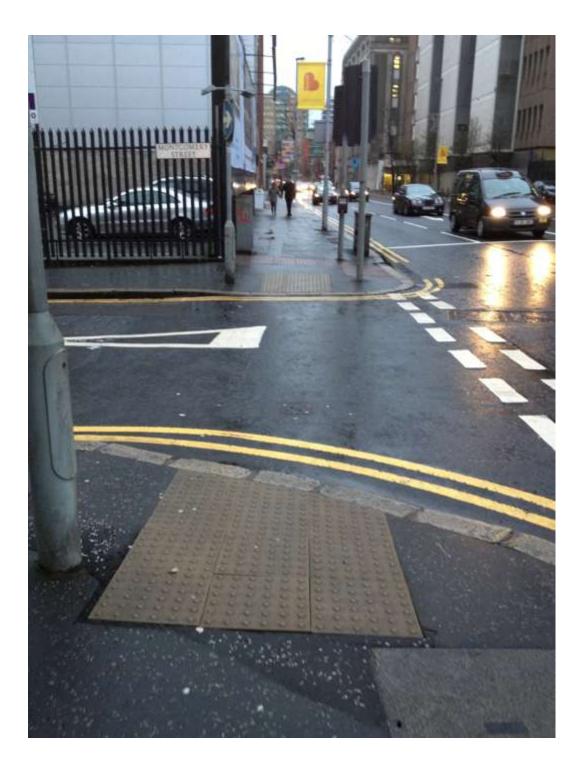
<u>Additional Update</u> - The junction of May Street and Upper Arthur Street/Alfred Street has been upgraded to provide a high quality controlled crossing.

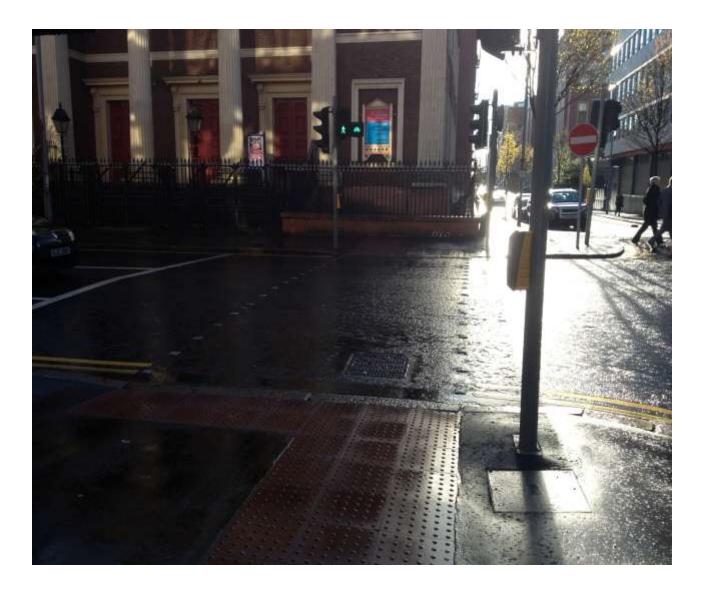
51 There is a good example of a controlled crossing across May Street at the junction of Adelaide Street and Donegall Square East.

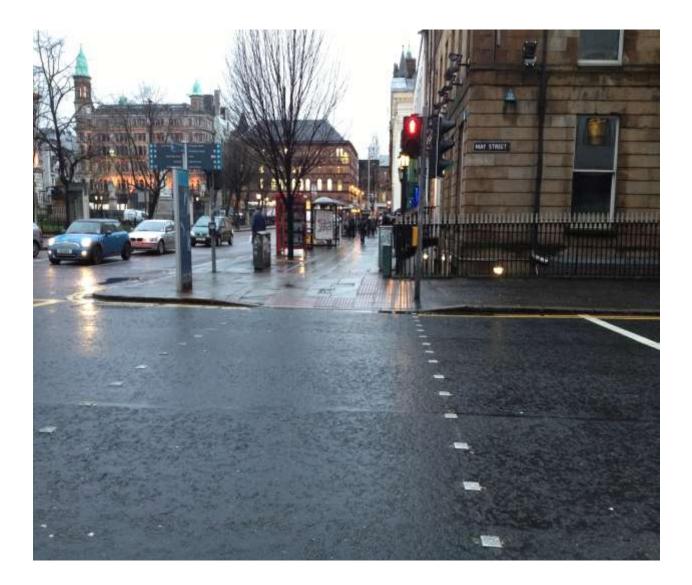
52 Issue -The dropped kerbs on the controlled crossings across Donegall square East are too high and represent a trip hazard.
