Report on Walking routes in Newry City Centre

April 2014

This report is the fifth in a series of reports compiled by Imtac looking at the accessibility of key walking routes for disabled people and older people in town and city centres across Northern Ireland. The report was compiled following an inspection of Newry city centre in December 2013. It considers provision on key pedestrian routes in Newry measured against accepted accessibility standards¹. The report is a snapshot of current provision and seeks to identify potential barriers for disabled people and older people and recommends how these barriers could be resolved. The report also highlights examples of good practice in the city centre. A key aspect of the report is linkage between the pedestrian environment and the bus station in Newry. We have produced two reports, a text only version and a version with photographs used to highlight barriers and good practice.

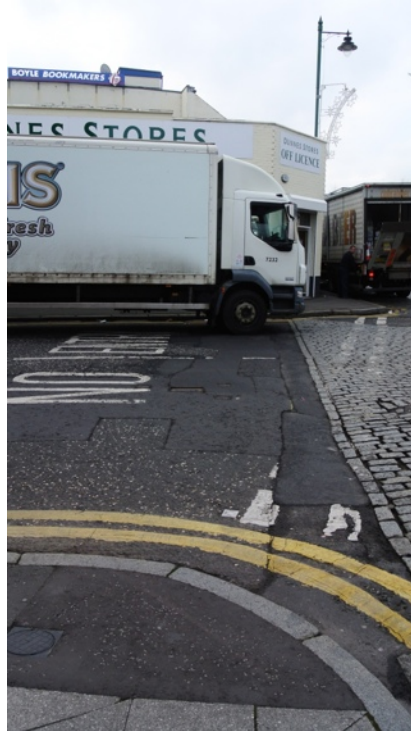
- 15 At the junction of Kildare Street and O'Hagan Street there is no appropriate crossing opportunity for pedestrians. The kerb has been dropped at one side of the junction only with no tactile paving provided. Parked delivery lorries and heavy traffic make this an intimidating junction for all pedestrians.

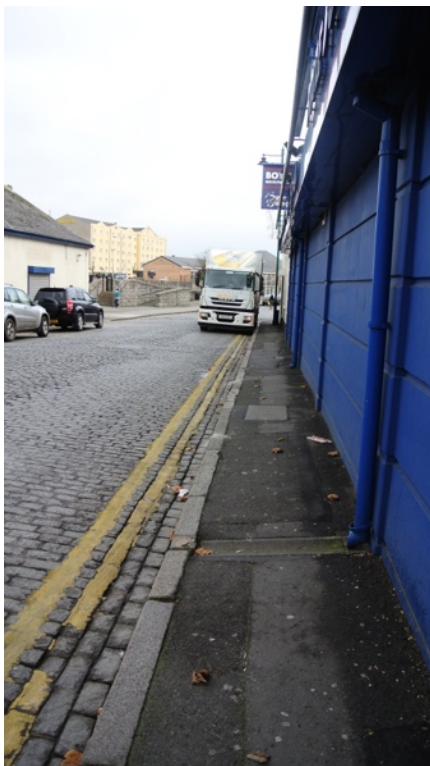
- 16 The pavement narrows considerably on both sides of Kildare Street after the junction with O'Hagan Street. The quality of the walking surfaces is generally poor and obstructions on the pavement are a significant issue.

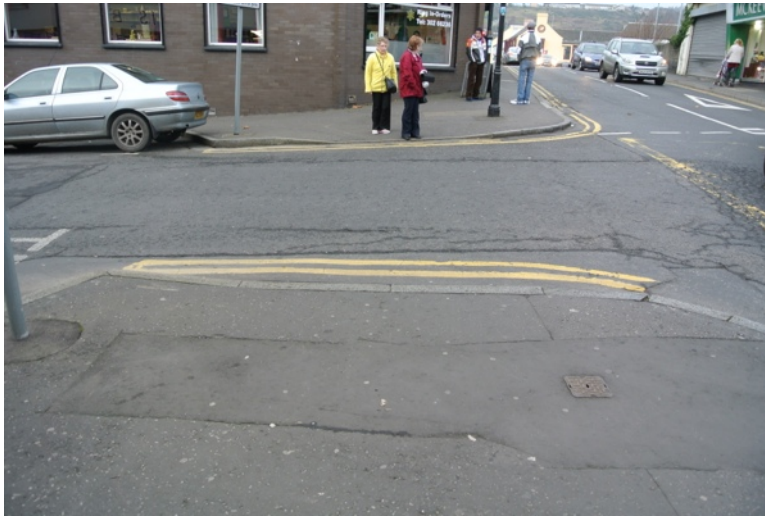
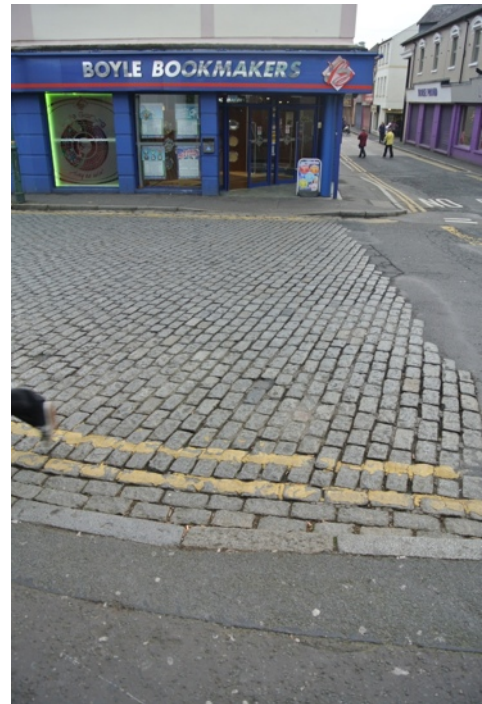
- 17 The junction at Kildare Street, Bridge Street and Mill Street is very busy. In-line Dropped kerbs have been provided across Kildare Street either side of the junction. However no tactile paving has been provided.

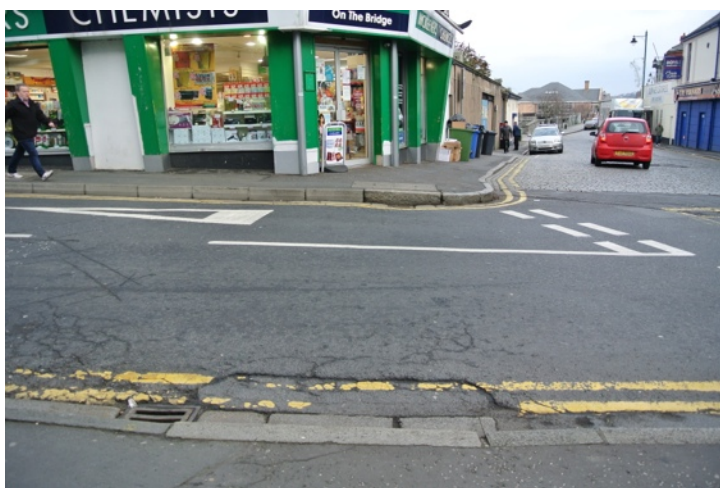
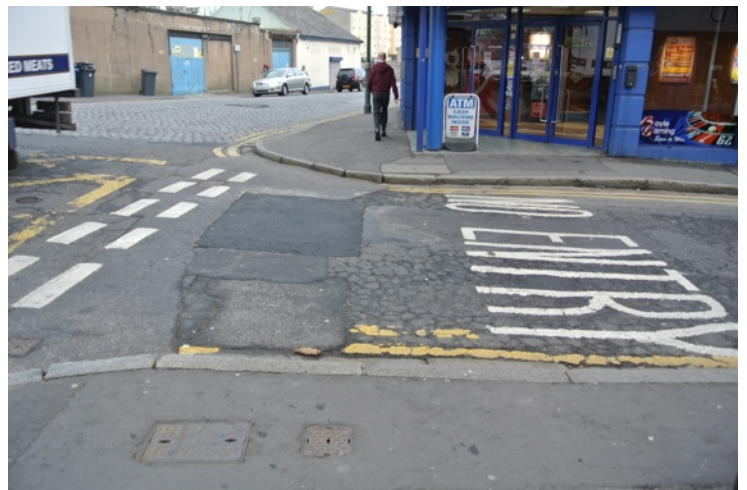
- 18 No dropped kerbs have been provided for pedestrians to cross either Bridge Street and Mill Street at the junction with Kildare Street.

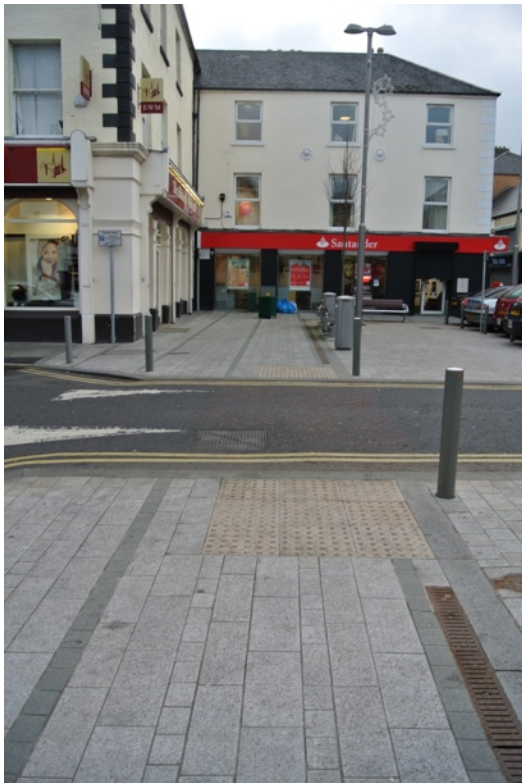
- 21 There are four in-line controlled crossings on the square. These follow good practice in relation to the provision of this type of crossing. However given the “shared” nature of the area consideration should be given to extending the length of the tactile paving at these crossings.

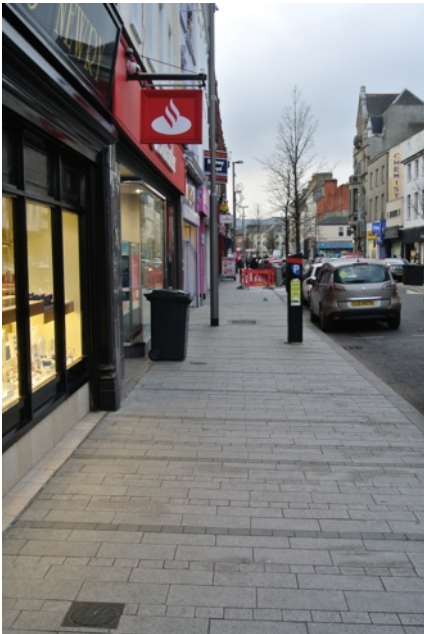
- 23 Proceeding up Hill Street towards Marcus Square the pavement on both sides provides a broad high quality walking surface. The kerb has been reintroduced at this point. There is a lack of consistency in the location of street furniture with parking meters located at the building line and kerb line in different locations.

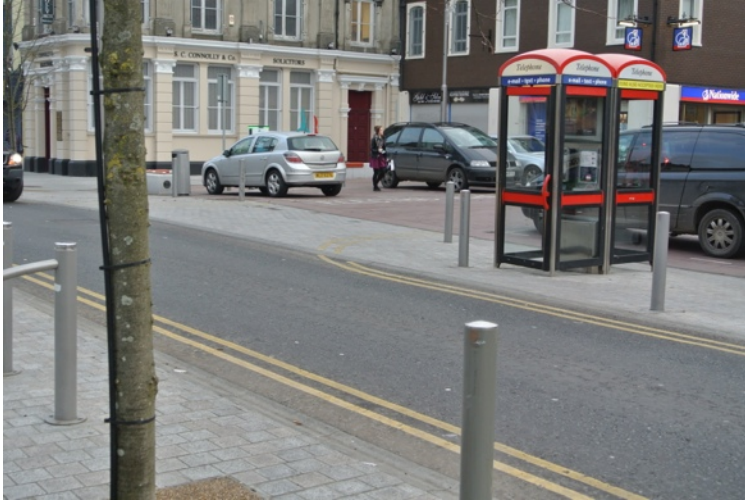
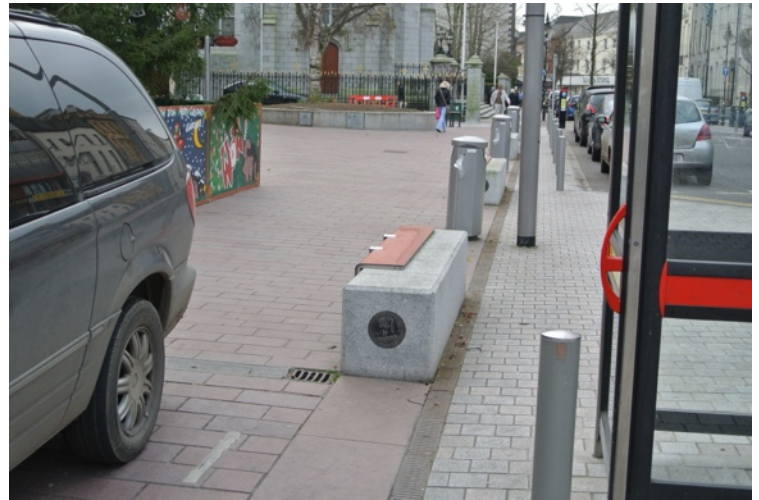
25 Similar shared space design used in Margaret Square has also been used in Marcus Square. There are significant issues with the design particularly on the eastern side of the square where there is no clear and safe route for pedestrians.

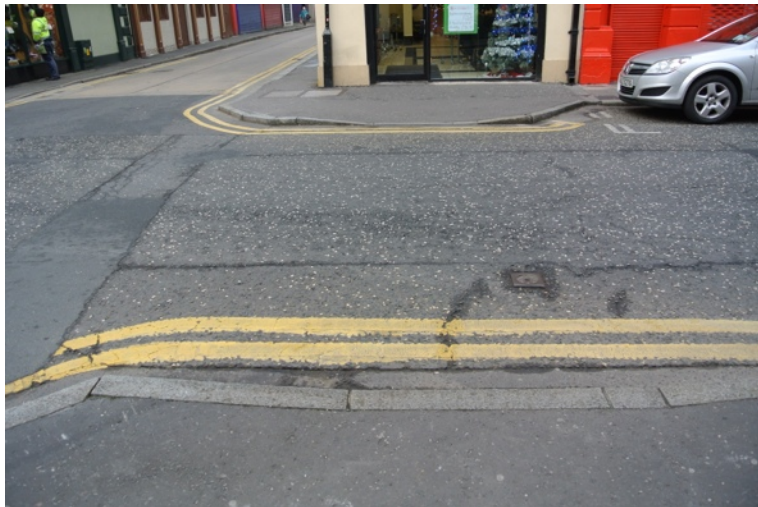
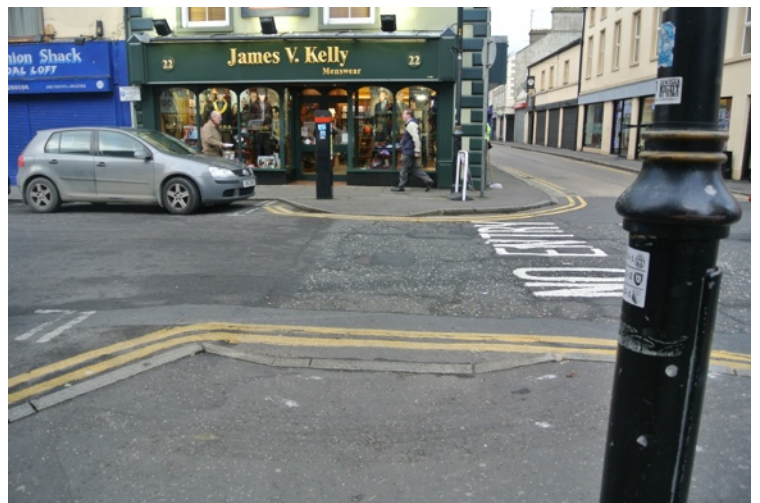
35 Kerbs have been dropped around the junction of Mill Street and Hill Street. Once again tactile paving is not provided.

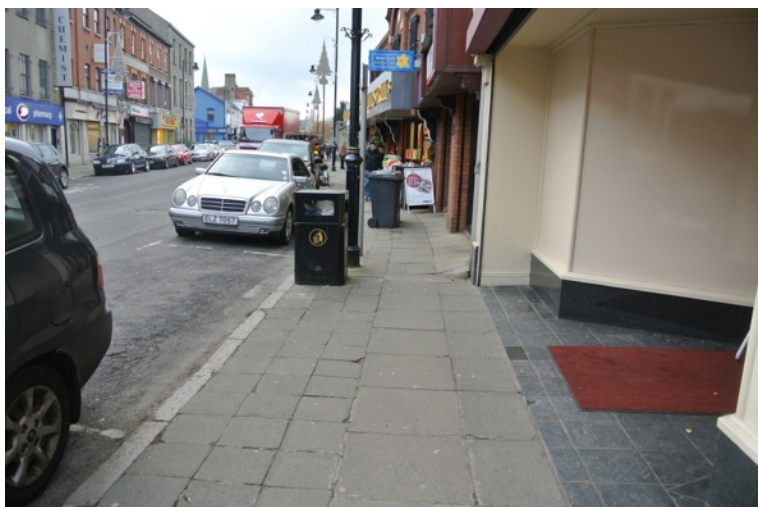
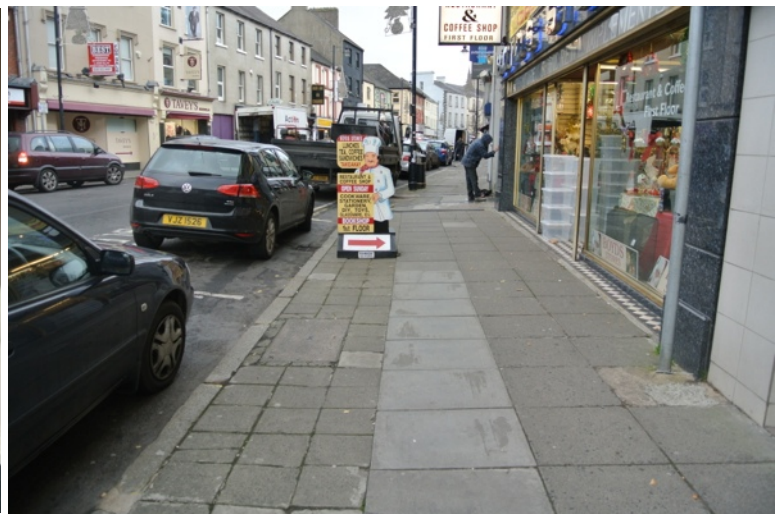
36 Clutter on the pavement including bins, Aboards, shop displays and pavement cafes restrict pavement width in this area of Hill Street.

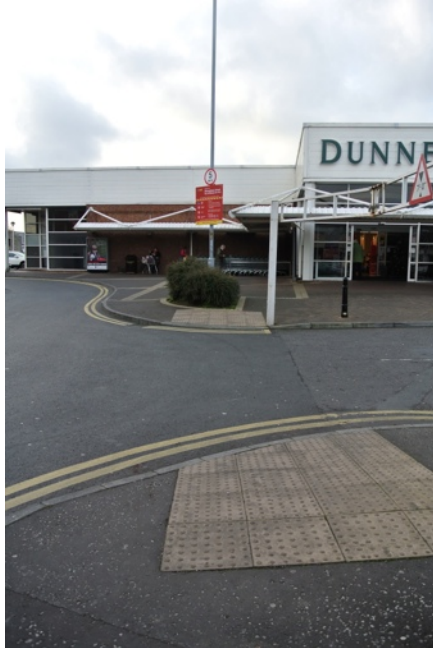
- 45 There is a Roads Service car park just off Monaghan Street close to the retail park. A reasonable in-line uncontrolled crossing has been provided. However on one side this leads pedestrians into bushes.

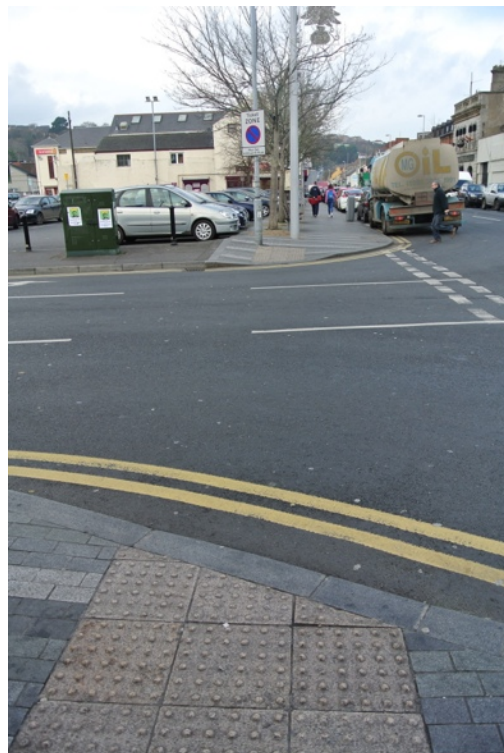
- 46 Monaghan Street has recently been subject of public realm improvements. A reasonable example of an in-line uncontrolled crossing has been provided at the entrance to the retail park. The location of poles at one end does create obstacles.

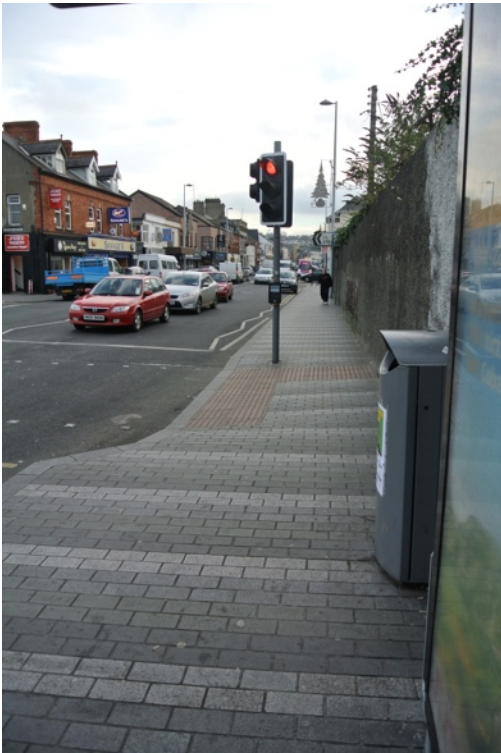
- 49 There is a good example of controlled pedestrian crossing close to the junction with Railway Avenue and Monaghan Street.

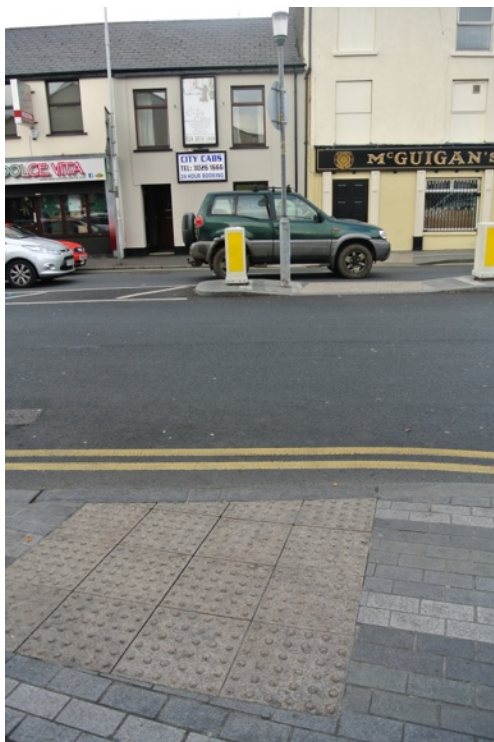
- 51 There is a reasonable in-line uncontrolled crossing at the junction between Monaghan Street and Patrick Street including an island in the middle. Given the traffic levels in the area this junction will present a challenge for some disabled people and older people.

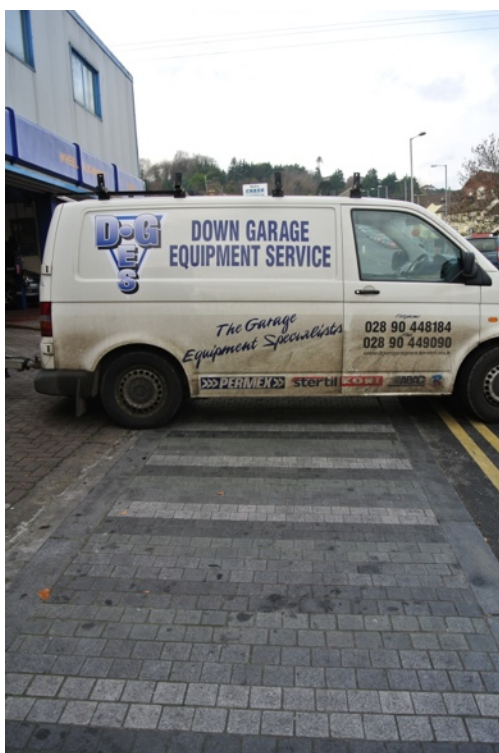
- 52 Close to the roundabout at the western end of Monaghan Street a garage forecourt extends on to the pedestrian area presenting unexpected obstacles.

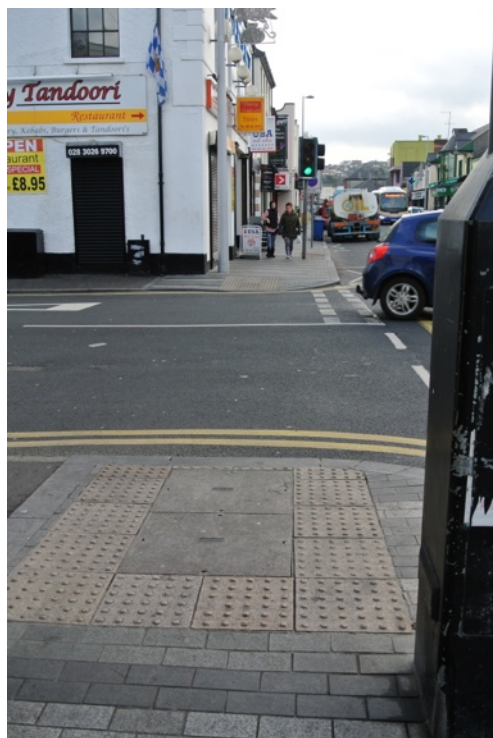
- 58 There is another reasonable example of an in-line uncontrolled crossing at the junction with Kilmorey Street. The utility covers do have the potential to minimise the impact of tactile on the western end of the junction.

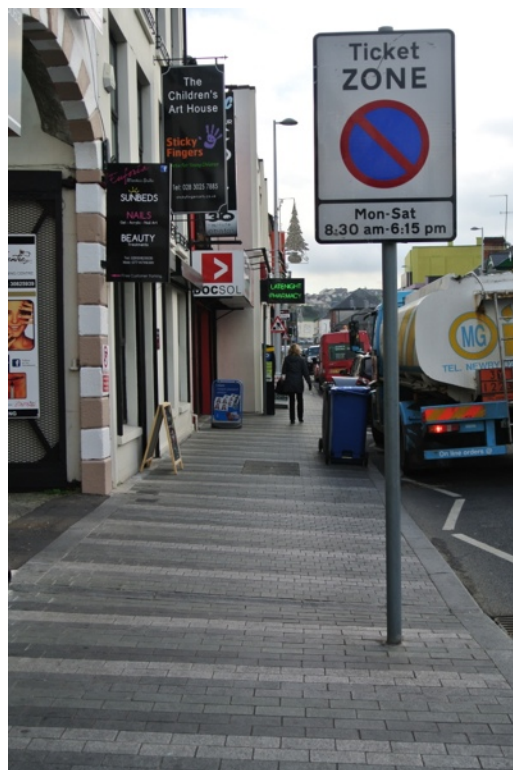
- 60 The northern pavement narrows as it approaches the junction with Merchants Quay. Clutter on the pavement restricts pavement width further and creates obstacles.

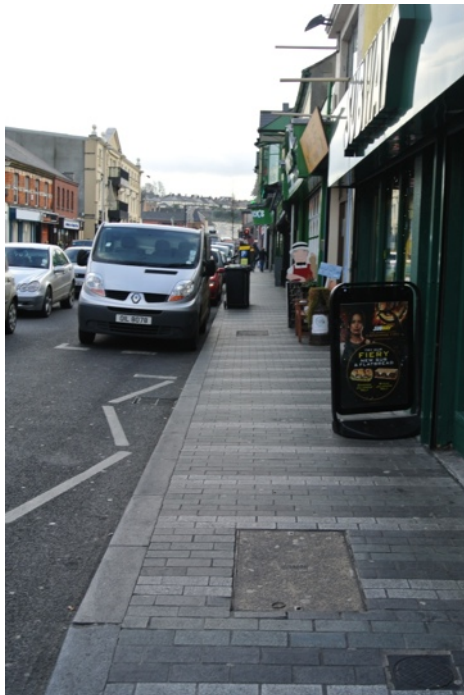
- 61 The problems with clutter are worse on the southern section of pavement in the same location.

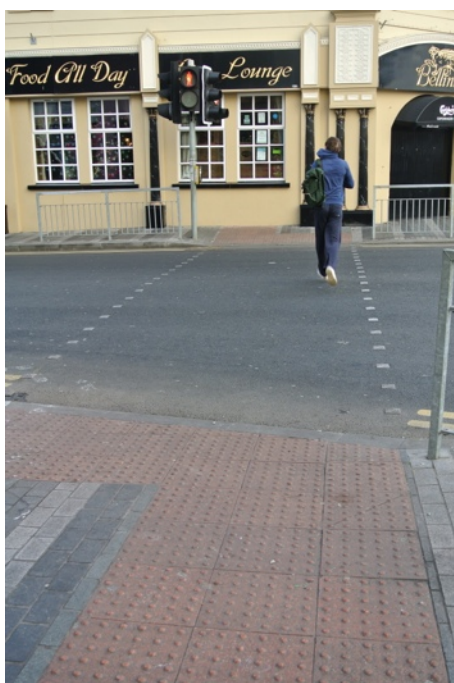
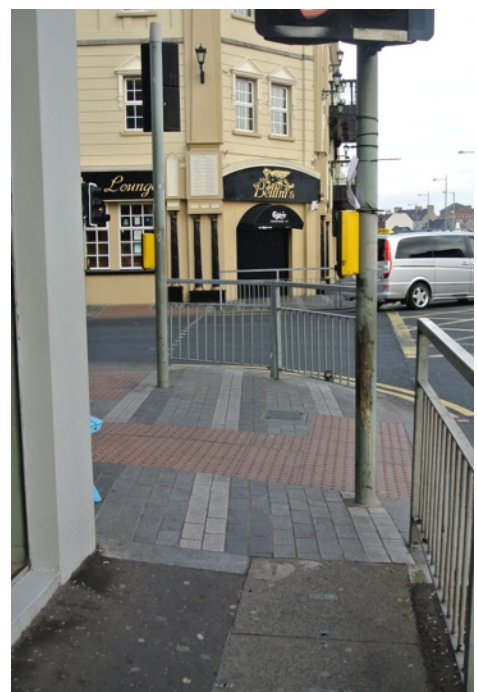
- 62 The junction with Monaghan Street, Merchant Quay and Margaret Street is heavily trafficked. There is a controlled crossing across Monaghan Street which is reasonable apart from the signals not having rotating tactile cones.

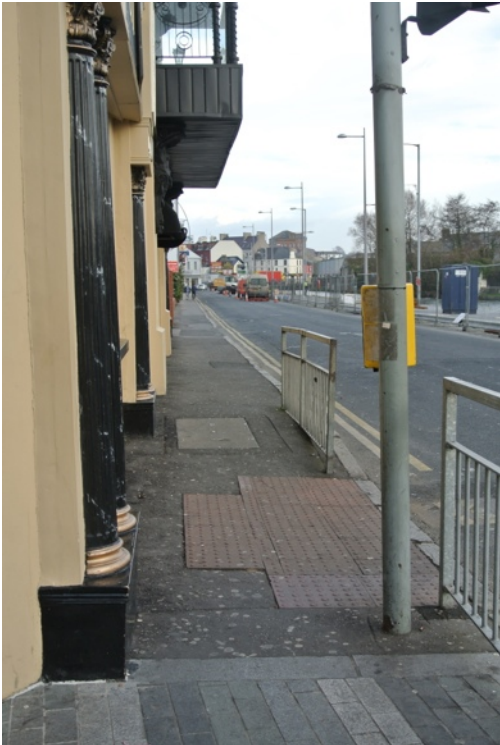
- 63 There are further controlled crossings across Merchant Quay and across Margaret Street. The provision at these crossings is very poor with inappropriate use of tactile paving, poor locations for control boxes and no rotating tactile cones. There are public realm improvements in the vicinity so it would be hoped that problems with the pedestrian facilities will be addressed.

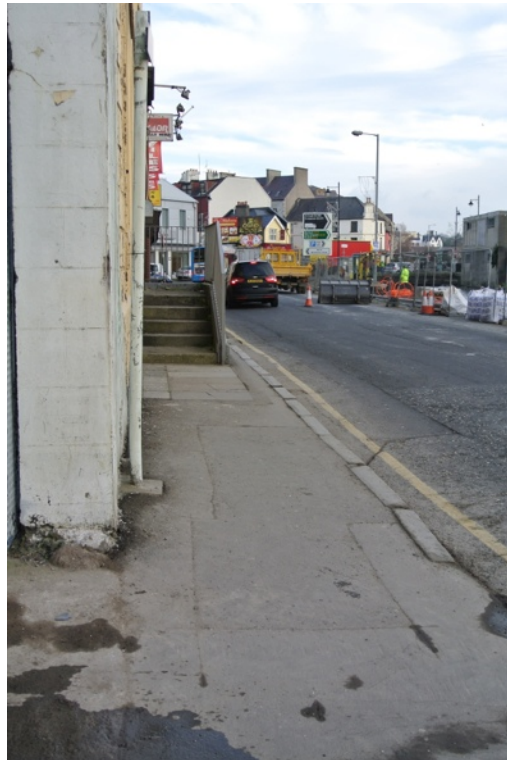
- 66 The frontage of buildings extend into the pavement in one location forcing pedestrians into the road.

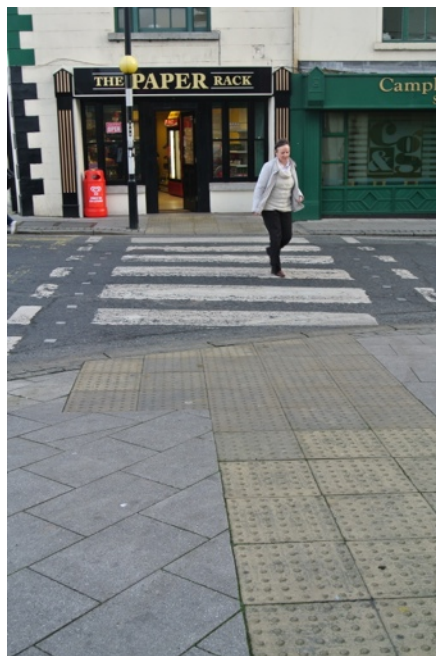
- 71 There is a controlled zebra crossing at this point across Sugar Island. The wrong colour tactile paving has been laid.

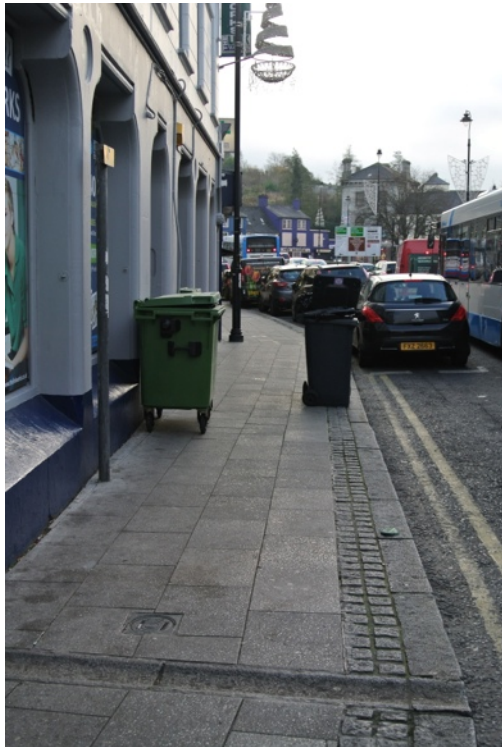
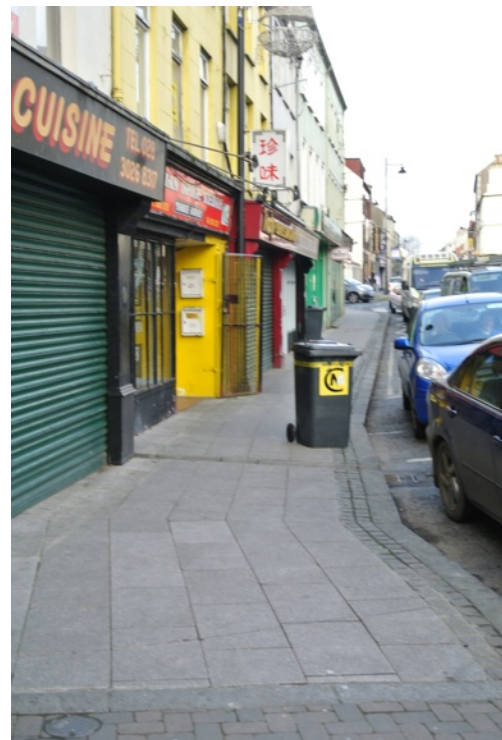
- 72 Bins and other clutter obstruct what is already a narrow pavement on both sides of the road.
